BUFORD MIDDLE SCHOOL
1000 CHERRY AVENUE
CHARLOTTESVILLE, VIRGINIA

ECS PROJECT NO. 46:6713

CITY OF CHARLOTTESVILLE - FACILITIES DEVELOPMENT

Reference: Facility Condition Assessment Report for Buford Middle School, 1000 Cherry Avenue,
Charlottesville, Virginia

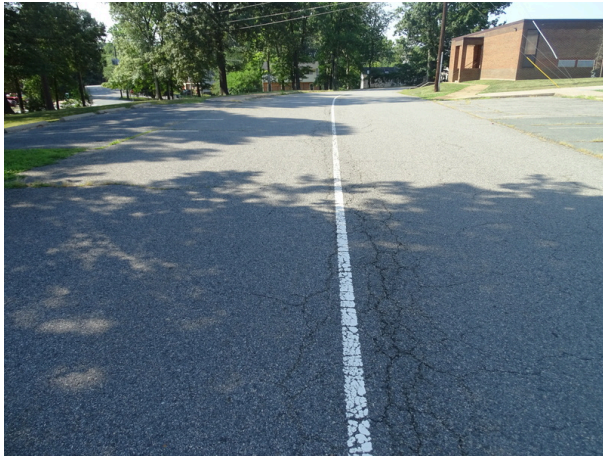
Asphalt-paved drive lanes and parking areas are located on the north and south side of the site which also provides access to the site. Additional parking is provided along the southern drive lane. The asphalt pavement was observed to be in generally good to fair condition with minor cracks observed on the pavement. Striping was in fair condition. The expected useful life of asphalt pavement is 20 years. We have provided allowances to repair the cracked areas of asphalt pavement.

Asphalt pavements east side of the site drive
lane - note cracking

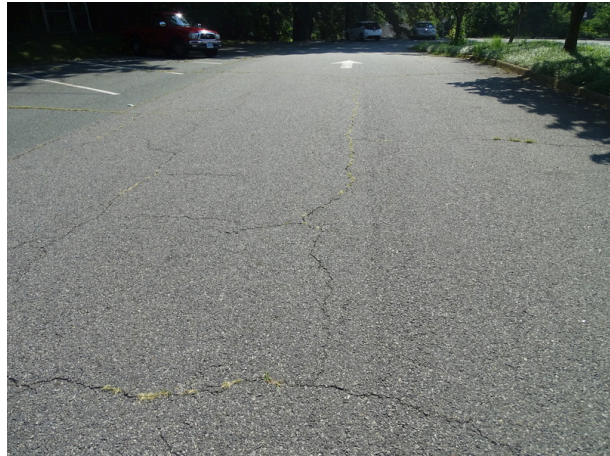
Asphalt pavements - note alligator cracks

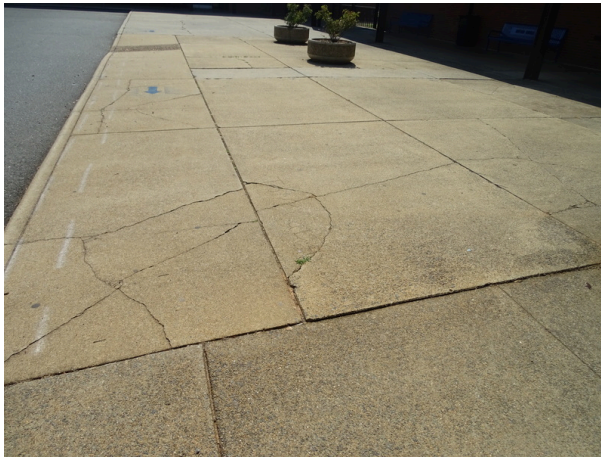
Concrete sidewalk west side of Building B - note cracking

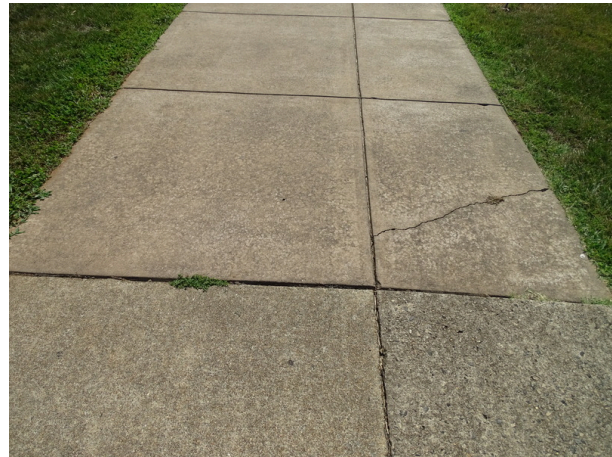
Typical concrete sidewalk - note cracking

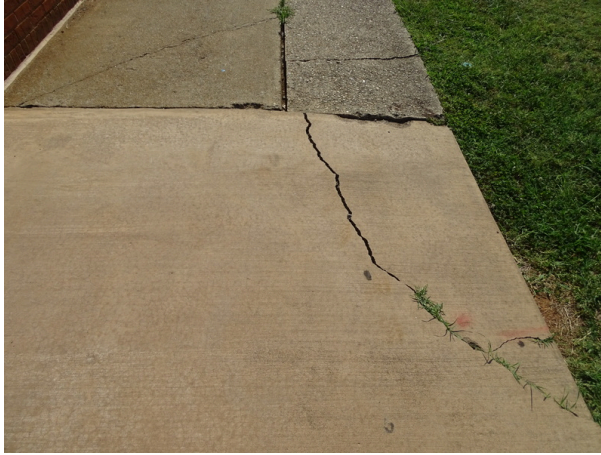
Typical concrete sidewalk - note deterioration

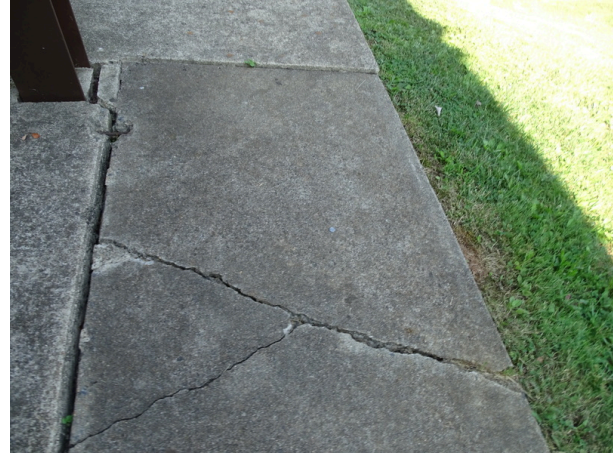
Typical concrete sidewalk - note cracking

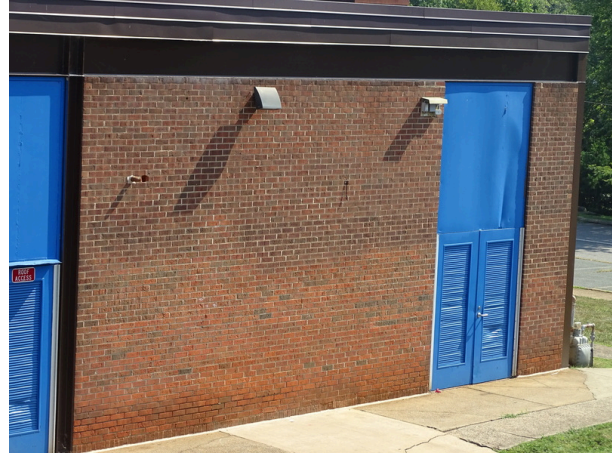
Building exterior - note deterioration

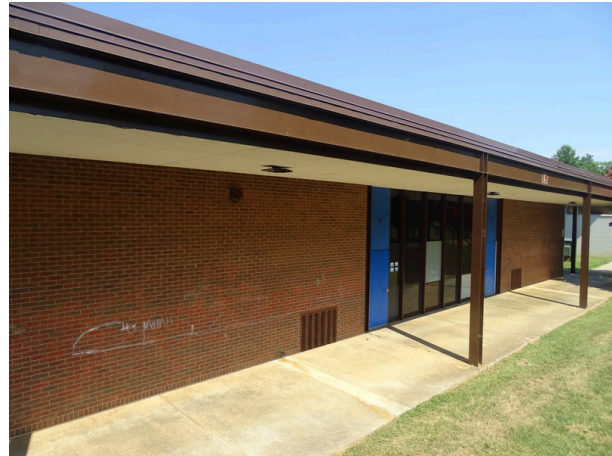
Building exterior - note need cleaning

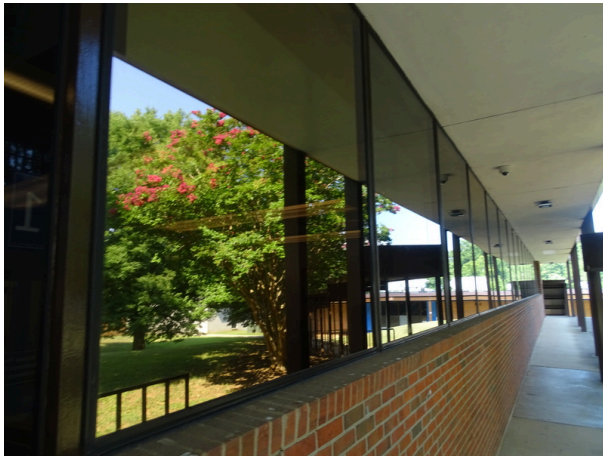
Older exterior windows - note reportedly wide temperature fluctuation in offices

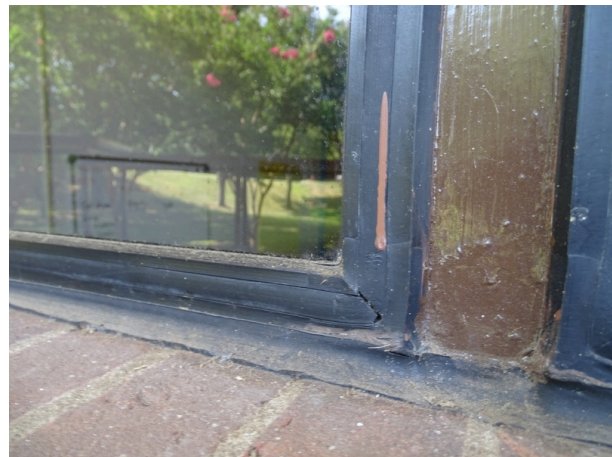
Typical exterior window - note gasket deterioration

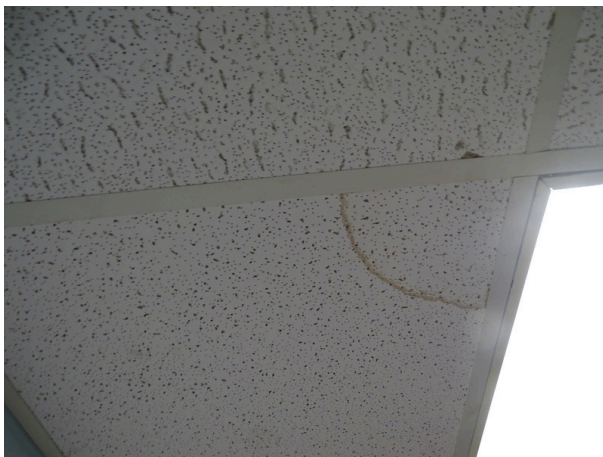
Typical interior ceiling - note water leakage

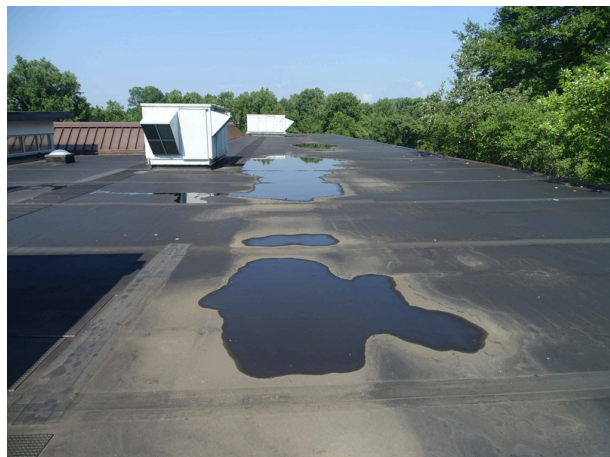
Single-ply roofing system - note ponding

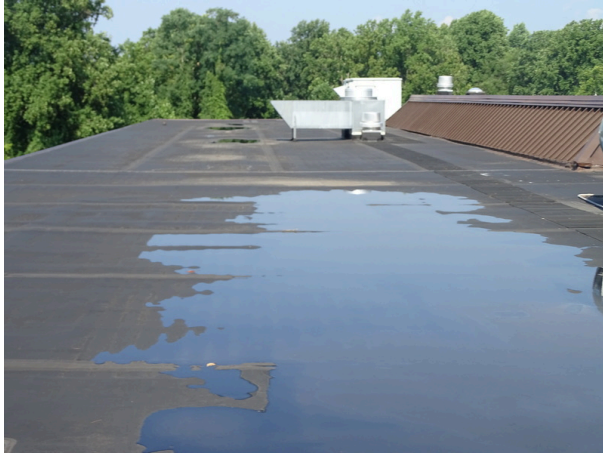
Single-ply roofing system - note ponding

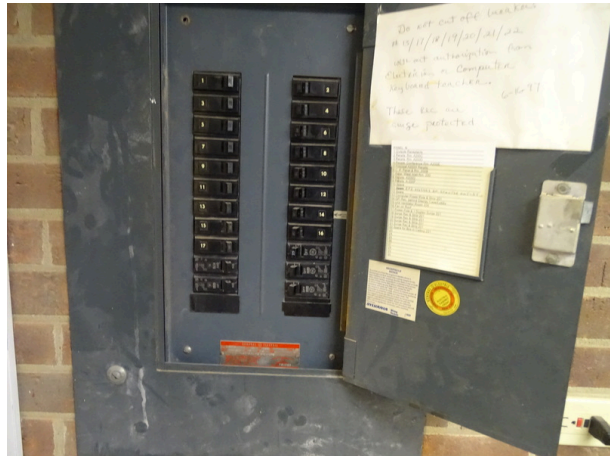
Power is distributed by copper wire from circuit breaker panels located throughout the building. The expected useful life of sub-panels is 50 years with proper maintenance. Some of the the circuit breaker panels were reportedly recently replaced. The circuit breaker panels were observed to be in generally good to fair condition. We recommend replacing the remainder of the older circuit breaker panels.

Typical older electrical circuit breaker panel

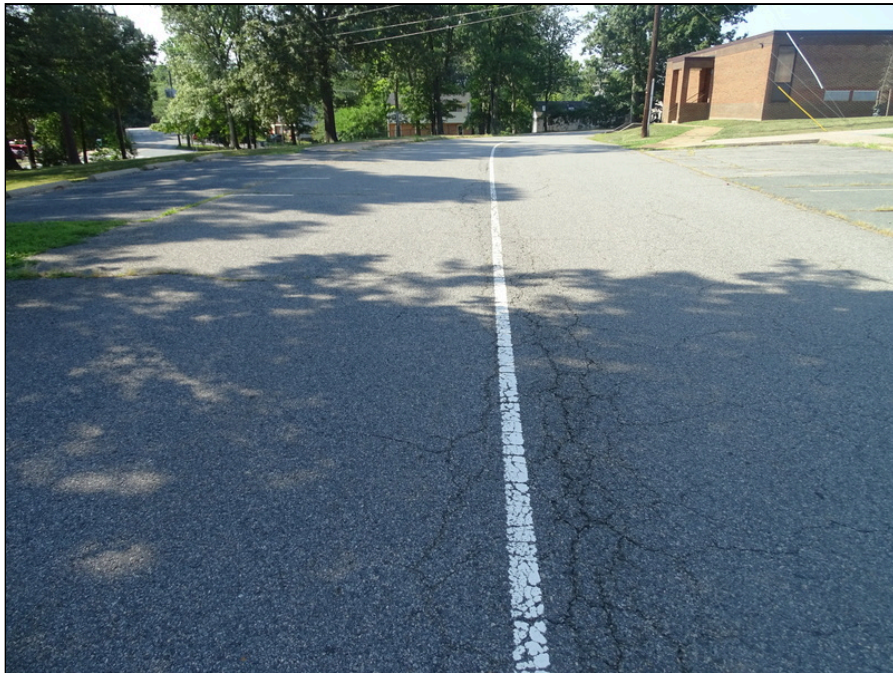
4 - Asphalt pavements east side of the site drive lane - note cracking

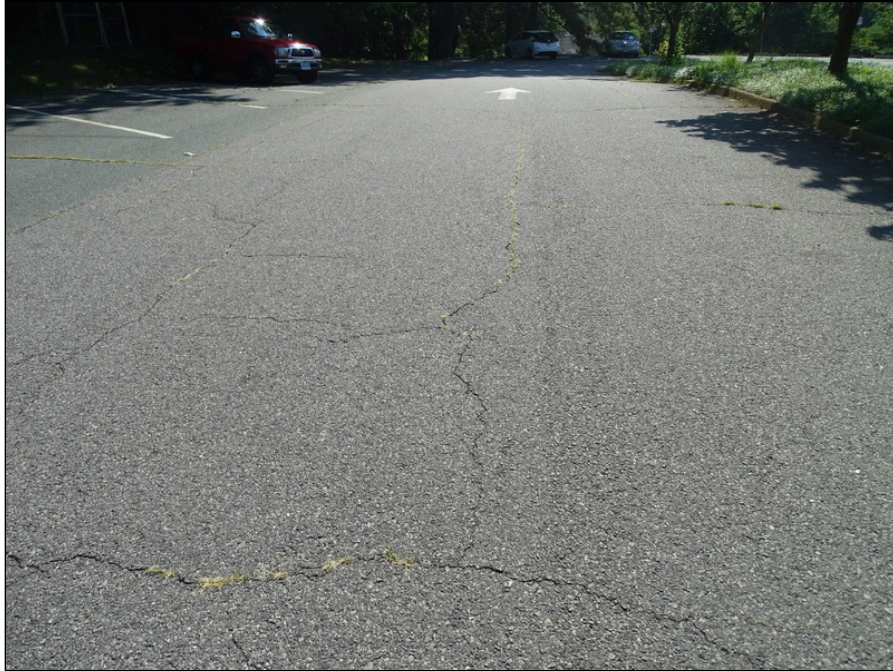
5 - Asphalt pavements - note alligator cracks

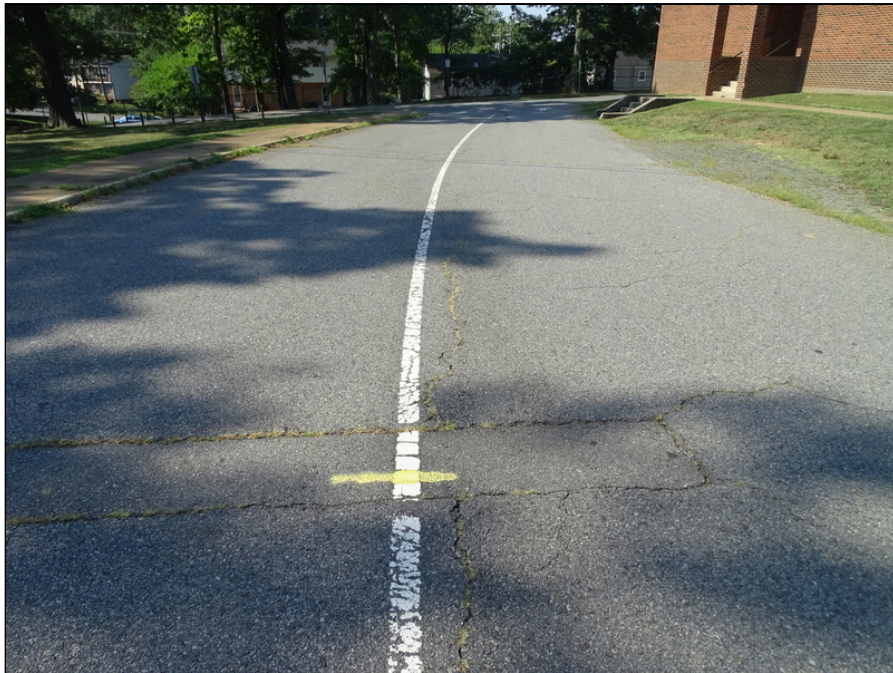
6 - Asphalt pavements east side of the site drive lane - note cracking and previous repair

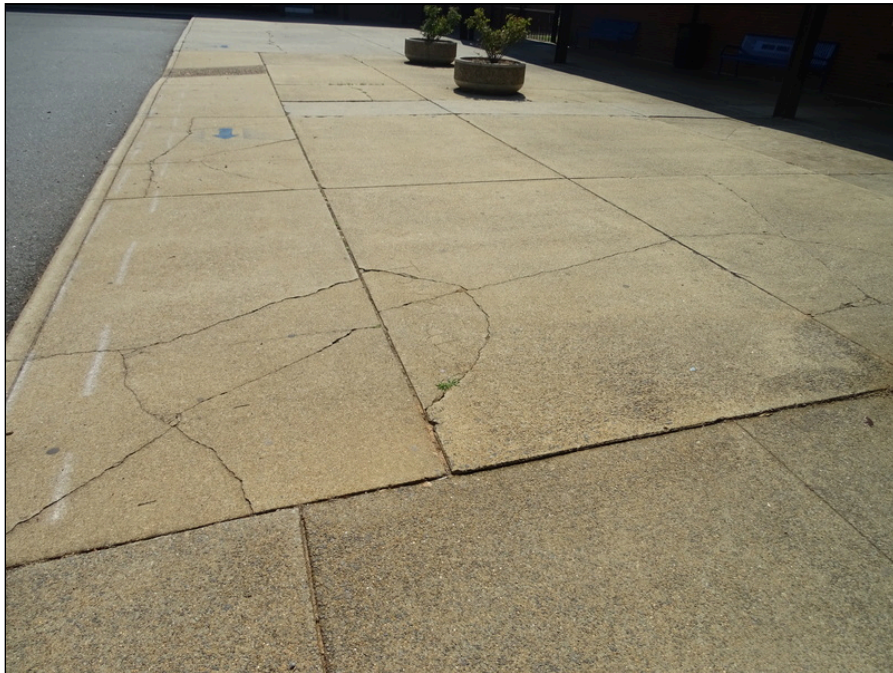
8 - Concrete sidewalk west side of Building B - note cracking

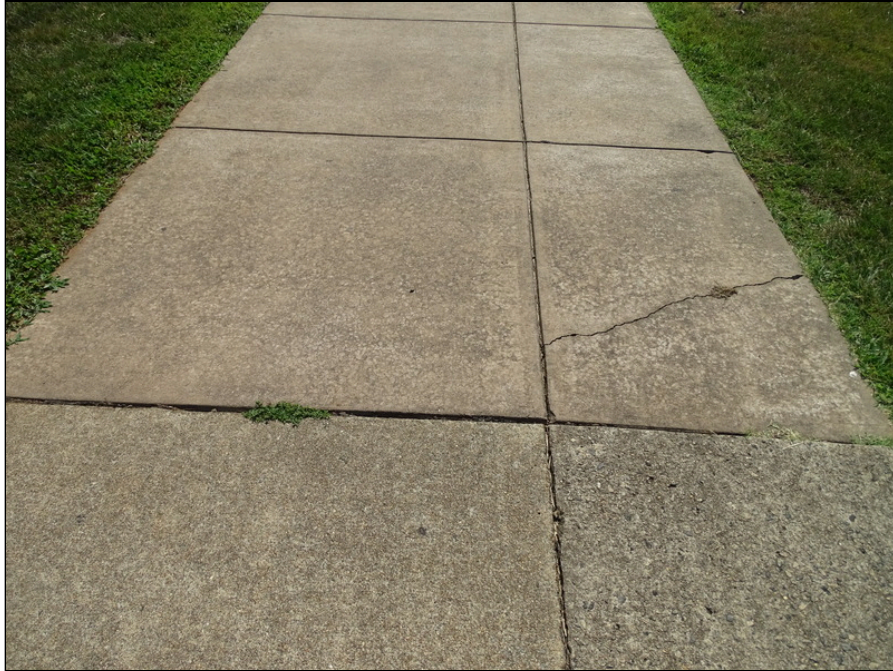
9 - Typical concrete sidewalk - note cracking

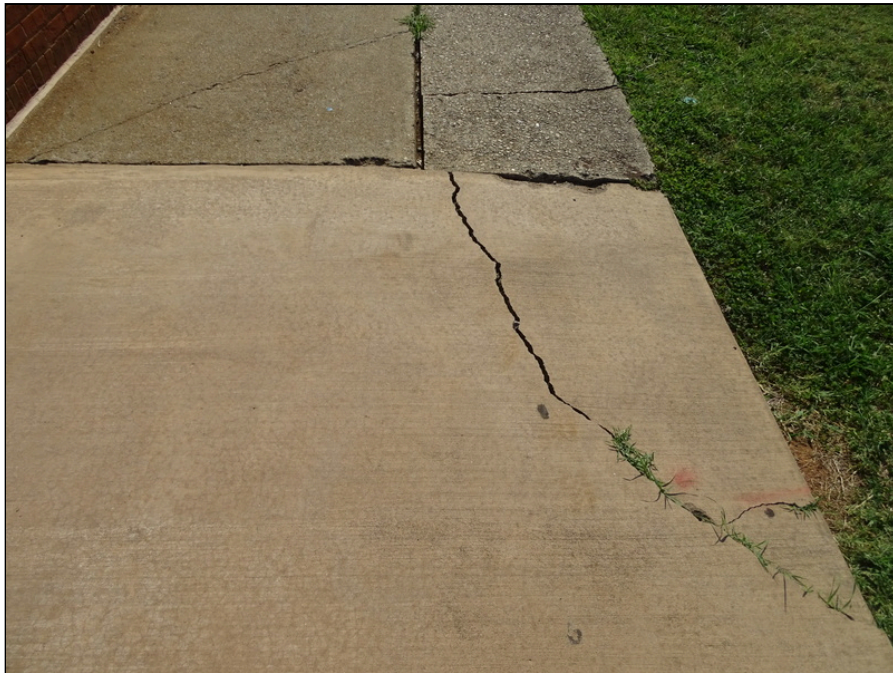
10 - Typical concrete sidewalk - note deterioration

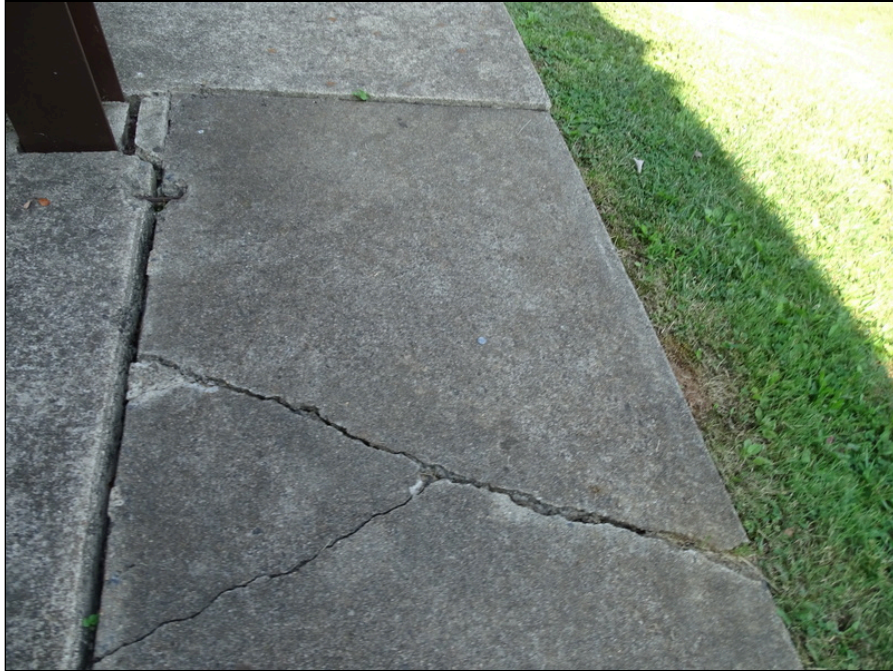
11 - Typical concrete sidewalk - note cracking

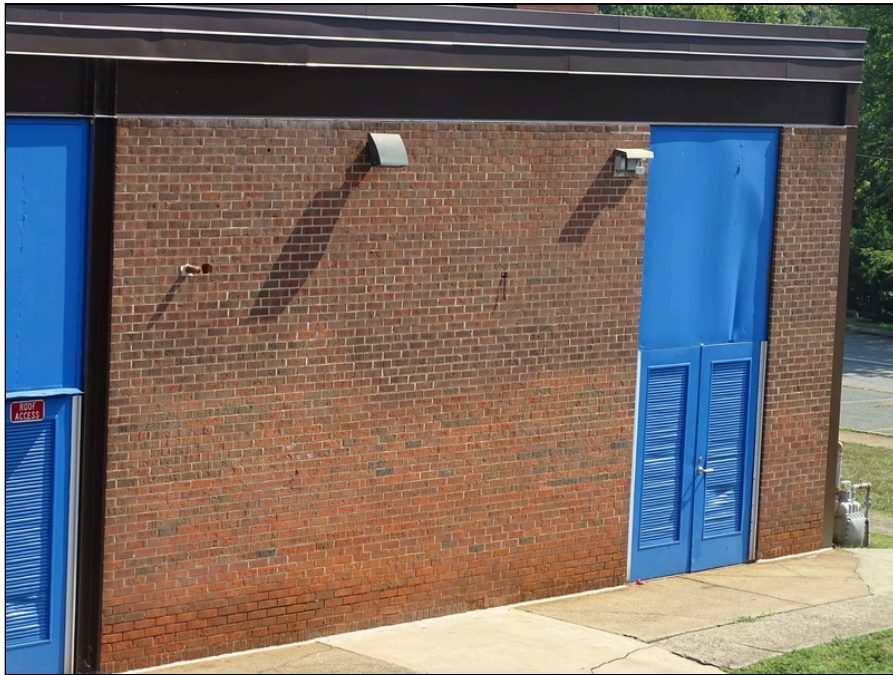
18 - Building exterior - note efflorescence

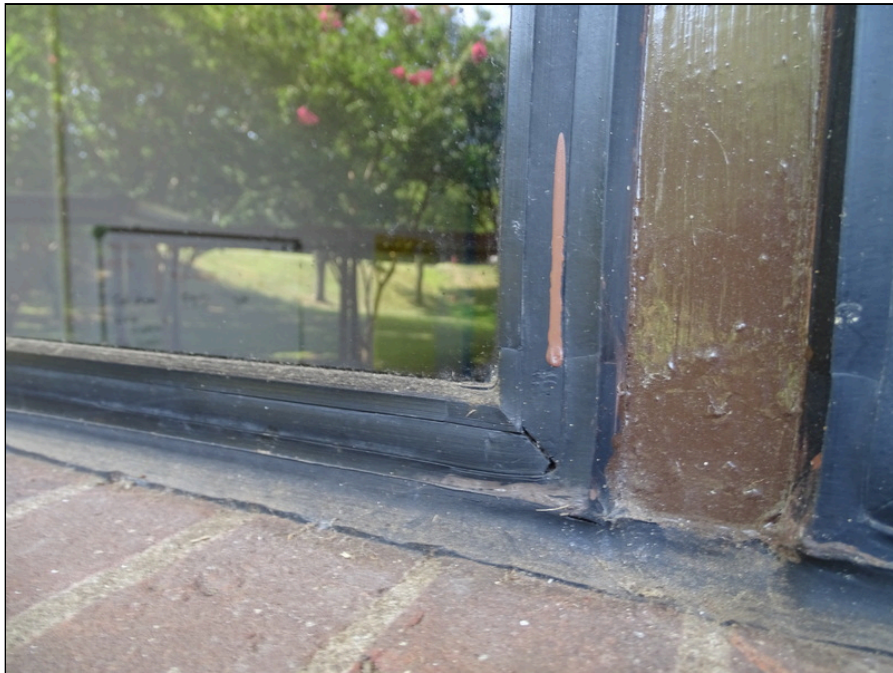
28 - Typical exterior window - note gasket deterioration

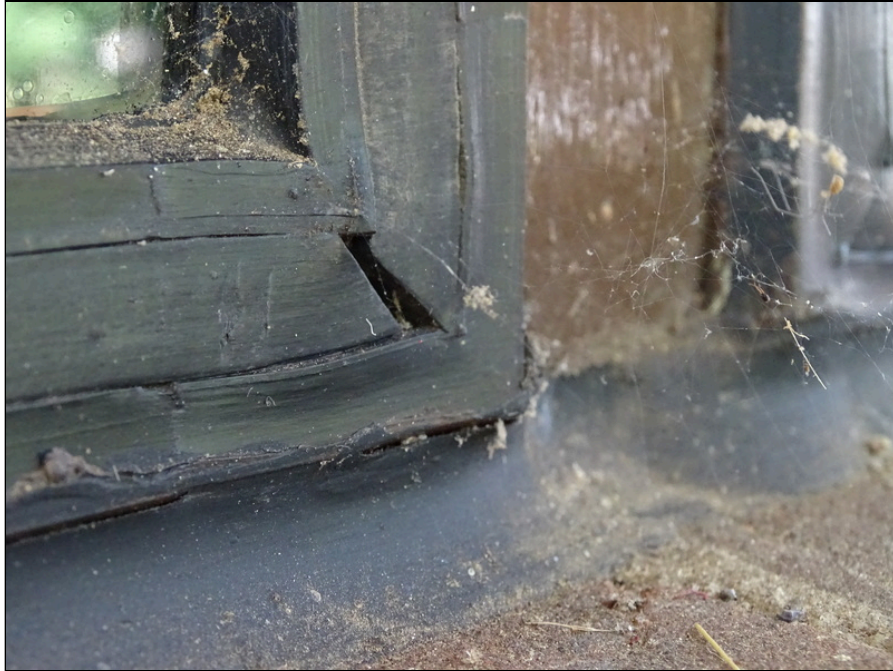
29 - Typical exterior window - note gasket deterioration

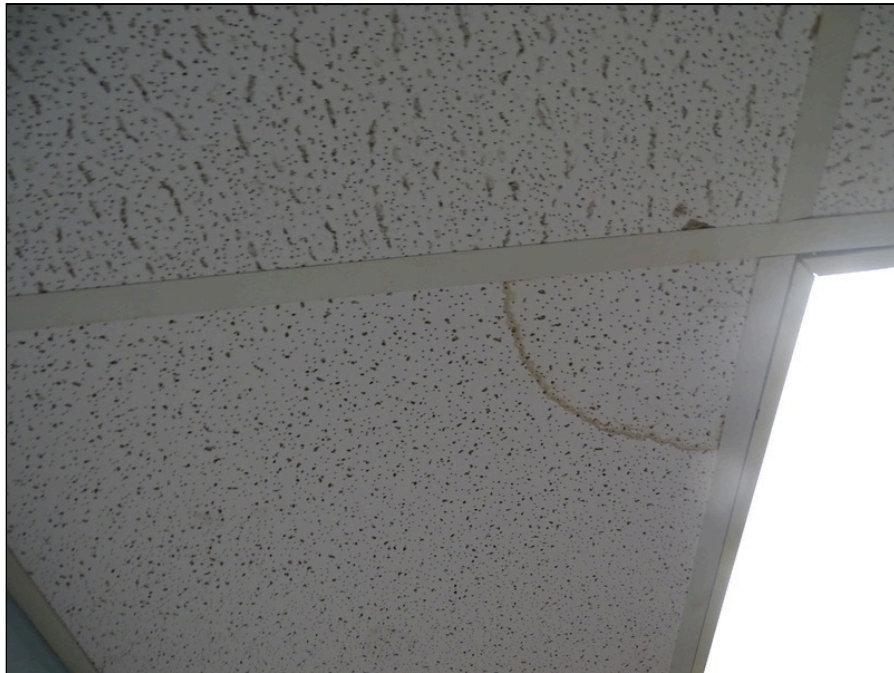
32 - Typical interior ceiling - note water leakage

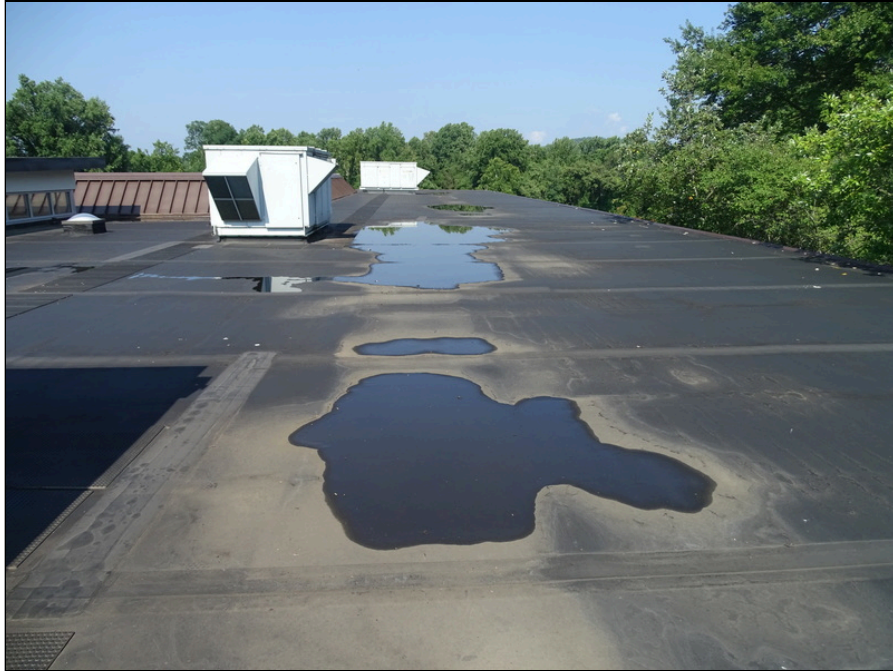
33 - Single-ply roofing system - note ponding
