BURNLEY MORAN ELEMENTARY SCHOOL  
1300 LONG STREET  
CHARLOTTESVILLE, VIRGINIA

ECS PROJECT NO. 46:6713

CITY OF CHARLOTTESVILLE - FACILITIES DEVELOPMENT

Reference: Facility Condition Assessment Report for Burnley Moran Elementary School, 1300 Long Street, Charlottesville, Virginia

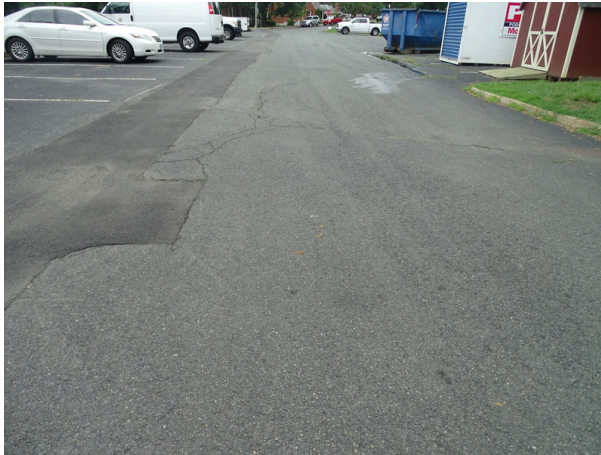
Asphalt parking area at the center of the site -  
note cracking and previous repair

Asphalt-paved drive lanes and parking areas are located on the north and south side of the site which also provides access to the site. Additional parking is provided along the southern drive lane. The asphalt pavement was observed to be in generally good to fair condition with minor cracks observed on the pavement. Striping was in fair condition. The expected useful life of asphalt pavement is 20 years. We have provided allowances to repair the cracked areas of asphalt pavement.

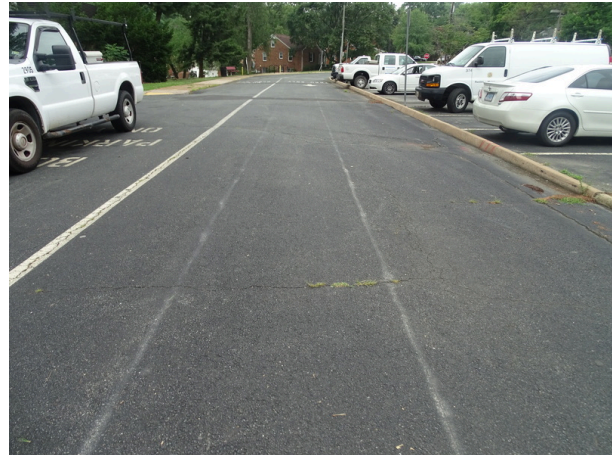
Asphalt drive lane at center of the site

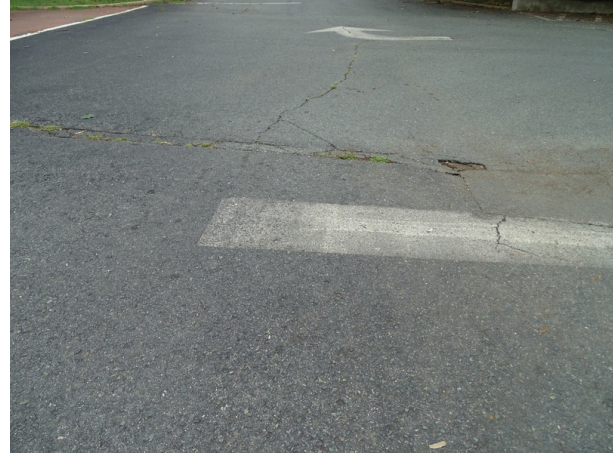
Asphalt parking area at the center of the site -  
note cracking

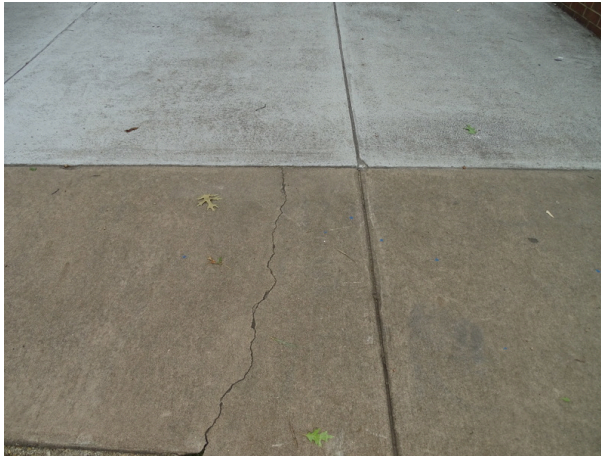
Concrete sidewalk - note cracking

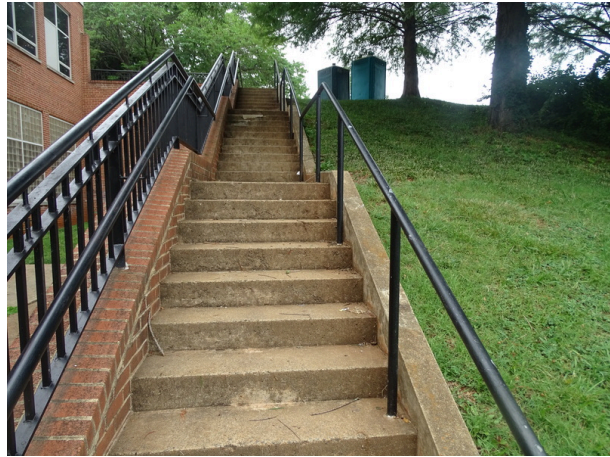
Typical exterior concrete steps

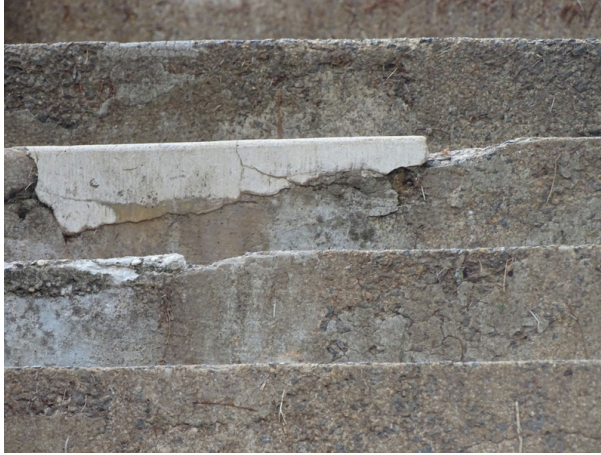
Typical exterior concrete steps - note deterioration

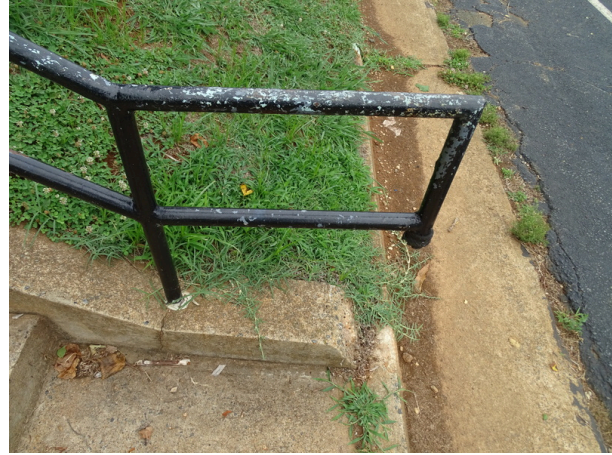
Typical exterior concrete steps - note handrail peeled

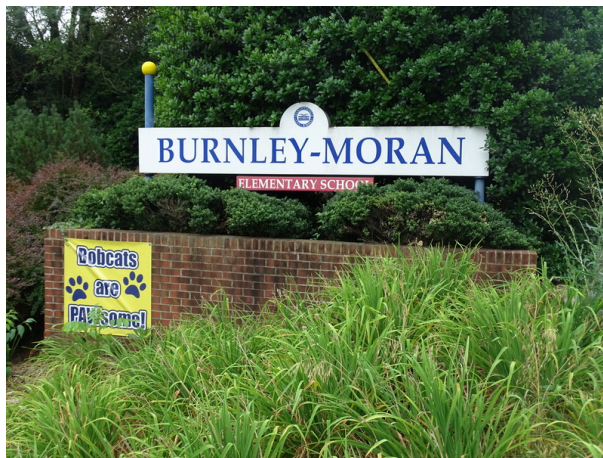
Monument sign and landscaping

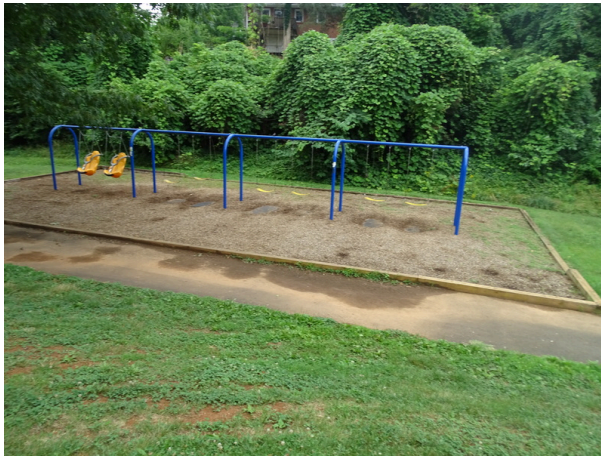
Playground equipment at south end of site

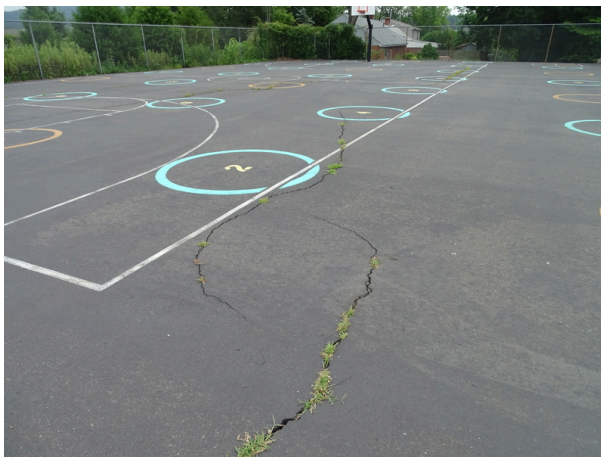
Basketball court surface - note cracking and deterioration

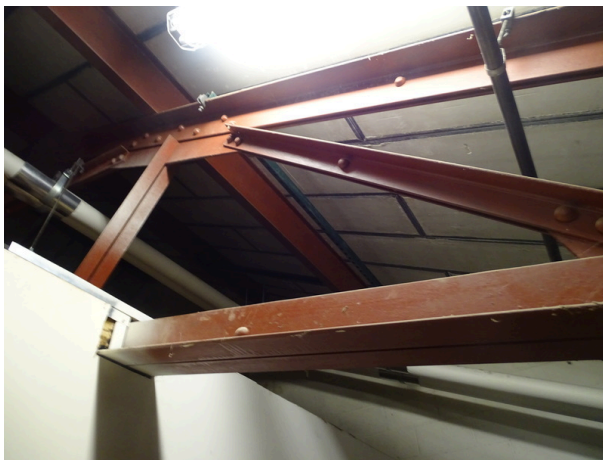
Building framing

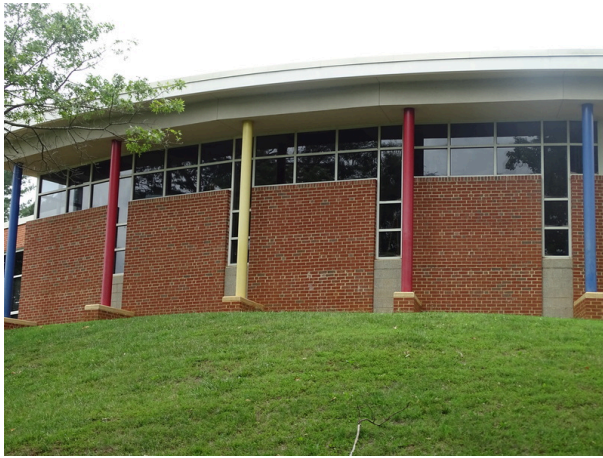
Building exterior finishes

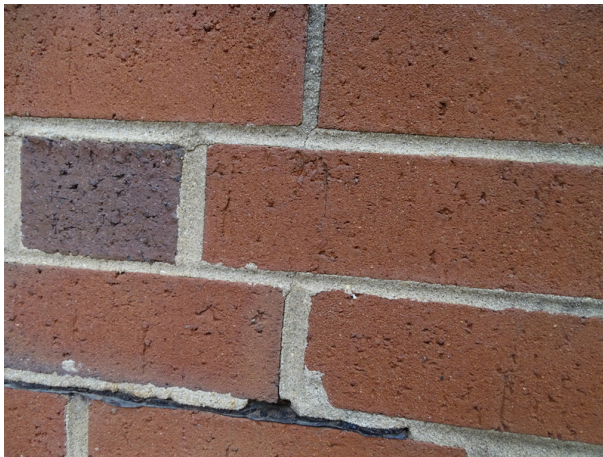
Building exterior finishes - note mortar joint deterioration

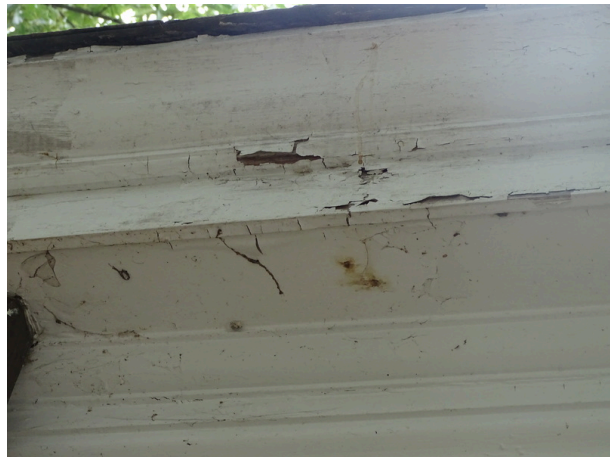
Building exteriors - note deterioration of wood cornice

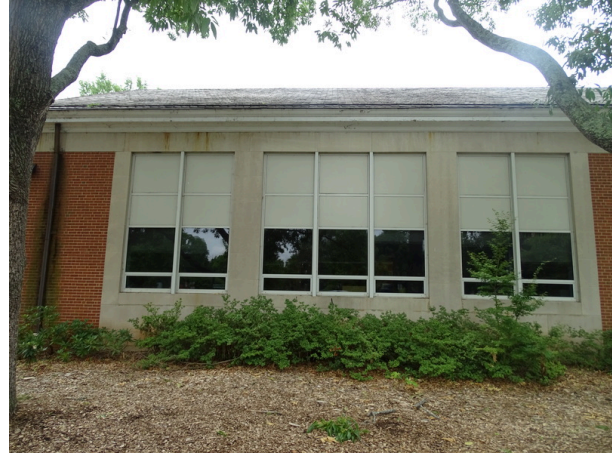
Typical exterior windows

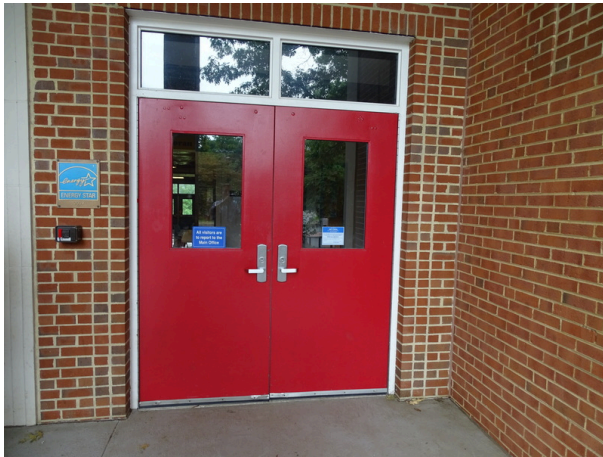
Exterior doors at main entrance north side of the building

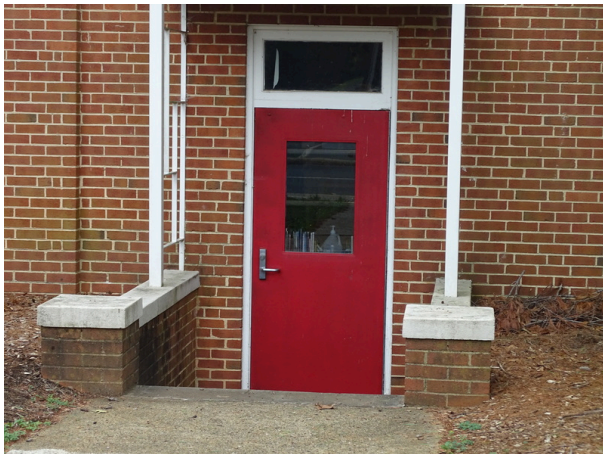
Exterior door at east entrance

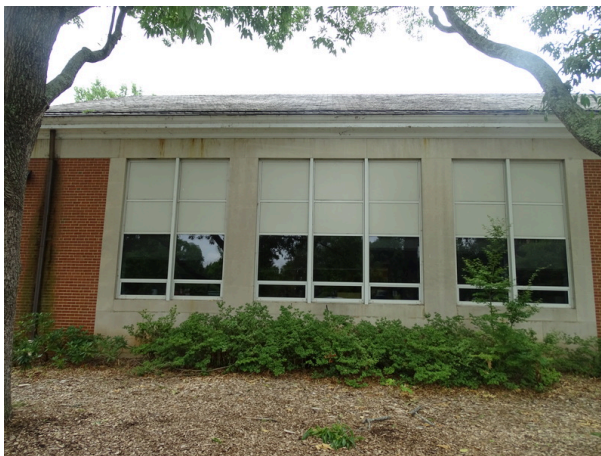
Typical exterior windows

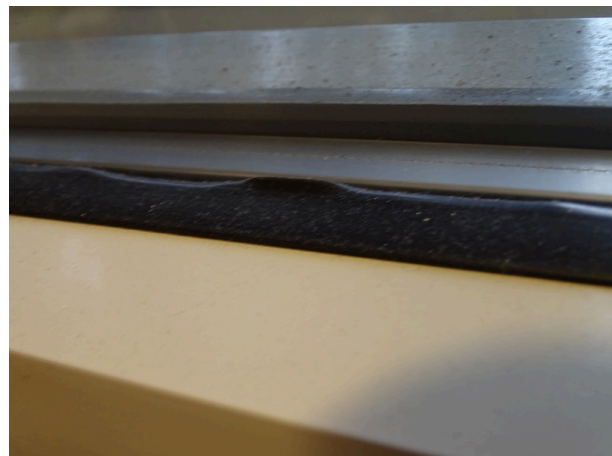
Exterior window - note gasket needing replacement

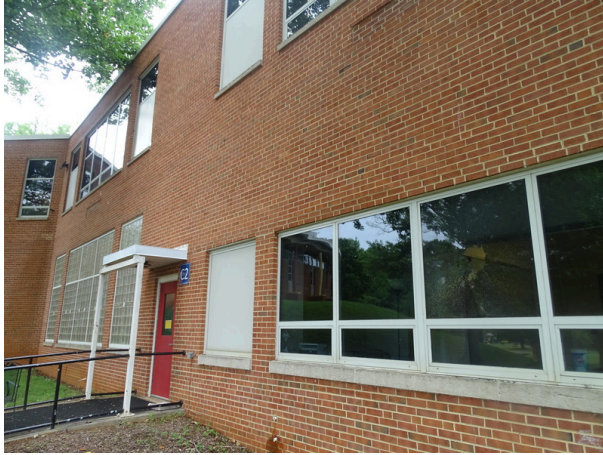
Typical exterior windows

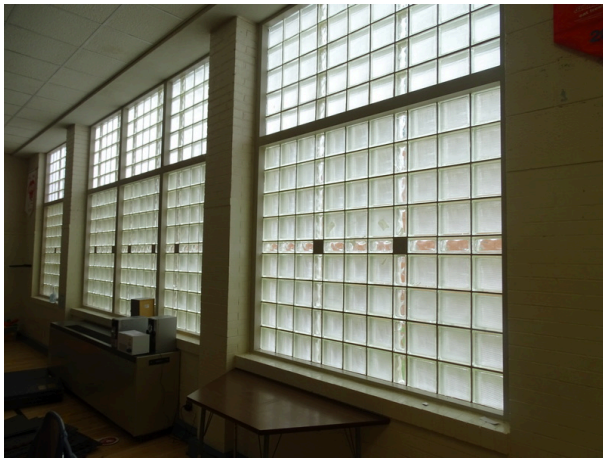
Typical exterior windows

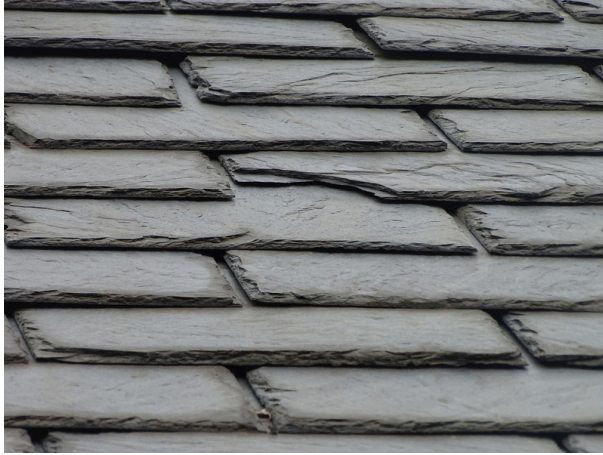
Slate shingle roofing system - note repair needed

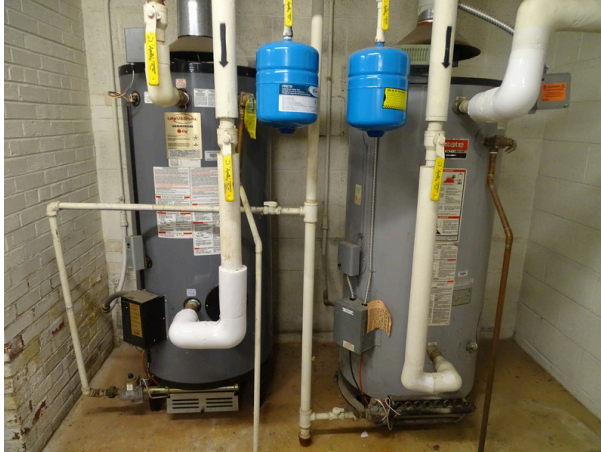
Domestic water heaters

The expected useful life of a Gas domestic water heater is approximately 12 to 15 years with proper maintenance. We recommend the Gas domestic water heaters be replaced during the study period.

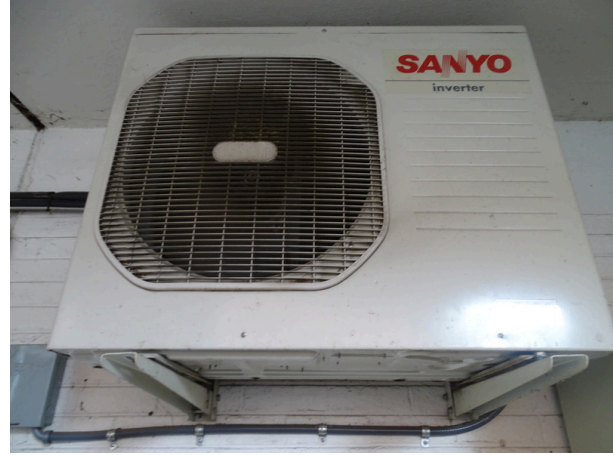
Split system

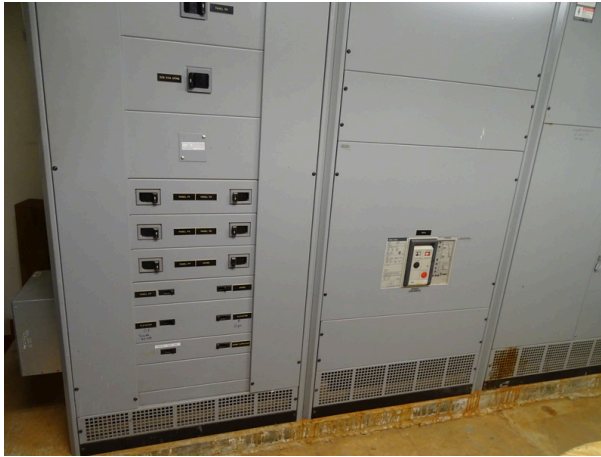
Main electrical switchgear

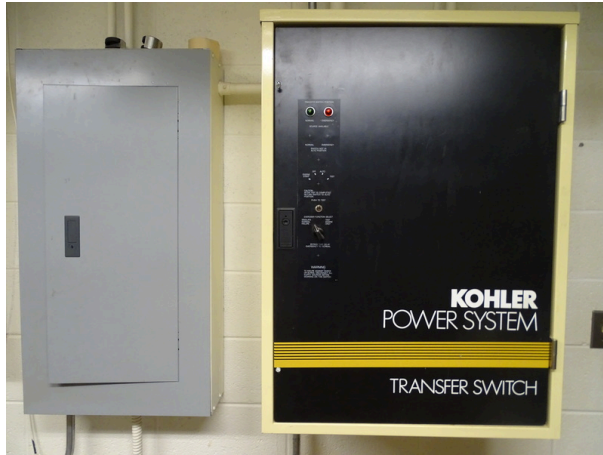
Emergency power transfer switch

The emergency back up power generator transfer switch was manufactured by Kohler and is located in the main mechanical room. The transfer switch installation date was unknown with an expected useful life of 25 years with proper maintenance. The transfer switch should be replaced in conjunction with the generator.

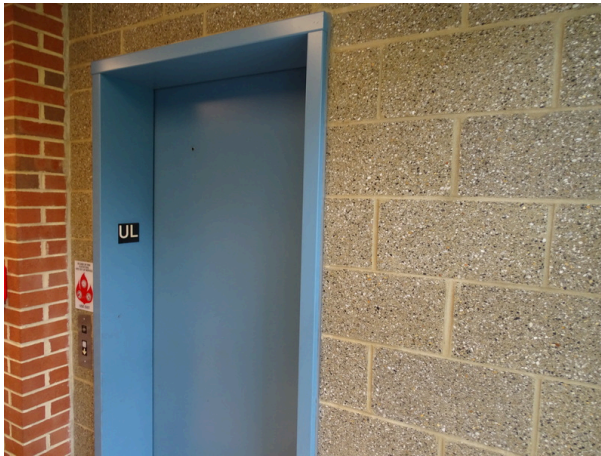
Typical elevator cab

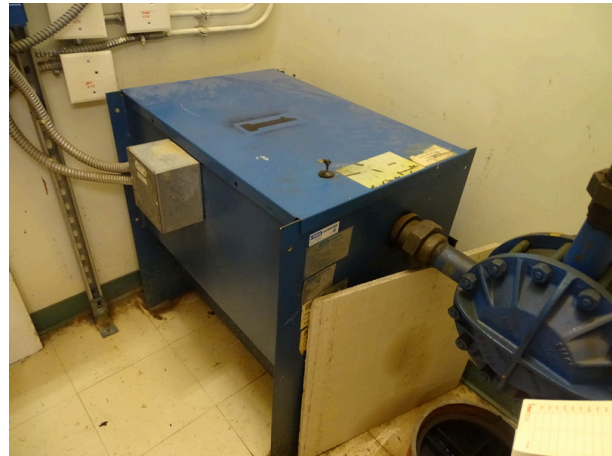
Typical elevator machine and controls

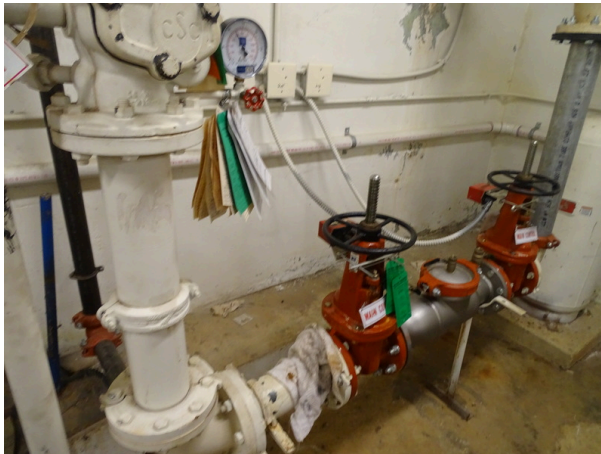
Fire sprinkler system

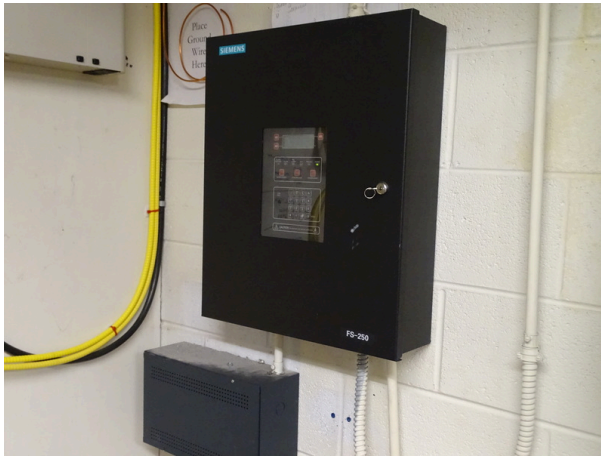
Fire alarm controls

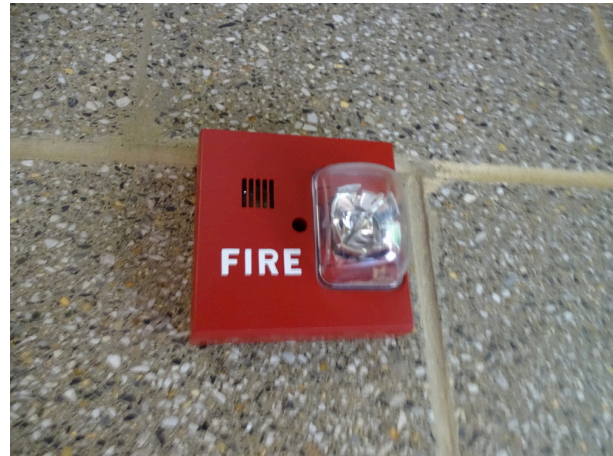
Fire alarm strobe and bell

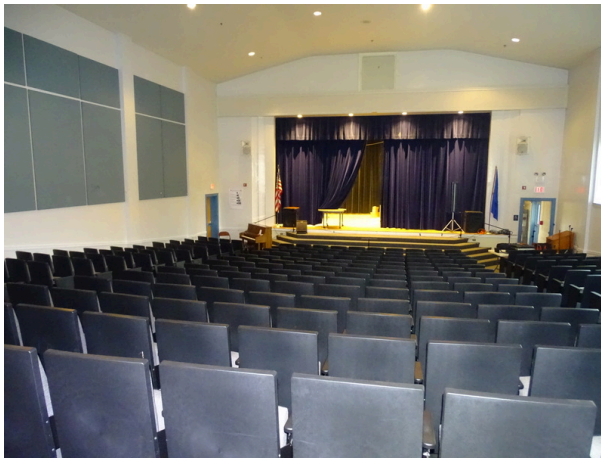
Auditorium area interior finishes

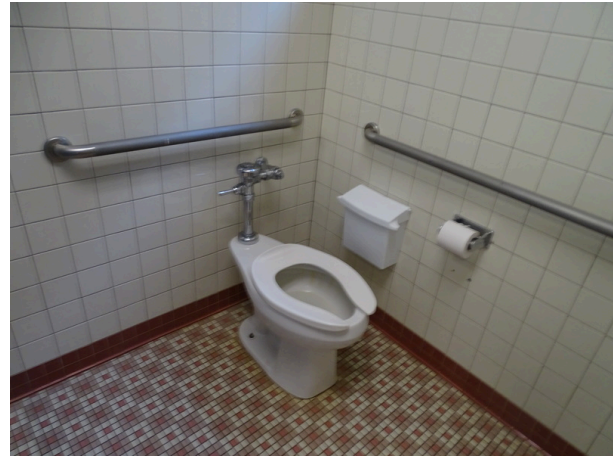
Accessible restroom

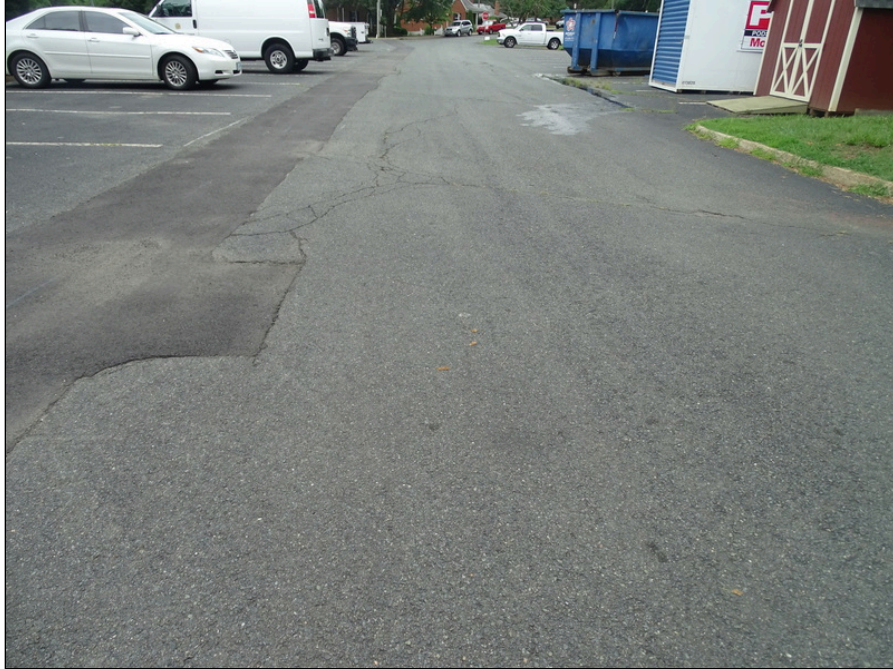
3 - Asphalt parking area at the center of the site - note cracking and previous repair

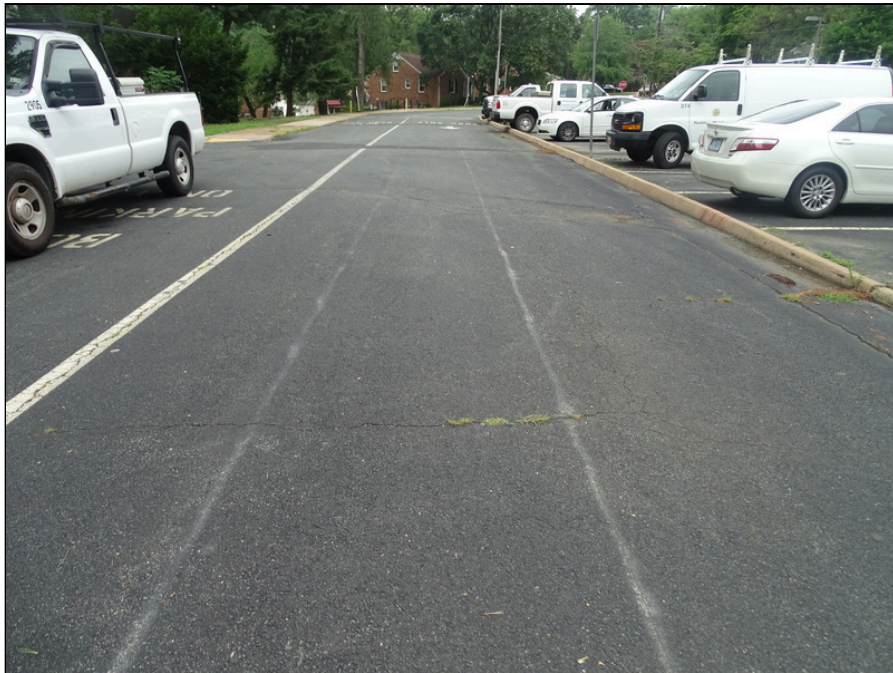
4 - Asphalt drive lane at center of the site

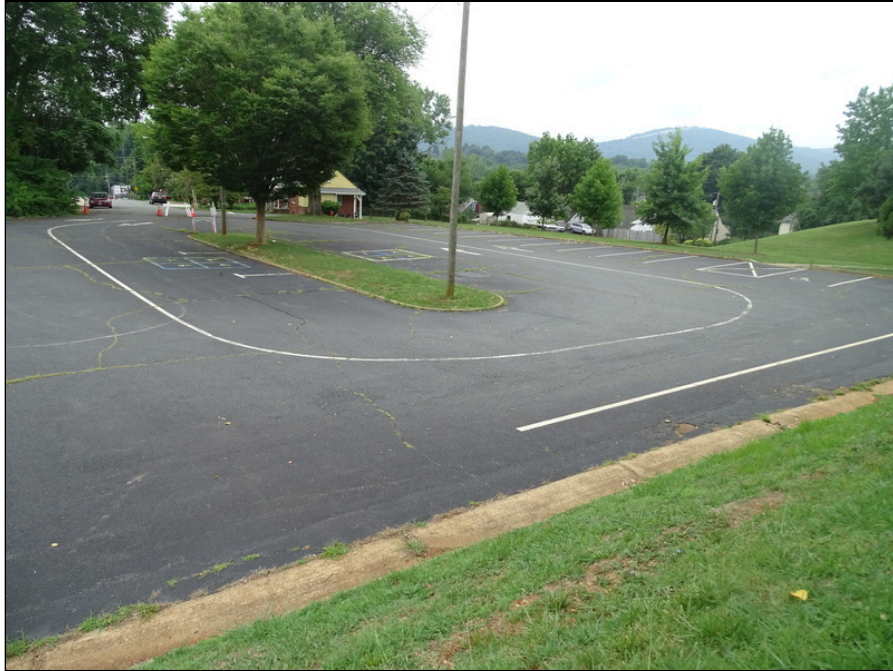
5 - Asphalt parking and drive lanes lower level north end of the site - note cracking

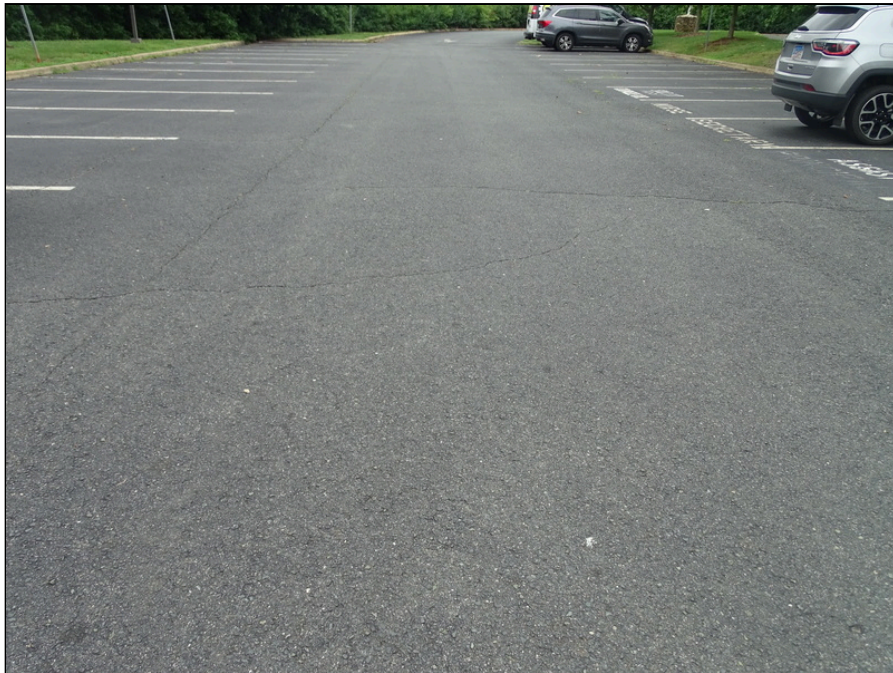
6 - Asphalt drive lane at west side of the site

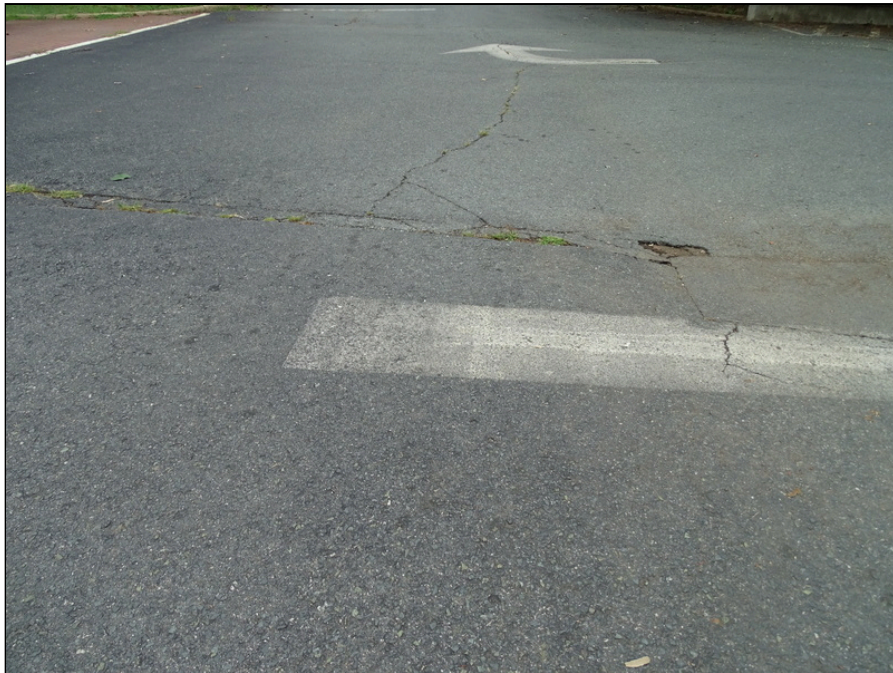
8 - Asphalt parking area at the center of the site - note cracking

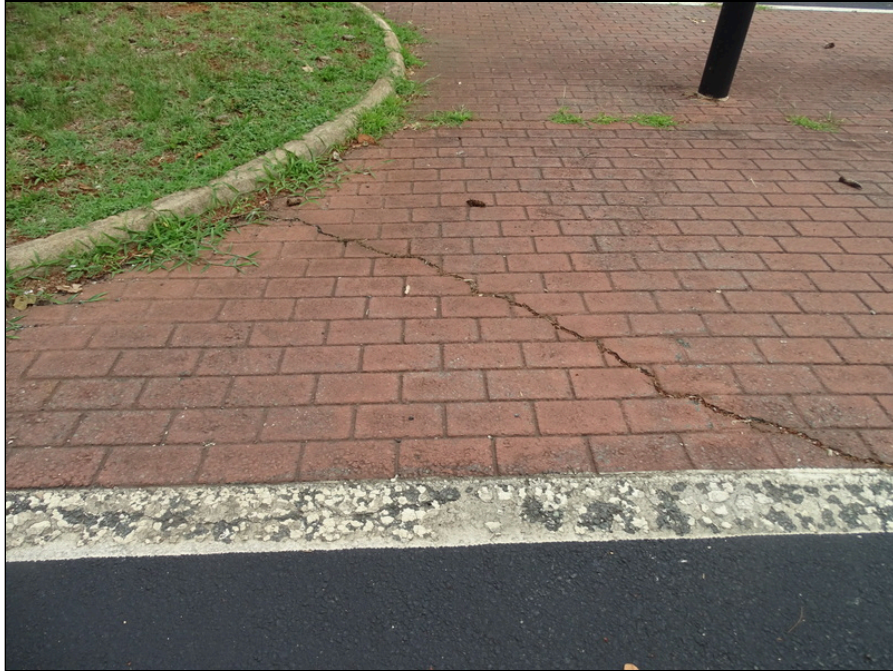
9 - Brick sidewalk - note cracking

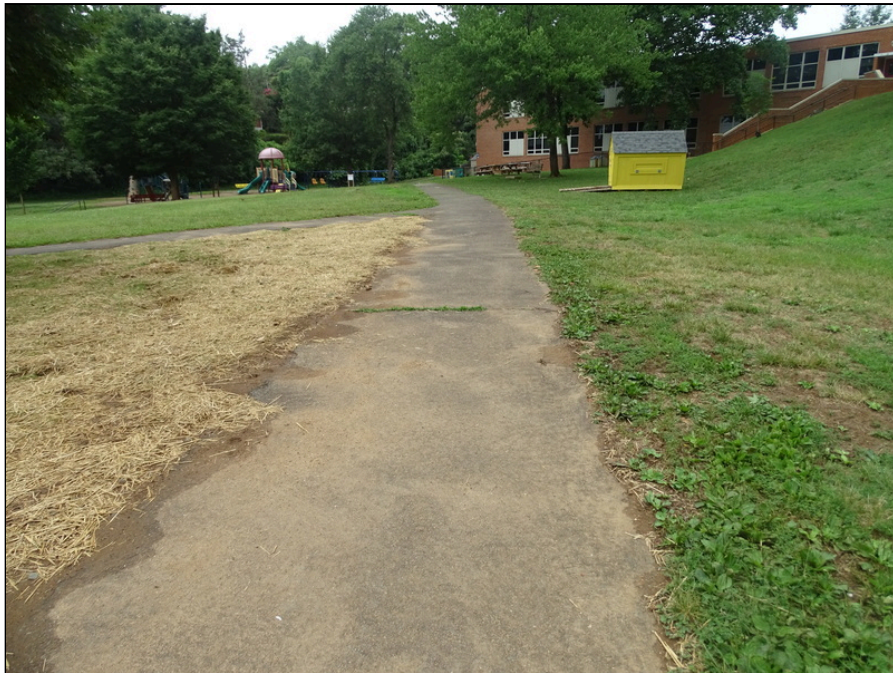
10 - Asphalt sidewalk at west end of site

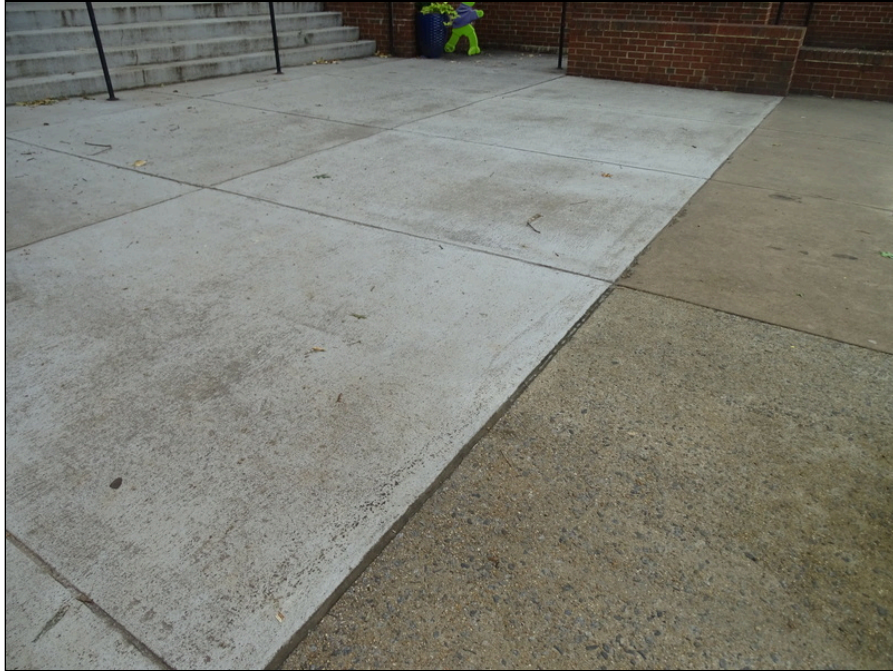
11 - Concrete sidewalk - note recent replacement

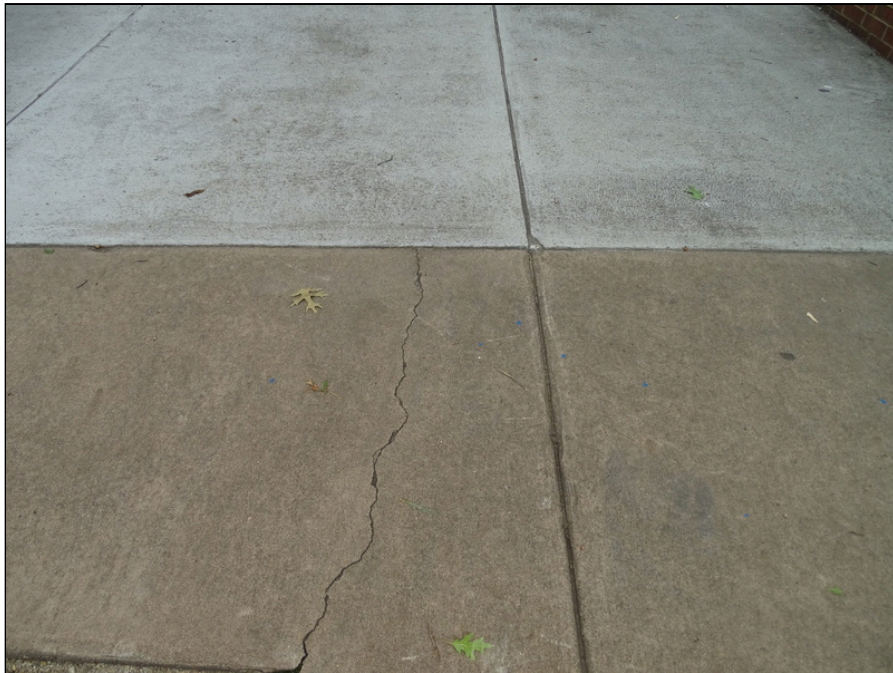
12 - Concrete sidewalk - note cracking

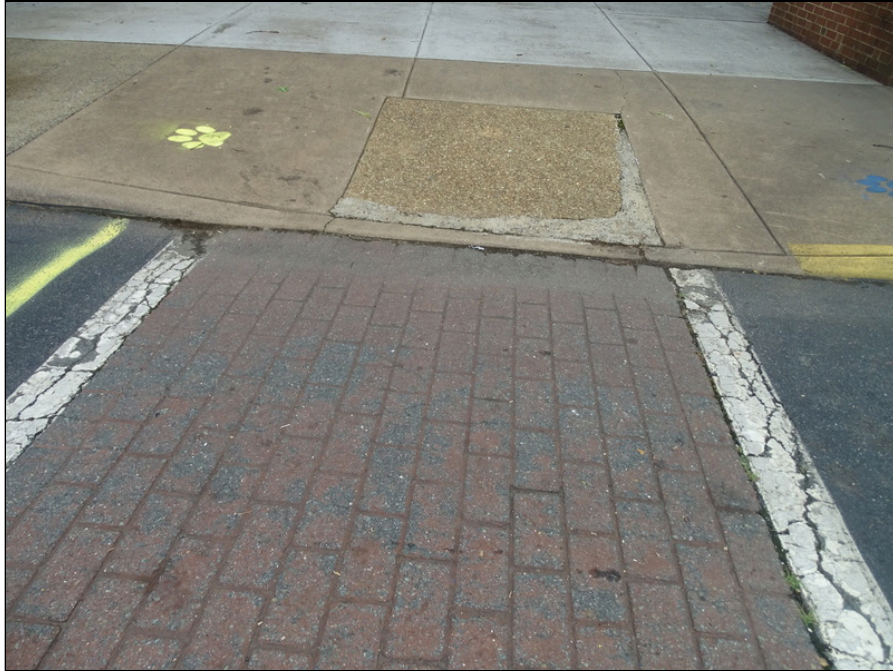
13 - Concrete ramp- note need to install truncated domes

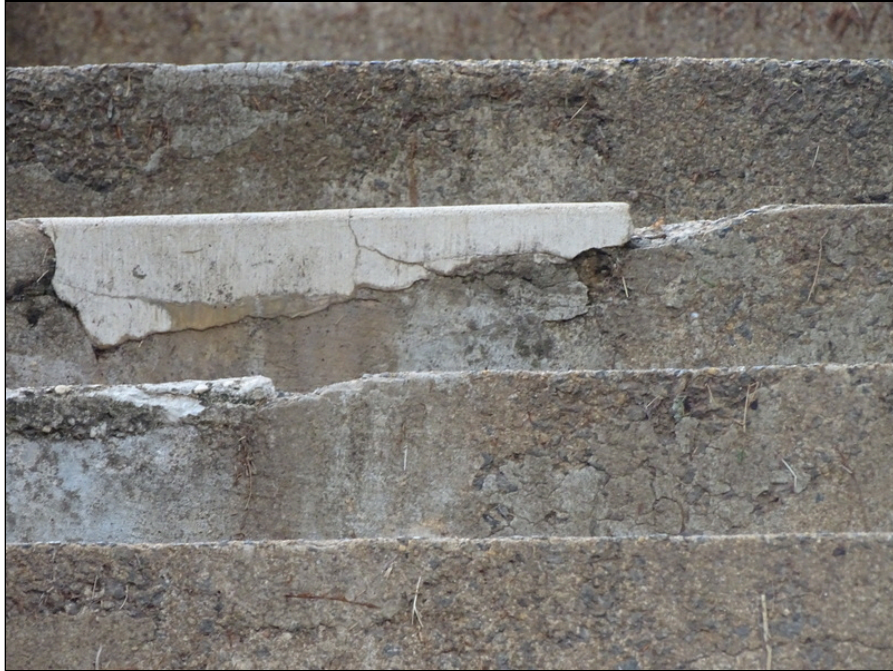
15 - Typical exterior concrete steps - note deterioration

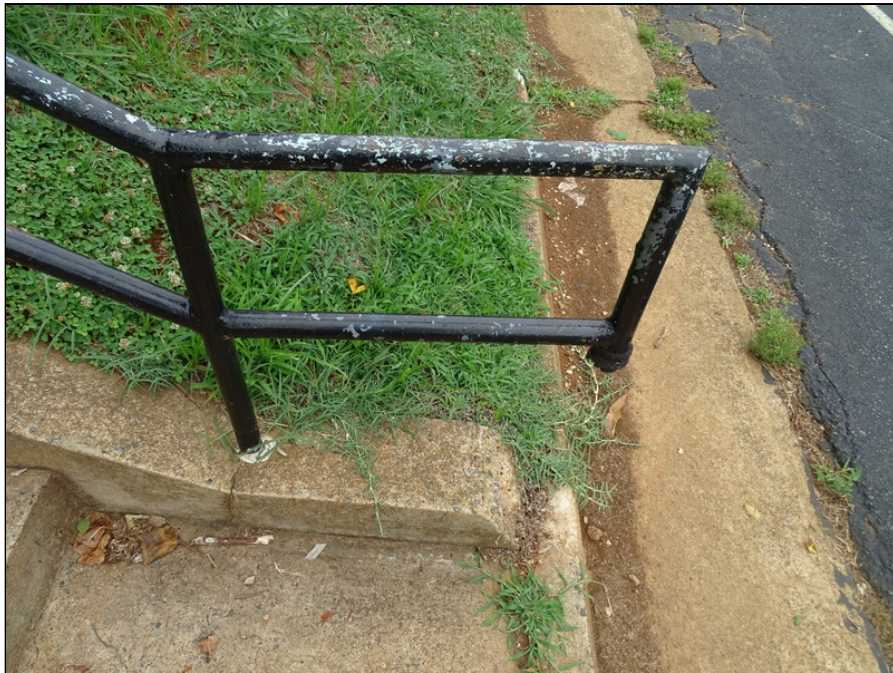
16 - Typical exterior concrete steps - note handrail peeled

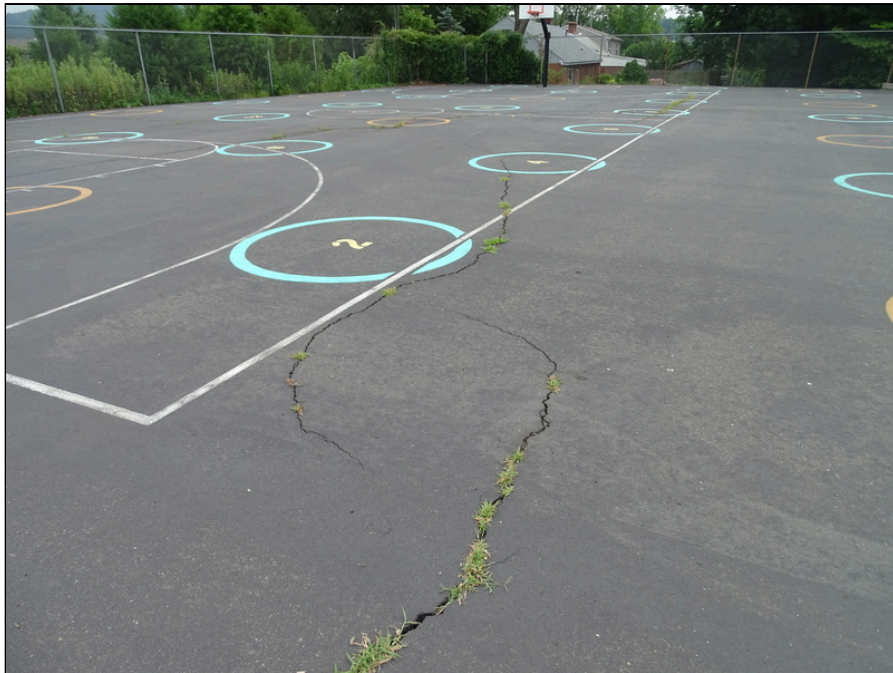
26 - Basketball court surface - note cracking and deterioration

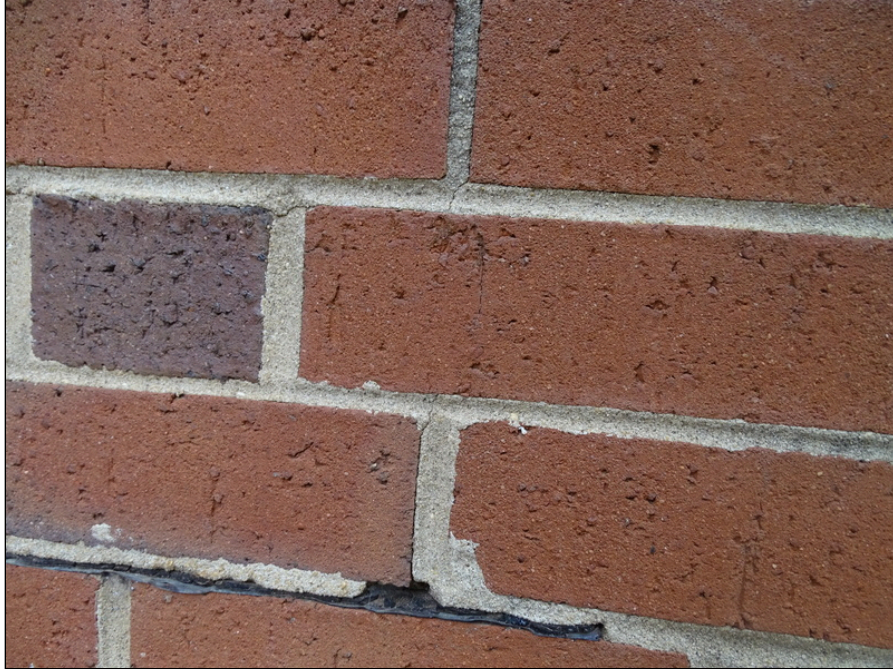
33 - Building exterior finishes - note mortar joint deterioration

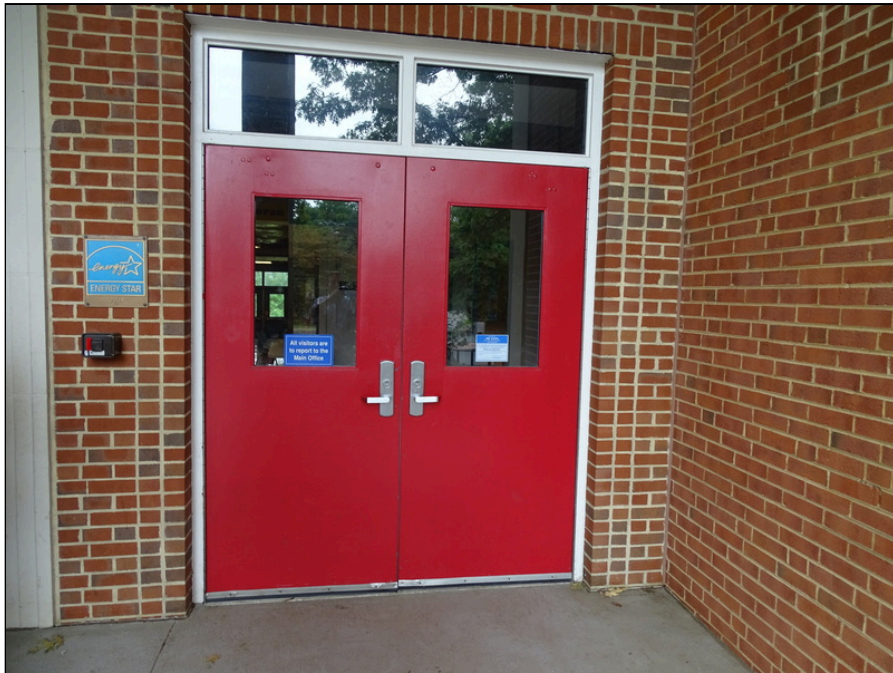
34 - Exterior doors at main entrance north side of the building

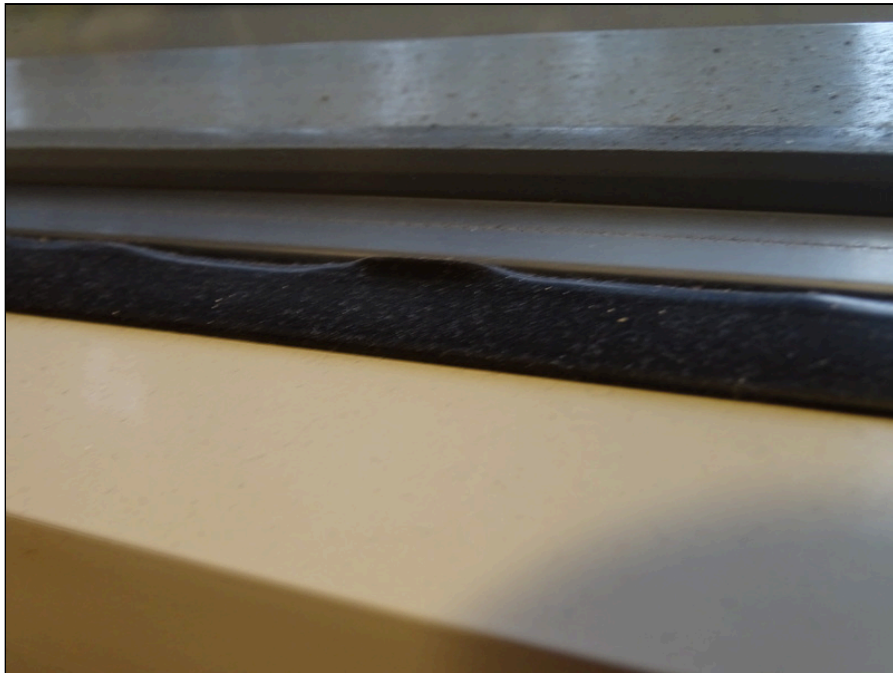
40 - Exterior window - note gasket needing replacement

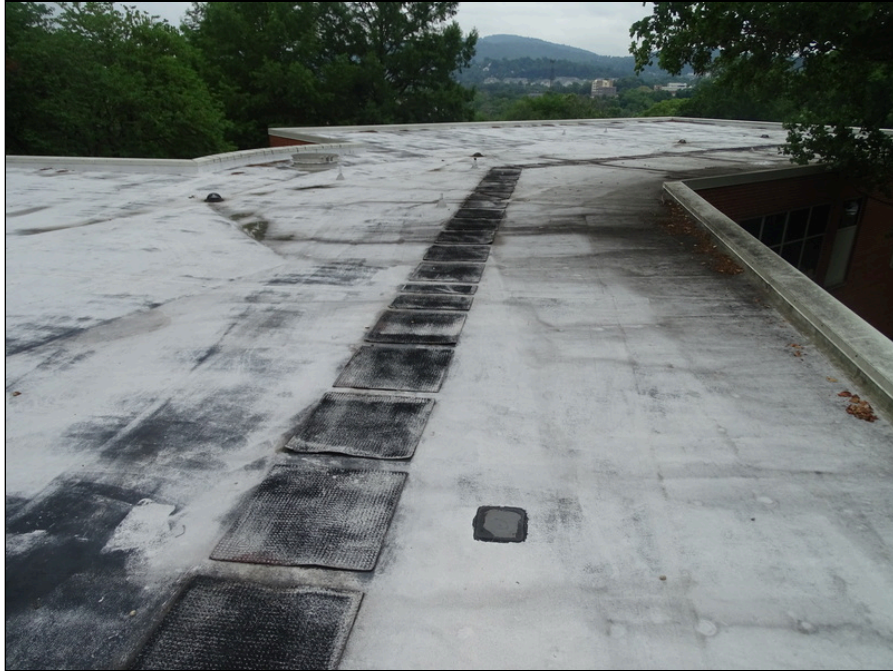
41 - Single-ply membrane roofing system east side of the building

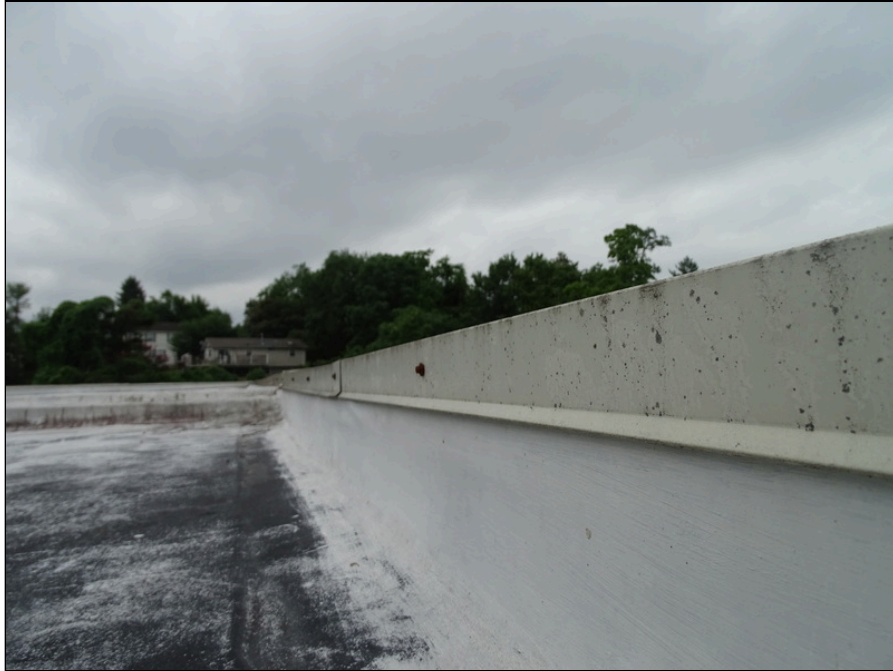
49 - Typical metal coping and parapet wall - note deterioration

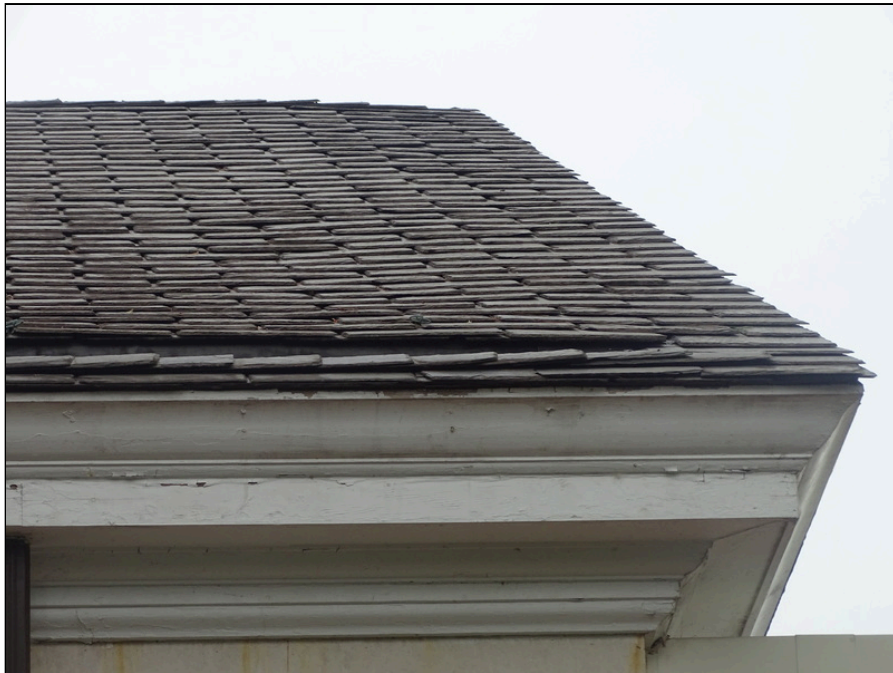
50 - Slate shingle roofing system

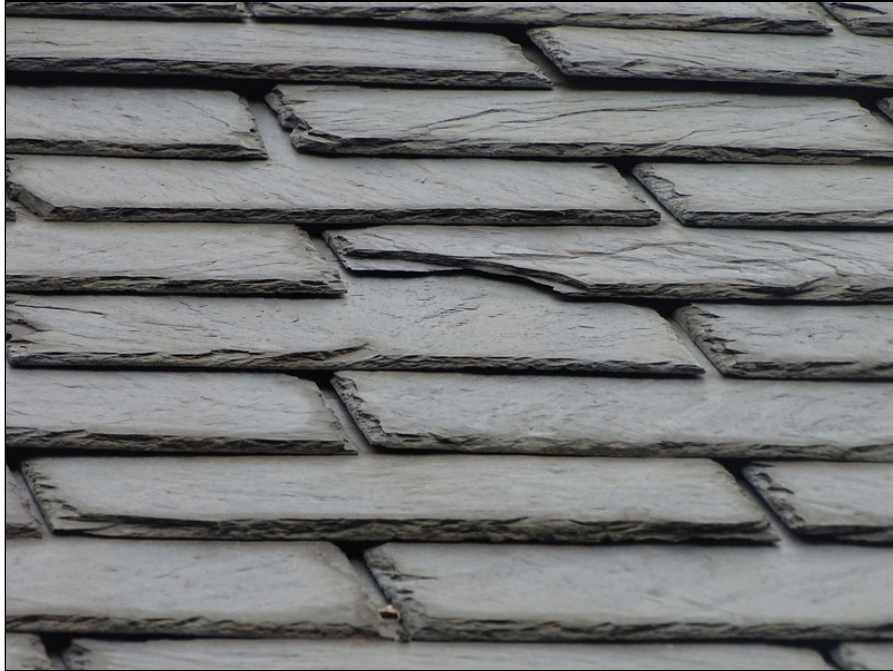
51 - Slate shingle roofing system - note repair needed

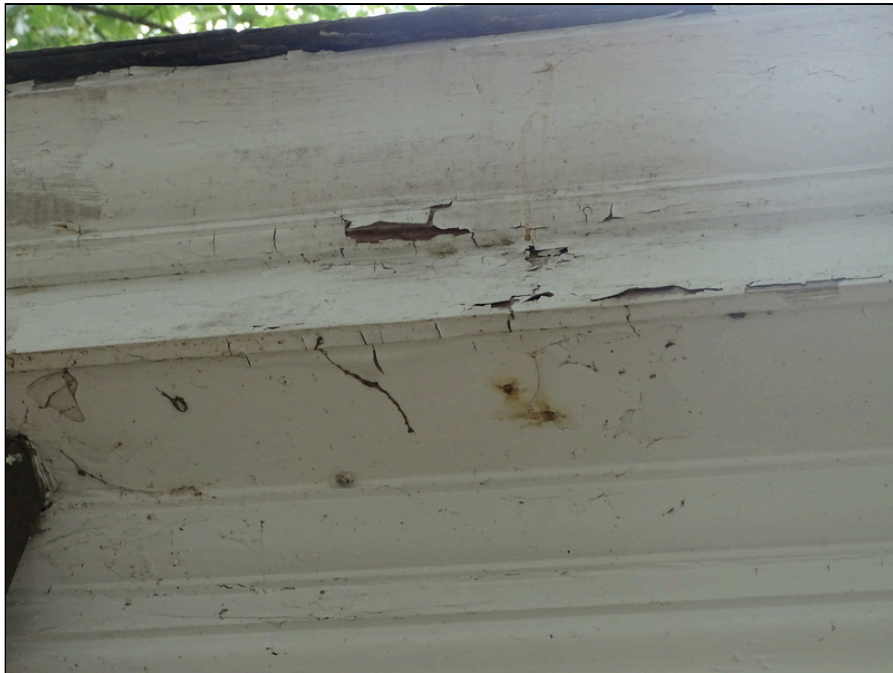
52 - Building exteriors - note deterioration of wood cornice

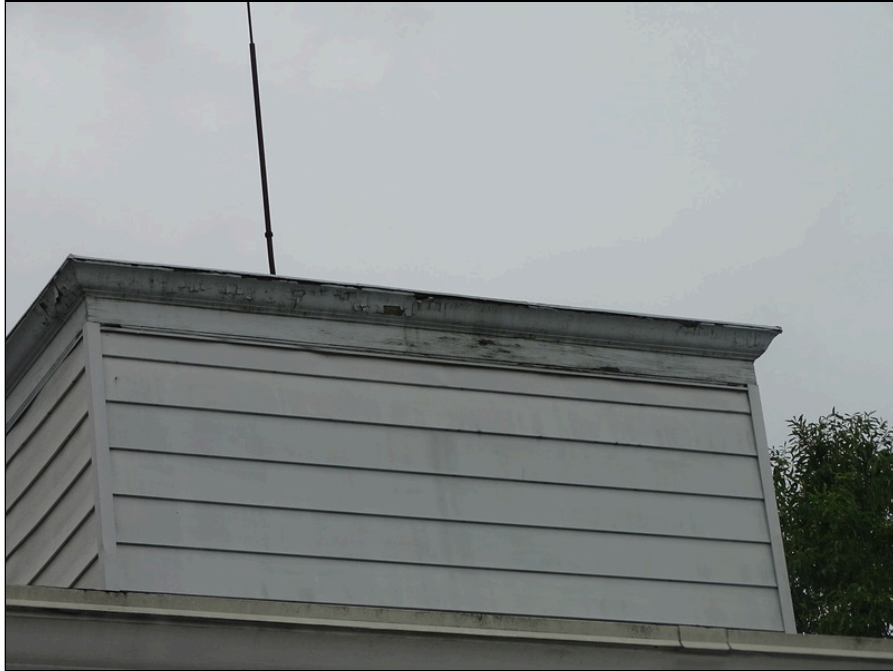
53 - Building exteriors - note deterioration
