BURNLEY MORAN ELEMENTARY SCHOOL  
1300 LONG STREET  
CHARLOTTESVILLE, VIRGINIA

ECS PROJECT NO. 46:6713

CITY OF CHARLOTTESVILLE - FACILITIES DEVELOPMENT

Reference: Facility Condition Assessment Report for Burnley Moran Elementary School, 1300 Long Street, Charlottesville, Virginia

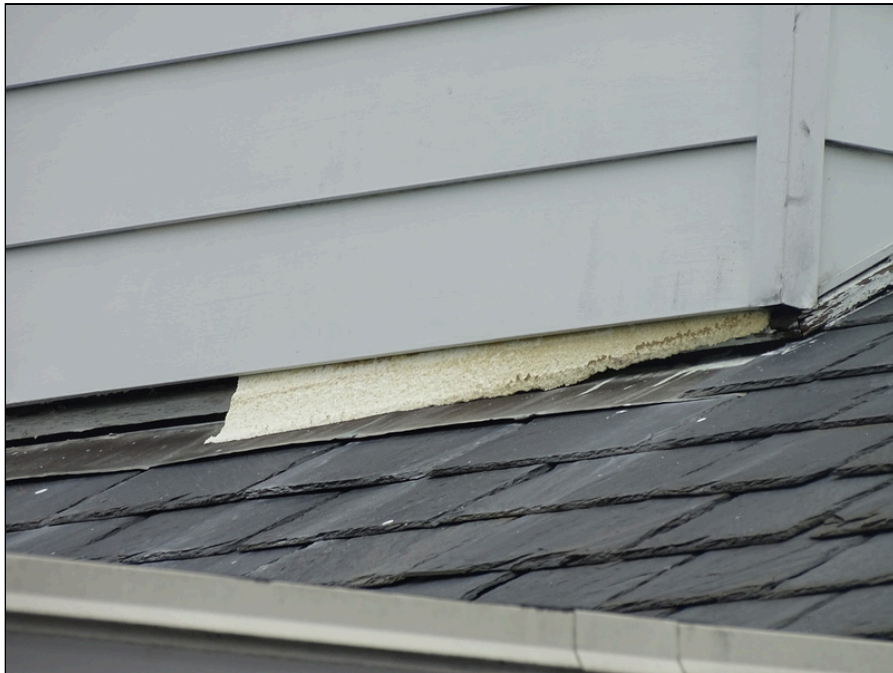
54 - Building exteriors - note deterioration

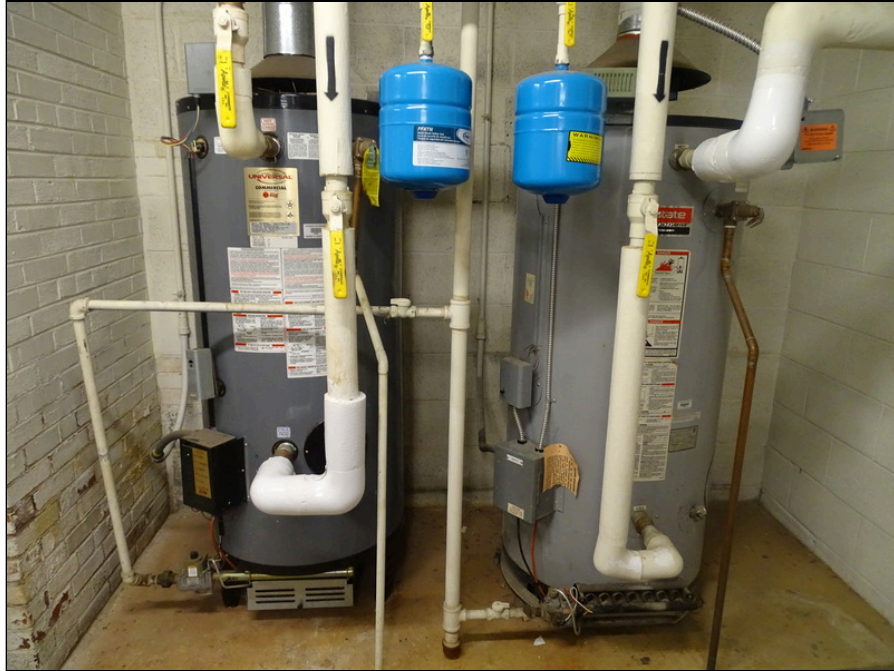
55 - Domestic water heaters

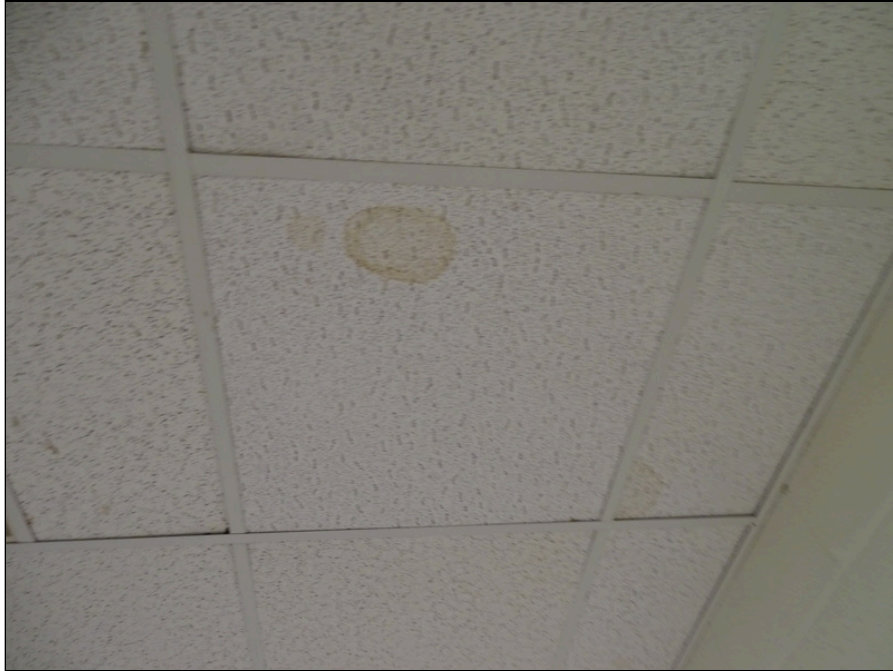
97 - Interior ceiling - note water leakage

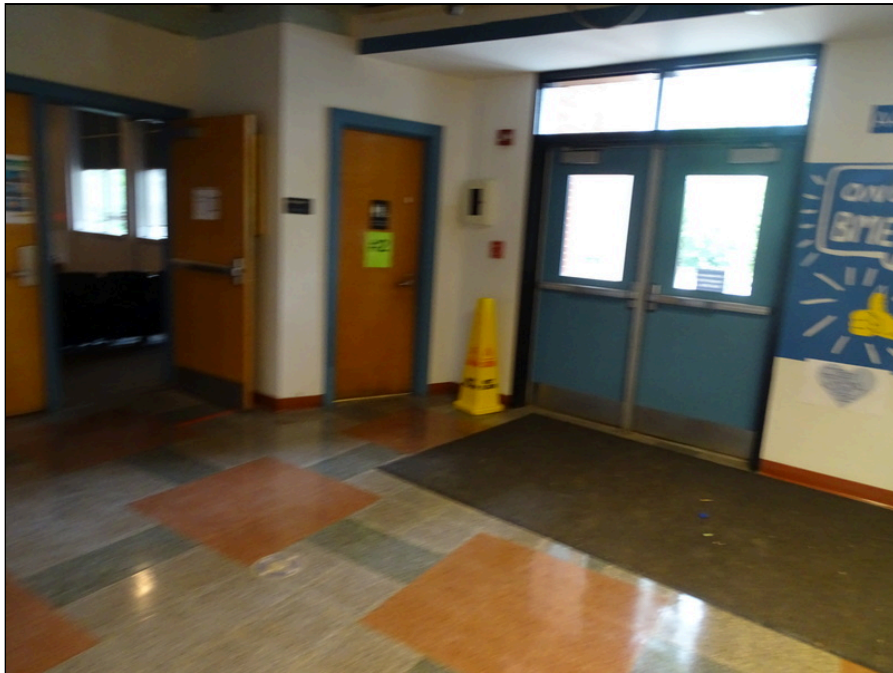
98 - Typical lobby area interior

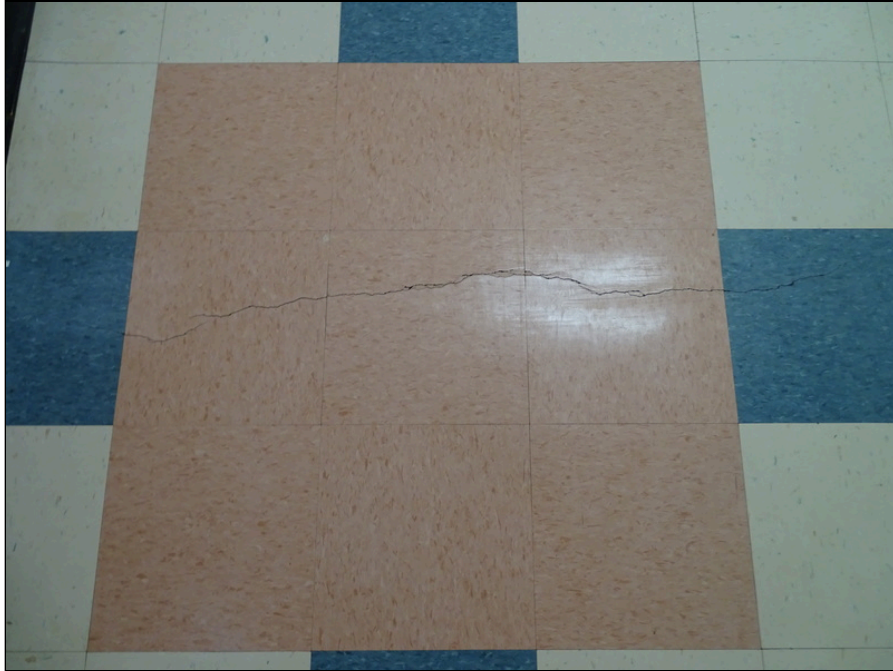
101 - Typical floor area - note deterioration

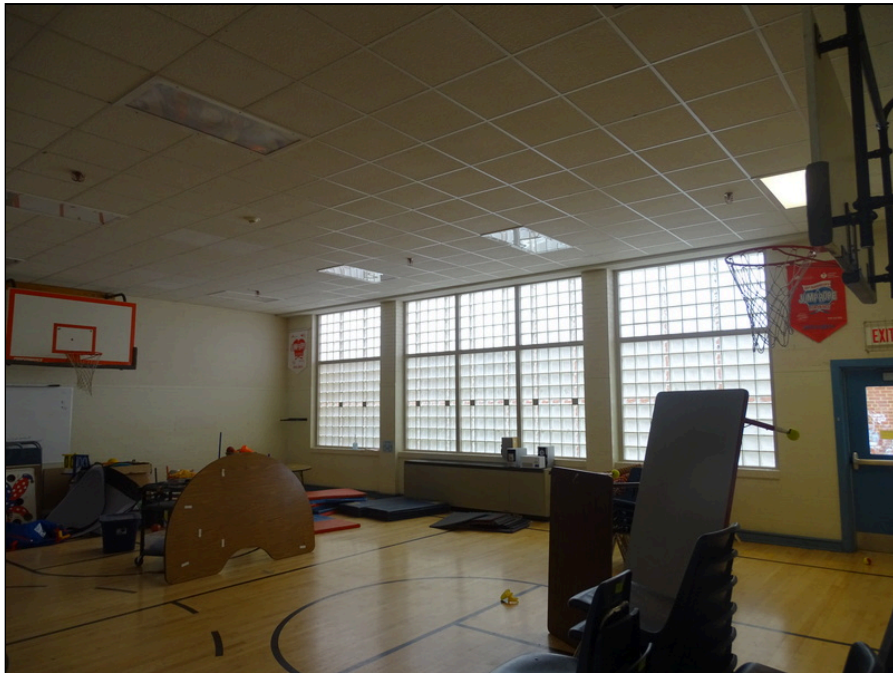
102 - Interior finishes of gymnasium area
