DOWNTOWN TRANSIT CENTER
615 WATER STREET
CHARLOTTESVILLE, VIRGINIA

ECS PROJECT NO. 46:6713

CITY OF CHARLOTTESVILLE - FACILITIES DEVELOPMENT

Reference: Facility Condition Assessment Report for Downtown Transit Center, 615 Water Street,
Charlottesville, Virginia

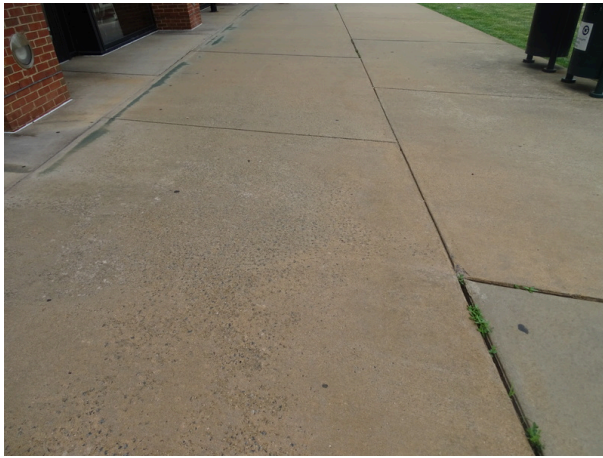
There are Concrete sidewalks of undetermined thickness provided on the south and west sides of the building. Regularly spaced control joints were observed. The concrete sidewalks were generally in good to fair condition with replacement of sections observed. The walking surface on the north side of the building is brick pavers. There are concrete steps on the west side of the building. The expected useful life of concrete sidewalks and steps is 25 years. We recommend an allowance for future replacement as needed.

Concrete sidewalk at the south side of the building

3.2.5 Flatwork																													
REPLACE CONCRETE SIDEWALK AND REPAIR CONCRETE STEPS AS NEEDED	25	24	1	1	LS	\$10,000.00	\$10,000	100%	\$2,500									\$2,500					\$2,500					\$2,500	\$10,000

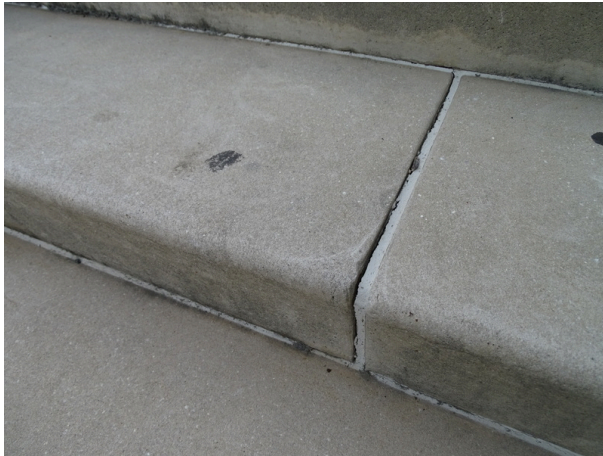
Concrete steps at the west side of the building -
note sealant deterioration

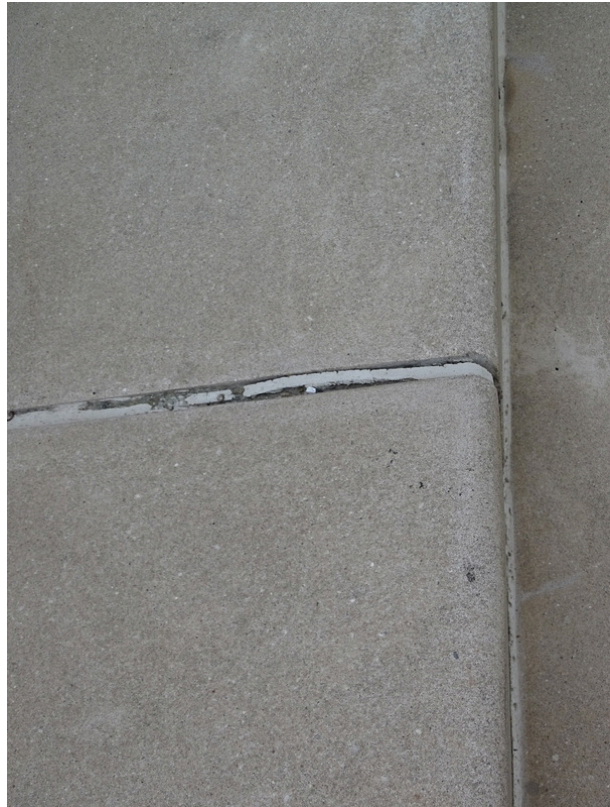
Concrete steps at the west side of the building -
note sealant deterioration

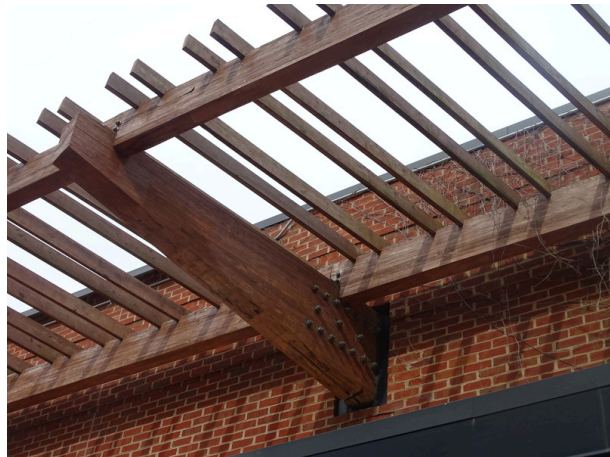
There is wood pergola on the east and south sides of the building. There is a wood shade screen located on the upper elevations of the west side of the building. The wood accent materials were weathered and cracking was observed. The wood accent was in fair condition. We recommend an allowance to treat the wood accent materials.

Wood accent on the east side of the building -
note cracking

3.3.3 Building Exteriors																													
REPOINT BRICKWORK	20	14	6	1	LS	\$30,000.00	\$30,000	100%						\$30,000															\$30,000
REPLACE SEALANTS	12	11	1	12	EA	\$15,000.00	\$180,000	100%	\$90,000											\$90,000									\$180,000
TREAT WOOD ACCENT MATERIALS	5	4	1	1	LS	\$30,000.00	\$30,000	100%	\$10,000				\$5,000					\$5,000					\$5,000					\$5,000	\$30,000
CLEAN THE BRICKWORK	20	19	1	1	LS	\$5,000.00	\$5,000	100%	\$5,000																				\$5,000

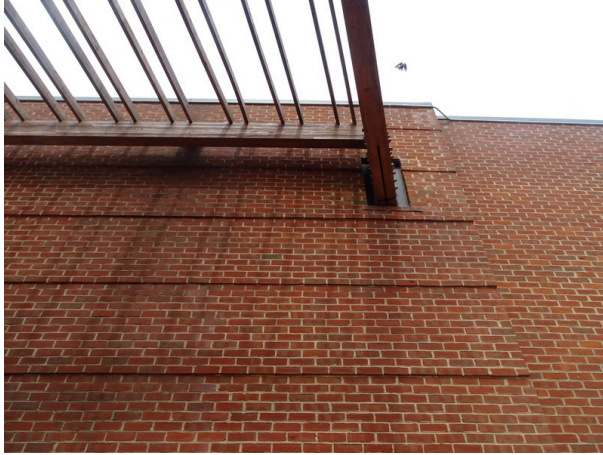
Wood accent on the east side of the building -
note cracking

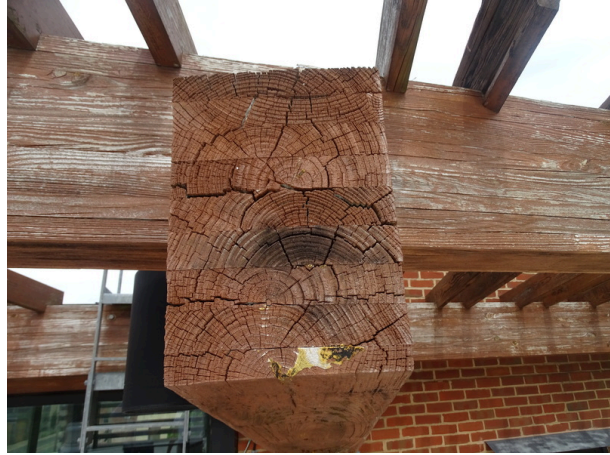
Wood accent on the east side of the building -
note cracking

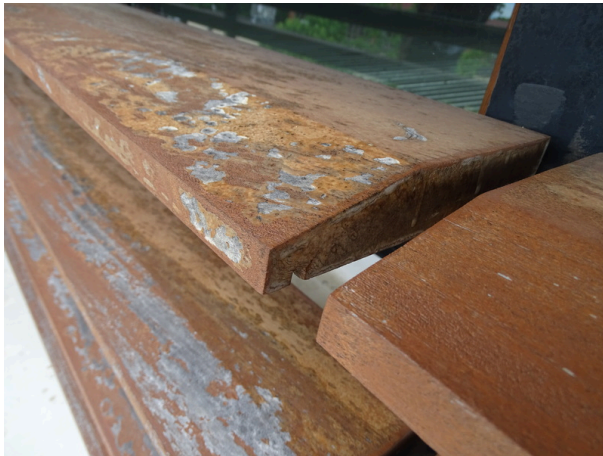
Wood shade screen on west side of the building
- note deterioration

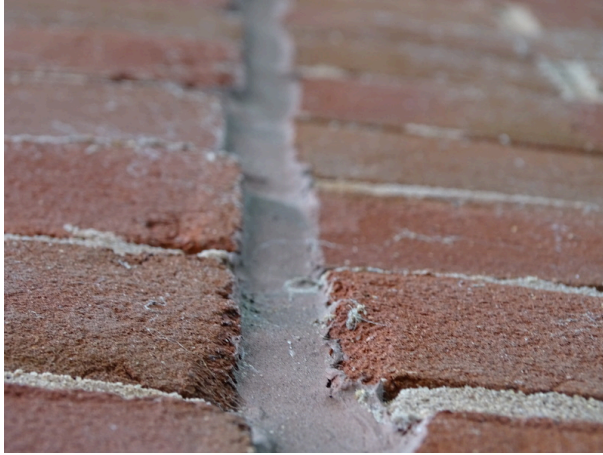
Exterior wall - note sealant deterioration

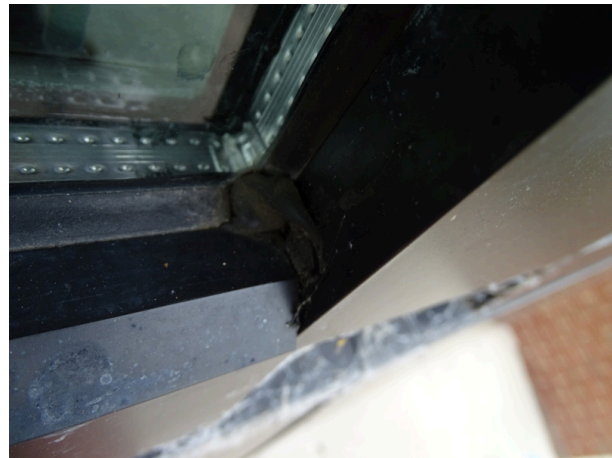
The window gaskets were generally in fair condition based on their age. The typical useful life of window gaskets is 20 years. We recommend replacing the window gaskets during the report period.

Typical exterior window - note gasket deterioration

3.3.4 Exterior Doors																													
REPAIR ENTRANCE DOOR				1	EA	\$1,000.00	\$1,000	100%	\$1,000																				\$1,000
3.3.5 Exterior Windows																													
REPLACE WINDOW GASKETS	25	14	11	1	LS	\$10,000.00	\$10,000	100%											\$10,000										\$10,000

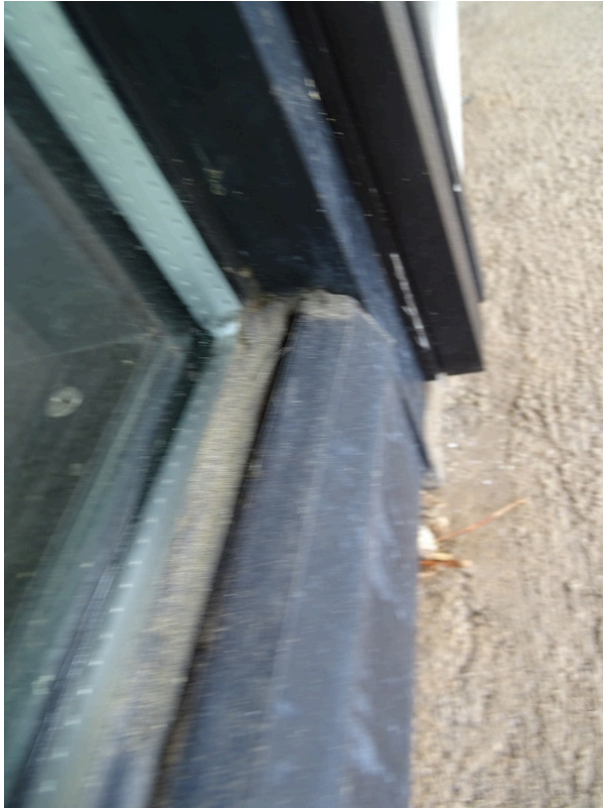
Typical exterior window - note gasket deterioration

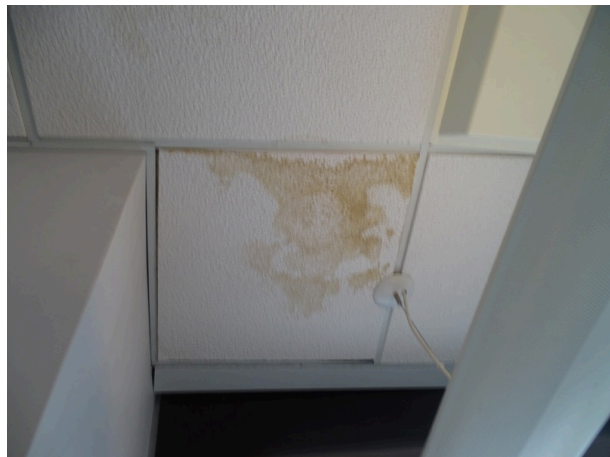
Area of reported leakage of roofing system

3.3.6 Roofing Systems																													
REPLACE SINGLE-PLY ROOFING SYSTEM	20	14	6	7,500	SF	\$14.00	\$105,000	100%						\$105,000															\$105,000

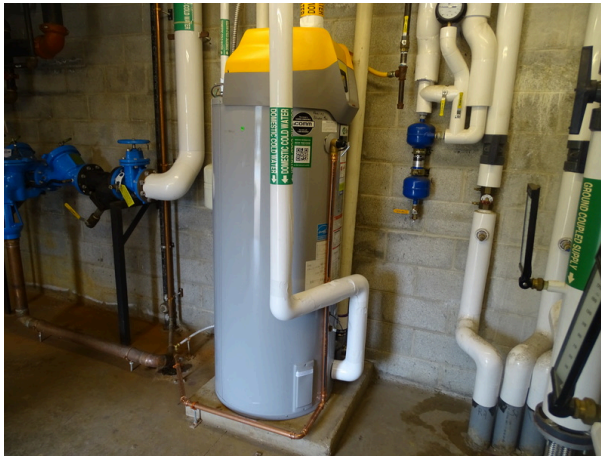
Domestic hot water to the building is provided by Hybrid gas domestic water heater located in the main utility room. The Hybrid gas domestic water heater was reportedly recently replaced. The expected useful life of an Hybrid gas domestic water heater is approximately 12 to 15 years. We recommend the Hybrid gas domestic water heater be replaced during the report period.

Gas domestic water heater

3.4.1.2 Domestic Hot Water Production																													
REPLACE WATER HEATER	12	2	10	1	EA	\$2,000.00	\$2,000	100%										\$2,000											\$2,000

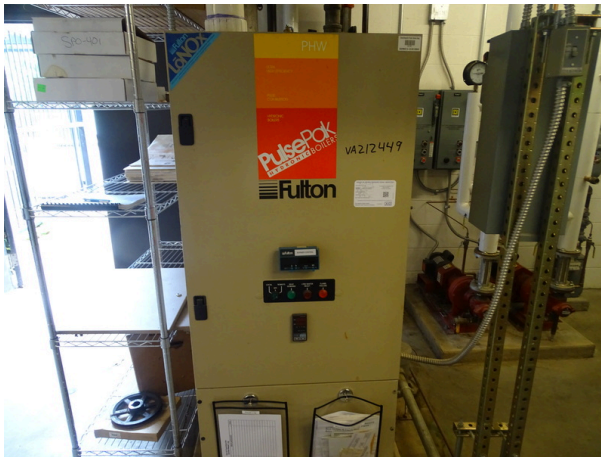
Boiler located in main utility room

Item	EUL	AGE	RUL	Quantity	Unit	Unit Cost	Cycle Replace	Replace Percent	2021	2022	2023	2024	2025	2026	2027	2028	2029	2030	2031	2032	2033	2034	2035	2036	2037	2038	2039	2040	Total Cost	
REPLACE BOILER	15	14	1	1	LS	\$25,000.00	\$25,000	100%	\$25,000																			\$25,000		
REPLACE PACKAGED AIR CONDITIONER UNIT	15	14	1	1	EA	\$25,000.00	\$25,000	100%	\$25,000																			\$25,000		
REPLACE WATER SOURCE HEAT PUMPS	15	14	1	5	EA	\$2,500.00	\$12,500	100%	\$12,500																			\$12,500		
REPLACE FAN COIL UNITS	25	14	11	2	EA	\$2,500.00	\$5,000	100%										\$5,000										\$5,000

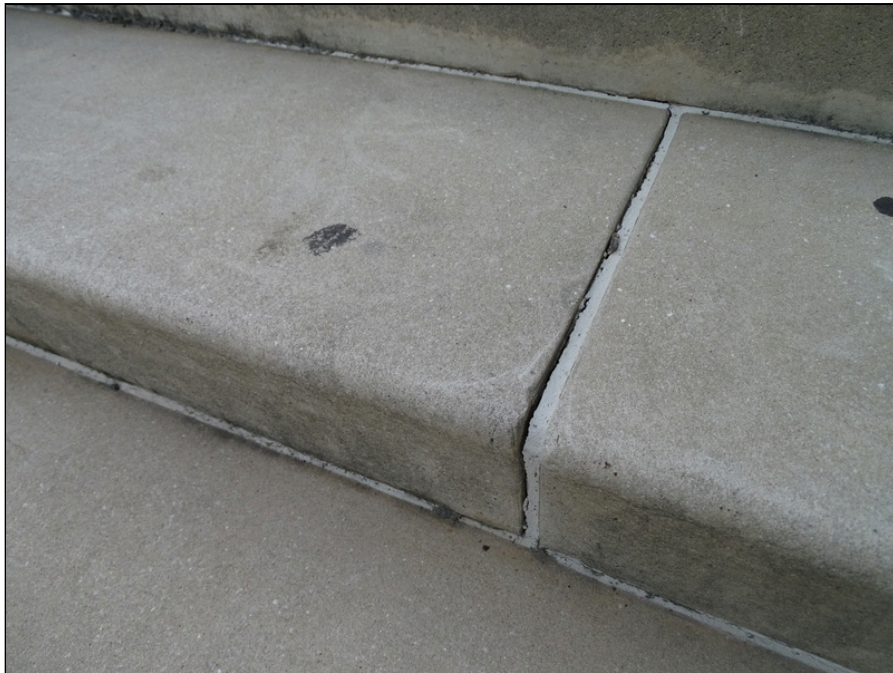
4 - Concrete steps at the west side of the building - note sealant deterioration

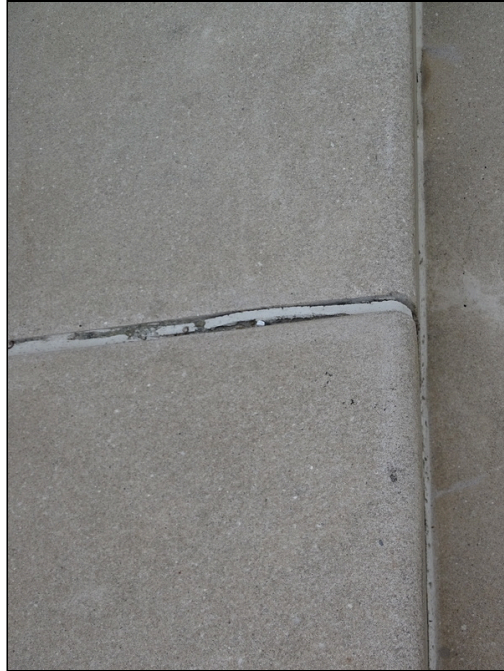
5 - Concrete steps at the west side of the building - note sealant deterioration

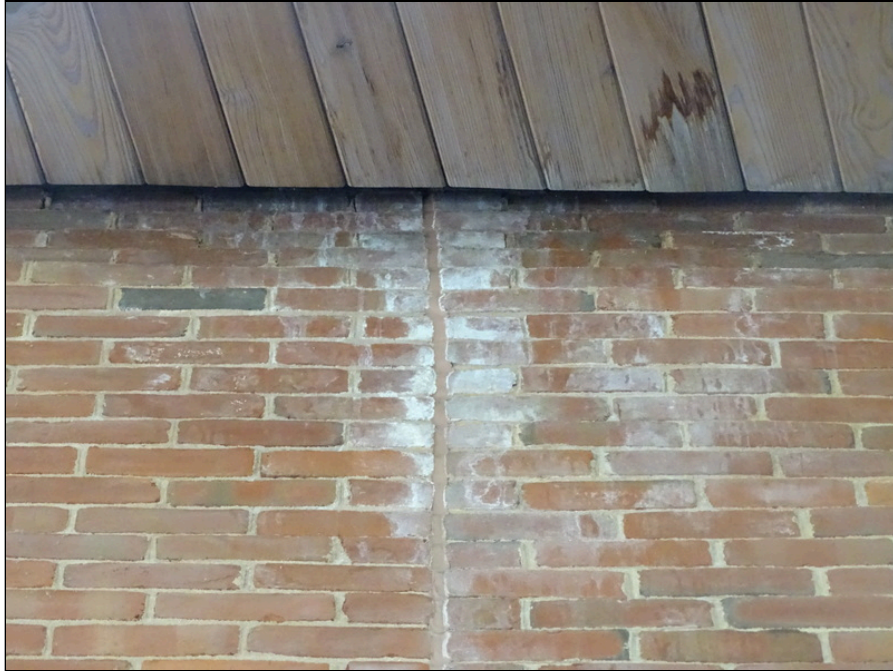
11 - Building exterior south side of the building - note deterioration

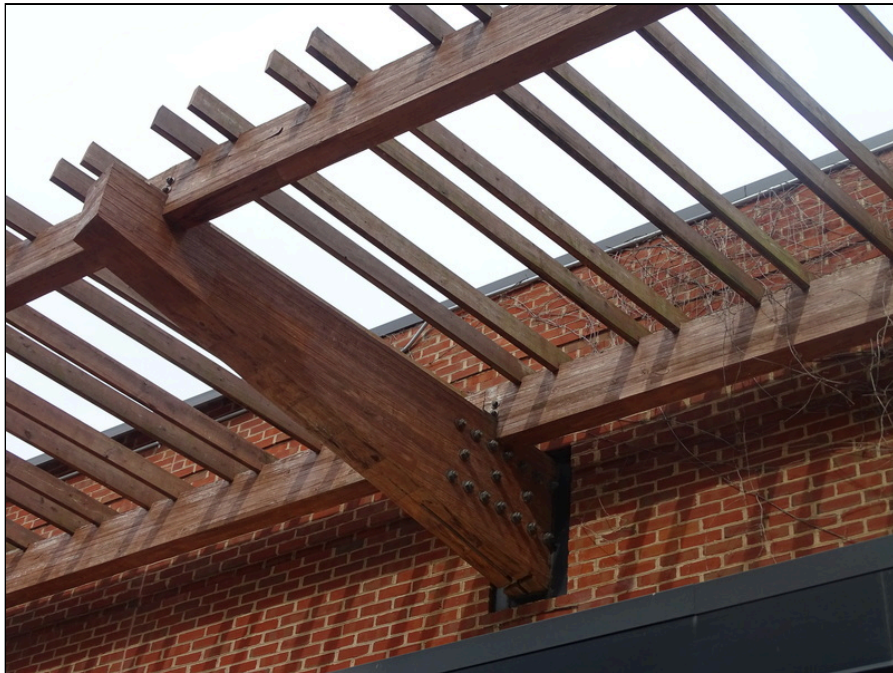
12 - Wood accent on the east side of the building - note cracking

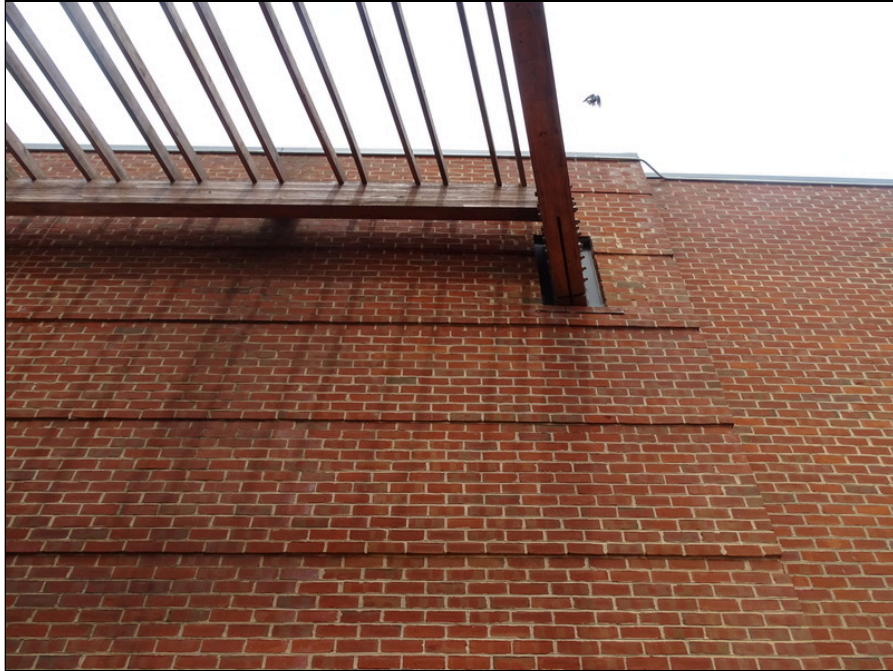
13 - Wood accent on the east side of the building - note cracking

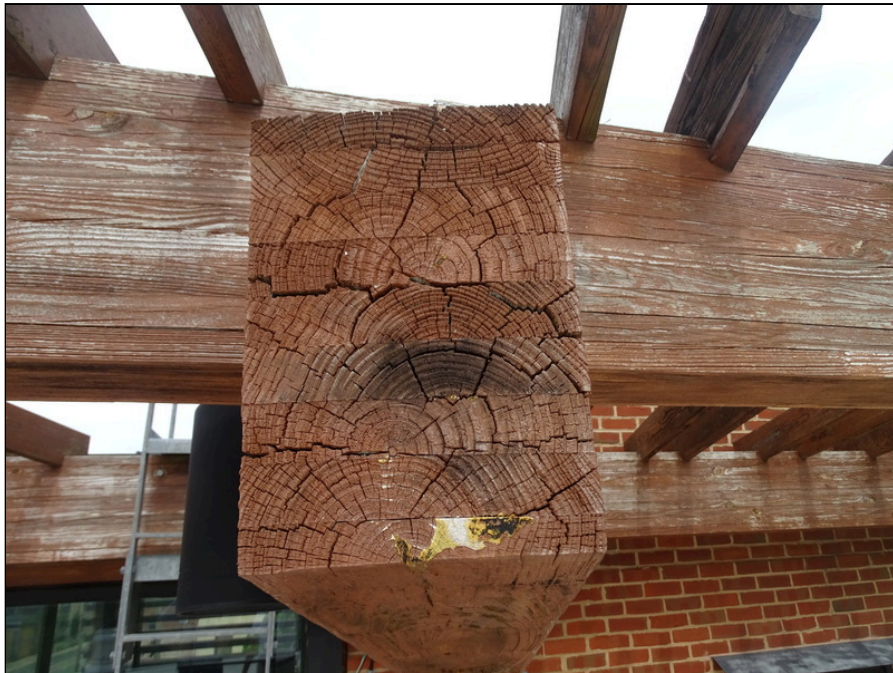
14 - Wood accent on the east side of the building - note cracking

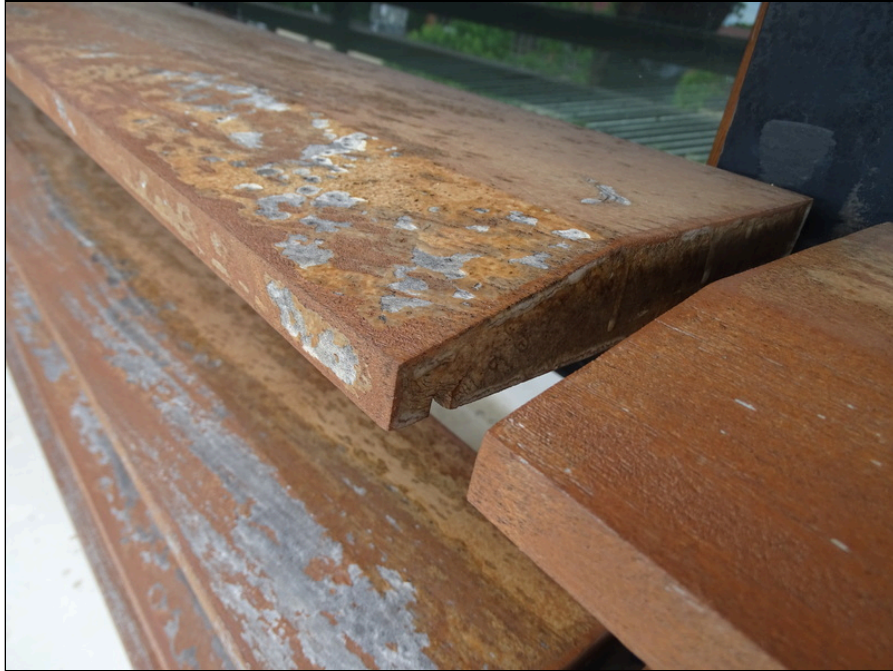
15 - Wood shade screen on west side of the building - note deterioration

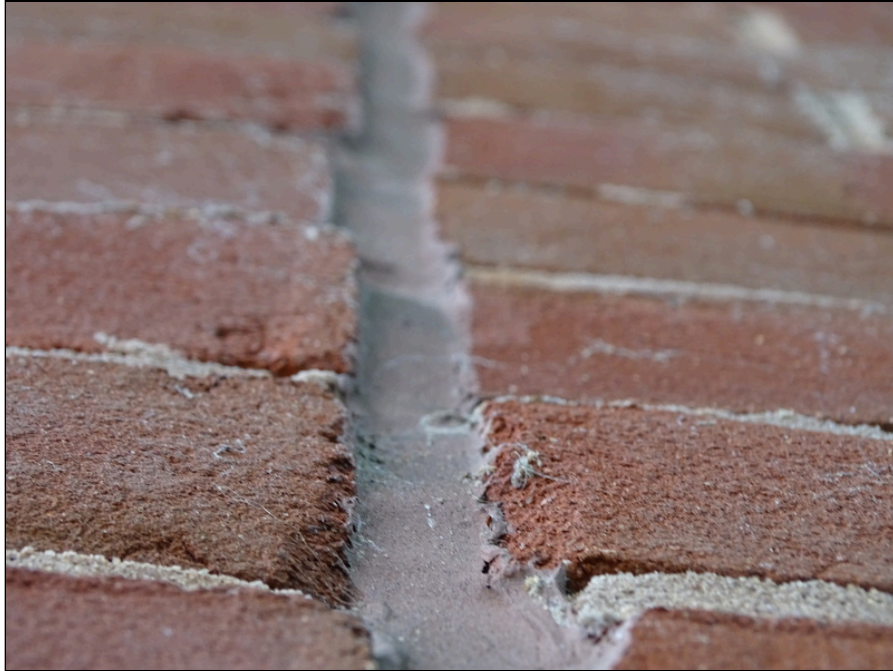
17 - Exterior wall - note sealant deterioration

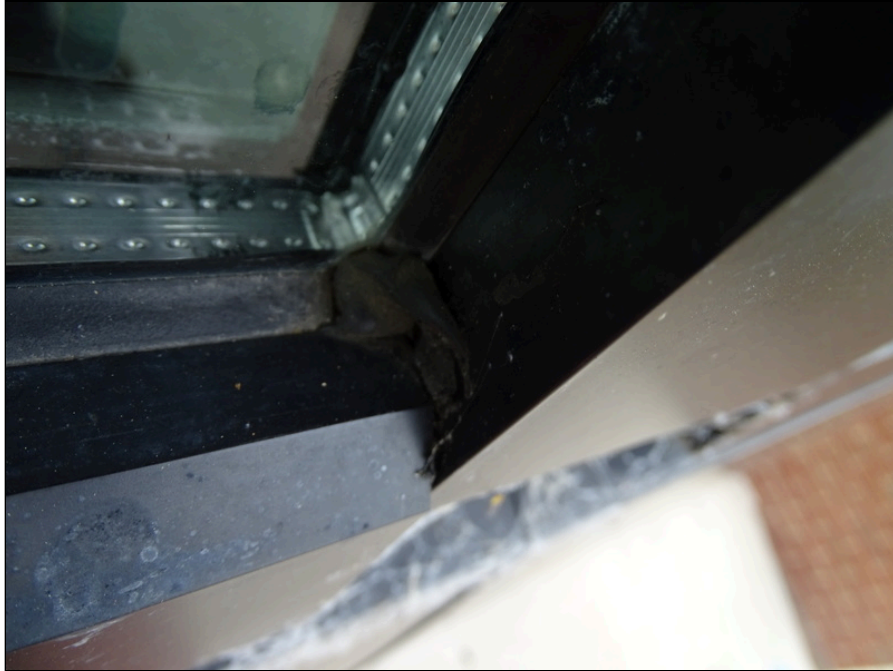
25 - Typical exterior window - note gasket deterioration

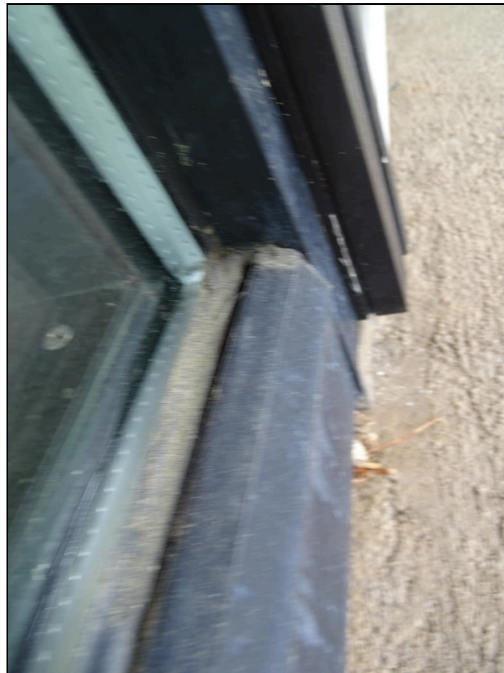
26 - Typical exterior window - note gasket deterioration

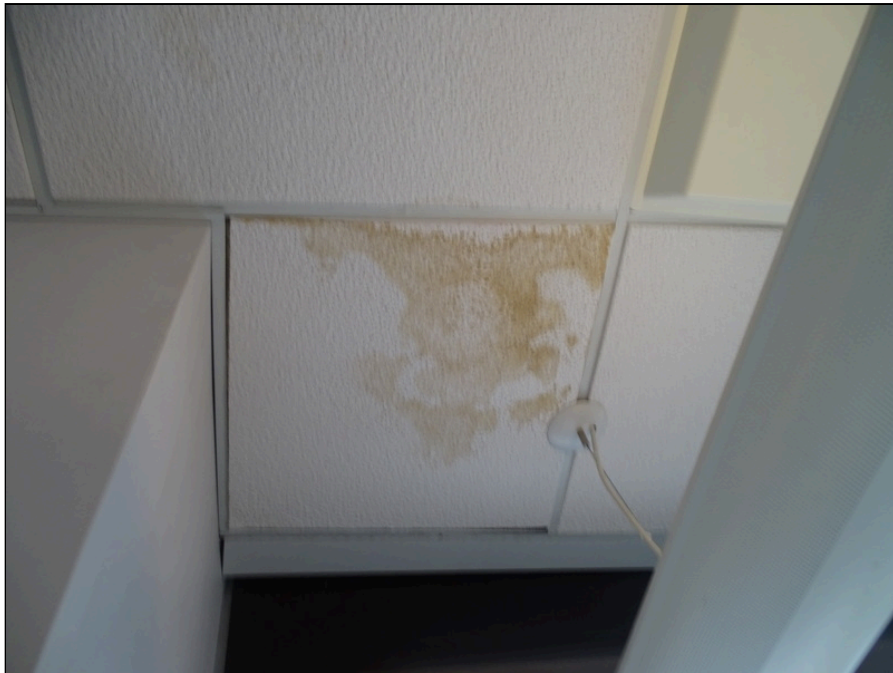
30 - Area of reported leakage of roofing system
