CAT OPERATIONS CENTER  
1545 AVON STREET EXT  
CHARLOTTESVILLE, VIRGINIA

ECS PROJECT NO. 46:6713

CITY OF CHARLOTTESVILLE - FACILITIES DEVELOPMENT

Reference: Facility Condition Assessment Report for CAT Operations Center, 1545 Avon Street Ext,  
Charlottesville, Virginia

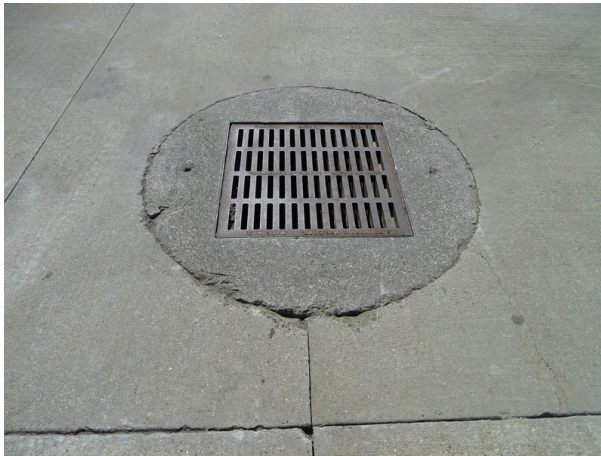
Typical storm sewer drop inlet

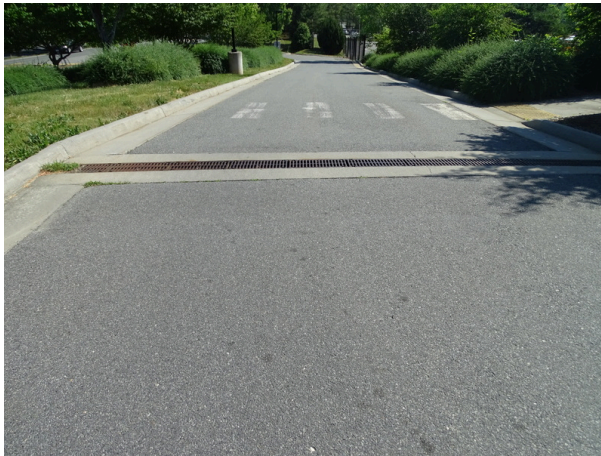
Vehicular access to the site is located on the northwest and southwest sides of the property. The entrance aprons are constructed of asphalt and were observed to be in generally good condition. Fire truck access is available on the north sides of Buildings A and B and on the south sides of Buildings C and D.

Asphalt pavement north side of site at entrance

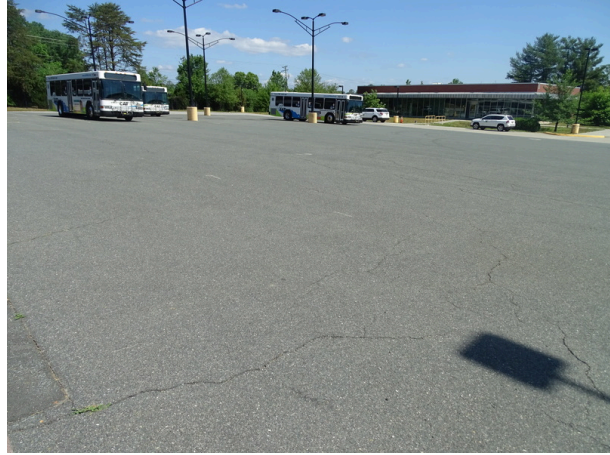
Asphalt pavement at bus parking area

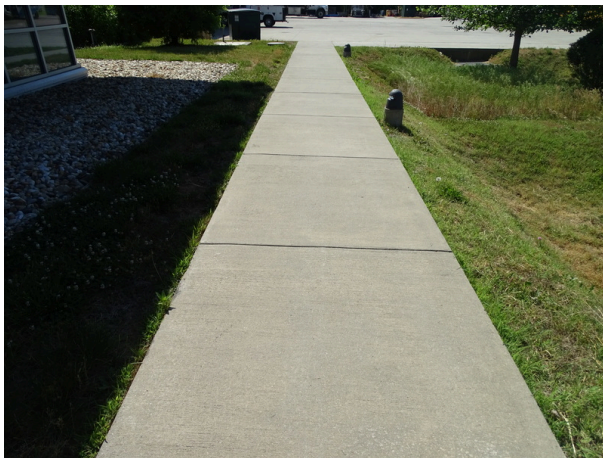
The site contains concrete sidewalks of undetermined thickness with regularly spaced control joints. The sidewalks and concrete areas were observed to be in good to fair condition. No cracked sections were observed, however, some areas showed spalling and therefore allowances for repair have been included over the duration of the report period.

Typical concrete sidewalk

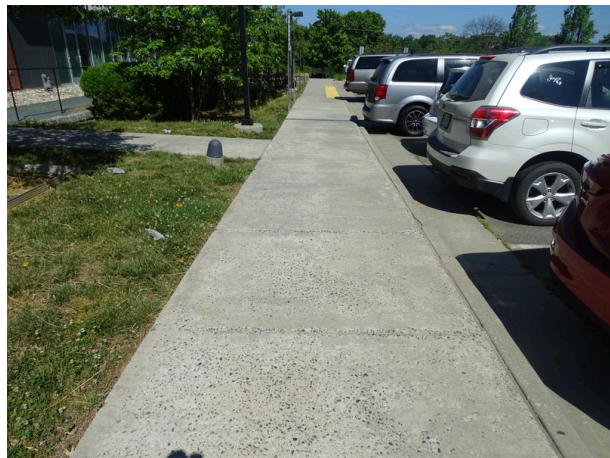
Concrete sidewalk - note spalling

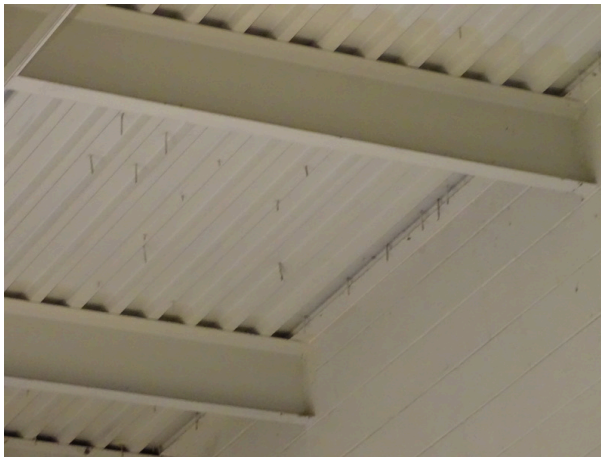
The structure of the buildings generally consist of concrete slab on-grade with metal columns, metal roof decks, and Concrete masonry unit bearing walls. The structural frame of the buildings were generally in good condition.

Typical structural framing

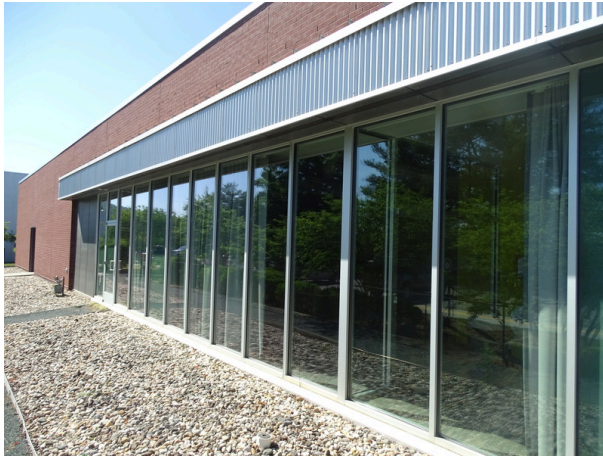
The primary exterior of Building A consists of brick veneer and metal panels. Decorative composite panels are located at the exterior walls near the windows. The building exteriors were generally in good condition. The expected useful life of mortared joints is approximately 20 years before re-pointing is required. Deterioration of mortar joints was not observed, but an allowance has been included during the study period for the repointing of joints. Exterior sealants are located around window and door frames, and vertical sealant joints are present in the bricks. Sealants have an expected useful life of 10 years to 12 years before replacement is needed. The sealants were in good condition and an allowance for replacement has been included during the study period.

Building exteriors at Building A

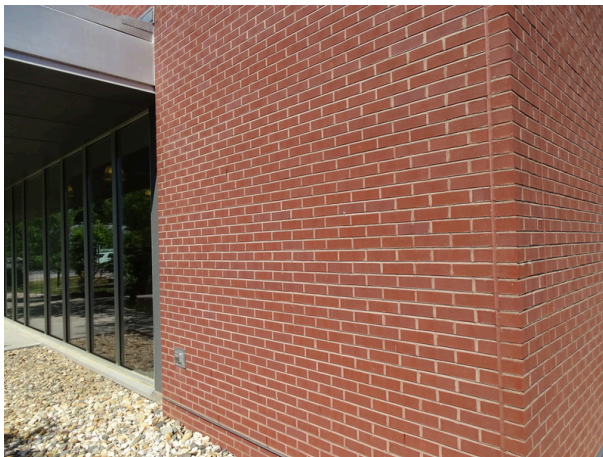
Building exteriors at Building A

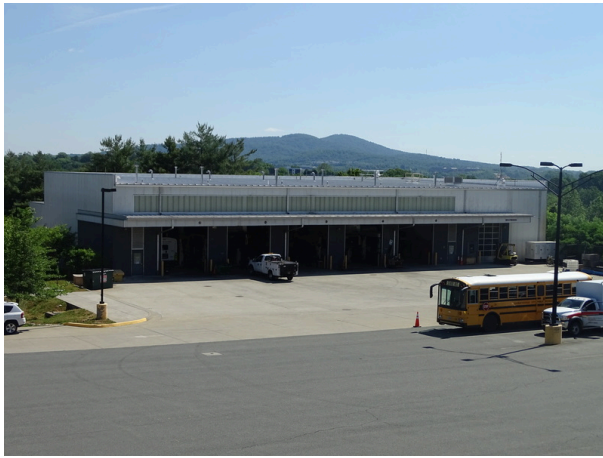
The primary exterior of Building B consists of metal panels and composite panels. Decorative composite panels are located at the exterior walls near the windows and doors. The building exteriors were generally in good condition. Exterior sealants are located around window and door frames. Sealants have an expected useful life of 10 years to 12 years before replacement is needed. The sealants were in good condition and an allowance for replacement has been included during the study period.

Building exteriors at Building B

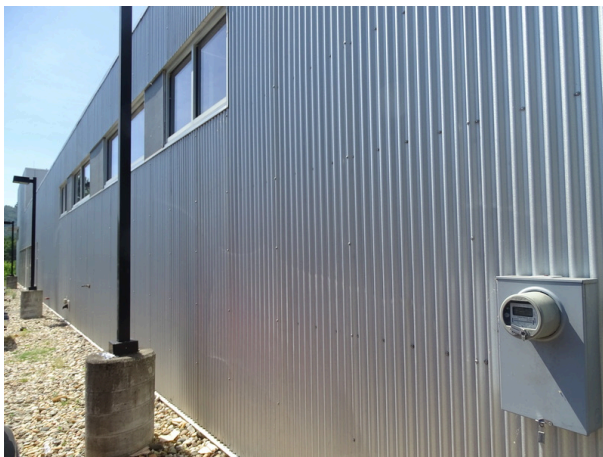
Building exteriors at Building B

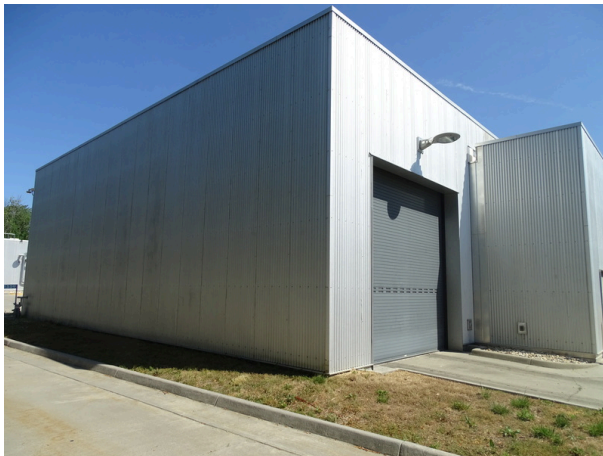
The primary exterior of Building D primarily consists of metal panels. Decorative composite panels are located at the exterior walls near the exit doors. The building exteriors were generally in good condition.

Building exteriors at Building D

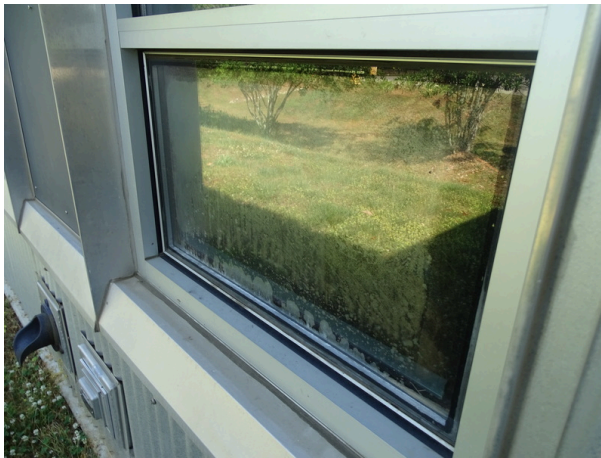
The window system for Building A consists of Ribbon window - double pane window units. Buildings B and C consisted of large picture windows. Building D did not have any windows. The gaskets in the windows were generally in good condition. The expected useful life of gaskets is typically 20 years; allowances have been included during the study period for window repairs as required over the study period.

Foggy window

3.3.8 Exterior Windows																													
REPAIR OR REPLACE WINDOW COMPONENTS	20	11	9	5,000	EA	\$1.00	\$5,000	100%									\$2,500							\$2,500					\$5,000

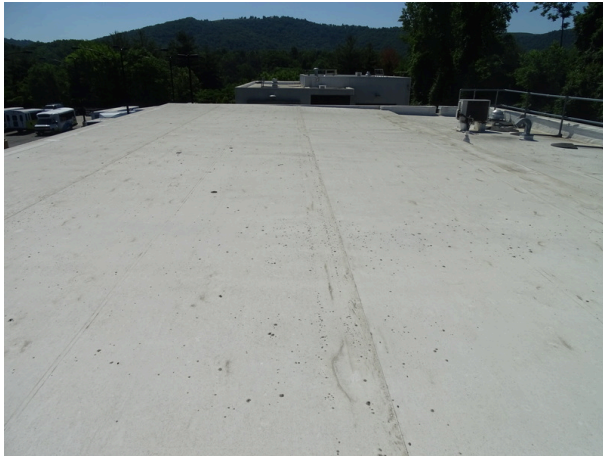
Building C roof

3.3.9 Roofing Systems																													
REPLACE SINGLE-PLY ROOFING SYSTEM AT BUILDING C	15	11	4	4,700	SF	\$14.00	\$65,800	100%				\$65,800																	\$65,800
REPLACE SINGLE-PLY ROOFING SYSTEM AT BUILDING D	15	11	4	5,700	SF	\$14.00	\$79,800	100%				\$79,800																	\$79,800

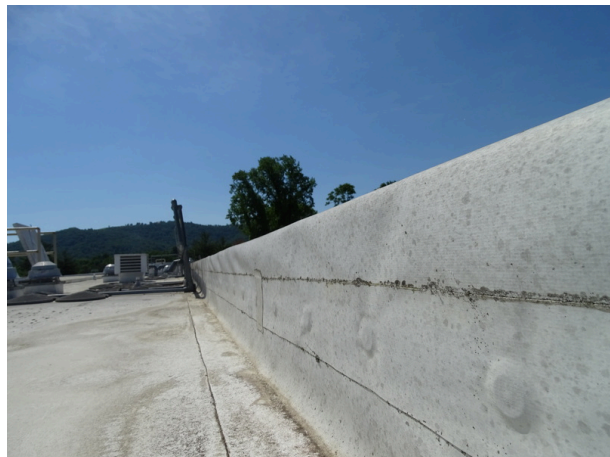
Building C roof - parapet wall deterioration

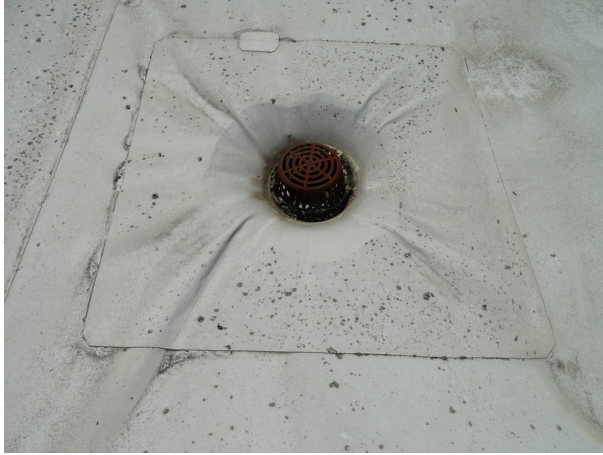
Building C roof - internal drainage

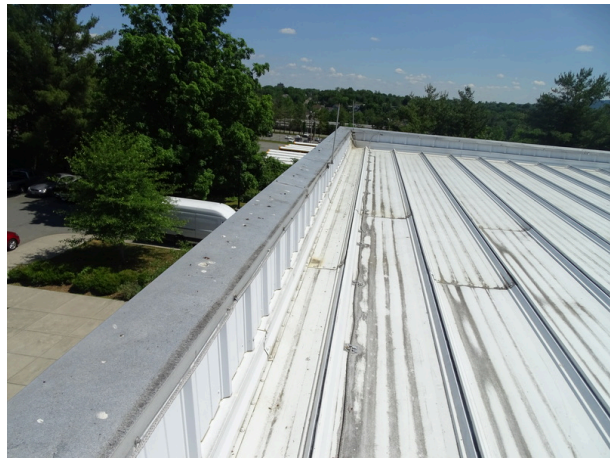
Building A roof

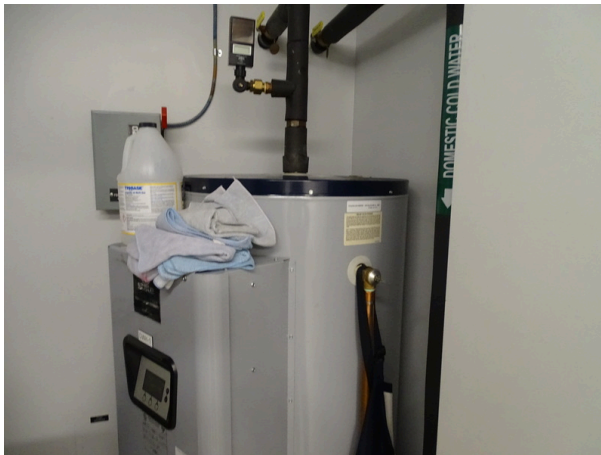
The expected useful life of a Electric domestic water heater is approximately 12 to 15 years. We recommend the Electric domestic water heaters be replaced during the study period.

Building A water heater

3.4.1.2 Domestic Hot Water Production																													
REPLACE WATER HEATER	12	11	1	4	EA	\$2,500.00	\$10,000	100%	\$2,500	\$2,500											\$2,500	\$2,500							\$10,000

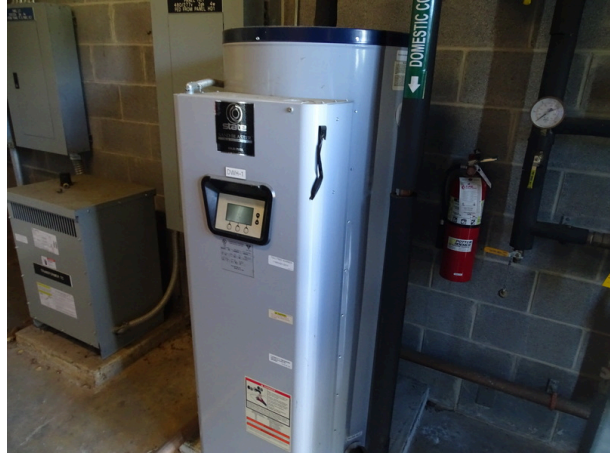
Building D water heater

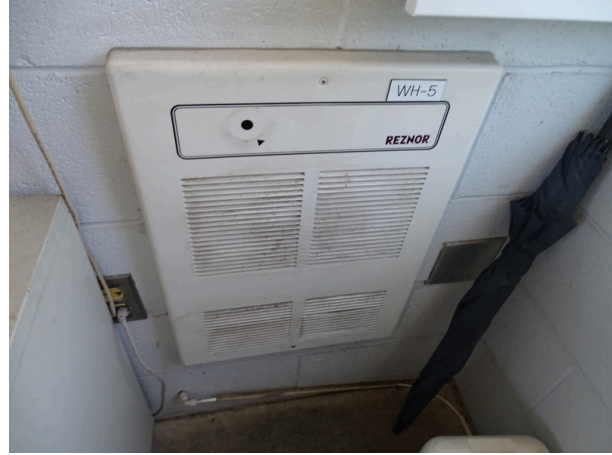
Building C unit heater

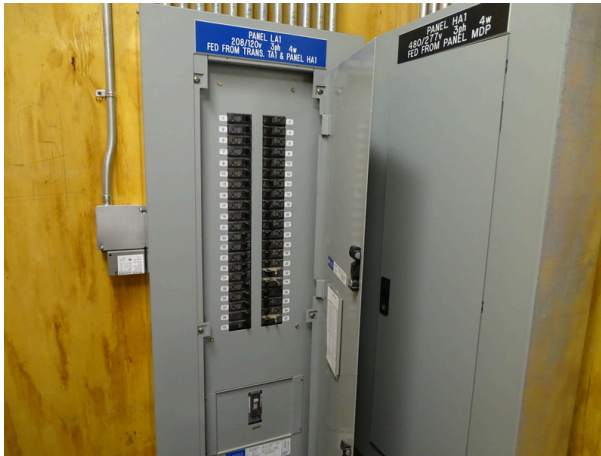
Power is distributed by copper wire from circuit breaker panels located throughout the buildings. The expected useful life of sub-panels is 50 years with proper maintenance. The circuit breaker panels were observed to be in generally good condition.

Building A electrical panels

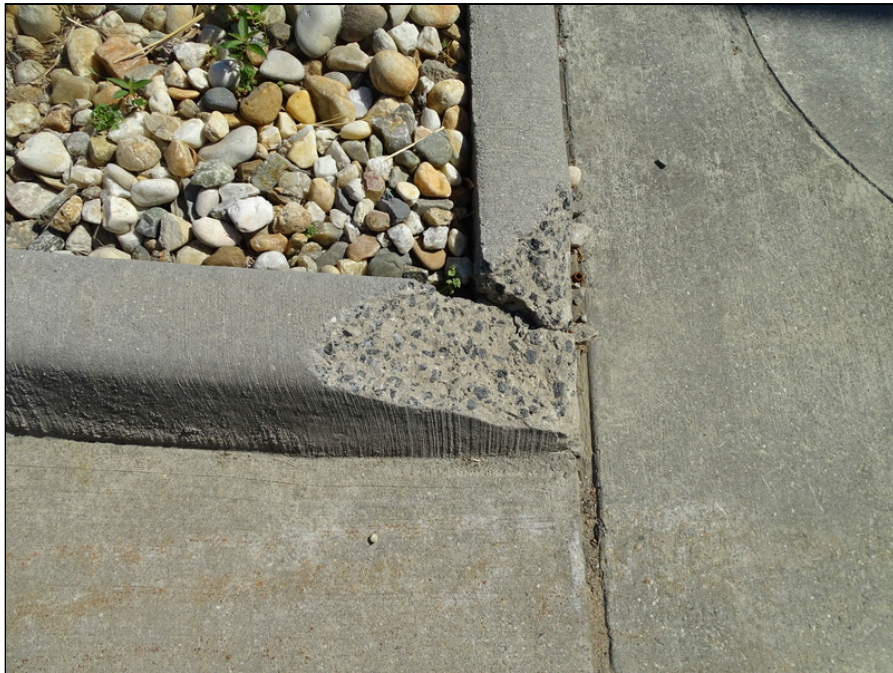
14 - Concrete curb - note damage

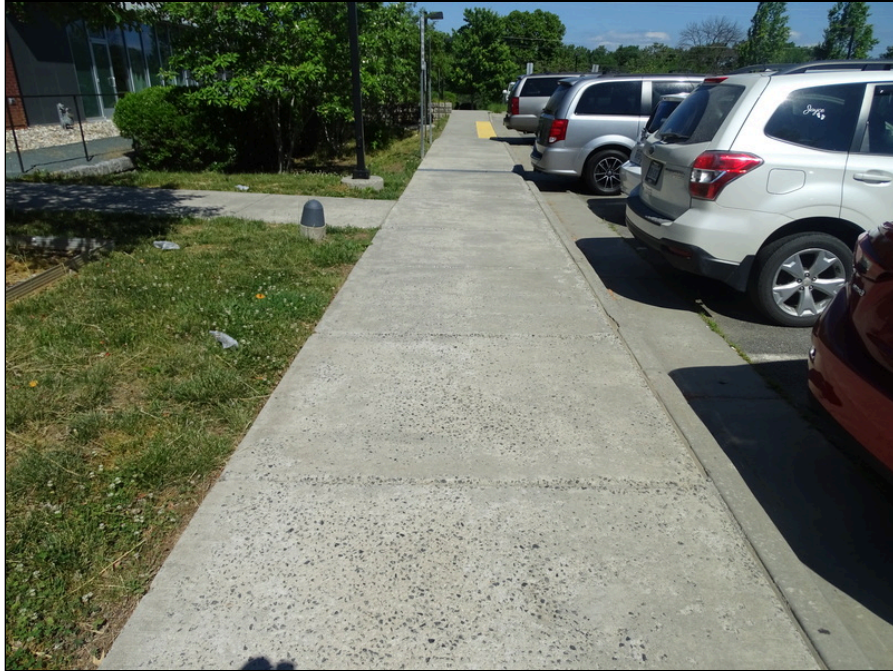
15 - Concrete sidewalk - note spalling

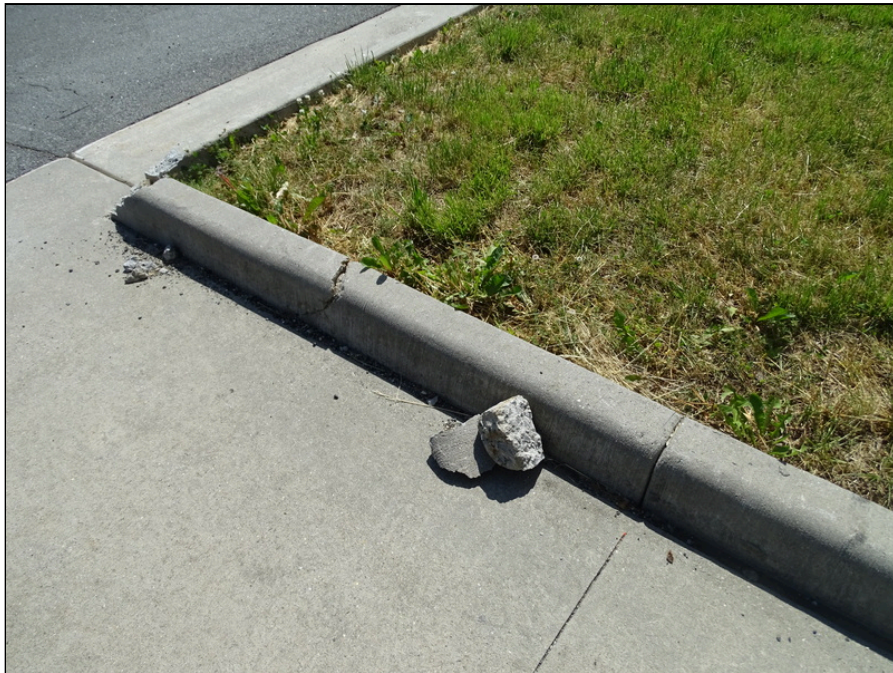
16 - Concrete curb - note damage

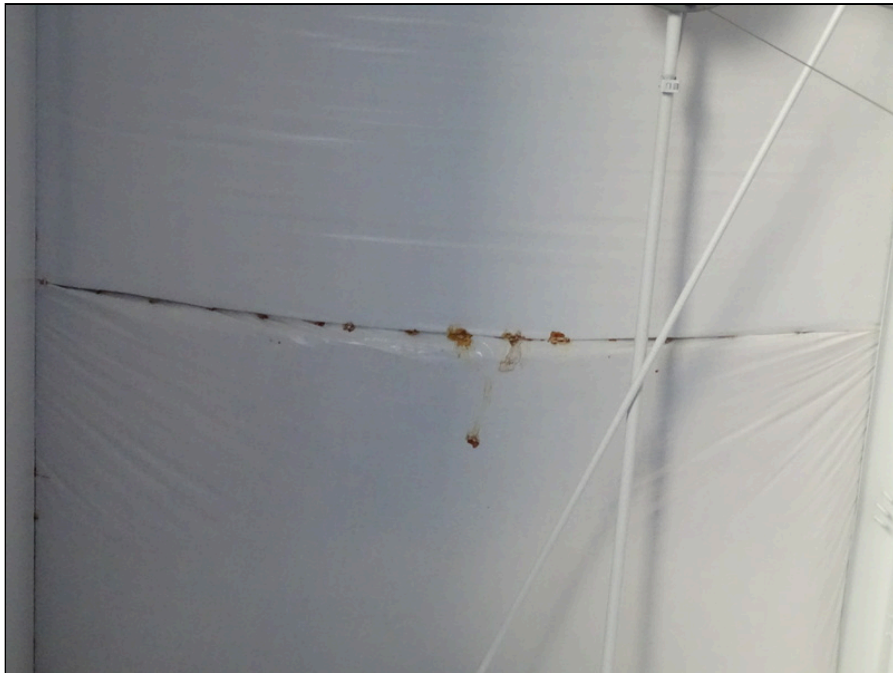
120 - Water leakage
