CATEC
1000 RIO ROAD EAST
CHARLOTTESVILLE, VIRGINIA

ECS PROJECT NO. 46:6713

CITY OF CHARLOTTESVILLE - FACILITIES DEVELOPMENT

Reference: Facility Condition Assessment Report for CATEC, 1000 Rio Road East, Charlottesville, Virginia

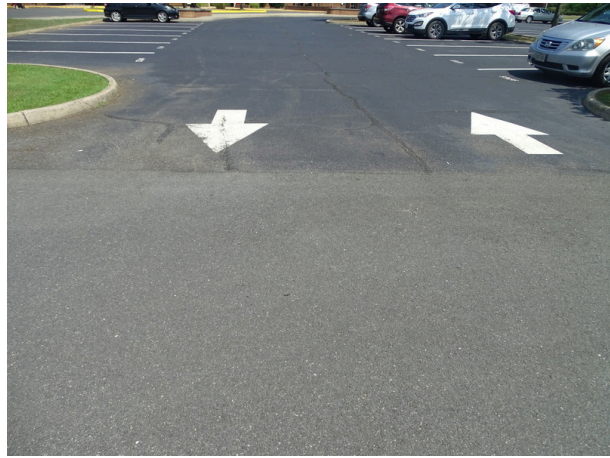
Asphalt pavement center drive lane looking north - note previous repair

Cost Recommendation	EUL	EFF AGE	RUL	Year	Cost
MILL, OVERLAY AND RESTRIPE EXISTING ASPHALT	20	1	19	20	\$80,000
Total					\$80,000

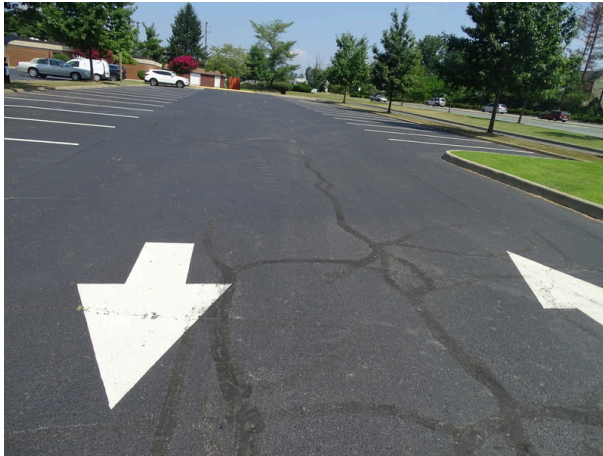
Asphalt pavement center drive lane looking north - note previous repair

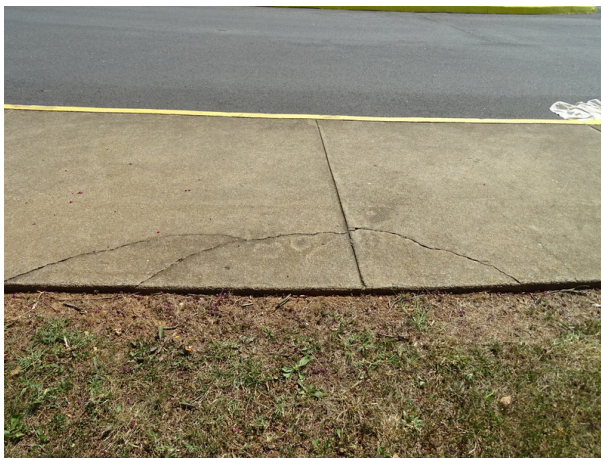
Typical concrete sidewalk - note cracking

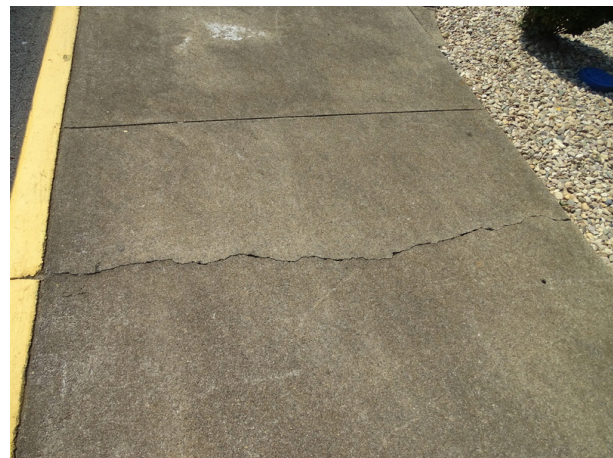
Typical concrete sidewalk - note cracking

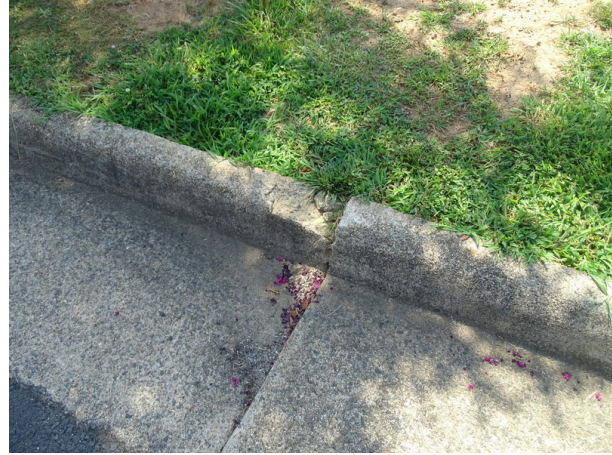
Typical concrete curb - note deterioration

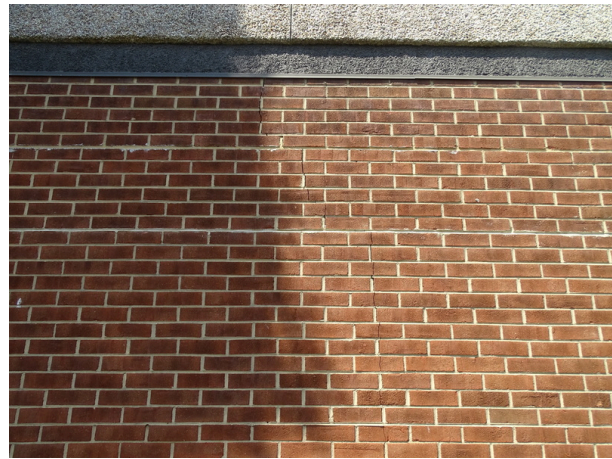
Building exterior southeast side of the building -
note cracking

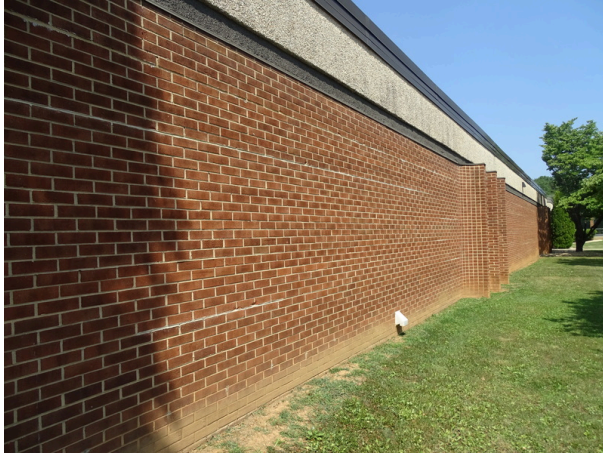
Building exterior east side of the building - note deterioration

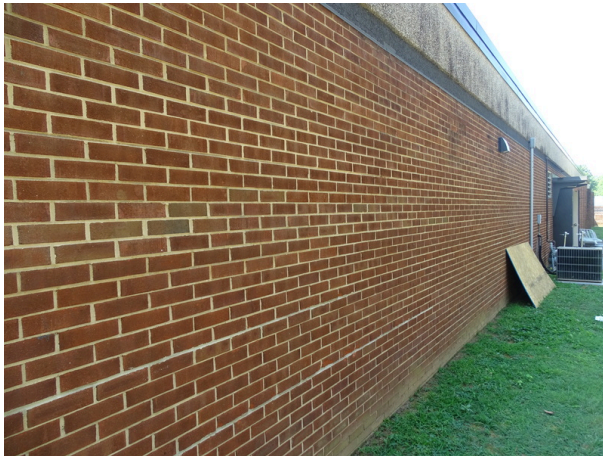
Building exterior east side of the building - note efflorescence

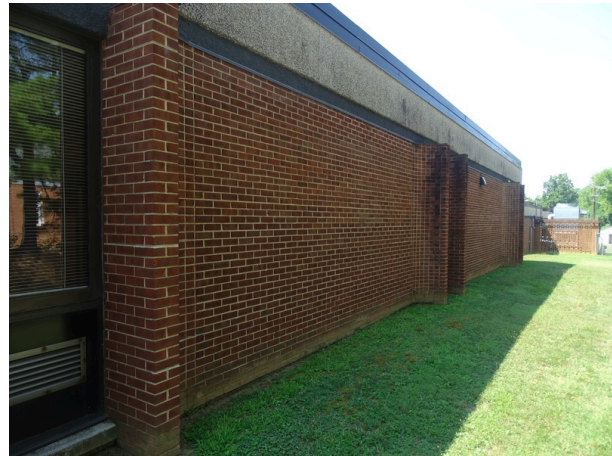
Building exterior northwest side of the building - note efflorescence

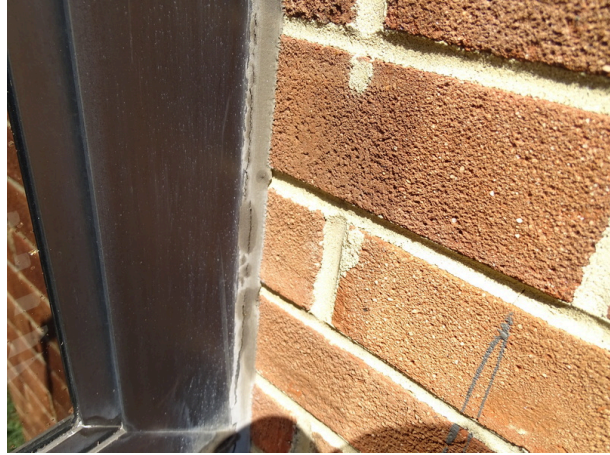
Typical exterior windows - note sealant deterioration

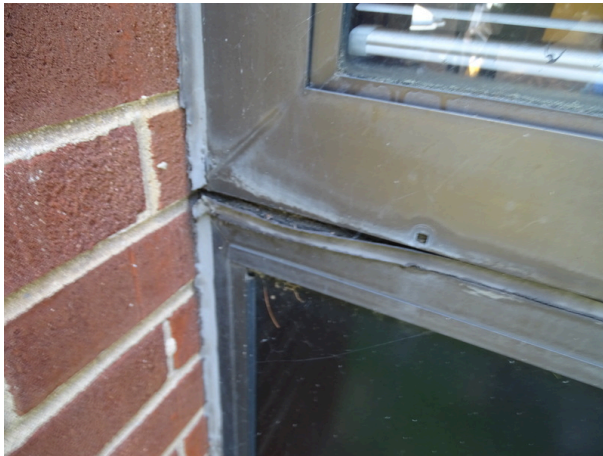
Typical exterior windows - note gasket deterioration

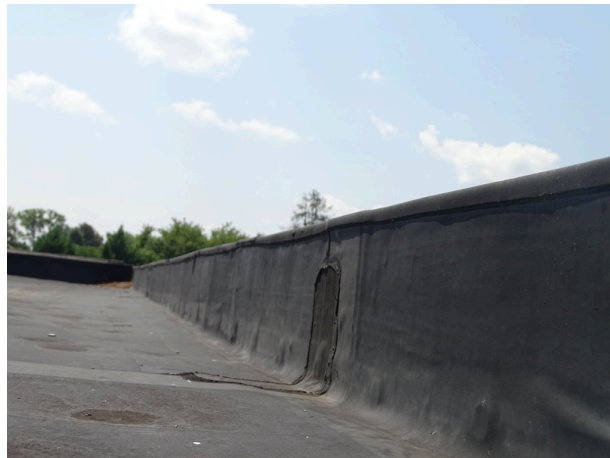
Single-ply membrane roofing system - note patching

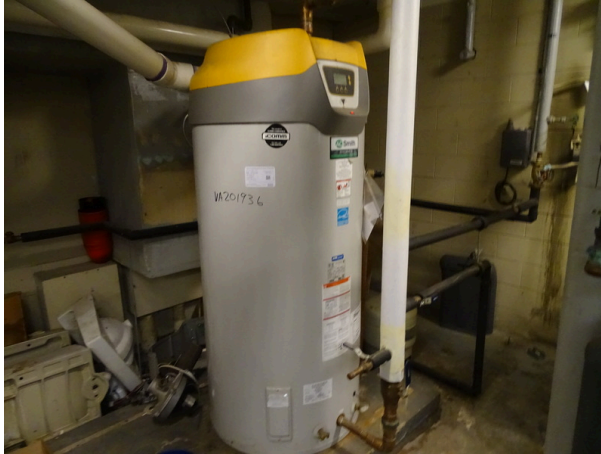
The expected useful life of a Gas water heater is approximately 15 years with proper maintenance. We recommend the Gas water heater be replaced during the study period.

Gas water heater located in main utility room

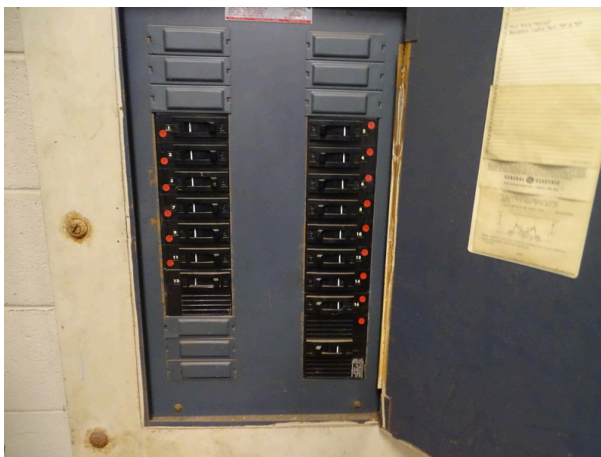
Power is distributed by copper wire from circuit breaker panels located throughout the building. The expected useful life of sub-panels is 50 years with proper maintenance. Some circuit breaker panels were reportedly original equipment. The circuit breaker panels were observed to be in generally fair condition. We recommend replacing the older, original panels.

Typical electrical circuit breaker panel

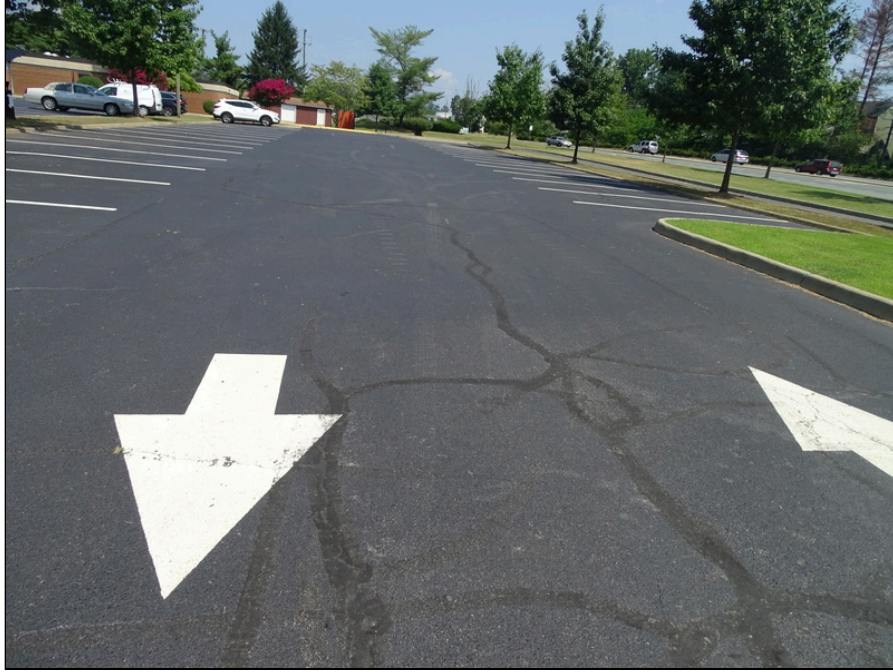
3 - Asphalt pavement center drive lane looking north - note previous repair

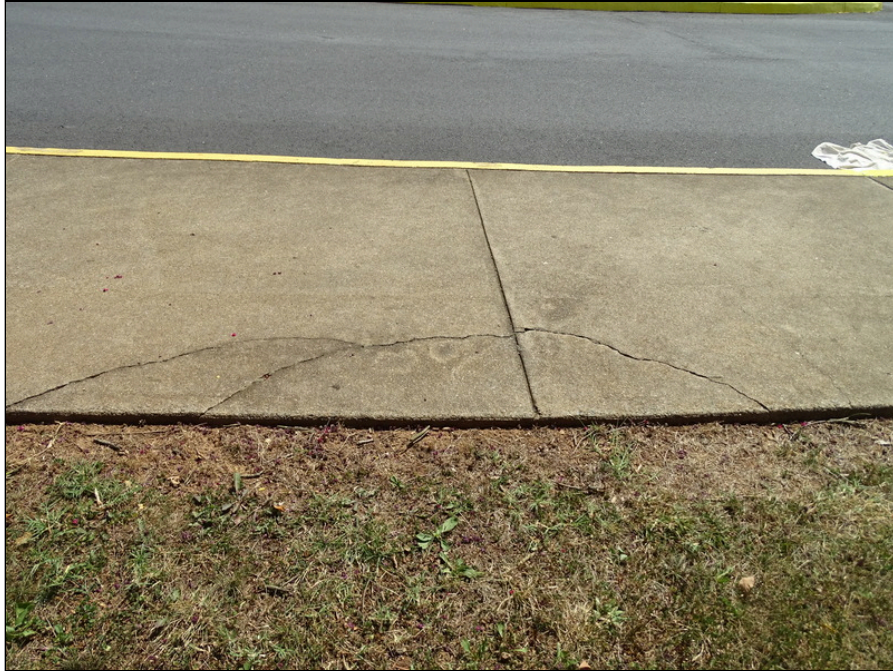
5 - Typical concrete sidewalk - note cracking

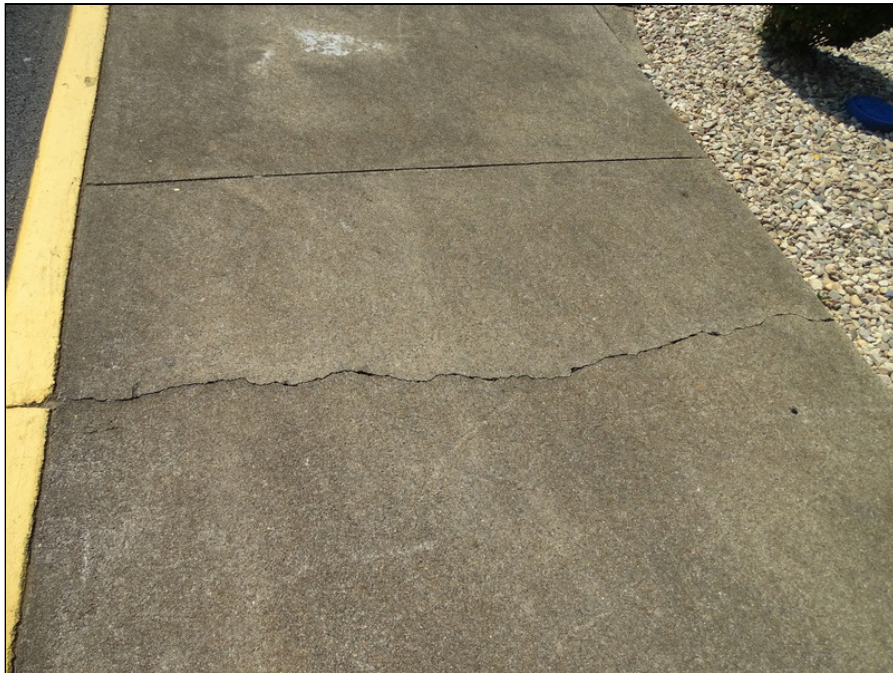
6 - Typical concrete sidewalk - note cracking

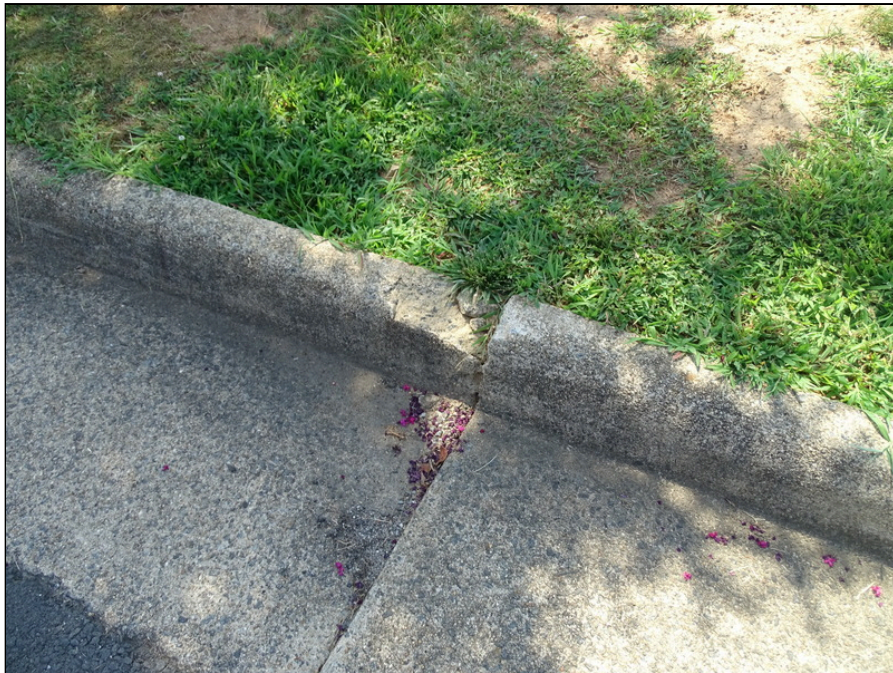
8 - Typical concrete curb - note deterioration

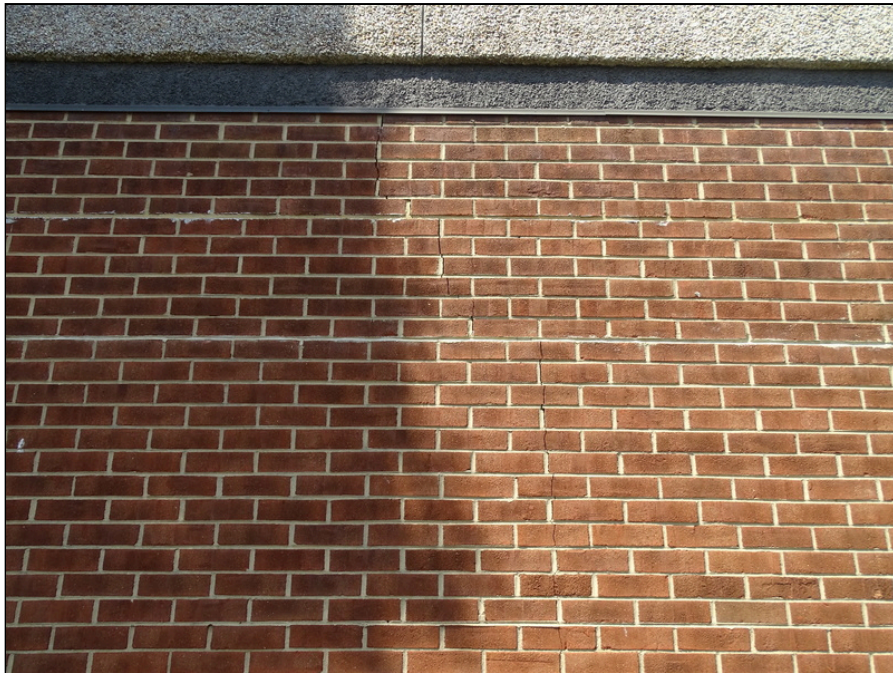
24 - Building exterior southeast side of the building - note cracking

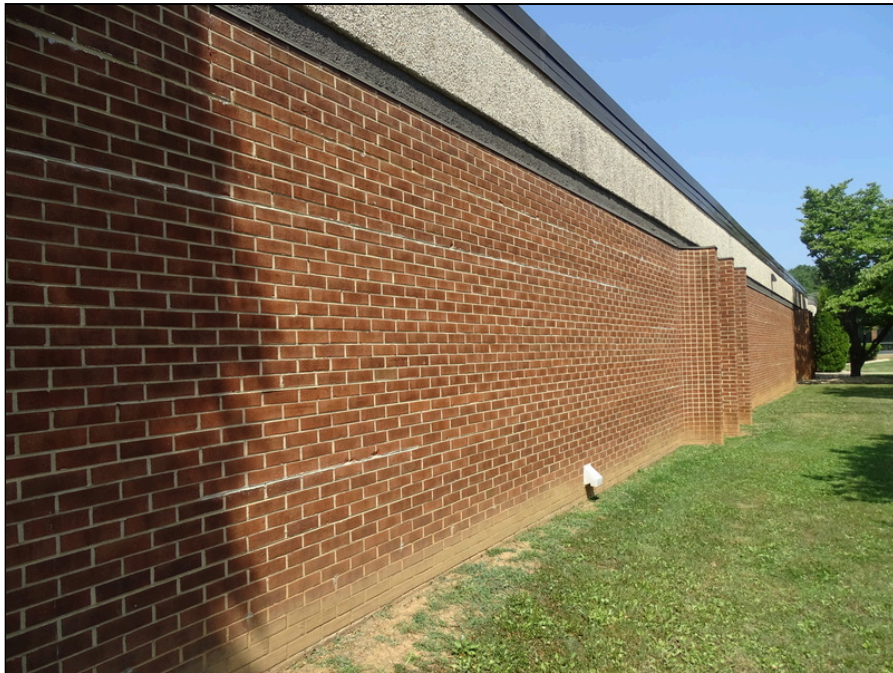
26 - Building exterior east side of the building - note deterioration

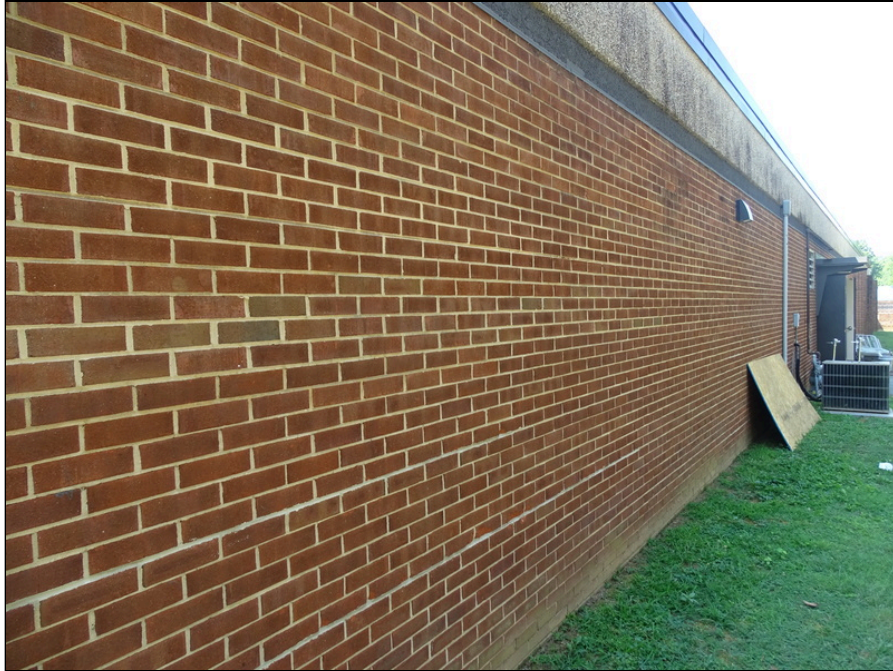
27 - Building exterior east side of the building - note efflorescence

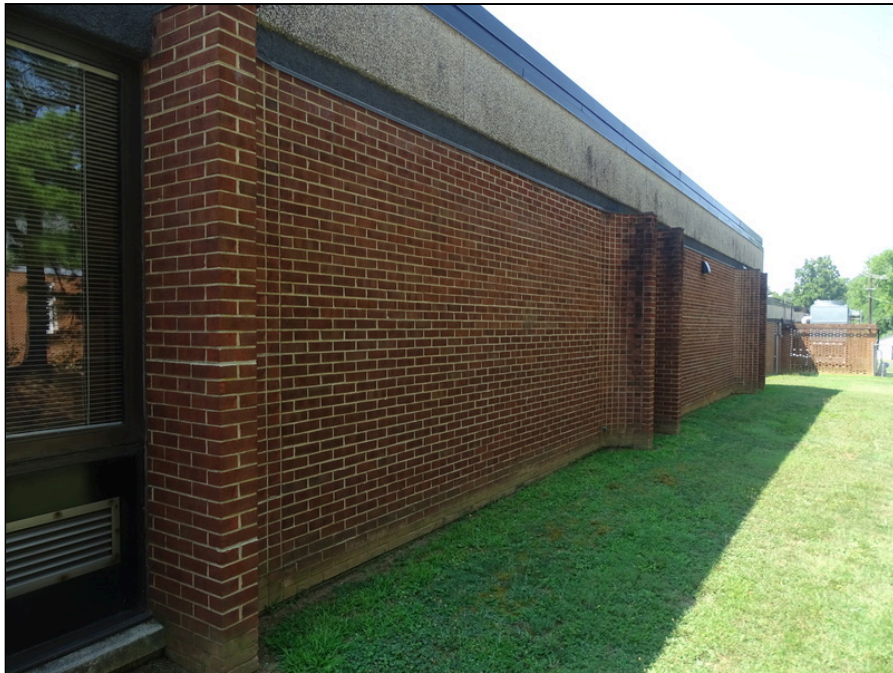
28 - Building exterior northwest side of the building - note efflorescence

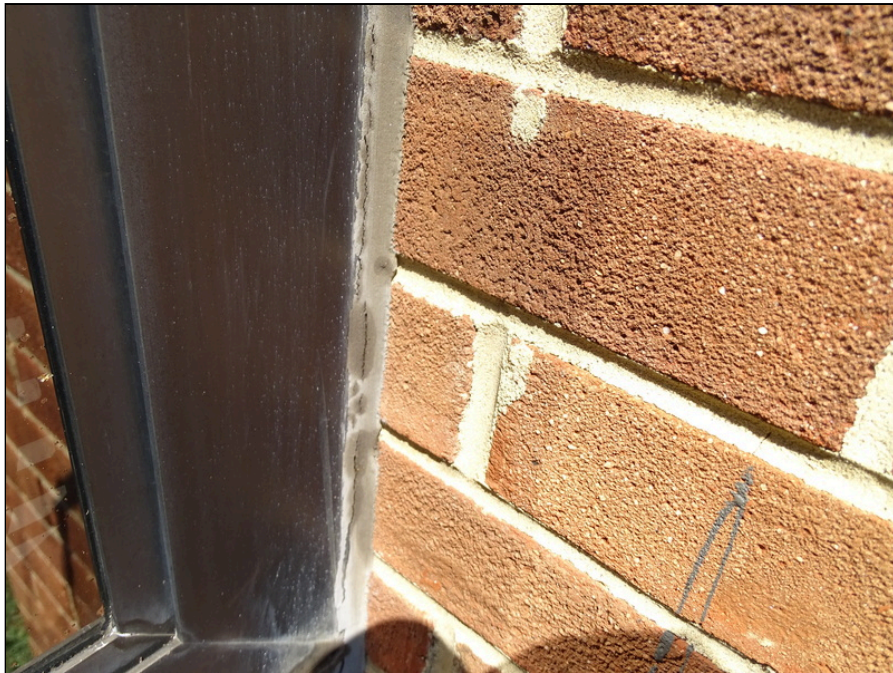
36 - Typical exterior windows - note sealant deterioration

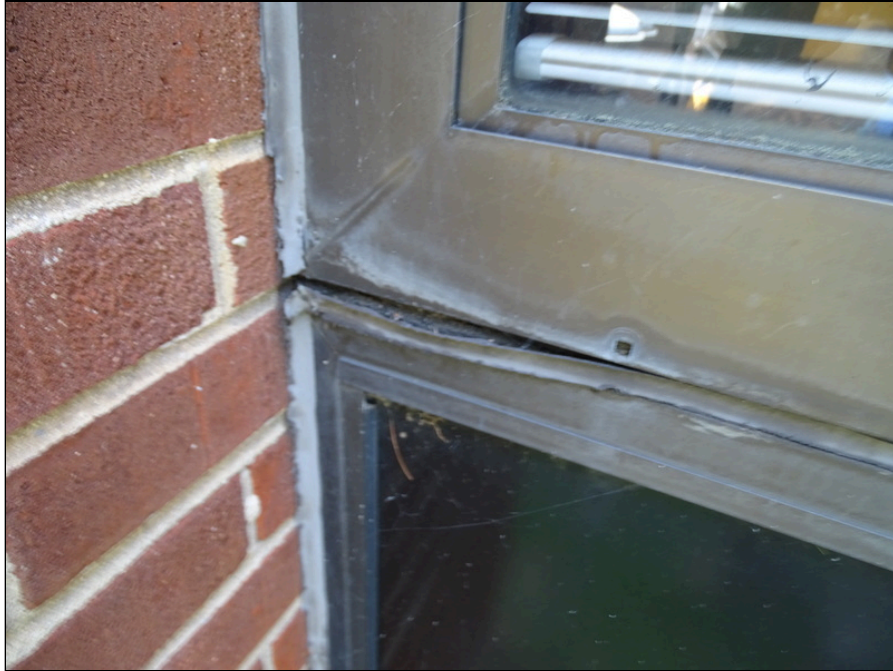
37 - Typical exterior windows - note gasket deterioration

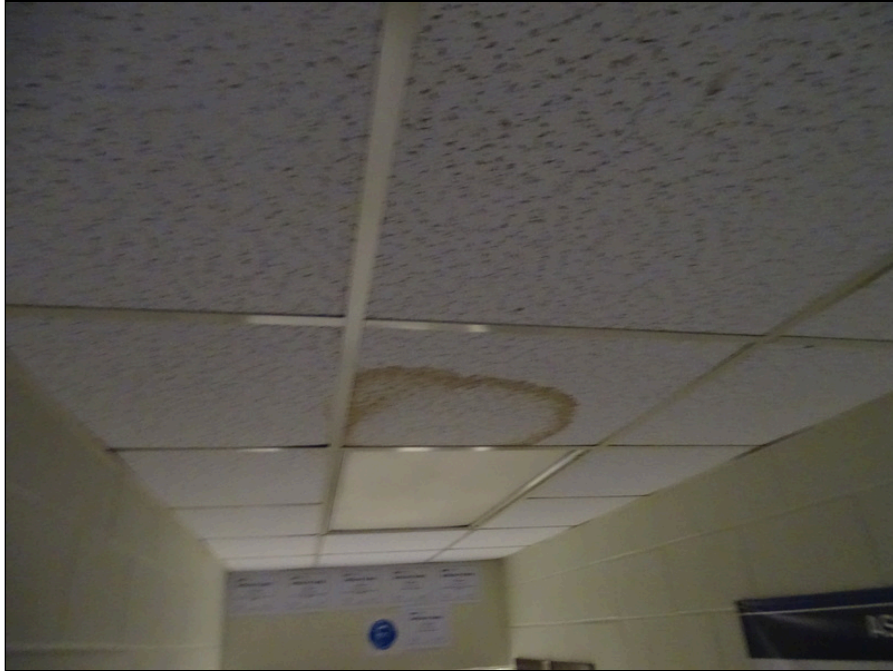
47 - Typical ceiling - note water leakage
