CHARLOTTESVILLE HIGH SCHOOL STADIUM FIELD HOUSE
1401 MELBOURNE ROAD
CHARLOTTESVILLE, VIRGINIA

ECS PROJECT NO. 46:6713

CITY OF CHARLOTTESVILLE - FACILITIES DEVELOPMENT

Reference: Facility Condition Assessment Report for Charlottesville High School Stadium Field House,
1401 Melbourne Road, Charlottesville, Virginia

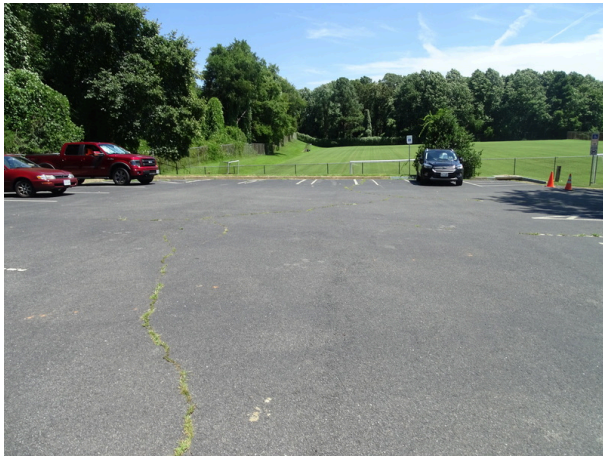
Asphalt-paved drive lanes and parking areas are located on the northwest and southwest end of the site which also provides access to the site. The asphalt pavement was observed to be in generally good to fair condition with some limited cracks observed on the pavement and fading of striping observed. Striping was in fair condition. The expected useful life of asphalt pavement is 20 years. Based on the limited areas of cracking, we recommend an allowance to perform repairs as needed.

Asphalt drive lane and parking area at
northwest end of site - note cracking

Cost Recommendation	EUL	EFF AGE	RUL	Year	Cost
REPAIR ASPHALT PAVEMENTS AS NEEDED	20	15	5	5	\$3,000
				10	\$3,000
				15	\$3,000
Total					\$9,000

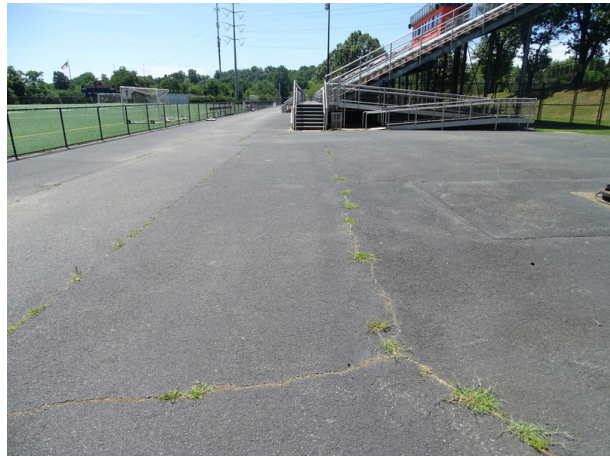
Asphalt walkway west end of site - note cracking

An asphalt sidewalk is located around the perimeter of the field and field house building. The asphalt sidewalk was generally in good to fair condition condition. We recommend that cracked areas be repaired as needed.

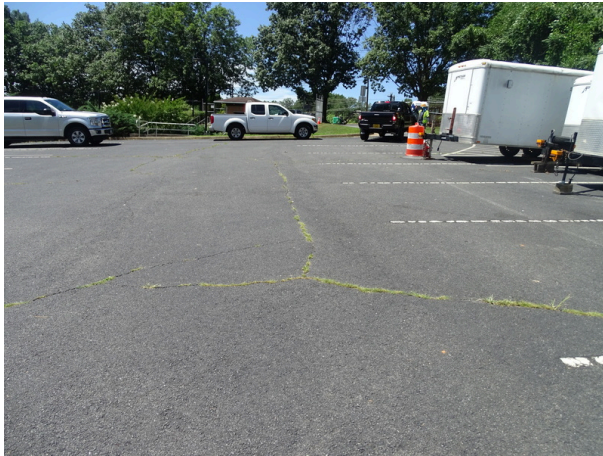
Asphalt pavement - note cracking

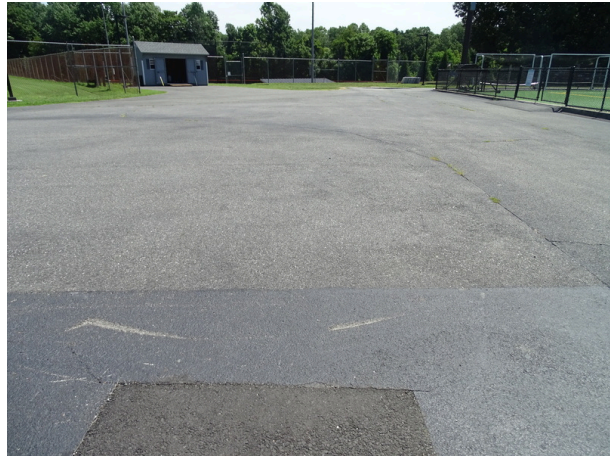
Asphalt pavement - note cracking

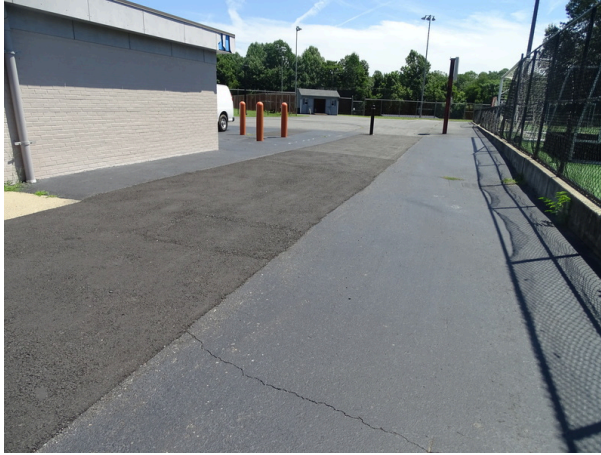
Asphalt walkways - note cracking and previous repair

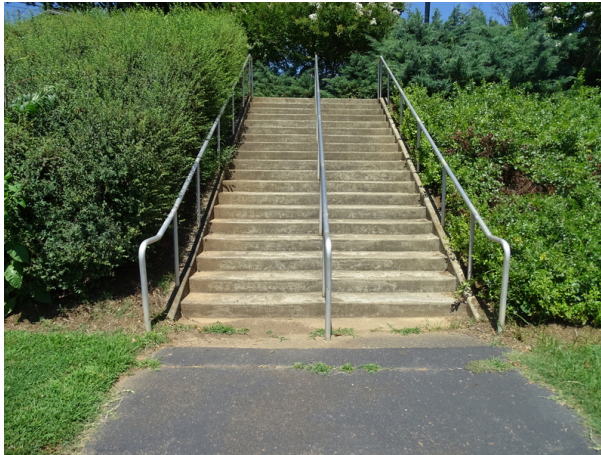
The concrete steps and ramps were observed to be in generally good to fair condition. The handrails adjacent to the steps and ramps were observed to be in generally good condition. We recommend the concrete steps be repaired as needed.

Concrete stair at north end of the site

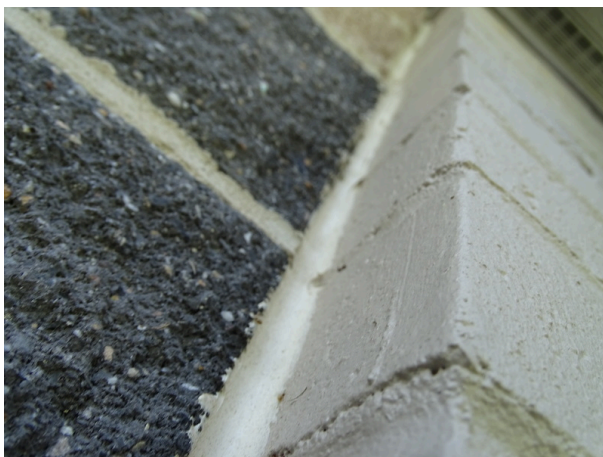
Various sealants were observed at material transitions and were in good condition. The expected useful life of sealants is 15 years. an allowance has been provided to replace the sealants during the report period.

Exterior sealant - note deterioration

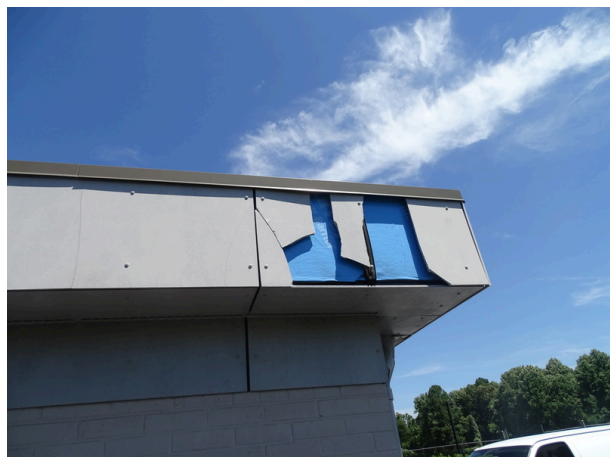
Typical exterior - note deterioration

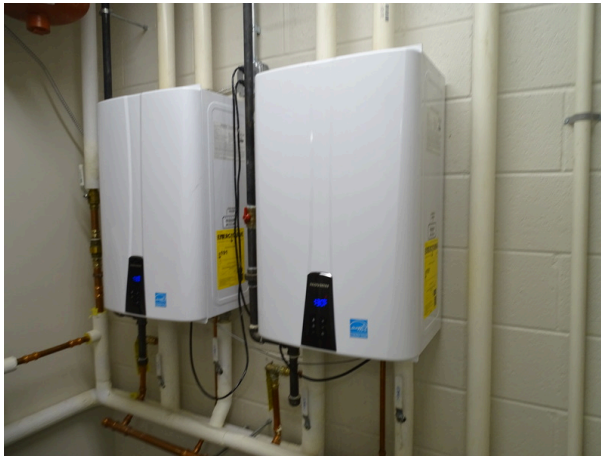
Domestic hot water to the building is provided by Tankless gas domestic water heaters and an electric water heater. The expected useful life of a water heater is approximately 12 to 15 years with proper maintenance. The water heaters were generally in good condition. We recommend the water heaters be replaced during the report period.

Tankless water heaters

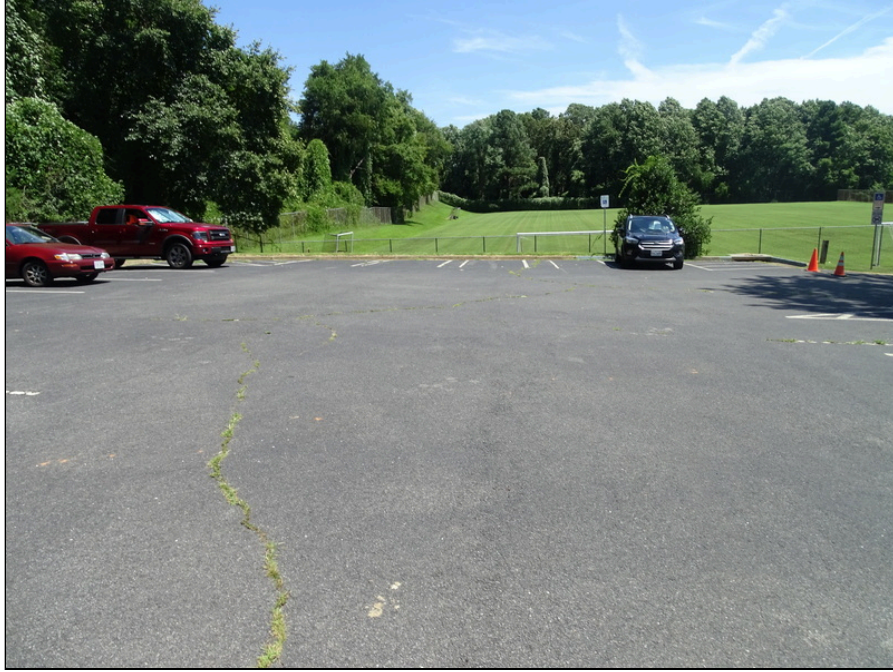
3 - Asphalt drive lane and parking area at northwest end of site - note cracking

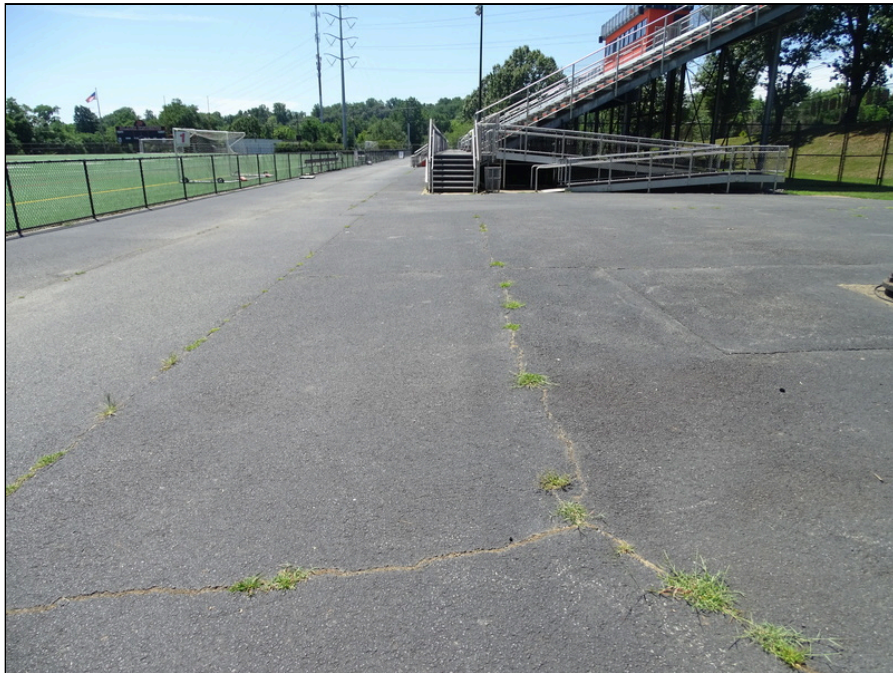
4 - Asphalt walkway west end of site - note cracking

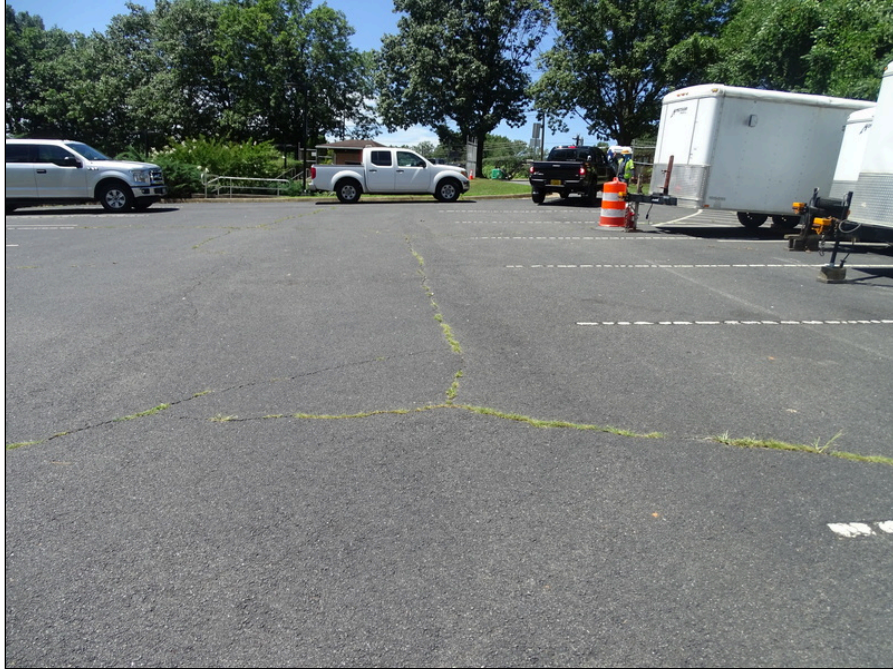
5 - Asphalt pavement - note cracking

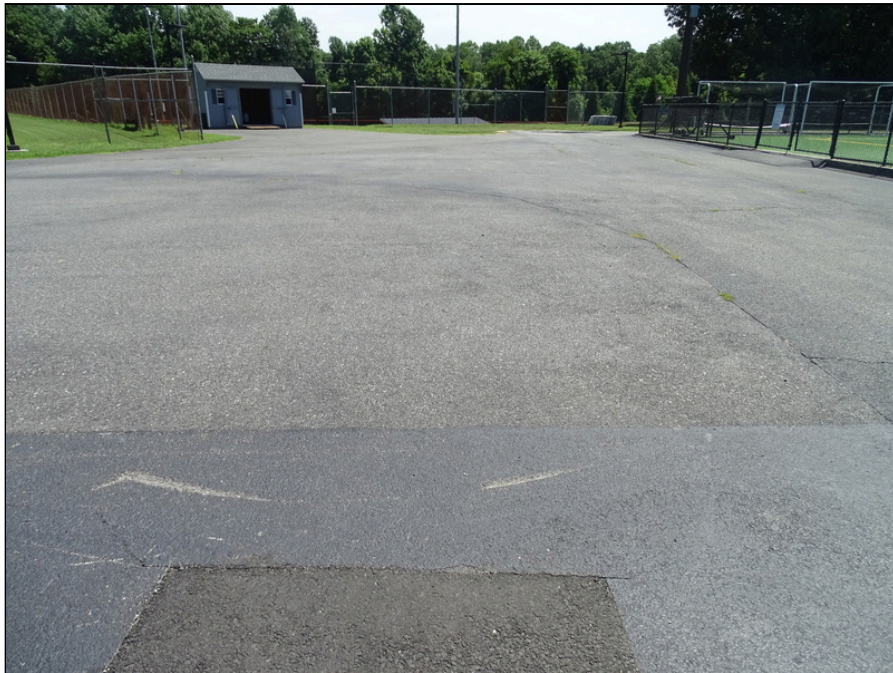
6 - Asphalt pavement - note cracking

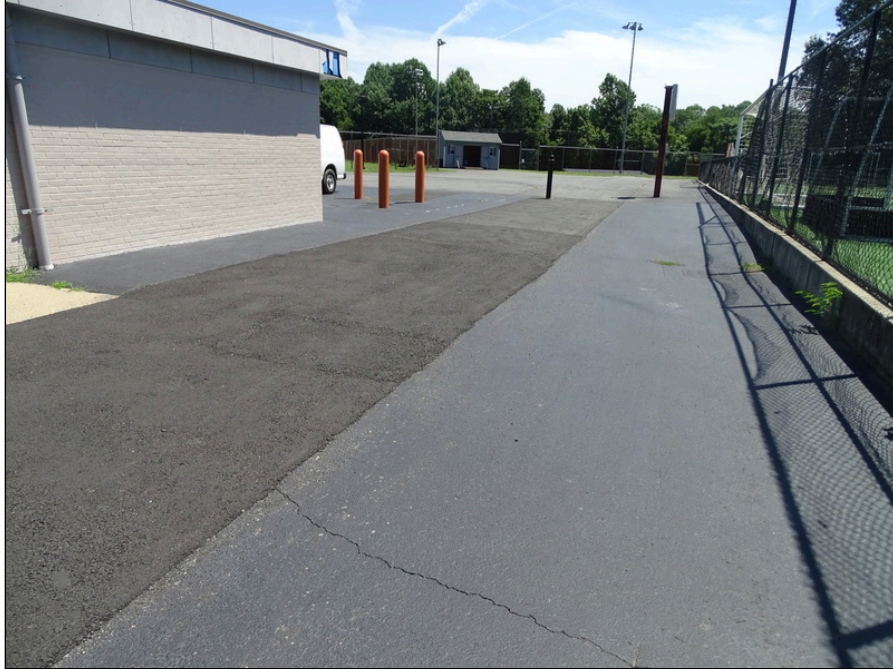
7 - Asphalt walkways - note cracking and previous repair

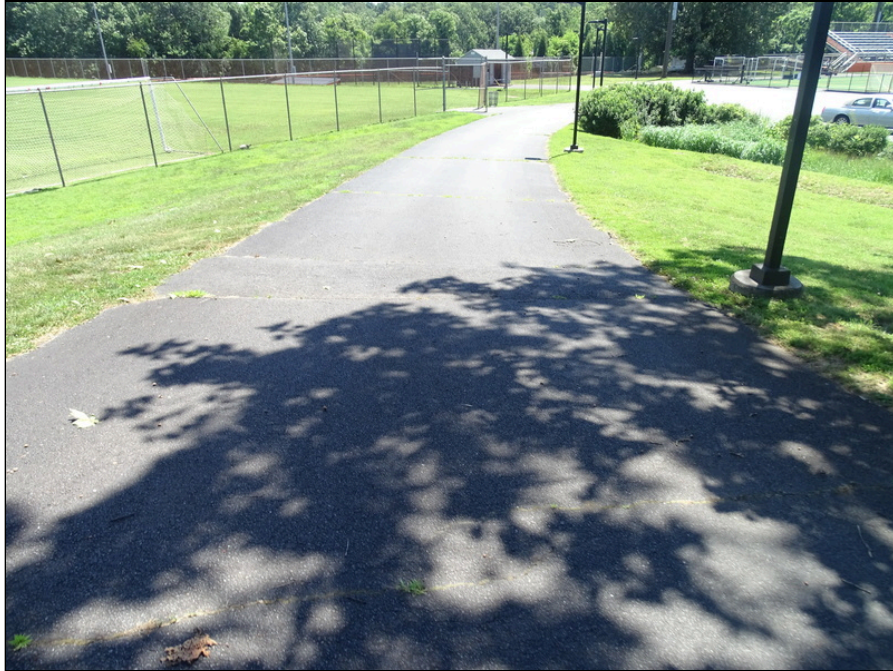
9 - Asphalt drive lane at northeast end of the site - note limited cracking

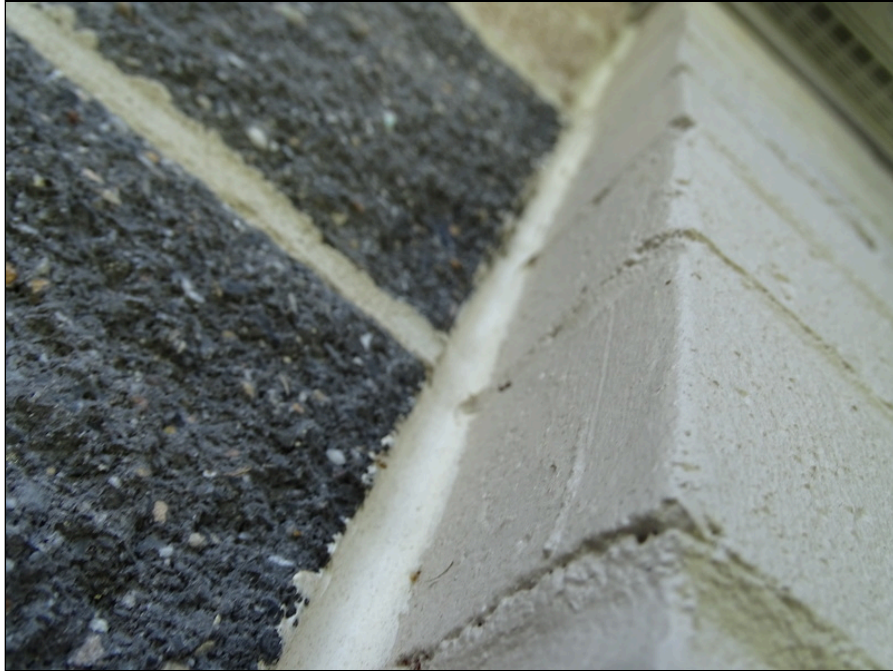
27 - Exterior sealant - note deterioration

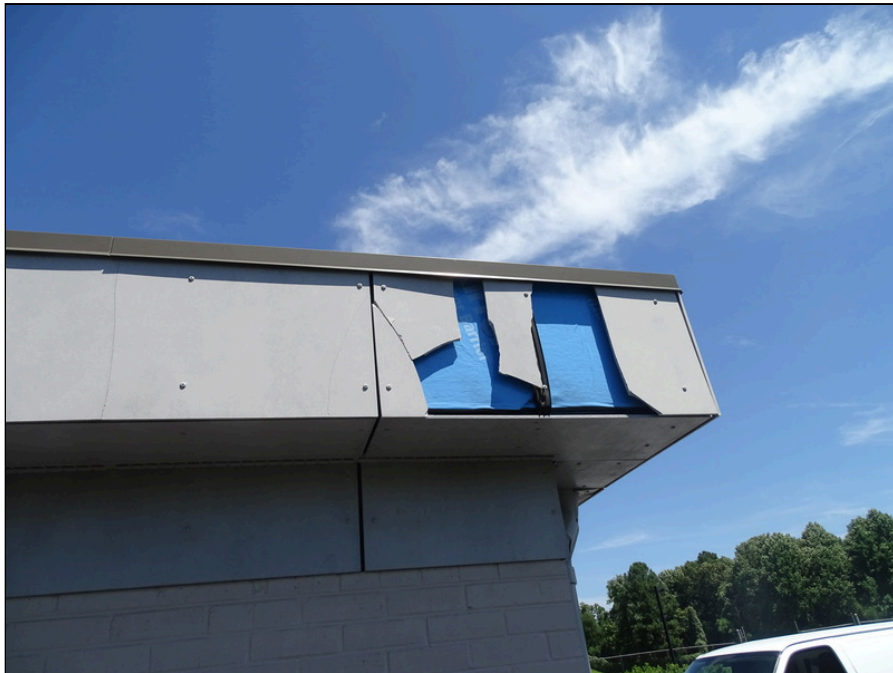
28 - Typical exterior - note deterioration

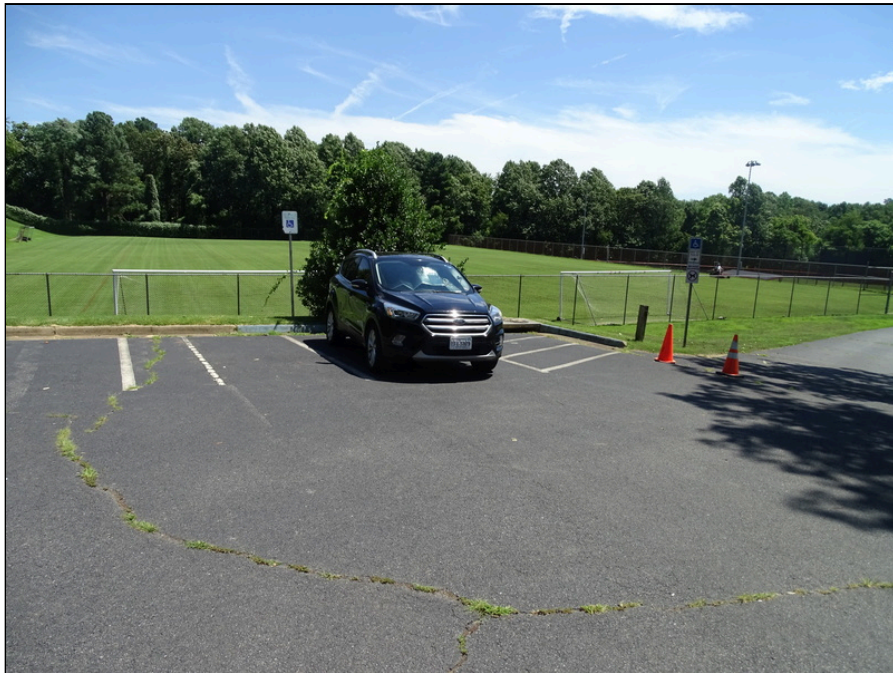
46 - Accessible asphalt parking - note cracking
