CHARLOTTESVILLE HIGH SCHOOL POST-GRAD AND TRACK BUILDINGS
1400 MELBOURNE ROAD
CHARLOTTESVILLE, VIRGINIA

ECS PROJECT NO. 46:6713

CITY OF CHARLOTTESVILLE - FACILITIES DEVELOPMENT

Reference: Facility Condition Assessment Report for Charlottesville High School Post-Grad and Track Buildings, 1400 Melbourne Road, Charlottesville, Virginia

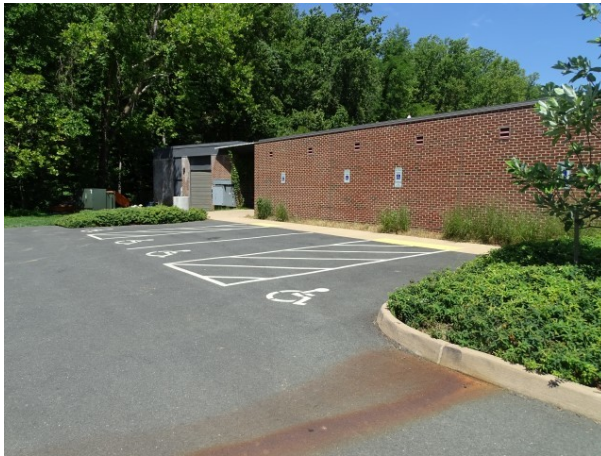
Four accessible, including one van, spaces are provided at the track building. Additional parking and access for these buildings is provided at the Charlottesville High School campus.

Track Building accessible parking

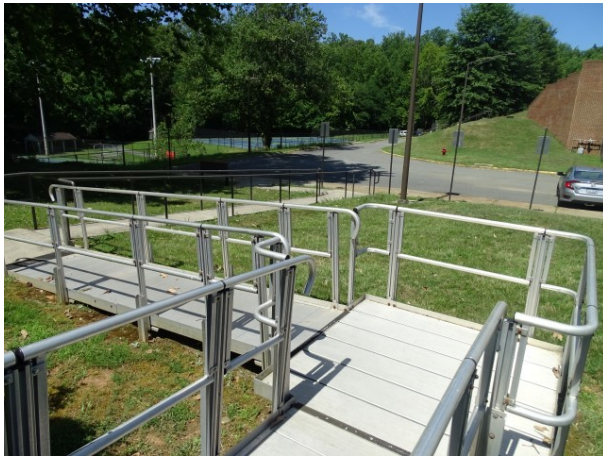
A concrete ramp and landing and an aluminum ramp and landing structure provided access to the post-grad building. These elements were observed to be in generally good condition. The handrails adjacent to the ramps were observed to be in generally good condition.

PG Building ramp

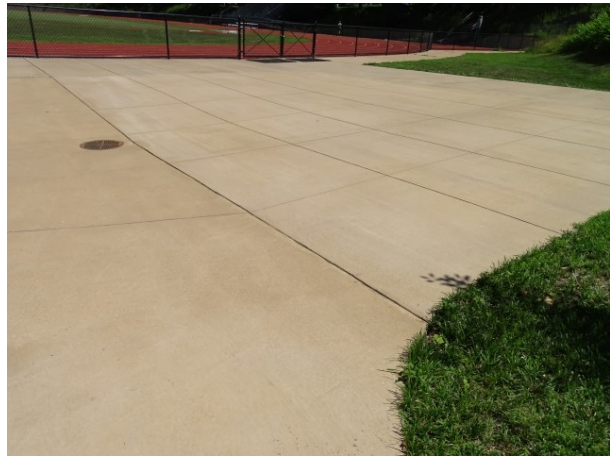
Concrete sidewalks and plaza of undetermined thickness are provided around the track building. Regularly spaced control joints were observed. The concrete pavements were generally in good condition.

Track Building concrete pavement

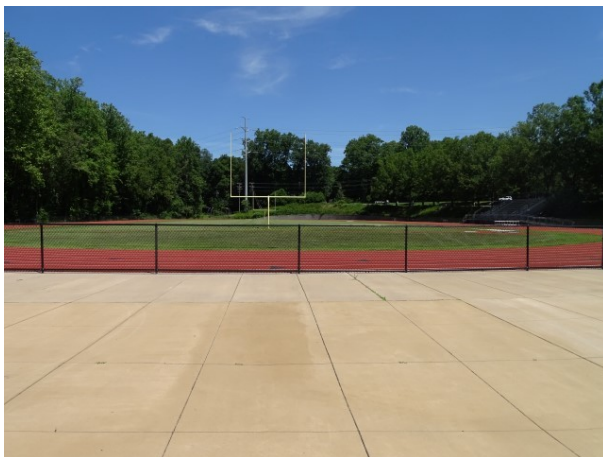
Track Building concrete pavement

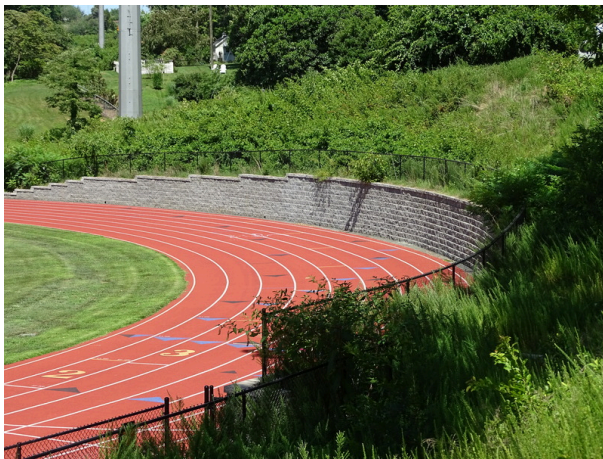
A segmented block retaining wall is located on the north side of the track. The segmented block retaining wall was generally in good condition.

Segmented block retaining wall at north side of track

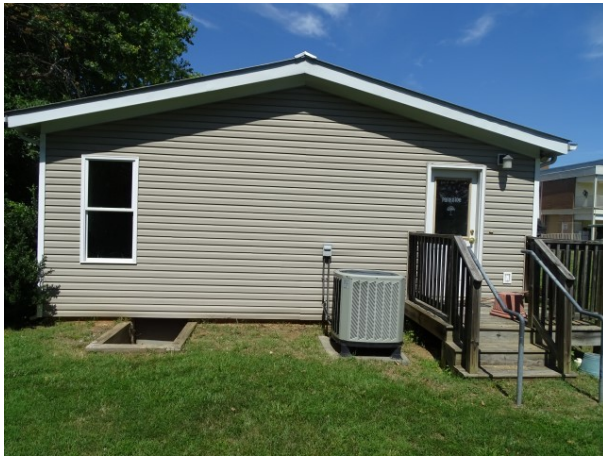
Various sealants were observed at material transitions and were in good to fair condition. The expected useful life of sealants is 15 years. An allowance has been provided to replace the sealants during the report period.

PG Building exterior finishes

3.3.3 Building Exteriors																													
REPOINT OLDER BRICKWORK	20	18	2	1	LS	\$5,000.00	\$5,000	100%		\$5,000																			\$5,000
REPLACE EXTERIOR SEALANTS	15	13	2	1	EA	\$2,000.00	\$2,000	200%		\$2,000															\$2,000				\$4,000

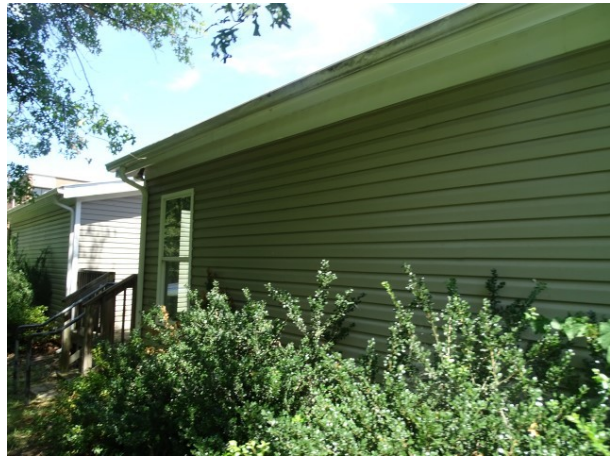
PG Building exterior finishes

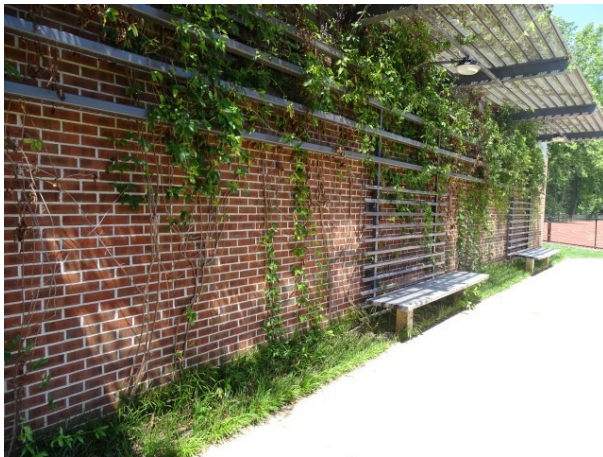
Track Building exterior

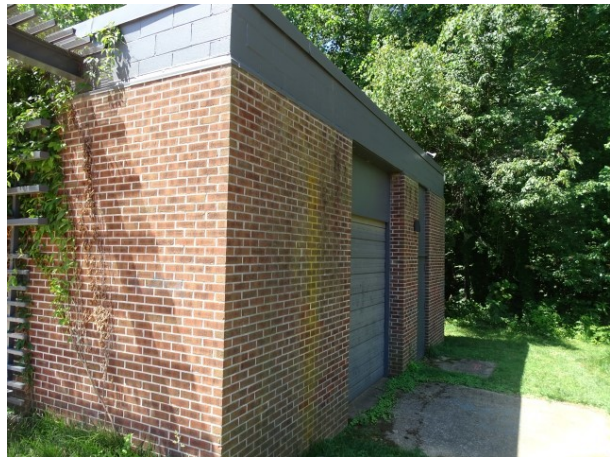
Track Building exterior

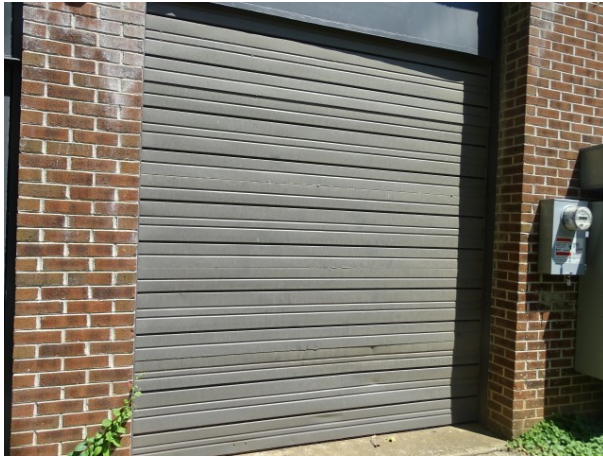
Overhead doors are located at the track building. The overhead doors were observed to be in fair condition with minor denting noted.

Track Building roll-up door

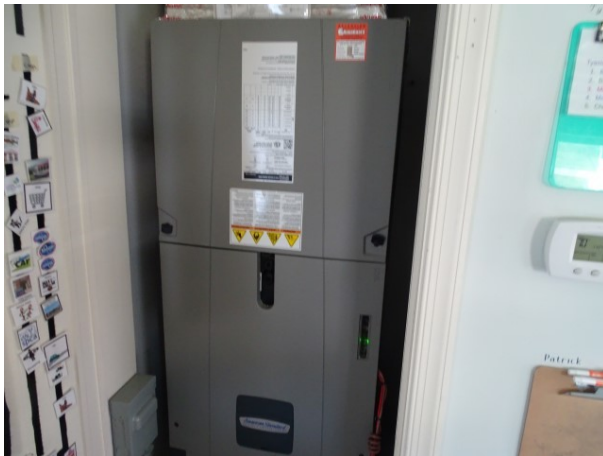
PG Building air handler

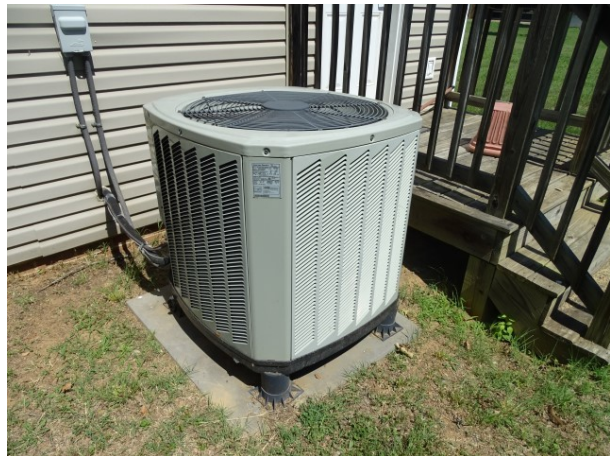
PG Building condensing unit

3.4.2.1 Equipment																													
REPLACE SPLIT SYSTEM	15	10	5	1	EA	\$5,500.00	\$5,500	200%					\$5,500															\$5,500	\$11,000
Total (Uninflated)									\$0.00	\$7,000.00	\$0.00	\$0.00	\$5,500.00	\$0.00	\$0.00	\$0.00	\$0.00	\$0.00	\$0.00	\$0.00	\$10,500.00	\$0.00	\$0.00	\$0.00	\$2,000.00	\$0.00	\$0.00	\$5,500.00	\$30,500.00
Inflation Factor (2.5%)									1.0	1.025	1.051	1.077	1.104	1.131	1.16	1.189	1.218	1.249	1.28	1.312	1.345	1.379	1.413	1.448	1.485	1.522	1.56	1.599	
Total (inflated)									\$0.00	\$7,175.00	\$0.00	\$0.00	\$6,070.97	\$0.00	\$0.00	\$0.00	\$0.00	\$0.00	\$0.00	\$0.00	\$14,121.33	\$0.00	\$0.00	\$0.00	\$2,969.01	\$0.00	\$0.00	\$8,792.58	\$39,128.89
Evaluation Period:									20

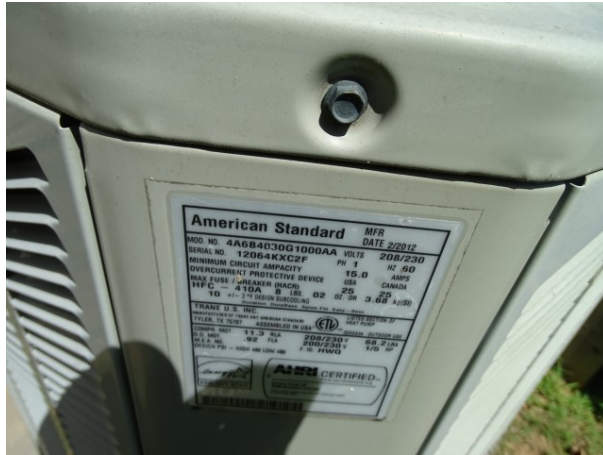
PG Building condensing unit

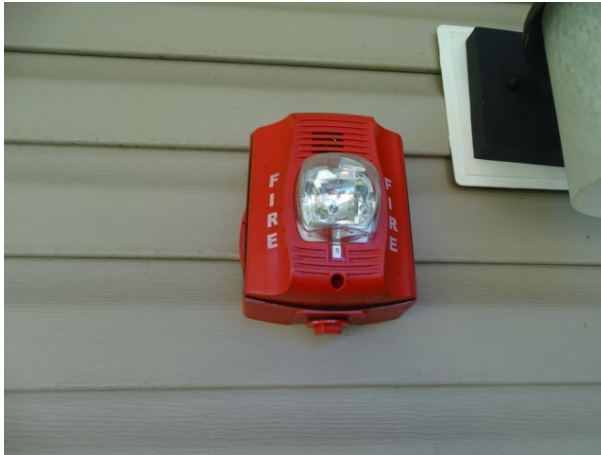
A fire alarm system was located in the post-grad building consisting of a control panel, smoke detectors, pull stations, horns, and strobes. Emergency exit lights and signage are located in the building. The systems were generally in good condition.

PG Building typical horn/strobe

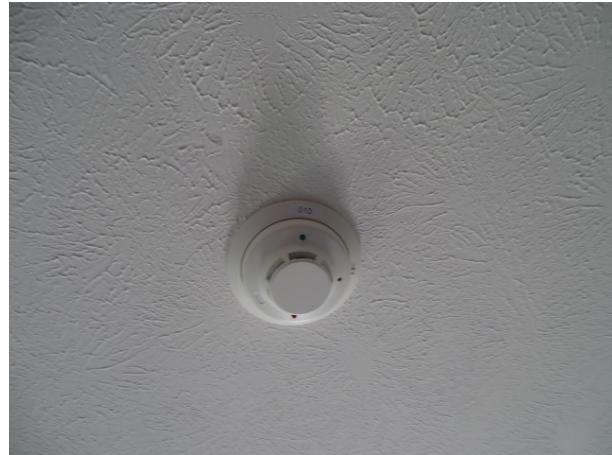
PG Building smoke detector

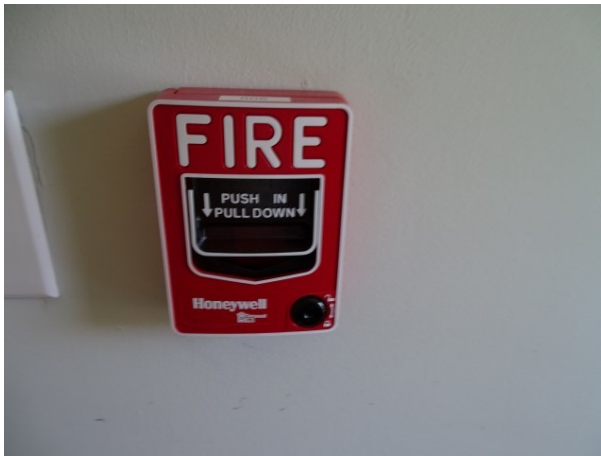
PG Building fire alarm

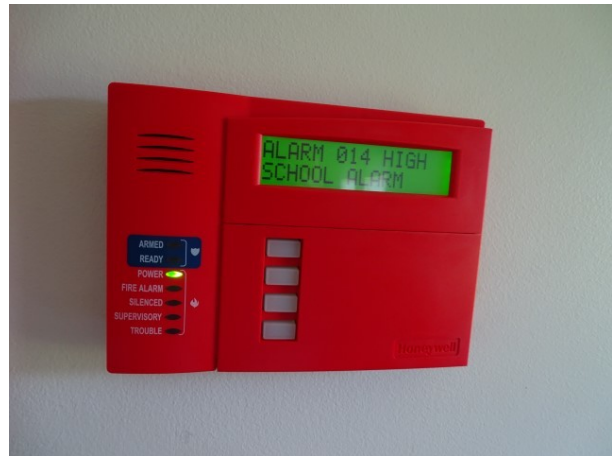
PG Building alarm panel

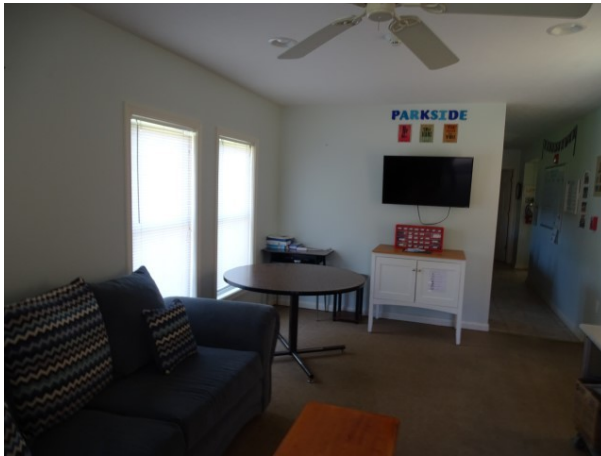
The finishes in the meeting/office rooms include carpeted floors and painted gypsum board walls and ceilings. The finishes in the meeting/office rooms were observed to be in generally good condition.

PG Building interior

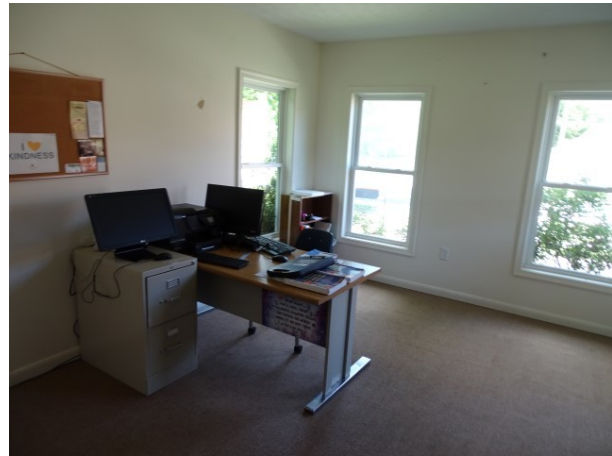
PG Building office

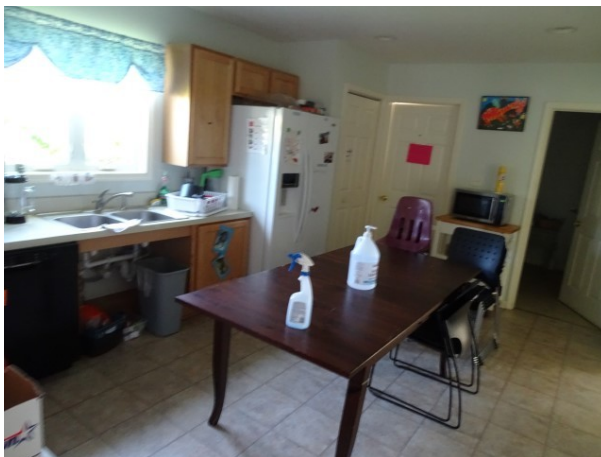
PG Building kitchen

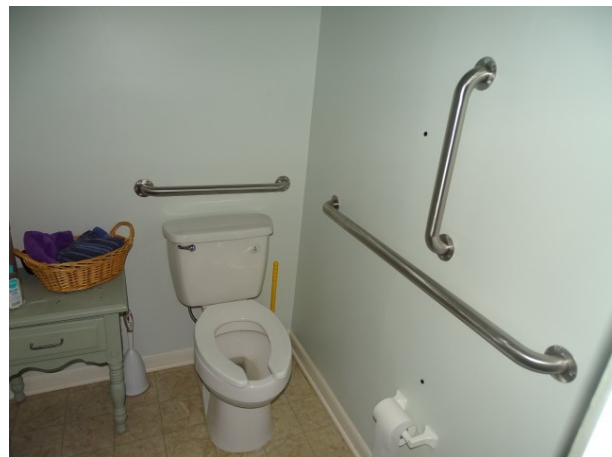
PG Building accessible restroom
