FACILITY CONDITION ASSESSMENT

CENTRAL LIBRARY
201 E MARKET STREET
CHARLOTTESVILLE, VIRGINIA

ECS PROJECT NO. 46:6713

NOVEMBER 2, 2021

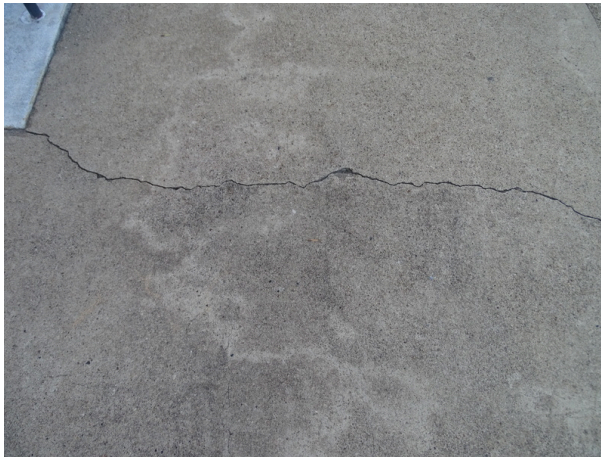
Concrete sidewalks of undetermined thickness are provided at the south side of the building. A concrete ramp is provided at the southwest end of the building. Regularly spaced control joints were observed. The Concrete sidewalks and ramps were generally in fair to good condition, respectively. We recommend an allowance for concrete sidewalk repairs as needed during the report period.

Concrete sidewalk - note cracking

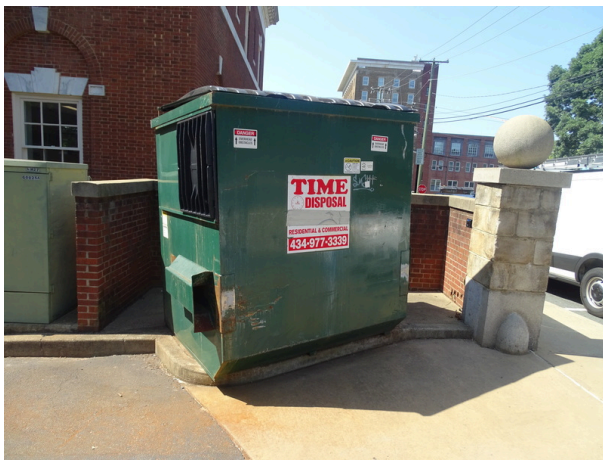
The landscaping consists generally of mature trees, small shrubs, and grassed areas around the site. The landscaping was observed to be in generally good condition. A dumpster area is located on the northwest side of the building. The dumpster area was generally in good condition.

Dumpster area

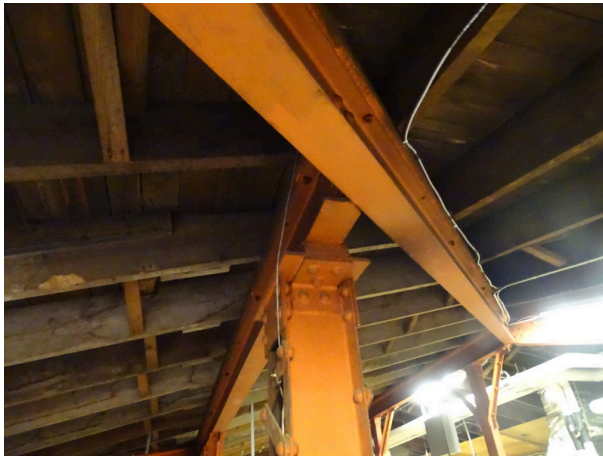
The structure of the building consists of Masonry bearing walls with wood and structural steel roof framing. The first floor framing consists of clay block with wood framing for upper levels. The structural frame of the building was generally in good condition.

Structural framing

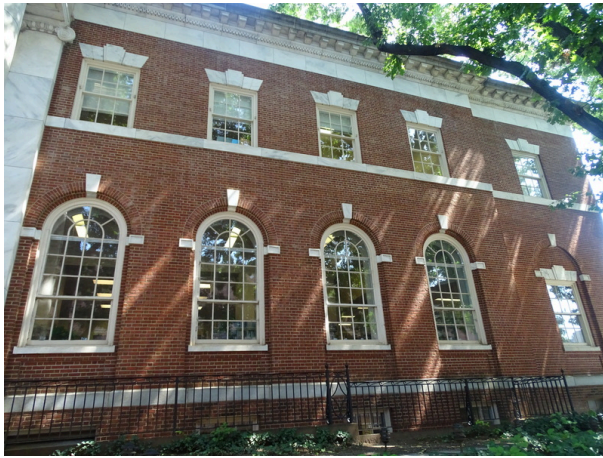
Building exterior south side of the building

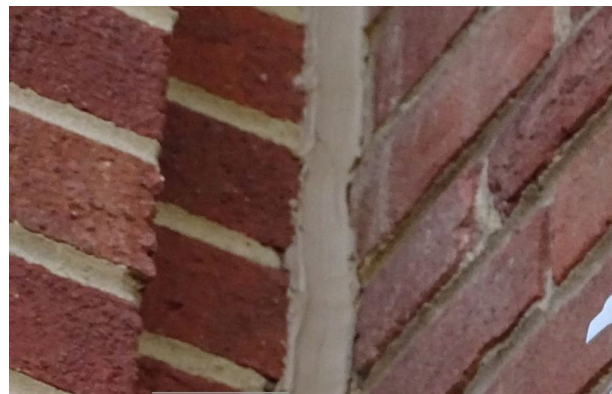
Exterior sealants are located around the window and door frames, horizontal joints, and vertical joints in the Brick veneer. The expected useful life of exterior sealants is approximately 10 to 12 years before replacement is needed. The exterior sealants were generally in poor condition. The sealants were observed to be hard and separated from the substrate. We recommend that the exterior sealants be replaced during brick repointing.

Exterior sealants - note deterioration

3.3.3 Building Exteriors																													
REPOINT BRICKWORK	20	10	10	1	LS	\$150,000.00	\$150,000	100%										\$150,000											\$150,000
REPLACE SEALANTS	12	1	11	1	LS	\$12,000.00	\$12,000	100%											\$12,000										\$12,000

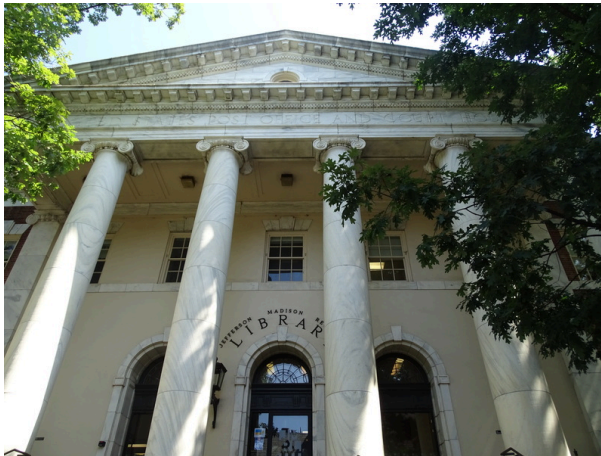
The main entrance is a Storefront entrance. The main entrance doors were generally in good condition. Personnel doors are located on the north, east, and west sides of the building. The personnel doors were generally in good condition. Exterior doors typically have an expected useful life of 20 to 30 years.

Main entrance south side of the building

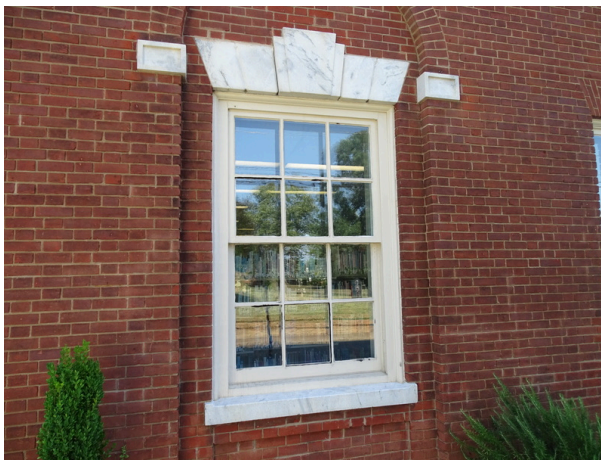
The window system for the building primarily consists of Wood-framed single-pane operable window units with inoperable wood-framed single-pane window units located above the entrances. The expected useful life of windows is typically 30 years. The windows can be considered historical in nature. Based on the historical requirements, we recommend repair and/or replacement of the window units as needed.

Typical exterior window

3.3.5 Exterior Windows																													
REPAIR WINDOWS AS NEEDED	30	29	1	1	LS	\$20,000.00	\$20,000	100%	\$20,000																				\$20,000

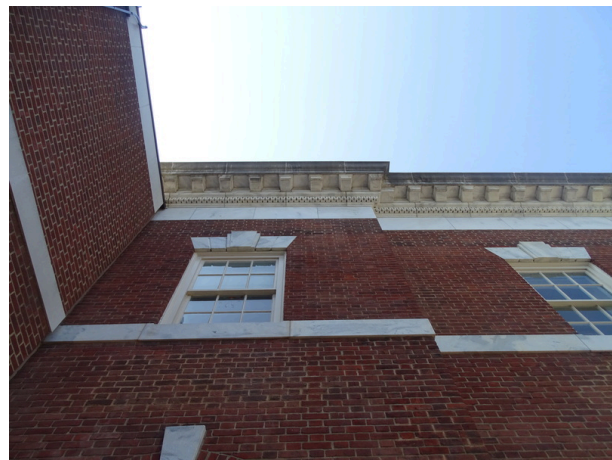
Typical exterior window

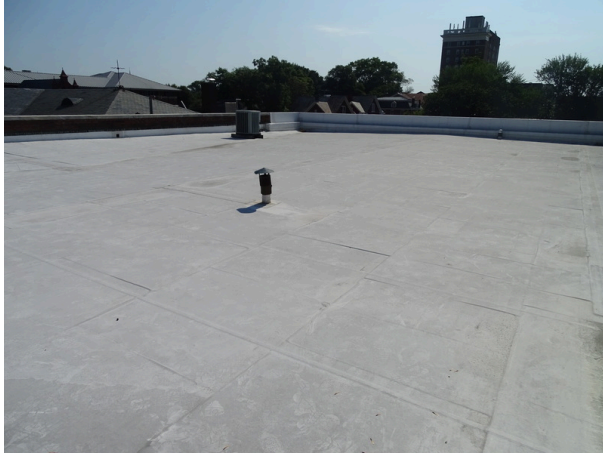
Single-ply sheet membrane roofing system located at the northeast side of the building

3.3.6 Roofing Systems																													
REPLACE SINGLE-PLY ROOFING SYSTEM	20	11	9	4,000	SF	\$14.00	\$56,000	100%								\$56,000													\$56,000
RE-COAT METAL ROOFING SYSTEM	20	15	5	6,500	SF	\$6.00	\$39,000	100%					\$39,000																\$39,000

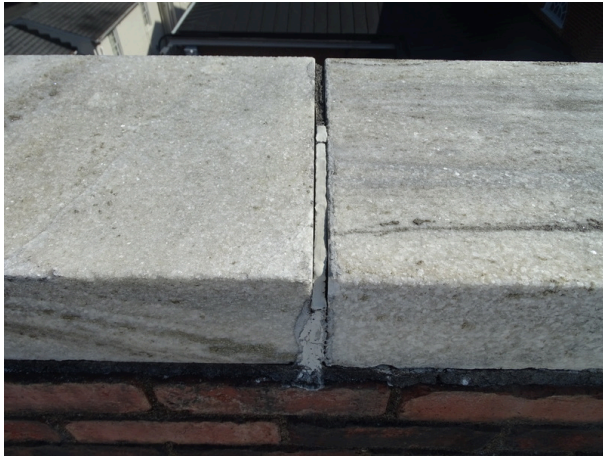
Typical parapet wall - note mortar joint deterioration

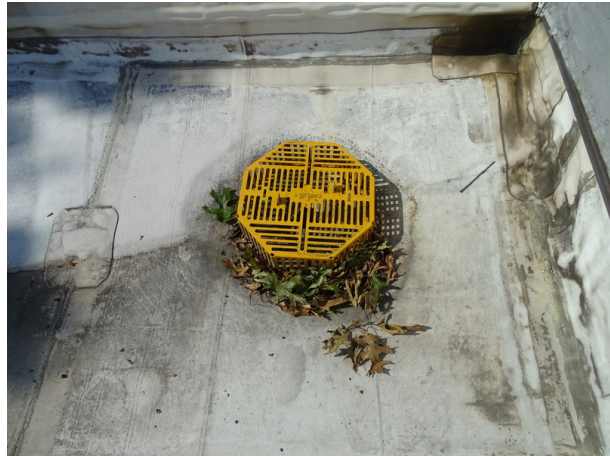
Typical internal drain

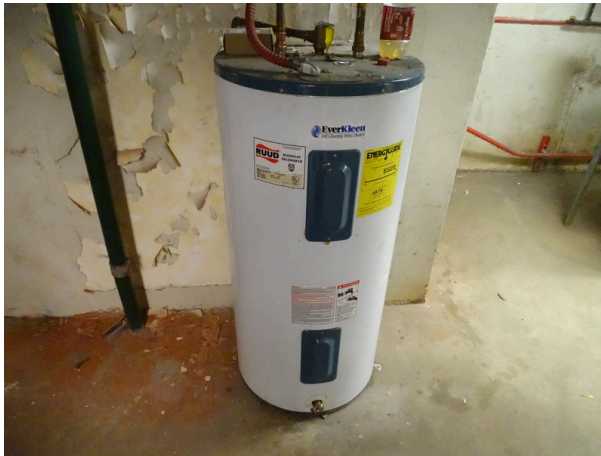
Domestic hot water to the building is provided by Electric domestic water heater located in the main utility room. The Electric domestic water heater was manufactured by Ruud. The expected useful life of a Electric domestic water heater is approximately 12 to 15 years and We recommend the Electric domestic water heater be replaced.

Electric domestic water heater

3.4.1.2 Domestic Hot Water Production																													
REPLACE ELECTRIC DOMESTIC WATER HEATER	12	11	1	1	EA	\$1,000.00	\$1,000	200%	\$1,000											\$1,000									\$2,000

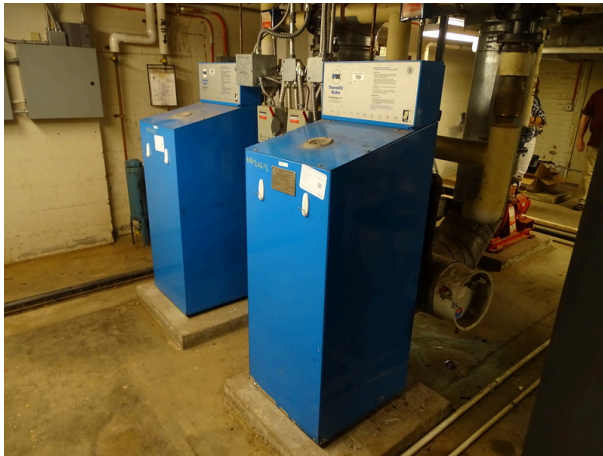
Boilers located in main utility room

3.4.2.1 Equipment																													
REPLACE BOILERS	15	14	1	2	EA	\$25,000.00	\$50,000	200%	\$50,000															\$50,000					\$100,000
REPLACE CONDENSER ON ROOF	20	17	3	1	EA	\$20,000.00	\$20,000	100%			\$20,000																		\$20,000
REPLACE AIR HANDLER UNITS	15	14	1	5	EA	\$7,500.00	\$37,500	120%	\$7,500					\$7,500				\$7,500	\$15,000					\$7,500					\$45,000

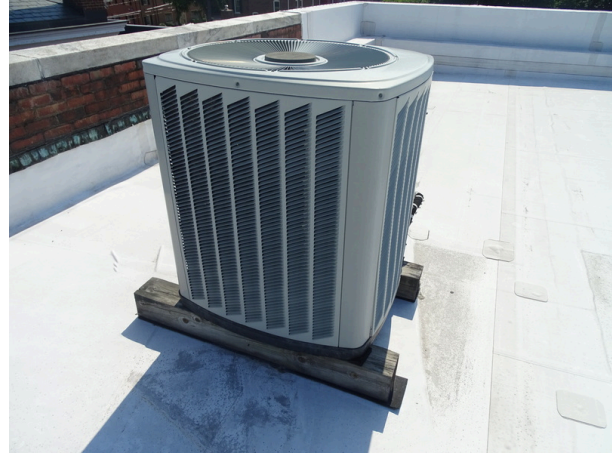
Typical condenser

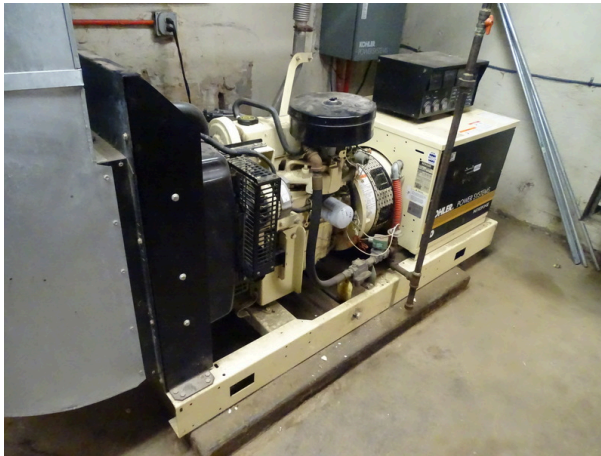
An emergency generator manufactured by Kohler was reportedly installed in 2002 and is located in the main utility room. The emergency generator is reportedly tested on a weekly basis. The expected useful life of an emergency generator is 25 years with proper maintenance. The emergency generator was observed to be in fair condition. Based on the age of the generator, we recommend replacement during the report period.

Emergency Power generator and transfer switch

3.4.3.1 Service and Metering																													
REPLACE EMERGENCY GENERATOR AND TRANSFER SWITCH	25	19	6	1	LS	\$20,000.00	\$20,000	100%						\$20,000														\$20,000

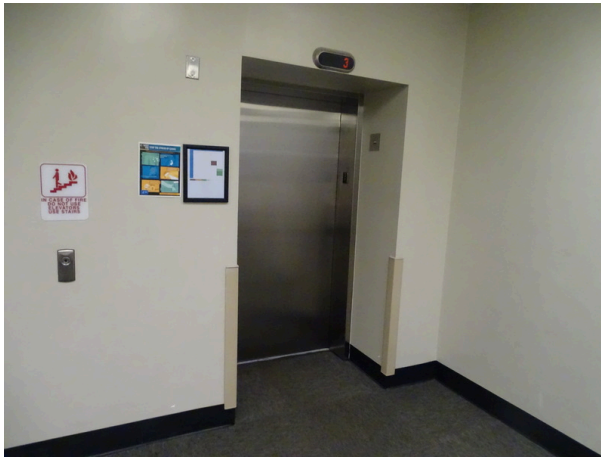
The building is served by one passenger elevator. The elevator was manufactured by KONE and was reportedly installed in 2013. The expected useful life of the elevator controls is 30 to 40 years with proper maintenance. Routine maintenance is considered adequate to keep the elevator system in good condition during the projection period of this report.

Elevator

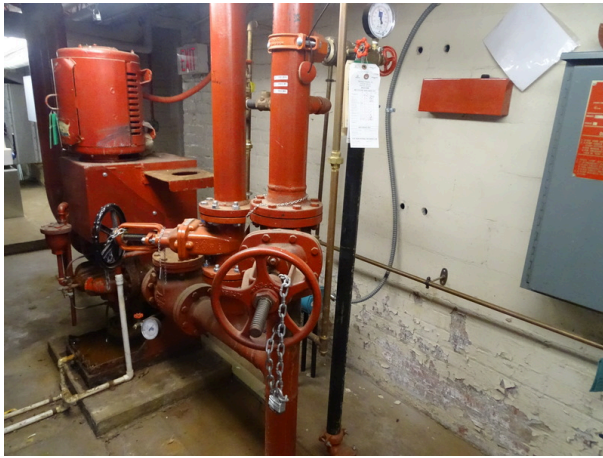
Fire sprinkler system located in main utility room

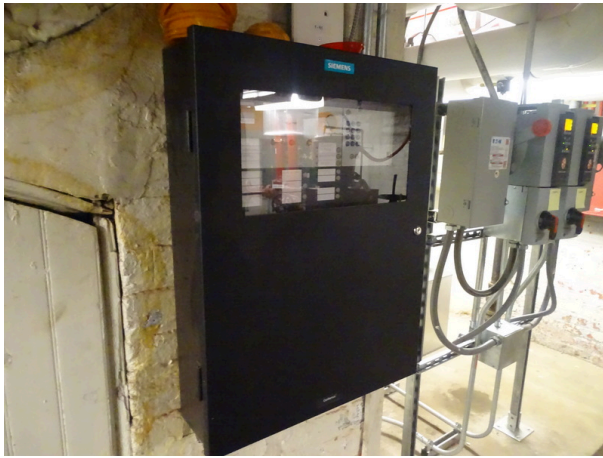
Fire sprinkler electronic controls

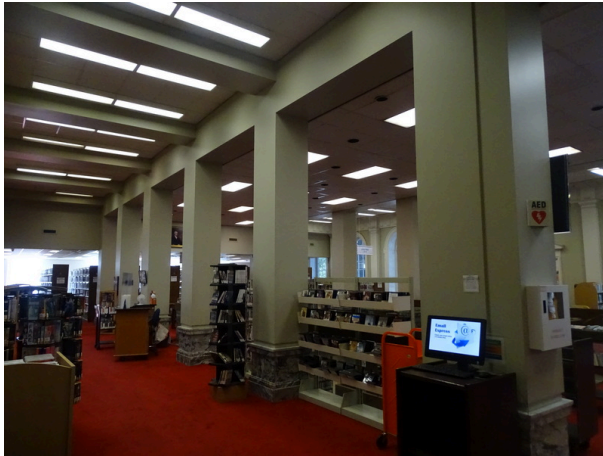
Interior finishes lobby - library area

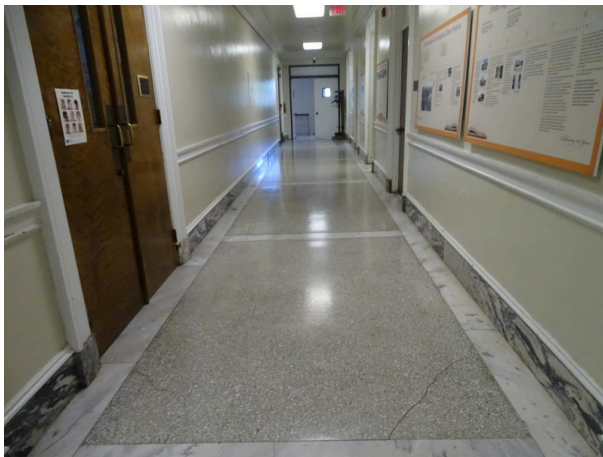
Interior finishes corridor area - note cracking

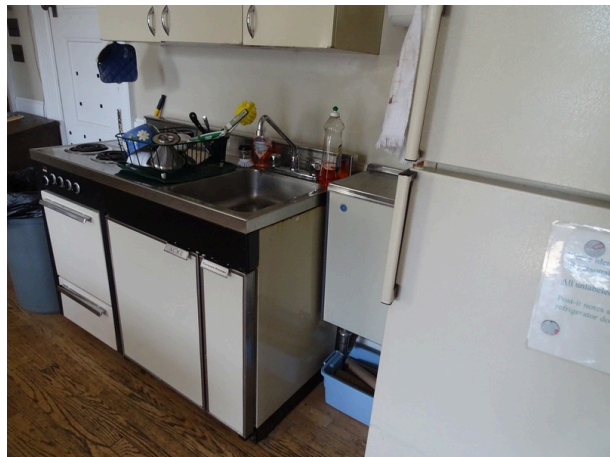
Interior finishes kitchen area

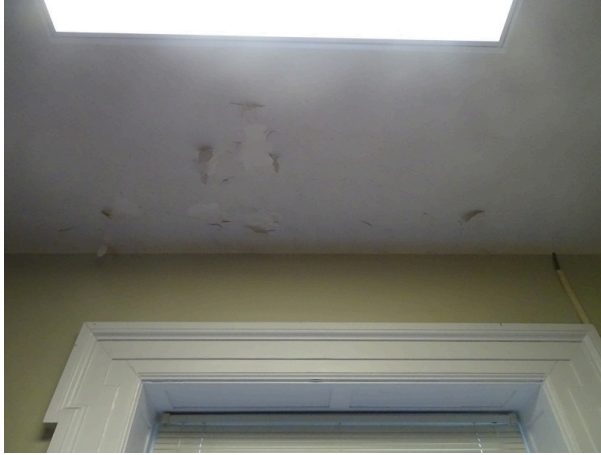
Typical interior - note peeling paint

3.7.1 Interior Finishes of Common Areas																													
REPAIR, REPAINT WALLS AND CEILINGS AS NEEDED			0	1	EA	\$2,000.00	\$2,000	100%	\$2,000																			\$2,000	
Total (Uninflated)									\$143,000.00	\$0.00	\$20,000.00	\$0.00	\$39,000.00	\$27,500.00	\$0.00	\$0.00	\$56,000.00	\$157,500.00	\$27,000.00	\$0.00	\$1,000.00	\$0.00	\$2,500.00	\$57,500.00	\$0.00	\$0.00	\$0.00	\$0.00	\$531,000.00
Inflation Factor (2.5%)									1.0	1.025	1.051	1.077	1.104	1.131	1.16	1.189	1.218	1.249	1.28	1.312	1.345	1.379	1.413	1.448	1.485	1.522	1.56	1.599	
Total (inflated)									\$143,000.00	\$0.00	\$21,012.50	\$0.00	\$43,048.70	\$31,113.73	\$0.00	\$0.00	\$68,230.56	\$196,695.92	\$34,562.28	\$0.00	\$1,344.89	\$0.00	\$3,532.43	\$83,277.14	\$0.00	\$0.00	\$0.00	\$0.00	\$625,818.16
Evaluation Period:									20

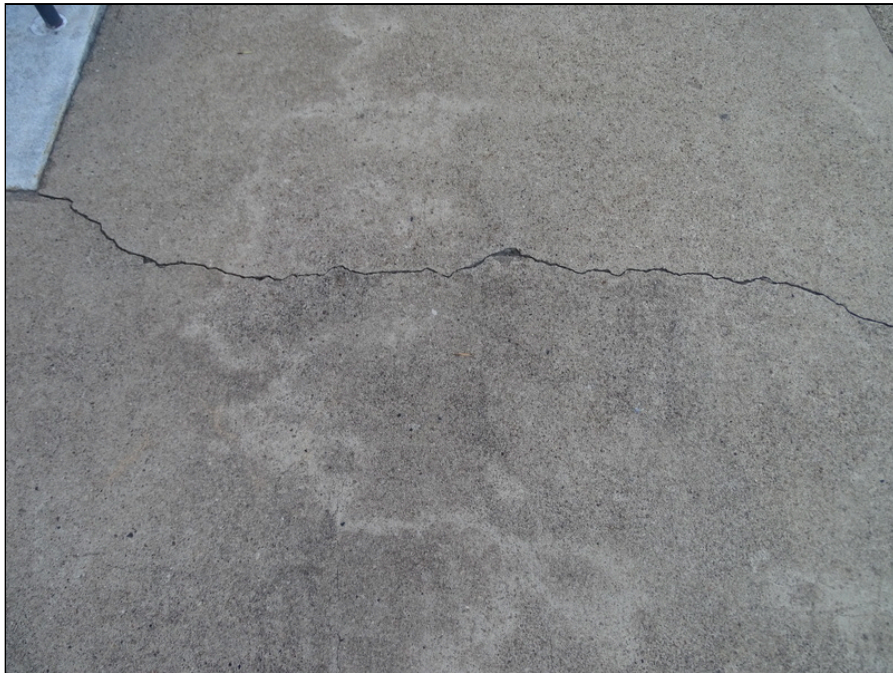
2 - Concrete sidewalk - note cracking

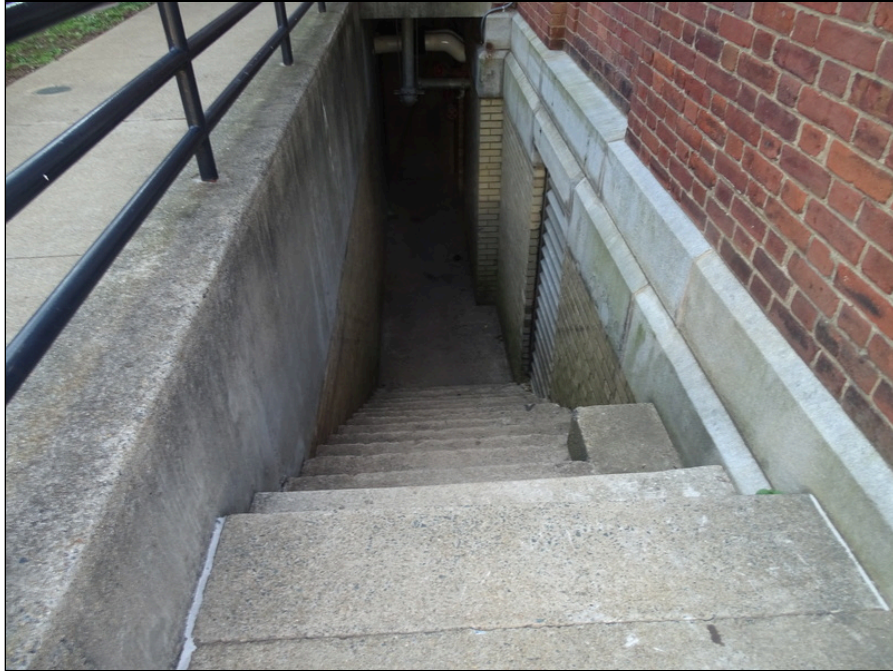
3 - Concrete steps

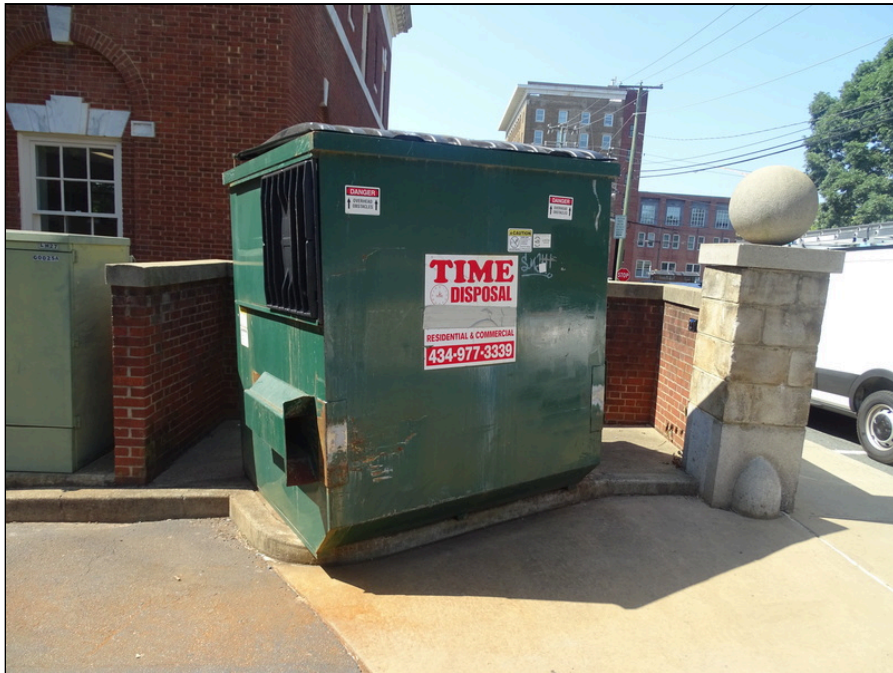
4 - Dumpster area

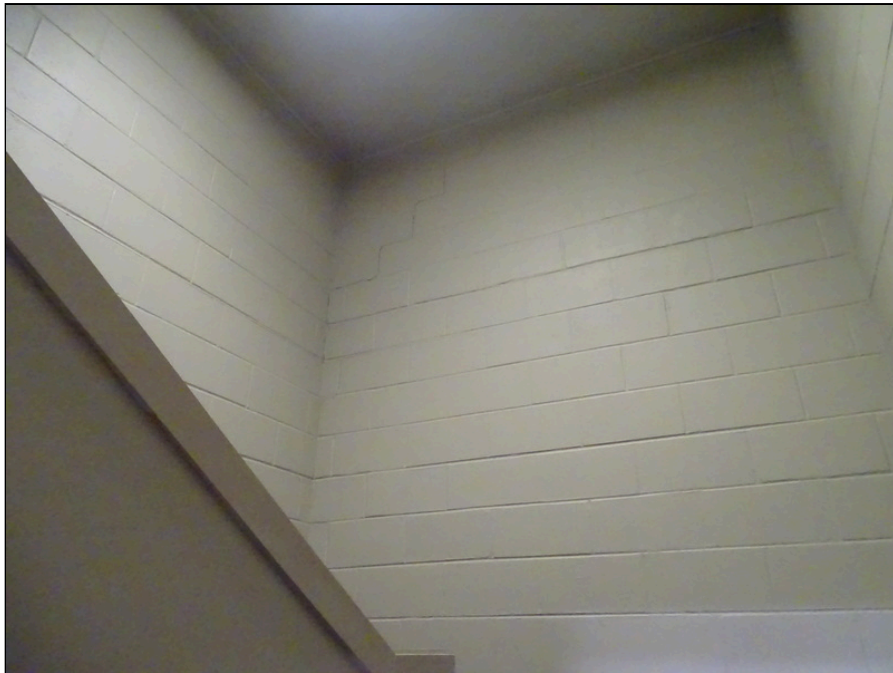
8 - Structural framing - note step cracking

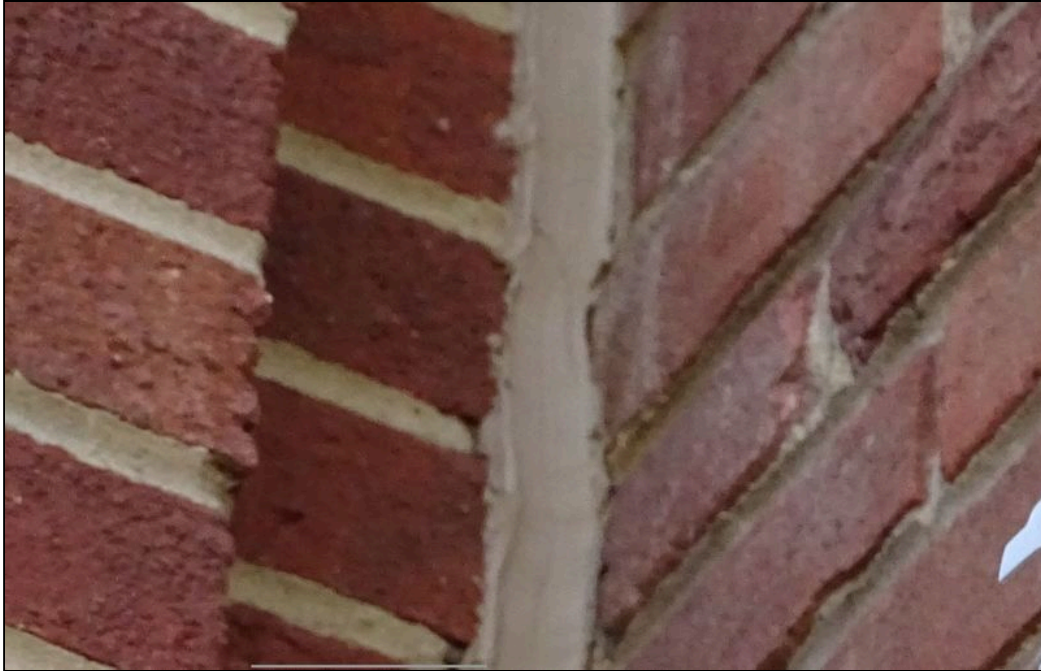
15 - Exterior sealants - note deterioration

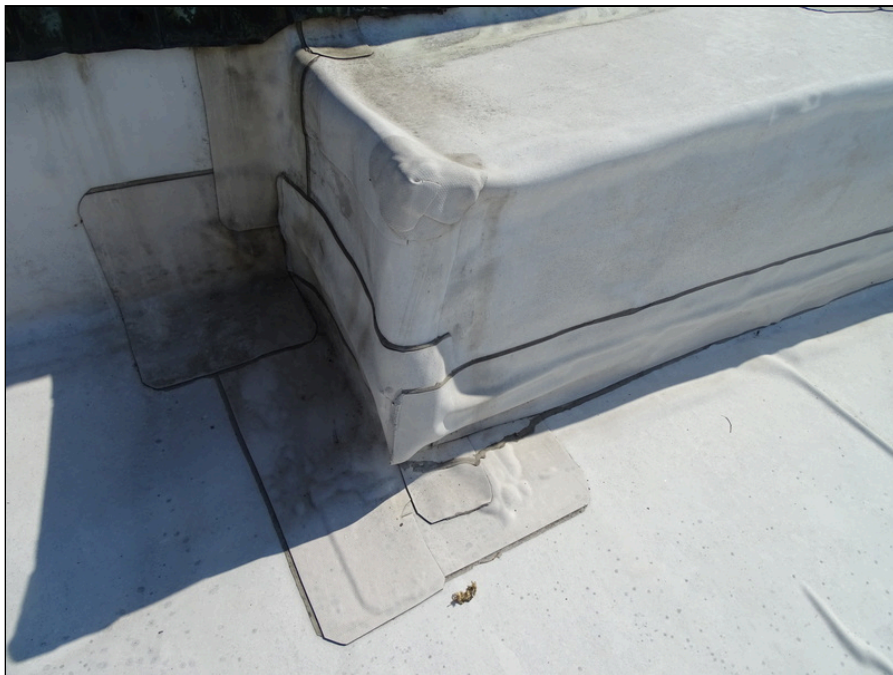
22 - Typical parapet wall - note patching

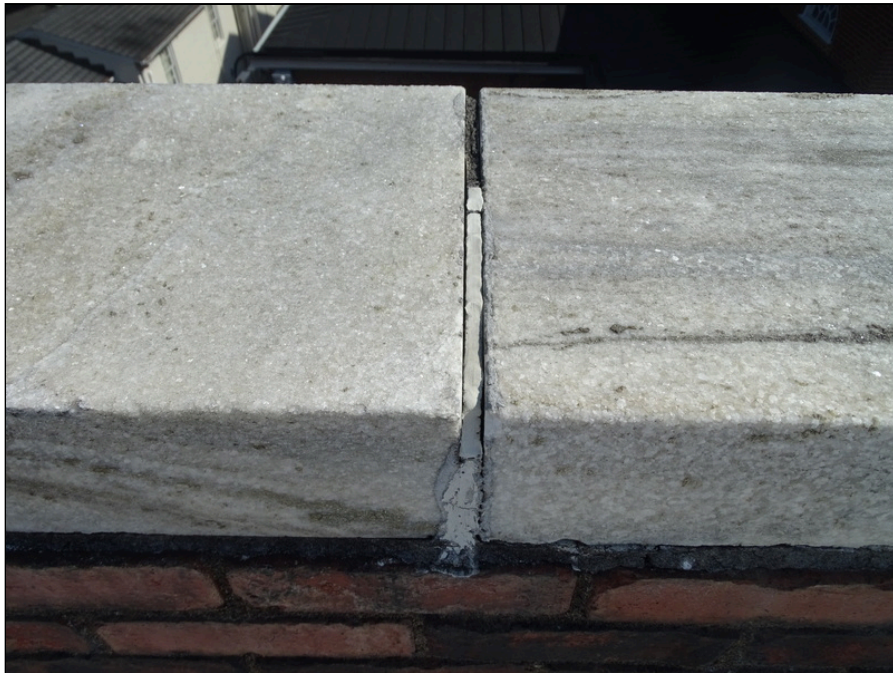
24 - Typical parapet wall - note mortar joint deterioration

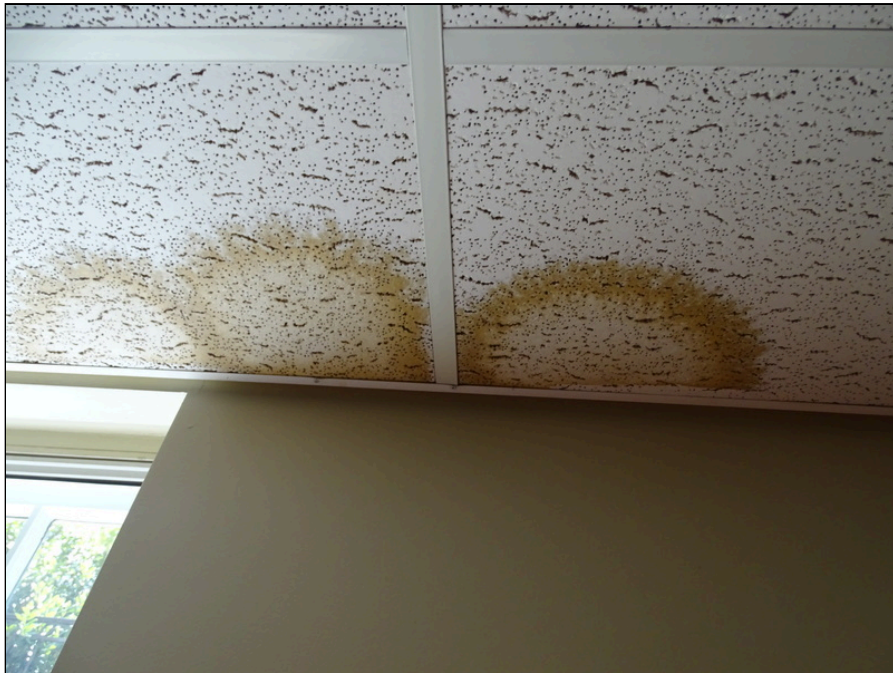
28 - Water leakage at ceiling

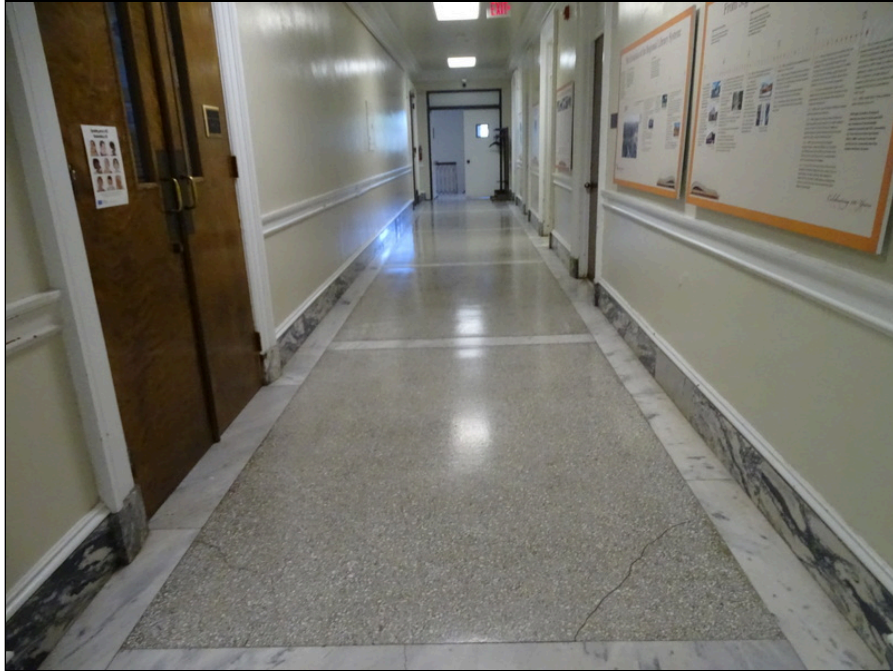
63 - Interior finishes corridor area - note cracking

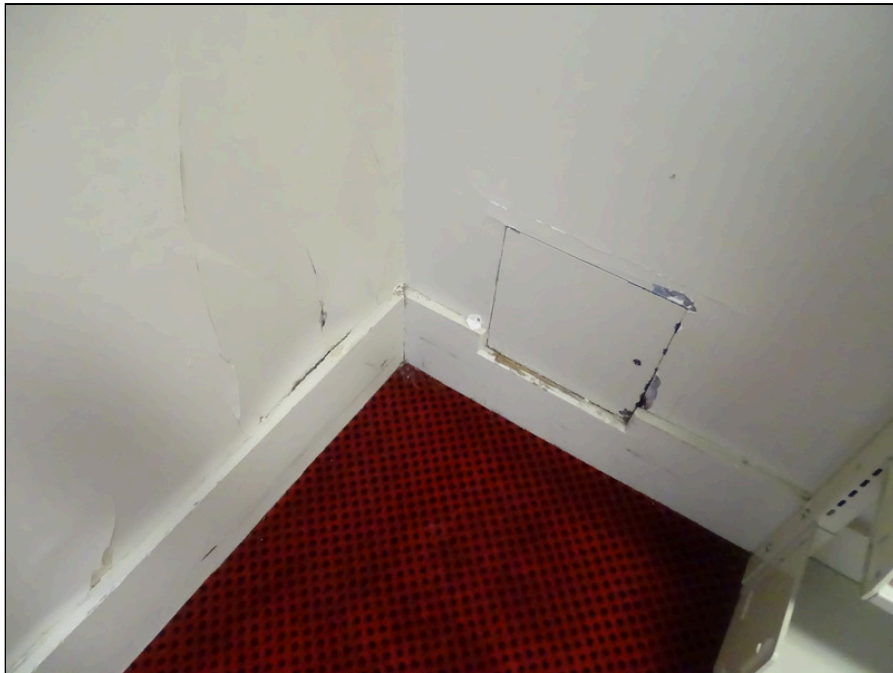
72 - Typical interior - note peeling paint

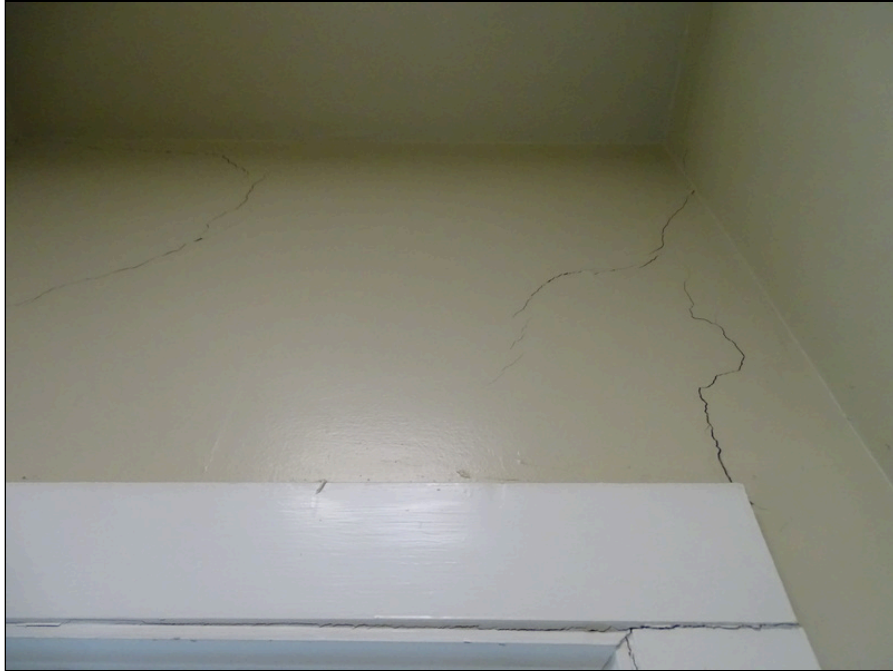
75 - Typical interior - note cracking

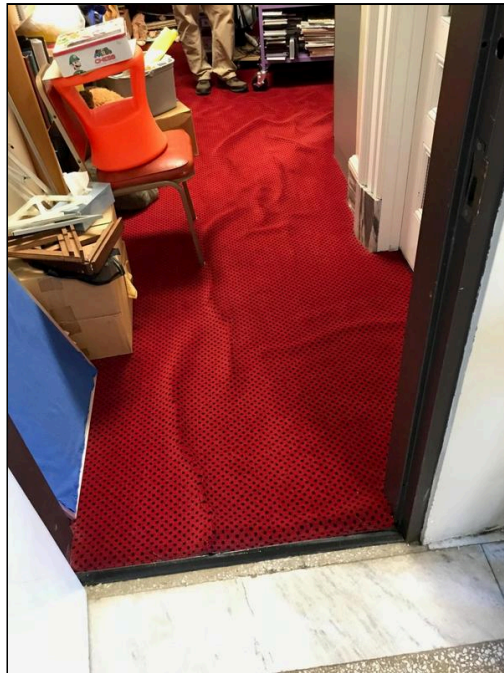
Two stairwells serve the building. The enclosed stairwell was observed to be in generally good condition. The open stairway Included a carpet runner that was in fair to poor condition. The stairs to the third floor was buckling and could cause tripping and pose a safety hazard. We recommend repairing/replacing the carpet in the immediate future.

76 - Third Floor Carpet

Immediate Repair Cost					
Item	Quantity	Unit	Unit Cost	Replacement Percent	Immediate Total
3.7.1 Interior Finishes of Common Areas					
REPAIR/REPLACE CARPET ON STAIRS AND THIRD FLOOR	1	EA	\$1,500.00	100%	\$1,500
Total Repair Cost					\$1,500.00
