CIRCUIT COURT
315-317 EAST HIGH STREET
CHARLOTTESVILLE, VIRGINIA

ECS PROJECT NO. 46:6713

CITY OF CHARLOTTESVILLE - FACILITIES DEVELOPMENT

Reference: Facility Condition Assessment Report for Circuit Court, 315-317 East High Street,
Charlottesville, Virginia

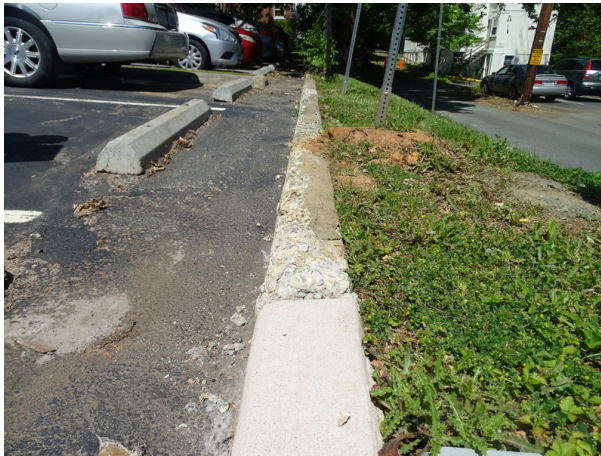
Asphalt-paved drive lanes are located on the north side of the site. The asphalt pavement was observed to be in generally good condition. The expected useful life of asphalt pavement is 20 years. Concrete curbs are located around the site. The concrete curb and gutters were damaged, cracked, and deteriorated at several locations. The curbs were observed to be in generally fair condition. The expected useful life of concrete curb is approximately 30 years. We recommend that the damaged concrete curbs be replaced. Please note that portions of the deteriorated curb noted in 2016 have been replaced. This can be seen in the first picture on page 16 as well as photograph number eight on page 68 of this report.

Concrete curb - note deterioration

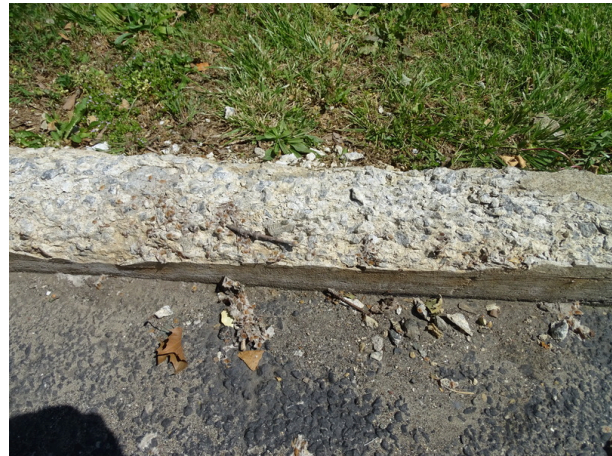
Concrete curb - note deterioration

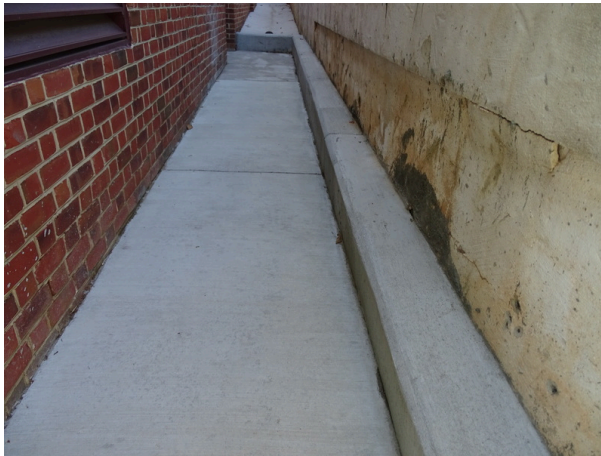
Concrete side walk - note wall deterioration

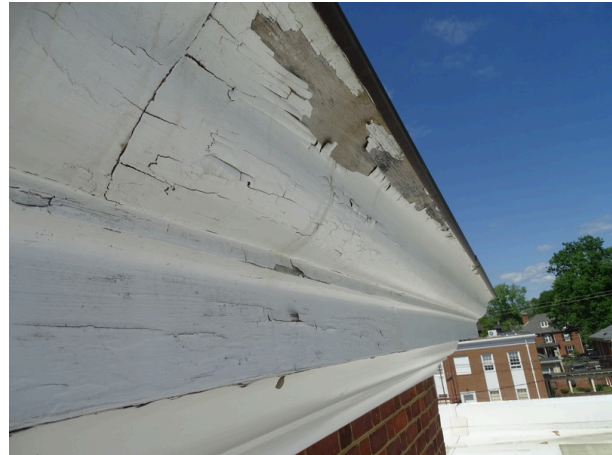
Exterior cornice - note deterioration

Exterior sealants are located around the window and door frames, horizontal joints, and vertical joints in the brick veneer. The expected useful life of exterior sealants is approximately 10 to 12 years before replacement is needed. The exterior sealants were generally in poor condition. The sealants were observed to be hard and separated from the substrate. We recommend that the exterior sealants be replaced during brick repointing.

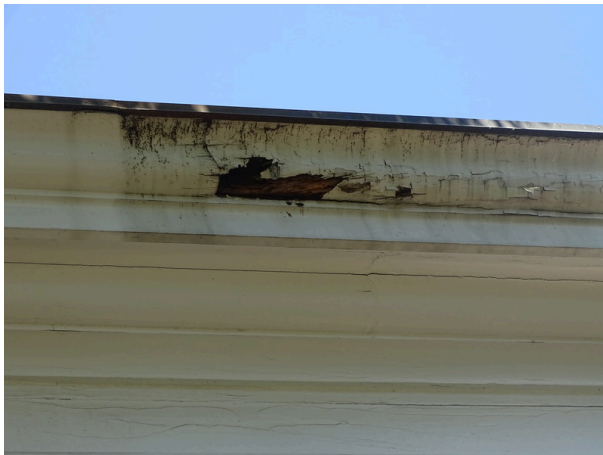
Exterior cornice - note deterioration

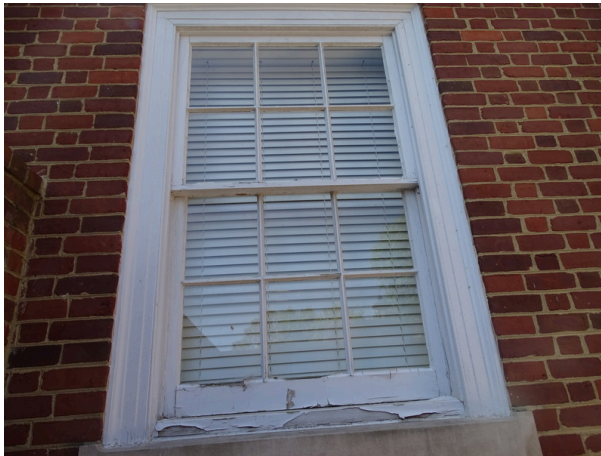
The window system for the building primarily consists of Metal-frame single-pane window units with wood-framed single-pane operable window units located on the east side of the building. The gaskets in the windows were generally in fair condition. The expected useful life of gaskets is typically 20 years. The windows on the east side of the building were reportedly recently repaired and repainted, however, deterioration was observed. We recommend the east side windows be repaired as needed.

Typical exterior window - note deterioration

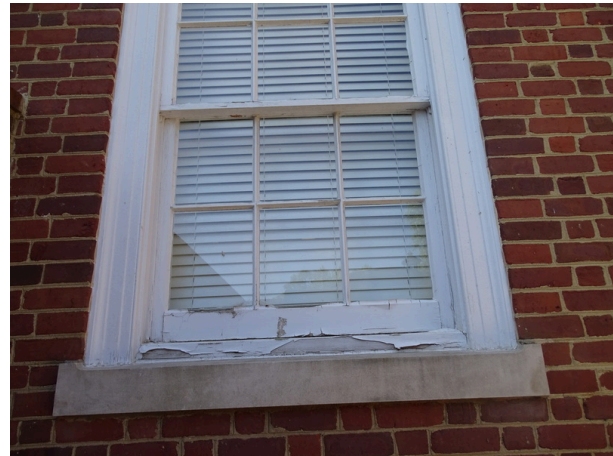
Typical exterior window - note deterioration

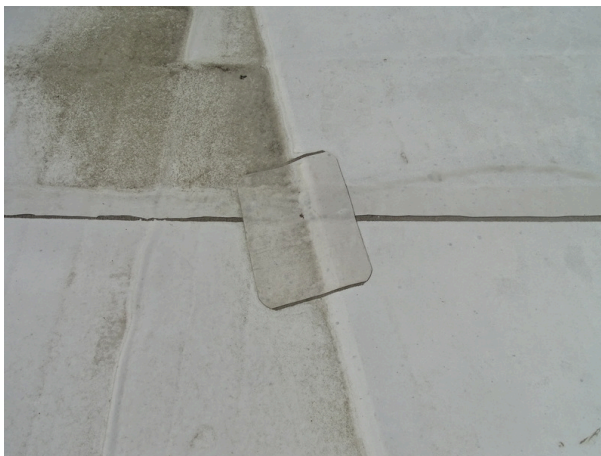
Drainage for the roofing system is provided by gutters with downspouts and through-wall scupper drains. The drainage was observed to be in generally fair condition. Maintenance of the drains is needed to clear fall leaves from clogging the drains. The parapet walls consist of brick with wood trim and spindles with metal flashing. The parapet walls were capped with metal coping. The parapet walls were observed to be in generally fair condition. We recommend the parapet wall flashing and capping be replaced with the above noted roofing replacement.

Single-ply membrane roofing system at parapet wall - note patching

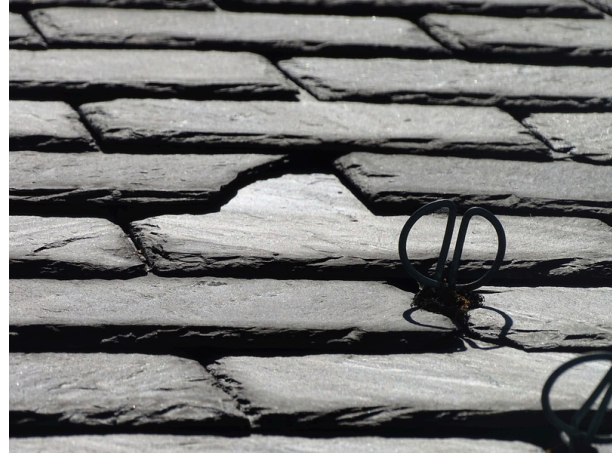
Slate roofing system - note deterioration

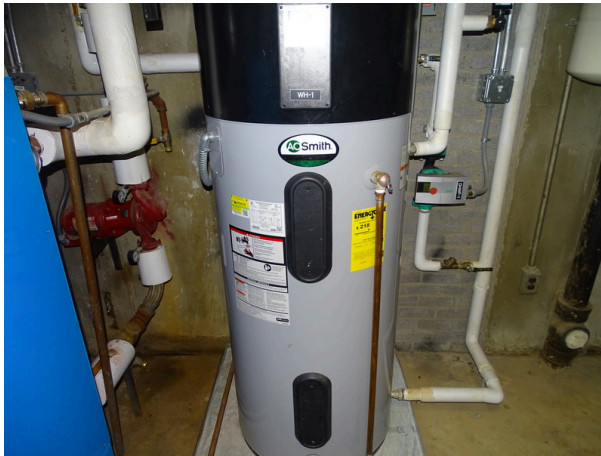
Domestic hot water to the building is provided by Electric water heater located in the main utility room. The Electric water heater was manufactured by A.O. Smith reportedly within the last three years. The expected useful life of a Electric water heater is approximately 12 to 15 years. We recommend the Electric water heater be replaced during the report period as a maintenance item.

Electric water heater

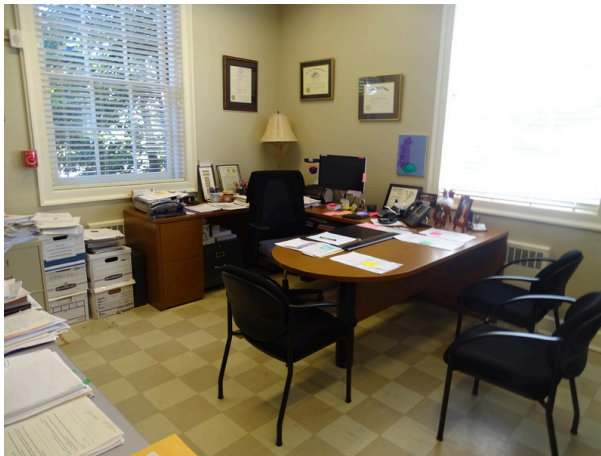
It was noted during our site visit the vinyl tiles in the clerk of the courts area were not replaced during the recent renovations.

Typical office area interior - note older vinyl tile

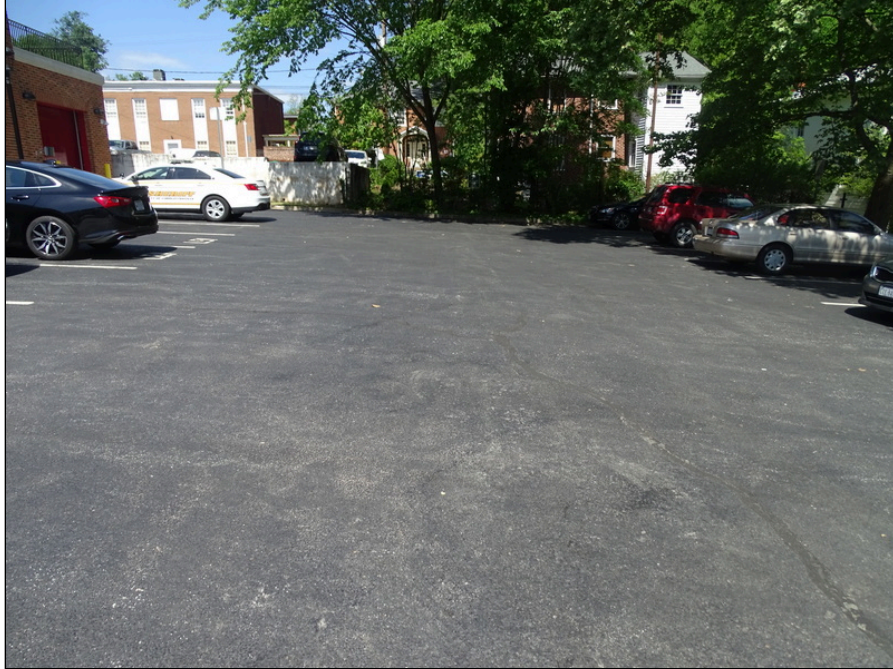
3 - Asphalt pavement on north side of site - note cracking

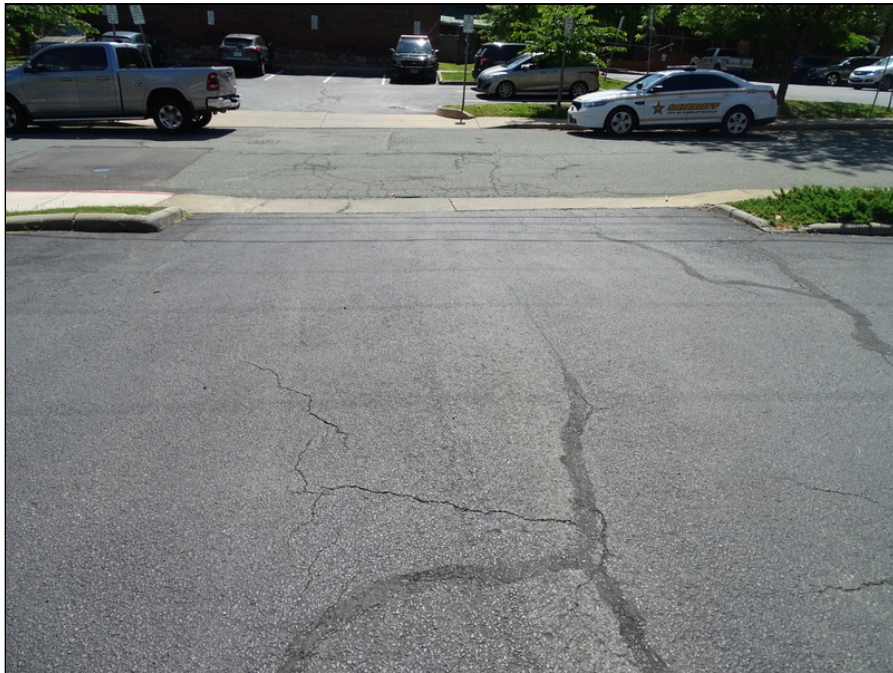
4 - Asphalt pavement on north side of site - note cracking

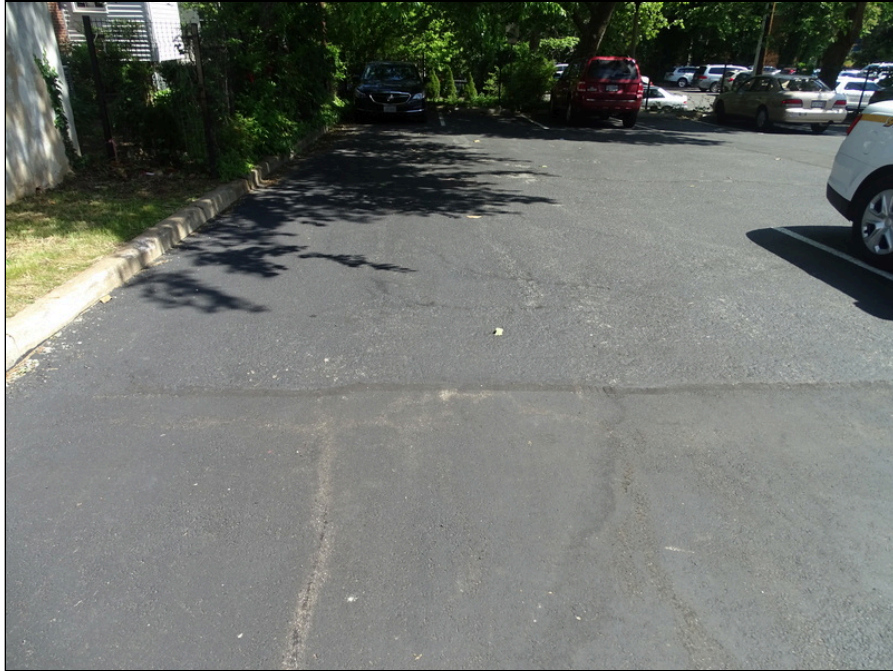
5 - Asphalt pavement on north side of site - note cracking

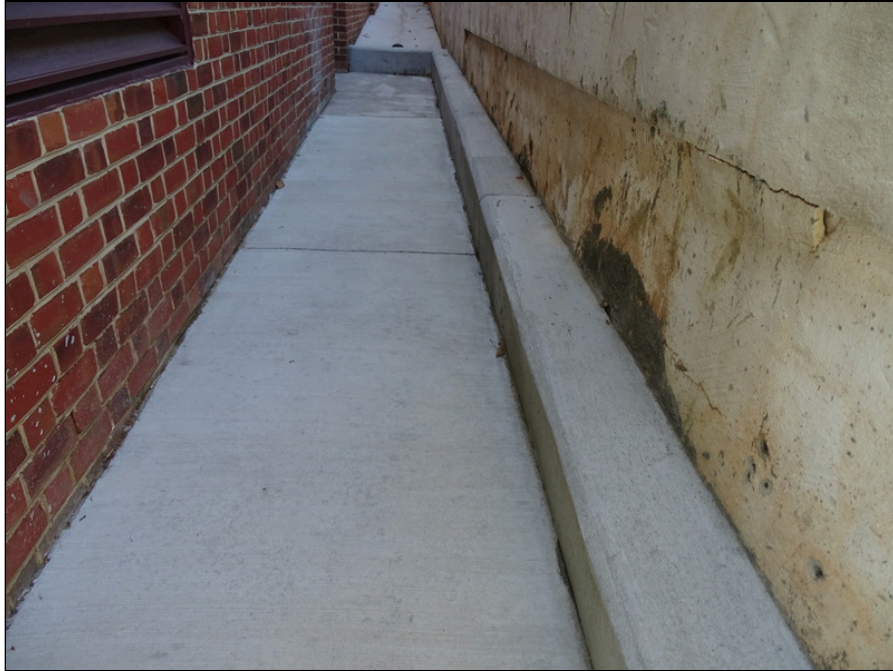
7 - Concrete side walk - note wall deterioration

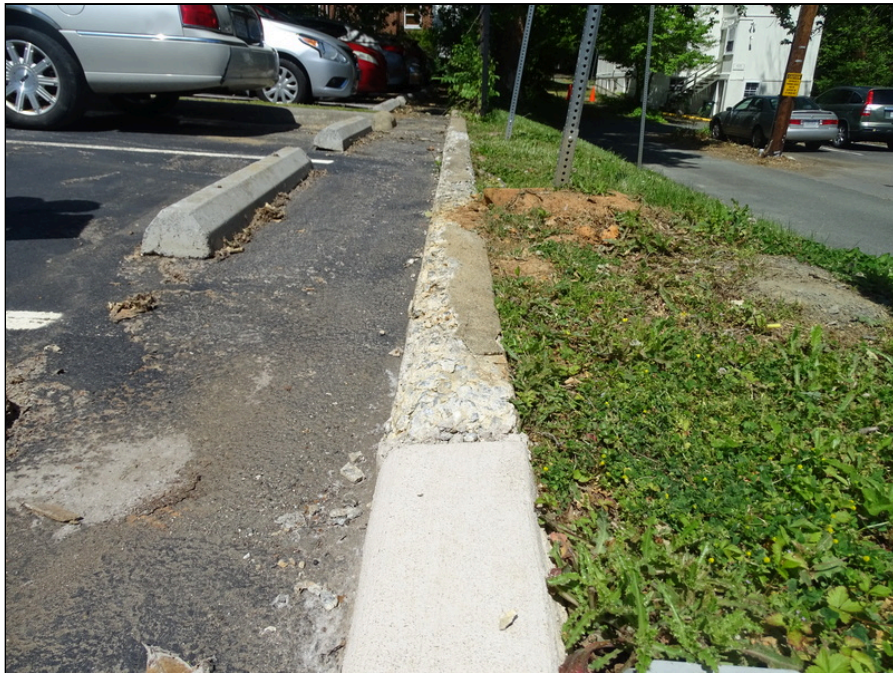
8 - Concrete curb - note deterioration

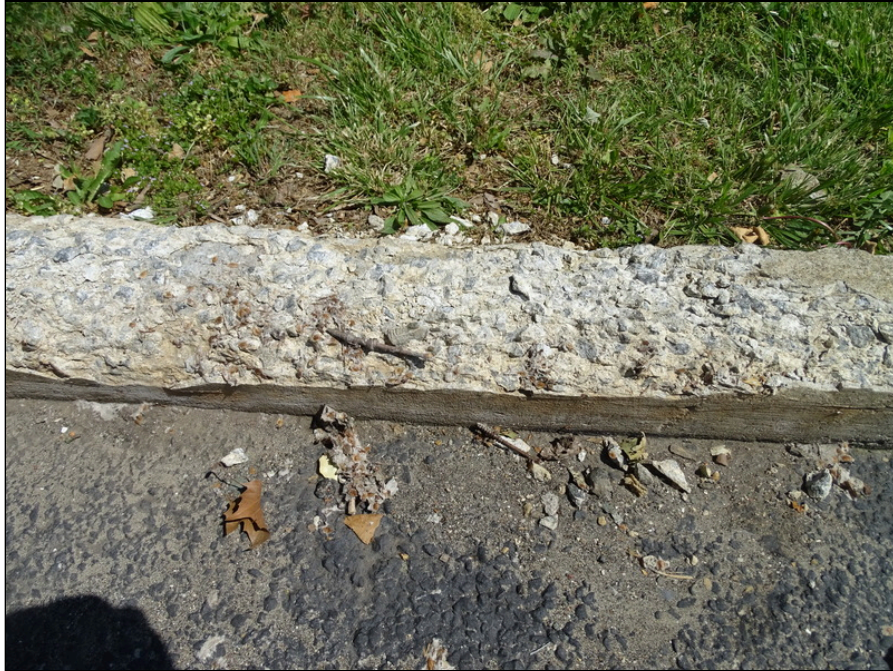
9 - Concrete curb - note deterioration

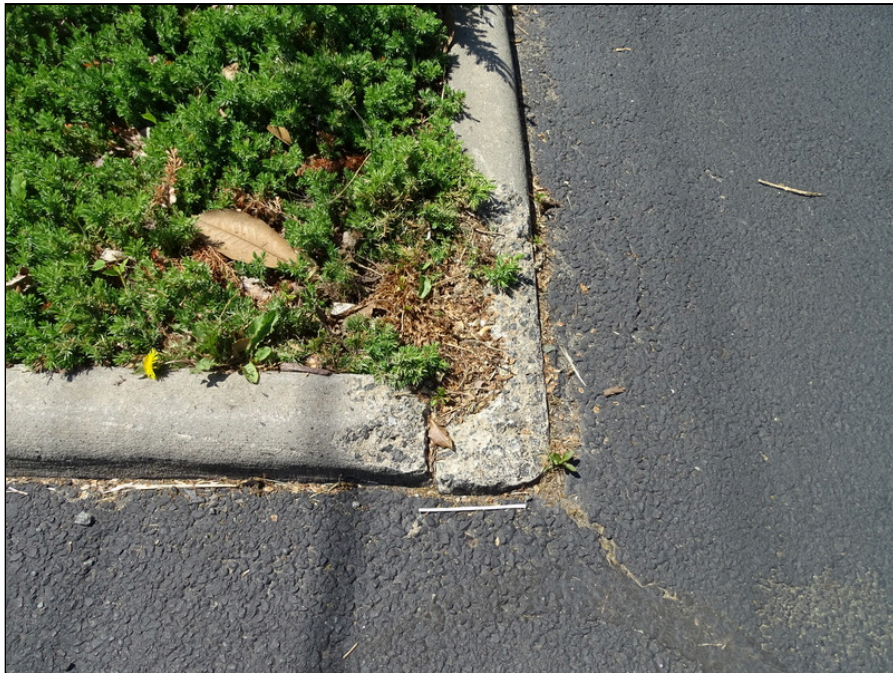
10 - Concrete curb - note deterioration

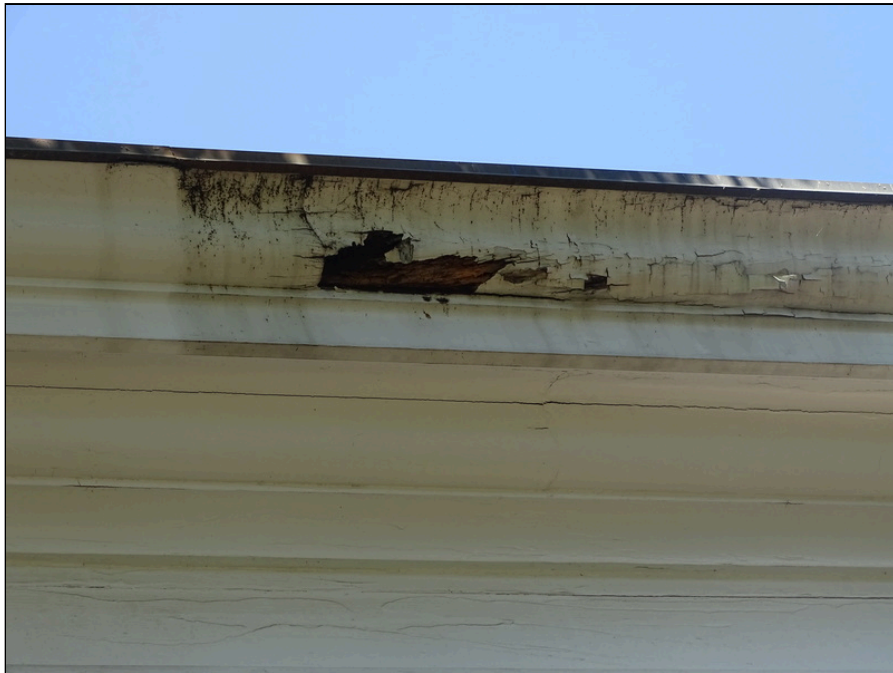
22 - Exterior cornice - note deterioration

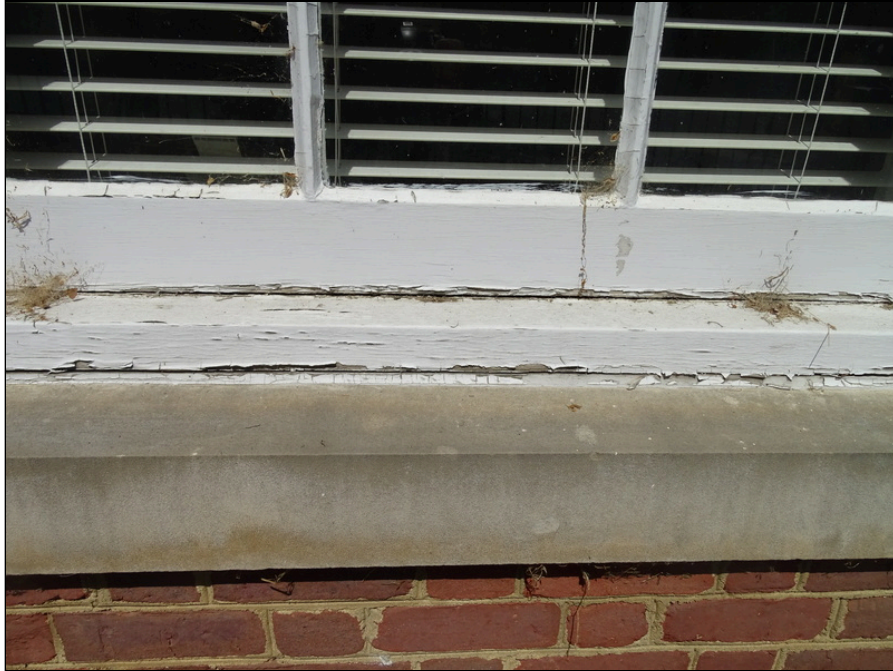
23 - Typical exterior window - note deterioration

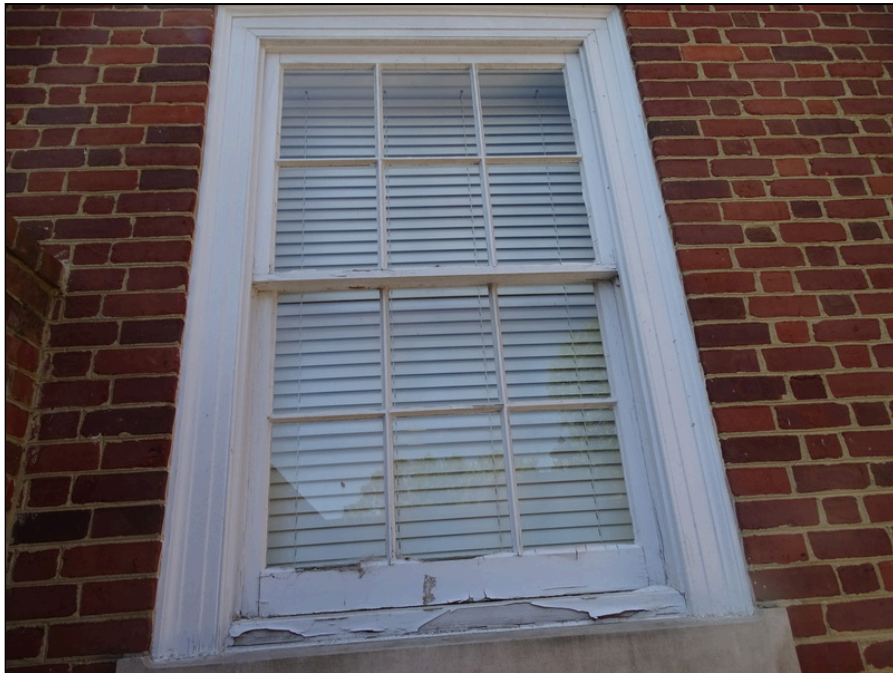
28 - Typical exterior window - note deterioration

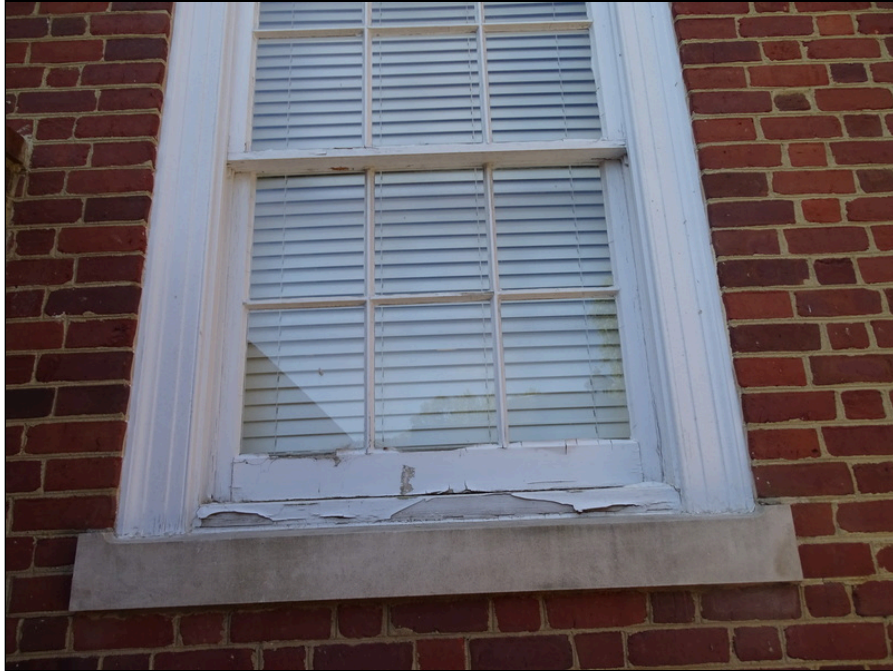
29 - Typical exterior window - note deterioration

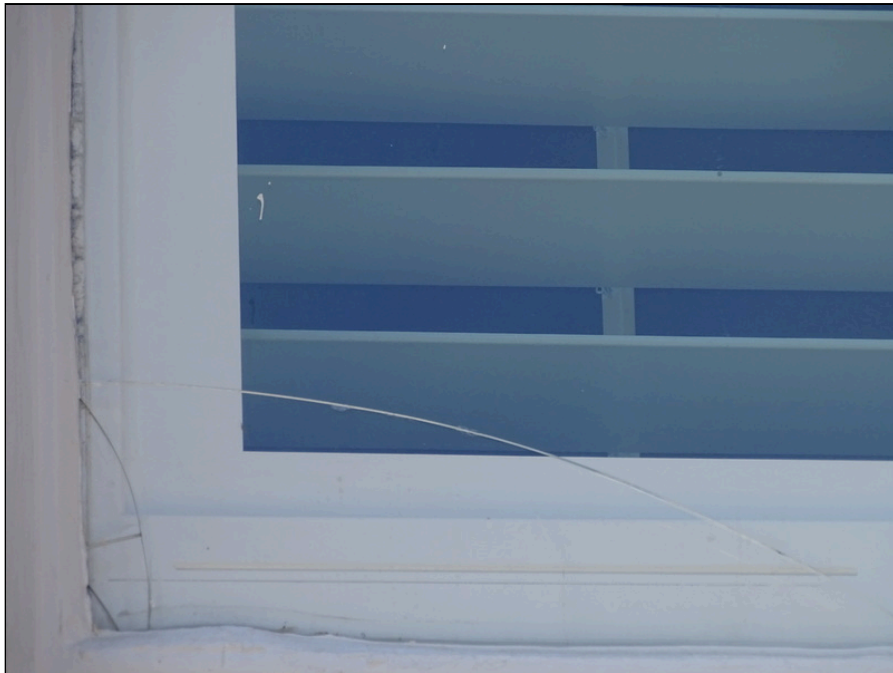
30 - Typical window exterior - note cracks in glass

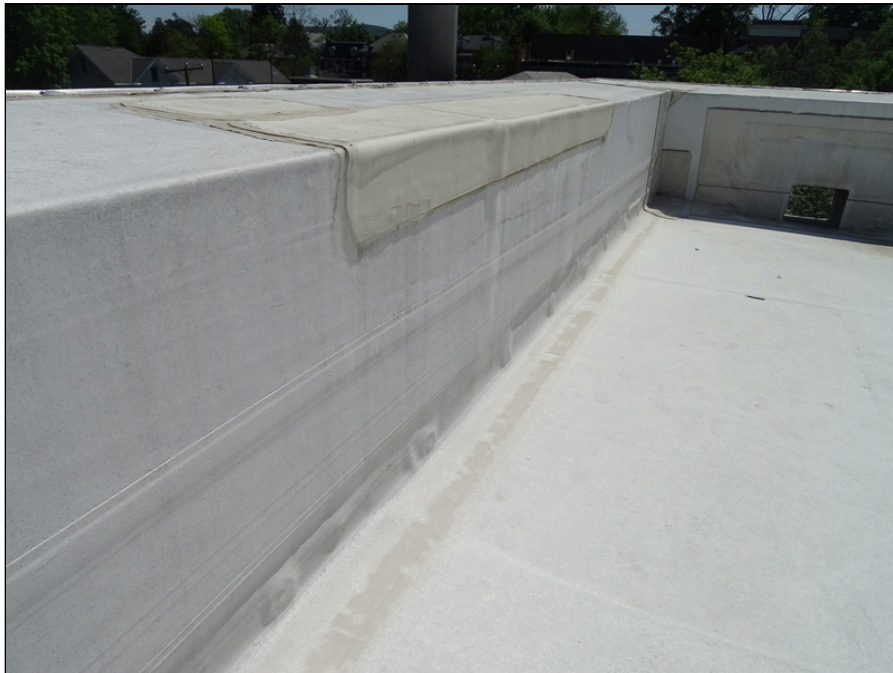
36 - Single-ply membrane roofing system at parapet wall - note patching

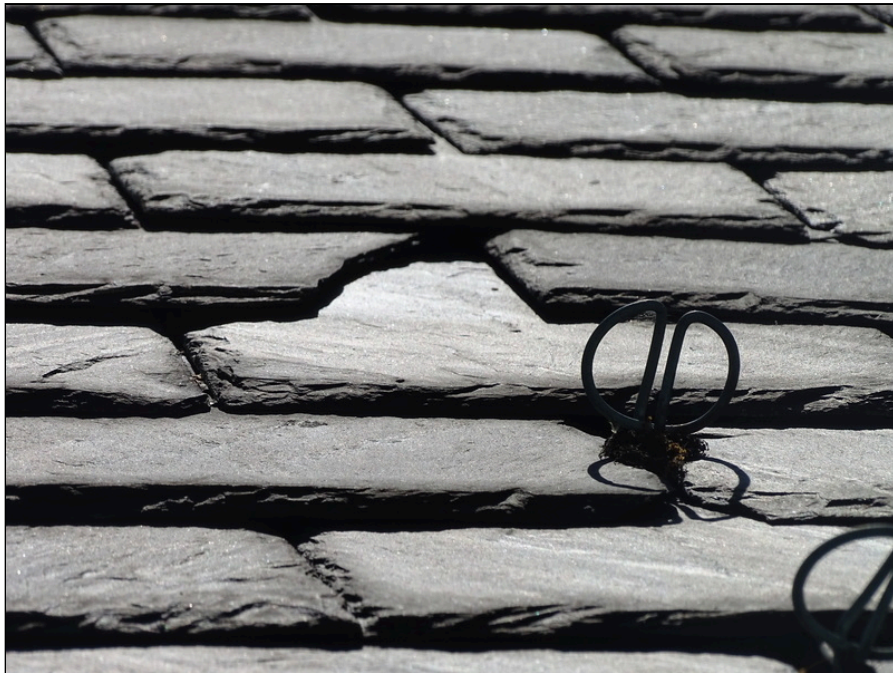
40 - Slate roofing system - note deterioration

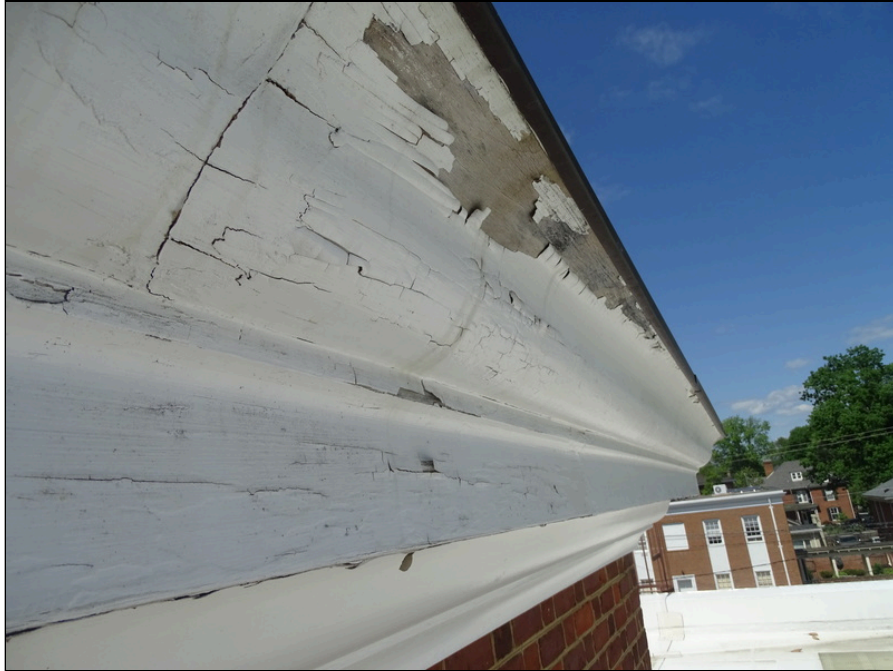
41 - Exterior cornice - note deterioration
