CITY HALL
605 EAST MAIN STREET
CHARLOTTESVILLE, VIRGINIA

ECS PROJECT NO. 46:6713

CITY OF CHARLOTTESVILLE - FACILITIES DEVELOPMENT

Reference: Facility Condition Assessment Report for City Hall, 605 East Main Street, Charlottesville, Virginia

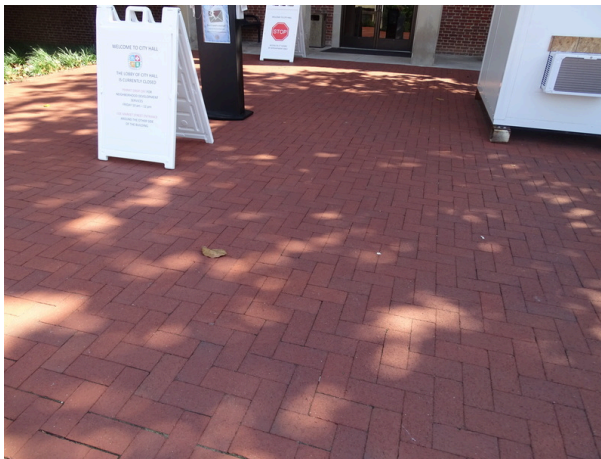
There are Brick paver sidewalks of undetermined thickness provided and the north and east sides of the building. The brick sidewalks were generally in good condition.

Typical brick sidewalk

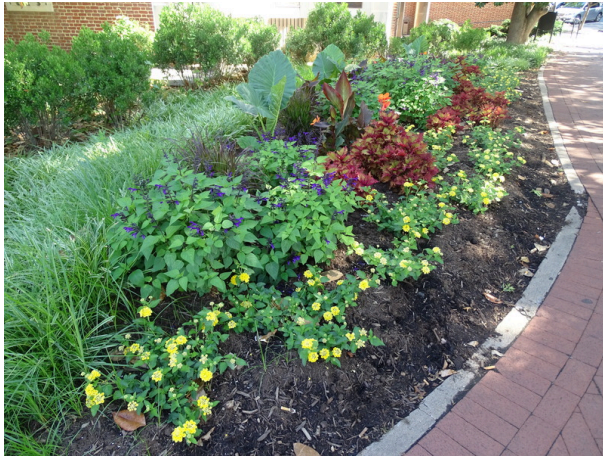
Landscaping consists of planting beds on the south and east sides of the building. The beds contain mature trees, small shrubbery, and flowering plants with mulch ground cover. Two flag poles stand at the south entrance. The landscaping elements were observed to be in good condition.

Typical landscaping

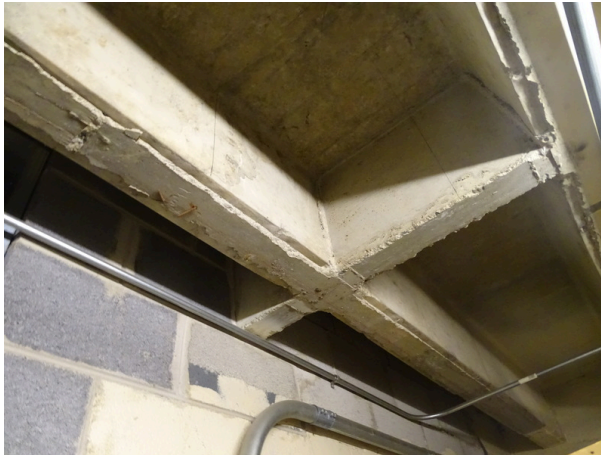
The structure of the building consists of concrete masonry unit bearing walls with interior concrete columns. There are concrete cast in place decks and joists for the framing of upper levels. The structural frame of the building was generally in good condition.

Structural framing lower level

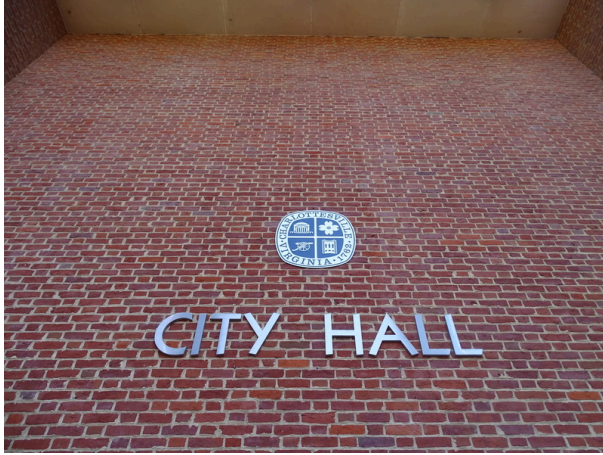
Building exterior west side of the building

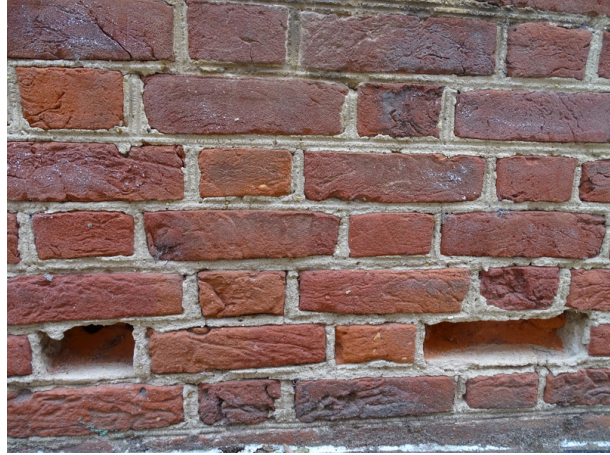
EXTERIOR FINISHES		
Item	Description	Condition
Masonry - Brick	Deterioration observed	Fair
Stone	Precast	Good
Sealants	Various	Fair

Building exterior west side of the building - note deterioration

Exterior sealants are located around the window and door frames, horizontal joints, and vertical joints in the Brick and precast elements. The expected useful life of exterior sealants is approximately 10 to 12 years before replacement is needed. The exterior sealants were generally in fair condition. The sealants were observed to be deteriorated. We recommend that the exterior sealants be replaced.

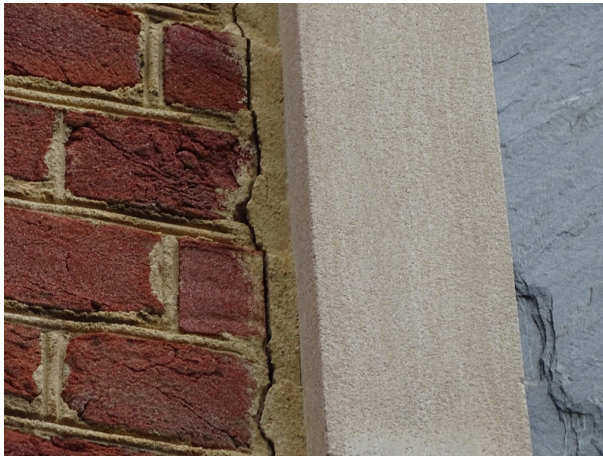
Building exterior - note deterioration

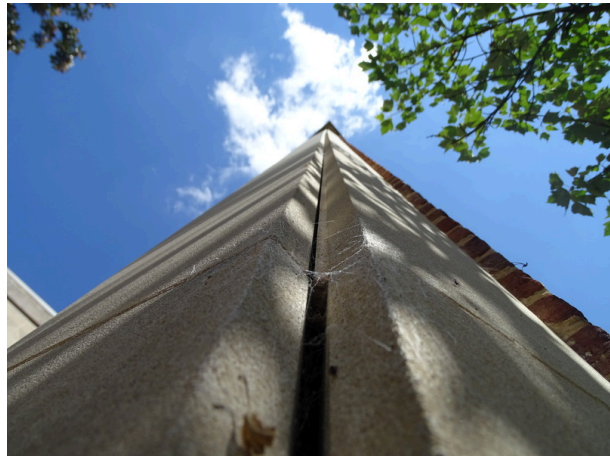
Building exterior - note deterioration

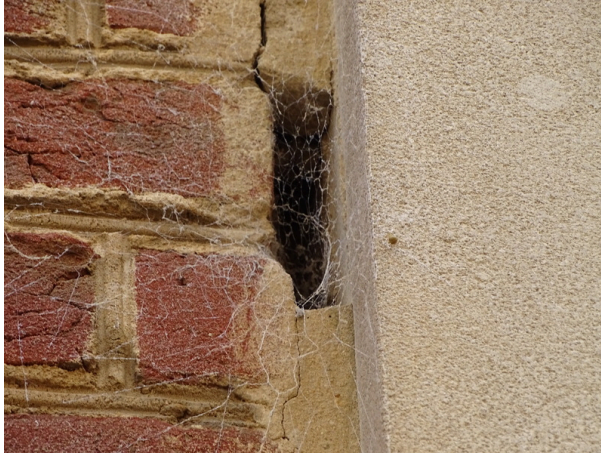
Building exterior - note deterioration

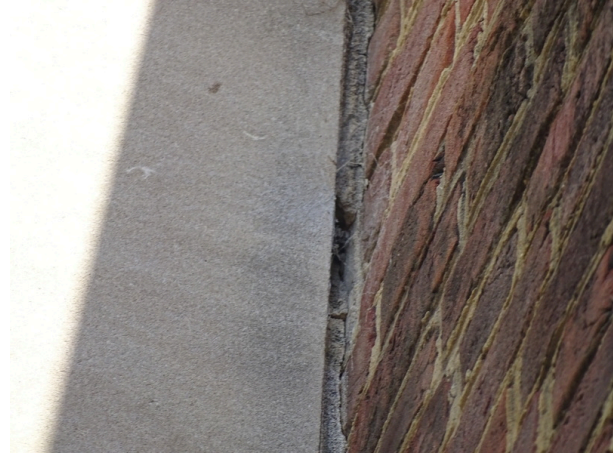
Building exterior - note deterioration

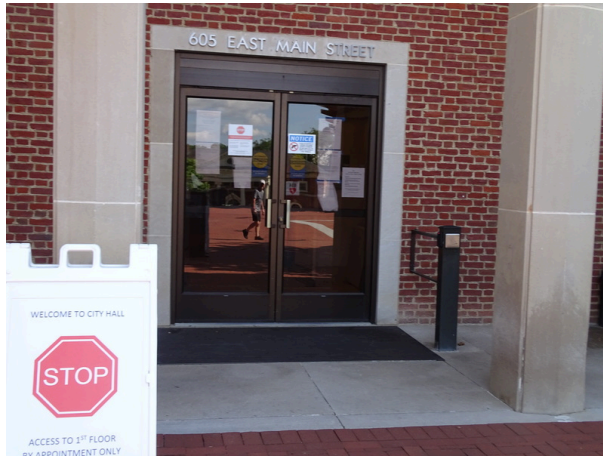
The main entrance is Metal doors with glass. The main entrance doors were generally in good condition.

Main entrance doors

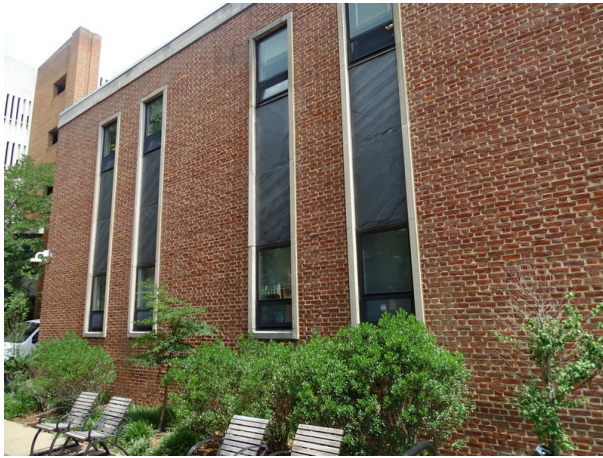
The window system for the building primarily consists of Aluminum frame double pane - operable window units. The windows were generally in good condition. The expected useful life of window units is typically 30 years.

Typical exterior window

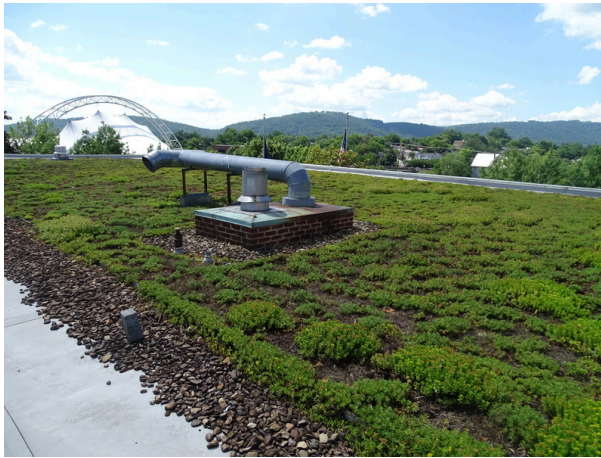
Green Roofing System west side of the building

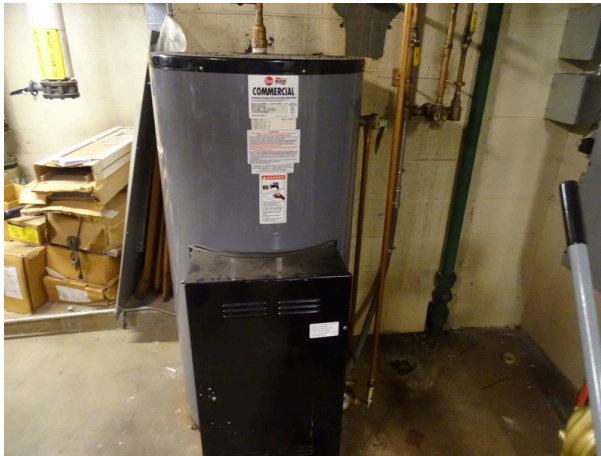
Domestic hot water to the building is provided by an Electric water heater located in the main utility room. The Electric water heater was manufactured by RUUD in 2007. The expected useful life of an Electric water heater is approximately 12 to 15 years. We recommend the Electric water heater be replaced during the report period.

Electric water heater located in main utility room

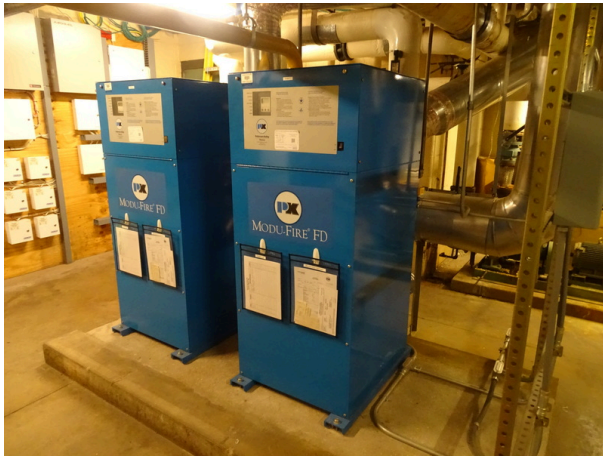
Boilers located in the City Hall Building

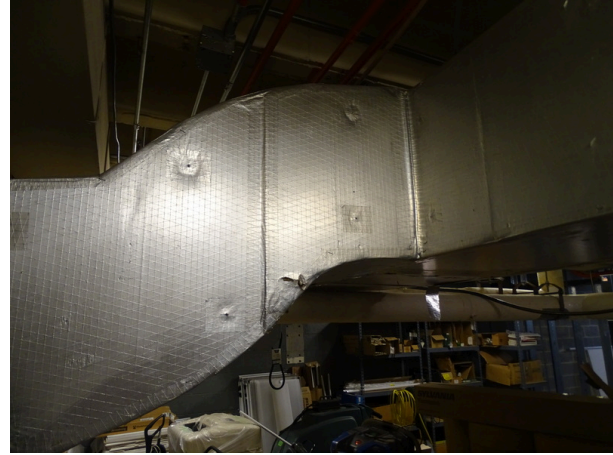
Typical mechanical duct

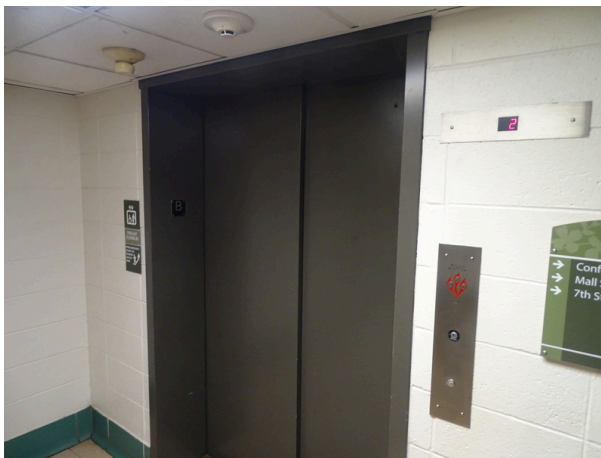
The two Dover elevators were reportedly added during the 1993 renovations. There is one freight elevator of capacity 7,000 pounds and one passenger elevator of capacity 3,000 pounds. The freight elevator was reportedly modernized in 2010 by Southern Elevator. The expected useful life of the elevator controls is 30 to 40 years with proper maintenance. Routine maintenance is considered adequate to keep the elevator system in good condition. An allowance for modernization of the passenger elevator during the report period has been included. The last annual inspection was performed in February 2021 by E&F Elevator Inspections and Consulting, Inc. and monthly maintenance is provided by Southern Elevator. The inspection reports are included in an appendix of this report.

Freight elevator system

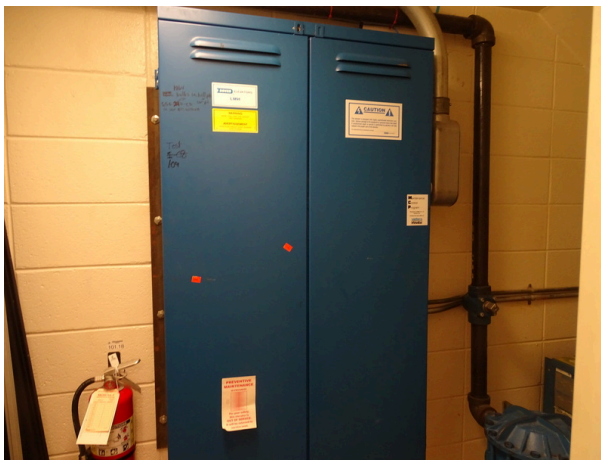
Passenger elevator controls

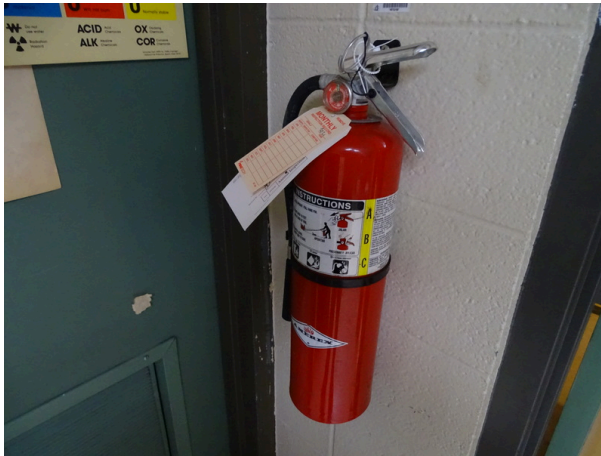
Typical fire extinguisher

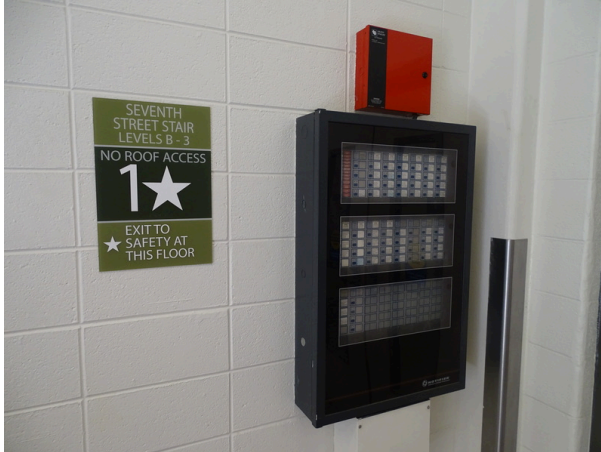
service or the fire department in the event of trouble. The expected useful life of the fire alarm system is typically 30-40 years. An allowance has been included for replacement of the fire alarm control panel during the report period.

Fire alarm annunciator and control panel

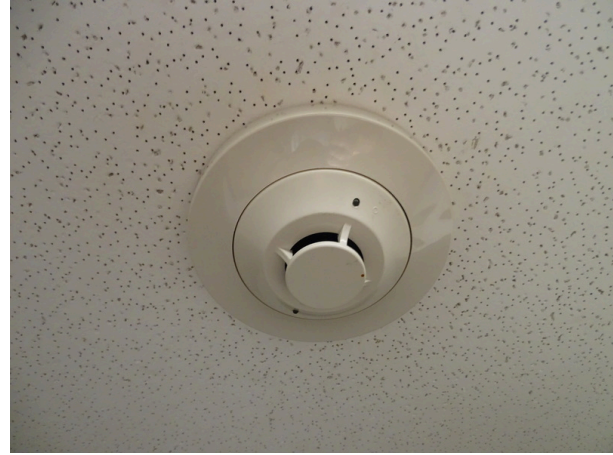
Typical smoke detector

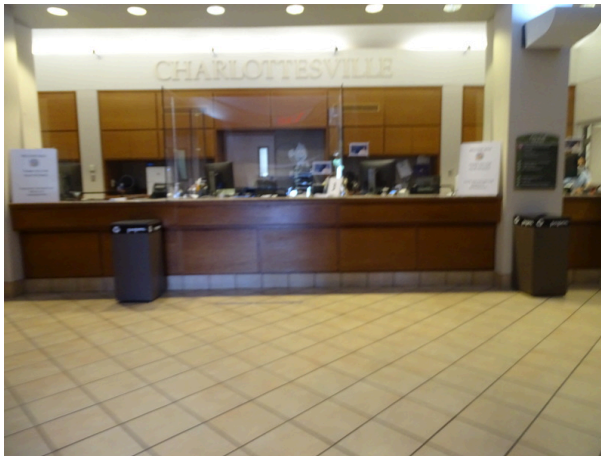
Interior finishes entrance area

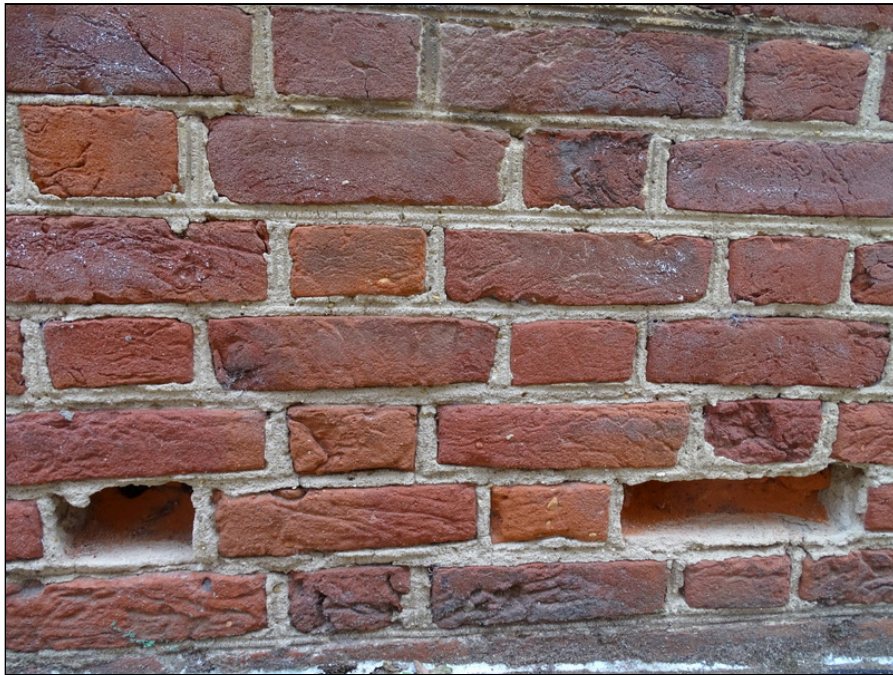
10 - Building exterior west side of the building - note deterioration

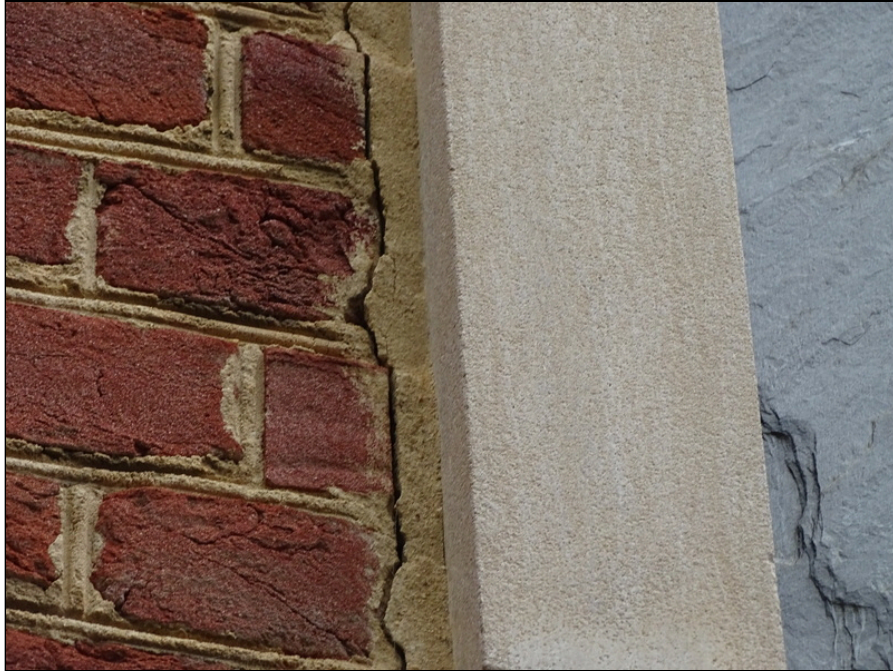
11 - Building exterior - note deterioration

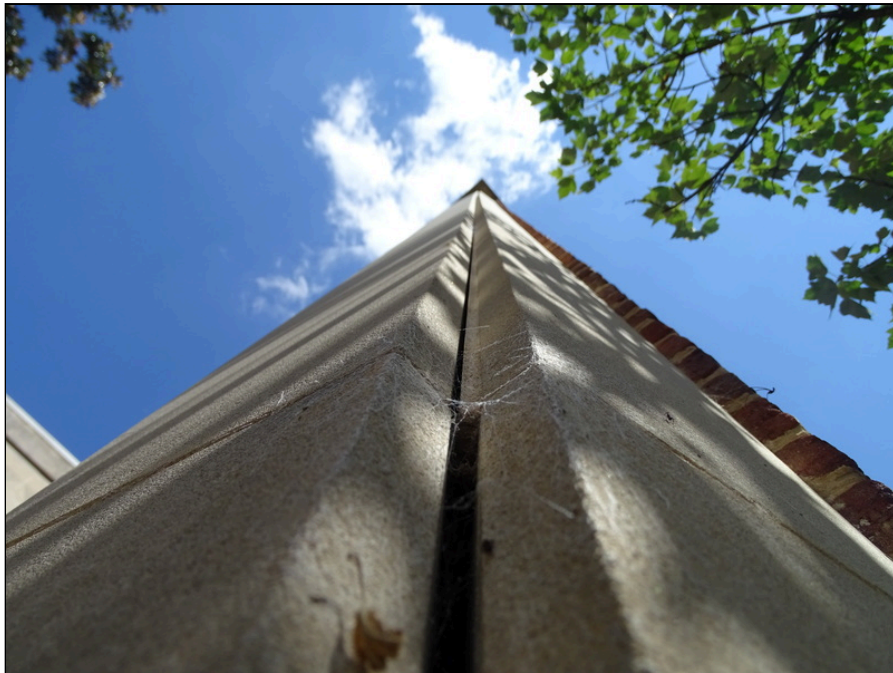
12 - Building exterior - note deterioration

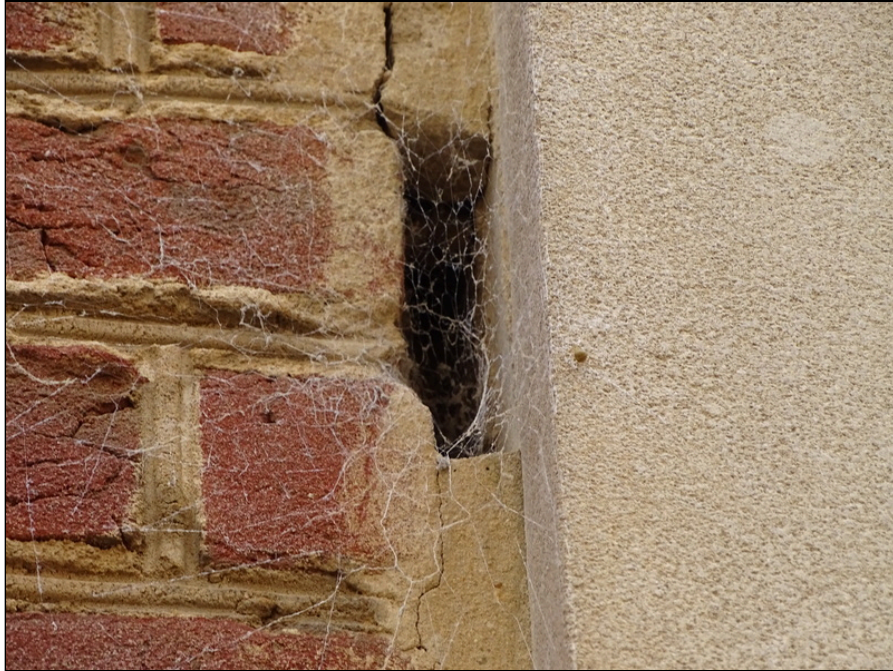
13 - Building exterior - note deterioration

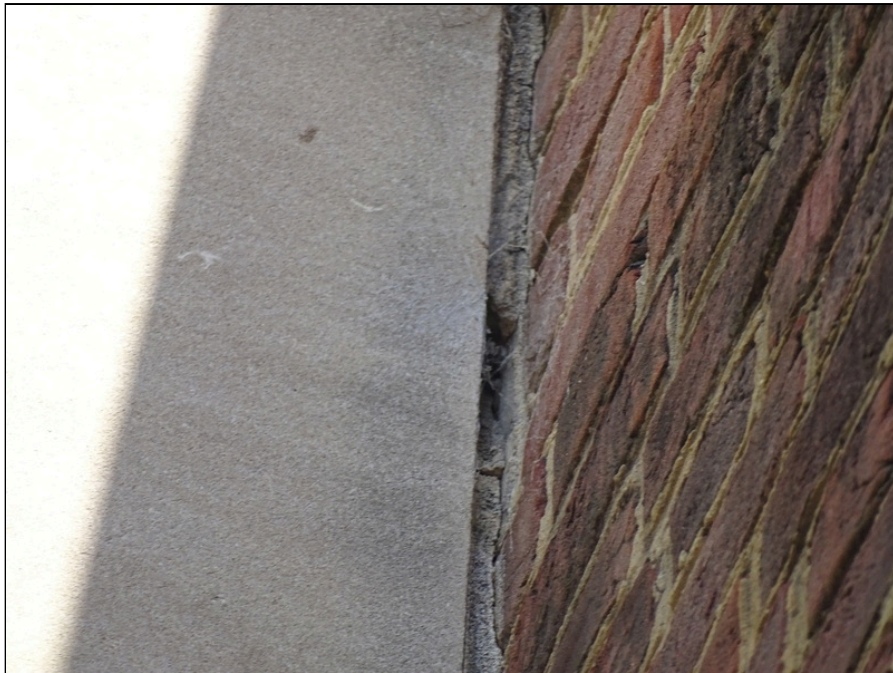
14 - Building exterior - note deterioration

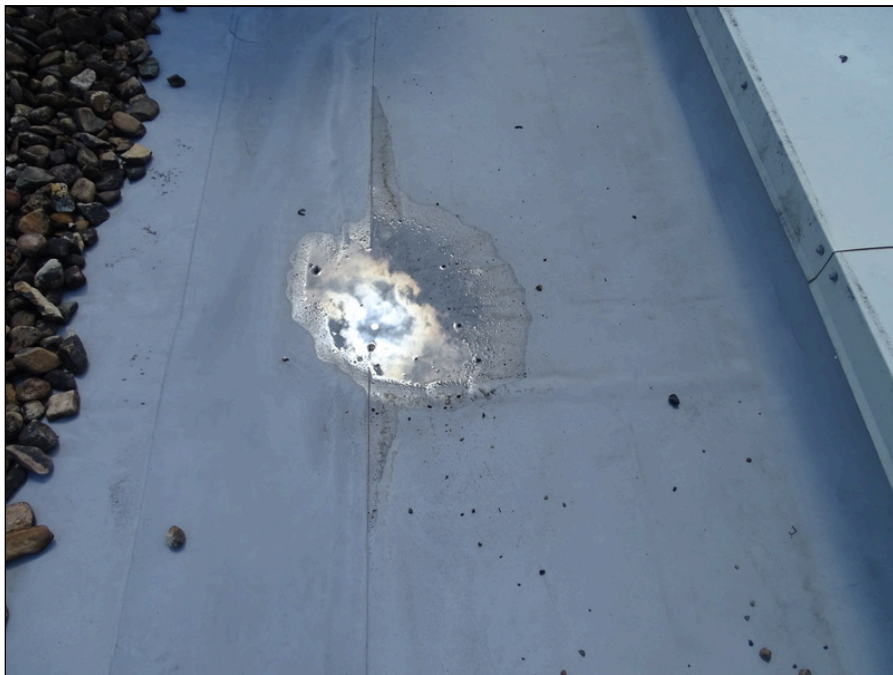
20 - single-ply roofing system west side of the building - note ponding
