CITY HALL ANNEX
120 7TH STREET NE
CHARLOTTESVILLE, VIRGINIA

ECS PROJECT NO. 46:6713

CITY OF CHARLOTTESVILLE - FACILITIES DEVELOPMENT

Reference: Facility Condition Assessment Report for City Hall Annex, 120 7th Street NE, Charlottesville, Virginia

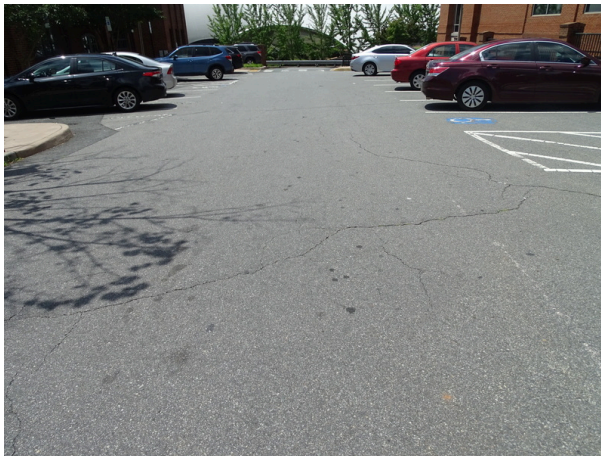
Parking area on east side of building

Cost Recommendation	EUL	EFF AGE	RUL	Year	Cost
MILL, OVERLAY AND RESTRIPE EXISTING ASPHALT	20	11	9	9	\$12,750

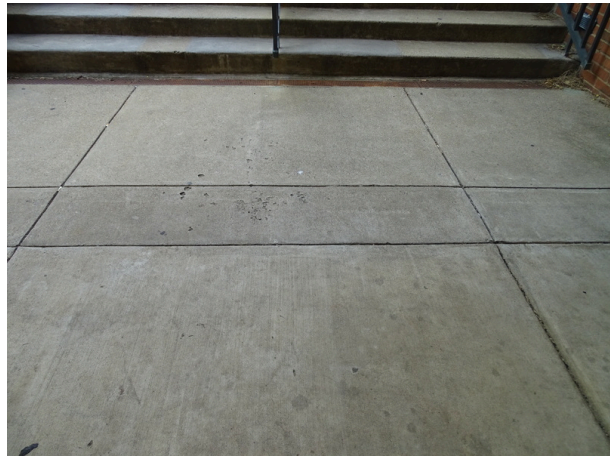
Concrete sidewalks were located throughout the perimeter of the building and provided access to various building entrances. Regularly spaced control joints were observed. The sidewalks were generally in good condition, with one trip hazard observed on the west side of the building. We recommend this section of sidewalk be replaced. Concrete stairs were located at the north, east, and west entrances and contained painted metal pipe handrails. The stairs and handrails were in generally good condition with the exception of various railing bases were observed to be corroded. The pockets where the railings are installed into the concrete should be grout filled to prevent water from corroding the railing bases (this is considered a maintenance item).

Typical concrete sidewalk condition

Cost Recommendation	EUL	EFF AGE	RUL	Year	Cost
REPLACE CONCRETE SIDEWALK	30	25	5	5	\$2,500
Total					\$2,500

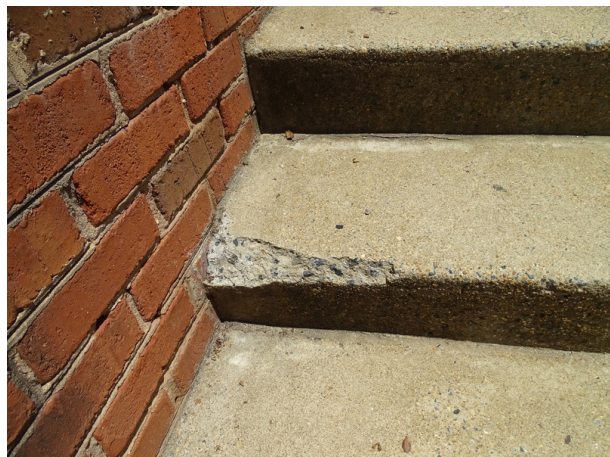
Exterior concrete stair deteriorated

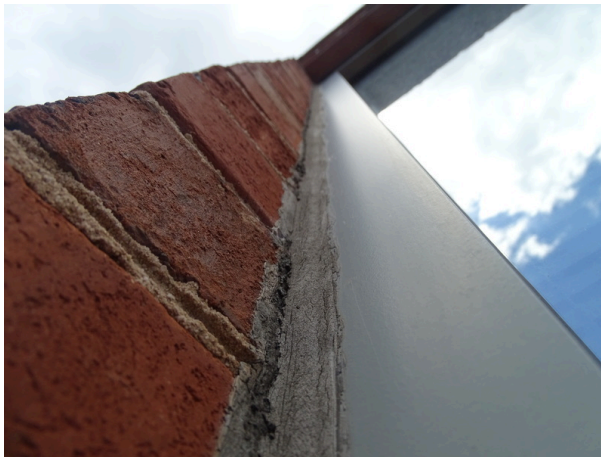
Exterior sealants are located around the window and door frames, and vertical joints in the Brick veneer. The expected useful life of exterior sealants is approximately 10 to 12 years before replacement is needed. The exterior sealants were generally in poor condition. The sealants were observed to be hard and separated from the substrate; we recommend that the exterior sealants be replaced in conjunction with the repointing project.

Window perimeter sealant

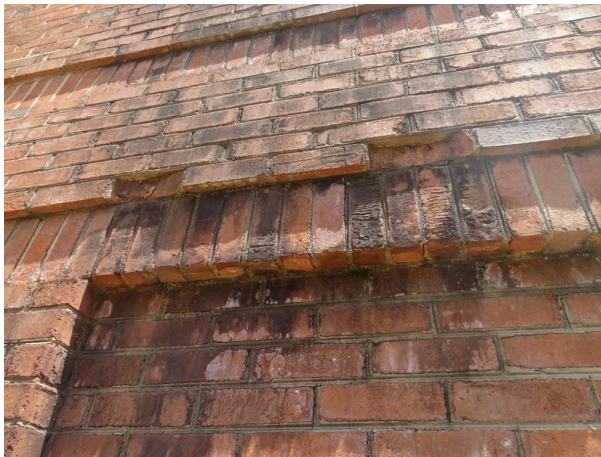
Typical exterior - note spalled bricks

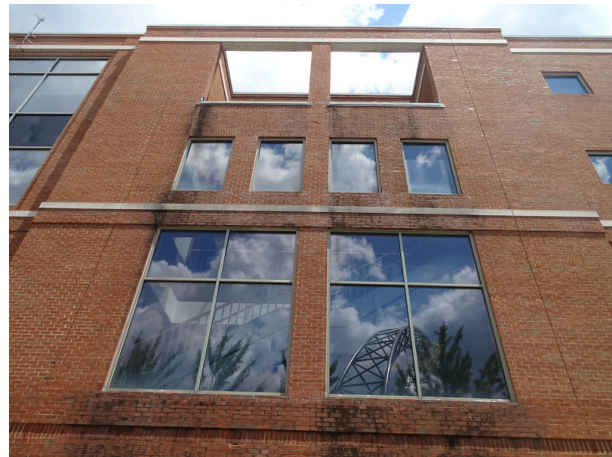
Typical exterior - note efflorescence

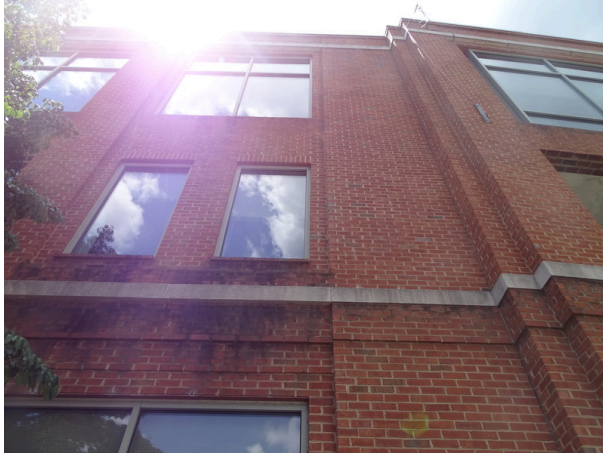
Efflorescence and soiled exterior

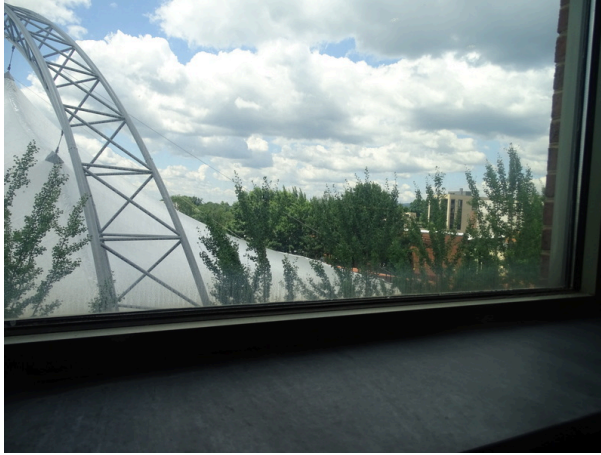
Typical window - note fogged glass

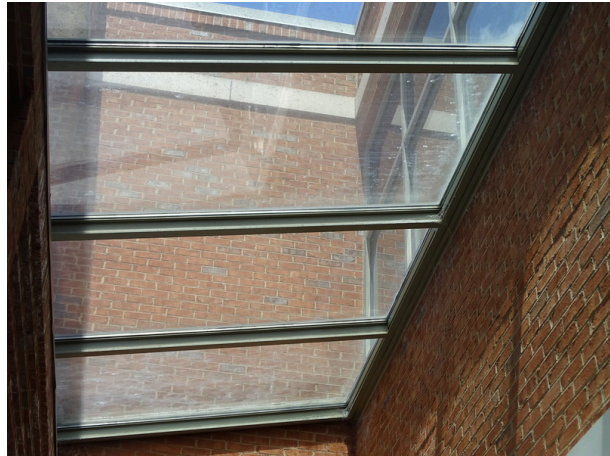
At the third level, south side of the building, there was a skylight that framed into the underside of exterior windows. It was reported during our site visit that a previous water infiltration was repaired at an earlier date.

Skylight

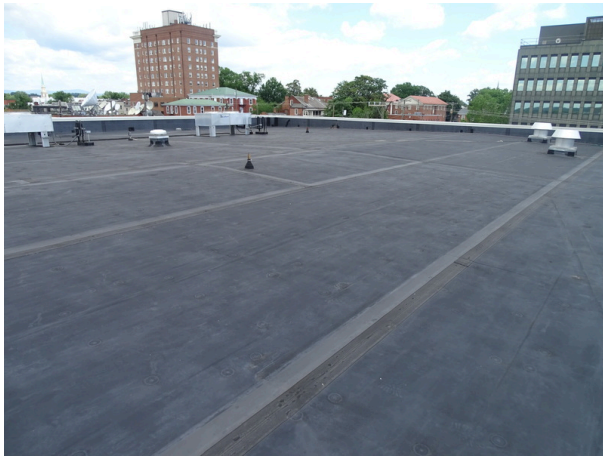
The single-ply roofing system was replaced in 2007 and was generally in fair condition, with a Firestone manufacturer warranty providing coverage until 2027. It was reported in 2016 that after installation, bubbling of the membrane was observed in various locations, including at corner reinforcement and seam overlaps. The roofing contractor repaired the bubbling membrane by applying patches throughout. At the time of the site visit, the patches were reportedly performed as routine maintenance. No leaks were reported from the roof; it was reported that the roof warranty would not cover the bubbling membrane unless leaks were reported. It is recommended that the bubbles be monitored for additional deterioration and signs of leaks.

Roof overview

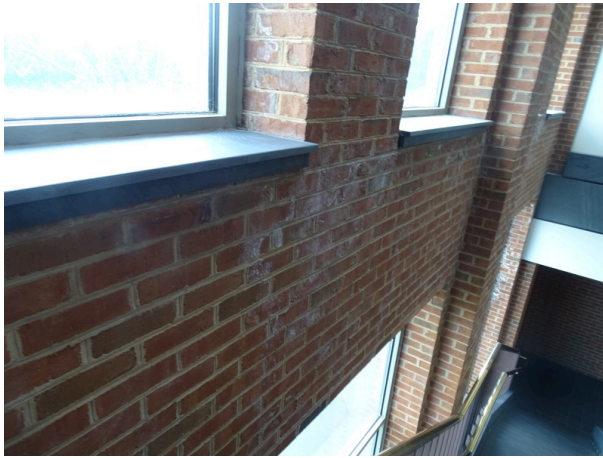
Efflorescence and soiled interior

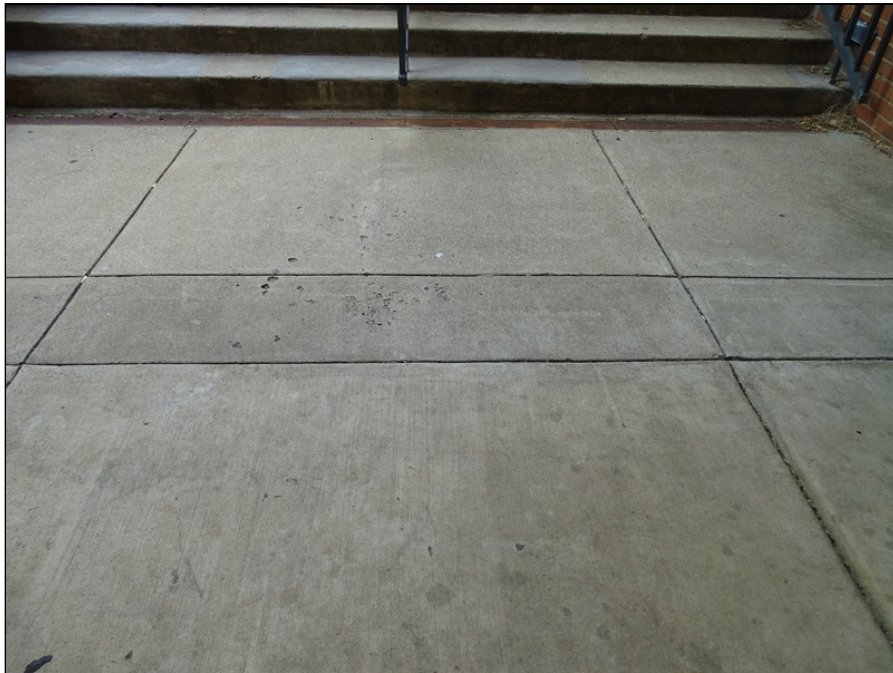
4 - Typical concrete sidewalk condition

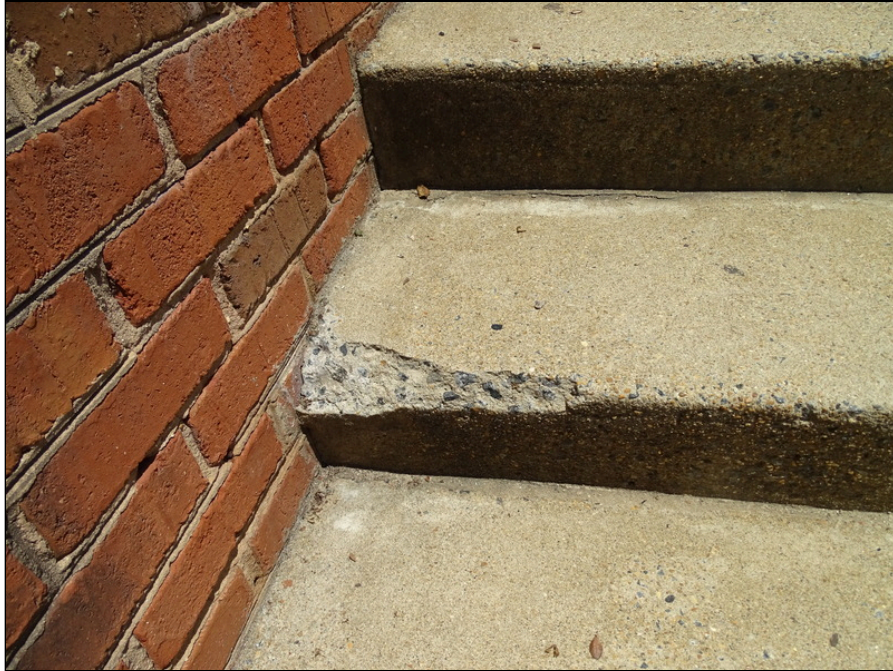
7 - Exterior concrete stair deteriorated

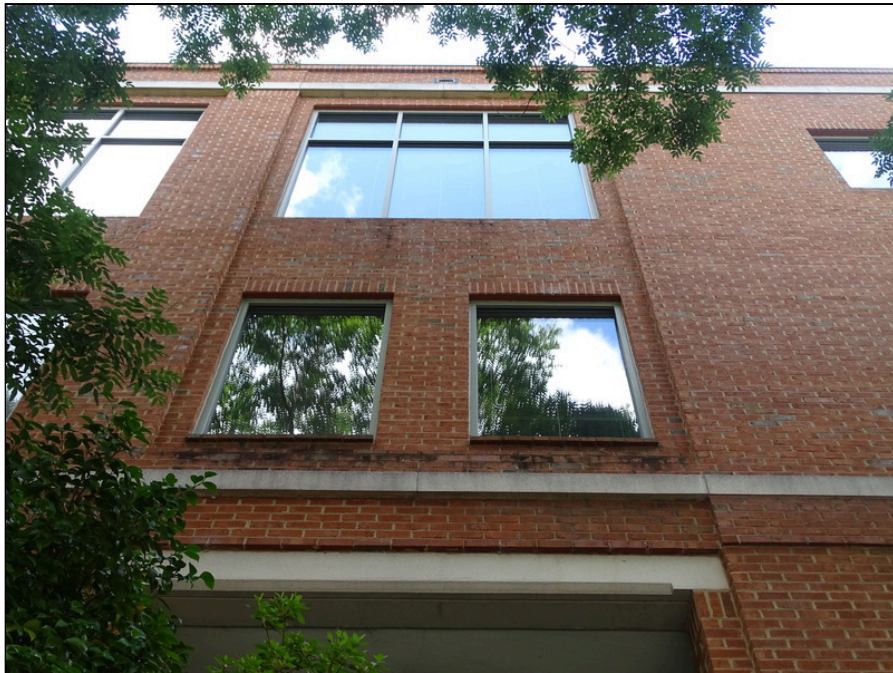
16 - Exterior north elevation - note stained wall

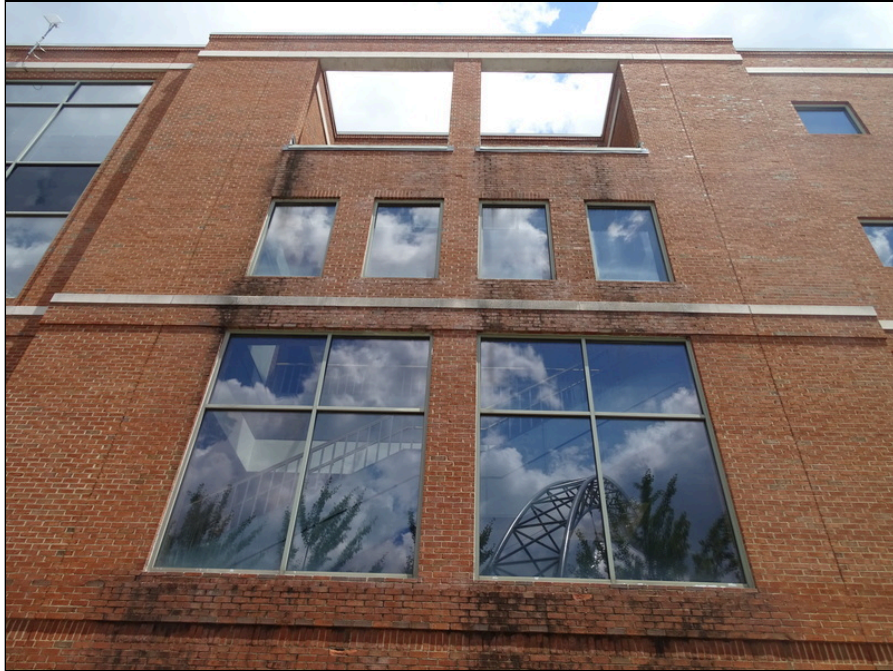
17 - Typical exterior - note efflorescence

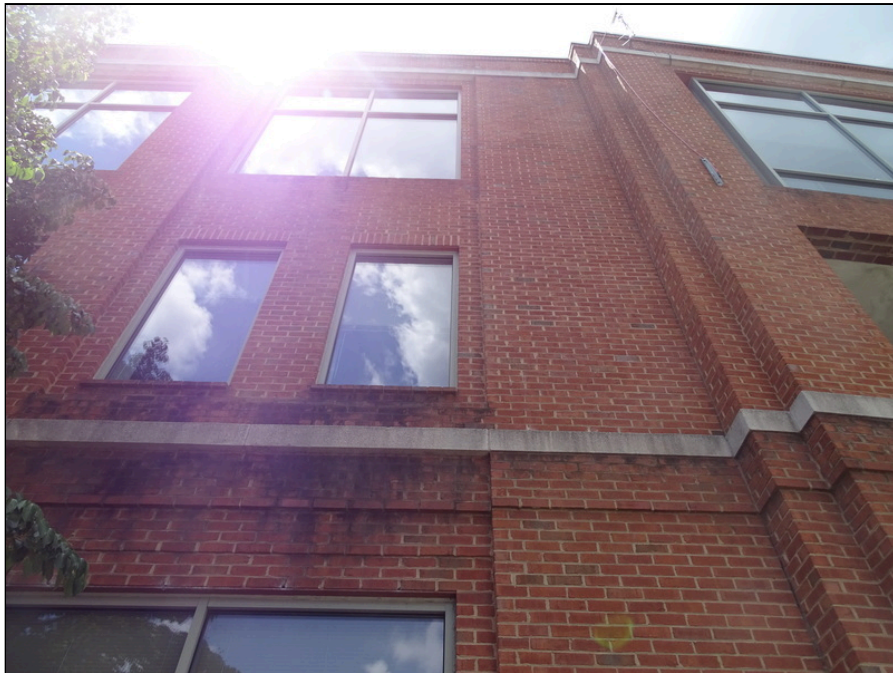
18 - Typical exterior - note efflorescence

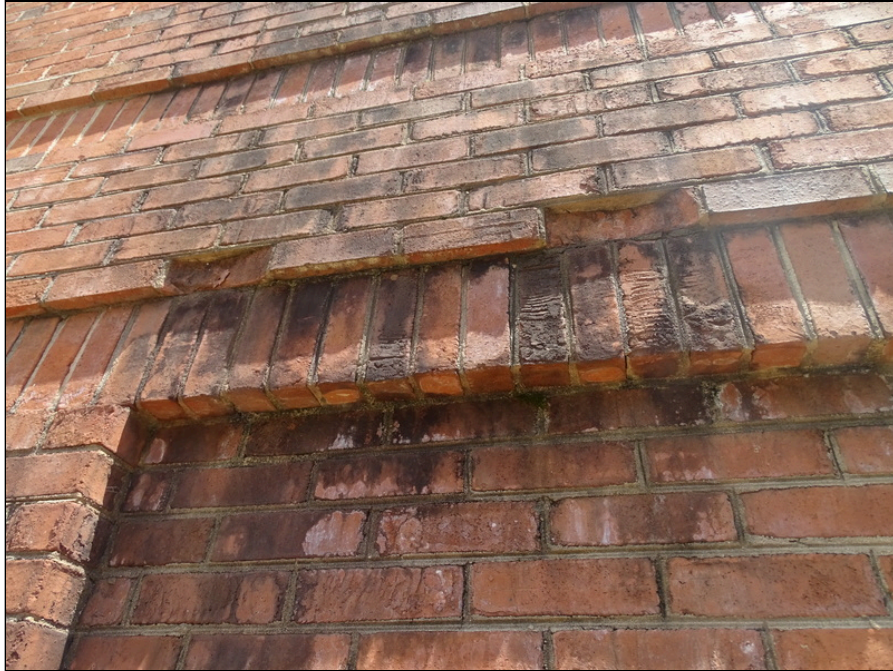
19 - Typical exterior - note spalled bricks

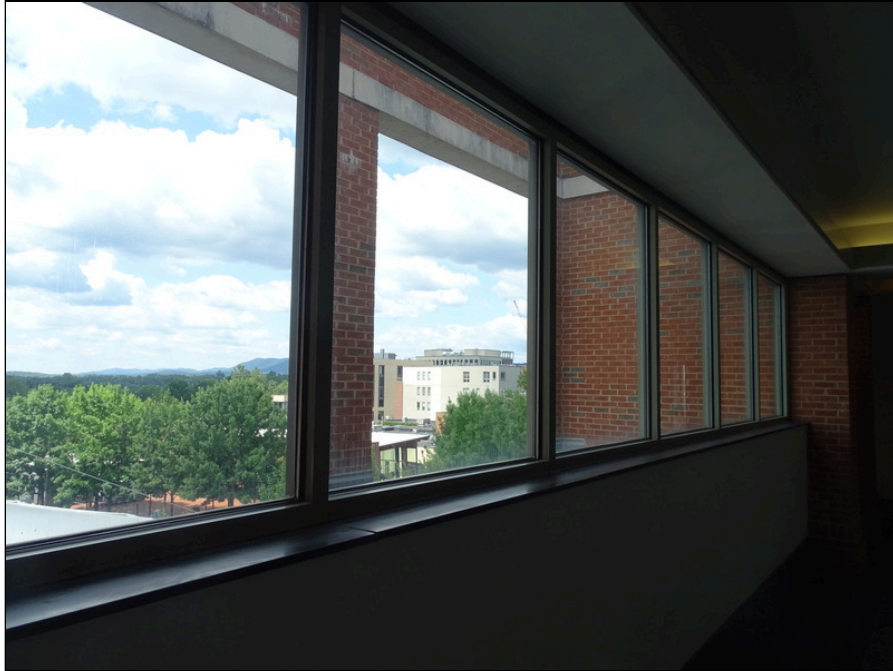
23 - Water infiltration at skylight and window intersection

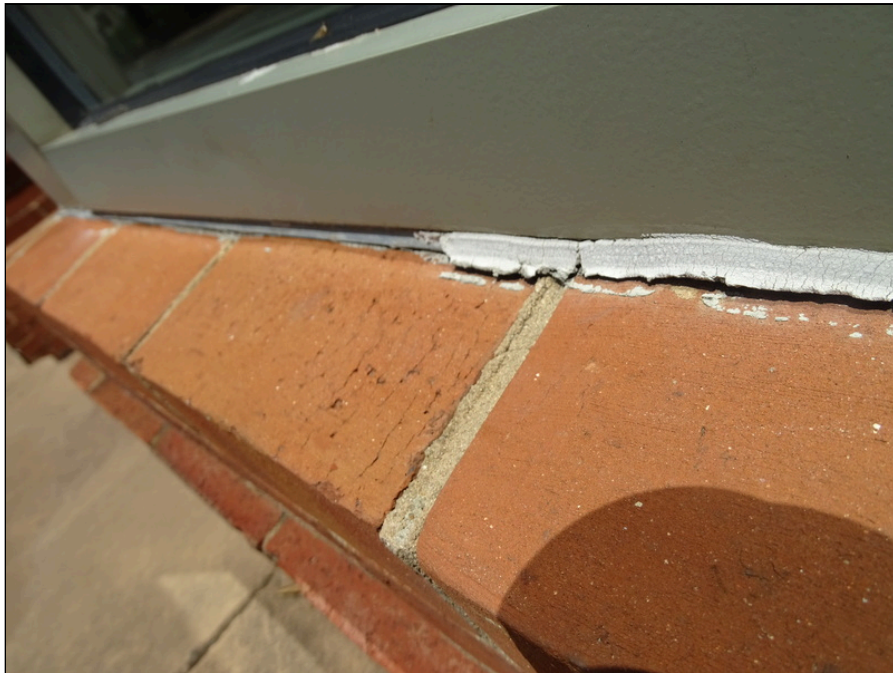
24 - Typical window - note window perimeter sealant

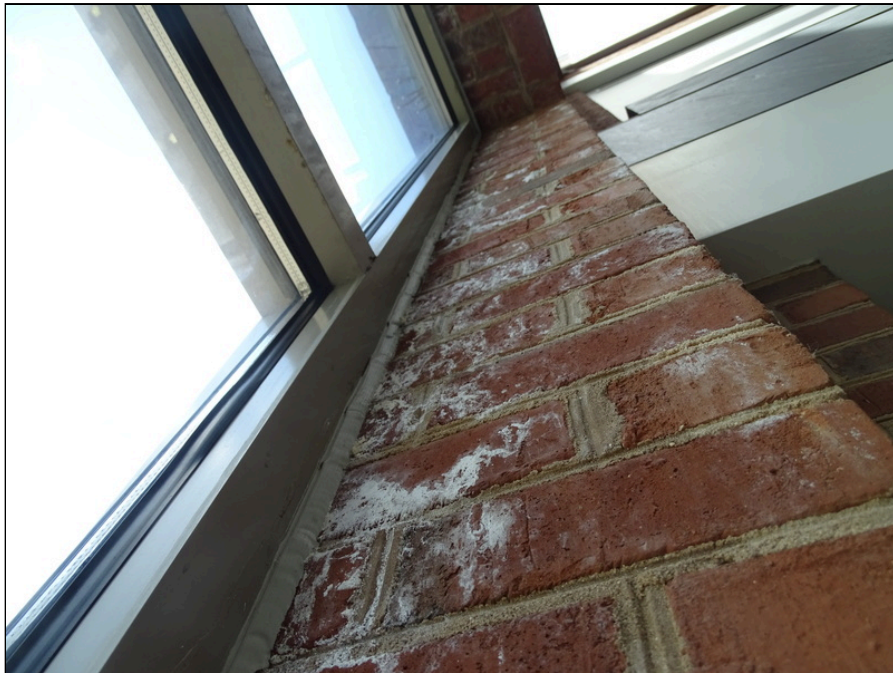
26 - Efflorescence and soiled interior

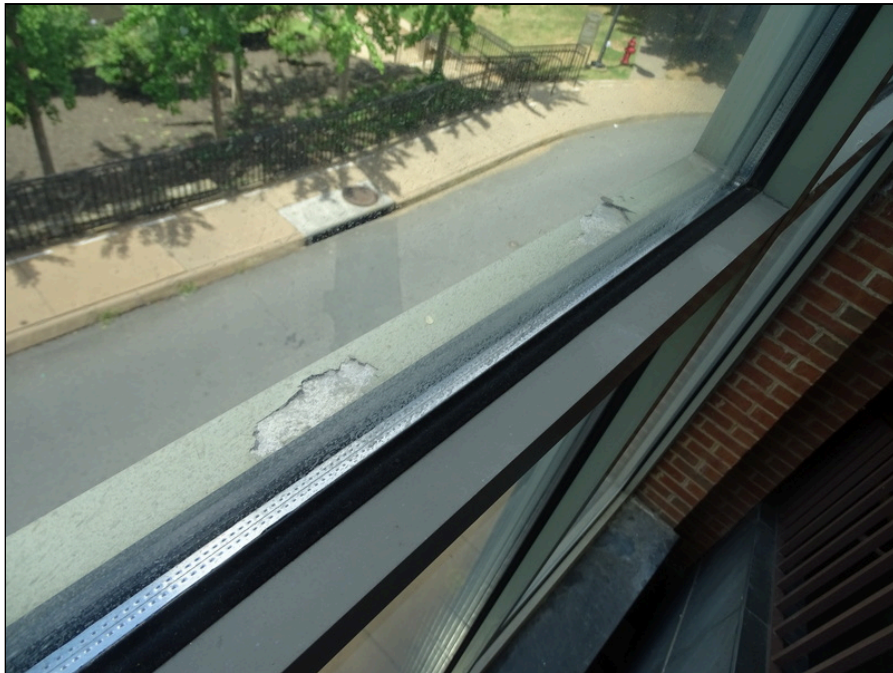
28 - Typical window - note peeling paint

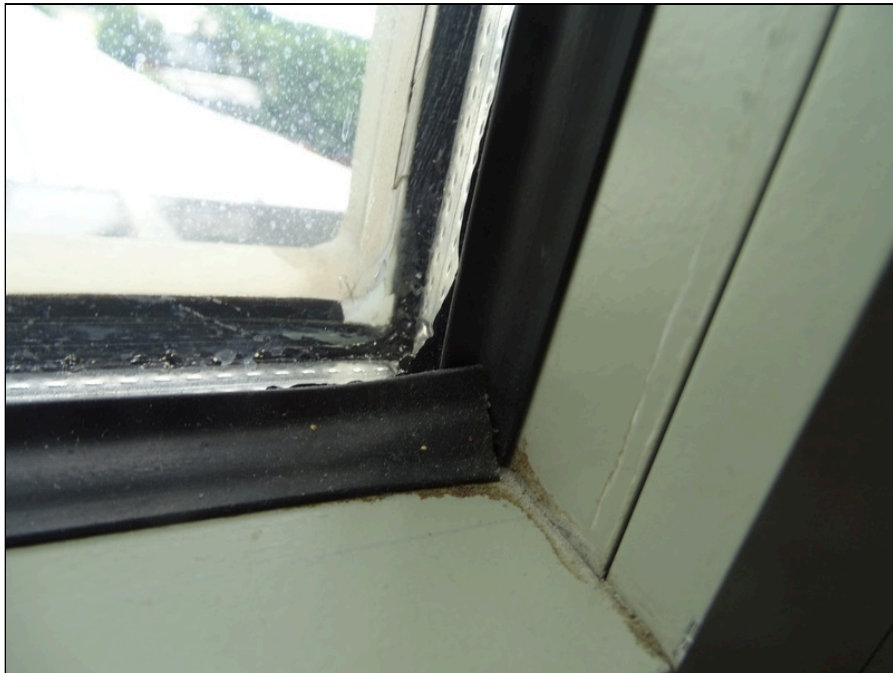
30 - Typical window - note gasket deterioration

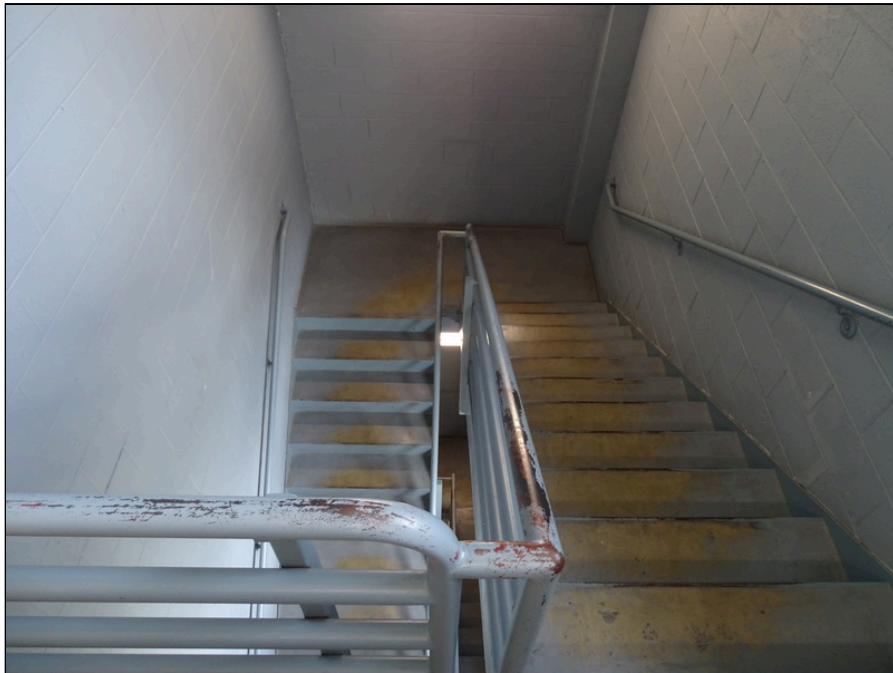
68 - Peeled stair handrail
