CITY YARD WASH FACILITY AND STORAGE BUILDING
309 4TH STREET NW
CHARLOTTESVILLE, VIRGINIA

ECS PROJECT NO. 46:6713

CITY OF CHARLOTTESVILLE - FACILITIES DEVELOPMENT

Reference: Facility Condition Assessment Report for City Yard Wash Facility and Storage Building, 309 4th Street NW, Charlottesville, Virginia

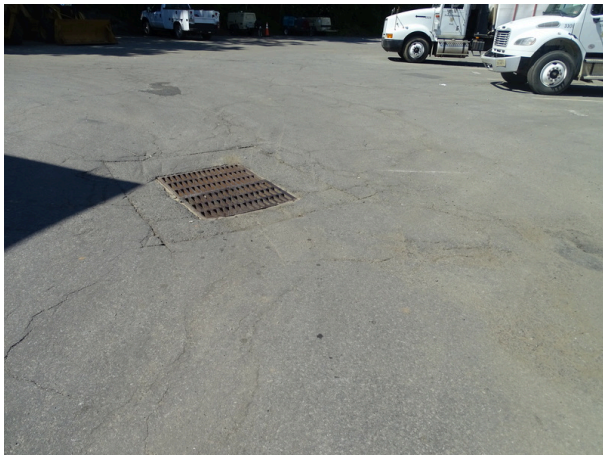
Asphalt pavement - note cracking

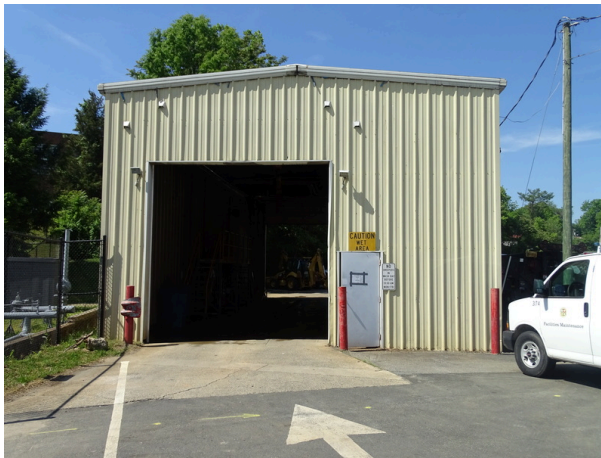
There is a concrete pavement section surrounding the gas pumps and canopies and at the entrance to the bus wash facility. The concrete pavement section was cracked in some areas. We recommend an allowance to replace the cracked sections of concrete pavement.

Concrete pavement - note cracking

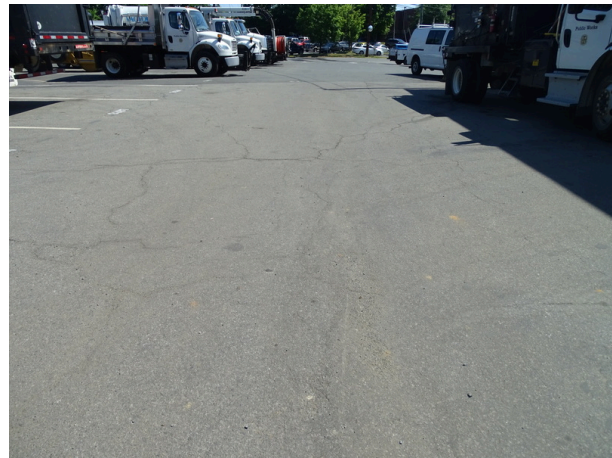
Asphalt pavement and parking - note cracking

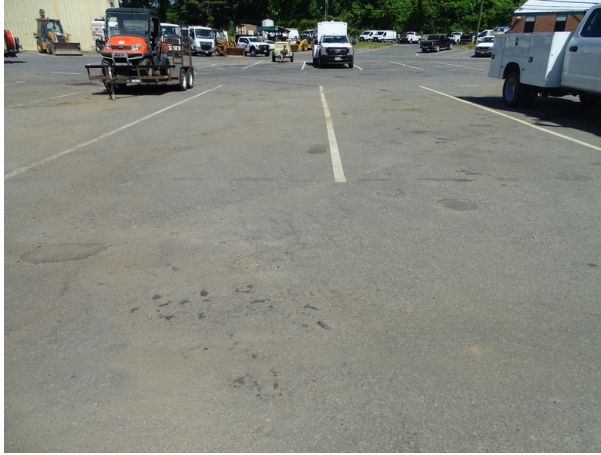
Asphalt pavement - note cracking

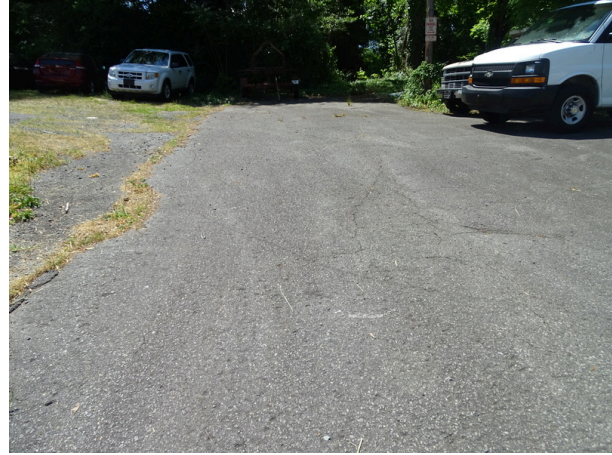
Asphalt pavement - note cracking

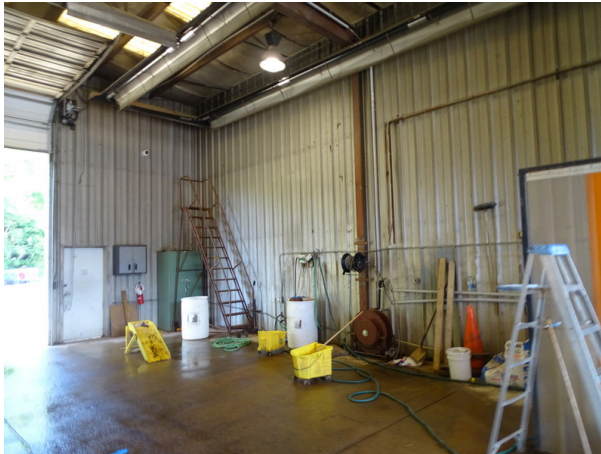
The structure of the buildings consists of concrete slab-on-grade for both buildings. The roof framing consists of structural steel for bus wash building. The storage building contained concrete masonry unit bearing walls. The structural framing of the storage building was generally in good condition. The wash building reportedly had an additional structural study performed by others with detailed design recommendations for repairs included in the report. The report is included as an appendix to this report. We recommend an allowance to perform the structural repairs.

Structure framing

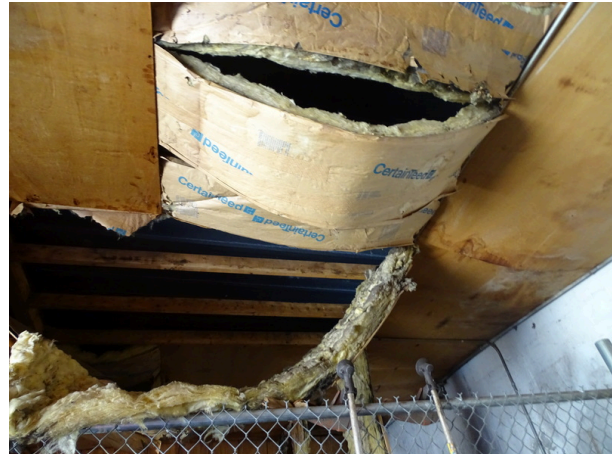
Structure framing - Storage

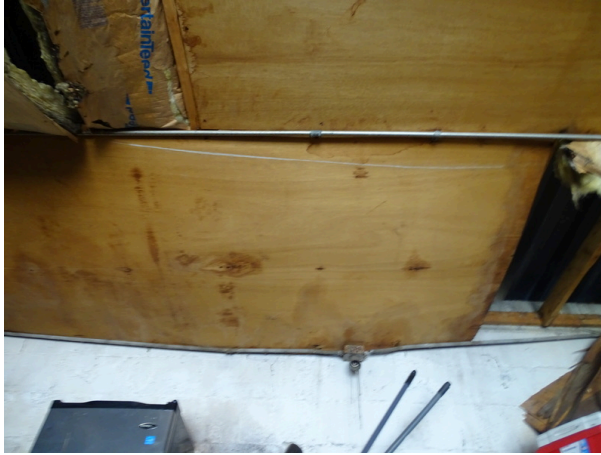
Structure framing - Storage

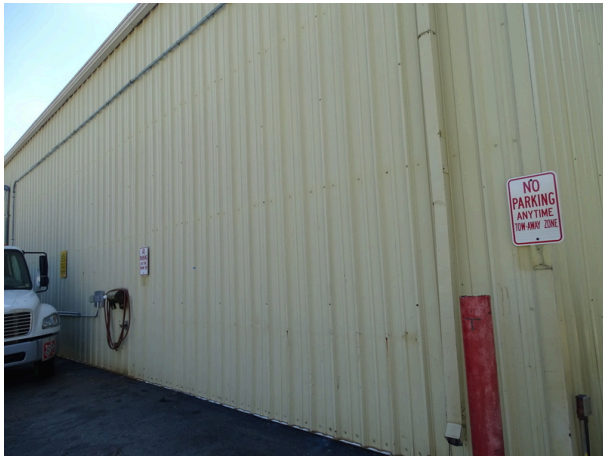
The exterior of the bus wash building consists of metal. The metal exterior was damaged in some locations and deteriorating at the bottom. We recommend repairs to the metal exterior as needed. The paint on the building exteriors was generally in fair condition. We recommend painting both buildings during the report period as needed.

Building exterior bus wash building

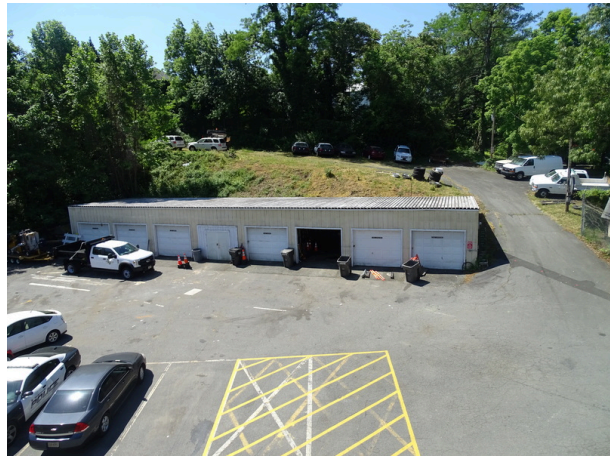
Storage Building

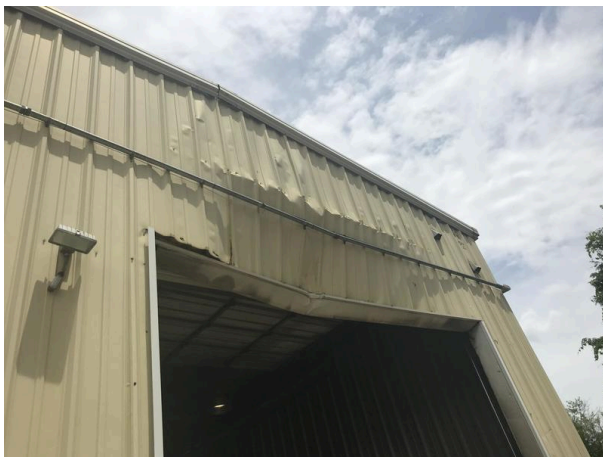
Bus Wash Damage 1

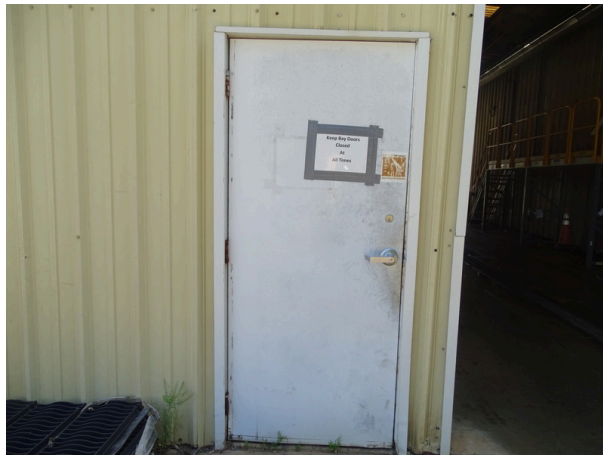
Overhead doors are located at the bus wash and storage buildings. The overhead doors were observed to be damaged. The overhead doors were generally in fair condition. We recommend the damaged overhead doors be replaced.

Exterior doors at bus wash building

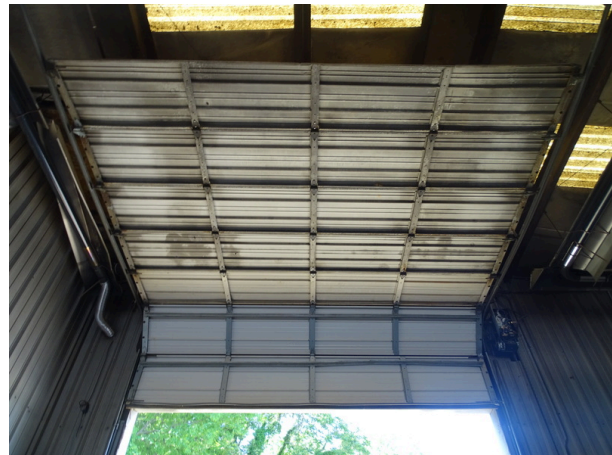
Typical overhead door in bus wash building

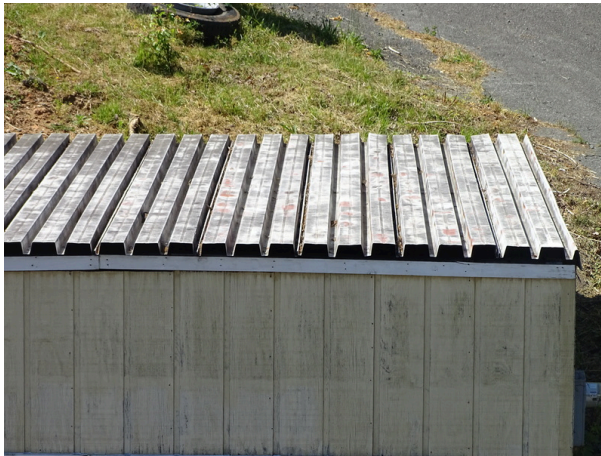
Roofing system of storage building

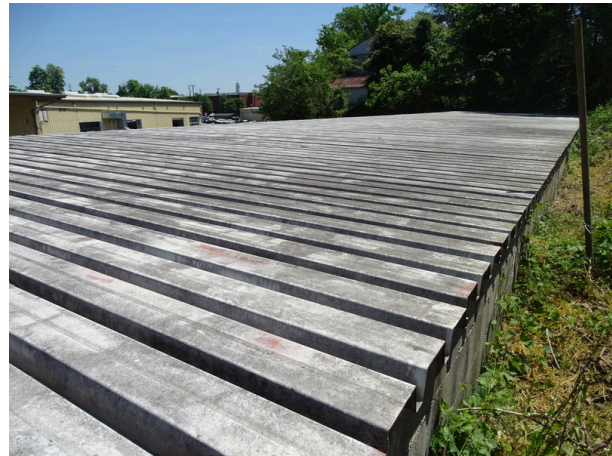
Roofing system of storage building

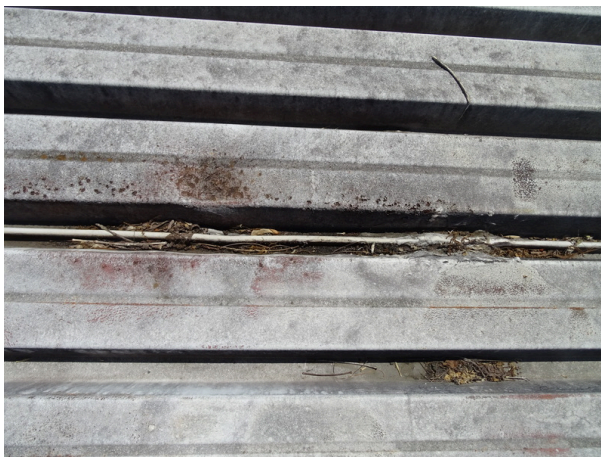
Drainage for the roofing systems is provided by gutters and downspouts. Damage to these items was observed at both buildings. We recommend that the gutters and downspouts be replaced during the scheduled roof replacement.

Roofing system of storage building - note deterioration

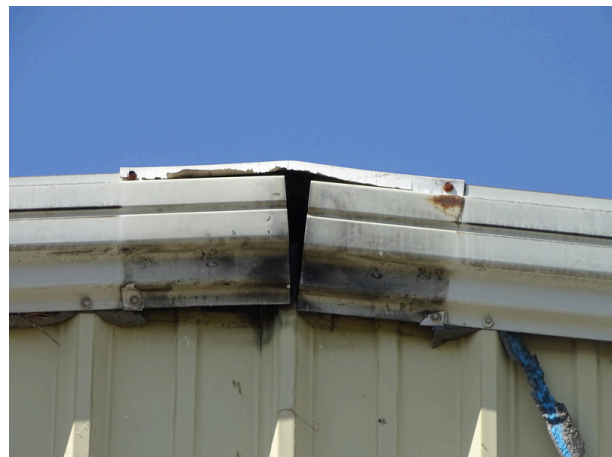
Roofing system of bus wash building - note deterioration

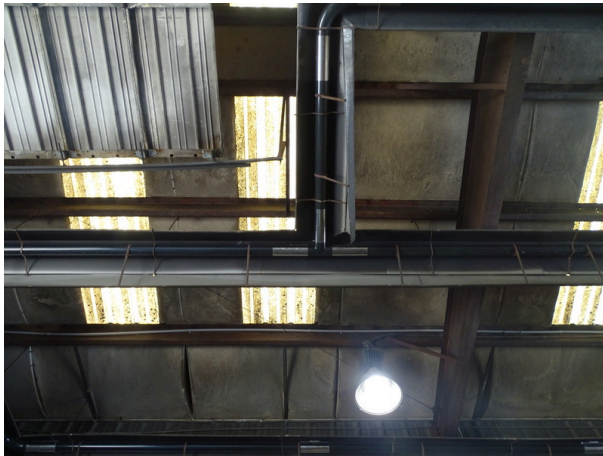
Space Heater is located within the Bus Wash Building. The space heater installation date and manufacturer were unknown. The expected useful life of a space heater is 15 years with proper maintenance. The space heater was observed to be in fair condition.

Space heater located in bus wash building

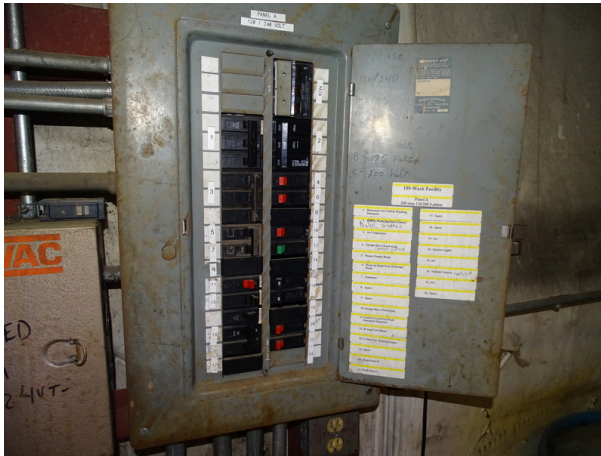
Power is distributed by copper wire from circuit breaker panels located within the buildings. The circuit breaker panels were observed to be in generally fair condition in the bus wash building with breakers missing from the panel. We recommend replacing the circuit breaker panel.

Electrical panel in bus wash building

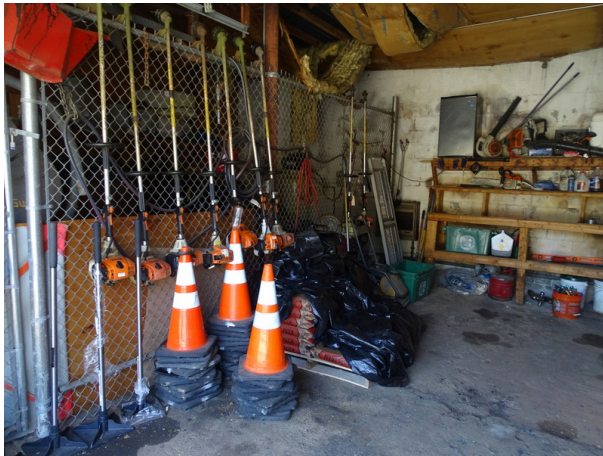
The finishes in the utility areas include unfinished concrete floors, and unfinished or painted CMU walls and unfinished ceilings. The finishes in the utility areas were observed to be in generally good condition.

Interior finishes of storage building

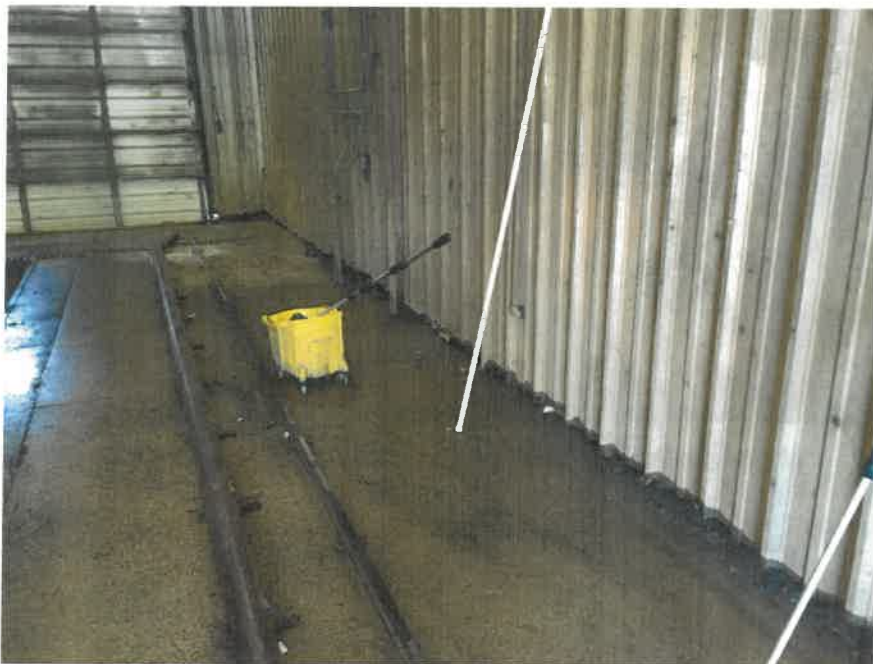
The grade around the building is nearly flat and asphalt paving surrounds much of the building. The foundations for the building are likely the turned down edge of the interior concrete slab on grade. The slab appears to be in good condition with little evidence of settlement, cracking or other damage.

Interior concrete slab on grade

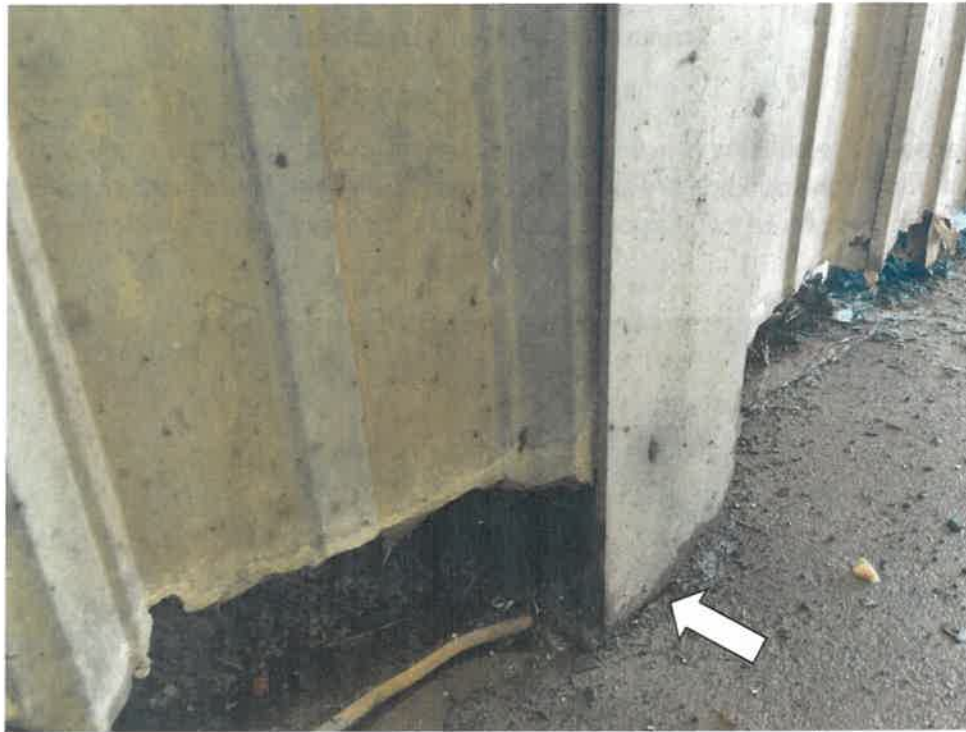
As a wash building, the interior of the building is wet and corrosion of certain building components is an issue. However, in general we found that the structural steel columns, base plates, rod bracing and elevated structural steel components have relatively minor corrosion. It appears that there is little evidence of section loss in these structural steel components. A cleaning and coating repair, particularly near the bottom of the columns, could be implemented to prolong the life of these main structural components. As noted below, corrosion of other minor component elements of the structure is an issue.

Minor surface rust on steel column and base plate

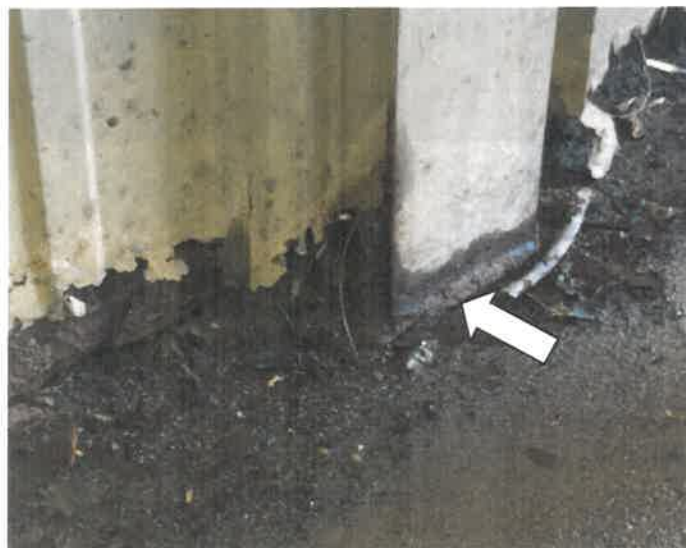
More advanced corrosion of structural steel, but little section loss.

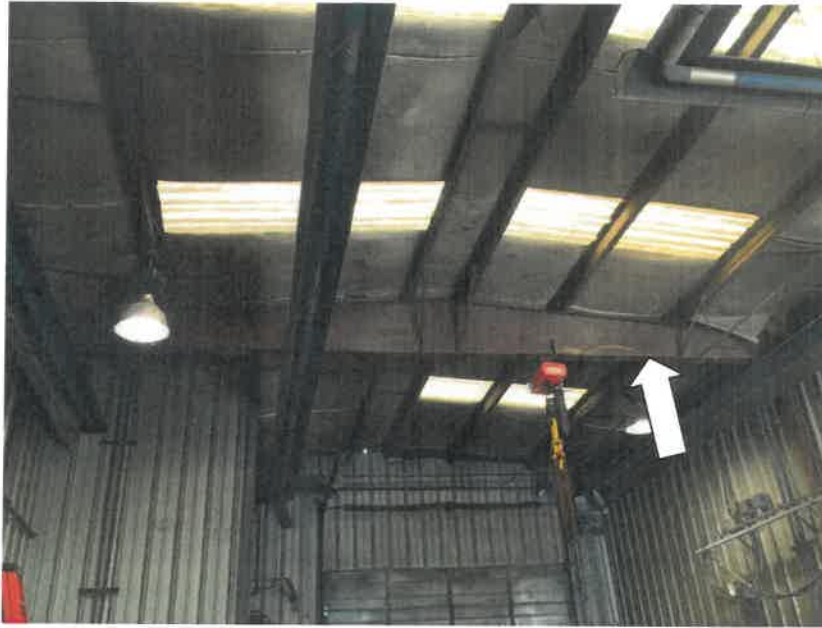
Elevated structural steel with little corrosion.

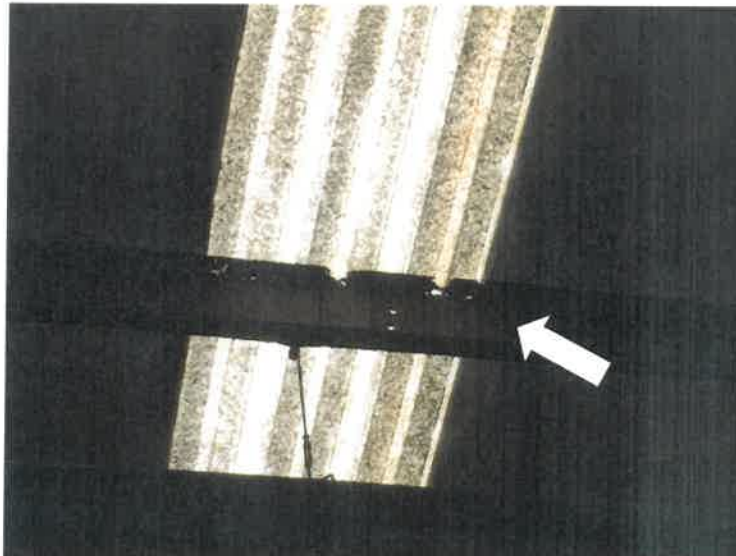
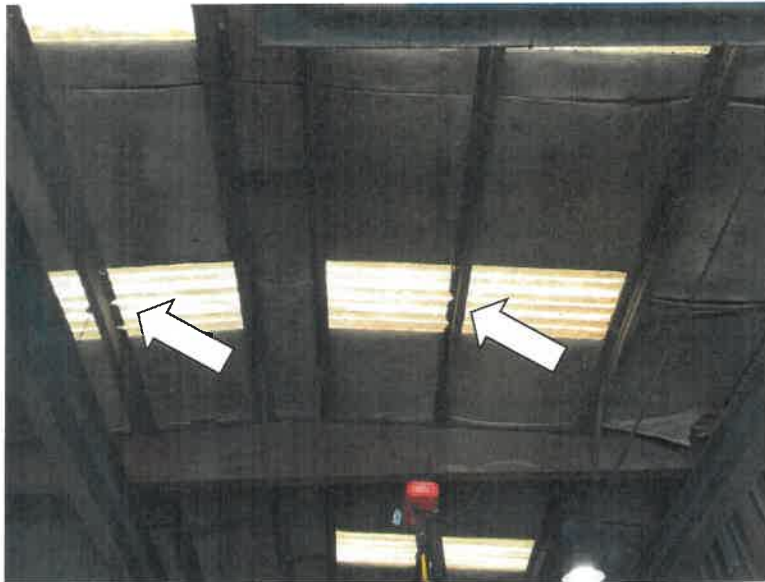
Corrosion of the cold-formed steel z-purlins that support the roof deck is severe where they cross the skylights. These purlins should be replaced or supplemented with additional purlins. Most of the other purlin areas appear to be ok.

Severely corroded cold-formed z-purlin at skylight

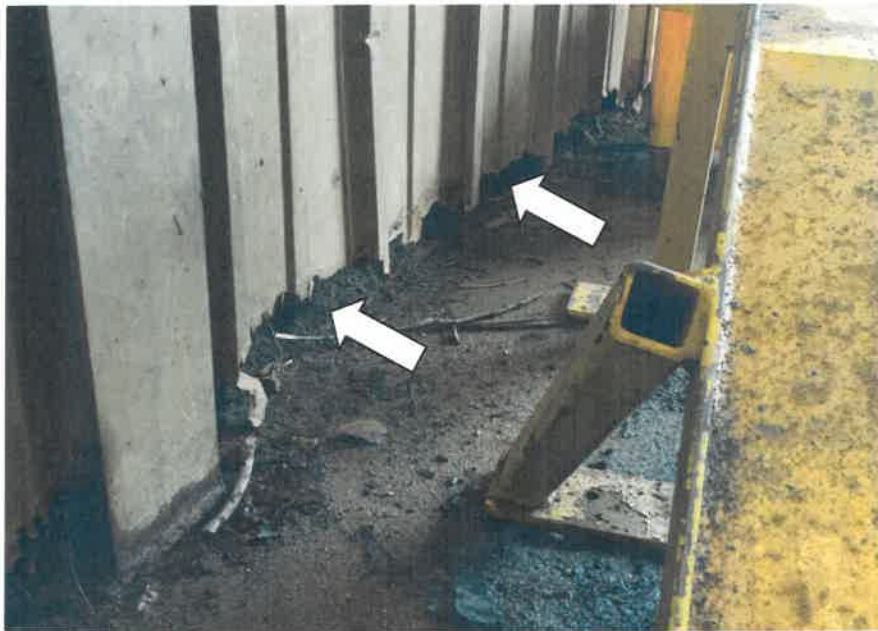
The bases of the interior corrugated metal wall panels are severely corroded. It also appears that the steel clip angles that support the bottoms of the panels are also corroded. The exterior wall panels along the east side and north entry door are similarly damaged. The horizontal girts are concealed from view, but the first girt is at 5' above floor level and we suspect they are in good condition. We recommend replacing the bottom clip angle and the bottom sections of wall panels. Alternatively, these lower sections of these wall panels could be replaced with concrete block for durability.

Severe corrosion and damage to bottom of interior wall panels and supporting clip angles.

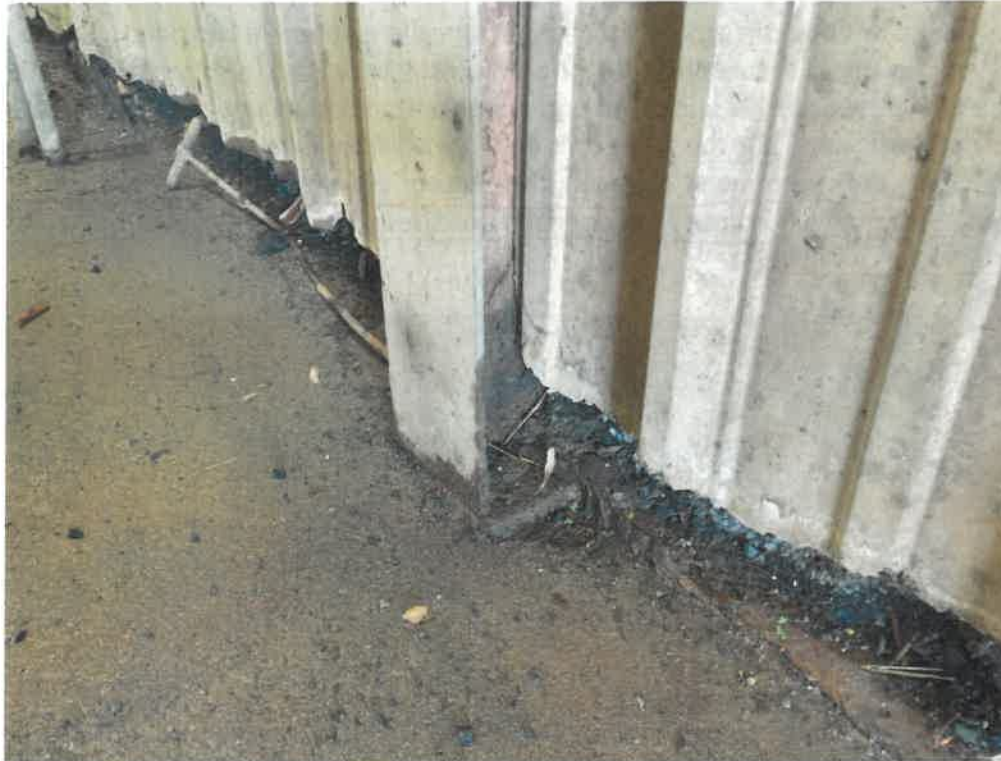
Damaged bottom of interior wall panels, but structural steel column in relatively good condition.

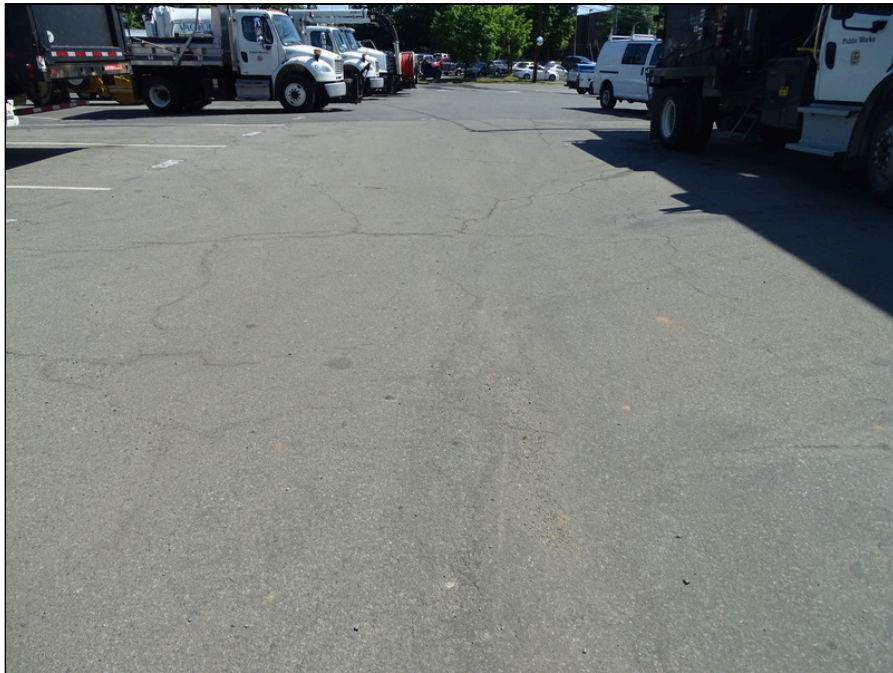
2 - Asphalt pavement and parking - note cracking

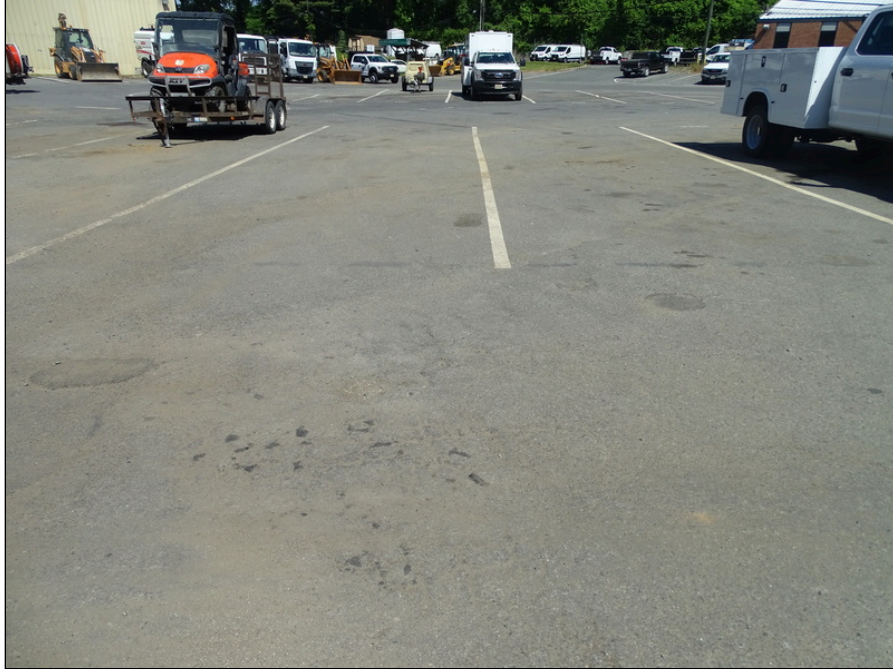
3 - Asphalt pavement - note cracking

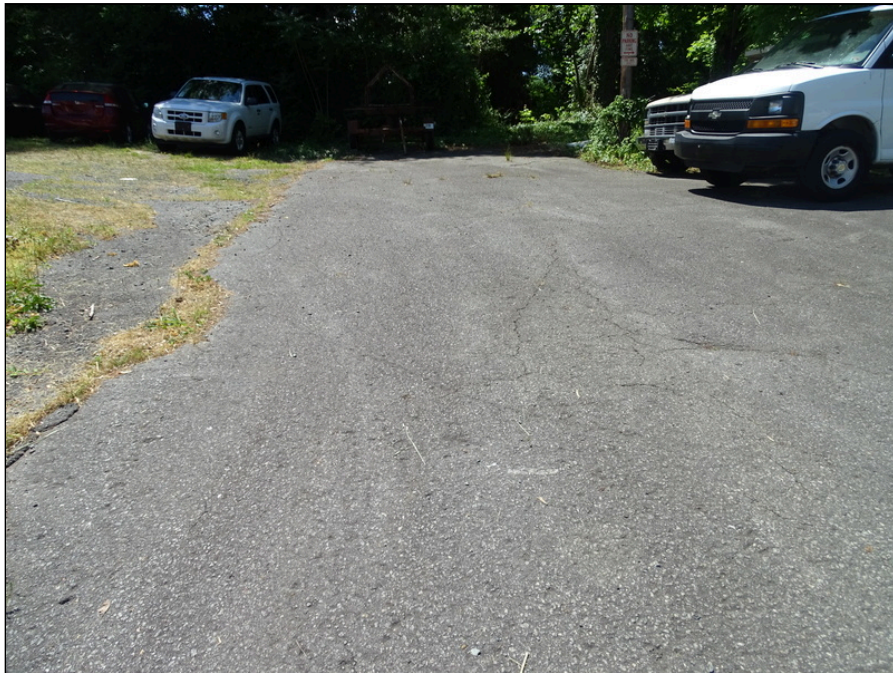
4 - Asphalt pavement - note cracking

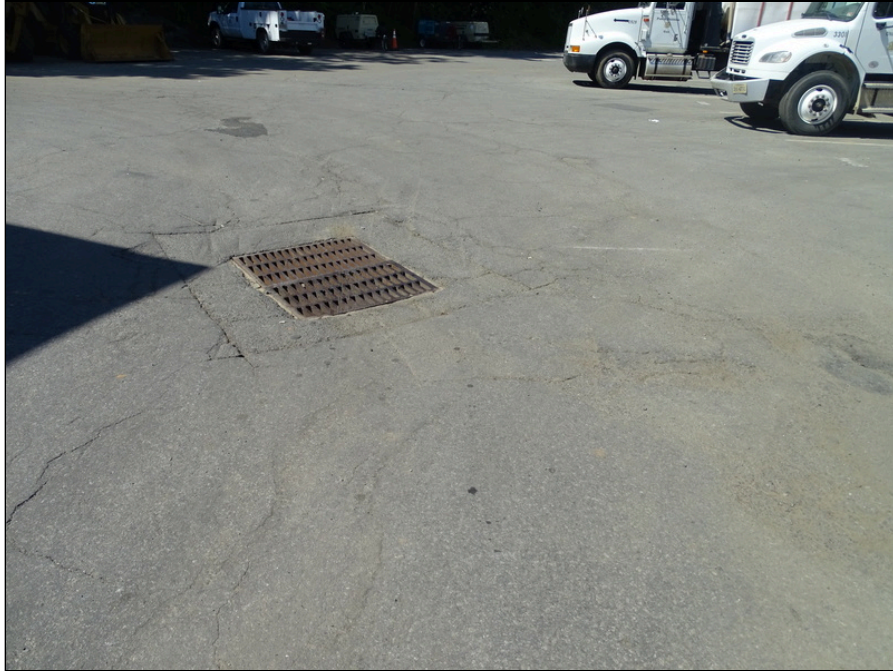
5 - Asphalt pavement - note cracking

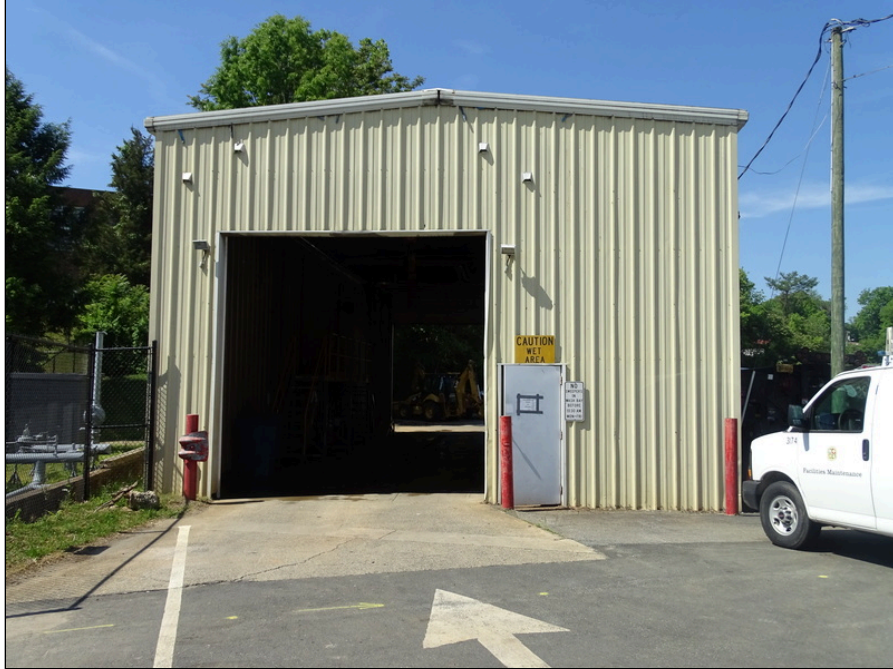
7 - Concrete pavement - note cracking

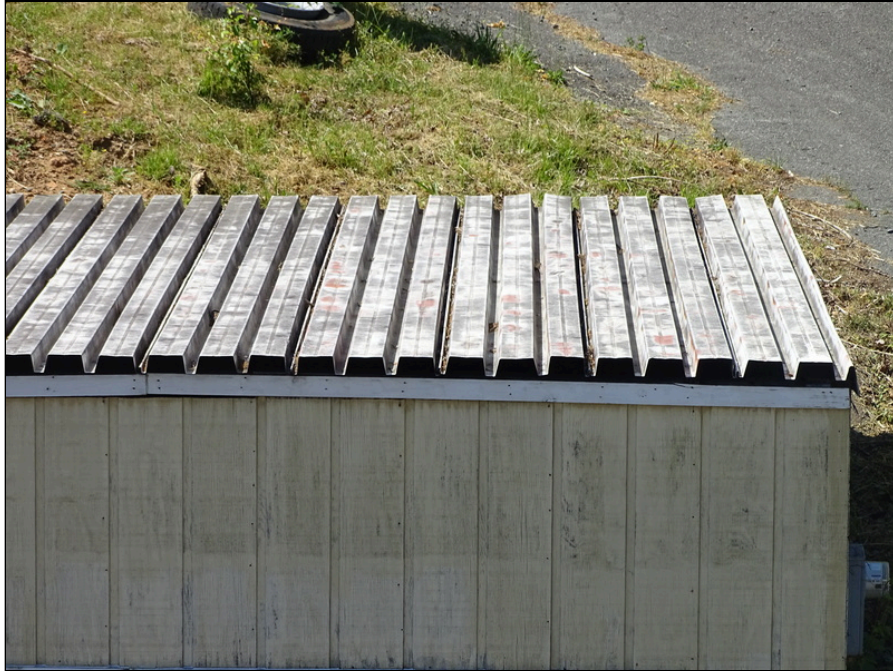
15 - Roofing system of storage building

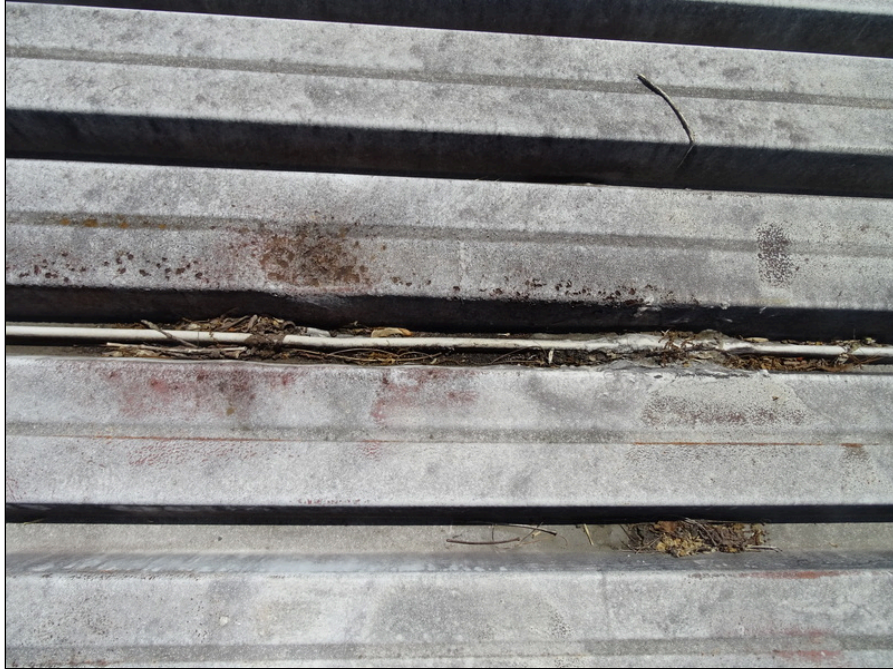
17 - Roofing system of storage building - note deterioration

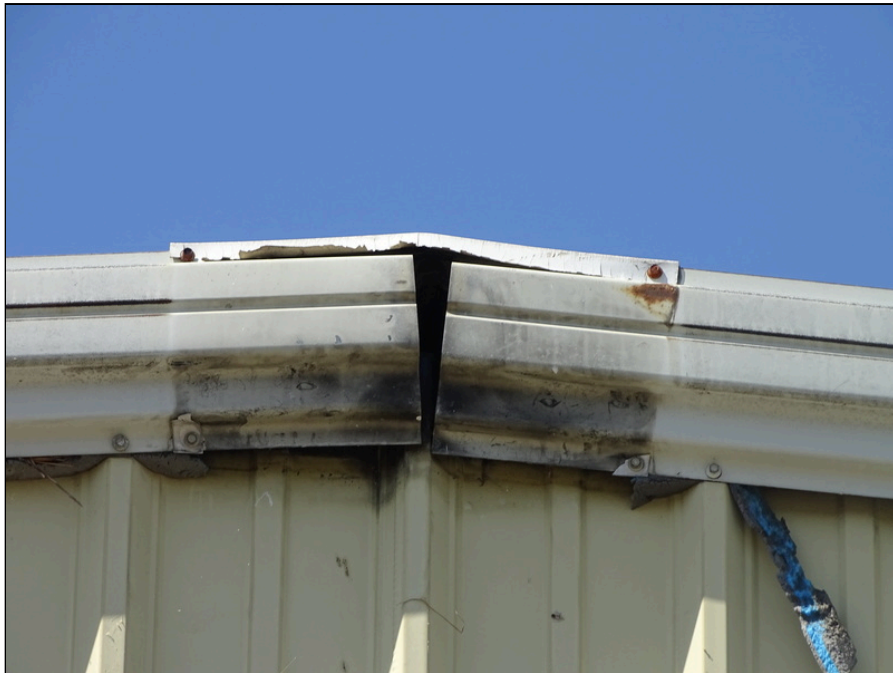
18 - Roofing system of bus wash building - note deterioration

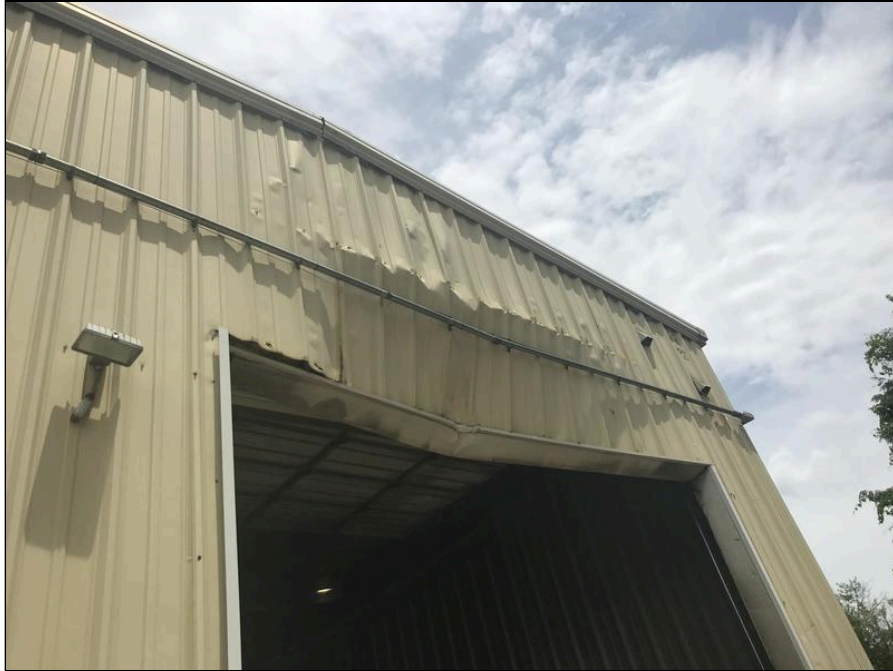
21 - Bus Wash Damage 1

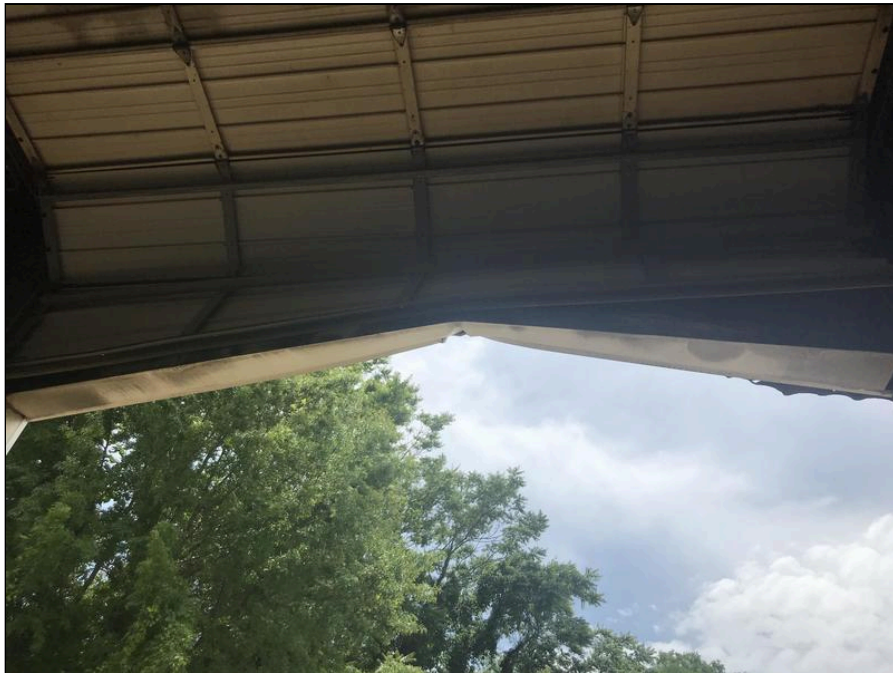
22 - Bus Wash Damage 2
