FACILITIES WAREHOUSE - FLEET BUILDING
325 4TH STREET NW
CHARLOTTESVILLE, VIRGINIA

ECS PROJECT NO. 46:6713

CITY OF CHARLOTTESVILLE - FACILITIES DEVELOPMENT

Reference: Facility Condition Assessment Report for Facilities Warehouse - Fleet Building, 325 4th Street NW, Charlottesville, Virginia

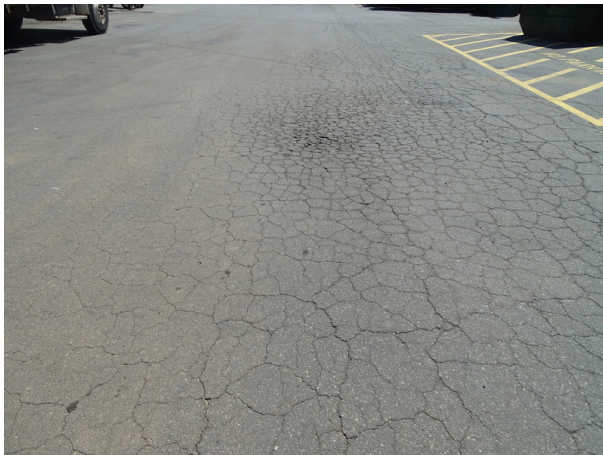
Asphalt-paved drive lanes and parking are located on the four sides of the building. The expected useful life of asphalt pavement is 20 years. The asphalt pavement was observed to be in generally fair condition with cracking observed at various locations. Some of the drainage issues are being caused by the deterioration of the loading area as water pools on the deteriorated asphalt. Based on the areas of cracking, we recommend an allowance to perform repairs as needed during the report period.

Asphalt pavement west side of the site - note alligator cracks

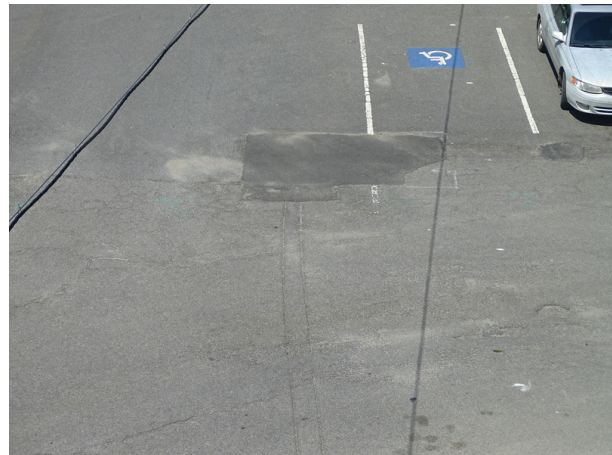
Asphalt pavement - note previous repair

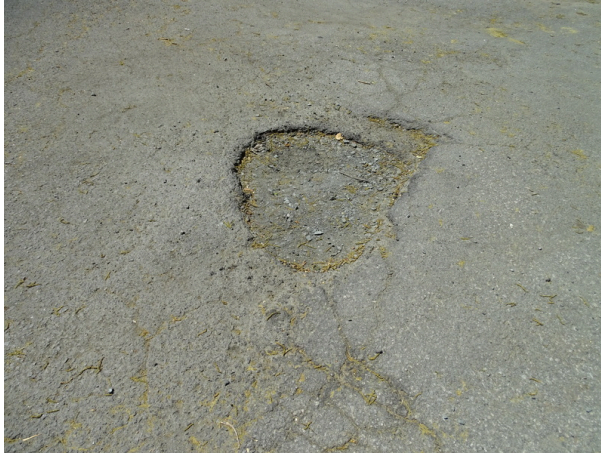
Asphalt pavement - note deterioration

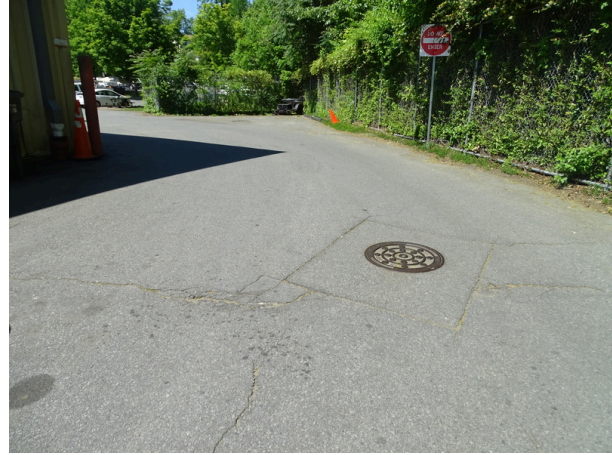
Typical asphalt pavement - note cracking

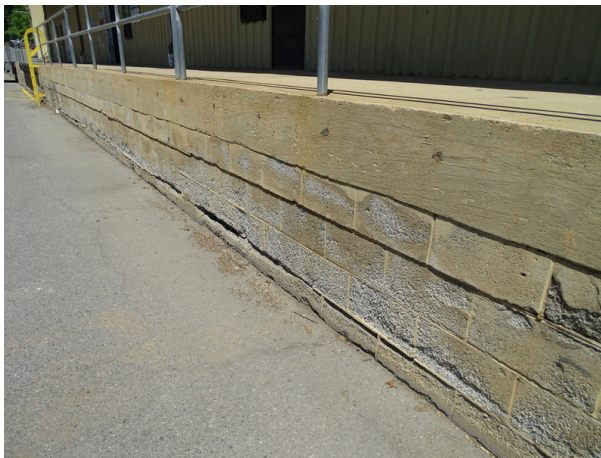
The concrete steps and concrete loading area were cracking and deteriorated at various locations. The concrete ramp was generally in fair to poor condition. We recommend an allowance for concrete repairs during the report period.

Concrete sidewalk and loading area at south side of the building - note deterioration

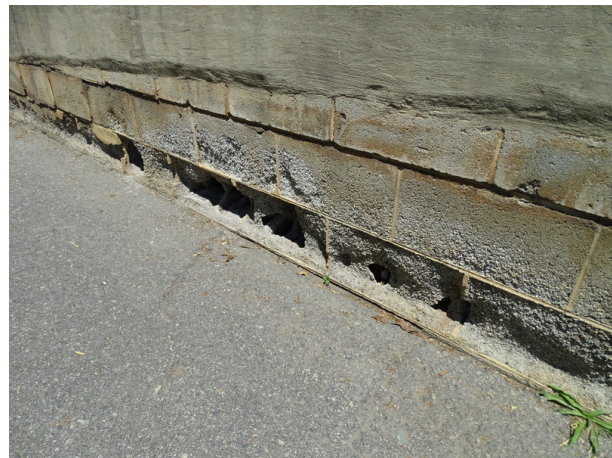
Concrete loading area at north side of the building - note deterioration

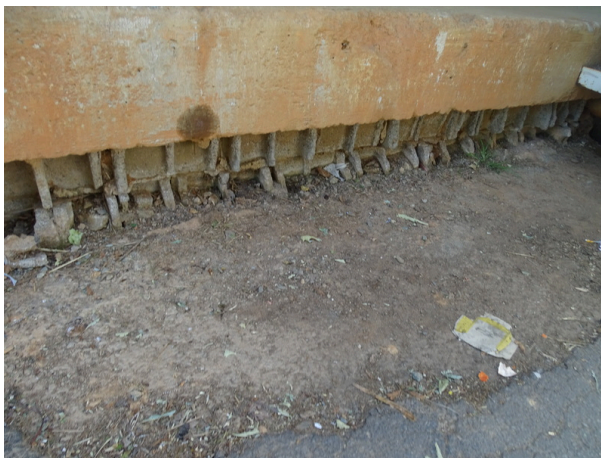
Concrete loading area at north side of the building - note deterioration

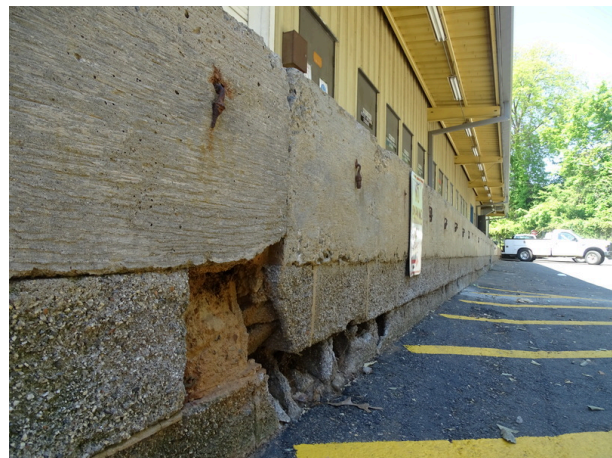
Concrete loading area at north side of the building - note deterioration

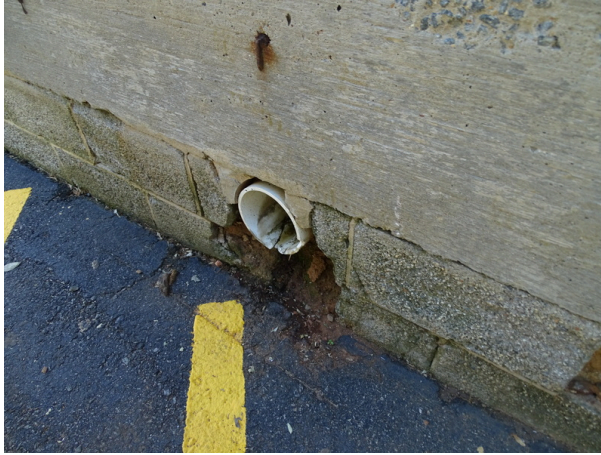
Concrete loading area at north side of the building - note deterioration

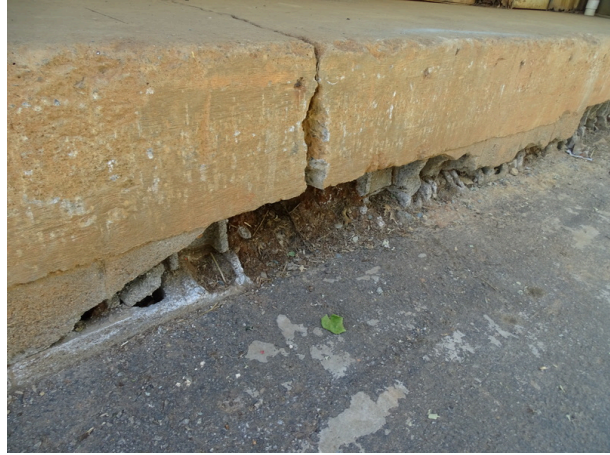
Typical concrete sidewalk - note deterioration

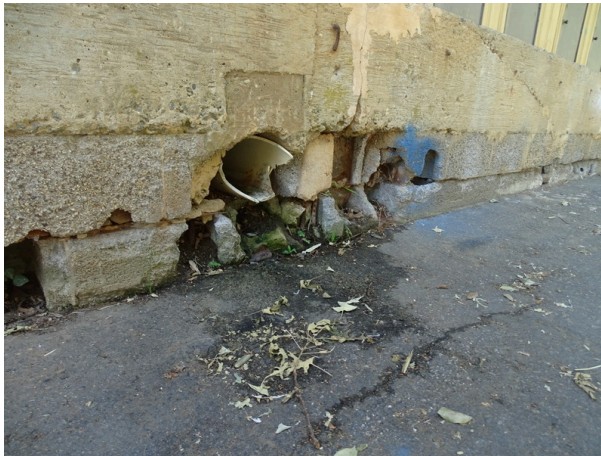
Typical concrete sidewalk - note deterioration

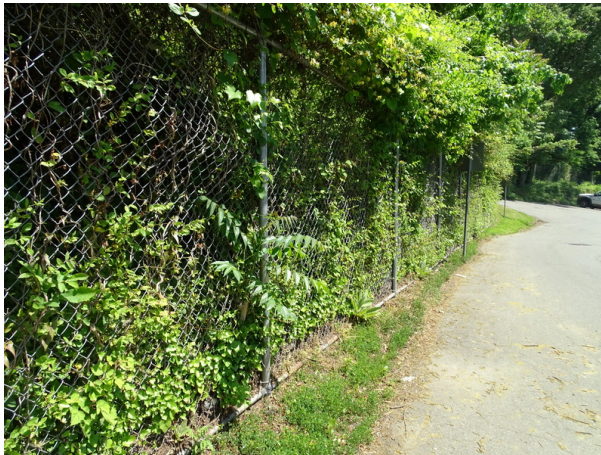
Typical chain link fence note deterioration

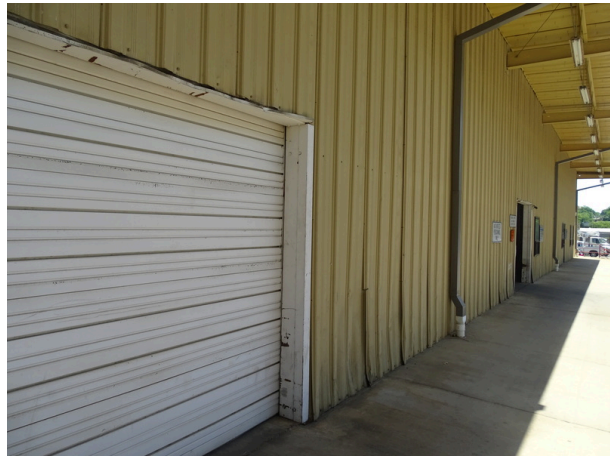
The primary exterior of the building consists of Metal. The metal siding was physically damaged and deteriorated at various locations. The building exteriors were generally in fair condition. The expected useful life of metal siding is approximately 50 years. We recommend that the metal siding be replaced.

Typical building exterior - note metal siding
physical damage

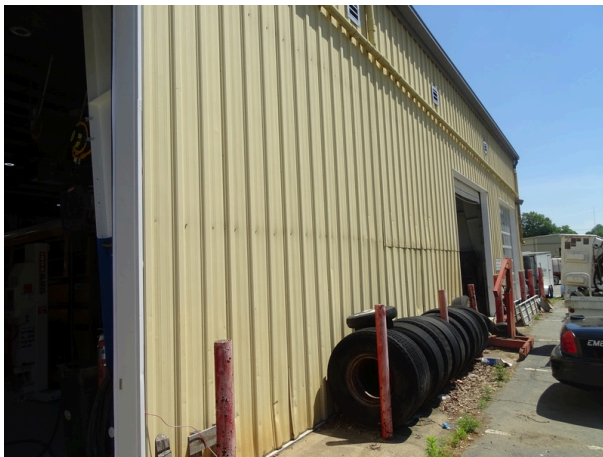
Typical building exterior - note metal siding
physical damage

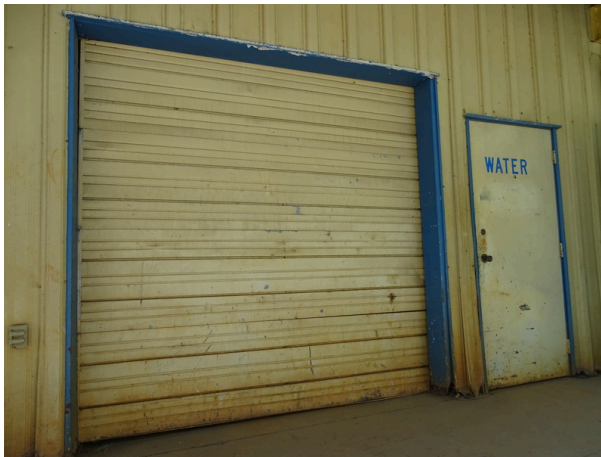
An overhead door is located at the west side of the building. The overhead doors were generally in fair condition with vehicular damage to some. It was noted by the tenants that the overhead doors to the warehouse area were not wide enough to process deliveries to and from the facility. Overhead doors typically have an expected useful life of 20 years. We recommend the damaged overhead doors to be replaced.

Typical overhead door - note deterioration

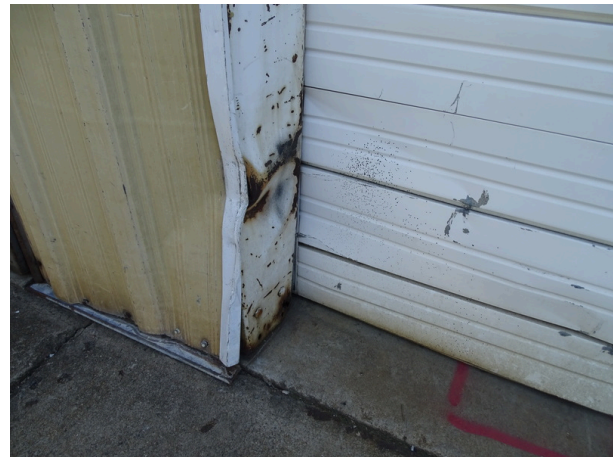
Typical overhead door - note physical damaged

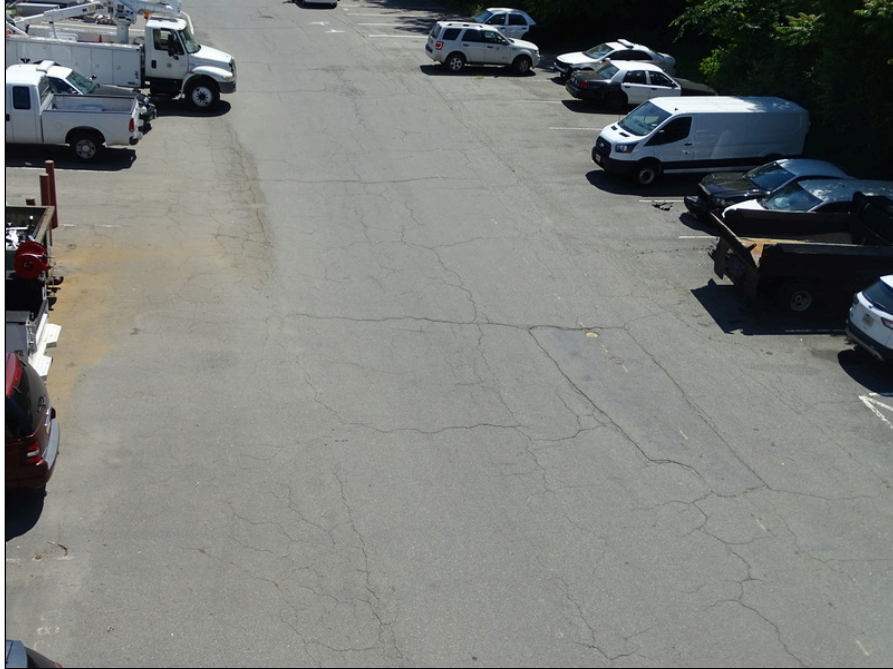
3 - Asphalt pavement west side of the site - note cracking

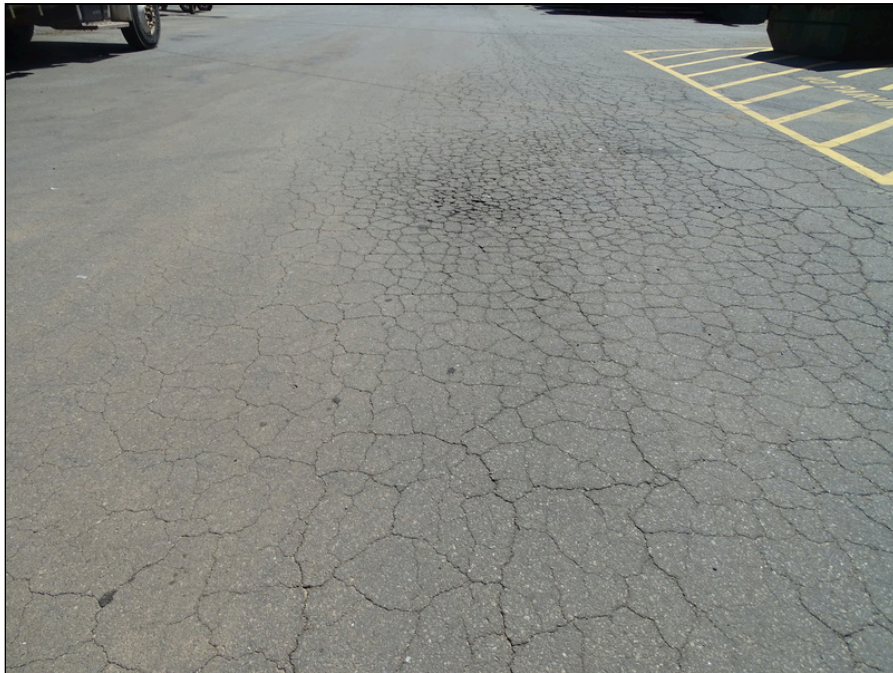
4 - Asphalt pavement west side of the site - note alligator cracks

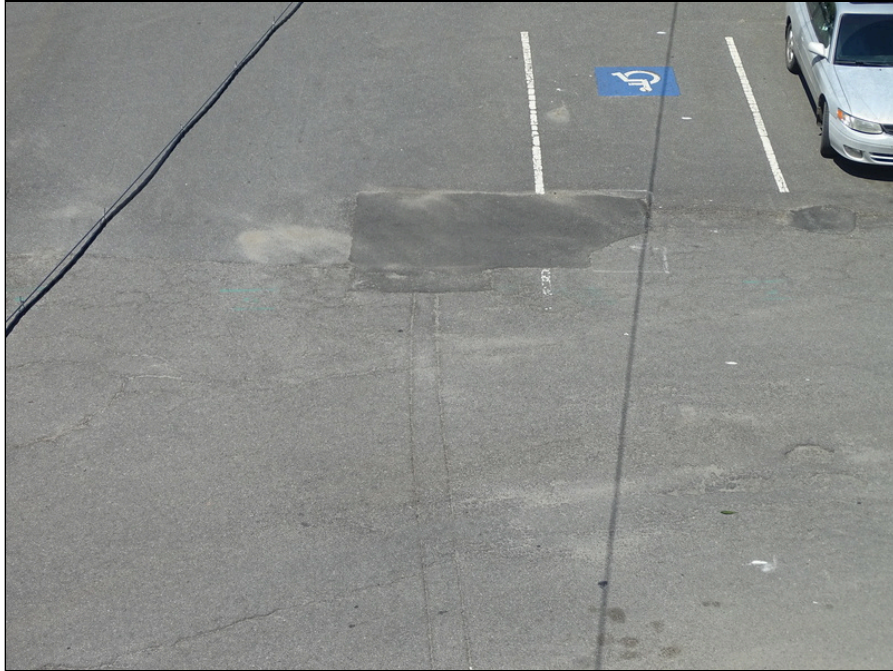
5 - Asphalt pavement - note previous repair

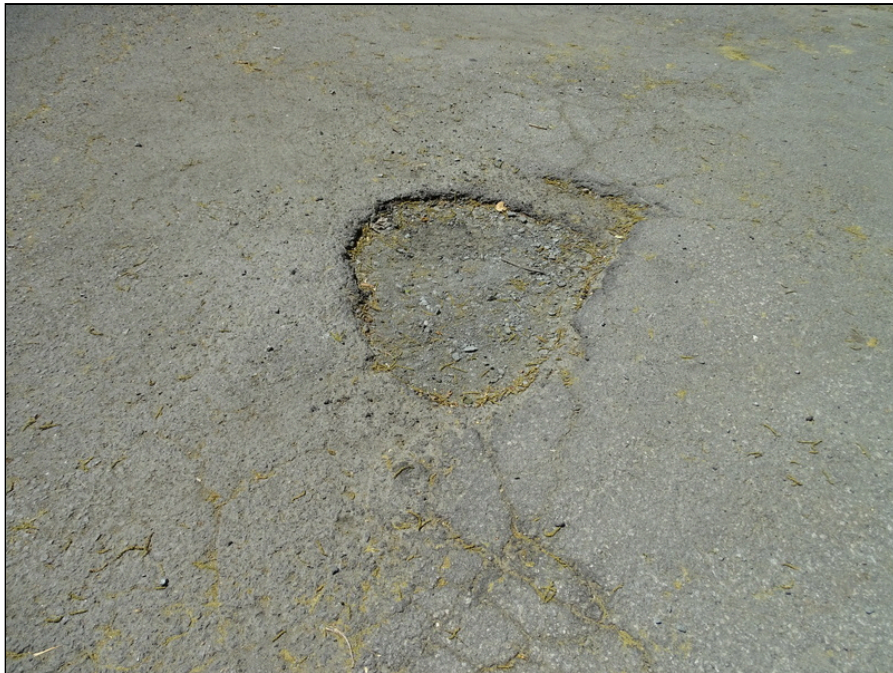
6 - Asphalt pavement - note deterioration

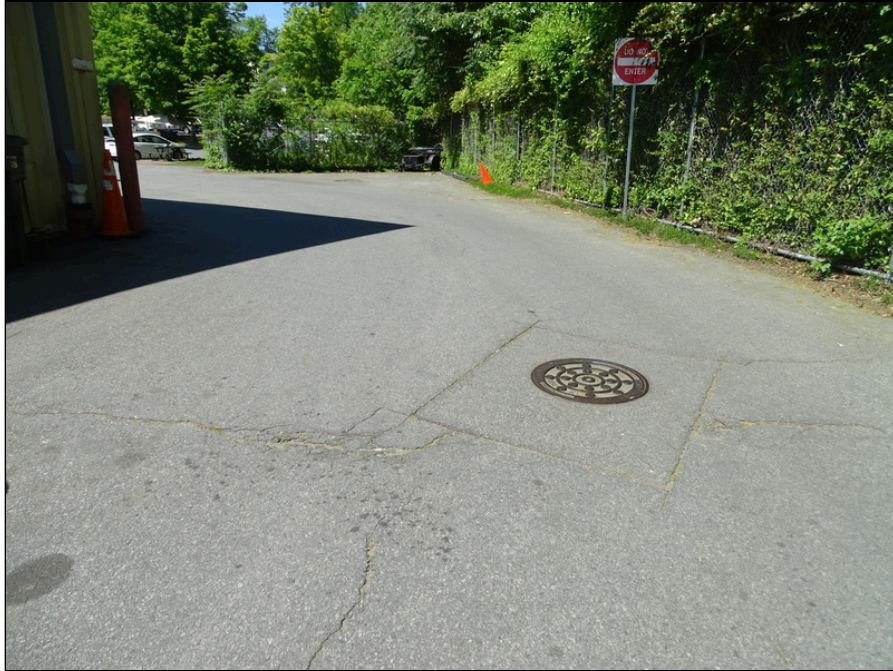
7 - Typical asphalt pavement - note cracking

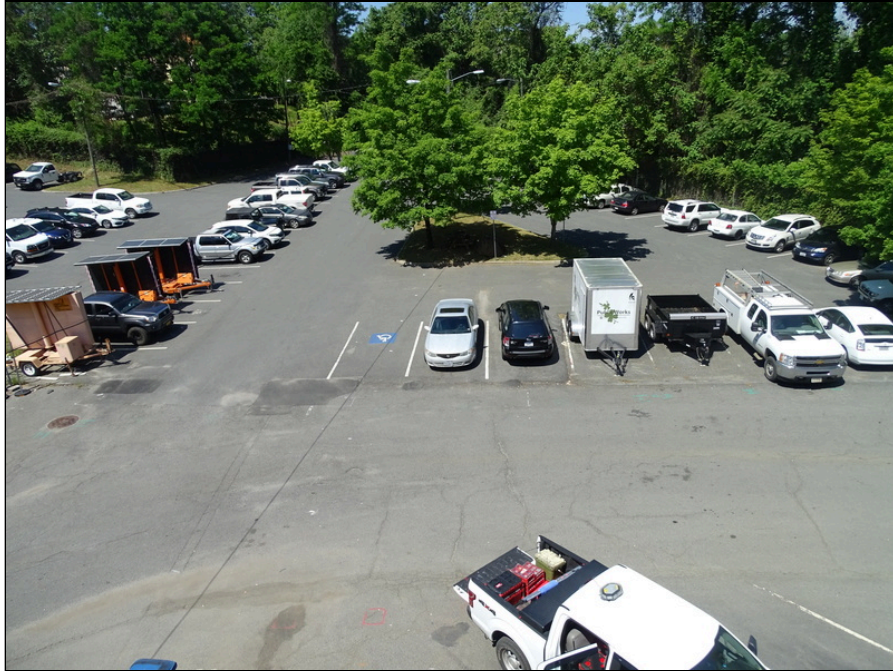
9 - Asphalt parking and pavement - note previous repair

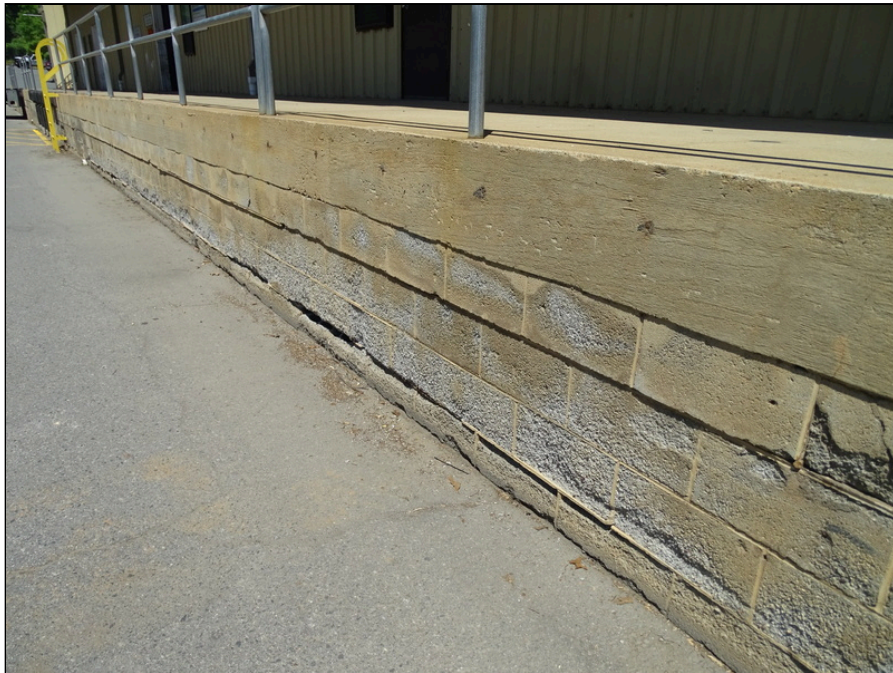
10 - Concrete sidewalk and loading area at south side of the building - note deterioration

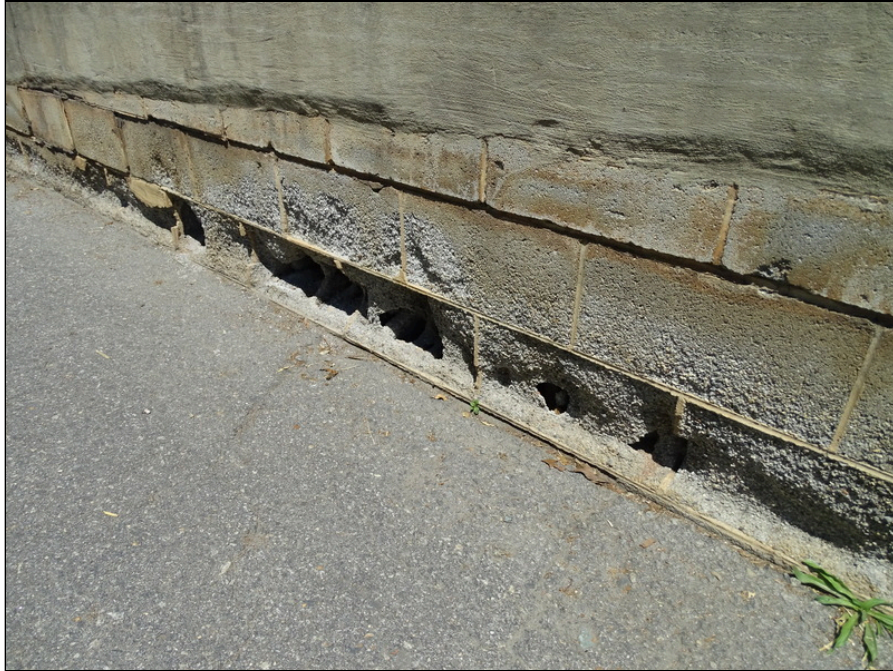
11 - Concrete loading area at north side of the building - note deterioration

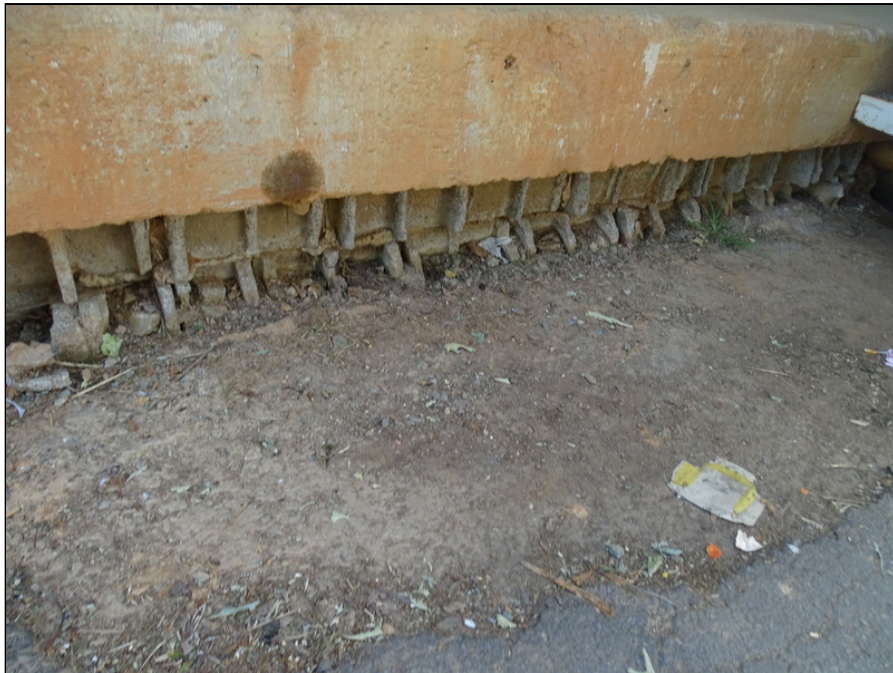
12 - Concrete loading area at north side of the building - note deterioration

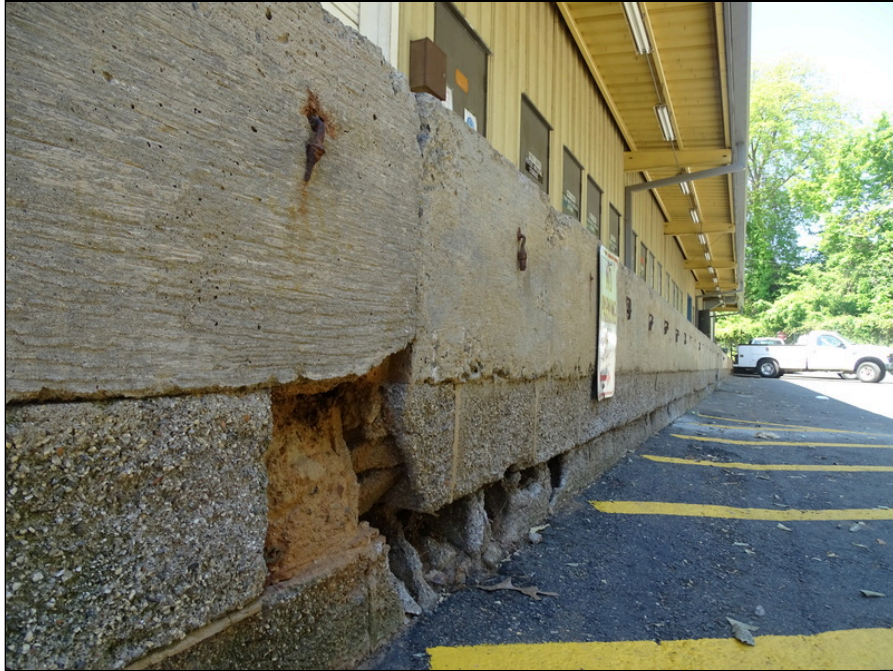
13 - Concrete loading area at north side of the building - note deterioration

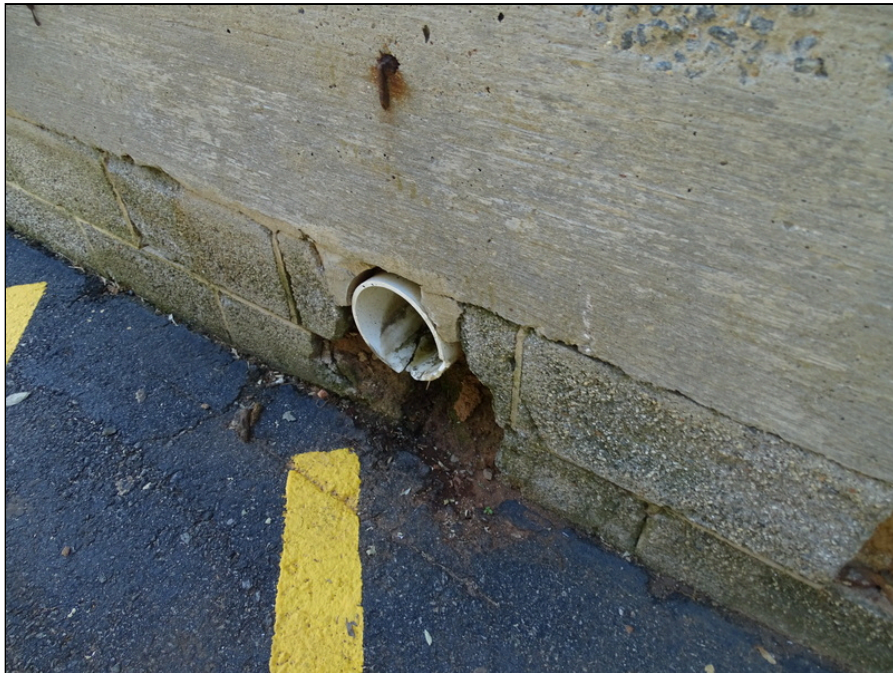
14 - Concrete loading area at north side of the building - note deterioration

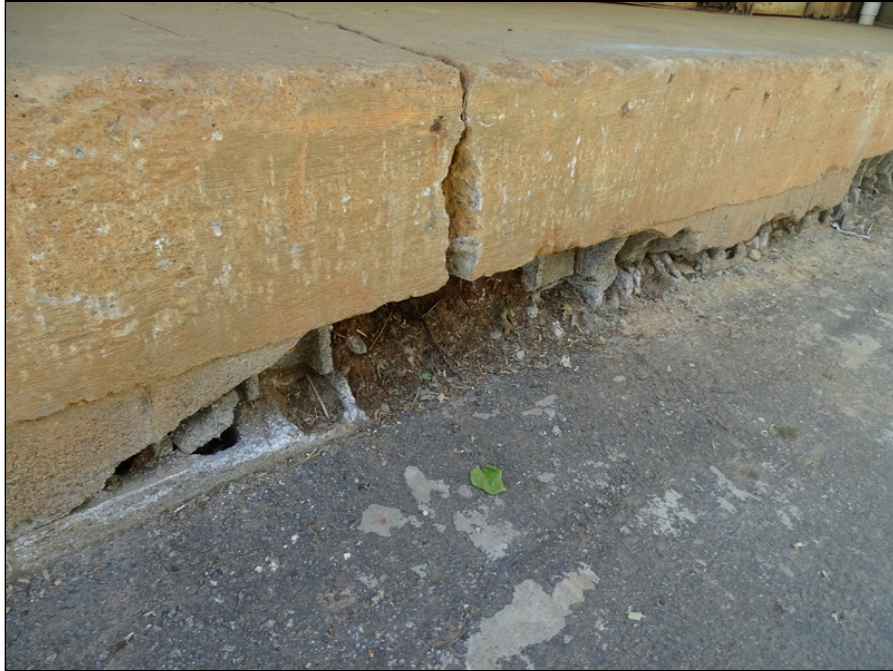
15 - Typical concrete sidewalk - note deterioration

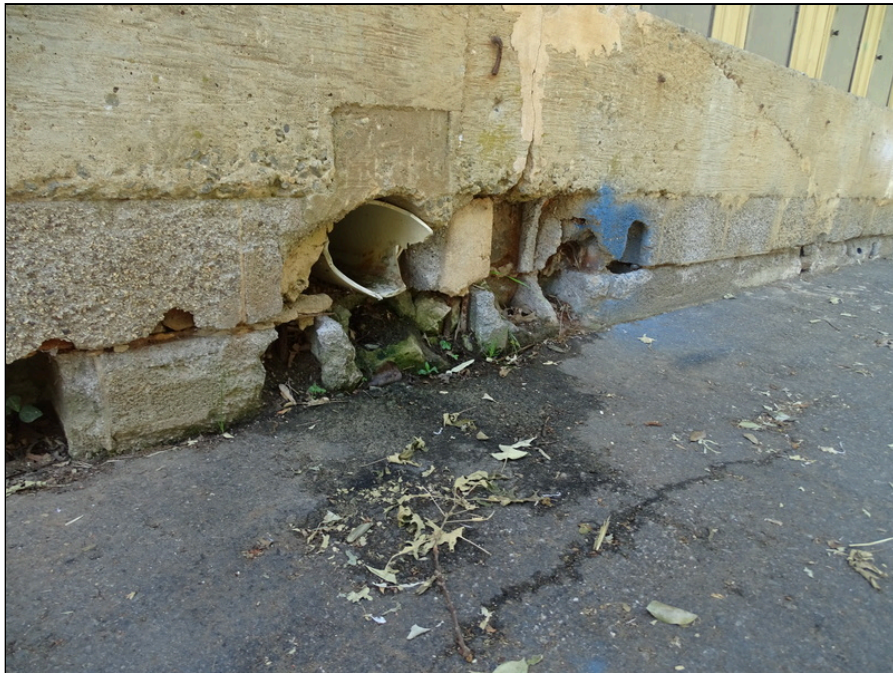
16 - Typical concrete sidewalk - note deterioration

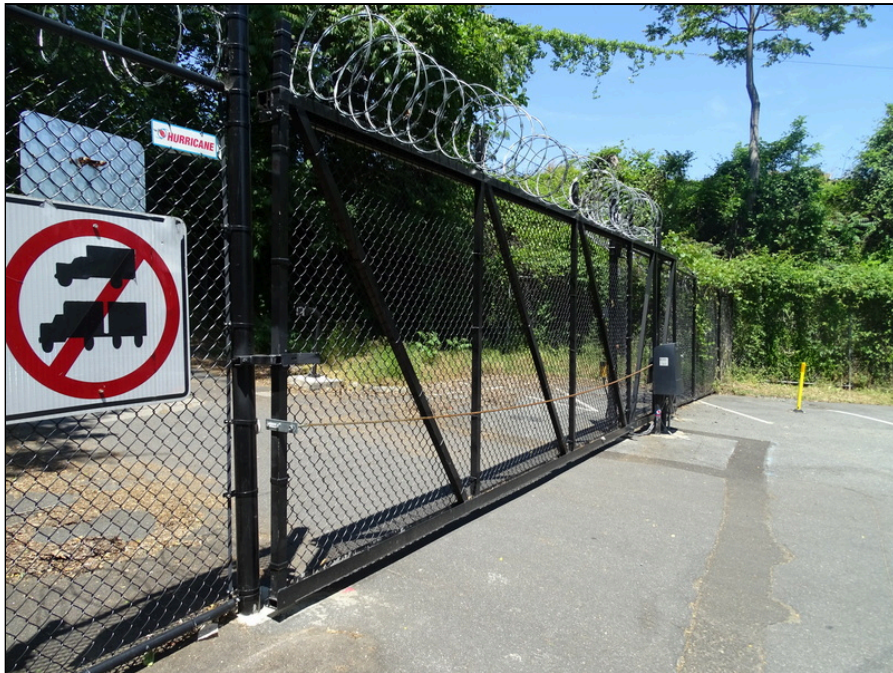
21 - Typical chain link fence note deterioration

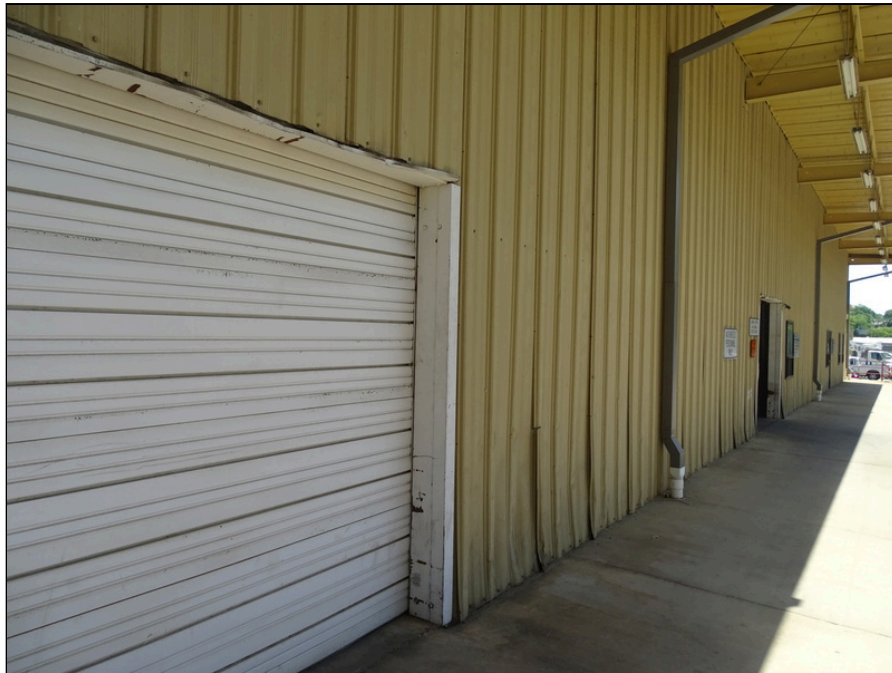
28 - Typical building exterior - note metal siding physical damage

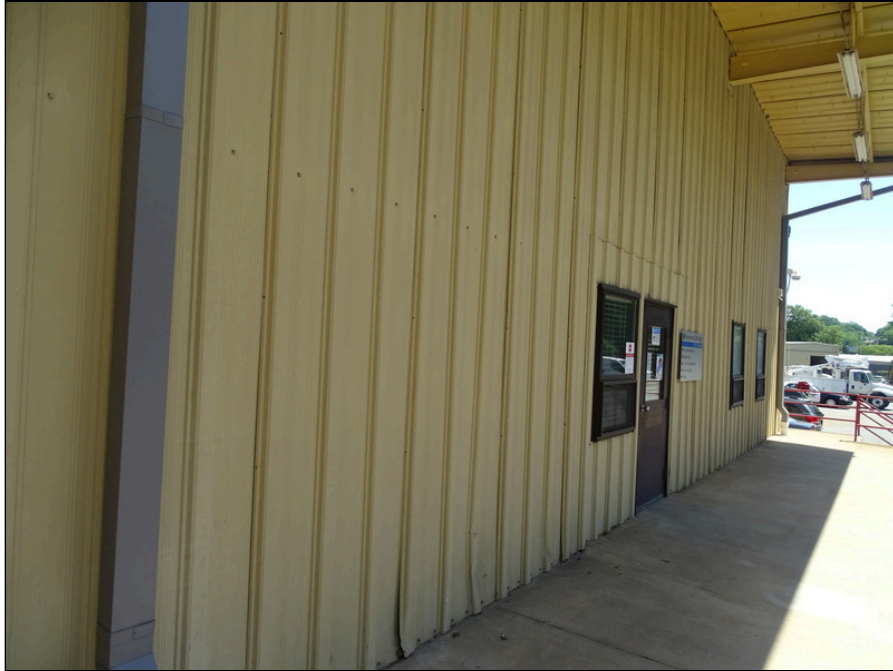
29 - Typical building exterior - note metal siding physical damage

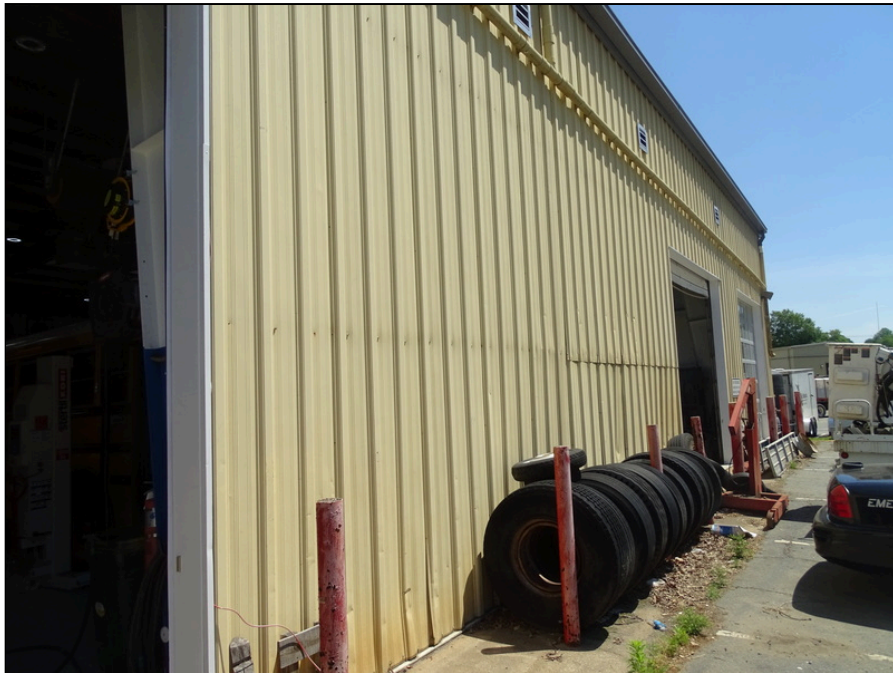
30 - Typical building exterior - note metal siding physical damage

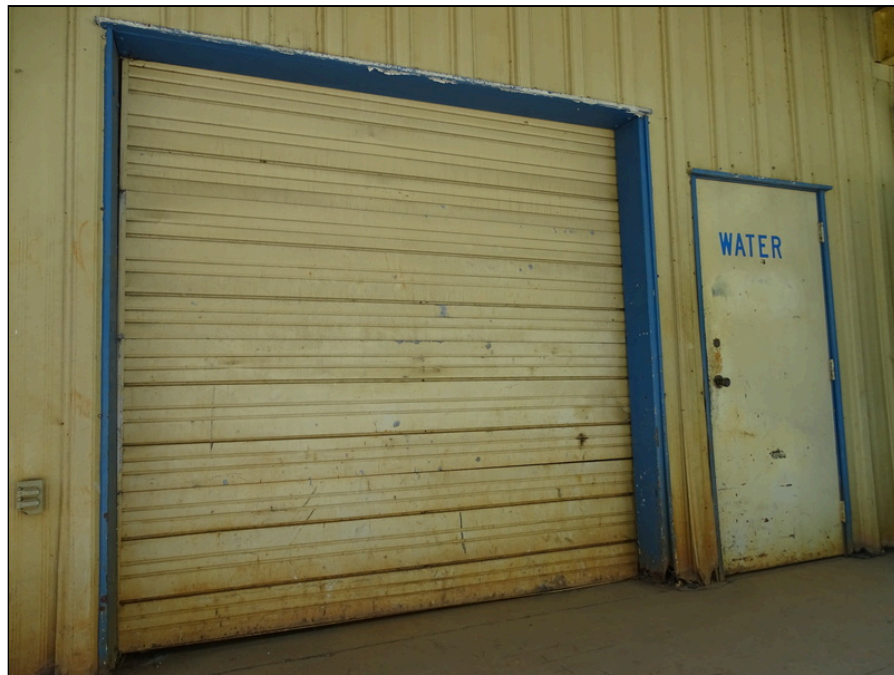
36 - Typical overhead door - note deterioration

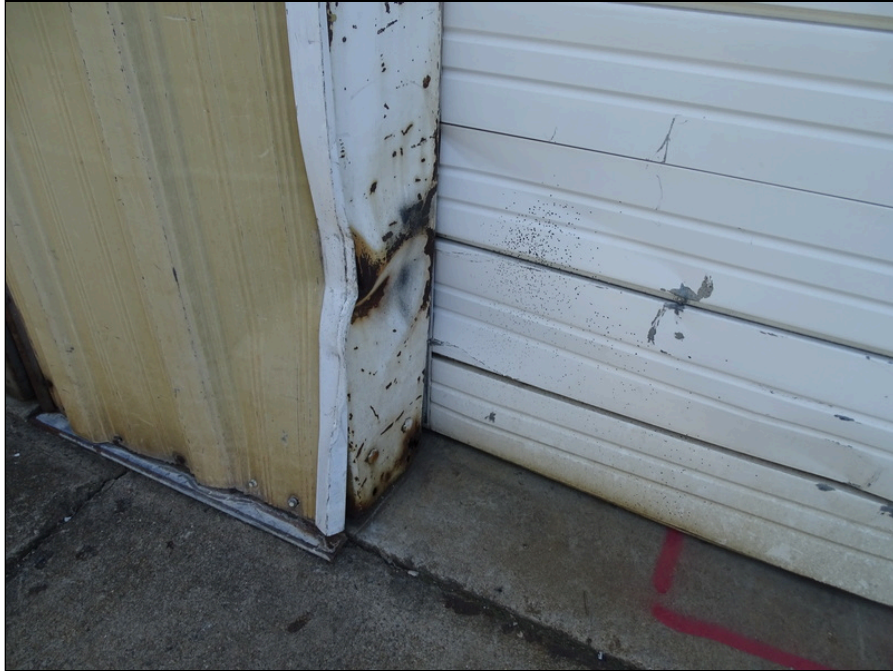
37 - Typical overhead door - note physical damaged

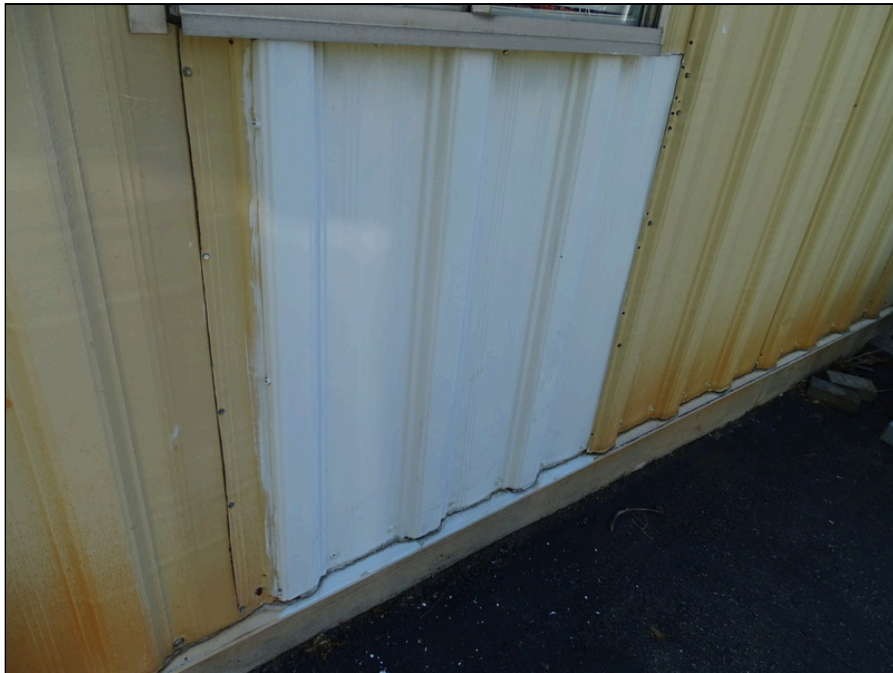
38 - Building exterior - note patching

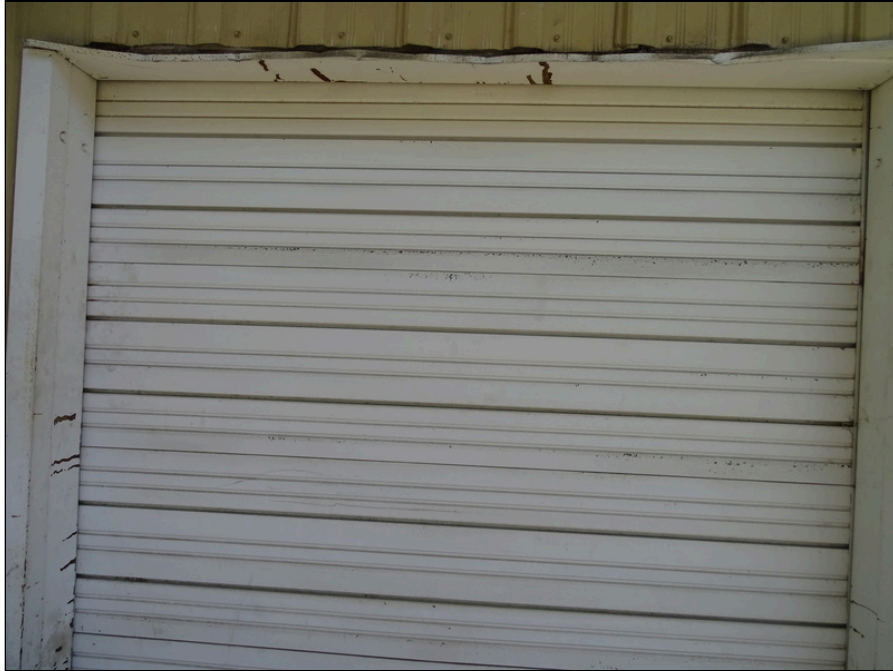
39 - Typical overhead door - note damaged
