CITY OF PROMISE  
708 PAGE STREET  
CHARLOTTESVILLE, VIRGINIA

ECS PROJECT NO. 46:6713

CITY OF CHARLOTTESVILLE - FACILITIES DEVELOPMENT

Reference: Facility Condition Assessment Report for City of Promise, 708 Page Street, Charlottesville, Virginia

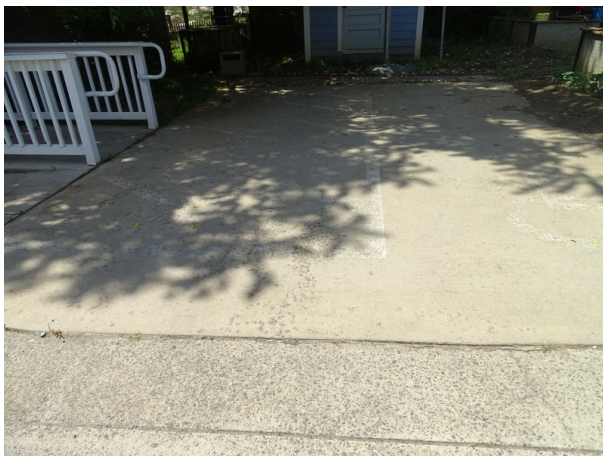
Concrete pavement is located on the west side of the site. The pavement was observed to be in generally good condition.

Concrete pavement at west side of site

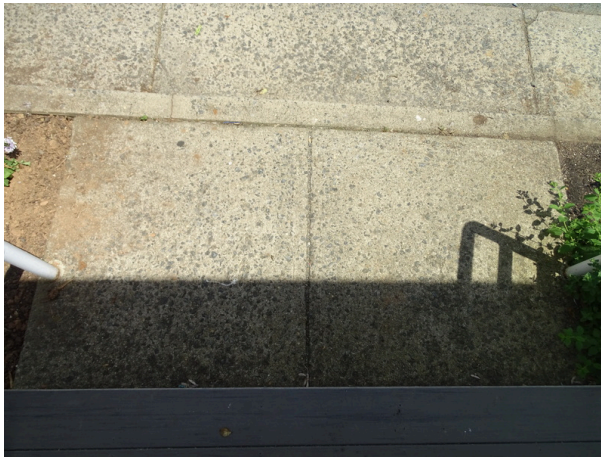
The north side of the site contains Concrete sidewalks of undetermined thickness. Regularly spaced control joints were observed. The Concrete sidewalks were generally in good condition.

Concrete sidewalk - note cracking

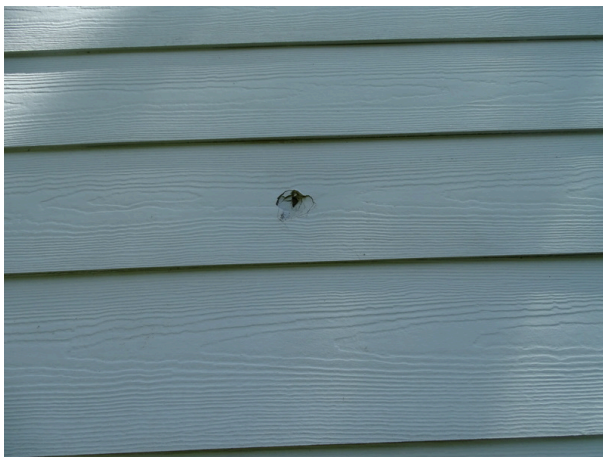
Exterior side - note deterioration

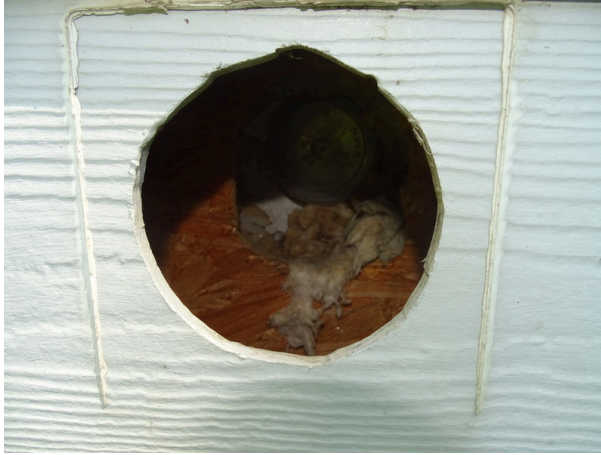
One small hole and one 4" hole, from a previous exhaust penetration, were observed in the siding. We recommend patching these holes as a maintenance item.

Siding Hole

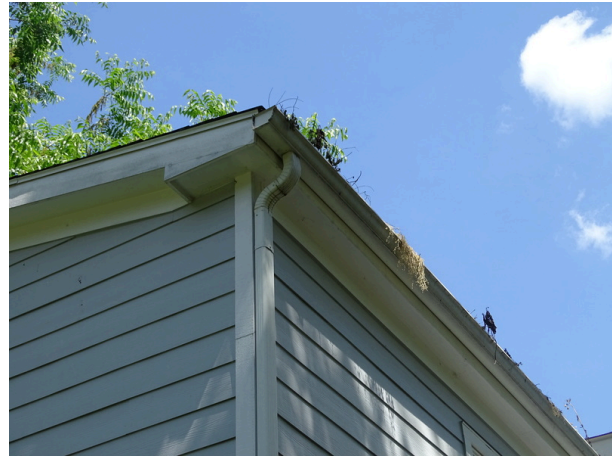
Drainage for the roofing system is provided by gutters and downspouts. The gutters and downspouts were observed to be in good condition. Vegetation was observed overflowing or growing from the gutter. We recommend regular cleaning of the gutters as a maintenance item.

Typical gutter and downspout

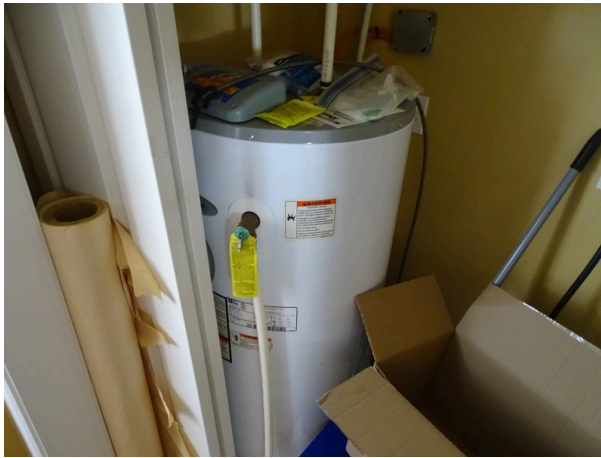
Domestic hot water to the building is provided by an Electric water heater located in a utility closet on the first level. The Electric water heater was manufactured by Whirlpool. The expected useful life of an Electric water heater is approximately 12 to 15 years. We recommend replacing the water heater during the report period.

Electric water heater

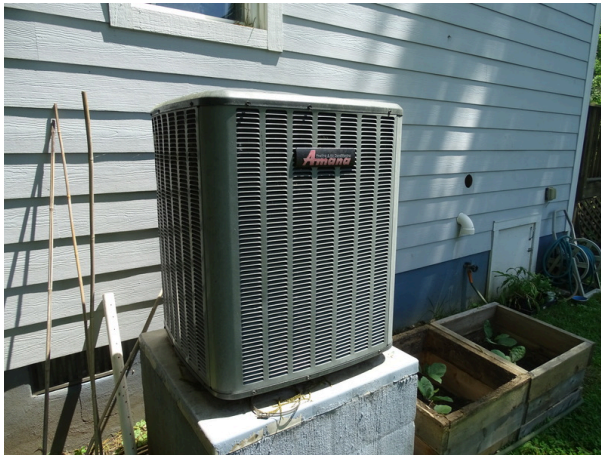
Condensing Unit

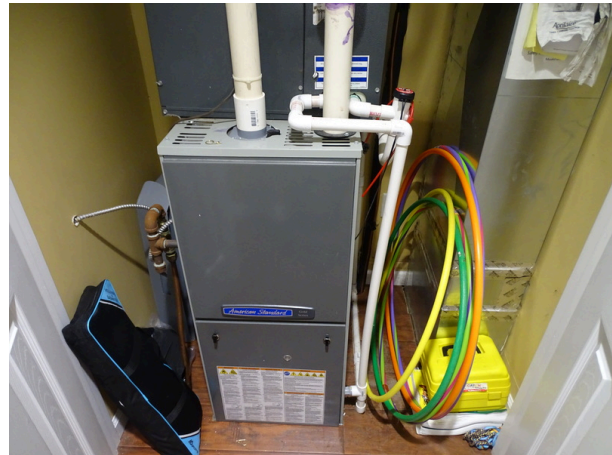
The gas furnace unit is located within a first floor closet. The furnace unit was manufactured by American Standard in 2010. The expected useful life of a furnace unit is 15 years with proper maintenance. The air handler was observed to be in good to fair condition. We recommend that the air handlers be replaced during the report period.

Furnace unit and Air Handler unit

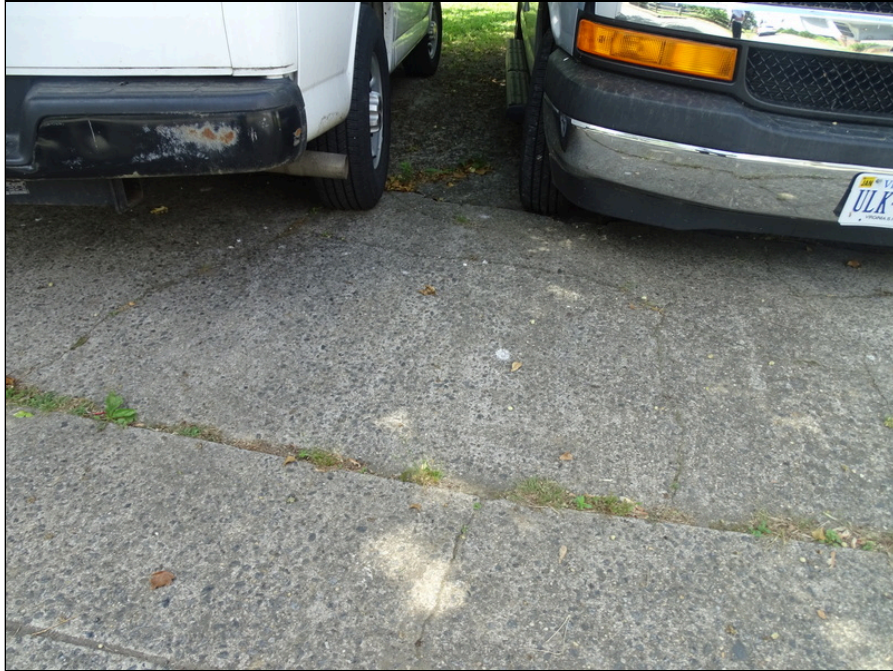
3 - Concrete pavement - note cracking

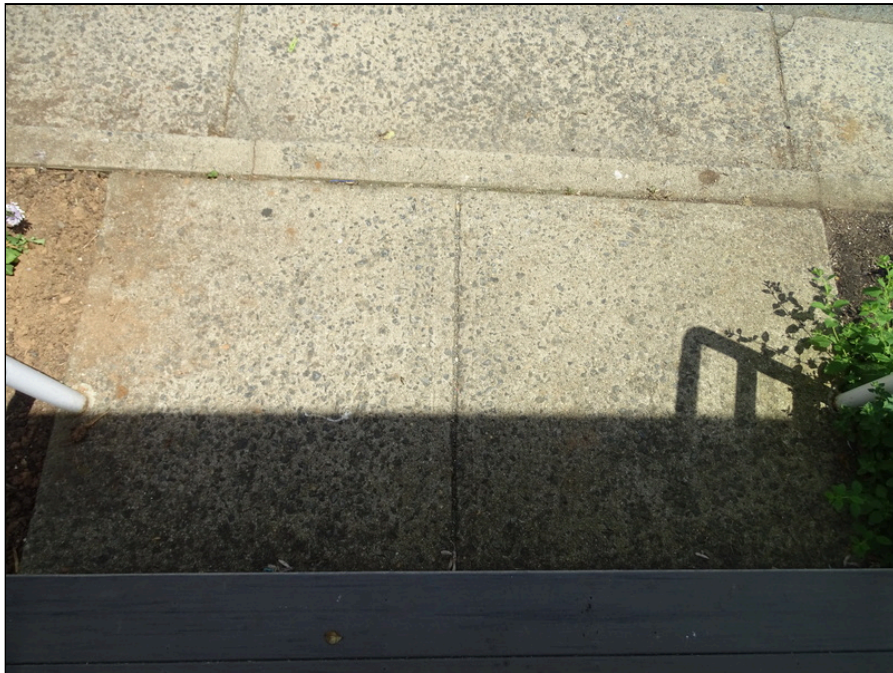
4 - Concrete sidewalk - note cracking

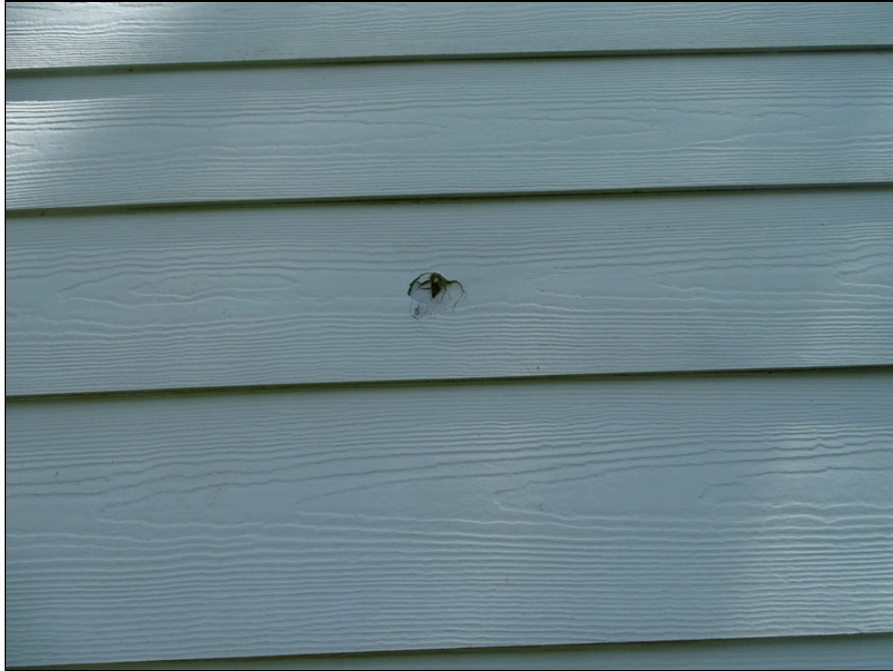
17 - Exterior side - note deterioration

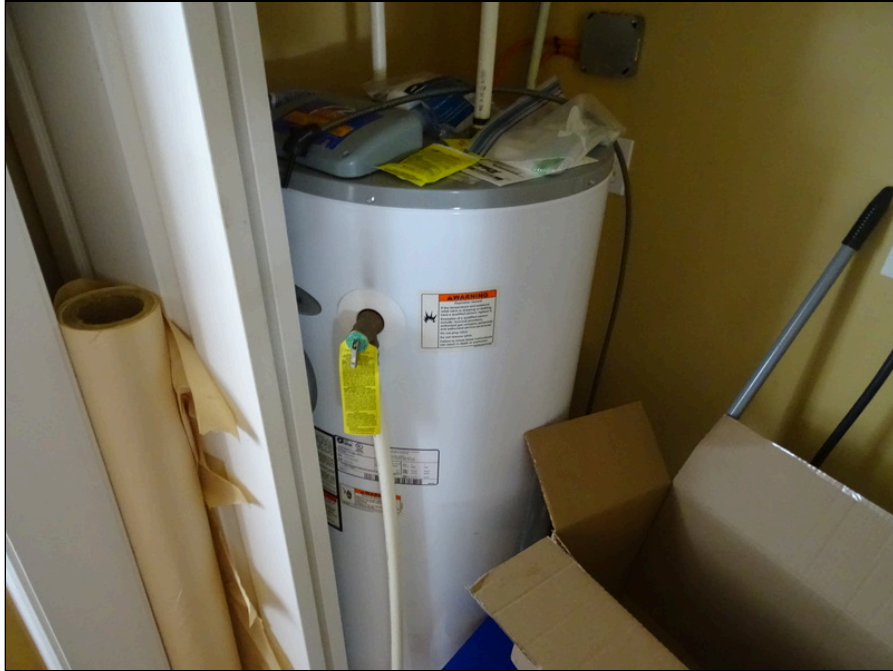
27 - Electric water heater

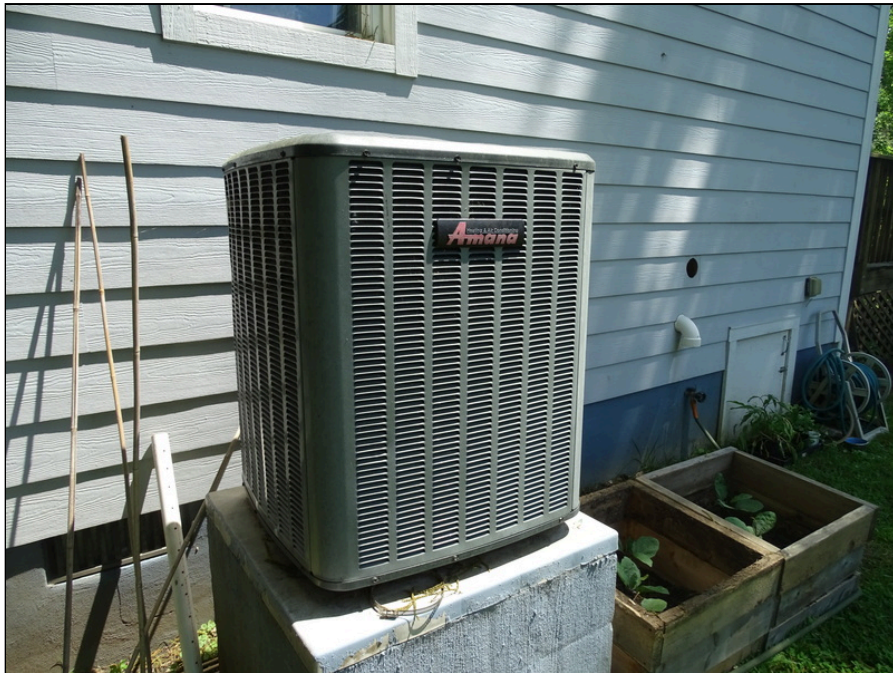
28 - Condensing Unit

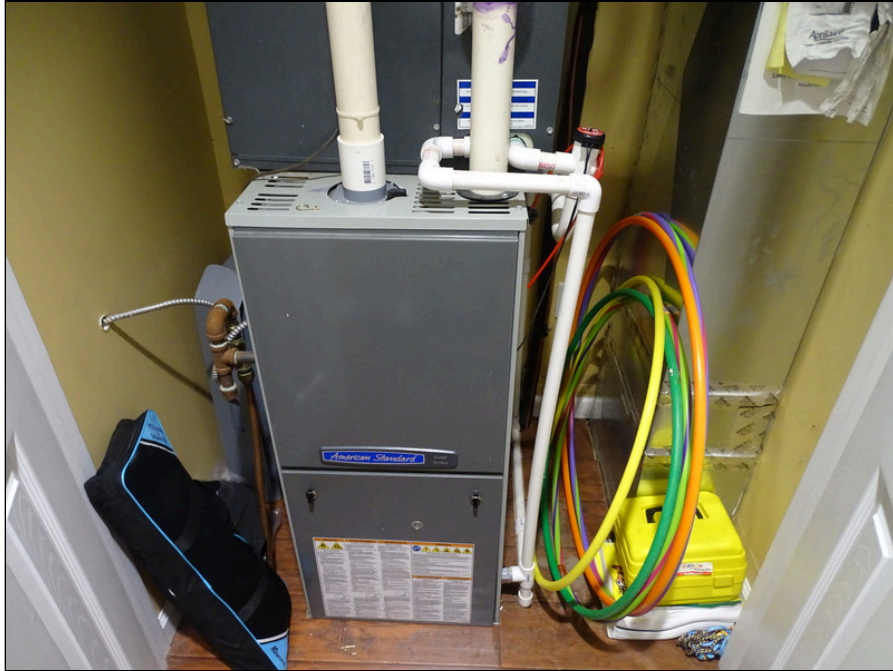
29 - Furnace unit and Air Handler unit

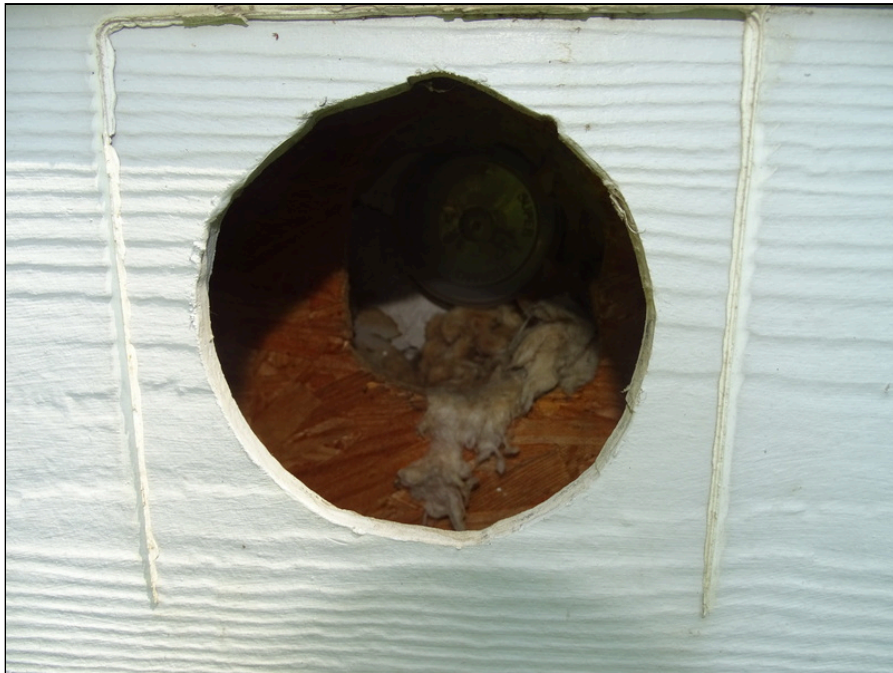
48 - Siding Hole
