CLARK ELEMENTARY SCHOOL
1000 BELMONT AVENUE
CHARLOTTESVILLE, VIRGINIA

ECS PROJECT NO. 46:6713

CITY OF CHARLOTTESVILLE - FACILITIES DEVELOPMENT

Reference: Facility Condition Assessment Report for Clark Elementary School, 1000 Belmont Avenue,
Charlottesville, Virginia

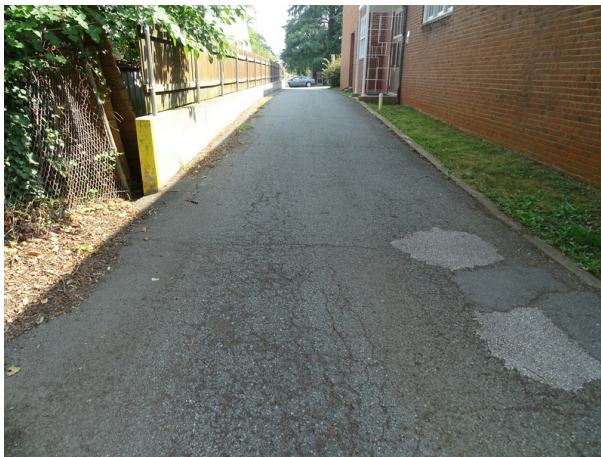
The storm water collection system is a municipal system. Drainage on the west side of the building and site was limited with reported ponding of water on the pavement. We recommend an allowance to provide an additional study to design and build a drainage solution on the west side of the building and site.

Storm water drainage on west side of building and site - note ponding reported and deterioration

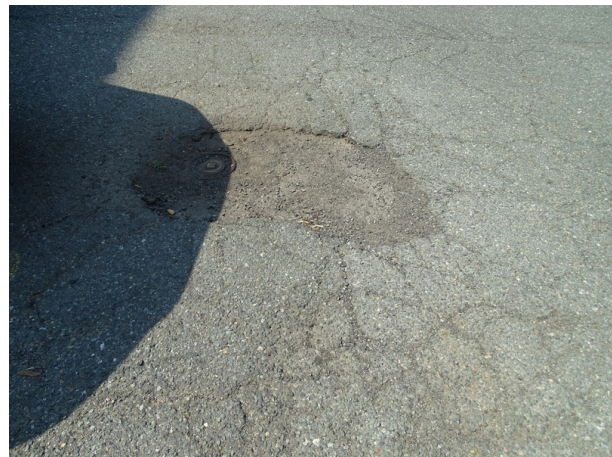
Storm water drainage on west side of building and site - note ponding reported and deterioration

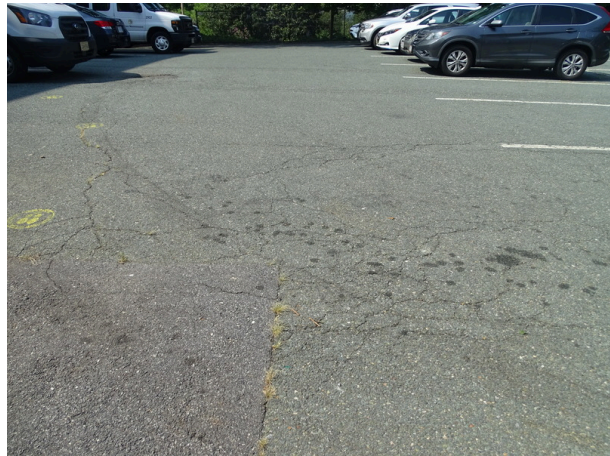
Asphalt-paved drive lanes and parking areas are located on the southwest side of the site which also provides access to the site. The asphalt pavement was observed to be in generally fair condition with minor cracks observed on the pavement. Striping was in fair condition. The expected useful life of asphalt pavement is 20 years. We have provided allowances to repair the cracked areas of asphalt pavement.

Asphalt parking - note cracking

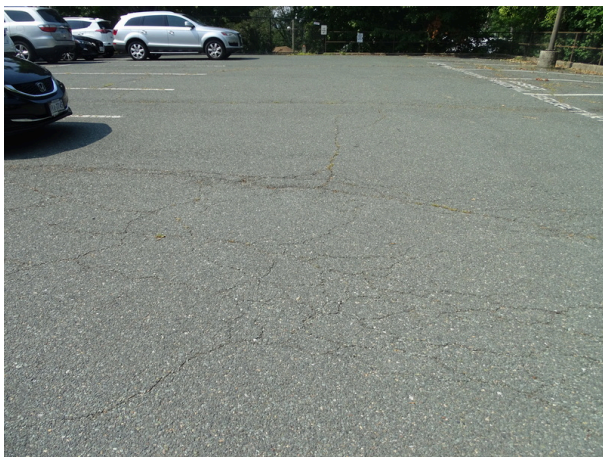
Asphalt parking - note cracking

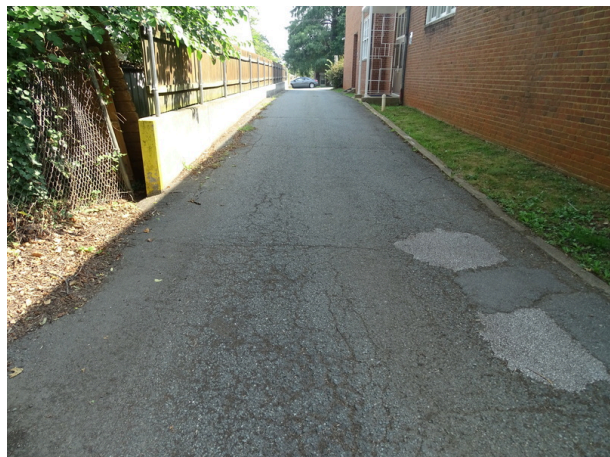
Asphalt pavement - note cracking

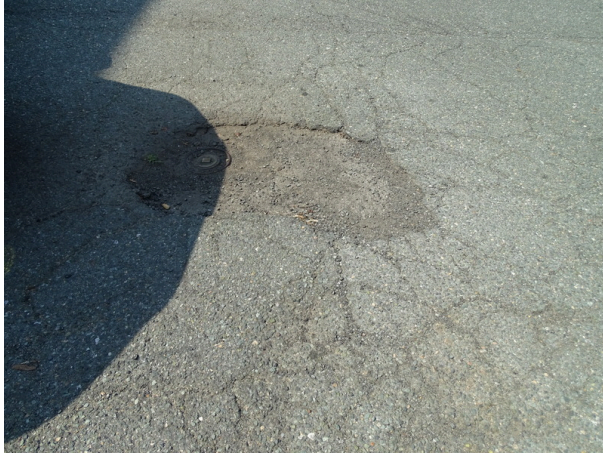
Asphalt parking - note minor cracking and deterioration

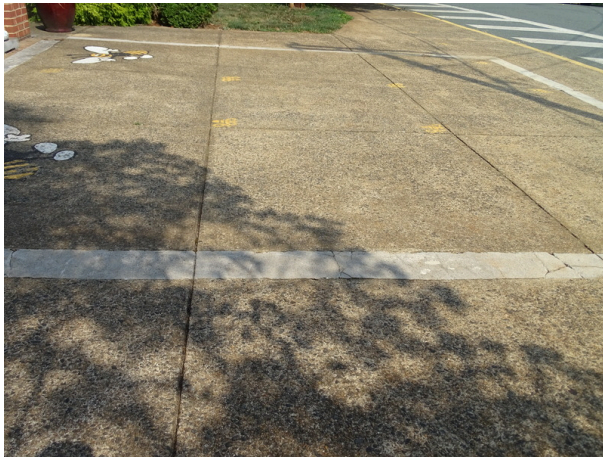
Typical concrete sidewalk - note cracking

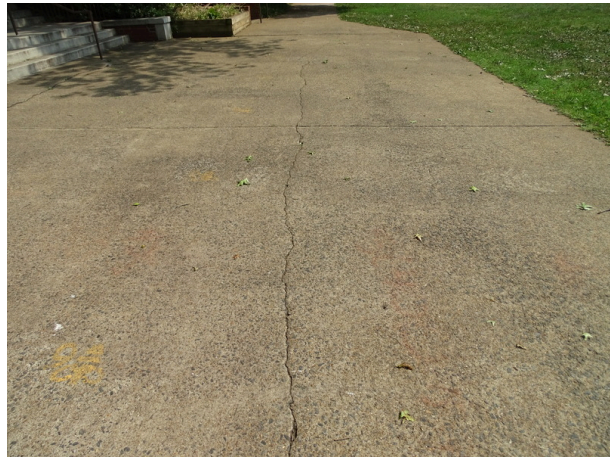
Typical concrete sidewalk - note cracking

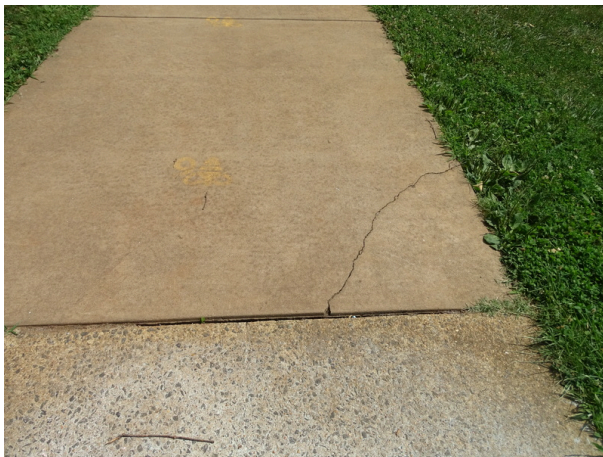
Typical concrete sidewalk - note cracking

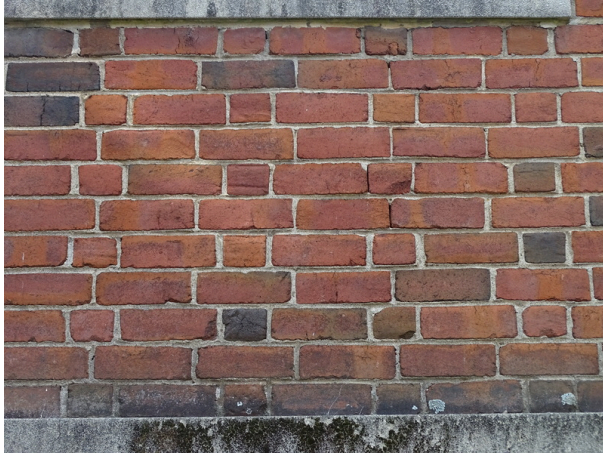
Retaining wall at southwest side of the building -
note efflorescence

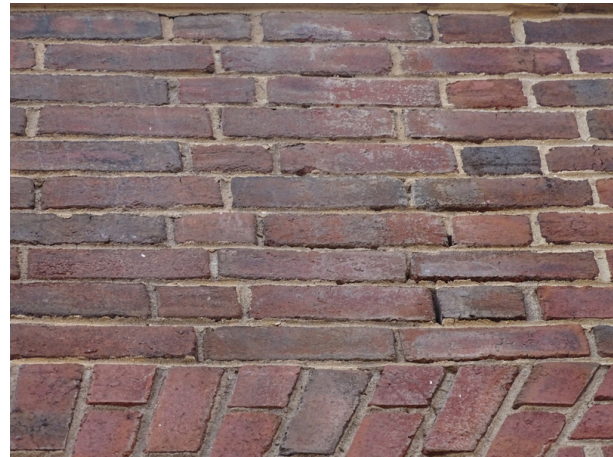
Building exterior - note deterioration

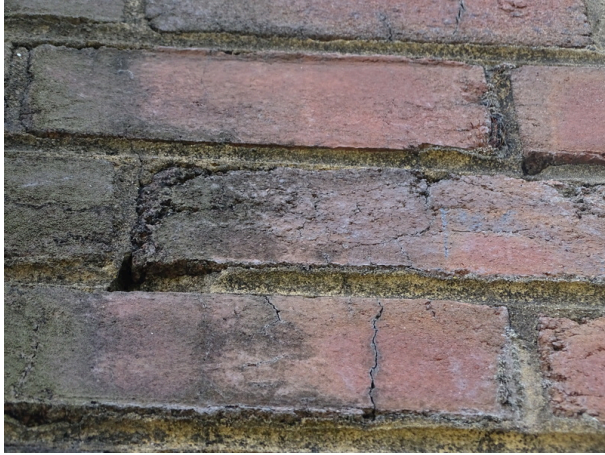
Building exterior - note deterioration

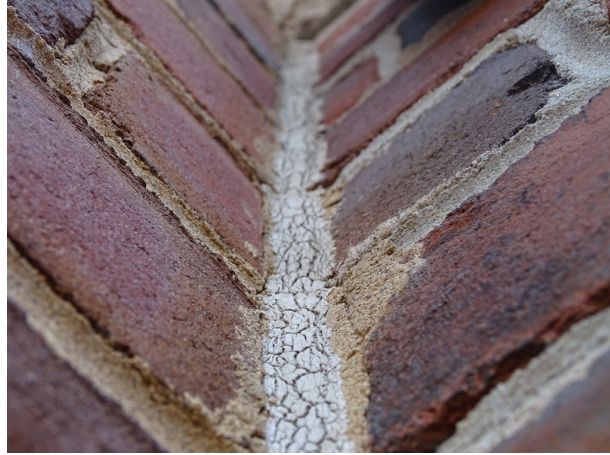
Building exterior - note deterioration

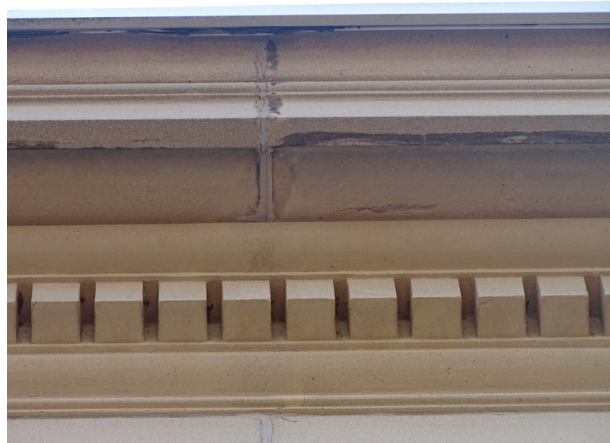
Building exterior - note deterioration

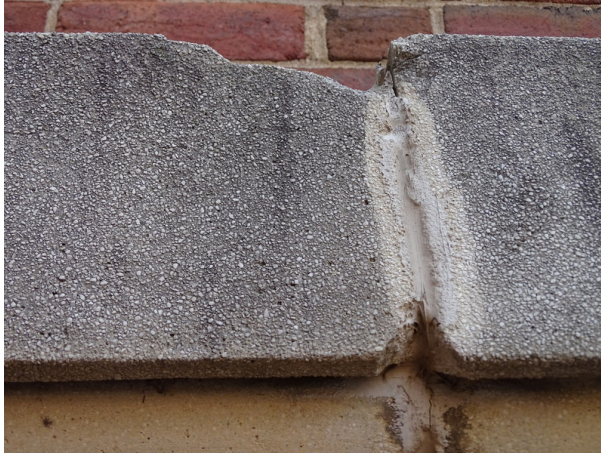
Building exterior - note deterioration

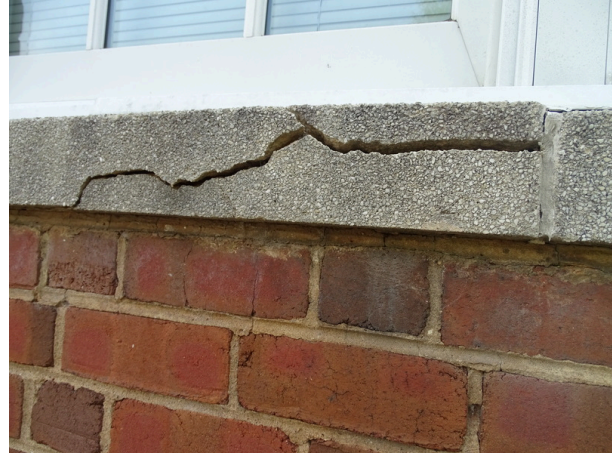
Building exterior - note deterioration

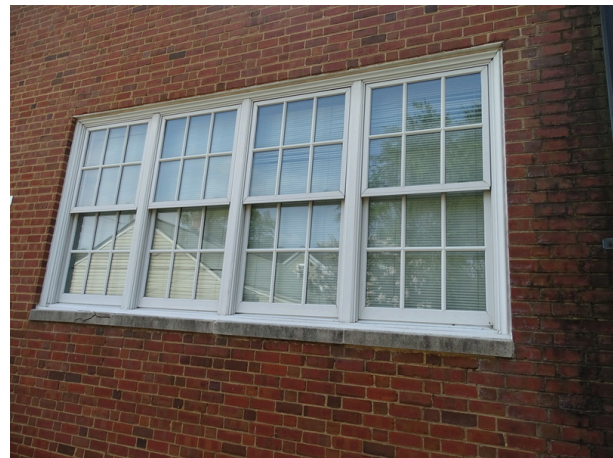
Typical exterior window - note sill cracking

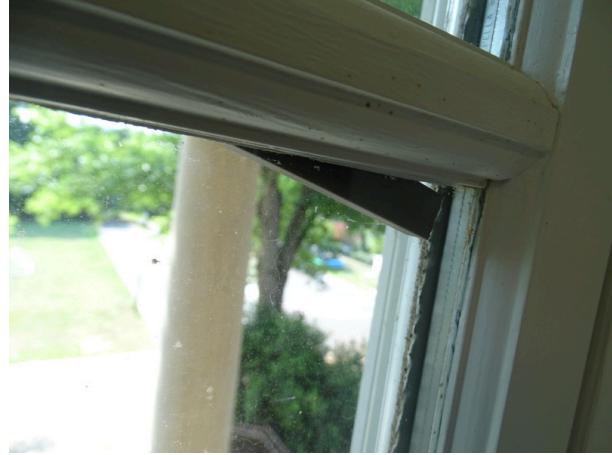
Typical exterior window - note gasket damaged

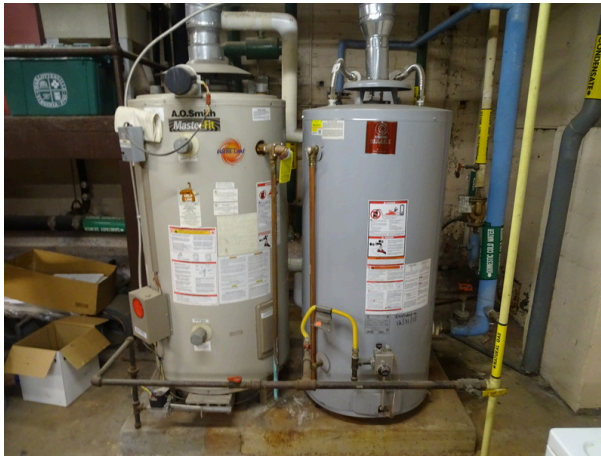
Domestic hot water to the building is provided by two Gas domestic water heaters. Both Gas domestic water heaters are located in the mechanical room on the east side of the building. One water heater was manufactured by A.O. Smith and reportedly installed in 1997, the other by State, installed in December 2015. The expected useful life of a Gas domestic water heater is approximately 12 to 15 years with proper maintenance. We recommend the Gas domestic water heaters be replaced during the study period.

Gas domestic water heaters

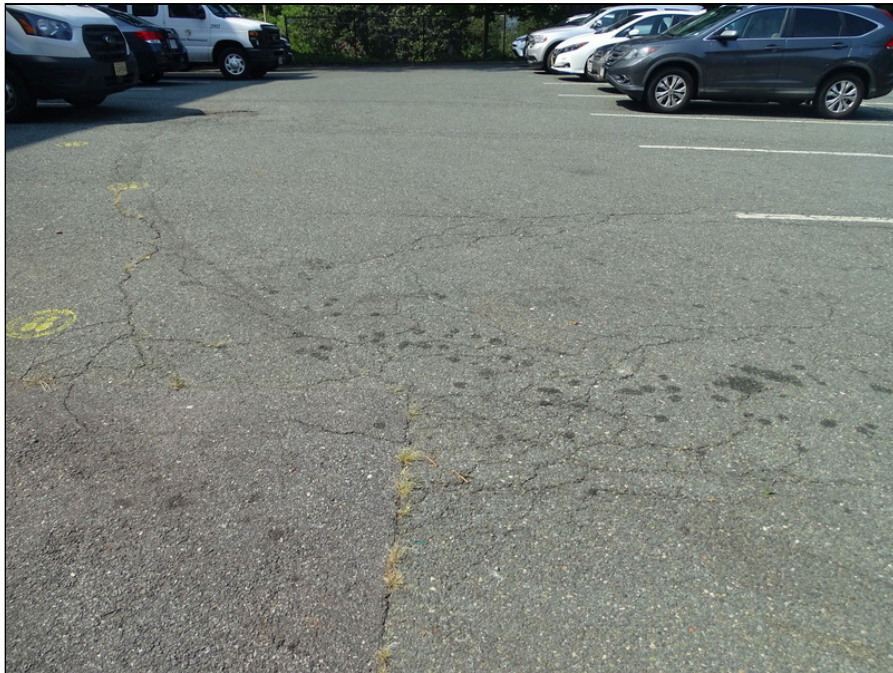
4 - Asphalt parking - note cracking

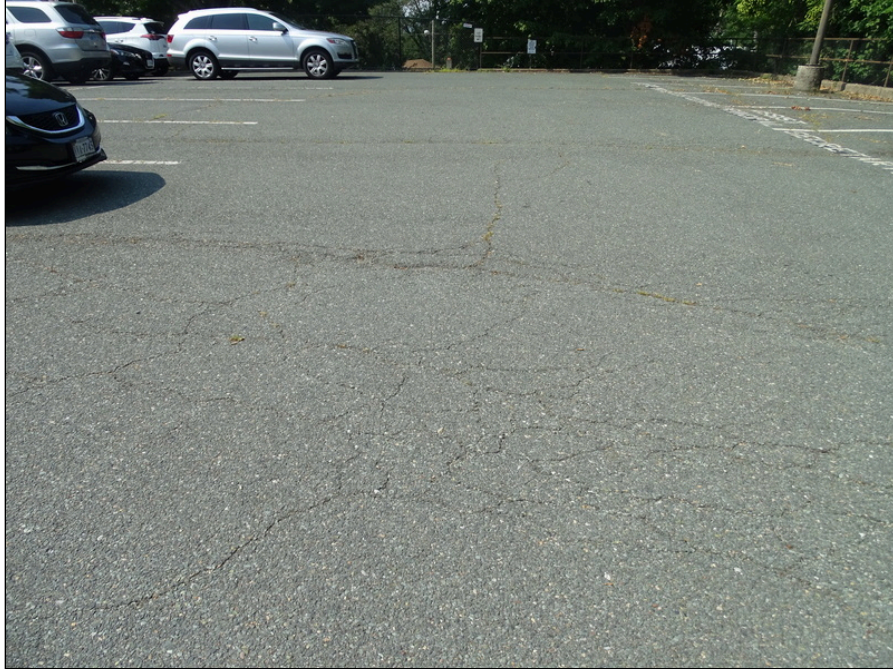
5 - Asphalt parking - note cracking

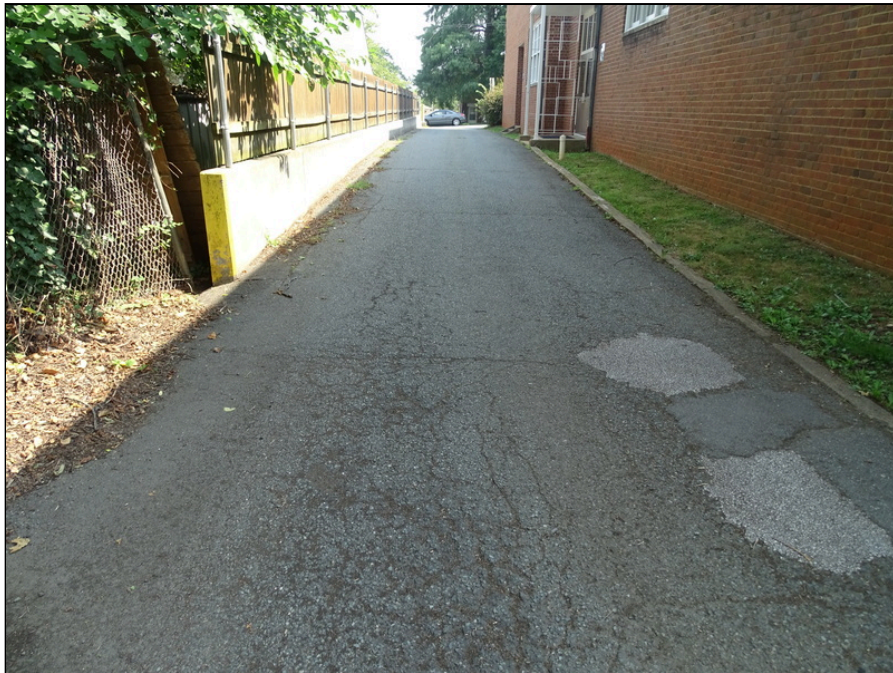
6 - Asphalt pavement - note cracking

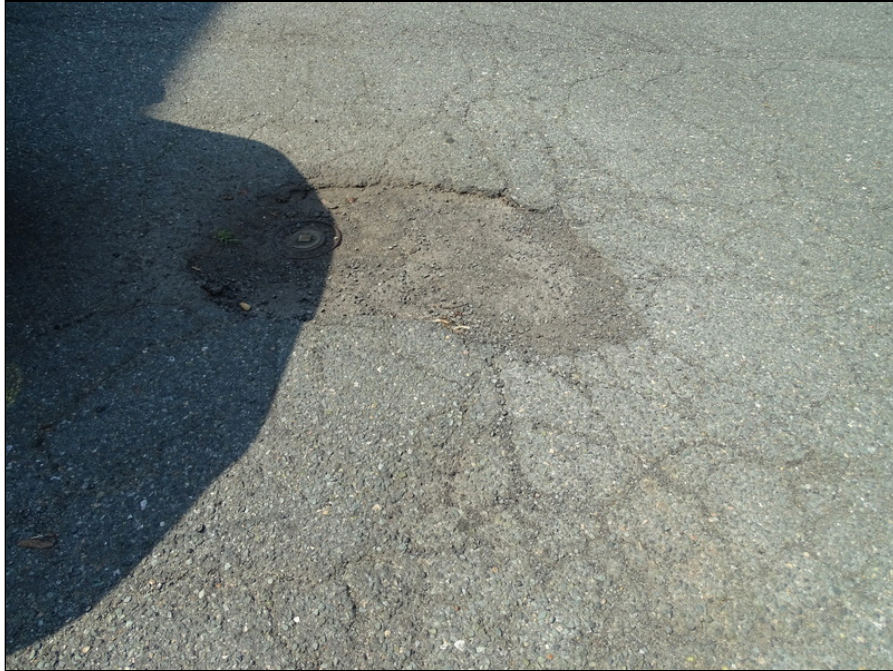
7 - Asphalt parking - note minor cracking and deterioration

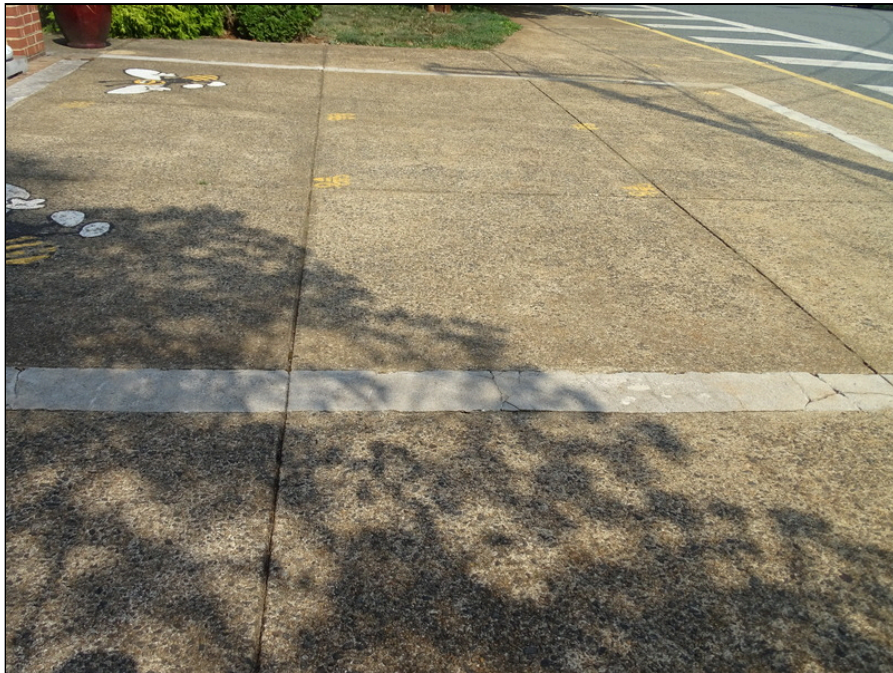
8 - Typical concrete sidewalk - note cracking

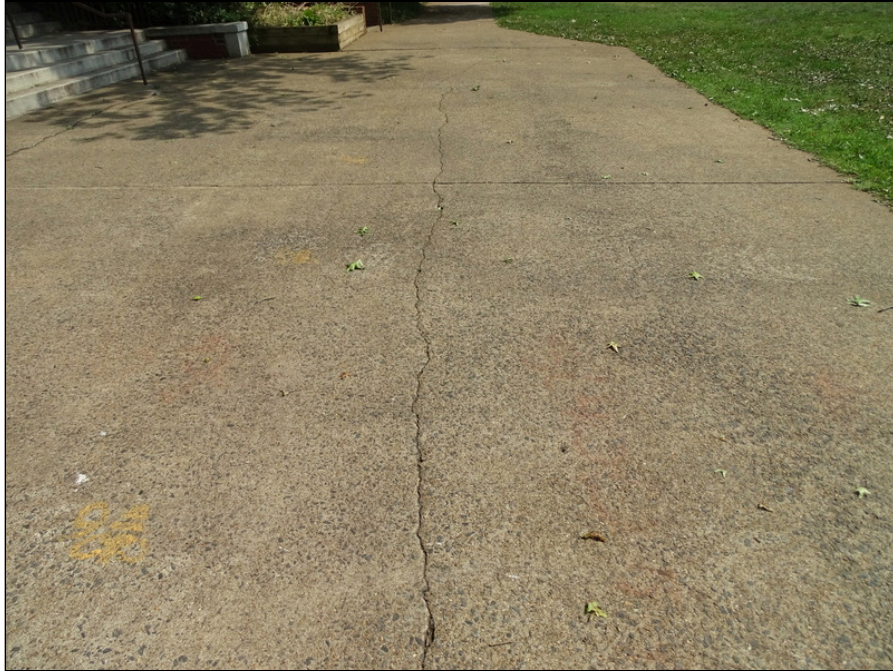
9 - Typical concrete sidewalk - note cracking

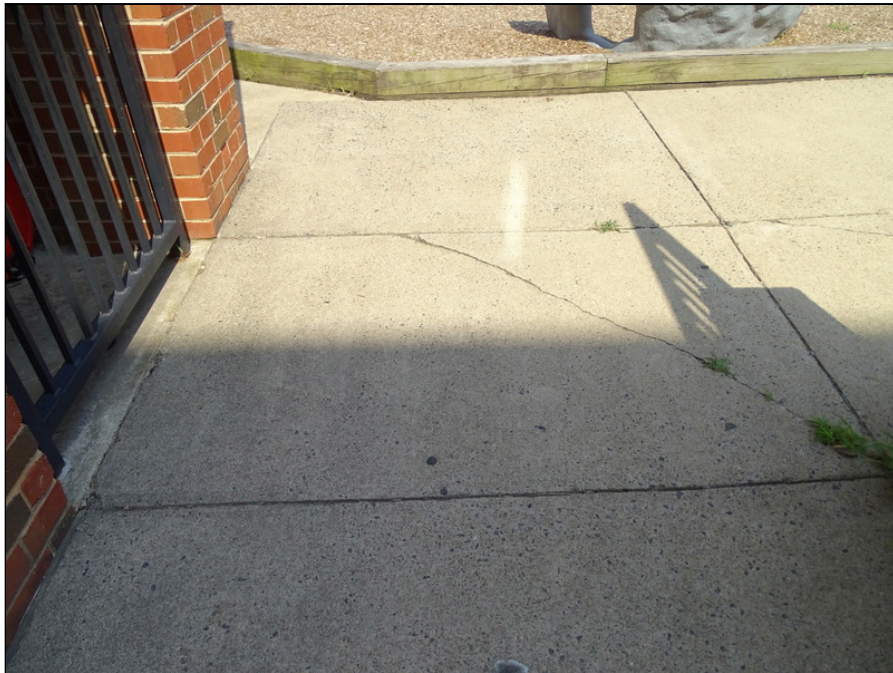
10 - Typical concrete sidewalk - note cracking

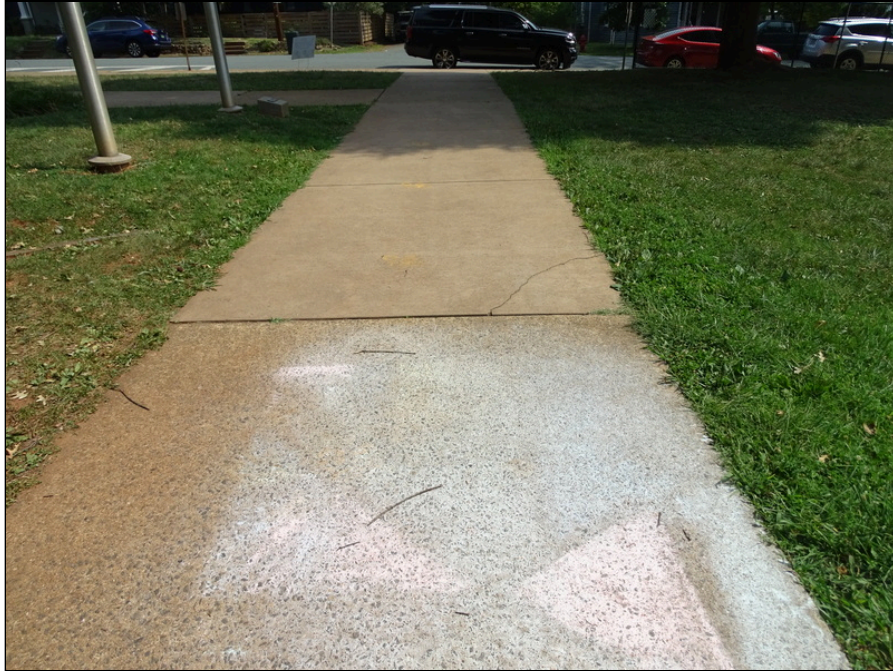
11 - Typical concrete sidewalk - note cracking

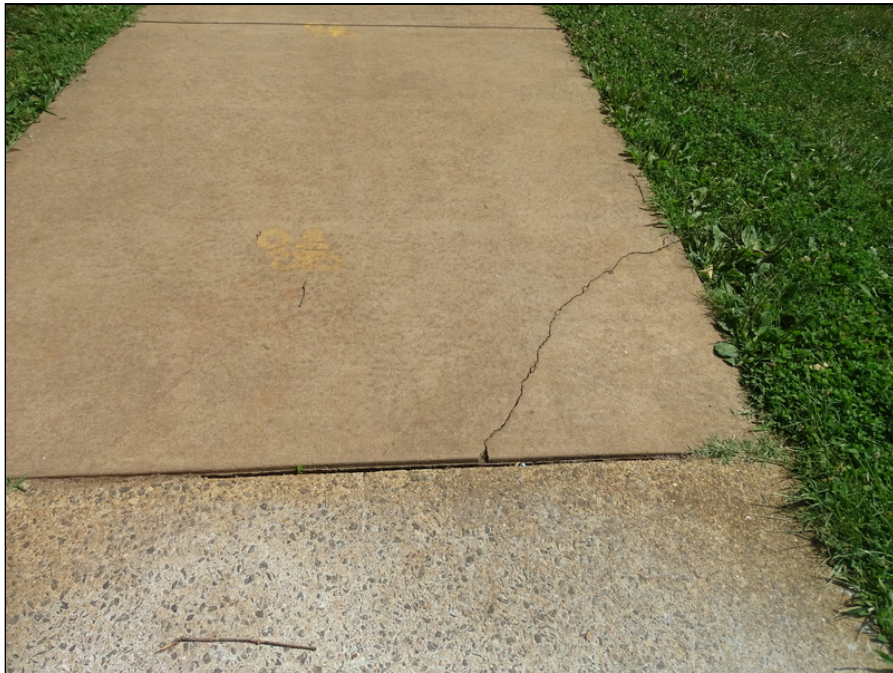
12 - Typical concrete sidewalk - note cracking

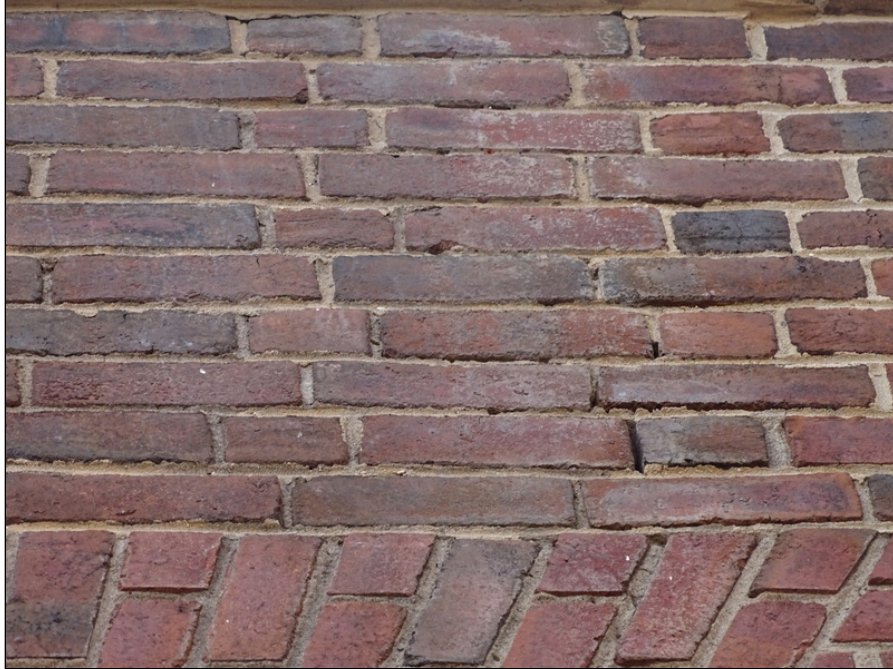
33 - Building exterior - note deterioration

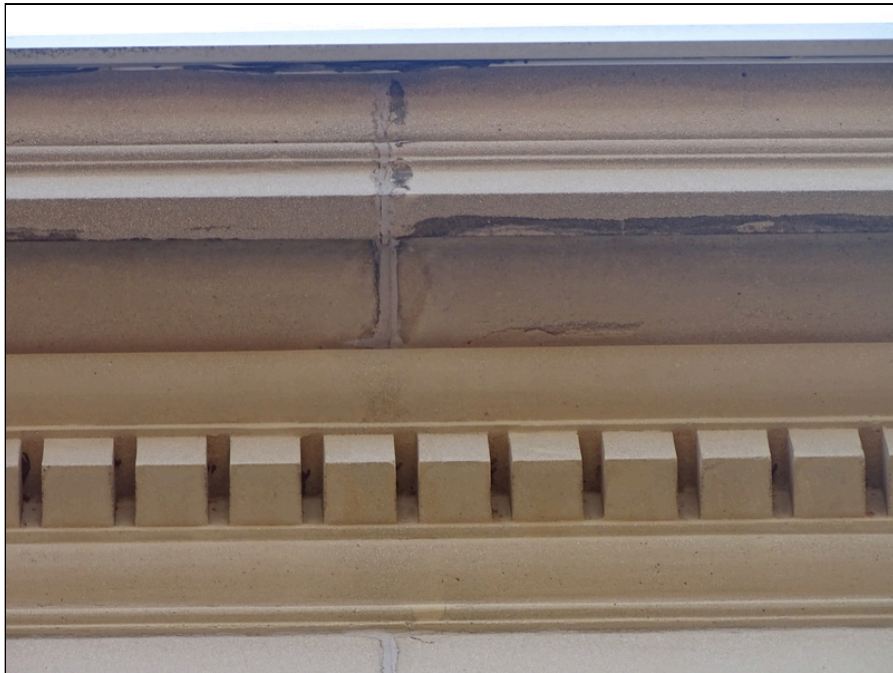
34 - Building exterior - note deterioration

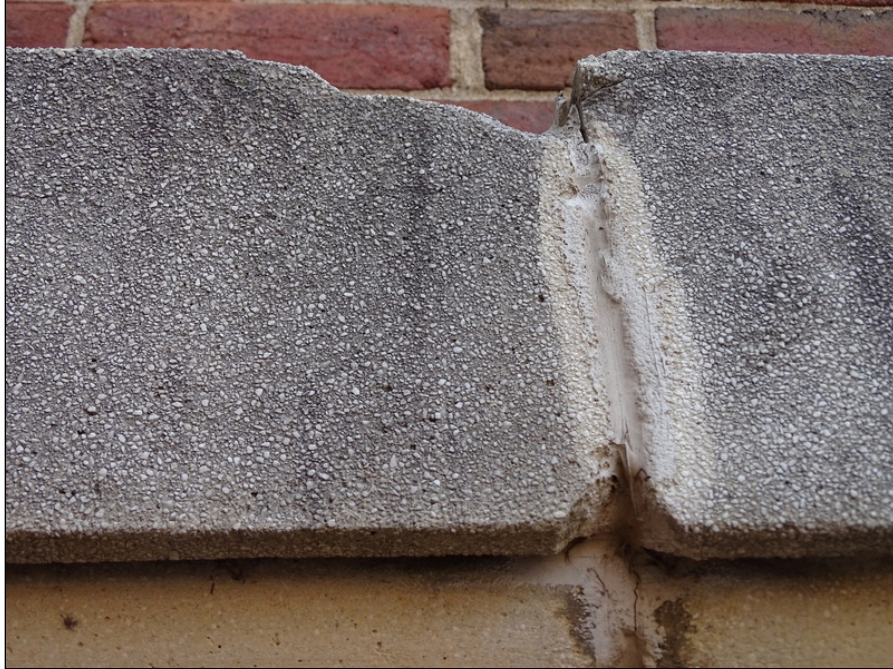
35 - Building exterior - note deterioration

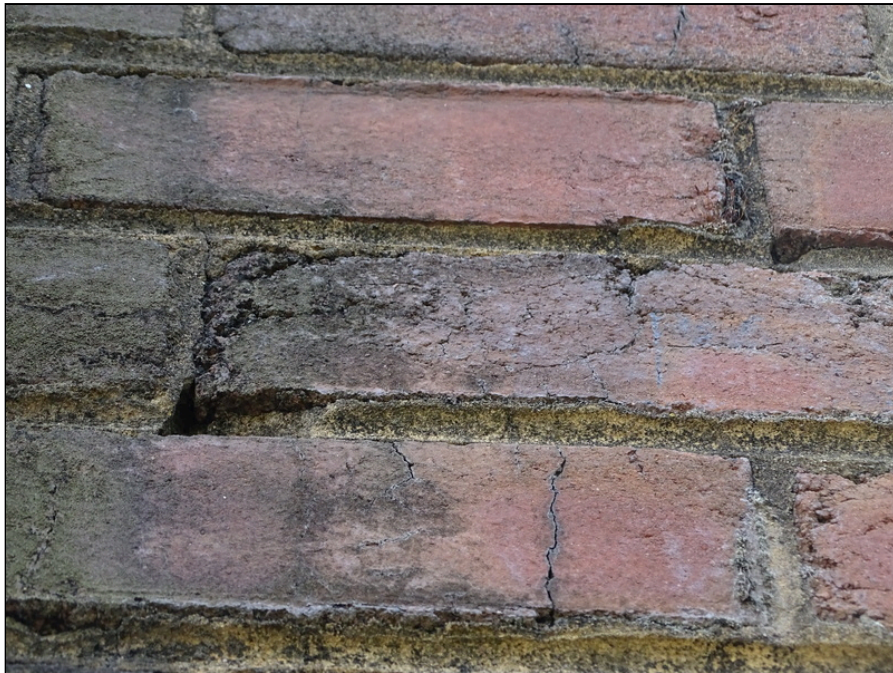
36 - Building exterior - note deterioration

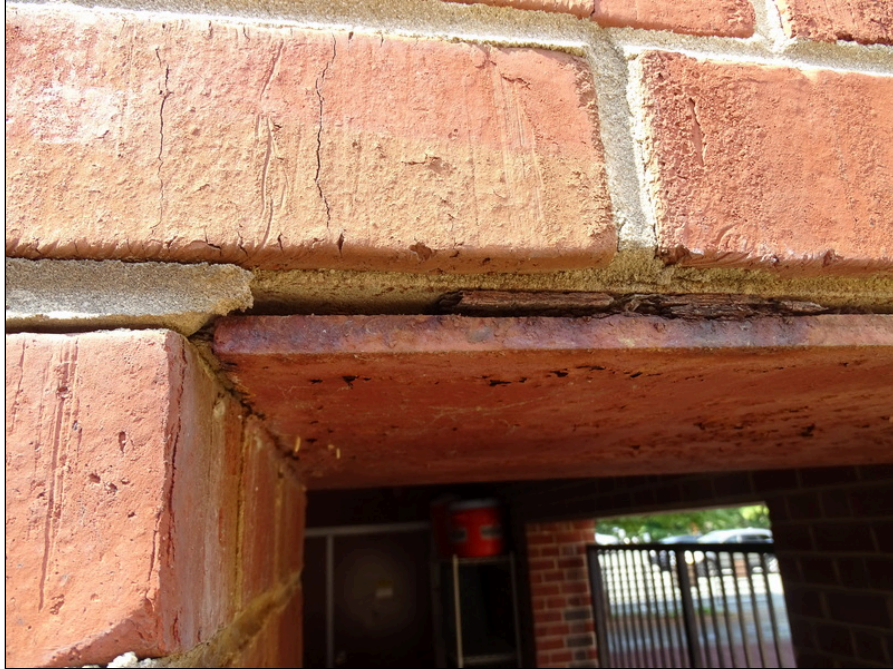
37 - Building exterior - note deterioration

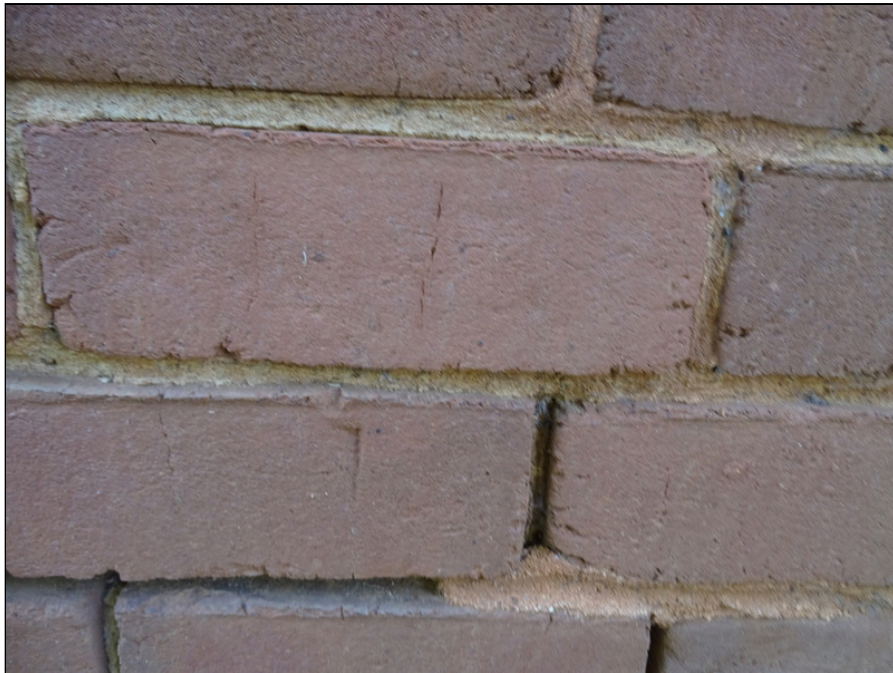
38 - Building exterior - note deterioration

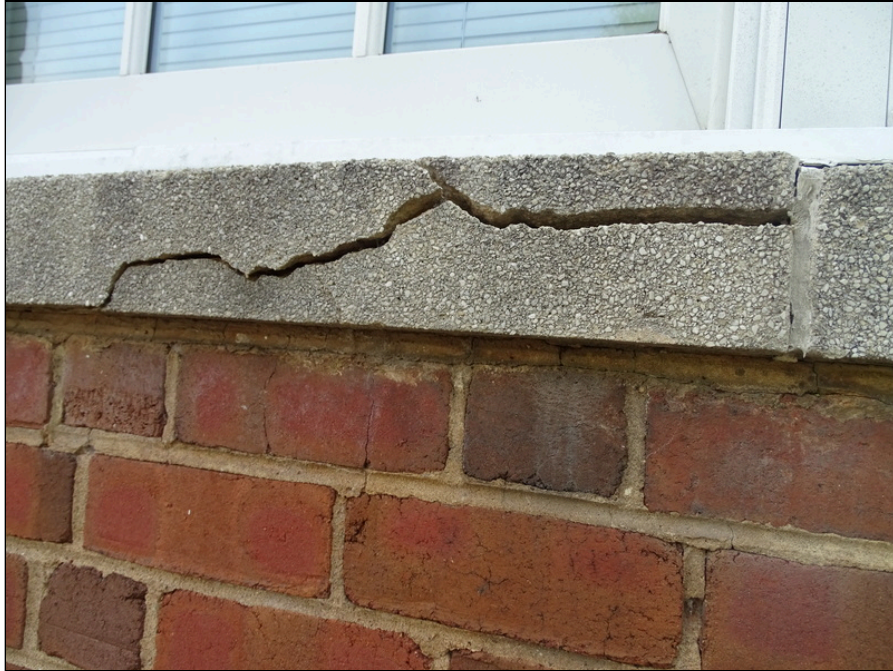
39 - Building exterior - note deterioration

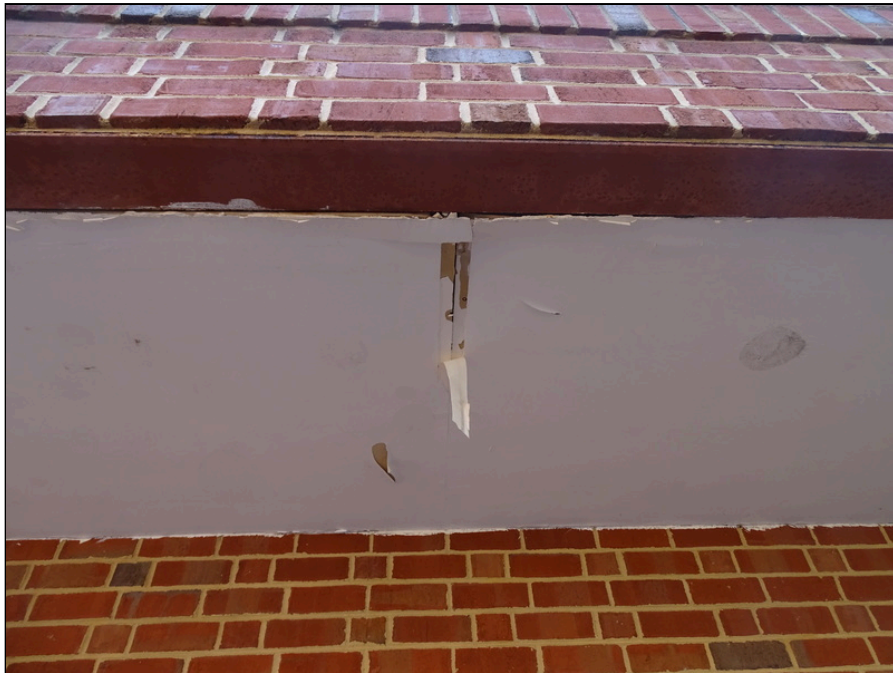
40 - Building exterior - note peeling paint

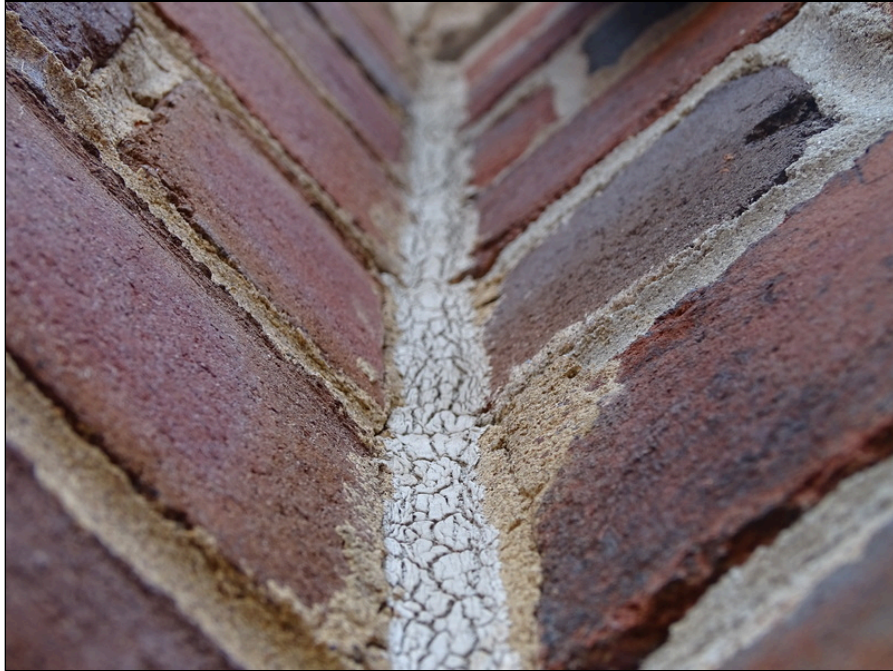
41 - Building exterior - note deterioration

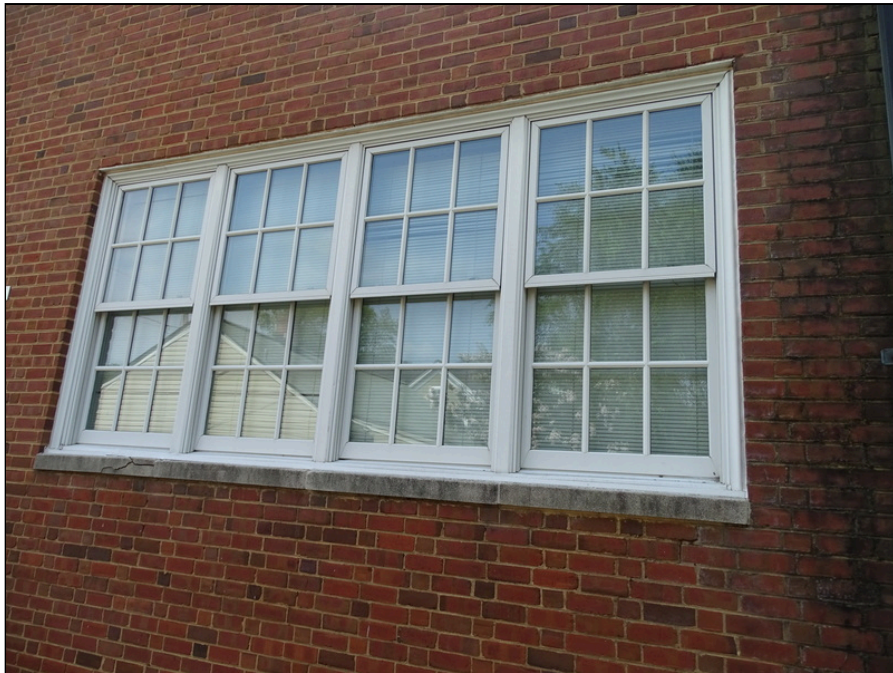
46 - Typical exterior window - note sill cracking

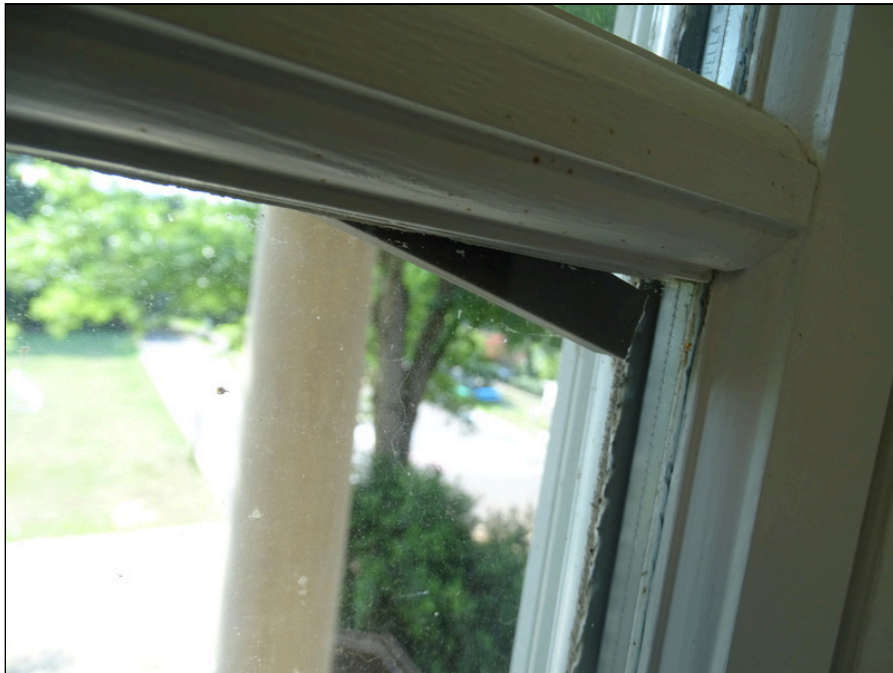
48 - Typical exterior window - note gasket damaged

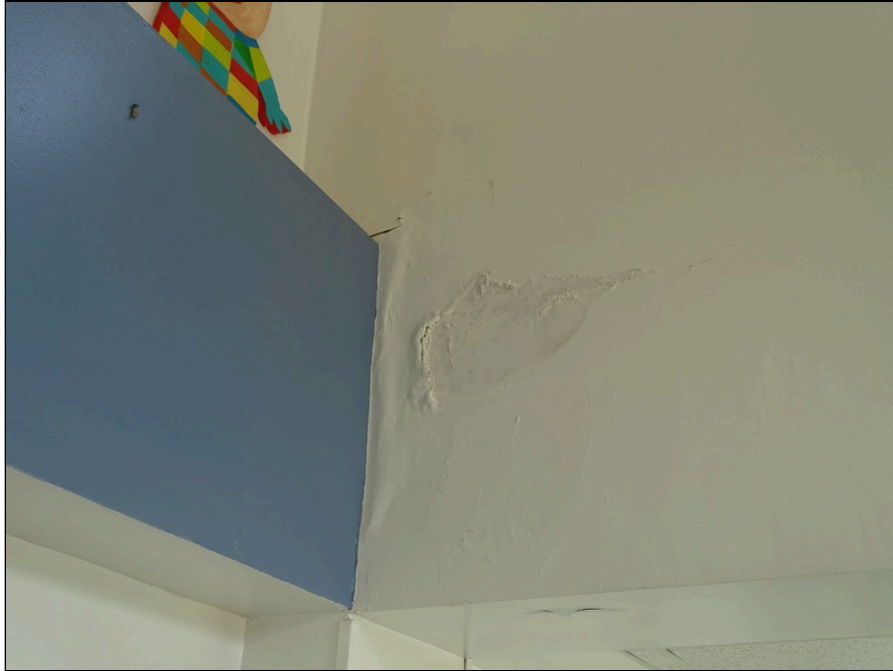
89 - Finish deterioration

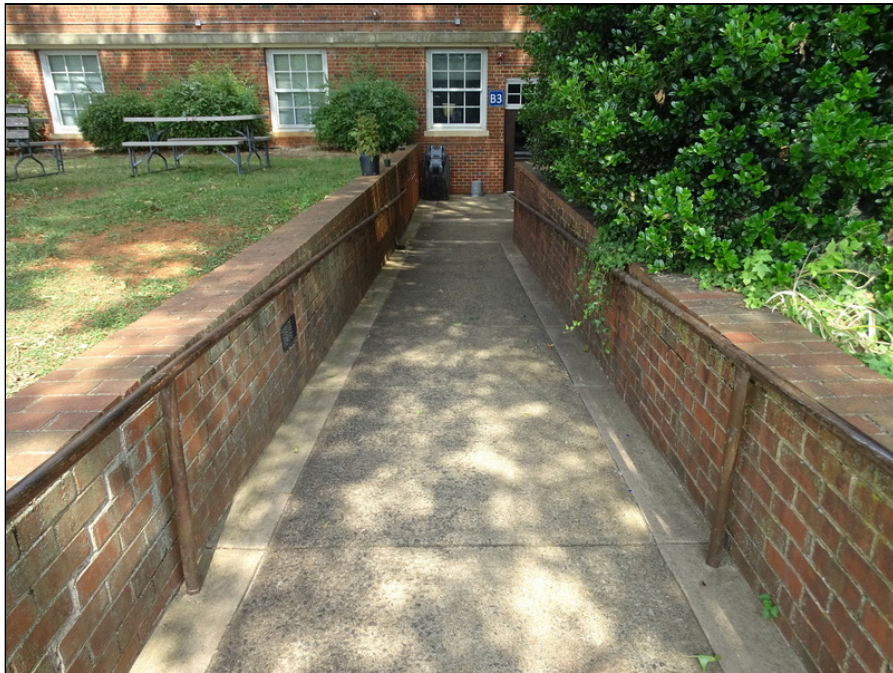
94 - Accessible ramp - note wall deterioration
