DISCOVERY MUSEUM
524 EAST MAIN STREET
CHARLOTTESVILLE, VIRGINIA

ECS PROJECT NO. 46:6713

CITY OF CHARLOTTESVILLE - FACILITIES DEVELOPMENT

Reference: Facility Condition Assessment Report for Discovery Museum, 524 East Main Street,
Charlottesville, Virginia

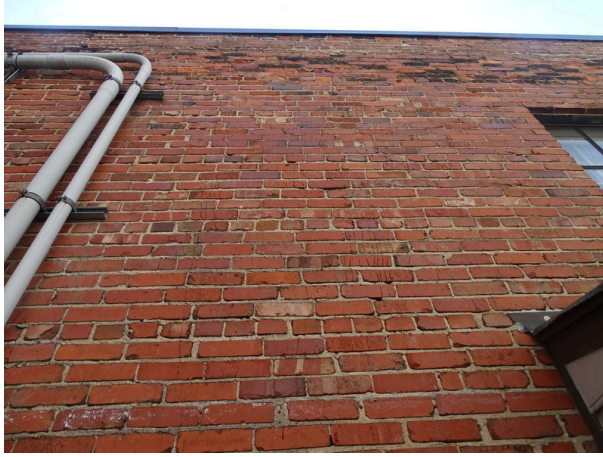
The primary exterior of the building consists of brick at the south, east, and west walls and painted stucco located at the north wall. The building exteriors were generally in good to fair condition. The expected useful life of mortared joints is approximately 20 years before re-pointing is required. Deterioration of mortar joints was observed and vegetation was observed growing on the southeast façade of the building. We recommend removing the vegetation growth and re-pointing of the deteriorated mortar joints.

Brick exterior at west side of the building - note deterioration above window

Cost Recommendation	EUL	EFF AGE	RUL	Year	Cost
REMOVE VEGETATION AND REPOINT BRICKWORK	20	19	1	1	\$25,000
PAINT STUCCO	7	5	2	2	\$5,000
				10	\$5,000
				17	\$5,000
REPLACE SEALANTS	12	11	1	1	\$2,500
				12	\$2,500

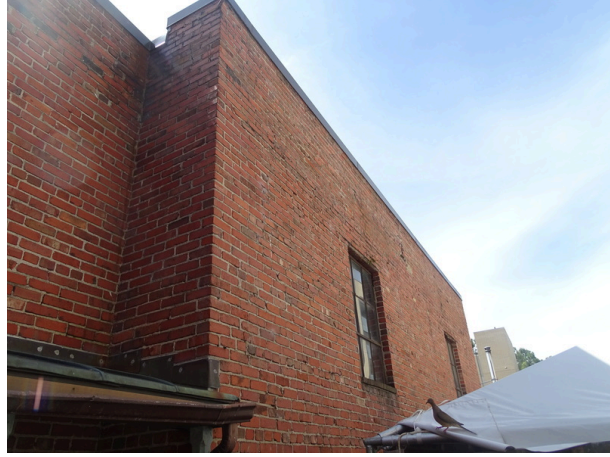
Brick exterior at west side of the building - note deterioration above window

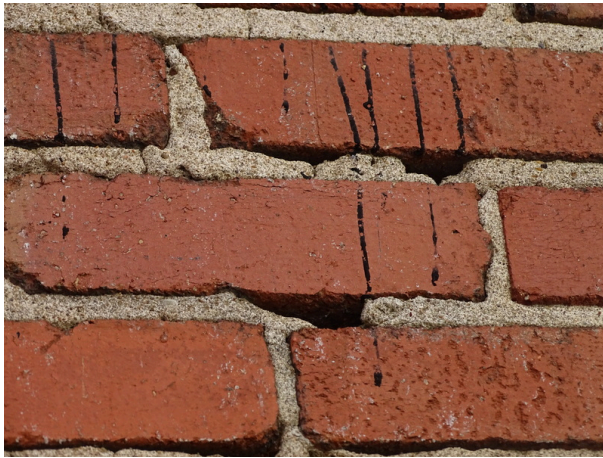
Brick exterior at west side of the building - note deterioration above window

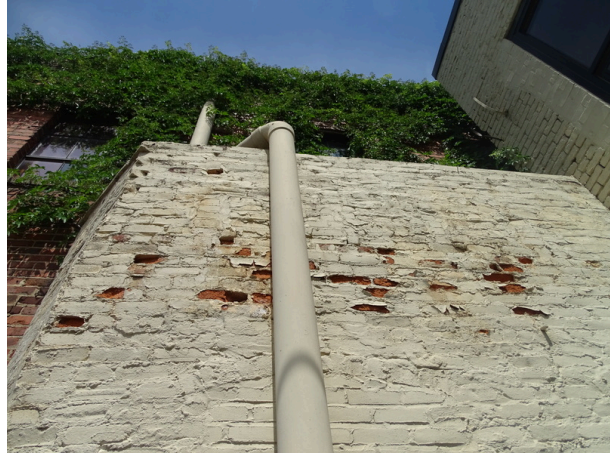
Typical exterior wall - note deterioration

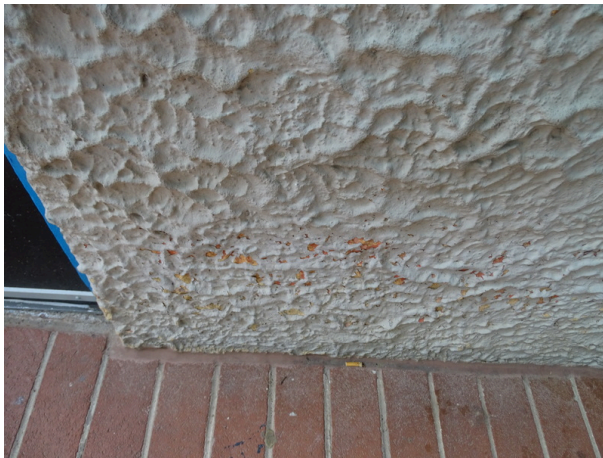
The stucco at the north side is painted. The paint was in good to fair condition. Painting of exterior components is typically recommended every 5 to 7 years. We recommend the stucco be painted during the report period.

Exterior stucco wall - note deterioration

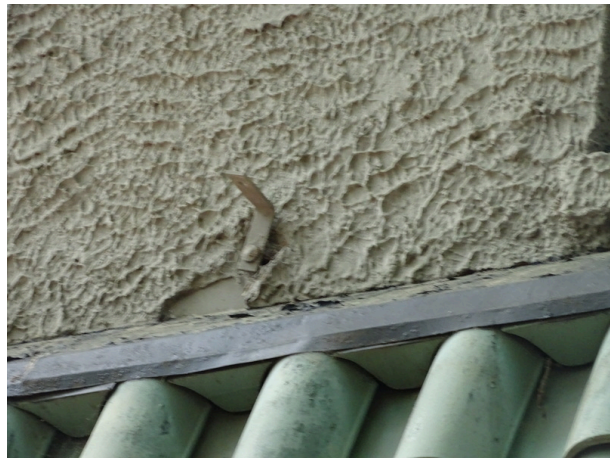
Exterior stucco wall - note deterioration

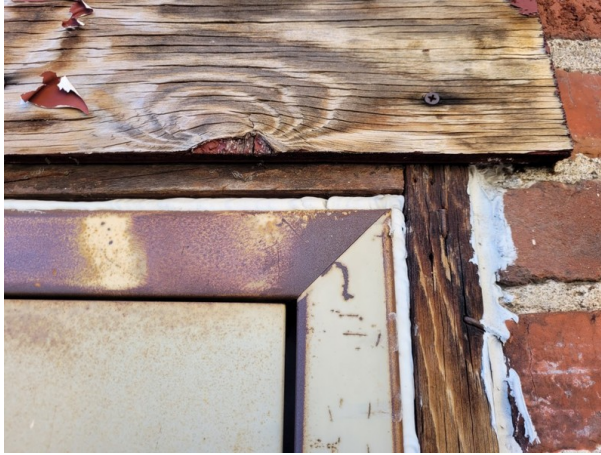
A steel personnel door is located at the south end, east side of the building. The personnel door was generally in poor condition with noticeable deterioration of the door slab and surrounding wood elements. A piece of plywood covers a former transom over the door and was also deteriorated. We recommend re-pointing the brick opening, replacing the wood infill, replacing the door and frame, and replacing or infilling the transom.

Rear door sealant condition

Cost Recommendation	EUL	EFF AGE	RUL	Year	Cost
REPLACE EXTERIOR DOOR AND INFILL	20	20	0	Immediate	\$2,400
Total					\$2,400

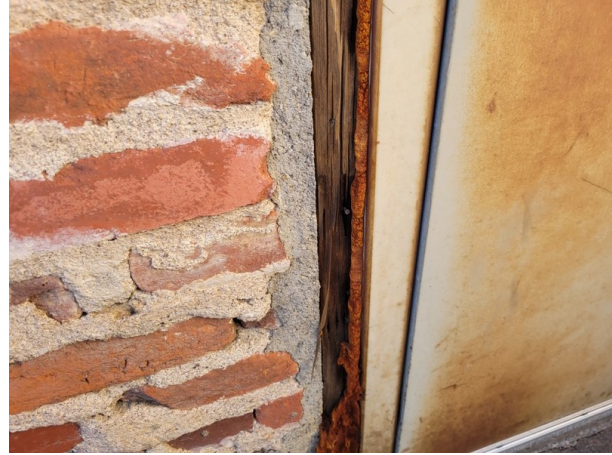
Rear door jamb condition

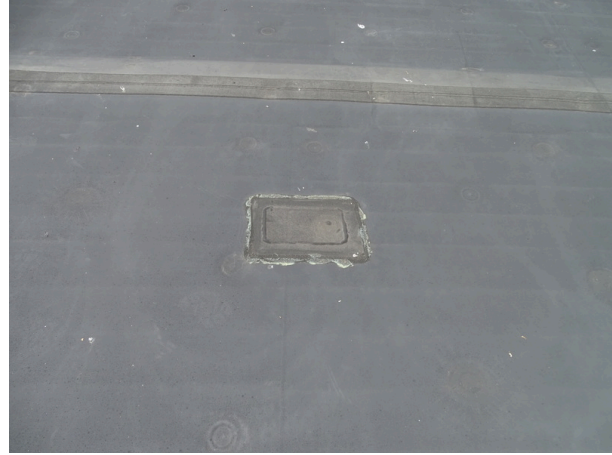
Roofing system - note patching

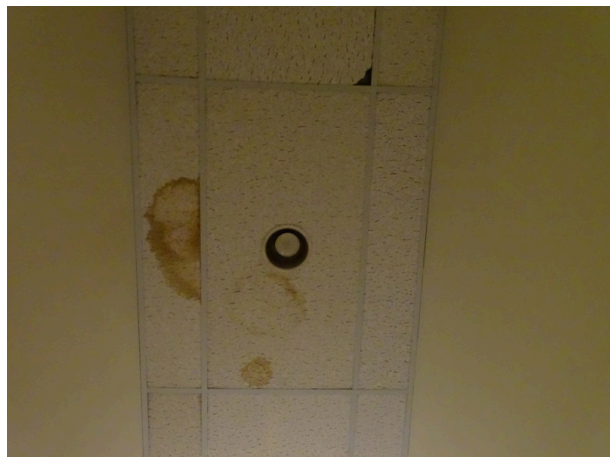
It was reported that the HVAC system was leaking and causing damage to the ceiling tiles below. We recommend the leaks are repaired as part of regular system maintenance.

Typical ceiling - note water leakage

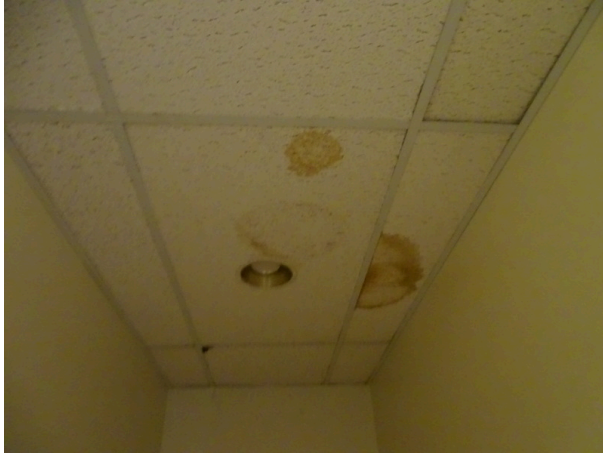
Typical ceiling - note water leakage

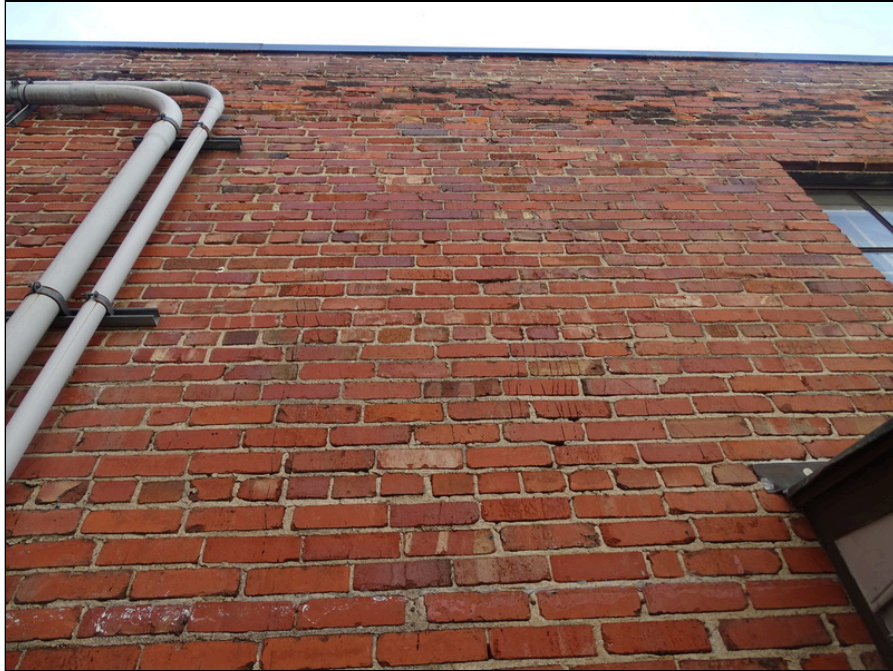
5 - Brick exterior at west side of the building - note deterioration above window

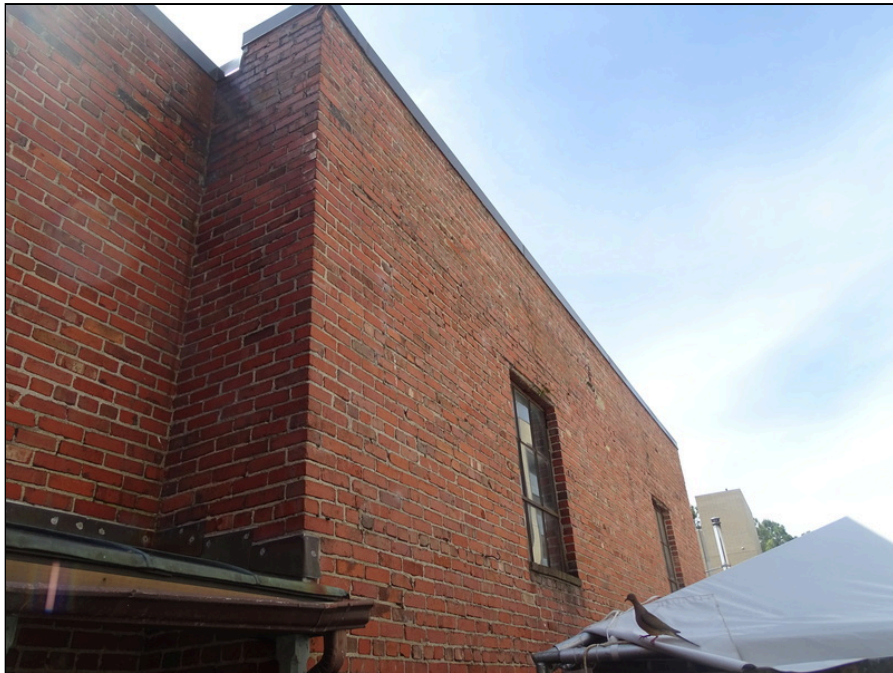
6 - Brick exterior at west side of the building - note deterioration above window

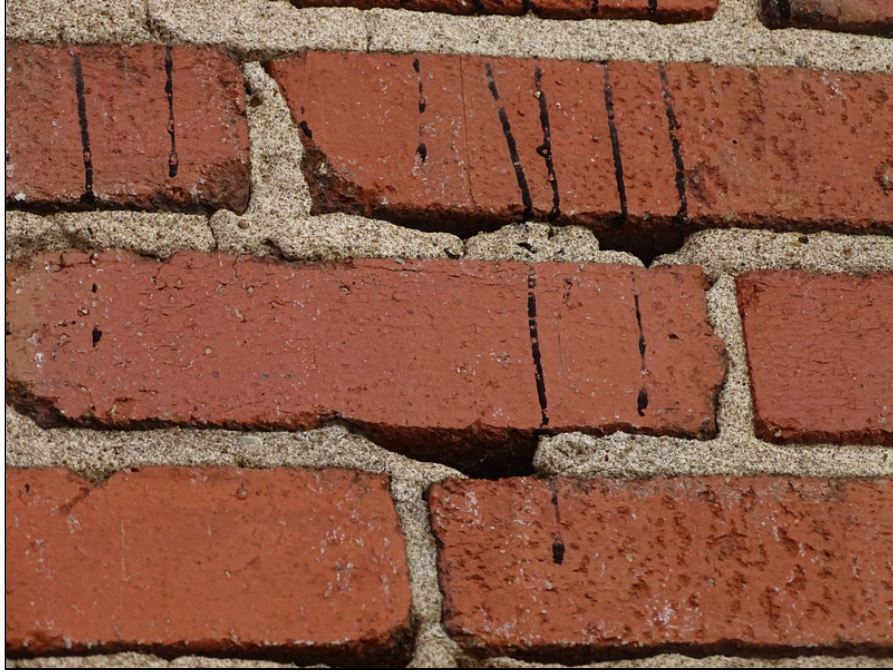
7 - Brick exterior at west side of the building - note deterioration above window

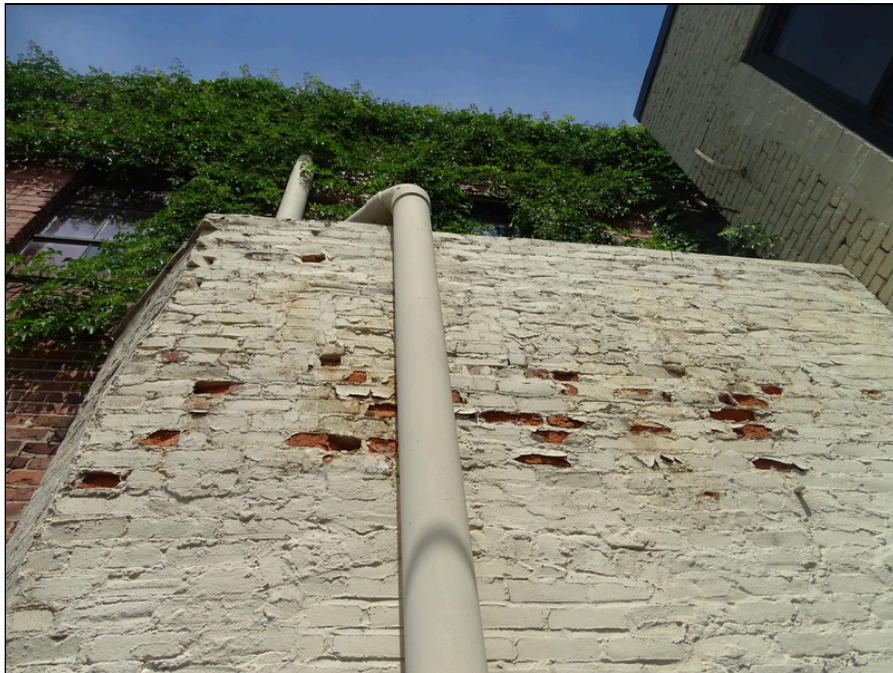
10 - Typical exterior wall - note deterioration

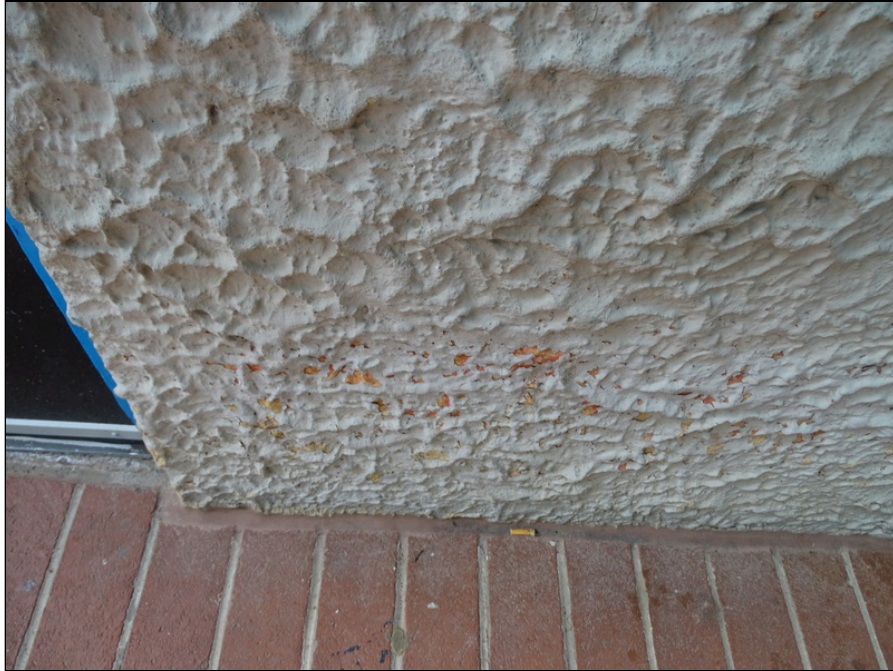
11 - Exterior stucco wall - note deterioration

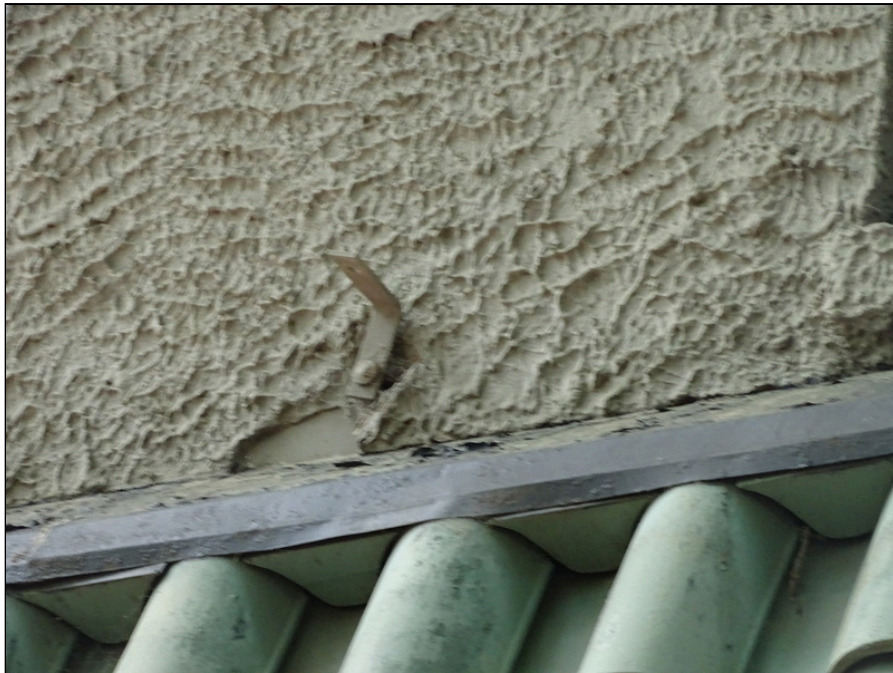
12 - Exterior stucco wall - note deterioration

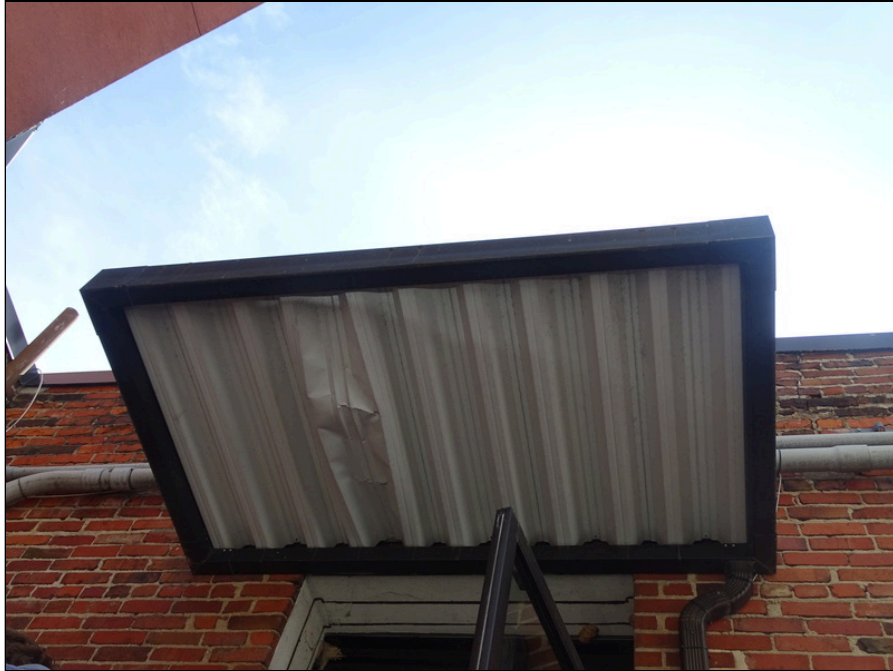
13 - Typical metal awning - note deterioration

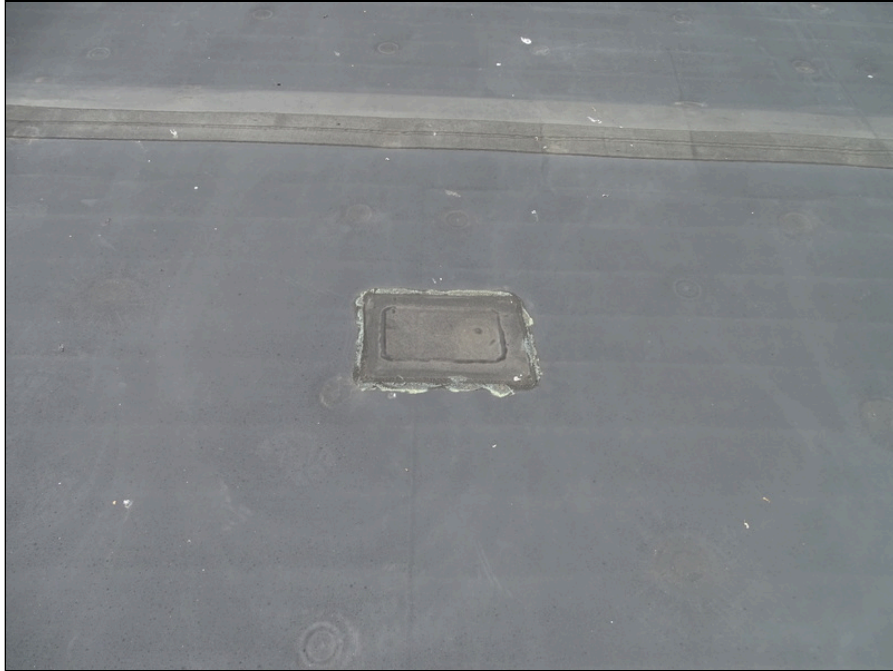
23 - Roofing system - note patching

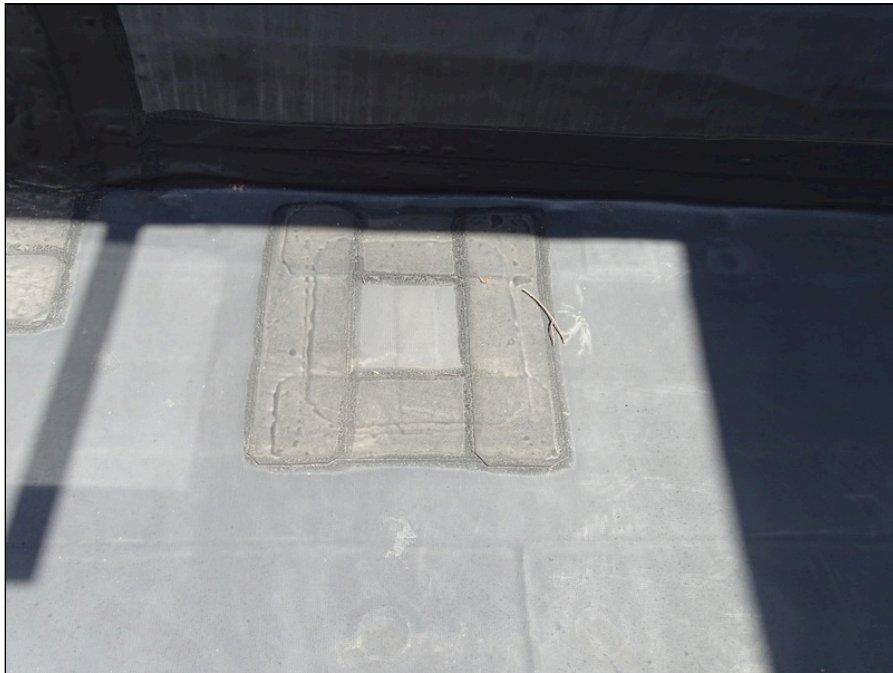
24 - Roofing system - note patching

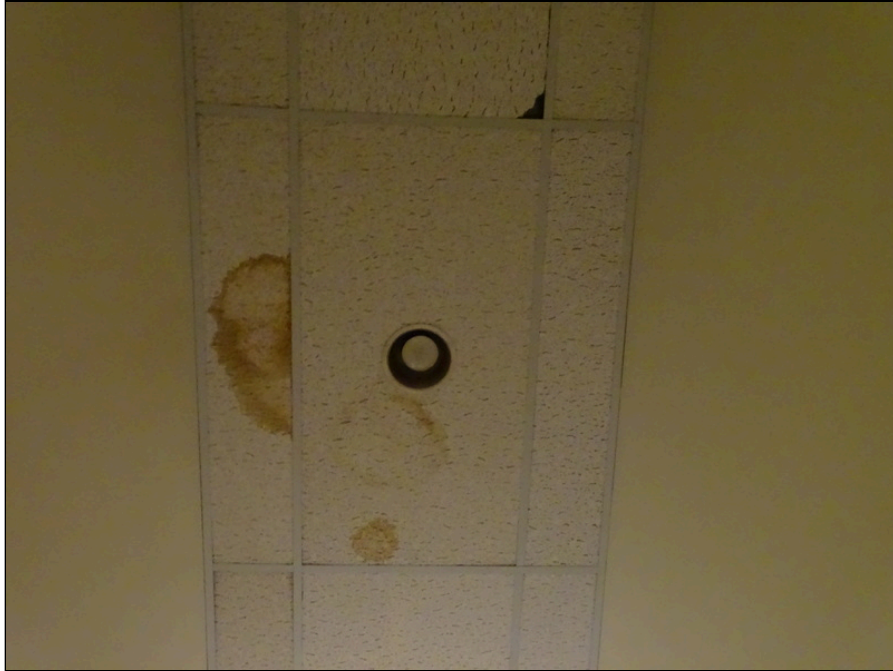
25 - Typical ceiling - note water leakage

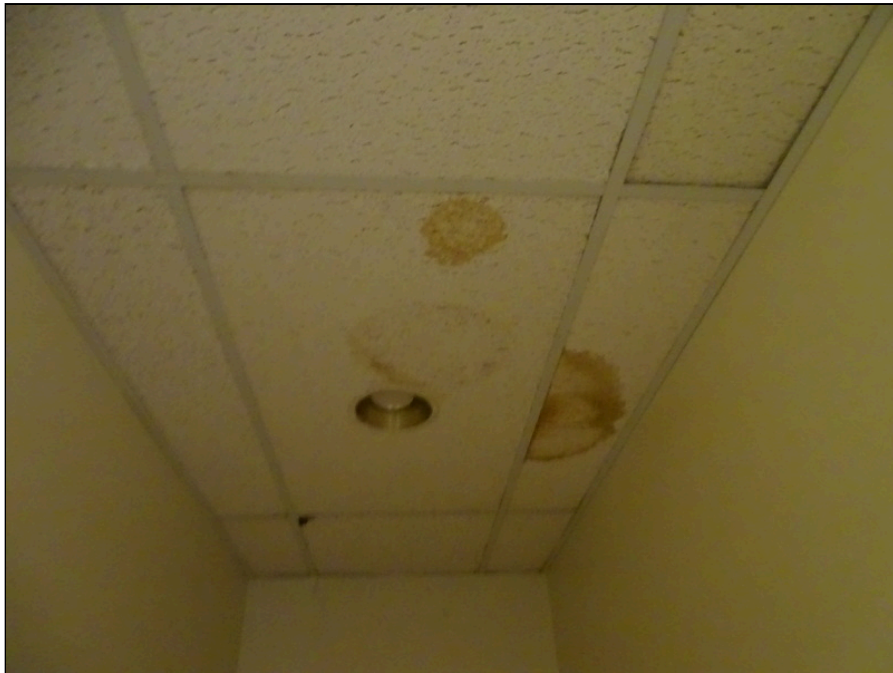
26 - Typical ceiling - note water leakage

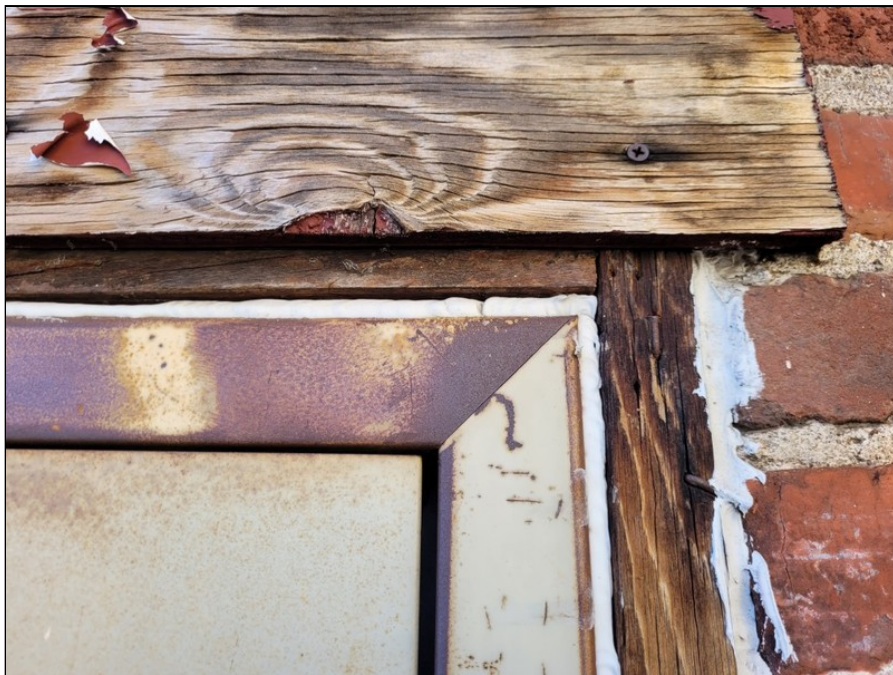
52 - Rear door sealant condition

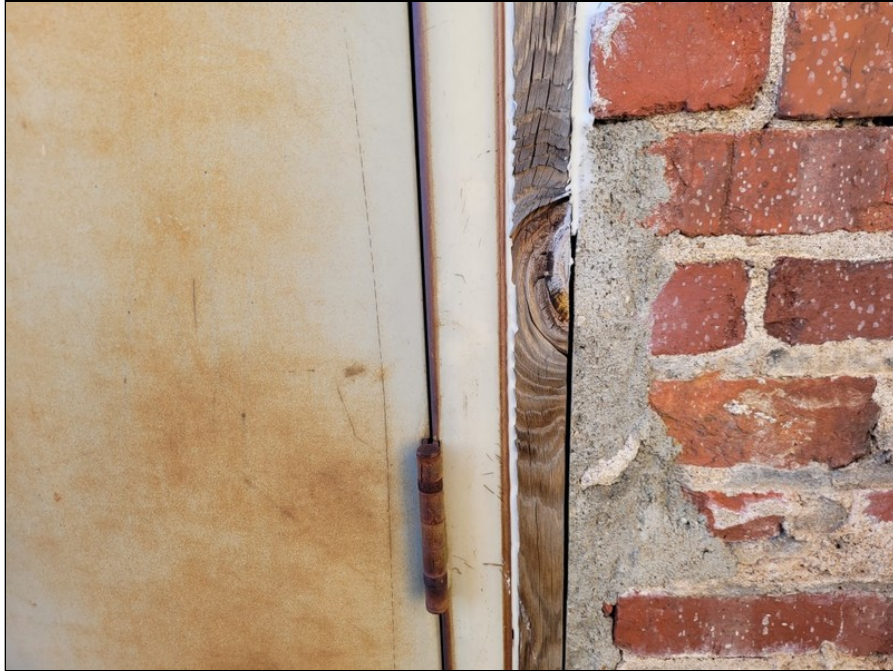
53 - Rear door jamb condition

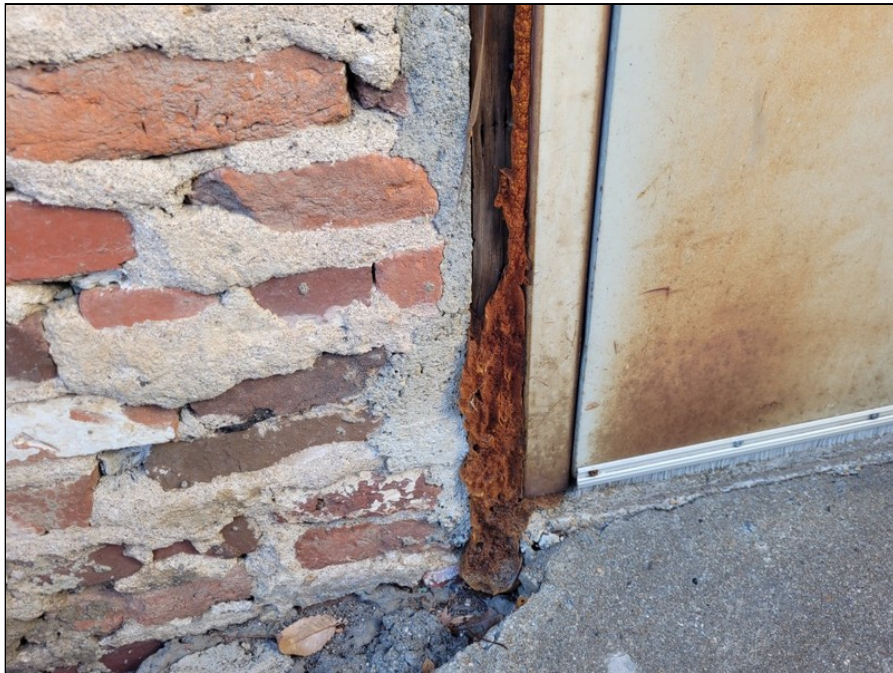
54 - Rear door sill condition

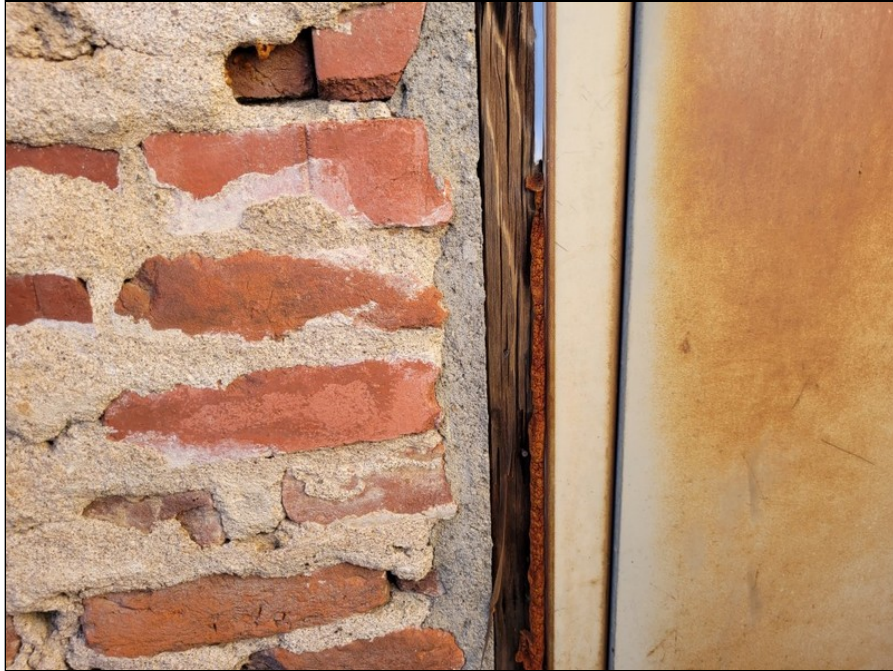
55 - Rear door jamb condition

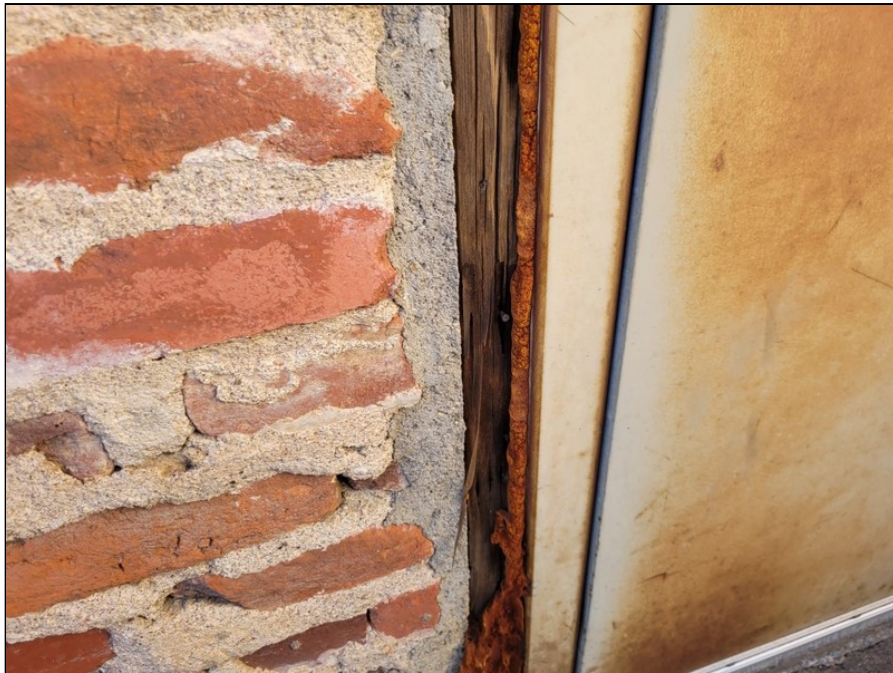
56 - Rear door jamb condition

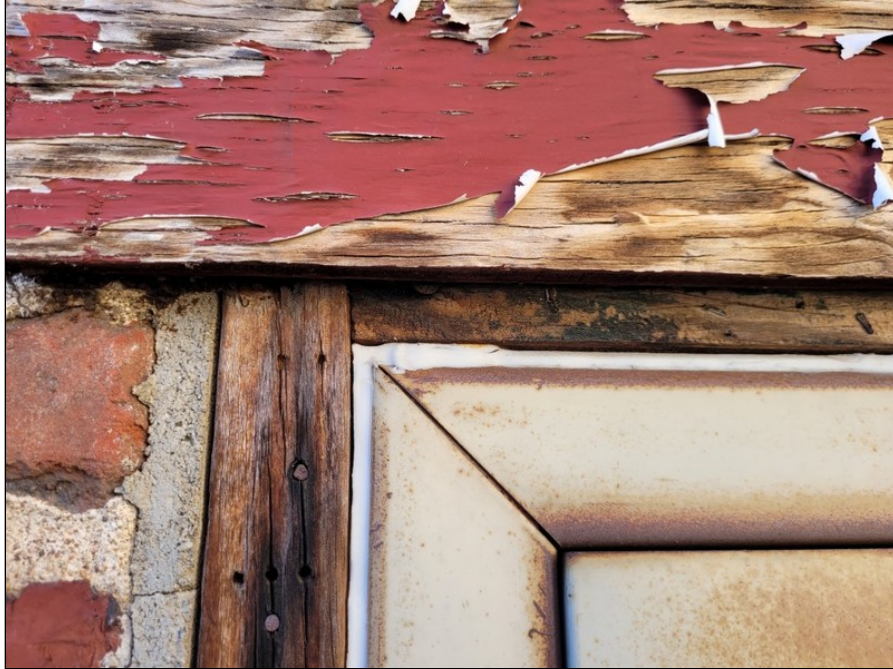
57 - Rear door head condition
