FONTAINE AVENUE FIRE STATION  
2420 FONTAINE AVENUE  
CHARLOTTESVILLE, VIRGINIA

ECS PROJECT NO. 46:6713

CITY OF CHARLOTTESVILLE - FACILITIES DEVELOPMENT

Reference: Facility Condition Assessment Report for Fontaine Avenue Fire Station, 2420 Fontaine Avenue, Charlottesville, Virginia

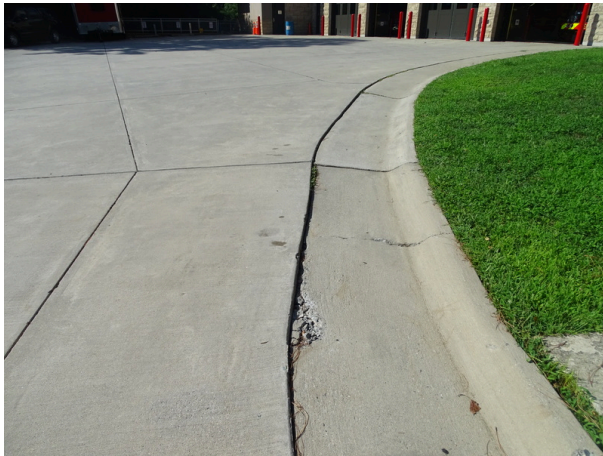
Concrete pavement - note cracked and deterioration

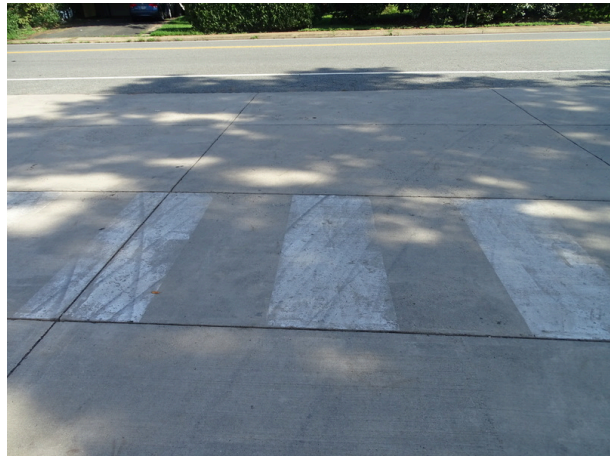
PARKING		
Item	Description	Condition
Striping	Fading observed at on-grade crosswalks	Fair

Striping condition

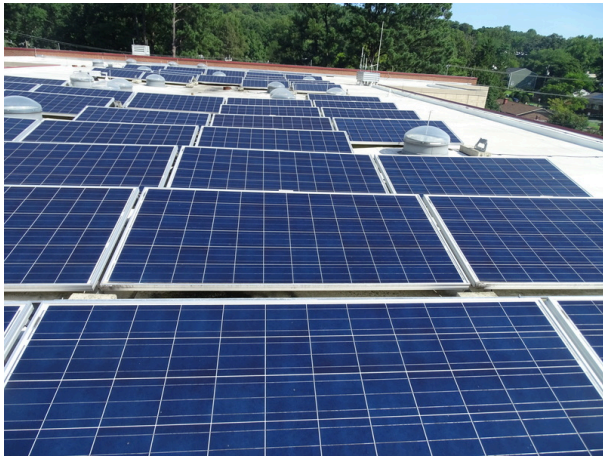
Typical solar PV system overview

The Property contains solar panels on the roof. The expect life of solar panels is 20 years. We recommend replacing the solar panels near the end of the report period..

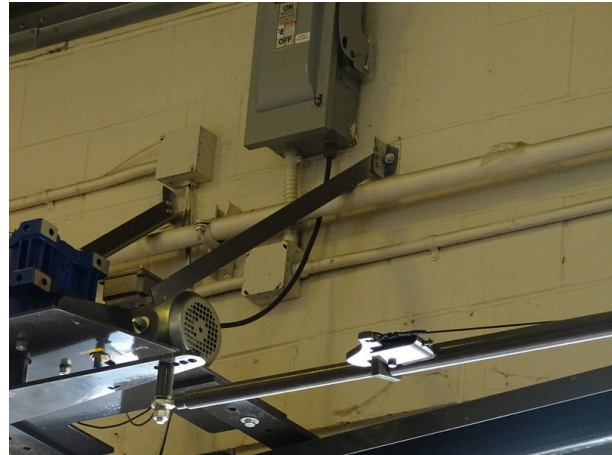
Folding bay doors are located on the east and west sides of the building. The bay doors were reportedly having problems with bracing and generally in good to fair condition. We recommend repairing the overhead door bracing as needed.

Overhead doors with reported problems with bracing

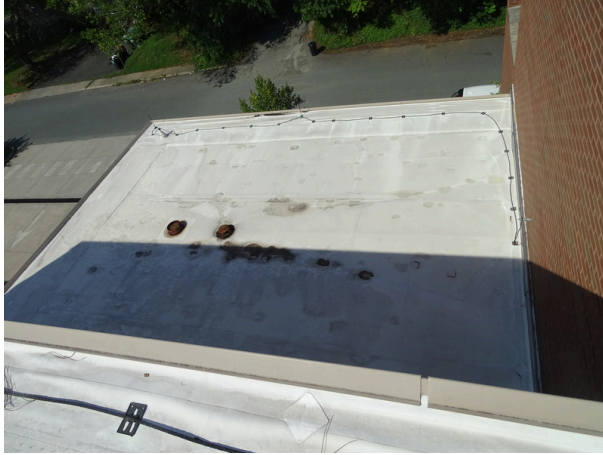
The roofing system consists of a Single-ply sheet membrane roofing system. The roofing was in generally good to fair condition with some patching and ponding noted. Reported leakage was noted during our site visit with repairs made as needed. The roofing system age is 8 years in age from original construction. The expected useful life of a single-ply roofing system is 20 years with proper maintenance. We recommend an allowance for continued roofing repairs as needed until recommended replacement later in the report period.

Single ply roof - note deterioration

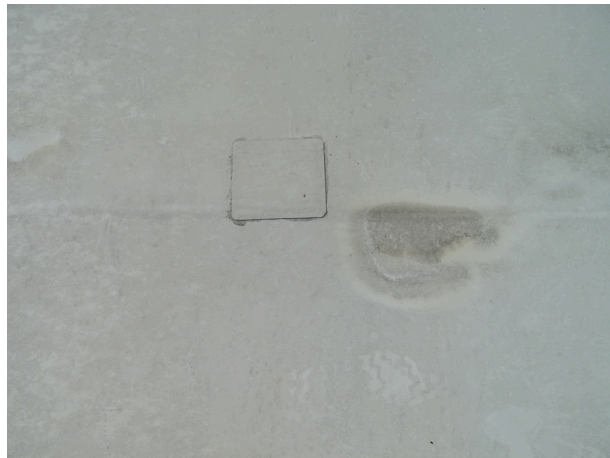
Previous repair

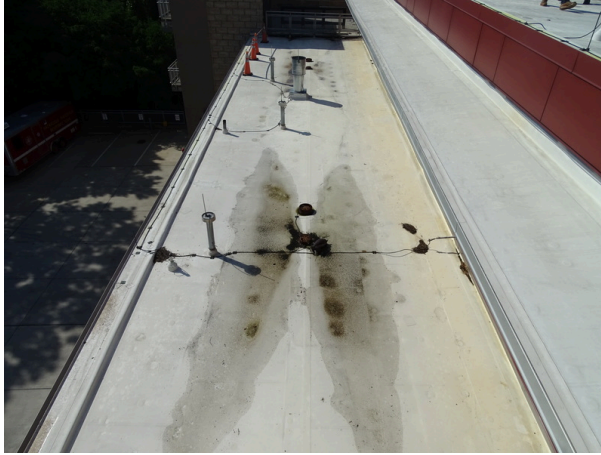
Water ponding on top of the roof

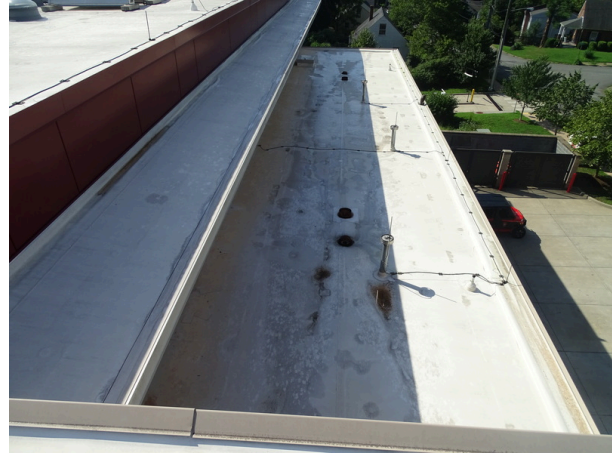
Deteriorated single Ply - roof

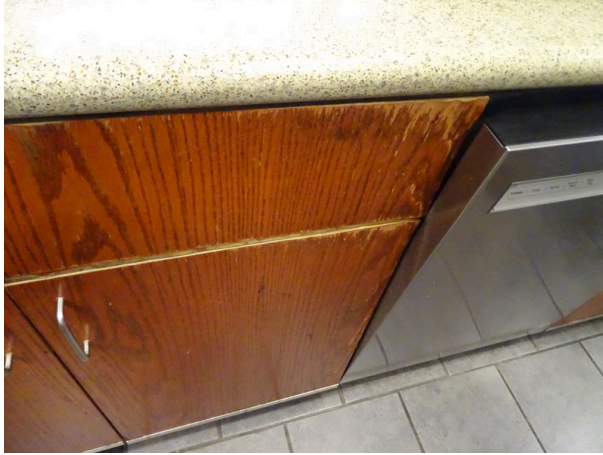
Based on the fair condition of the interior finishes at the kitchen, we recommend the kitchen interiors be renovated.

Deterioration of the kitchen cabinet

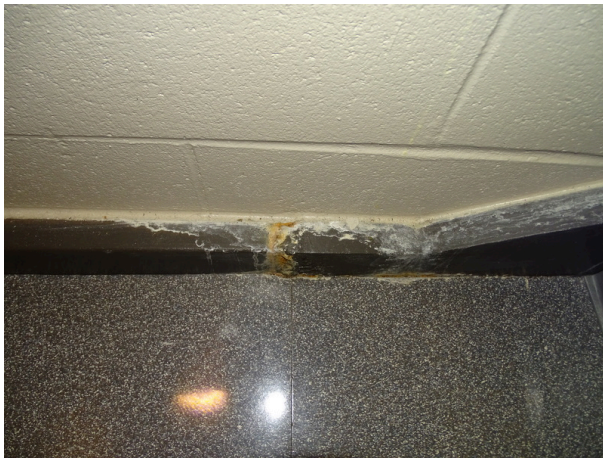
Water leakage at ceiling

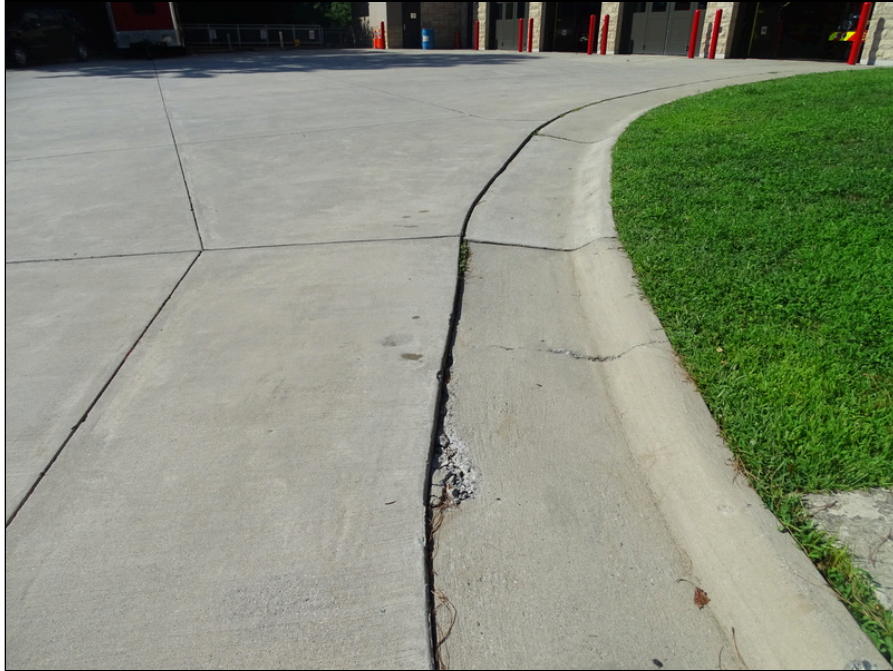
3 - Concrete pavement - note cracked and deterioration

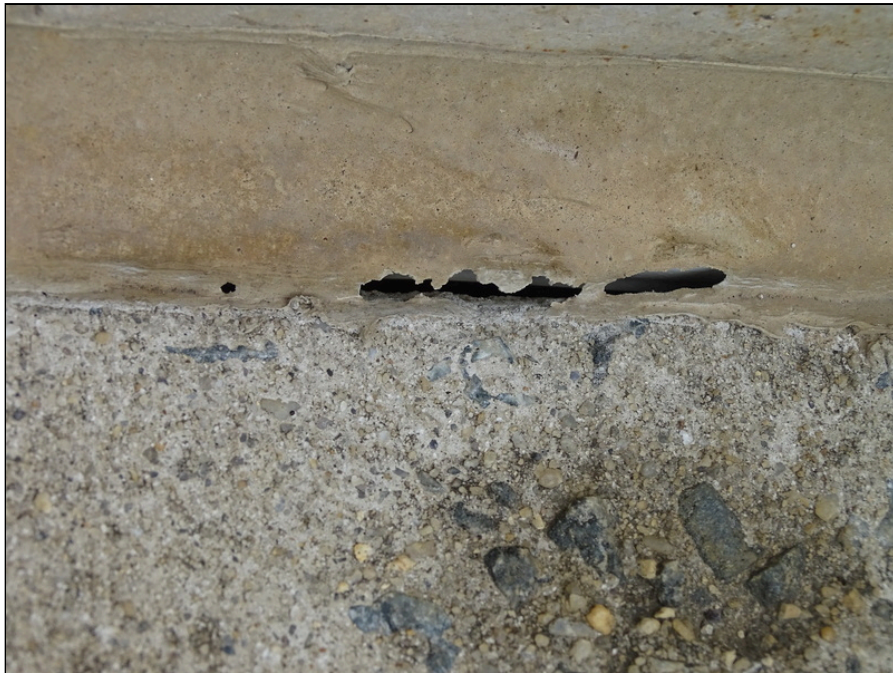
12 - Deterioration and damaged concrete

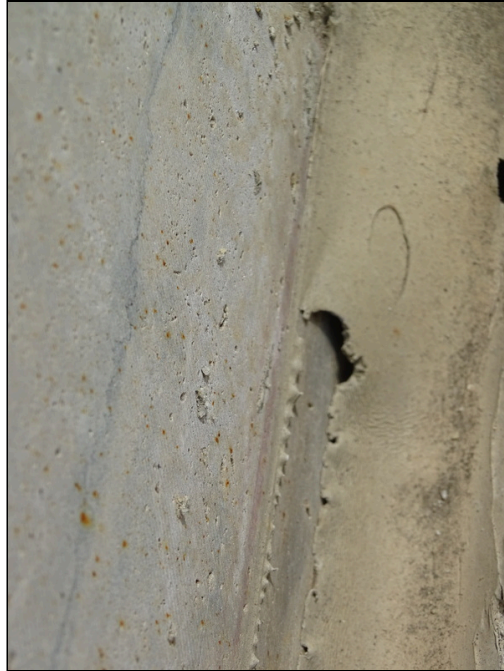
13 - Deterioration and damaged concrete

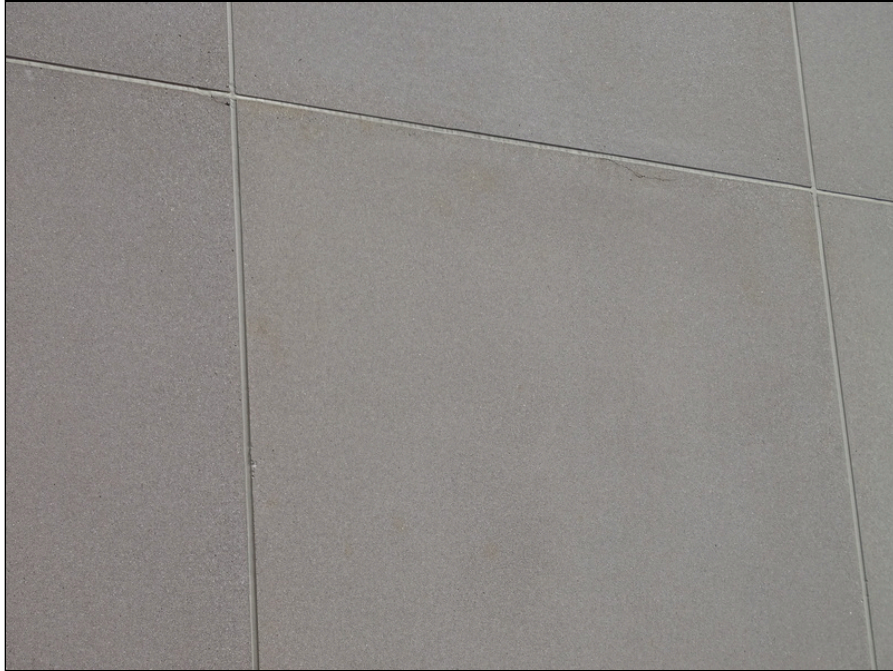
25 - Cracked in exterior wall

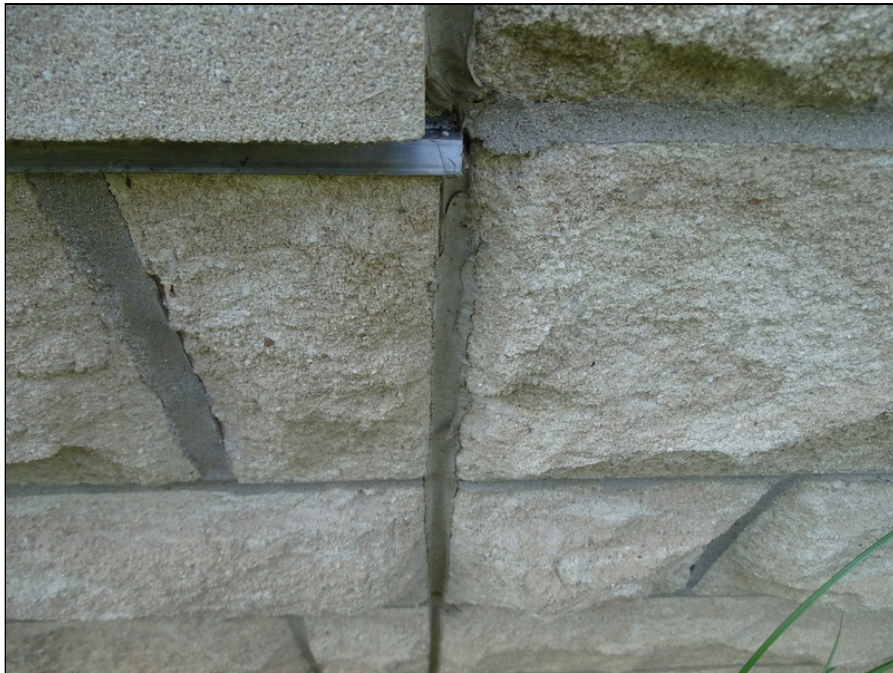
26 - Building exterior - note minor deterioration and damage to mortar

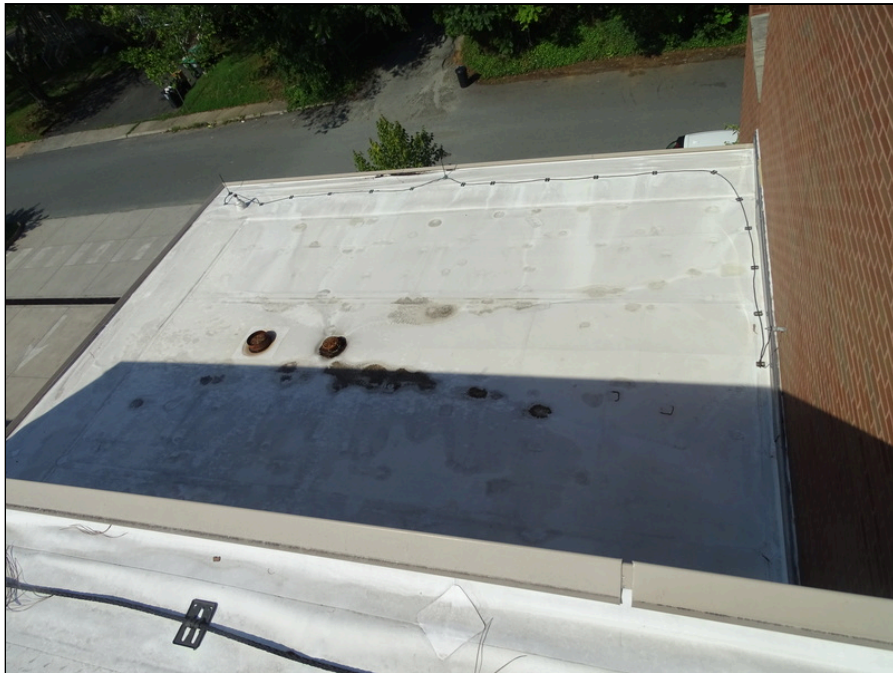
42 - Single ply roof - note deterioration

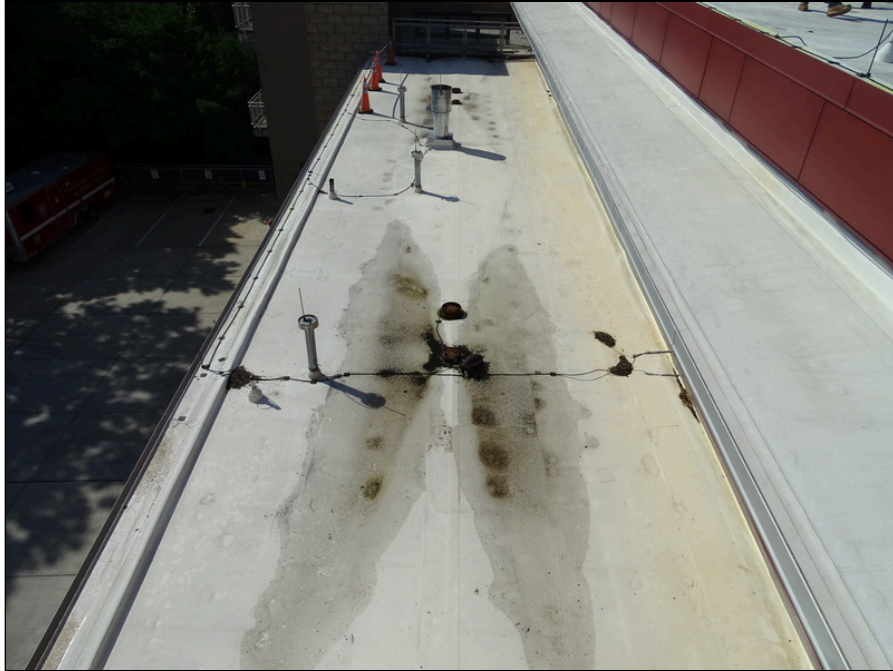
43 - Water ponding on top of the roof

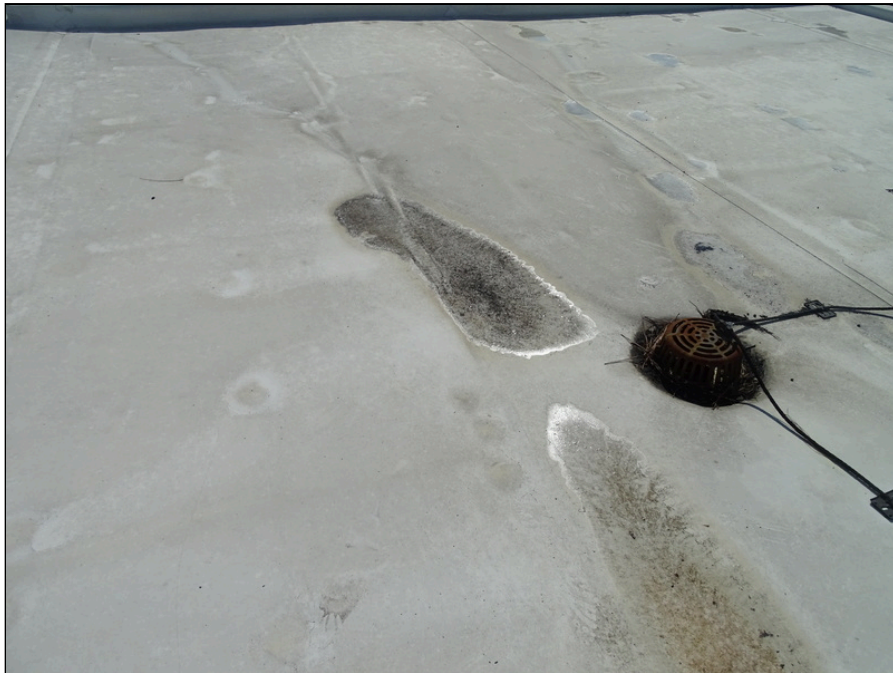
44 - Deteriorated internal drain

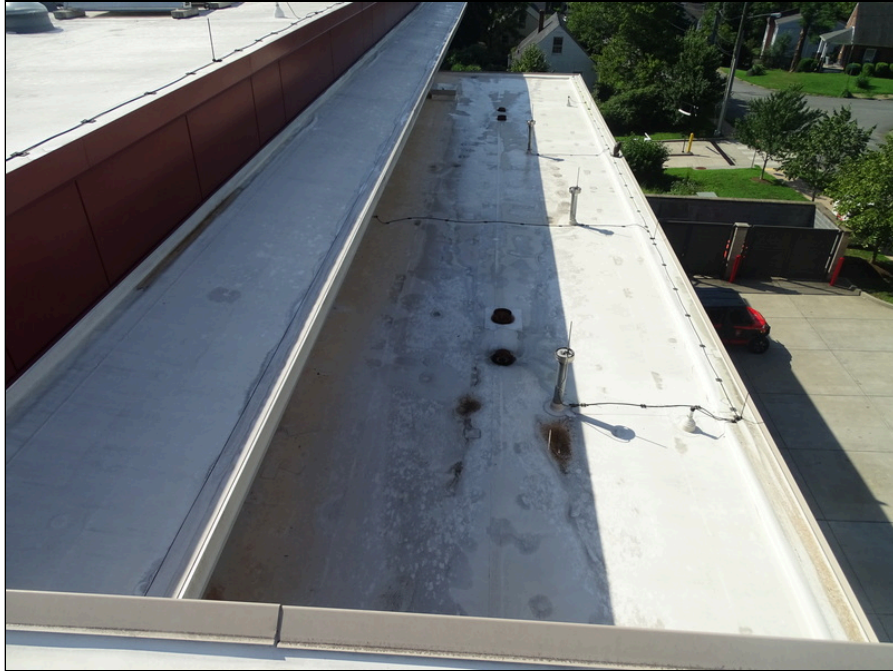
45 - Deteriorated single Ply - roof

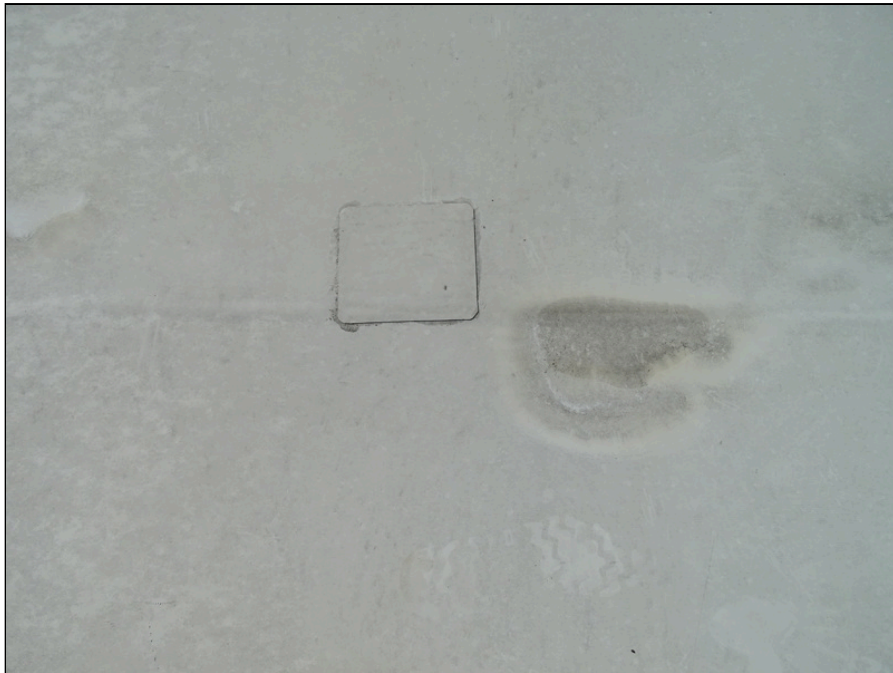
50 - Previous repair

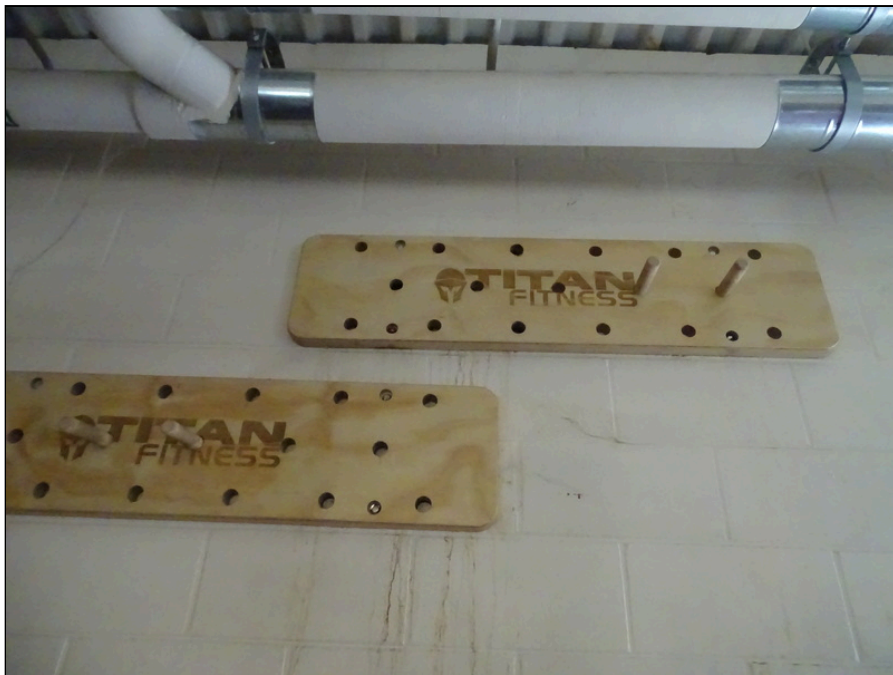
98 - Water leakage on wall

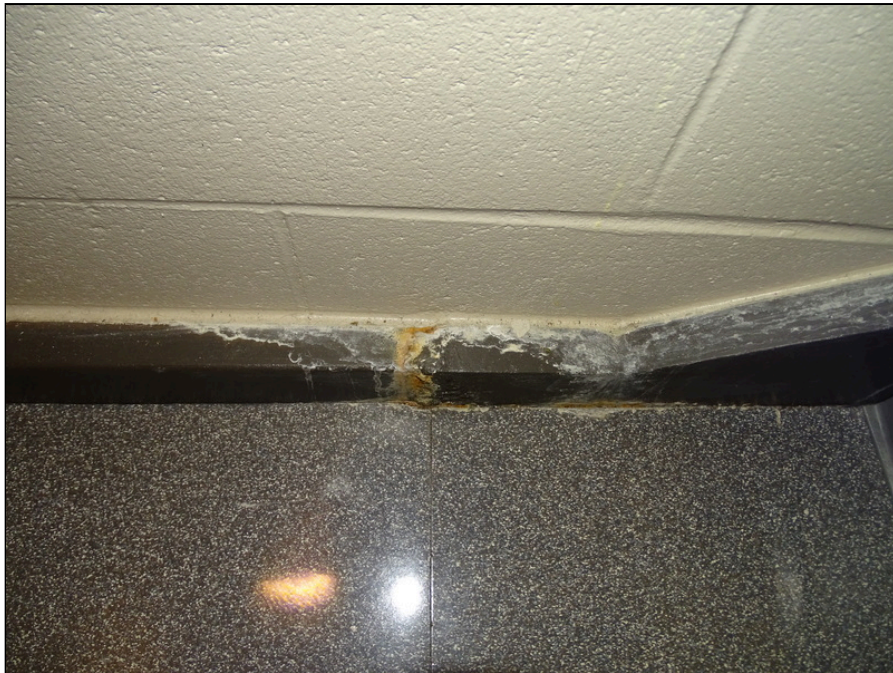
108 - Water leakage at ceiling

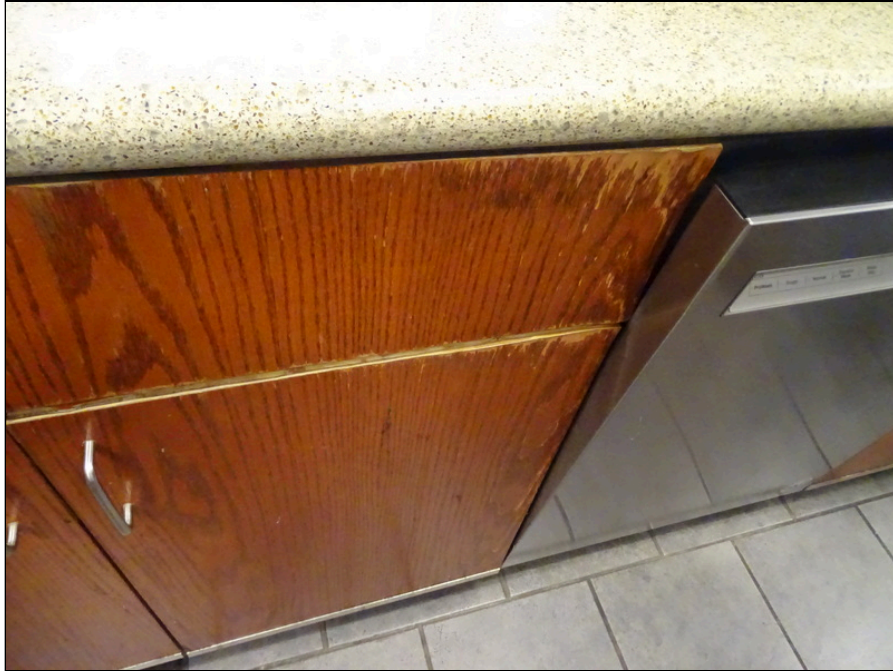
117 - Deterioration of the kitchen cabinet

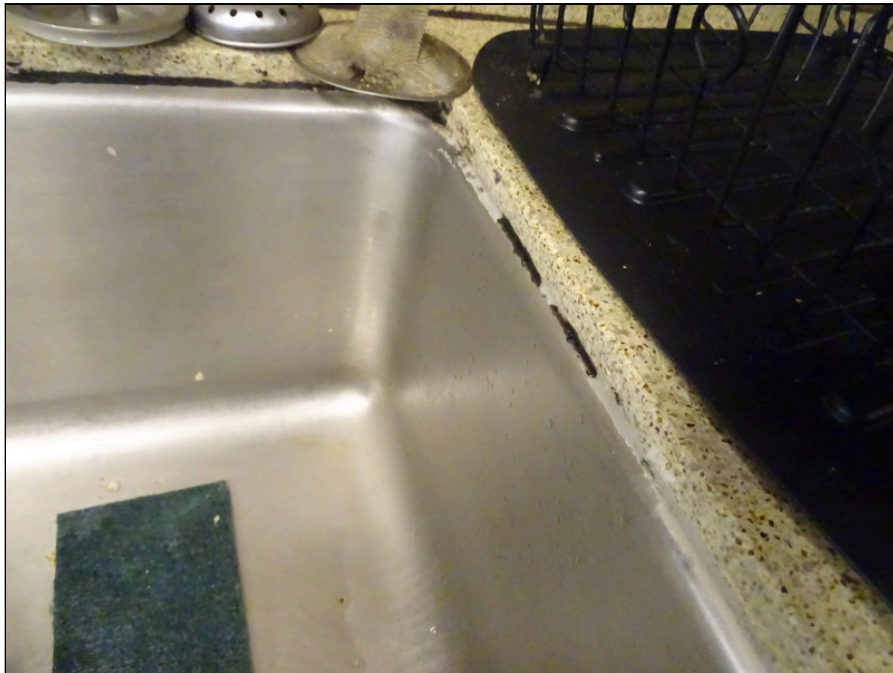
118 - Deterioration of the kitchen sink sealant

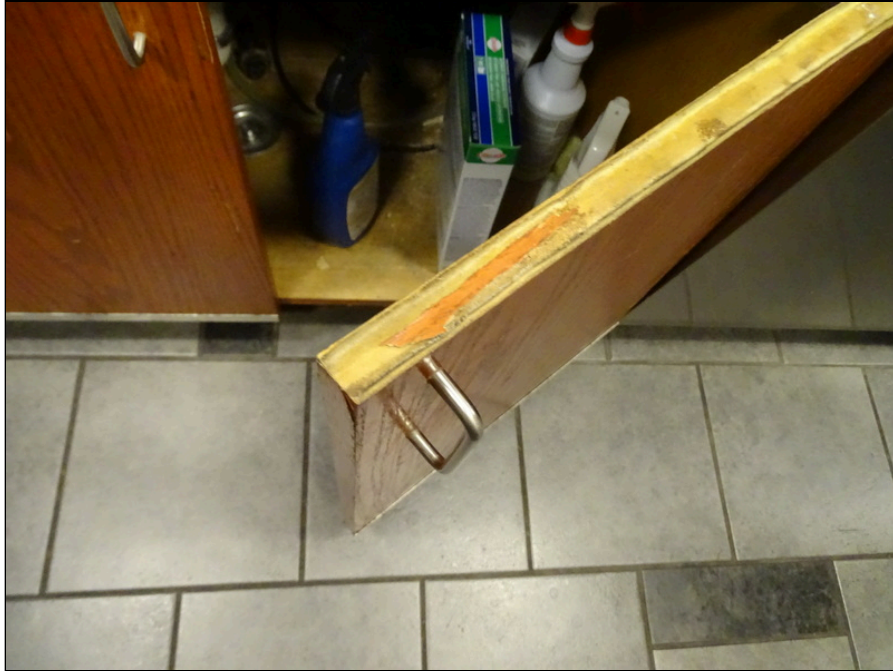
119 - Deterioration of the kitchen cabinet
