RIDGE STREET FIRE STATION & HOSE TOWER  
203 RIDGE STREET  
CHARLOTTESVILLE, VIRGINIA

ECS PROJECT NO. 46:6713

SEPTEMBER 14, 2021

Reference: Facility Condition Assessment Report for Ridge Street Fire Station & Hose Tower, 203 Ridge Street, Charlottesville, Virginia

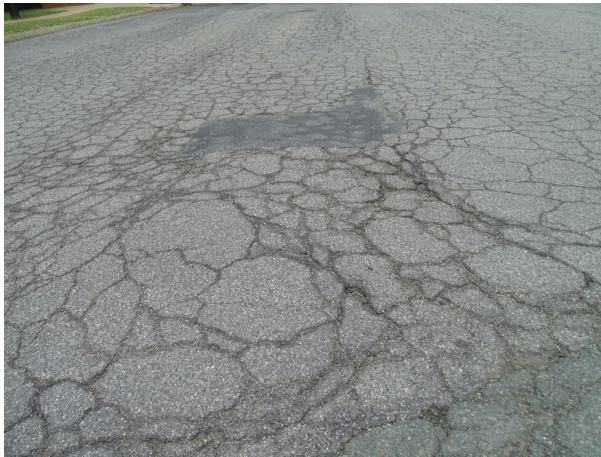
Asphalt-paved drive lanes and parking areas are located on the east, north and northwest, sides of the site. The asphalt pavement was observed to be in generally poor condition. We observed areas of block and alligator cracks in the drive lanes and parking spaces. The expected useful life of asphalt pavement is 20 years. We recommend repairing these areas of asphalt pavement and providing an allowance to overlay the asphalt pavement. Based on the information available, the asphalt pavements were not repaired as previously recommended.

Asphalt paving drive lane and parking northwest side of the building - note alligator cracking

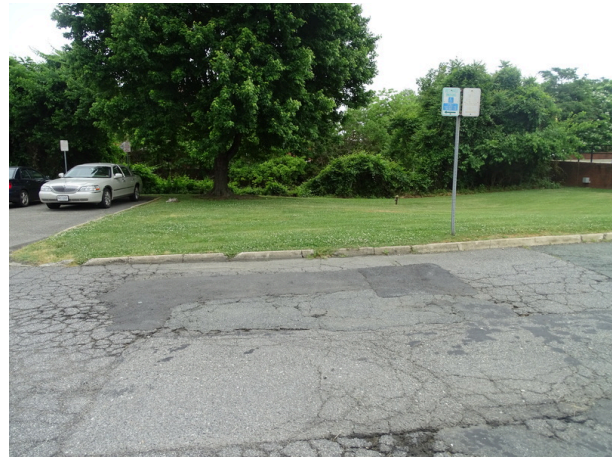
Asphalt paving drive lane and parking northwest side of the building - note alligator cracking

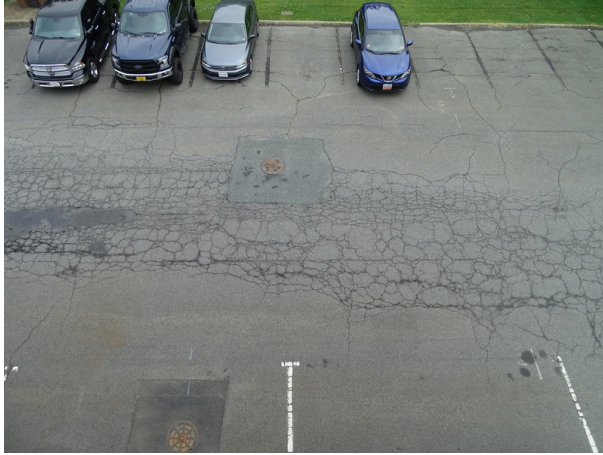
Asphalt paving drive lane and parking northwest side of the building - note alligator cracking

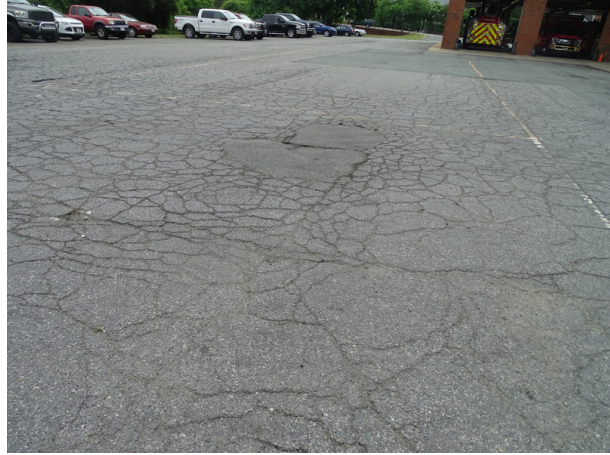
Asphalt paving drive lane and parking northwest side of the building - note alligator cracking

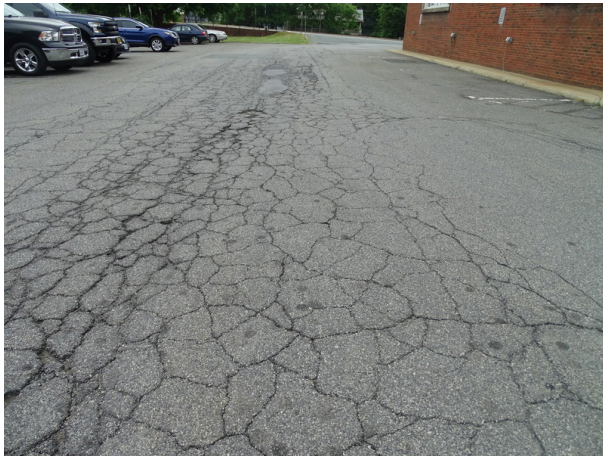
Asphalt paving drive lane and parking northwest side of the building - note alligator cracking

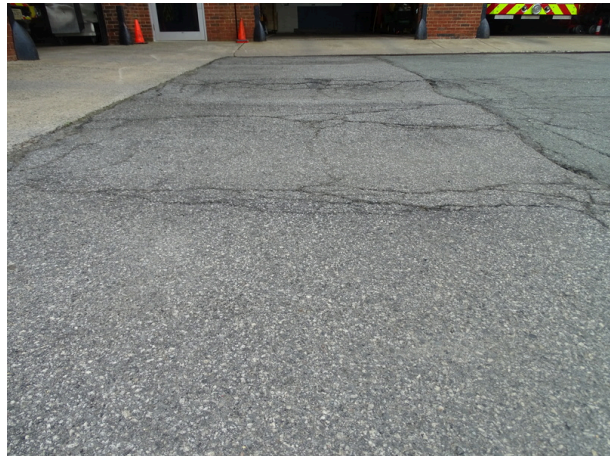
Asphalt paving drive lane and parking northwest side of the building - note alligator cracking

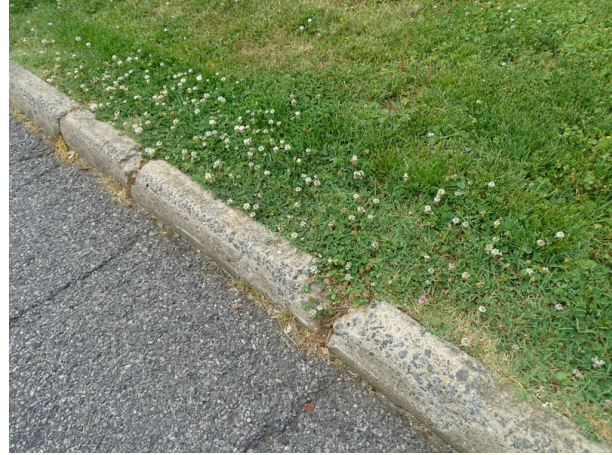
Concrete curb - note deterioration

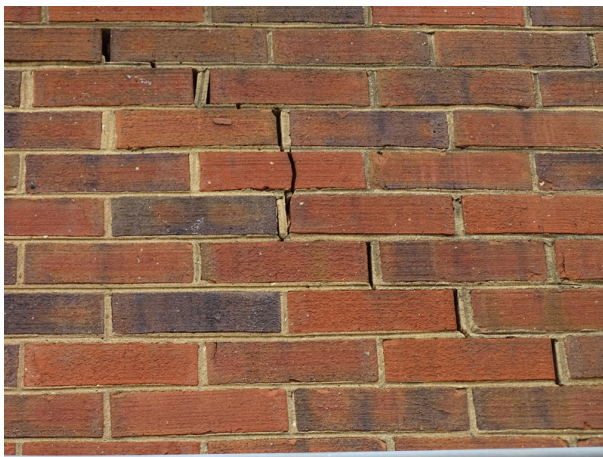
Building exterior -note crack in brick work.

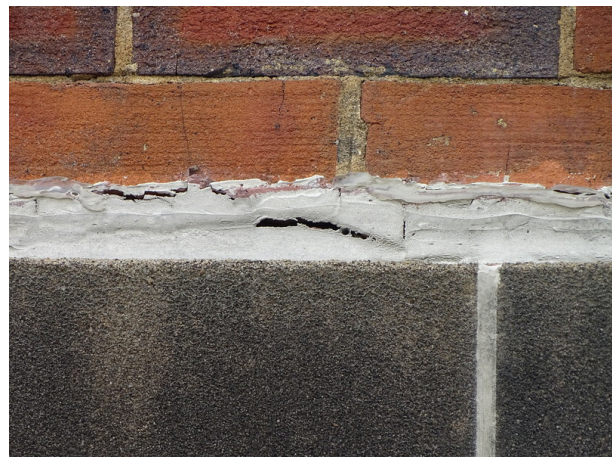
Exterior sealants are located around the window and door frames, horizontal joints, and vertical joints in the Brick veneer. The expected useful life of exterior sealants is approximately 10 to 12 years before replacement is needed. The exterior sealants were generally in fair condition. We recommend that the exterior sealants be replaced during the report period.

Typical sealant condition

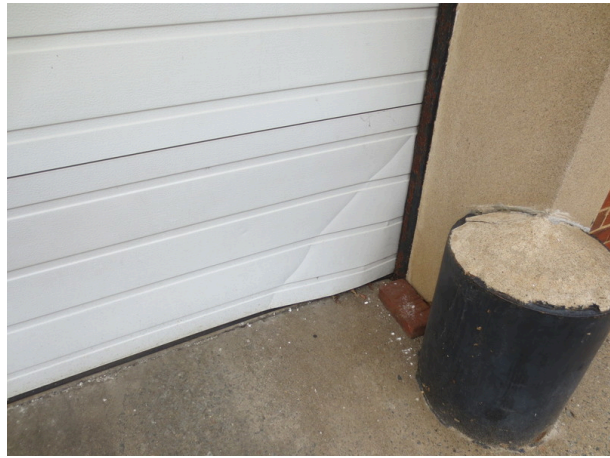
Overhead doors are located at north side of the west bay area and the east and west sides of the east bay area. The overhead doors on the north and west sides were generally in good condition. The three overhead doors on the east side of the building were damaged and in need of replacement.

Overhead door damage - east

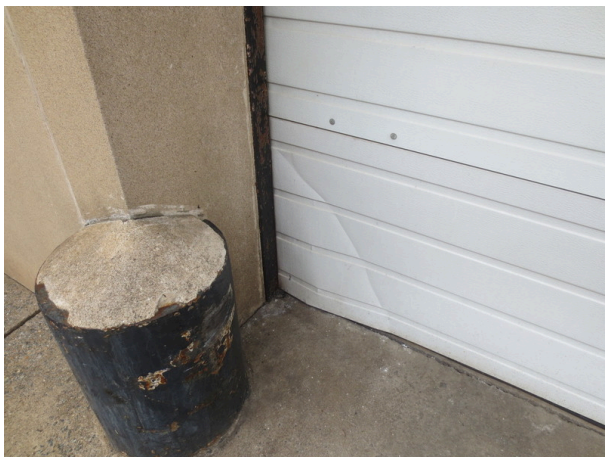
Overhead door damage east

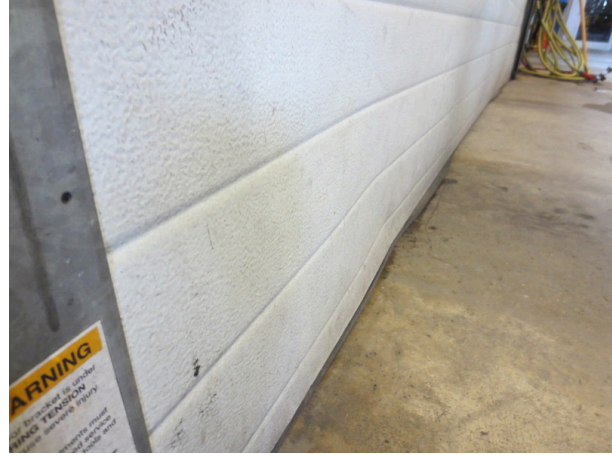
Overhead door damage east

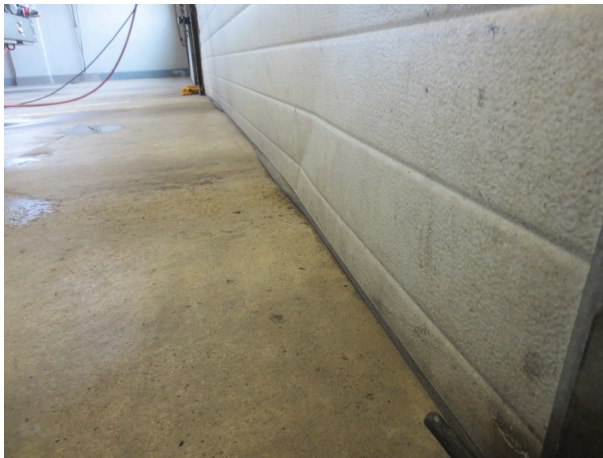
Overhead door damage east

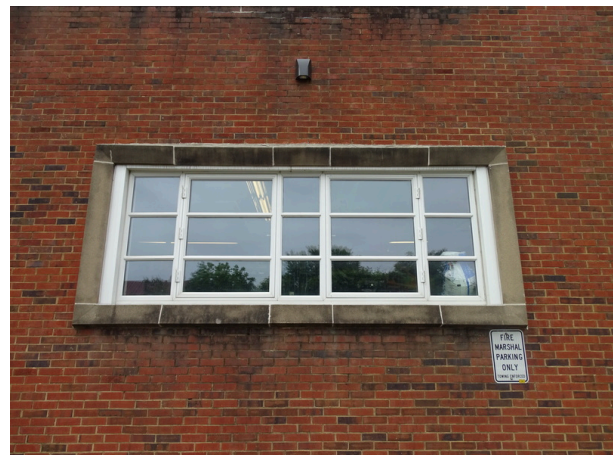
Typical window - note water staining

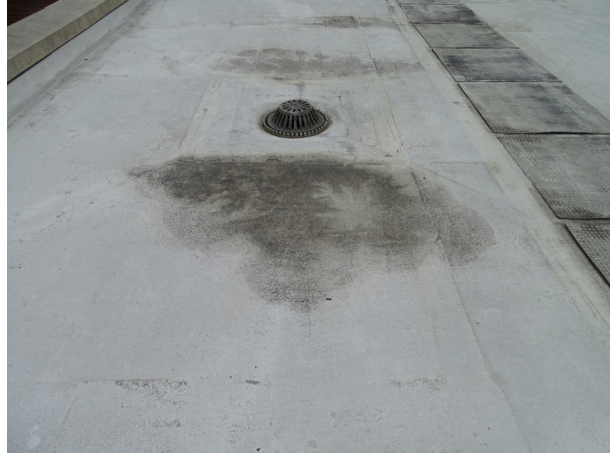
Single-ply membrane roofing main building area  
- note areas of ponding and deterioration

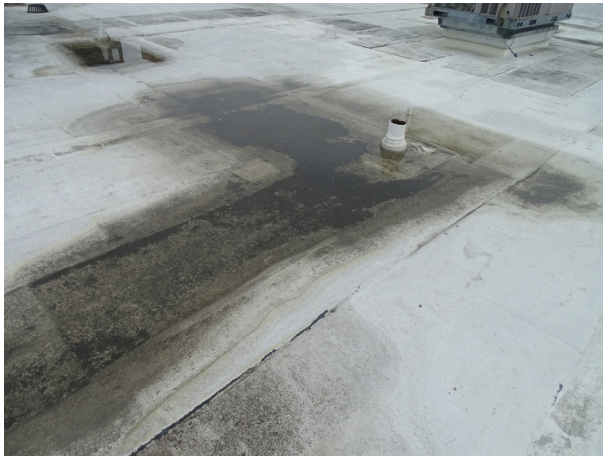
Single-ply membrane roofing main building area  
- note areas of ponding and deterioration

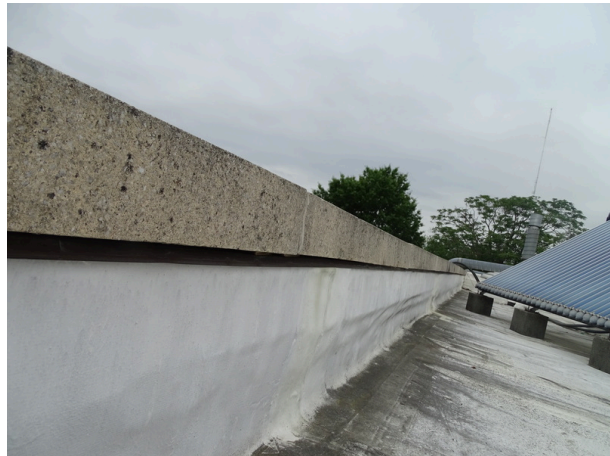
Typical parapet wall - note area of roofing  
system patching

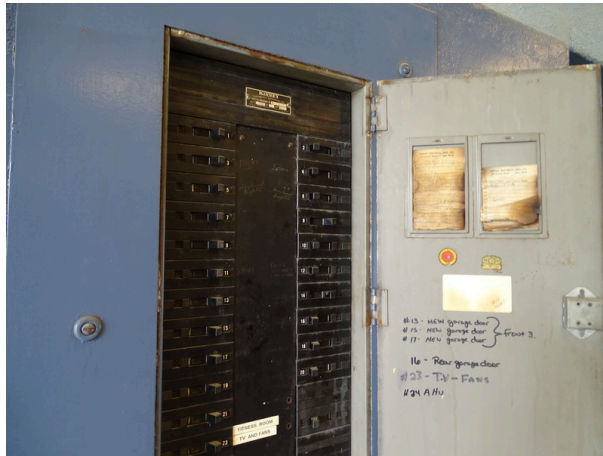
Power is distributed by copper wire from circuit breaker panels located throughout the building. The circuit breaker panels were observed to be in generally good condition, however, the replacement parts are reportedly no longer available. We recommend replacing the panels.

Typical electrical sub panel

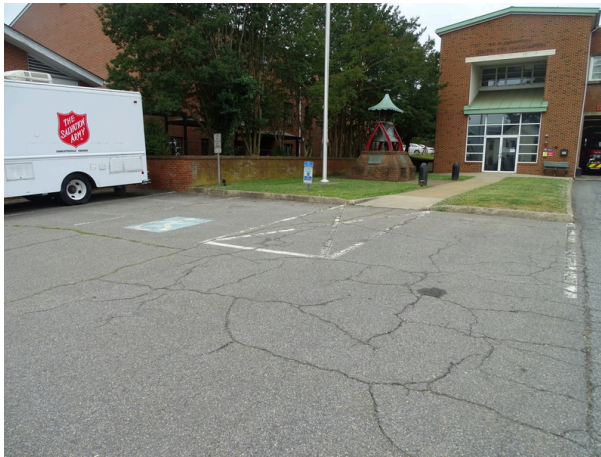
The parking area serving the property has a total of approximately 35 parking spaces. Of the parking spaces, One is accessible with One being van accessible. Accessibility requires that two accessible parking spaces be provided in parking areas with a total of 26 to 50 spaces. One in six of the accessible parking spaces are required to be van accessible. A minimum of a 60-inch wide access aisle is required to be provided for every two accessible parking spaces. Accessible aisles were observed to be provided for one space. The number of parking spaces provided does not meet accessibility requirements. We recommend installing one accessible space with accessible aisle as an immediate item.

Accessible parking space - note one space provided when two are required

Item	Quantity	Unit	Unit Cost	Replacement Percent	Immediate Total
<b>3.7 Accessibility (ADA) Compliance</b>					
PROVIDE ACCESSIBLE PARKING SPACE AND ACCESS AISLE	1	LS	\$500.00	100%	\$500
Total Repair Cost					\$500.00

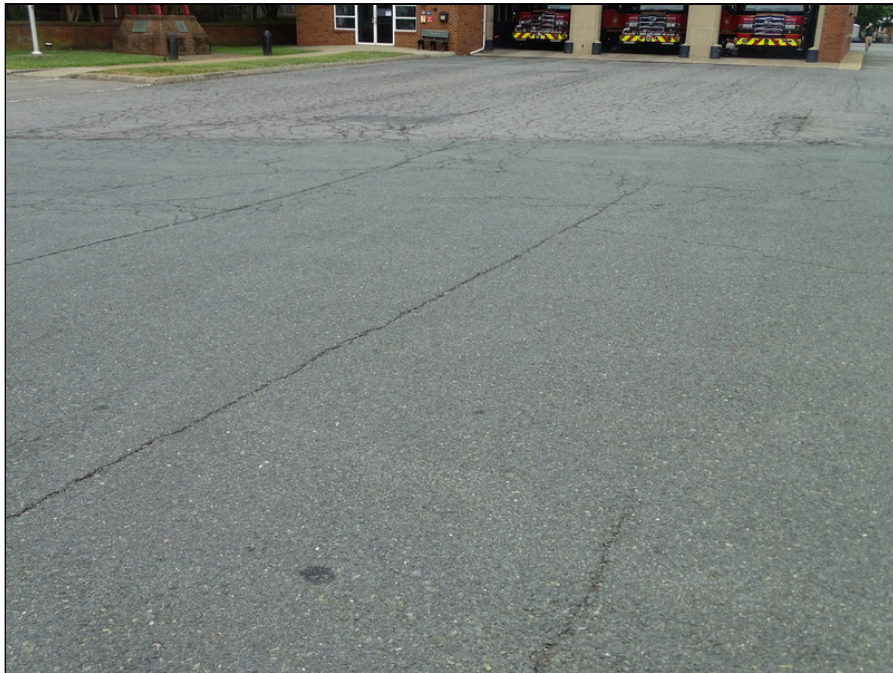
2 - Asphalt paving drive lane and parking northwest side of the building - note alligator cracking

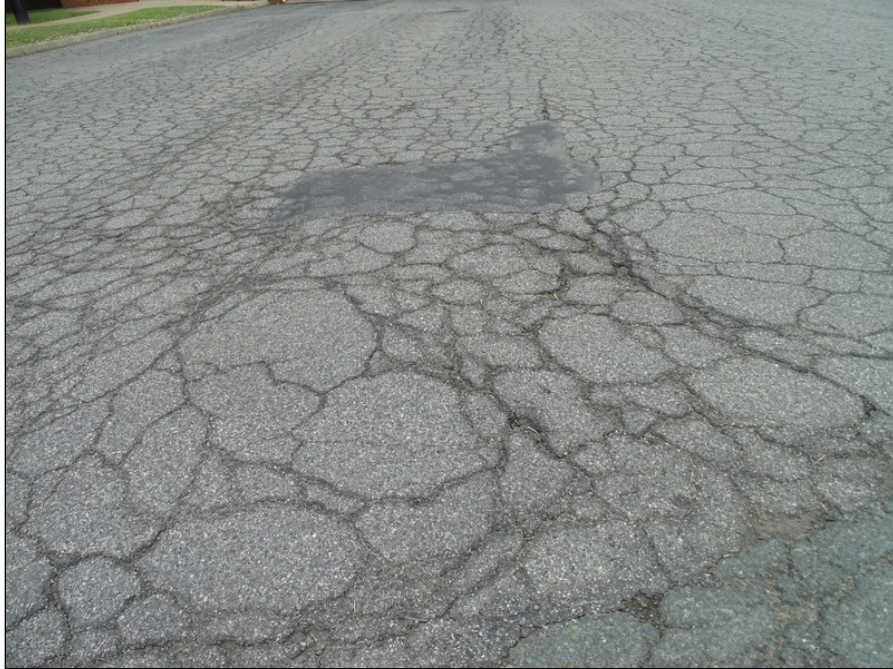
3 - Asphalt paving drive lane and parking northwest side of the building - note alligator cracking

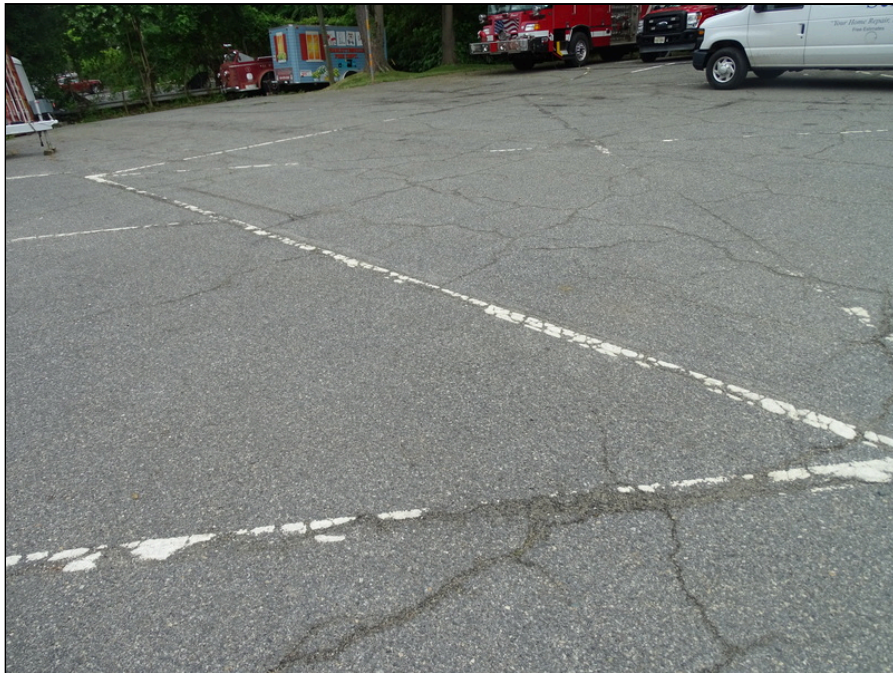
4 - Asphalt paving drive lane and parking northwest area of the site - note alligator cracking

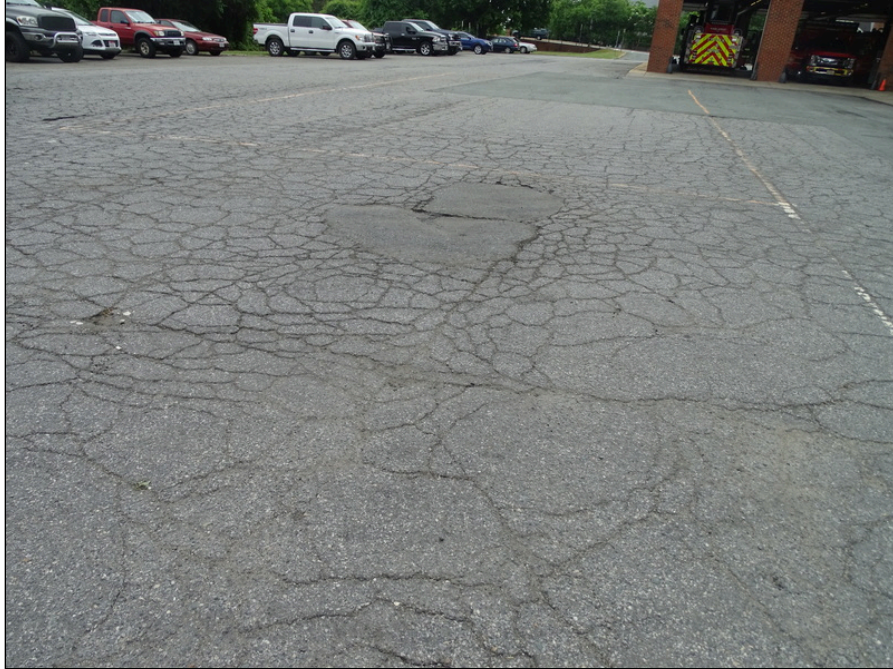
5 - Asphalt paving drive lane and parking northwest side of the building - note alligator cracking

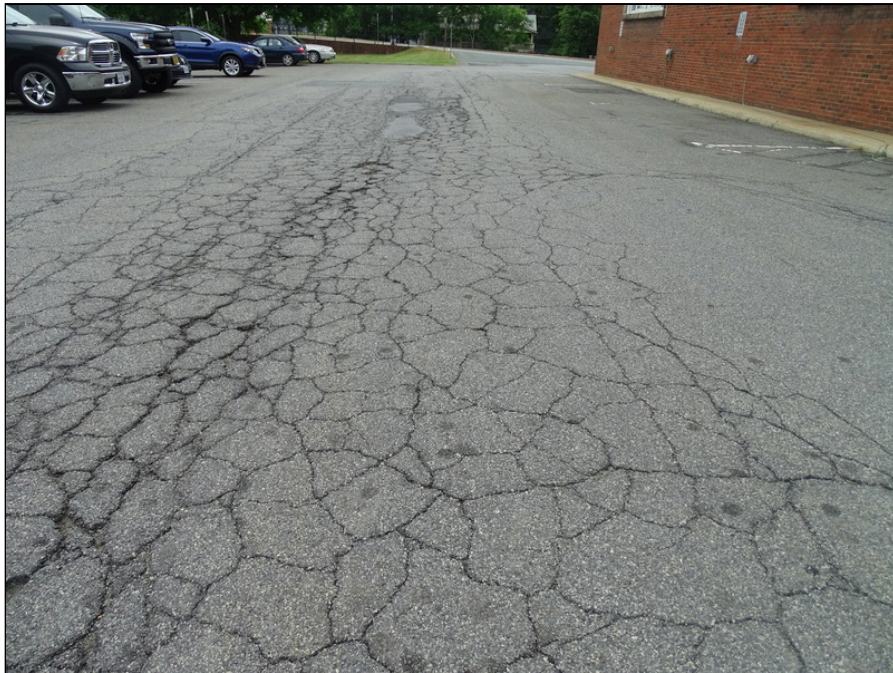
6 - Asphalt paving drive lane and parking northwest side of the building - note alligator cracking

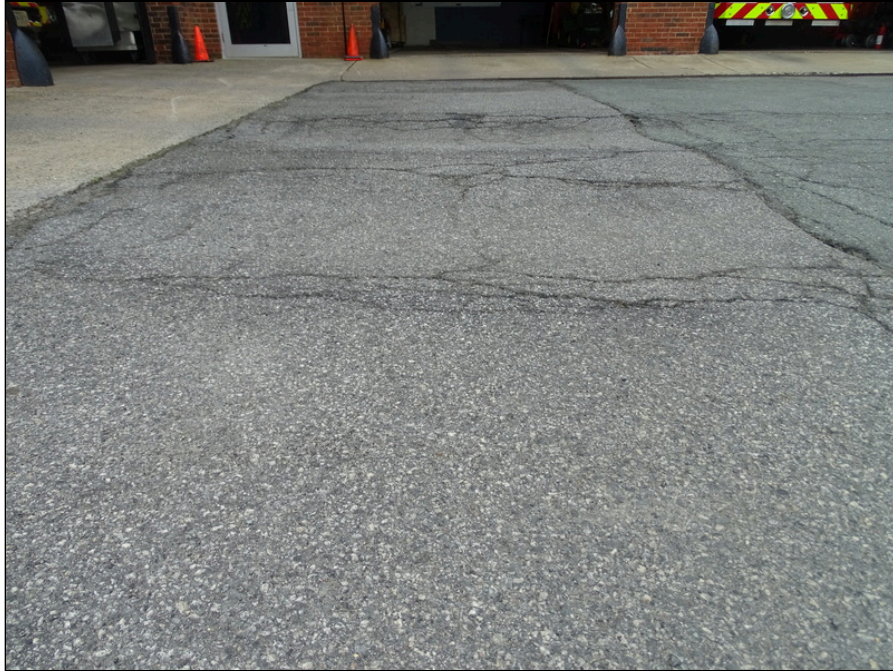
7 - Asphalt paving drive lane and parking northwest side of the building - note alligator cracking

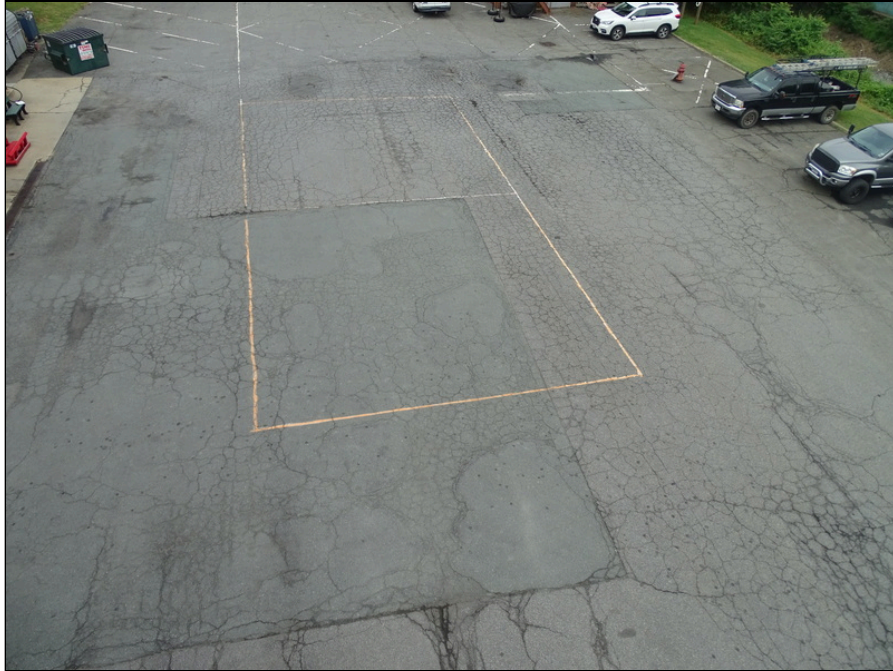
9 - Asphalt paving drive lane and parking northwest area of the site - note alligator cracking

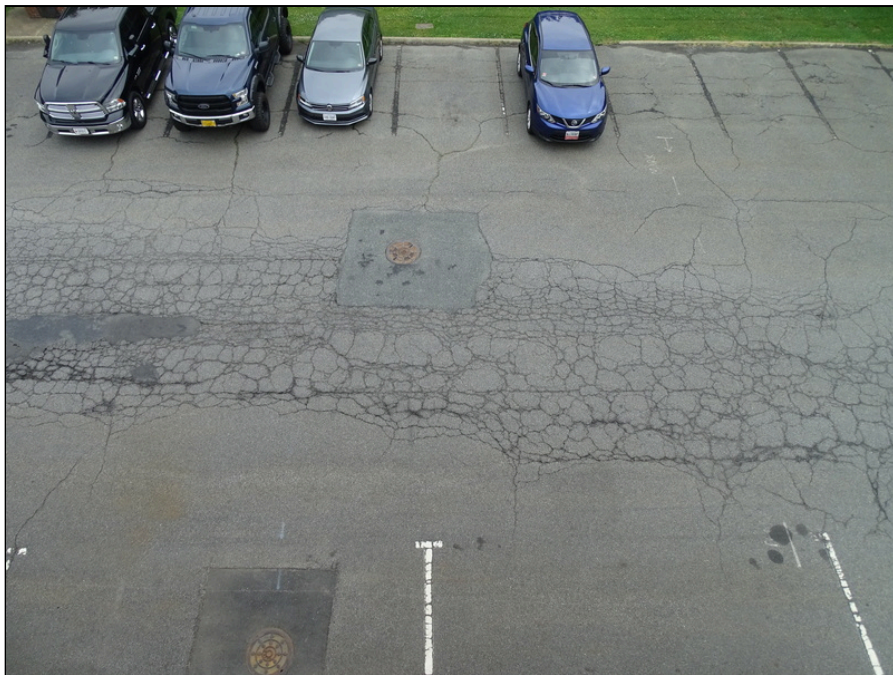
10 - Asphalt paving drive lane and parking northwest side of the building - note alligator cracking

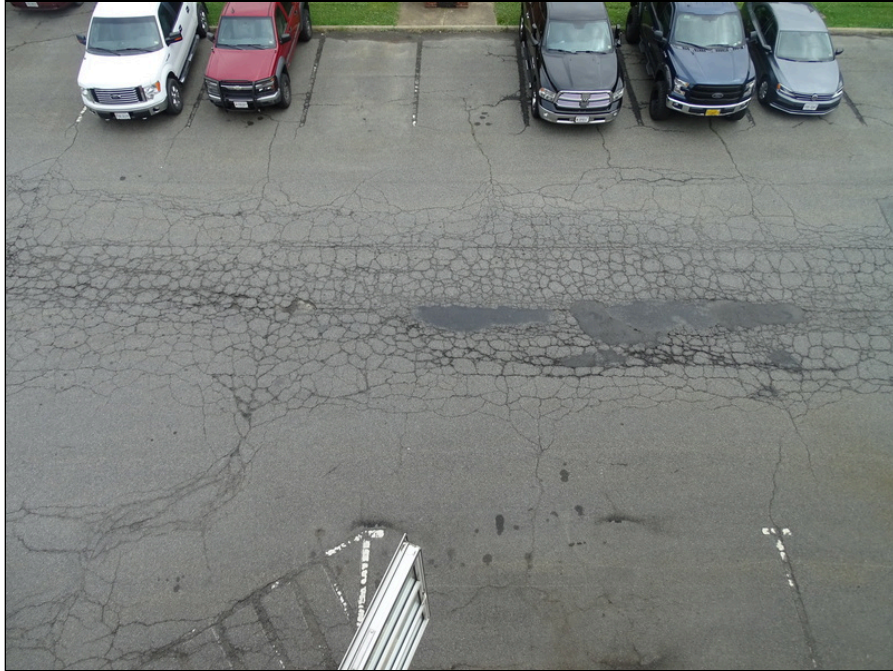
11 - Asphalt paving drive lane and parking northwest side of the building - note alligator cracking

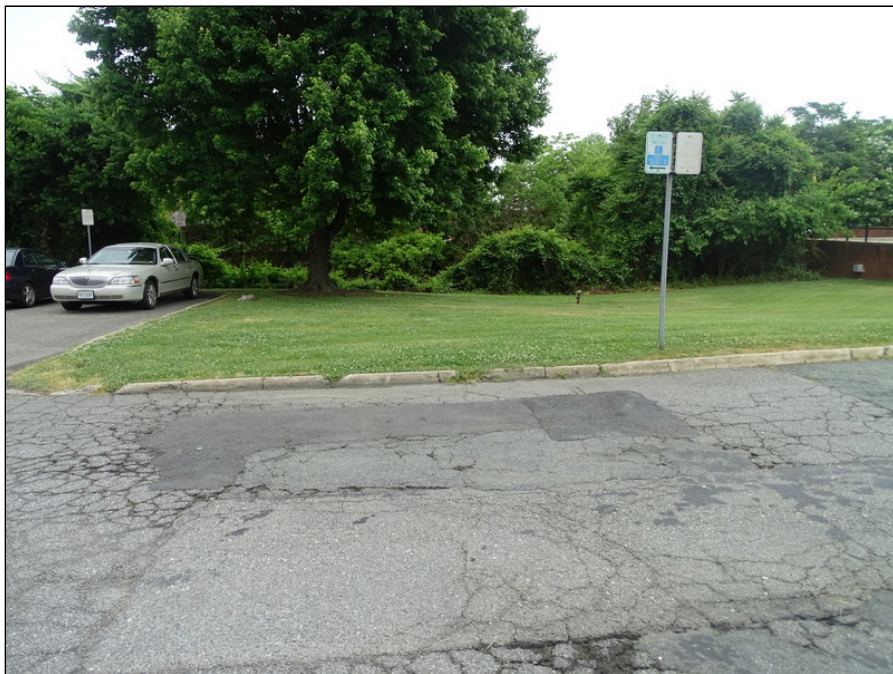
12 - Asphalt paving drive lane and parking northwest side of the building - note alligator cracking

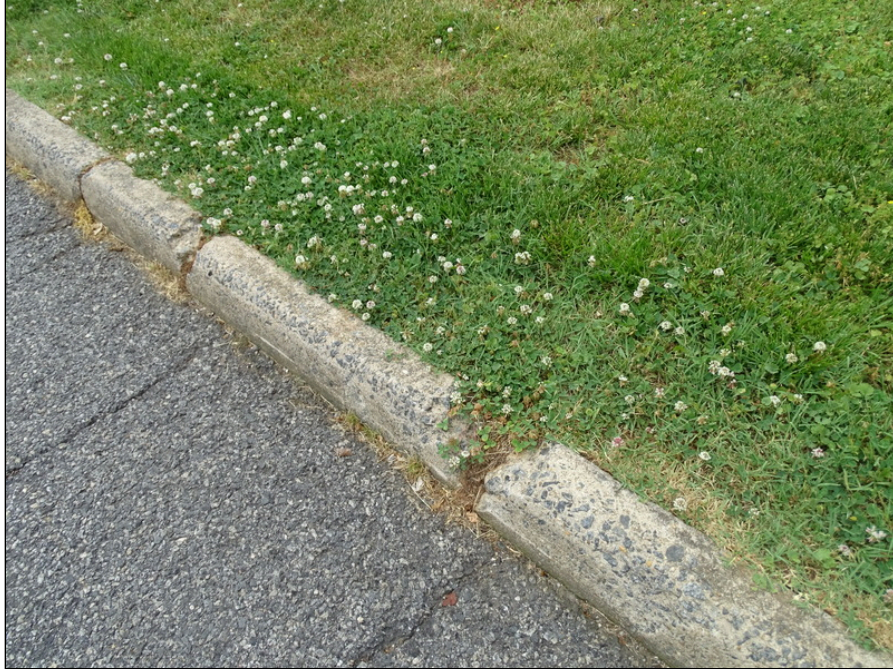
13 - Concrete curb - note deterioration

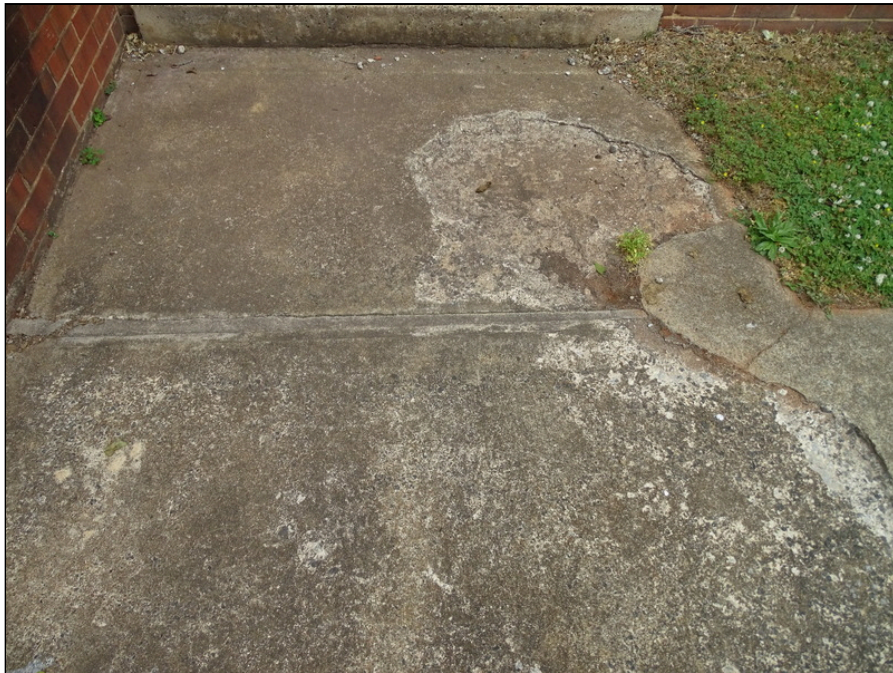
14 - Concrete sidewalk south side - note deterioration

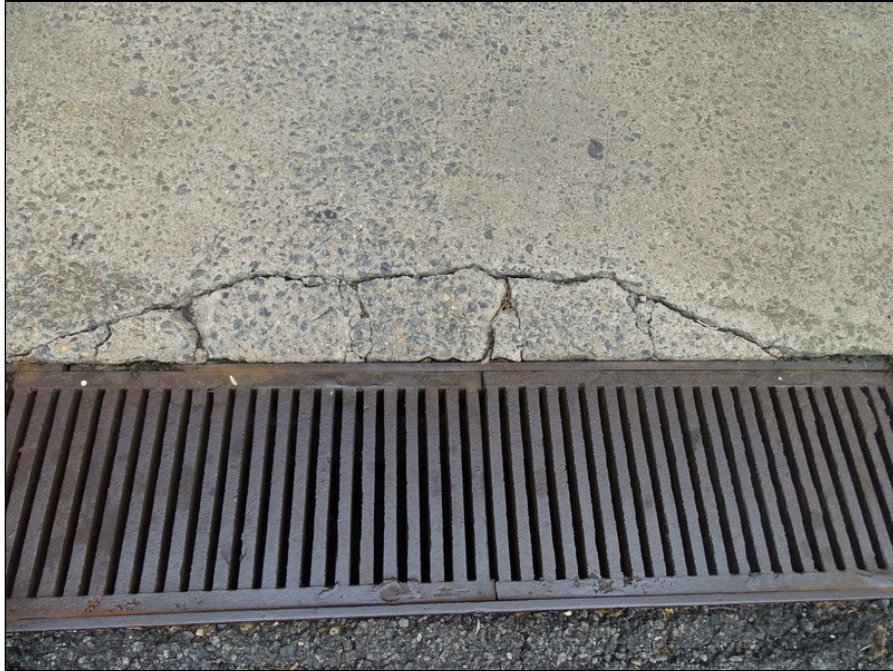
19 - Concrete crack along the drain

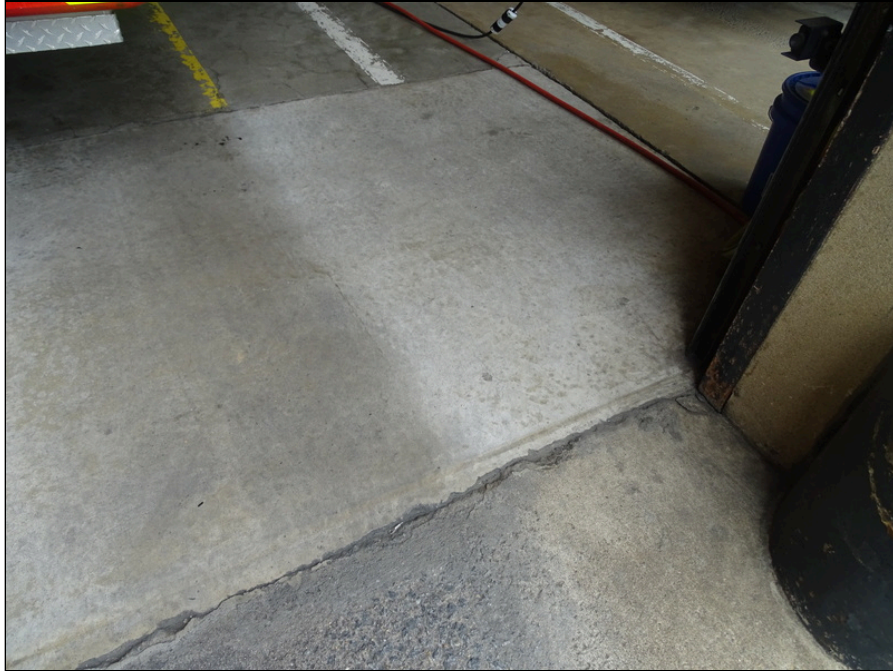
21 - Slab on grade at east bay area - note cracking and settlement

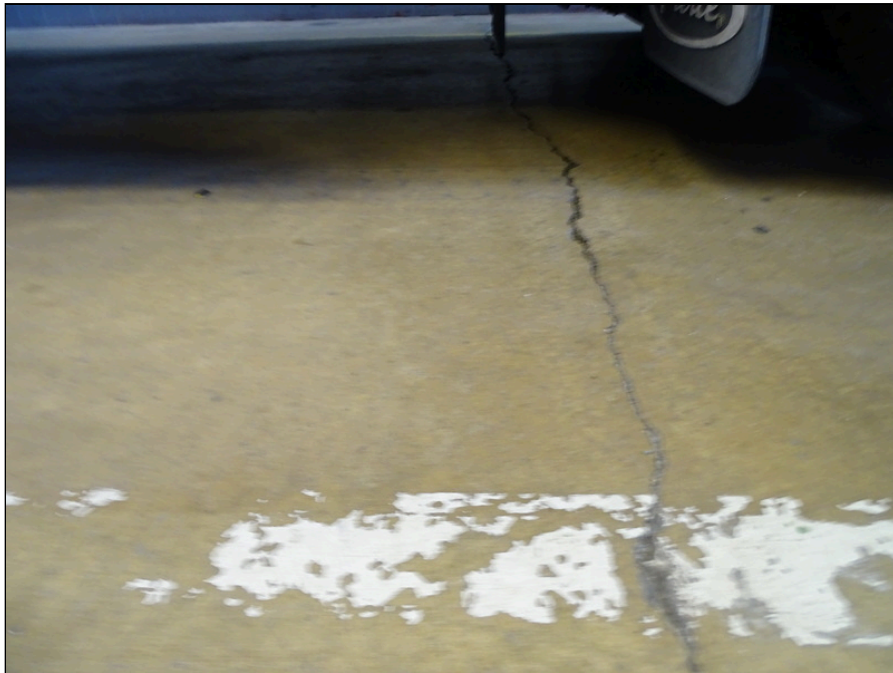
22 - Slab on grade at east bay area - note cracking and settlement

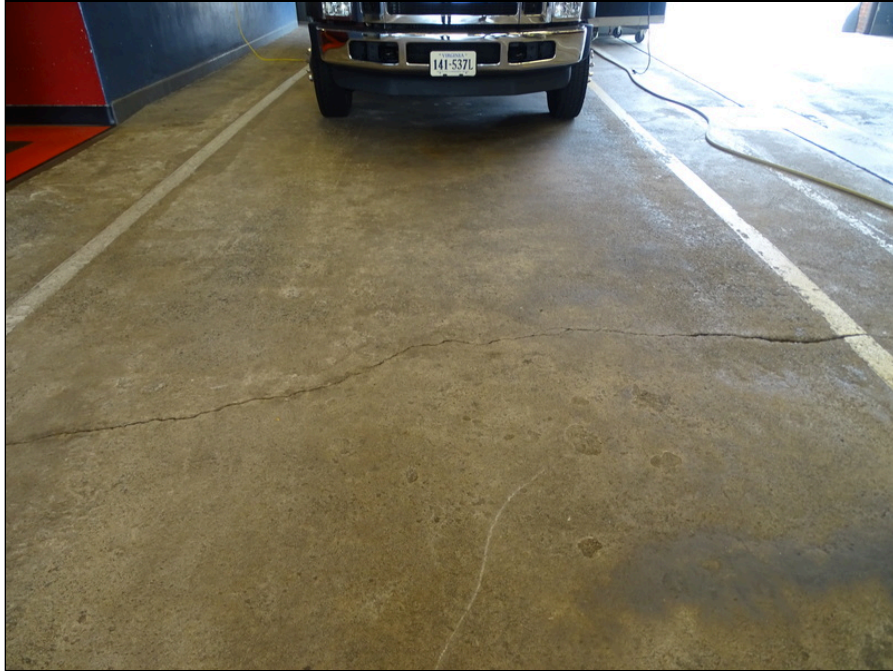
23 - Slab on grade at east bay area - note cracking and settlement

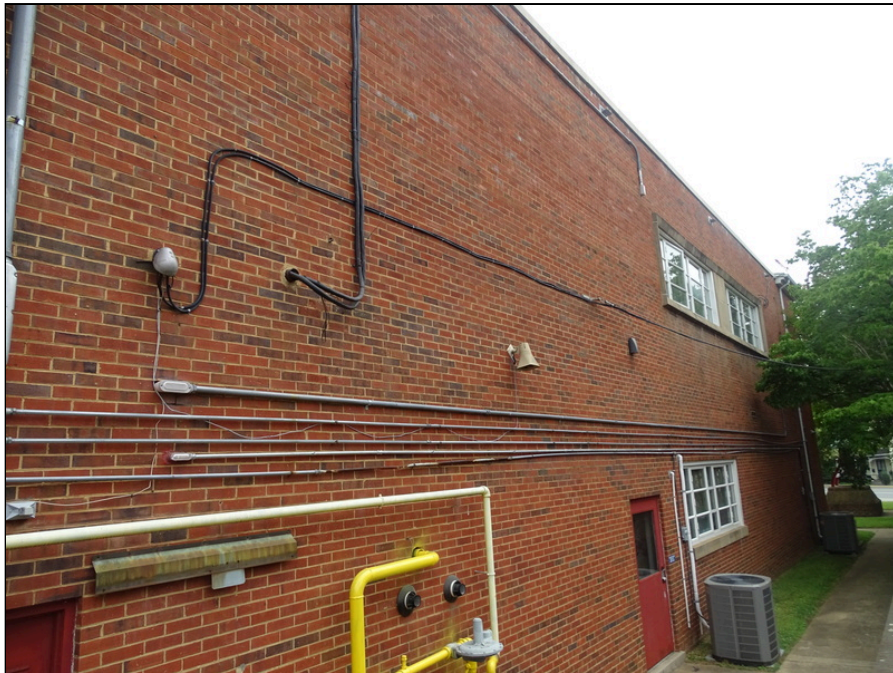
26 - Building exteriors - note deterioration

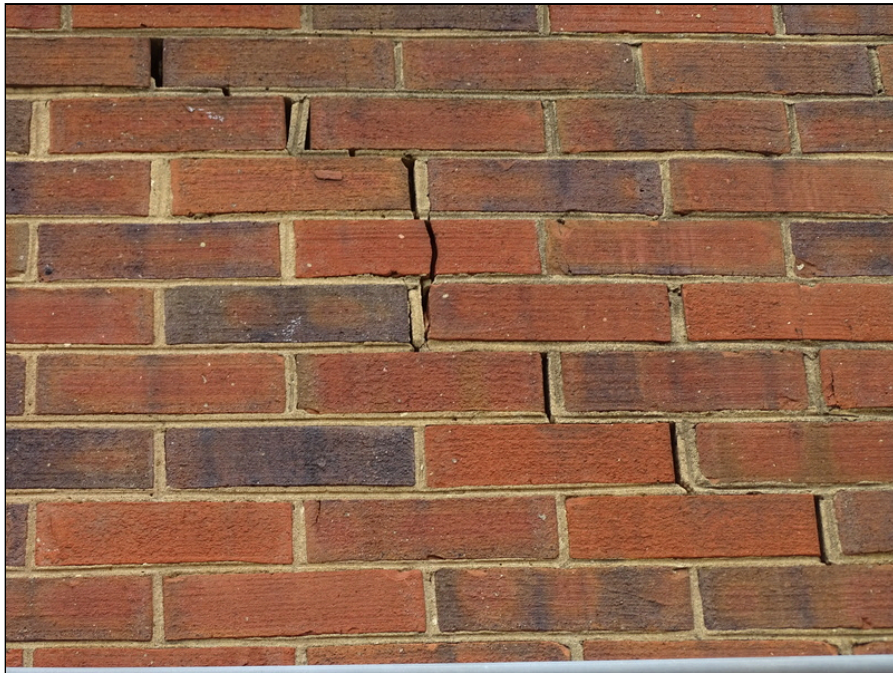
30 - Building exterior -note crack in brick work.

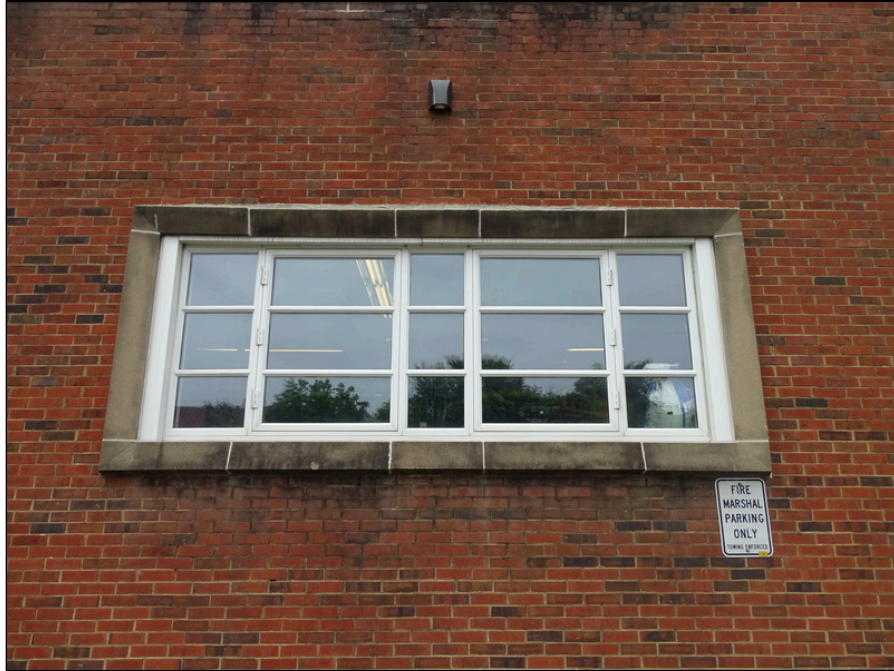
37 - Typical window - note water staining

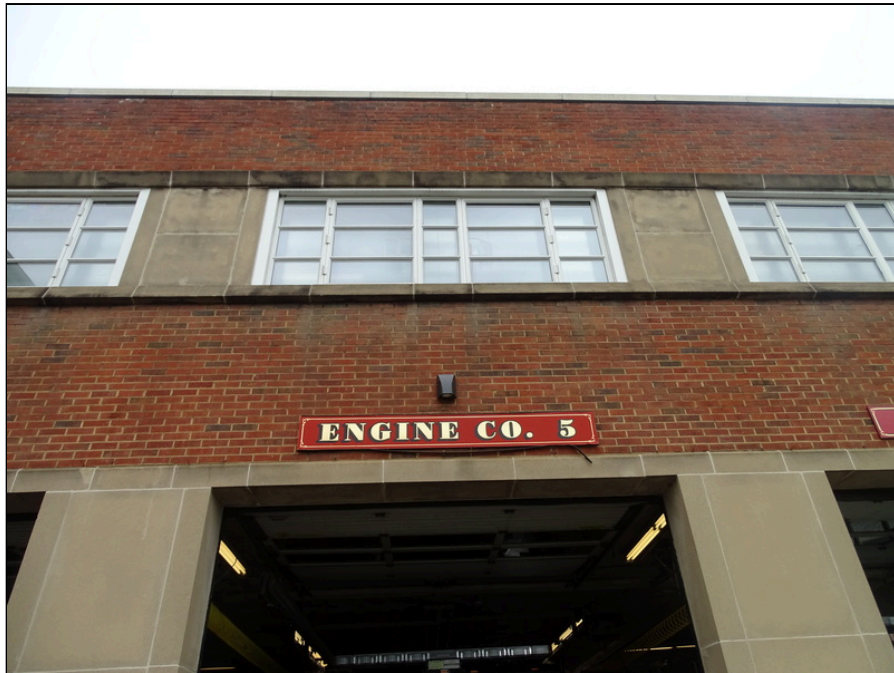
38 - Typical window - note water staining

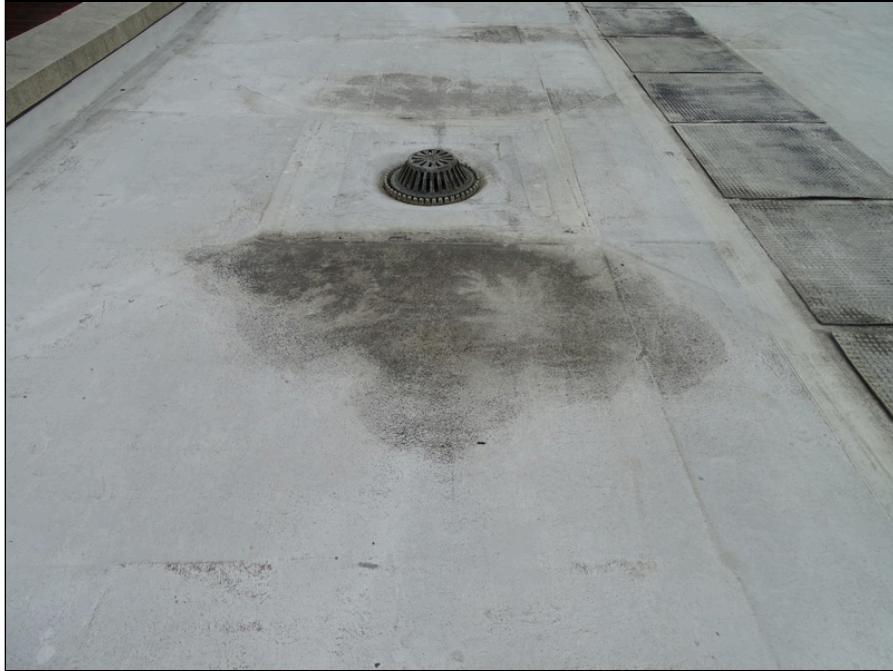
43 - Single-ply membrane roofing main building area - note areas of ponding and deterioration

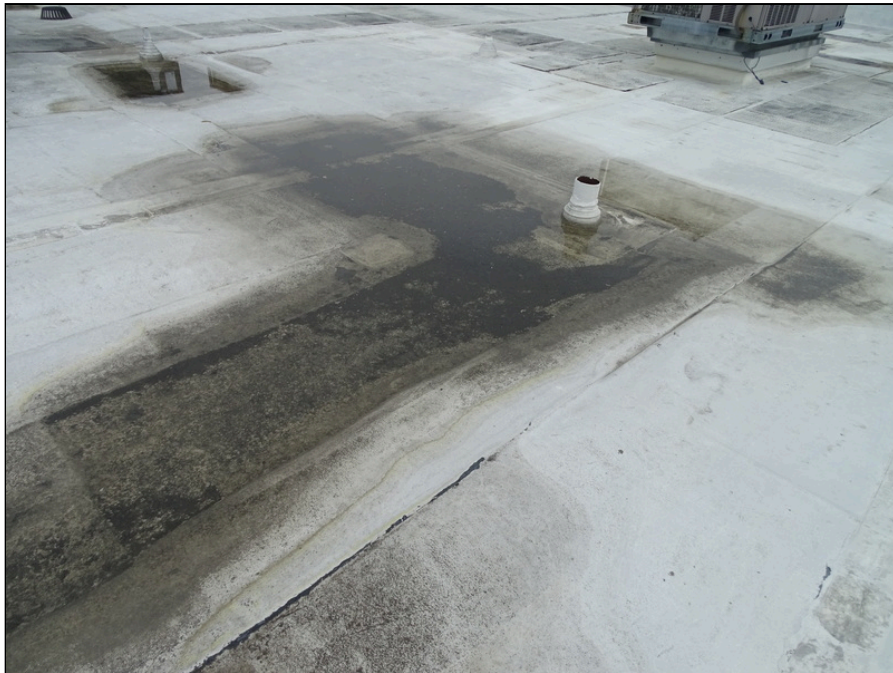
44 - Single-ply membrane roofing main building area - note areas of ponding and deterioration

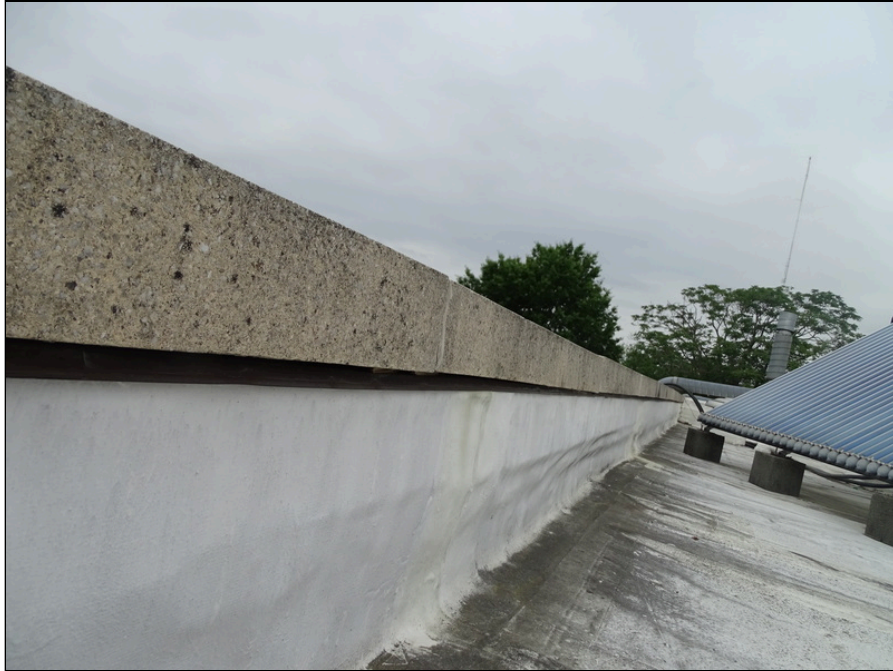
45 - Typical parapet wall - note area of roofing system patching

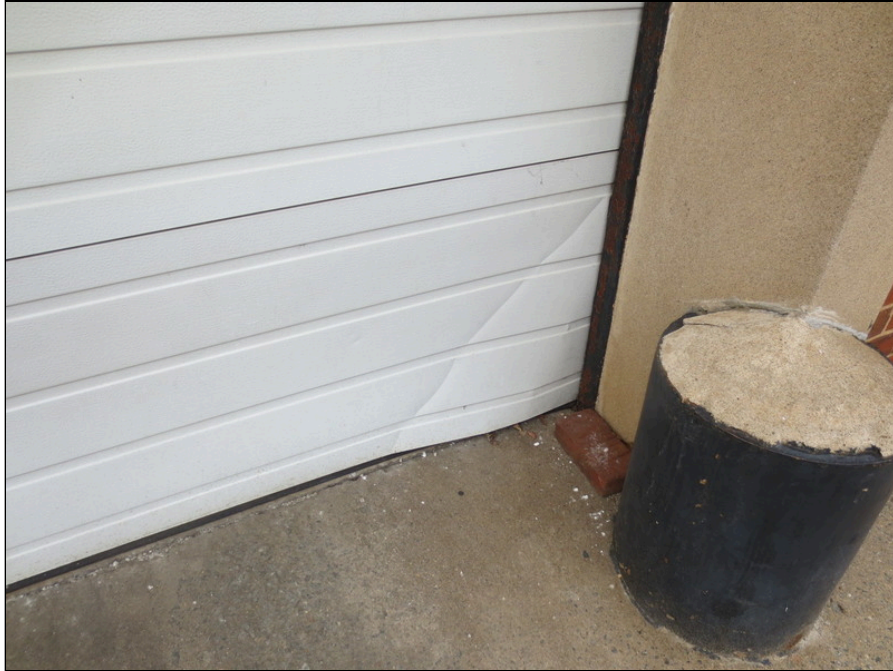
97 - Overhead door damage - east

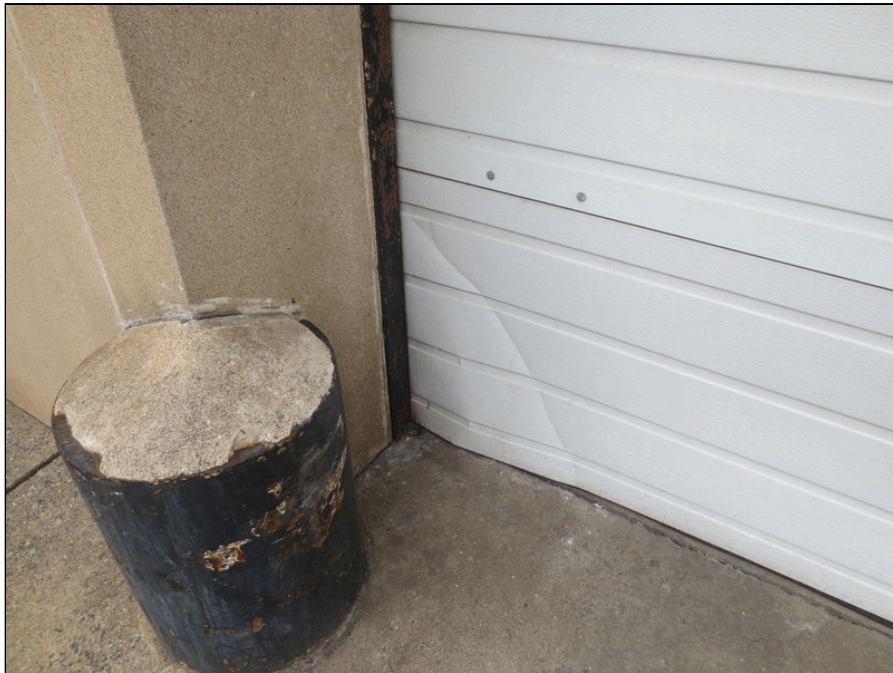
98 - Overhead door damage east

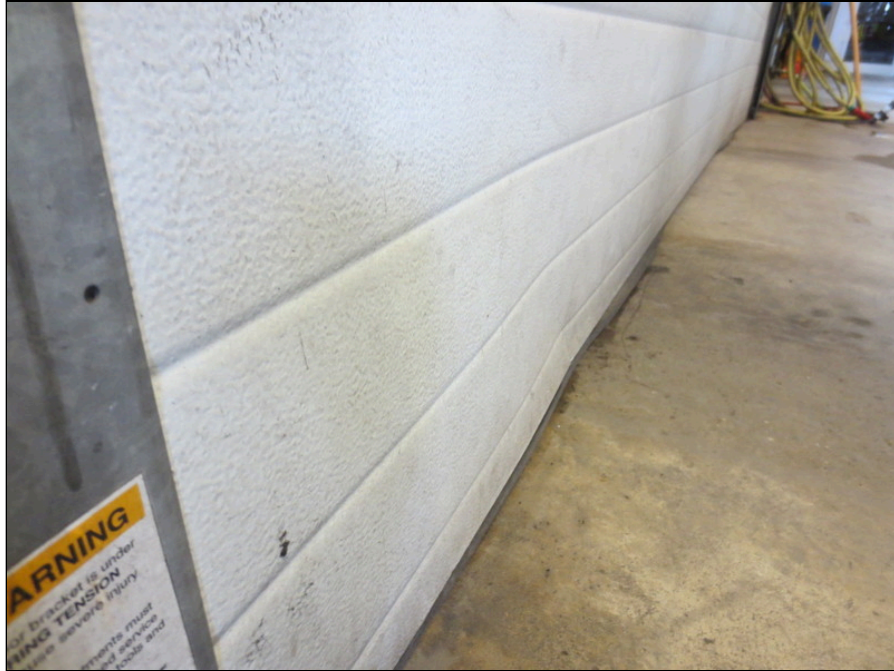
101 - Overhead door damage east

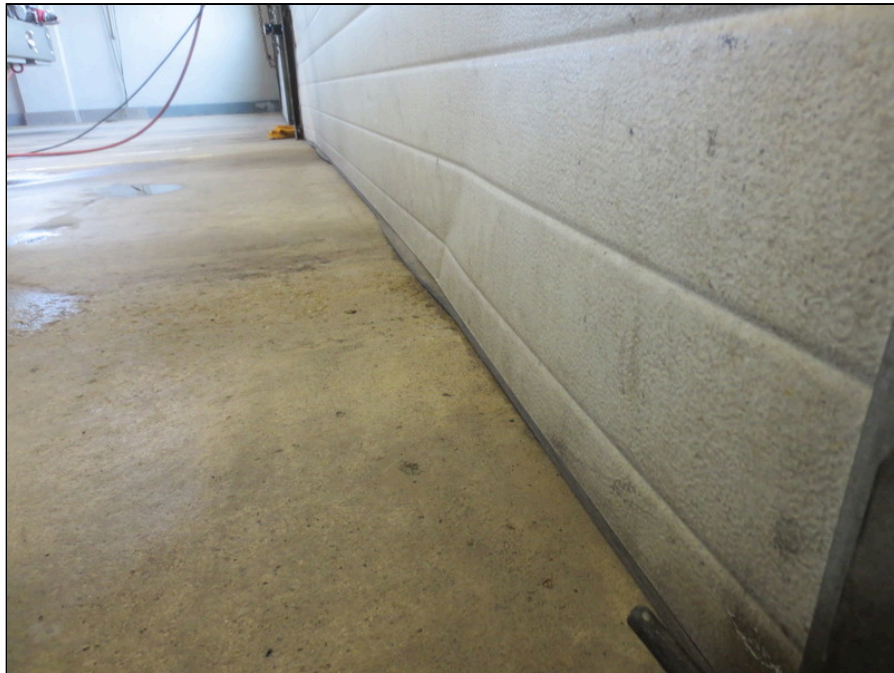
102 - Overhead door damage east
