FACILITY CONDITION ASSESSMENT

GORDON AVENUE LIBRARY
1500 GORDON AVENUE
CHARLOTTESVILLE, VIRGINIA

ECS PROJECT NO. 46:6713

NOVEMBER 2, 2021

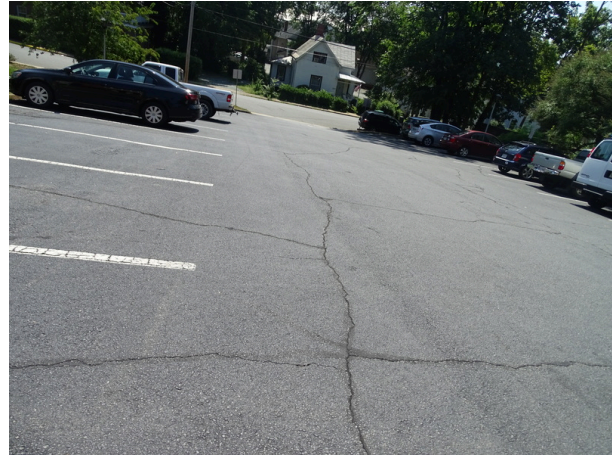
Asphalt-paved drive lanes and parking are located on the north, west, and east sides of the site. The asphalt pavement was observed to be in generally fair condition with cracking observed. The expected useful life of asphalt pavements is generally 20 years. We recommend the asphalt pavements be repaired during the report period.

Asphalt pavement east side of the site - note cracking

Cost Recommendation	EUL	EFF AGE	RUL	Year	Cost
REPAIR AND RE-STRIPE ASPHALT PAVEMENTS AS NEEDED	20	5	15	15	\$24,000
Total					\$24,000

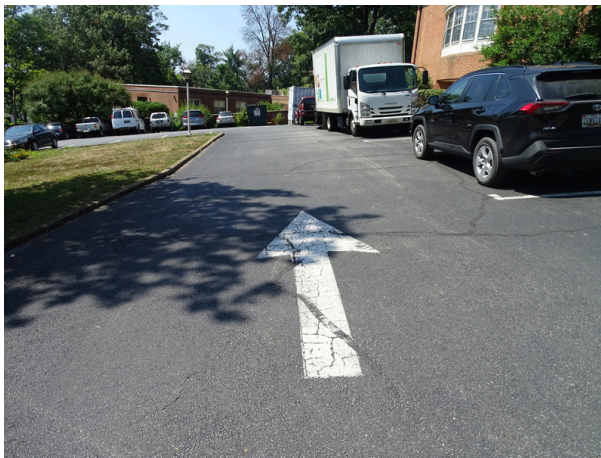
Asphalt pavement north side of the site - note cracking

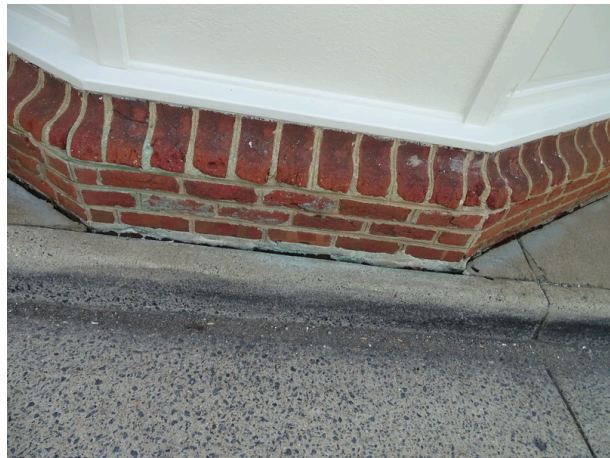
Brick at bay - note deterioration

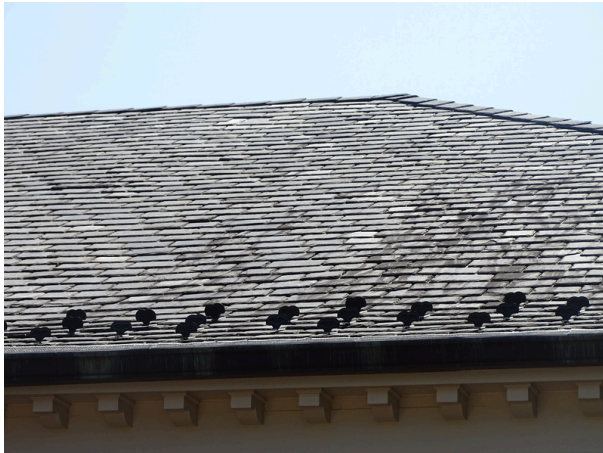
The roofing system consists of a Slate shingle roofing system over the building. Deterioration was observed in and around the gutter on the north side of the building. Some of the slate shingles were misaligned and will need eventual repair to prevent future leakage. We recommend periodic allowance over the report period to repair misaligned slate shingles and general deterioration of the roofing system.

Slate shingle roofing system - note deterioration

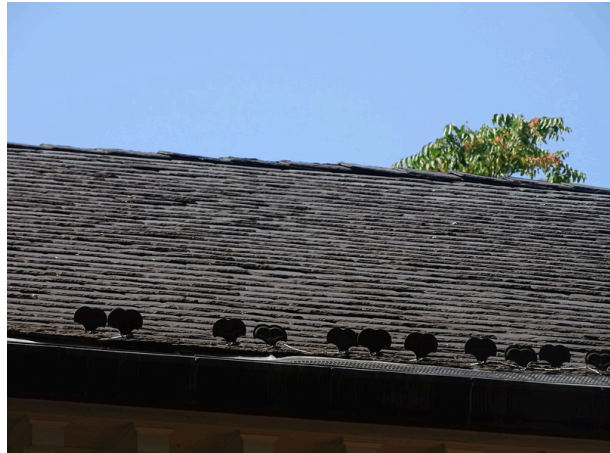
Slate shingle roofing system - note deterioration

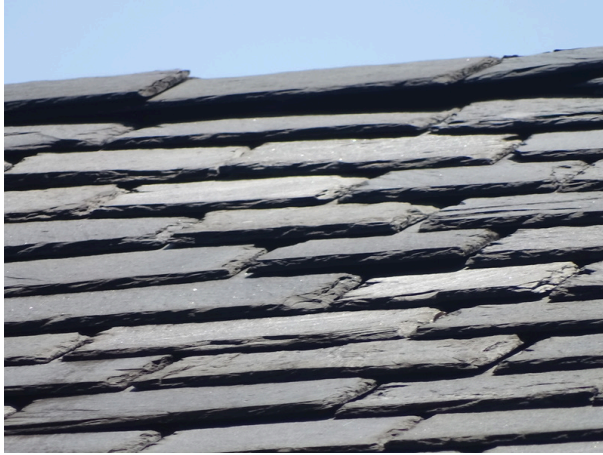
Slate shingle roofing system - note deterioration

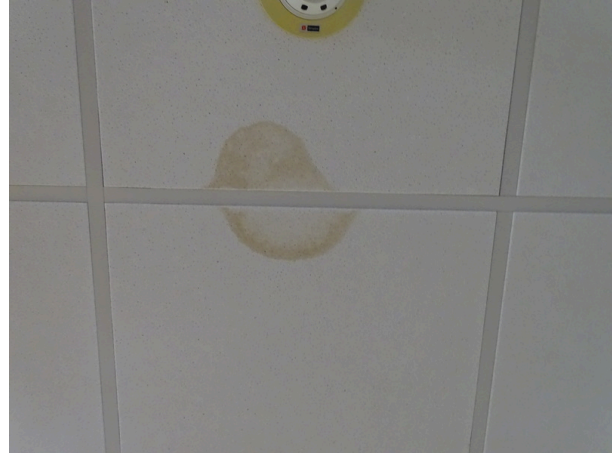
Water leakage at ceiling

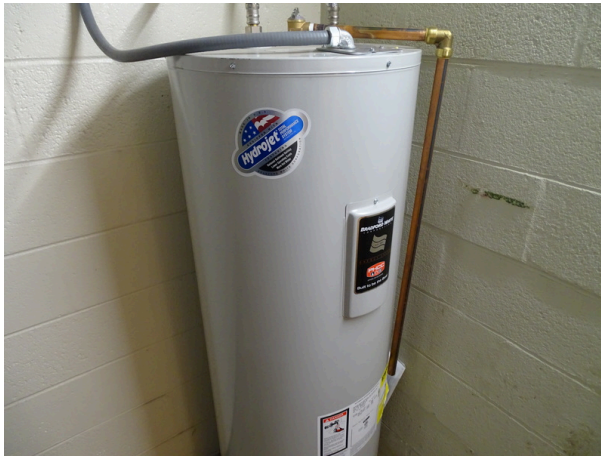
Domestic hot water to the building is provided by an Electric domestic water heater located in the main utility room. The Electric domestic water heater was manufactured by Bradford White. The expected useful life of a Electric domestic water heater is approximately 12 to 15 years and We recommend the Electric domestic water heater be replaced during the report period.

Electric domestic water heater

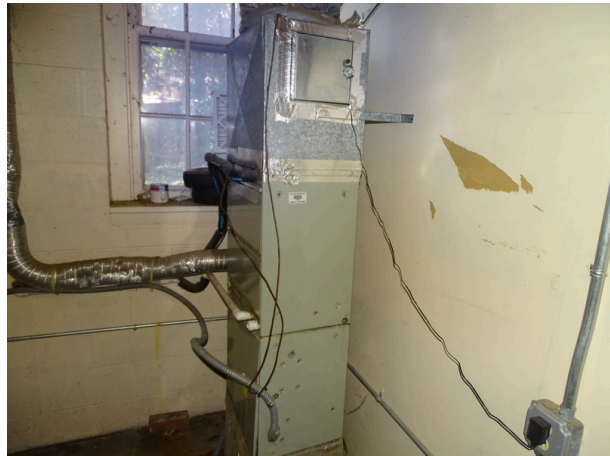
The split system is located at the southeast side of the building and was reportedly manufactured by Trane in 2006. The expected useful life of split systems is generally 15 to 20 years. The split systems were generally in fair condition. We recommend replacing the split systems during the report period.

Split System southeast side of the building

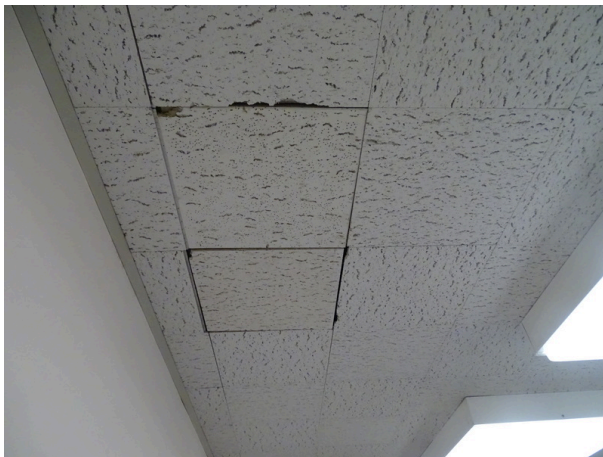
The finishes in the meeting rooms include carpet floors, painted CMU walls, and acoustical tile ceilings. The finishes in the meeting rooms were observed to be in generally good to fair condition. We recommend replacing the older acoustical tile ceilings.

Typical acoustical tile - note deterioration

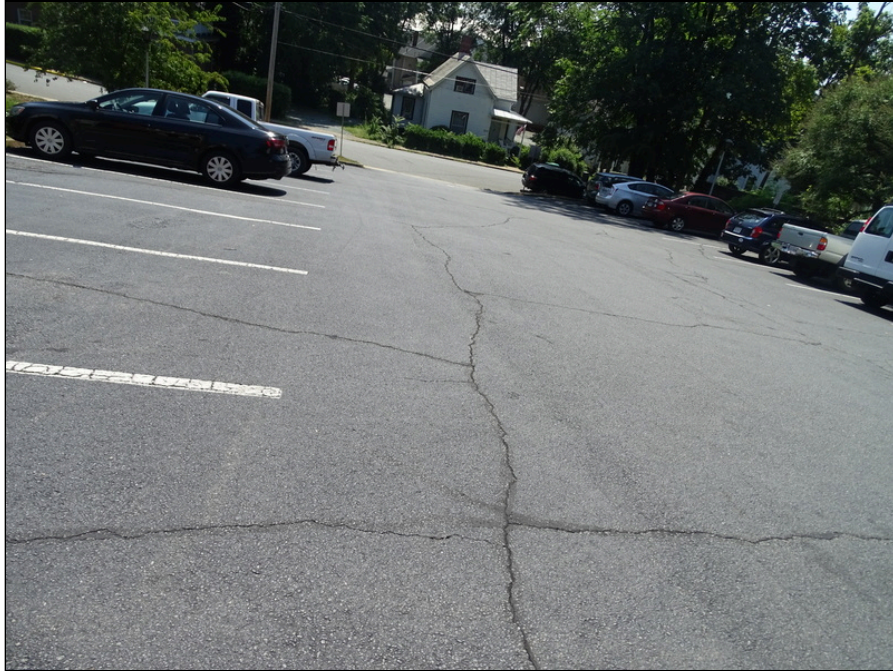
3 - Asphalt pavement east side of the site - note cracking

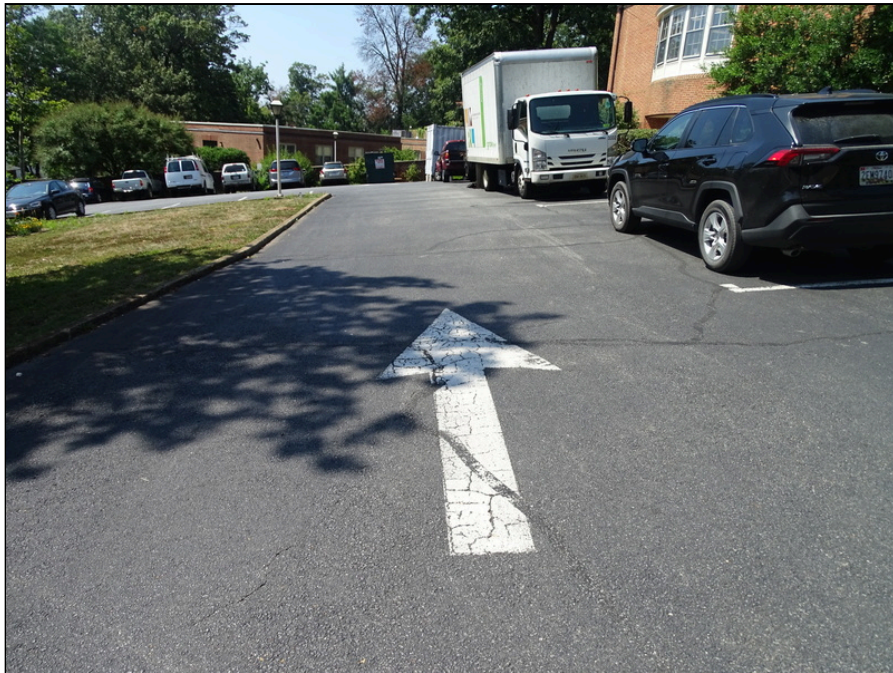
4 - Asphalt pavement north side of the site - note cracking

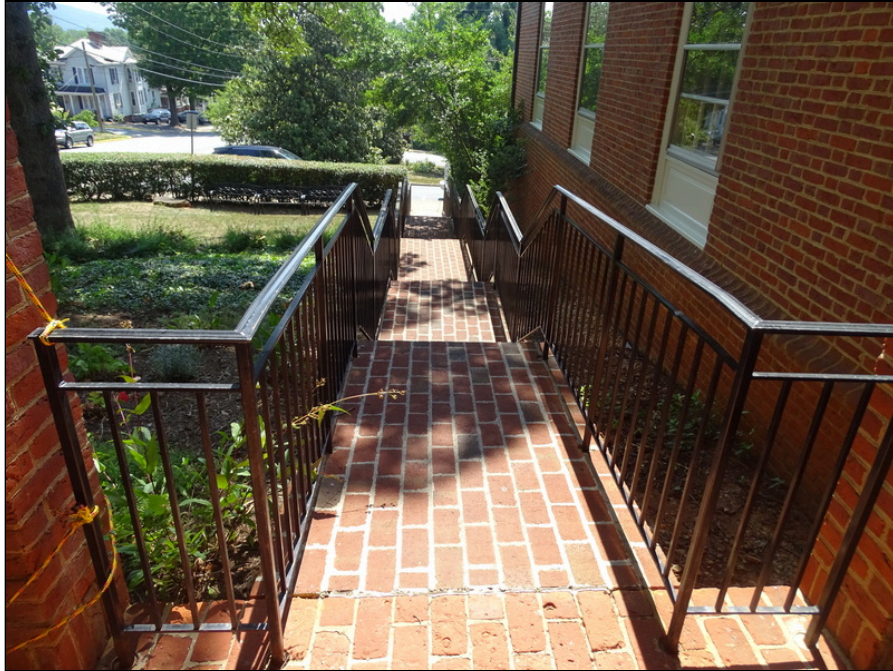
9 - Brick sidewalk and steps east side of the building - note deterioration

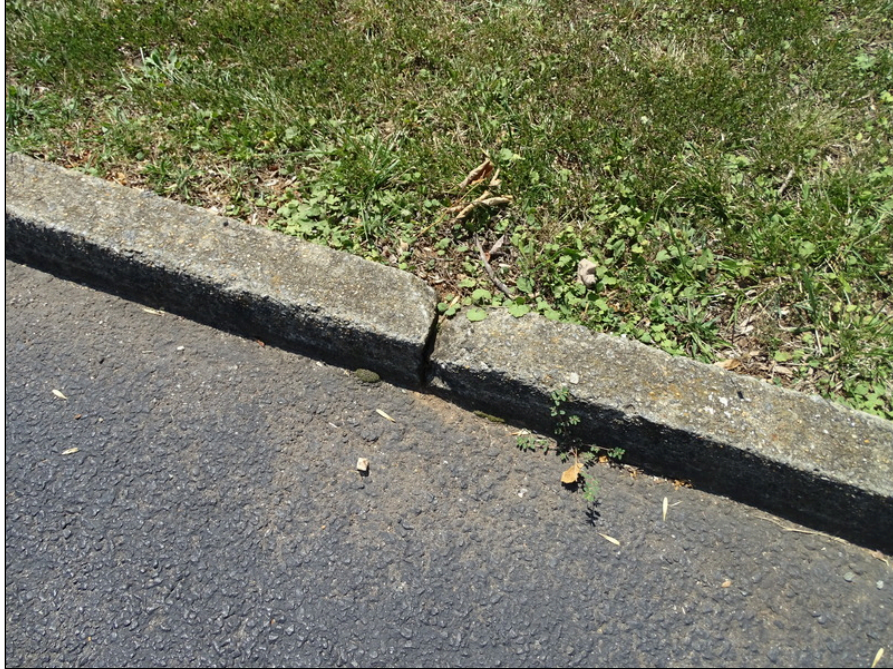
11 - Concrete curb - note deterioration

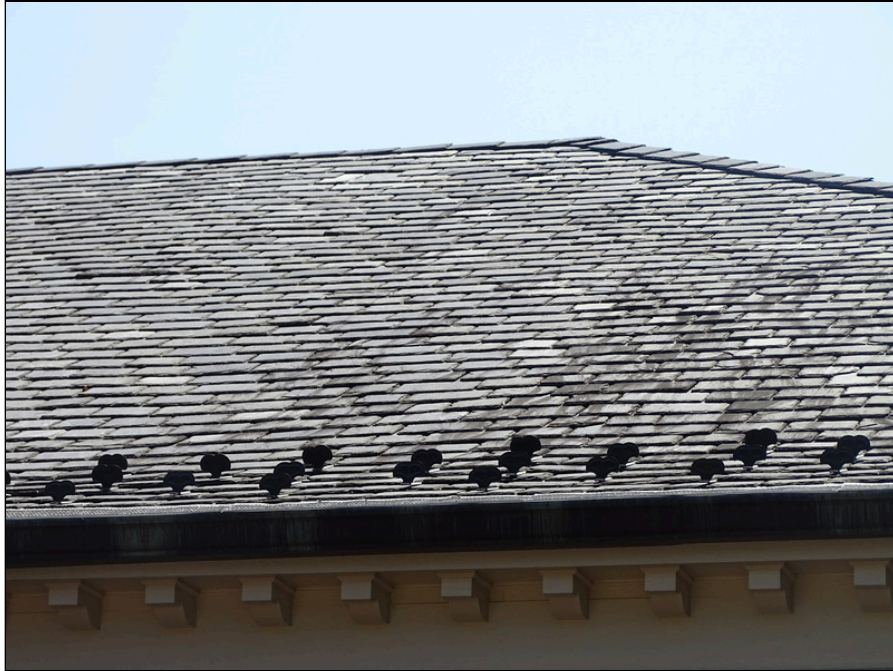
29 - Slate shingle roofing system - note deterioration

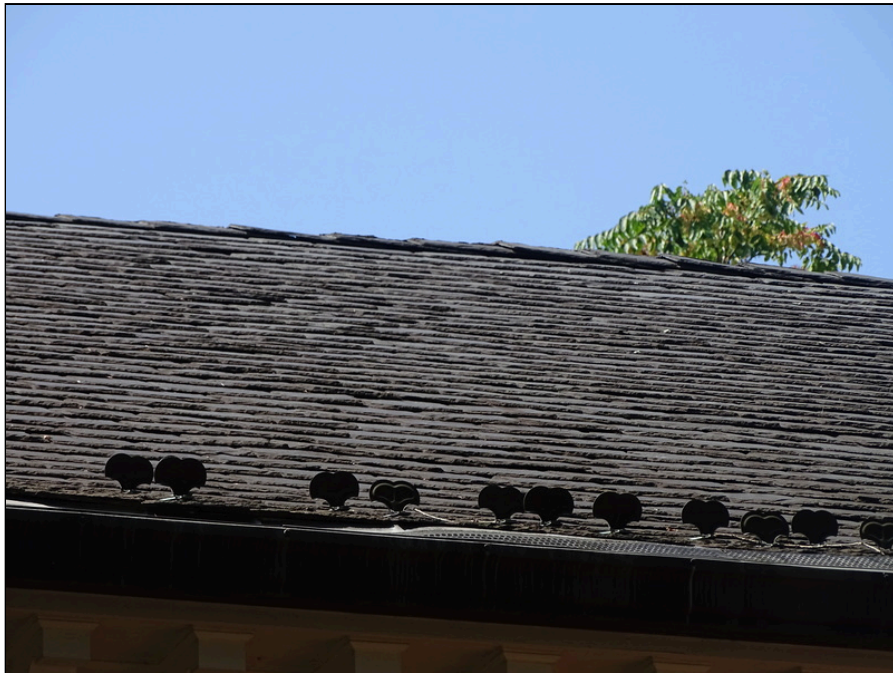
30 - Slate shingle roofing system - note deterioration

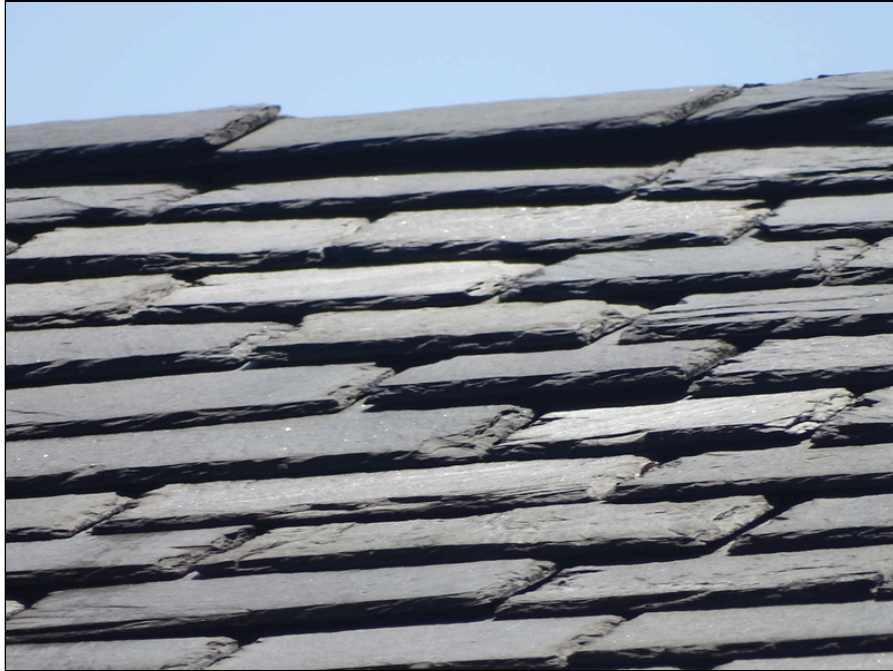
31 - Slate shingle roofing system - note deterioration

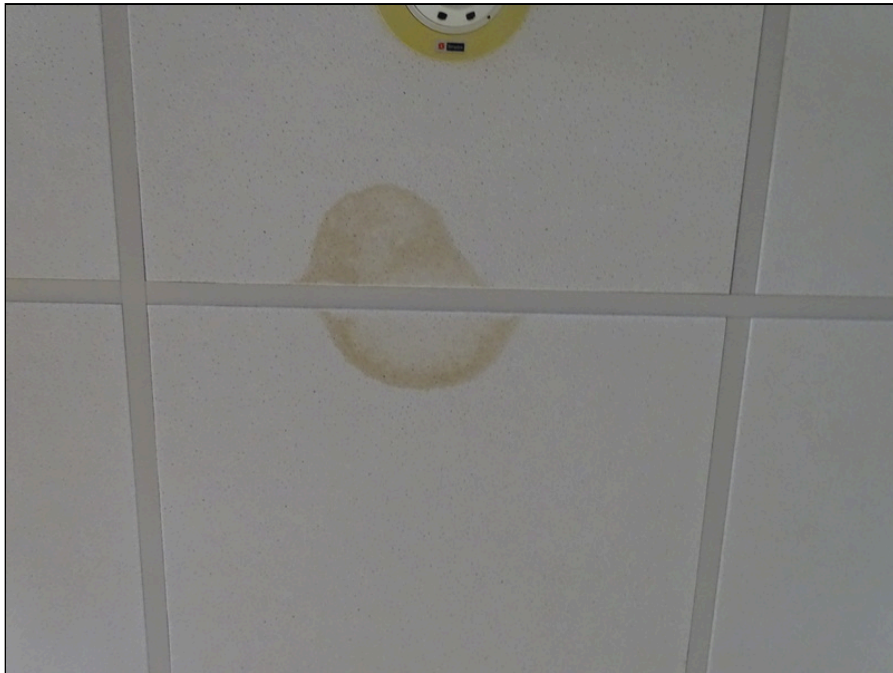
32 - Water leakage at ceiling

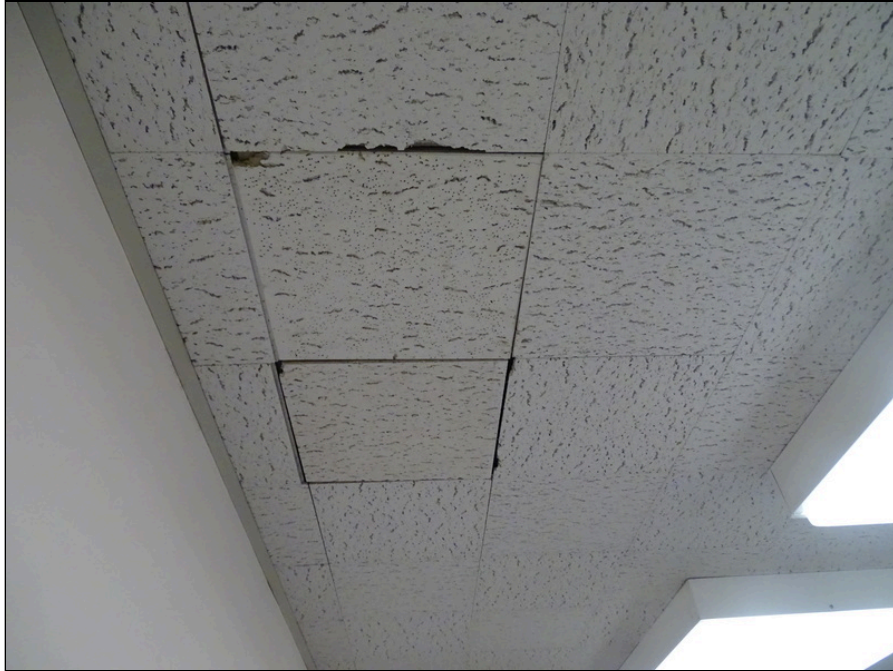
59 - Typical acoustical tile - note deterioration

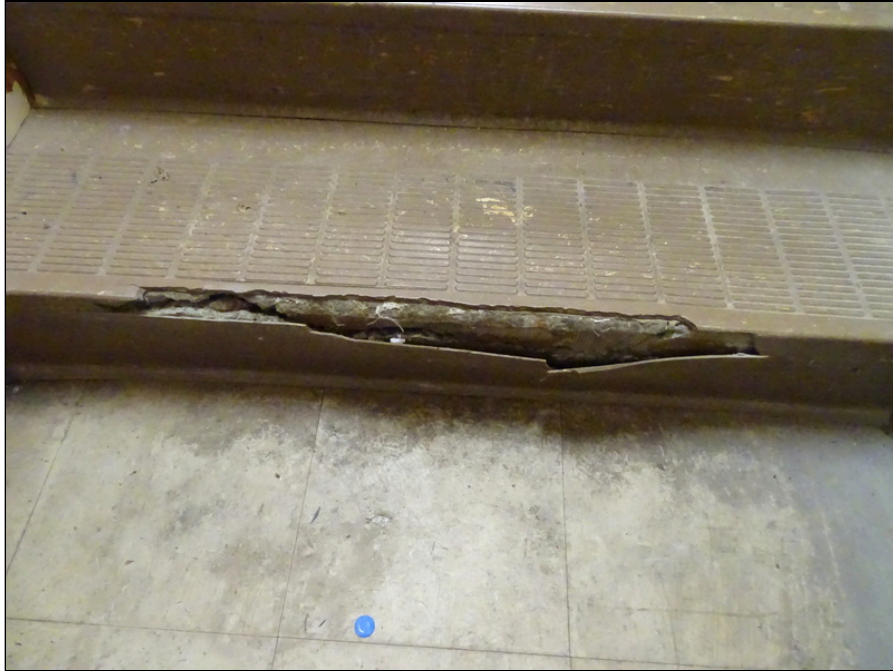
65 - Typical step - note deterioration

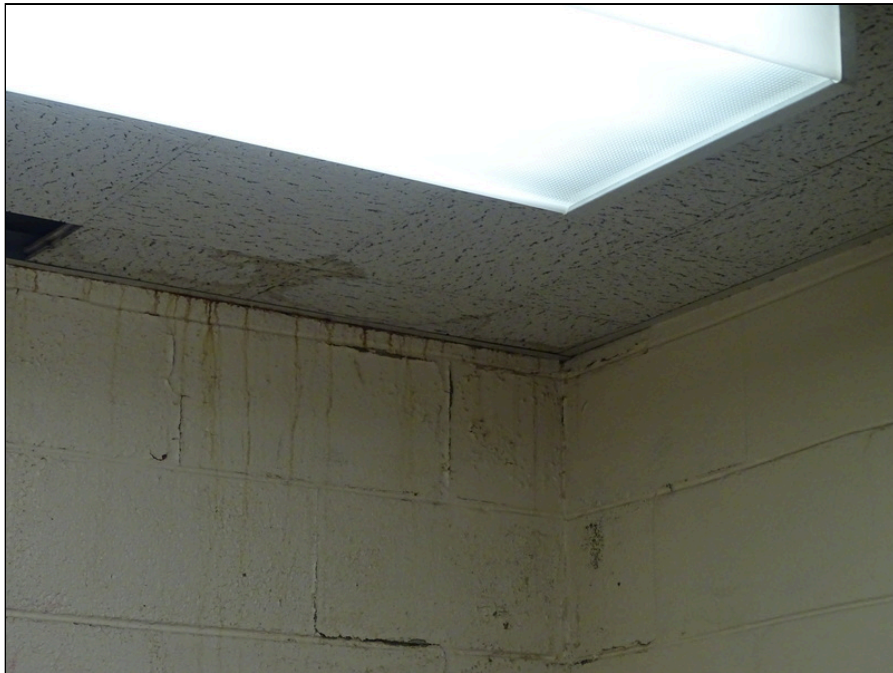
66 - Interior wall - note efflorescence

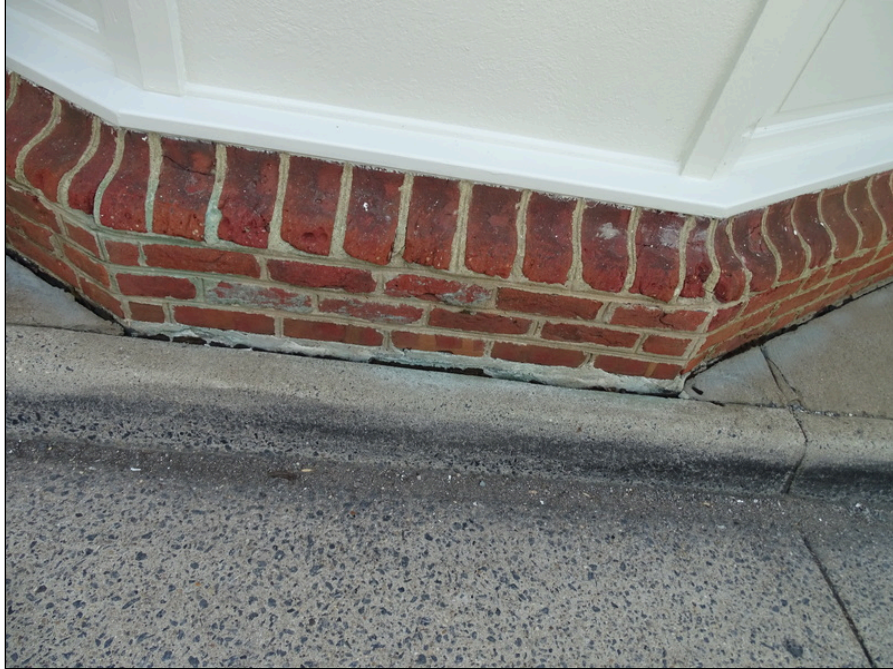
73 - Brick at bay - note deterioration
