GREENBRIER ELEMENTARY SCHOOL
2205 GREENBRIER DRIVE
CHARLOTTESVILLE, VIRGINIA

ECS PROJECT NO. 46:6713

CITY OF CHARLOTTESVILLE - FACILITIES DEVELOPMENT

Reference: Facility Condition Assessment Report for Greenbrier Elementary School, 2205 Greenbrier Drive, Charlottesville, Virginia

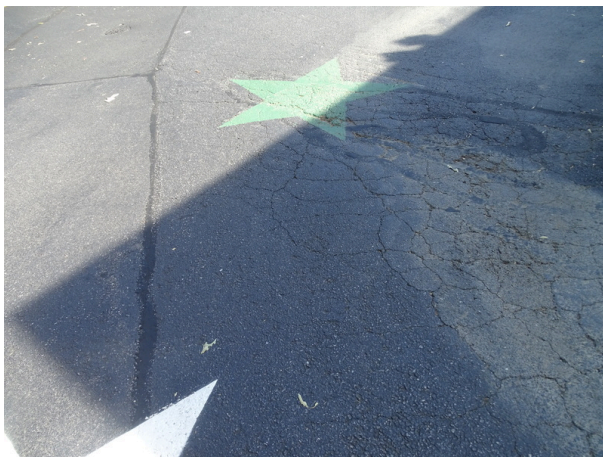
Alligator cracking in asphalt pavement

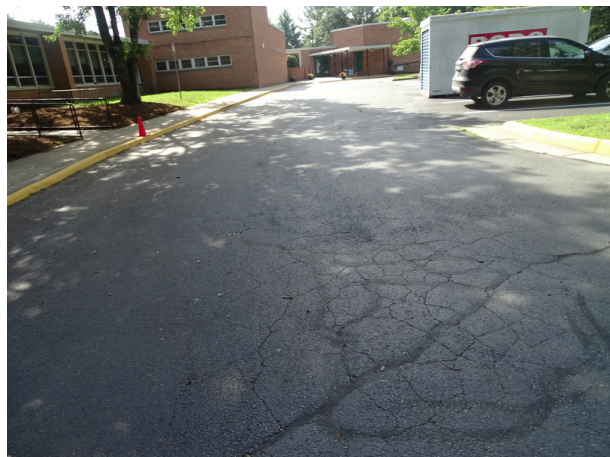
Alligator cracking in asphalt pavement

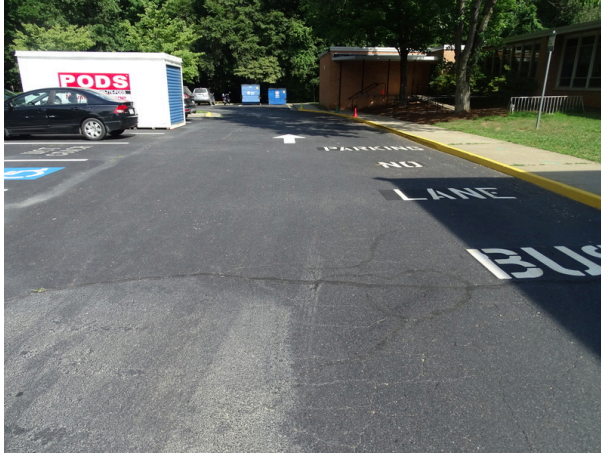
Previous repair of asphalt pavement

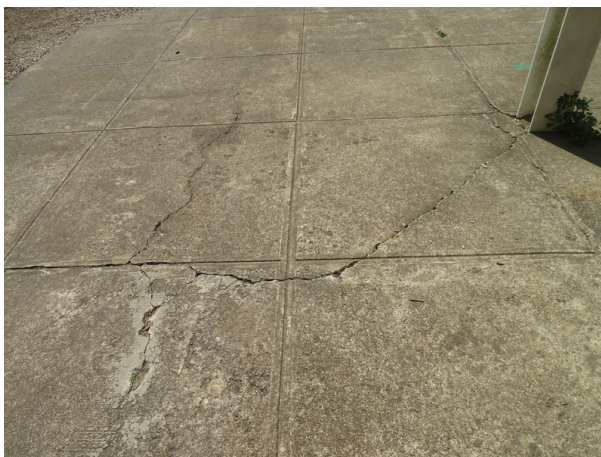
Concrete sidewalk - cracking

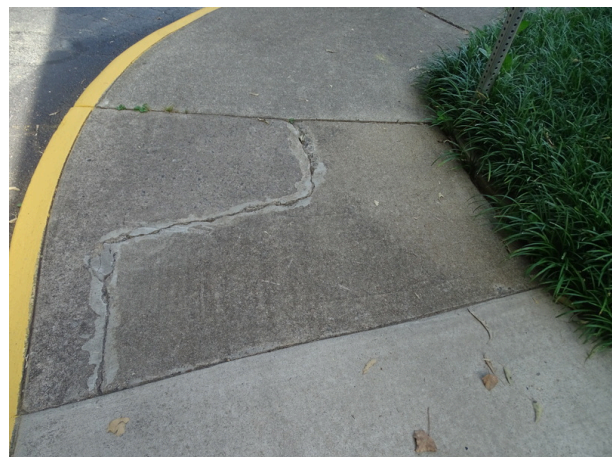
Concrete curb ramp - note cracking

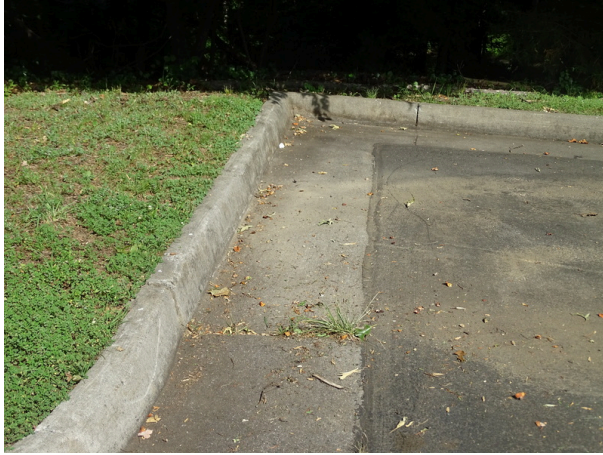
Concrete curb - note cracking

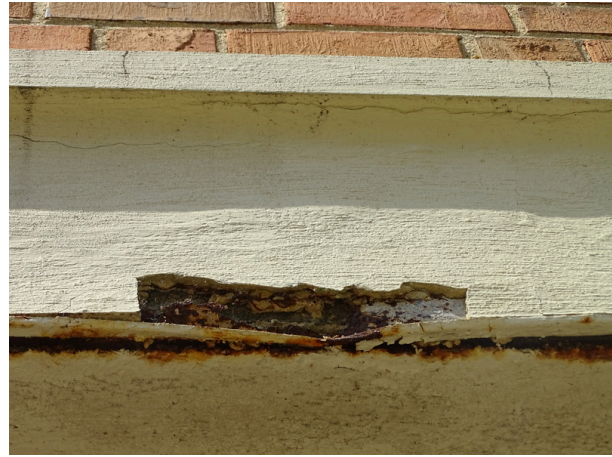
Exterior overview - note deterioration

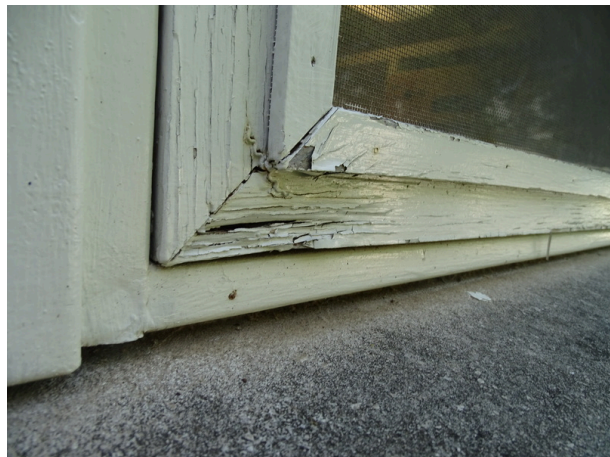
Deteriorated window sealant and glazing

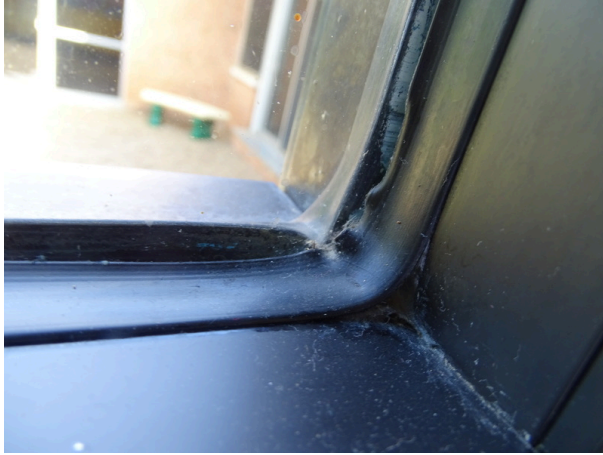
Deteriorated window glazing

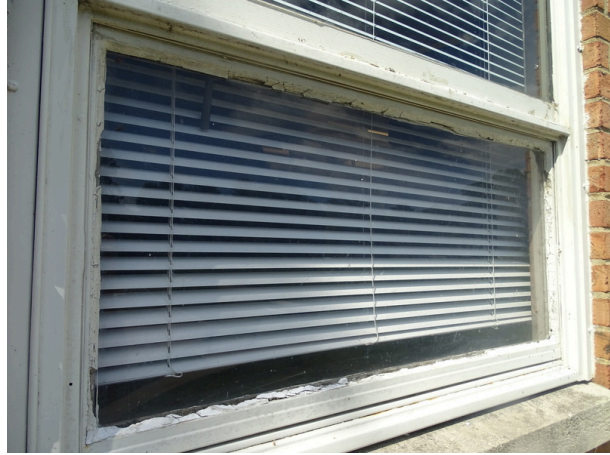
Deteriorated window sealant

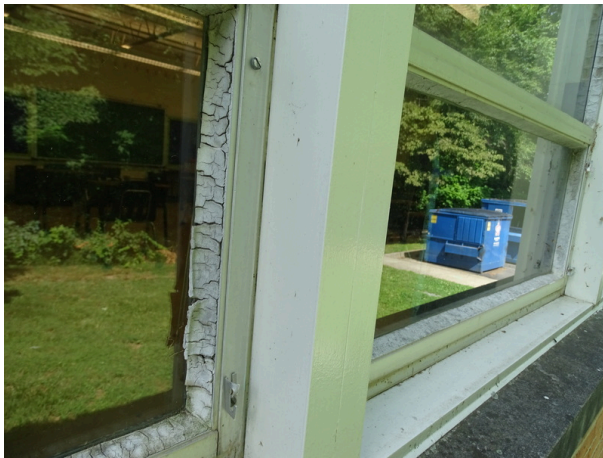
Deteriorated window sealant and glazing

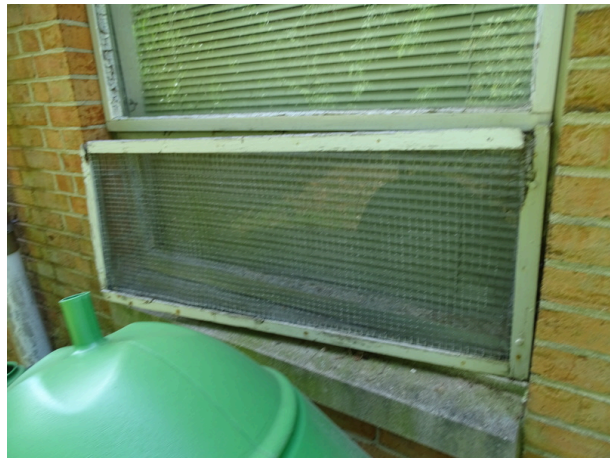
Deteriorated window sealant and glazing

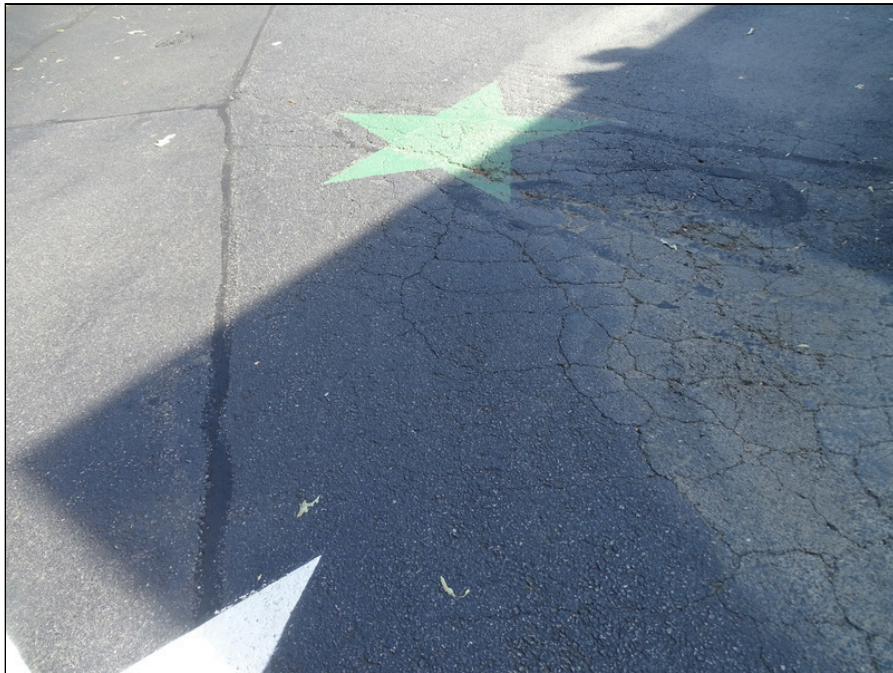
8 - Alligator cracking in asphalt pavement

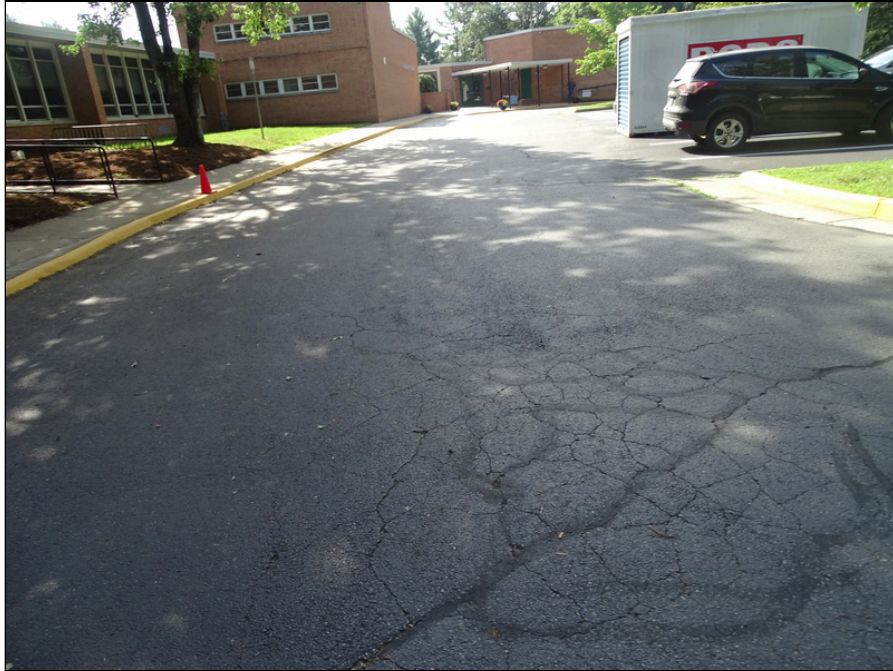
9 - Alligator cracking in asphalt pavement

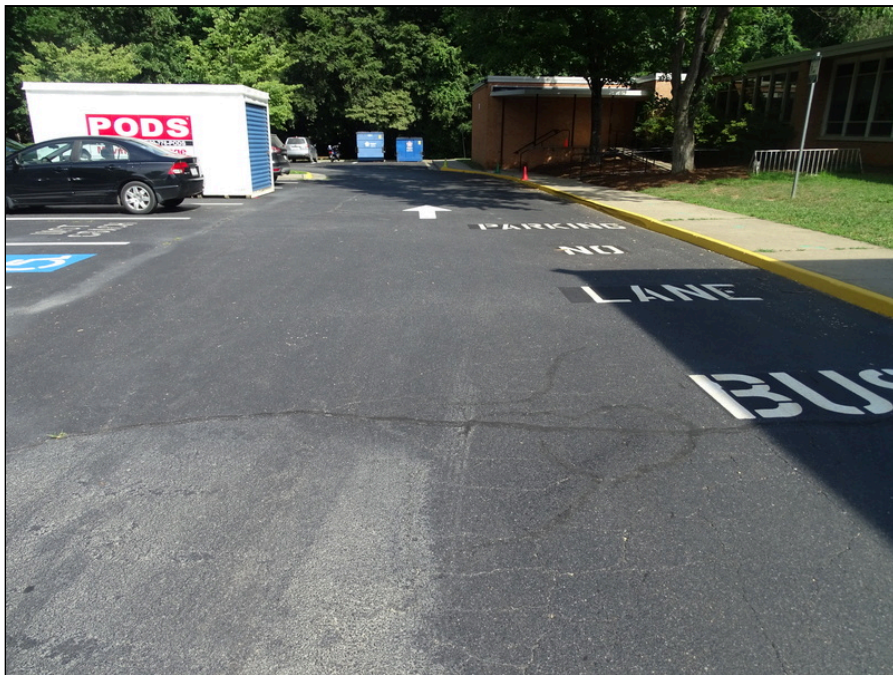
10 - Previous repair of asphalt pavement

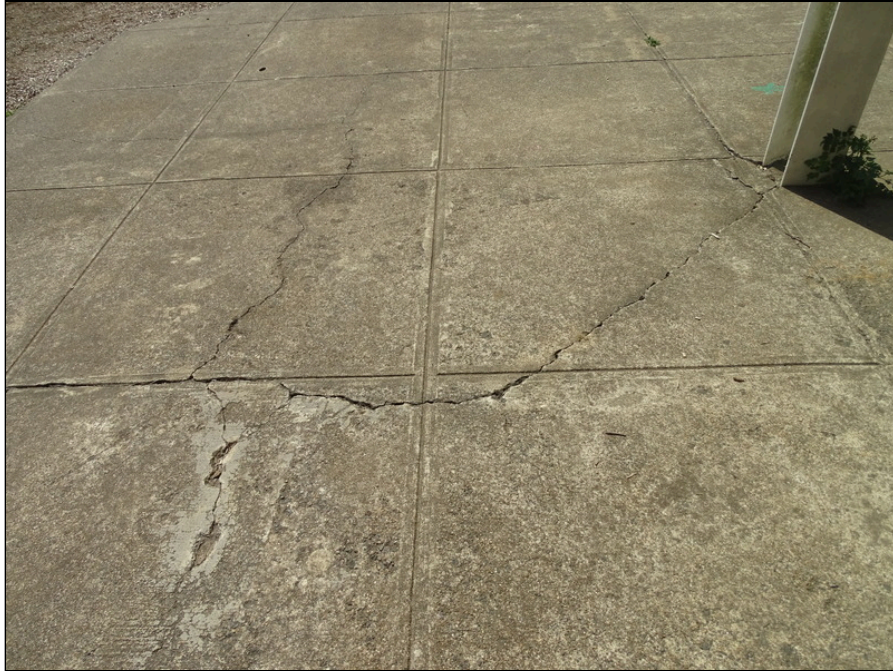
15 - Concrete sidewalk - cracking

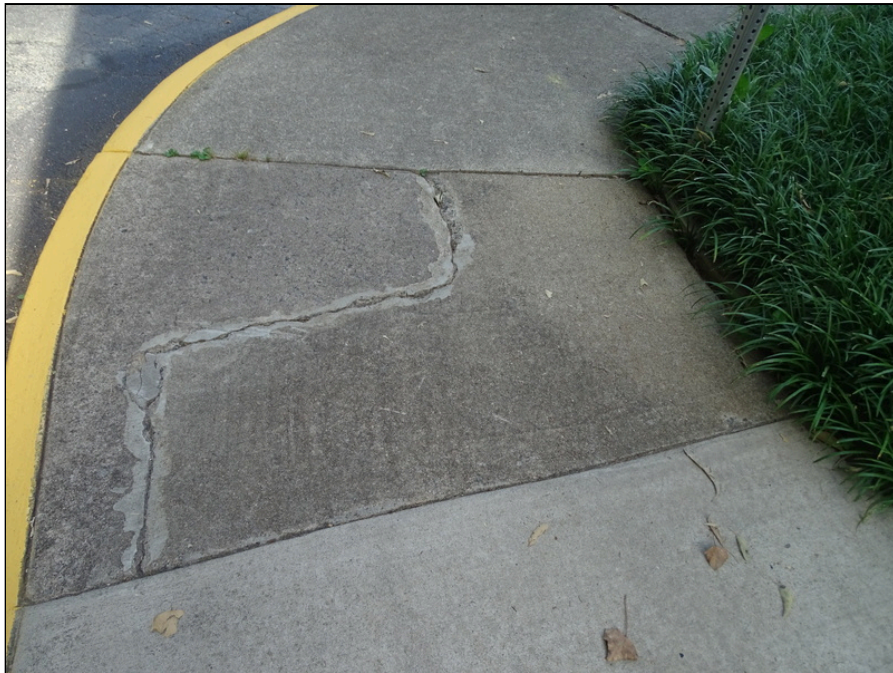
16 - Concrete curb ramp - note cracking

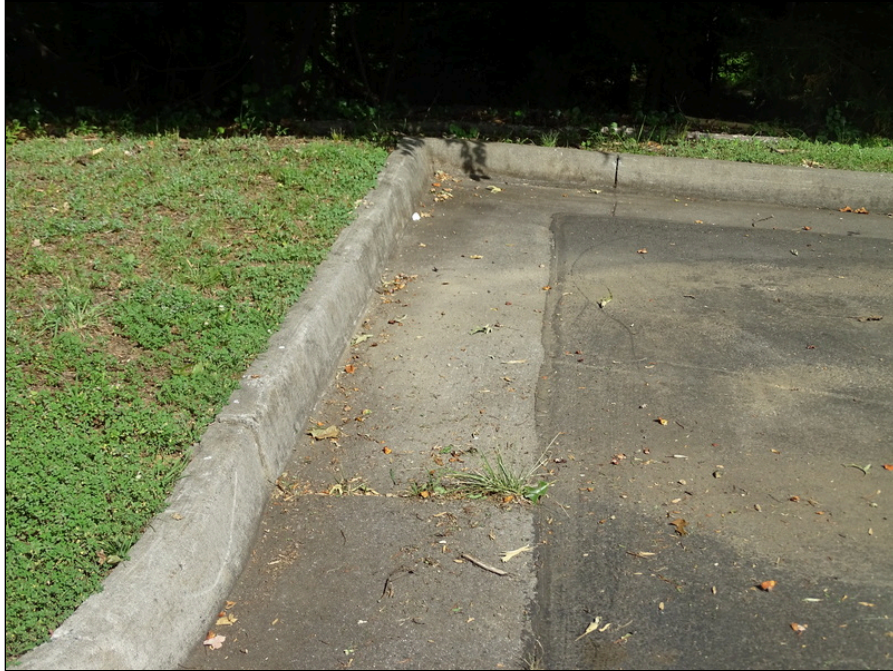
17 - Concrete curb - note cracking

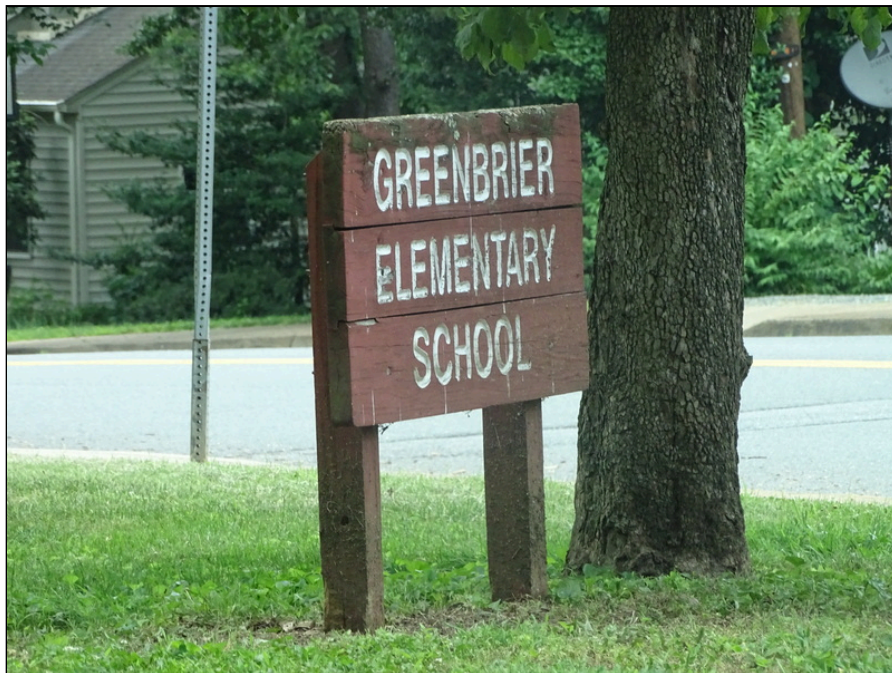
30 - Deterioration at top of sign

Two signs are located on the east side of the property along Greenbriar Road. One sign is a metal fence with a brick base and was in good condition. The second sign is a painted wooden sign. The painted wooden sign was deteriorated at the top of the sign. We recommend the wood sign be painted.

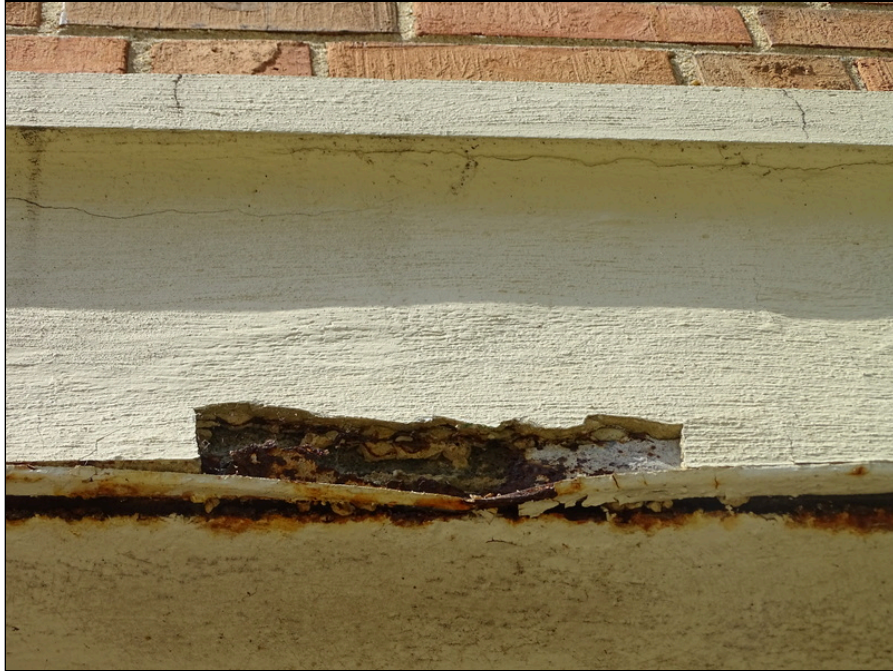
45 - Exterior overview - note deterioration

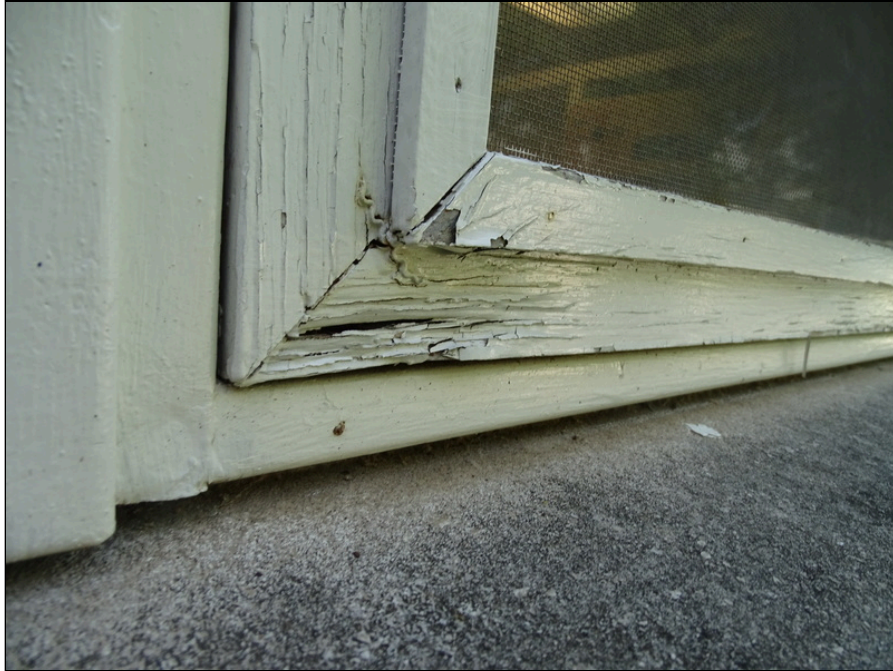
49 - Deteriorated window sealant and glazing

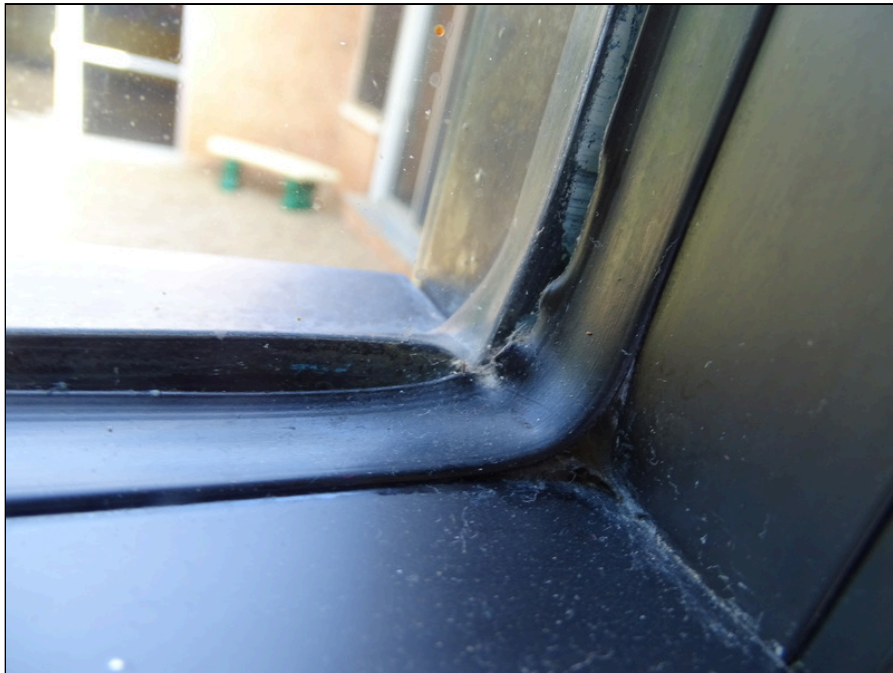
50 - Deteriorated window glazing

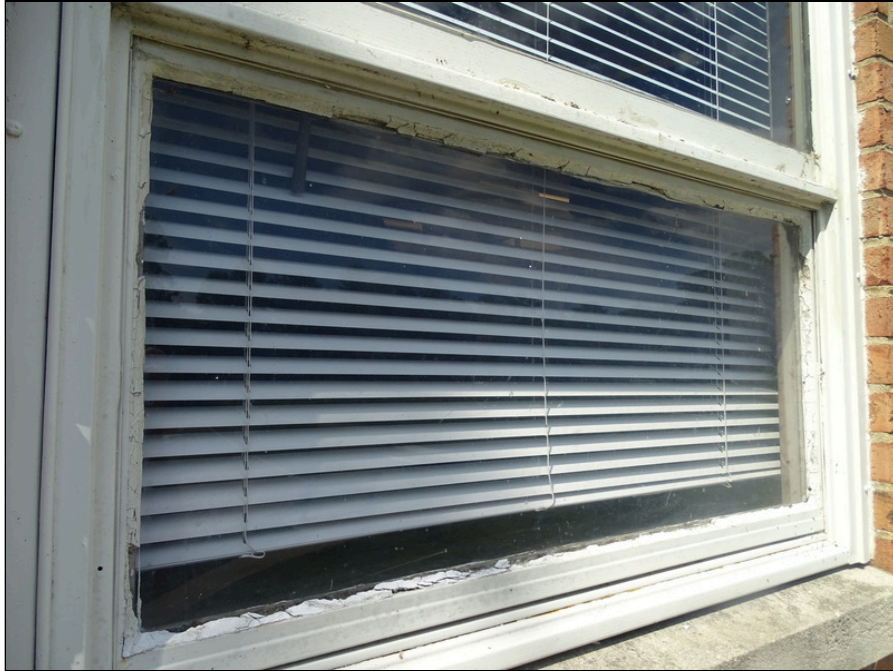
51 - Deteriorated window sealant

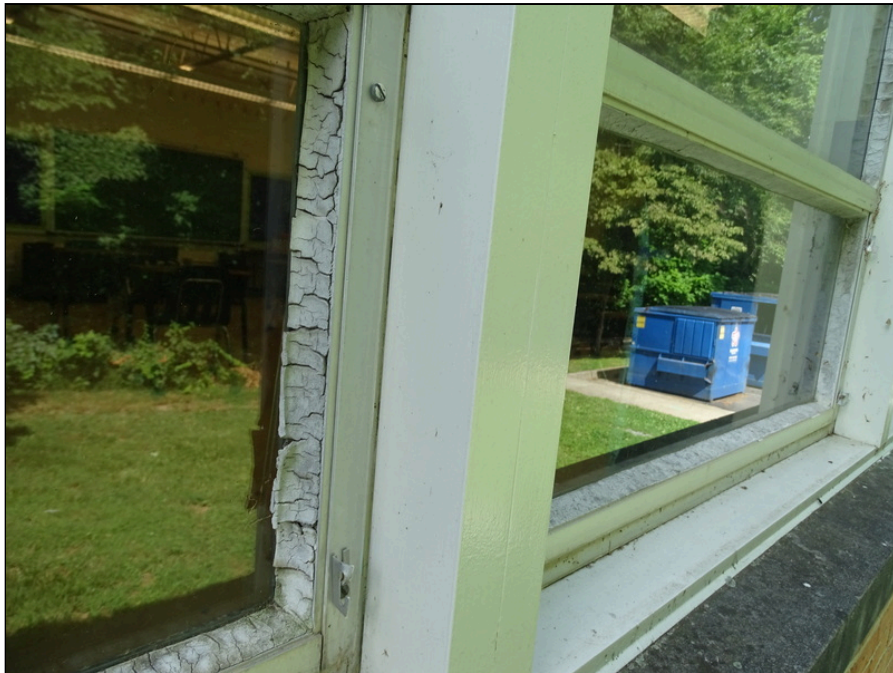
52 - Deteriorated window sealant and glazing

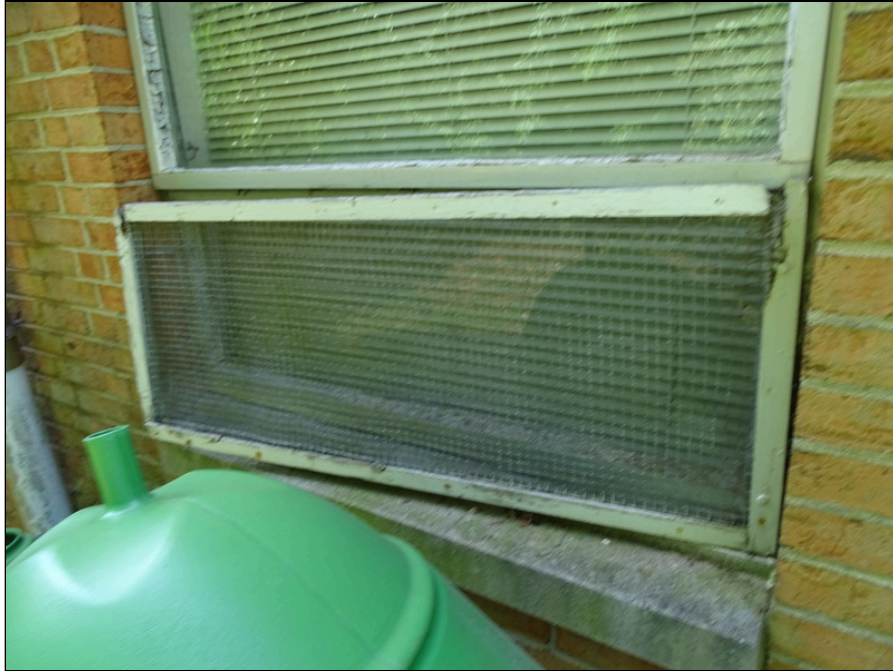
53 - Deteriorated window sealant and glazing

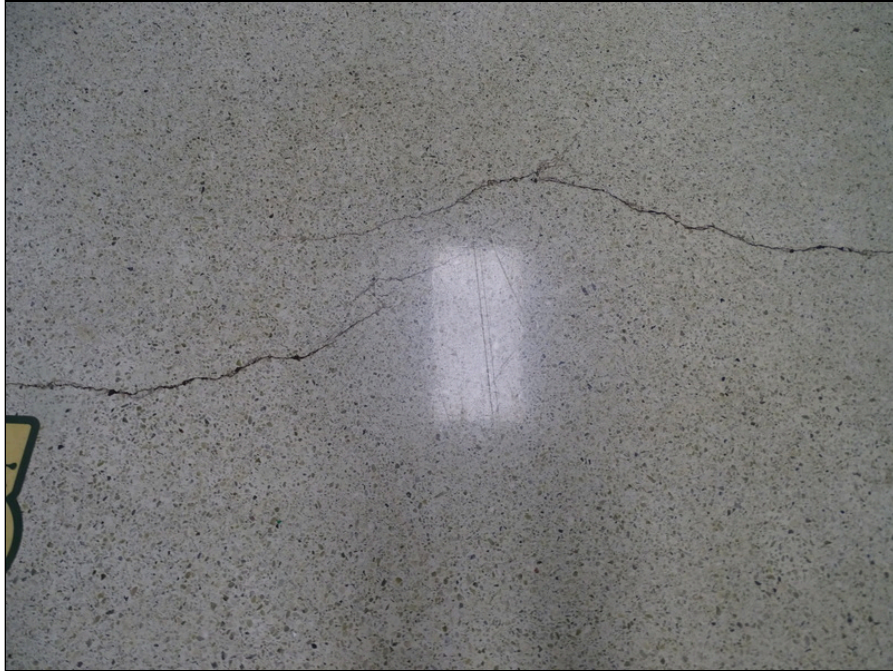
111 - Cracked terrazzo in corridor

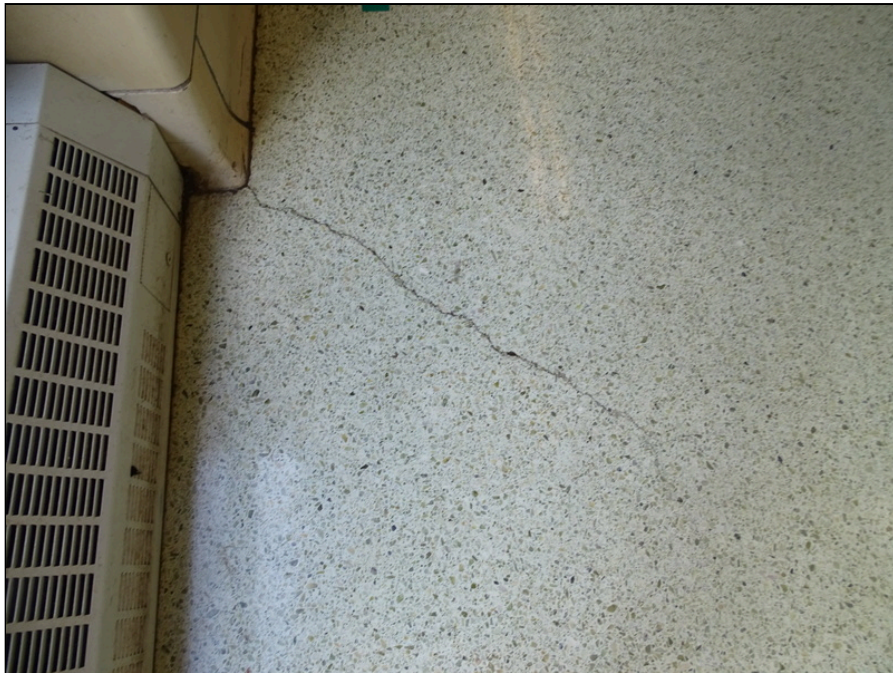
112 - Cracked terrazzo in corridor

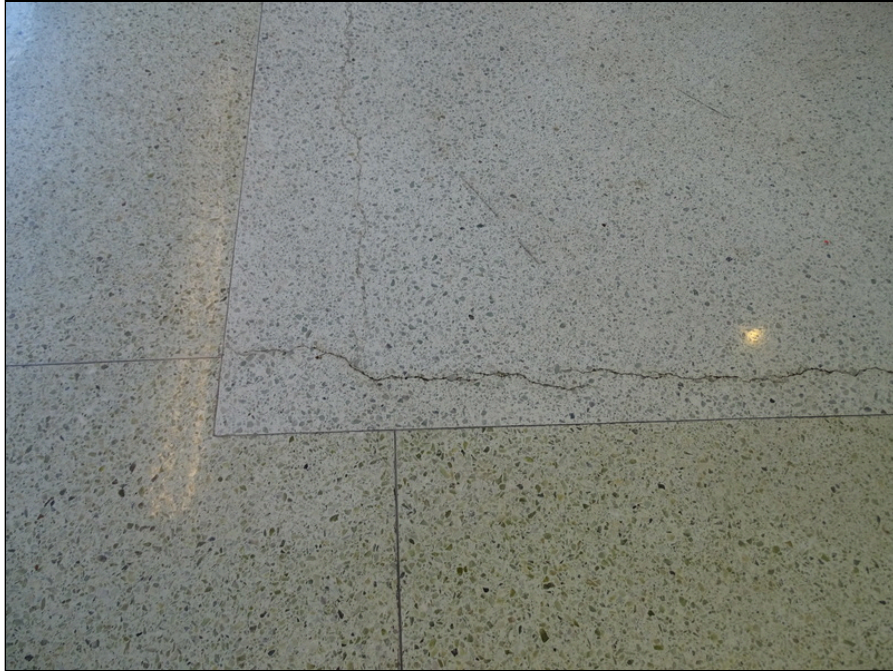
113 - Cracked terrazzo in corridor

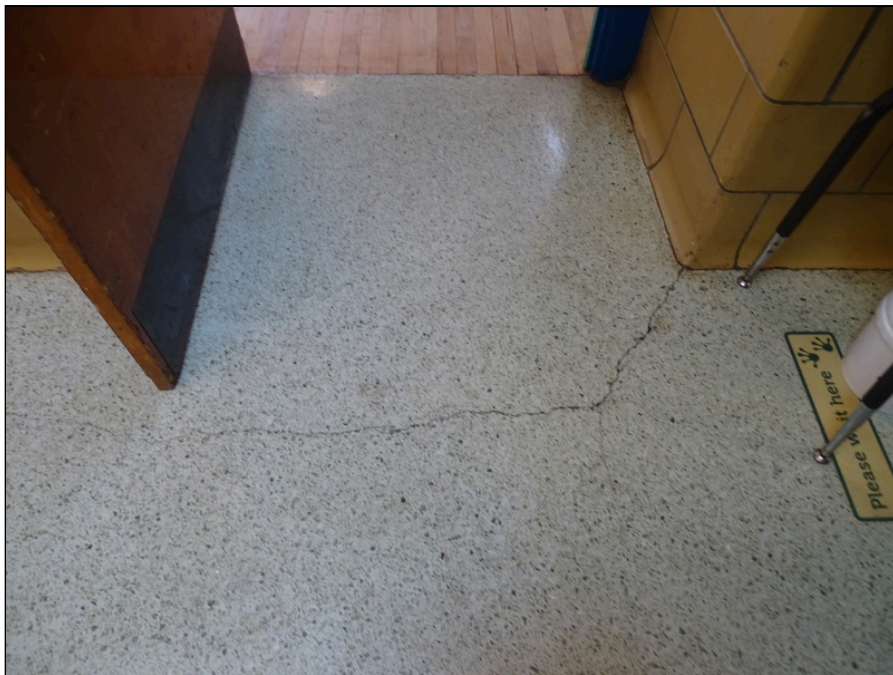
114 - Cracked terrazzo in corridor

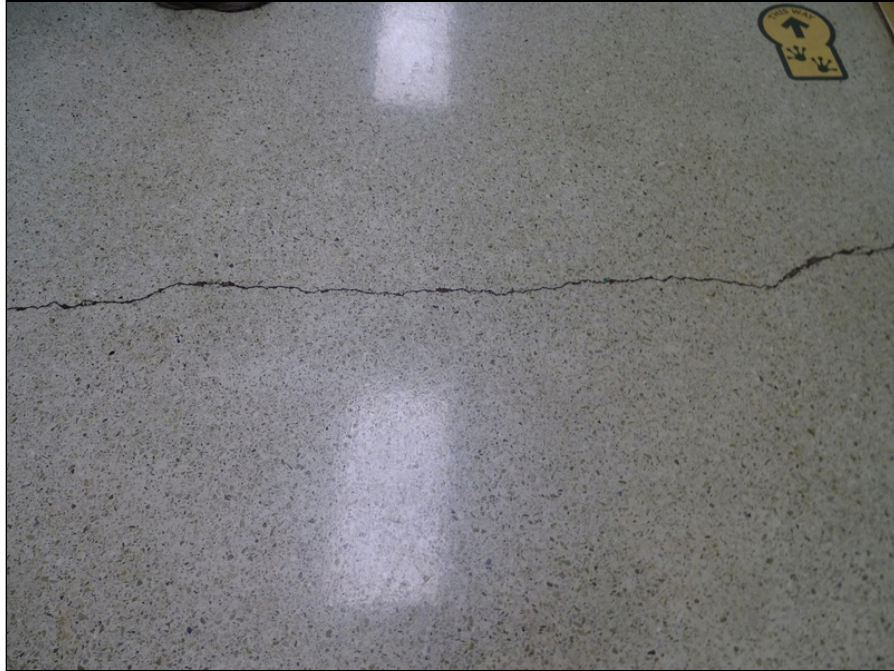
115 - Cracked terrazzo in corridor
