HEALTH DEPARTMENT  
1138 ROSE HILL DRIVE  
CHARLOTTESVILLE, VIRGINIA

OCTOBER 29, 2021

Reference: Facility Condition Assessment Report for Health Department, 1138 Rose Hill Drive,  
Charlottesville, Virginia

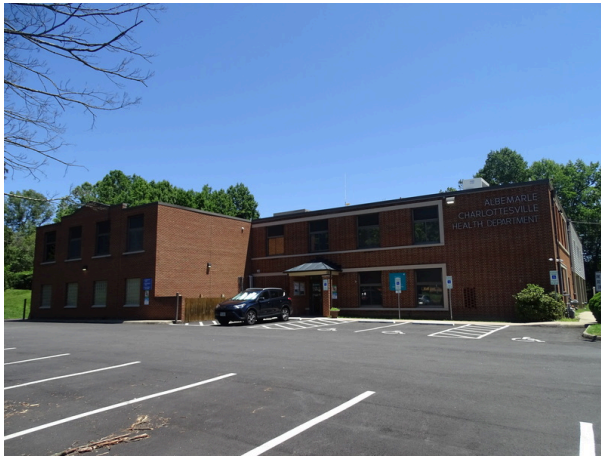
The parking is provided by at-grade asphalt pavement on the west, north, and east sides of the property. The asphalt pavement appears to be recently installed and is in good condition.

Asphalt pavement overview

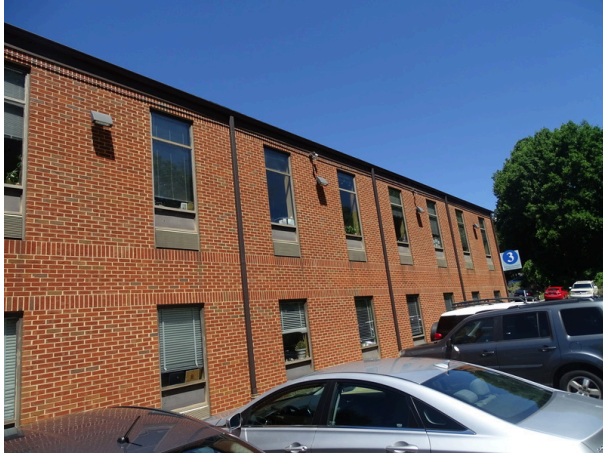
Exterior wall finishes

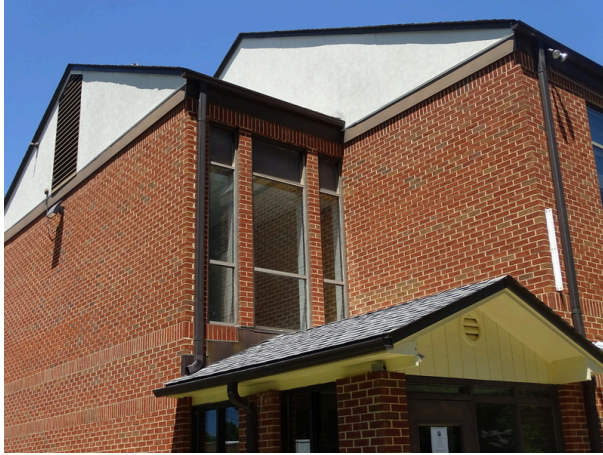
Exterior wall finishes

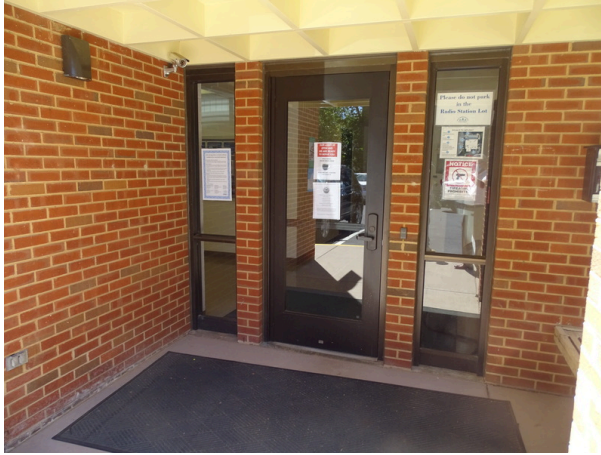
Typical main entrance

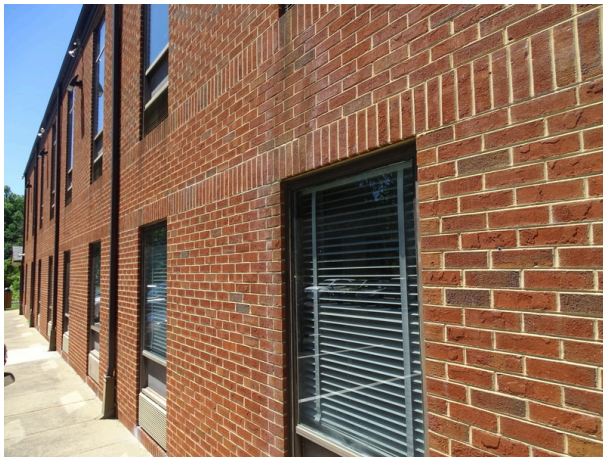
Several openings on the west side of the building contained glass block. The glass block was generally in good condition.

Exterior wall finishes

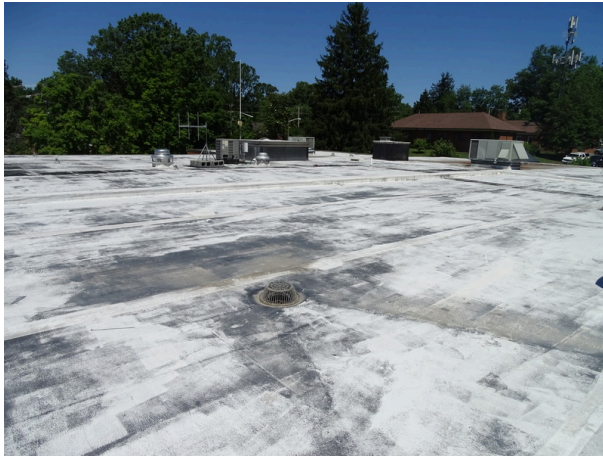
Single-ply roofing system side of the building -  
note deterioration

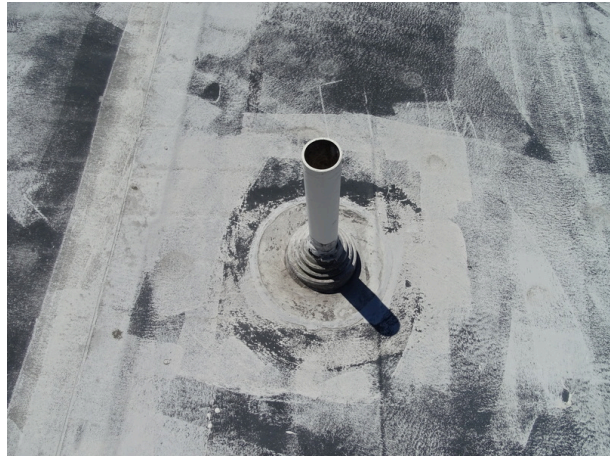
Single-ply roofing system side of the building -  
note plumbing penetration

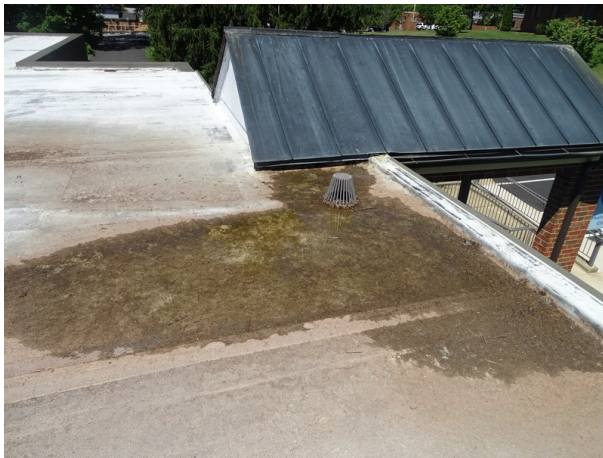
A standing seam metal roof system covers the west entrance area to the building. The metal roofing system was observed to be in fair condition of unknown age. We recommend the metal roofing system is cleaned and recoated during the report period. Drainage for the metal roofing system was provided by gutters and downspouts.

Metal roofing system

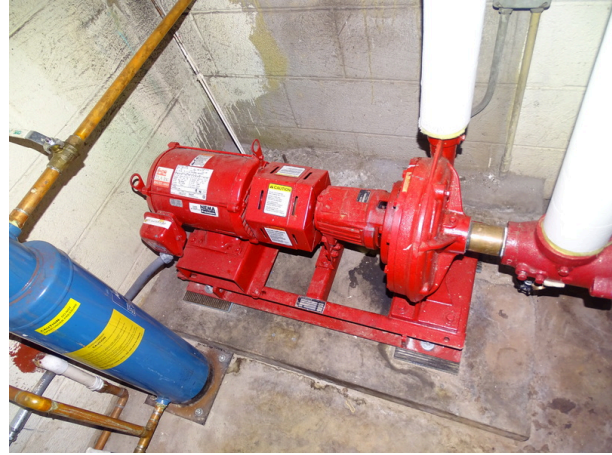
Hydronic pump

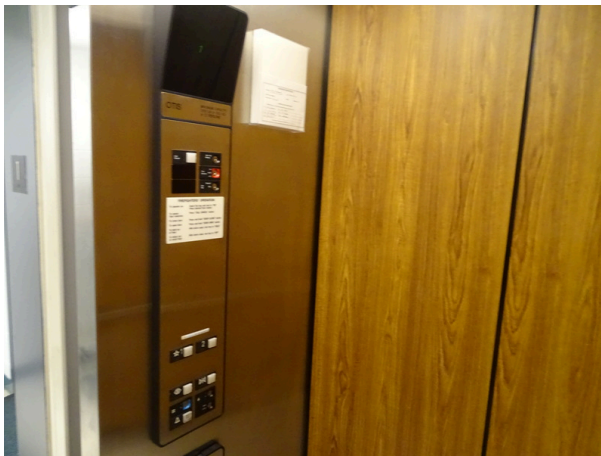
A passenger elevator was located in the west side of the building. The capacity was rated at 2,100 pounds. Routine maintenance is considered adequate to keep the elevator system in good condition during the projection period of this report. The last annual inspection was performed in February 2021 by E&F Elevator Inspections and Consulting, Inc. and monthly maintenance is provided by Southern Elevator.

Elevator cab interior

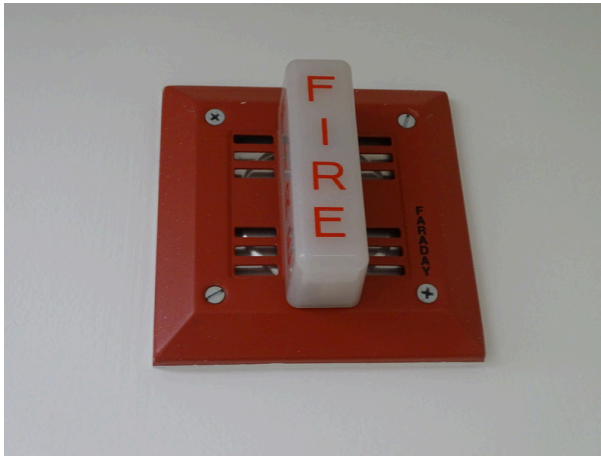
The fire alarm system was observed but not tested. There are smoke detectors, pull stations, bells and strobes, exit signs, and emergency lighting located throughout the building.

Typical fire alarm

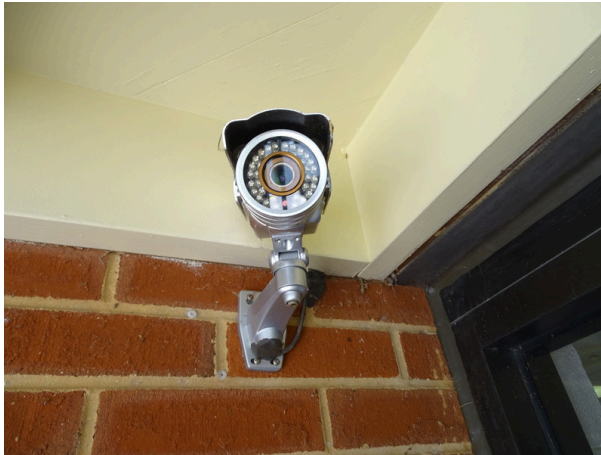
The building is monitored 24-hours a day by a computerized security system with cameras. Security cameras were observed at locations at the building interior and exterior. The security system was generally in good condition.

Security camera

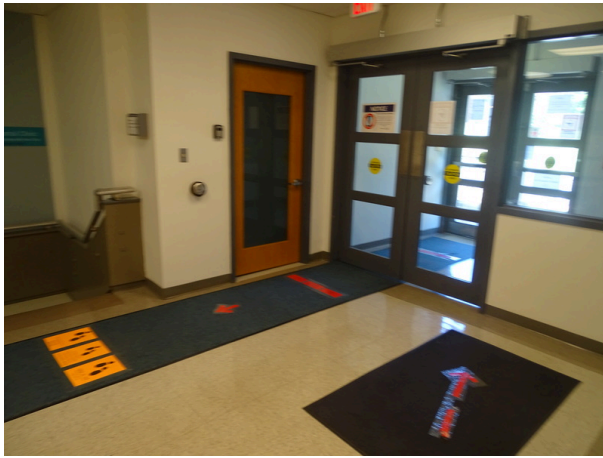
Interior finishes Lobby area

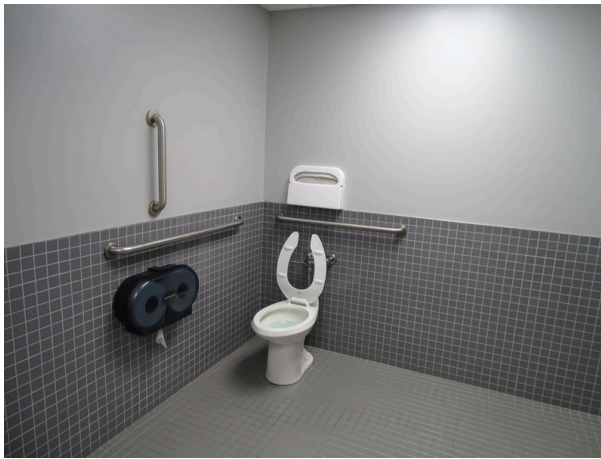
Accessible restroom

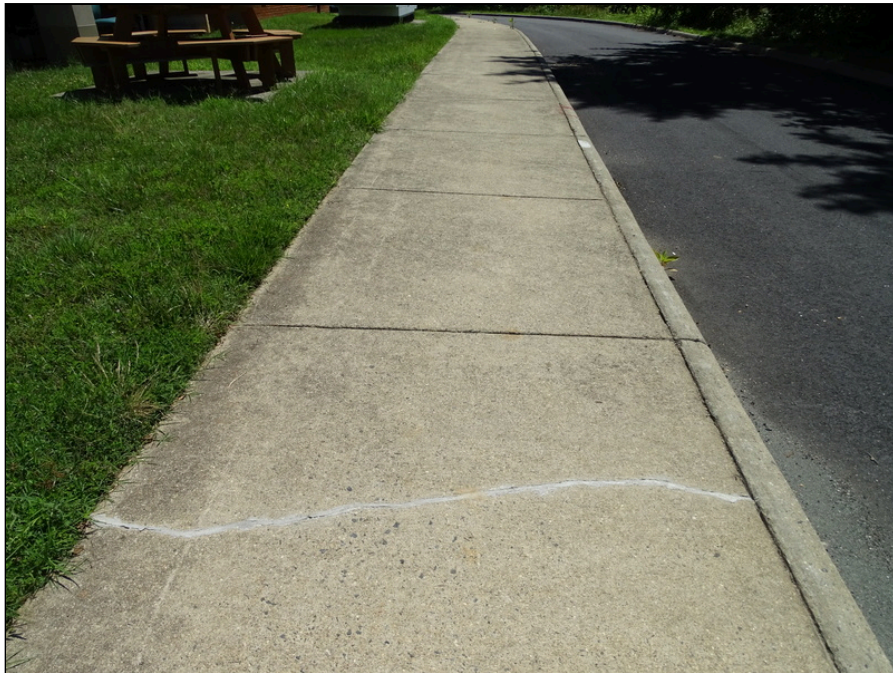
There are Concrete sidewalks of undetermined thickness provided on all sides of the building. Regularly spaced control joints were observed. The concrete sidewalks were generally in good to fair condition with recent replacement of sections observed. We recommend an allowance for future replacement as needed.

10 - Typical concrete sidewalk

Cost Recommendation	EUL	EFF AGE	RUL	Year	Cost
REPLACE CONCRETE SIDEWALK AS NEEDED	20	10	10	10 20	\$1,000 \$1,000
Total					\$2,000

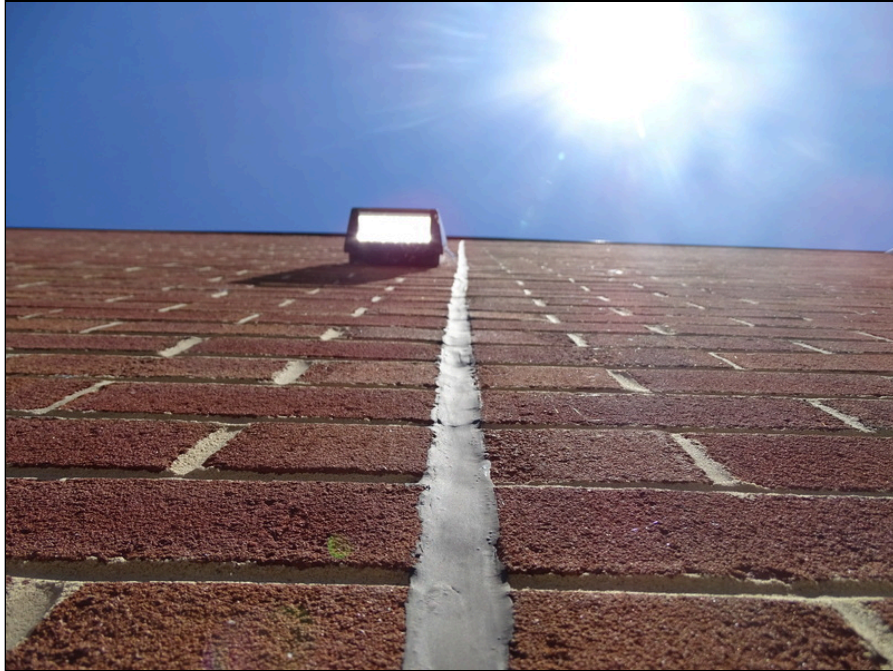
Exterior sealants are located around the window and door frames, horizontal joints, and vertical joints in the Brick. The expected useful life of exterior sealants is approximately 10 to 12 years before replacement is needed. The exterior sealants were generally in good condition. We recommend an allowance to replace the sealants during the report period.

25 - Exterior wall finishes - note sealant condition

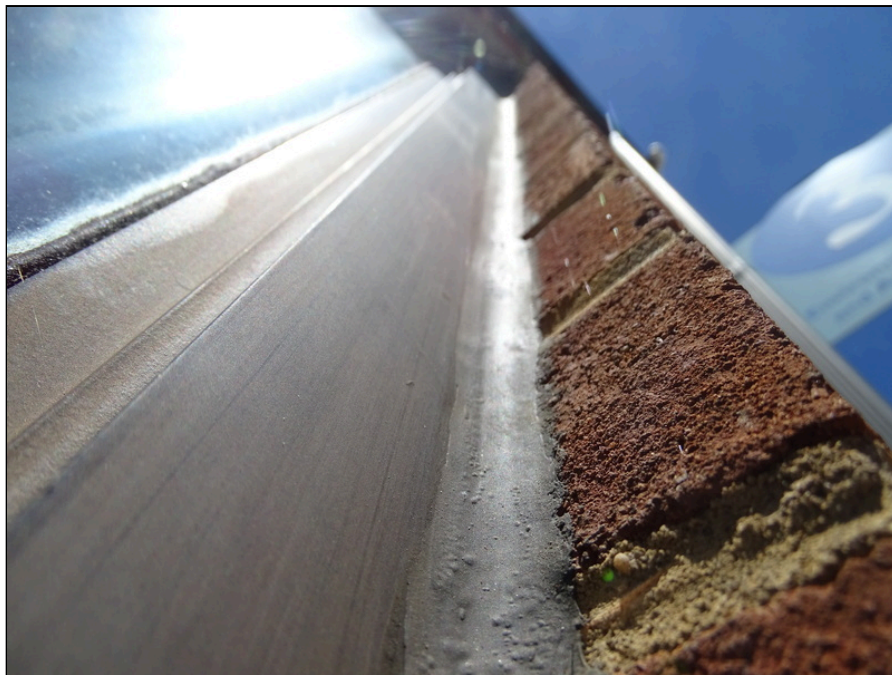
32 - Exterior window finishes - note sealant condition

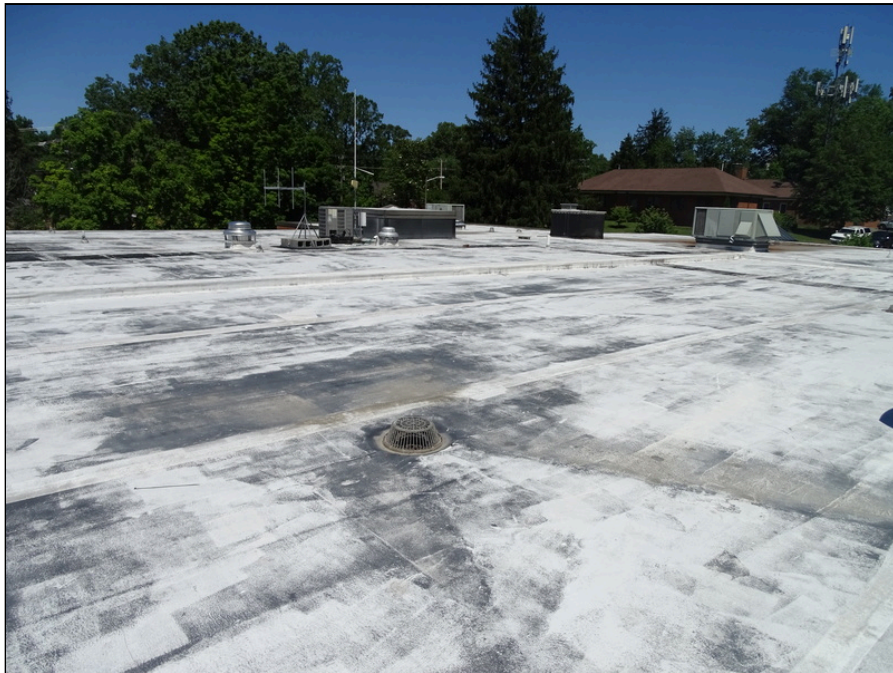
34 - Single-ply roofing system side of the building - note deterioration

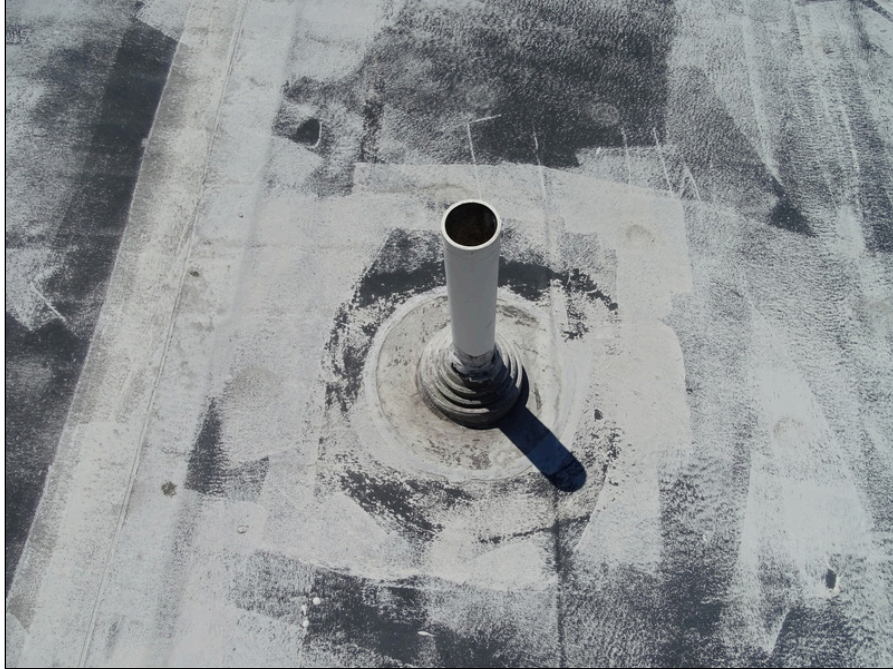
35 - Single-ply roofing system side of the building - note plumbing penetration

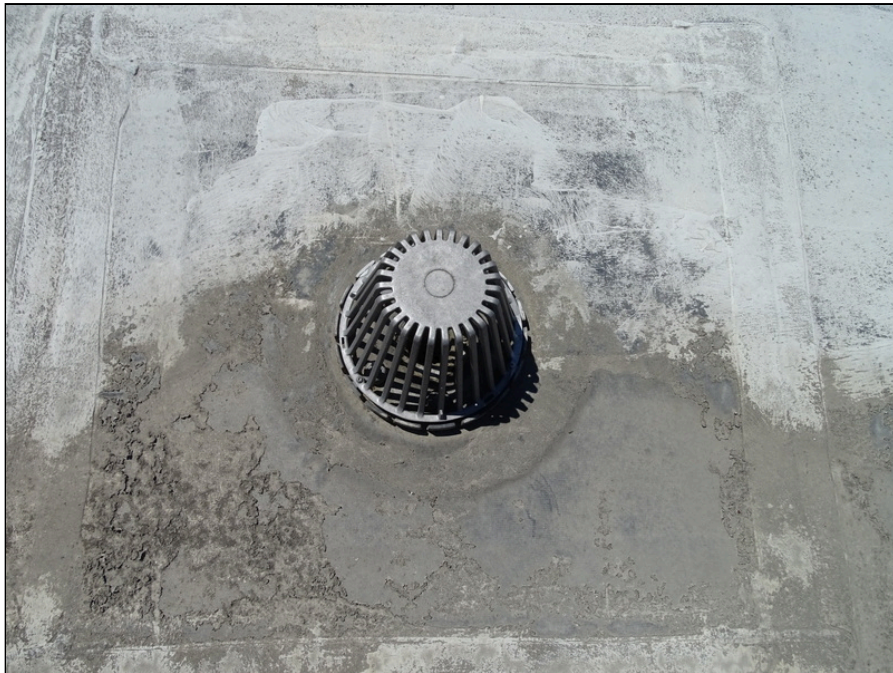
36 - Single-ply roofing system side of the building - note internal drain

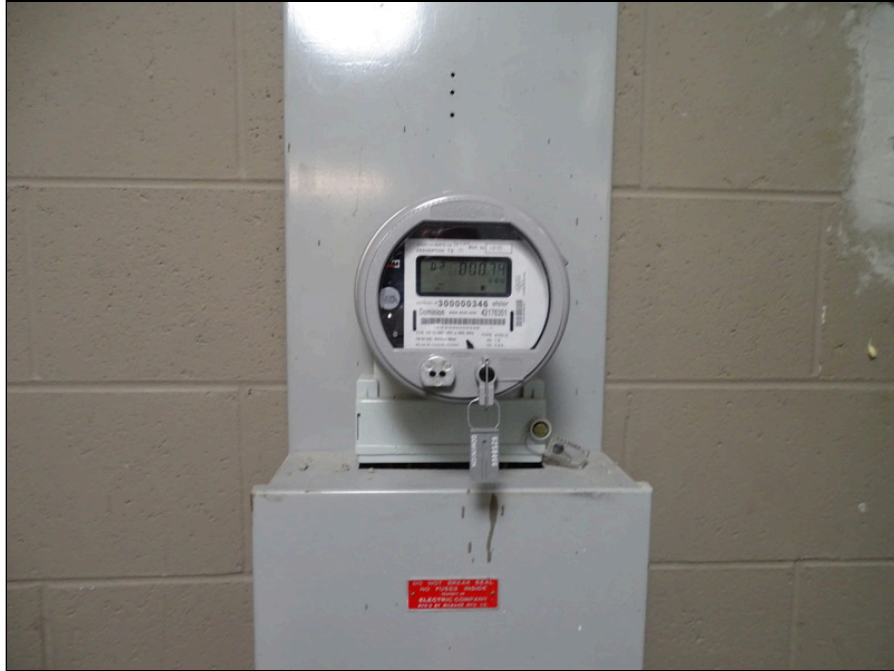
59 - Electrical meter
