ATTENTION HOME
414 4TH STREET NE
CHARLOTTESVILLE, VIRGINIA

ECS PROJECT NO. 46:6713

CITY OF CHARLOTTESVILLE - FACILITIES DEVELOPMENT

Reference: Facility Condition Assessment Report for Attention Home, 414 4TH Street NE,
Charlottesville, Virginia

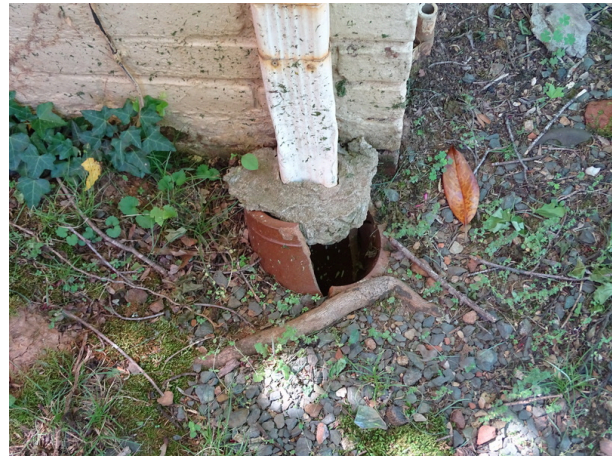
The storm water collection system includes a municipal system. The storm drainage connection from downspouts at some locations were damaged and vegetation was observed growing in the yard inlet. We recommend repairing damaged areas and removing vegetation as a maintenance item as needed.

Storm drainage from gutter - note repair needed as maintenance item

3.2.2 Storm Water Drainage																														
REPAIR STORM WATER DRAINAGE AS NEEDED				1	LS	\$3,000.00	\$3,000	100%	\$3,000																					\$3,000

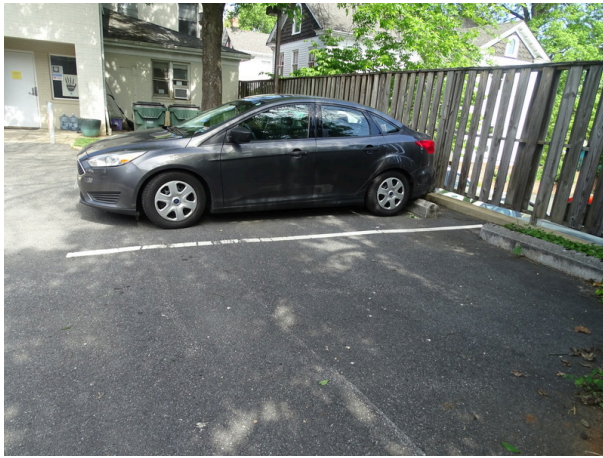
Asphalt pavement at east side of the site - note recent repairs

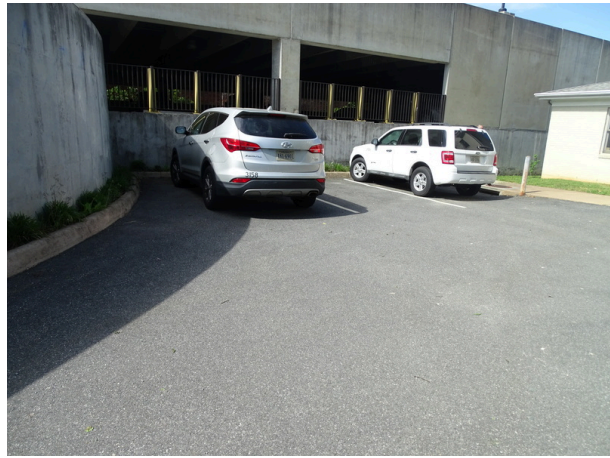
Asphalt pavement at east side of the site - note recent repairs

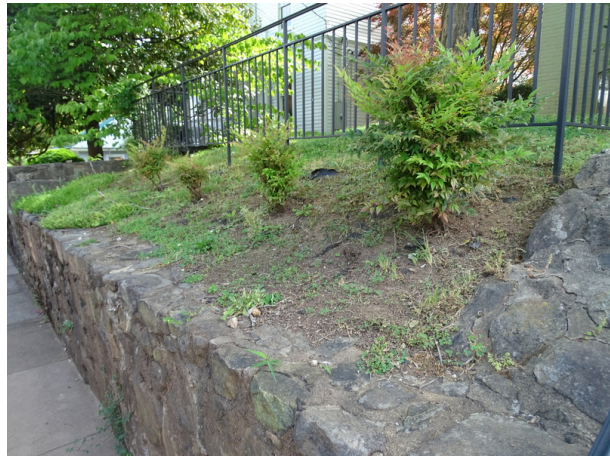
Retaining wall - note mortar deterioration

3.2.6 Landscaping and Appurtenances																														
REPAIR DETERIORATION OF MORTAR IN RETAINING WALL AS NEEDED	25	24	1	1	LS	\$5,000.00	\$5,000	100%	\$5,000																					\$5,000
REPLACE WOOD SITE FENCING AS NEEDED	20	10	10	1	LS	\$5,000.00	\$5,000	100%										\$5,000												\$5,000

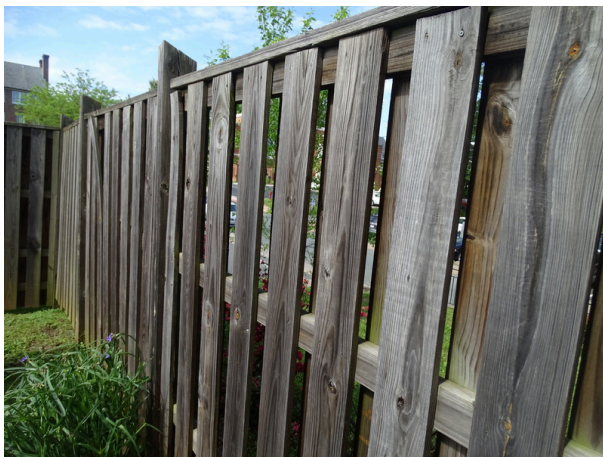
Site wood fencing - note deterioration

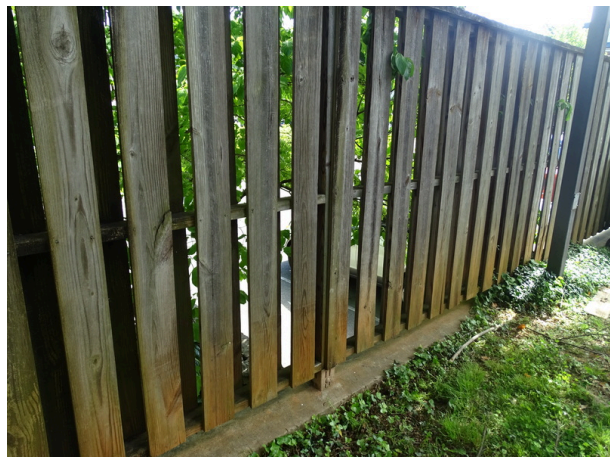
Site wood fencing - note deterioration

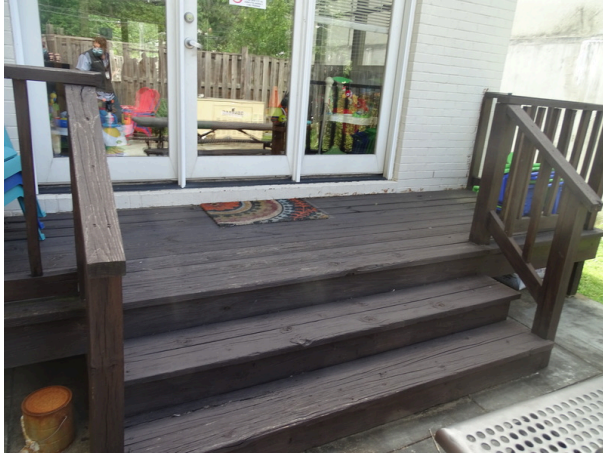
Wood deck on south side of building - note deterioration and railing loose

Immediate Repair Cost					
Item	Quantity	Unit	Unit Cost	Replacement Percent	Immediate Total
3.2.6 Landscaping and Appurtenances					
REPAIR-REPLACE WOOD DECK AND RAILINGS FOR SAFETY	1	LS	\$5,000.00	100%	\$5,000
3.3.3 Building Exteriors					
PATCH VOID IN EXTERIOR BRICK	1	Allow	\$1,000.00	100%	\$1,000
Total Repair Cost					\$6,000.00

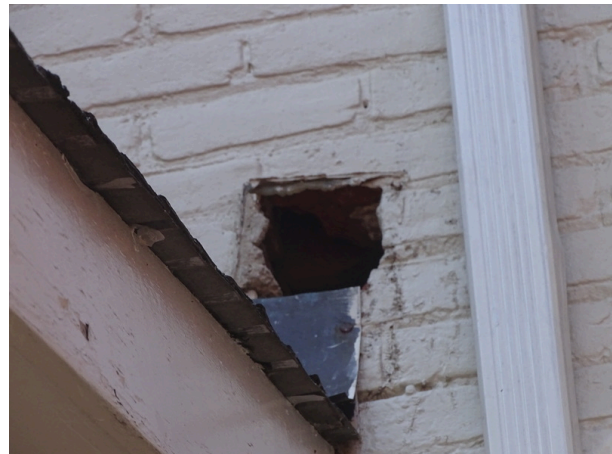
Building exteriors north side of the building - note penetration in exterior needing repair

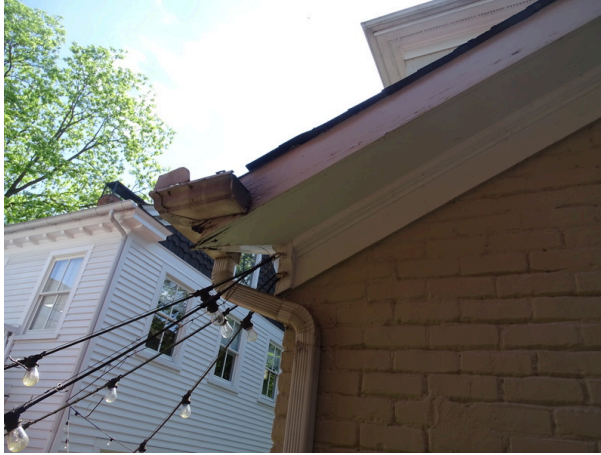
The wood trim and wood covered soffits are painted. The paint was generally in good to fair condition with some peeling and wood trim deterioration observed. Painting of exterior components is typically recommended every 5 to 7 years. We recommend the brick and wood trim be painted during the report period.

Building exteriors west side of the building -
note deterioration of wood trim

3.3.3 Building Exteriors																														
PAINT EXTERIOR AND REPAIR DETERIORATED WOOD TRIM AS NEEDED	7	6	1	3	EA	\$7,500.00	\$22,500	100%	\$7,500							\$7,500							\$7,500							\$22,500

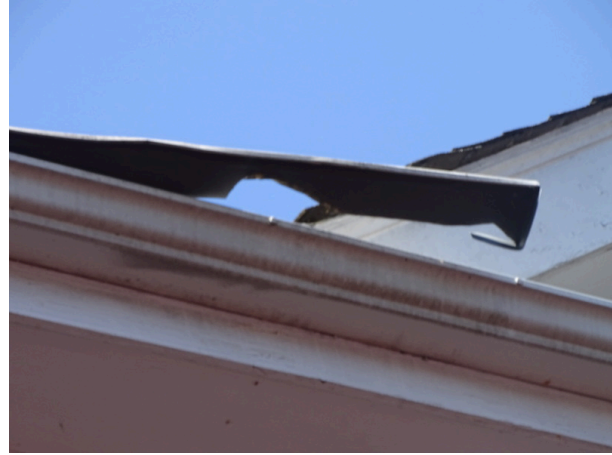
Building exteriors north side of the building -
note deterioration

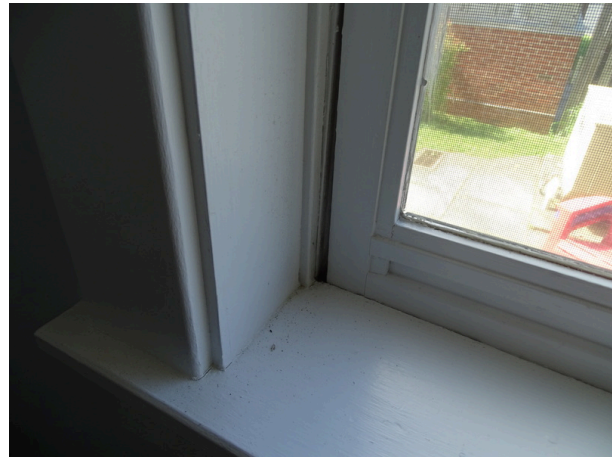
The window system for the building primarily consists of Wood-framed single-pane window units with some inoperable window units located at grade level. The expected useful life of windows is typically 30 years. The window units were in good to fair condition. We recommend the windows be replaced during the report period.

Exterior window - note operation of window difficult

3.3.4 Exterior Doors																														
REPLACE ENTRANCE DOORS	30	20	10	2	EA	\$1,500.00	\$3,000	100%										\$3,000												\$3,000
3.3.5 Exterior Windows																														
REPLACE WINDOWS AS NEEDED	30	20	10	25	EA	\$1,000.00	\$25,000	100%										\$25,000												\$25,000

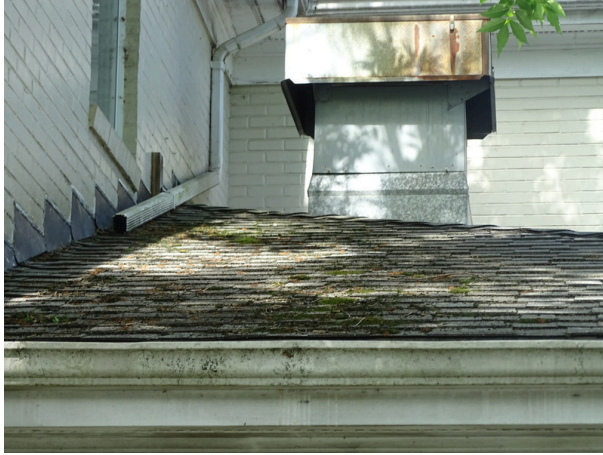
The main roofing system consists of an Asphalt shingle roofing system over the building. The roofing system appears to be replaced within the last 15 to 20 years. The expected useful life of an asphalt shingle roofing system is typically 20 years. We recommend replacing the roofing system when needed during the report period. Drainage for the roofing system is provided by gutters and downspouts. We recommend that the gutters and downspouts be replaced during the scheduled roof replacement. Roofing penetrations included plumbing vents and exhaust vents throughout the roofing system.

Roofing system - note deterioration

3.3.6 Roofing Systems																														
REPLACE ASPHALT SHINGLED ROOFING SYSTEM	20	15	5	3,500	SF	\$5.00	\$17,500	100%					\$17,500																	\$17,500

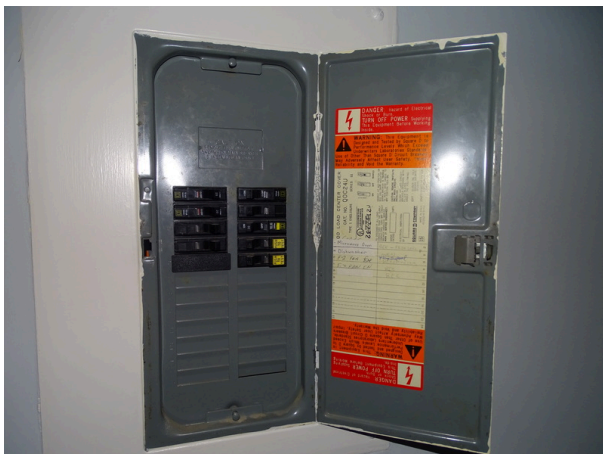
Power is distributed by copper wire from circuit breaker panels located throughout the building. Older circuit breaker panels were observed to be in generally fair condition. We recommend replacing the older circuit breaker panels.

Typical older circuit breaker panel

3.4.3.2 Distribution																													
REPLACE OLDER CIRCUIT BREAKER PANELS	50	49	1	1	LS	\$5,000.00	\$5,000	100%	\$5,000																				\$5,000
Total (Uninflated)									\$59,800.00	\$0.00	\$0.00	\$0.00	\$17,500.00	\$0.00	\$0.00	\$7,500.00	\$0.00	\$48,000.00	\$0.00	\$0.00	\$4,500.00	\$0.00	\$7,500.00	\$34,800.00	\$0.00	\$0.00	\$0.00	\$0.00	\$179,600.00
Inflation Factor (2.5%)									1.0	1.025	1.051	1.077	1.104	1.131	1.16	1.189	1.218	1.249	1.28	1.312	1.345	1.379	1.413	1.448	1.485	1.522	1.56	1.599	
Total (inflated)									\$59,800.00	\$0.00	\$0.00	\$0.00	\$19,316.73	\$0.00	\$0.00	\$8,915.14	\$0.00	\$59,945.42	\$0.00	\$0.00	\$6,052.00	\$0.00	\$10,597.30	\$50,400.78	\$0.00	\$0.00	\$0.00	\$0.00	\$215,027.37
Evaluation Period:									20

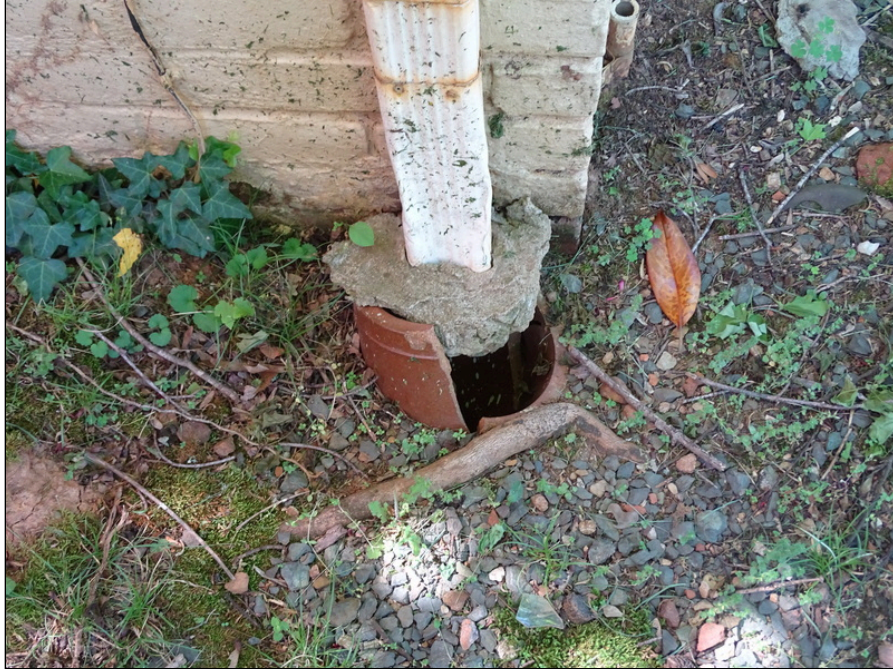
3 - Storm drainage from gutter - note repair needed as maintenance item

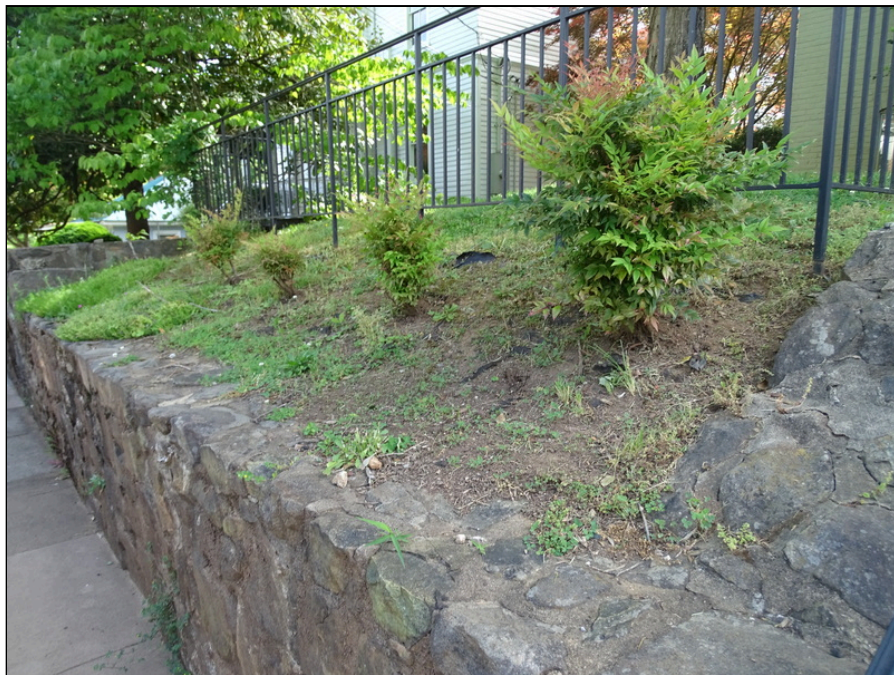
8 - Retaining wall - note mortar deterioration

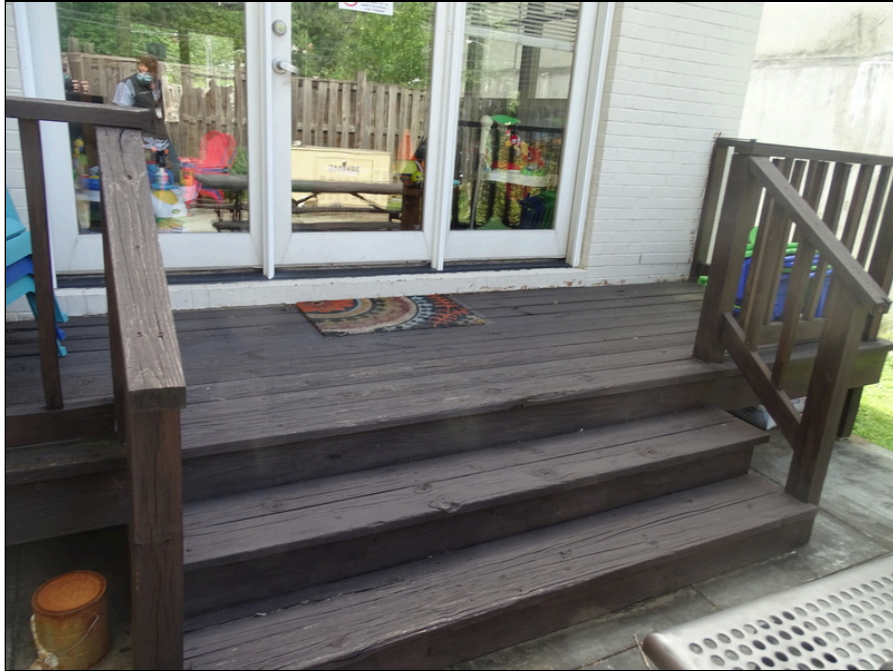
9 - Wood deck on south side of building - note deterioration and railing loose

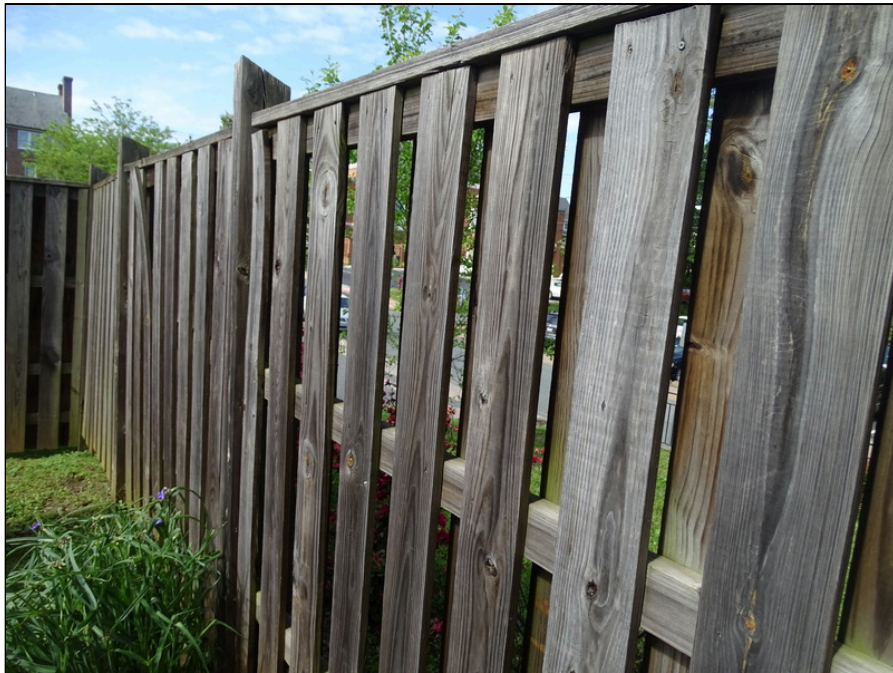
10 - Site wood fencing - note deterioration

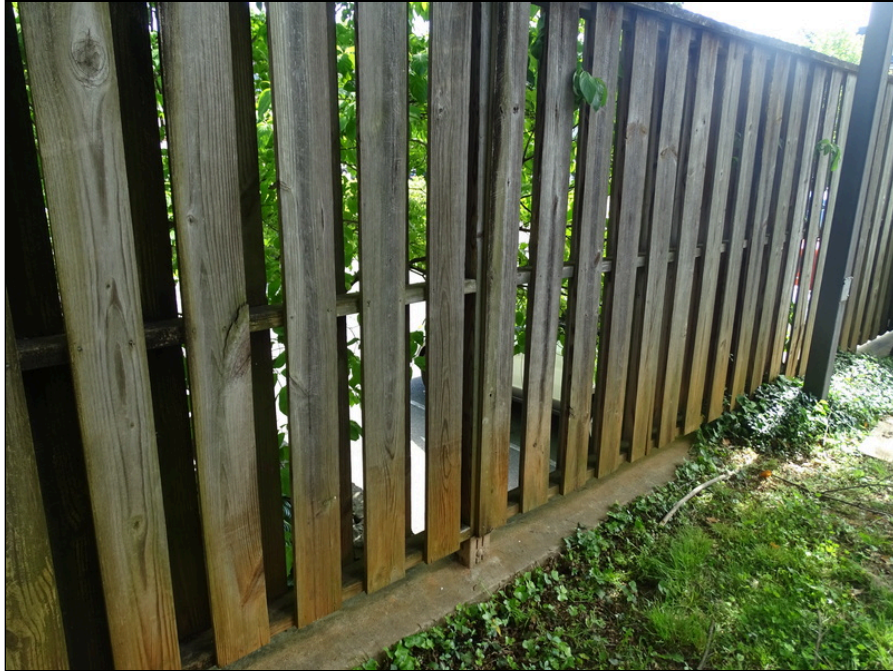
11 - Site wood fencing - note deterioration

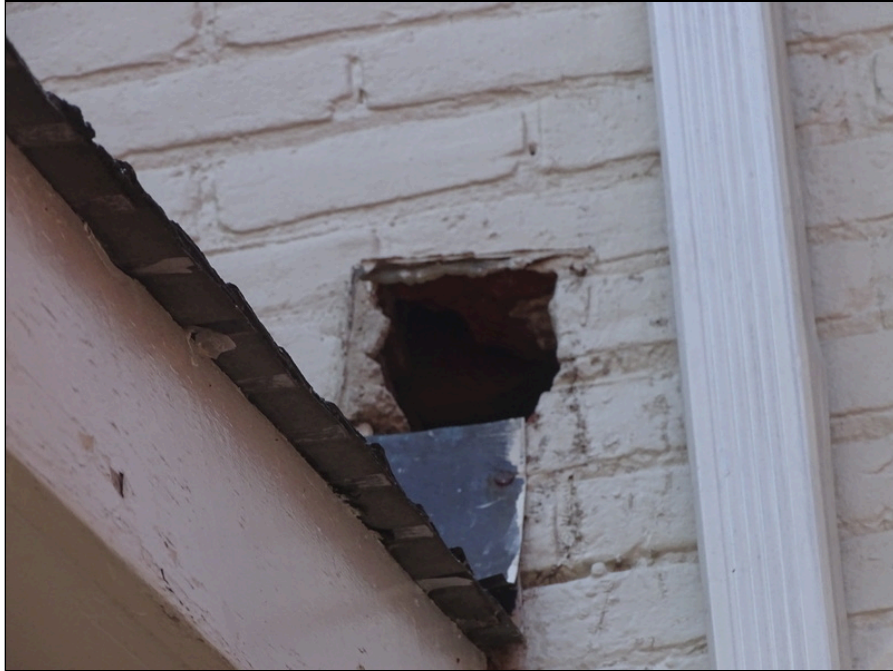
17 - Building exteriors north side of the building - note penetration in exterior needing repair

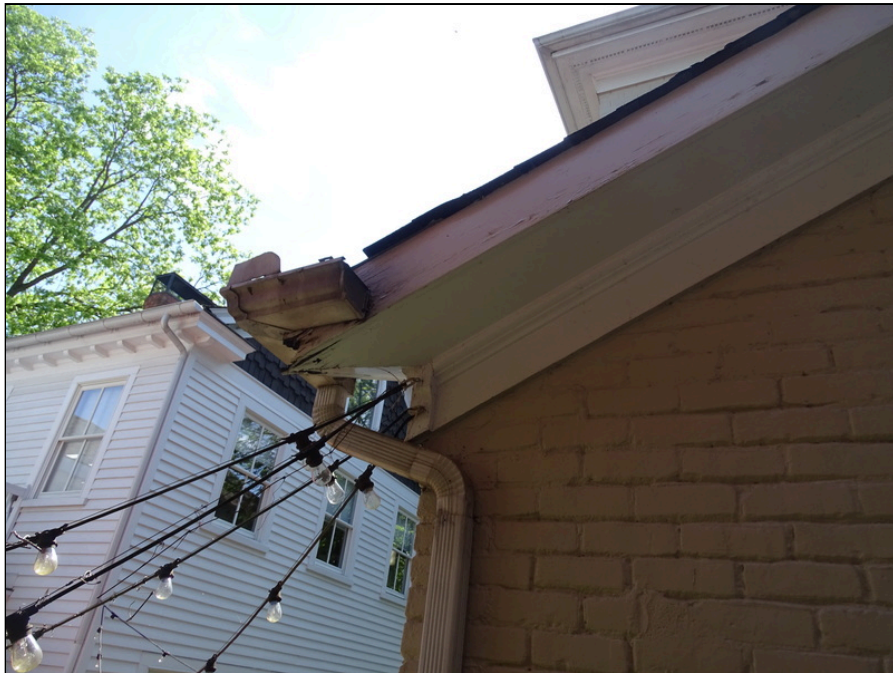
18 - Building exteriors west side of the building - note deterioration of wood trim

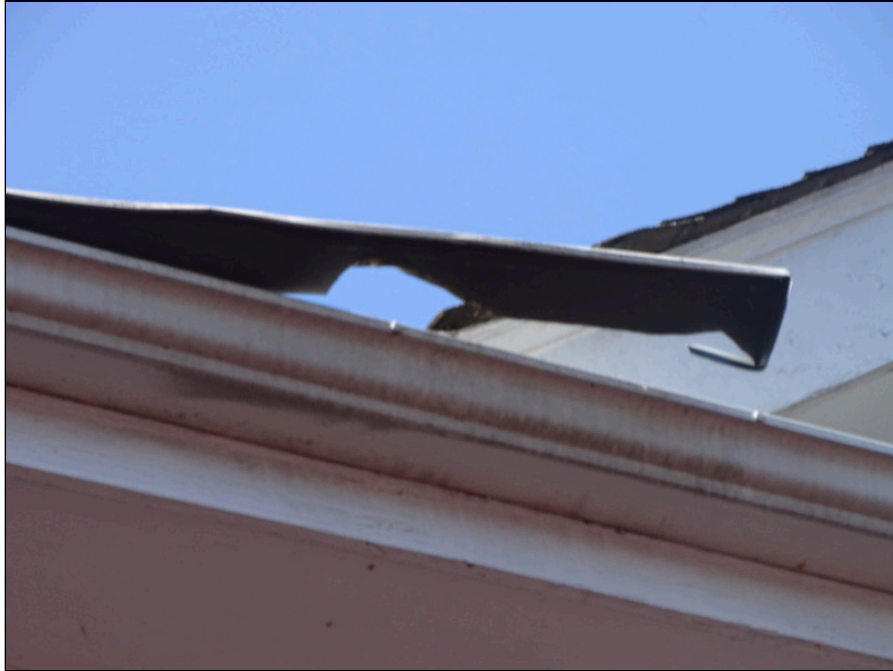
19 - Building exteriors north side of the building - note deterioration

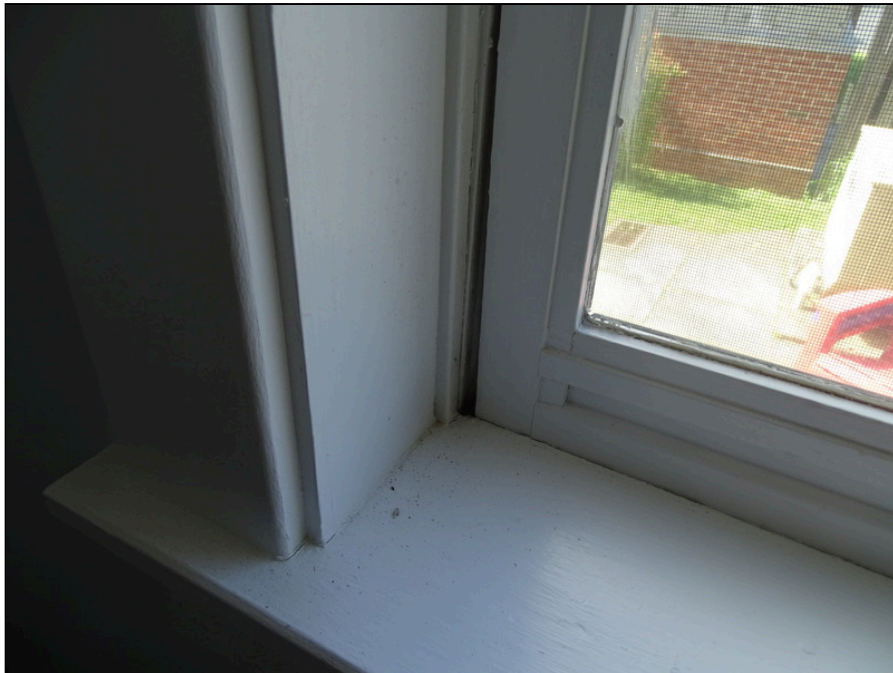
22 - Exterior window - note operation of window difficult

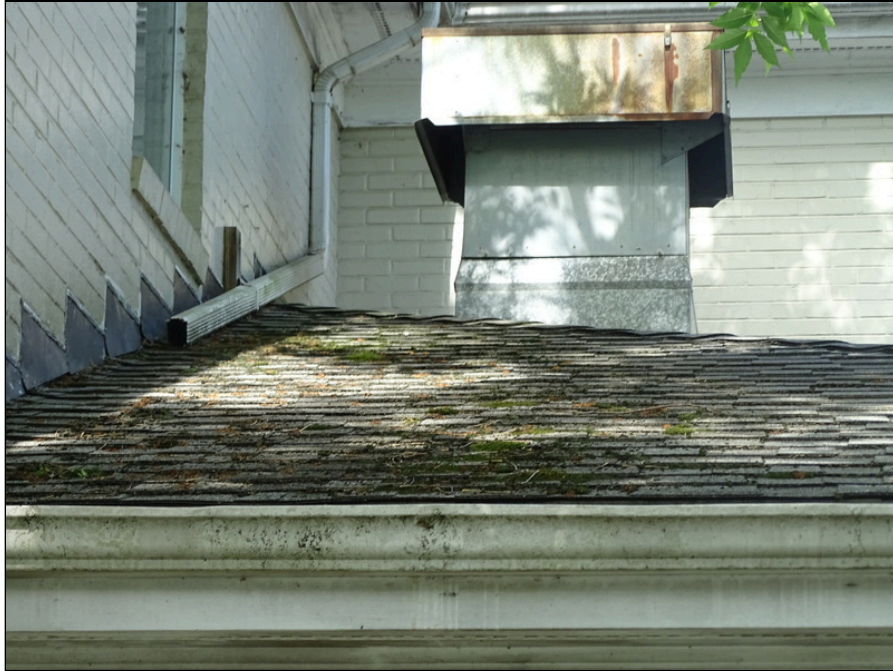
25 - Roofing system - note deterioration
