COMMUNITY ATTENTION BUILDING (E JEFFERSON)
907 EAST JEFFERSON STREET
CHARLOTTESVILLE, VIRGINIA

ECS PROJECT NO. 46:6713

CITY OF CHARLOTTESVILLE - FACILITIES DEVELOPMENT

Reference: Facility Condition Assessment Report for Community Attention Building (E Jefferson), 907 East Jefferson Street, Charlottesville, Virginia

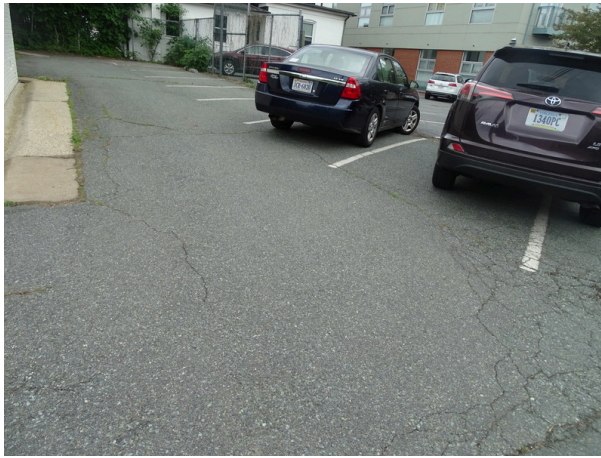
Asphalt parking north side of the building - note cracking

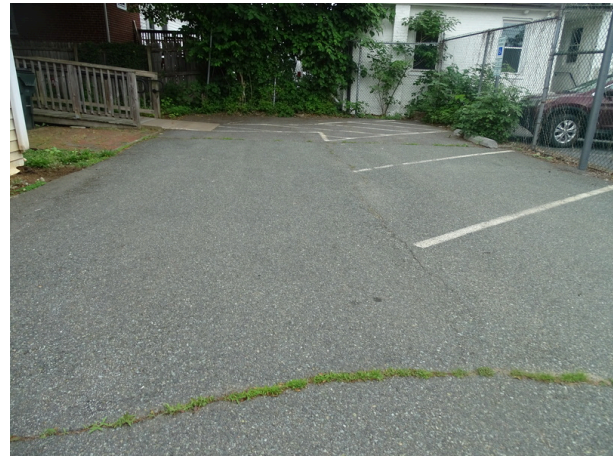
Asphalt parking north side of the building - note cracking

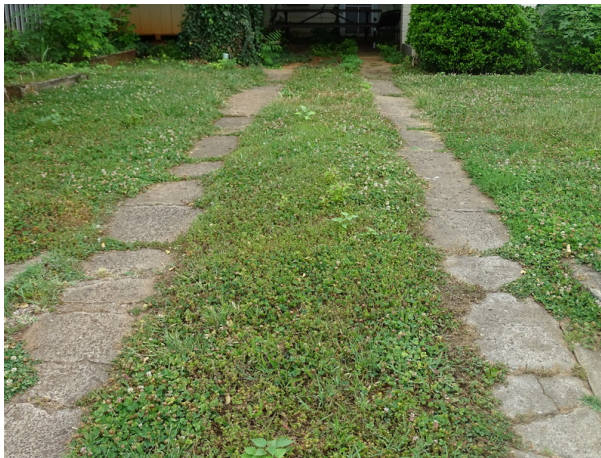
There is a concrete driveway at the south side of the building. Full depth cracking was observed with some concrete sections missing. We recommend replacing the concrete driveway during the report period.

Concrete driveway at south side - note cracking of concrete

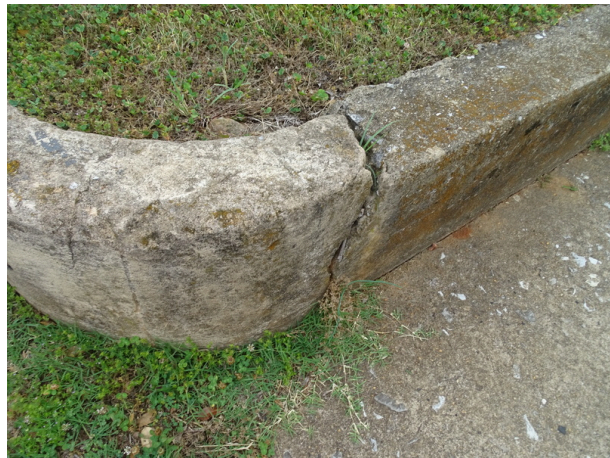
Concrete curb driveway at south side - note cracking of concrete

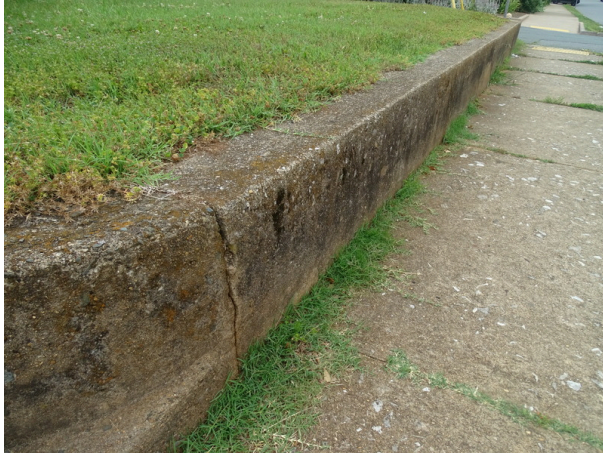
Concrete ramp at south side of the building -
note cracking of concrete wall

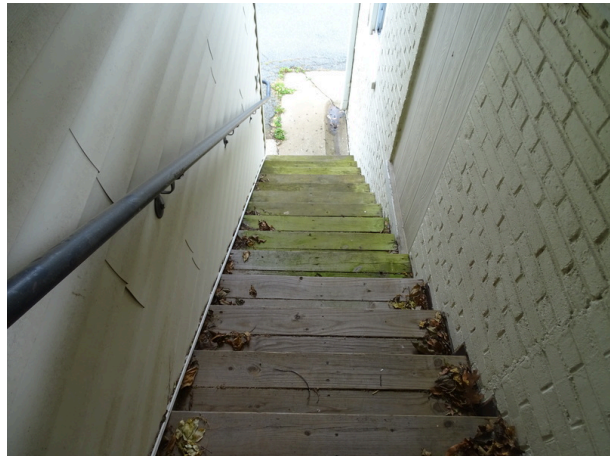
Exterior steps - note algae growth

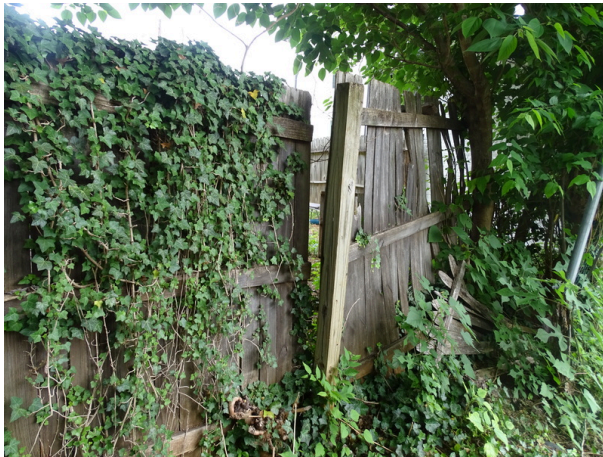
A wood fence is located on the west side of the site. The fence was generally in fair condition with damage and deterioration observed. We recommend an allowance to replace the wood fence and prune vegetation during the report period.

Wood fence at west side of the property - note damage and deterioration

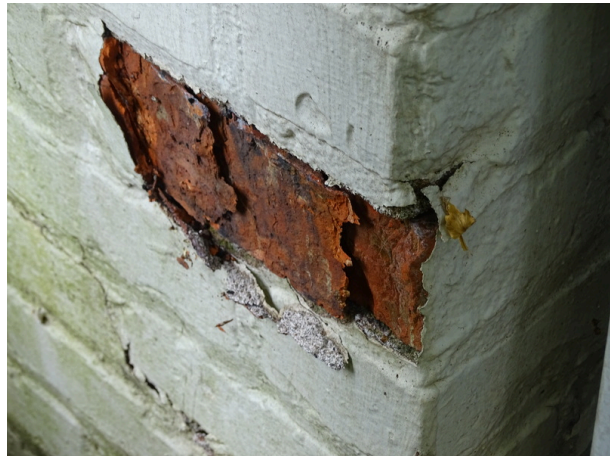
Building exterior - note deterioration

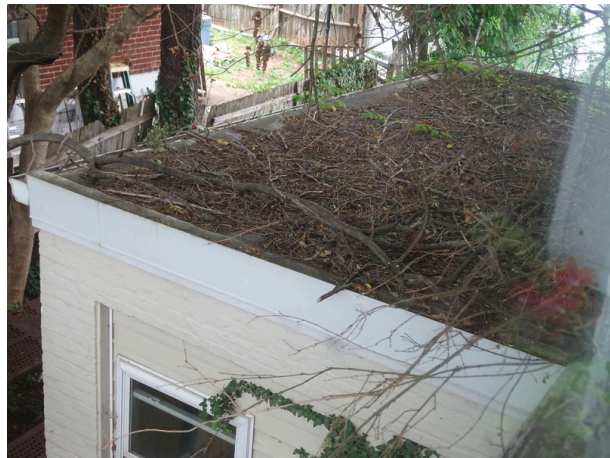
The west addition was covered by a single-ply membrane roofing system. The single-ply membrane roof was observed to be in fair condition and covered with debris. We recommend replacing the single-ply membrane roof and removing the debris as part of regular maintenance.

Single-ply roofing system at west addition

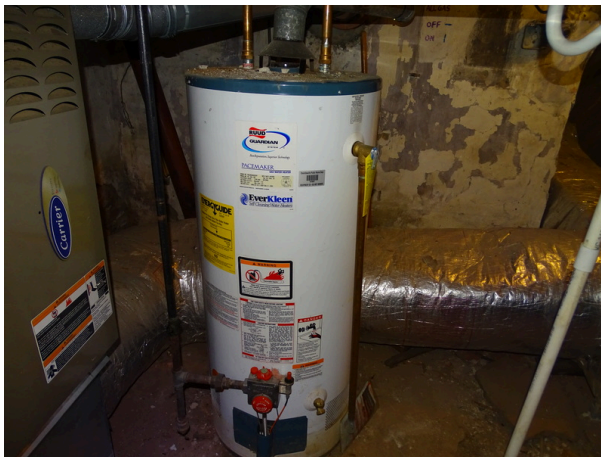
Domestic hot water to the building is provided by a Gas water heater located in the basement. The Gas water heater was manufactured by RUUD Industries in 2006. The expected useful life of Gas water heater is approximately 12 to 15 years. We recommend the Gas water heater be replaced during the report period.

Gas domestic water heater

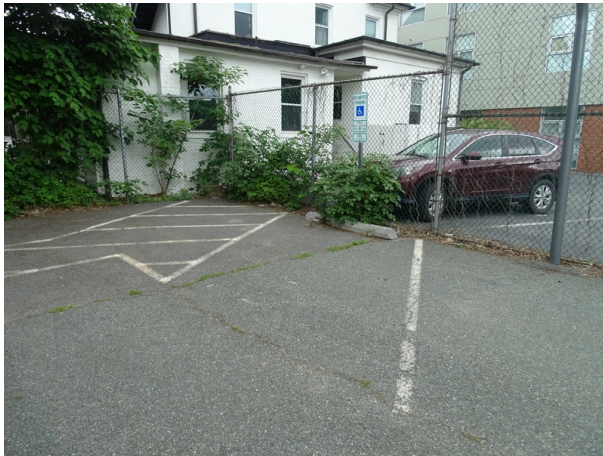
Accessible parking north side of the building -
note stripping faded

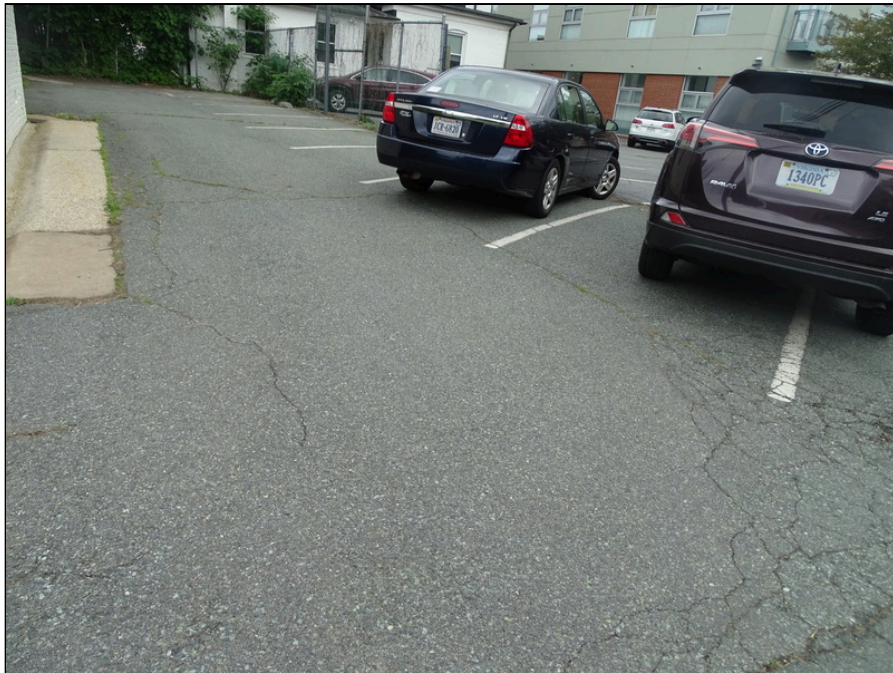
2 - Asphalt parking north side of the building - note cracking

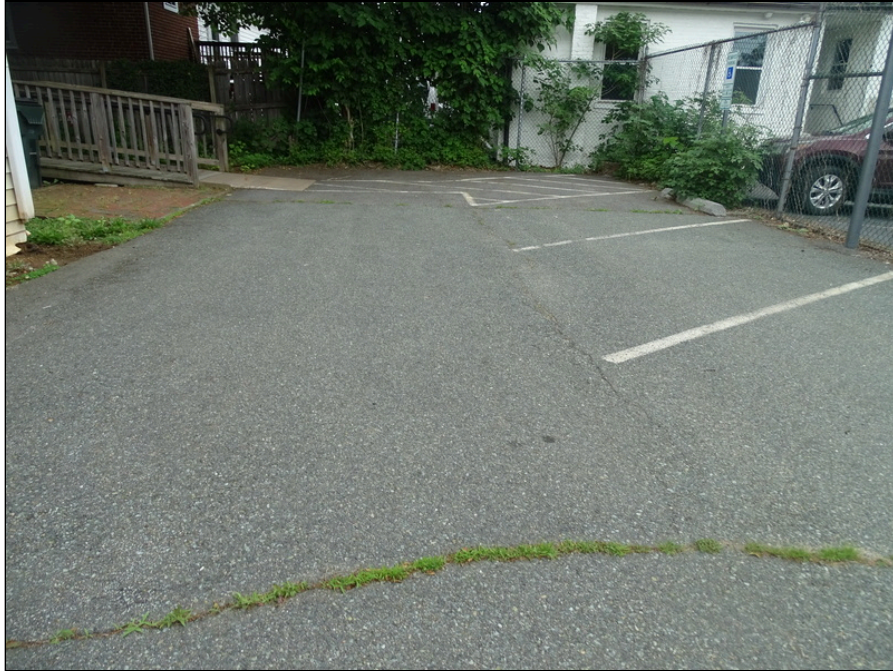
3 - Asphalt parking north side of the building - note cracking

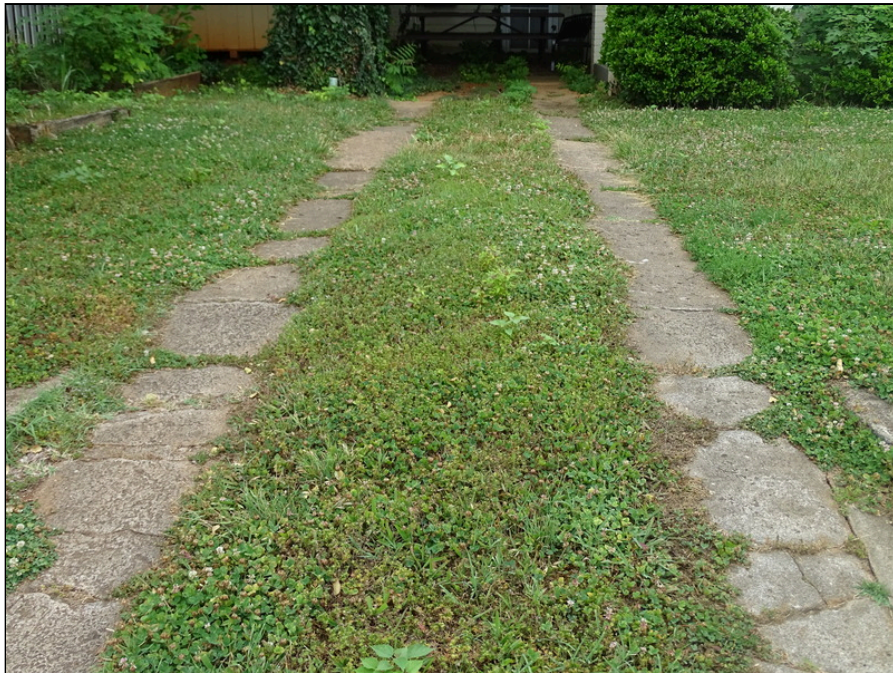
4 - Concrete driveway at south side - note cracking of concrete

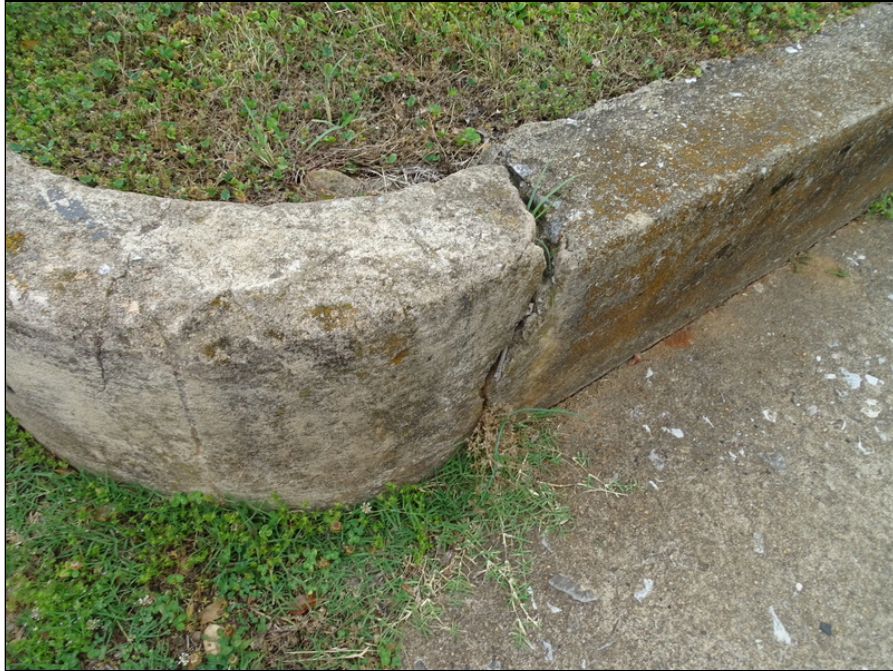
5 - Concrete curb driveway at south side - note cracking of concrete

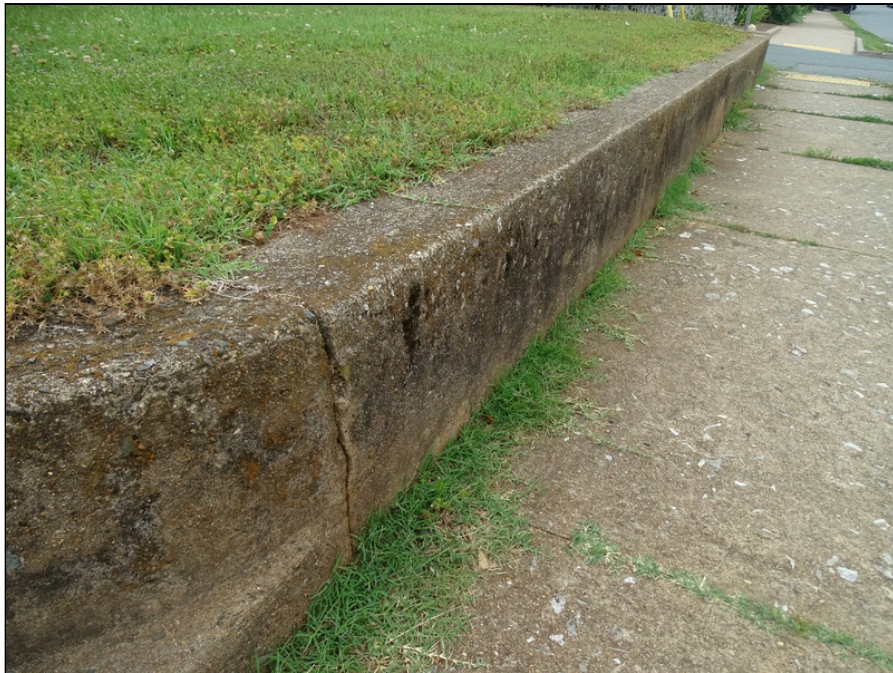
6 - Concrete ramp at south side of the building - note cracking of concrete wall

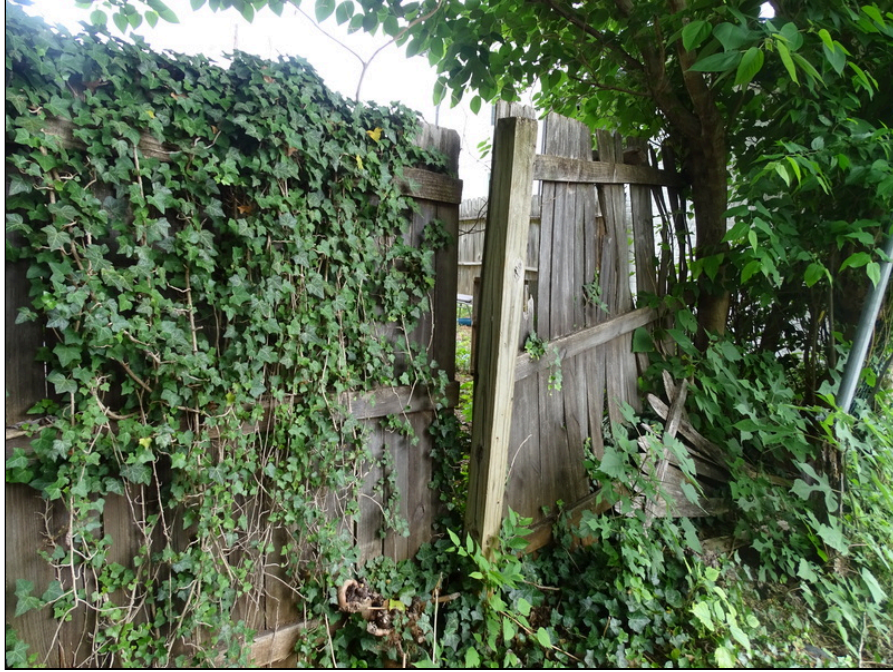
9 - Wood fence at west side of the property - note damage and deterioration

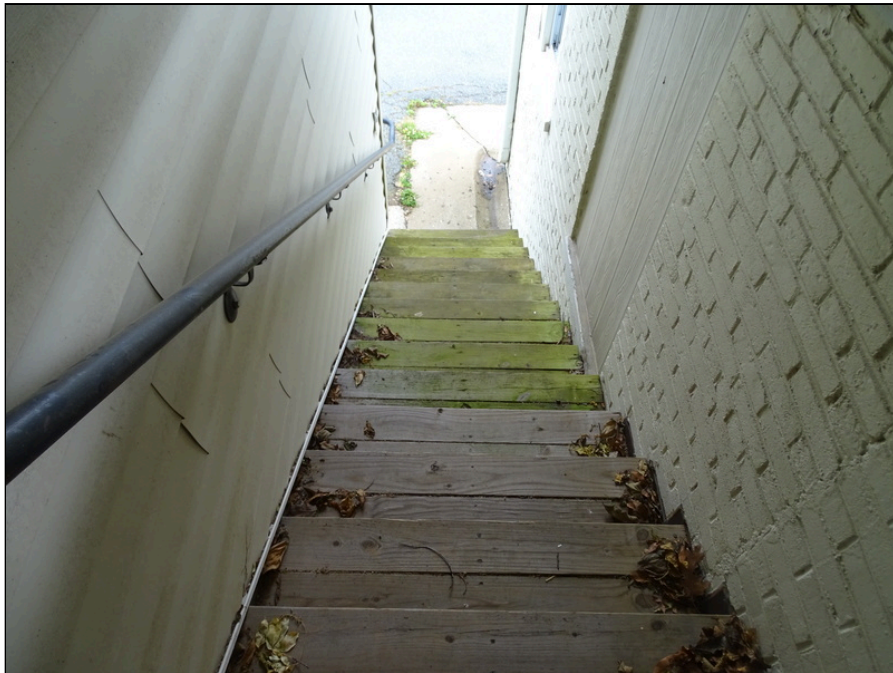
10 - Exterior steps - note algae growth

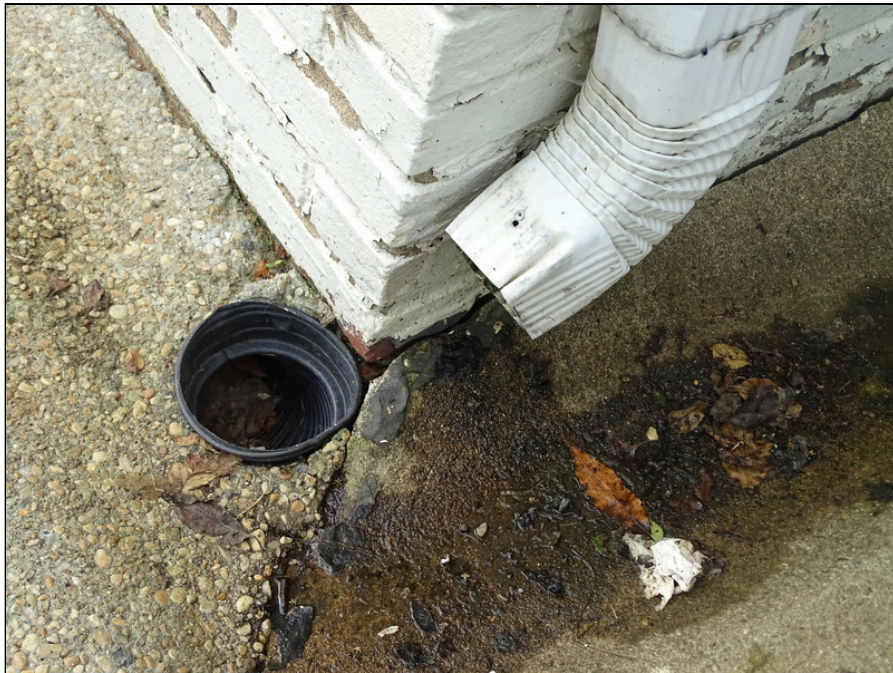
12 - Typical downspout - note deterioration

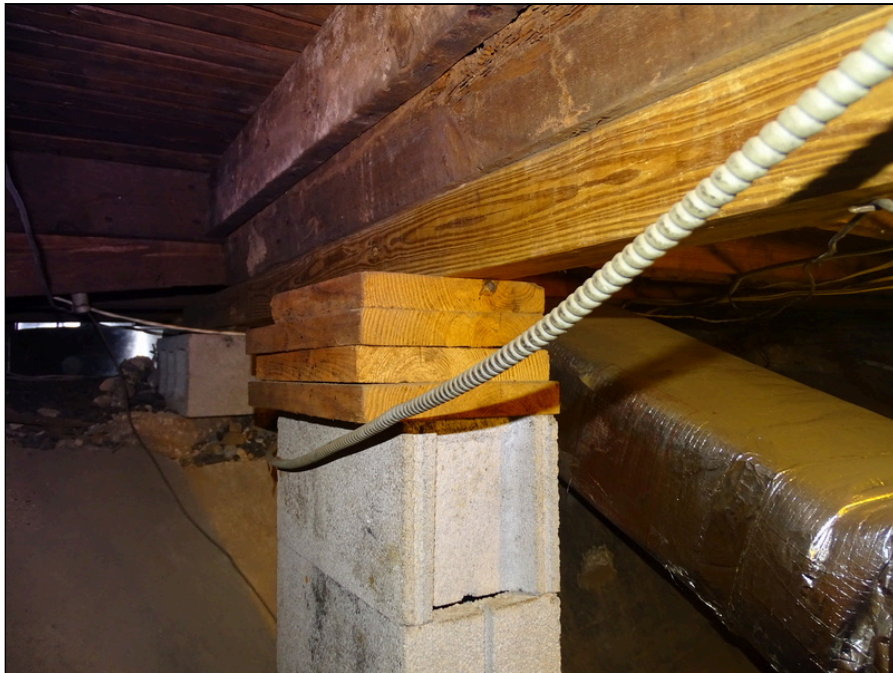
14 - Structural framing - note CMU column deterioration

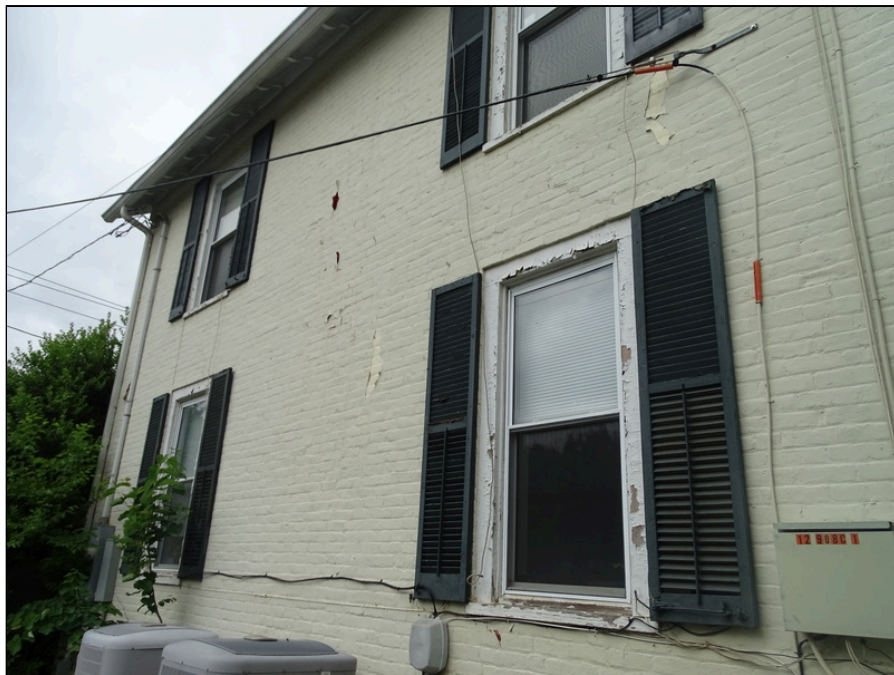
22 - Building exterior east side of the building - note peeling paint

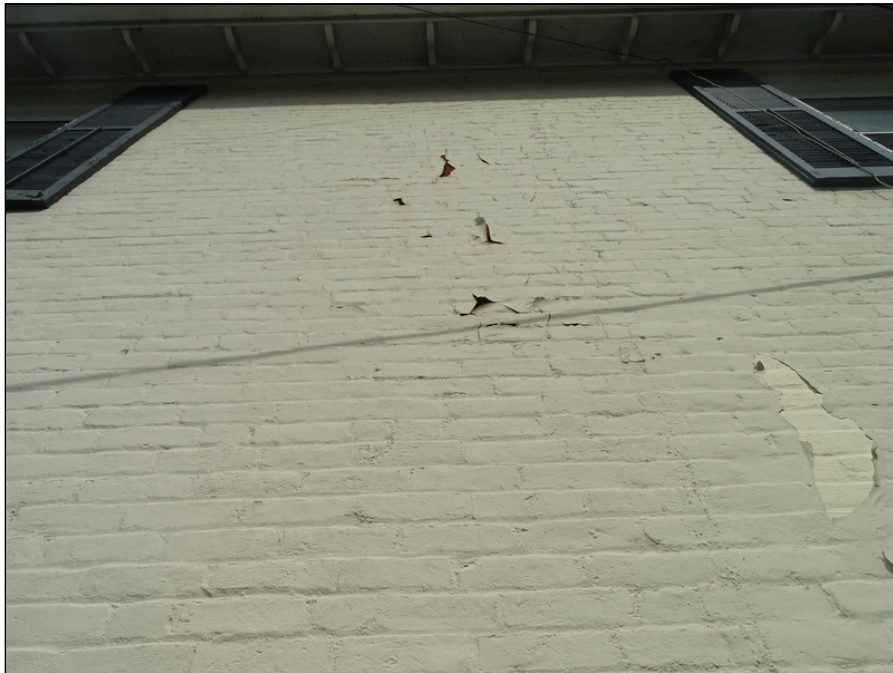
24 - Building exterior east side of the building - note peeling paint

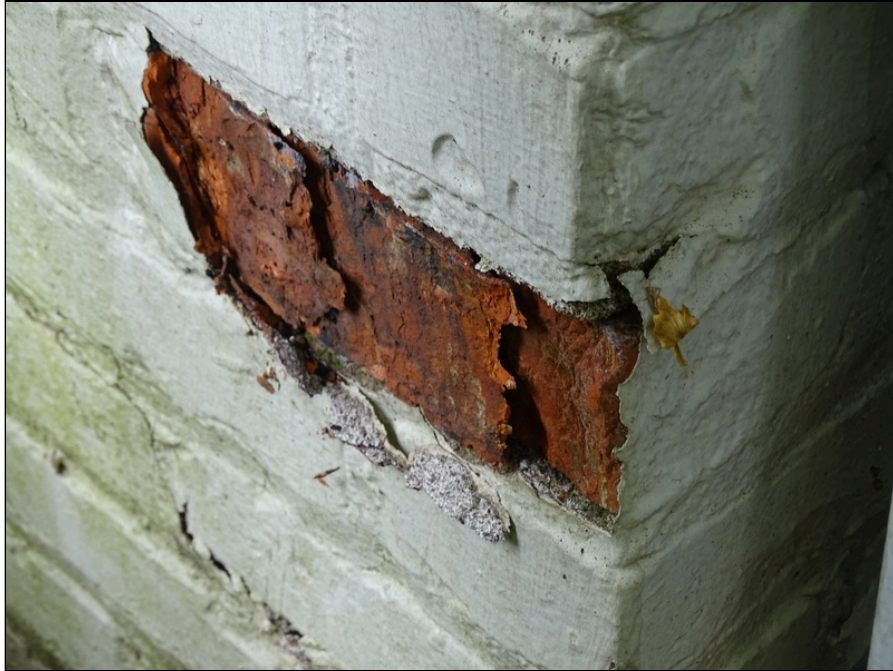
25 - Building exterior - note deterioration

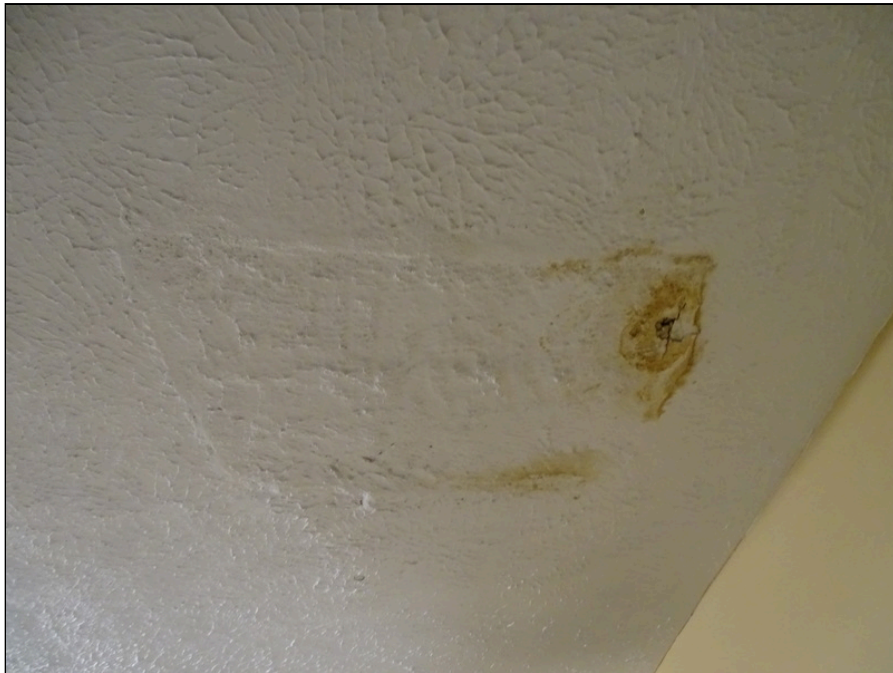
40 - Reported leakage of roofing system

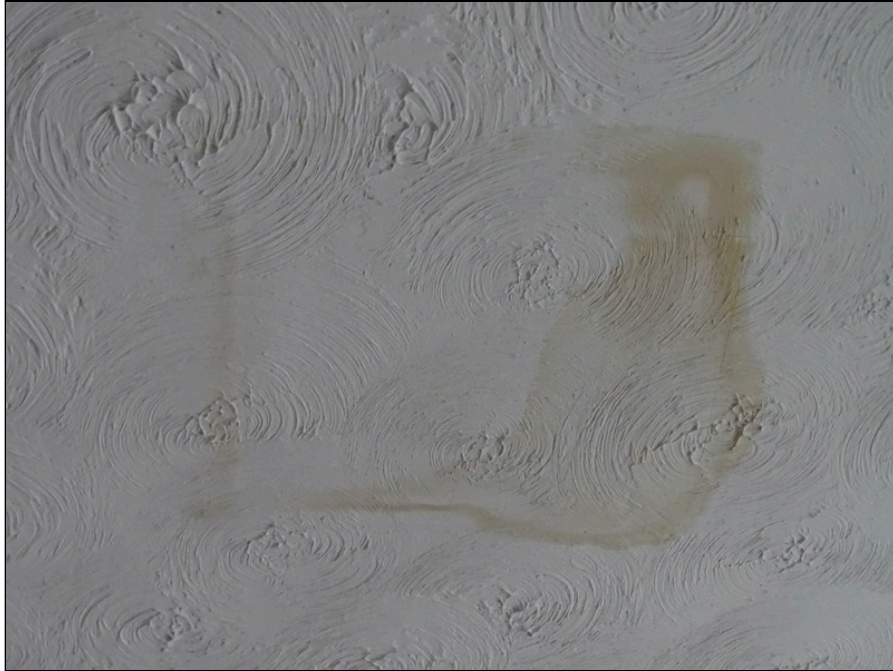
41 - Reported leakage of roofing system

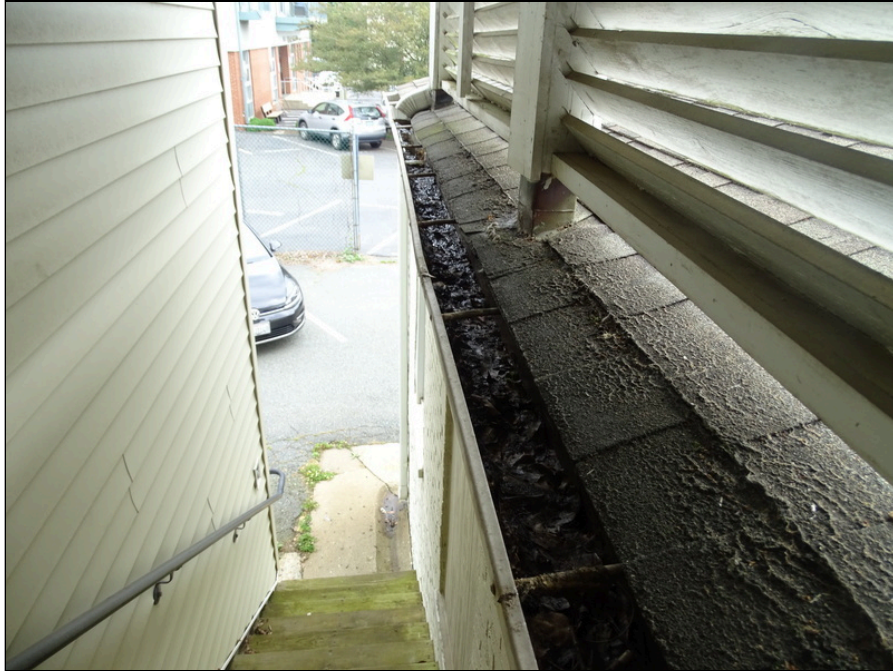
43 - Gutter - note deterioration

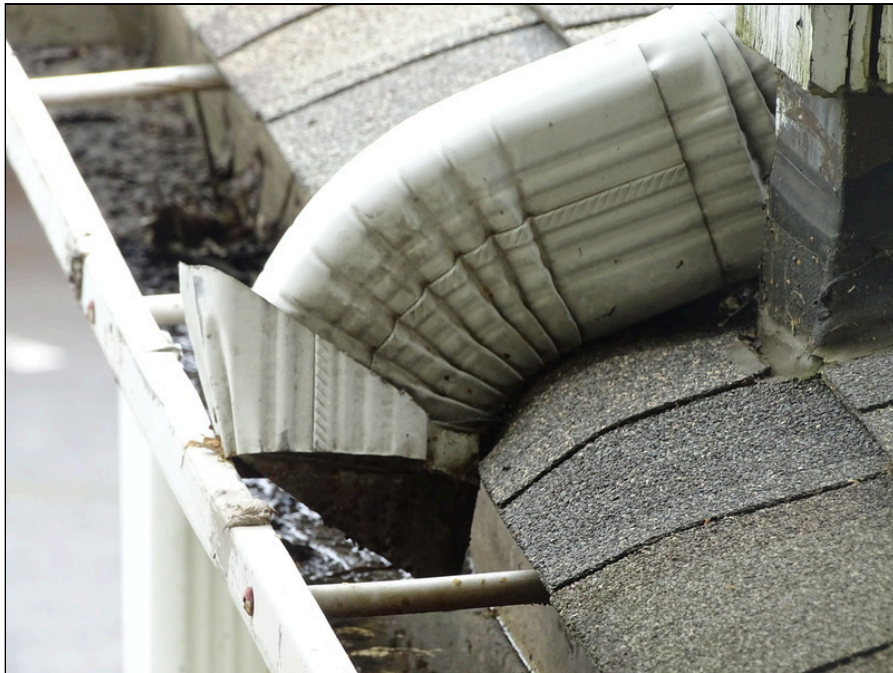
44 - Gutter and downspout - note derterioration

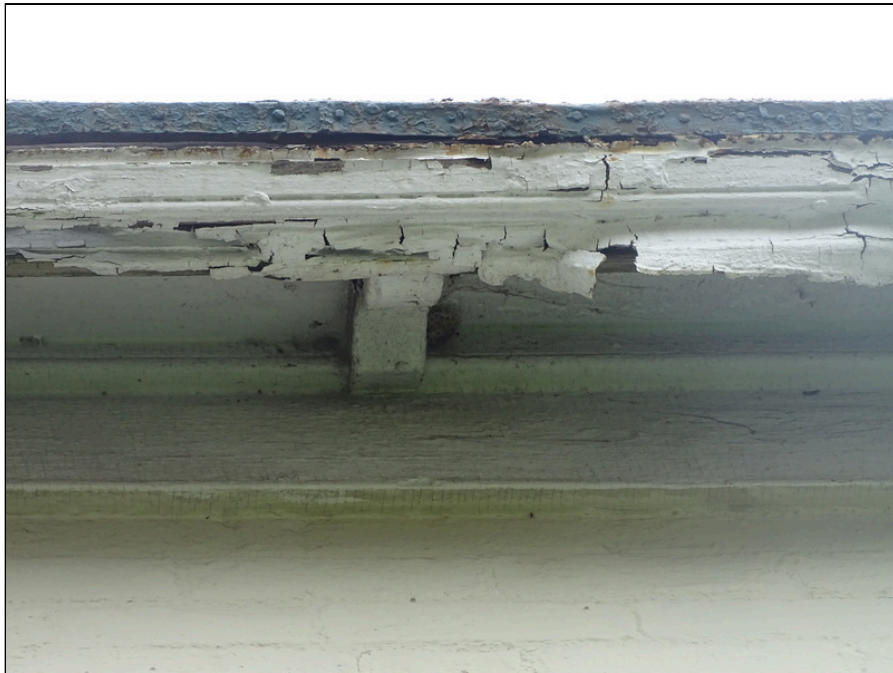
46 - Typical soffit - note peeling paint

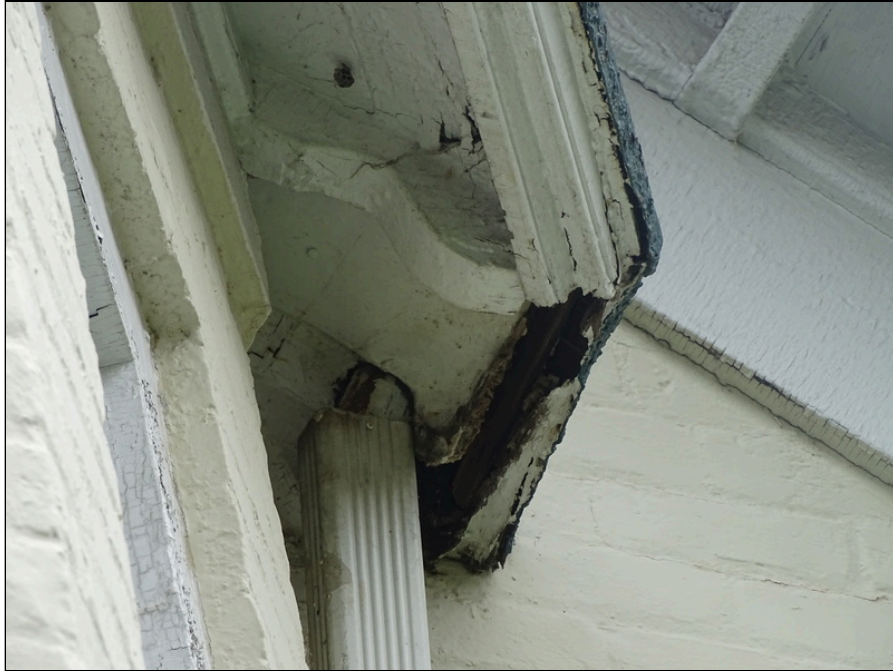
49 - Typical soffit - note deterioration

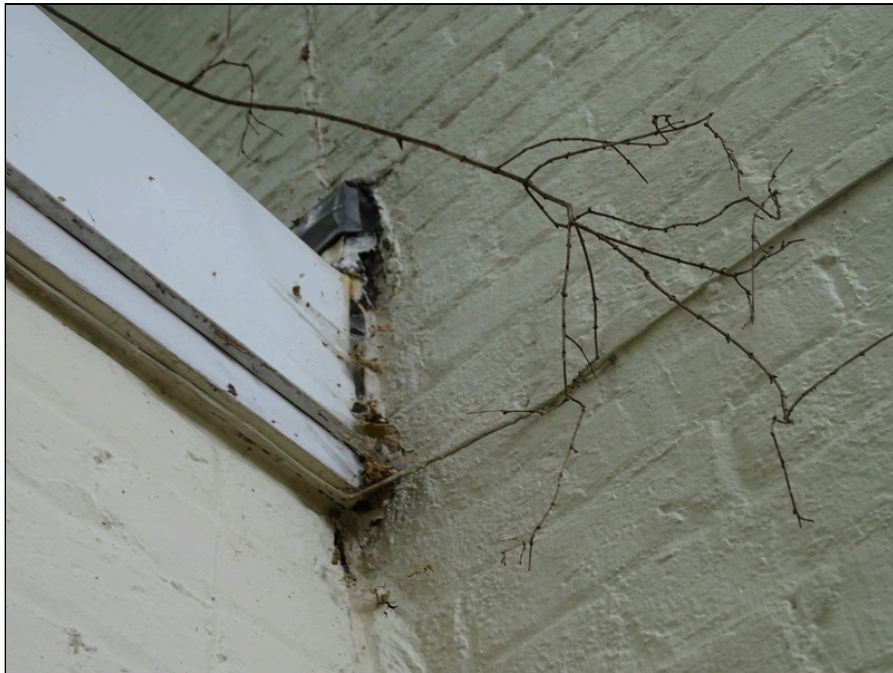
50 - Typical soffit - note deterioration

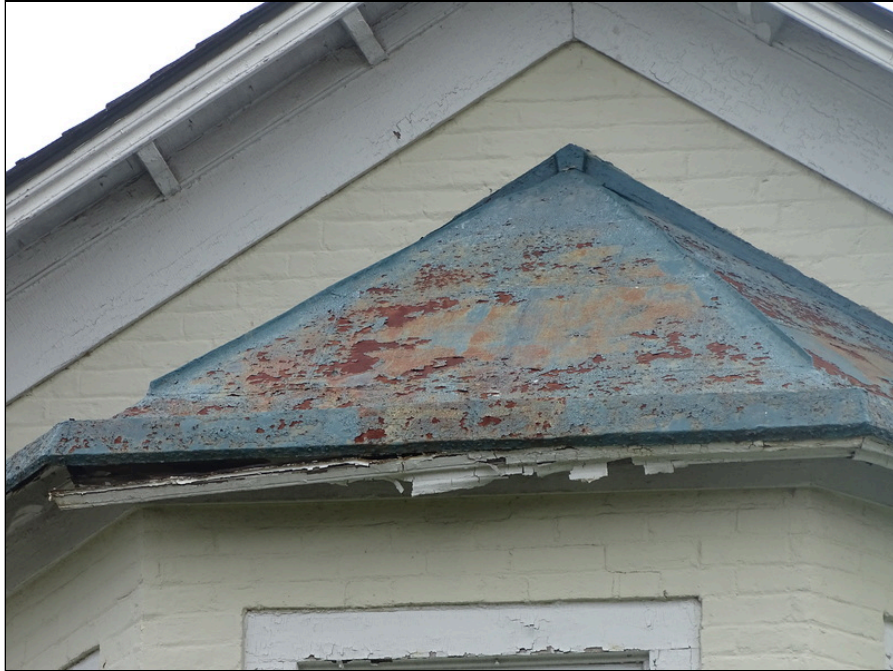
51 - Wood trim - note deterioration
