COMMUNITY ATTENTION BUILDING (E MARKET)
909 EAST MARKET STREET
CHARLOTTESVILLE, VIRGINIA

ECS PROJECT NO. 46:6713

CITY OF CHARLOTTESVILLE - FACILITIES DEVELOPMENT

Reference: Facility Condition Assessment Report for Community Attention Building (E Market), 909 East Market Street, Charlottesville, Virginia

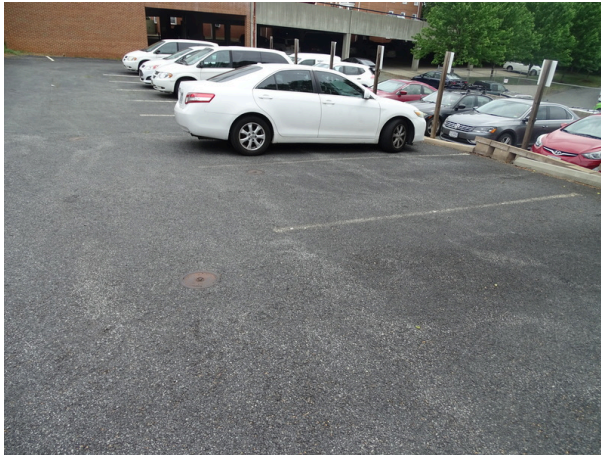
Asphalt-paved drive lanes and parking are located on the north side of the site. We observed areas of minor cracking. The expected useful life of asphalt pavement is 20 years. The asphalt pavement was observed to be in generally good condition.

Asphalt parking north side of the building - note stripping faded

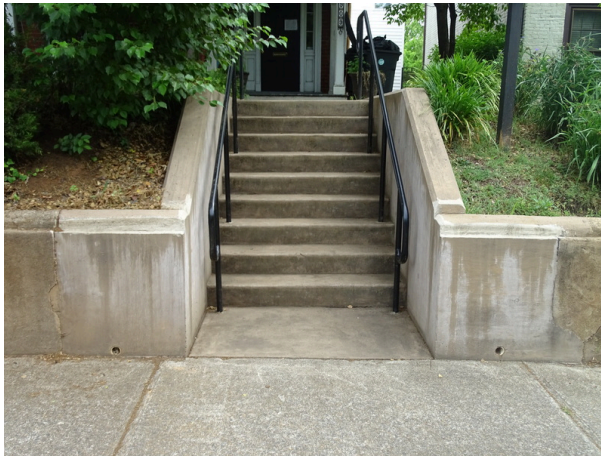
At the north side of the building, Concrete sidewalks of undetermined thickness are provided. At the south side of the building, concrete sidewalks and steps are provided. Regularly spaced control joints were observed. The Concrete sidewalks and steps were generally in good condition.

Typical concrete steps

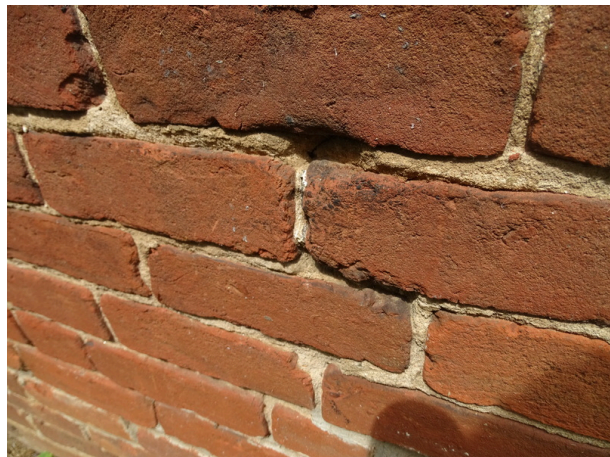
Building exterior at southeast end of the
building - note deterioration

3.3.3 Building Exteriors																													
PAINT EXTERIOR AND REPAIR DETERIORATED WOOD TRIM AS NEEDED	7	6	1	3	EA	\$15,000.00	\$45,000	100%	\$15,000							\$15,000									\$15,000				\$45,000
REPOINT BRICKWORK	20	19	1	1	LS	\$15,000.00	\$15,000	100%	\$15,000																				\$15,000

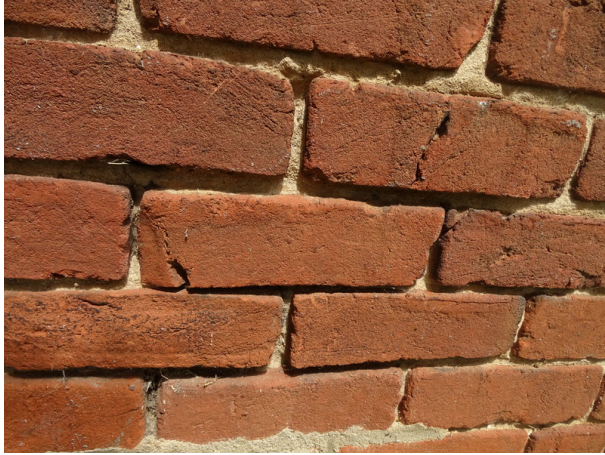
Building exterior at southeast end of the
building - note deterioration

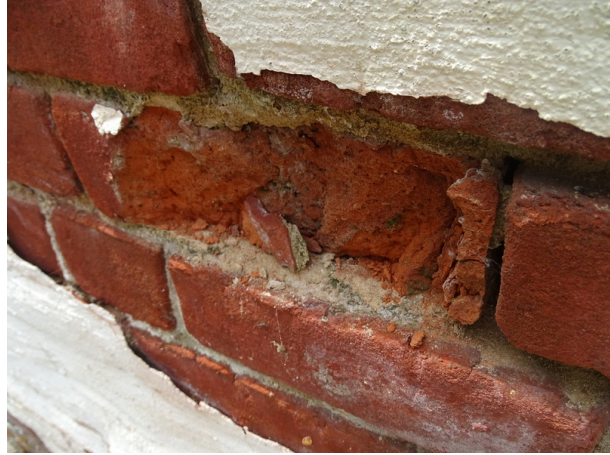
Building exterior - note deterioration

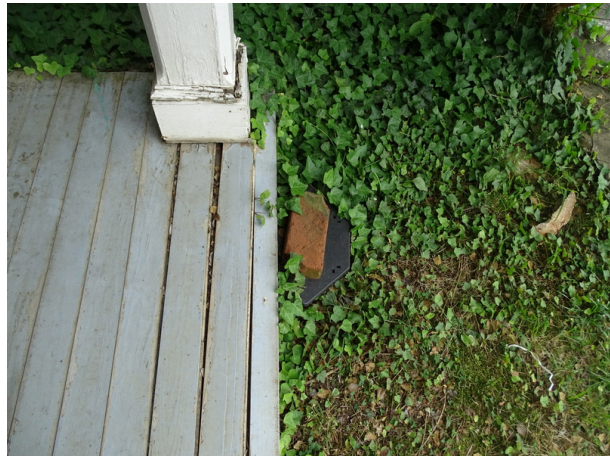
Typical column - note deterioration

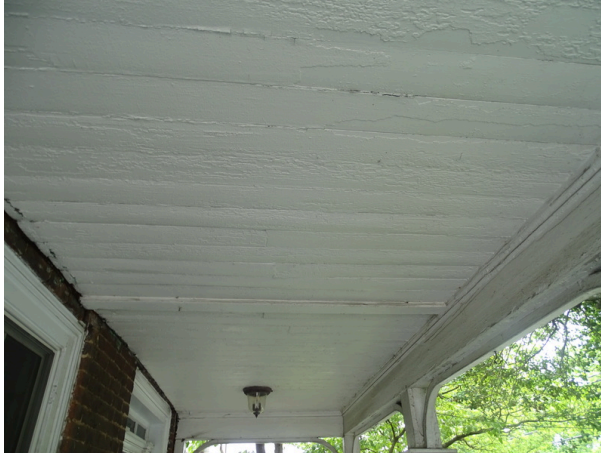
Typical Patio ceiling - note deterioration

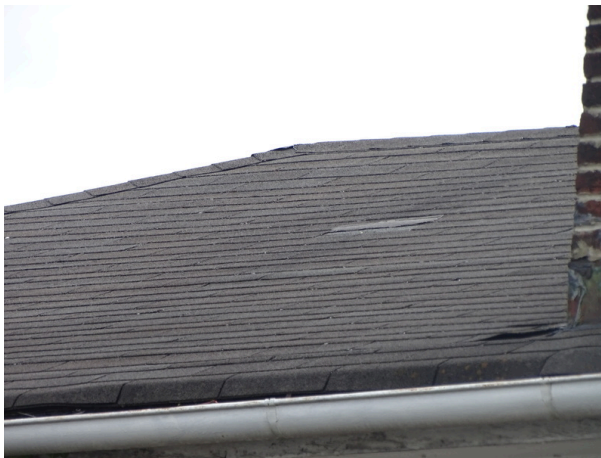
The main roofing system consists of an Asphalt shingle roofing system over the building and single-ply membrane roofing system over the north addition. The roofing system replacements are unknown. The expected useful life of an asphalt shingle roofing system and single-ply membrane roofing system is typically 15 to 20 years. We recommend replacing the roofing system in the first year of the report period. Drainage for the roofing system is provided by gutters and downspouts. We recommend that the gutters and downspouts be replaced during the scheduled roof replacement. Roofing penetrations included plumbing vents and exhaust vents throughout the roofing system.

Asphalt shingle roofing system

3.3.6 Roofing Systems																													
REPLACE ASPHALT SHINGLED ROOFING SYSTEM	20	19	1	1,500	SF	\$5.00	\$7,500	100%	\$7,500																				\$7,500
REPLACE SINGLE-PLY ROOFING SYSTEM	20	19	1	1,600	SF	\$14.00	\$22,400	100%	\$22,400																				\$22,400

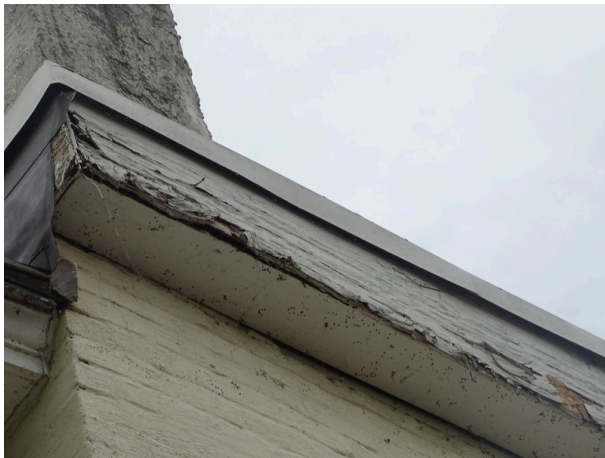
Building exterior at north end of the building -
note deteriorated wood trim

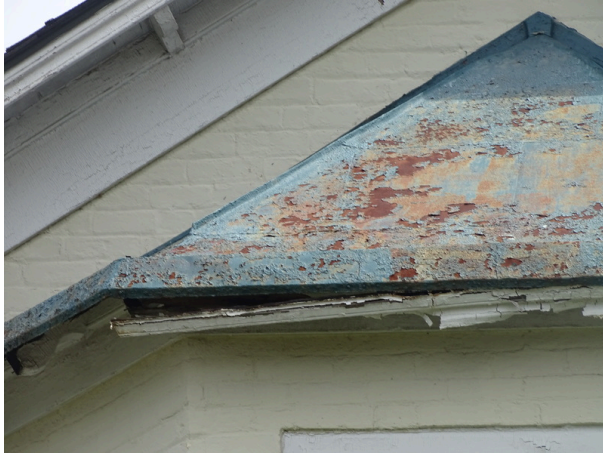
Typical wood trim - note deterioration

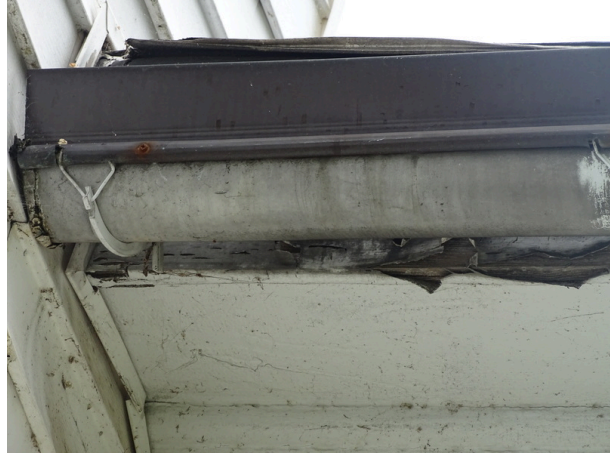
Typical gutter - note deterioration

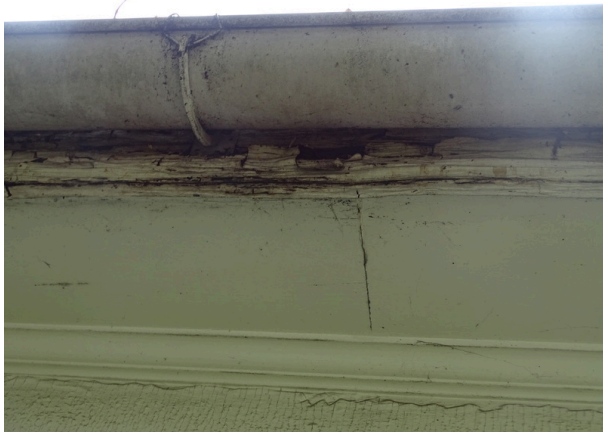
Typical gutter - note deterioration

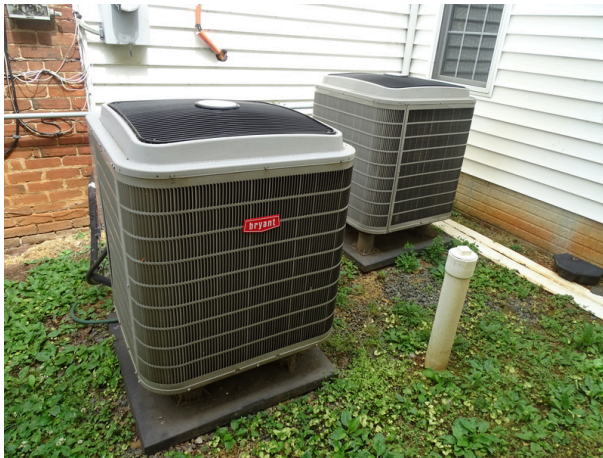
Condenser unit on east side of the building

3.4.2.1 Equipment																													
REPLACE CONDENSER UNITS	15	7	8	2	EA	\$5,500.00	\$11,000	100%							\$11,000														\$11,000
REPLACE GAS FURNACE - AIR HANDLER UNITS	15	7	8	2	EA	\$5,000.00	\$10,000	100%							\$10,000														\$10,000
REPLACE SPLIT SYTEM	15	7	8	1	EA	\$2,500.00	\$2,500	100%							\$2,500														\$2,500
Total (Uninflated)									\$60,900.00	\$0.00	\$0.00	\$0.00	\$0.00	\$0.00	\$0.00	\$23,500.00	\$15,000.00	\$0.00	\$0.00	\$0.00	\$1,000.00	\$0.00	\$0.00	\$0.00	\$15,000.00	\$0.00	\$0.00	\$0.00	\$115,400.00

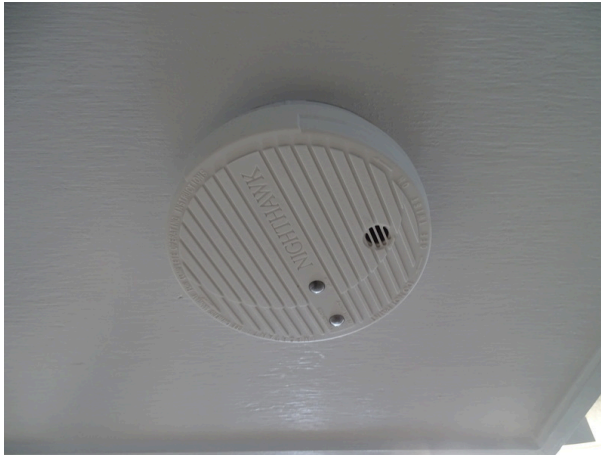
The fire alarm system was observed but not tested. Smoke detectors are located throughout the building. We did not observe exit signs and emergency lighting. As a life safety item, we make an immediate recommendation to install exit signs and emergency lighting.

Typical smoke detector

Immediate Repair Cost					
Item	Quantity	Unit	Unit Cost	Replacement Percent	Immediate Total
3.6.2 Alarm Systems					
INSTALL EXIT SIGNS AND EMERGENCY LIGHTING	1	LS	\$1,000.00	100%	\$1,000
Total Repair Cost					\$1,000.00

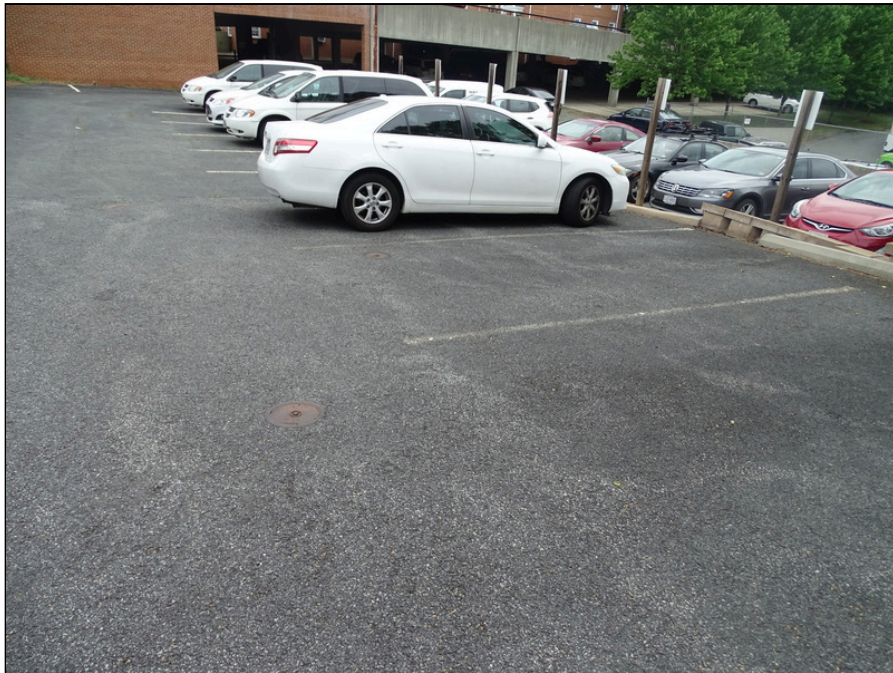
2 - Asphalt parking north side of the building - note stripping faded

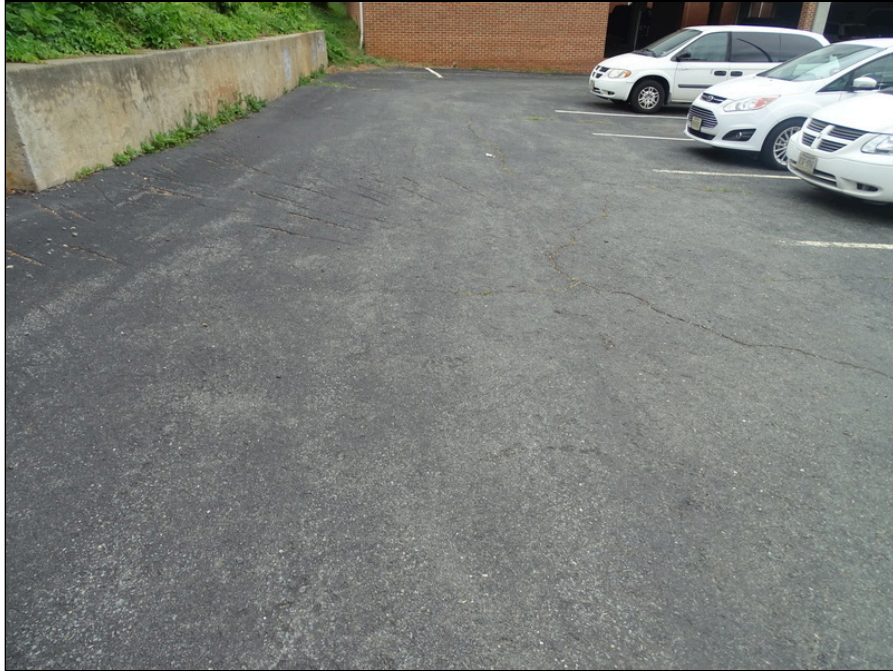
3 - Asphalt parking north side of the building - note stripping faded

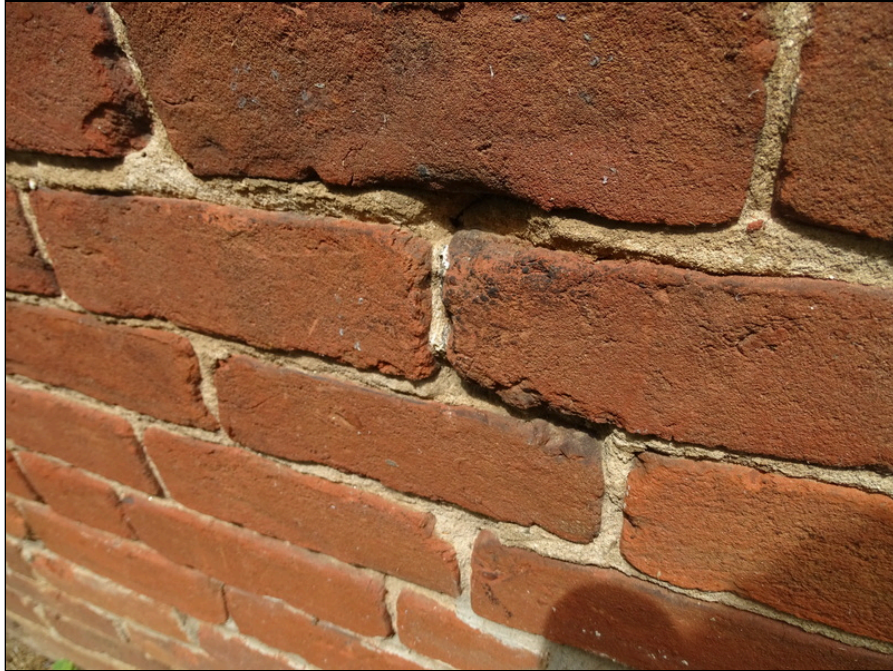
13 - Building exterior at southeast end of the building - note deterioration

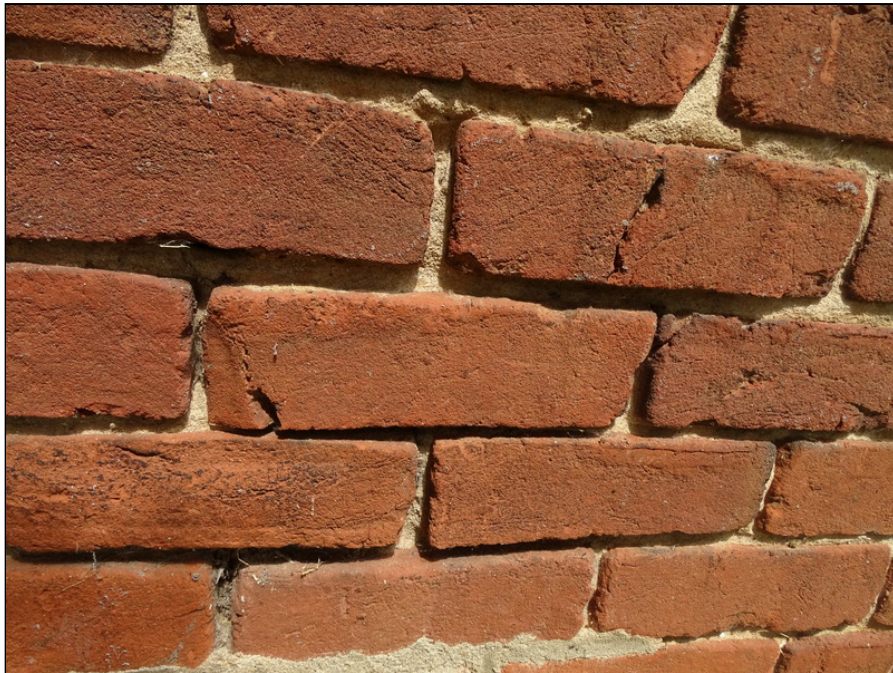
14 - Building exterior at southeast end of the building - note deterioration

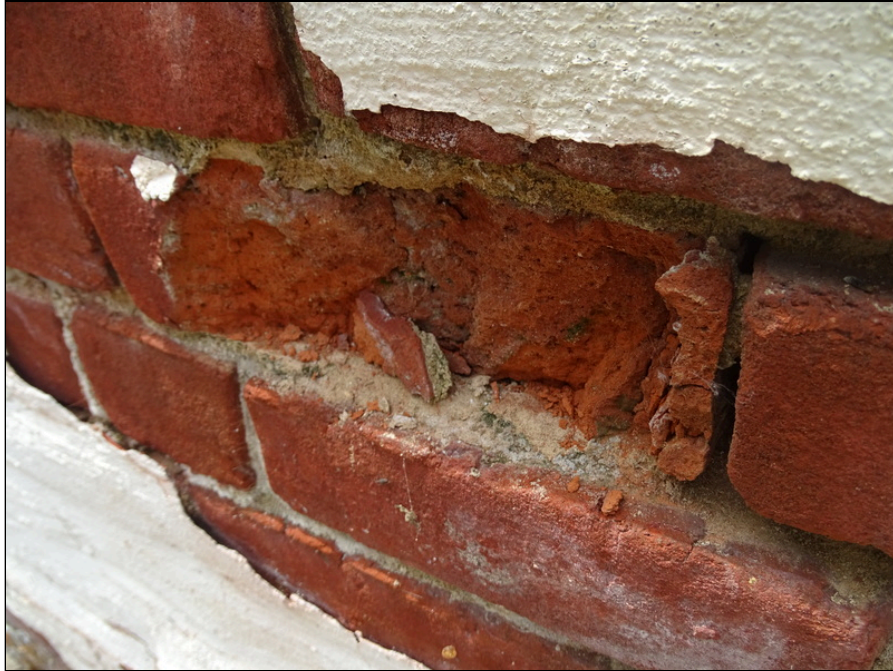
15 - Building exterior - note deterioration

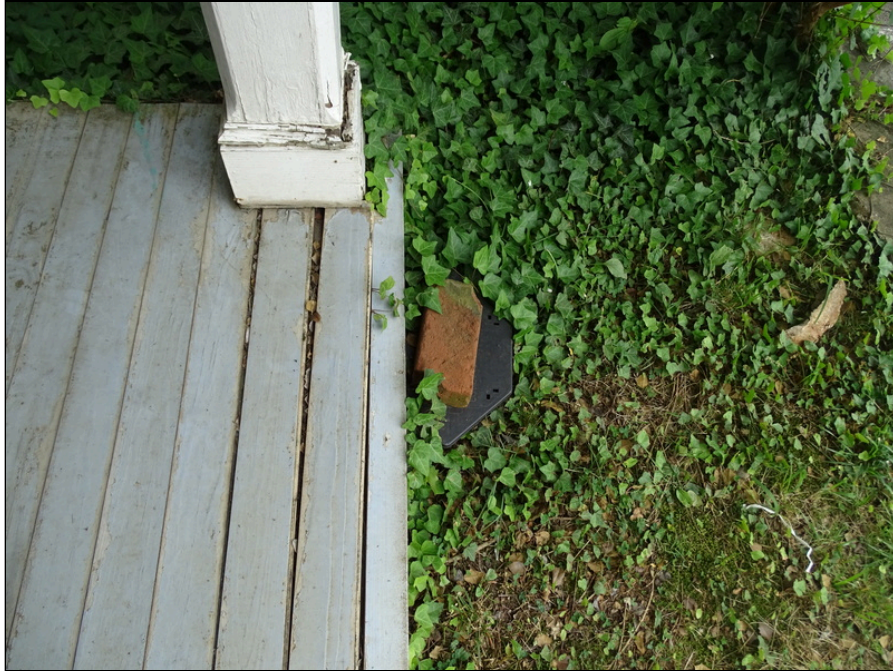
17 - Typical column - note deterioration

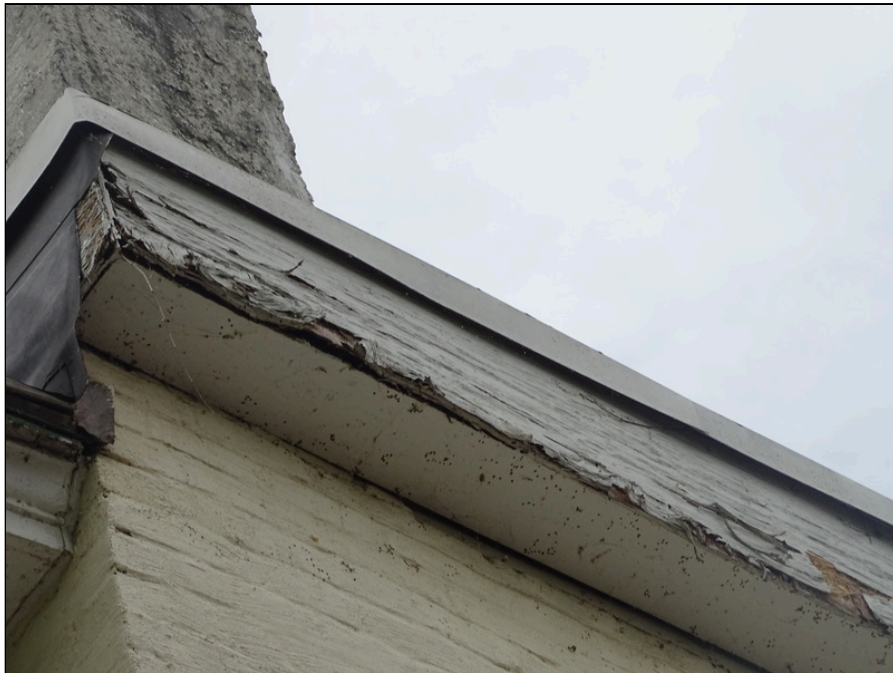
26 - Building exterior at north end of the building - note deteriorated wood trim

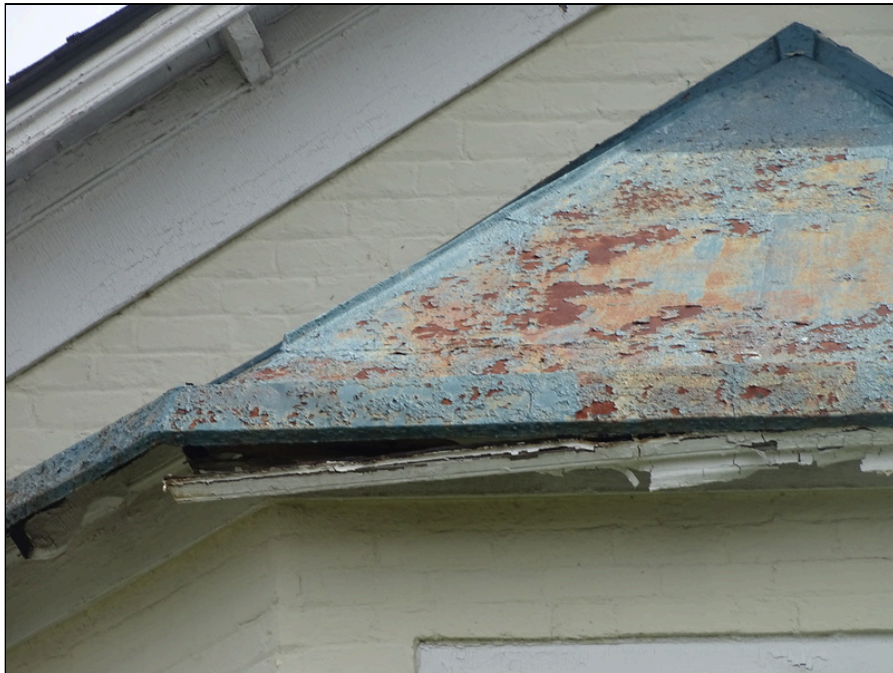
28 - Typical wood trim - note deterioration

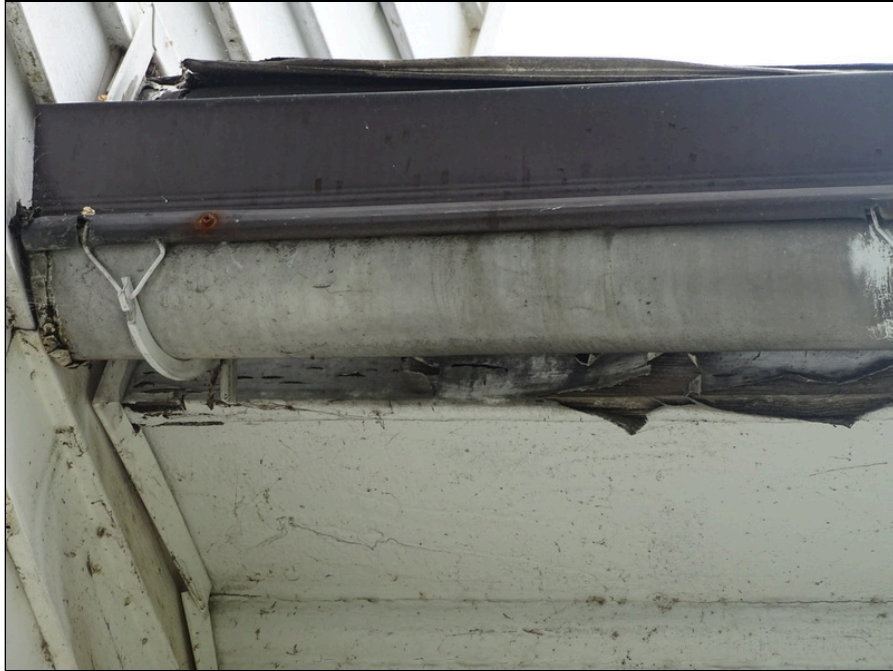
29 - Typical gutter - note deterioration

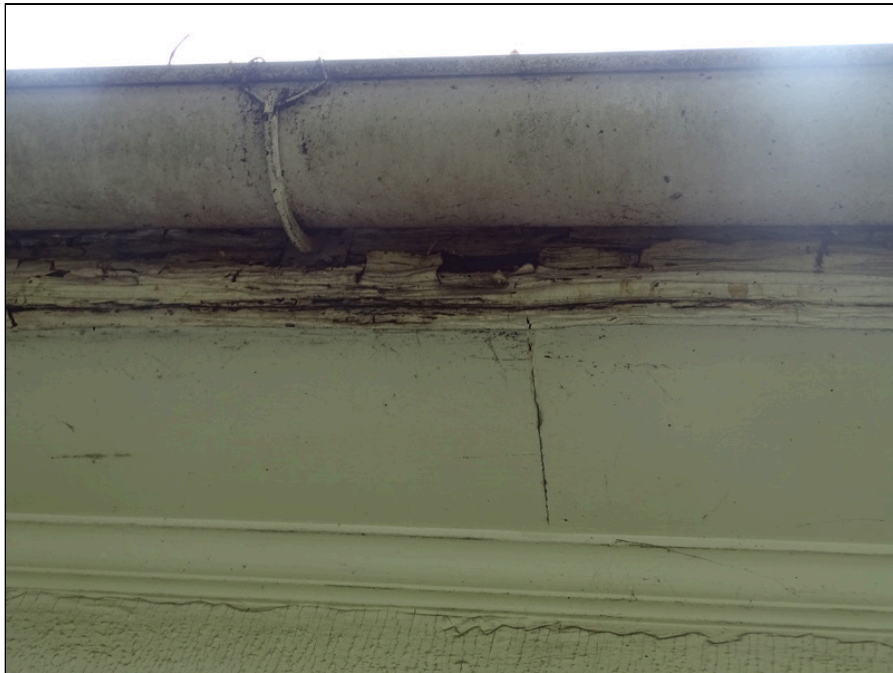
30 - Typical gutter - note deterioration

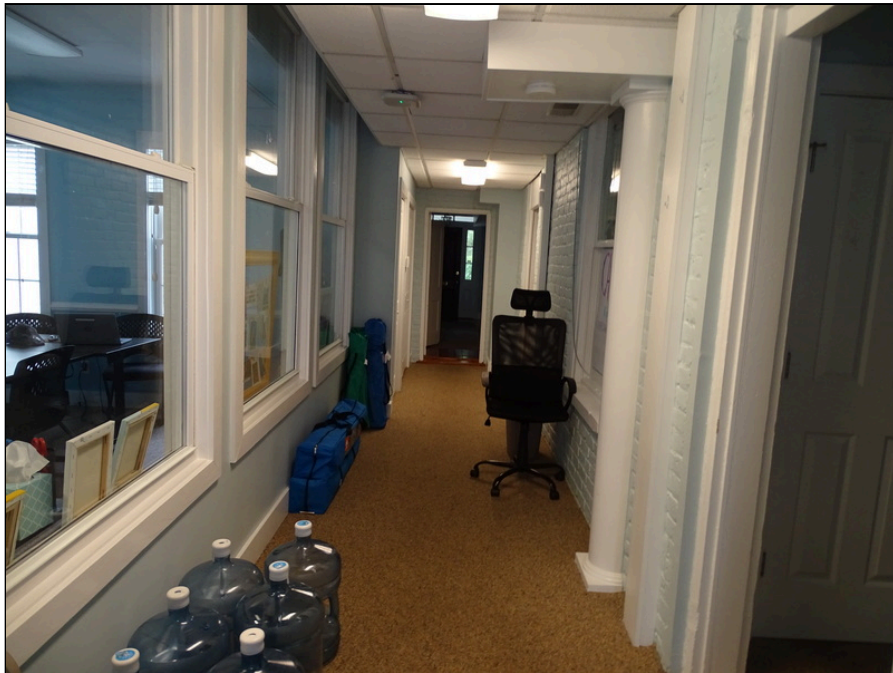
42 - Exit signs and emergency lighting were not observed

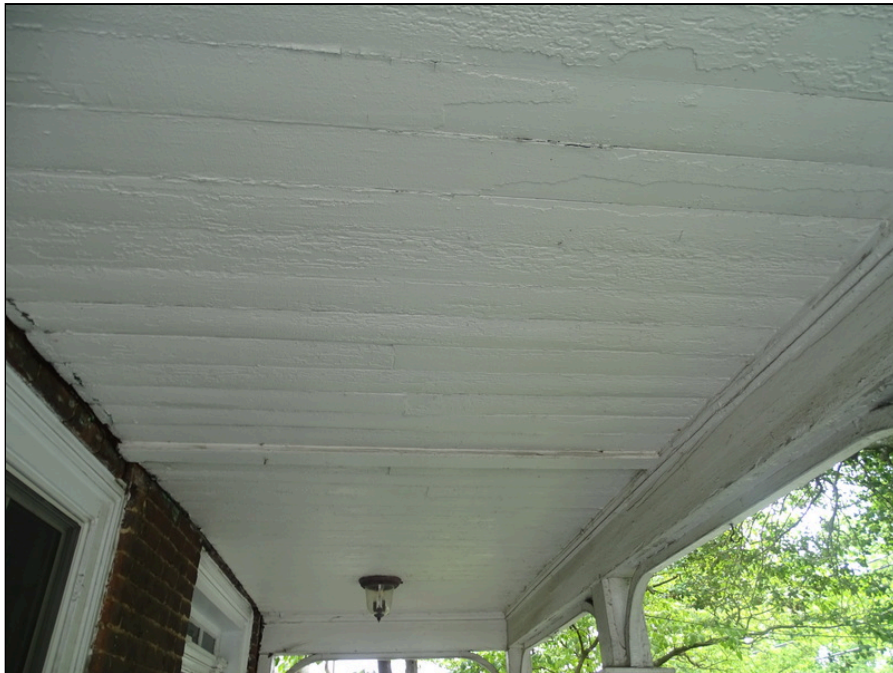
52 - Typical Patio ceiling - note deterioration
