JUVENILE AND DOMESTIC RELATIONS COURT - SHERIFF'S OFFICE -
PARKING GARAGE COMPLEX
411 EAST HIGH STREET
CHARLOTTESVILLE, VIRGINIA

ECS PROJECT NO. 46:6713

CITY OF CHARLOTTESVILLE - FACILITIES DEVELOPMENT

Reference: Facility Condition Assessment Report for Juvenile and Domestic Relations Court - Sherriff's Office - Parking Garage Complex, 411 East High Street, Charlottesville, Virginia

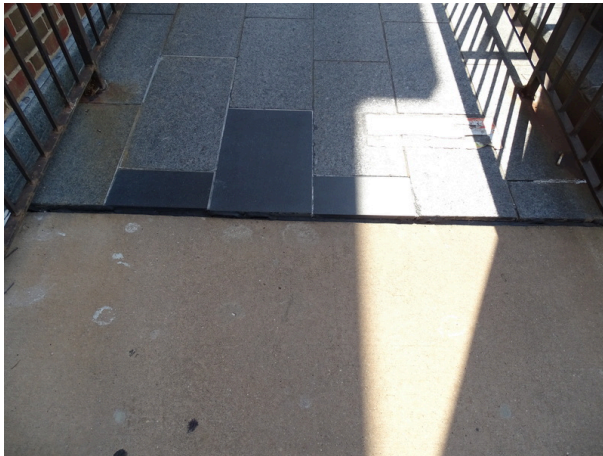
Ramp at southwest side of courthouse building -
note trip hazard

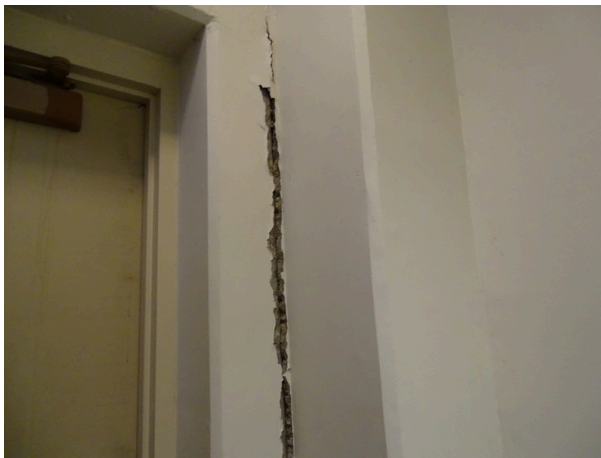
Building frame at sheriffs office north side at lower level entrance - note cracking

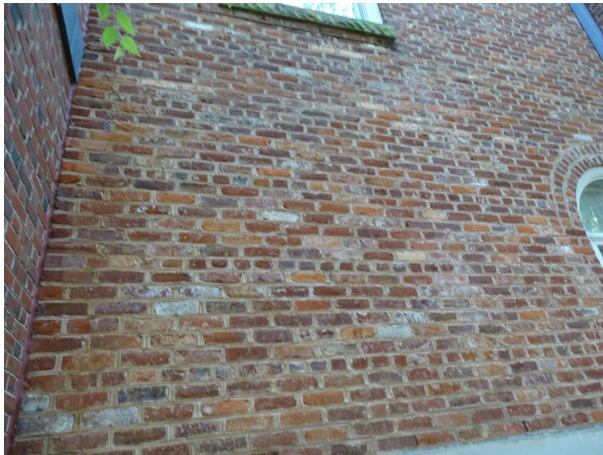
Exterior wall- note efflorescence

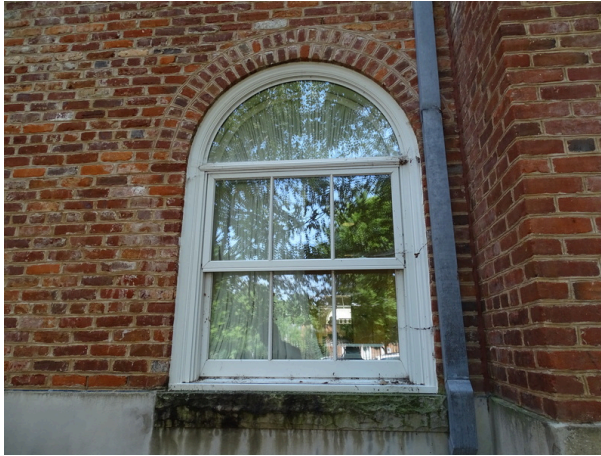
Typical window at courthouse - note
efflorescence

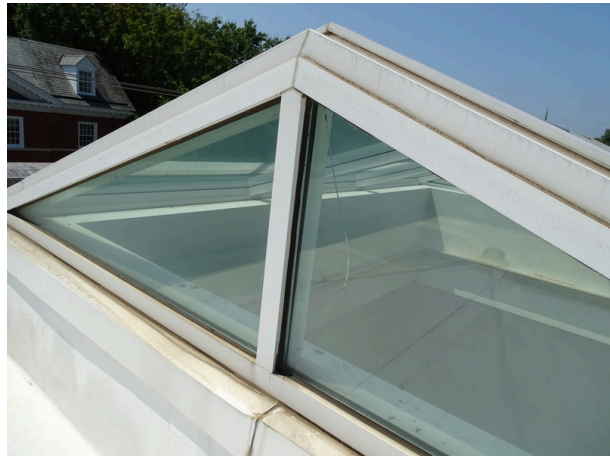
Skylight - note crack in glass on east side

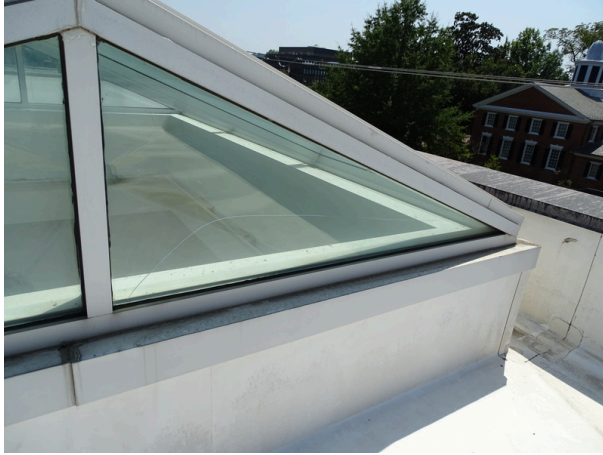
Skylight - note crack in glass on east side

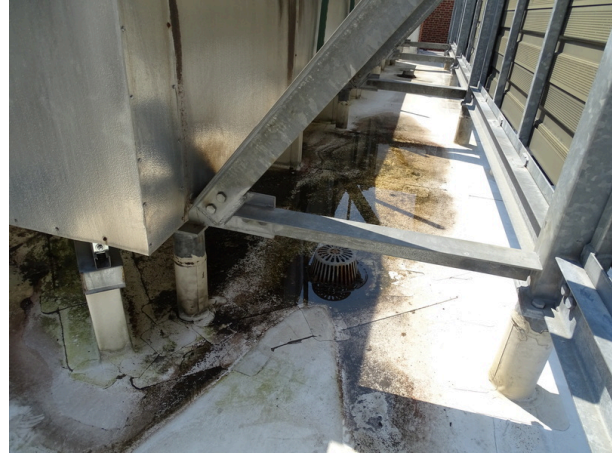
Roofing system at center portion of courthouse -
note ponding

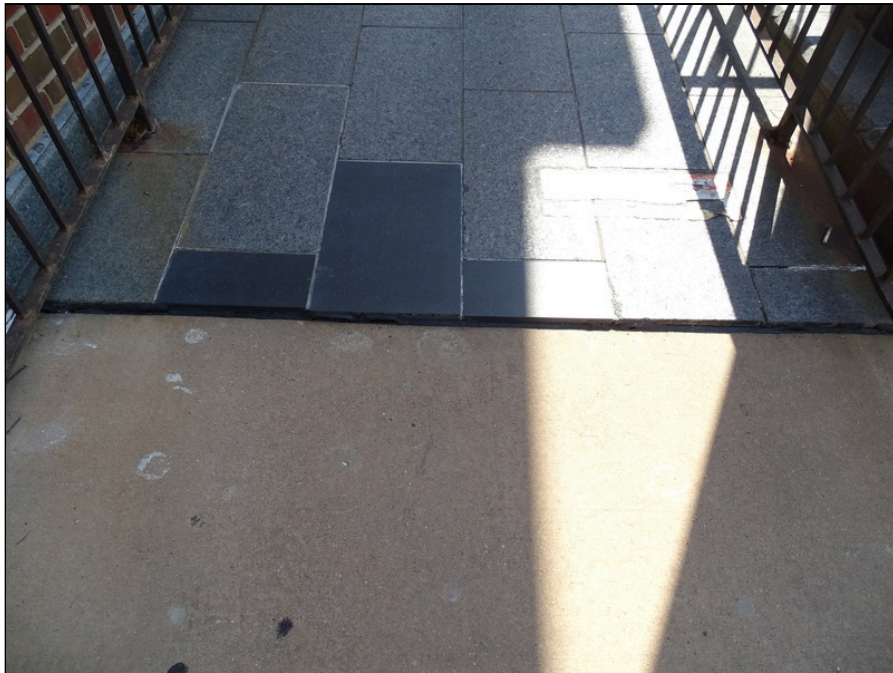
4 - Ramp at southwest side of courthouse building - note trip hazard

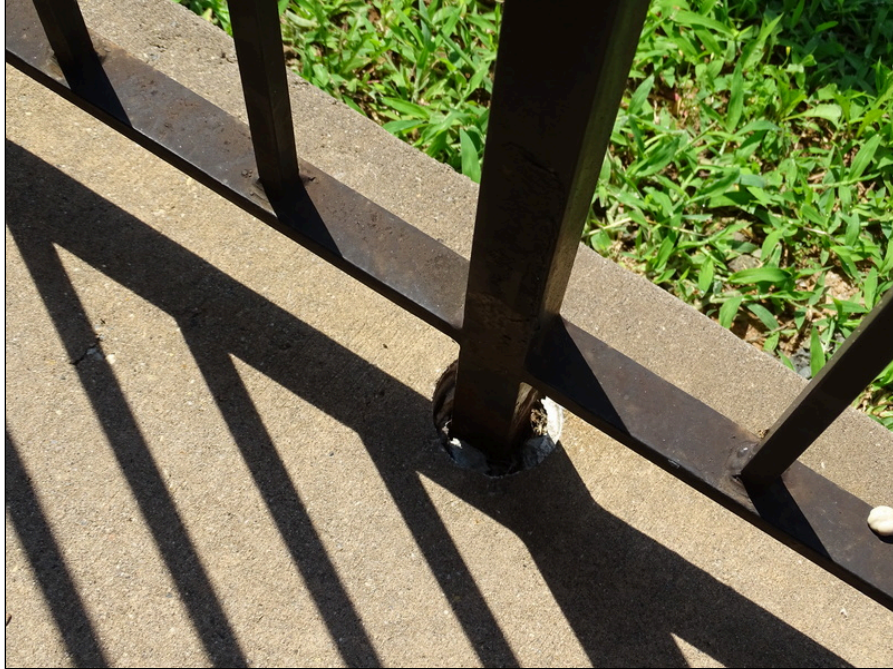
5 - Ramp at southwest side of courthouse building. Note deterioration of handrail base

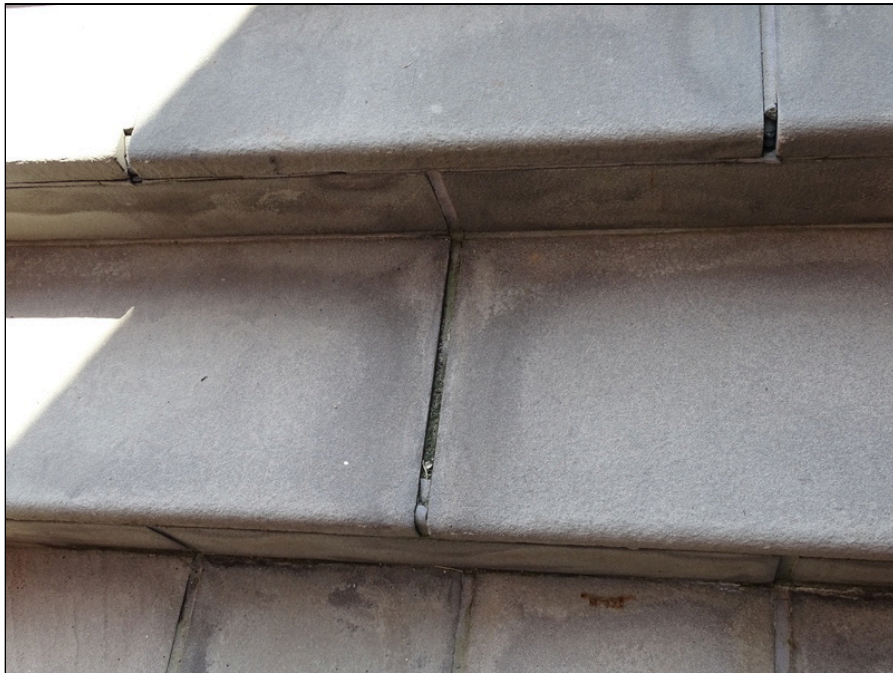
10 - Exterior stair at north of Sheriffs office - note deterioration

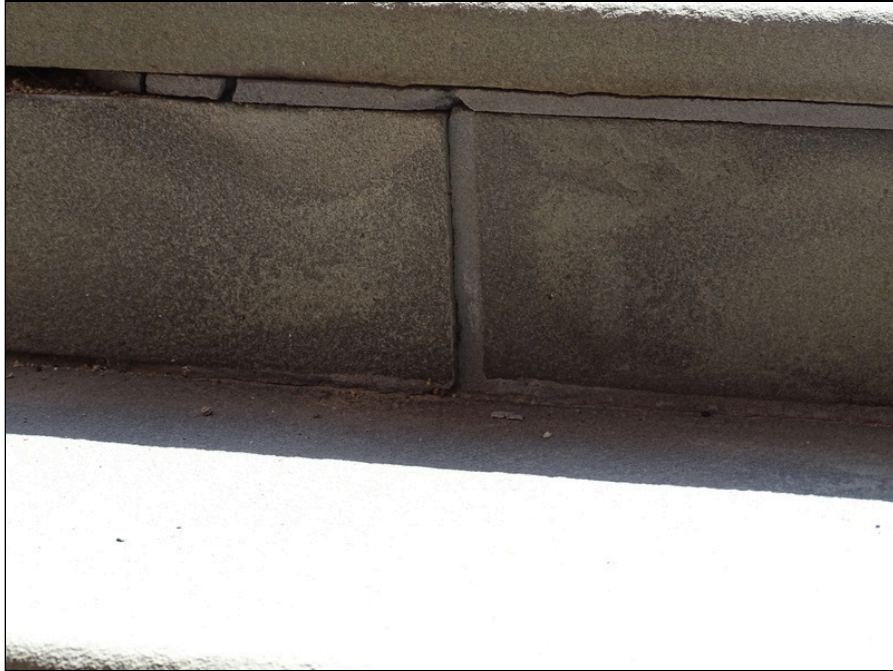
11 - Exterior stair at north of Sheriffs office - note deterioration

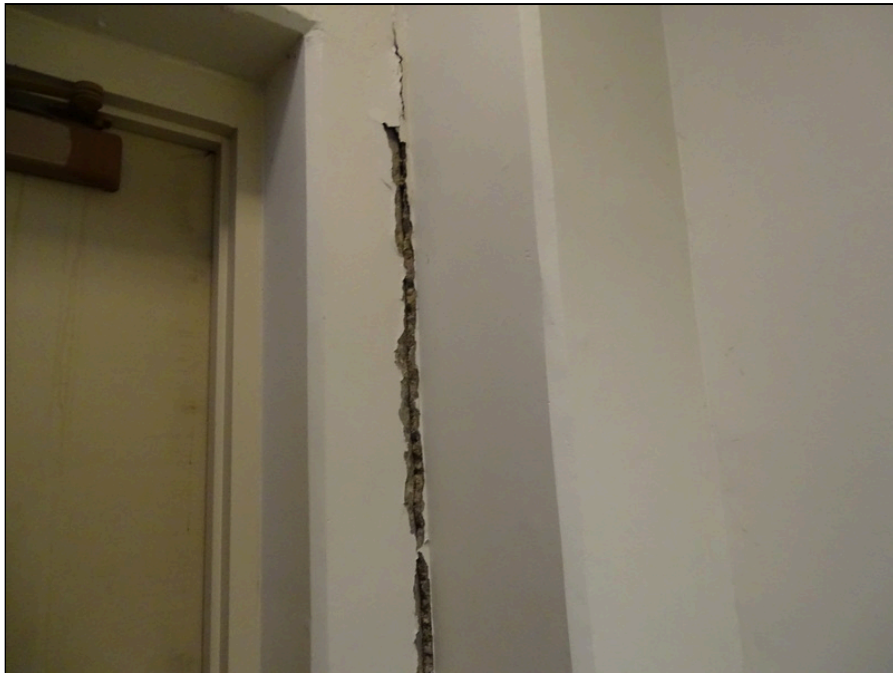
22 - Building frame at sheriffs office north side at lower level entrance - note cracking

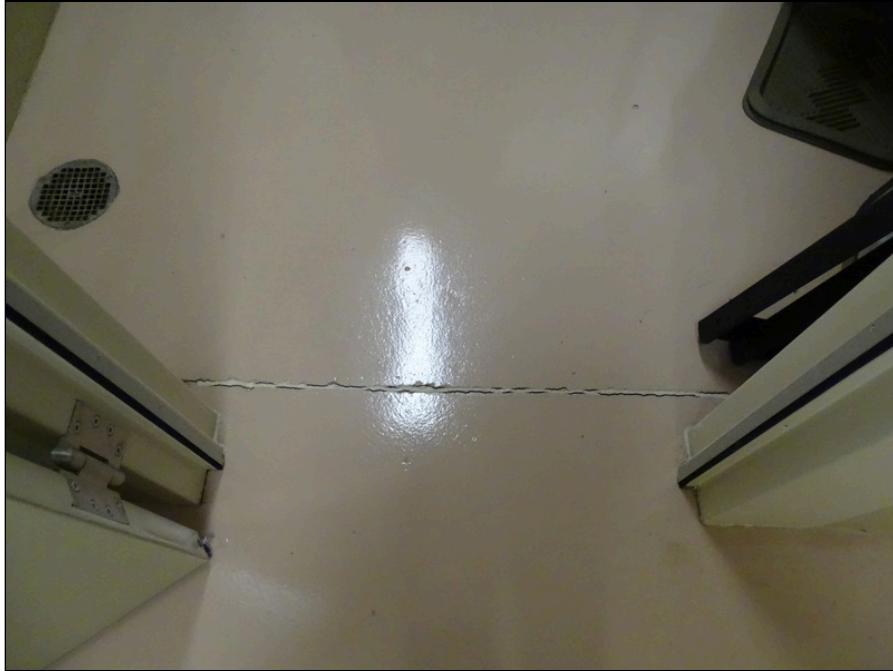
23 - Parking garage - note crack in floor

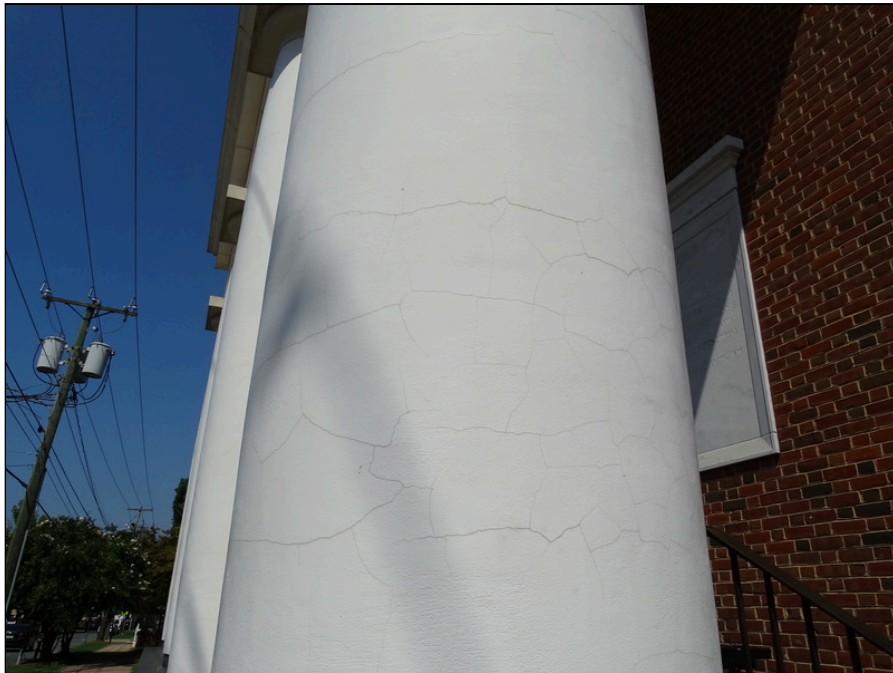
24 - Cracks in column at south side of Juvenile and Domestic Courts - Sheriff's Office - Parking
Garage Complex

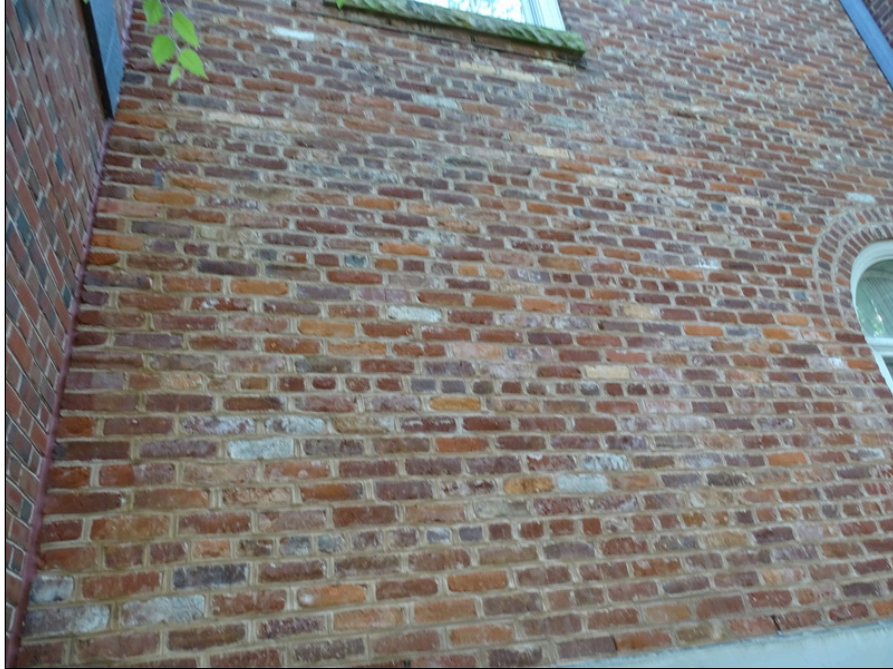
25 - Exterior wall- note efflorescence

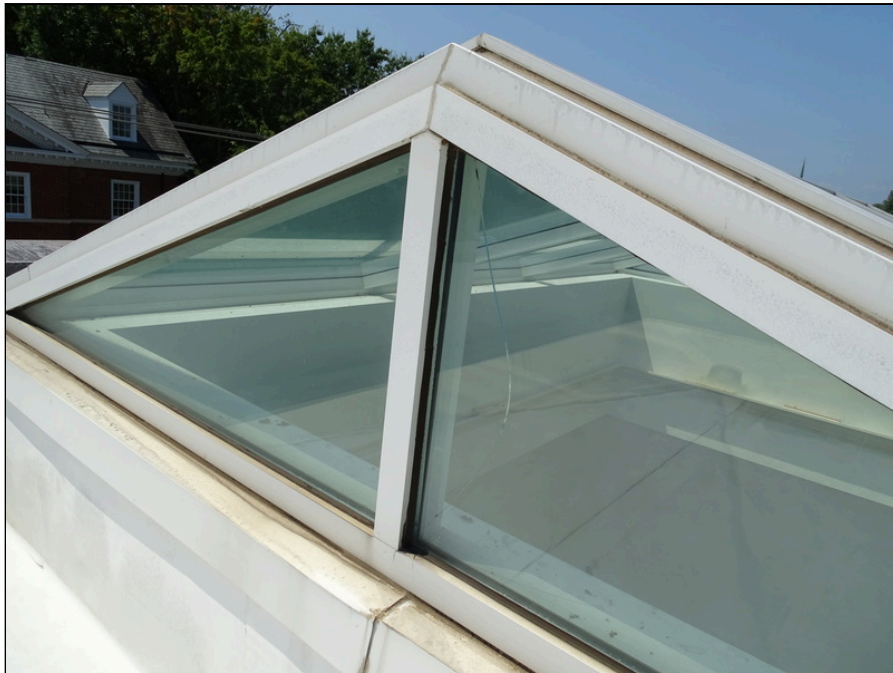
44 - Skylight - note crack in glass on east side

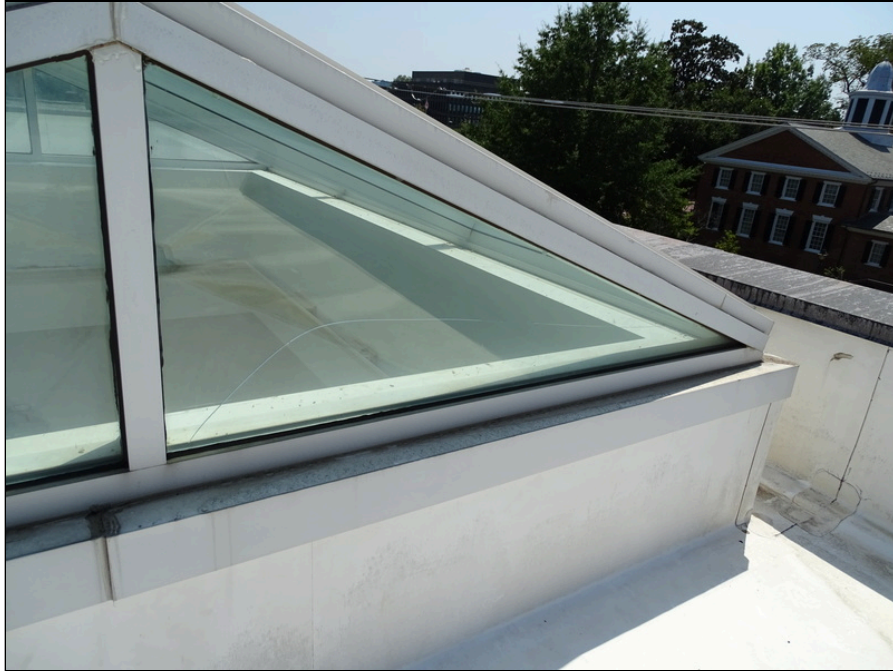
45 - Skylight - note crack in glass on east side

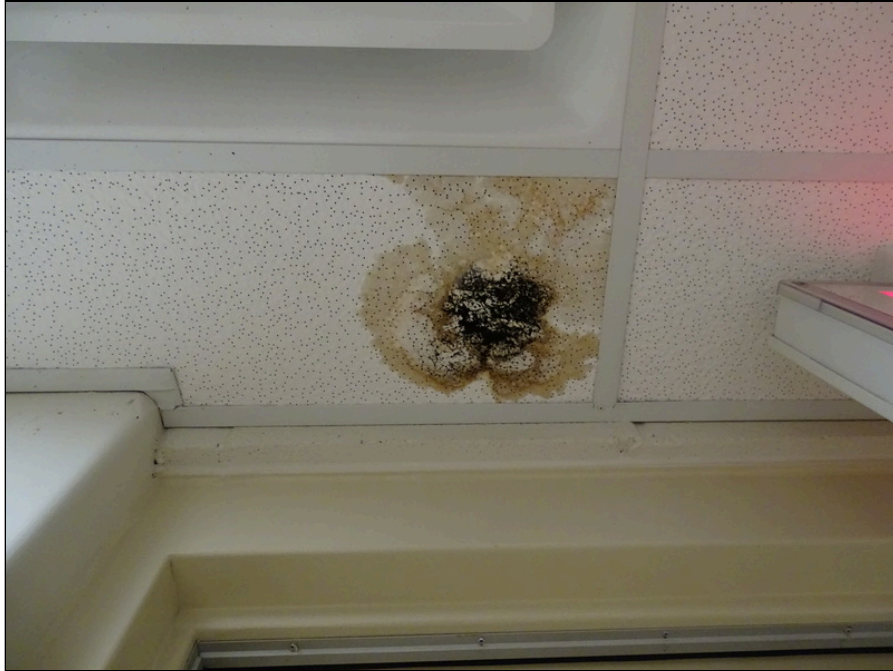
99 - Stained in the ceiling panel

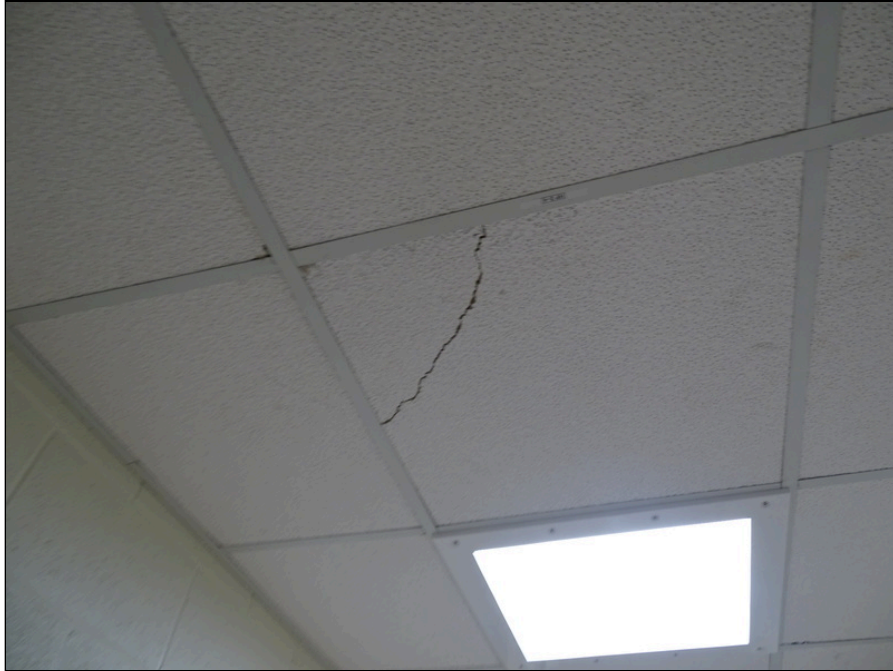
101 - Interior lobby - note ceiling panel deterioration

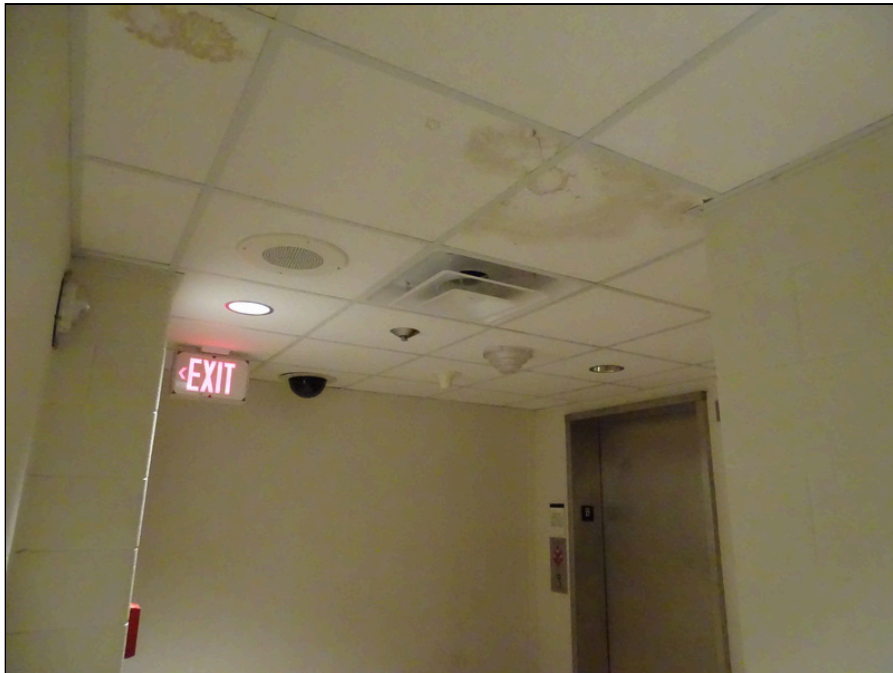
102 - Interior lobby - note water leakage and stains in the ceiling

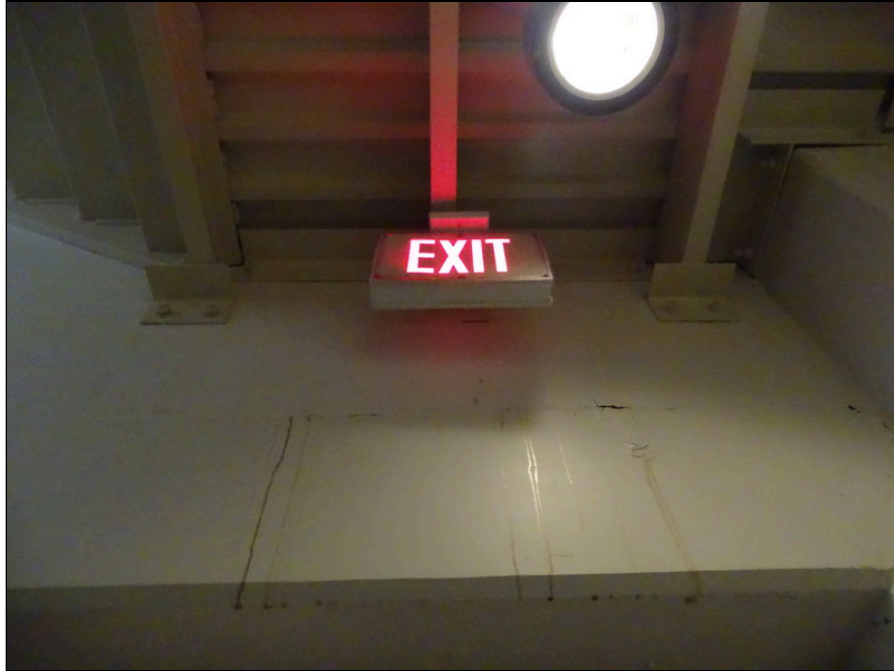
105 - Parking garage - note water leakage

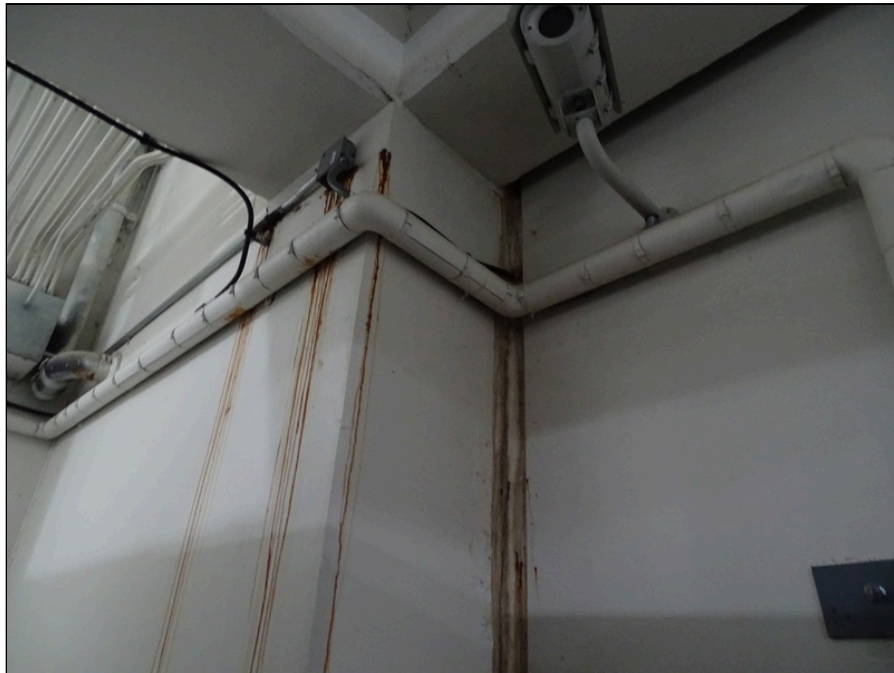
106 - Parking garage - note water leakage

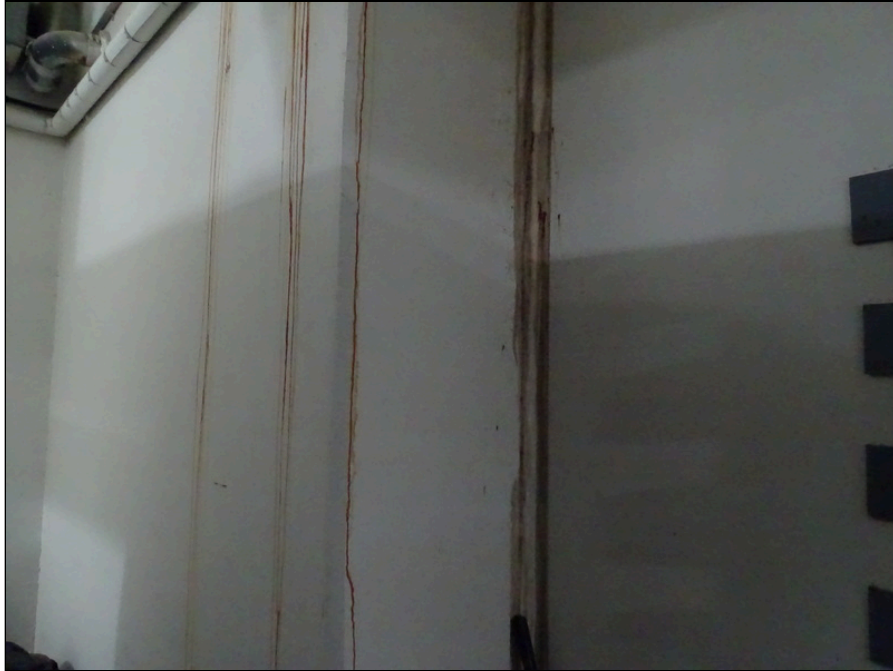
107 - Parking garage - note water leakage

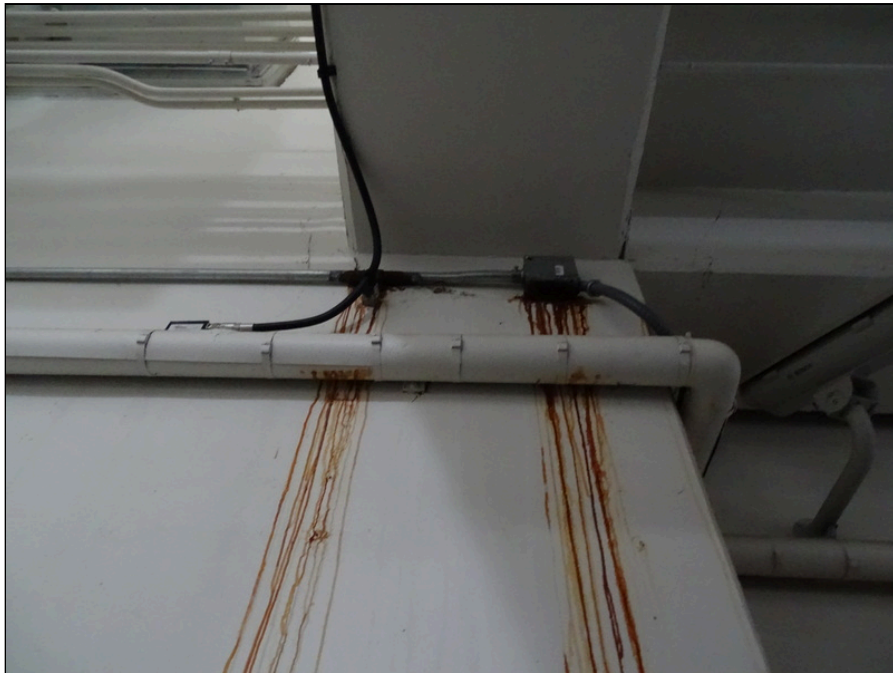
108 - Parking garage - note water leakage

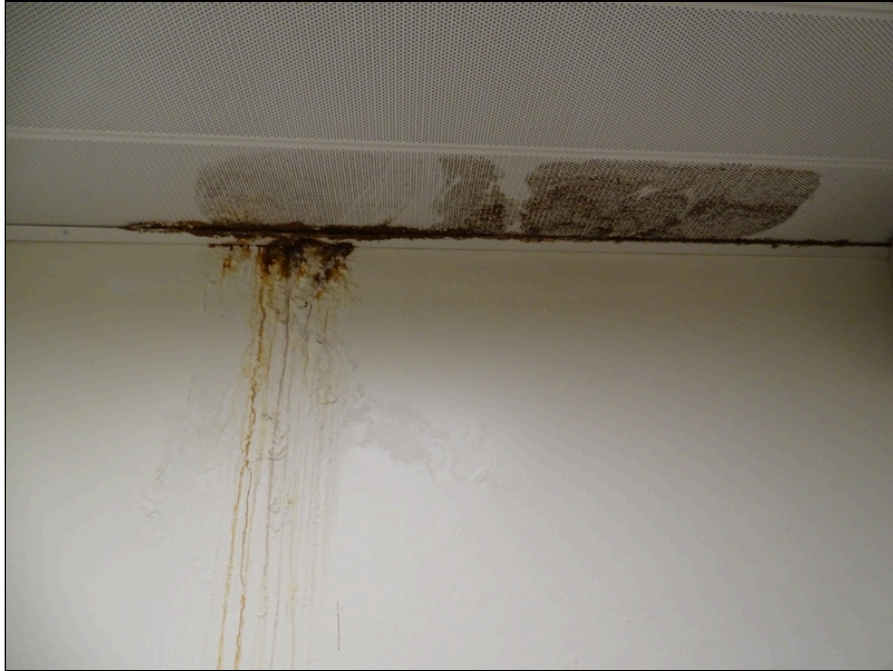
109 - Parking garage - note water leakage
