JACKSON VIA ELEMENTARY SCHOOL
508 HARRIS ROAD
CHARLOTTESVILLE, VIRGINIA

ECS PROJECT NO. 46:6713

CITY OF CHARLOTTESVILLE - FACILITIES DEVELOPMENT

Reference: Facility Condition Assessment Report for Jackson Via Elementary School, 508 Harris Road,
Charlottesville, Virginia

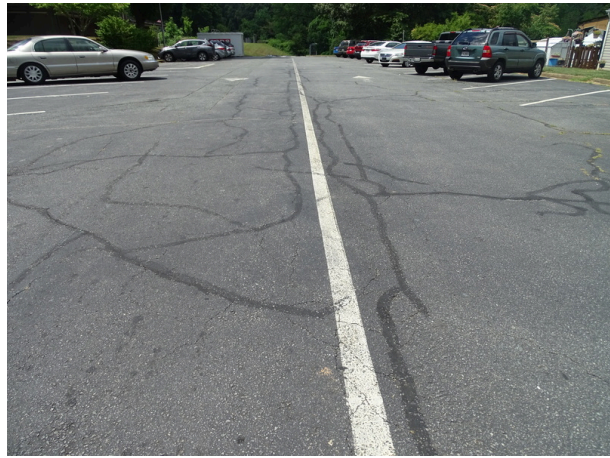
Asphalt drive lane east side of the site - note
cracking and previous repair

Cost Recommendation	EUL	EFF AGE	RUL	Year	Cost
MILL, OVERLAY AND RESTRIPE EXISTING ASPHALT	20	19	1	1 10	\$12,500 \$12,500
Total					\$25,000

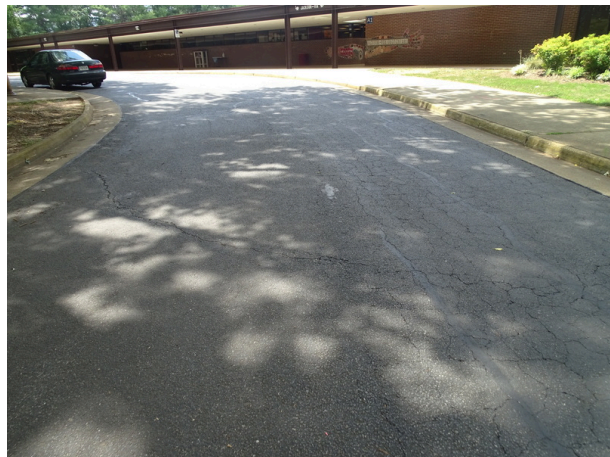
Asphalt drive lane west side of the site - note
alligator cracks

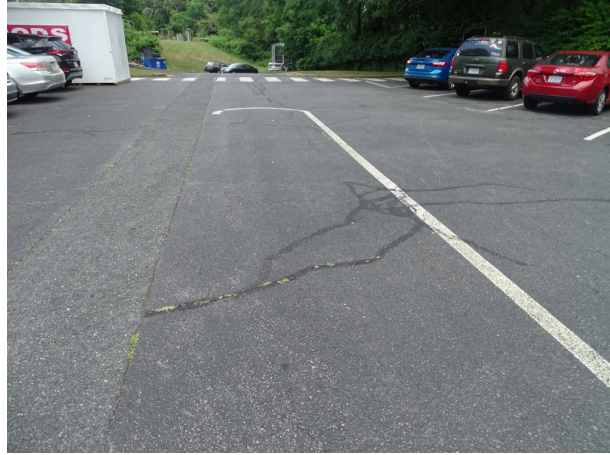
Asphalt drive lane east side of the site - note
cracking and previous repair

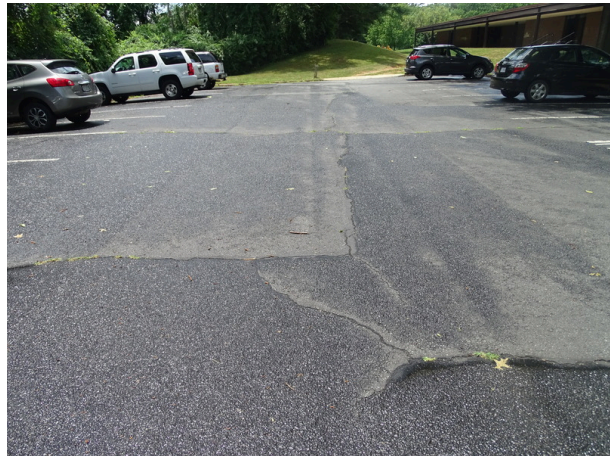
Asphalt parking east side of site - note cracking

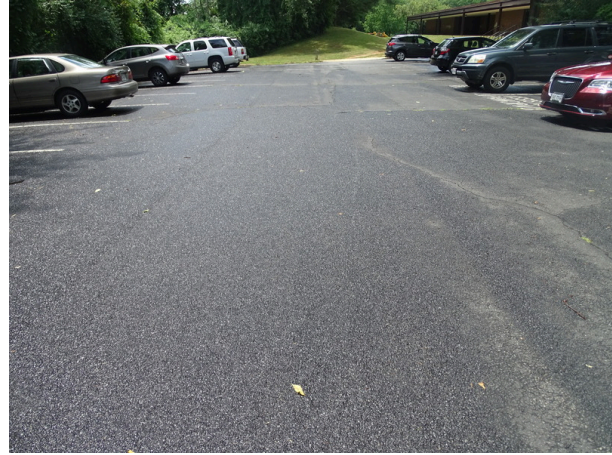
Asphalt parking east side of site - note cracking

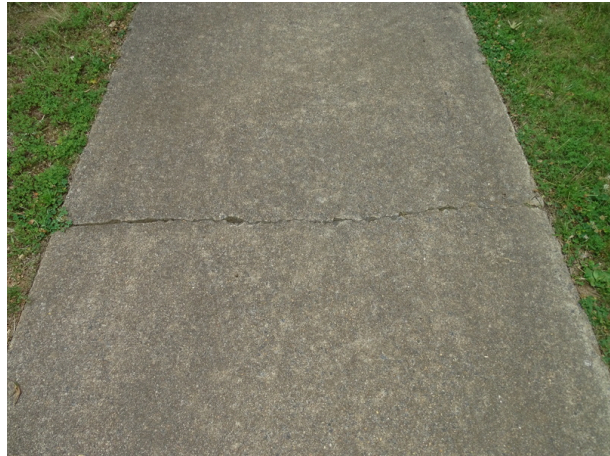
Concrete sidewalk - note cracking

At the perimeter of the building, concrete sidewalks of undetermined thickness are provided. Regularly spaced control joints were observed. The concrete sidewalks were generally in fair condition, with some cracked sections observed. We recommend the cracked and settled sections be replaced as necessary.

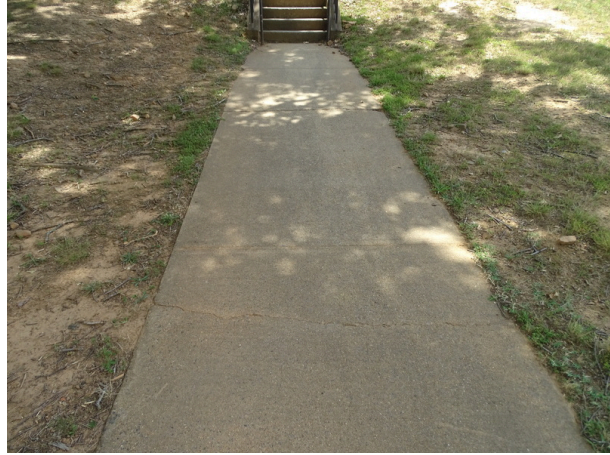
Concrete sidewalk - note cracking

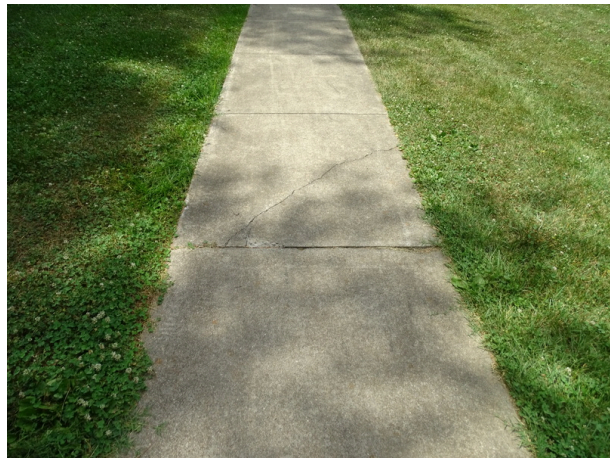
Concrete sidewalk - note cracking

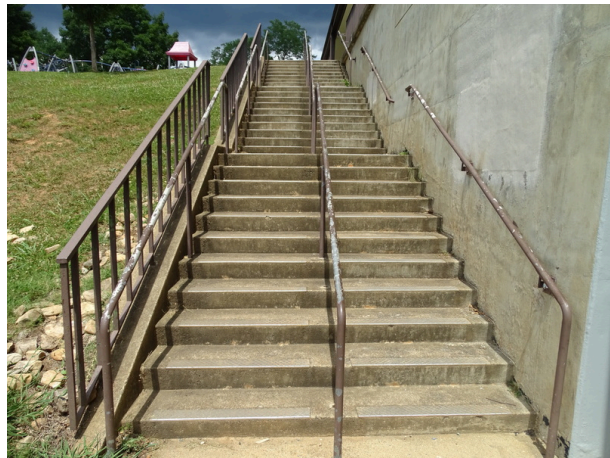
Concrete stair handrail - note deterioration

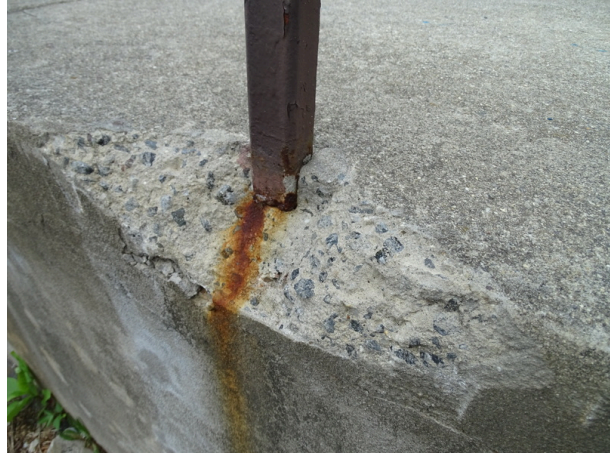
Concrete ramp- note deterioration

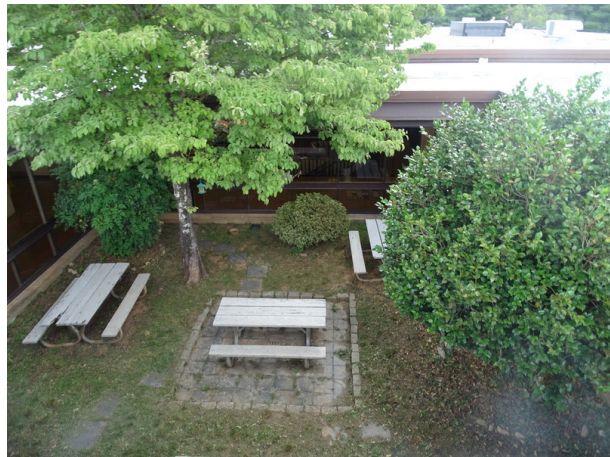
Typical landscape and setting area - note table broken

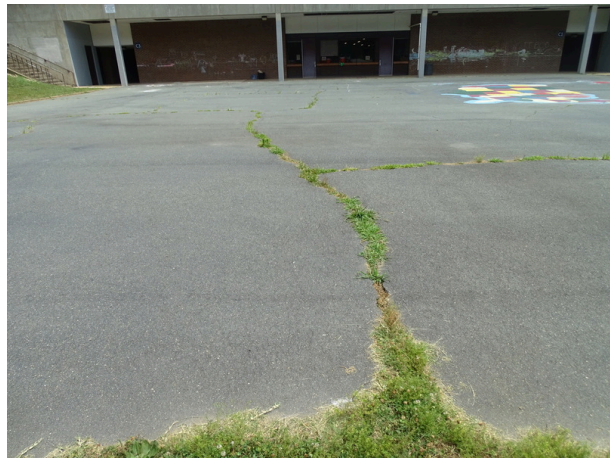
Asphalt playing surface - note cracking and grass growing

3.2.7 Recreational Facilities																													
REPLACE PLAYGROUND EQUIPMENT	20	10	10	1	EA	\$45,000.00	\$45,000	100%										\$45,000											\$45,000
RESURFACE BASKETBALL COURT	20	19	1	1	LS	\$14,000.00	\$14,000	100%	\$14,000																				\$14,000

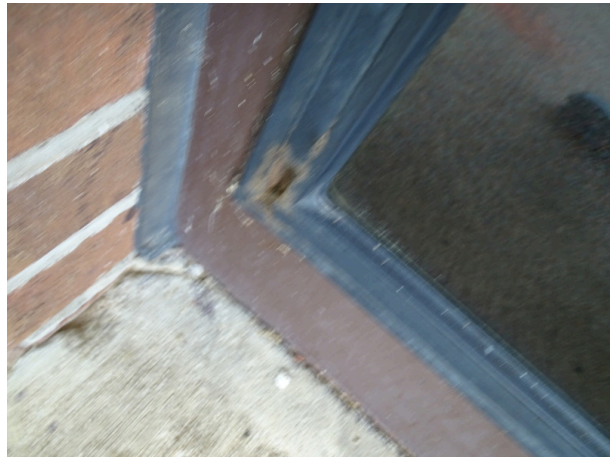
Typical exterior window - note deterioration of gasket

3.3.5 Exterior Windows																													
REPLACE WINDOW UNITS	20	19	1	100	EA	\$1,000.00	\$100,000	100%	\$50,000	\$50,000																			\$100,000

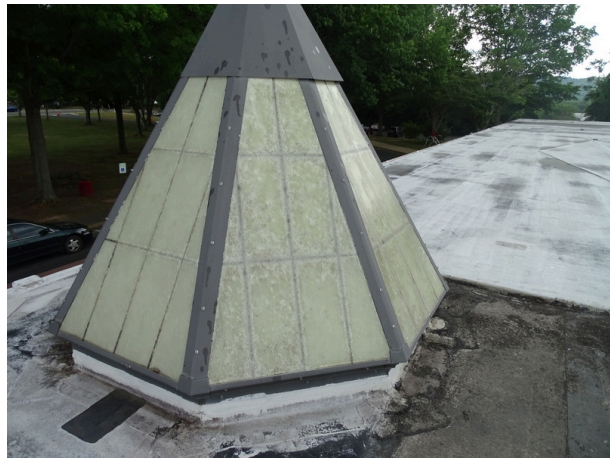
Skylight located on north side of the building

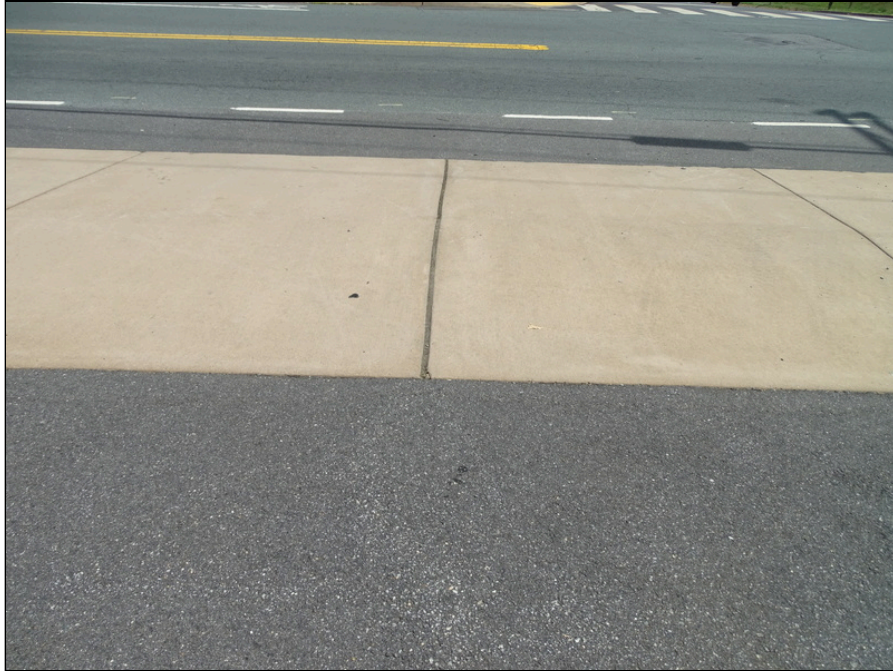
4 - Asphalt drive lane east side of the site - note cracking and previous repair

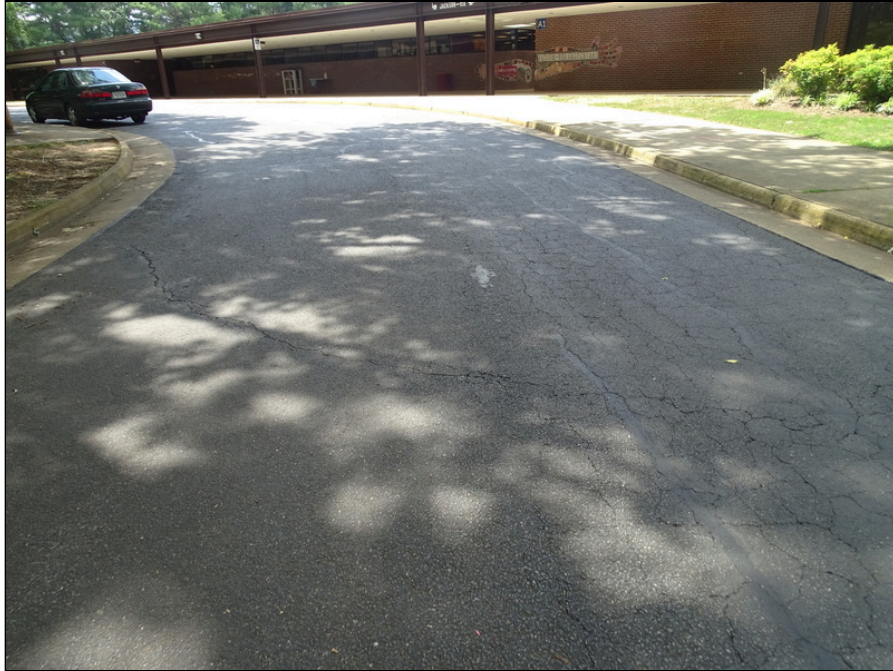
6 - Asphalt drive lane west side of the site - note cracking

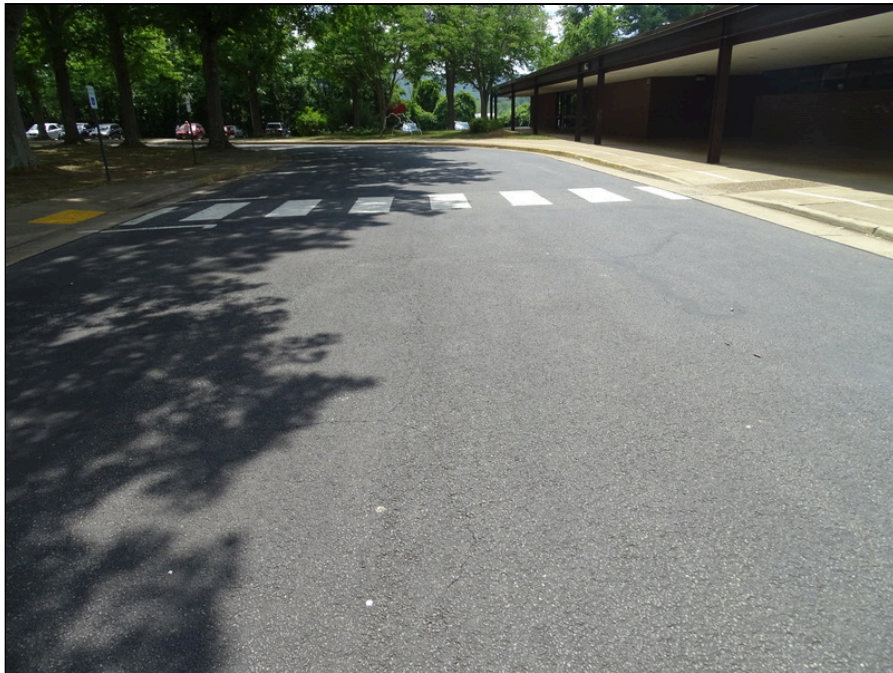
7 - Asphalt drive lane west side of the site - note alligator cracks

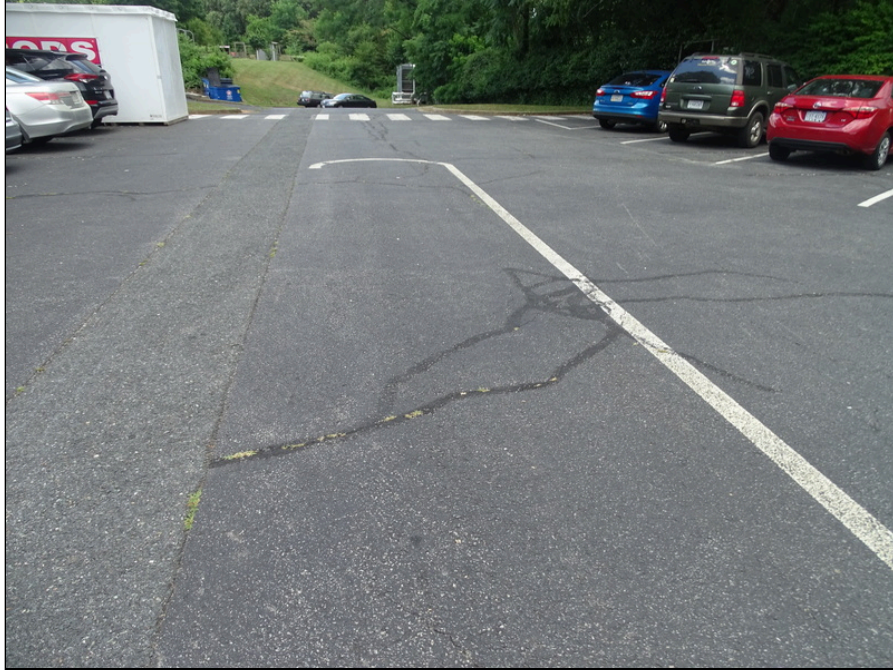
8 - Asphalt drive lane - note cracking

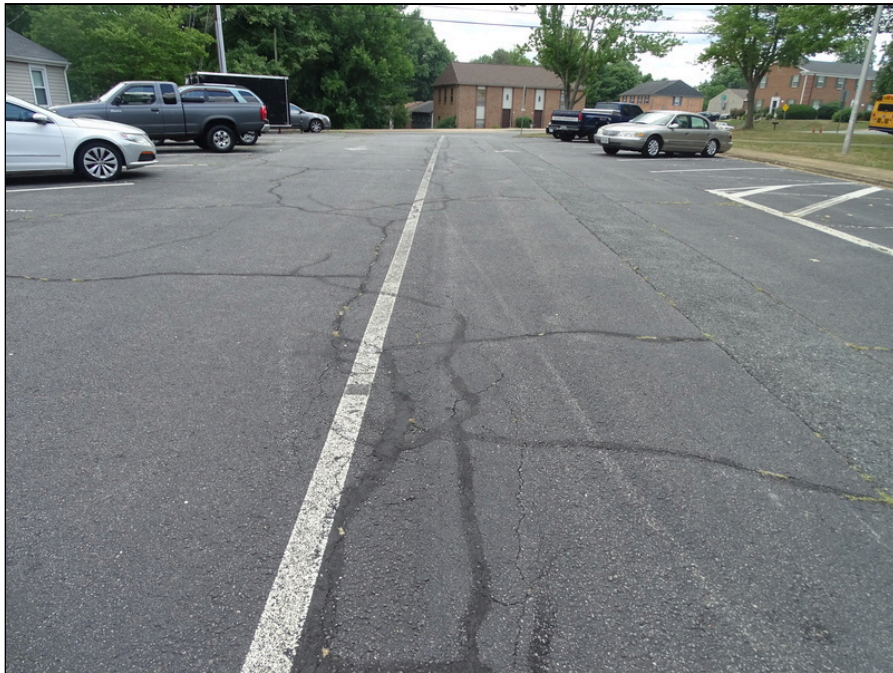
9 - Asphalt drive lane east side of the site - note cracking and previous repair

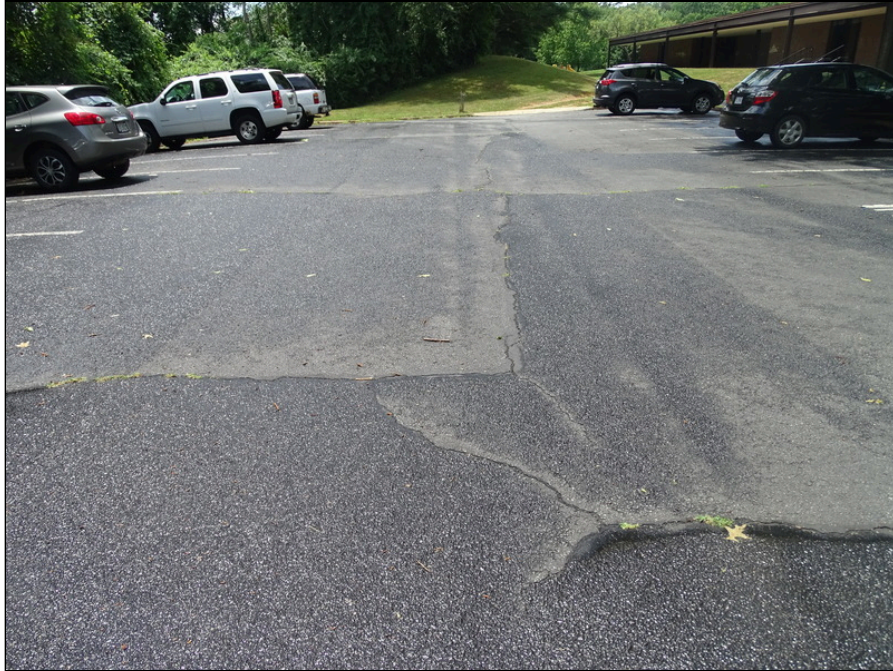
10 - Asphalt drive lane east side of the site - note cracking and previous repair

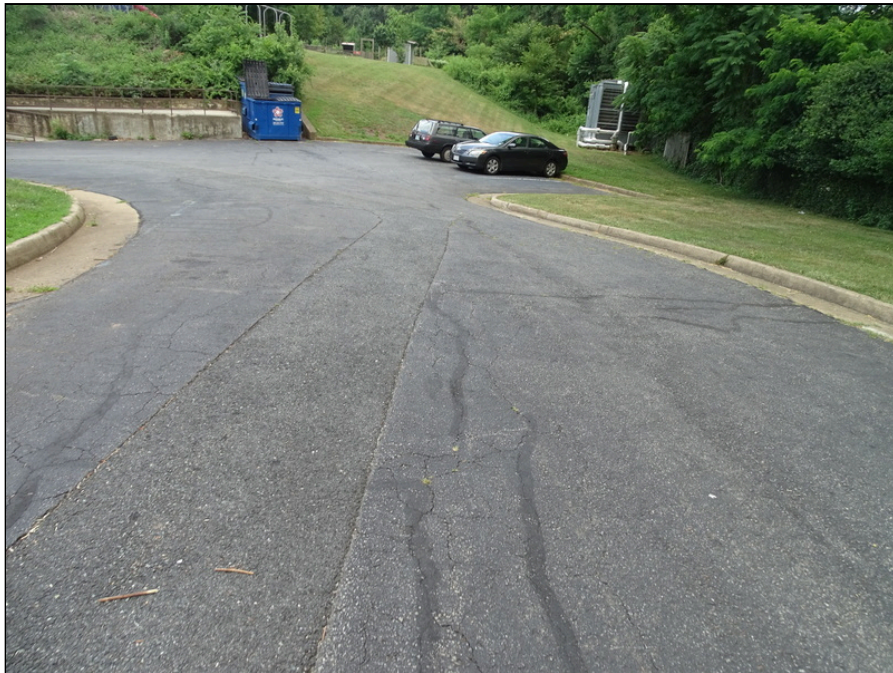
11 - Asphalt parking east side of site - note cracking

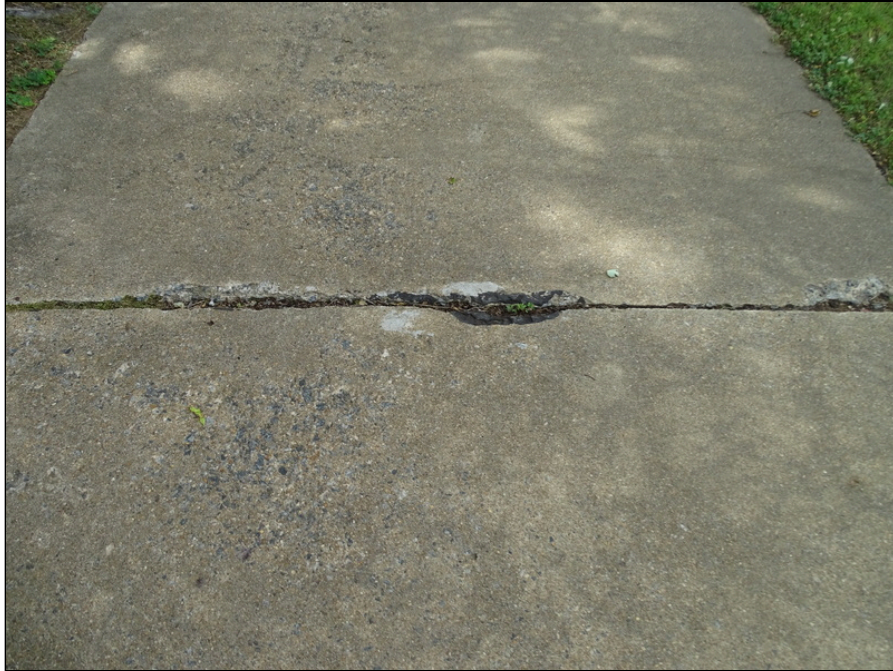
16 - Concrete ramp - note deterioration

3.2.5 Flatwork																													
REPLACE CONCRETE SIDEWALKS, STEPS, AND RAMP SECTIONS AS NEEDED	25	24	1	4	EA	\$5,000.00	\$20,000	100%	\$5,000					\$5,000					\$5,000					\$5,000					\$20,000

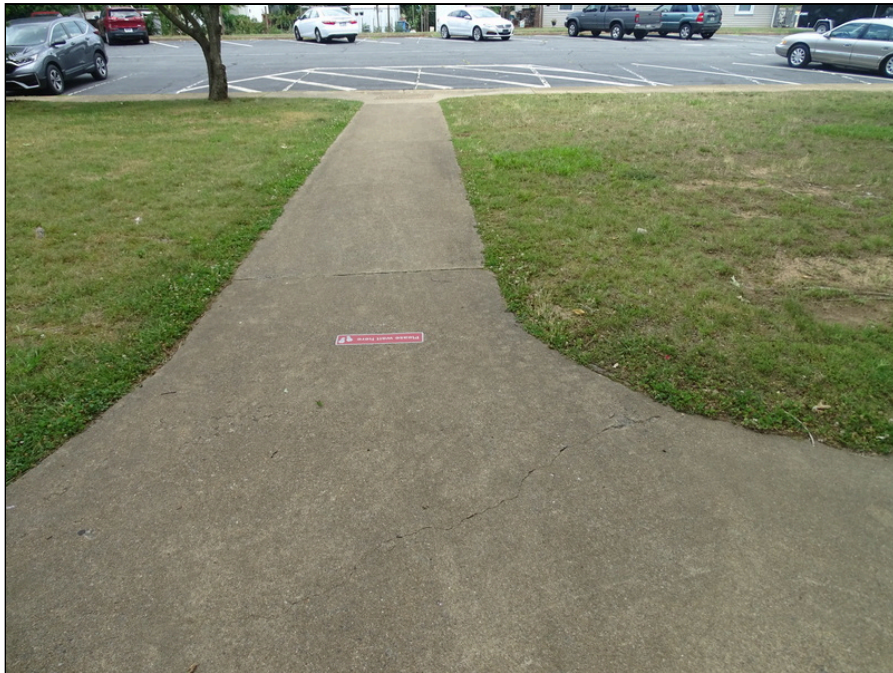
17 - Concrete sidewalk - note deterioration

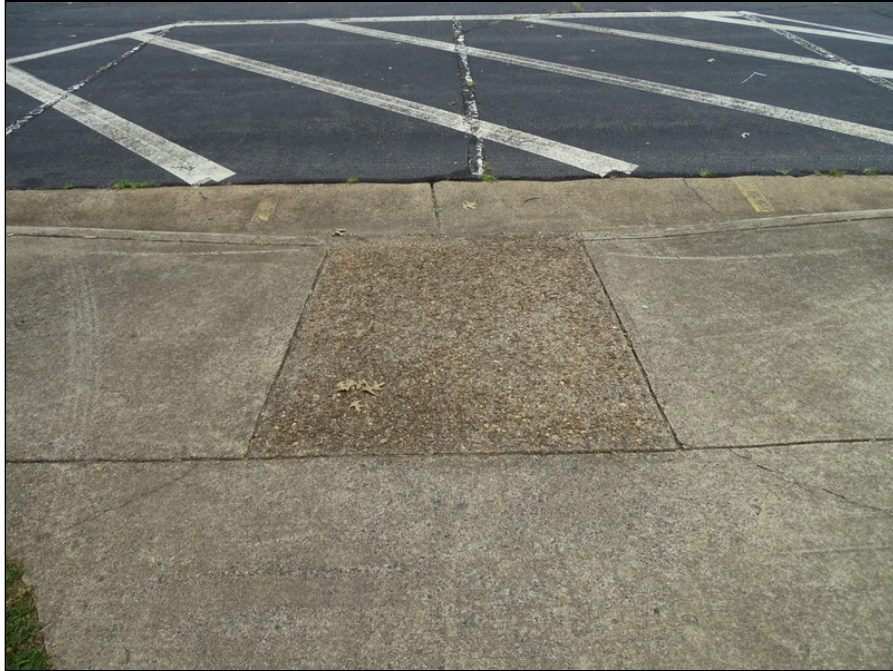
18 - Concrete sidewalk - note cracking

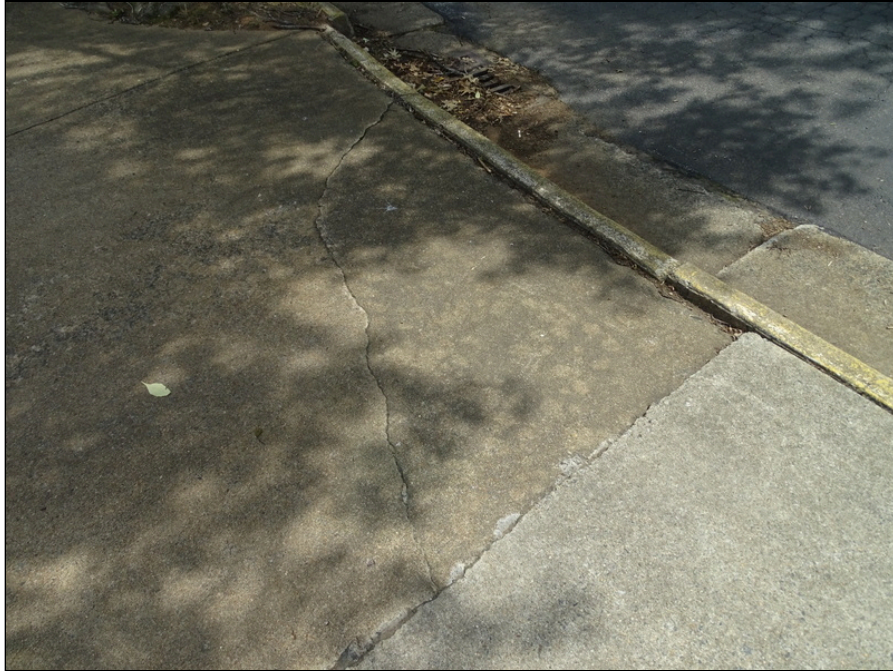
20 - Concrete sidewalk - note cracking

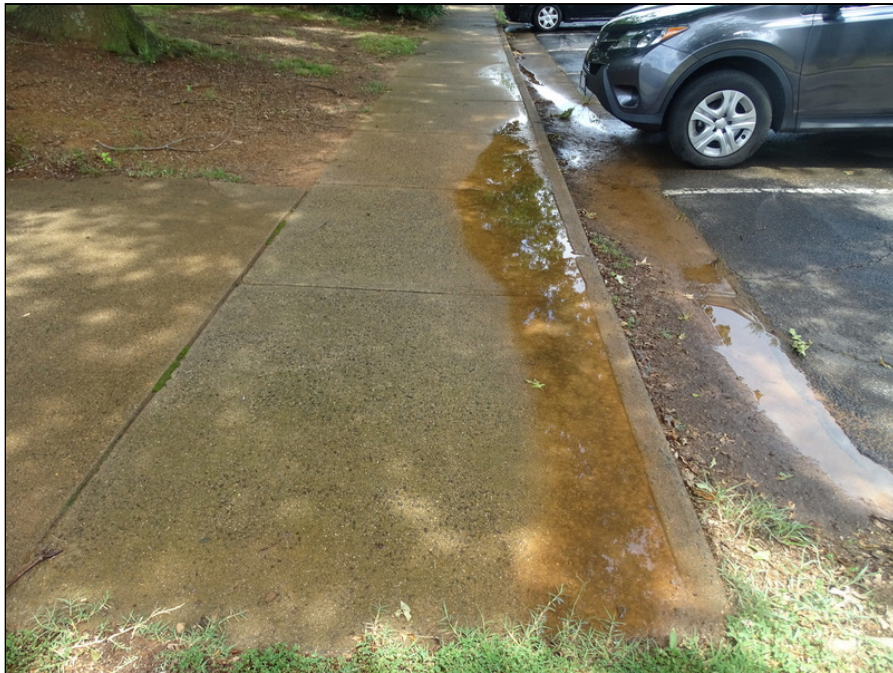
21 - Concrete sidewalk - note cracking

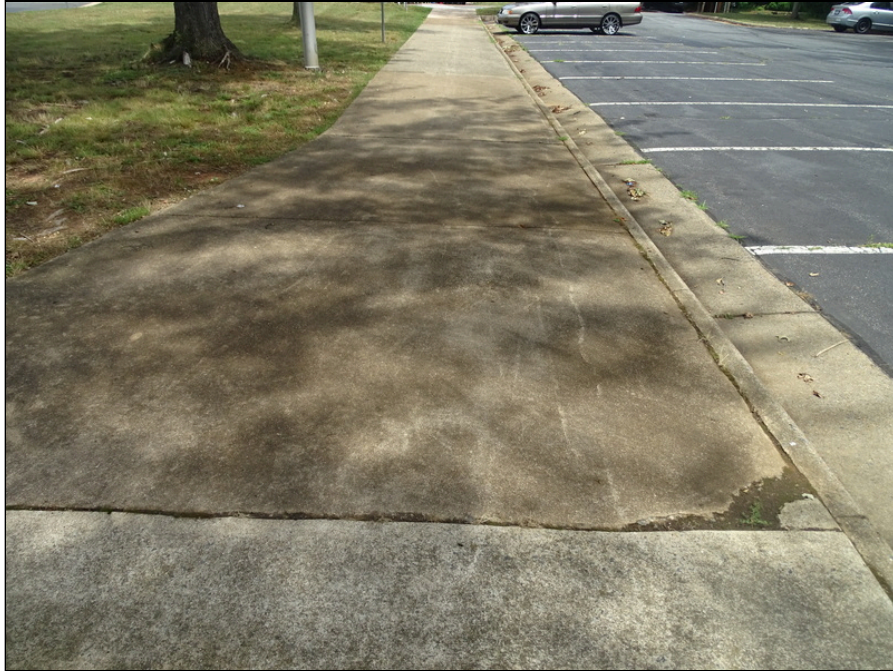
22 - Concrete sidewalk - note ponding

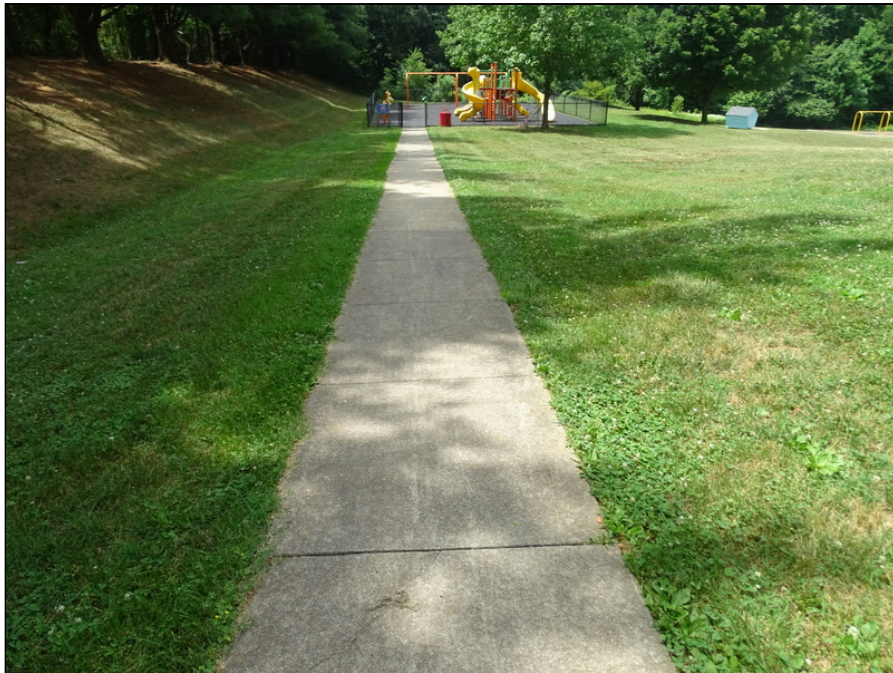
25 - Concrete sidewalk - note cracking

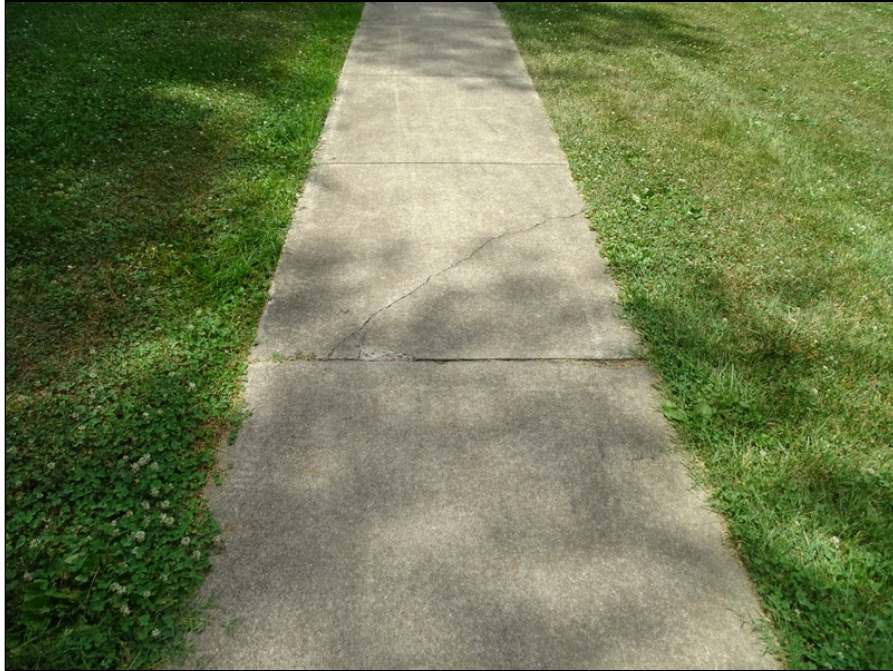
26 - Concrete sidewalk - note cracking

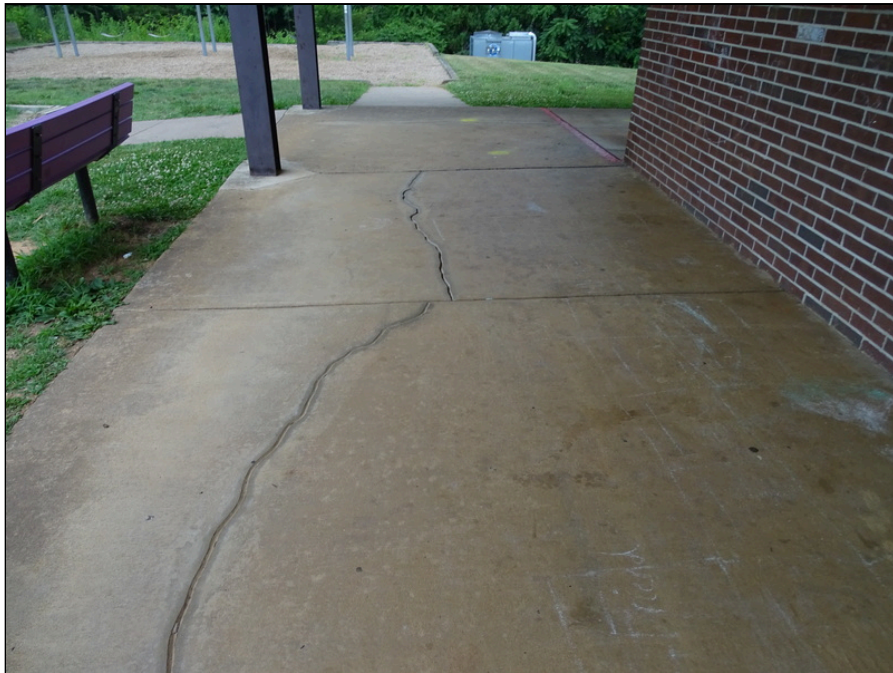
27 - Concrete sidewalk - note cracking

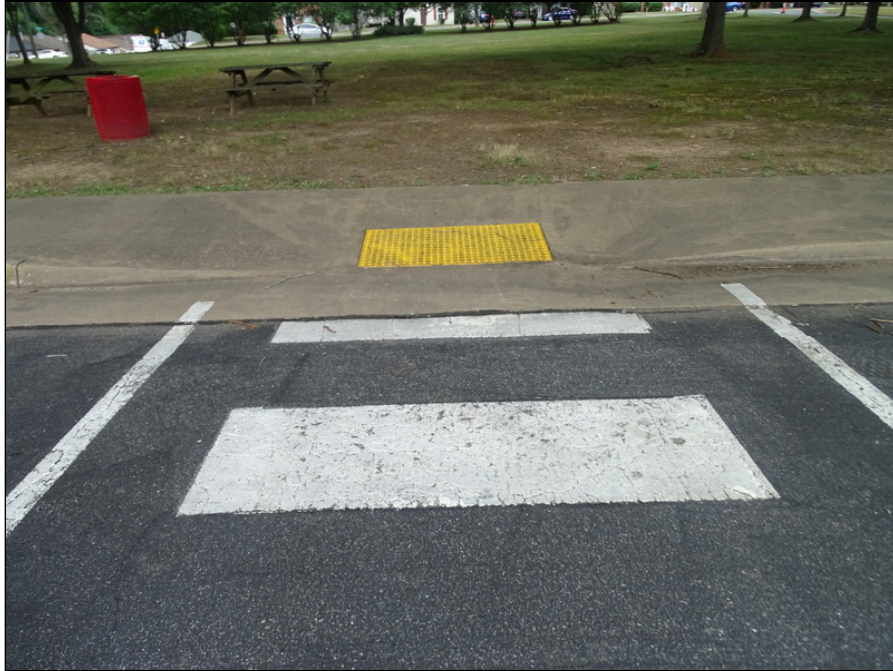
28 - Concrete sidewalk - note cracking

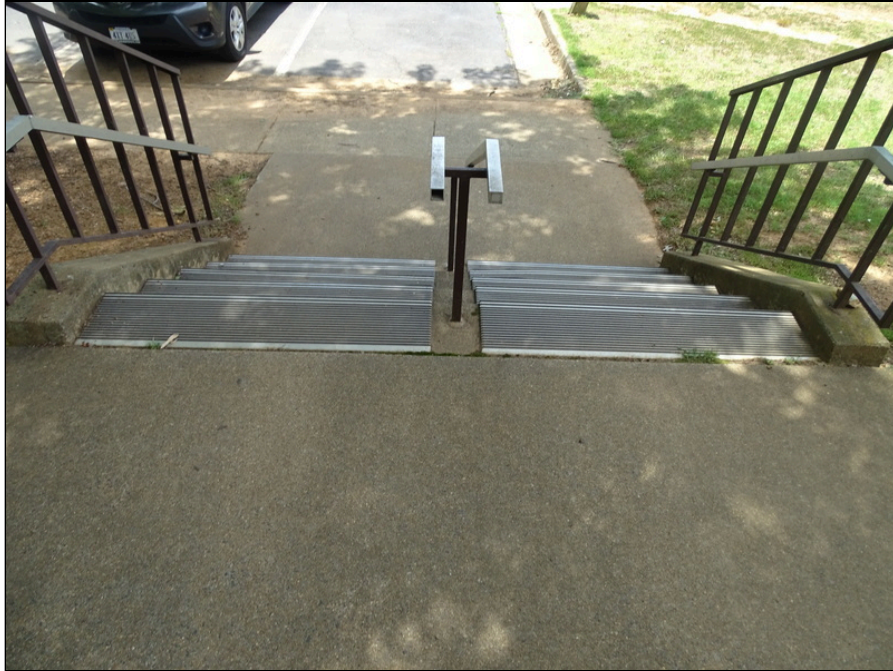
30 - Concrete sidewalk - note deterioration

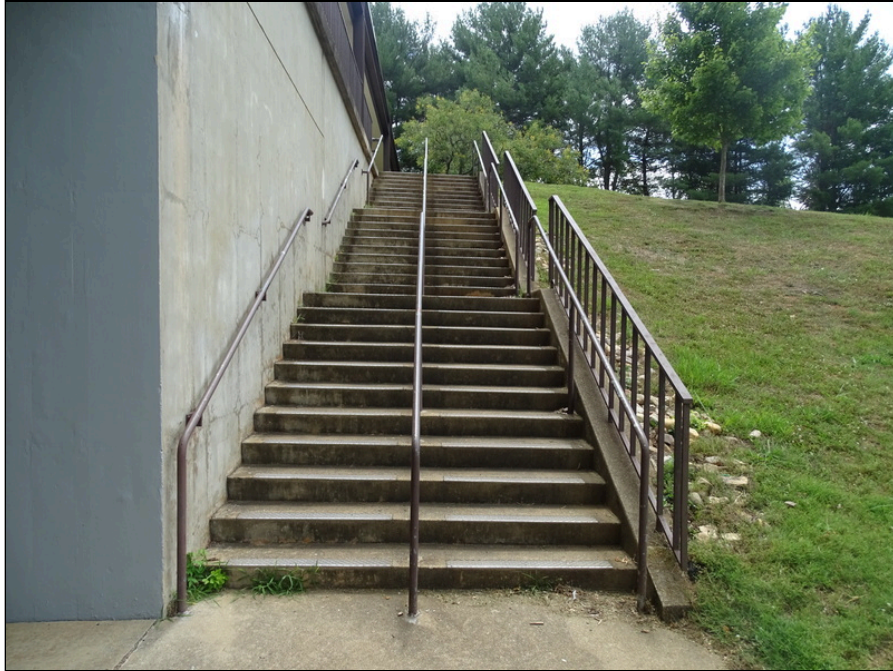
32 - Concrete stair - note stained

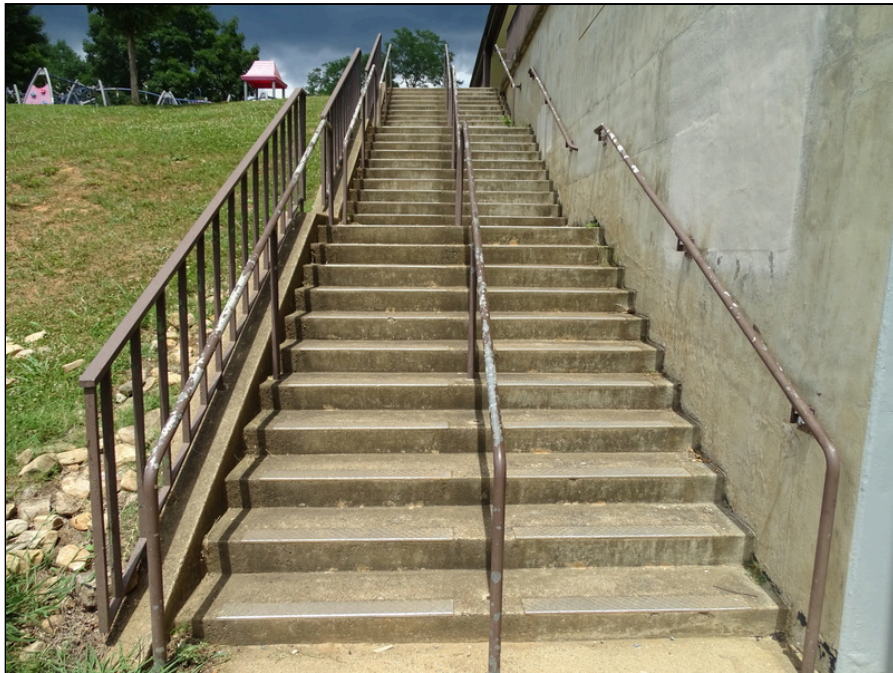
33 - Concrete stair - note stained and wall cracking

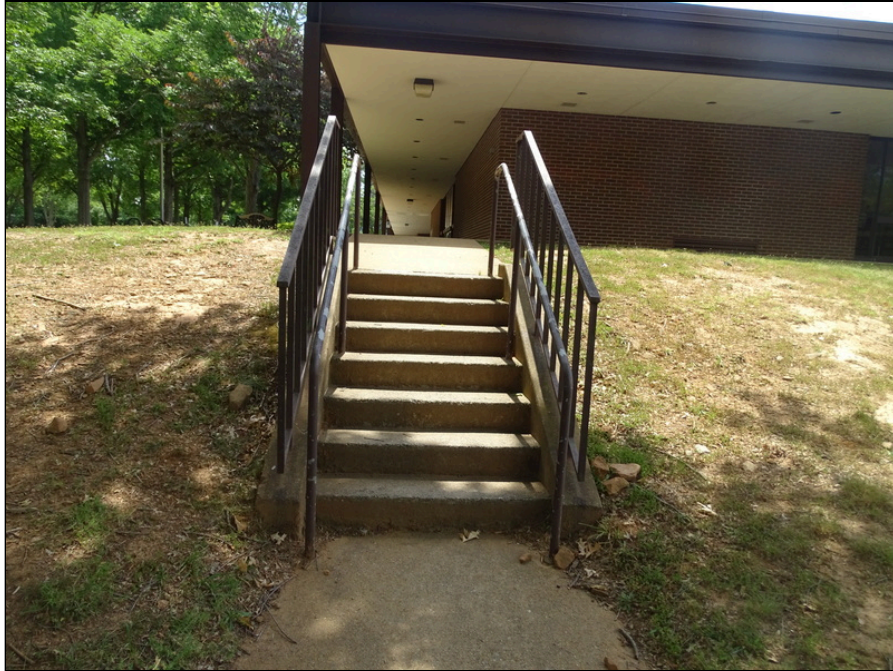
34 - Concrete stair handrail - note deterioration

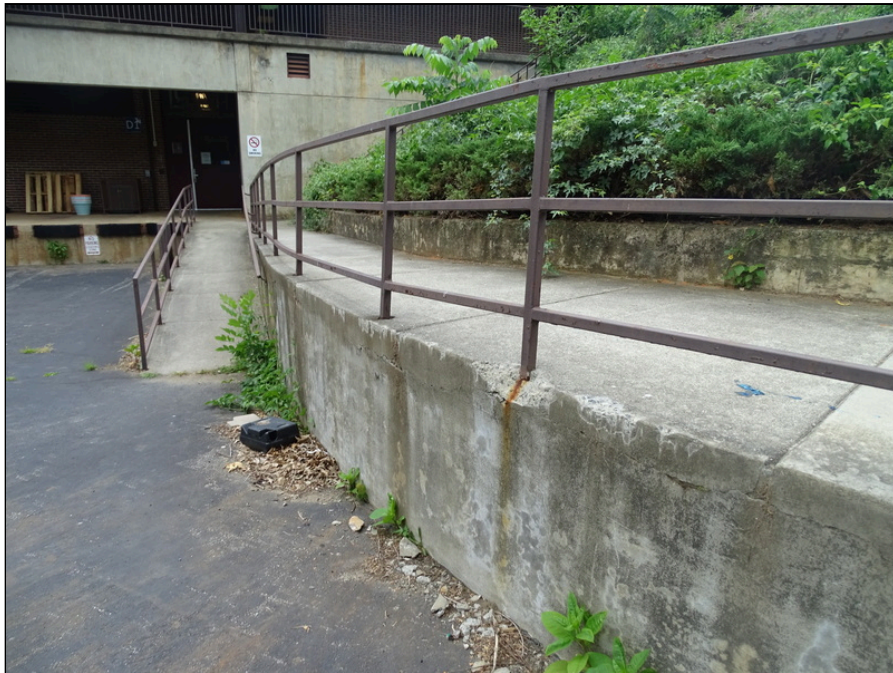
35 - Asphalt surface - note cracking and grass growing

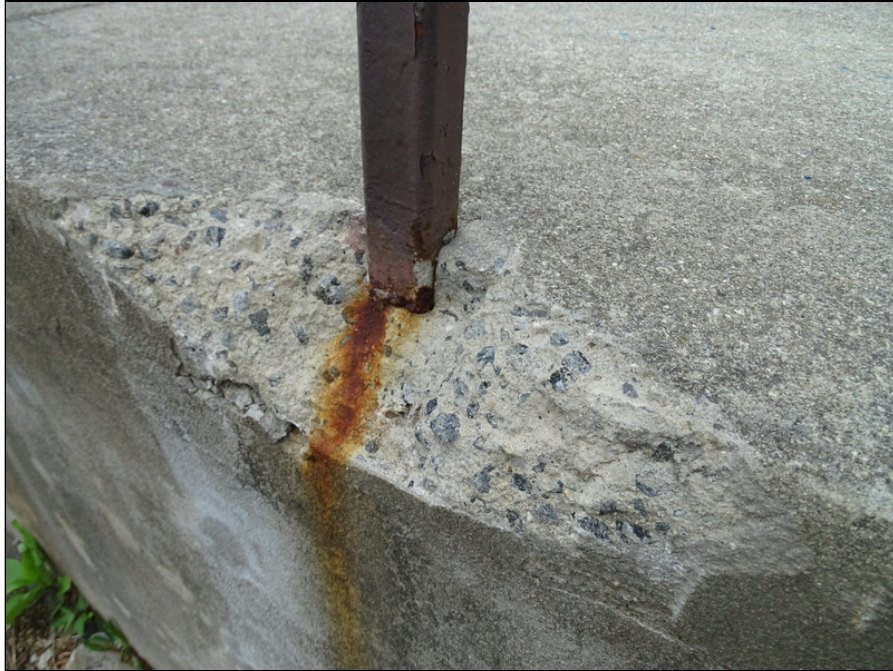
36 - Concrete ramp- note deterioration

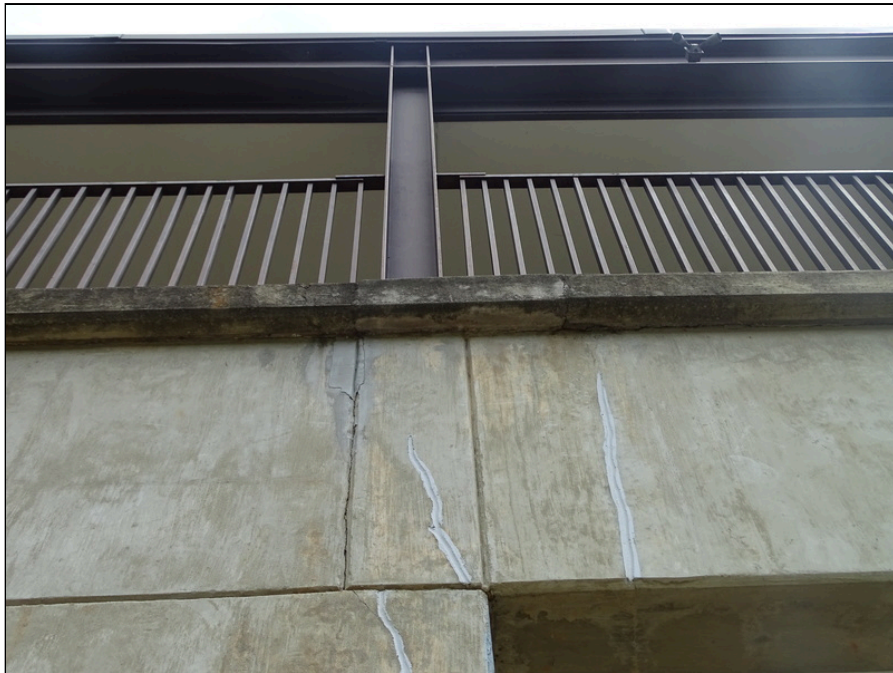
55 - Building exterior - note column cracking

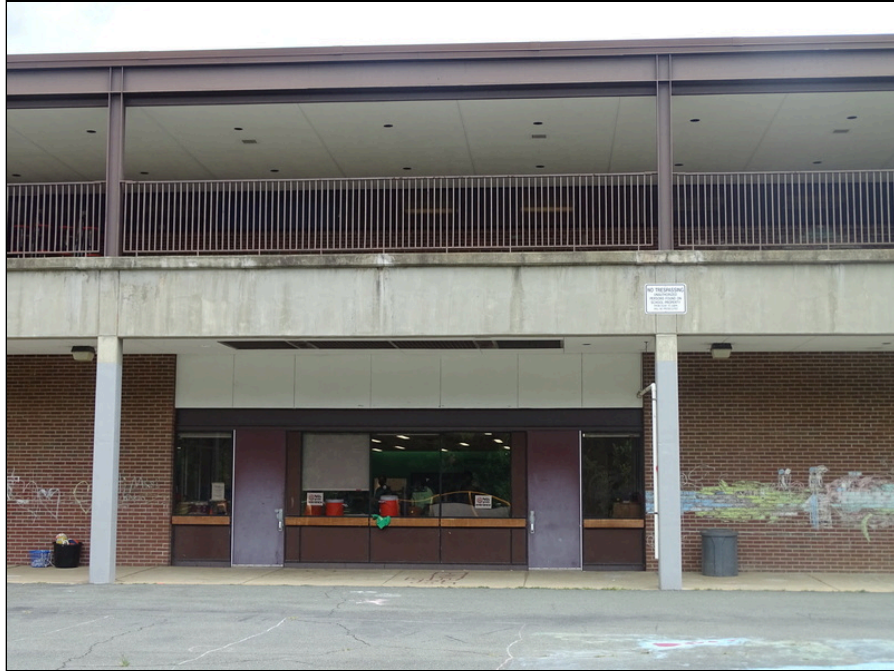
56 - Building exterior - note stained and sealant repair

3.3.3 Building Exteriors																													
REPOINT BRICKWORK	20	8	12	1	LS	\$30,000.00	\$30,000	100%												\$30,000									\$30,000
PAINT EXPOSED STEEL ELEMENTS	10	1	9	1	LS	\$15,000.00	\$15,000	100%								\$7,500										\$7,500			\$15,000
REPLACE SEALANTS	12	10	2	1	LS	\$25,000.00	\$25,000	100%		\$12,500											\$12,500								\$25,000

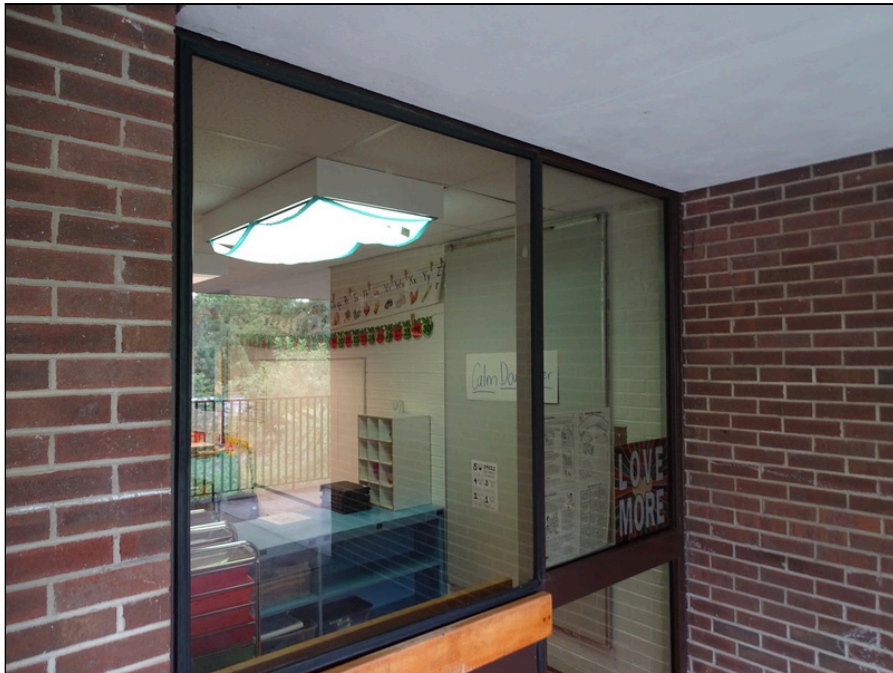
63 - Typical exterior window - note deterioration of gasket

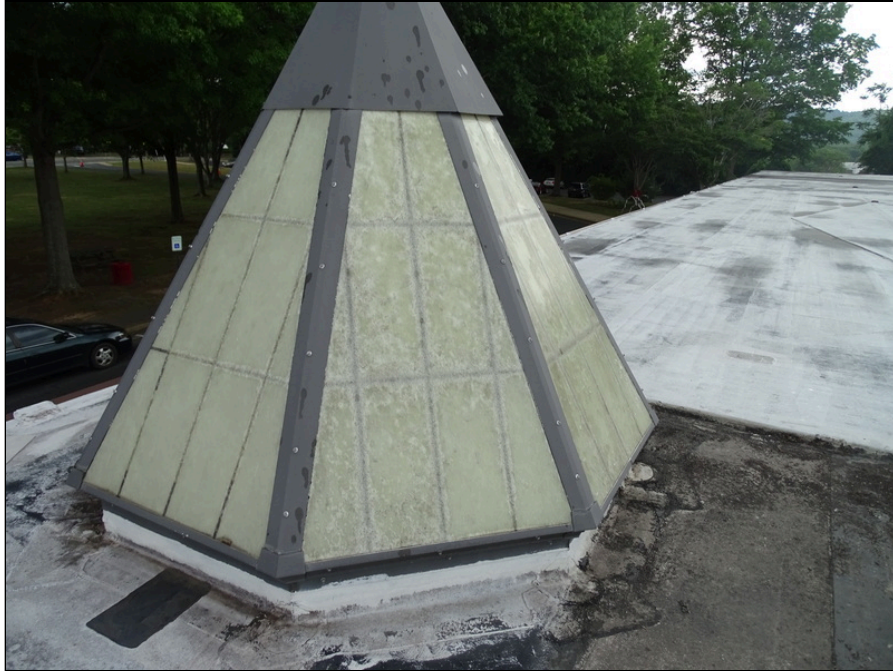
78 - Skylights located on north side of the building - note glass cracked

3.3.6 Roofing Systems																													
REPLACE SINGLE-PLY ROOFING SYSTEM	15	15	0	55,000	SF	\$14.00	\$770,000	100%	\$770,000																				\$770,000
REPLACE SKYLIGHTS AS NEEDED	20	19	1	1	LS	\$10,000.00	\$10,000	100%	\$10,000																				\$10,000

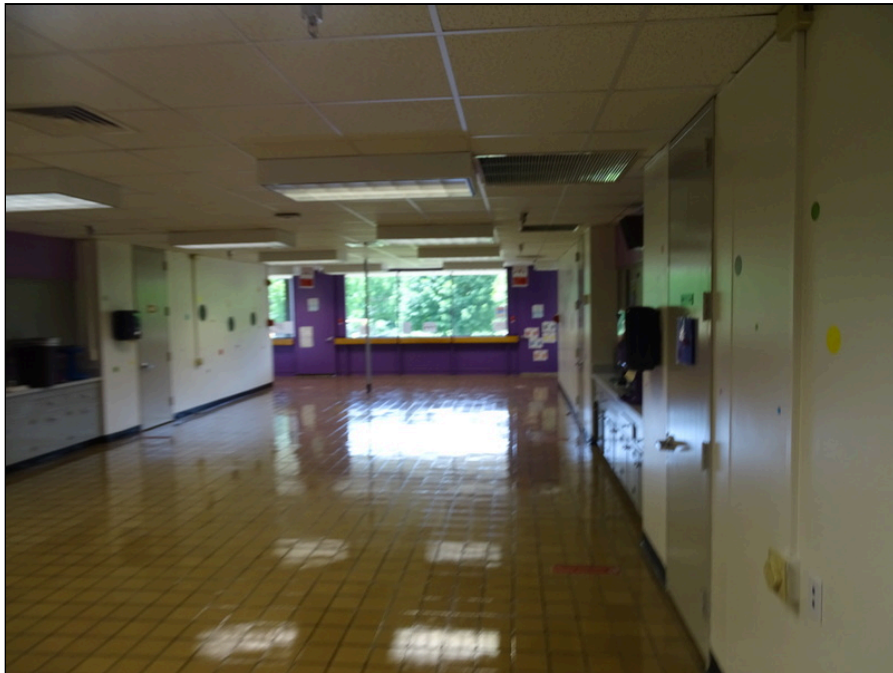
129 - Ceiling interior - water leakage
