JESSUP HOUSE
614 EAST HIGH STREET
CHARLOTTESVILLE, VIRGINIA

ECS PROJECT NO. 46:6713

CITY OF CHARLOTTESVILLE - FACILITIES DEVELOPMENT

Reference: Facility Condition Assessment Report for Jessup House, 614 East High Street,
Charlottesville, Virginia

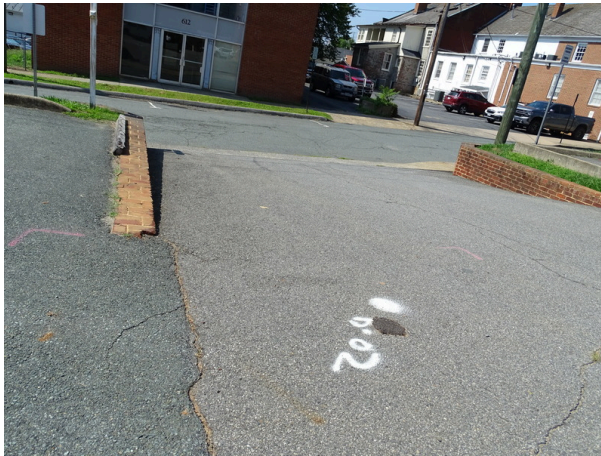
Site access from E Jefferson Street - note asphalt and brick wall deterioration

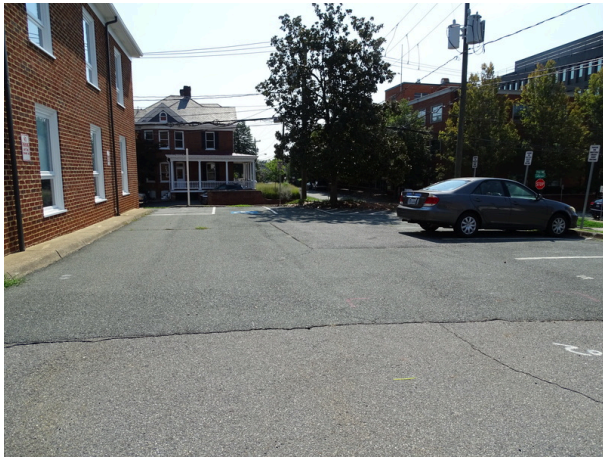
Asphalt-paved drive lanes and parking are located on the north side of the site. We observed areas of minor cracking. The expected useful life of asphalt pavement is 20 years. The asphalt pavement was observed to be in generally good condition. We recommend an allowance for asphalt repairs during the report period.

Asphalt pavements - note cracks

3.2.4 Paving, Curbing, and Parking																													
REPAIR ASPHALT PAVEMENT AS NEEDED	20	19	1	1	EA	\$7,500.00	\$7,500	200%	\$7,500																			\$7,500	\$15,000

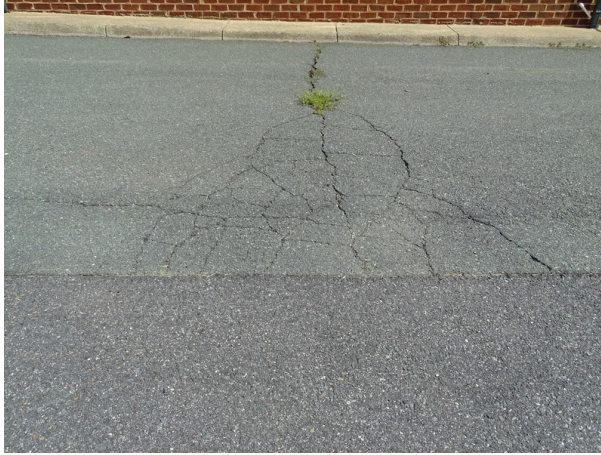
Asphalt pavement- note alligator cracks

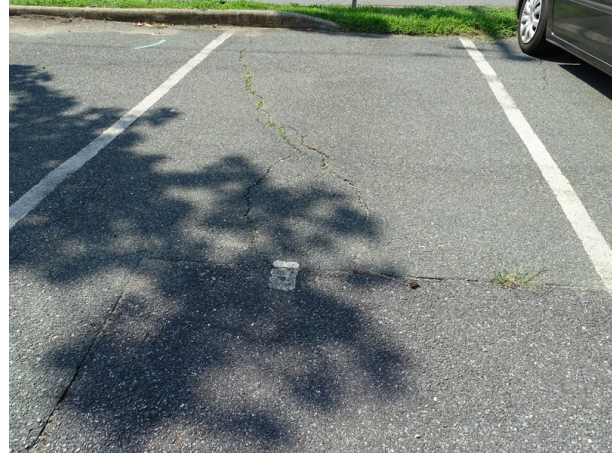
Asphalt parking- note alligator cracks

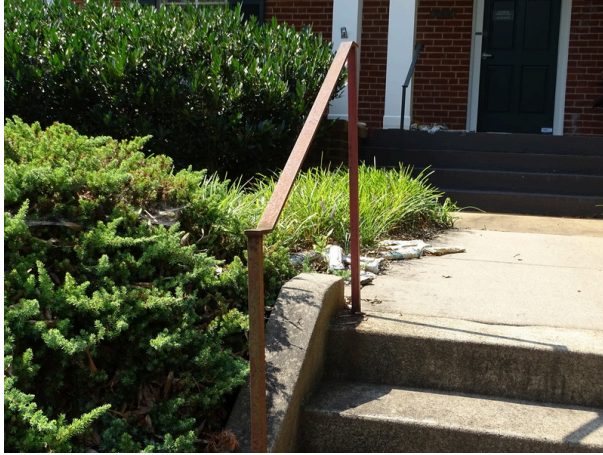
The concrete steps at the south side of the building were observed to be in fair condition with cracking at the bottom riser. We recommend repairing the concrete steps. Also noted was the missing handrail on the right side of the steps.

Exterior concrete stair handrail - note not with standard height

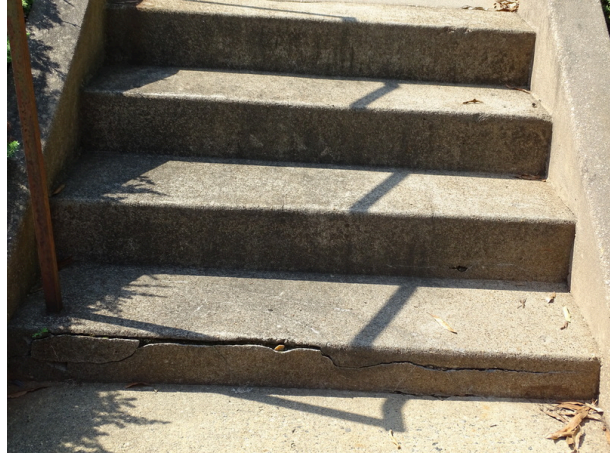
Exterior concrete stair - note deterioration

3.2.5 Flatwork																													
REPAIR CONCRETE STEPS AND SIDEWALKS AS NEEDED	20	19	1	1	EA	\$2,500.00	\$2,500	200%	\$2,500																			\$2,500	\$5,000

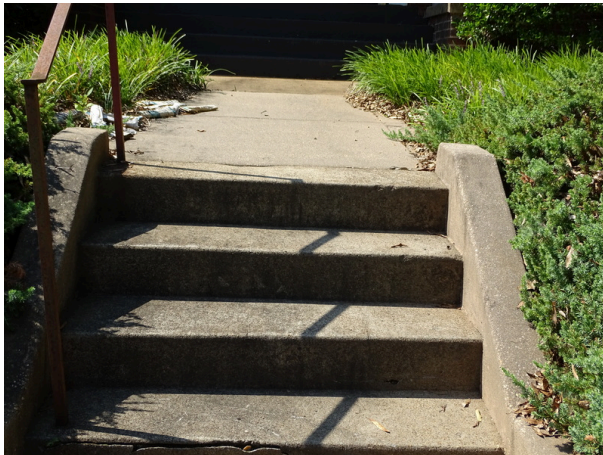
Exterior concrete stair - note installation of handrail in right side of stair

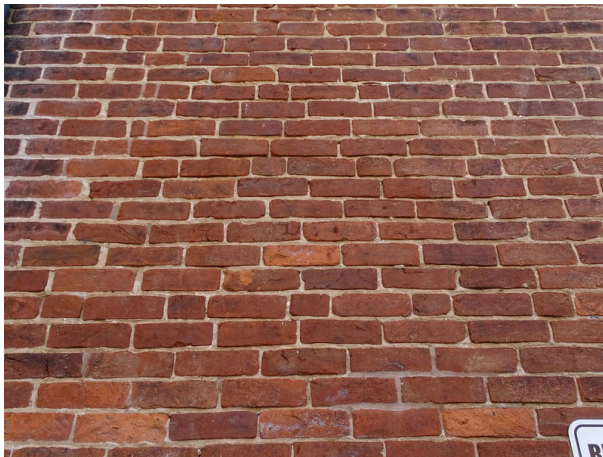
Building exterior wall - note mortar joint deterioration

3.3.3 Building Exteriors																													
REPOINT BRICKWORK - PAINT AND REPAIR WOOD TRIM AS NEEDED	20	19	1	1	LS	\$20,000.00	\$20,000	200%	\$20,000																			\$20,000	\$40,000

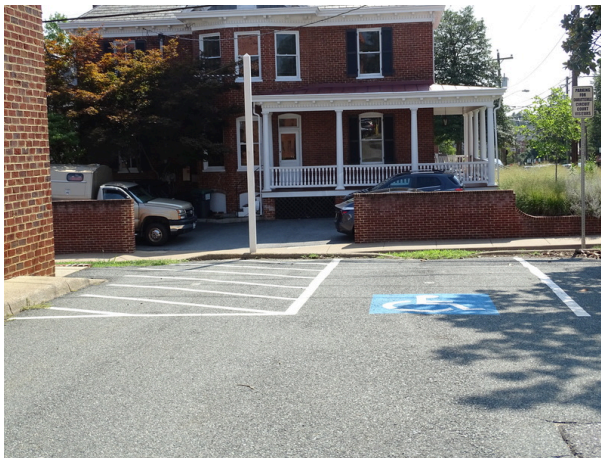
The parking area serving the property has a total of 11 parking spaces. Of the parking spaces, One is van accessible. Accessibility requires that 1 accessible parking space be provided in parking areas with a total of 1 to 25 spaces. One in six of the accessible parking spaces are required to be van accessible. A minimum of a 60-inch wide access aisle is required to be provided for every two accessible parking spaces. Accessible aisles were observed to be provided. The number of parking spaces provided meets accessibility requirements, but no signage was present. All accessible spaces and aisles are required to be marked with appropriate signage mounted 60" above grade. We recommend adding the appropriate signage at the accessible space and aisle.

Accessible parking

Immediate Repair Cost					
Item	Quantity	Unit	Unit Cost	Replacement Percent	Immediate Total
3.8 Accessibility (ADA) Compliance					
INSTALL ACCESSIBLE SIGNAGE	1	EA	\$600.00	100%	\$600
Total Repair Cost					\$600.00

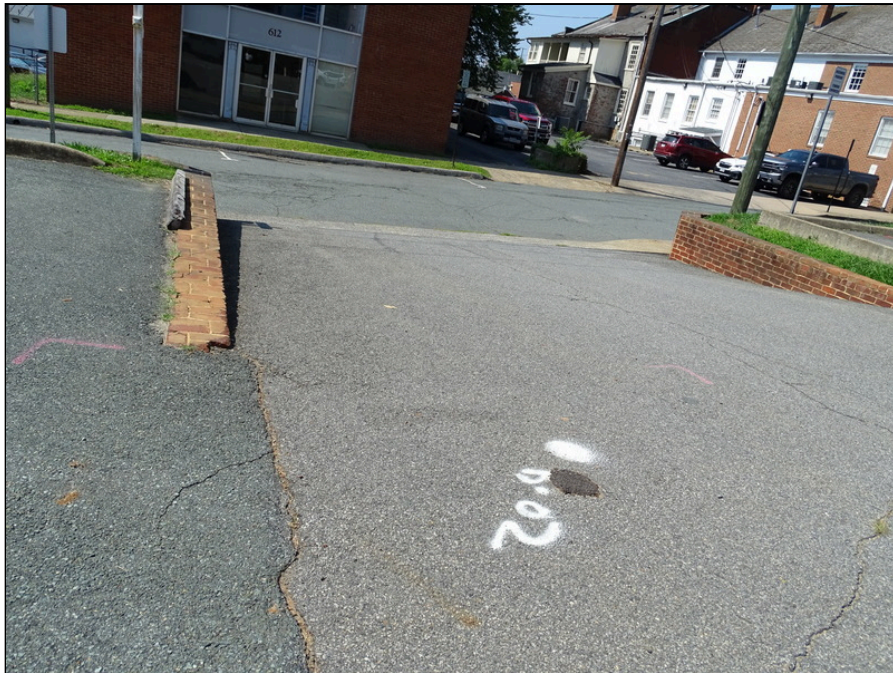
2 - Site access from E Jefferson Street - note asphalt and brick wall deterioration

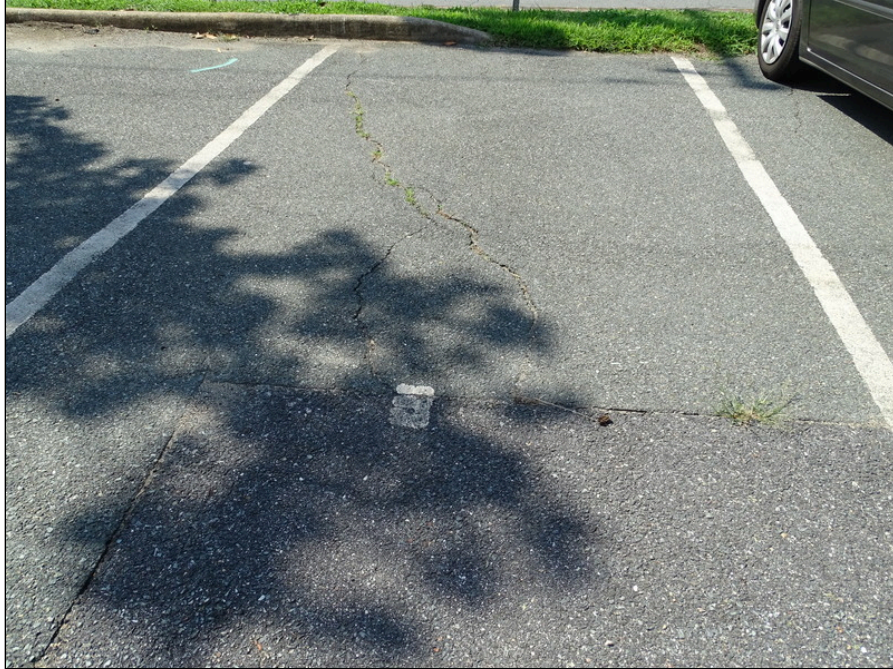
3 - Asphalt parking- note alligator cracks

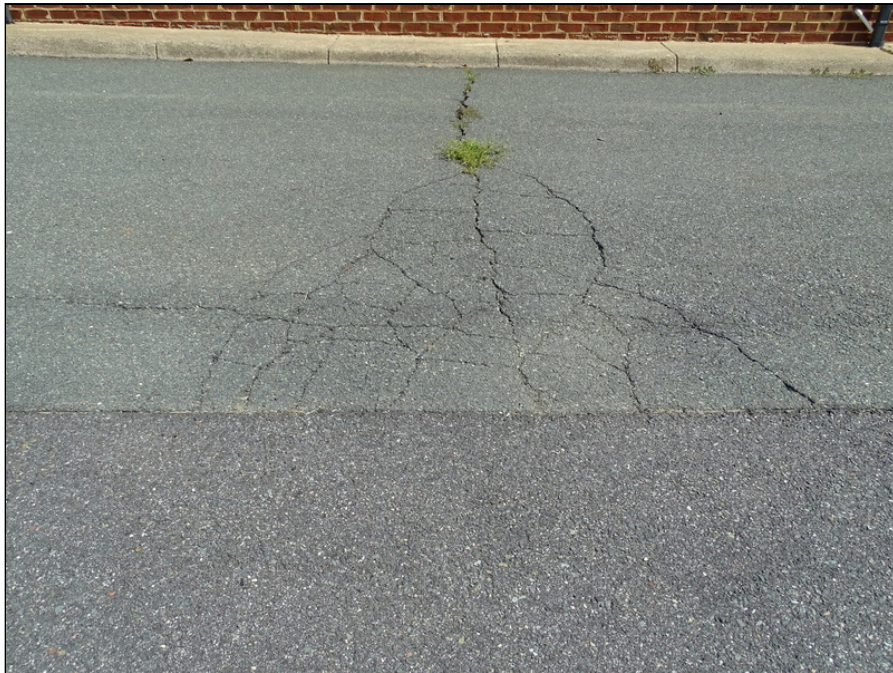
4 - Asphalt pavement- note alligator cracks

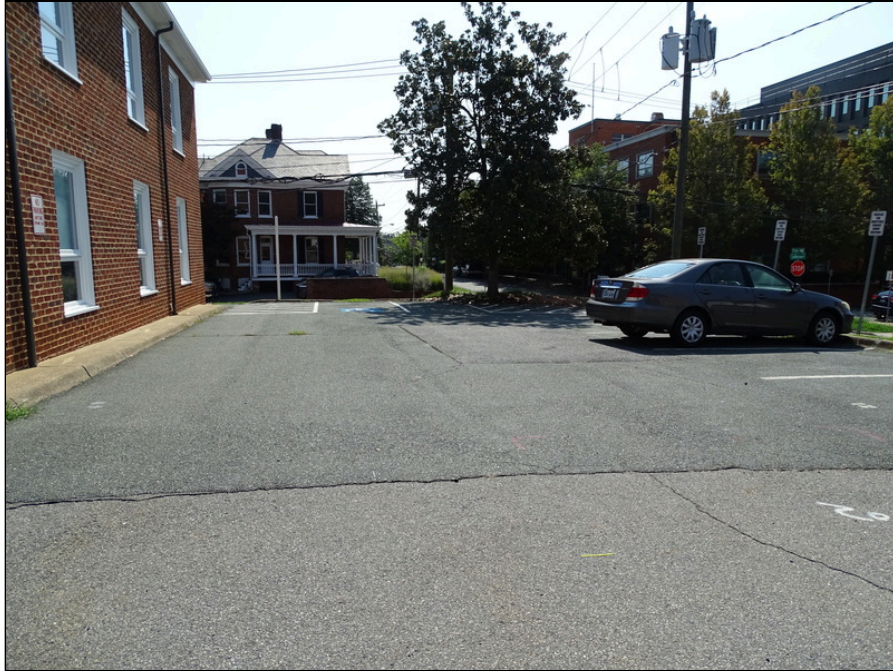
5 - Asphalt pavements - note cracks

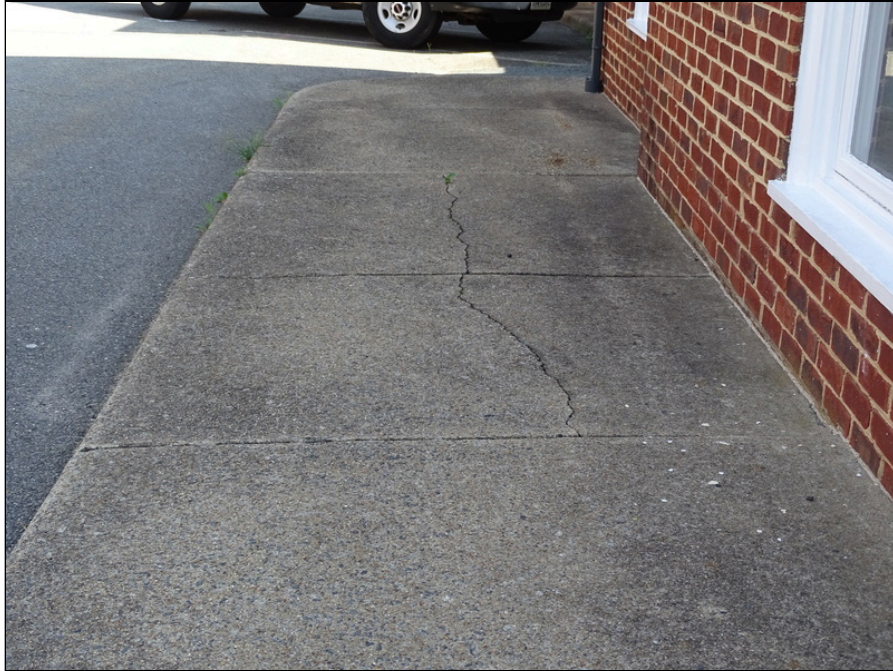
7 - Sidewalks - note cracks in concrete

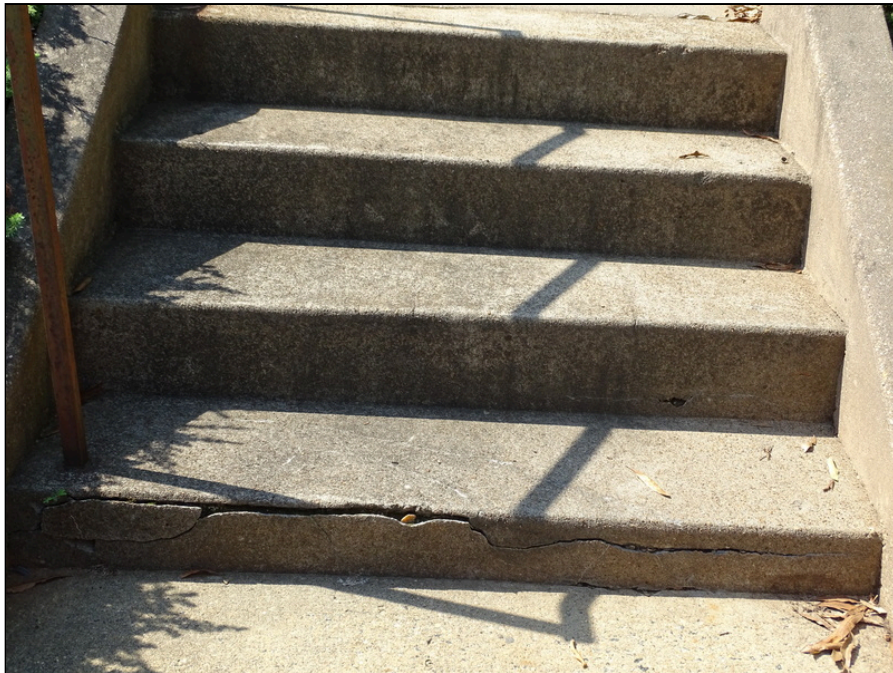
12 - Exterior concrete stair - note deterioration

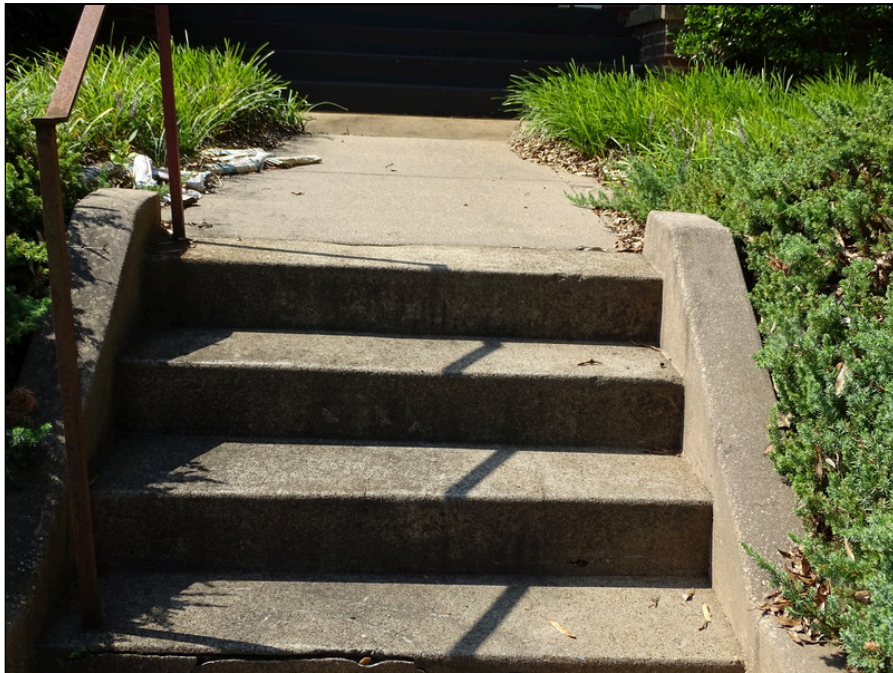
14 - Exterior concrete stair - note installation of handrail in right side of stair

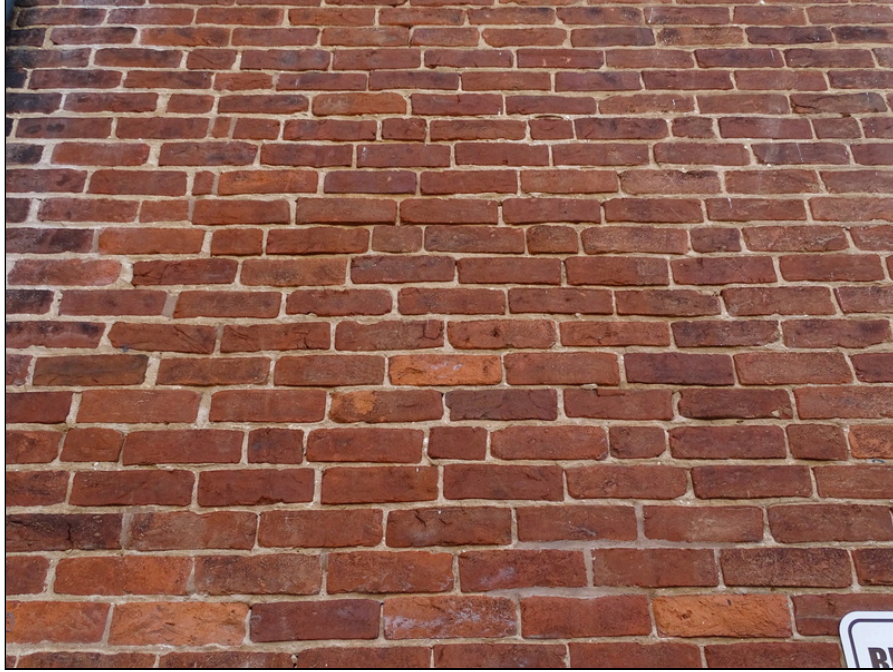
23 - Building exterior wall - note mortar joint deterioration

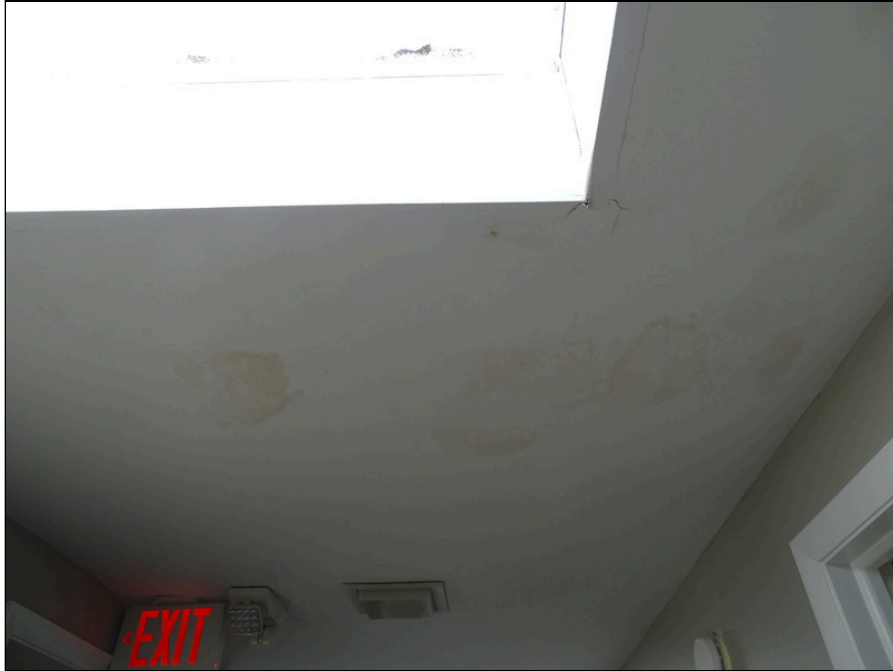
47 - Water leakage at ceiling of first floor corridor

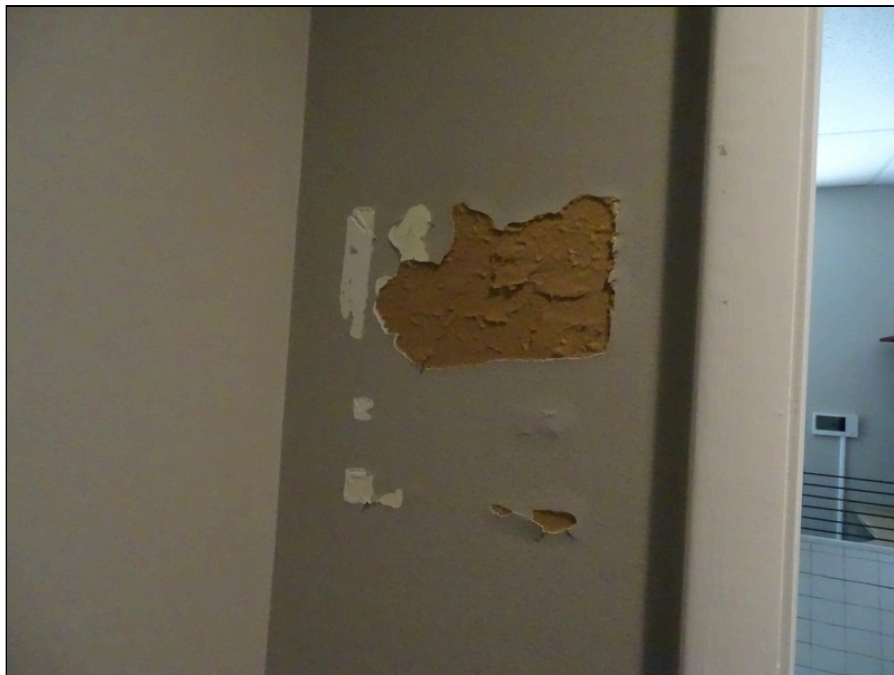
72 - Interior wall - note deterioration
