JOHNSON ELEMENTARY SCHOOL  
1645 CHERRY AVENUE  
CHARLOTTESVILLE, VIRGINIA

ECS PROJECT NO. 46:6713

CITY OF CHARLOTTESVILLE - FACILITIES DEVELOPMENT

Reference: Facility Condition Assessment Report for Johnson Elementary School, 1645 Cherry Avenue,  
Charlottesville, Virginia

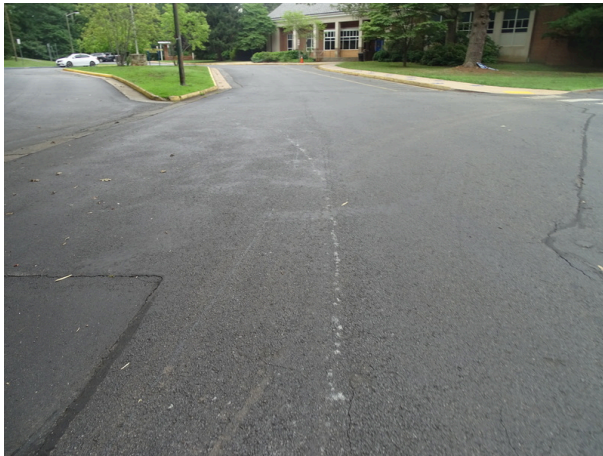
Asphalt-paved drive lanes and parking areas are located on the north and east side of the site which also provides access to the site. The asphalt pavement was observed to be in generally good to fair condition with minor cracks observed on the pavement. Striping was in fair condition. The expected useful life of asphalt pavement is 20 years. We have provided allowances to repair the cracked areas of asphalt pavement.

Asphalt drive lane - note cracks and previous repair

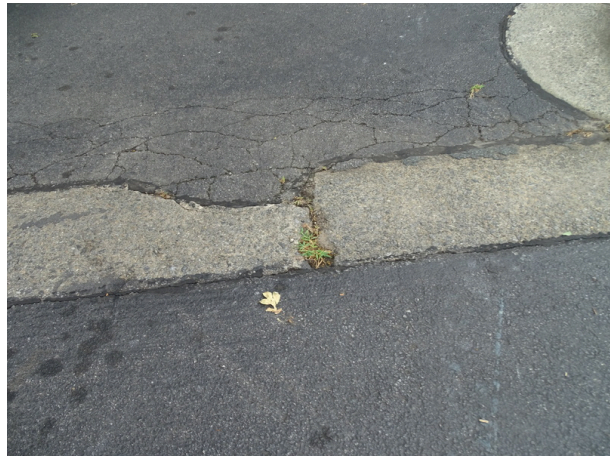
Asphalt apron - alligator cracking

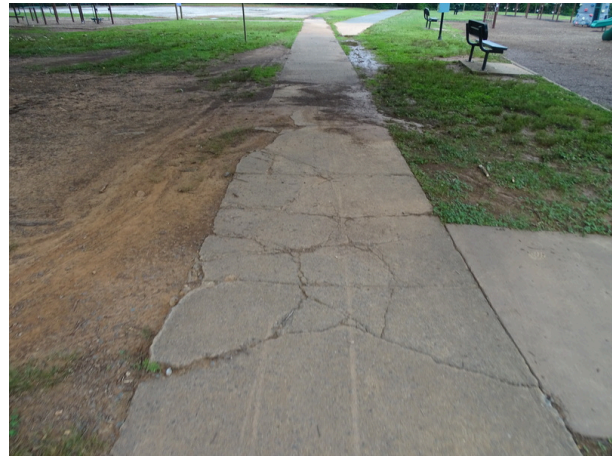
Typical concrete sidewalk - note cracking

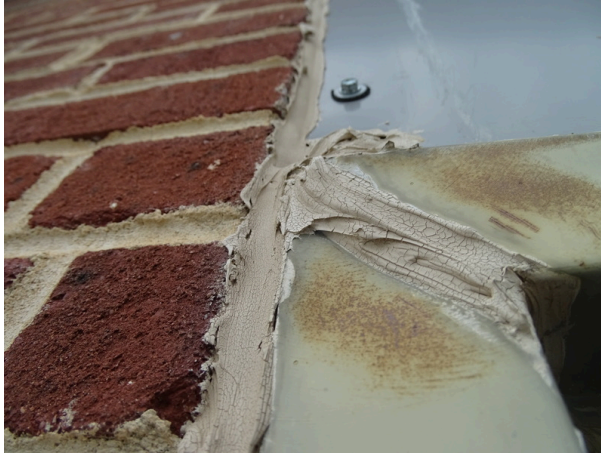
Exterior sealants are located around the window and door frames. The expected useful life of exterior sealants is approximately 10 to 12 years before replacement is needed. The exterior sealants were generally in fair condition. The sealants were observed to be hard and separated from the substrate. We recommend that the exterior sealants be replaced.

Building exterior - note sealant condition

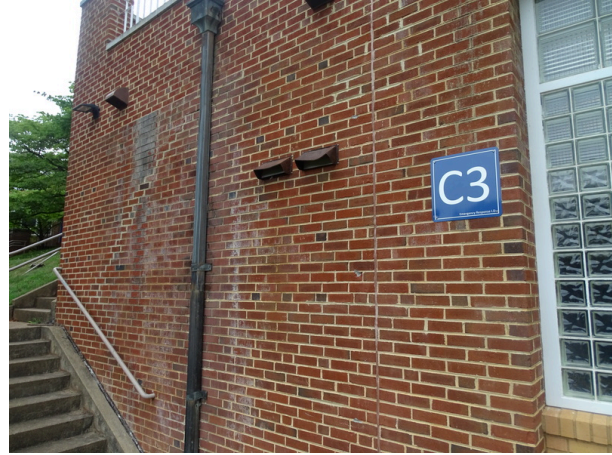
Building exterior - note efflorescence

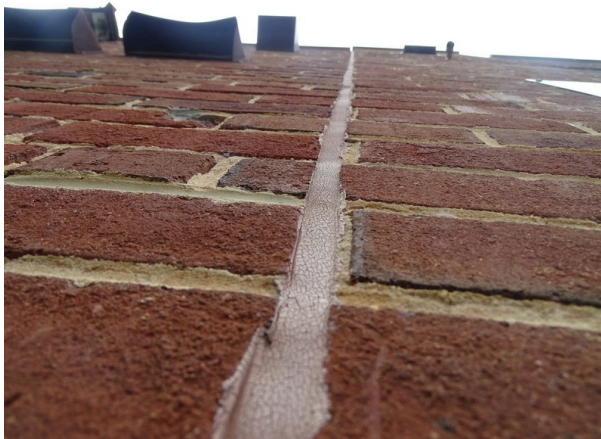
Building exterior - note vertical sealant condition

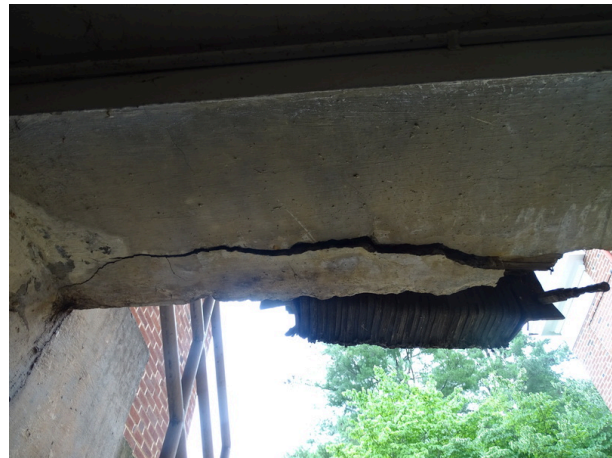
Building exteriors at loading dock area - note damage

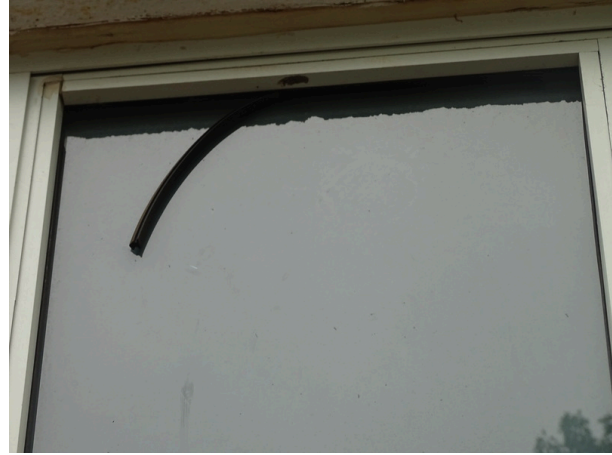
Window gaskets typically have an expected useful life of 15 to 20 years. Some of the gaskets were observed to be separating. We recommend replacing the window gaskets.

Typical exterior windows - note separation of gasket

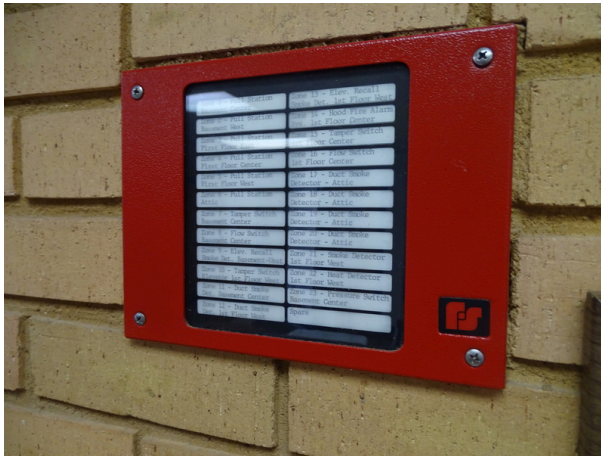
The fire alarm system was observed but not tested. A fire control panel is located in the Main Office. The fire control panel was reportedly an older system and observed to be in fair condition. Emergency exit signs and lighting, pull stations, fire extinguishers, smoke detectors, and alarm bells and strobes are located throughout the building.

Fire alarm panel - note older panel

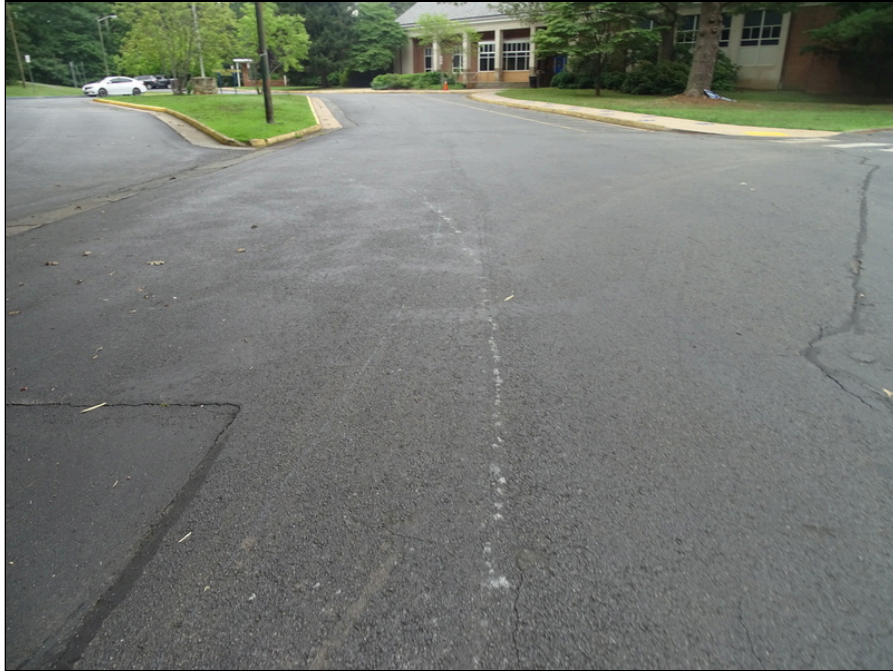
3 - Asphalt drive lane - note cracks and previous repair

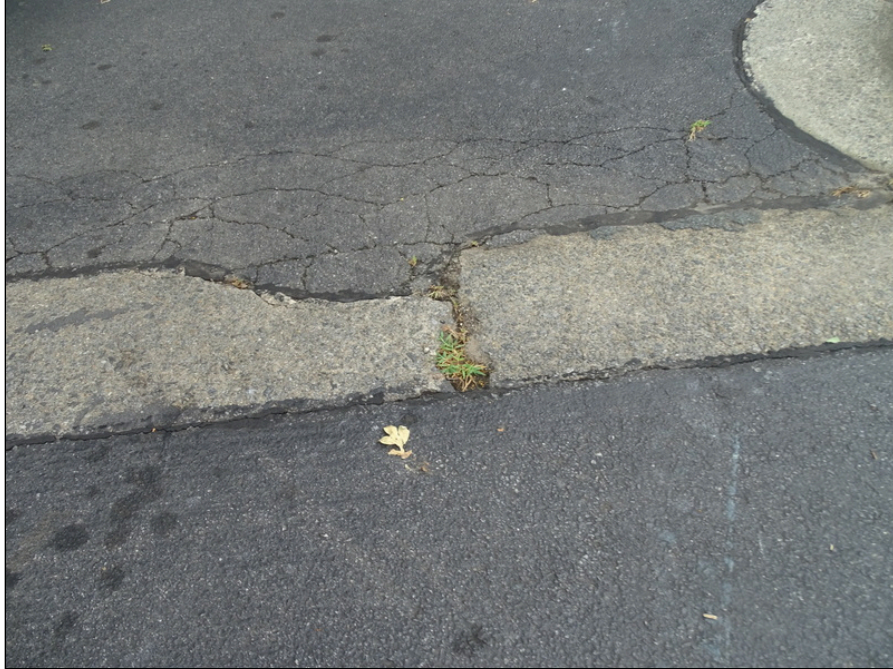
5 - Asphalt apron - alligator cracking

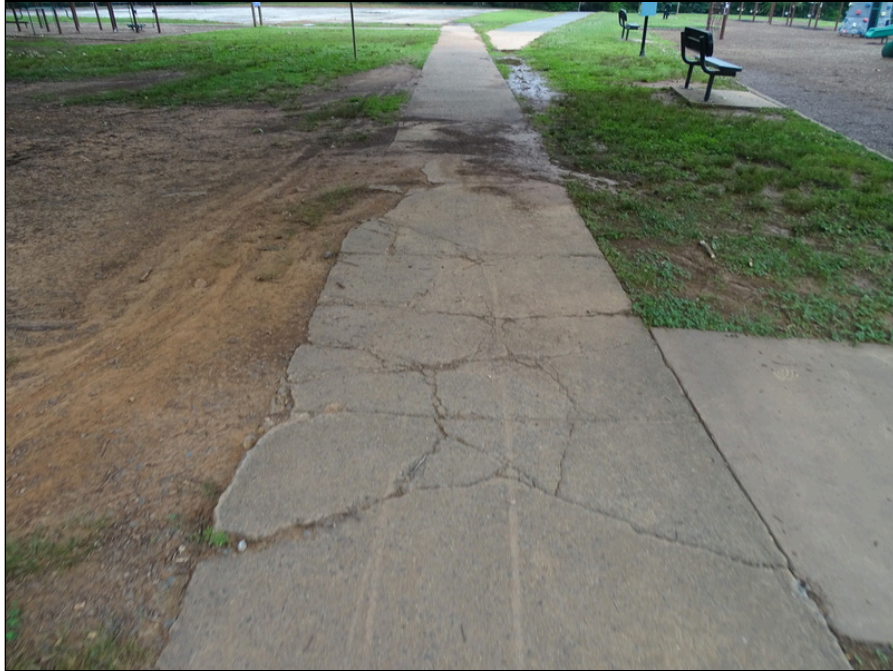
11 - Typical concrete sidewalk - note cracking

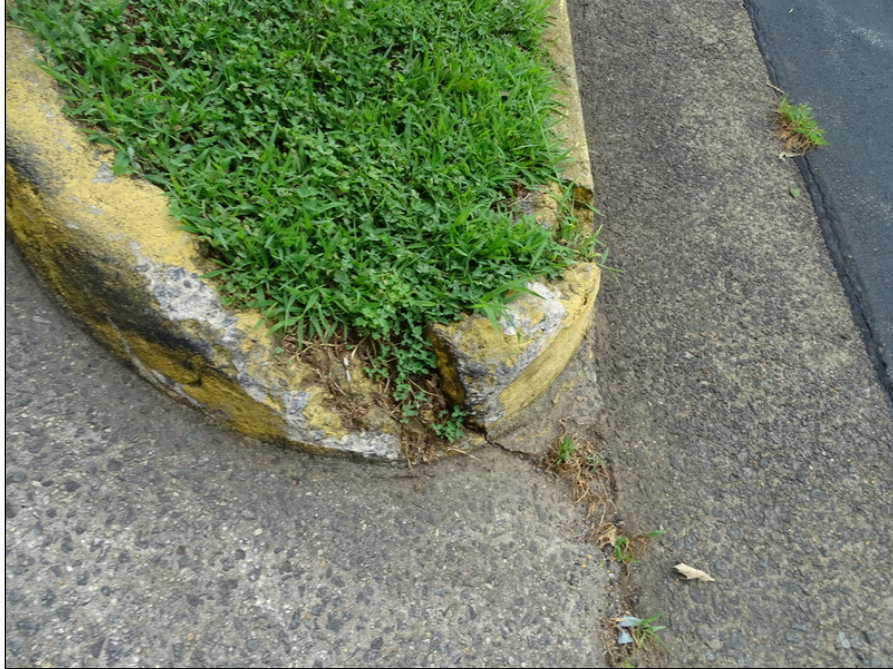
13 - concrete curb - note deterioration

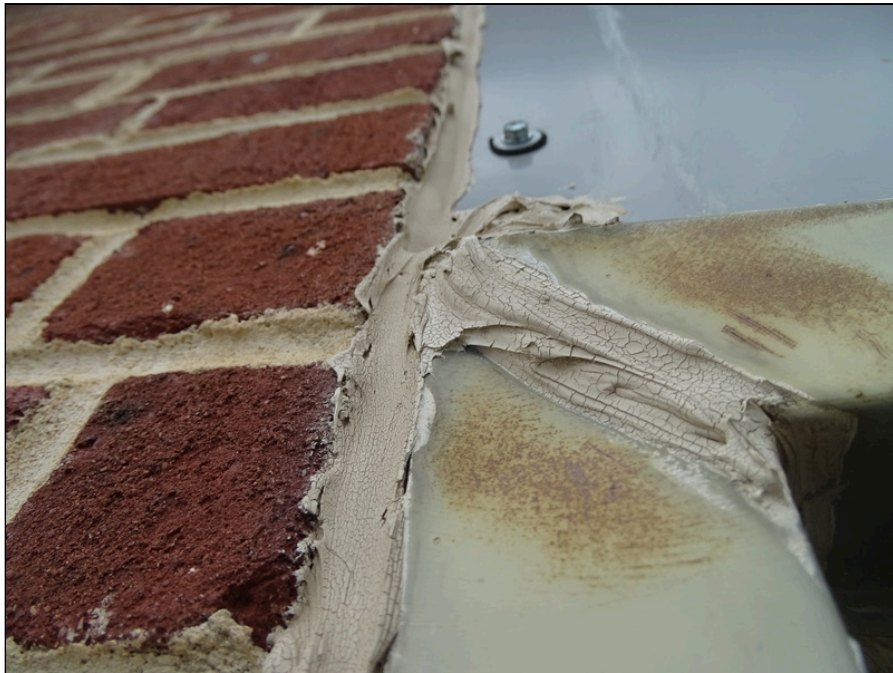
26 - Building exterior - note sealant condition

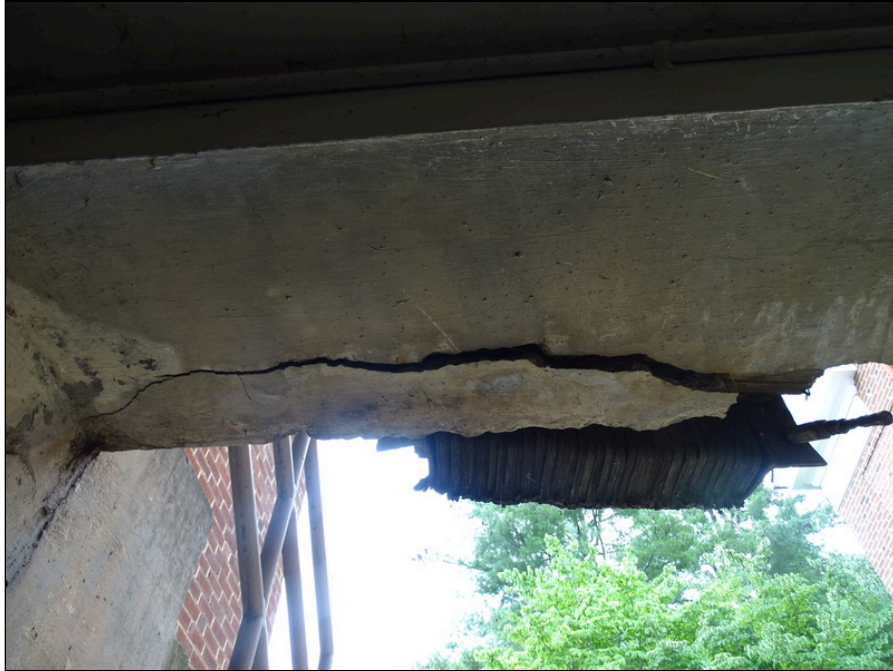
27 - Building exteriors at loading dock area - note damage

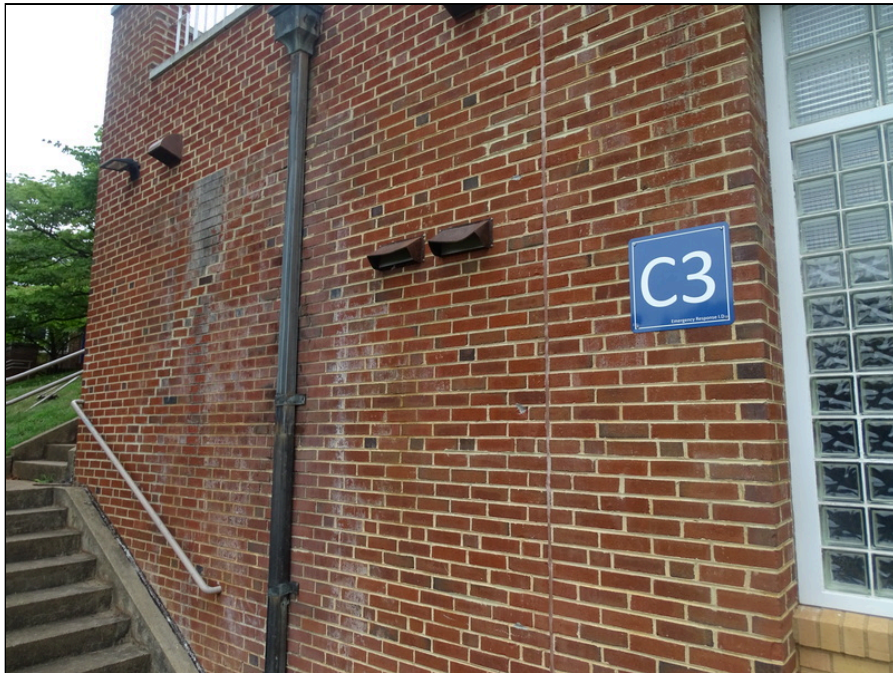
28 - Building exterior - note efflorescence

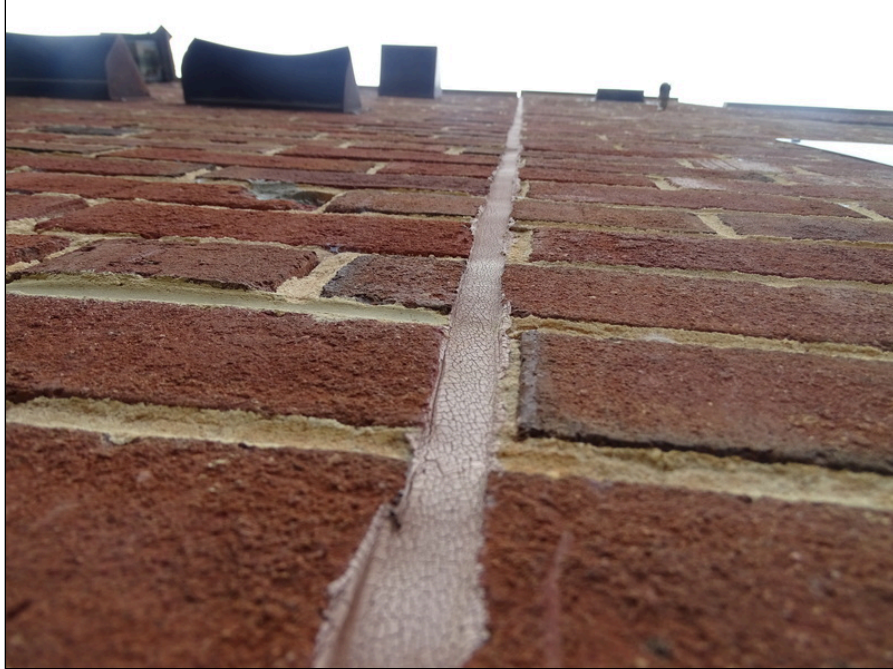
29 - Building exterior - note vertical sealant condition

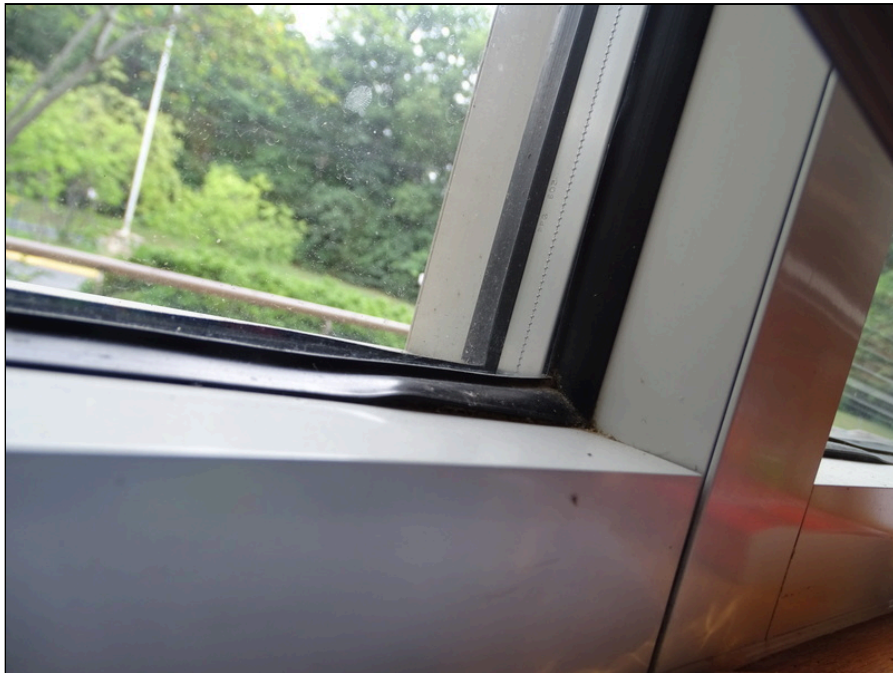
34 - Typical exterior windows - note separation of gasket

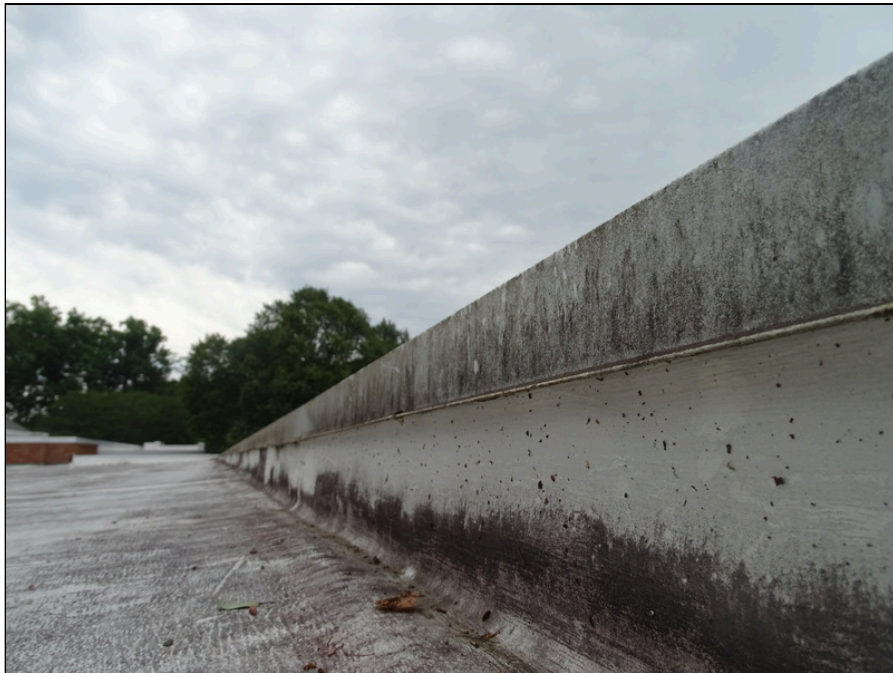
44 - Parapet wall - note deterioration

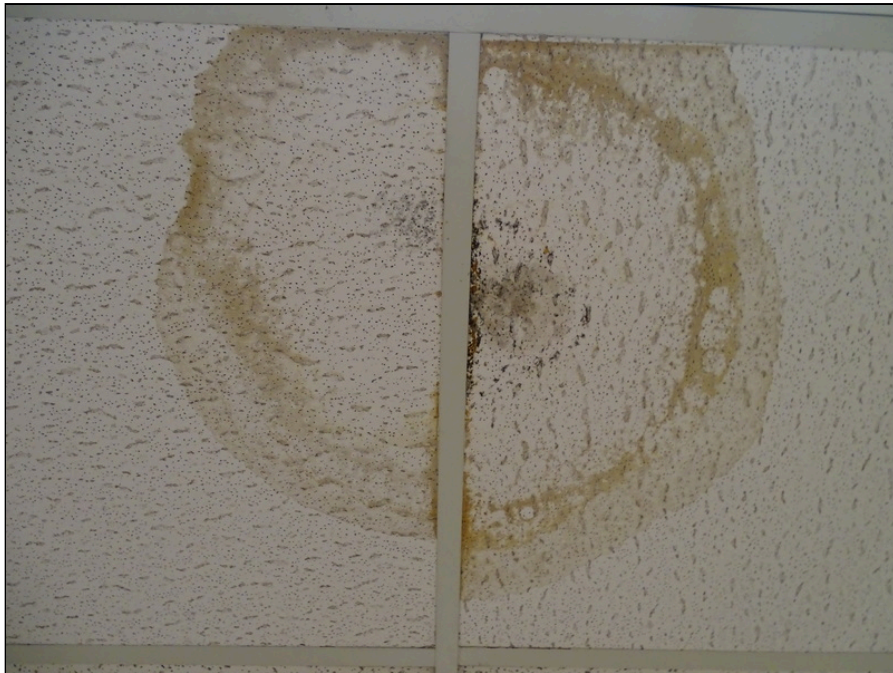
84 - Typical ceiling - note water leakage
