KEY RECREATION CENTER
800 EAST MARKET STREET
CHARLOTTESVILLE, VIRGINIA

ECS PROJECT NO. 46:6713

CITY OF CHARLOTTESVILLE - FACILITIES DEVELOPMENT

Reference: Facility Condition Assessment Report for Key Recreation Center, 800 East Market Street ,
Charlottesville, Virginia

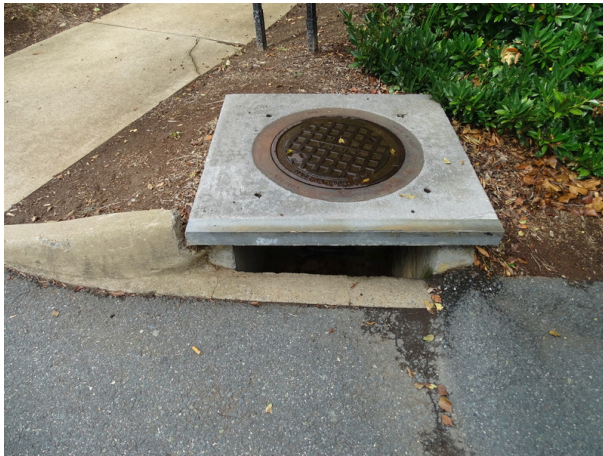
Storm sewer curb inlet

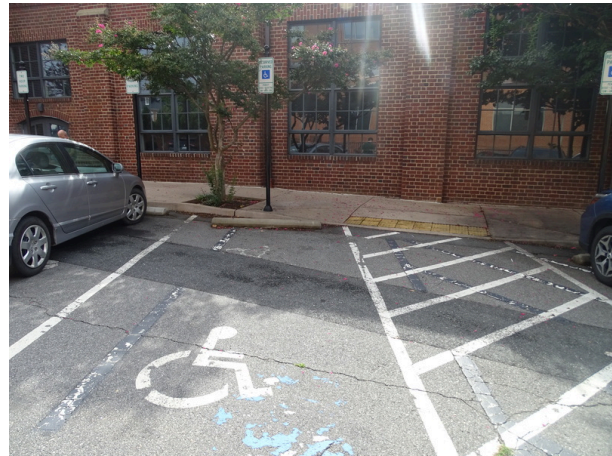
Accessible parking space

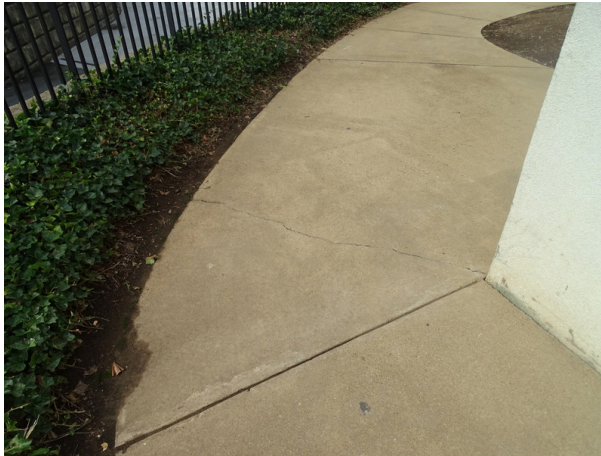
Concrete sidewalk

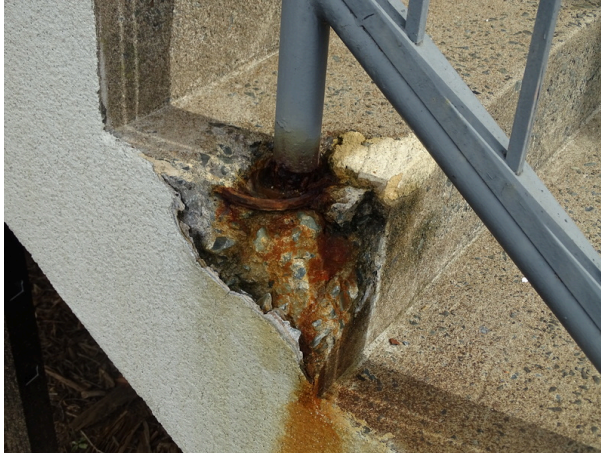
Concrete stairs with metal handrails provided access at various entrances throughout the exterior. The front entrance contained cut stone steps with metal railings. The metal handrails throughout the property generally appeared in good condition. At the stairs located on the south side of the building, spalled concrete was observed due to corrosion of the metal handrails. The handrails should be cleaned and painted every 5-7 years.

Concrete steps on south side of the building -
note deterioration

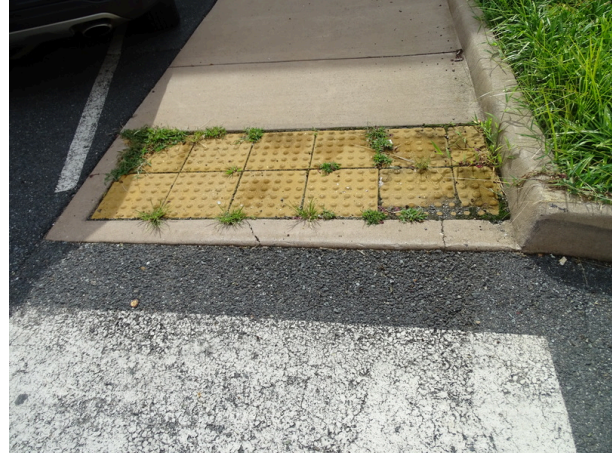
Accessible curb cut ramp with truncated domes

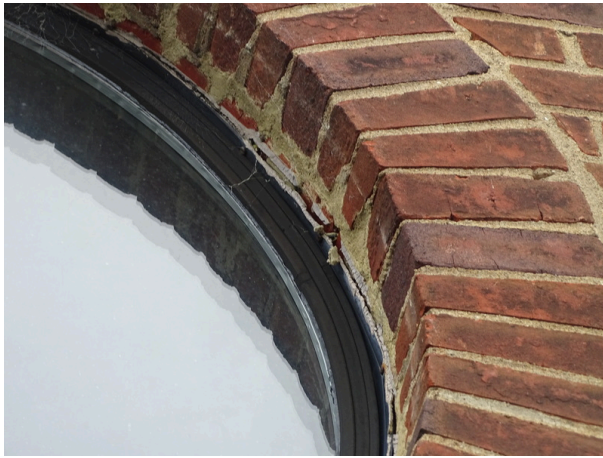
Building exterior sealants - note deterioration

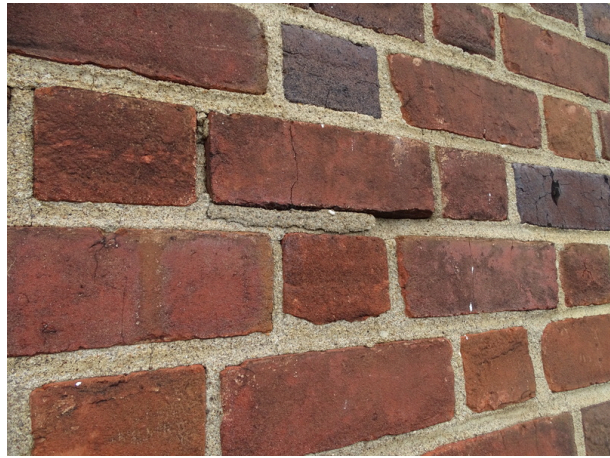
Building exteriors - note deterioration

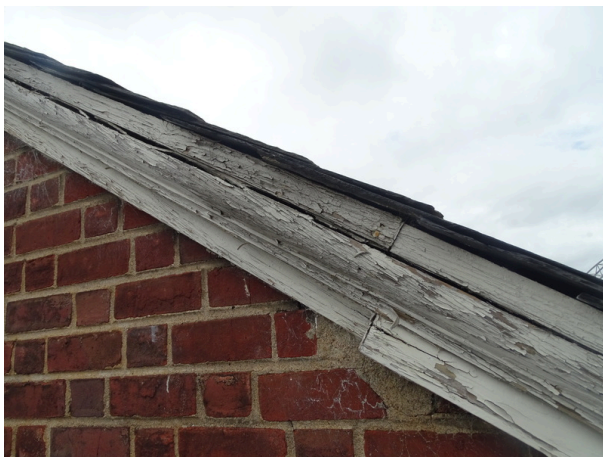
Building exteriors - note deterioration

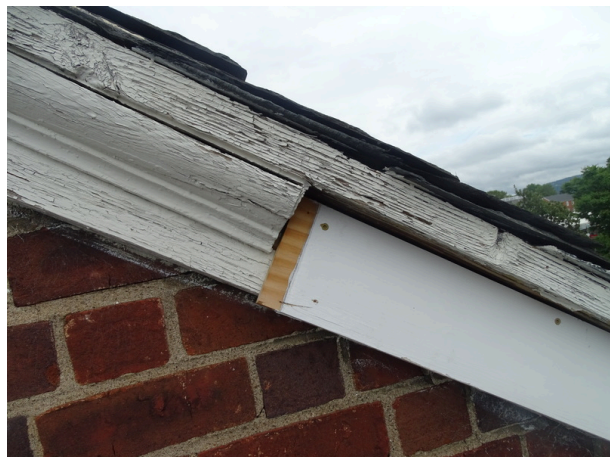
Building exteriors - note deterioration

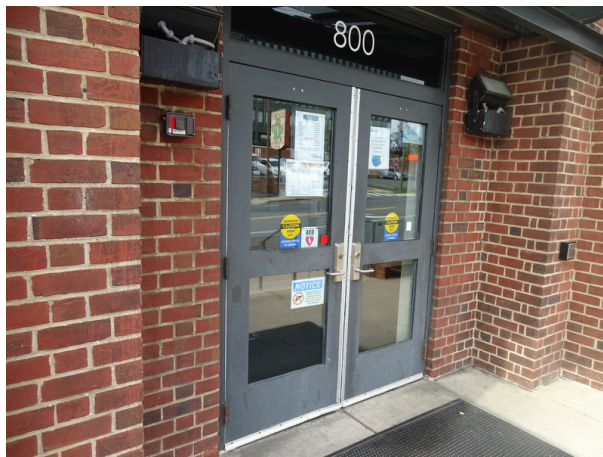
Main entrance doors

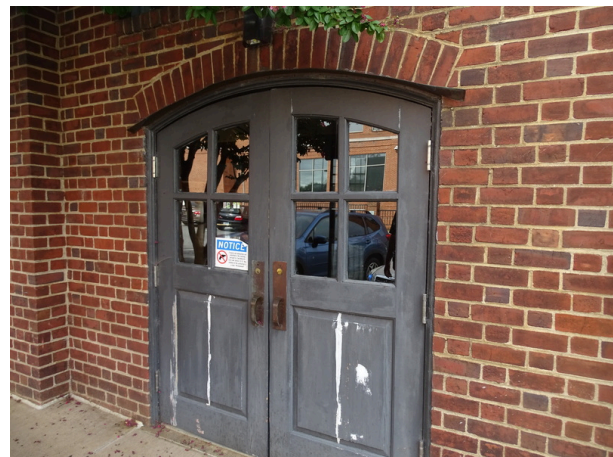
The wood exit doors from the basketball courts showed signs of repair and were generally in fair to poor condition. The doors did not align properly and there was a gap observed between the two wood doors. At the doors on the west side of the building where the overflowing drain was a problem, the gap in the doors allowed for water to enter into the basketball courts. The wood exterior doors should be replaced.

Typical wood doors - note deterioration

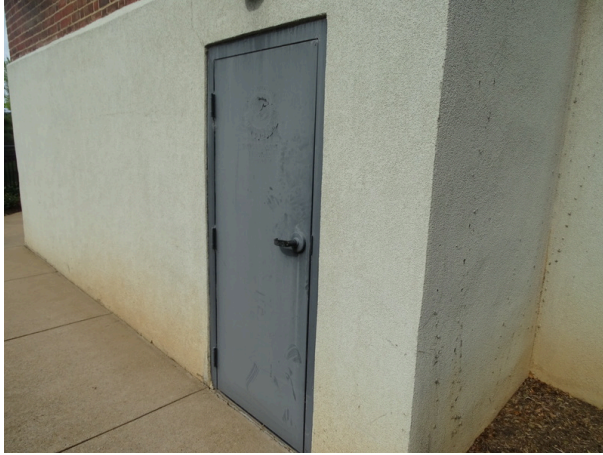
Typical personnel door

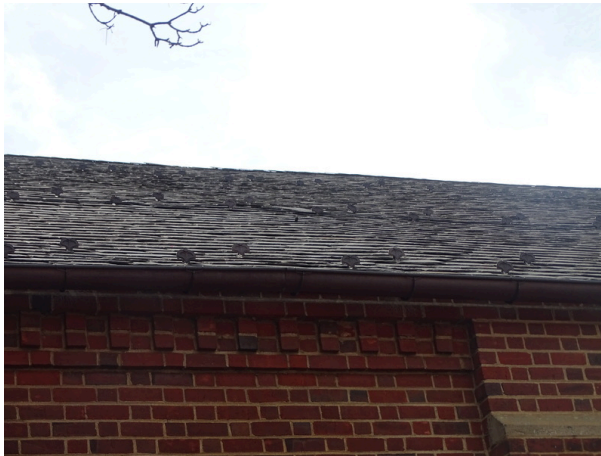
Slate shingle roofing system - note deterioration

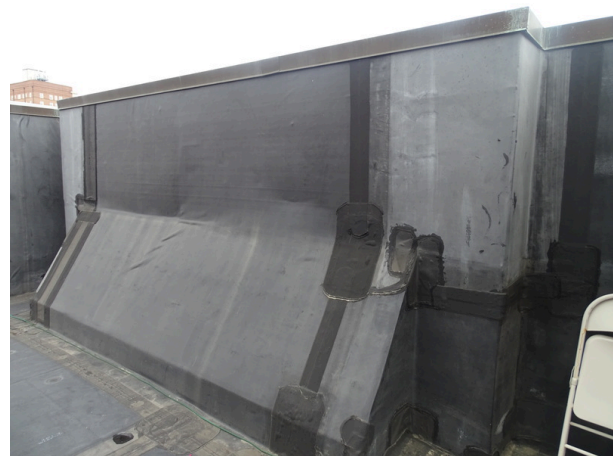
Single-ply sheet membrane roofing systems are present on the north and south portions of the building. Drainage for the roofing system is provided by through wall scuppers with downspouts. The drainage was observed to be in generally fair condition with no ponding observed at the time of the site visit. The parapet walls consist of single-ply membrane and were capped with metal coping. The parapet walls were observed to be in generally fair condition. No leaks or other issues were reported, however, stained ceiling tiles were observed in the building. The expected useful life of a single-ply membrane roof is approximately 15 years. We recommend that the north and south roofs be replaced during the study period.

Single-ply membrane roofing system parapet wall - note patching and deterioration

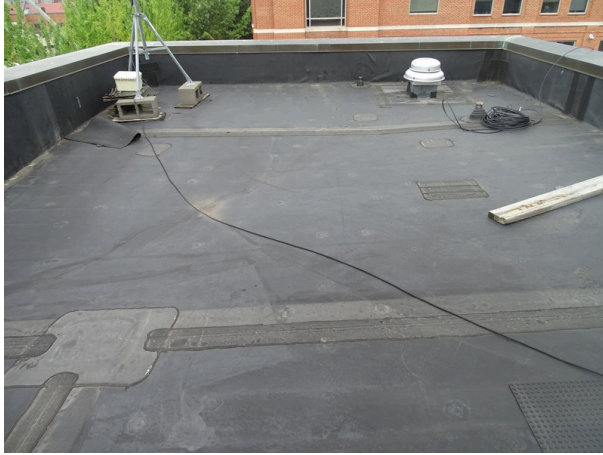
Single-ply membrane roofing system parapet wall - note deterioration

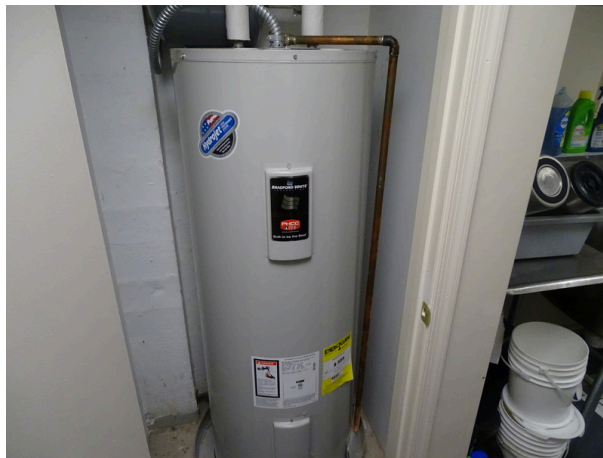
A portion of the building is supplied by an electric water heater manufactured by Bradford-White. The electric heater was observed to be in good condition. The expected useful life of an electric water heater is approximately 12 to 15 years. We recommend the electric water heater be replaced during the report period.

Electric domestic water heater

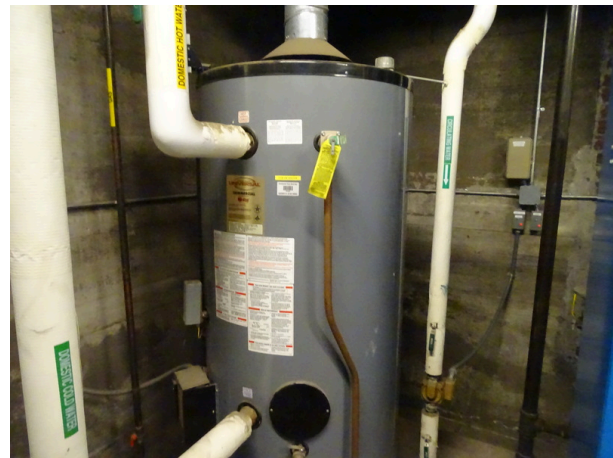
Natural gas domestic water heater

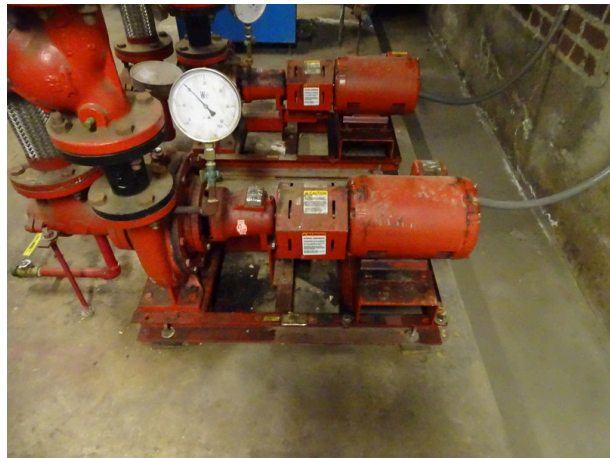
Mechanical system pumps

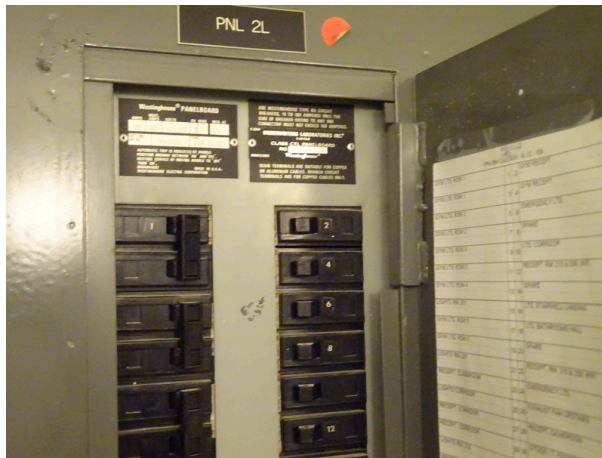
Power is distributed by copper wire from circuit breaker panels located throughout the building. Various panel manufacturers and vintages were observed throughout the building. The circuit breaker panels were observed to be in generally fair condition, however many have reached or will reach the end of their expected useful lives in the study period. Allowances have been provided to replace sub panels during the study period.

Typical older electrical circuit breaker panel

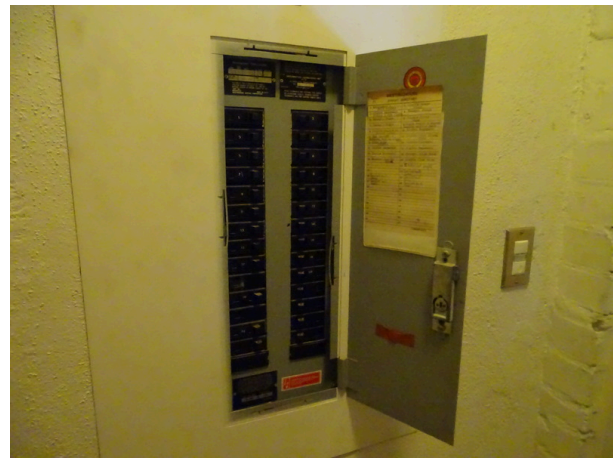
Typical older electrical circuit breaker panel

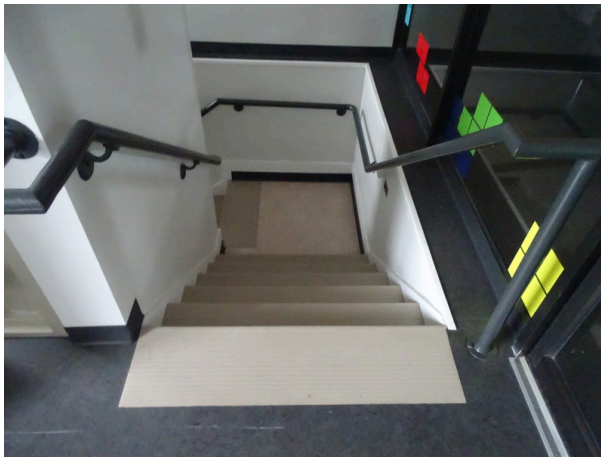
Interior finishes of stair area

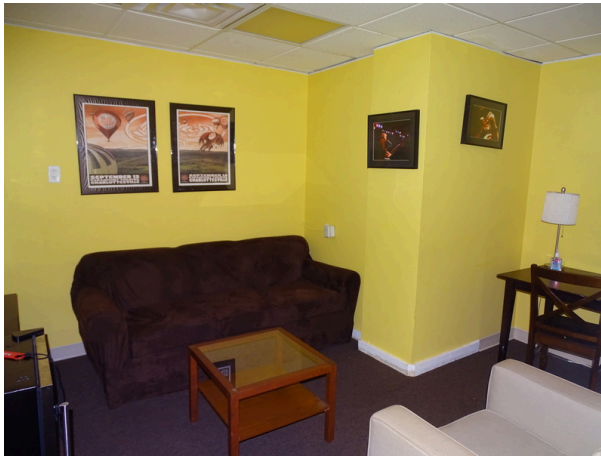
Interior finishes of musician area

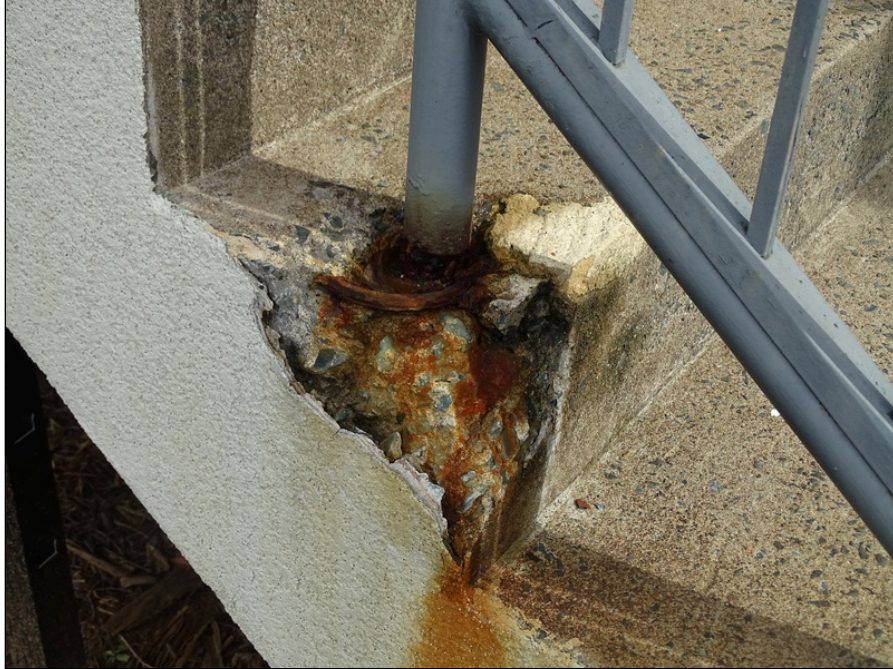
7 - Concrete steps on south side of the building - note deterioration

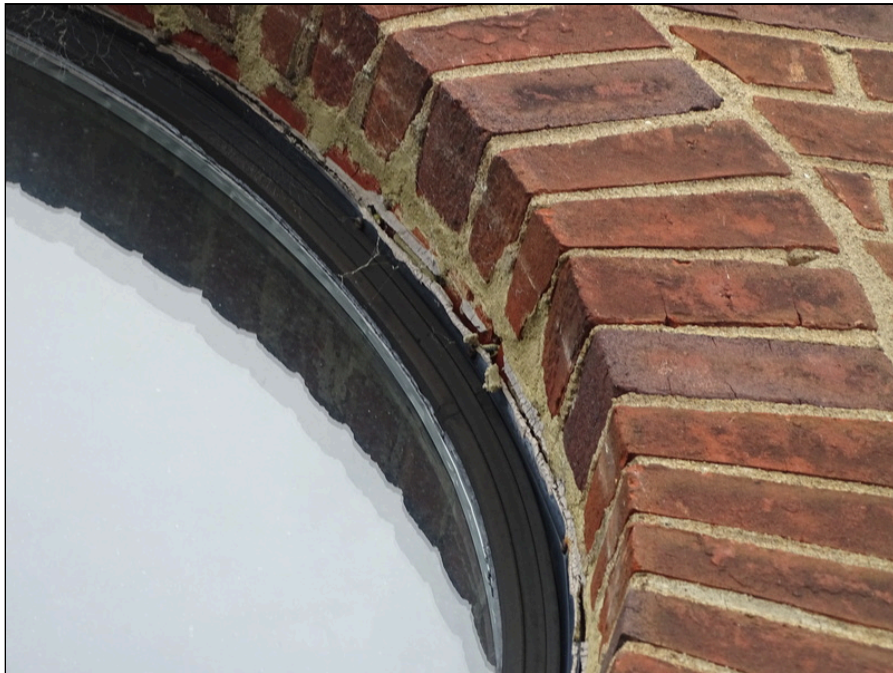
14 - Building exterior sealants - note deterioration

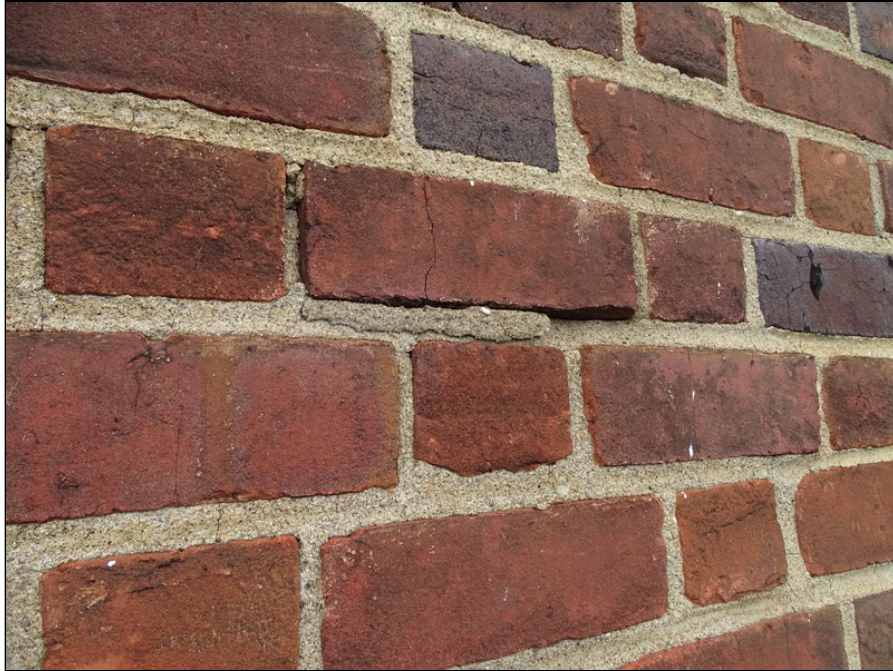
15 - Building exteriors - note deterioration

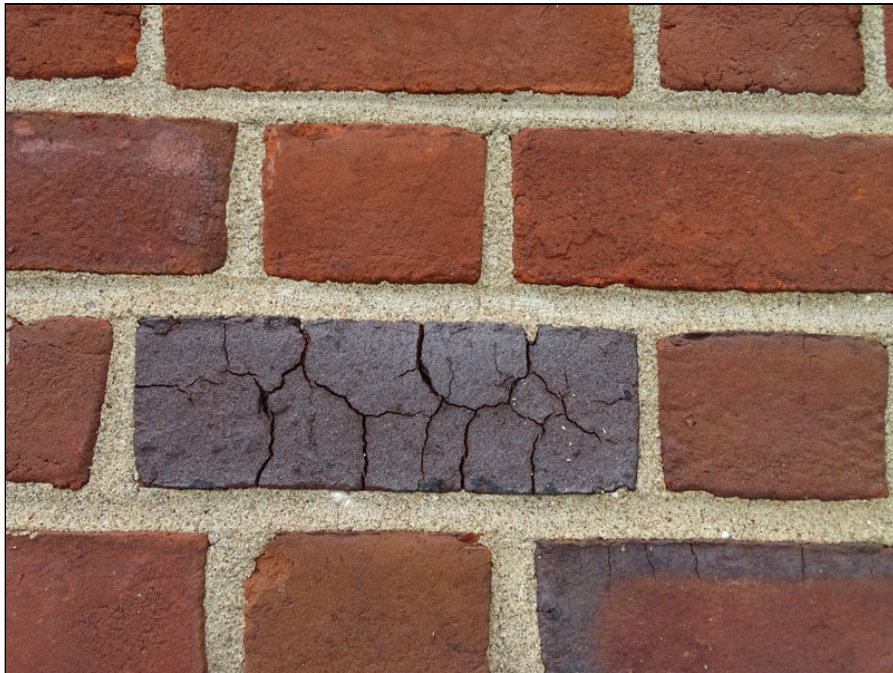
16 - Building exteriors - note deterioration

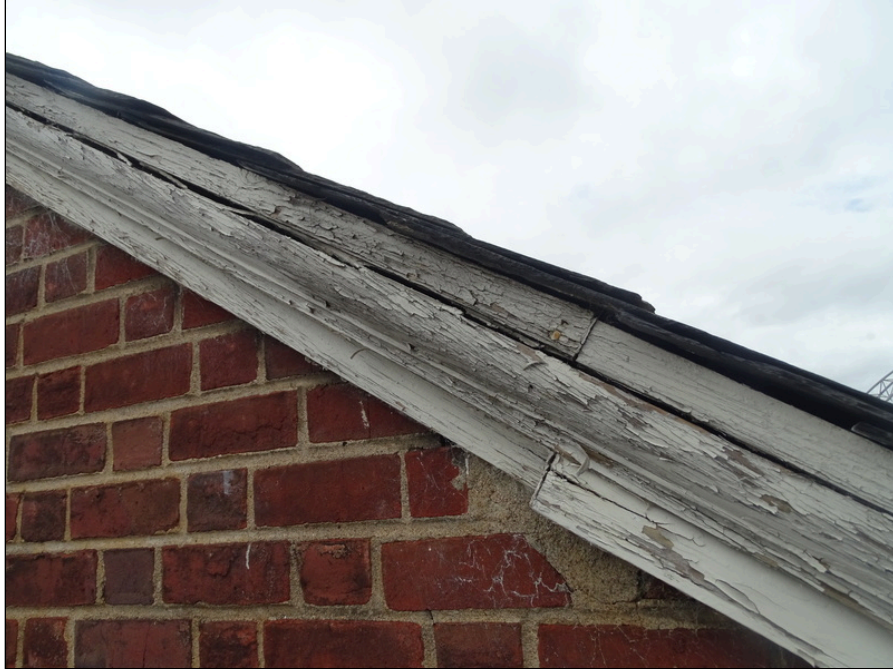
17 - Building exteriors - note deterioration

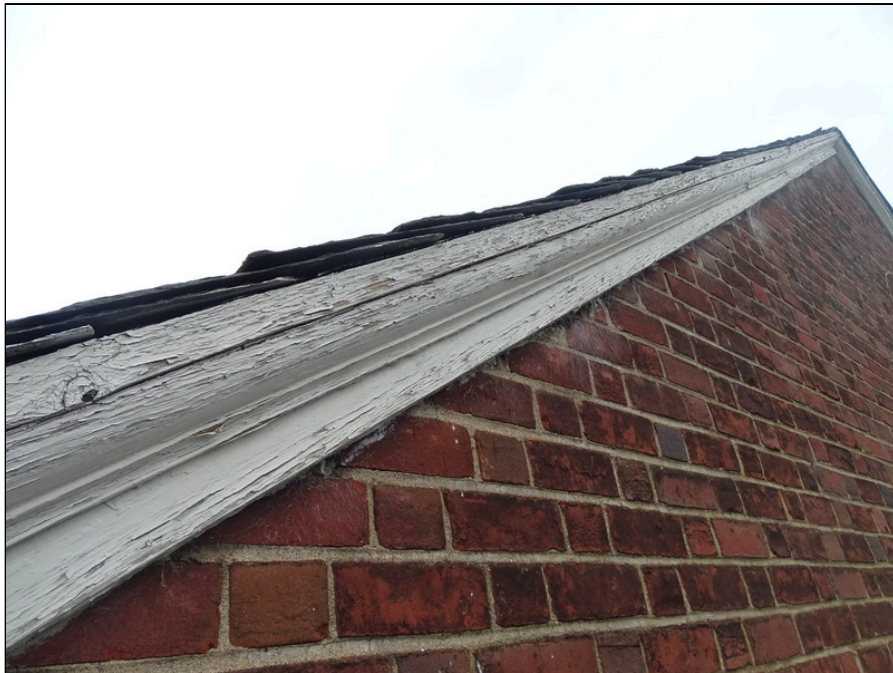
18 - Building exteriors - note deterioration

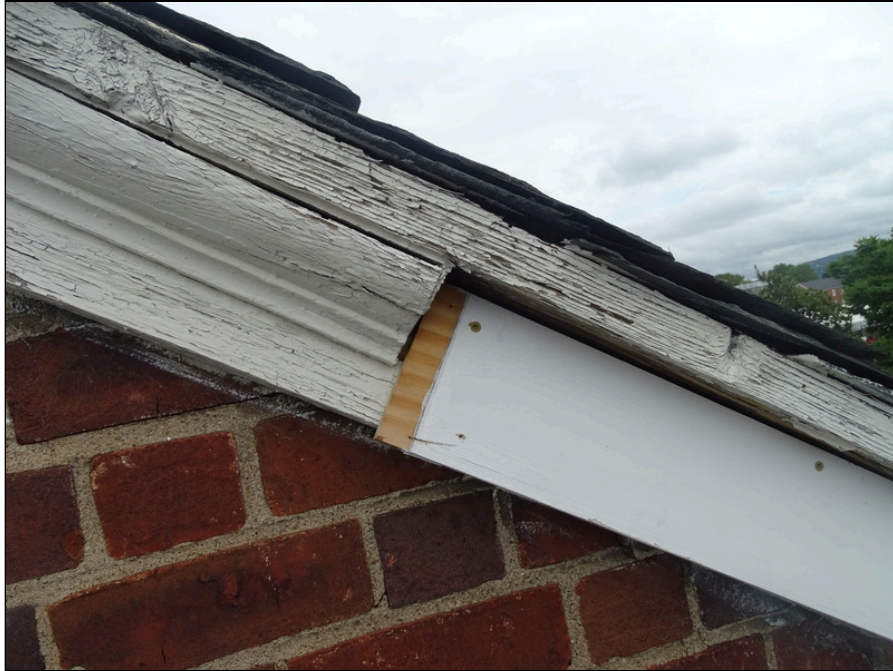
19 - Building exteriors - note deterioration

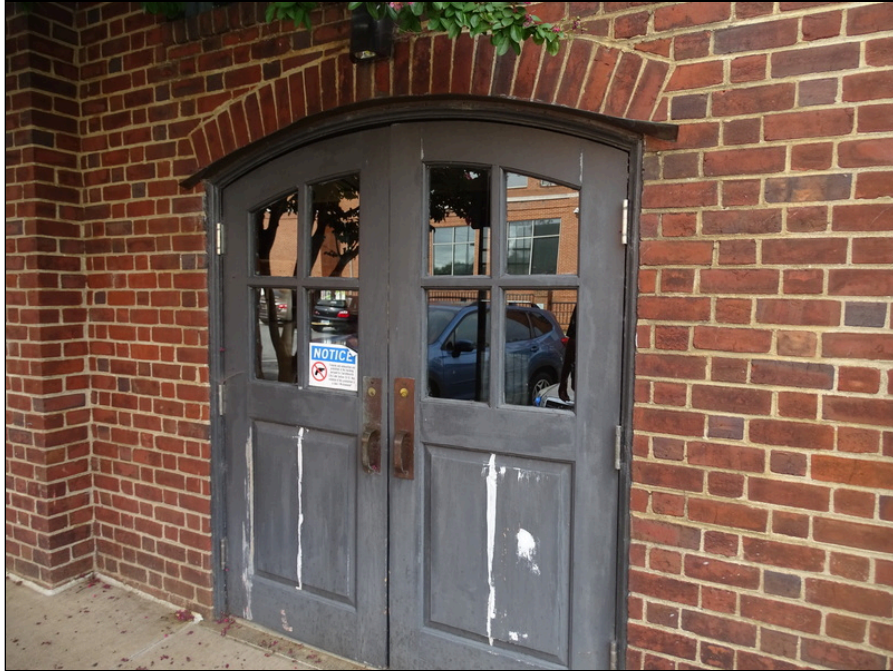
21 - Typical wood doors - note deterioration

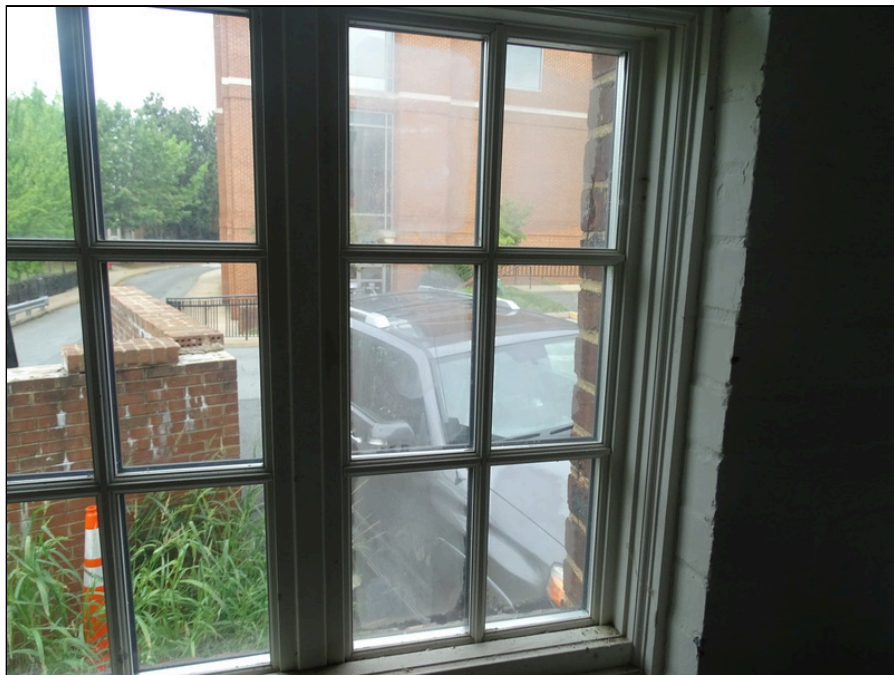
24 - Exterior windows - note fogging and deterioration

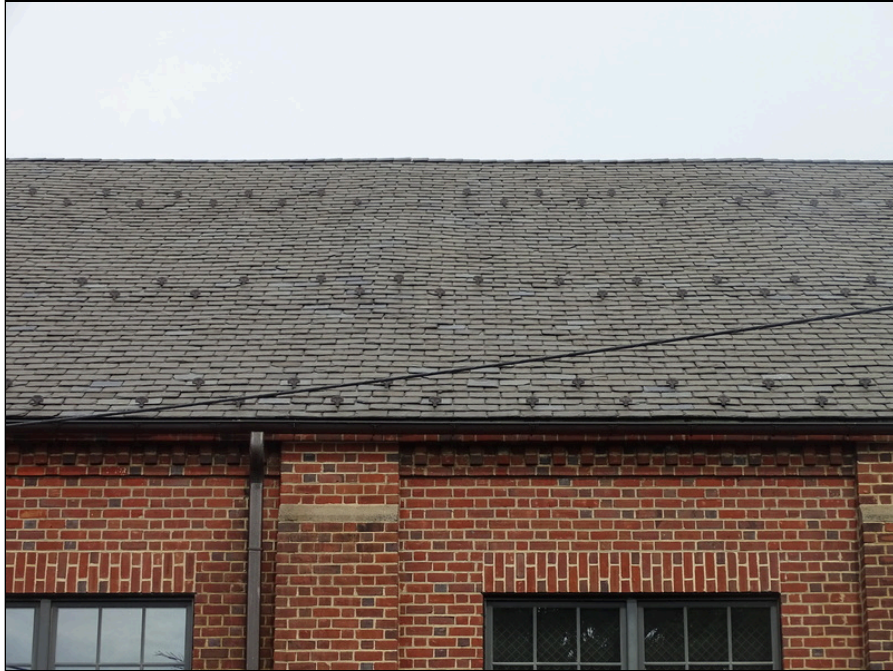
25 - Slate shingle roofing system - note deterioration

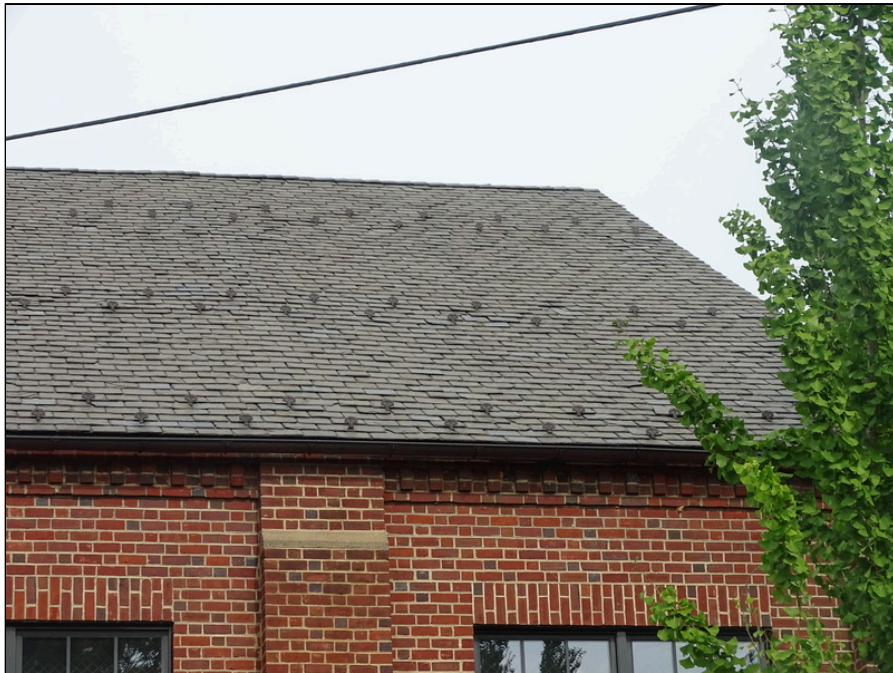
26 - Slate shingle roofing system - note deterioration

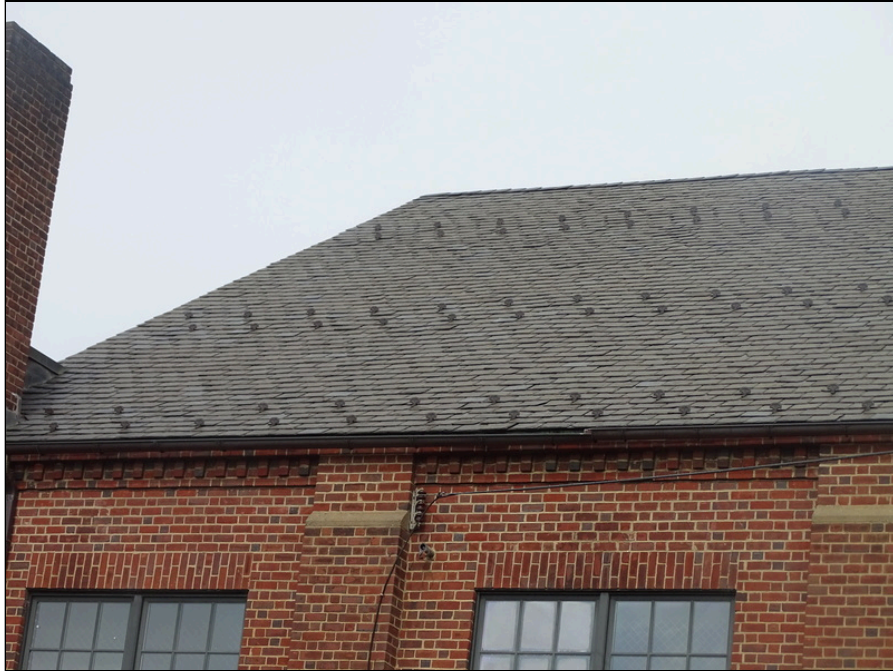
27 - Slate shingle roofing system - note deterioration

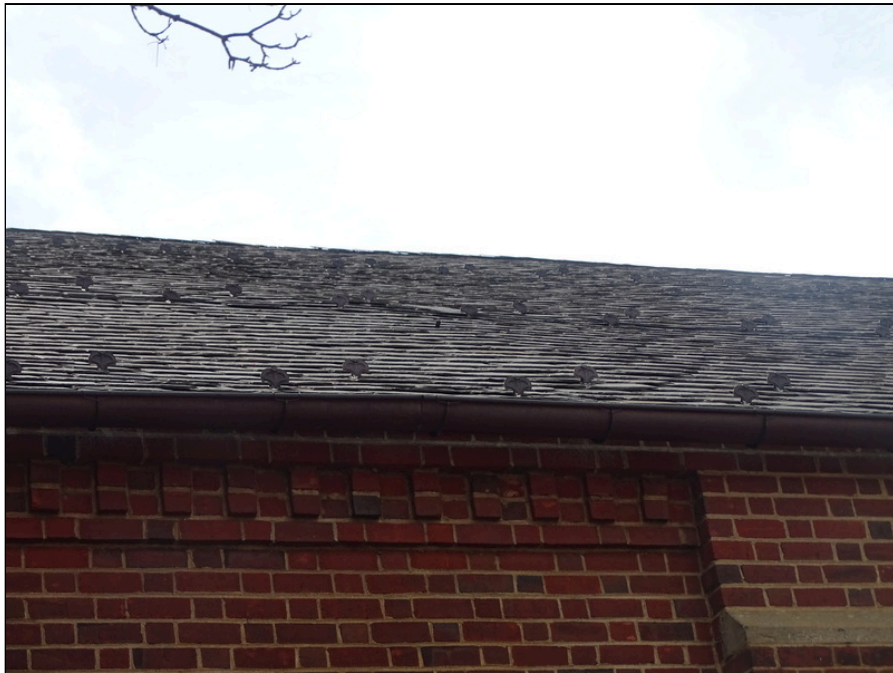
28 - Slate shingle roofing system - note deterioration

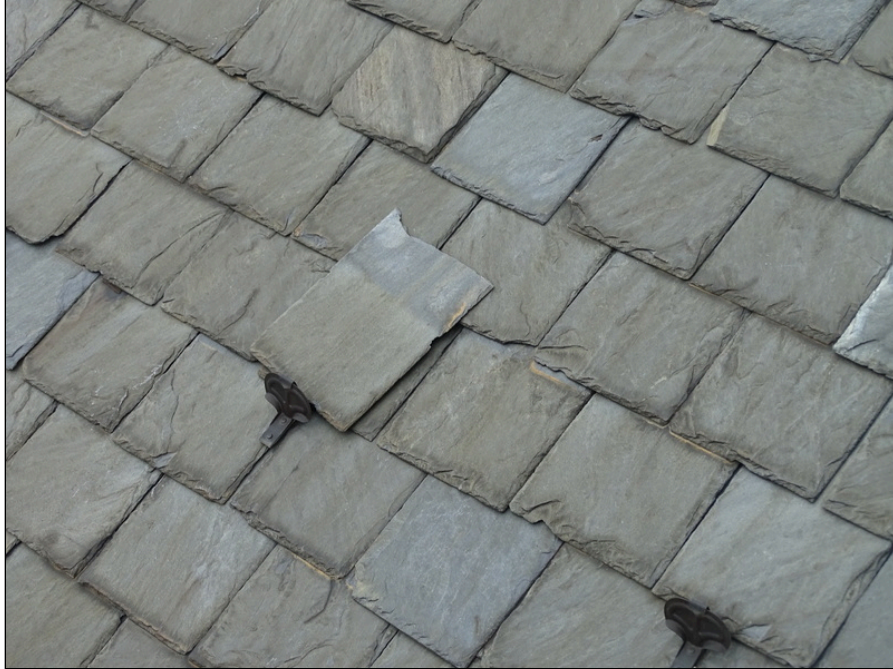
29 - Slate shingle roofing system - note deterioration

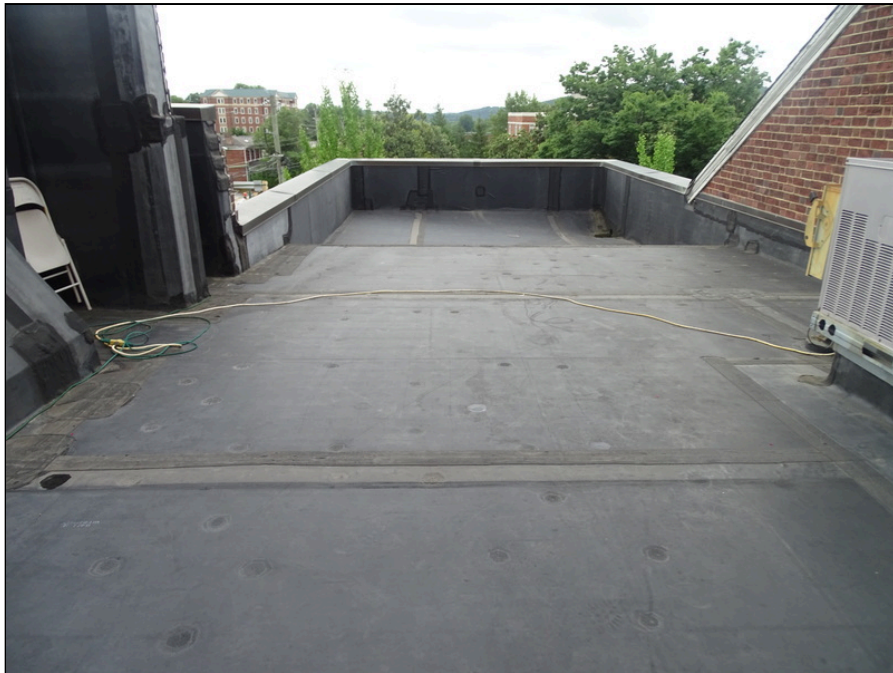
30 - Single-ply membrane roofing system - note deterioration

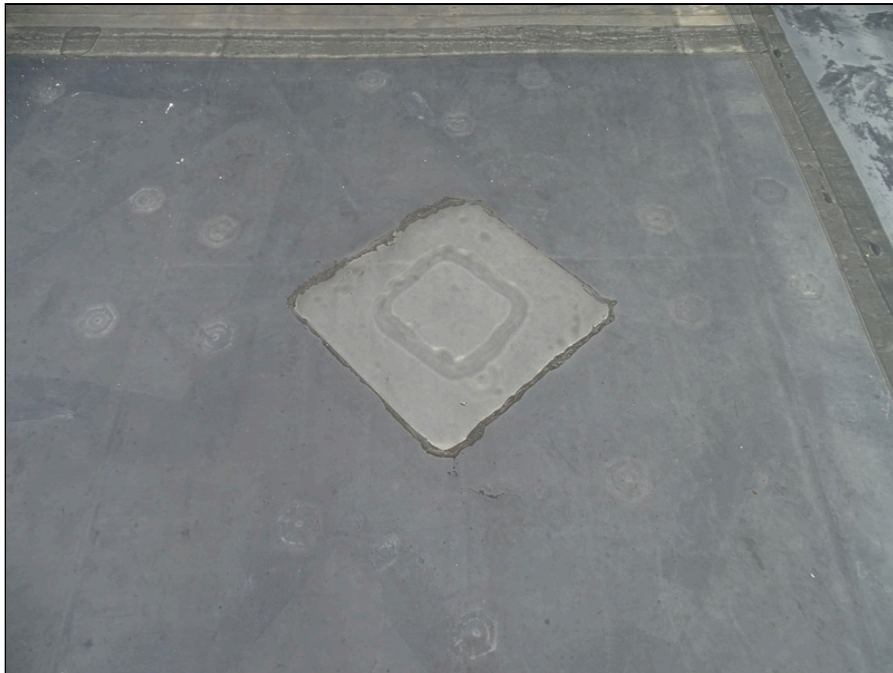
32 - Single-ply membrane roofing system - patching

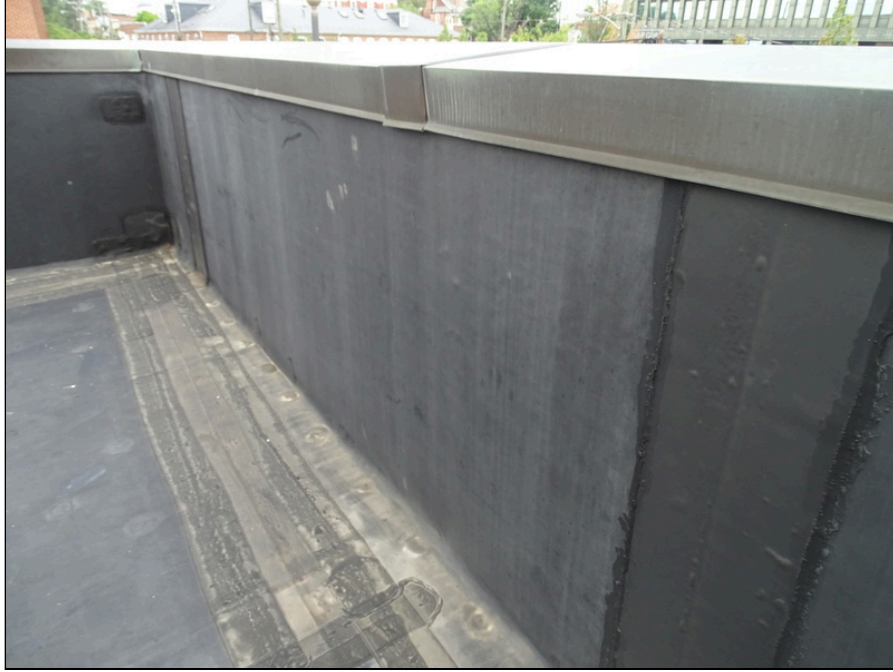
33 - Single-ply membrane roofing system parapet wall - note deterioration

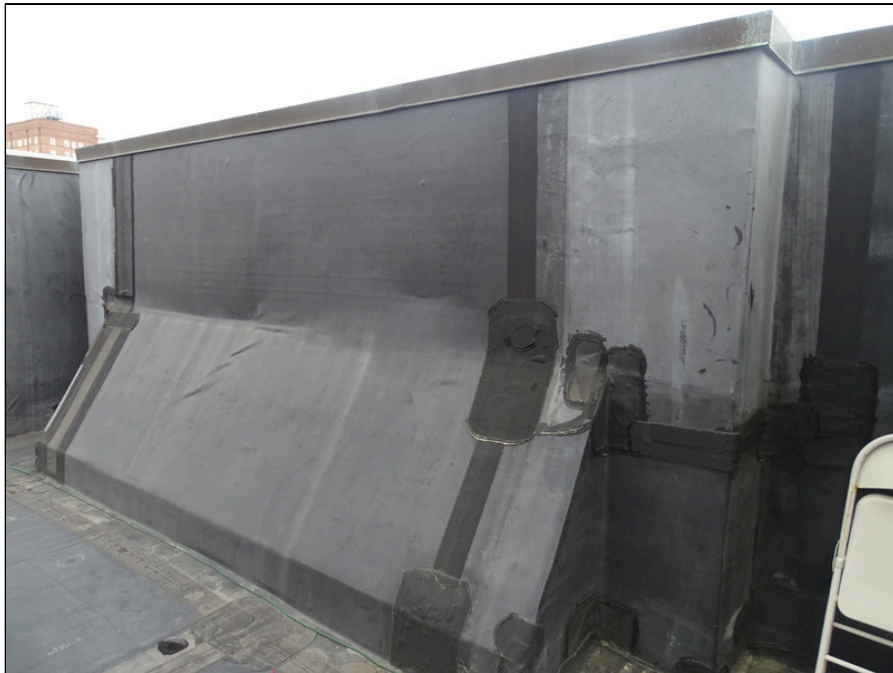
34 - Single-ply membrane roofing system parapet wall - note patching and deterioration

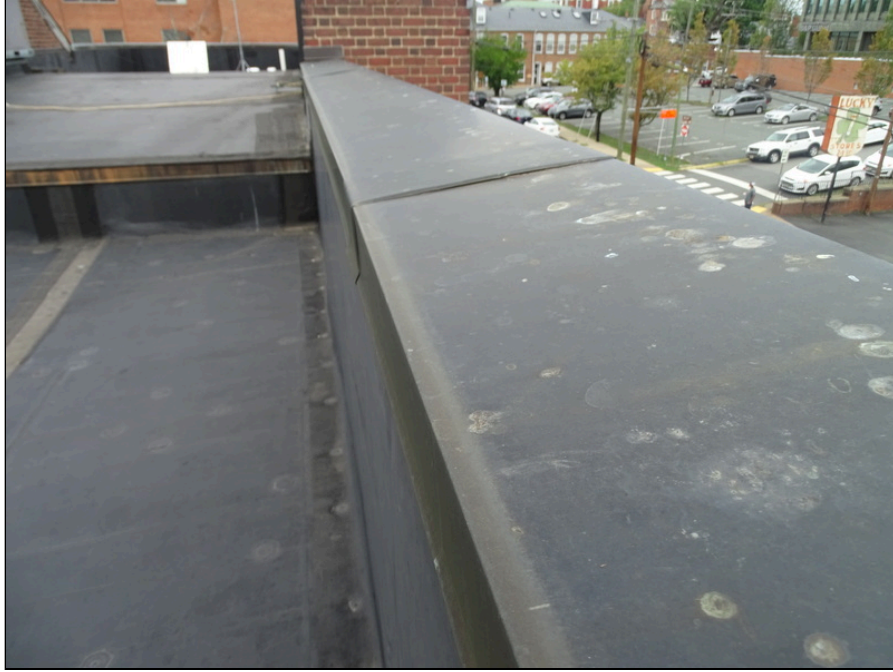
35 - Single-ply membrane roofing system parapet wall - note deterioration

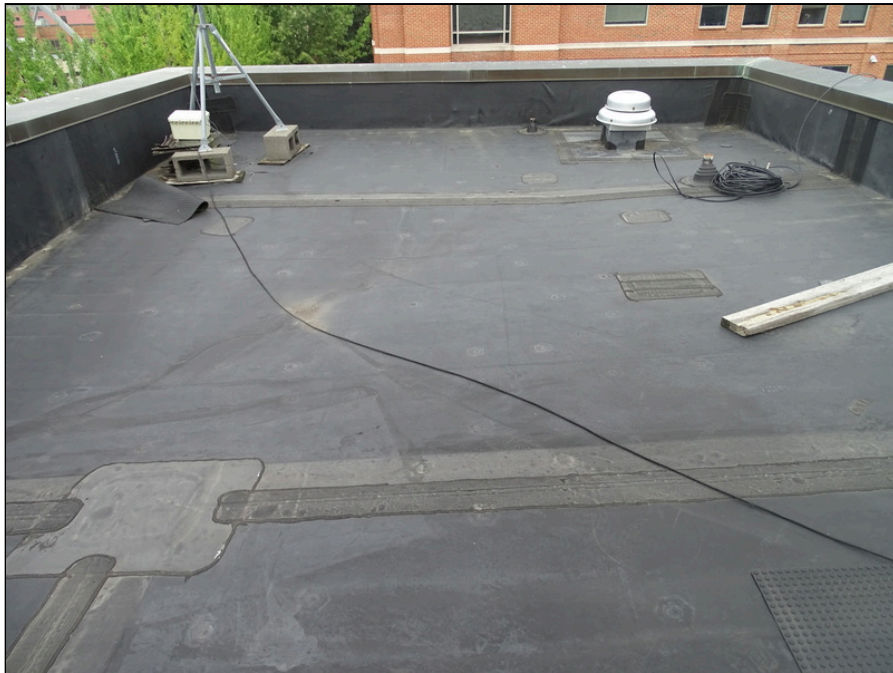
36 - Single-ply membrane roofing system parapet wall - note deterioration

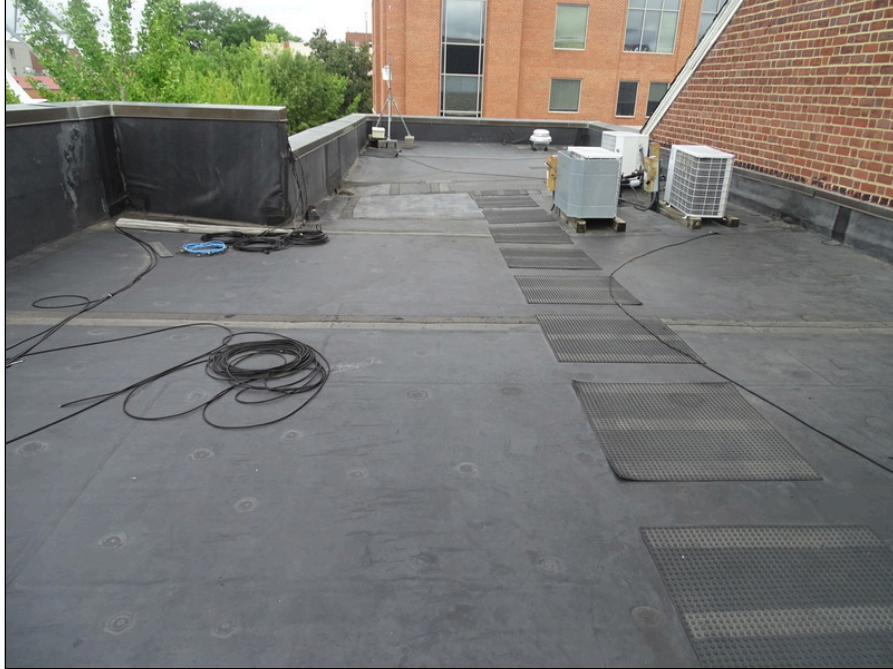
37 - Single-ply membrane roofing system parapet wall - note deterioration

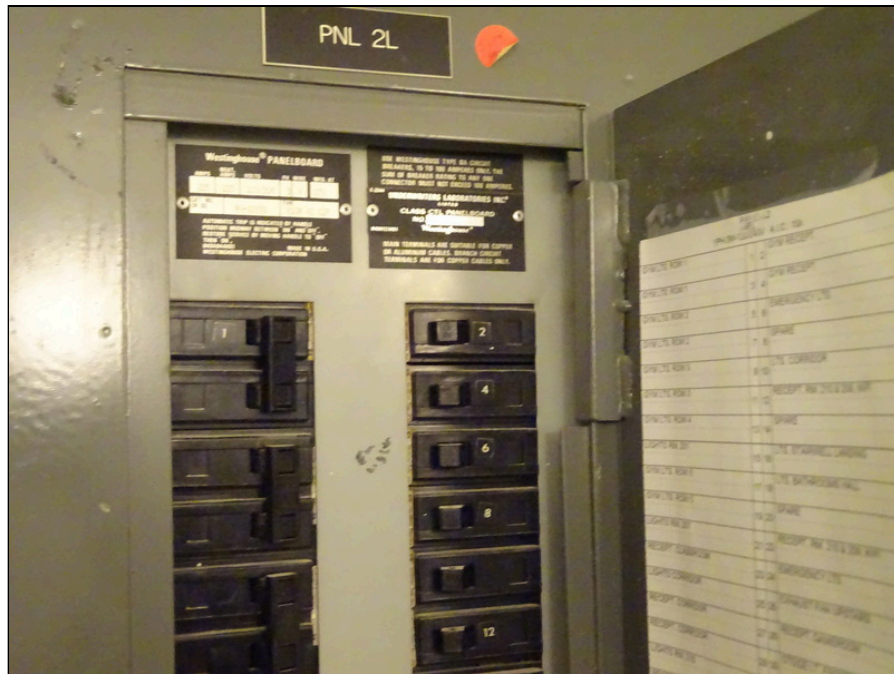
59 - Typical older electrical circuit breaker panel

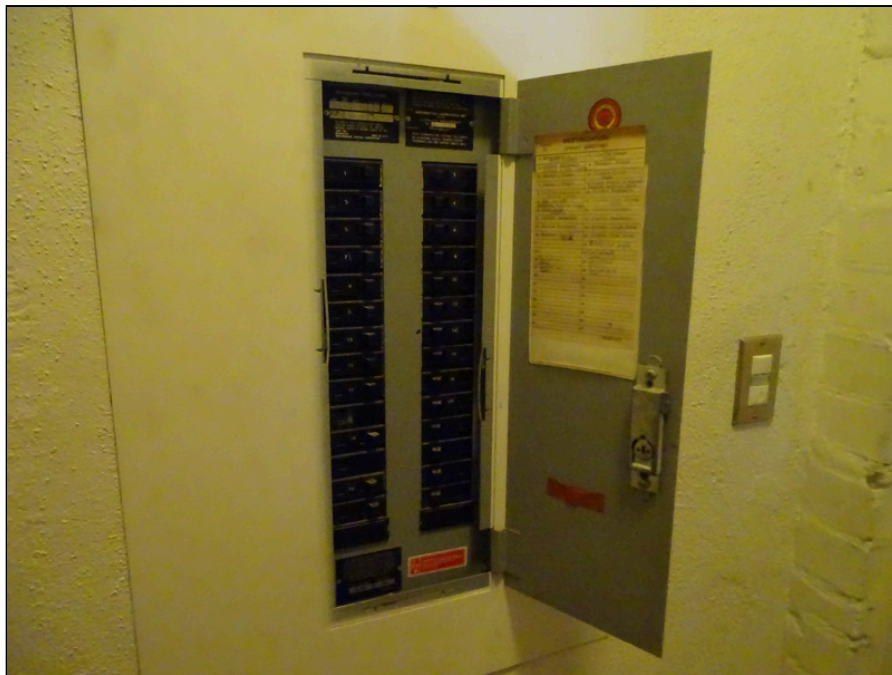
60 - Typical older electrical circuit breaker panel
