LUGO MCGINNESS ACADEMY
341-(A) 11TH STREET NW
CHARLOTTESVILLE, VIRGINIA

ECS PROJECT NO. 46:6713

CITY OF CHARLOTTESVILLE - FACILITIES DEVELOPMENT

Reference: Facility Condition Assessment Report for Lugo McGinness Academy, 341-(A) 11th Street NW, Charlottesville, Virginia

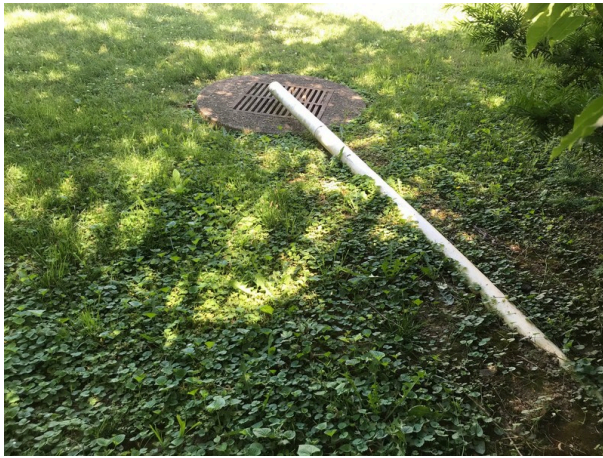
One catch basin drain carries water to a municipal grate drain in the back of an adjacent residential property. That drain line is above ground and weighted down by a rock in the end of the line. We recommend that this line be installed underground to prevent damage, allow for easy lawn maintenance, and eliminate the need for the rock weight inside the line creating a partial blockage.

Catch Basin Drain

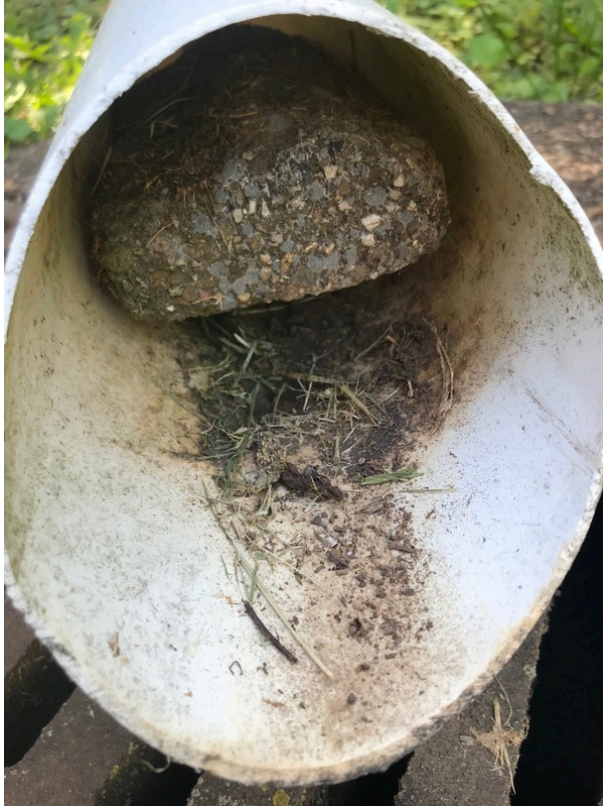
Rock Weighing Down CB Drain

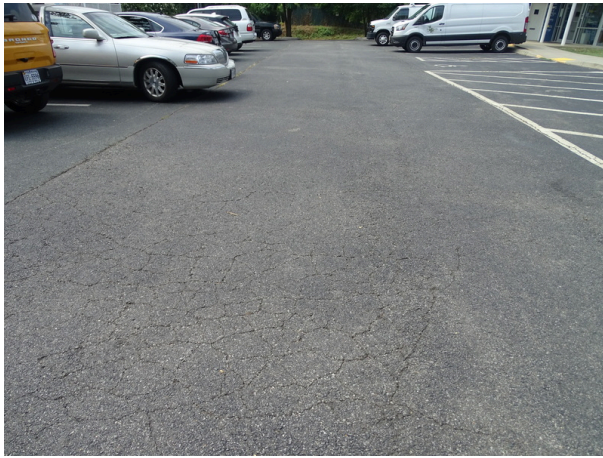
Asphalt-paved drive lane and parking are located on the east side of the site. The asphalt pavement was observed to be in generally good condition. The expected useful life of asphalt pavement is 20 years. We recommend repairing areas of asphalt pavement on an as-needed basis.

Asphalt drive lane and parking - note cracking

3.2.4 Paving, Curbing, and Parking																													
REPAIR ASPHALT AS NEEDED	20	7	13	1	LS	\$6,000.00	\$6,000	100%													\$6,000								\$6,000

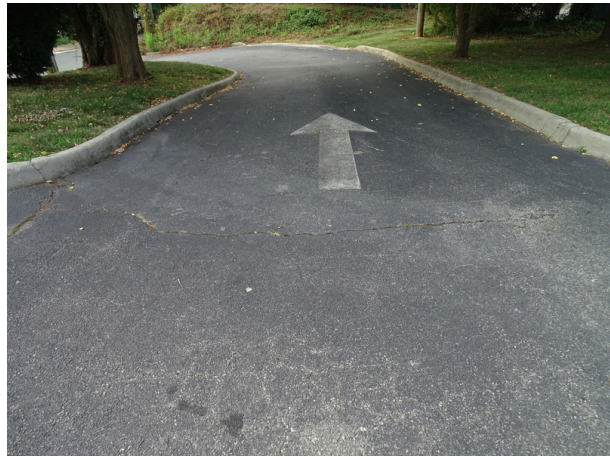
Asphalt drive lane looking north - note cracking

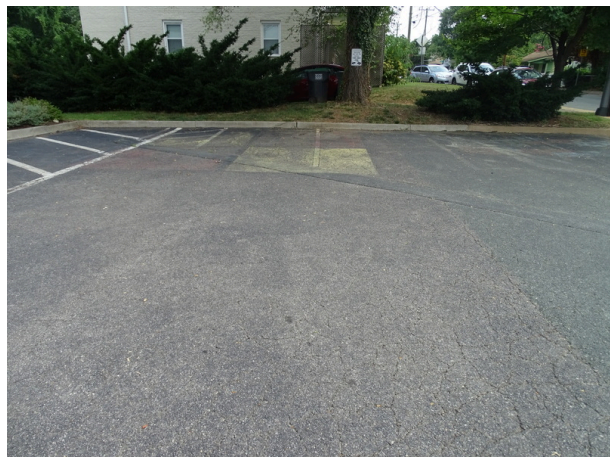
Asphalt parking - note faded striping

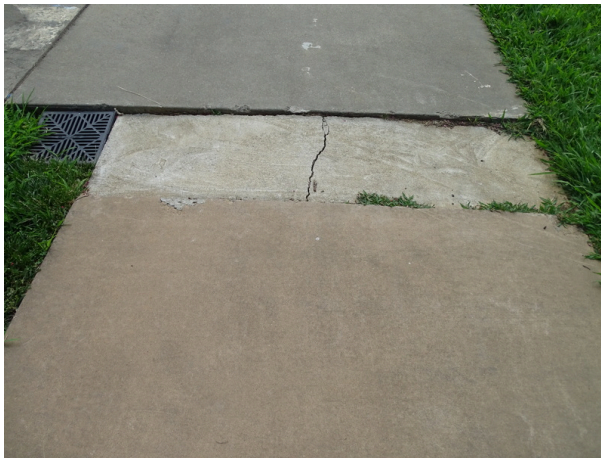
The site contains concrete sidewalks of undetermined thickness. Regularly spaced control joints were observed. The concrete sidewalks were in overall good condition. The expected useful life of concrete sidewalks is 20 years. We recommend an allowance for concrete sidewalk repairs as needed.

Typical concrete sidewalk - note deterioration

3.2.5 Flatwork																													
REPAIR CONCRETE SIDEWALKS AS NEEDED	20	19	1	1	LS	\$3,000.00	\$3,000	100%	\$3,000																				\$3,000
3.3.3 Building Exteriors																													
REPLACE SEALANTS	12	6	6	1	EA	\$5,000.00	\$5,000	100%						\$5,000															\$5,000
REPLACE FIBER CEMENT SIDING	20	19	1	1	EA	\$8,000.00	\$8,000	100%	\$8,000																				\$8,000

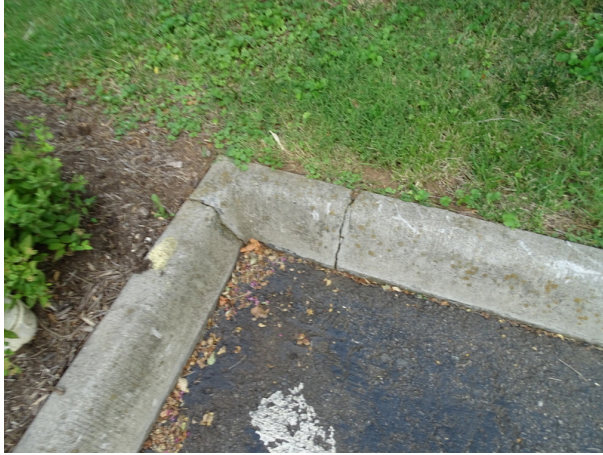
Typical concrete curb - note deterioration

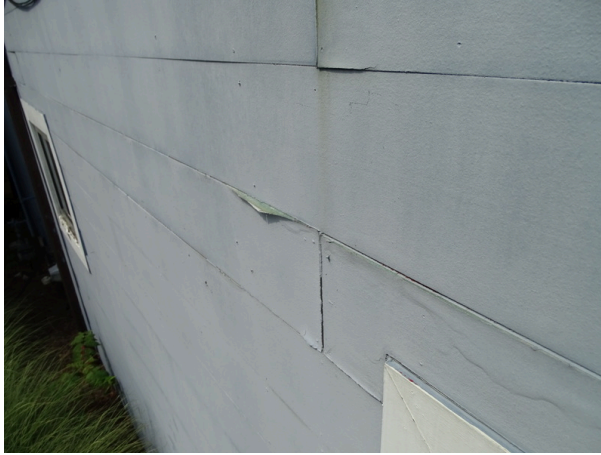
Exterior sealants are located around the window and door frames. The expected useful life of exterior sealants is approximately 10 to 12 years before replacement is needed. The exterior sealants were generally in fair condition. We recommend that the exterior sealants be replaced.

Typical exterior wall - note peeling paint and deterioration

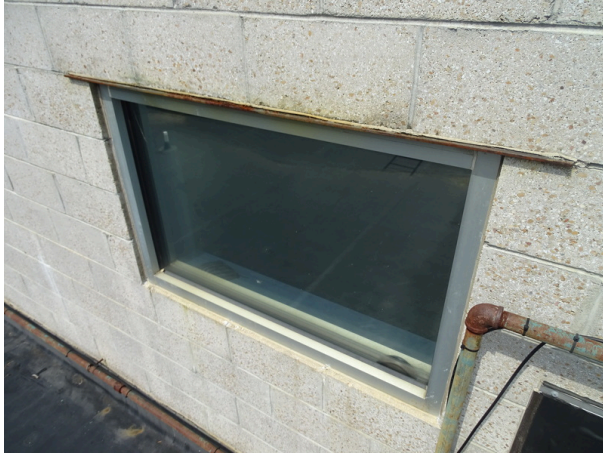
The window system for the building primarily consists of Aluminum frame double pane window units reportedly replaced during past renovations. The gaskets in the windows were generally in fair condition as some have become detached in places. The expected useful life of gaskets is typically 20 years.

Typical exterior windows - note gasket deterioration

3.3.5 Exterior Windows																													
REPLACE WINDOW GASKETS AS NEEDED	20	19	1	1	EA	\$2,500.00	\$2,500	100%	\$2,500																				\$2,500

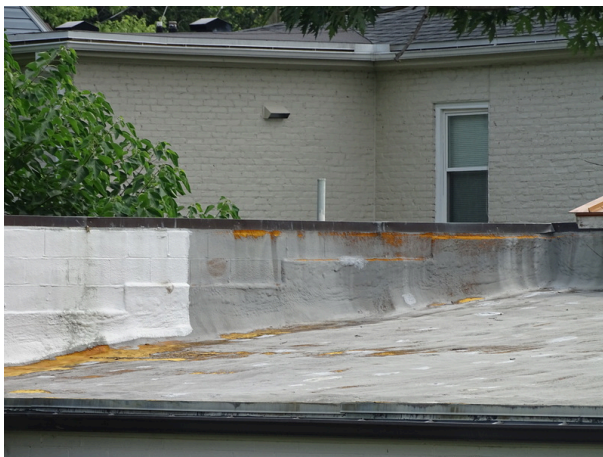
Typical parapet wall - note deterioration

3.3.6 Roofing Systems																													
REPLACE SINGLE-PLY ROOFING SYSTEM FOR GYMNASIUM BUILDING	15	8	7	3,850	SF	\$14.00	\$53,900	100%							\$53,900														\$53,900
REPLACE COATED ROOFING SYSTSEM FOR MAIN BUILDING	20	19	1	2,500	SF	\$14.00	\$35,000	100%	\$35,000																				\$35,000

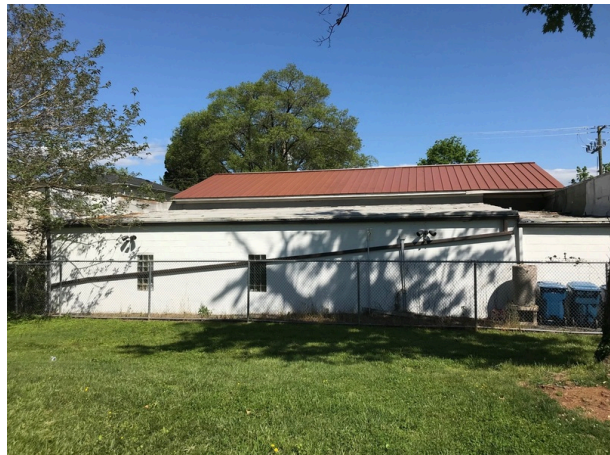
Slanted Downspout - North Building

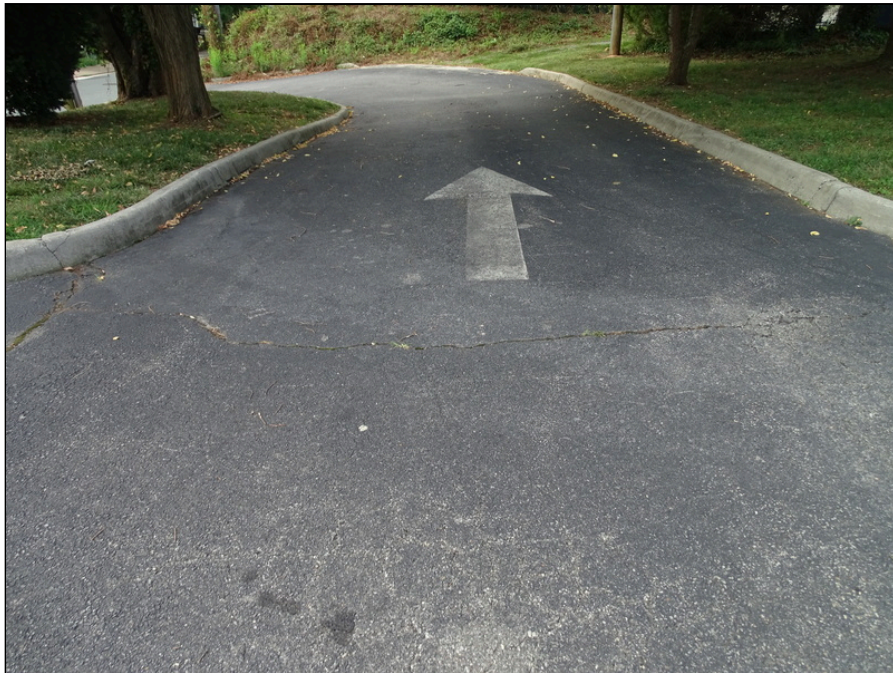
4 - Asphalt drive lane looking north - note cracking

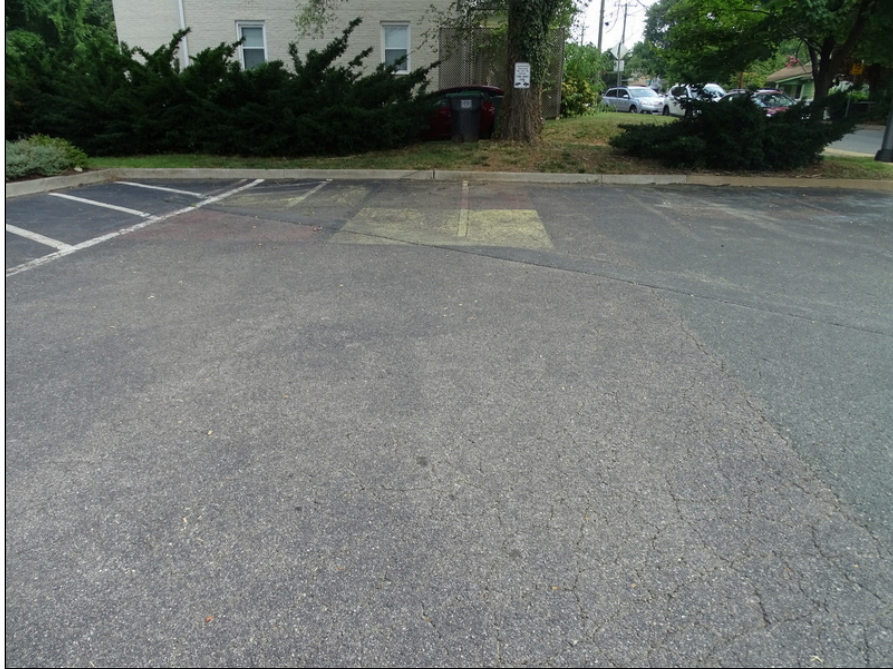
7 - Asphalt parking - note faded stripping

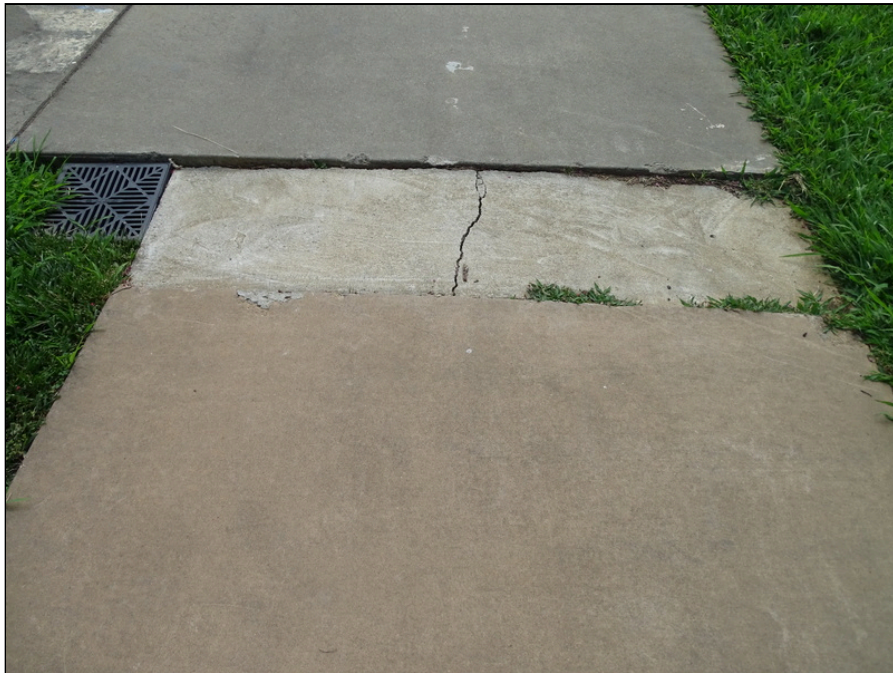
8 - Typical concrete sidewalk - note deterioration

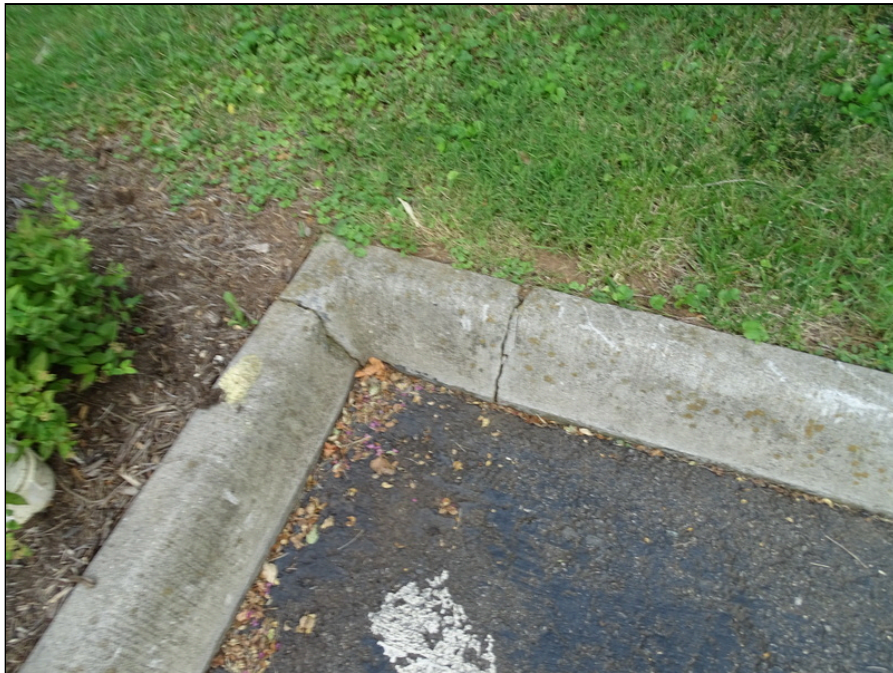
10 - Typical concrete curb - note deterioration

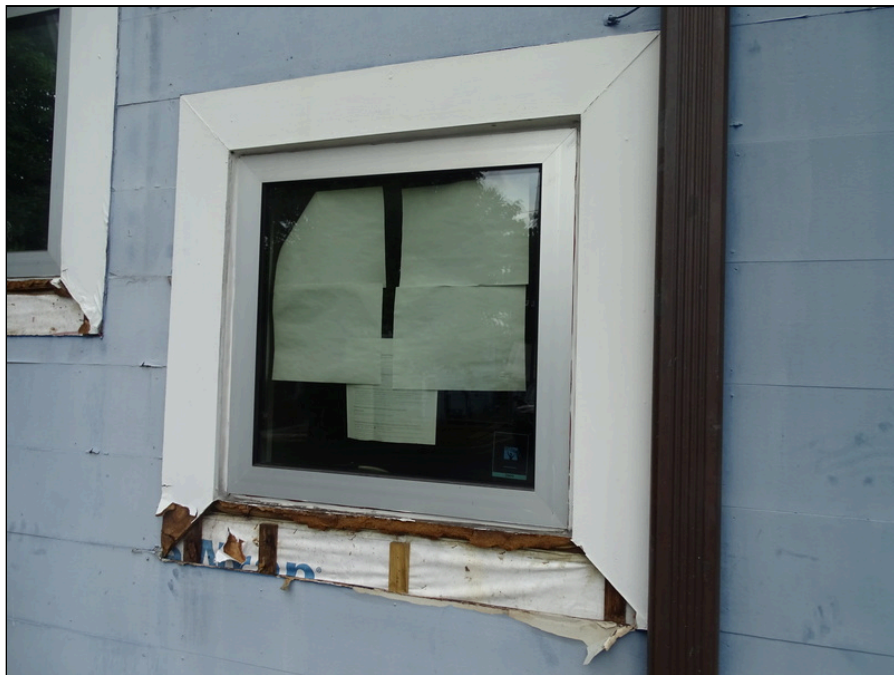
30 - Typical exterior windows - note deterioration

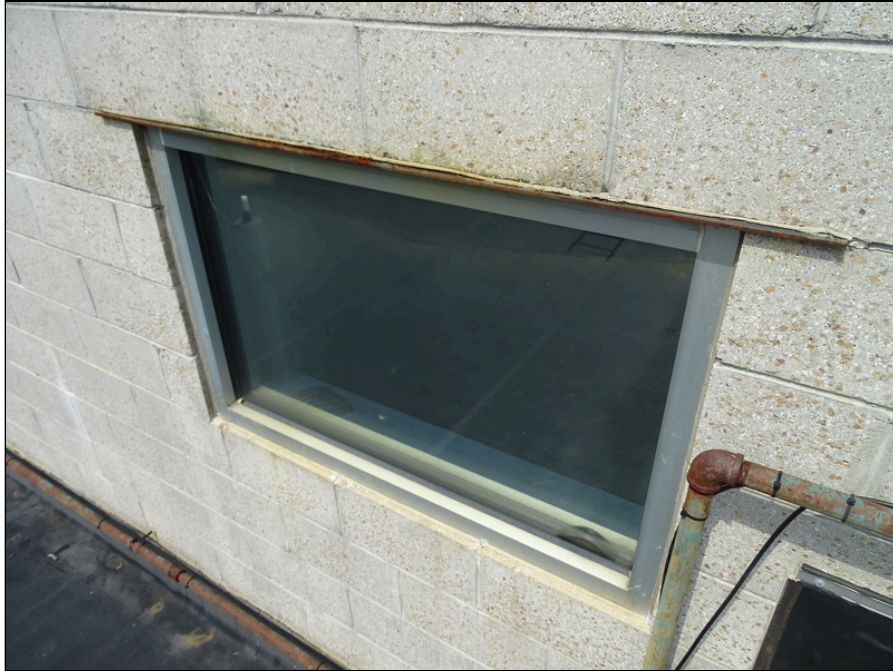
31 - Typical exterior windows - note gasket deterioration

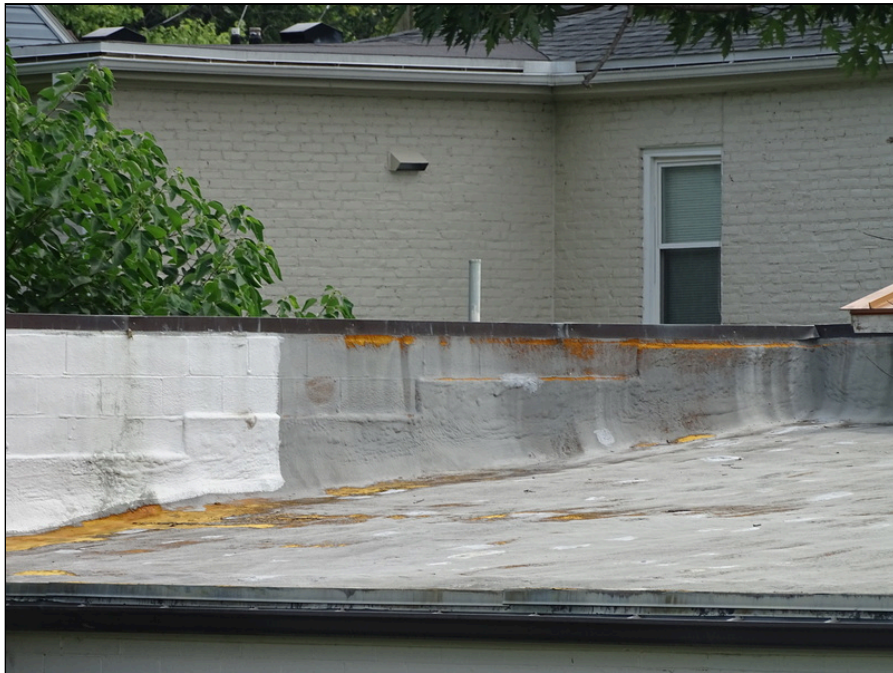
38 - Typical parapet wall - note deterioration

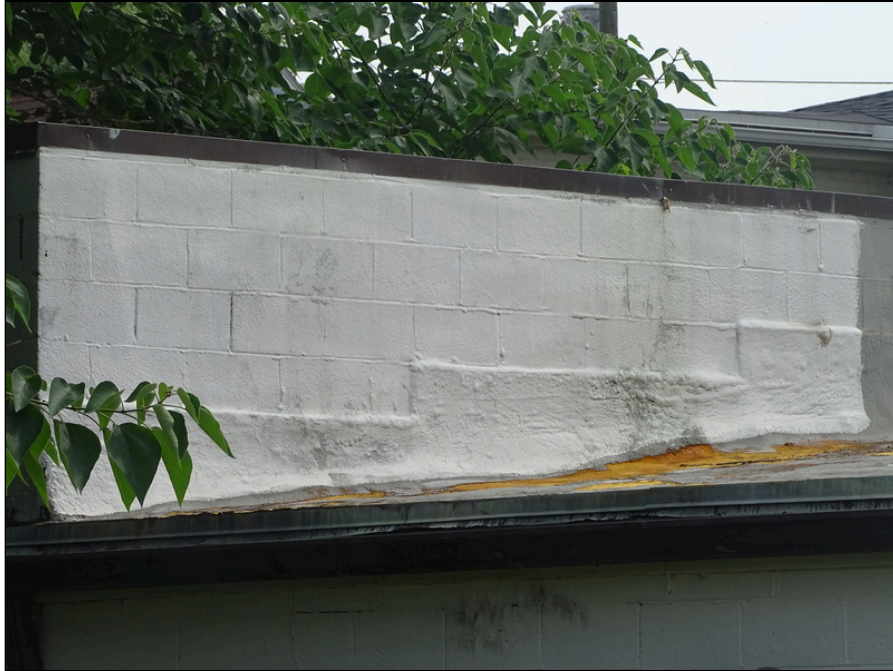
39 - Typical parapet wall - note deterioration

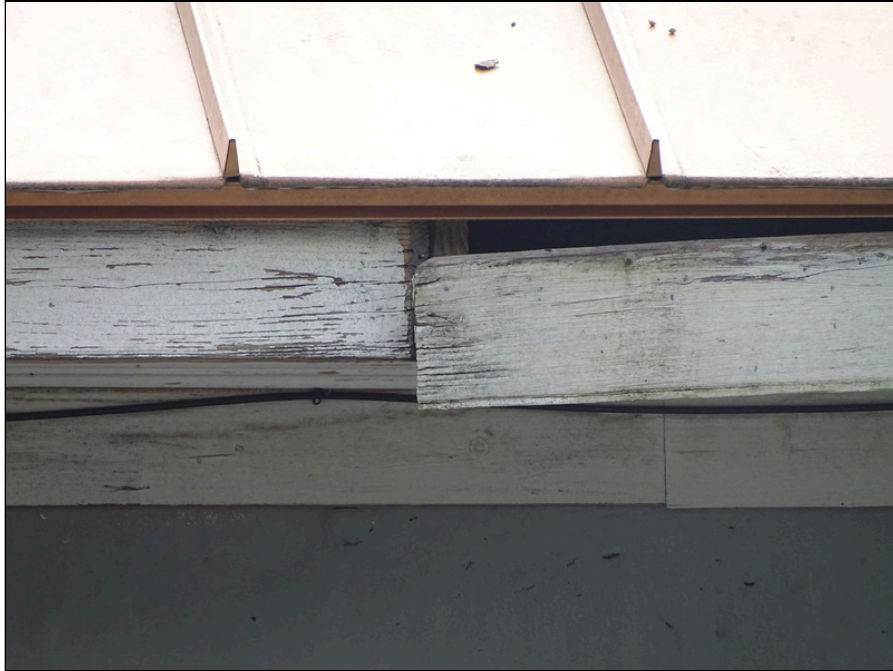
41 - Loose wood trim
