# Market Street Parking Garage Condition Assessment Report

SEPTEMBER 2021 | FINAL

Kimley-Horn and Associates, Inc.  
421 Fayetteville Street, Suite 600  
Raleigh, NC 27601

City of Charlottesville, Virginia  
305 4th Street NW  
Charlottesville, VA 22902

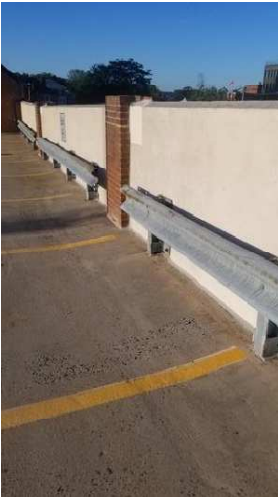
#14 Spall / Delamination / Exposed Rebar

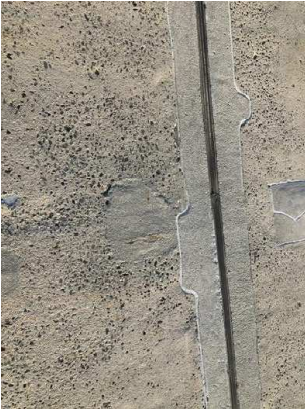
Description  
Failed vertical sealant

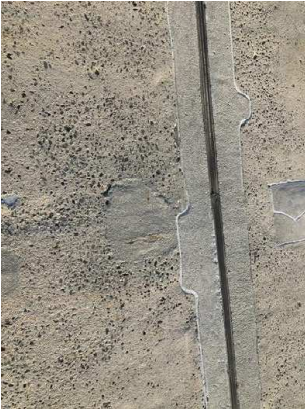
Description  
Failed vertical sealant

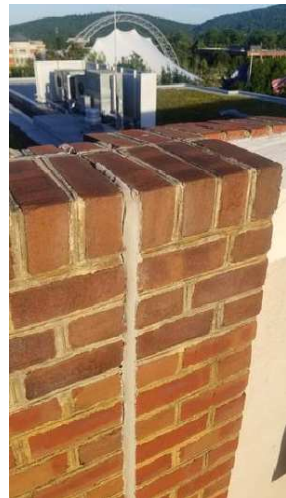
#17 Spall / Delamination / Exposed Rebar

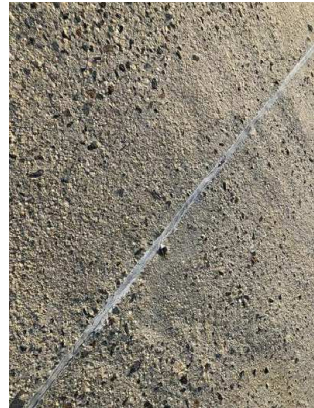
Description  
Failed sealant in CJ

#19 Joint sealant / CJ

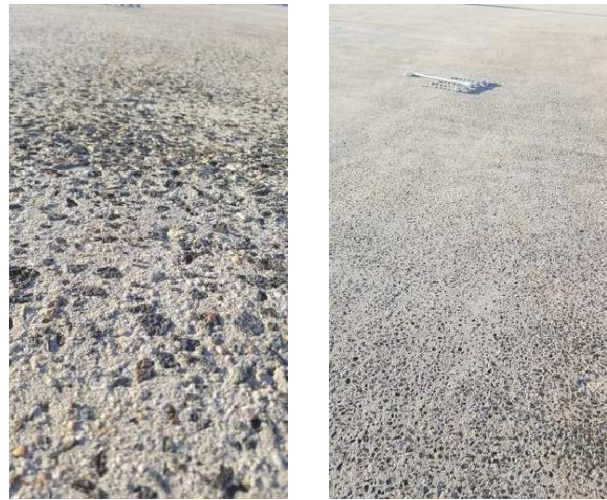
Description  
Abrasion deterioration on concrete slab

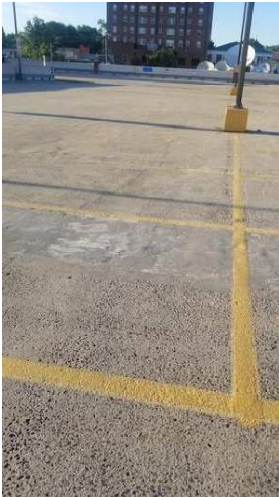
#25 Spall / Delamination / Exposed Rebar

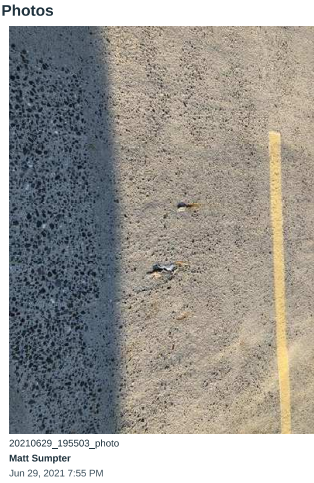
#33 Spall / Delamination / Exposed Rebar

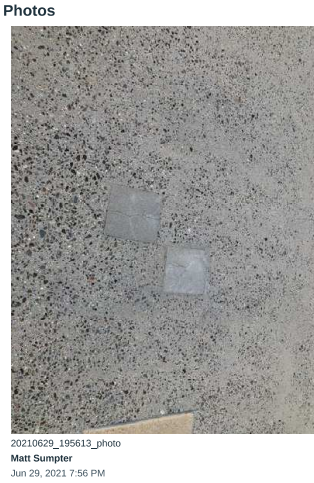
#34 Spall / Delamination / Exposed Rebar

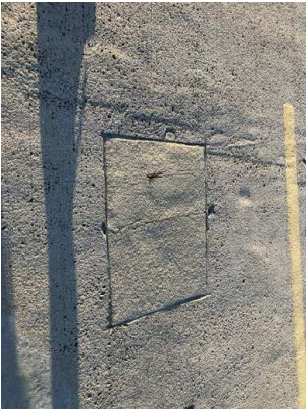
#39 Spall / Delamination / Exposed Rebar

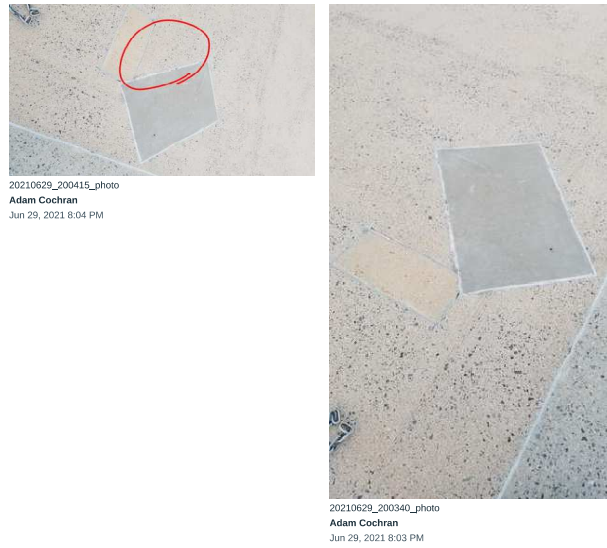
#40 Spall / Delamination / Exposed Rebar

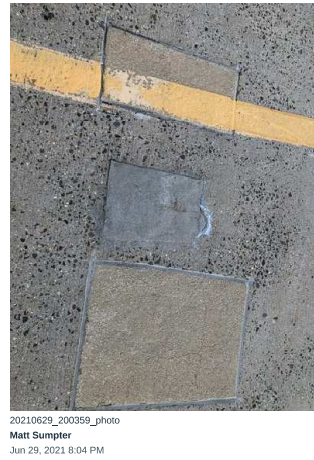
#41 Spall / Delamination / Exposed Rebar

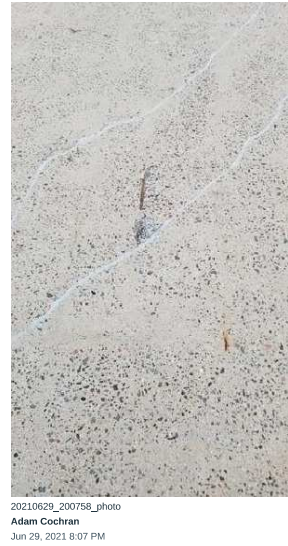
#45 Spall / Delamination / Exposed Rebar

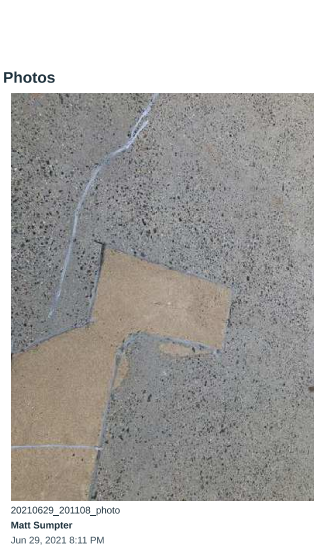
#51 Spall / Delamination / Exposed Rebar

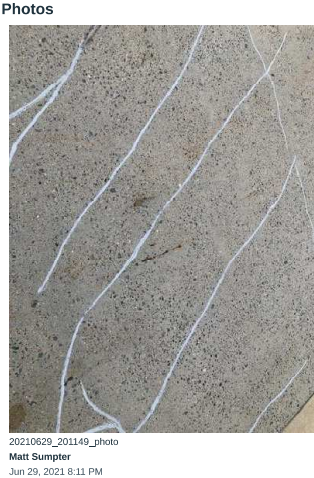
#52 Crack

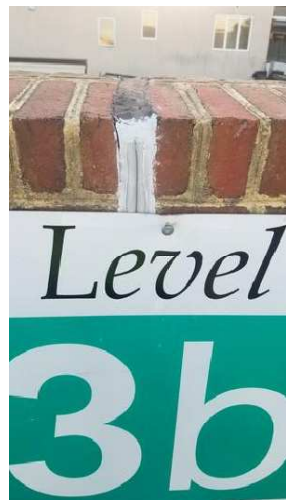
#56 Spall / Delamination / Exposed Rebar

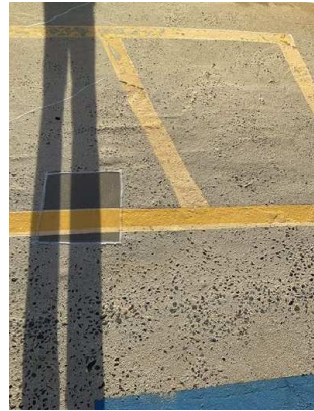
#106 Spall / Delamination / Exposed Rebar

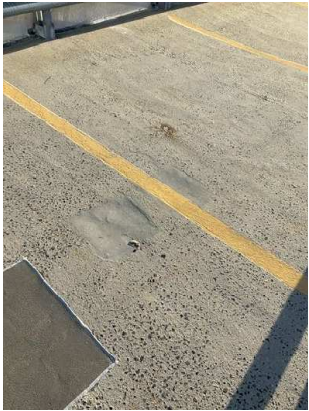
#107 Spall / Delamination / Exposed Rebar

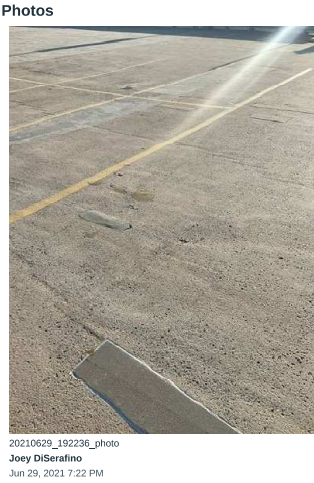
#108 Crack

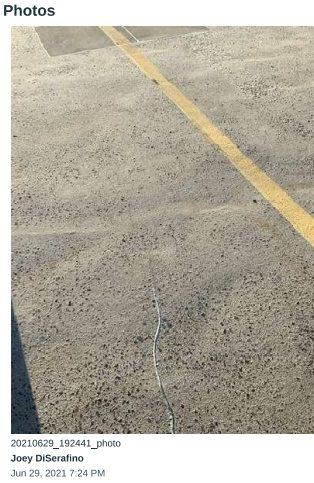
#109 Spall / Delamination / Exposed Rebar

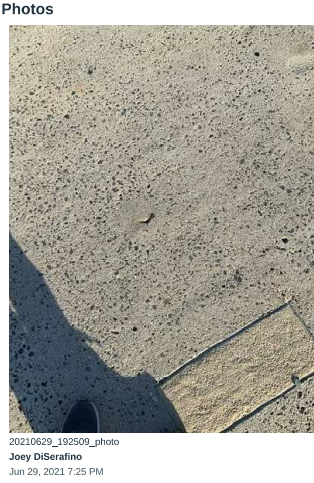
#110 Spall / Delamination / Exposed Rebar

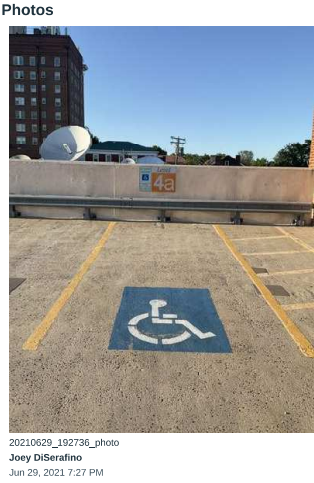
#112 Spall / Delamination / Exposed Rebar

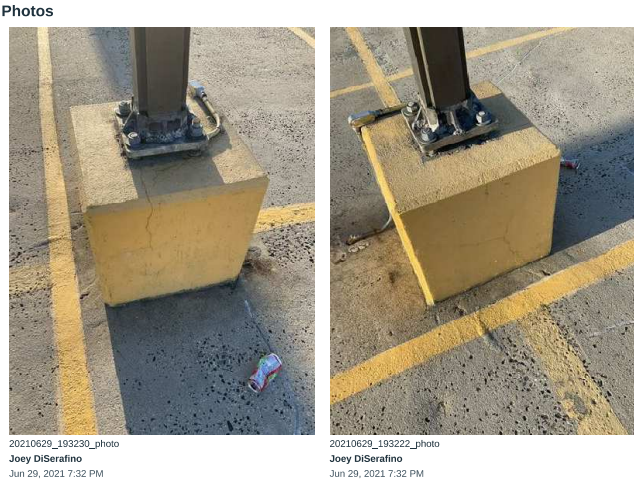
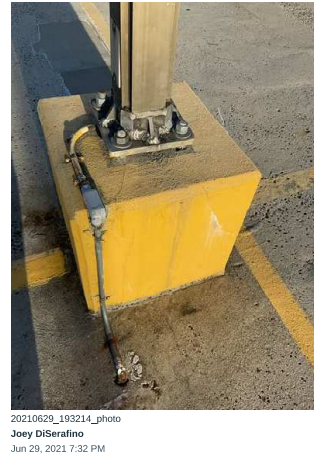
#114 Spall / Delamination / Exposed Rebar

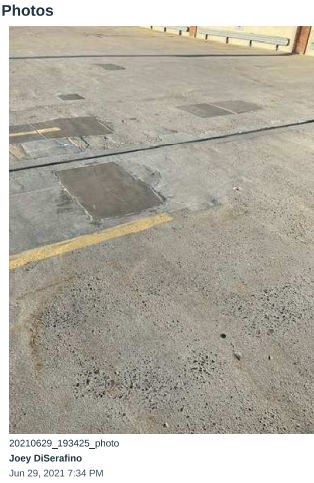
#115 Crack

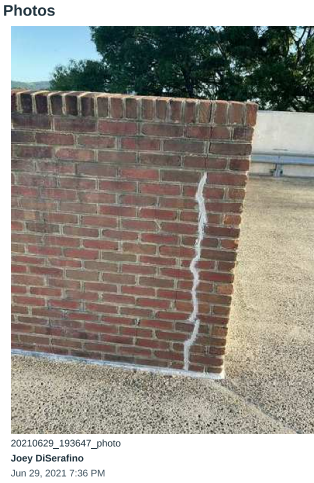
#116 Spall / Delamination / Exposed Rebar

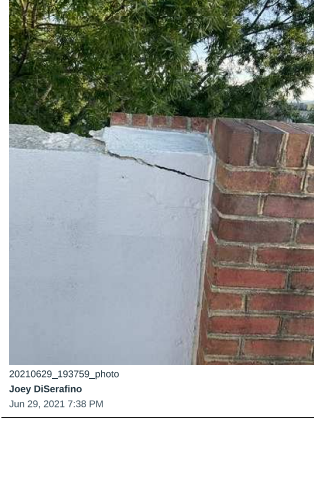
#117 Crack

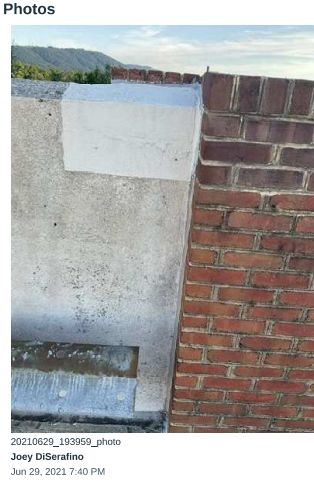
#118 Crack

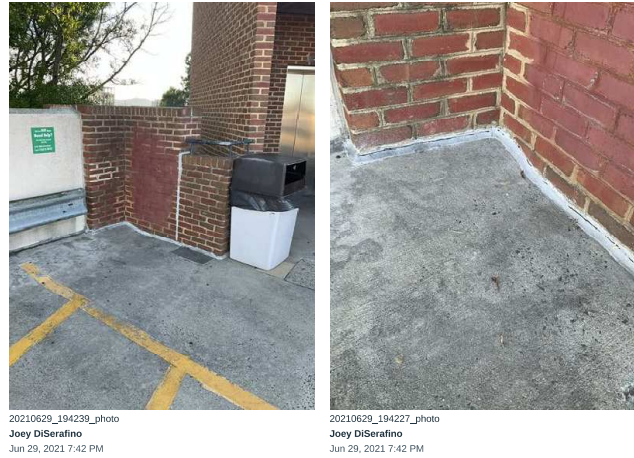
#121 Spall / Delamination / Exposed Rebar

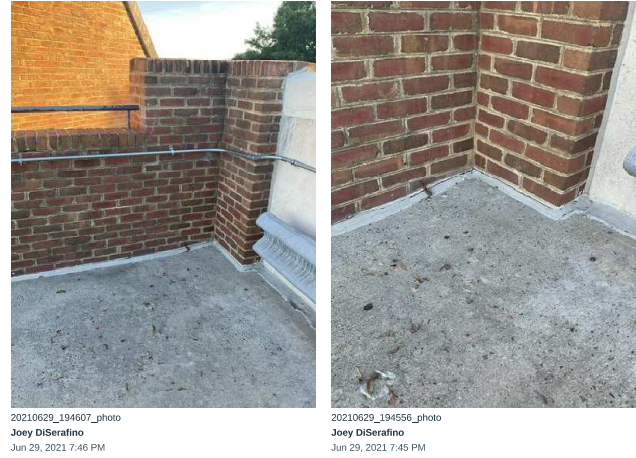
#124 Spall / Delamination / Exposed Rebar

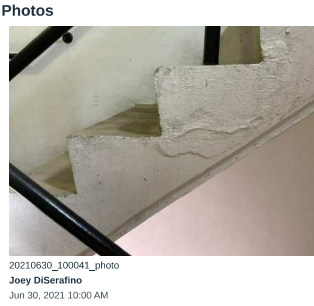
#57 Spall / Delamination / Exposed Rebar

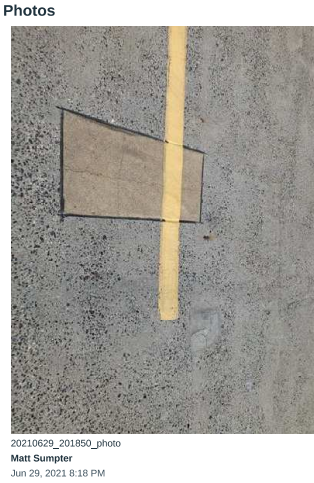
#59 Spall / Delamination / Exposed Rebar

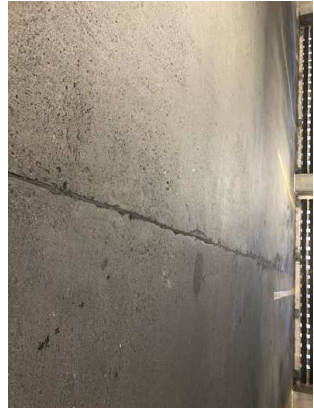
#67 Crack

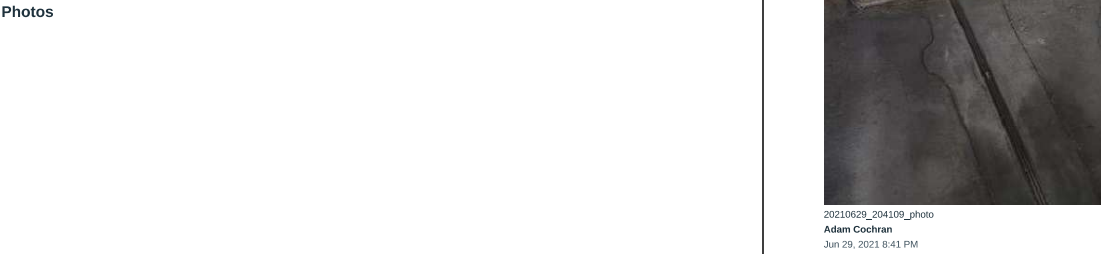
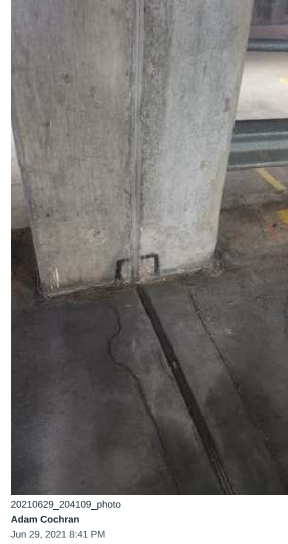
#72 Spall / Delamination / Exposed Rebar

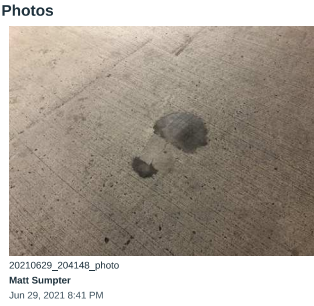
#73 Spall / Delamination / Exposed Rebar

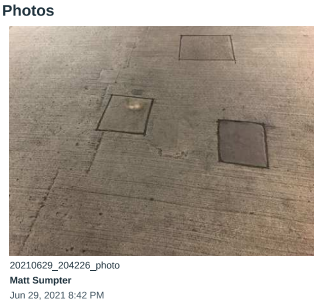
#74 Spall / Delamination / Exposed Rebar

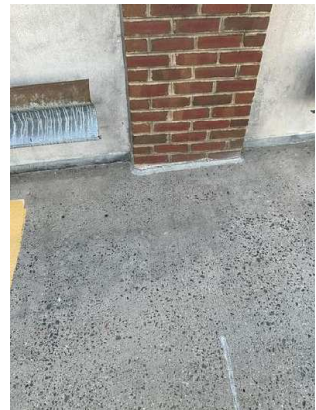
#142 Crack

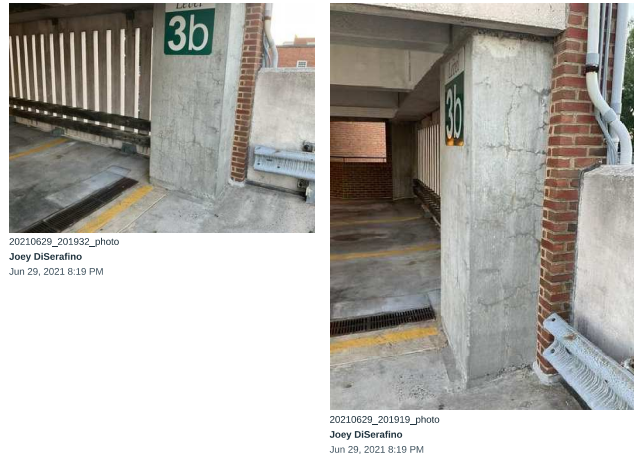
#143 Spall / Delamination / Exposed Rebar

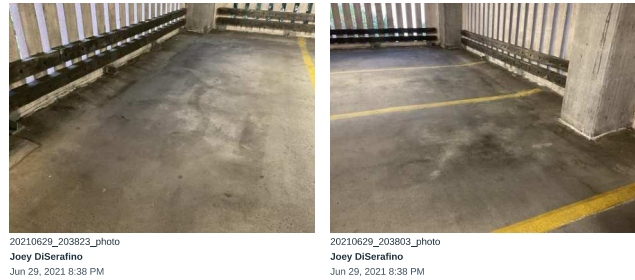
#152 Spall / Delamination / Exposed Rebar

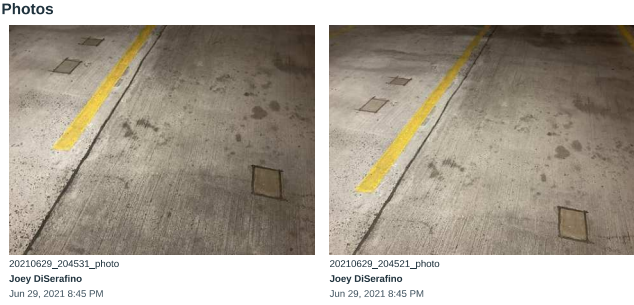
#157 Crack

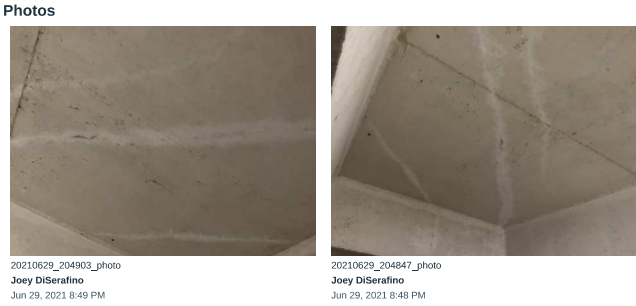
#160 Spall / Delamination / Exposed Rebar

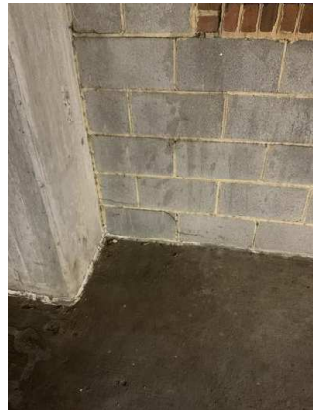
#168 Corrosion of metals

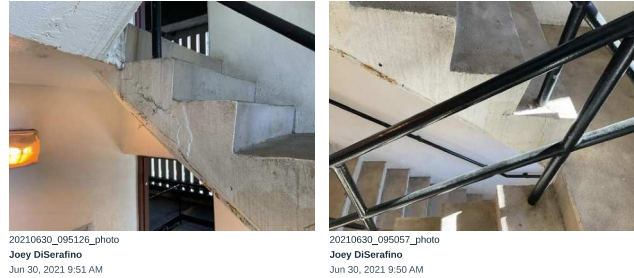
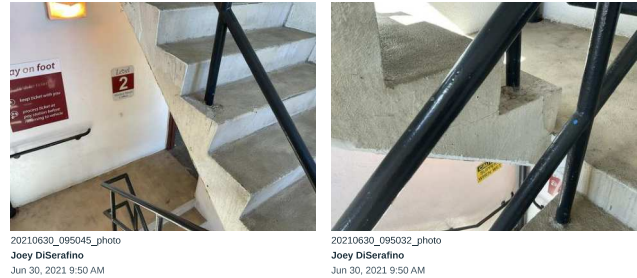
#304 Spall / Delamination / Exposed Rebar

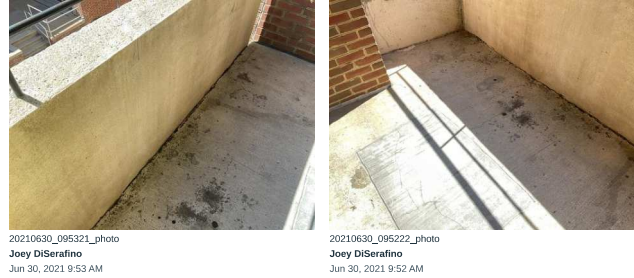
#305 Spall / Delamination / Exposed Rebar

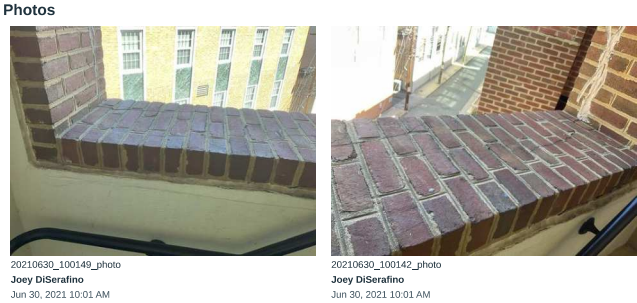
#316 Spall / Delamination / Exposed Rebar

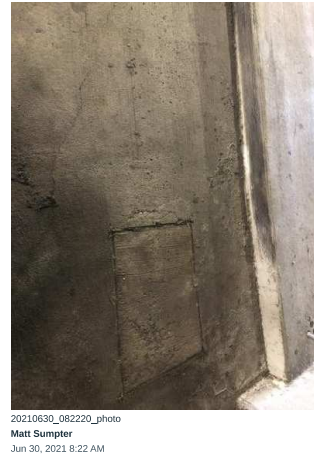
#178 Spall / Delamination / Exposed Rebar

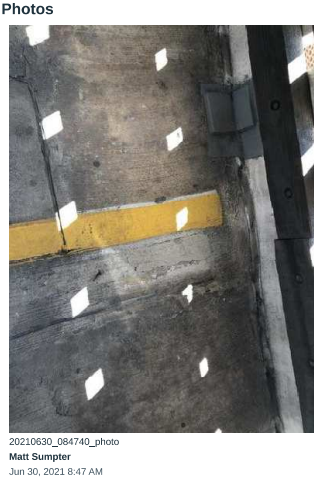
#195 Spall / Delamination / Exposed Rebar

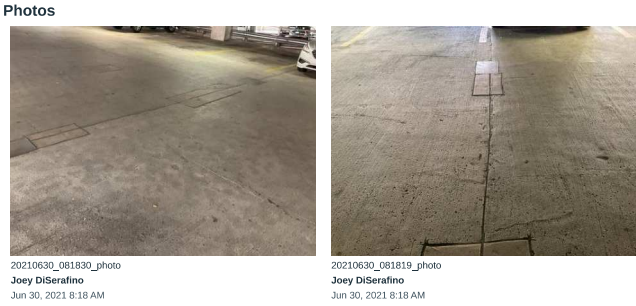
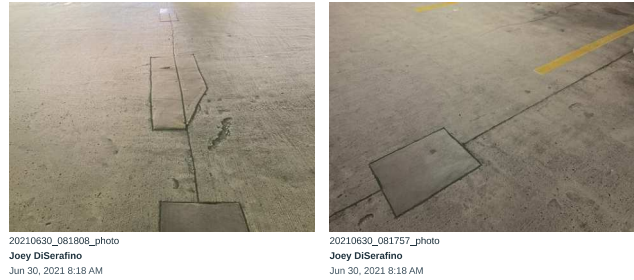
#262 Crack

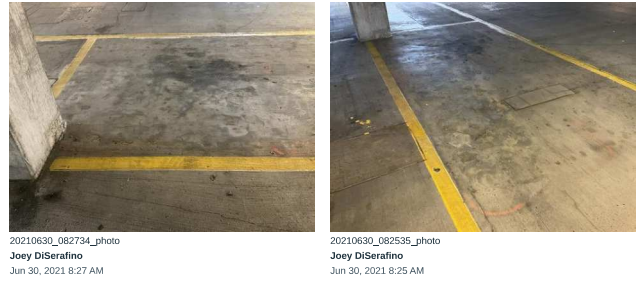
#267 Spall / Delamination / Exposed Rebar

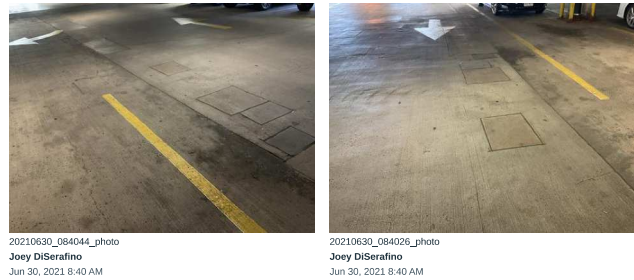
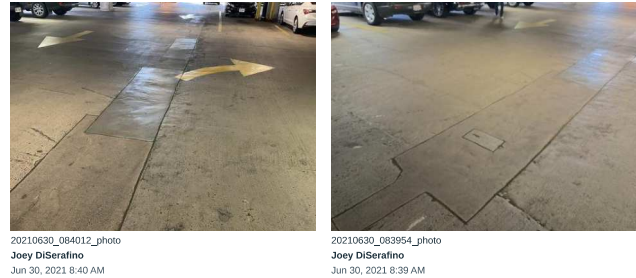
#276 Crack

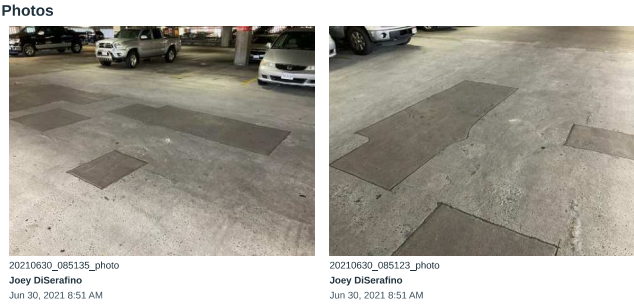
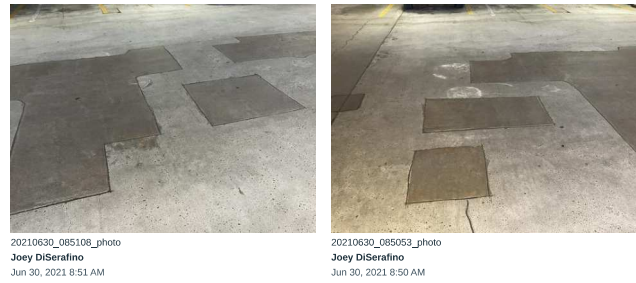
#282 Spall / Delamination / Exposed Rebar

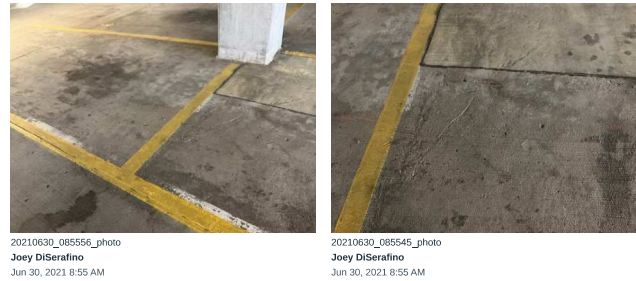
#286 Crack
