MCGUFFEY ART CENTER  
201 2ND STREET NW  
CHARLOTTESVILLE, VIRGINIA

ECS PROJECT NO. 46:6713

CITY OF CHARLOTTESVILLE - FACILITIES DEVELOPMENT

Reference: Facility Condition Assessment Report for McGuffey Art Center, 201 2ND Street NW,  
Charlottesville, Virginia

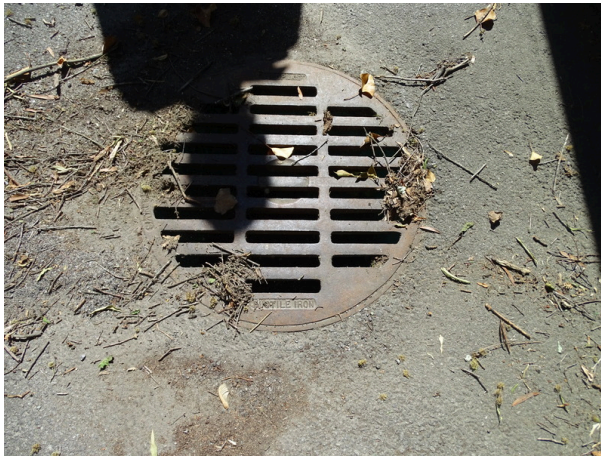
Typical storm water drainage

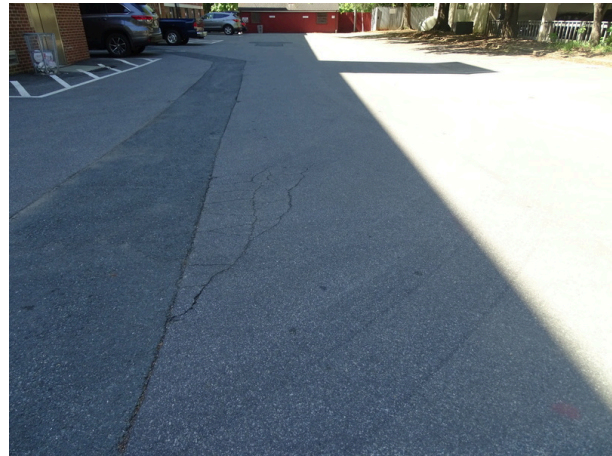
Asphalt-paved drive lanes are located on the west side of the site. The asphalt pavement was observed to be in generally good condition although the line striping was cracked in some areas. The expected useful life of asphalt pavement is 20 years. We recommend repairing areas of asphalt pavement on an as-needed basis and have provided an allowance to overlay the asphalt pavement later in the report period.

Asphalt paving - note fading of striping and some cracking

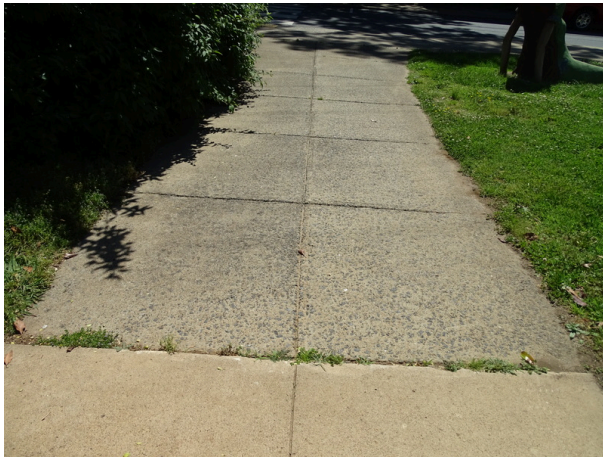
Typical concrete sidewalks - note spalling

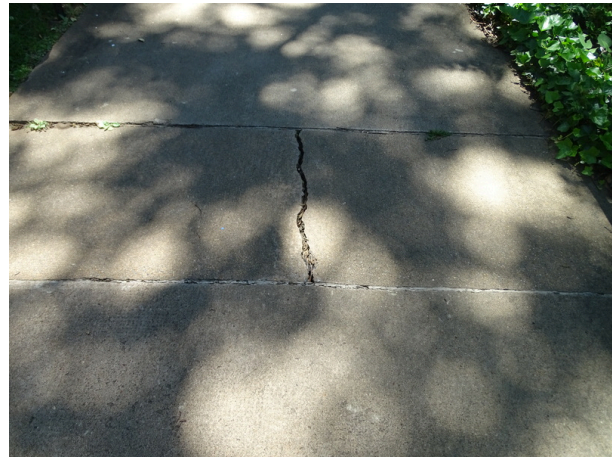
Typical concrete sidewalks - note deterioration

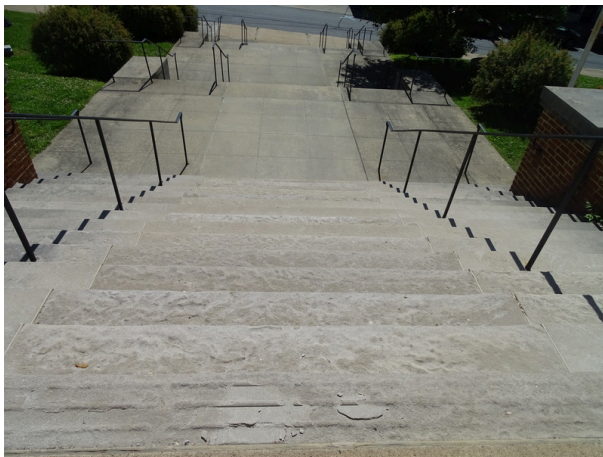
The concrete steps at the east entrance were observed to be spalling. We recommend repairing the spalling area of concrete steps.

Typical concrete steps- note spalling

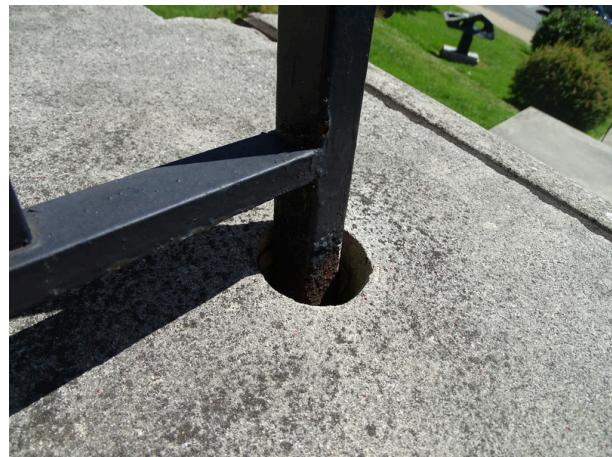
Typical steel hand rail - note deterioration

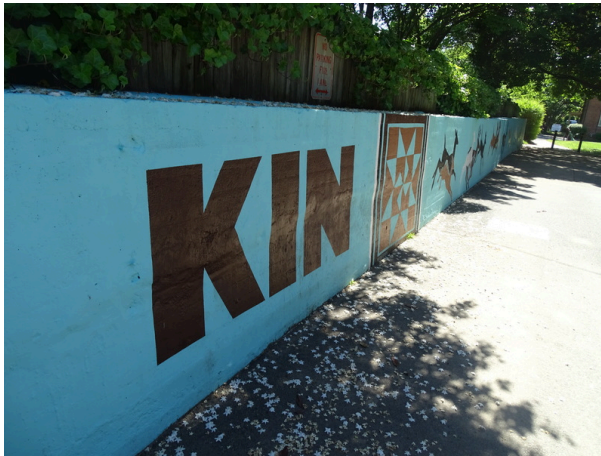
Typical concrete retaining wall

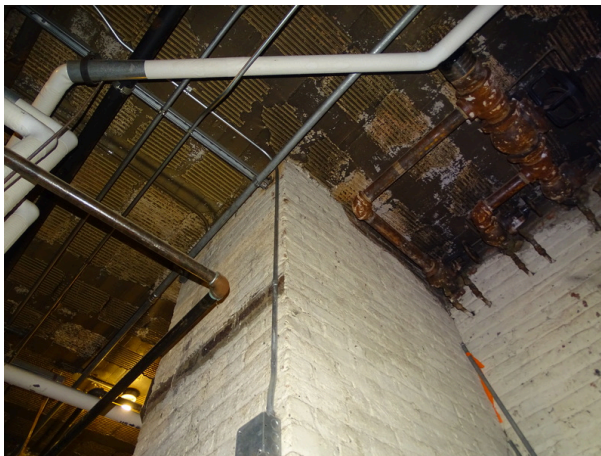
First floor framing with masonry column and wall

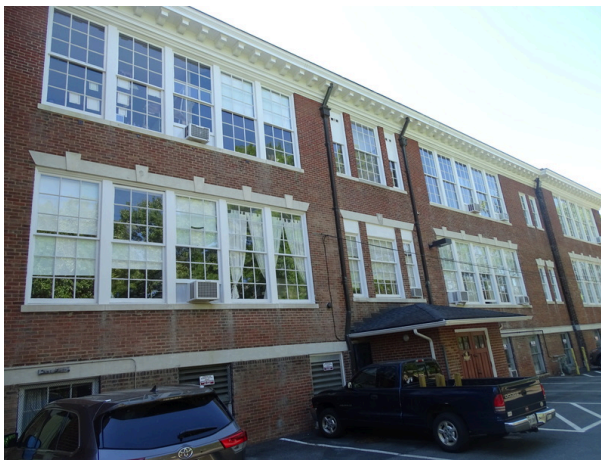
Typical exterior east side

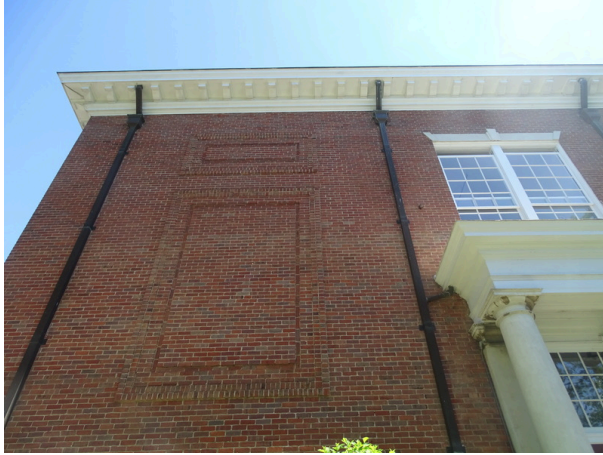
Typical exterior wall

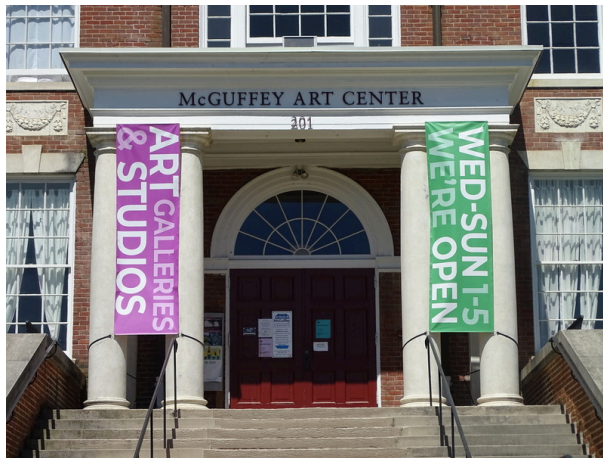
The main entrances are Wood doors. The main entrance doors were generally in fair condition. Wood personnel doors are located on the north, south, and west sides of the site. The personnel doors were generally in fair condition. Exterior doors typically have an expected useful life of 20 to 30 years. We recommend replacing the wood doors during the report period.

Wood doors at main entrance at the east side of the building

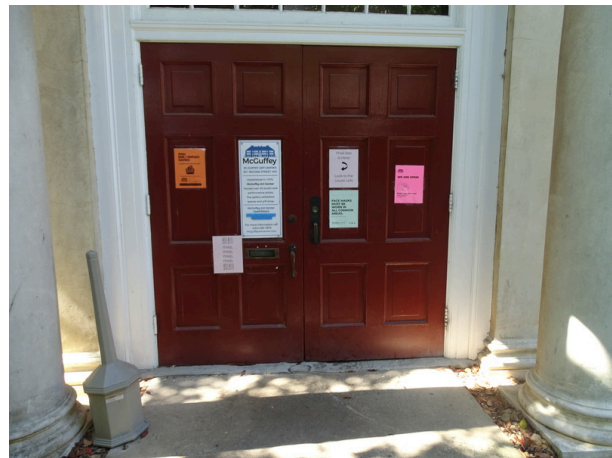
Wood personnel doors at the north side of the building

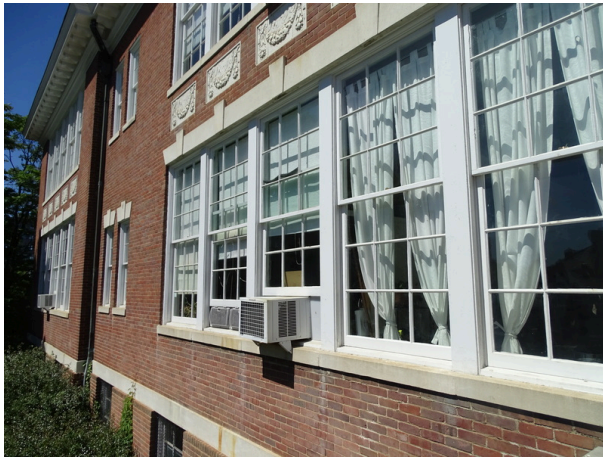
Typical exterior window units - note recent restoration

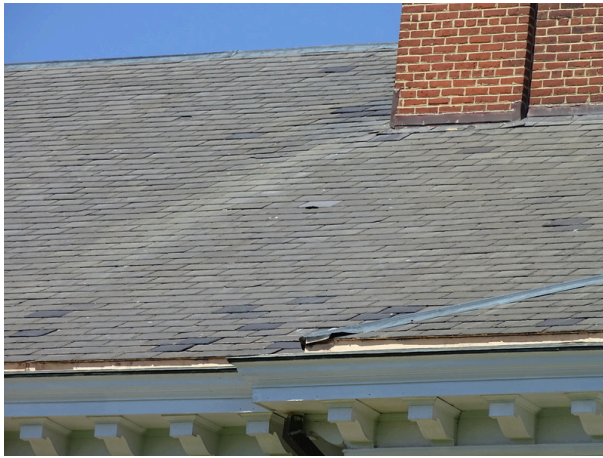
Slate shingle roofing system - note deterioration

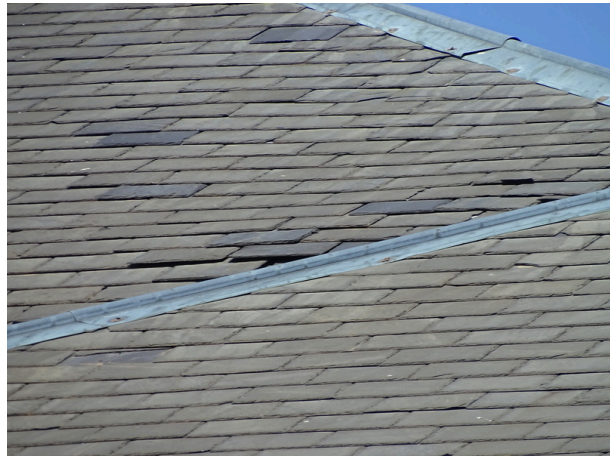
Slate shingle roofing system - note deterioration

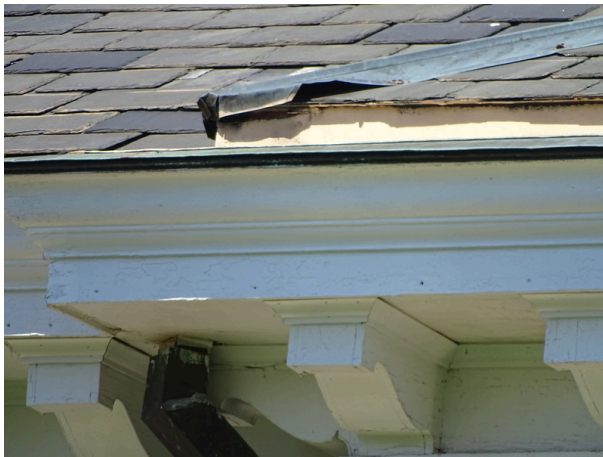
Slate shingle roofing system - note deterioration

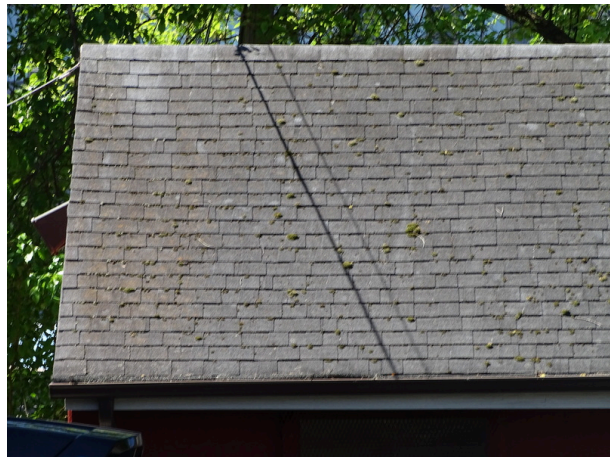
An asphalt shingle roofing system is located over the small southwest studio area. The asphalt shingle roofing system was generally in fair to poor condition. The expected useful life of an asphalt shingle roofing system is 20 years with proper maintenance. We recommend replacing the asphalt shingle roofing system during the report period.

Asphalt shingle roofing system located over  
studio area

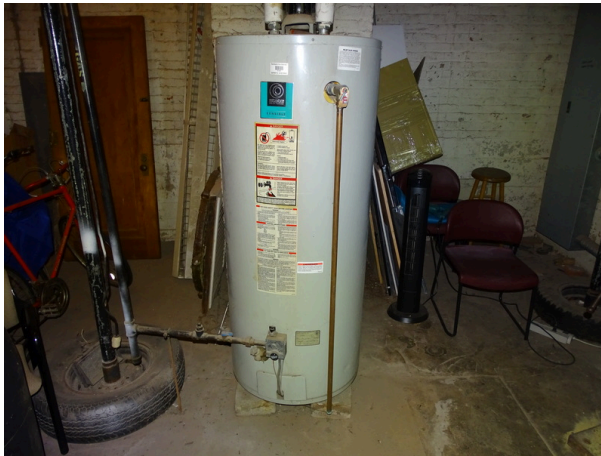
Domestic hot water to the building is provided by Gas water heater located in the main utility room. The Gas water heater was manufactured by State Industries, reportedly in 1998. The expected useful life of a Gas water heater is approximately 12 to 15 years and We recommend the Gas water heater be replaced.

Gas domestic water heater

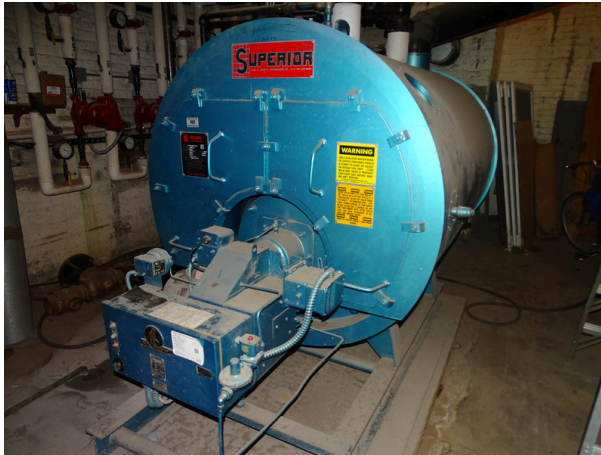
The expected useful life of an older boiler system is generally 15 to 20 years. We recommend replacing the boiler and associated pumps during the report period. The recommended useful life of radiator units can generally vary, therefore, we recommend replacement as needed during the report period.

Boiler system located in main utility room

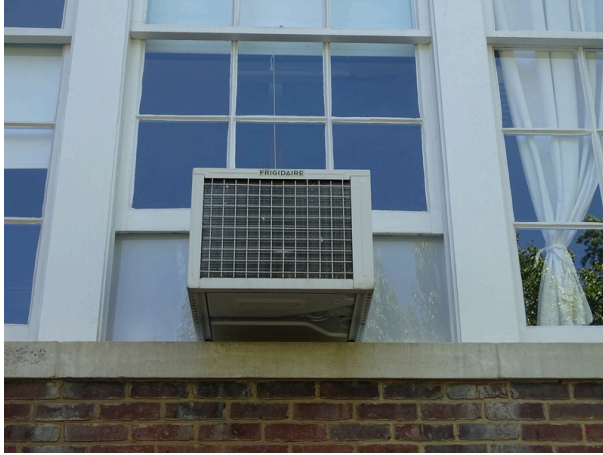
Typical window air conditioning unit

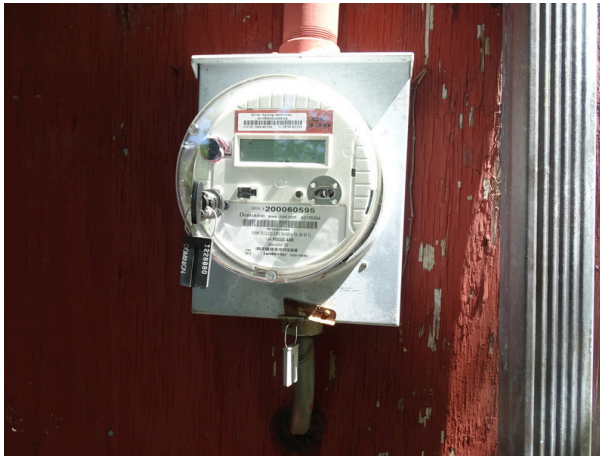
Electrical meter located in the main utility room

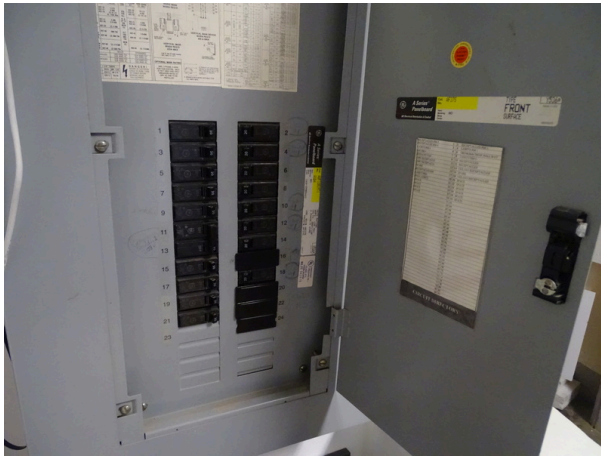
Typical circuit breaker panel

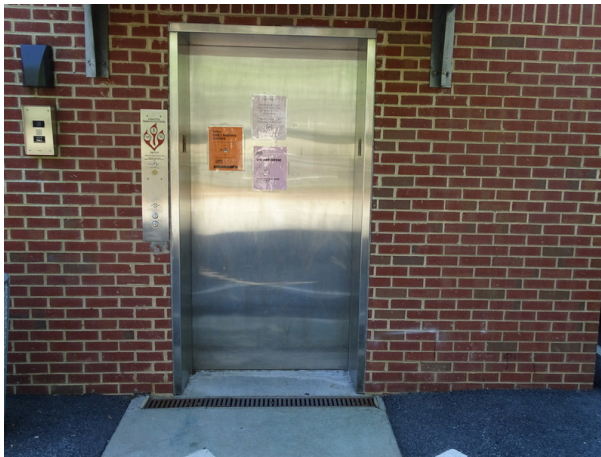
Elevator at ground level

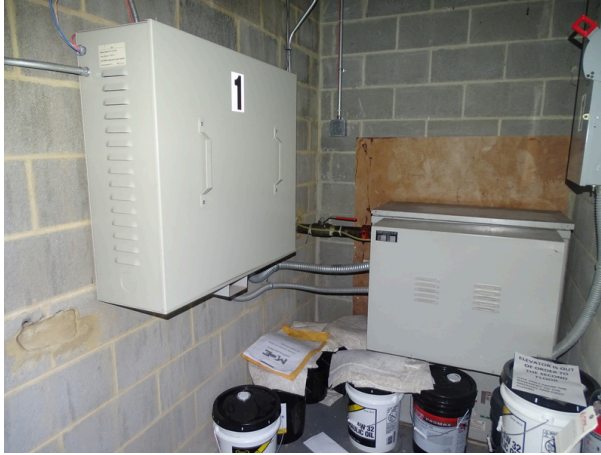
Elevator machinery and controls

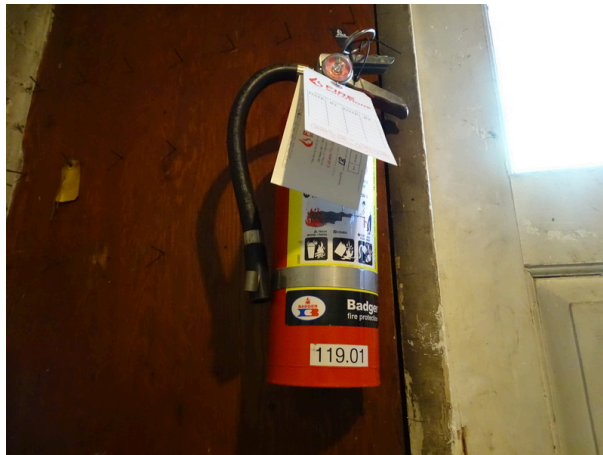
Typical fire extinguisher

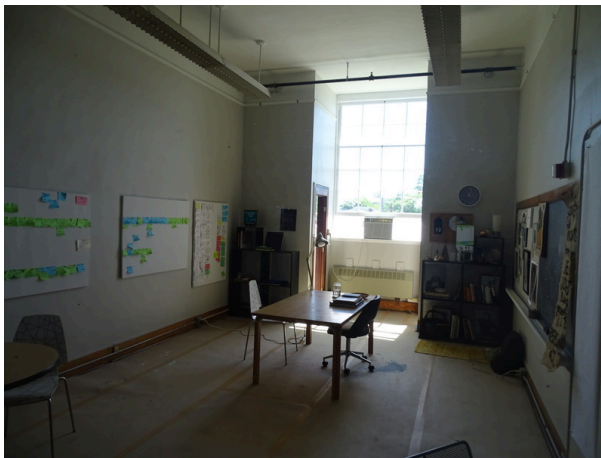
Interior finishes for office area

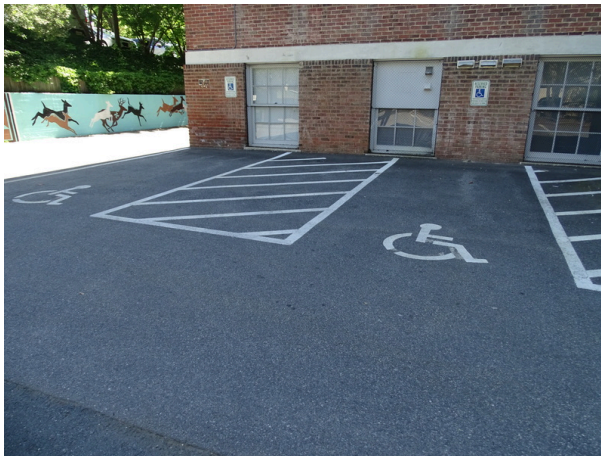
Accessible parking spaces on west side of the building

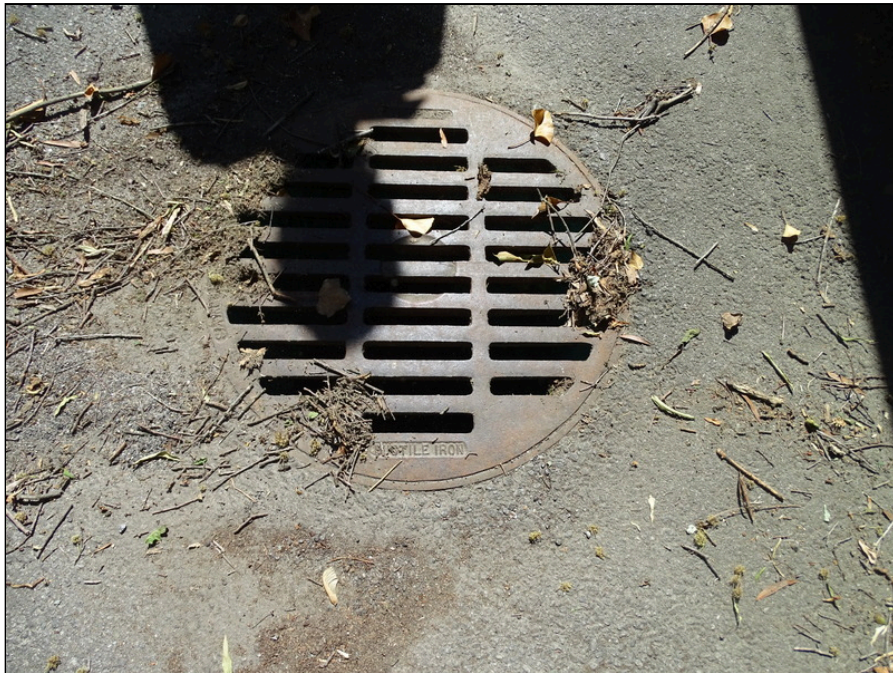
2 - Typical storm water drainage

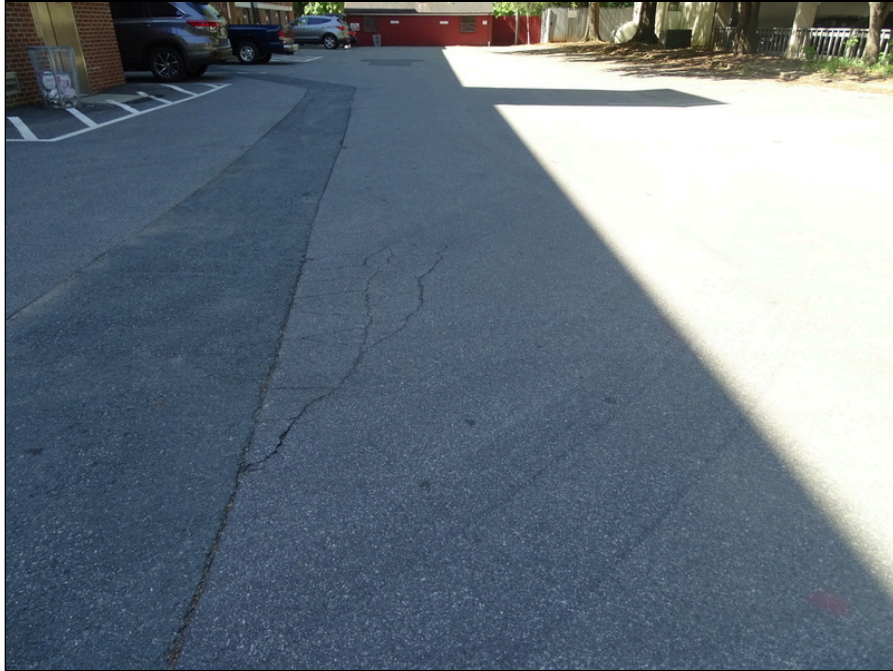
3 - Asphalt paving - note fading of striping and some cracking

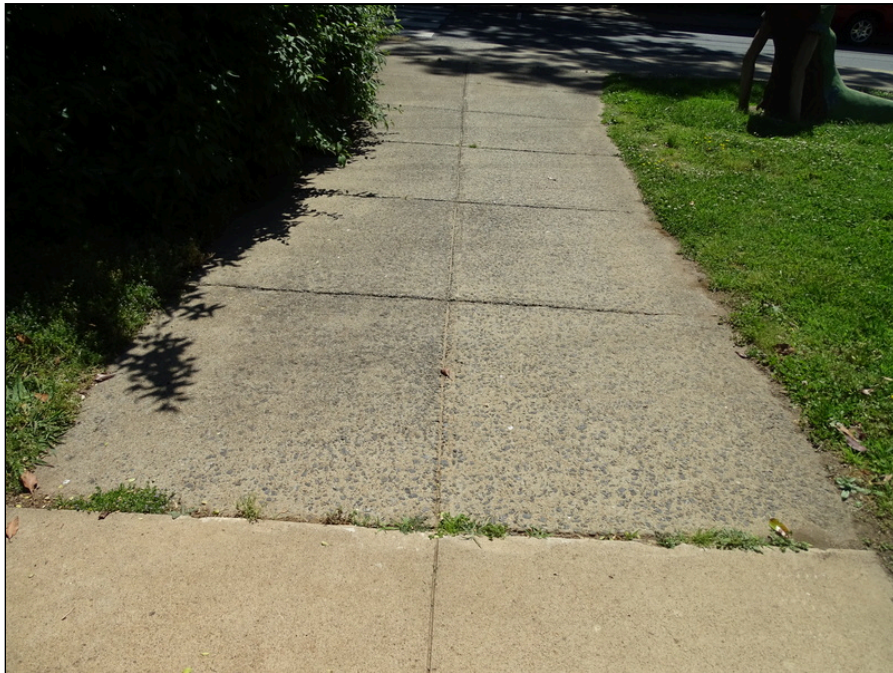
4 - Typical concrete sidewalks - note spalling

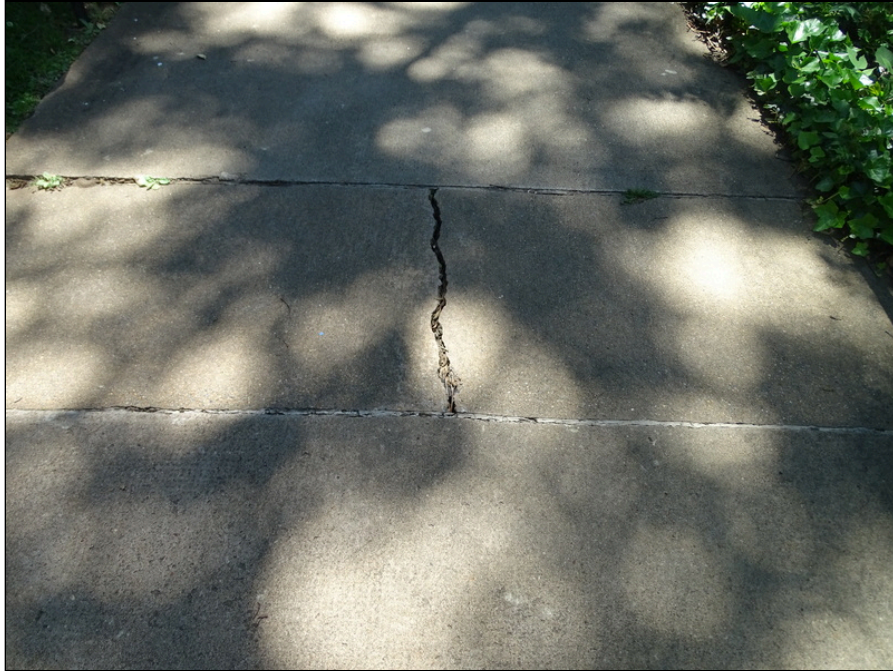
5 - Typical concrete sidewalks - note deterioration

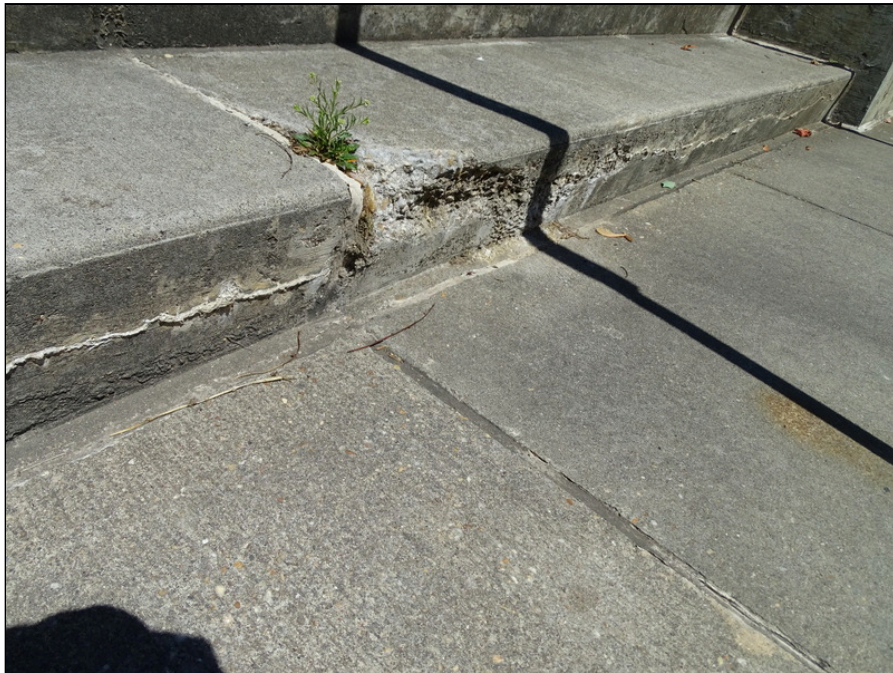
6 - Typical concrete sidewalks - note deterioration

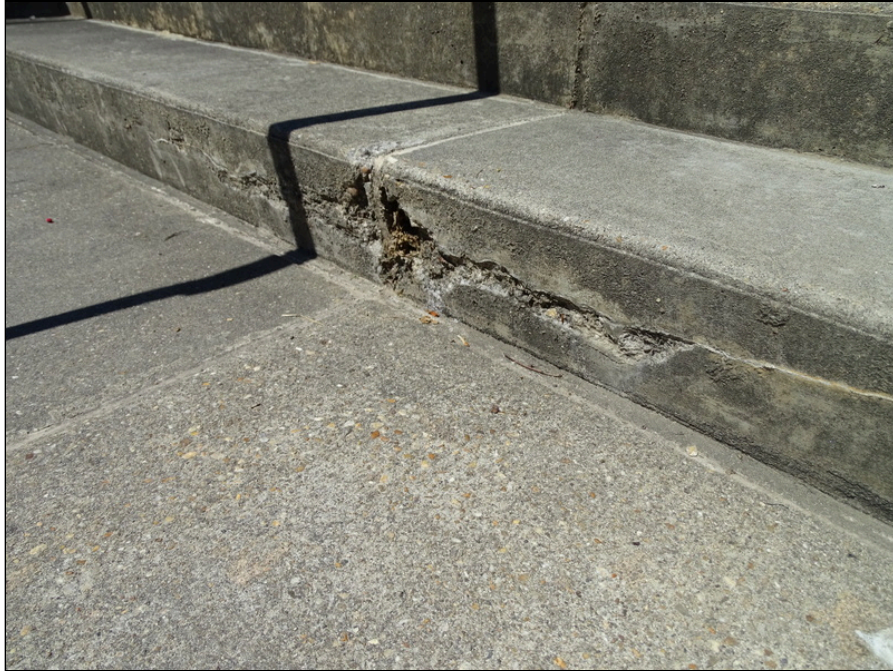
7 - Typical concrete sidewalks - note deterioration

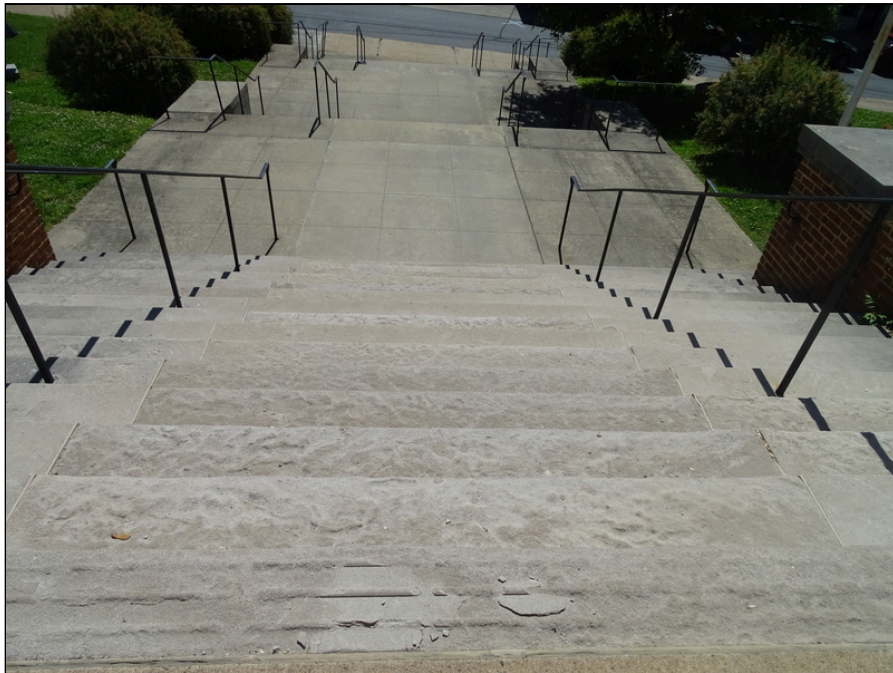
8 - Typical concrete steps- note spalling

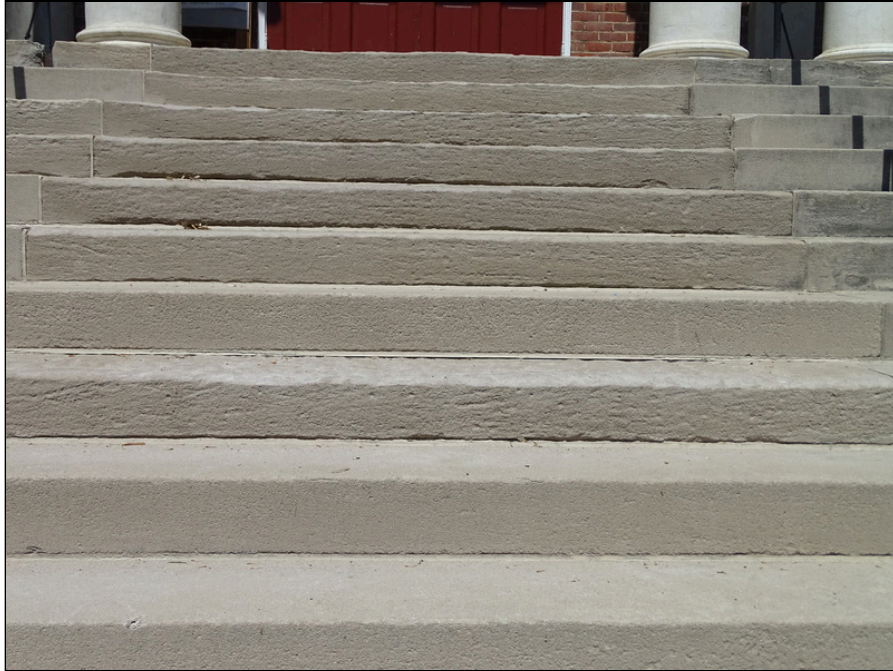
9 - Typical concrete steps- note deterioration

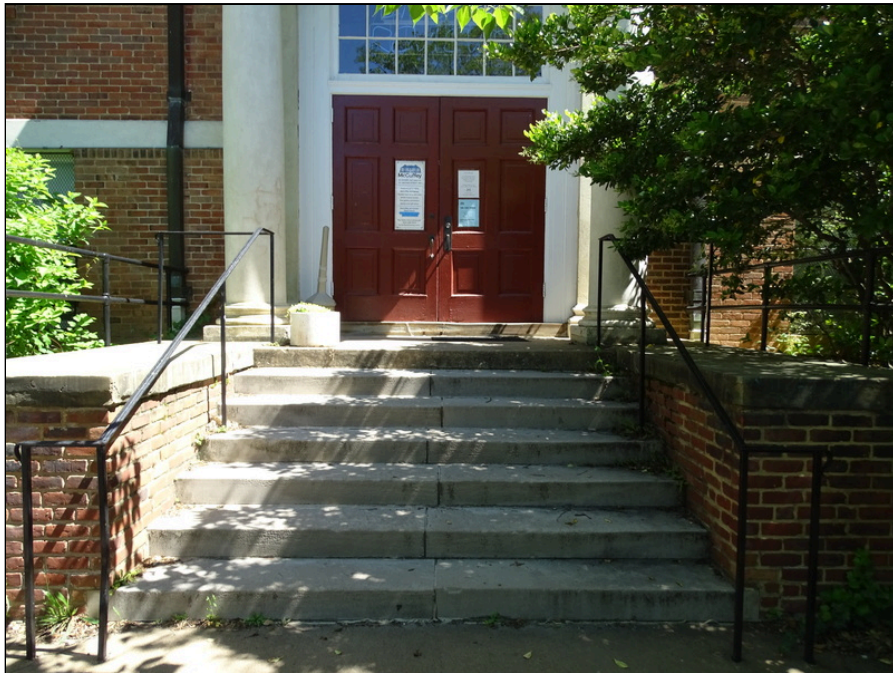
10 - Typical concrete steps at east entrance

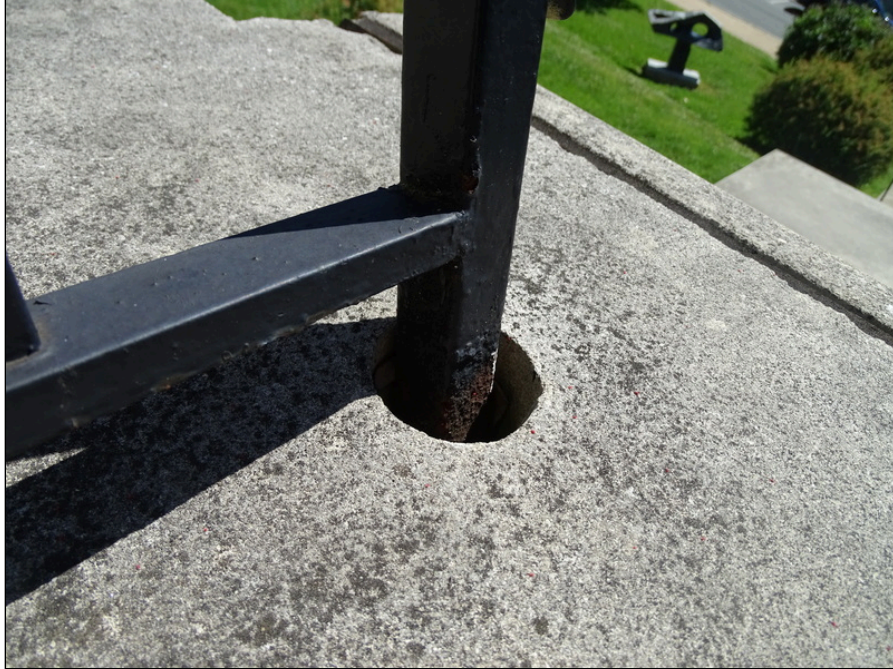
11 - Typical steel hand rail - note deterioration

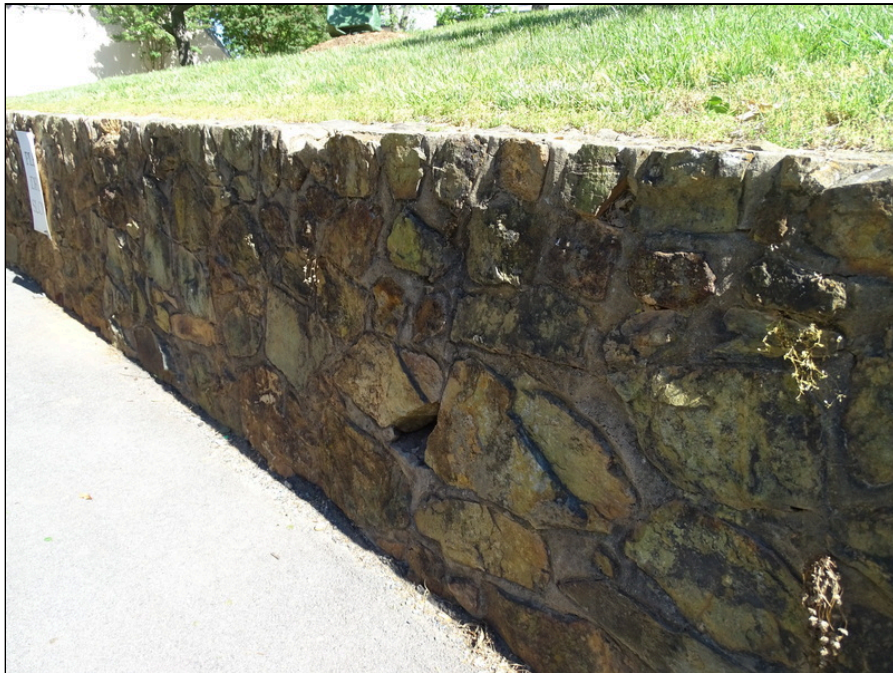
12 - Stone retaining wall

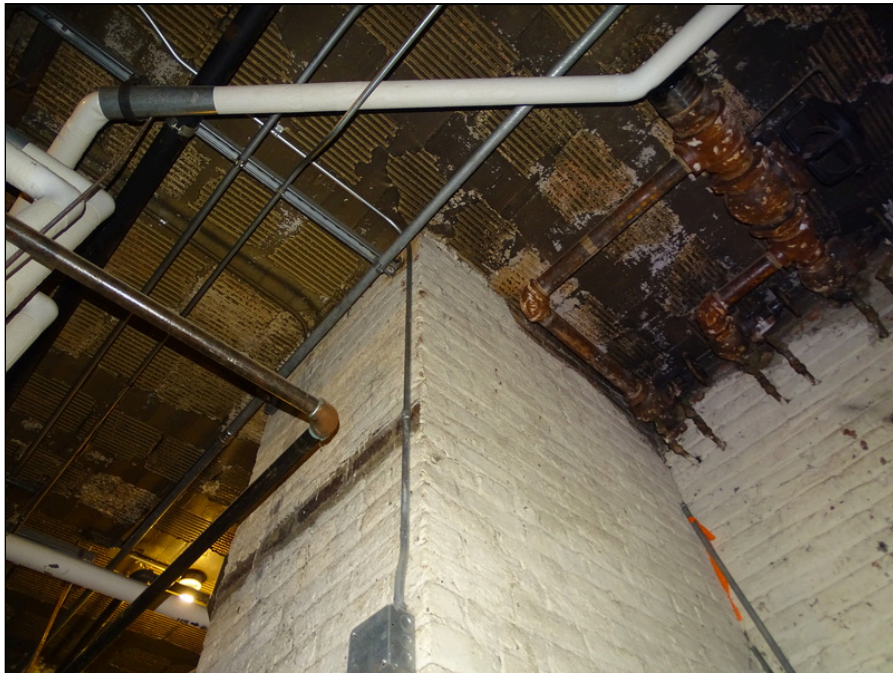
14 - Clay block first floor framing and masonry wall

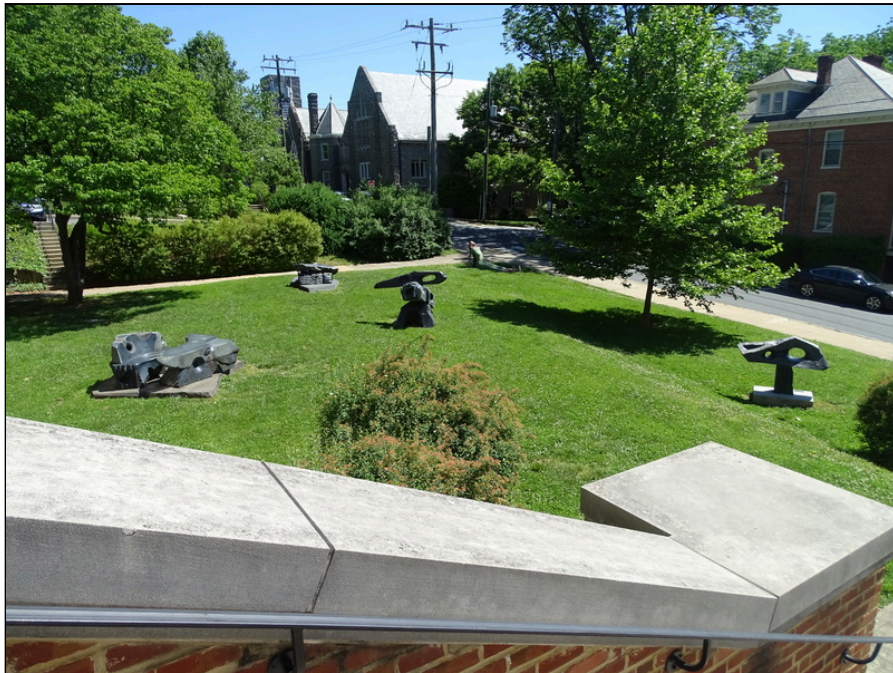
16 - Typical landscaping

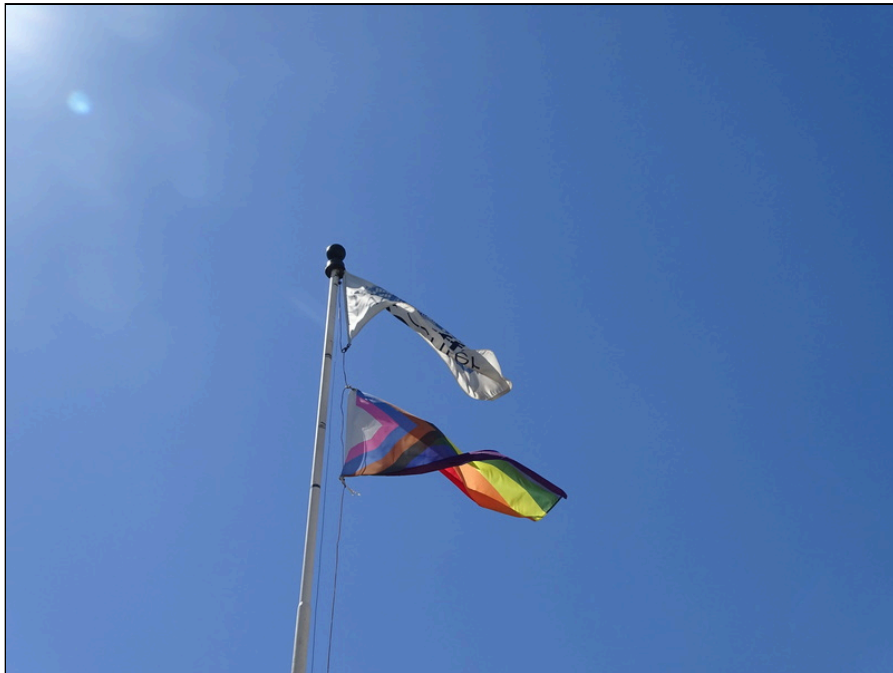
18 - Flag poles

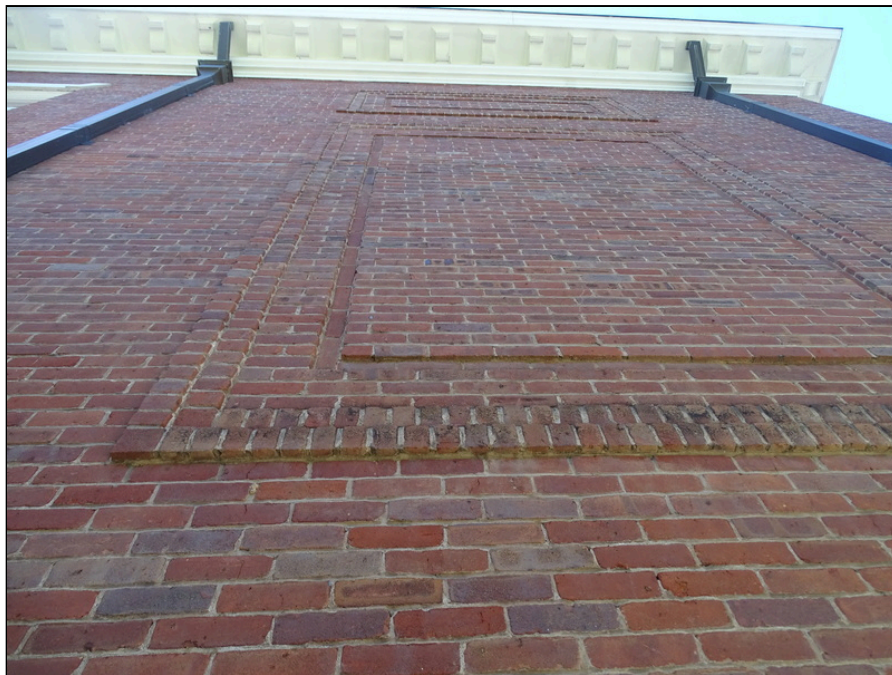
20 - Typical scupper and downspouts

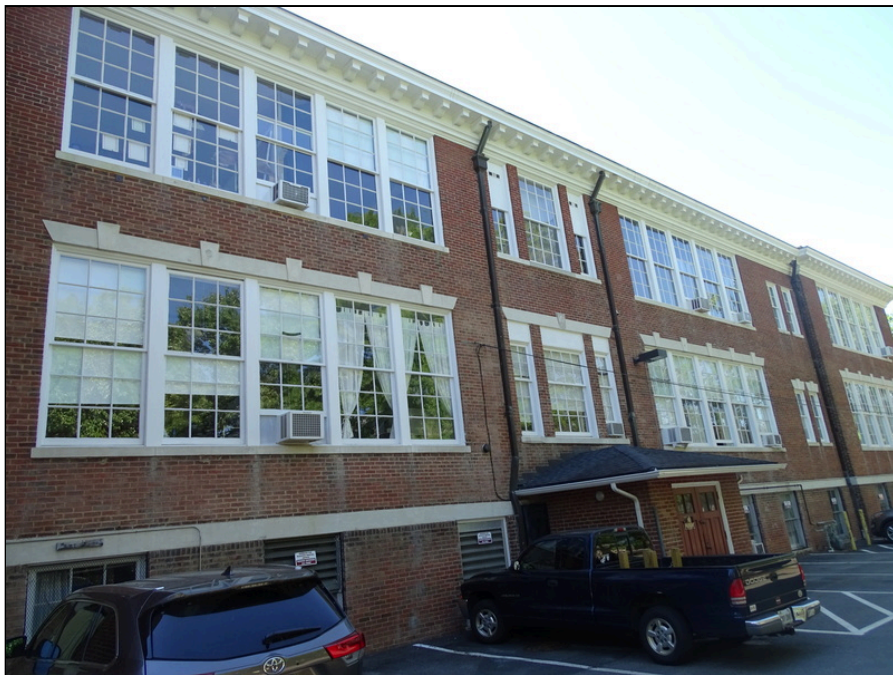
22 - Typical exterior east side

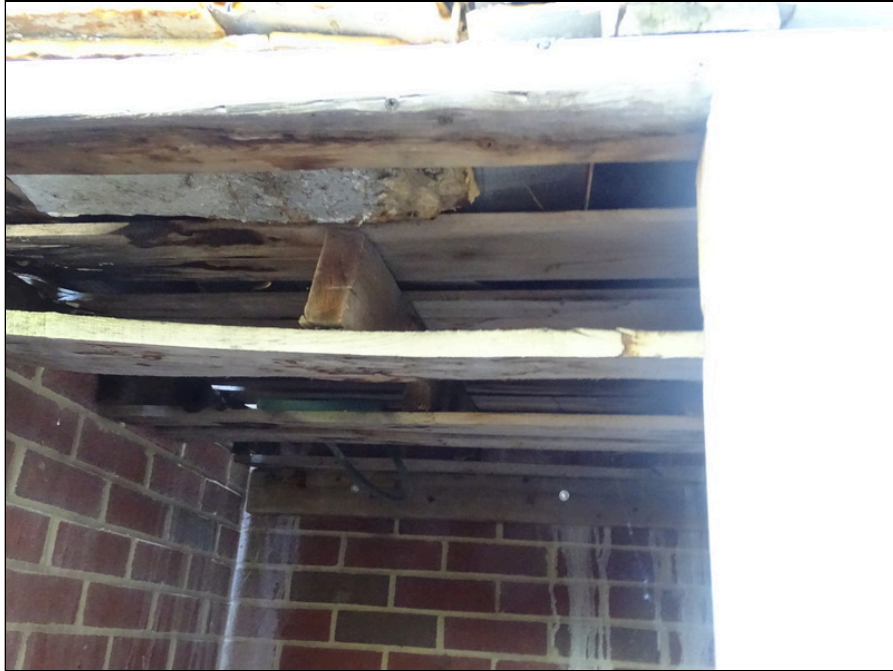
23 - Storage area at west side of the building - note deterioration

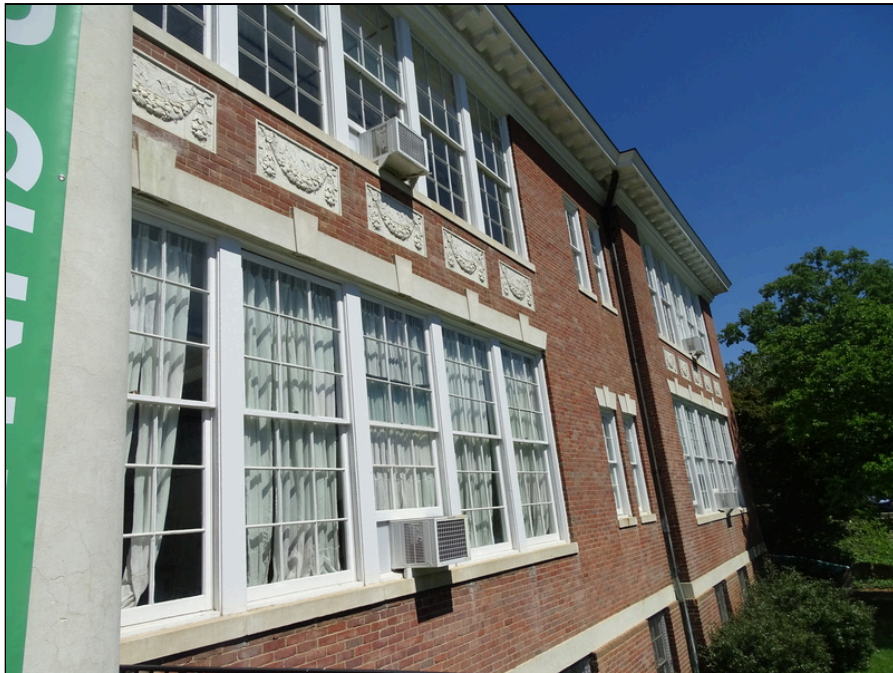
24 - Typical exterior east side

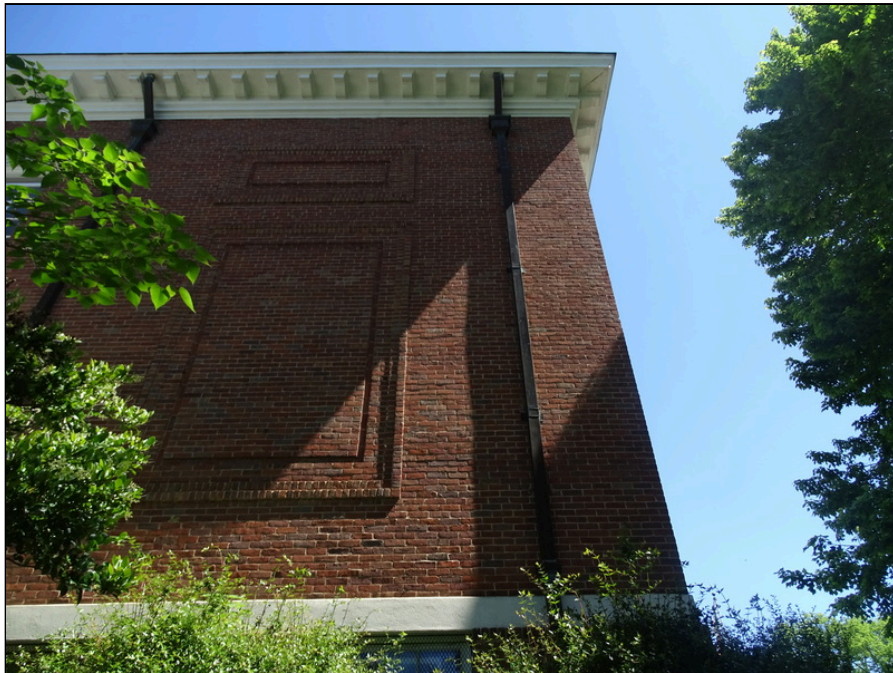
26 - Typical exterior wall

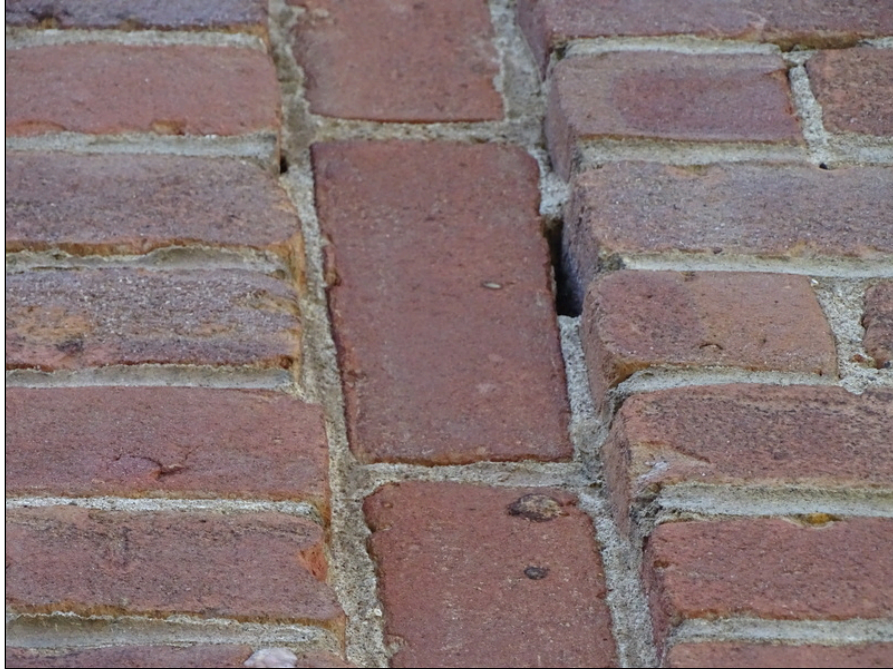
27 - Typical exterior wall - note deterioration of mortar

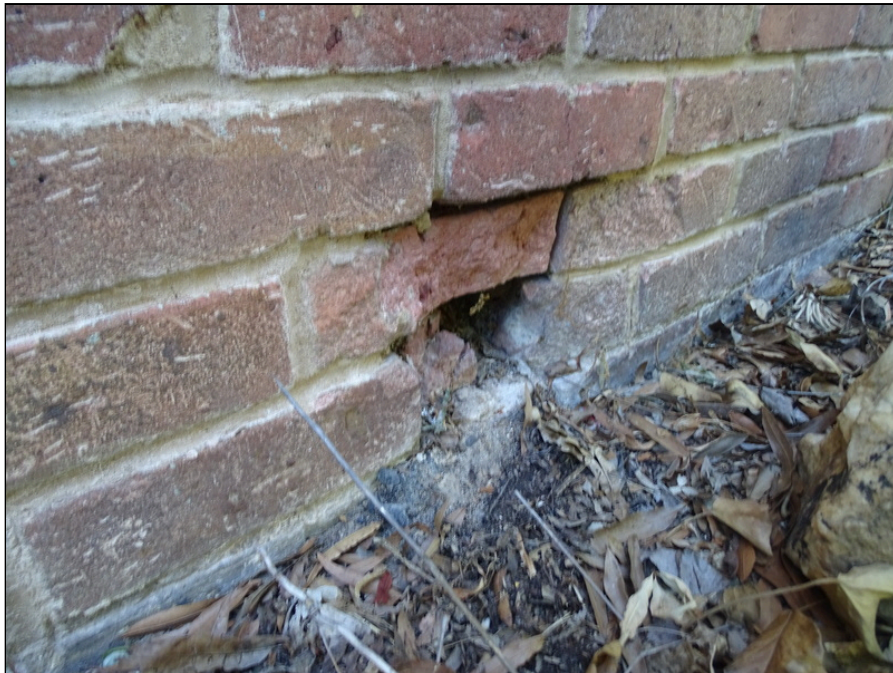
28 - Typical exterior wall - note deterioration of mortar

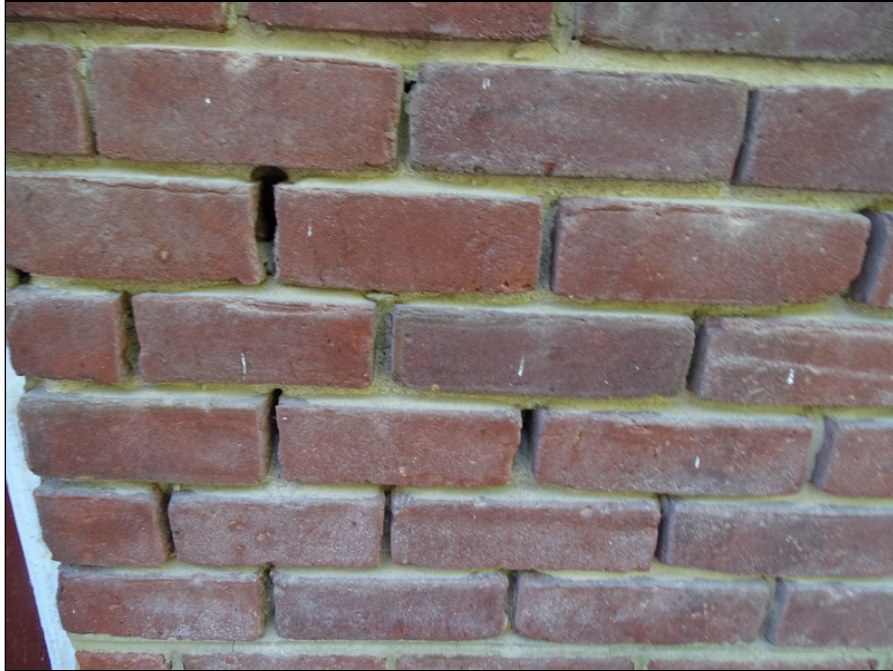
29 - Typical exterior wall - note deterioration of mortar

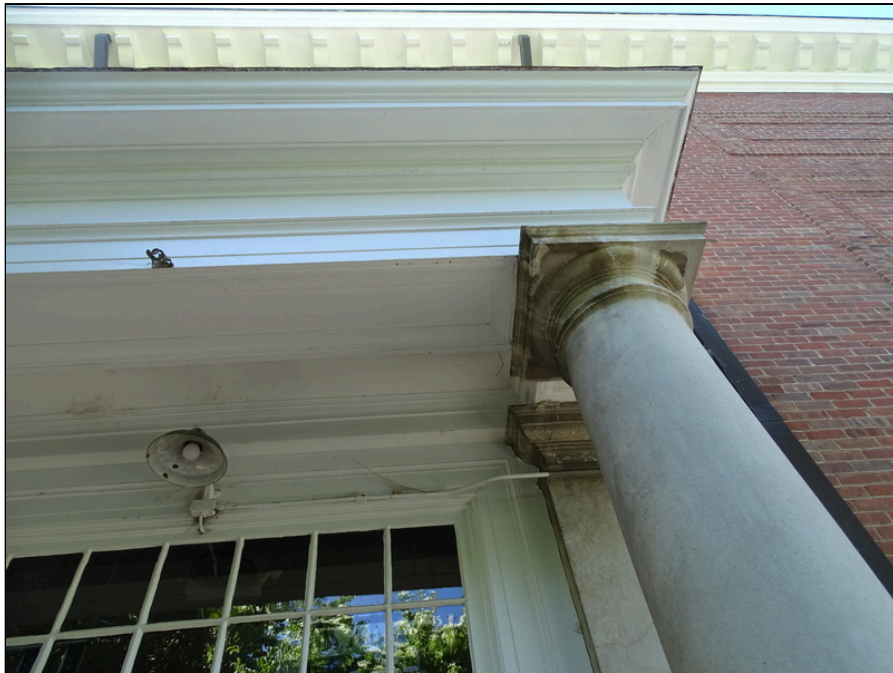
30 - Typical column - note efflorescence

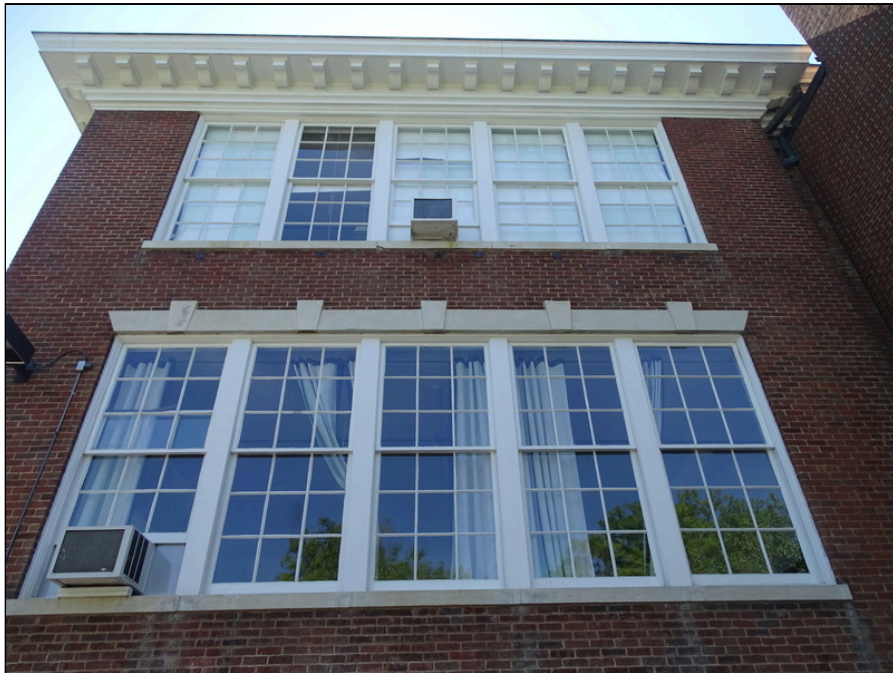
34 - Typical exterior window units - note recent restoration
