MCGUFFEY ART CENTER  
201 2ND STREET NW  
CHARLOTTESVILLE, VIRGINIA

ECS PROJECT NO. 46:6713

CITY OF CHARLOTTESVILLE - FACILITIES DEVELOPMENT

Reference: Facility Condition Assessment Report for McGuffey Art Center, 201 2ND Street NW,  
Charlottesville, Virginia

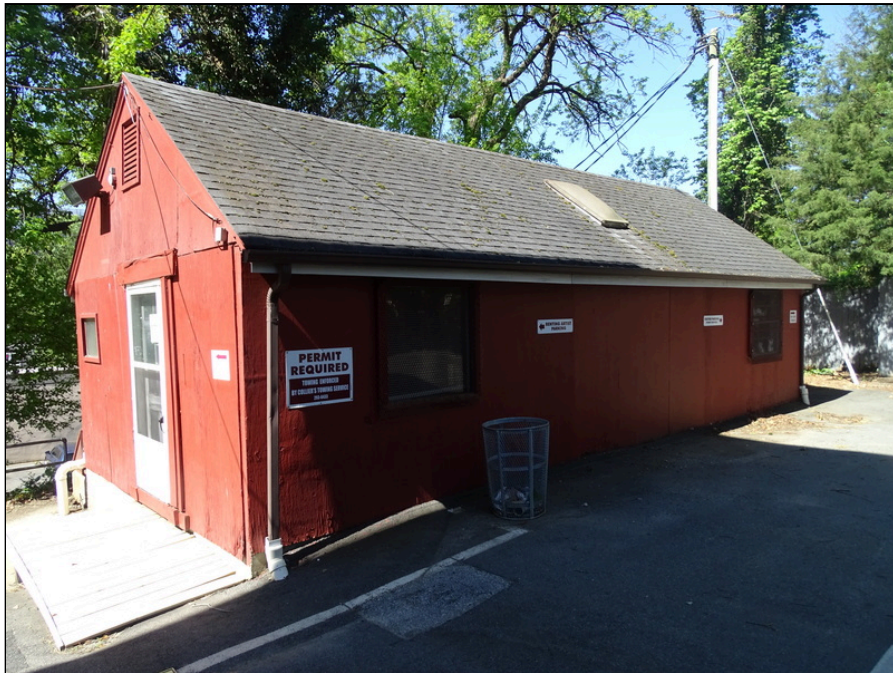
36 - Storage shed converted to two tenant studio spaces

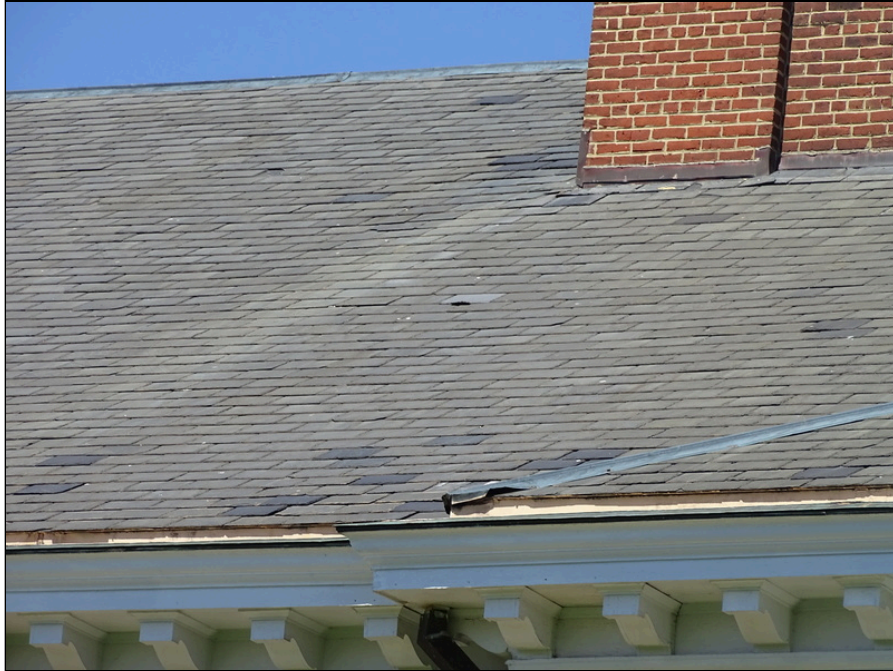
37 - Slate shingle roofing system - note deterioration

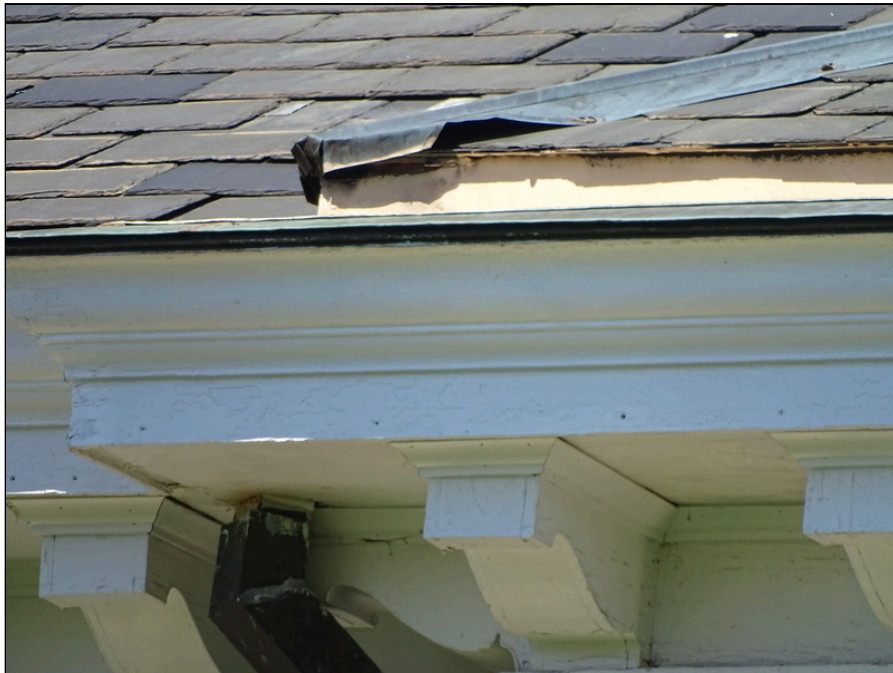
38 - Slate shingle roofing system - note deterioration

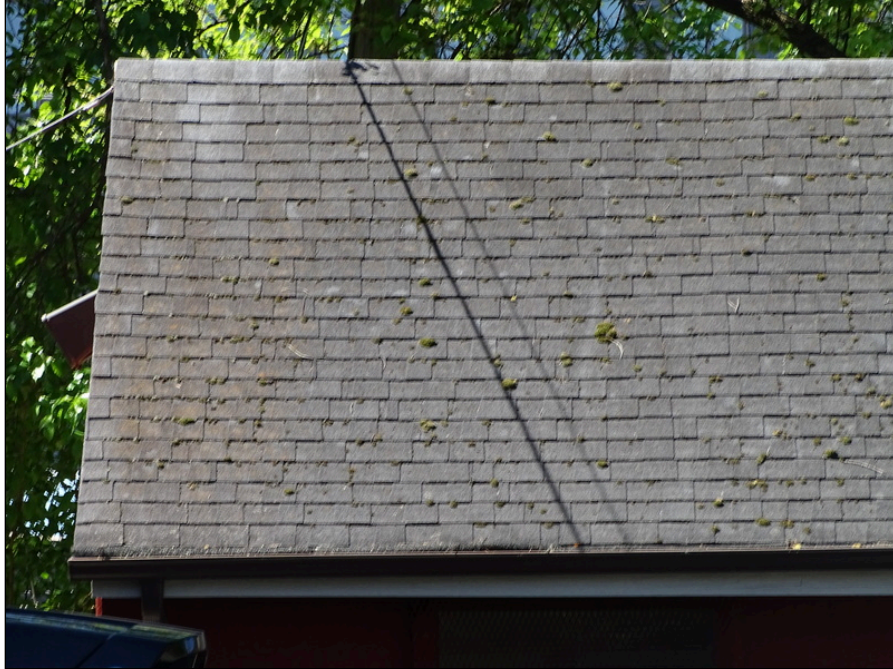
39 - Asphalt shingle roofing system - note deterioration

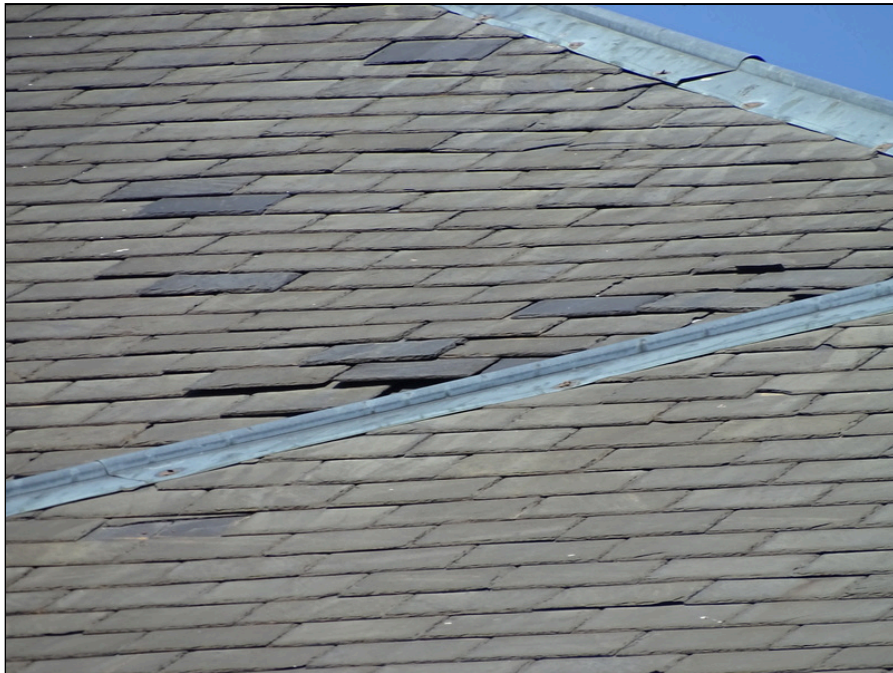
40 - Slate shingle roofing system - note deterioration

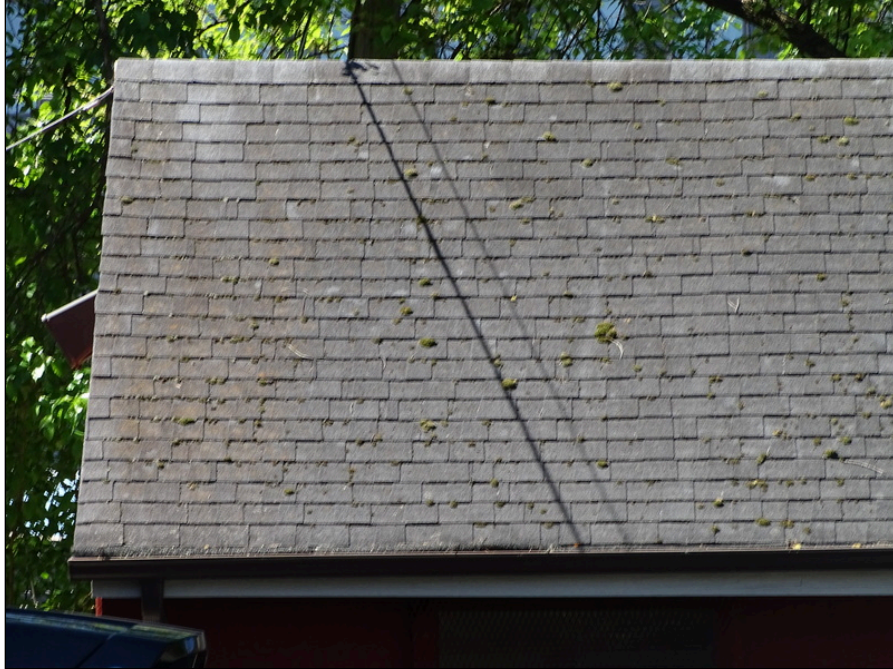
41 - Asphalt shingle roofing system located over studio area

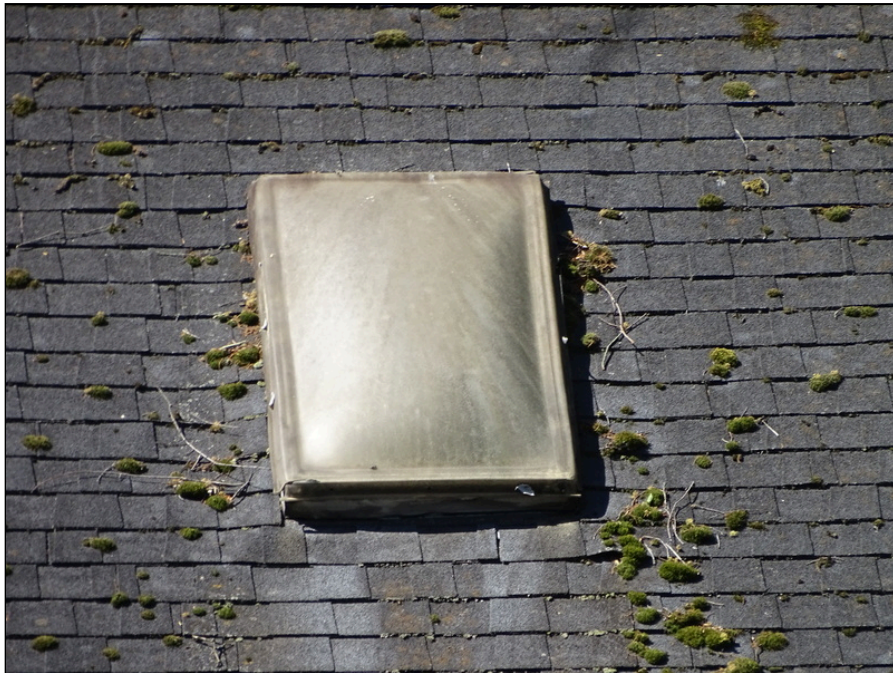
42 - Typical skylight at studio area

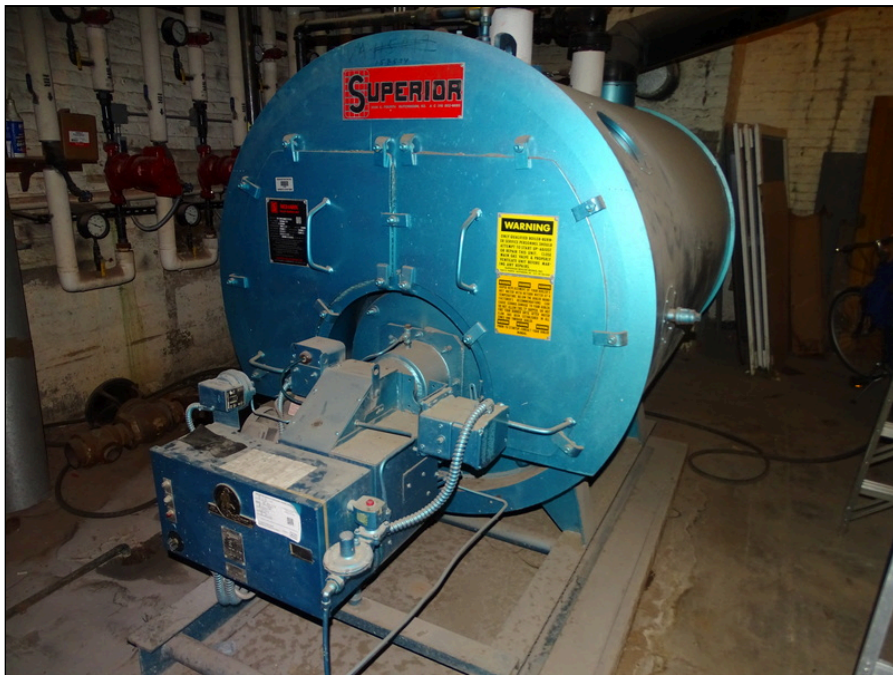
44 - Boiler system located in main utility room

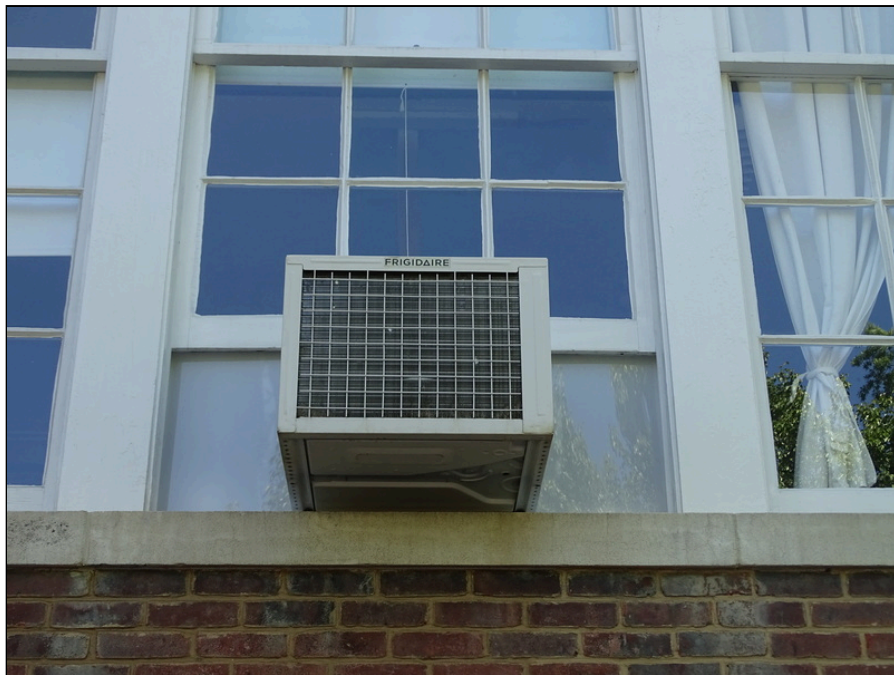
46 - Typical window air conditioning unit

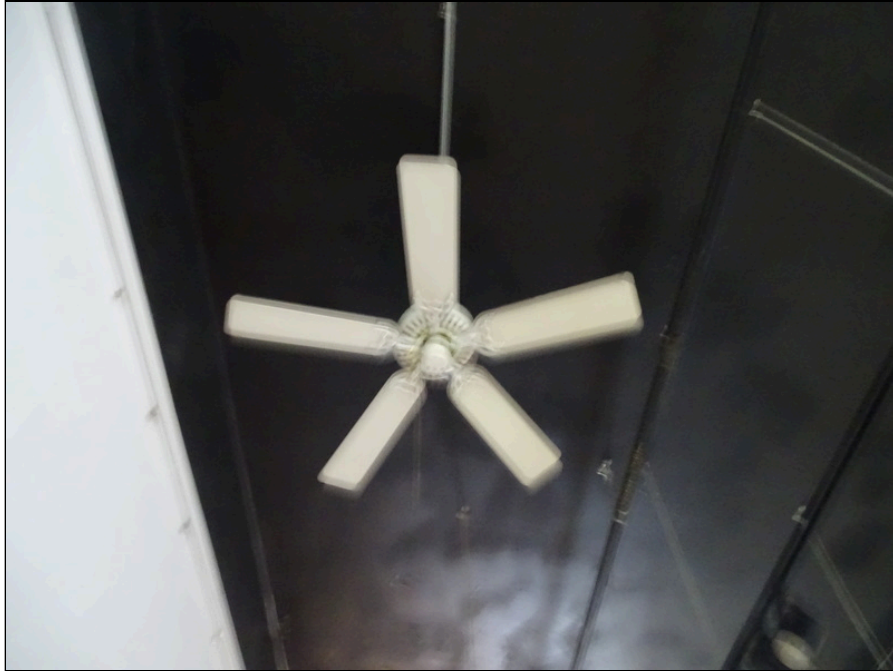
47 - Typical ceiling fan

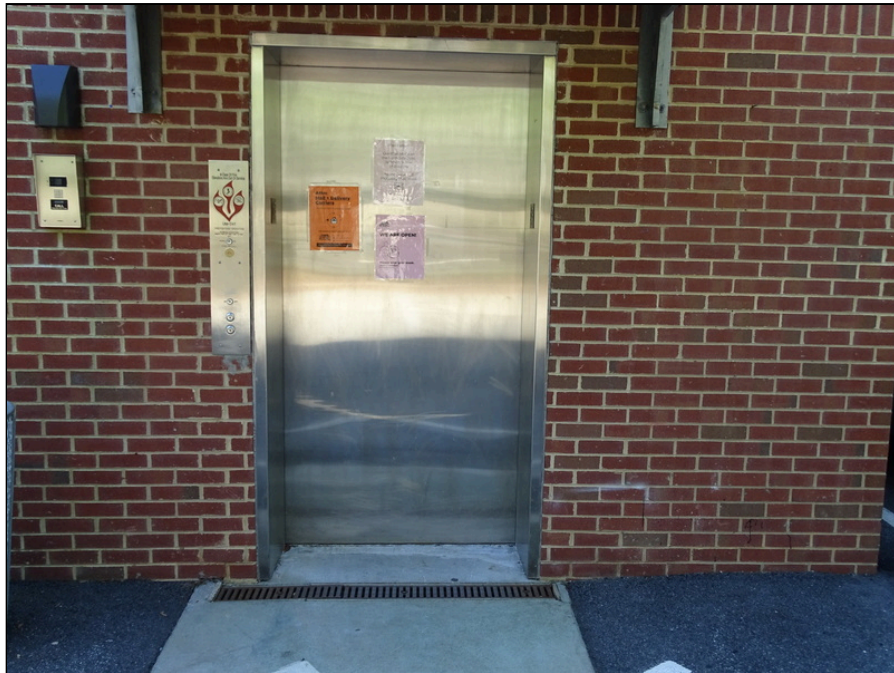
52 - Elevator at ground level

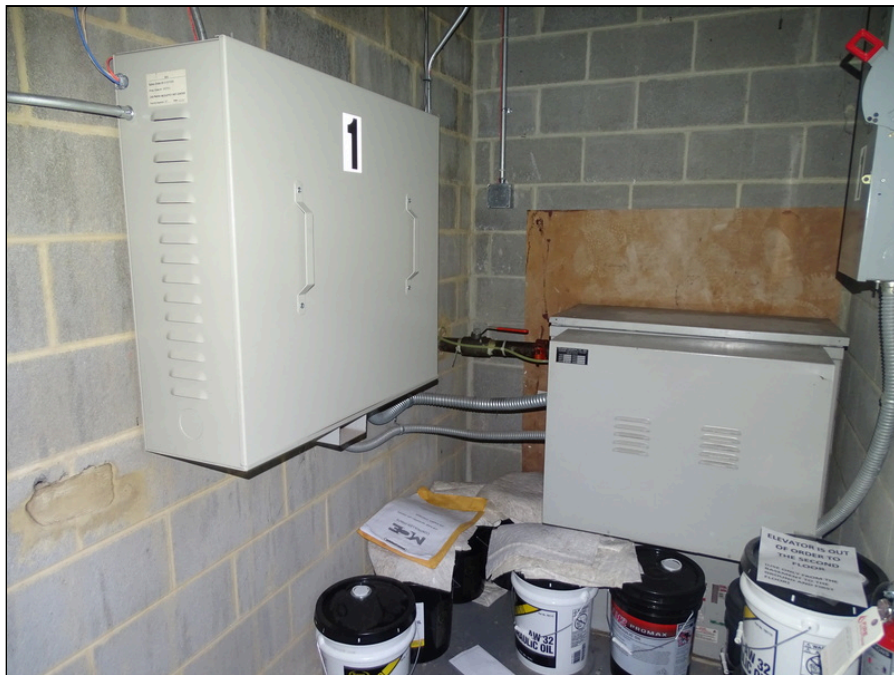
54 - Elevator machinery and controls

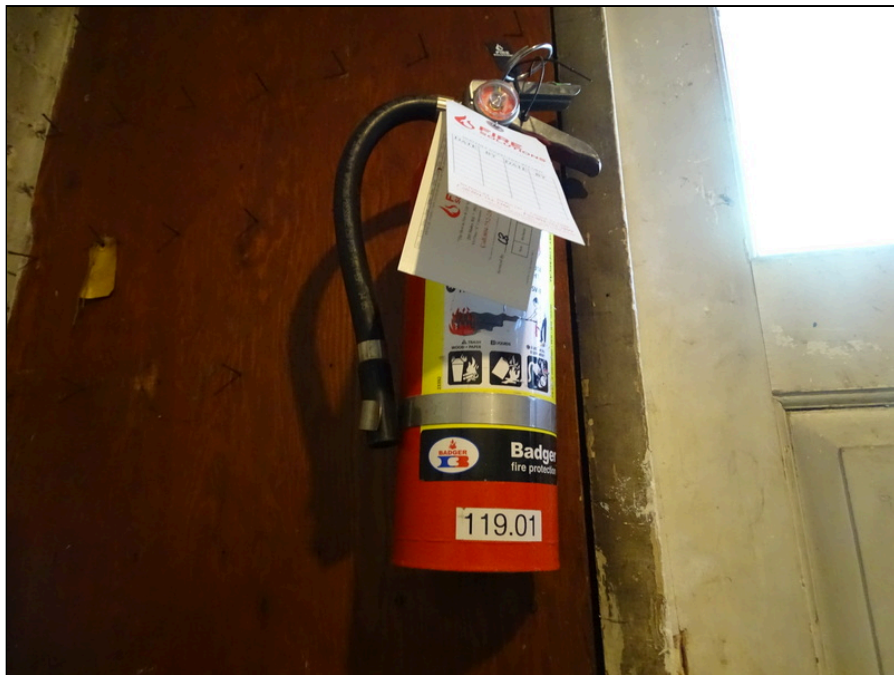
56 - Typical fire extinguisher

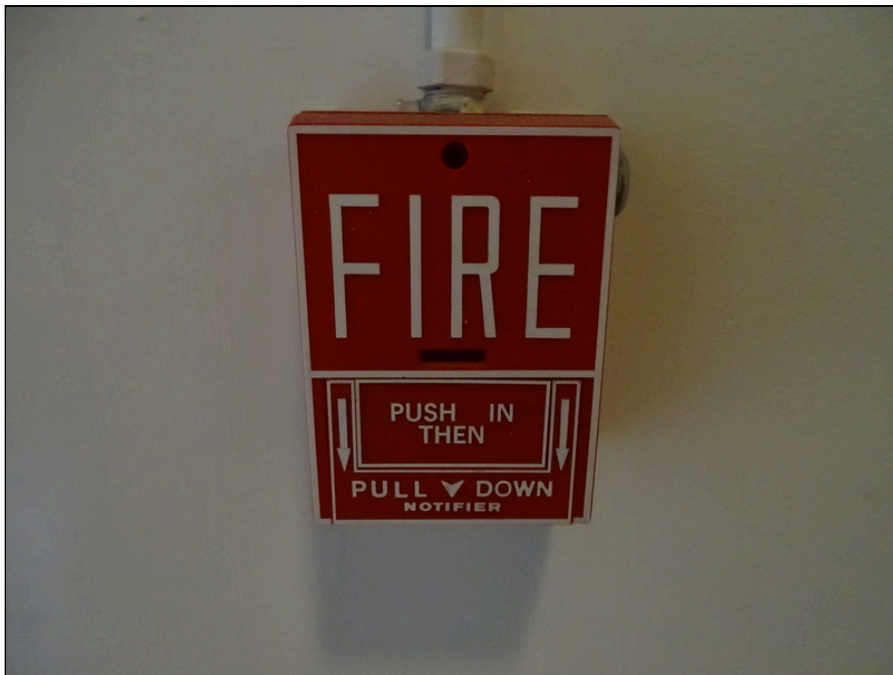
60 - Typical fire alarm pull down station
