MCINTIRE BUILDING
200 2ND STREET NE
CHARLOTTESVILLE, VIRGINIA

ECS PROJECT NO. 46:6713

CITY OF CHARLOTTESVILLE - FACILITIES DEVELOPMENT

Reference: Facility Condition Assessment Report for McIntire Building, 200 2nd Street NE,
Charlottesville, Virginia

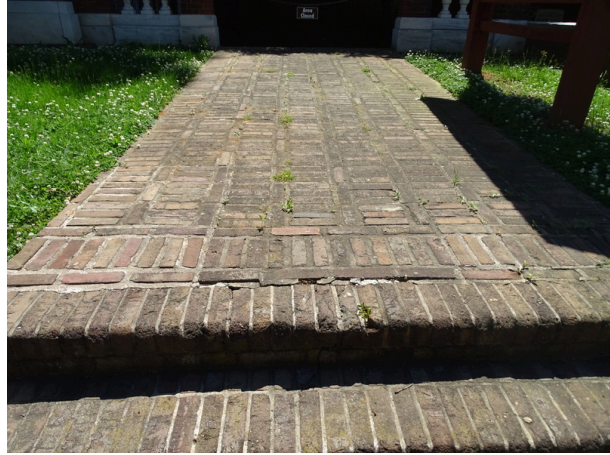
Brick pavers and steps at southwest end of site -
note Deterioration

Cost Recommendation	EUL	EFF AGE	RUL	Year	Cost
POINT UP BRICK PAVER AREAS	20	19	1	1	\$2,500
				5	\$2,500
				10	\$2,500
Total					\$7,500

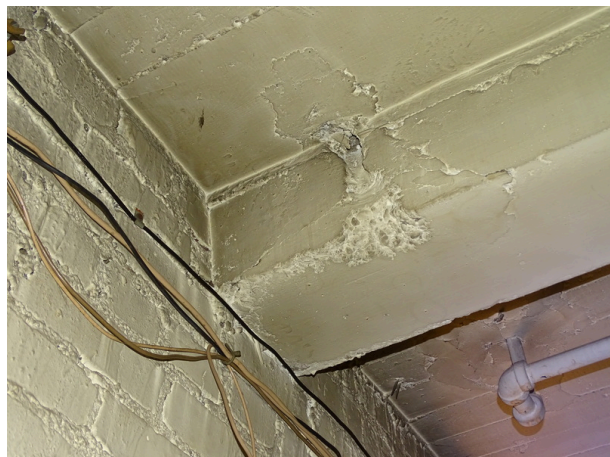
Structure framing - note deterioration

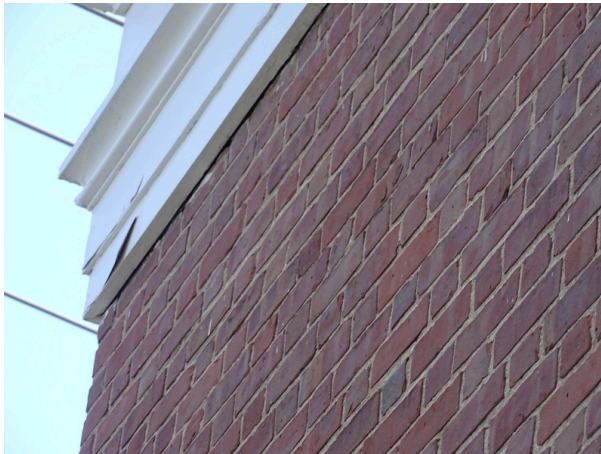
Building exterior - note some deterioration of mortar

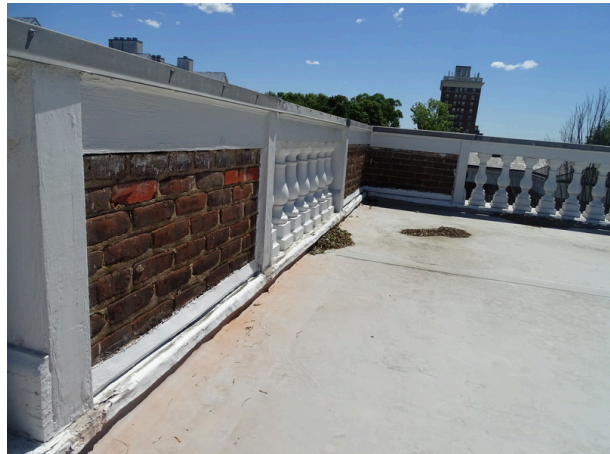
Roofing system - note needed maintenance

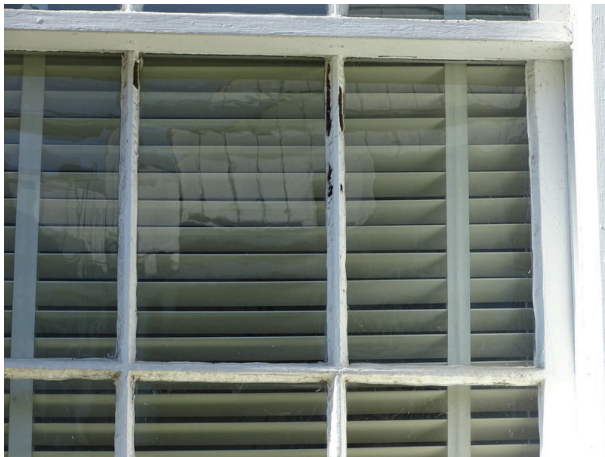
Typical exterior window - note deterioration

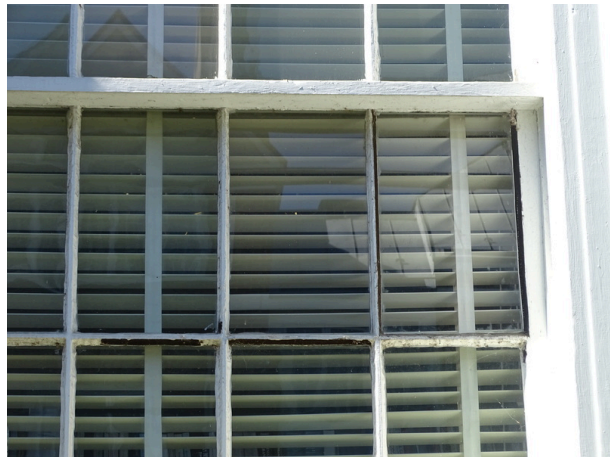
Typical exterior window - note deterioration

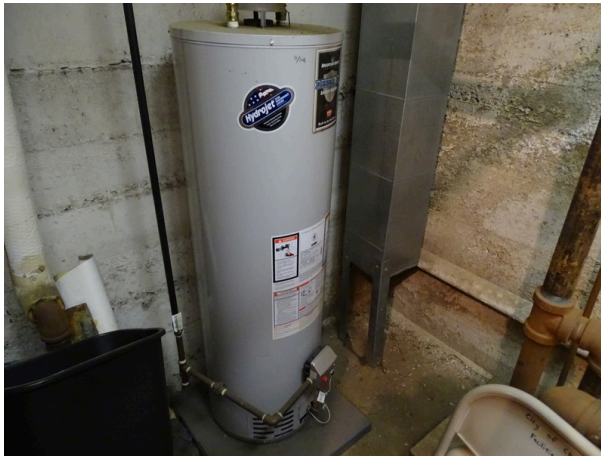
Domestic hot water to the building is provided by a Gas water heater located in the basement. The Gas water heater was manufactured by Bradford-White in 2016. The expected useful life of a Gas water heater is approximately 12 to 15 years. We recommend the Gas water heater be replaced during the report period.

Domestic water heater

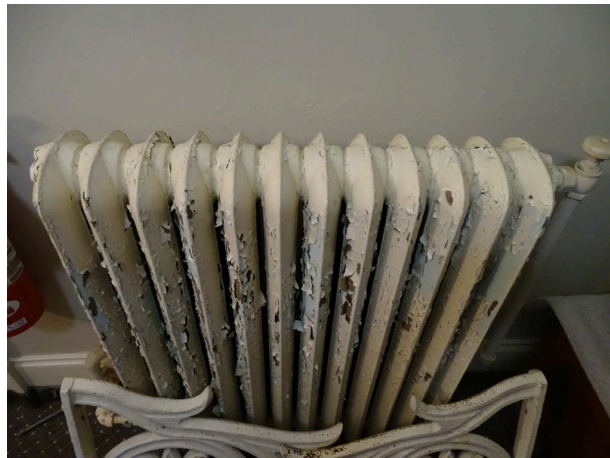
Typical radiator - note deterioration

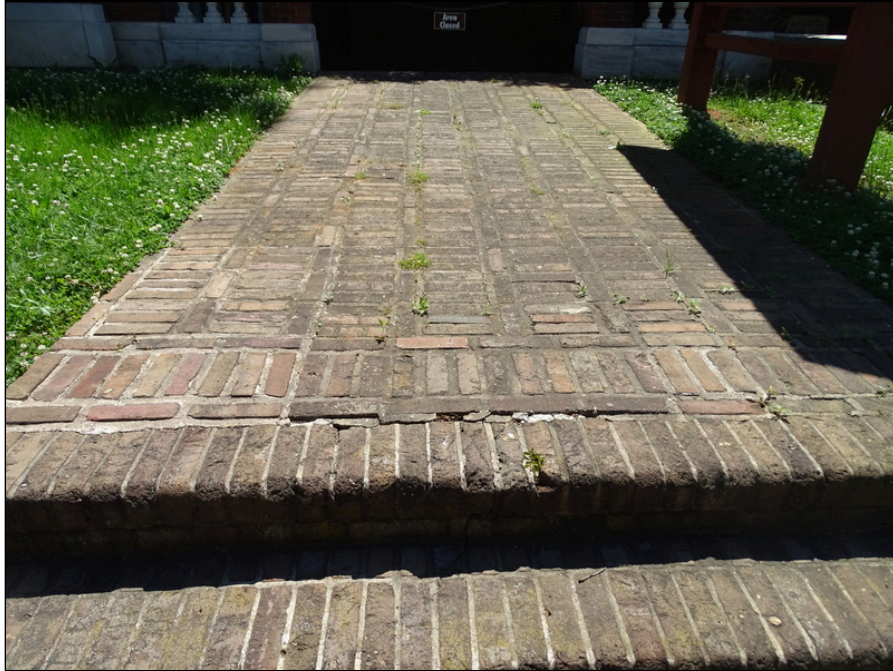
5 - Brick pavers and steps at southwest end of site - note Deterioration

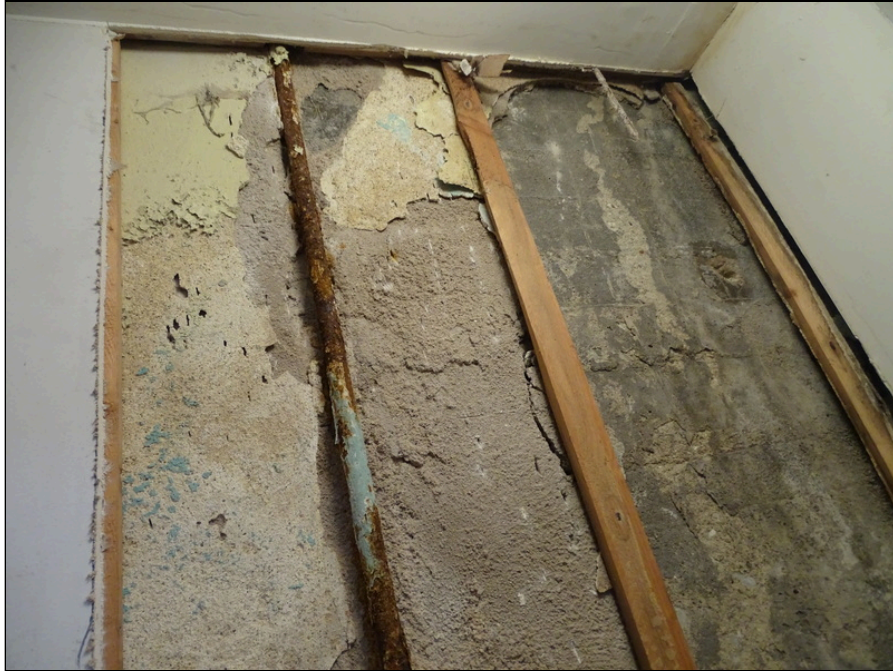
21 - Structure framing - note deterioration

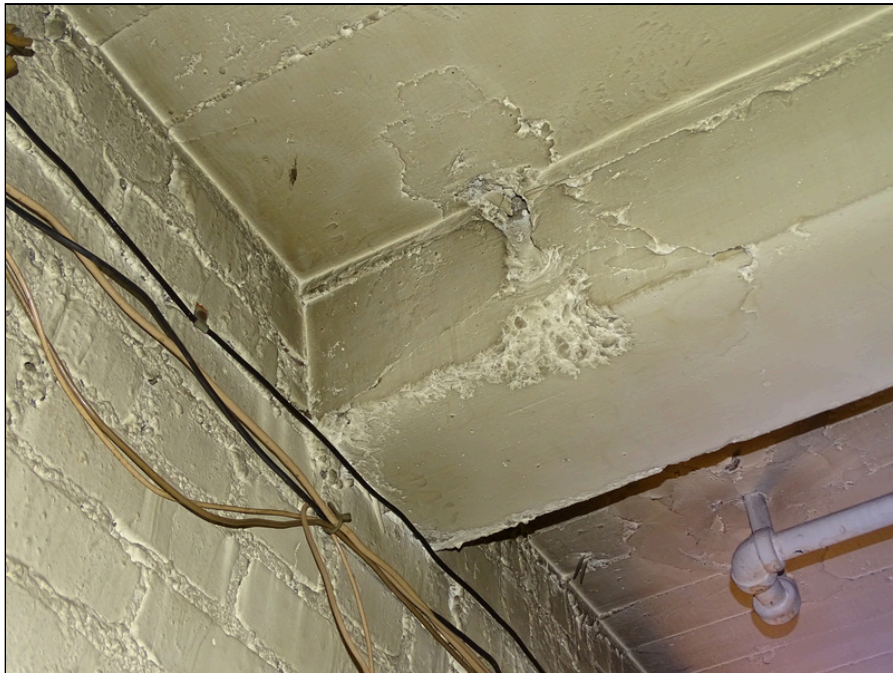
22 - Structure framing - note deterioration

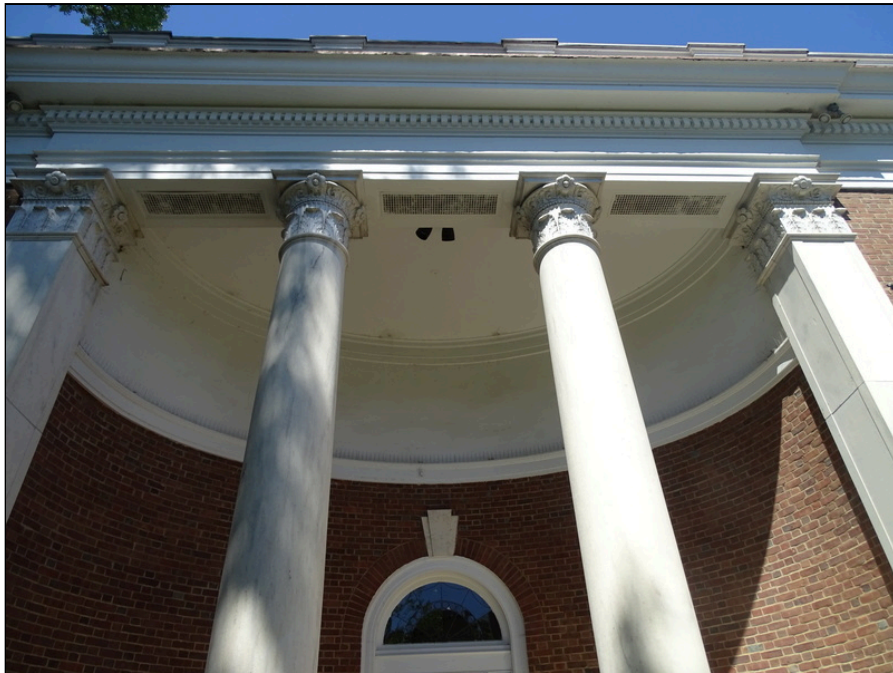
24 - Exterior wall and column - note need of maintenance

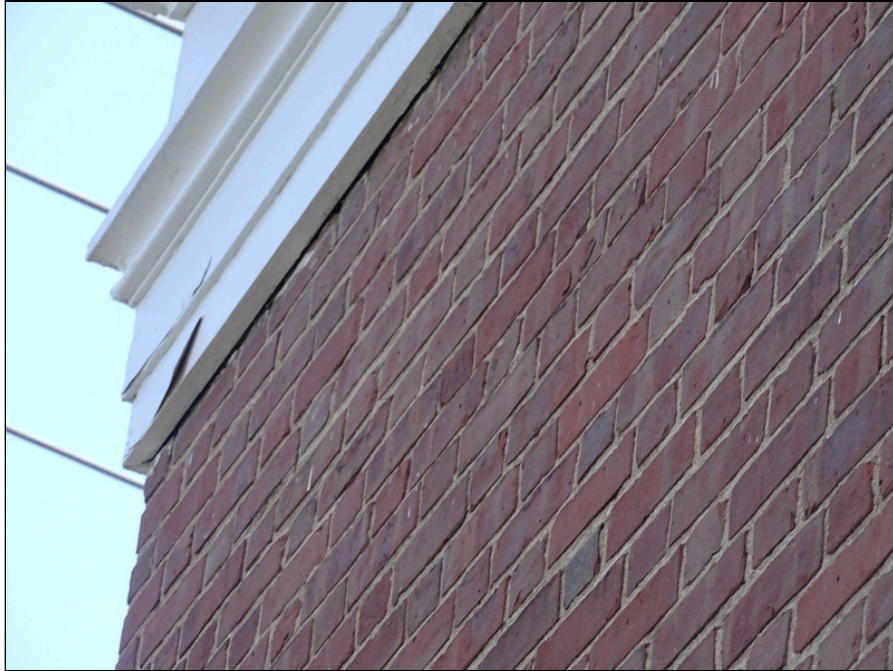
25 - Building exterior - note some deterioration of mortar

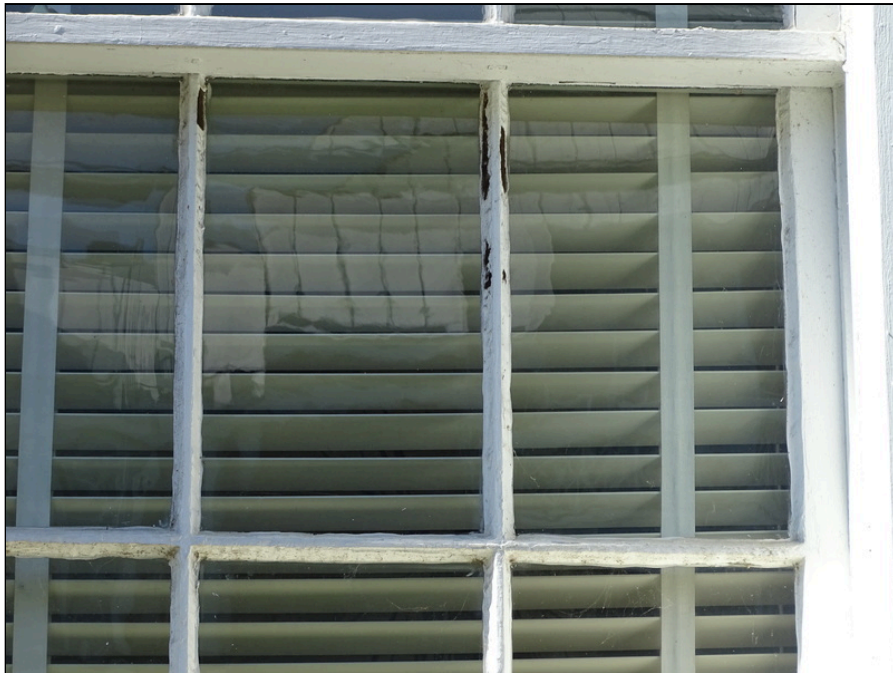
30 - Typical exterior window - note deterioration

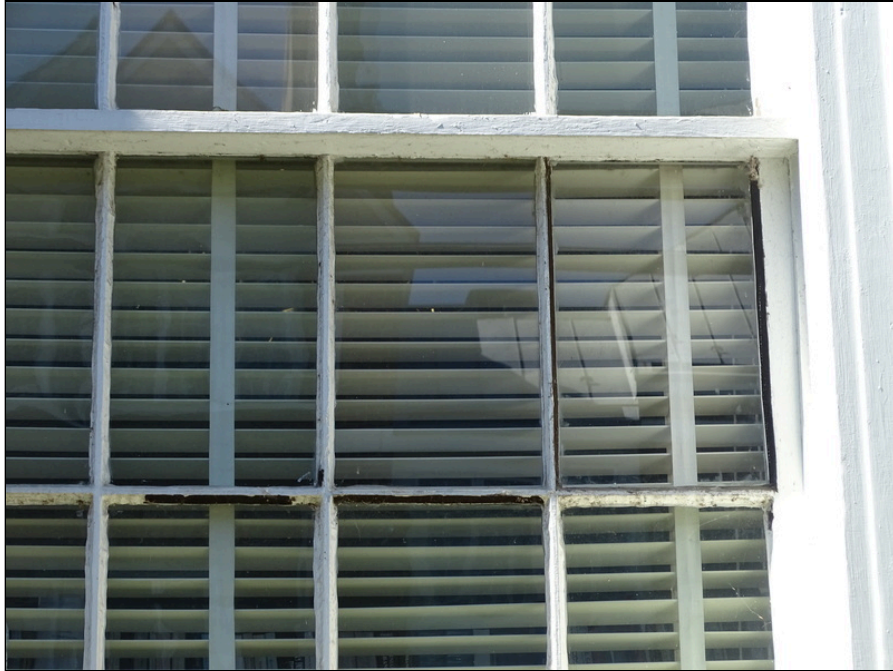
31 - Typical exterior window - note deterioration

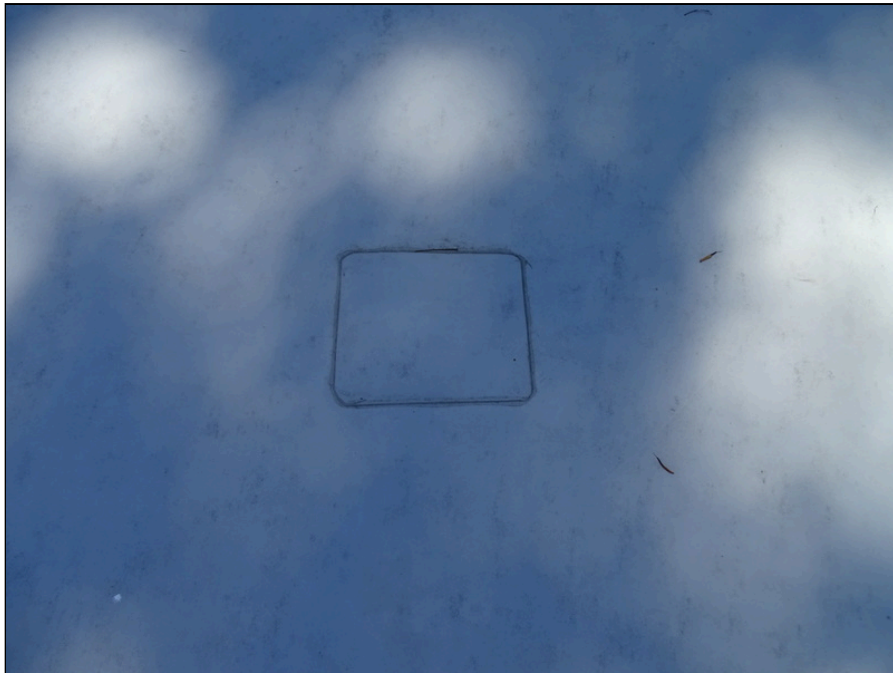
36 - Roofing system - note patching

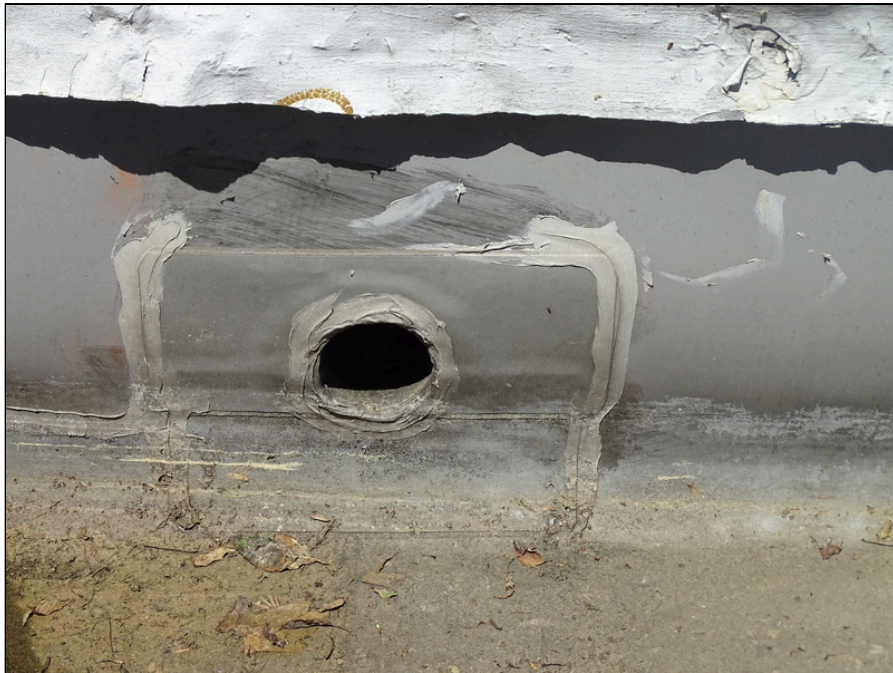
40 - Parapet wall and through wall drain - note patching

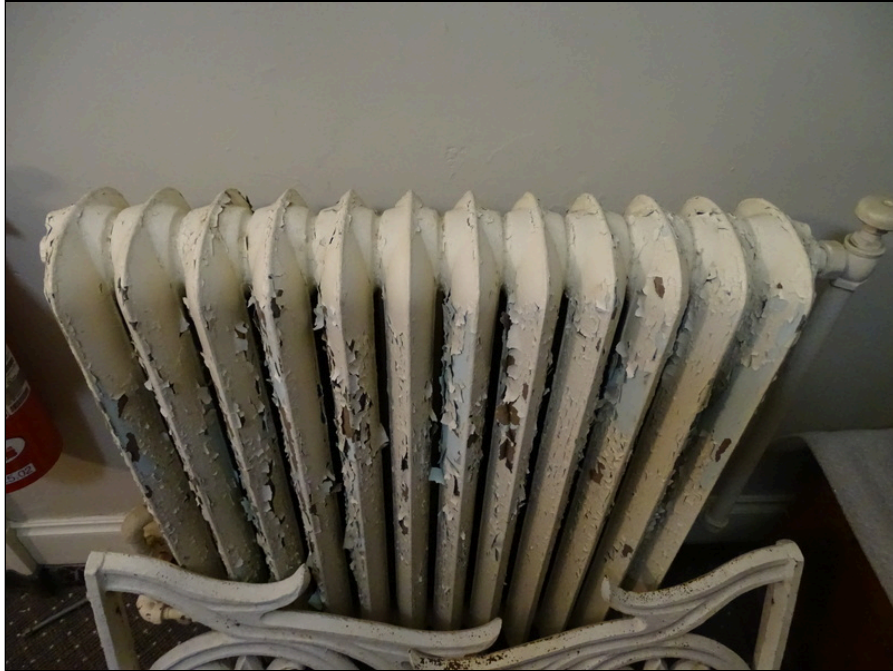
55 - Typical radiator - note deterioration
