MEADE PARK BATH HOUSE AND MECHANICAL BUILDING
300 MEADE AVENUE
CHARLOTTESVILLE, VIRGINIA

ECS PROJECT NO. 46:6713

CITY OF CHARLOTTESVILLE - FACILITIES DEVELOPMENT

Reference: Facility Condition Assessment Report for Meade Park Bath House and Mechanical Building, 300 Meade Avenue, Charlottesville, Virginia

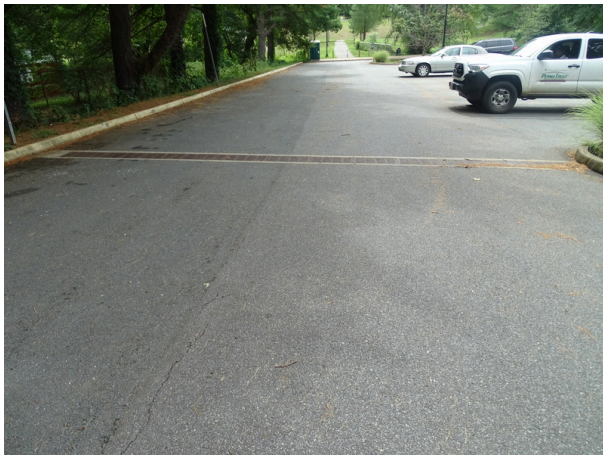
Stormwater drainage and asphalt pavement - note cracking

The expected useful life of asphalt pavement is 20 years. We recommend repairing areas of asphalt pavement on an as-needed basis and have provided an allowance to overlay the asphalt pavement later in the report period.

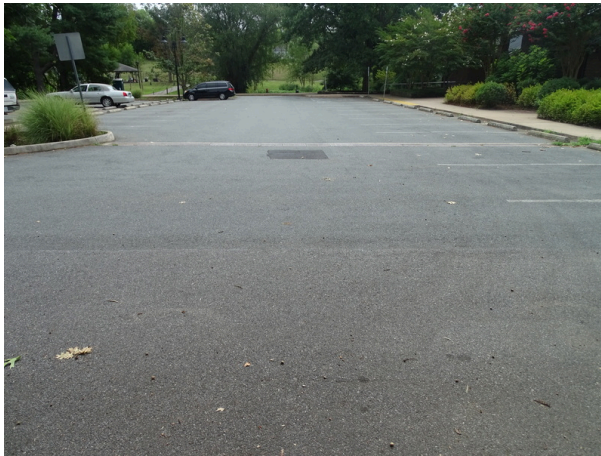
Asphalt pavement and parking - note striping faded

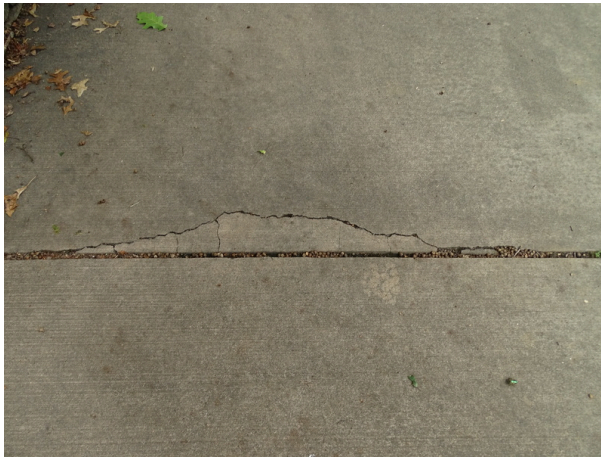
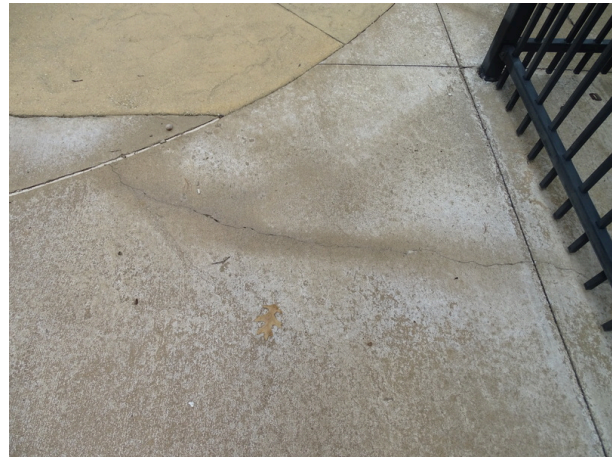
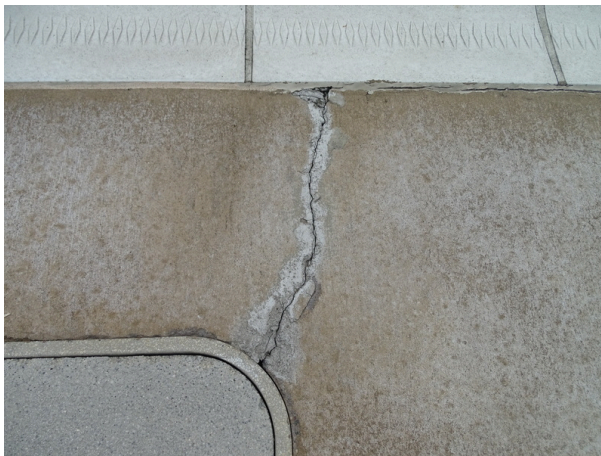
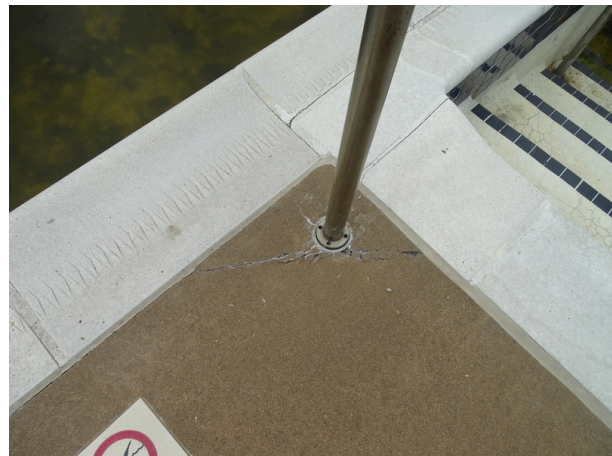
Typical concrete sidewalk - note cracking

3.2.5 Flatwork																														
REPLACE CONCRETE SIDEWALK	25	20	5	1	LS	\$10,000.00	\$10,000	100%					\$2,500					\$2,500					\$2,500					\$2,500	\$10,000

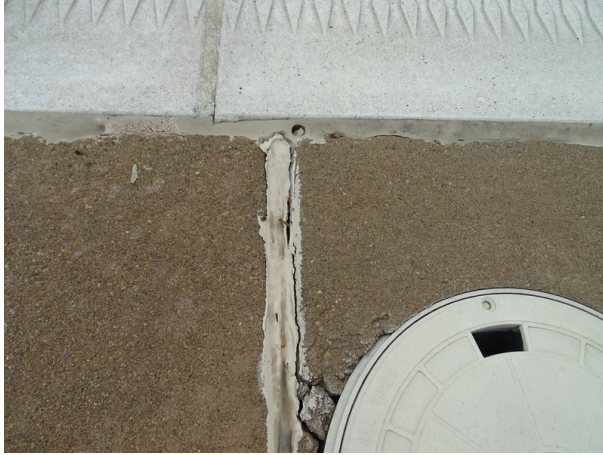
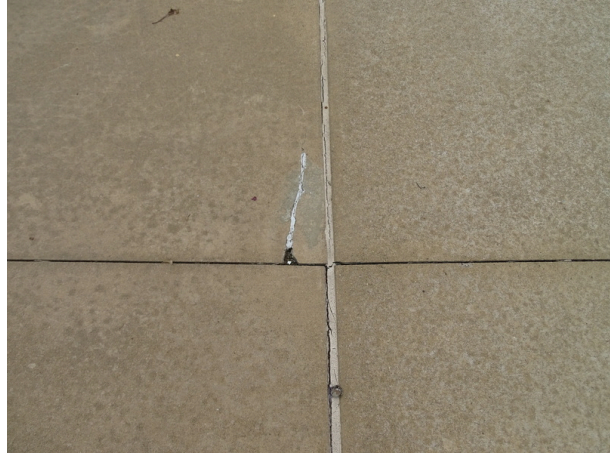
Deteriorated pool deck sealant

3.2.7 Recreational Facilities																														
REPLACE SEALANTS IN POOL DECK	12	11	1	1	LS	\$10,000.00	\$10,000	200%	\$10,000											\$10,000									\$20,000	
REPAIR POOL LINER AS NEEDED	8	7	1	1	LS	\$10,000.00	\$10,000	300%	\$10,000							\$10,000								\$10,000					\$30,000	
REPLACE WOOD TRELLIS	20	13	7	1	LS	\$10,000.00	\$10,000	100%						\$10,000															\$10,000

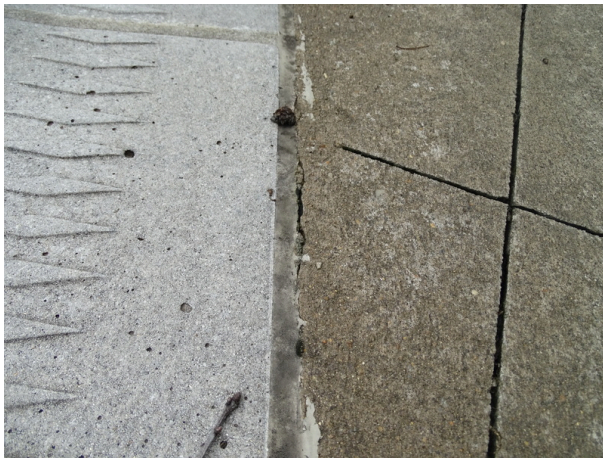
Pool deck - note cracking

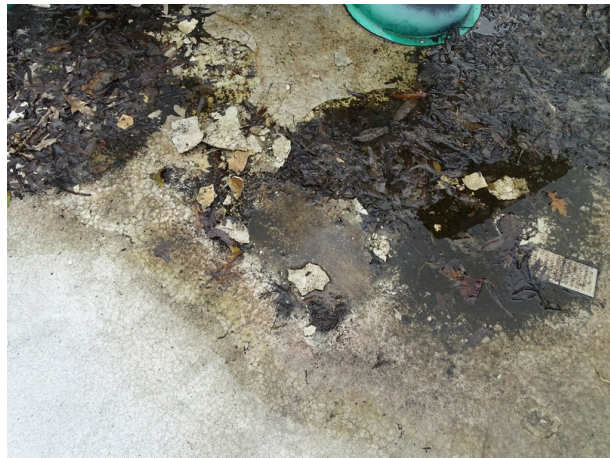
Pool liner deterioration

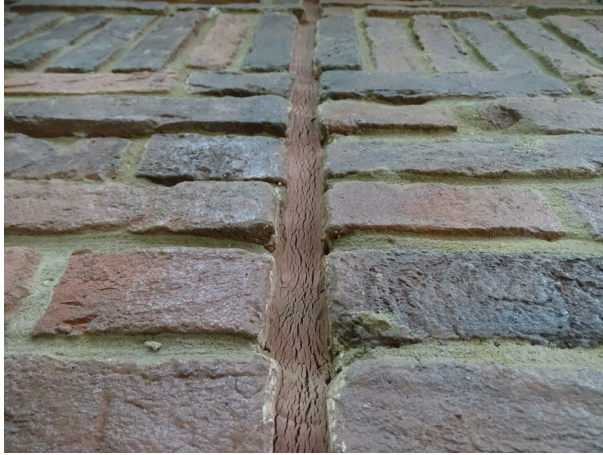
Typical exterior building - note vertical sealant deterioration

3.3.3 Building Exteriors																														
REPOINT BRICKWORK	20	8	12	1	LS	\$15,000.00	\$15,000	100%											\$15,000										\$15,000	
REPLACE EXTERIOR SEALANTS	12	11	1	2	LS	\$5,000.00	\$10,000	100%	\$5,000											\$5,000									\$10,000

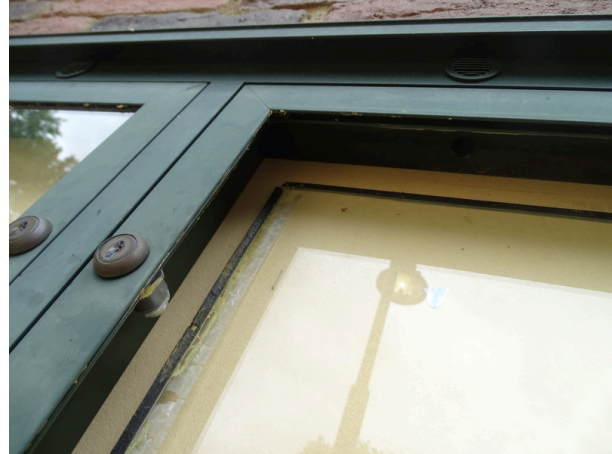
Two exterior display cabinets with glass inserts were installed on the south wall of the bath house. One of the glass panels was broken out. We recommend replacing this glass panel.

Exterior display - note broken glass

3.3.5 Exterior Windows																														
REPLACE DAMAGED GLASS				1	EA	\$1,000.00	\$1,000	100%	\$1,000																				\$1,000	
3.3.6 Roofing Systems

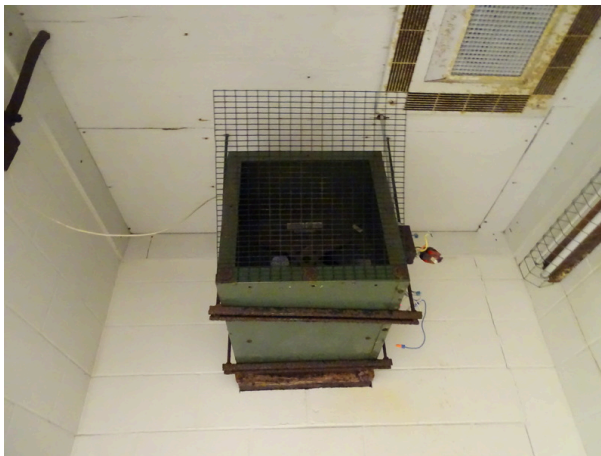
Typical space heater - note deterioration

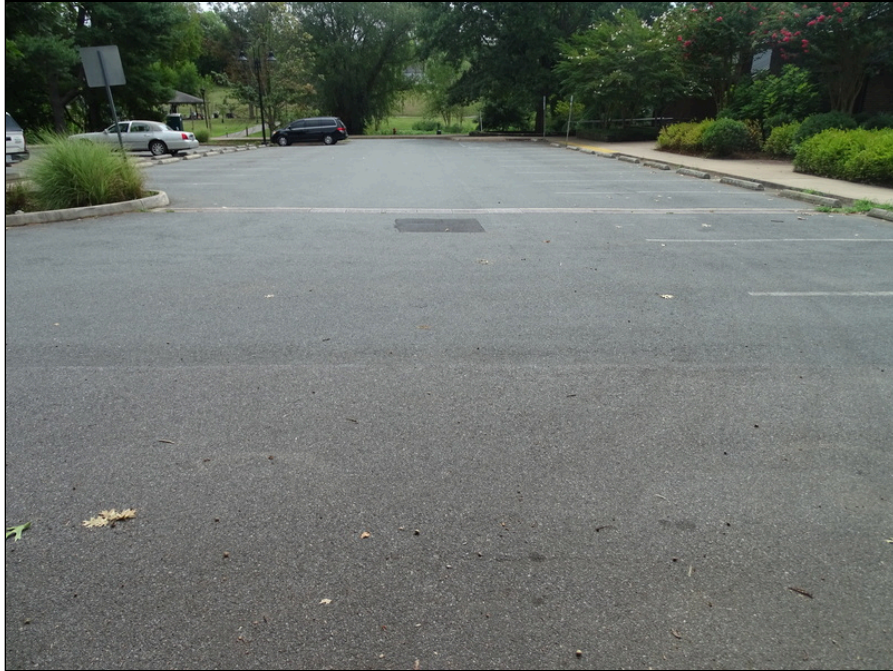
3 - Asphalt pavement and parking - note stripping faded

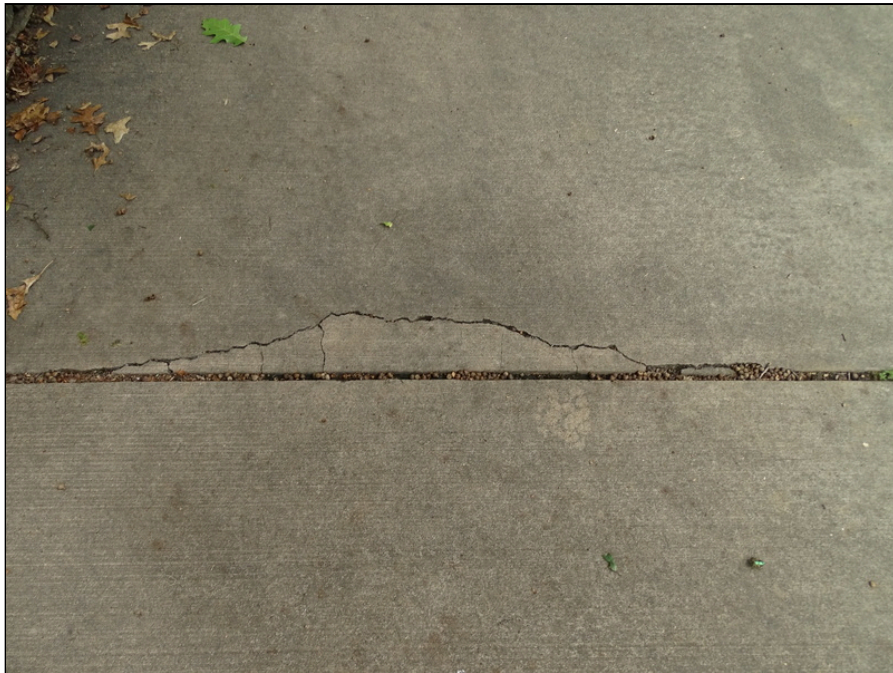
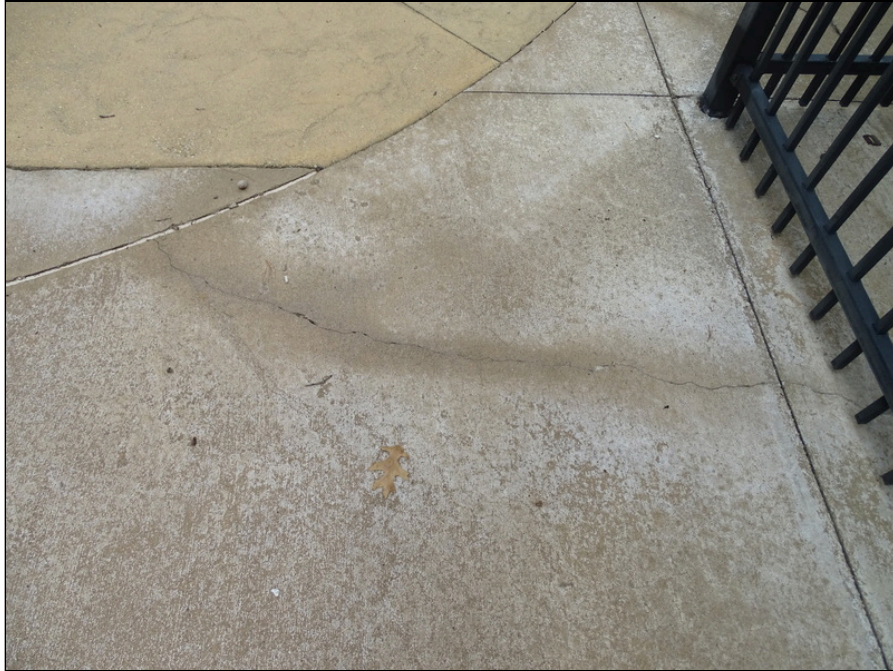
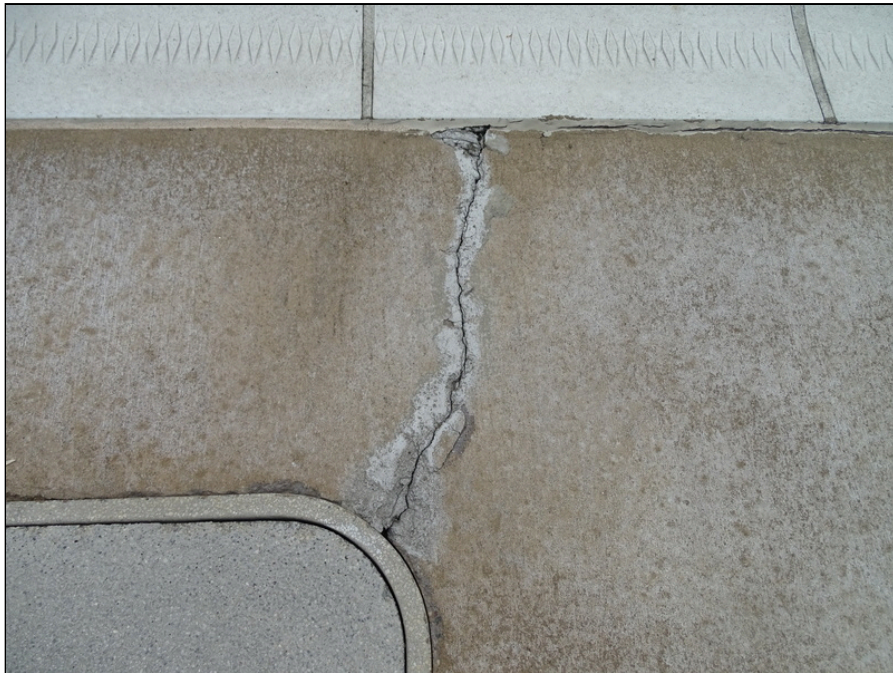
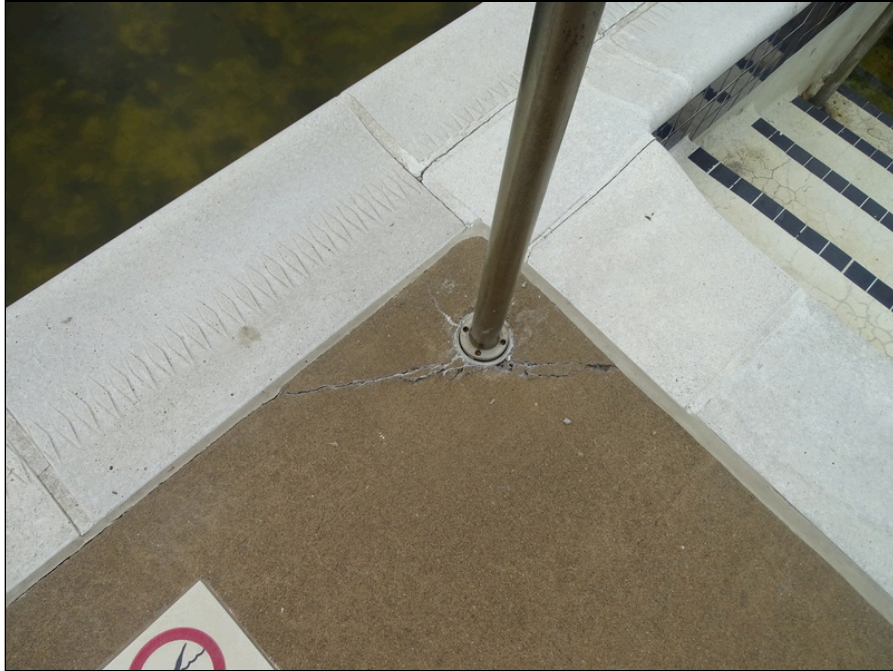
6 - Typical concrete sidewalk - note cracking

7 - Typical concrete sidewalk - note cracking

8 - Typical concrete sidewalk - note cracking

9 - Typical concrete sidewalk - note cracking

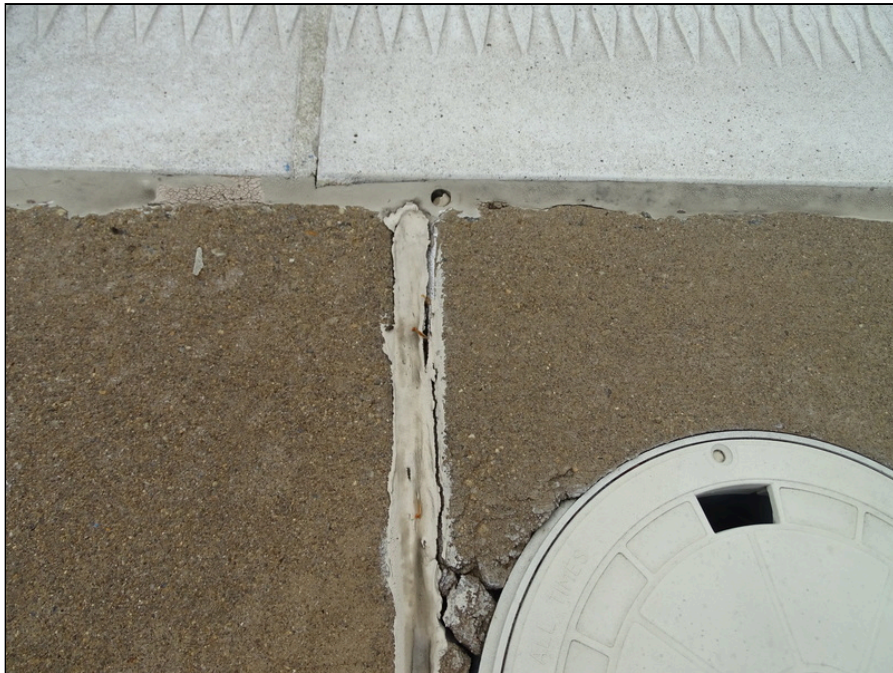
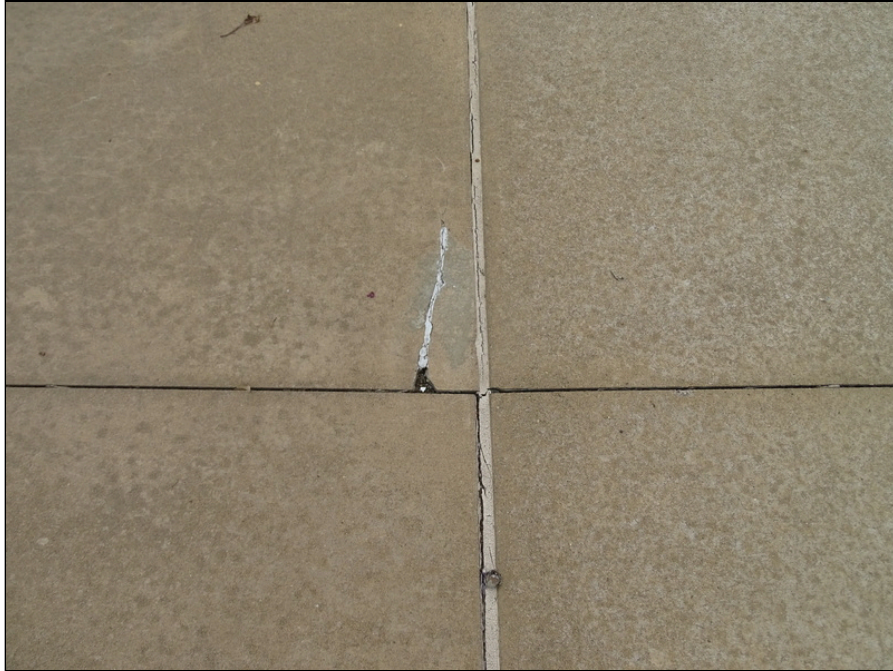
28 - Deteriorated pool deck sealant

29 - Deteriorated pool deck sealant

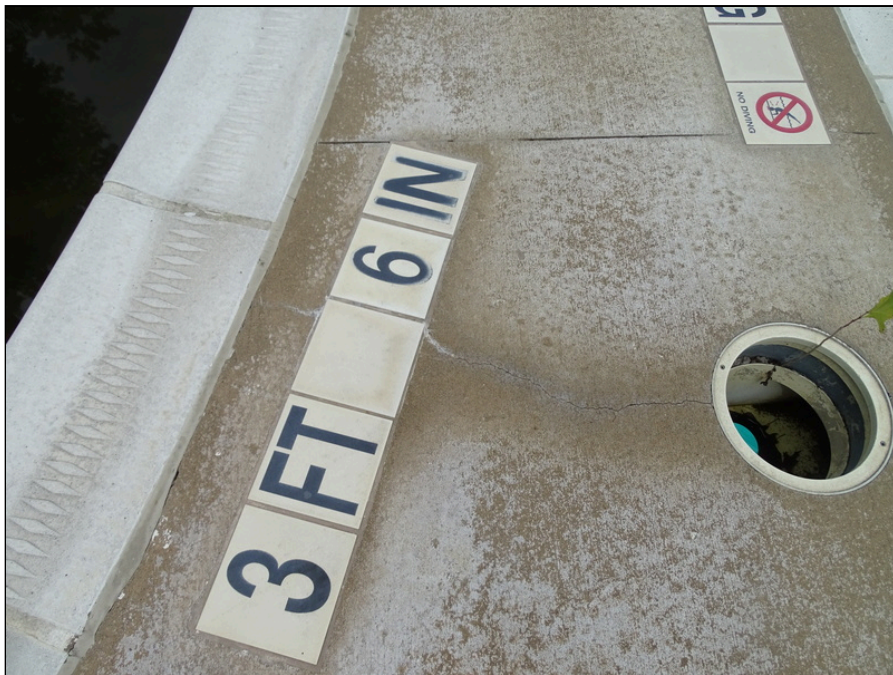
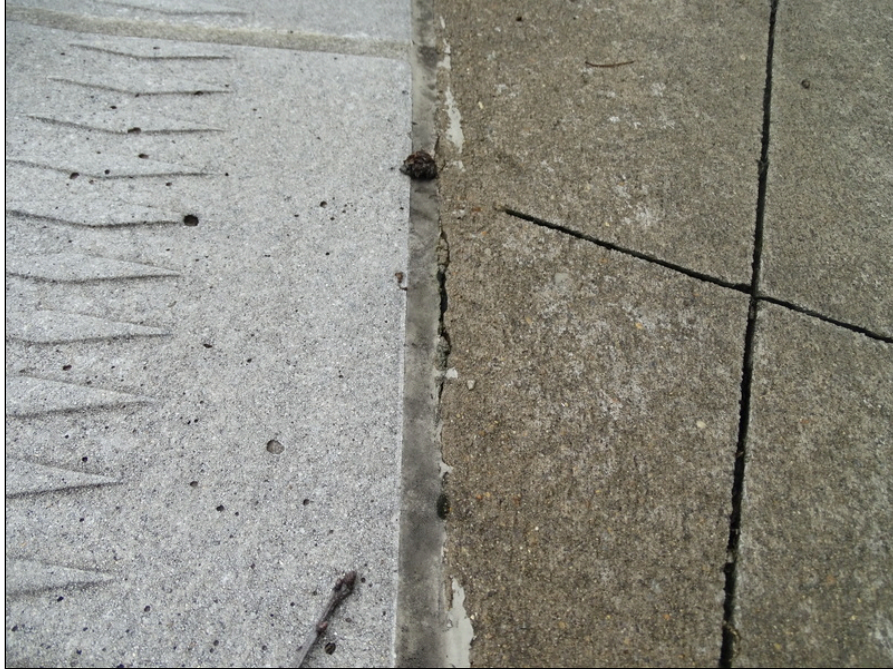
30 - Pool deck - note cracking

31 - Pool deck - note cracking

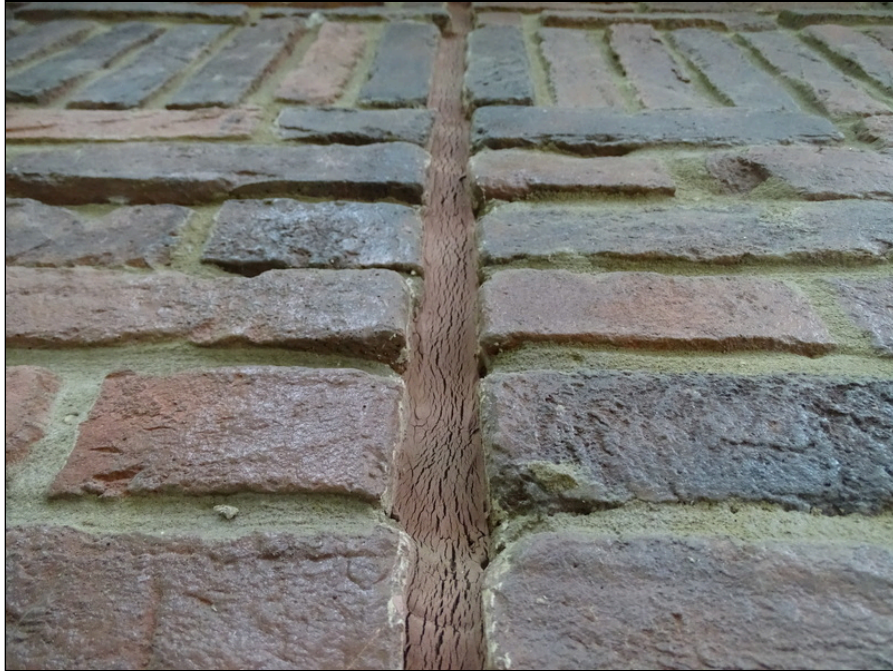
41 - Typical exterior building - note vertical sealant deterioration

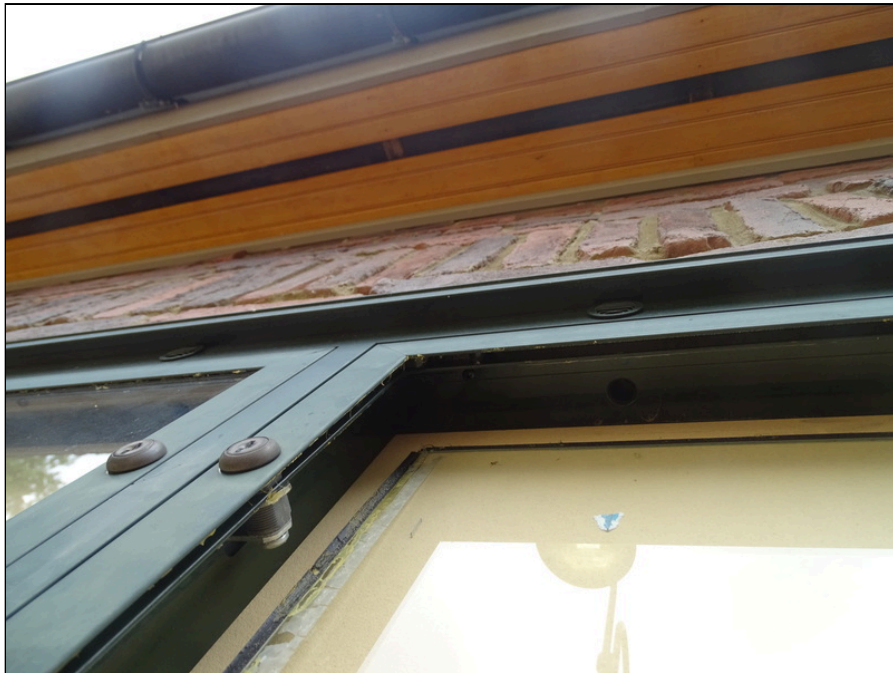
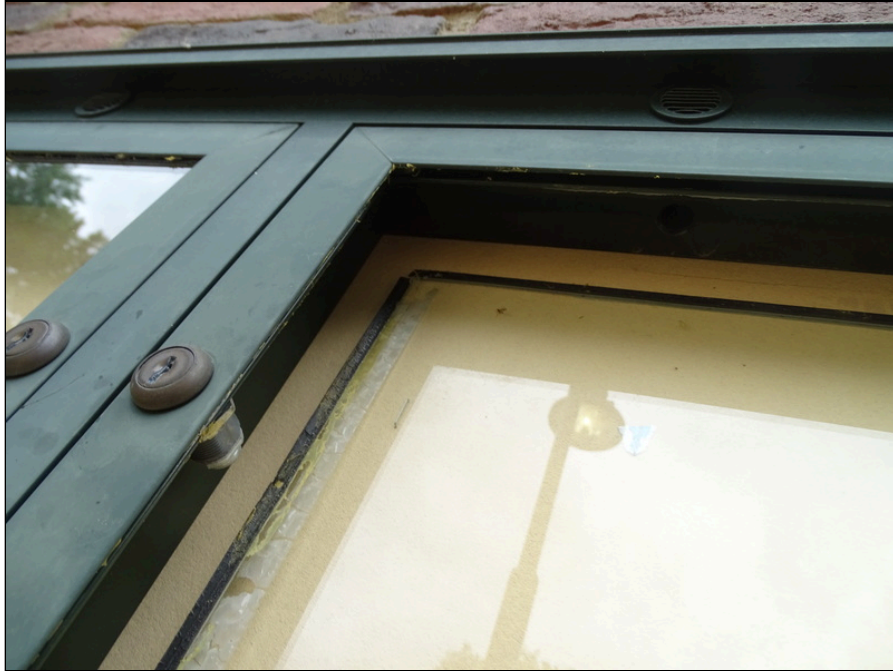
44 - Exterior display - note broken glass

45 - Exterior display - note broken glass

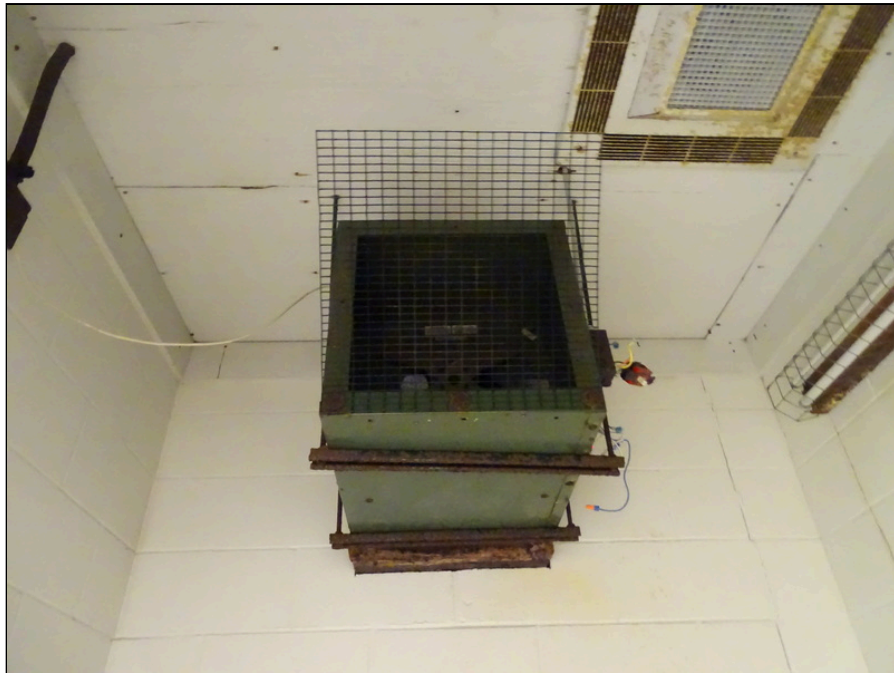
54 - Typical space heater - note deterioration

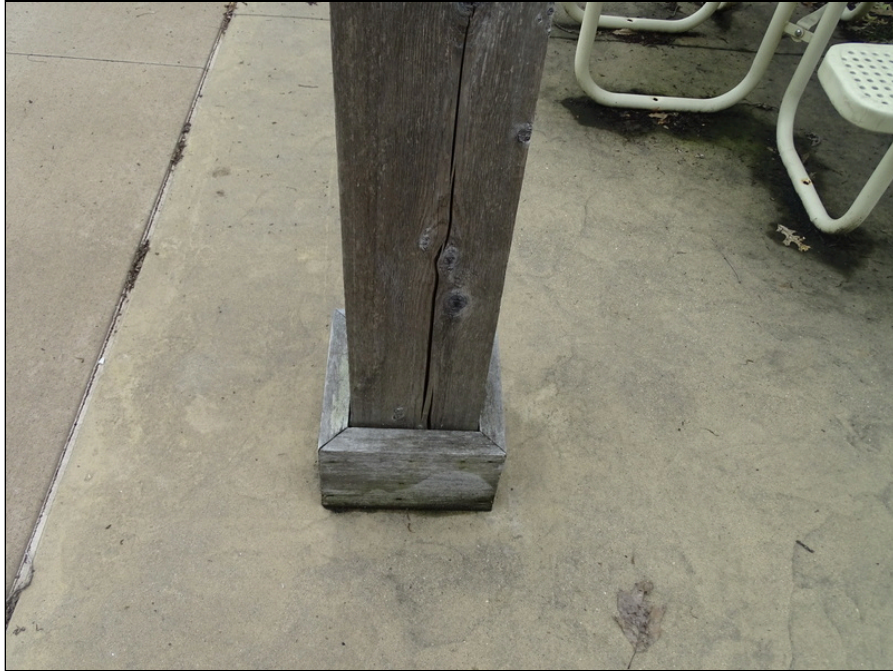
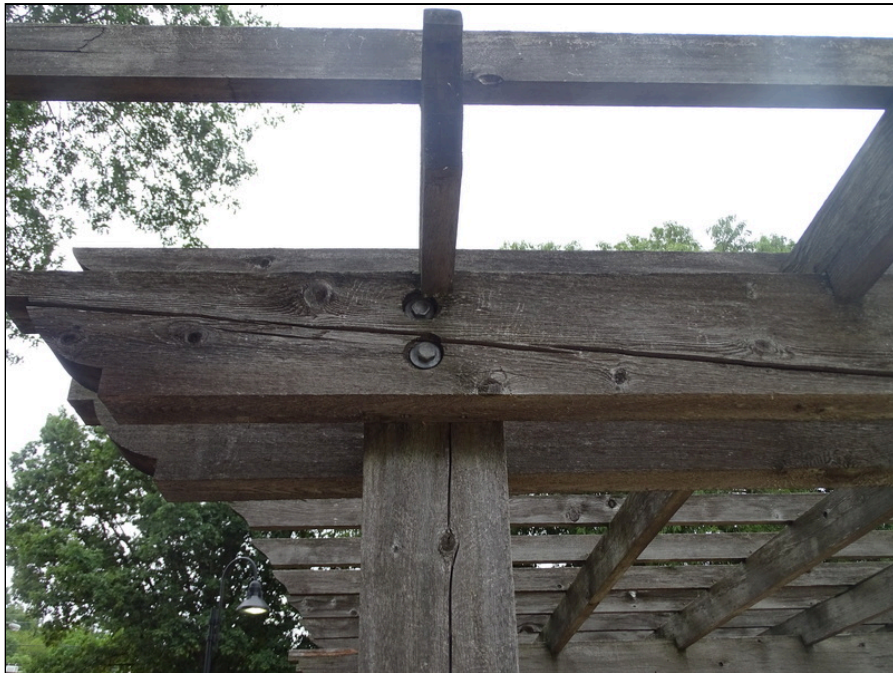
A wood trellis was located on the southwest side of the pool deck. The wood trellis was showing signs of weathering and cracking. We recommend the wood trellis to be replaced later in the report period.

79 - Wood trellis post - note deterioration

80 - Wood trellis - note weathering

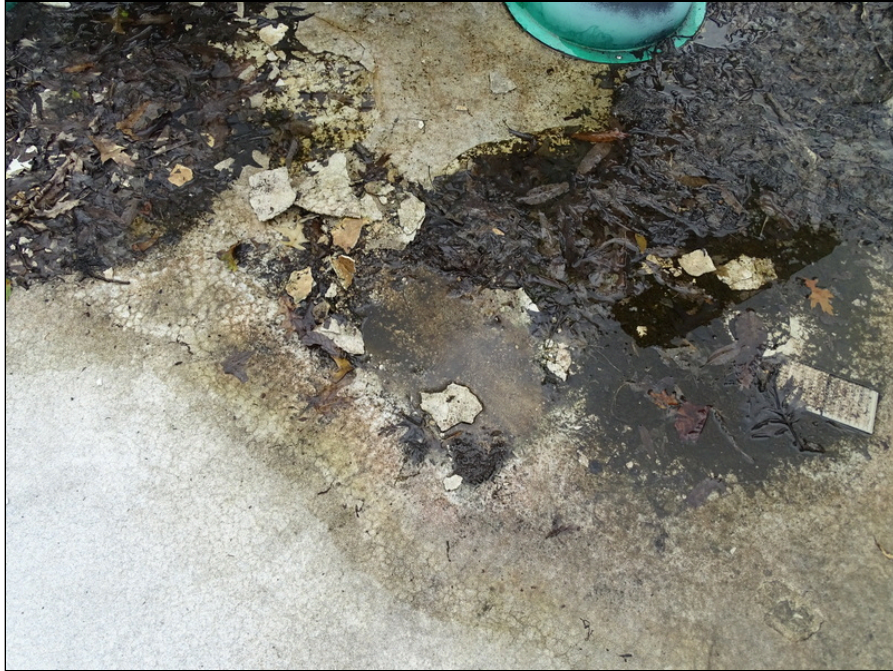
81 - Pool liner deterioration

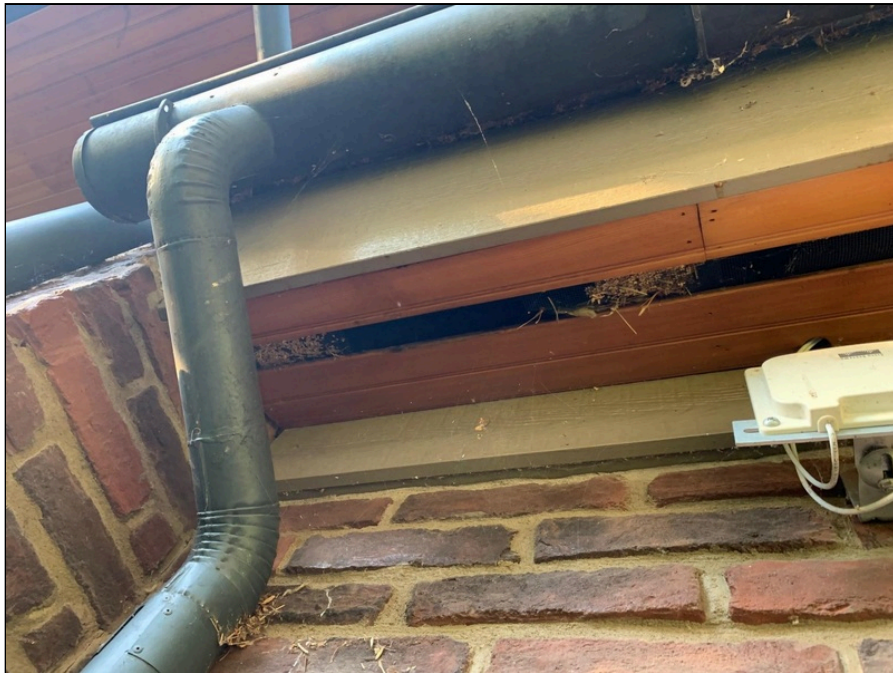
Squirrel nests were observed in the soffit vent of the building. We recommend removing the squirrels and nesting material and installing screening over the soffit vent as a maintenance item.

82 - Soffit Squirrel Nesting
