MEADOWCREEK GOLF COMPLEX  
1400 PEN PARK ROAD  
CHARLOTTESVILLE, VIRGINIA

ECS PROJECT NO. 46:6713

CITY OF CHARLOTTESVILLE - FACILITIES DEVELOPMENT

Reference: Facility Condition Assessment Report for Meadowcreek Golf Complex, 1400 Pen Park Road, Charlottesville, Virginia

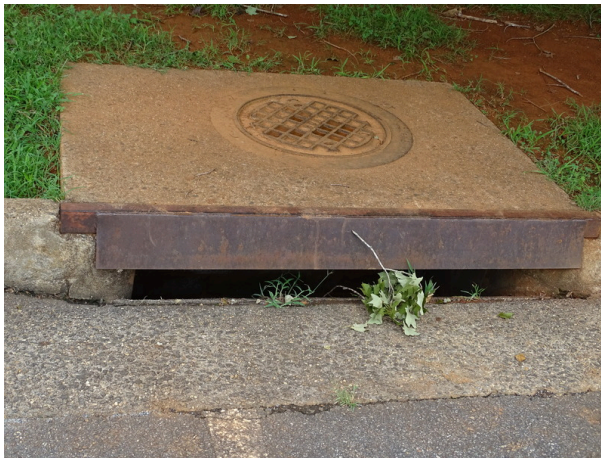
Stormwater drainage at parking lot

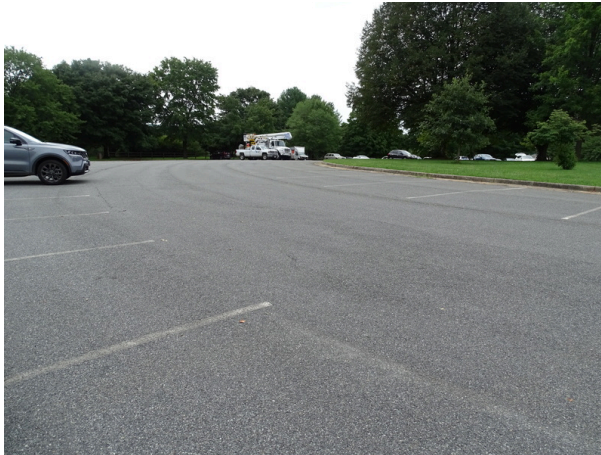
An asphalt-paved drive lane and parking are located on the north side of the site. Additional parking is provided further down Pen Park Road that is shared by the park. The asphalt pavement was observed to be in generally fair condition. We observed areas of cracking in the drive lanes and parking spaces. The line striping was cracked and faded. The expected useful life of asphalt pavement is 20 years. We recommend crack sealing areas of asphalt pavement and are providing an allowance to overlay the asphalt pavement later in the study period.

Faded striping and cracks in asphalt pavement

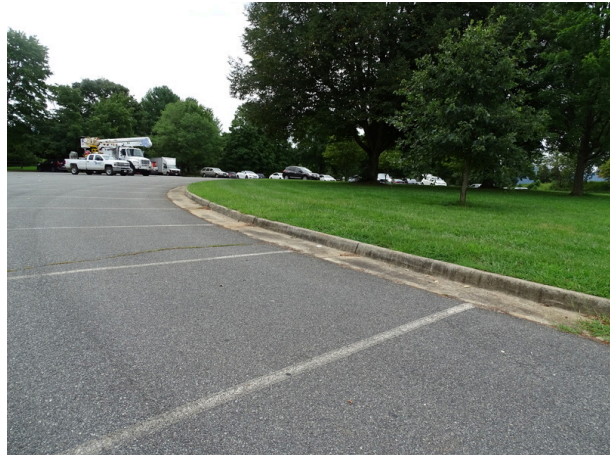
Faded striping and cracks in asphalt pavement

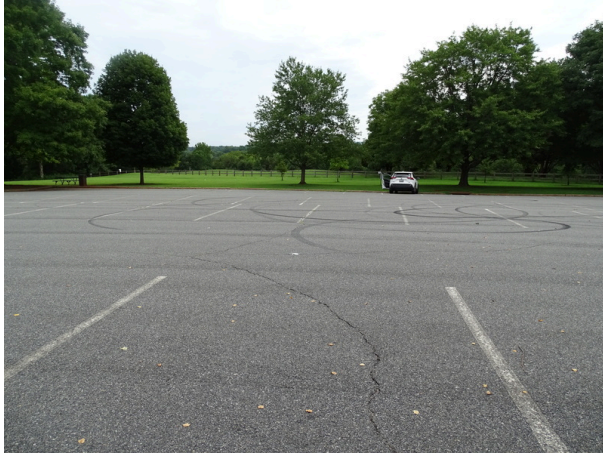
Faded striping and cracks in asphalt pavement

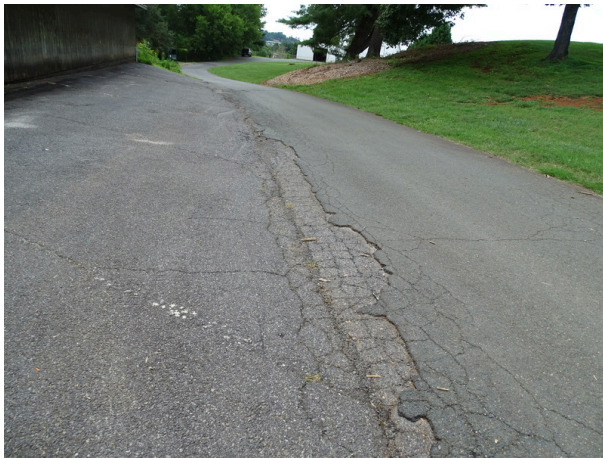
Golf cart shed side pavements - note asphalt deterioration

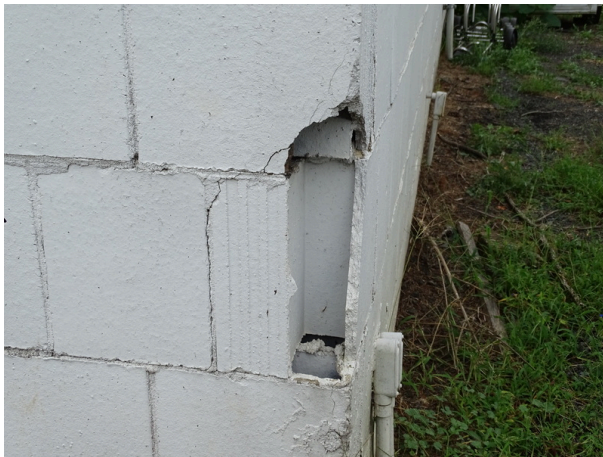
At the storage building, the glazed block mortar joints were observed to be cracked and deteriorated and damage to the block was noted on one corner. We recommend this block be repaired and the mortar joints repointed.

Storage building - note wall deterioration

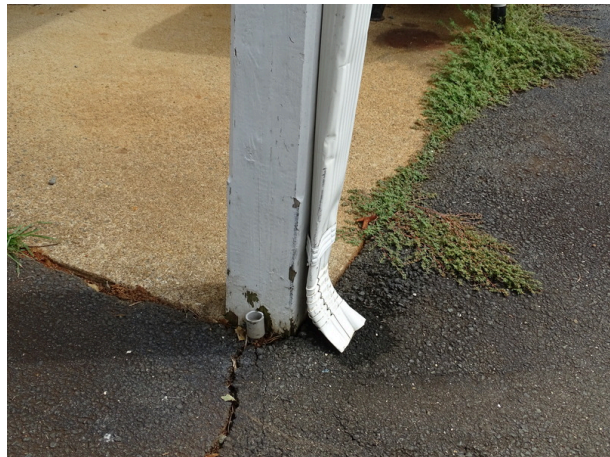
Clubhouse downspout - note damaged

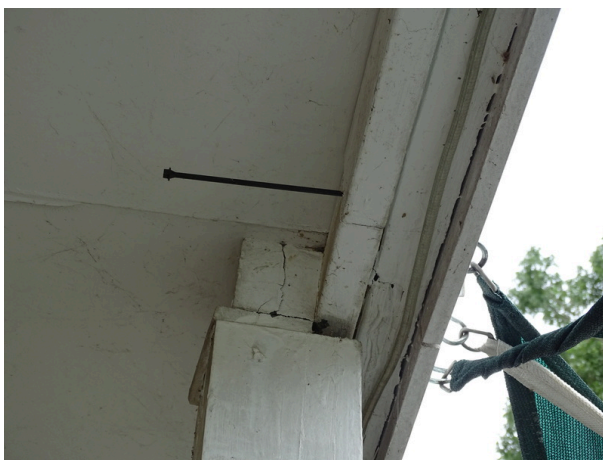
Clubhouse wood column rotten at top

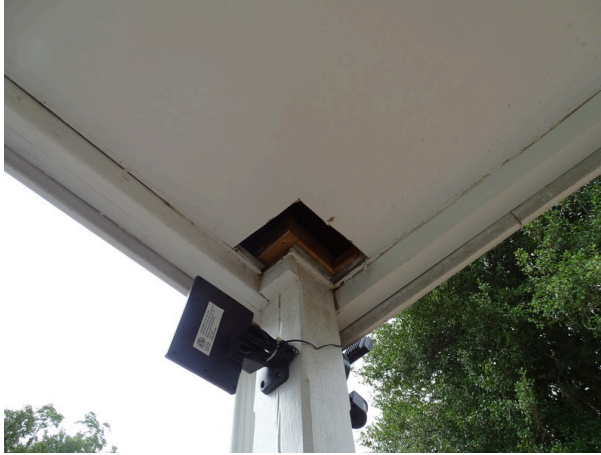
Clubhouse column - note deterioration

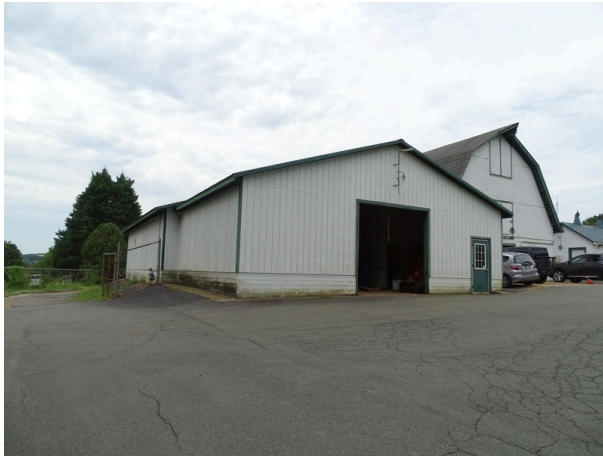
Maintenance Shop, note staining at north side  
of building

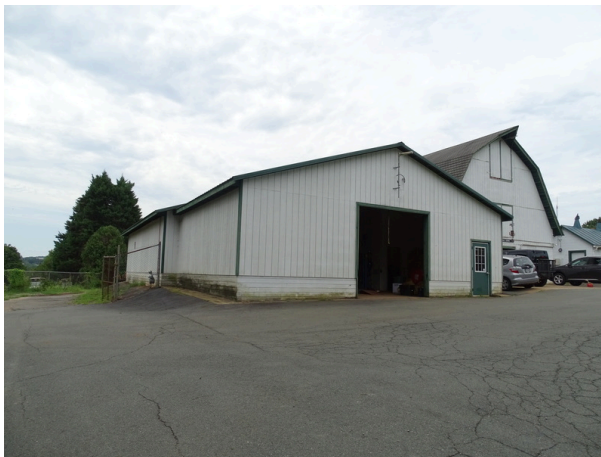
Maintenance Shop, note staining at north side of building

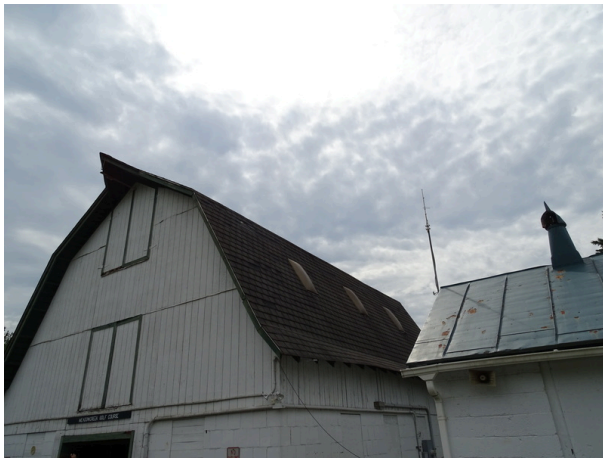
The Storage building roof consists of asphalt shingles. The roof was installed in 1990; shingled roof typically have an expected useful life of 20 years. The shingles were curled and many shingles were missing. The storage building roof was leaking, causing deterioration of drywall, and shifting staff operations. The roof should be scheduled for replacement.

Storage building roof

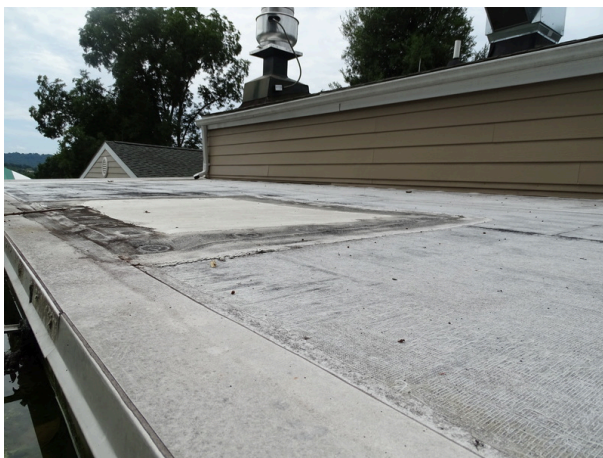
Clubhouse single-ply roof - note deterioration

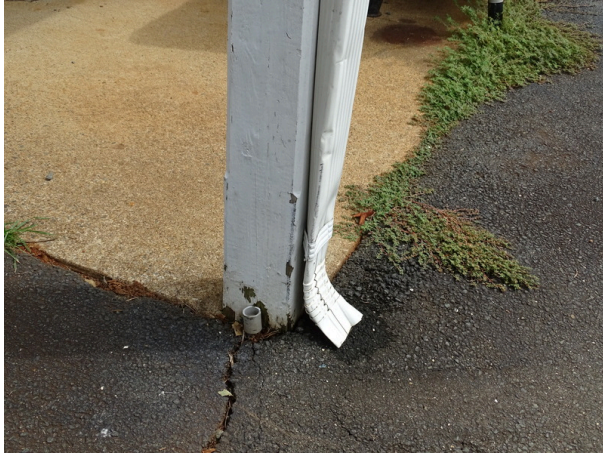
Clubhouse downspout - note damaged

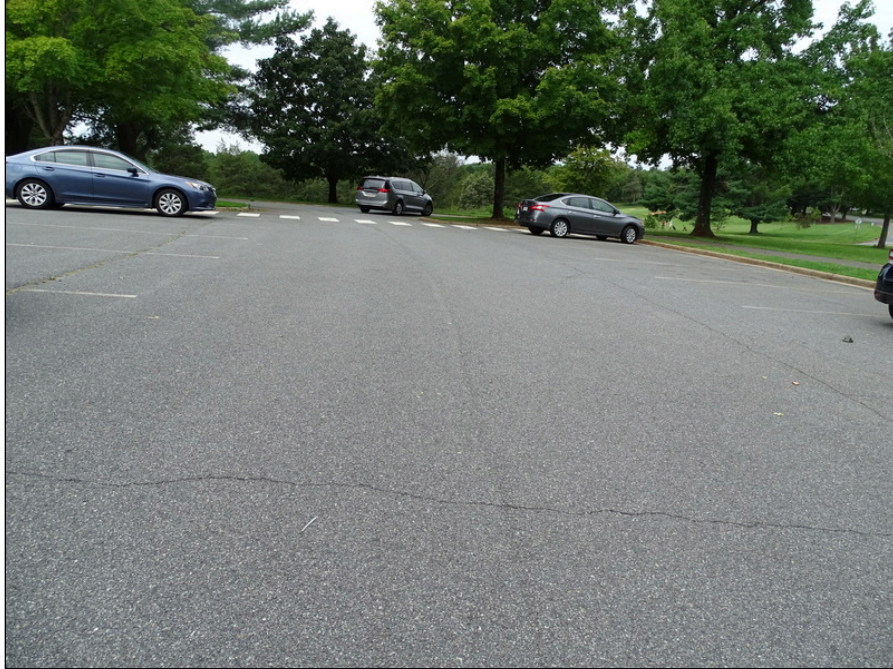
11 - Asphalt parking - note cracks in the asphalt pavement

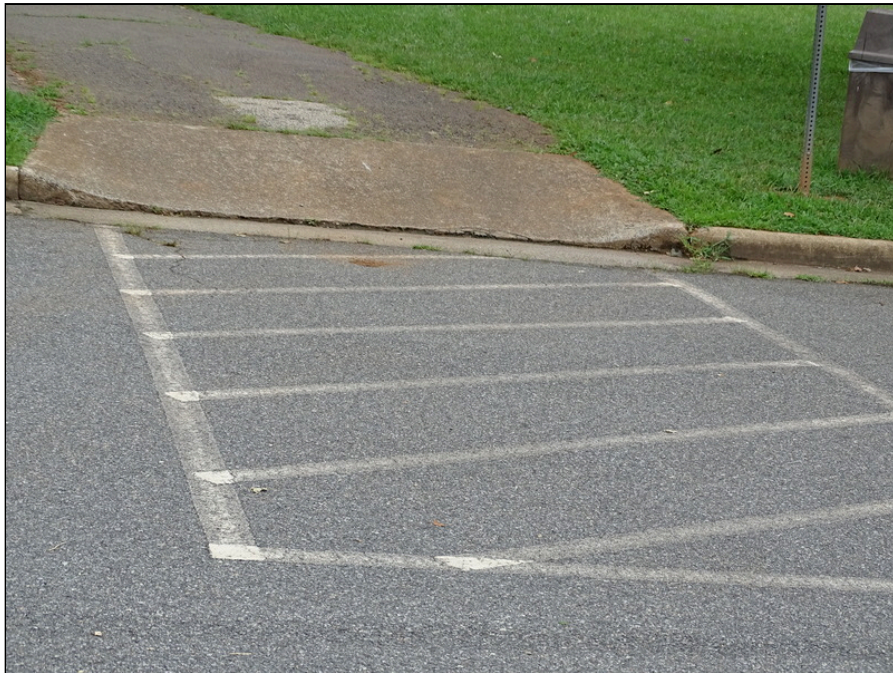
12 - Concrete apron condition - note no truncated domes

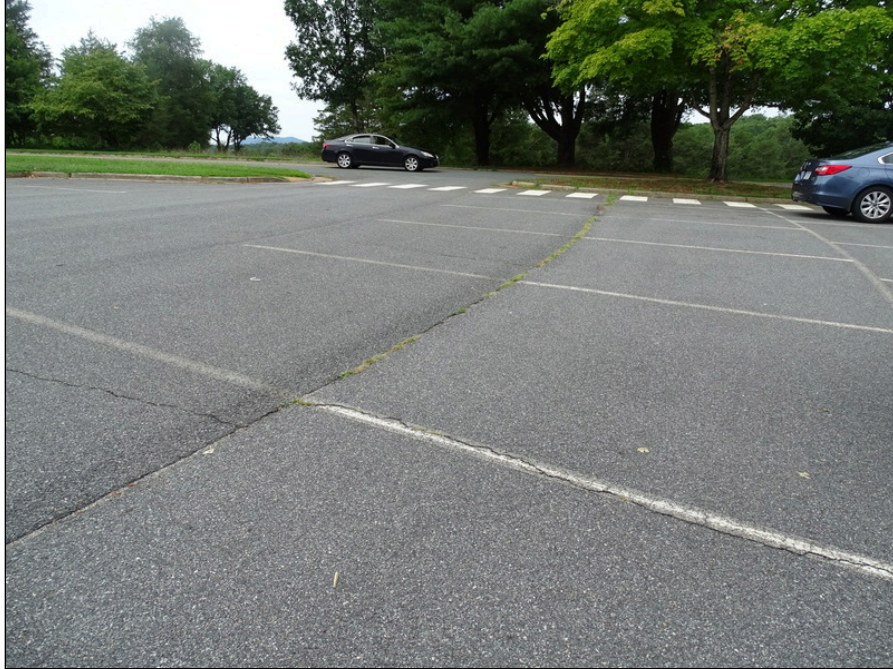
13 - Faded striping and cracks in asphalt pavement

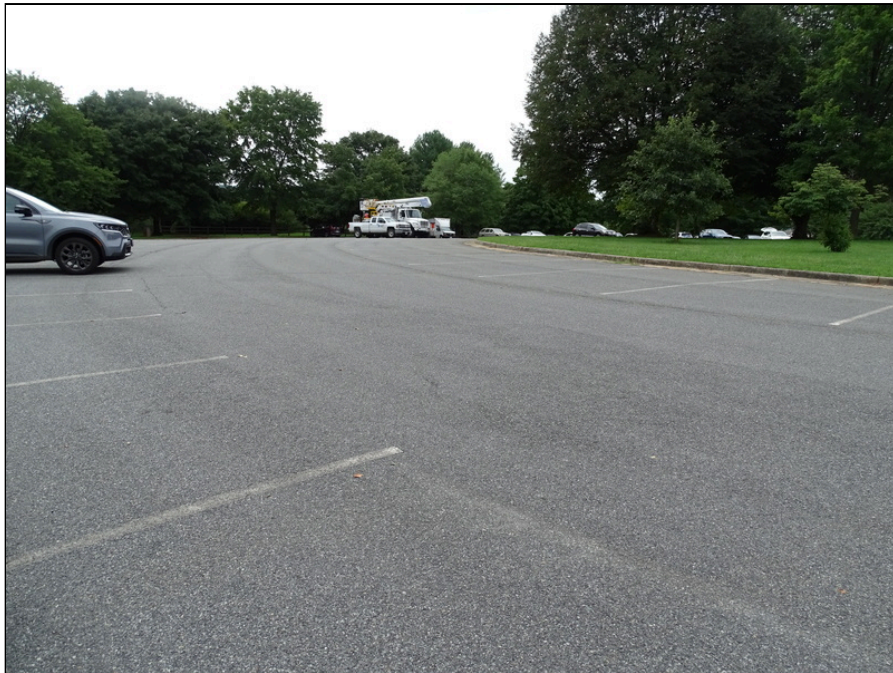
14 - Faded striping and cracks in asphalt pavement

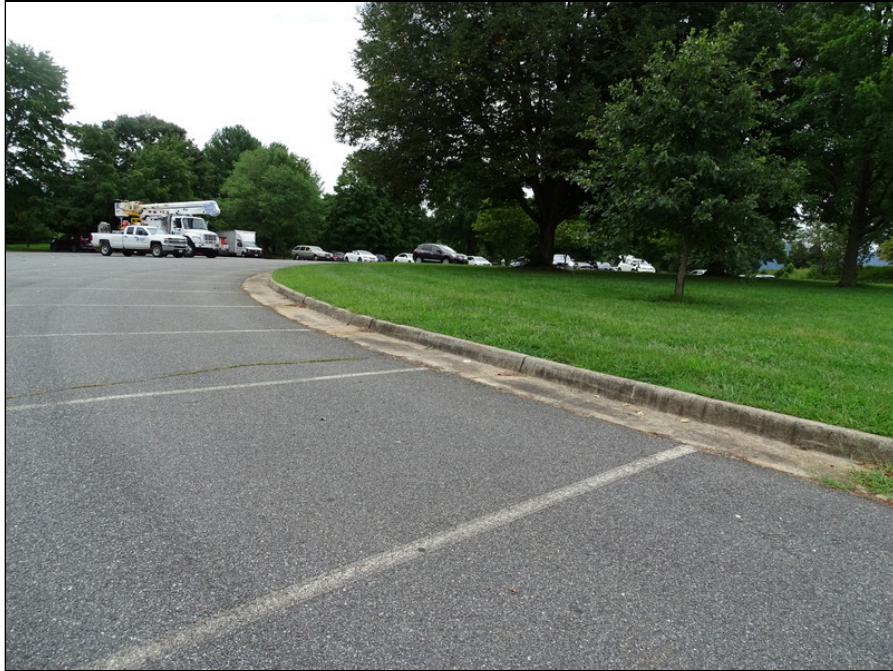
15 - Faded striping and cracks in asphalt pavement

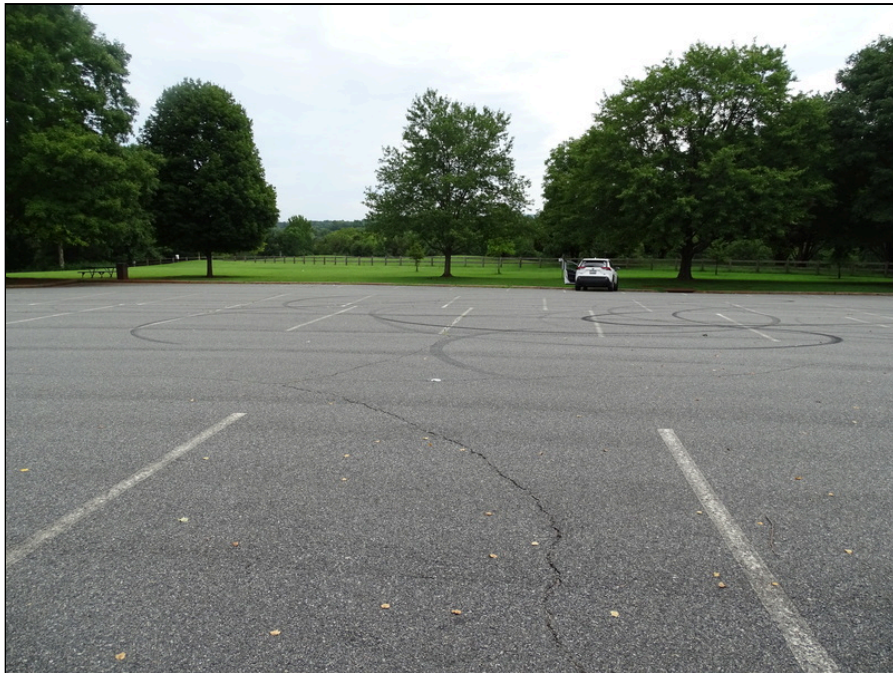
16 - Faded striping and cracks in asphalt pavement

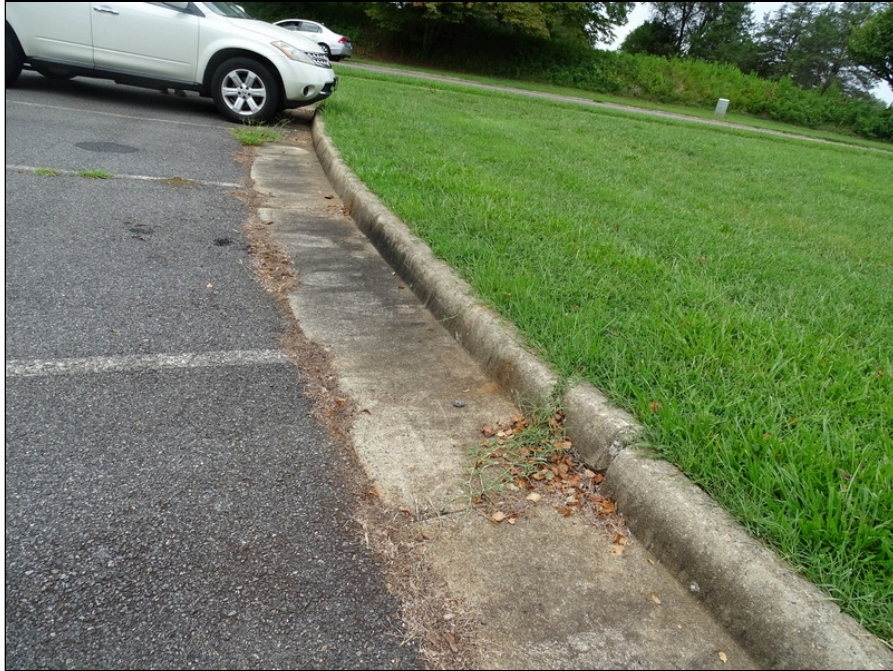
17 - Concrete curb - note deterioration

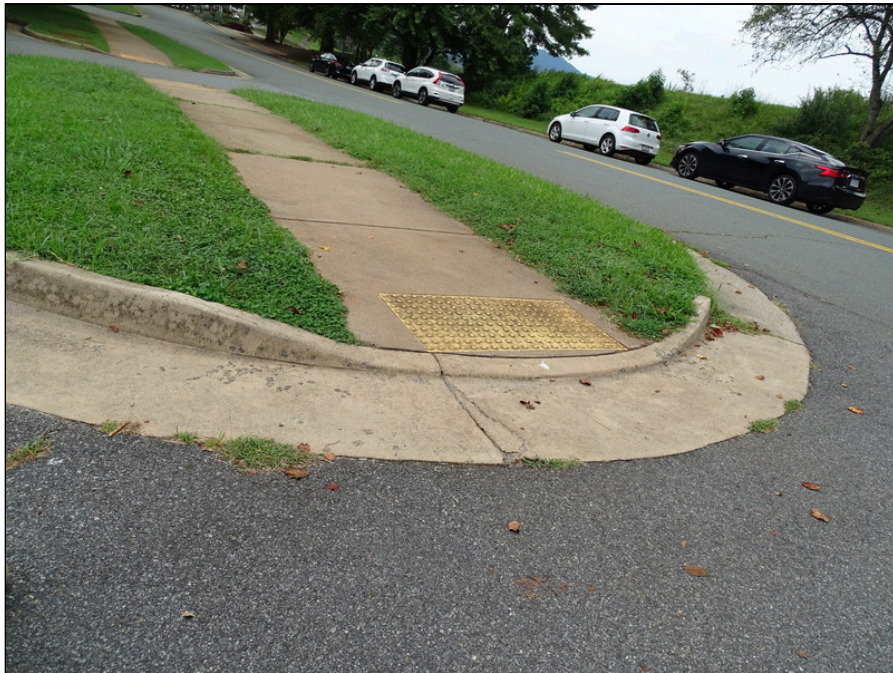
18 - Concrete ramp - note cracks in the apron

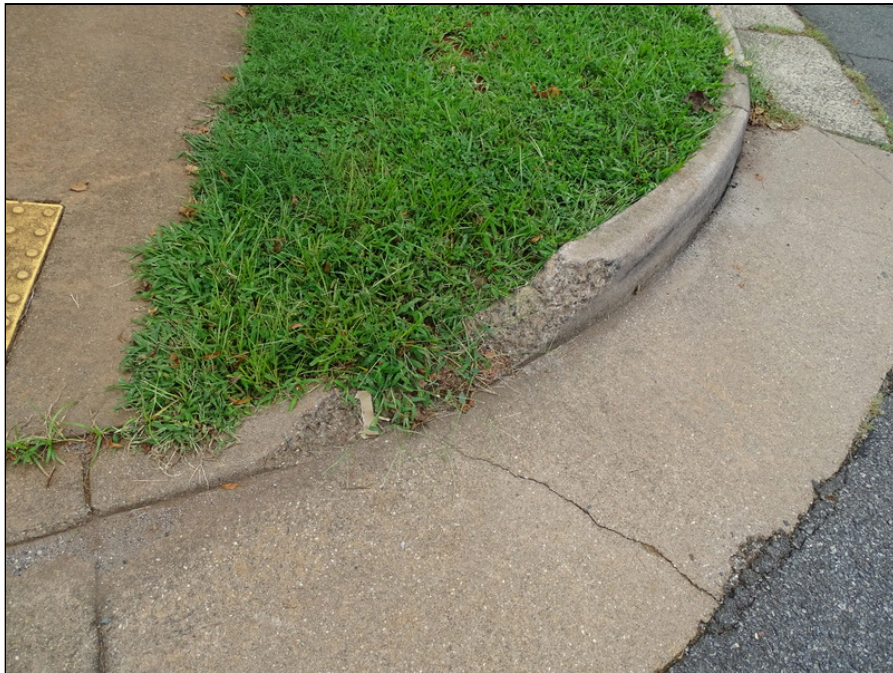
20 - Concrete curb - note deterioration

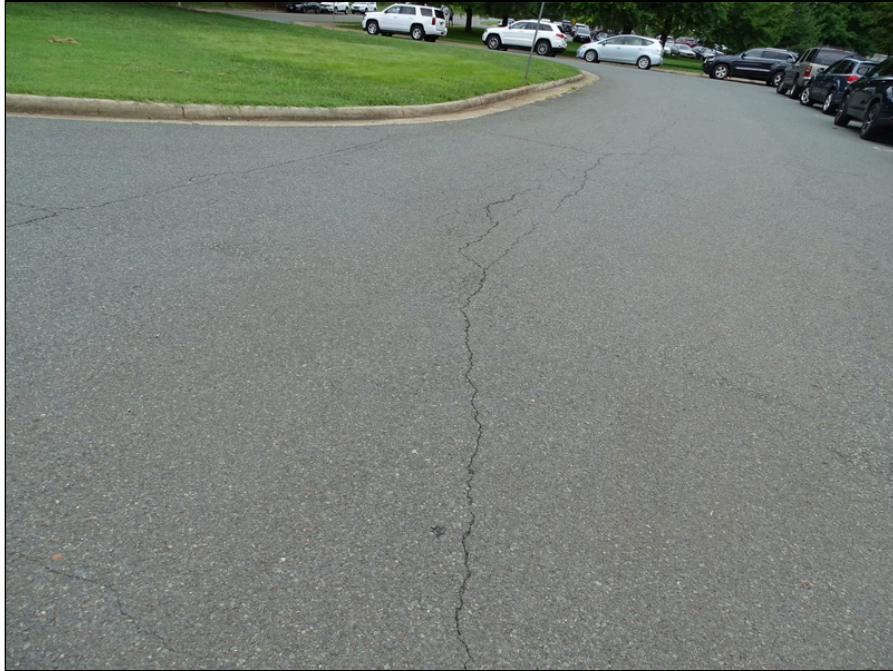
21 - Asphalt pavement - note cracks

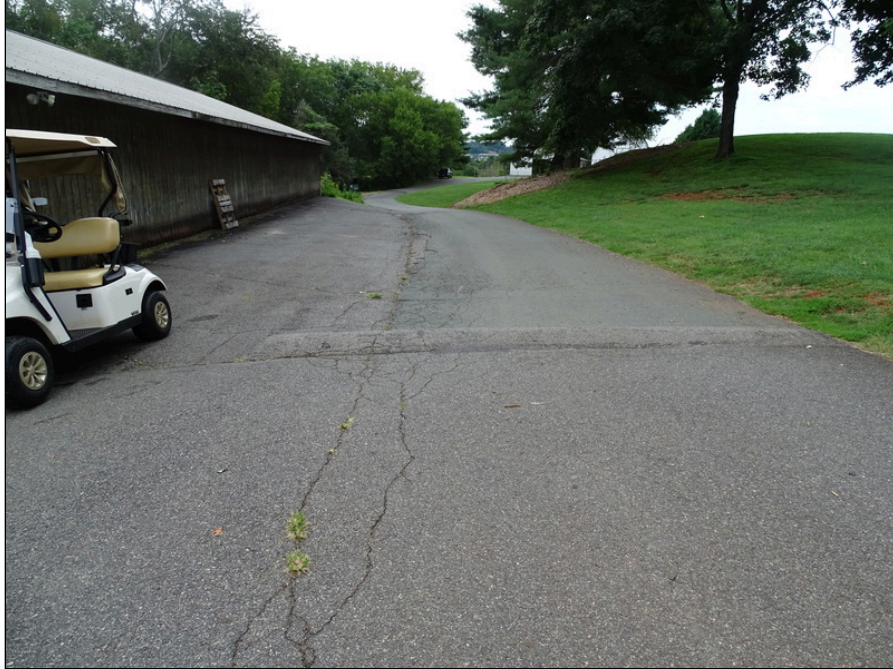
23 - Golf cart shed side pavements - note asphalt deterioration

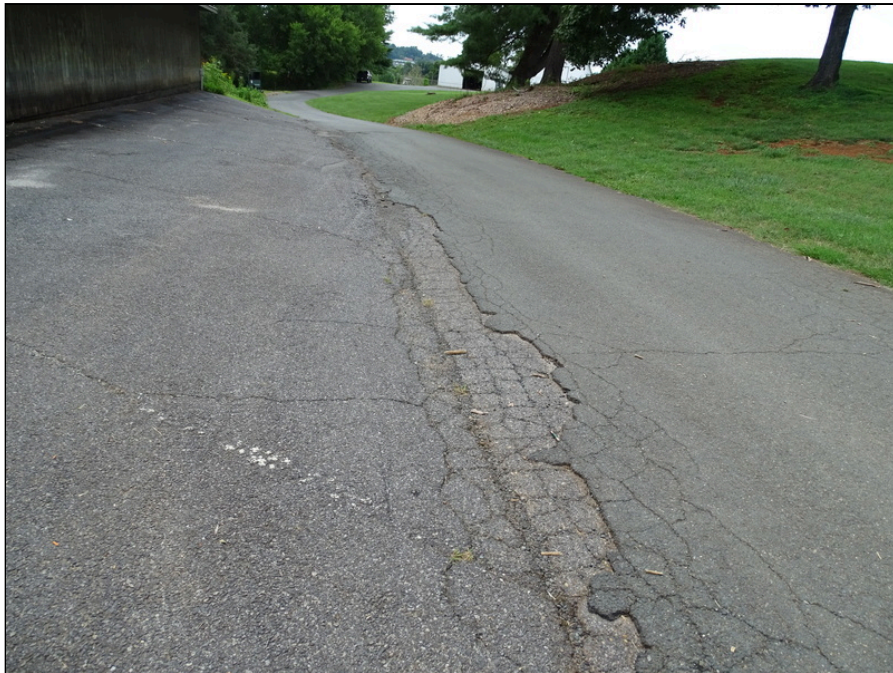
24 - Golf cart shed side pavements - note asphalt deterioration

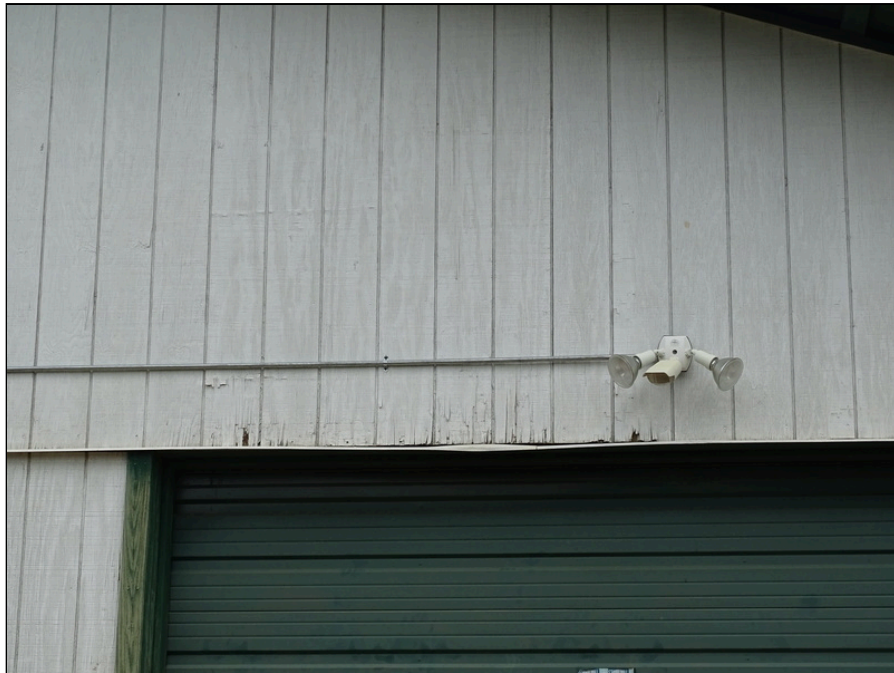
30 - Maintenance Shop exterior - note wood siding deterioration

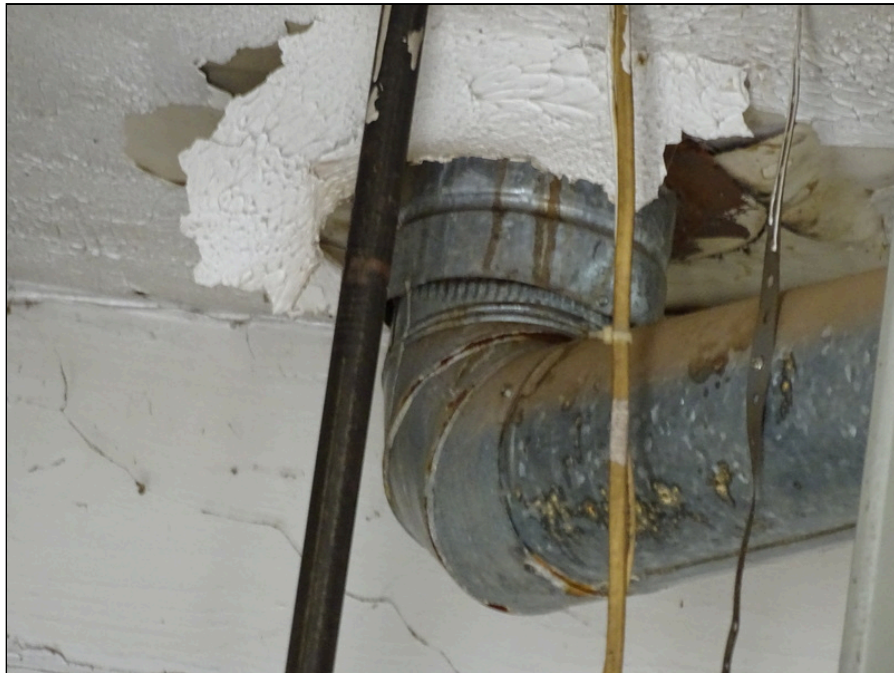
32 - Maintenance Shop - note ceiling deterioration

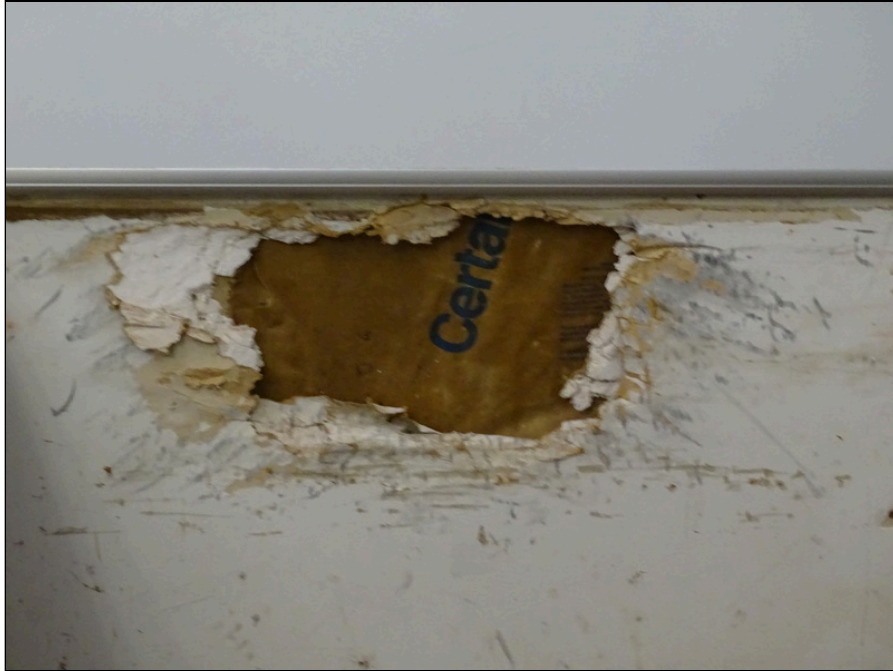
33 - Maintenance Shop - note wall deterioration

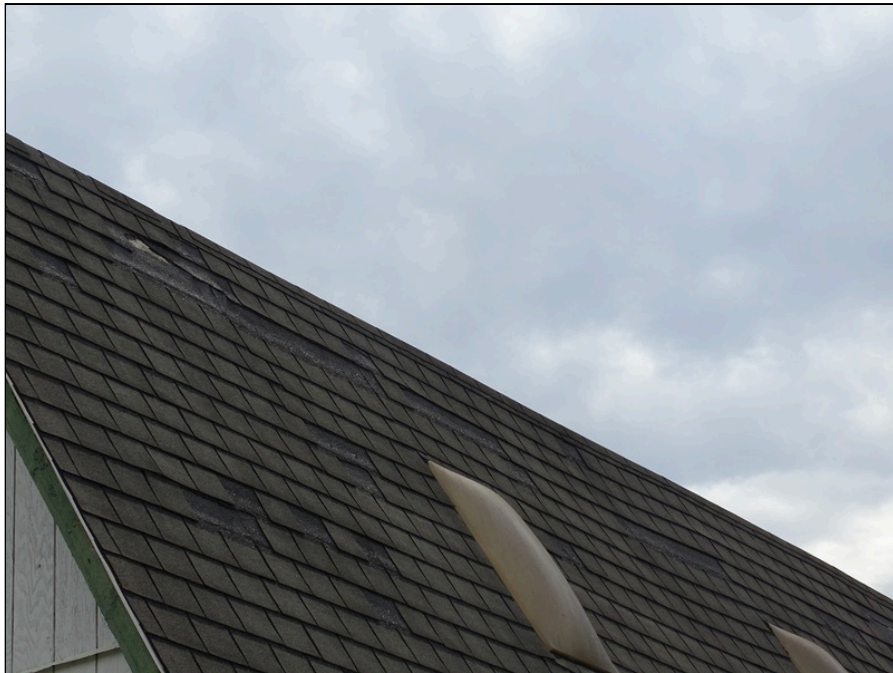
36 - Storage building roof - note deterioration of asphalt shingle

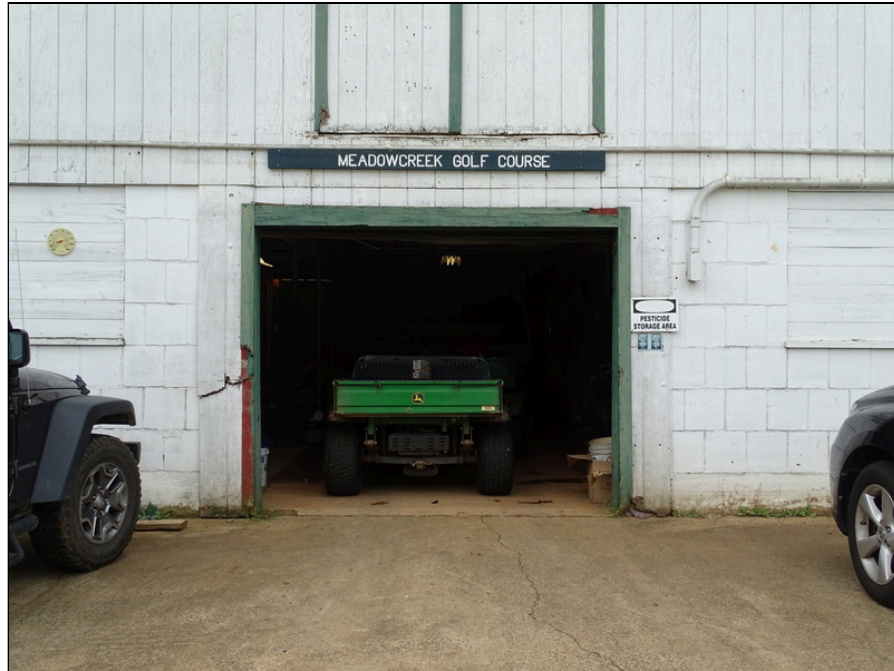
37 - Storage building wood siding faded paint

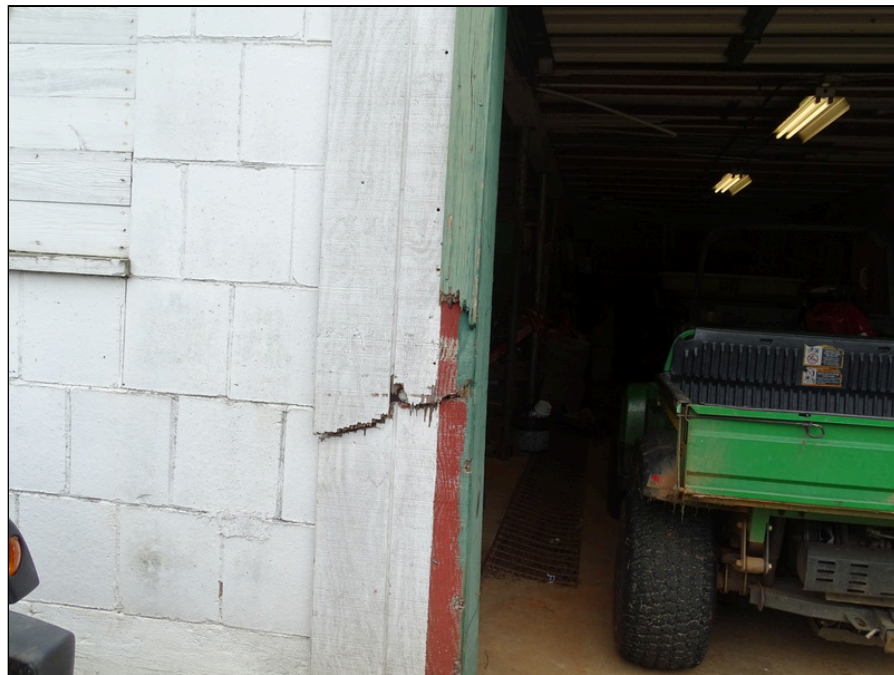
38 - Storage building rotten and broken wood trim

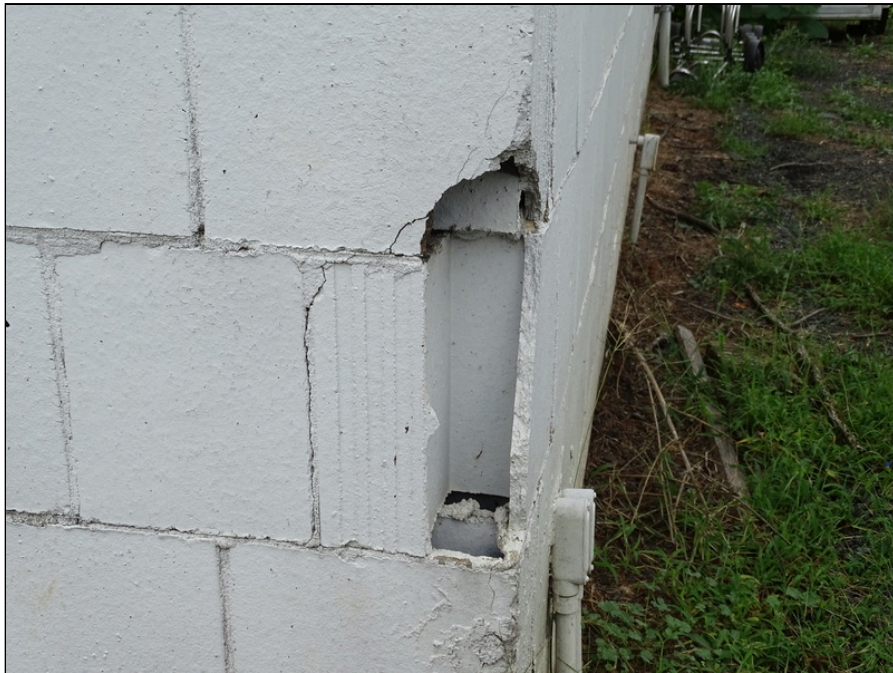
42 - Storage building - note wall deterioration

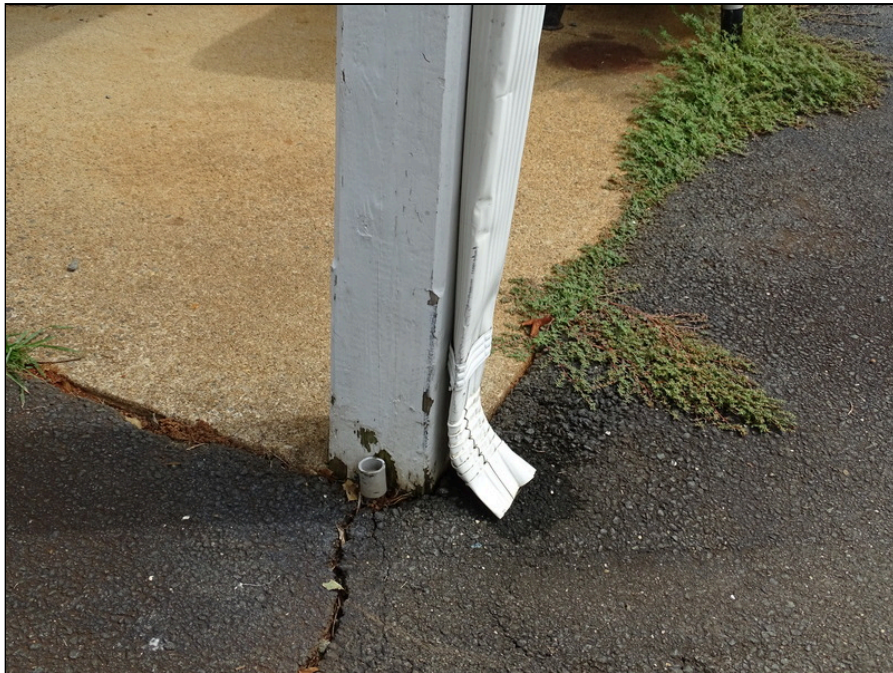
46 - Clubhouse downspout - note damaged

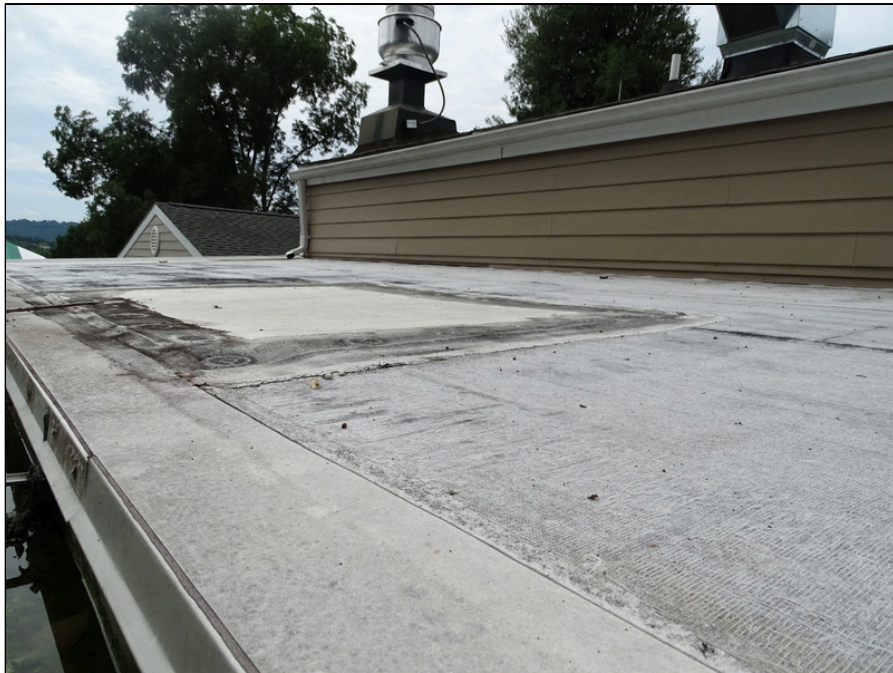
64 - Clubhouse single-ply roof - note deterioration

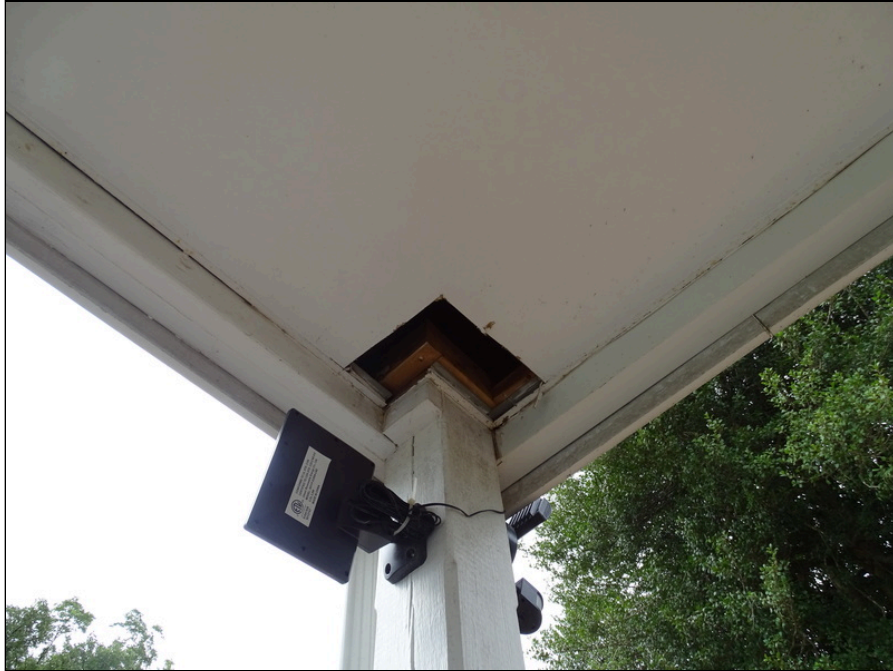
81 - Clubhouse column - note deterioration

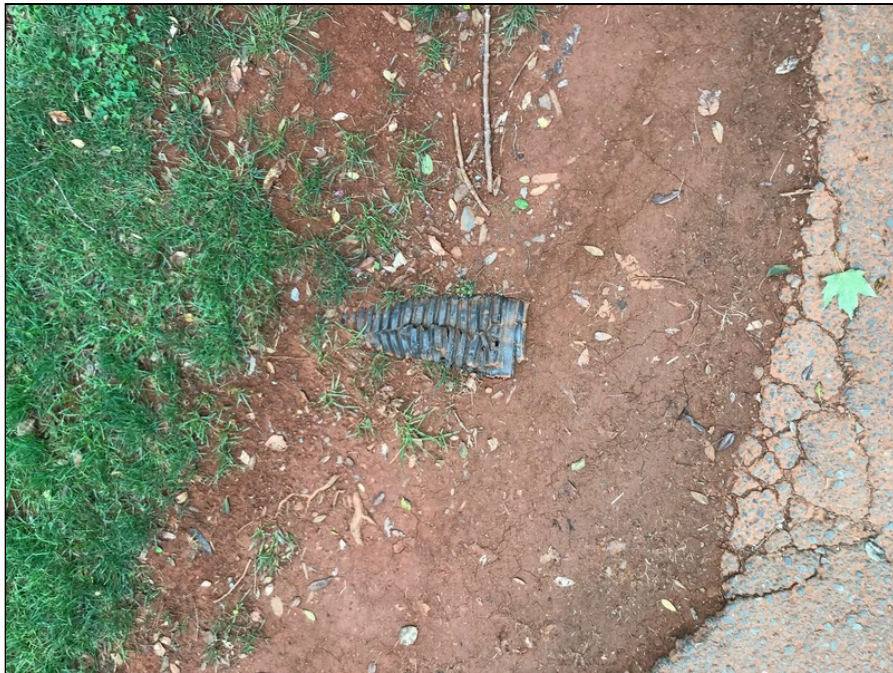
A downspout drainage pipe was observed to be crushed and should be replaced as a maintenance item.

82 - Crushed Downspout Drainage
