MICHIE BUILDING
610 EAST MARKET STREET
CHARLOTTESVILLE, VIRGINIA

ECS PROJECT NO. 46:6713

OCTOBER 26, 2021

Reference: Facility Condition Assessment Report for Michie Building, 610 East Market Street,
Charlottesville, Virginia

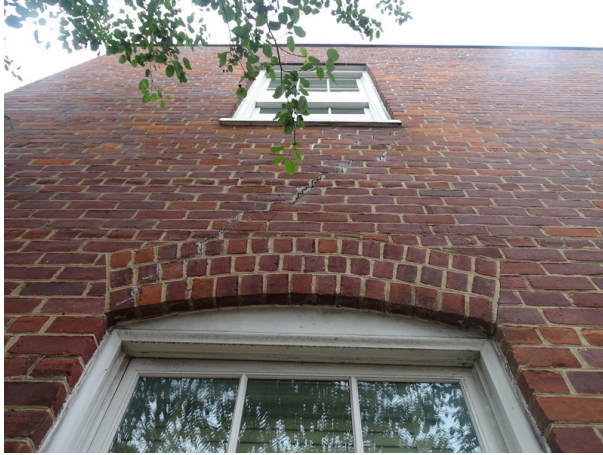
Typical building exterior - note step cracking at brick

3.3.3 Building Exteriors																														
REPOINT BRICKWORK	20	19	1	1	LS	\$75,000.00	\$75,000	100%	\$75,000																					\$75,000
REPLACE SEALANTS	12	10	2	1	EA	\$5,000.00	\$5,000	100%		\$5,000																				\$5,000

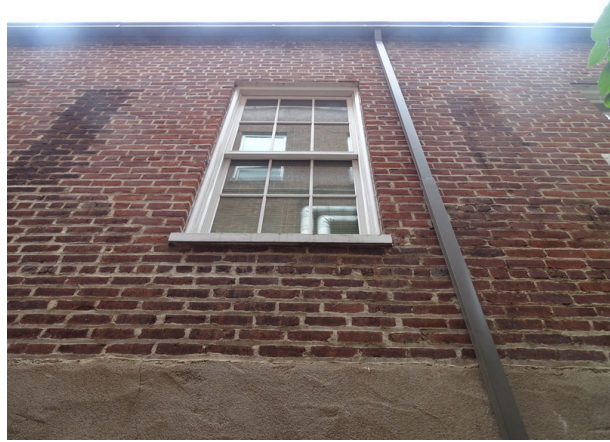
Typical building exterior - note deterioration

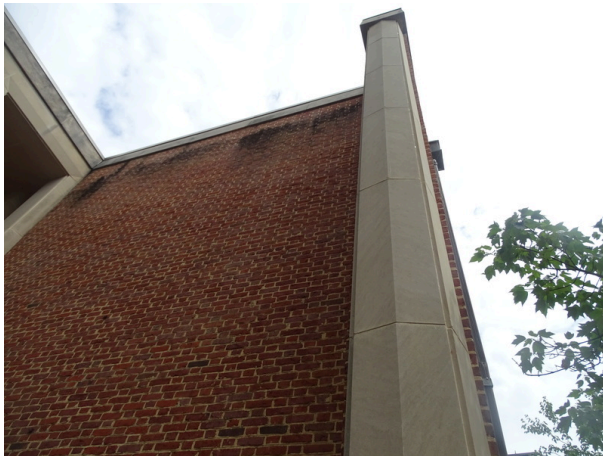
Typical building exterior - note efflorescence

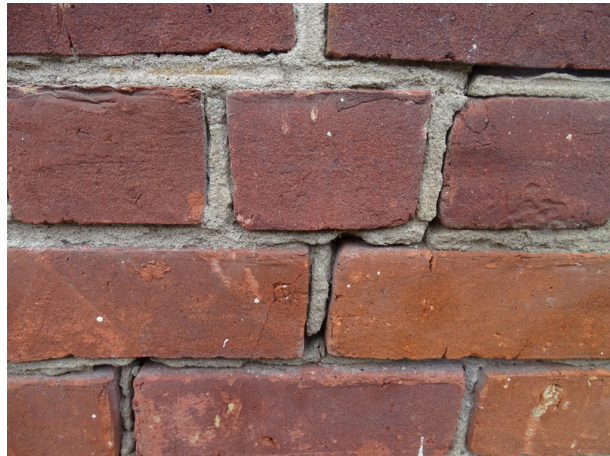
Typical building exterior - note step cracking at brick

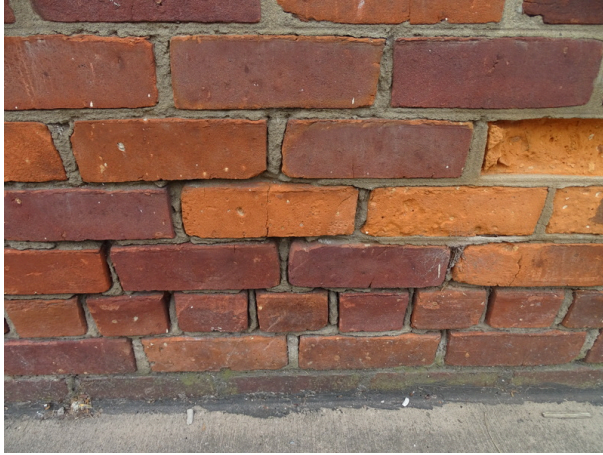
Typical building exterior - note deterioration

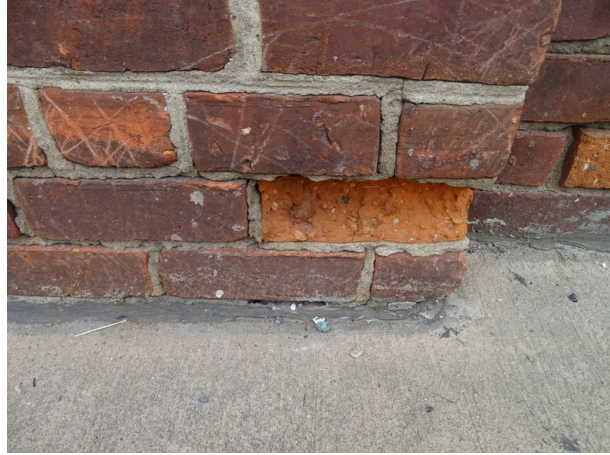
Typical building exterior - note deterioration

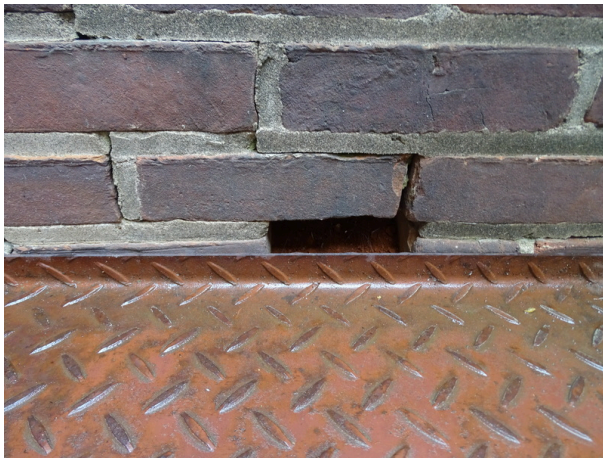
Typical building exterior - note deterioration

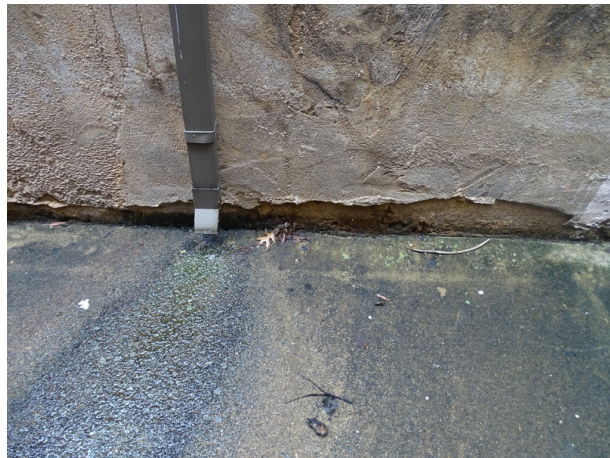
Typical building exterior - note deterioration

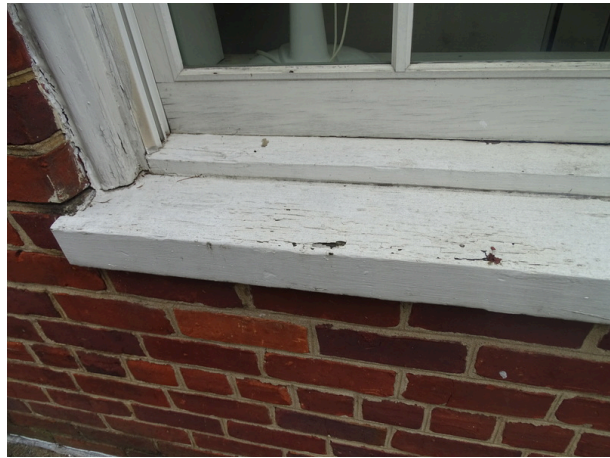
The window system for the building primarily consists of Wood-framed single-pane operable window units. The windows were generally in fair condition. The expected useful life of window units is typically 30 years. There was reported leakage of window units on the east side of the building. We recommend the windows be replaced.

Exterior window - note deterioration

3.3.5 Exterior Windows																														
REPLACE WINDOWS	30	29	1	1	EA	\$31,000.00	\$31,000	100%	\$31,000																					\$31,000
3.3.6 Roofing Systems																														
REPLACE SINGLE-PLY ROOFING SYSTEM	20	19	1	12,000	SF	\$14.00	\$168,000	100%	\$168,000																					\$168,000

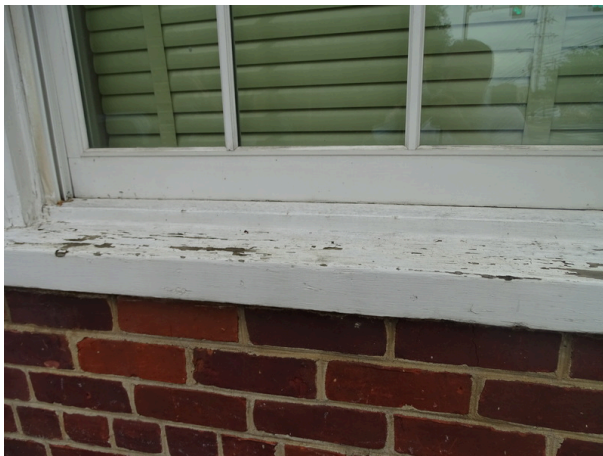
Exterior window - note deterioration

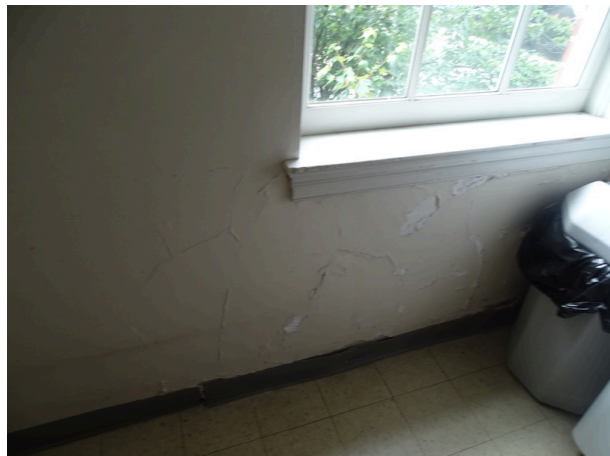
Exterior window - note leakage

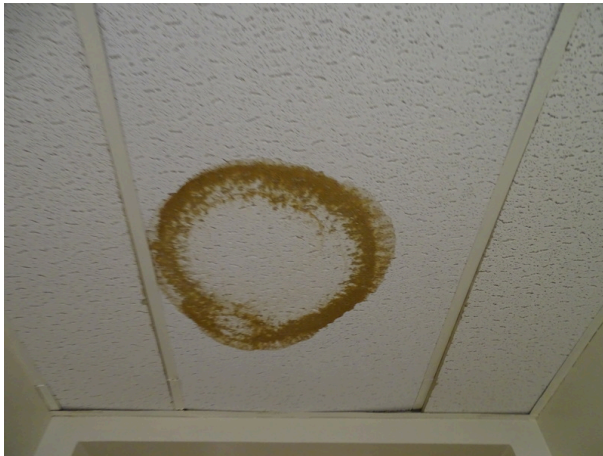
Water leakage at ceiling

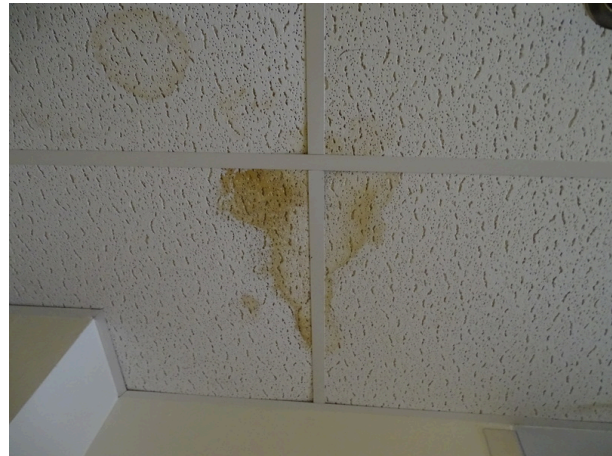
Water leakage at ceiling

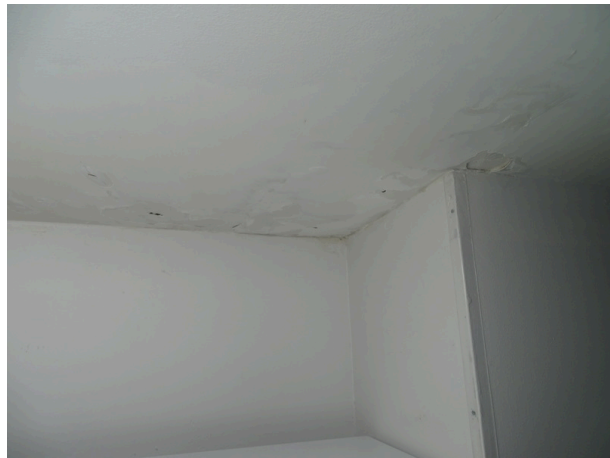
Water leakage at ceiling

3.7.1 Tenant Spaces																													
RENOVATE INTERIORS TO REPAIR MOISTURE DAMAGE			1	1	LS	\$20,000.00	\$20,000	100%	\$20,000																				\$20,000
Total (Uninflated)									\$300,600.00	\$5,000.00	\$10,000.00	\$80,000.00	\$0.00	\$0.00	\$0.00	\$0.00	\$0.00	\$0.00	\$0.00	\$0.00	\$1,600.00	\$0.00	\$0.00	\$0.00	\$0.00	\$0.00	\$0.00	\$0.00	\$397,200.00
Inflation Factor (2.5%)									1.0	1.025	1.051	1.077	1.104	1.131	1.16	1.189	1.218	1.249	1.28	1.312	1.345	1.379	1.413	1.448	1.485	1.522	1.56	1.599	
Total (inflated)									\$300,600.00	\$5,125.00	\$10,506.25	\$86,151.25	\$0.00	\$0.00	\$0.00	\$0.00	\$0.00	\$0.00	\$0.00	\$0.00	\$2,151.82	\$0.00	\$0.00	\$0.00	\$0.00	\$0.00	\$0.00	\$0.00	\$404,534.32
Evaluation Period:									20

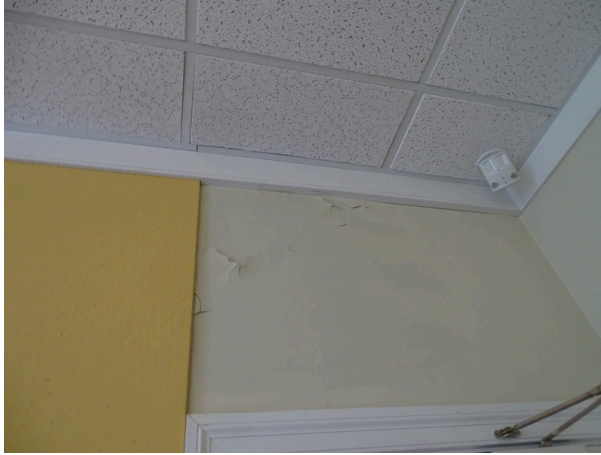
Typical wall - note efflorescence

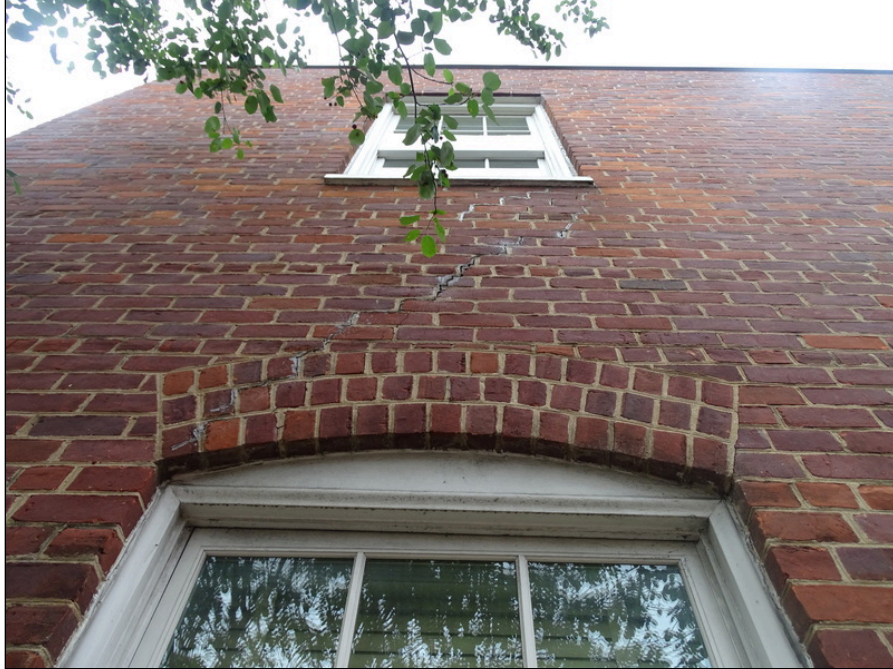
5 - Typical building exterior - note step cracking at brick

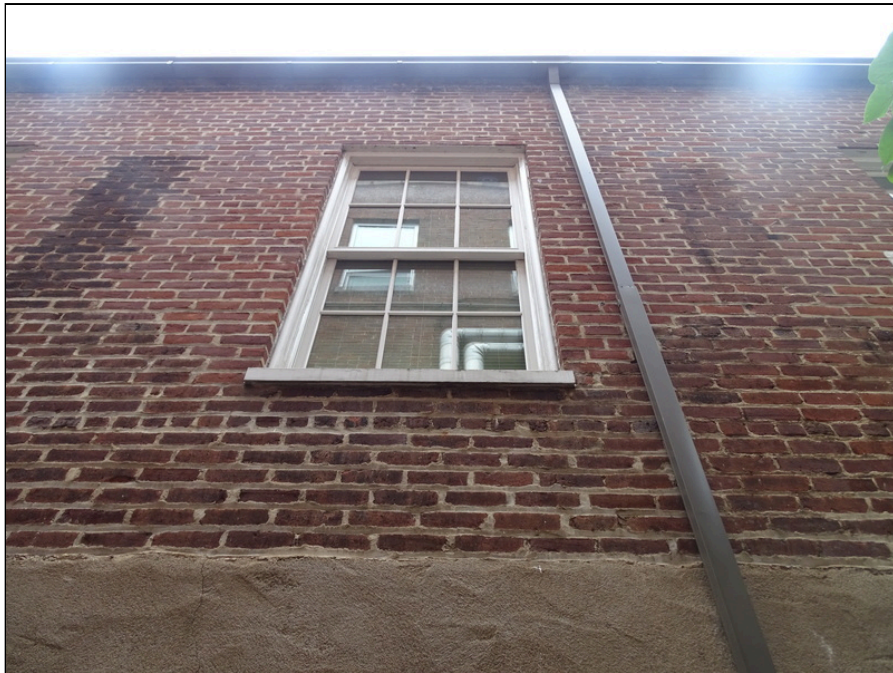
6 - Typical building exterior - note deterioration

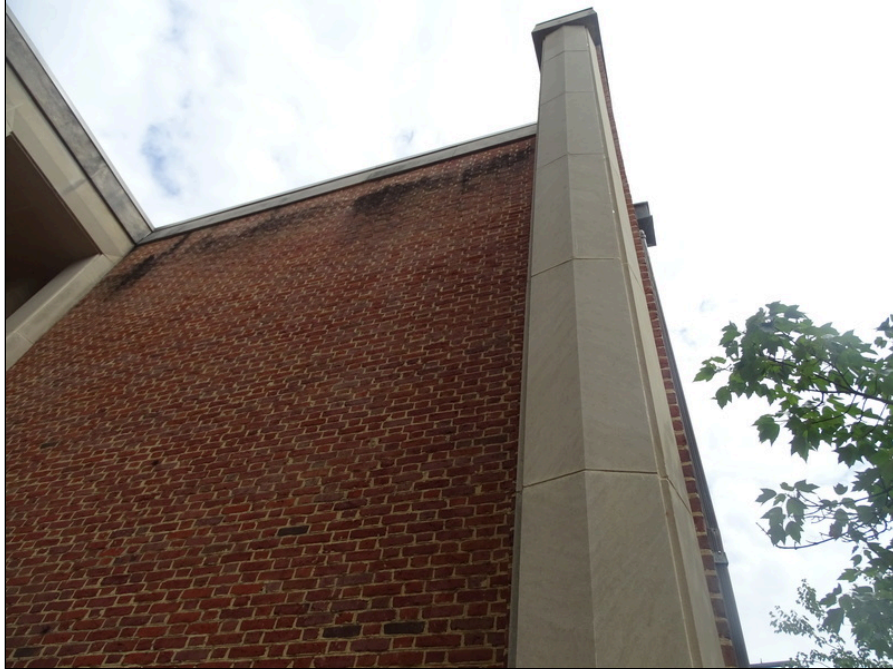
7 - Typical building exterior - note efflorescence

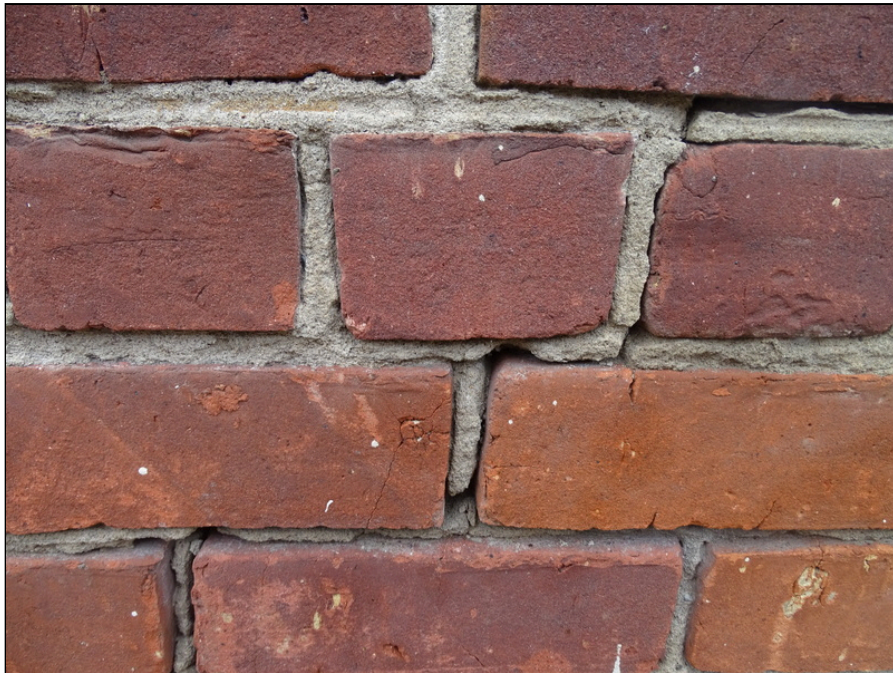
8 - Typical building exterior - note step cracking at brick

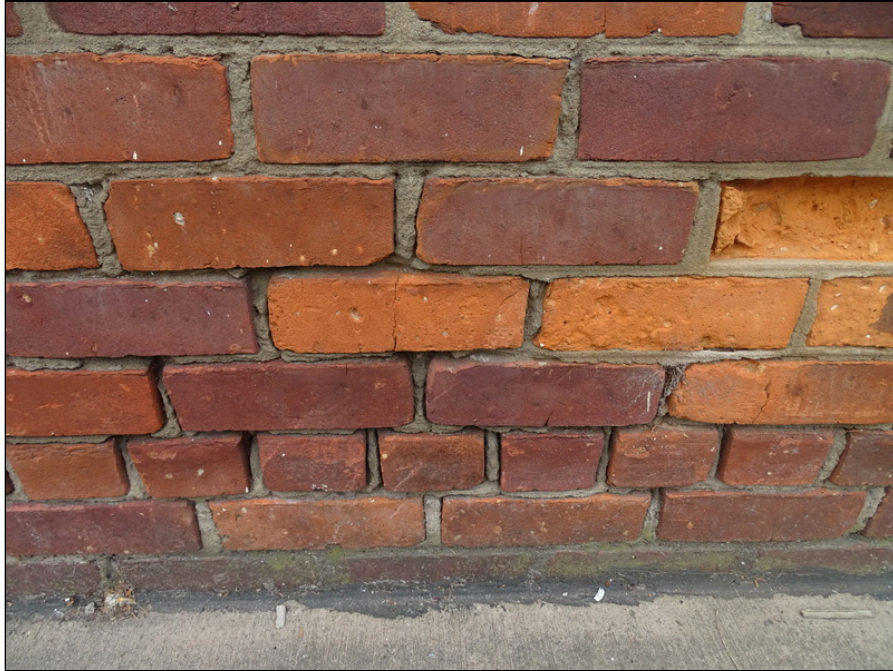
9 - Typical building exterior - note deterioration

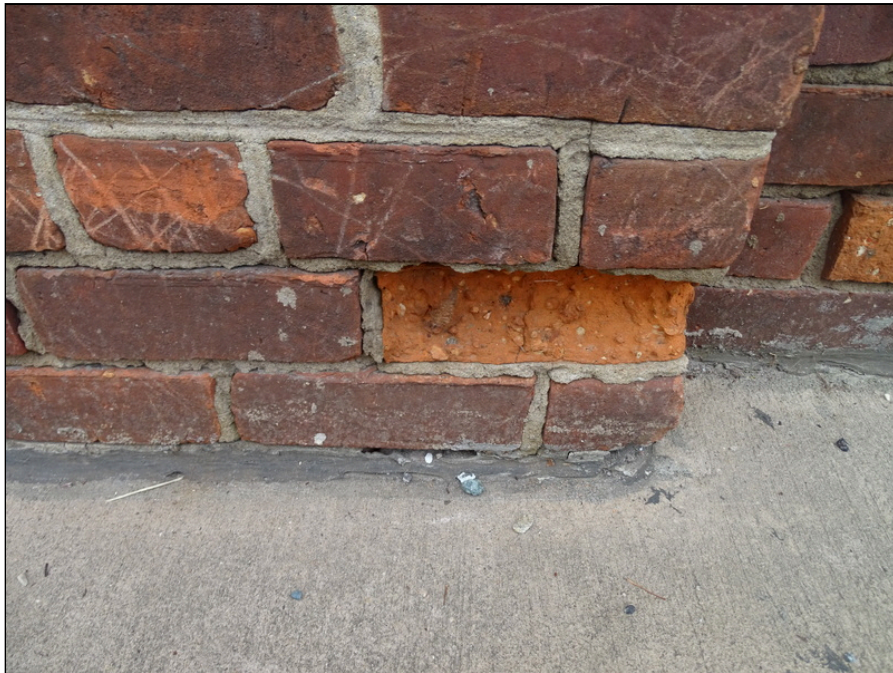
10 - Typical building exterior - note deterioration

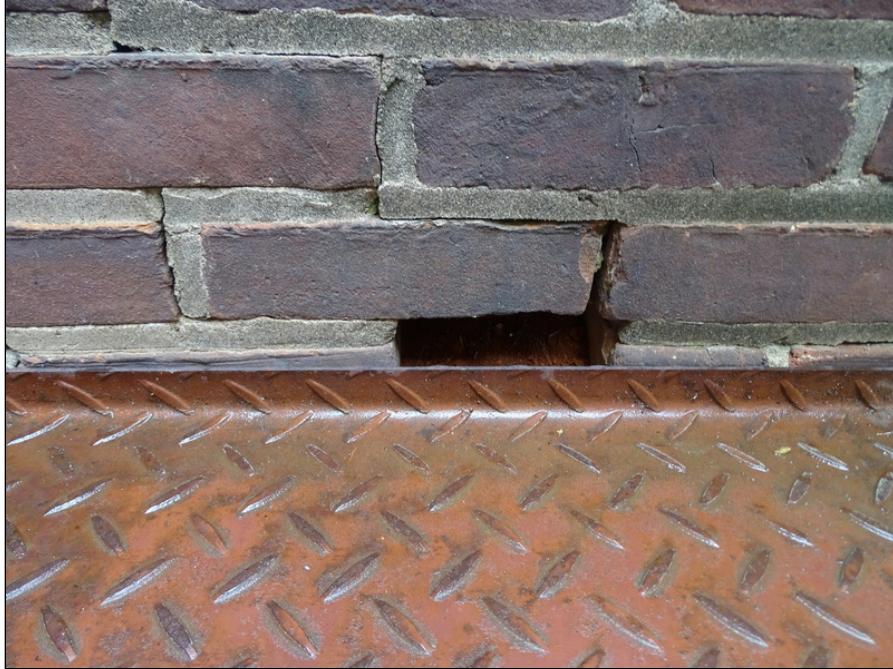
11 - Typical building exterior - note deterioration

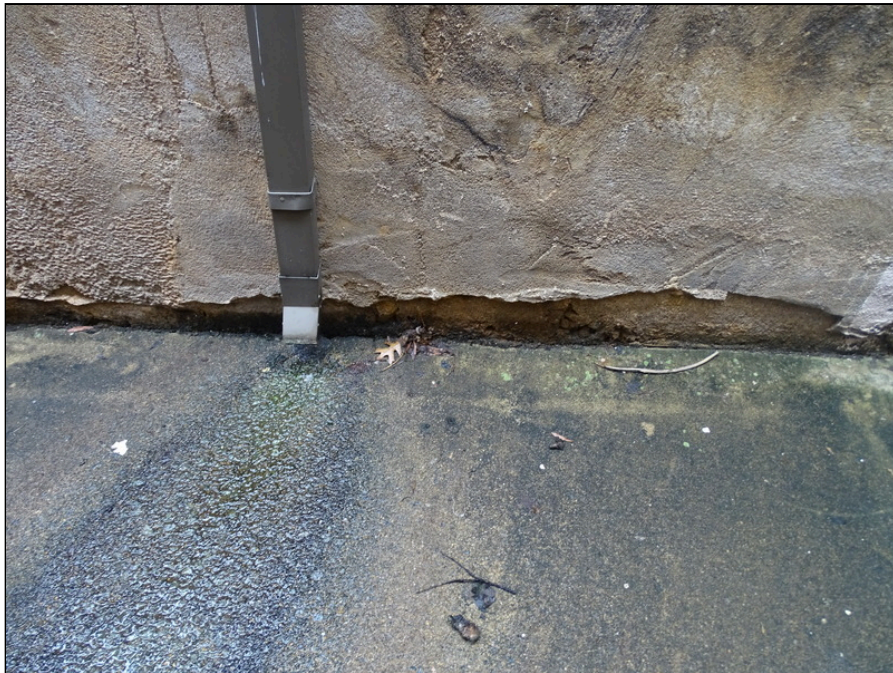
12 - Typical building exterior - note deterioration

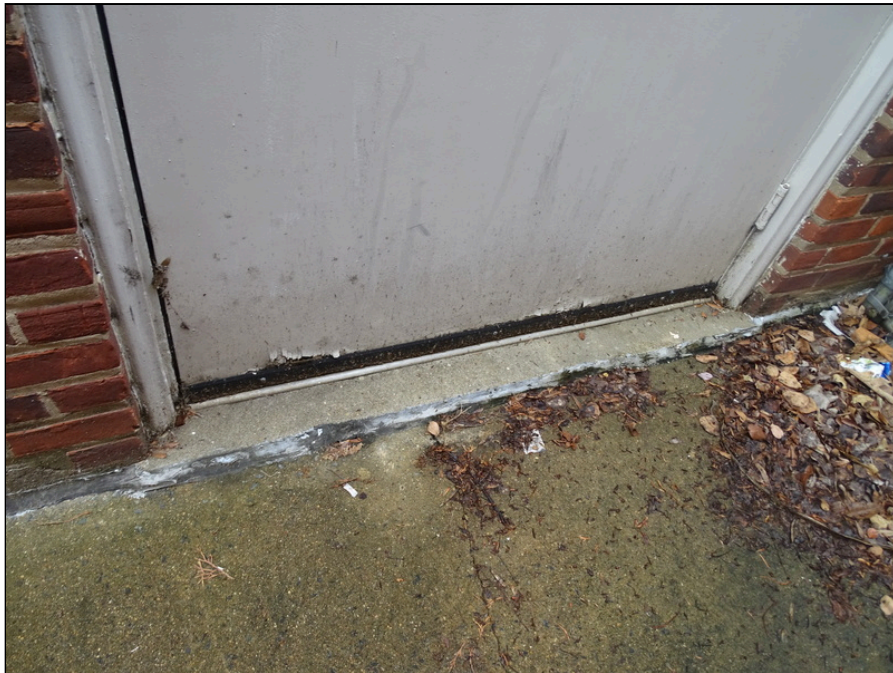
16 - Typical steel personal door - note peeling paint

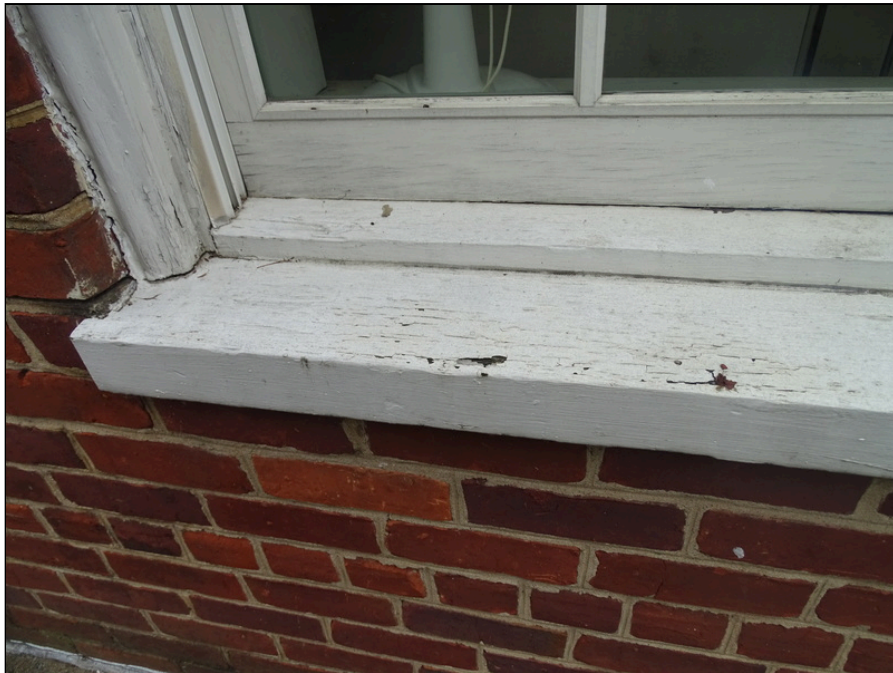
18 - Exterior window - note deterioration

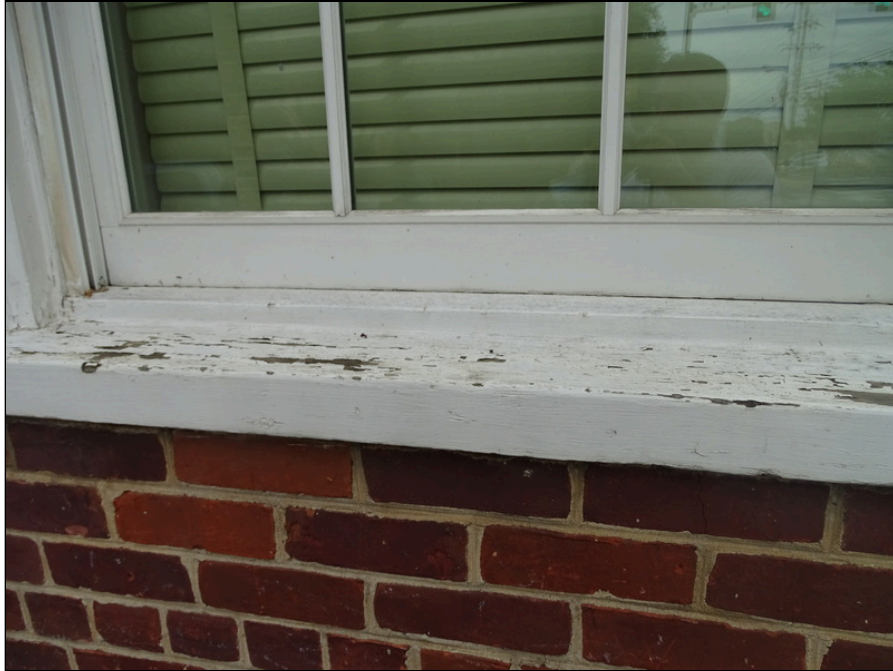
19 - Exterior window - note deterioration

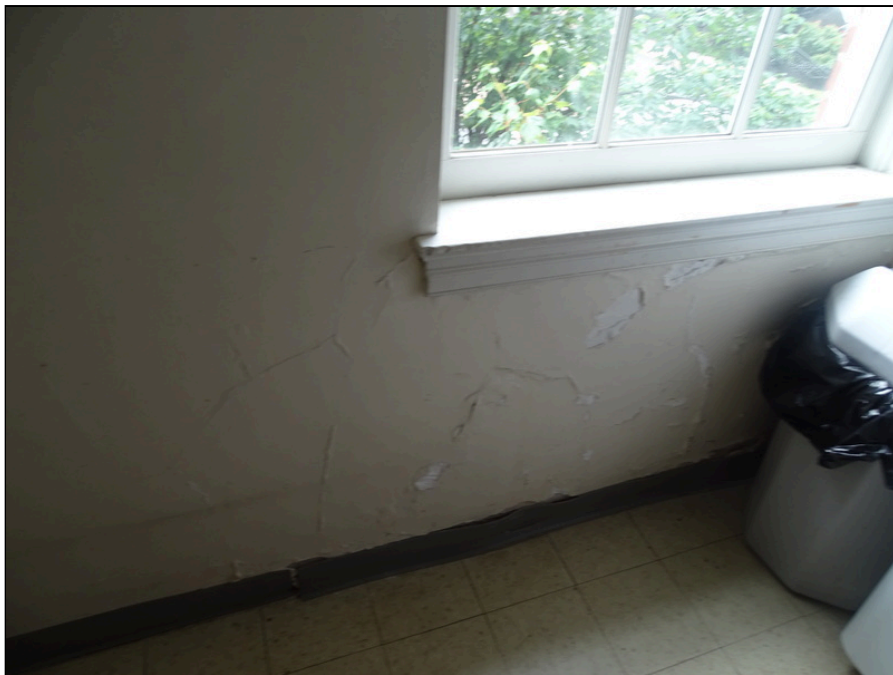
20 - Exterior window - note leakage

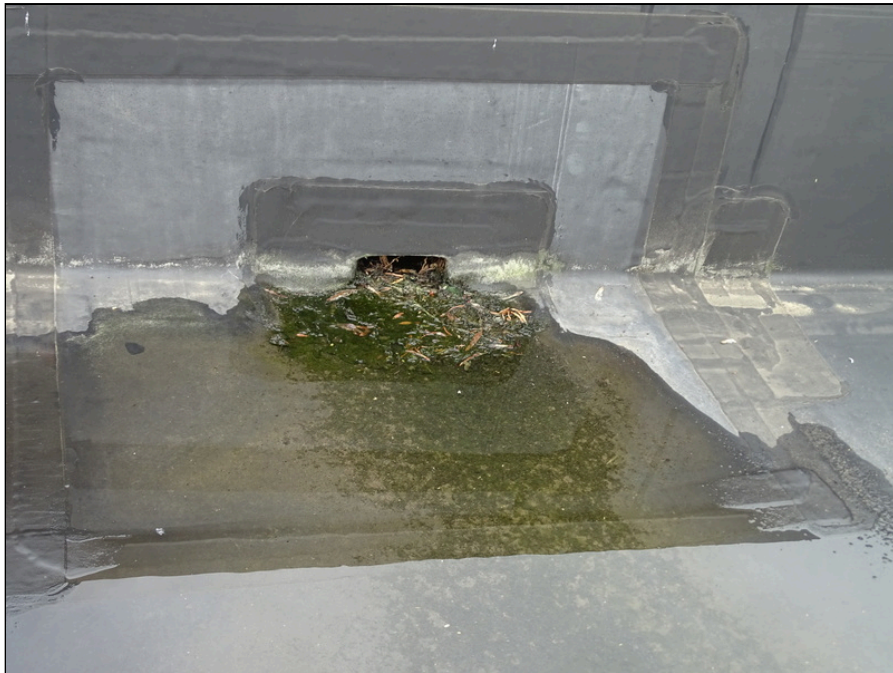
24 - Typical through wall scupper drain - note ponding

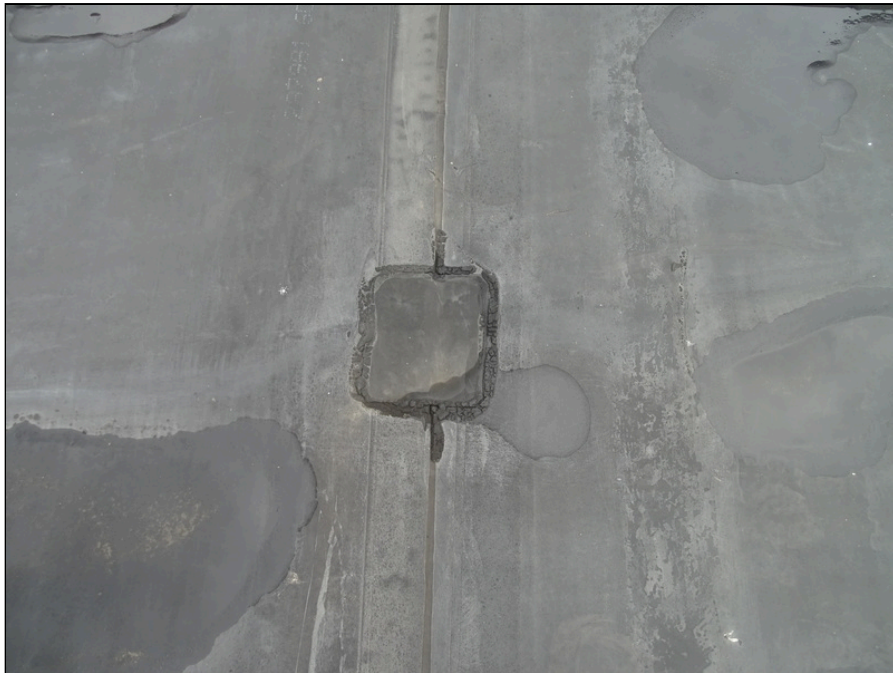
26 - Single-ply membrane roofing system - note patching

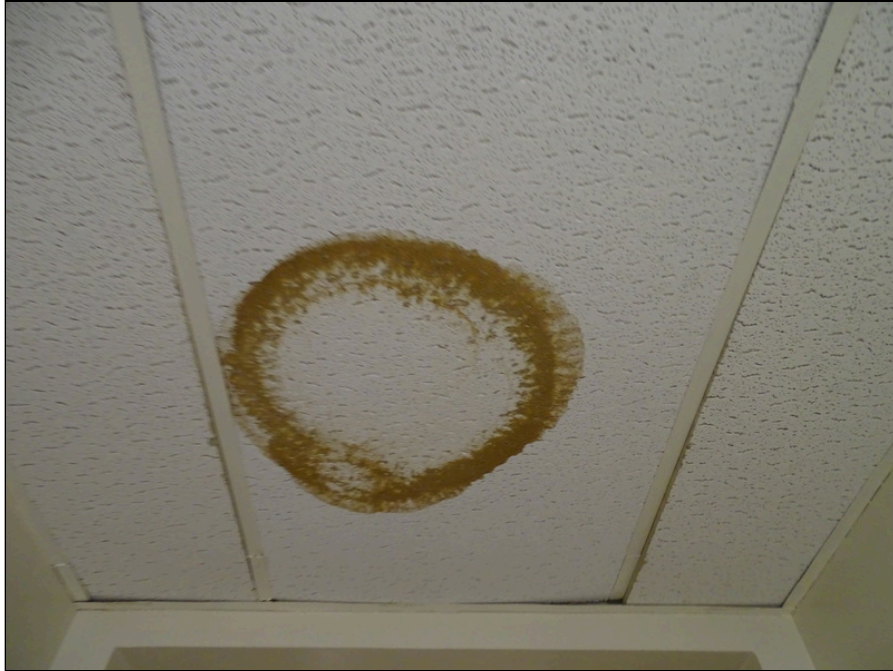
27 - Water leakage at ceiling

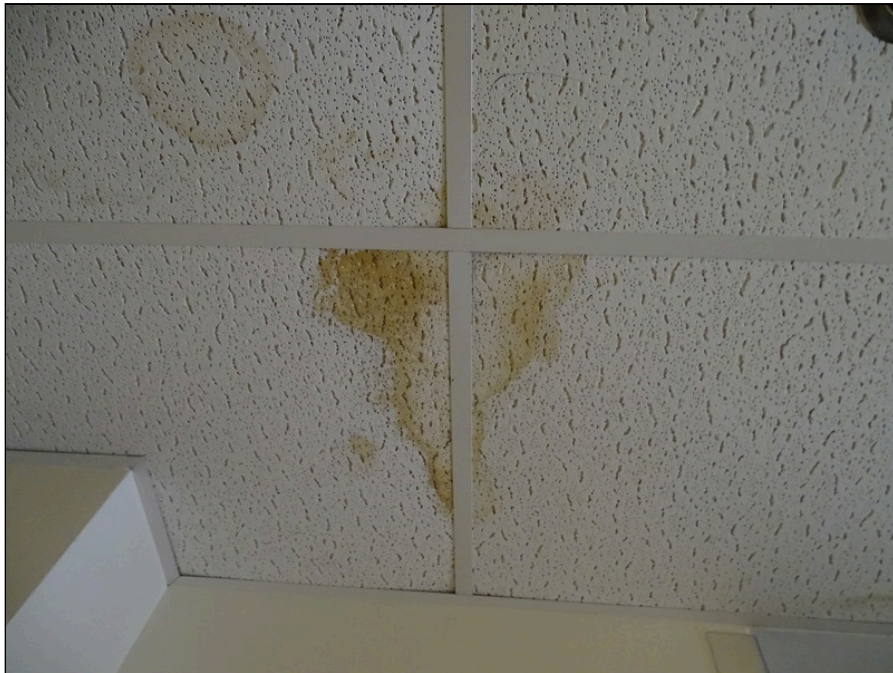
28 - Water leakage at ceiling

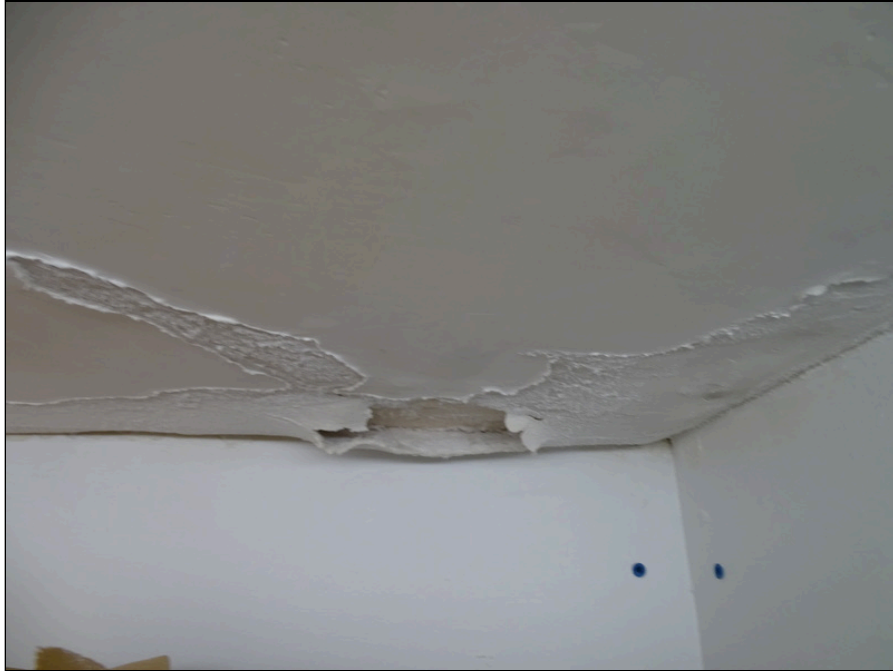
29 - Water leakage at ceiling

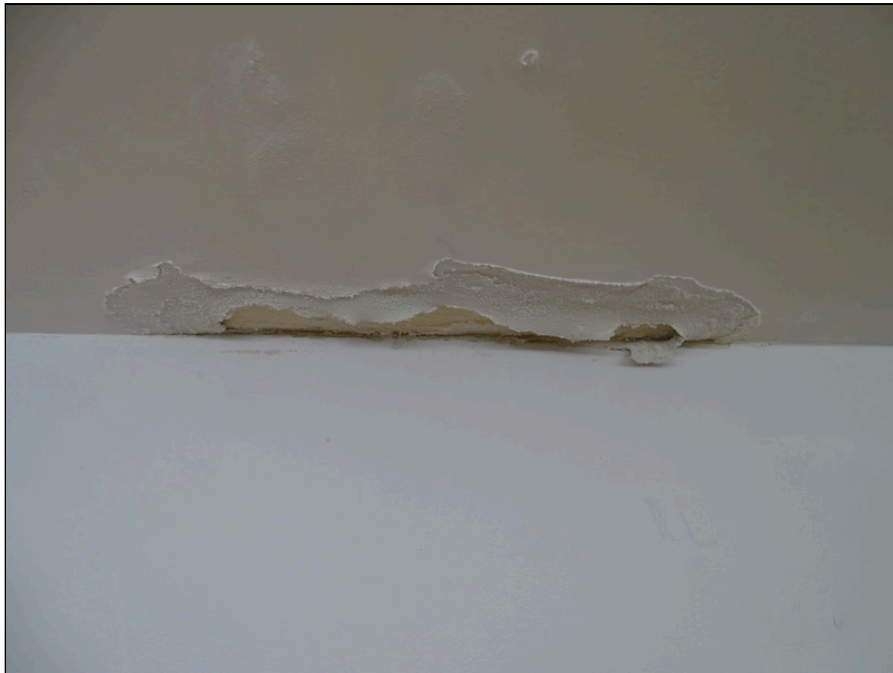
30 - Water leakage at ceiling

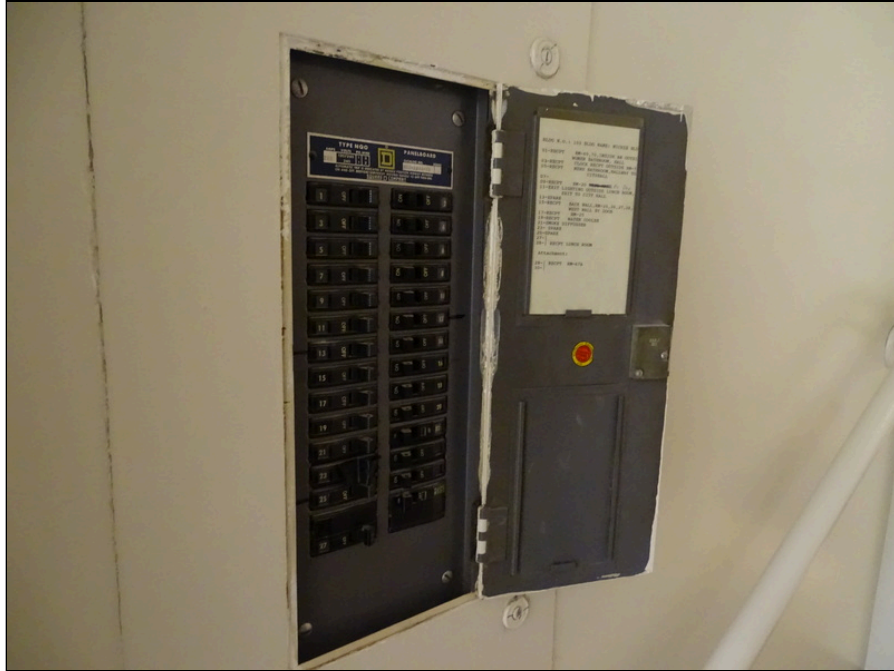
31 - Older circuit breaker panel

EUL	EFF AGE	RUL	Quantity	Unit	Unit Cost	Cycle Replace	Replace Percent	Year 1 2021	Year 2 2022	Year 3 2023	Year 4 2024	Year 5 2025	Year 6 2026	Year 7 2027	Year 8 2028	Year 9 2029	Year 10 2030	Year 11 2031	Year 12 2032	Year 13 2033	Year 14 2034	Year 15 2035	Year 16 2036	Year 17 2037	Year 18 2038	Year 19 2039	Year 20 2040	Total Cost
REPLACE OLDER CIRCUIT BREAKER PANELS	50	49	1	5	EA	\$1,000.00	\$5,000	100%	\$5,000																				\$5,000

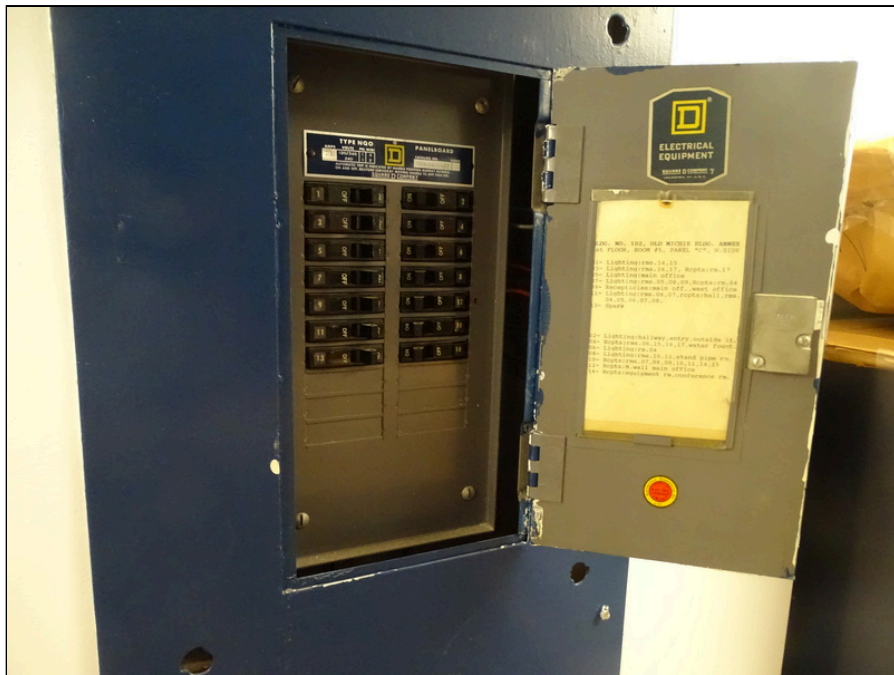
32 - Older circuit breaker panel

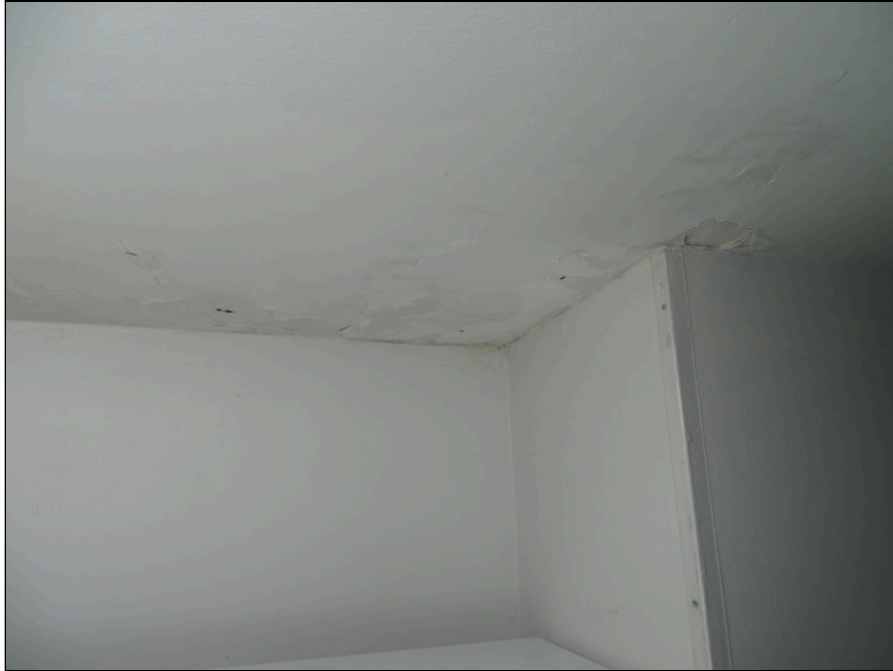
51 - Water leakage at ceiling

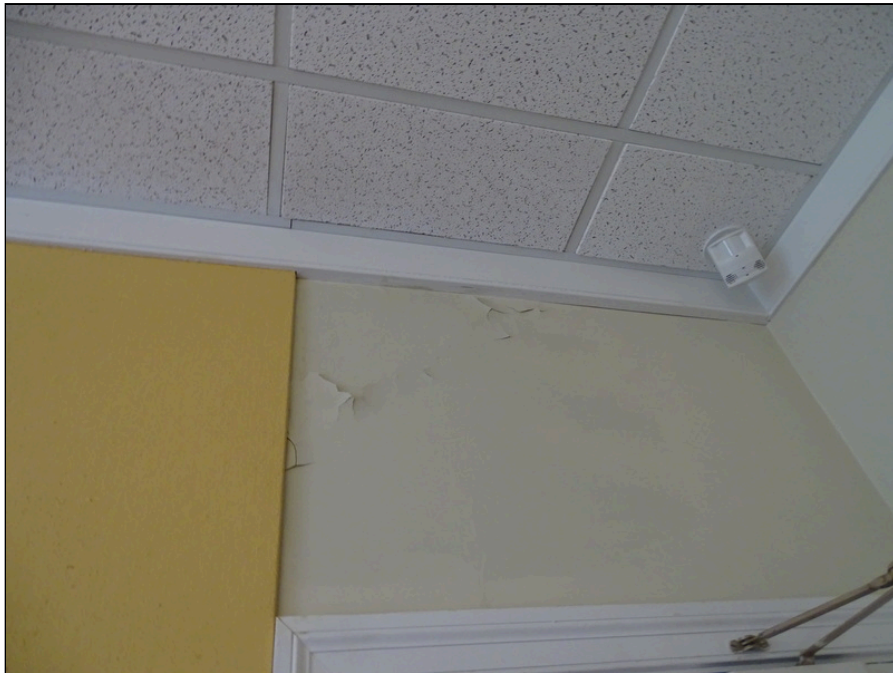
52 - Typical wall - note efflorescence

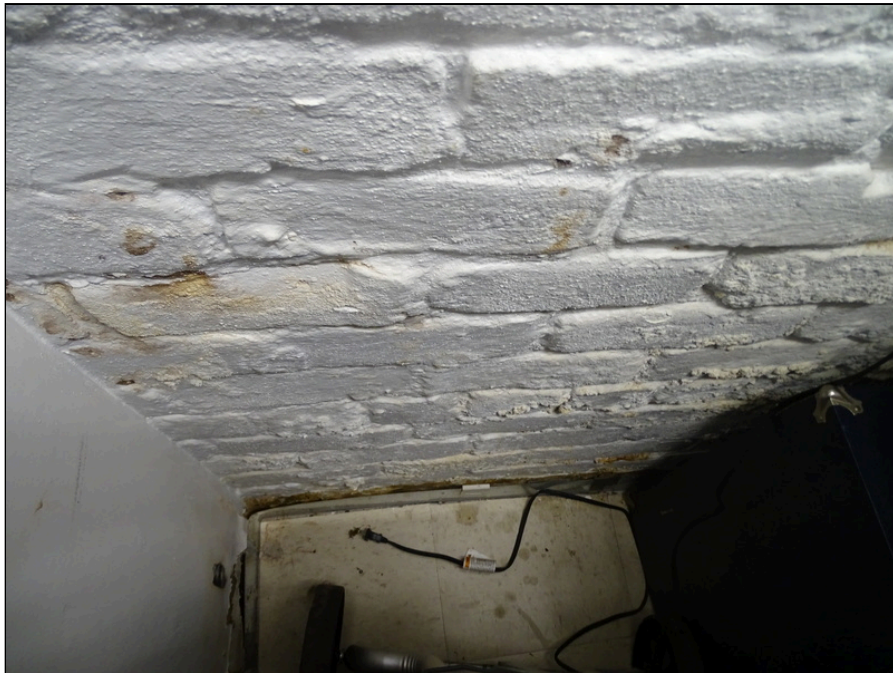
54 - Typical wall - note efflorescence

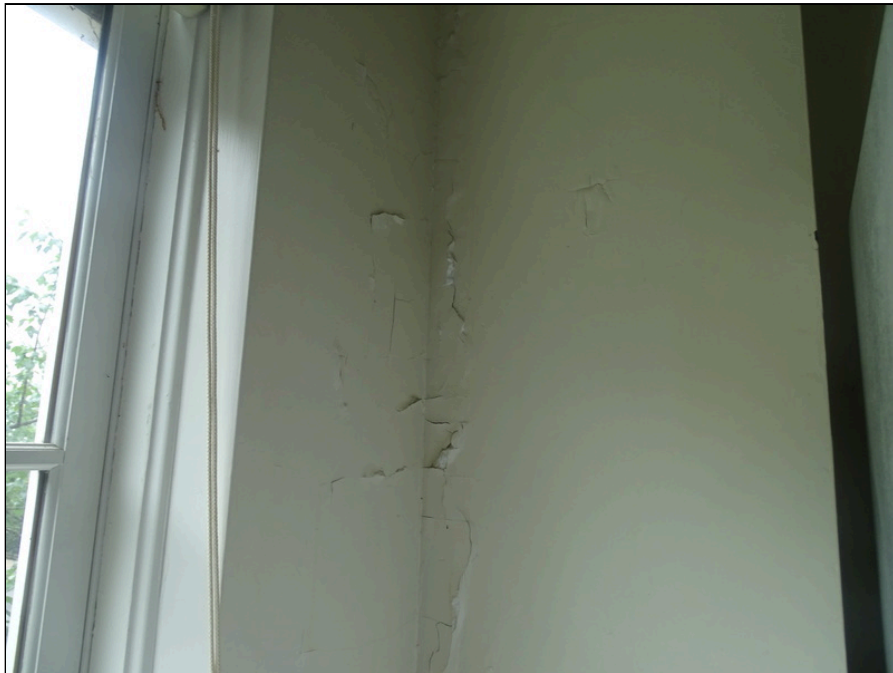
56 - Typical wall - note efflorescence
