PEN PARK COMPLEX
1300 PEN PARK ROAD
CHARLOTTESVILLE, VIRGINIA

ECS PROJECT NO. 46:6713

CITY OF CHARLOTTESVILLE - FACILITIES DEVELOPMENT

Reference: Facility Condition Assessment Report for Pen Park Complex, 1300 Pen Park Road,
Charlottesville, Virginia

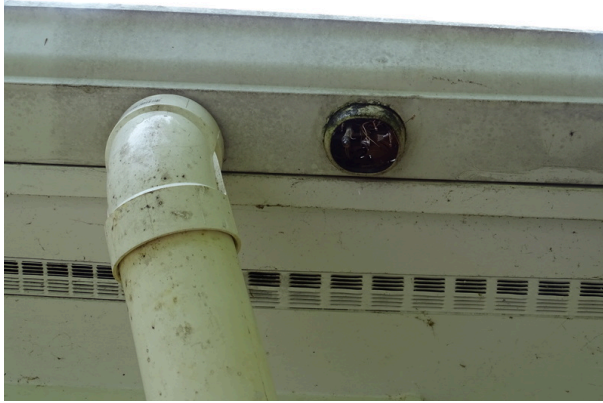
Gutter condition at pen park rest room area

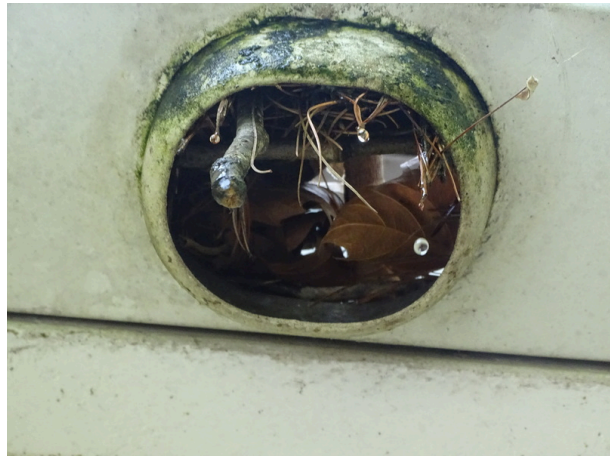
Gutter condition at pen park rest room area

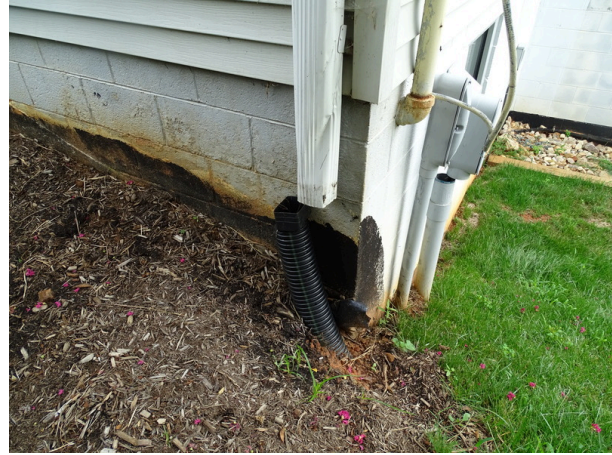
Division office typical downspout deterioration

We recommend re-attaching the corrugated pipe to the downspout at the office building.

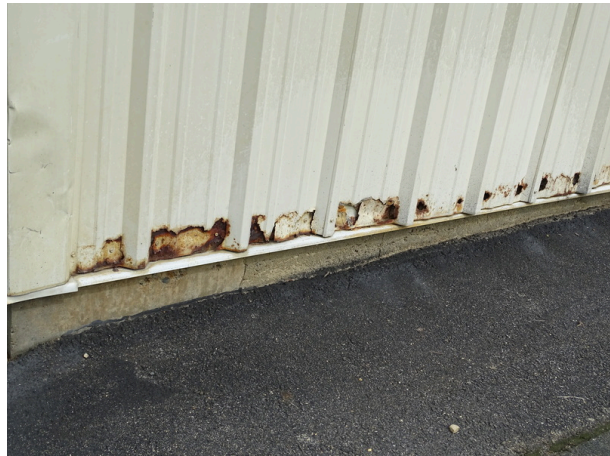
Parks Shop windows and corrosion at base of metal panels

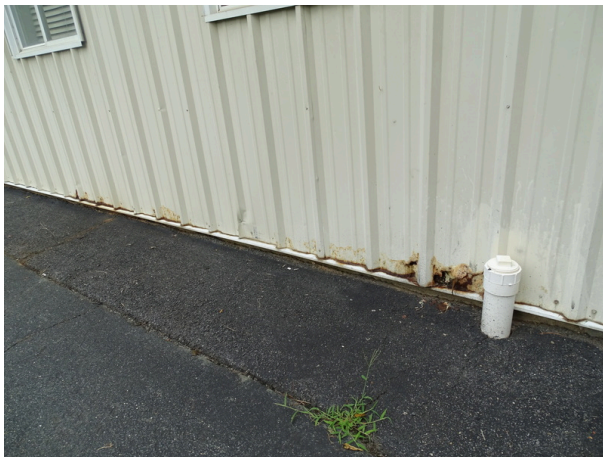
Parks Shop windows and corrosion at base of metal panels

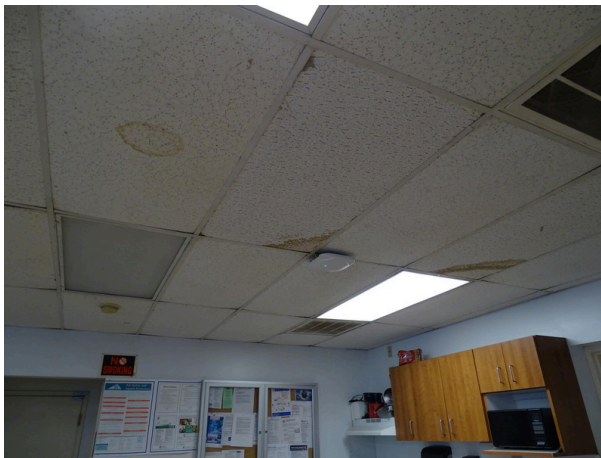
Parks Shop breakroom ceiling condition

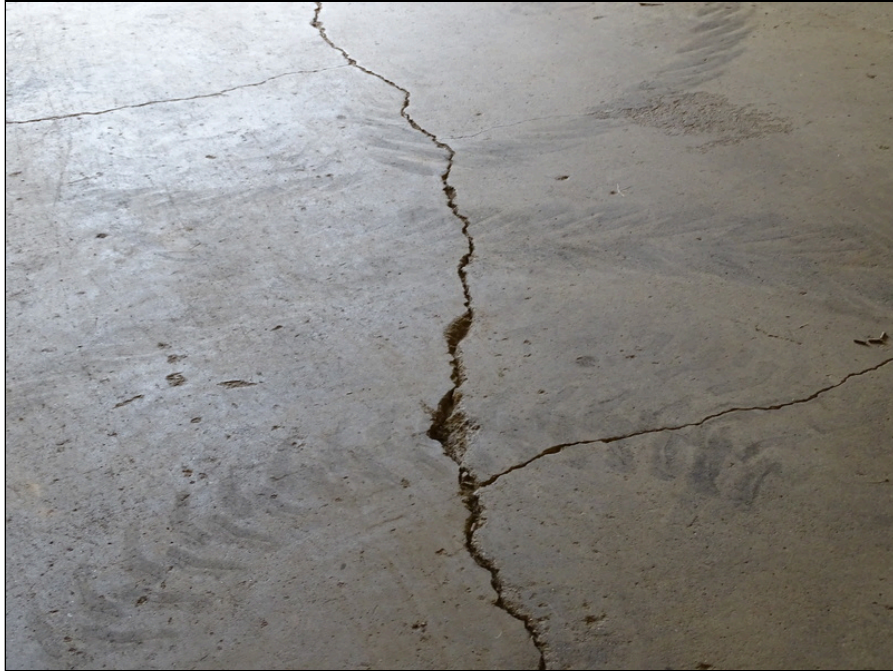
15 - Parks shop slab on-grade crack

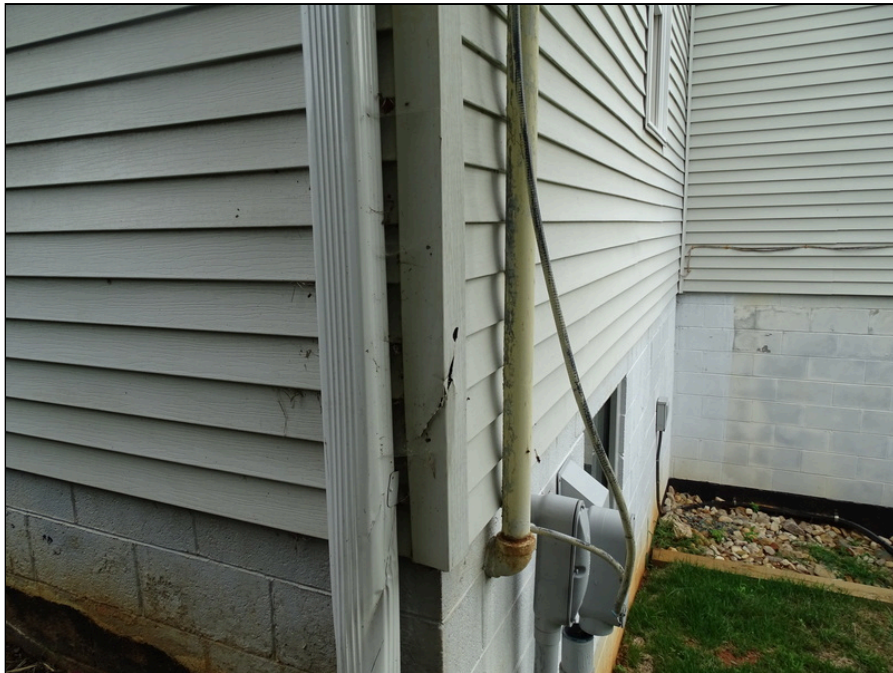
22 - Division Office damaged siding

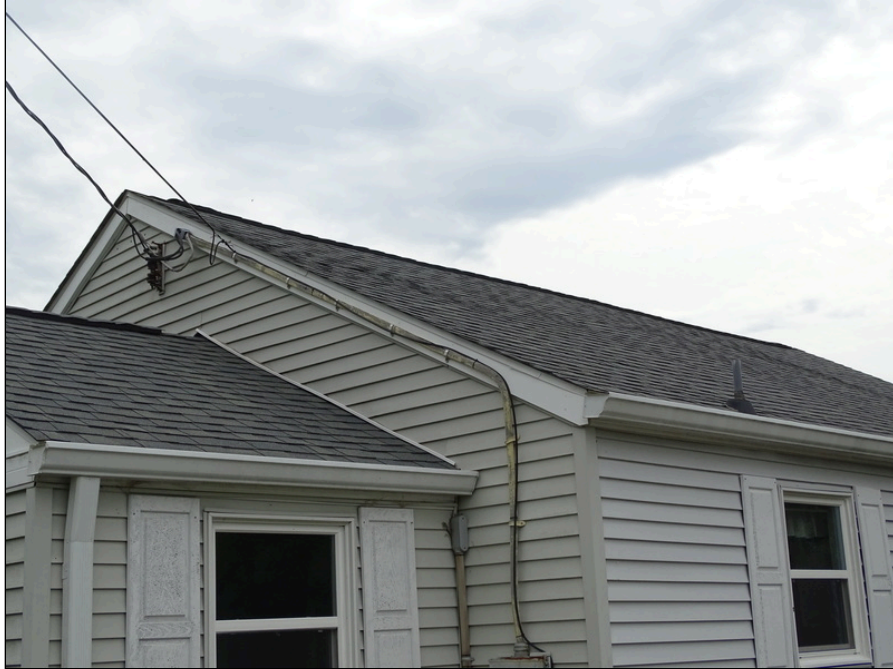
23 - Division office roof dent

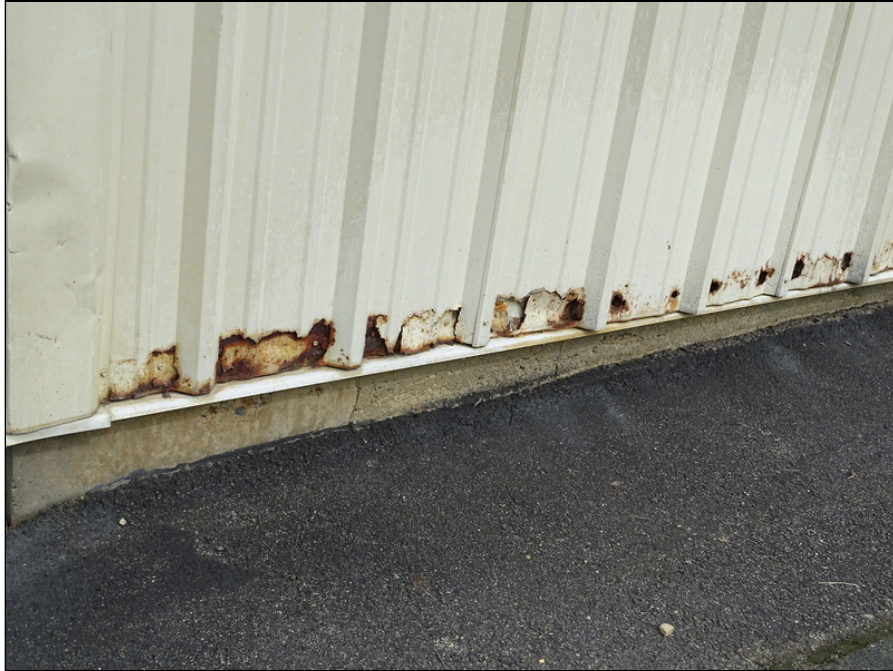
29 - Parks Shop windows and corrosion at base of metal panels

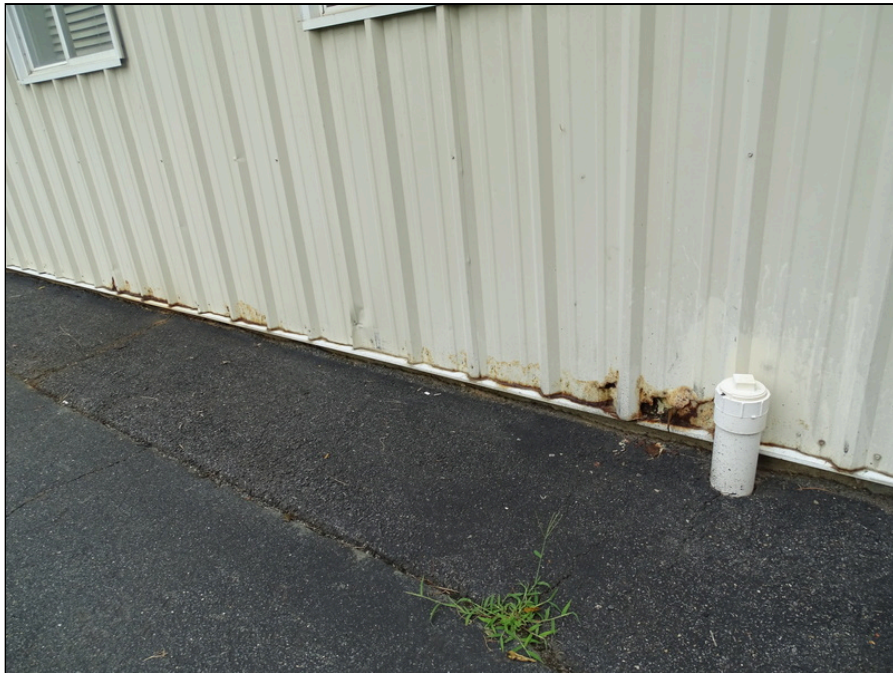
30 - Parks Shop windows and corrosion at base of metal panels

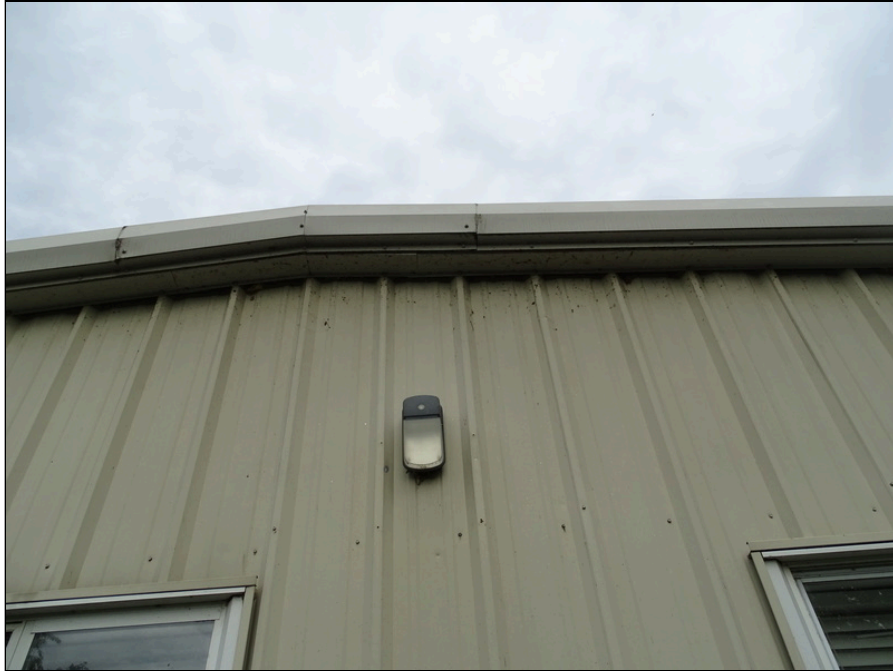
31 - Parks Shop gutter leak

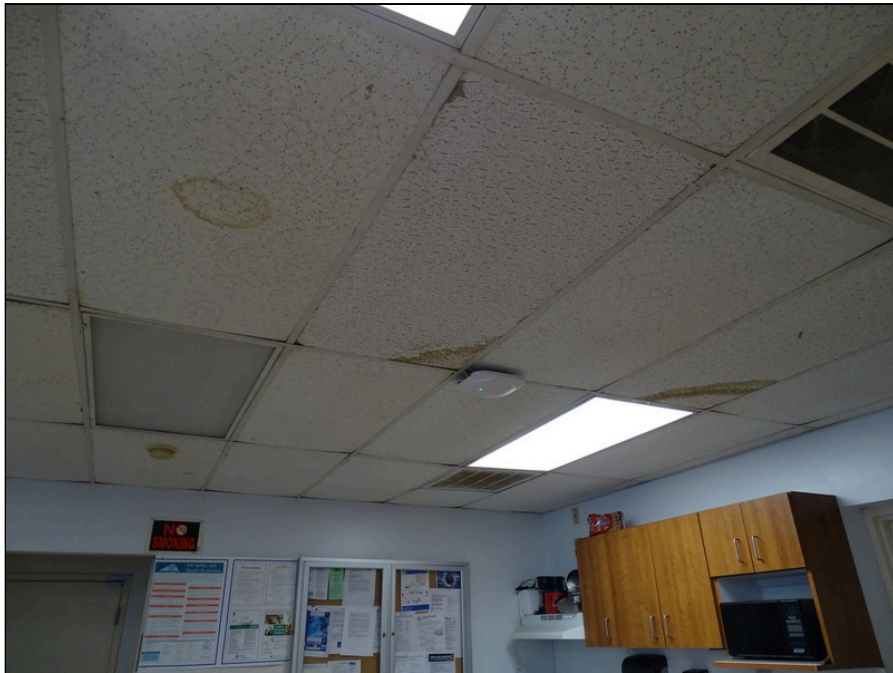
72 - Parks Shop breakroom ceiling condition

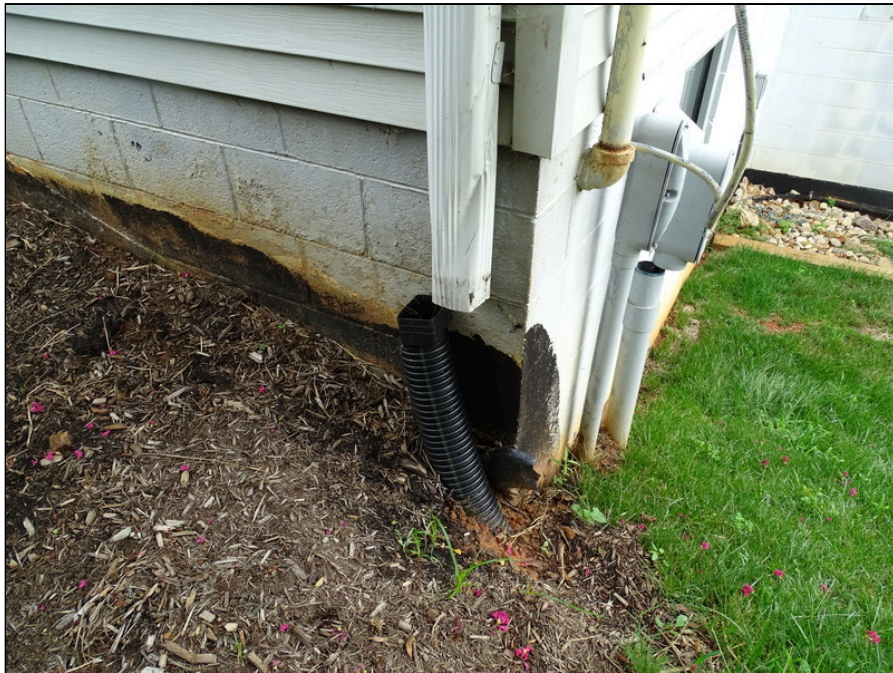
80 - Division office typical downspout deterioration
