PRESTON MORRIS BUILDING
407 EAST HIGH STREET
CHARLOTTESVILLE, VIRGINIA

ECS PROJECT NO. 46:6713

CITY OF CHARLOTTESVILLE - FACILITIES DEVELOPMENT

Reference: Facility Condition Assessment Report for Preston Morris Building, 407 East High Street, Charlottesville, Virginia

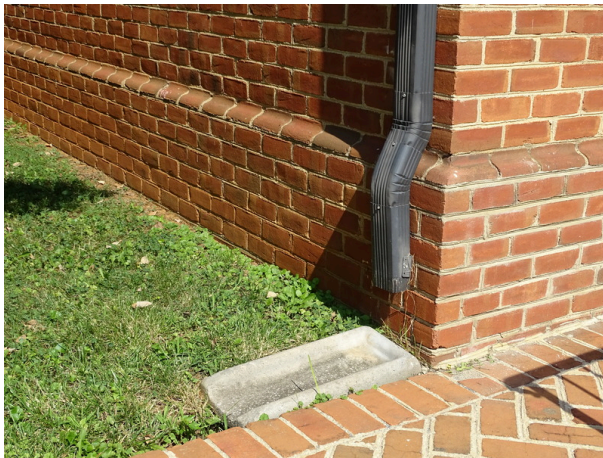
The storm water collection system includes a municipal system. Aluminum downspouts were observed to be damaged or missing elbows at their base. Downspouts should be repaired immediately to prevent water intrusion at foundation.

Downspout in south side of building

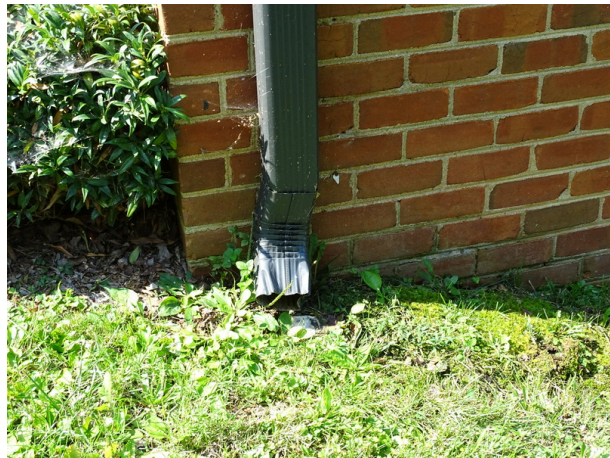
Building exterior north side of the building -
note downspout condition

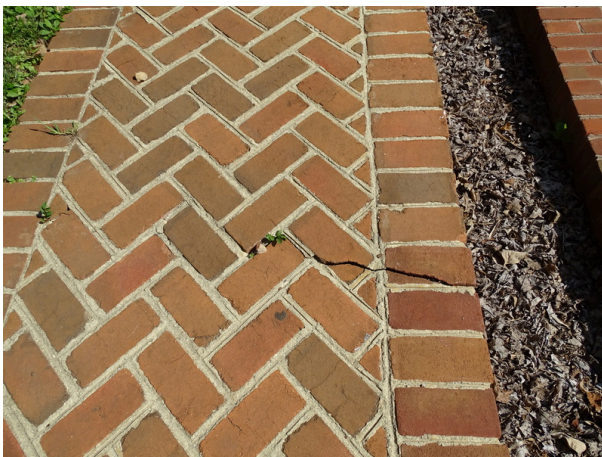
Cracked brick sidewalk at south side of building

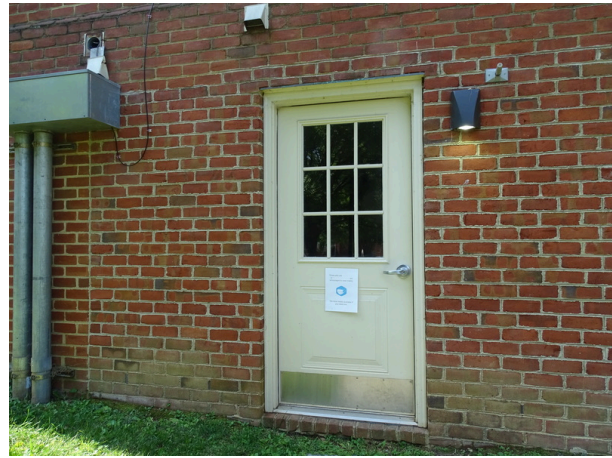
Building exterior north side of the building -
note deterioration

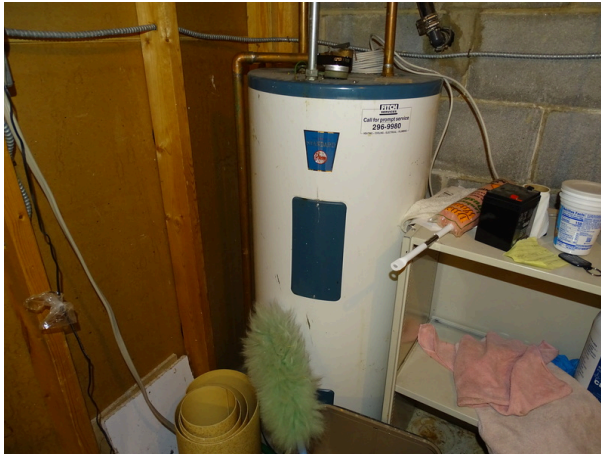
Domestic hot water to the building is provided by an Electric domestic water heater located in the basement. The Electric domestic water heater was manufactured by Rheem. The expected useful life of an Electric domestic water heater is approximately 12 to 15 years. We recommend the Electric domestic water heater be replaced during the report period.

Electric domestic water heater

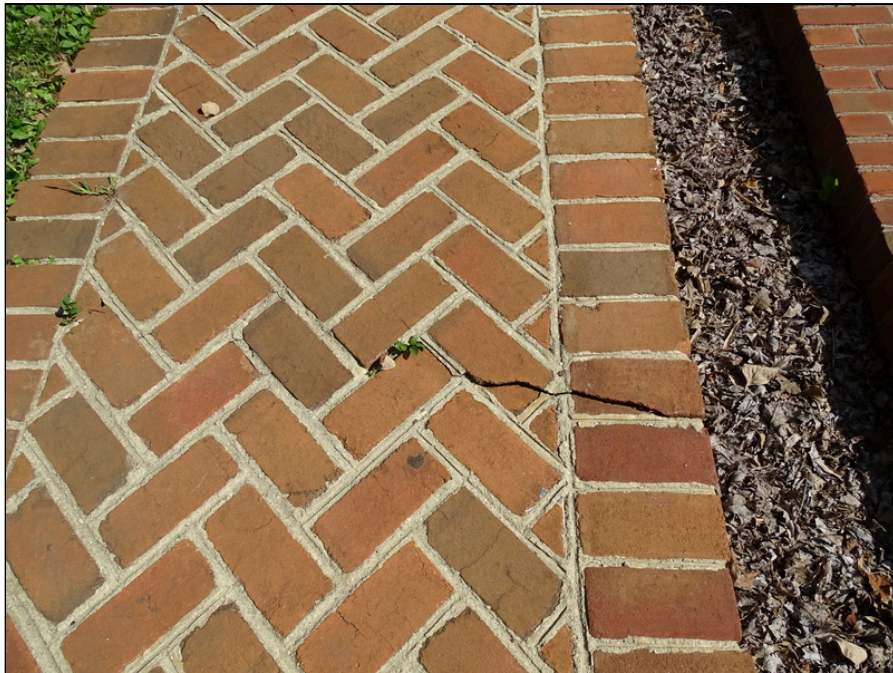
4 - Cracked brick sidewalk at south side of building

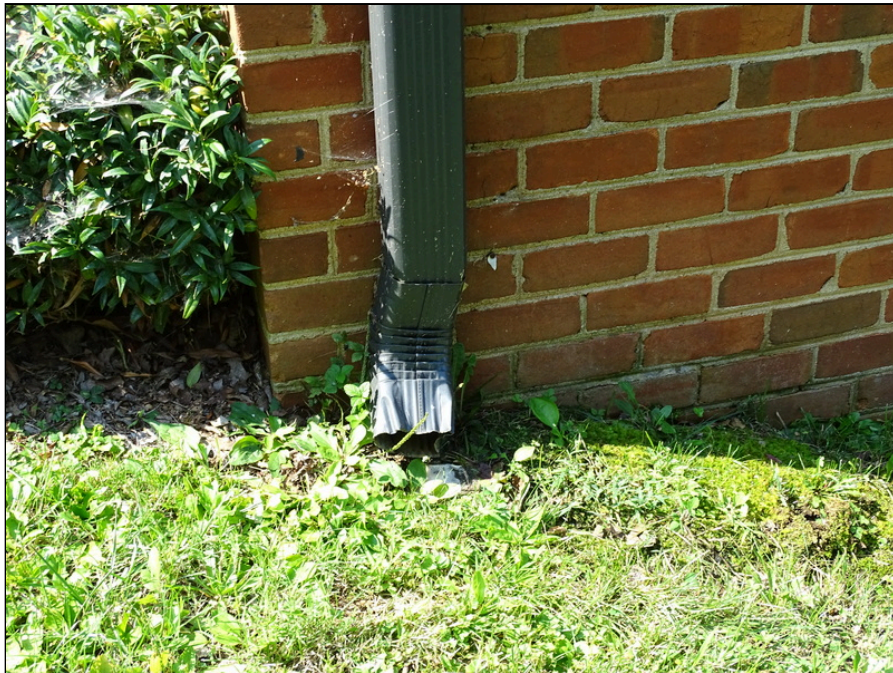
10 - Building exterior north side of the building - note downspout condition

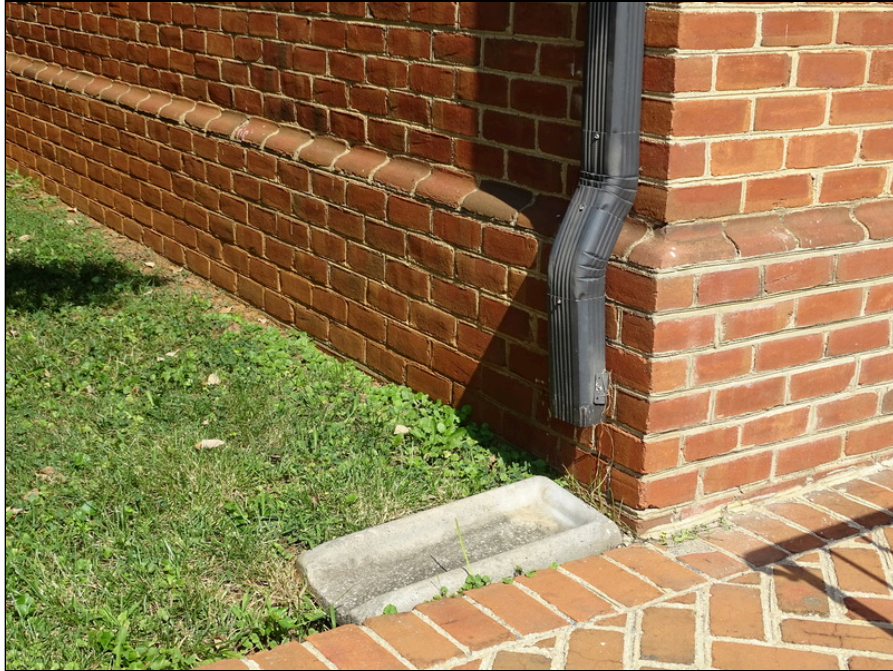
11 - Downspout in south side of building

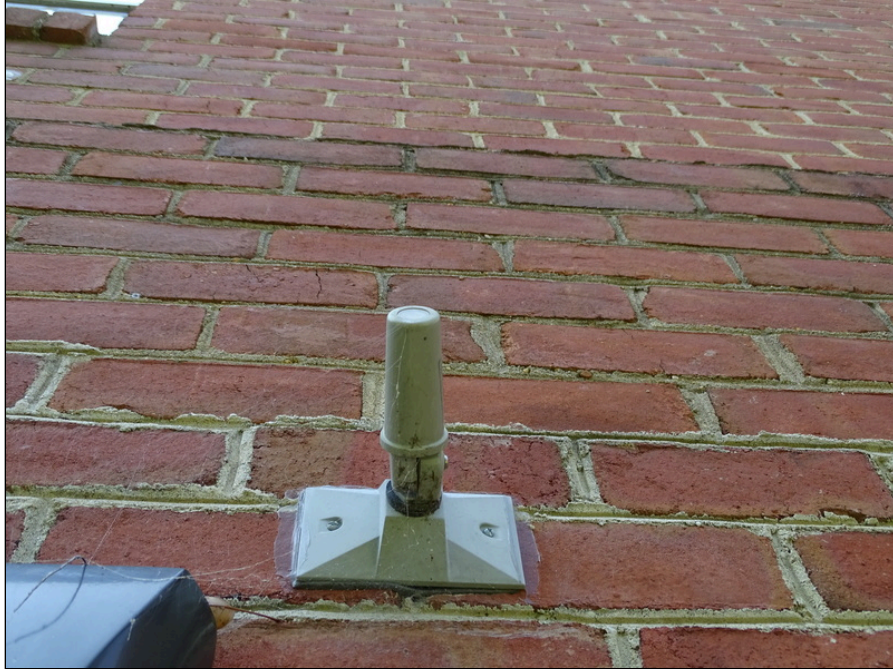
17 - Exterior wall condition on west side of building

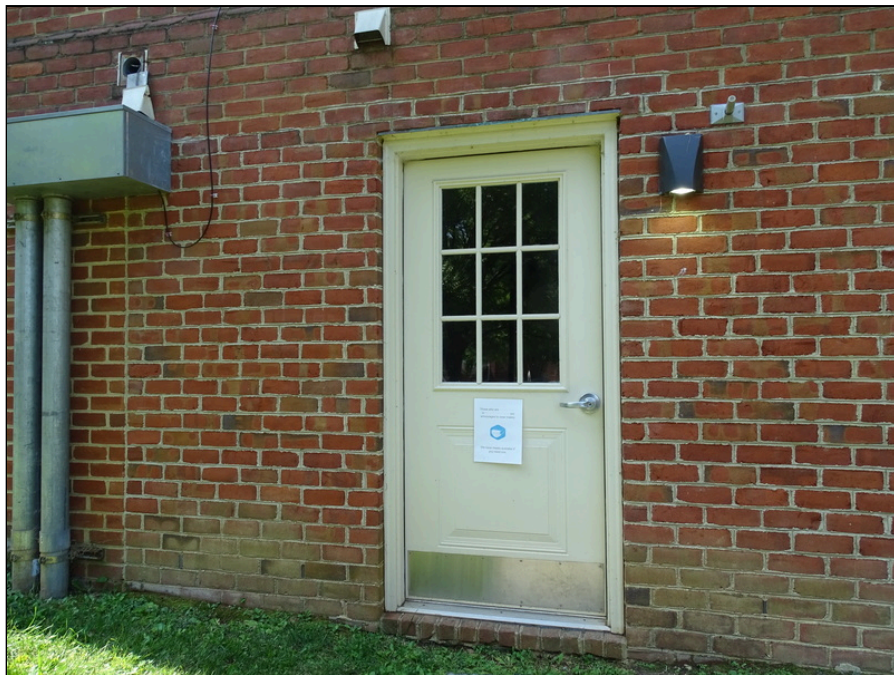
20 - Building exterior north side of the building - note deterioration
