PUBLIC WORKS ADMINISTRATION BUILDING
305 4TH STREET NW
CHARLOTTESVILLE, VIRGINIA

ECS PROJECT NO. 46:6713

CITY OF CHARLOTTESVILLE - FACILITIES DEVELOPMENT

Reference: Facility Condition Assessment Report for Public Works Administration Building, 305 4th Street NW, Charlottesville, Virginia

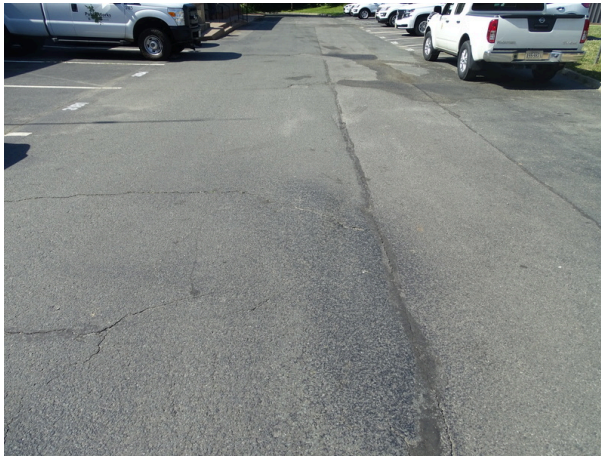
Asphalt-paved drive lanes are located on the north side of the site with drive lanes and parking located on the west and south sides of the building. The expected useful life of asphalt pavement is 20 years. The asphalt pavement was observed to be in generally fair condition.

Asphalt pavement drive lane and parking west side of the building

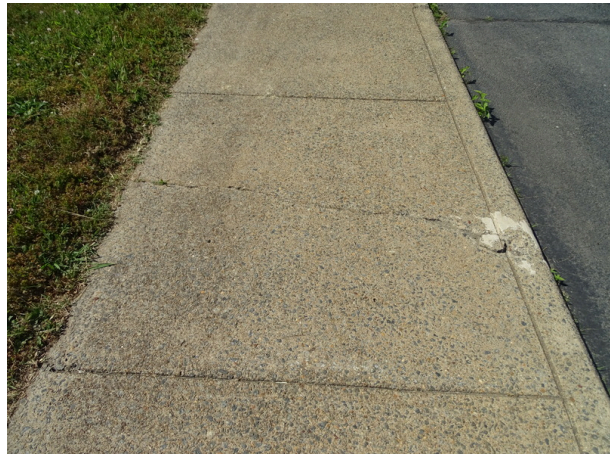
Typical concrete sidewalk - note cracking

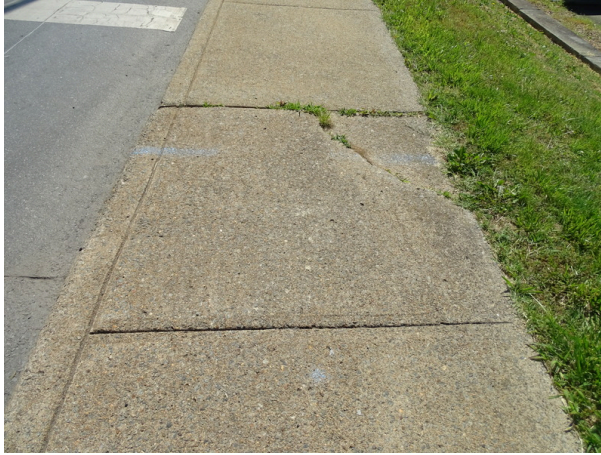
Typical concrete sidewalk - note cracking

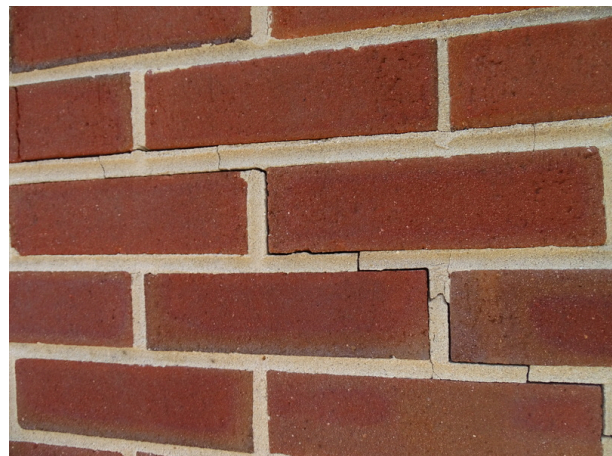
Typical building exterior - note step cracking and deterioration of mortar

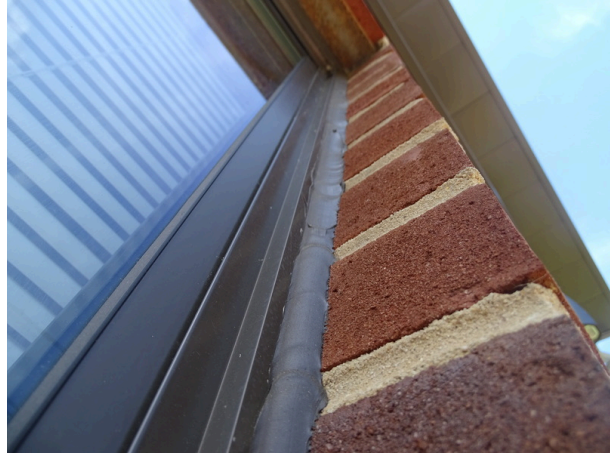
Exterior sealants are located around the window and door frames. The expected useful life of exterior sealants is approximately 10 to 12 years before replacement is needed. The exterior sealants were generally in fair condition. We recommend that the exterior sealants be replaced.

Typical exteriors - note sealant deterioration

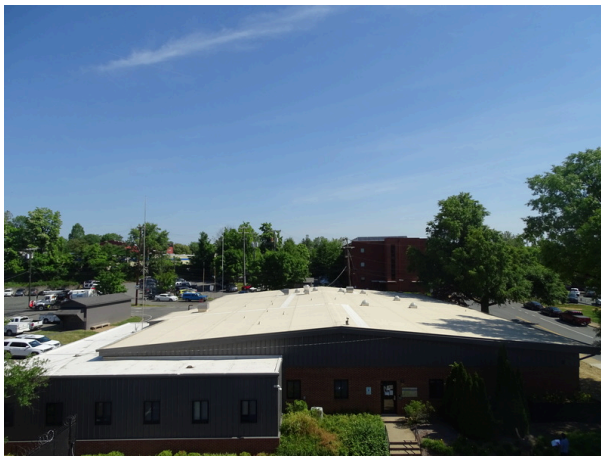
The main roofing system consists of single-ply sheet membrane roofing system. The roofing system was reportedly replaced in 2015. Drainage for the roofing system is provided by both gutters and downspouts and internal drains. The drainage was observed to be in generally good condition. The expected useful life of the roofing systems is generally 15 years. Based on the reported age of the roofing system, we recommend scheduled replacement during the study period.

Roofing system east and west side of the building looking north

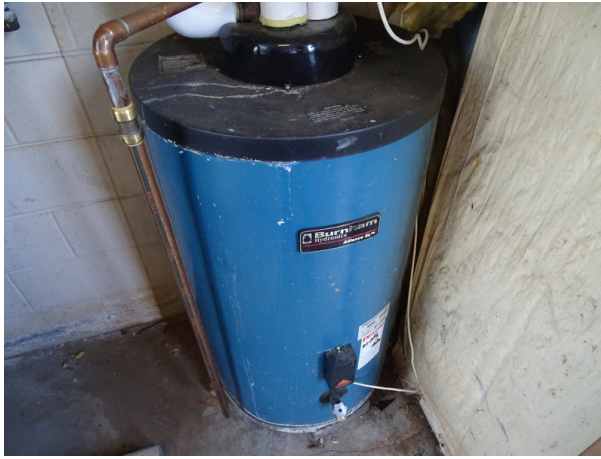
Domestic hot water to the building is provided by a 35-gallon storage tank connected to the boiler system domestic hot water supply located in the main utility room installed in 2009. The boiler system domestic hot water supply was manufactured by Burnham. The expected useful life of a storage tank connected to the boiler system domestic hot water supply is approximately 12 years. We recommend replacing the storage tank connected to the boiler system domestic hot water supply be replaced during the report period.

Boiler system domestic hot water supply

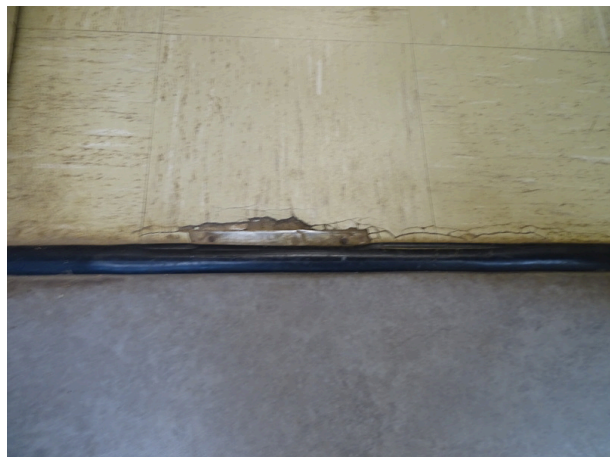
Interior finishes of restroom area - note
deterioration

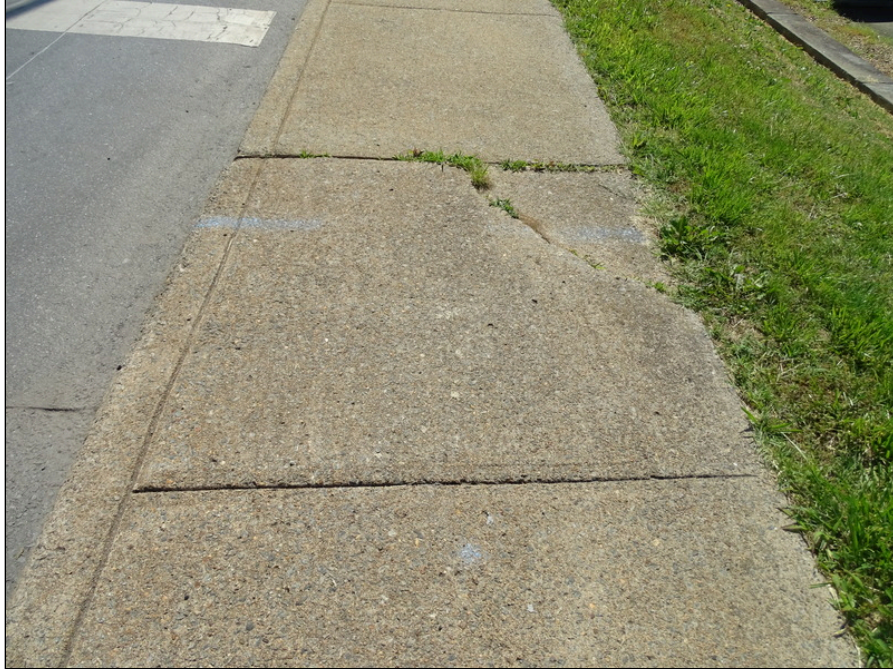
11 - Typical concrete sidewalk - note cracking

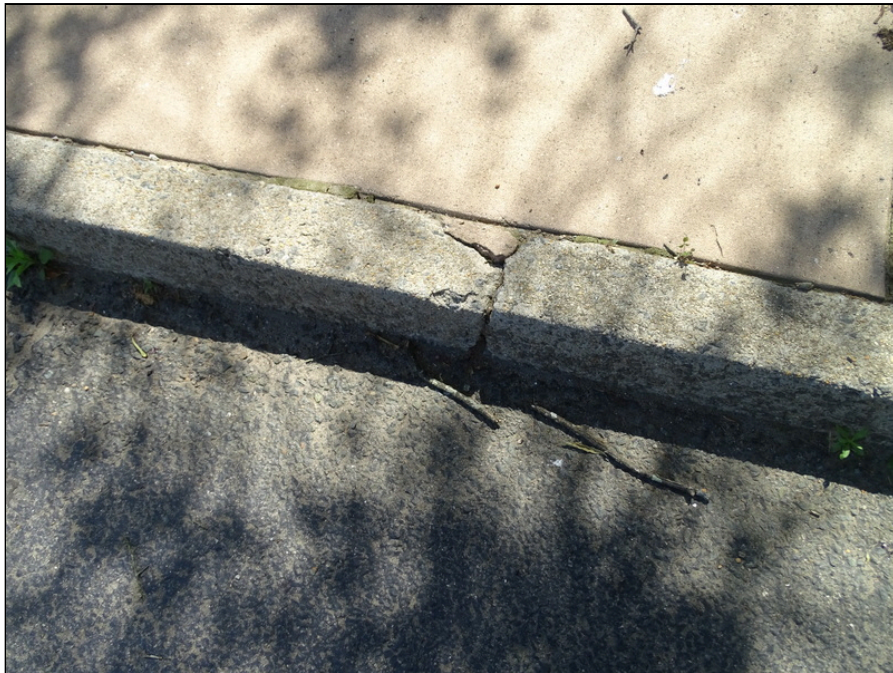
12 - Typical concrete sidewalk - note cracking

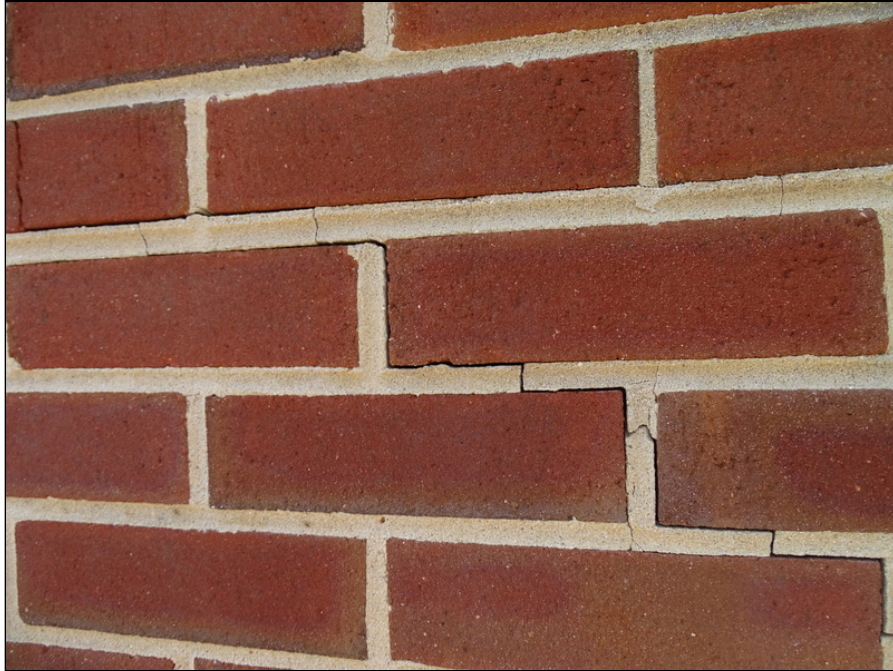
25 - Typical building exterior - note step cracking and deterioration of mortar

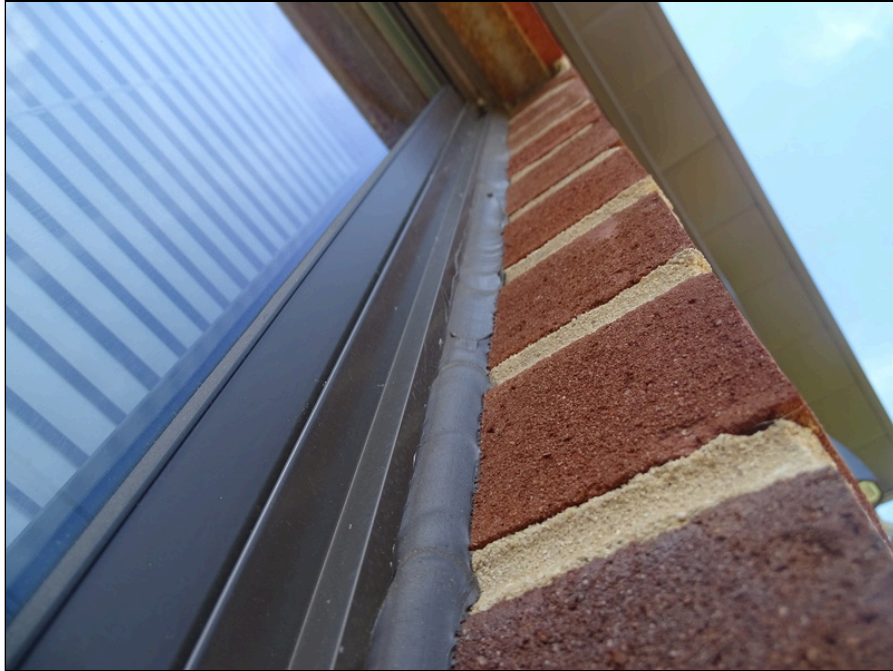
29 - Typical exteriors - note sealant deterioration

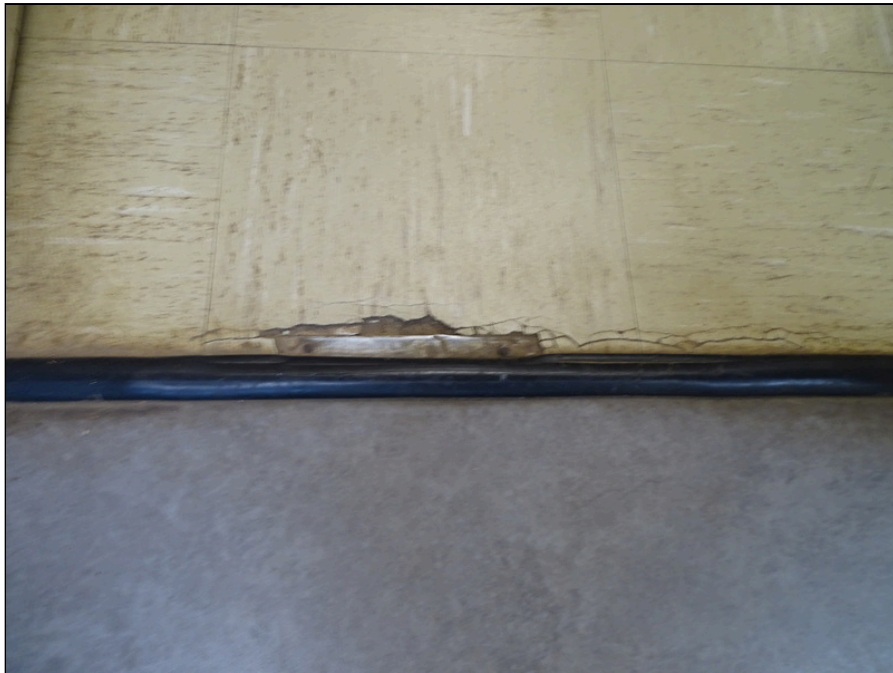
60 - Interior finishes of restroom area - note deterioration
