SCHOOL BUS YARD & FUEL STATION
1505 AVON STREET EXT
CHARLOTTESVILLE, VIRGINIA

ECS PROJECT NO. 46:6713

CITY OF CHARLOTTESVILLE - FACILITIES DEVELOPMENT

Reference: Facility Condition Assessment Report for School Bus Yard & Fuel Station, 1505 Avon Street Ext, Charlottesville, Virginia

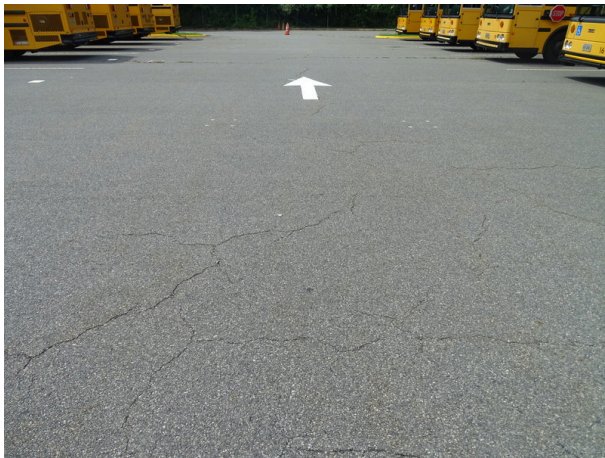
Cracking in bus lot asphalt

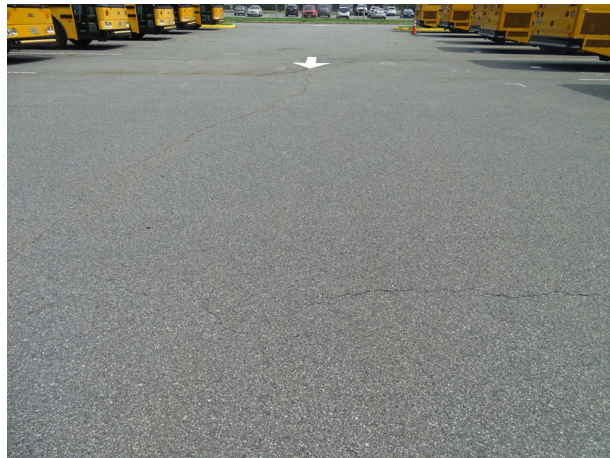
Cracking in bus lot asphalt

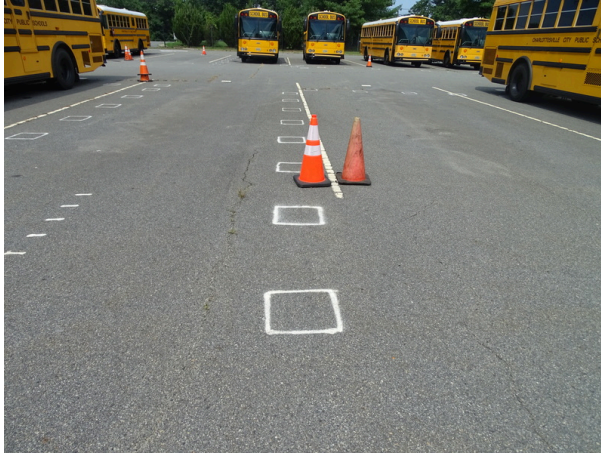
Cracking in bus lot asphalt

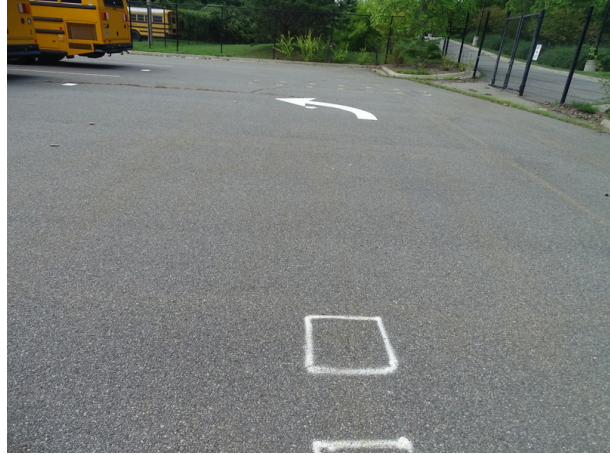
Cracking and surface markings in bus lot asphalt

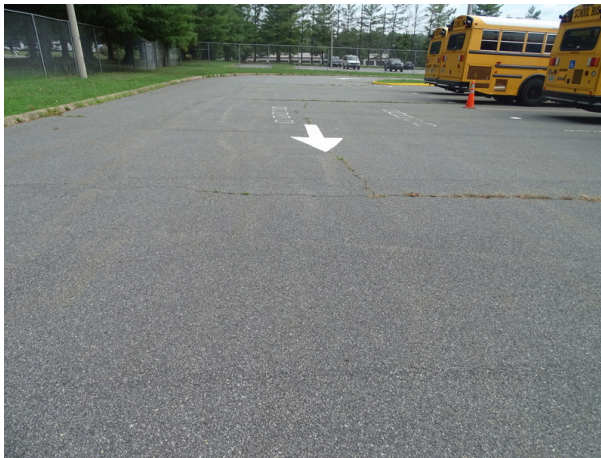
The concrete curbs surrounding the parking areas were generally in fair condition, with cracking and vegetation growth noted. We recommend removing the growth, monitoring the cracking, and replace as needed along with the sidewalk repairs noted later in the report.

Cracking asphalt and curb

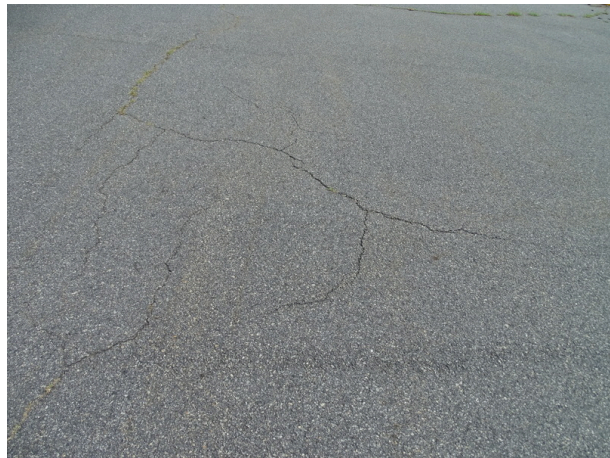
Cracking in bus lot asphalt

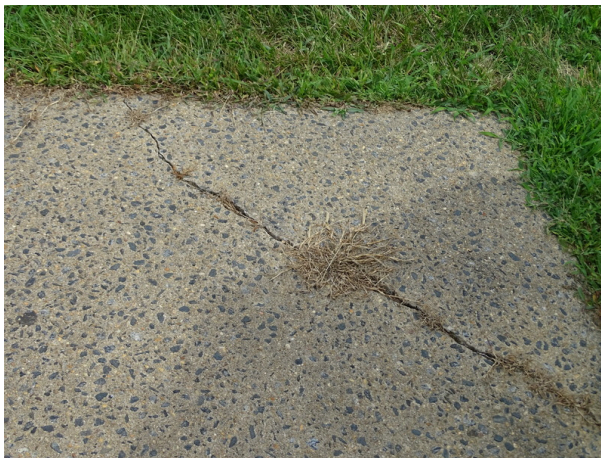
Cracked concrete sidewalk

Cost Recommendation	EUL	EFF AGE	RUL	Year	Cost
REPLACE CONCRETE SIDEWALK AND CURB	30	29	1	1	\$5,000
Total					\$5,000

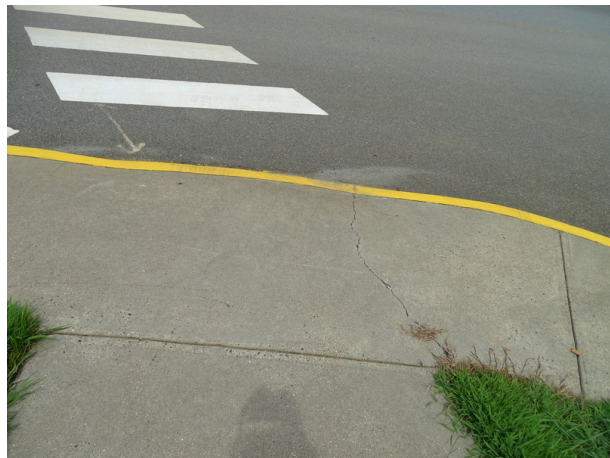
Cracked sidewalk

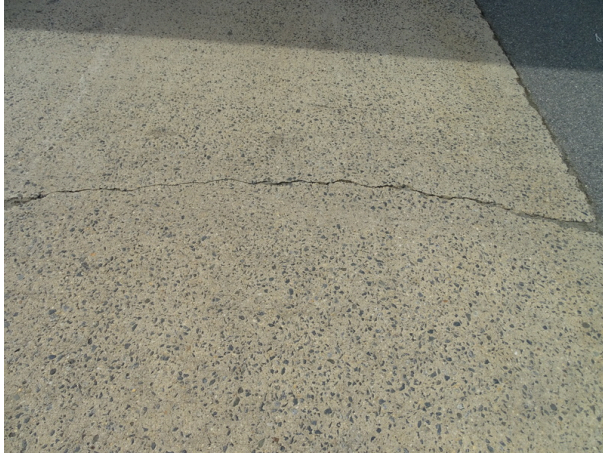
Cracked concrete sidewalk

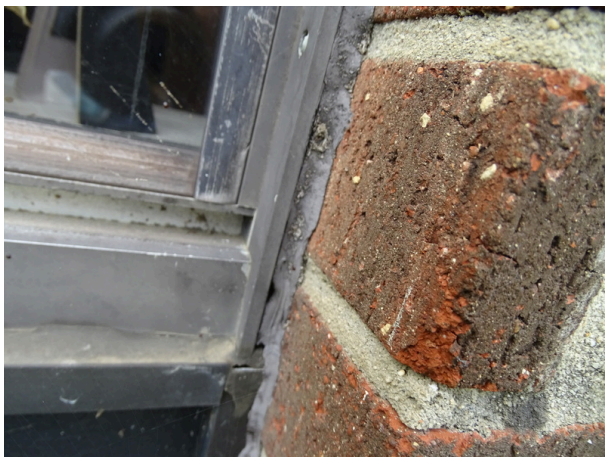
Sealant around window

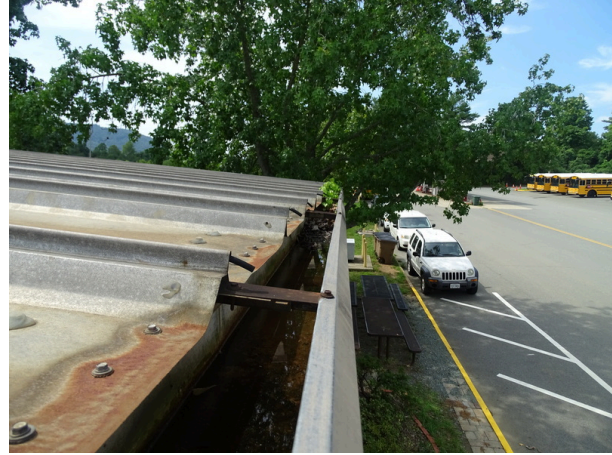
Vegetative growth was observed in the gutters. We recommend regular maintenance and cleaning of the gutters.

Metal gutter condition

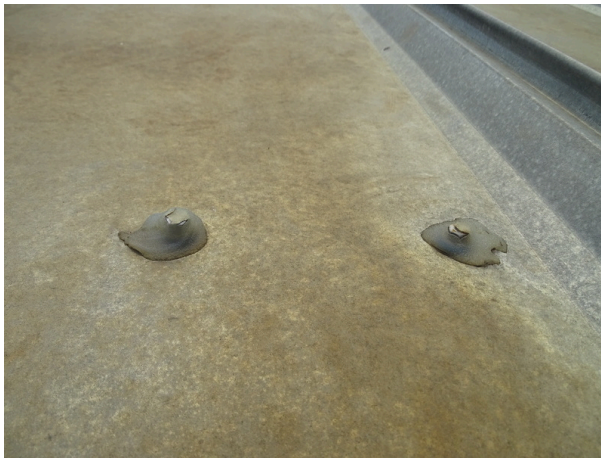
Previous repair on roof top

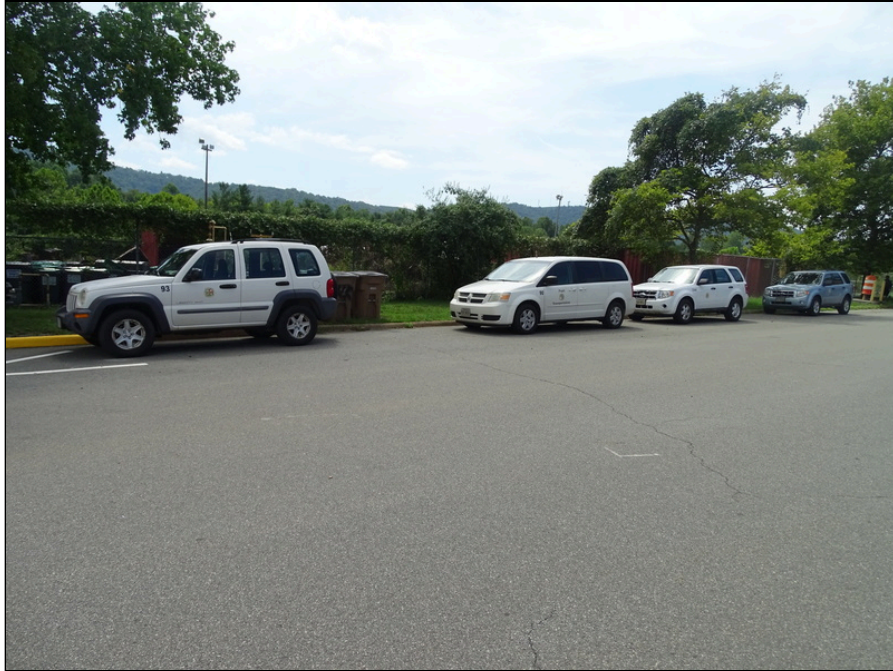
5 - Cracking in bus lot asphalt

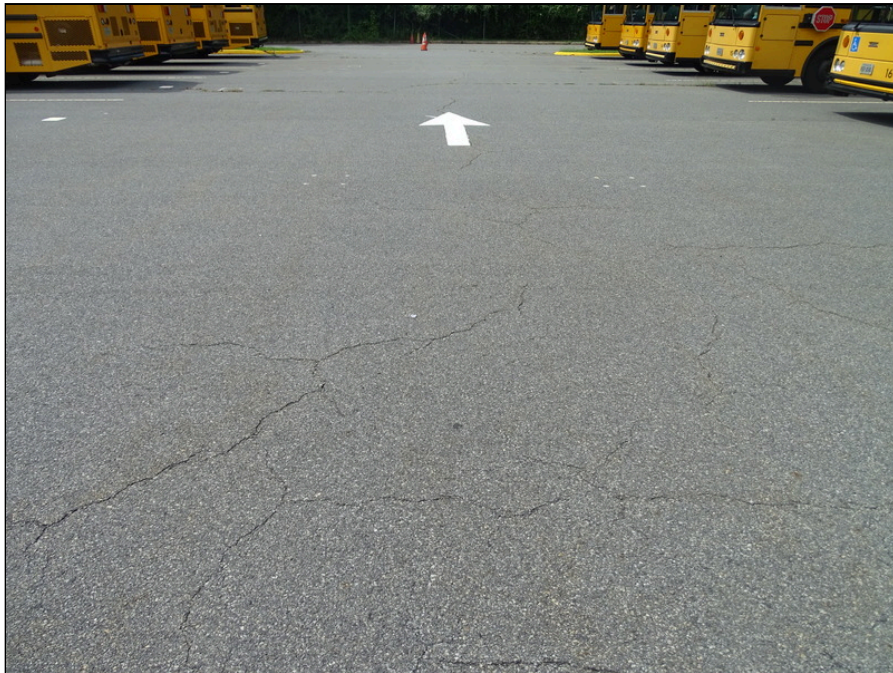
8 - Cracking in bus lot asphalt

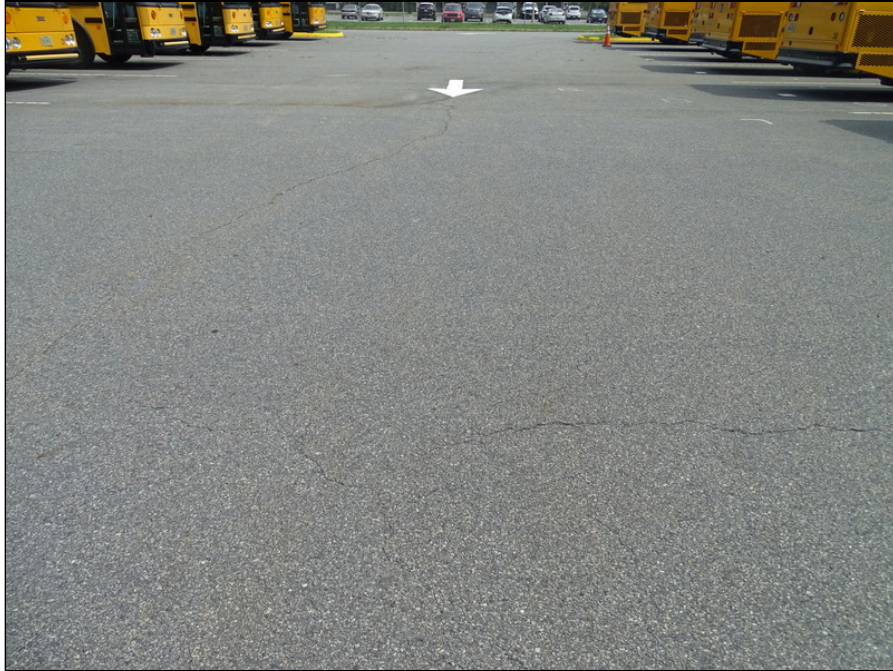
9 - Cracking in bus lot asphalt

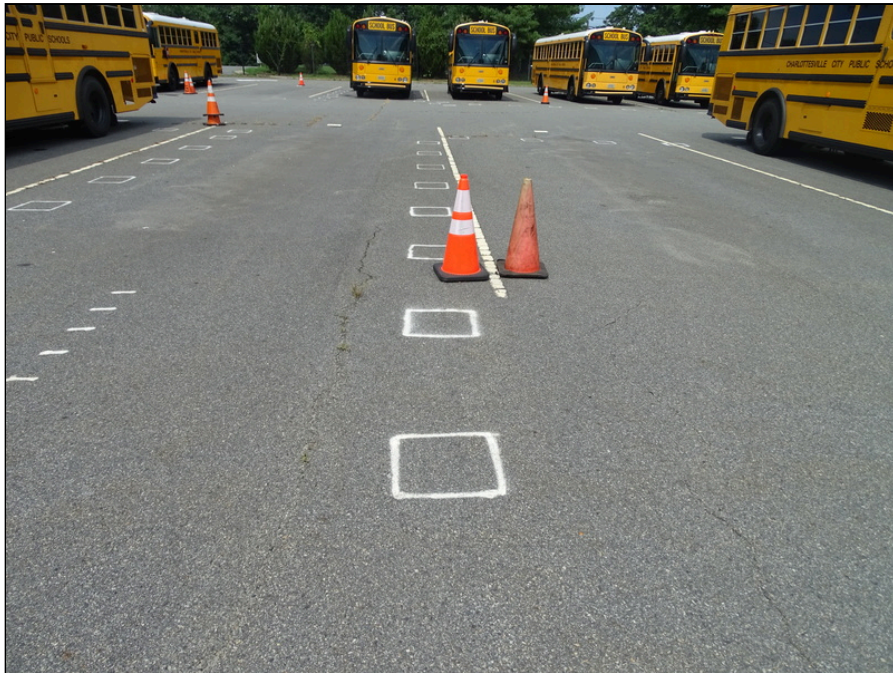
10 - Cracking in bus lot asphalt

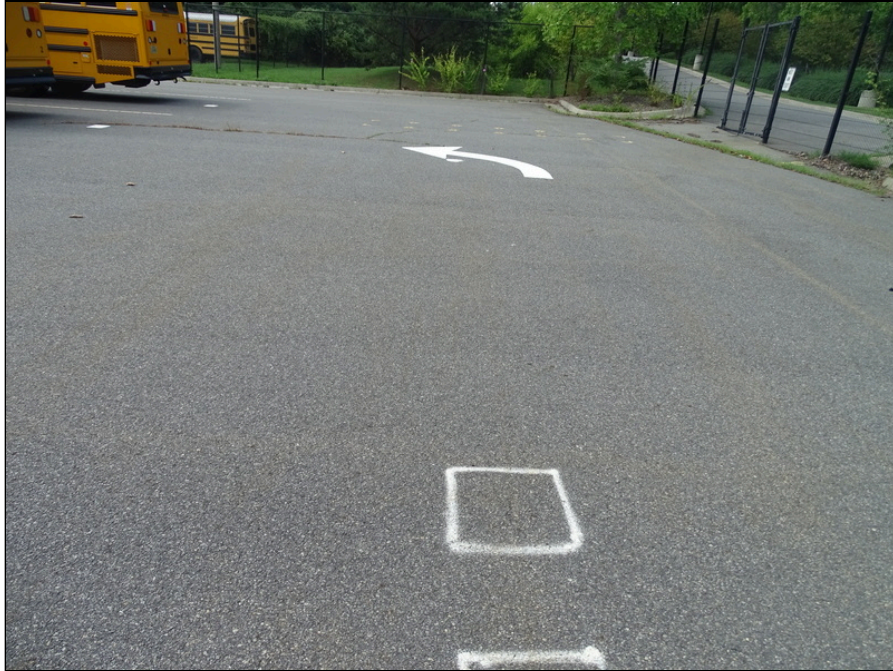
11 - Cracking and surface markings in bus lot asphalt

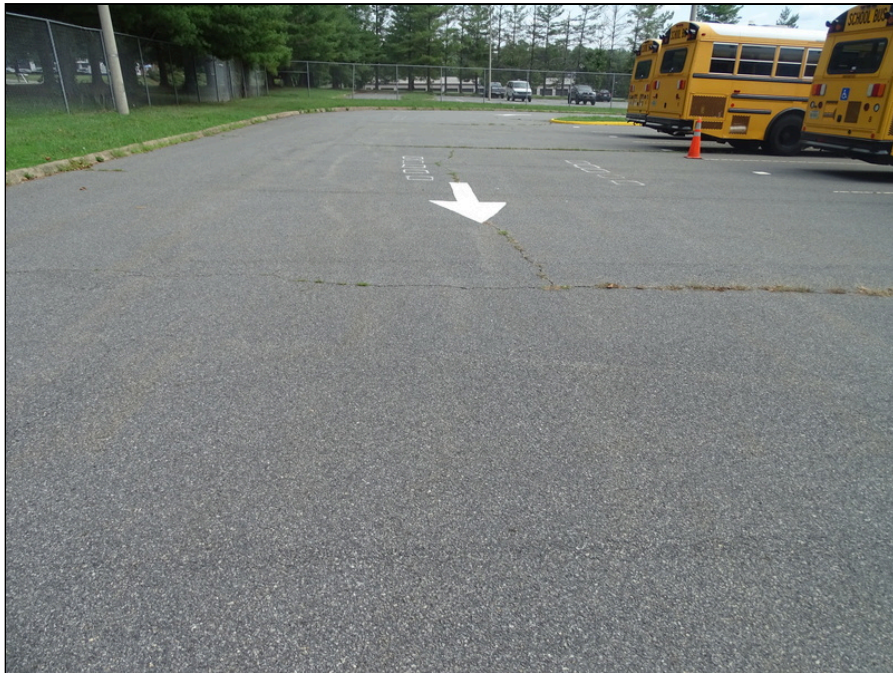
12 - Cracking in bus lot asphalt

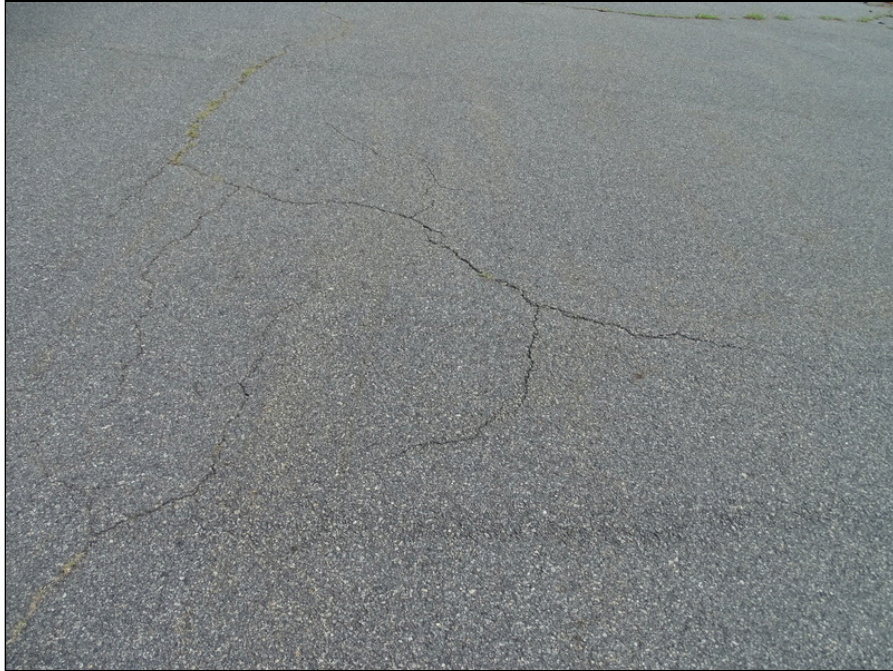
13 - Cracking in bus lot asphalt

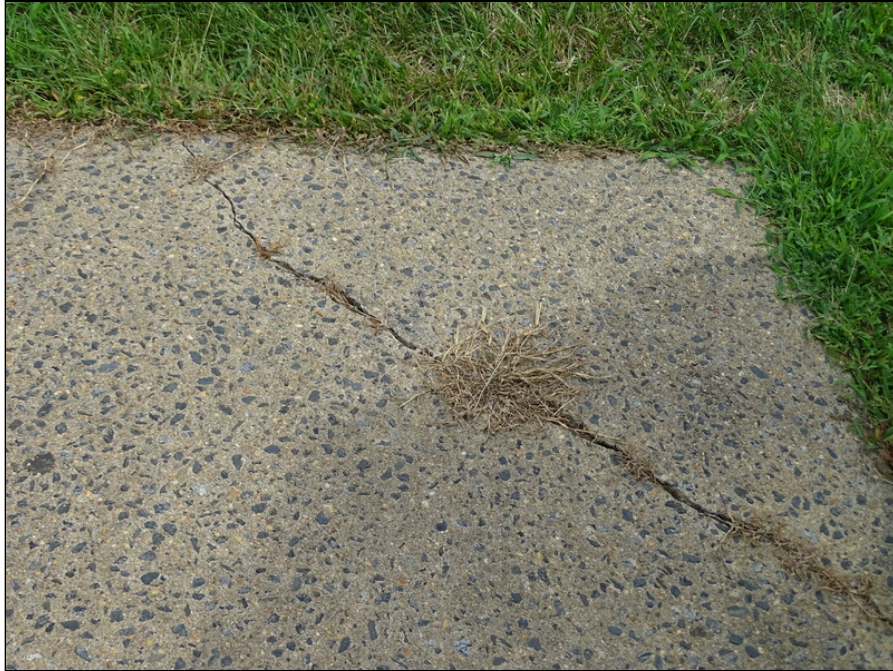
15 - Cracked concrete sidewalk

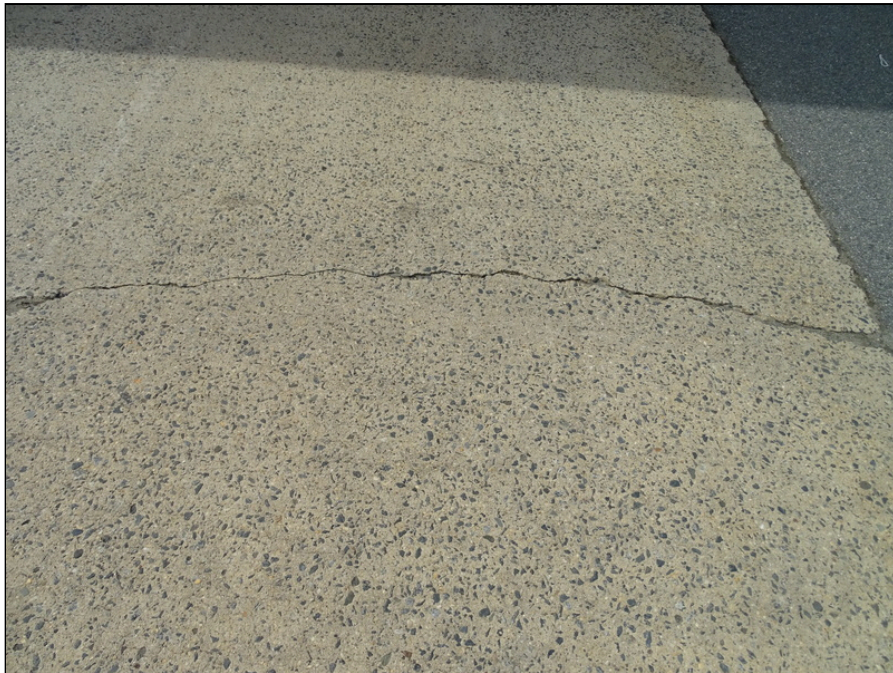
16 - Cracked concrete sidewalk

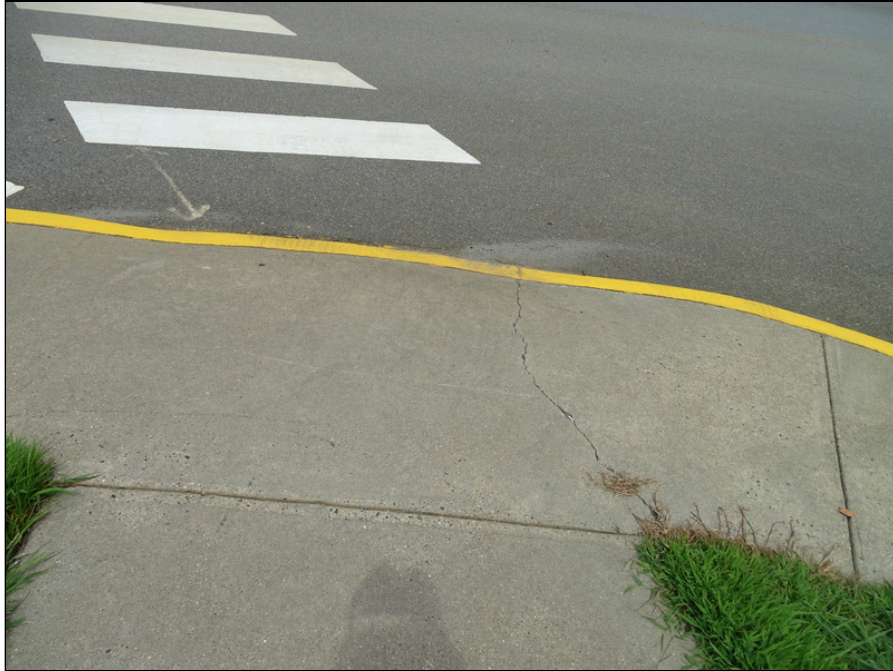
17 - Cracked sidewalk curb ramp

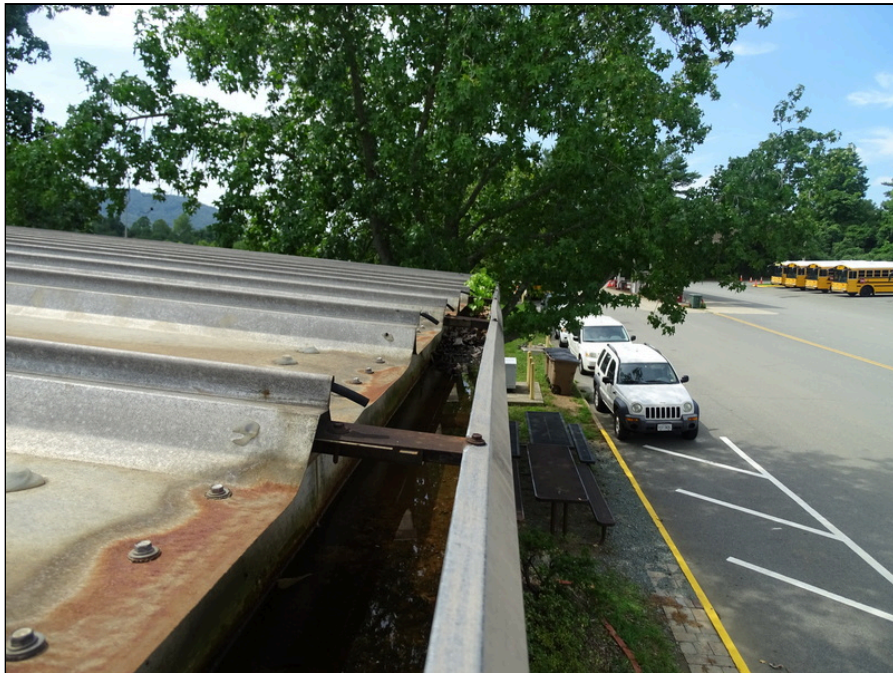
28 - Metal gutter condition

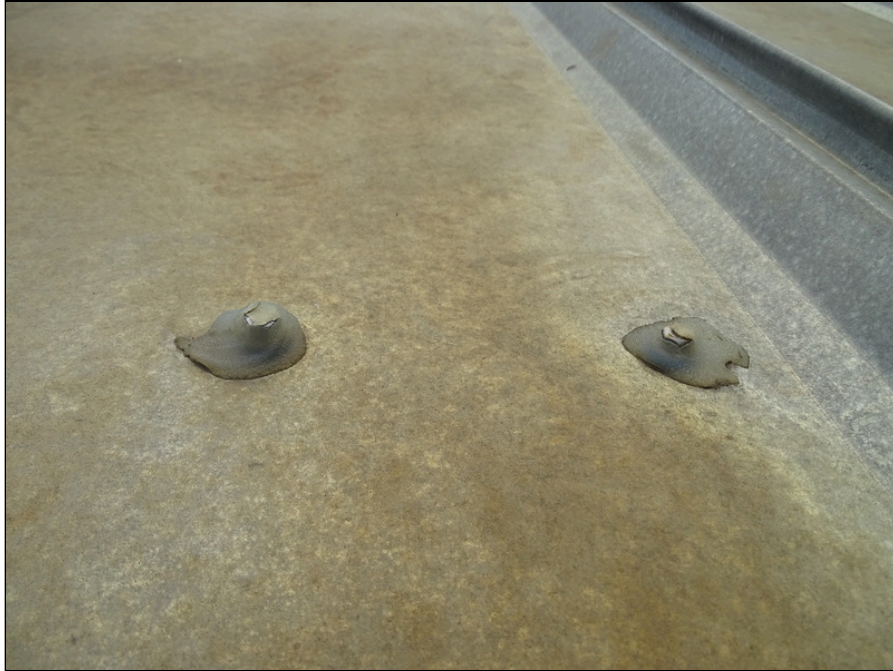
29 - Previous repair on roof top

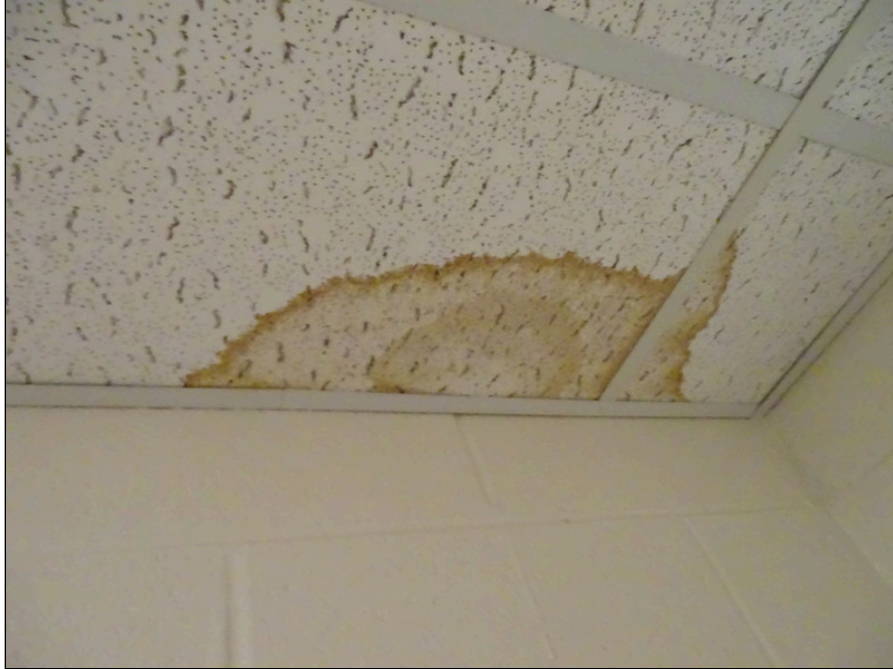
31 - Stained ceiling panel interior

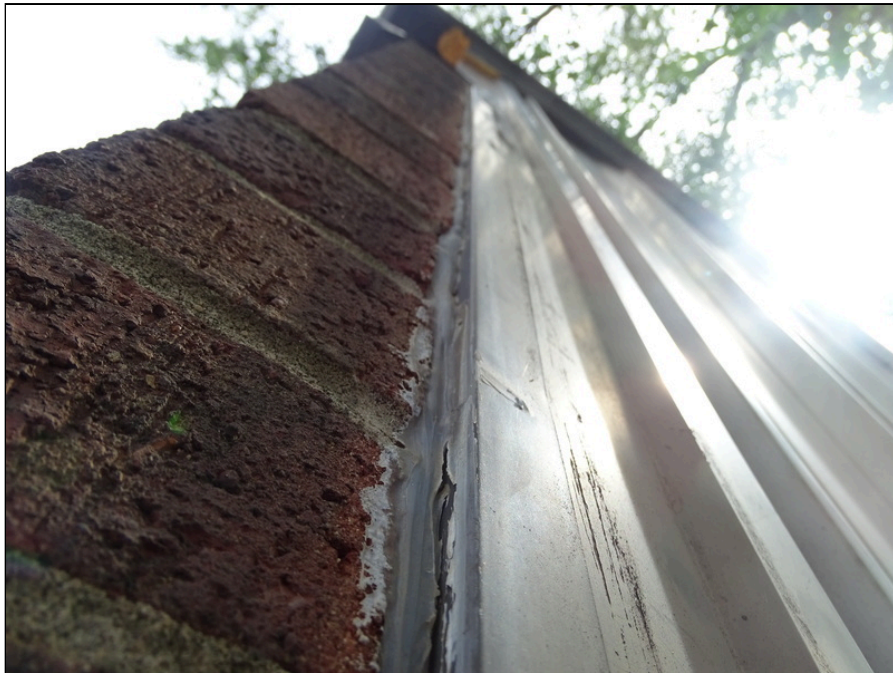
36 - Sealant condition around metal siding wall

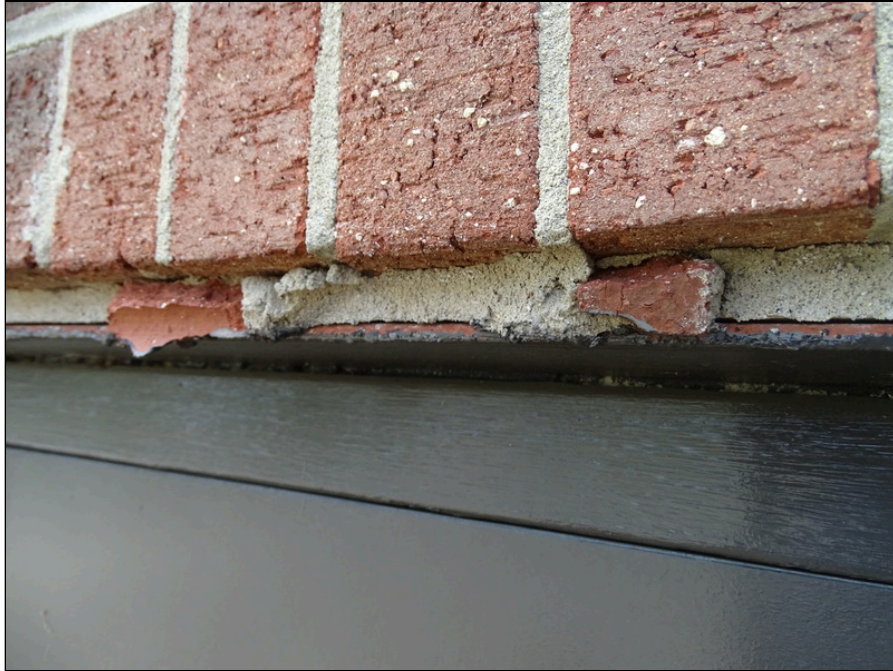
45 - Mortar joint condition
