SCHOOLS CENTRAL OFFICE  
1562 DAIRY ROAD  
CHARLOTTESVILLE, VIRGINIA

ECS PROJECT NO. 46:6713

CITY OF CHARLOTTESVILLE - FACILITIES DEVELOPMENT

Reference: Facility Condition Assessment Report for Schools Central Office, 1562 Dairy Road,  
Charlottesville, Virginia

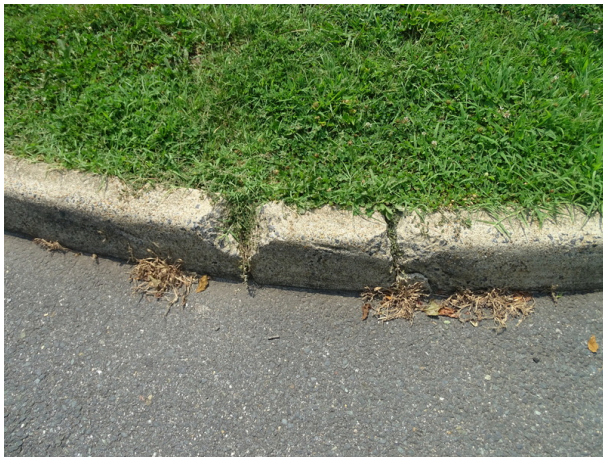
Typical concrete curb - note deterioration

3.2.5 Flatwork																														
REPLACE CONCRETE SIDEWALK AND CONCRETE CURBS AS NEEDED	20	17	3	4	Allow	\$5,000.00	\$20,000	100%			\$5,000				\$5,000						\$5,000					\$5,000			\$20,000

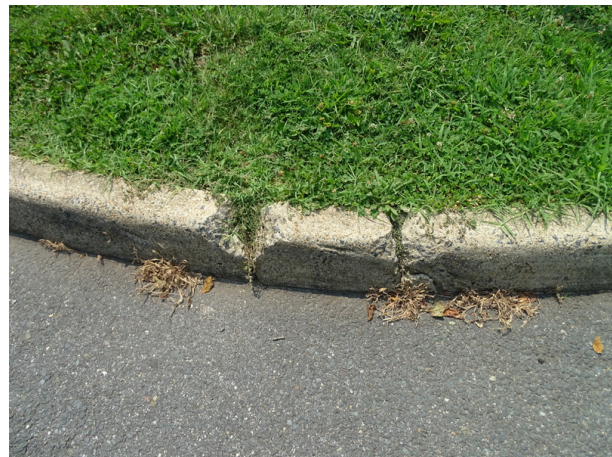
The site contains concrete sidewalks of undetermined thickness. Regularly spaced control joints were observed. Some of the sections of the concrete sidewalks were observed to have been recently replaced and the sidewalks were in overall good condition. We recommend that the settled and cracked sections of concrete sidewalks be replaced on an as-needed basis during the study period.

Typical concrete curb - note deterioration

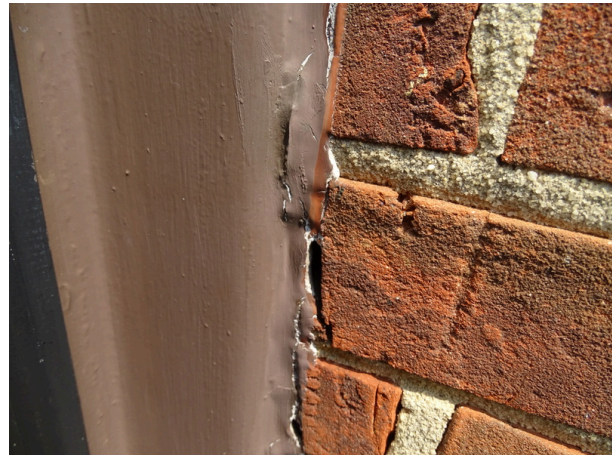
Exterior sealants are located around the window and door frames. The expected useful life of exterior sealants is approximately 10 to 12 years before replacement is needed. The exterior sealants were generally in fair condition. We recommend that the exterior sealants be replaced.

Building exterior overview - note sealant deterioration

3.3.3 Building Exteriors																														
REPOINT BRICKWORK	20	1	19	1	LS	\$15,000.00	\$15,000	100%																		\$15,000		\$15,000		
CLEAN AND PAINT STEEL FRAMING	7	1	6	3	LS	\$2,500.00	\$7,500	100%					\$2,500								\$2,500						\$2,500	\$7,500		
REPLACE SEALANTS	12	1	11	2	EA	\$5,000.00	\$10,000	100%										\$10,000										\$10,000

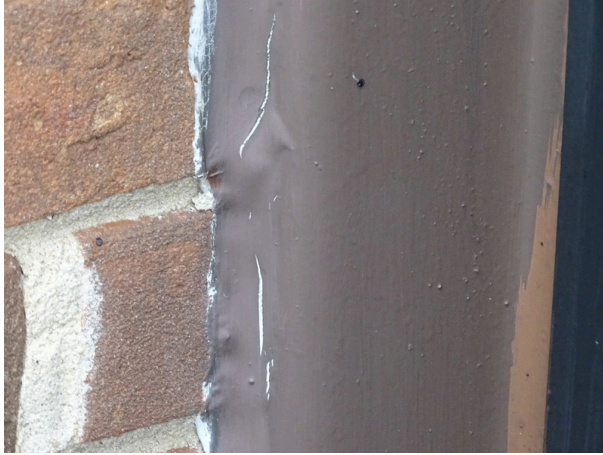
Building exterior overview - note sealant deterioration

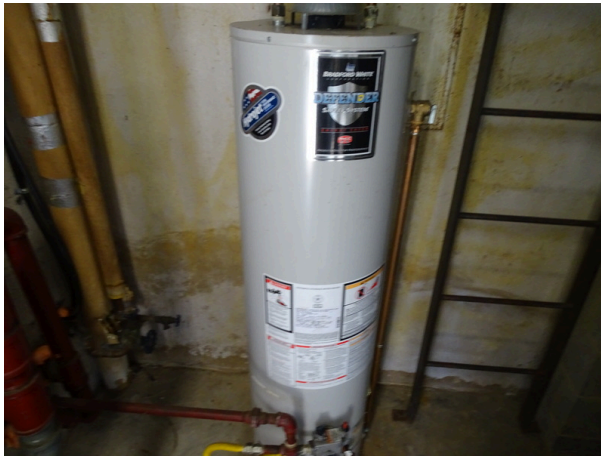
Domestic hot water to the building is provided by Gas domestic water heater located in the mechanical room. The 30 gallon Gas domestic water heater were manufactured by Bradford White in 2006. The expected useful life of a Gas domestic water heater is approximately 12 to 15 years with proper maintenance. We recommend the Gas domestic water heater be replaced during the study period.

Water heater and supply lines

3.4.1.2 Domestic Hot Water Production																														
REPLACE WATER HEATER	12	11	1	2	EA	\$1,000.00	\$2,000	100%	\$1,000												\$1,000								\$2,000

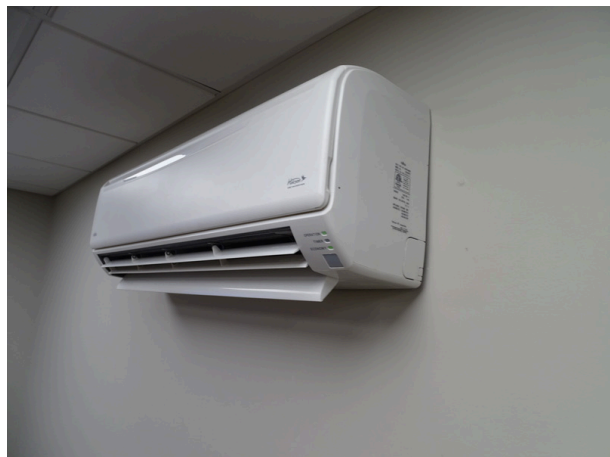
The split system located on the roof is in fair condition. Split systems have an expected useful life of 15 years and should be replaced during the study period.

Split system

3.4.2.1 Equipment																														
REPLACE CONDENSERS	15	12	3	4	EA	\$5,500.00	\$22,000	200%			\$22,000															\$22,000			\$44,000

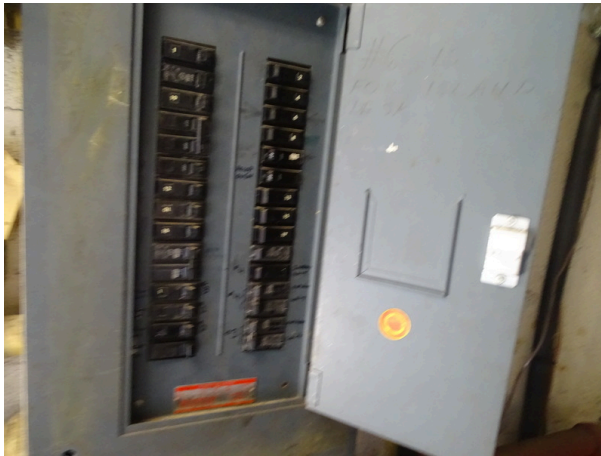
Power is distributed by copper wire from circuit breaker panels located throughout the building. The expected useful life of sub-panels is 50 years with proper maintenance. The circuit breaker panels were observed to be in generally fair condition. The 200 amp panel in mechanical room needs replacement.

Electrical panel - note missing components

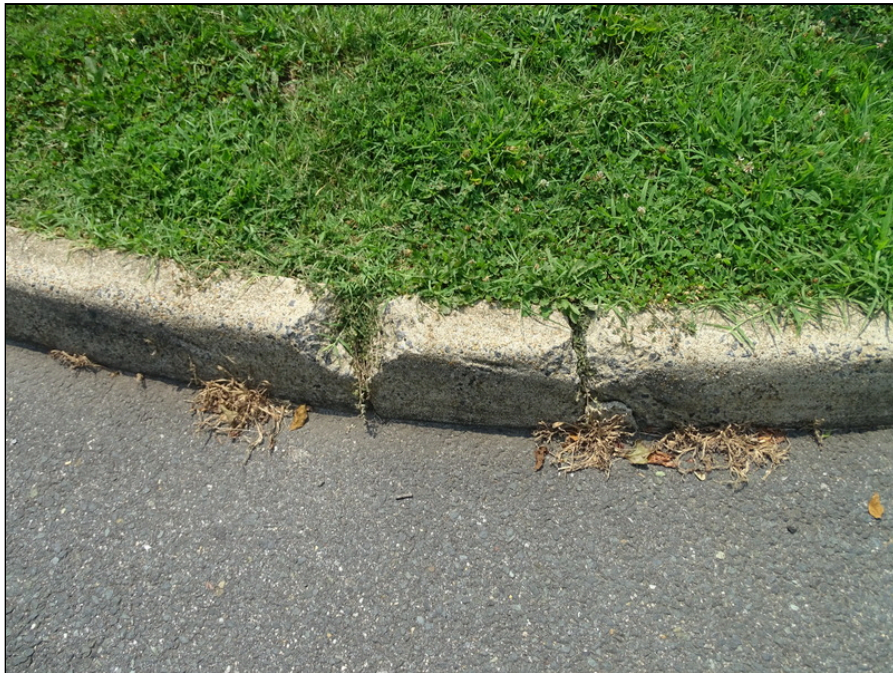
10 - Typical concrete curb - note deterioration

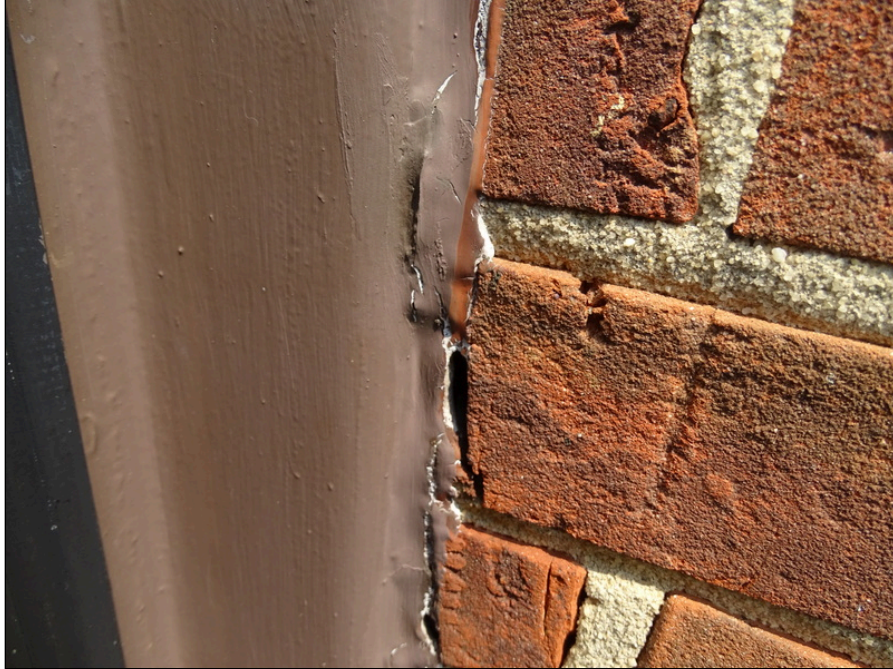
15 - Building exterior overview - note sealant deterioration

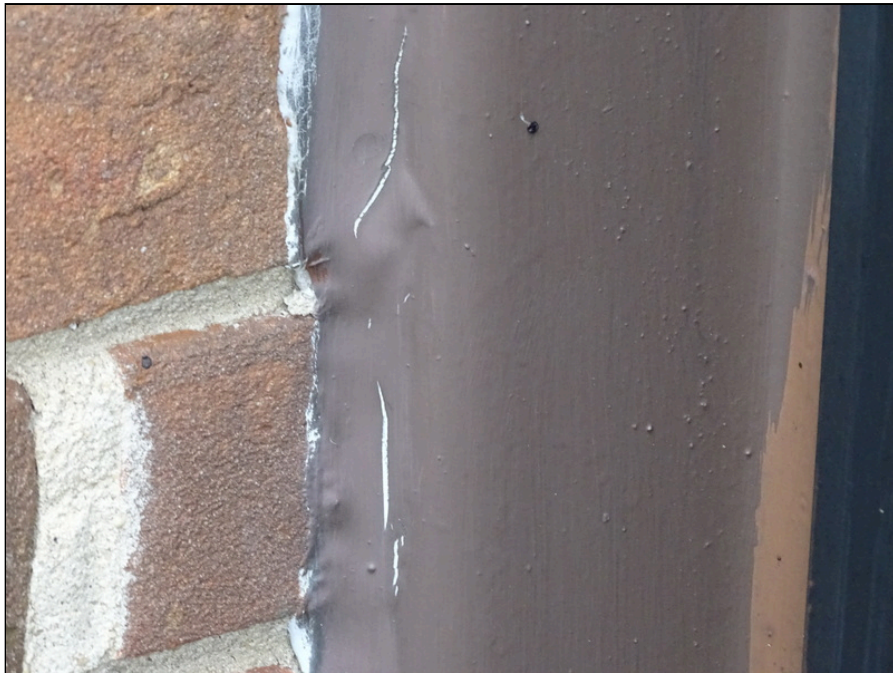
16 - Building exterior overview - note sealant deterioration

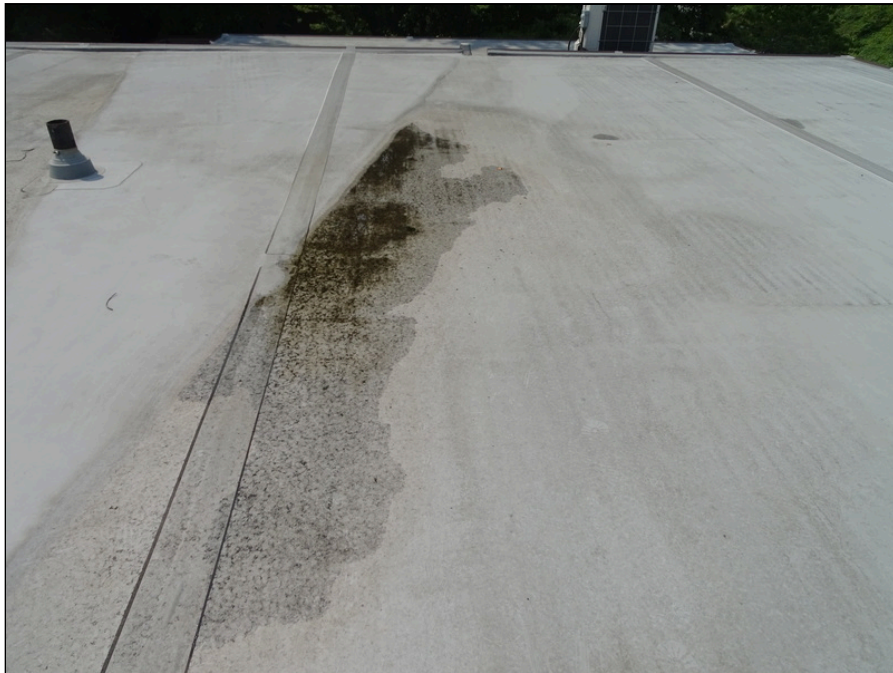
22 - Roof overview - note ponding

3.3.6 Roofing Systems																														
REPLACE SINGLE-PLY ROOFING SYSTEM	15	12	3	5,000	SF	\$14.00	\$70,000	100%			\$70,000																		\$70,000

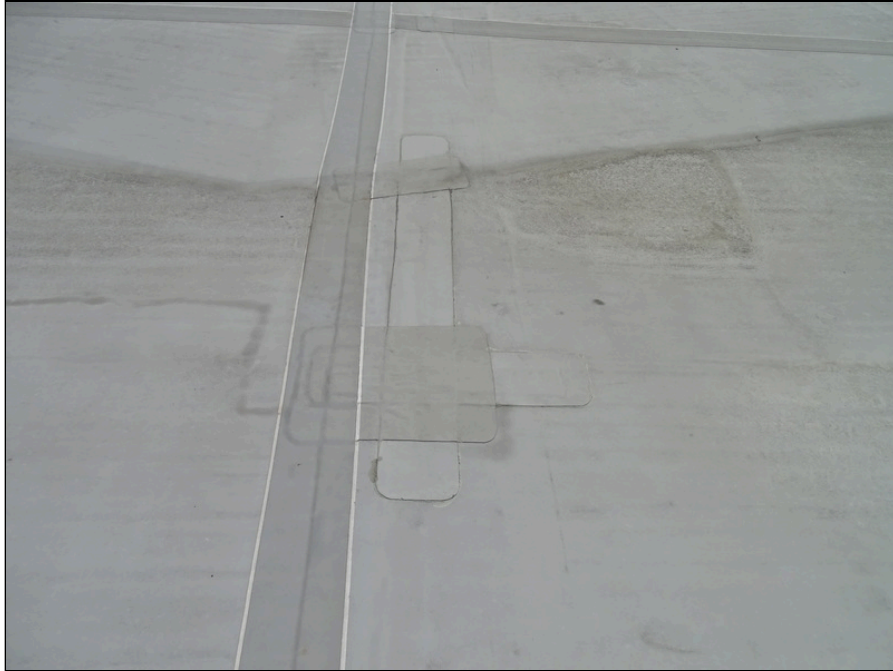
23 - Roof overview - note patching

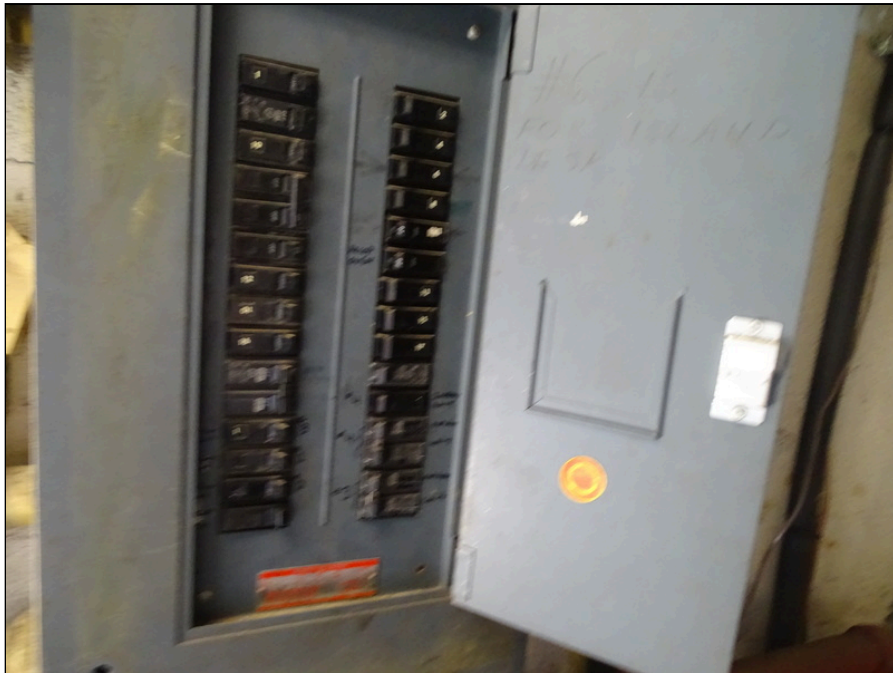
36 - Electrical panel - note missing components

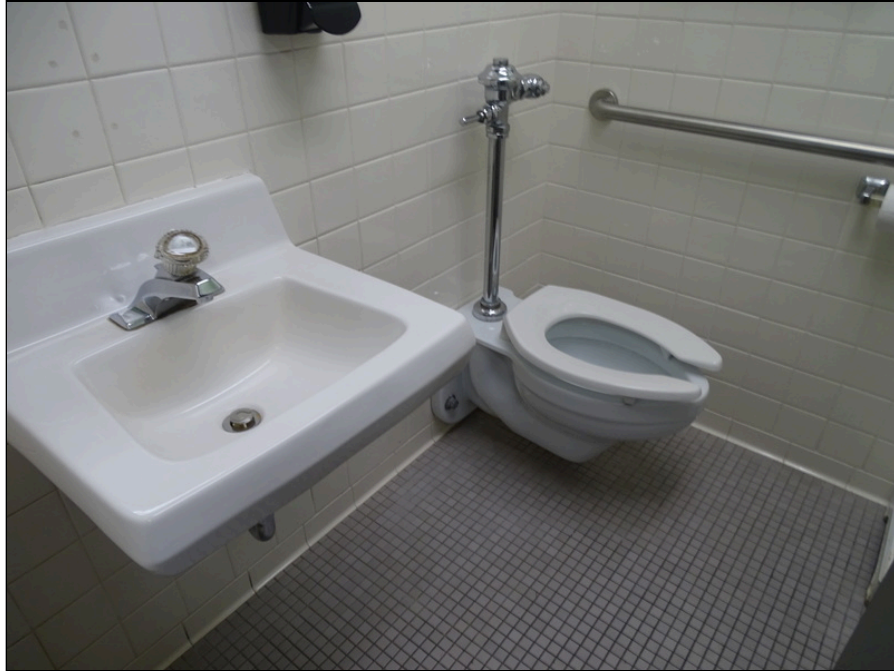
51 - Restroom without required accessible floor area

Item	Quantity	Unit	Unit Cost	Replacement Percent	Immediate Total
<b>3.8 Accessibility (ADA) Compliance</b>					
RECONFIGURE RESTROOM TO PROVIDE COMPLIANT FLOOR AREA	1	Allow	\$15,000.00	100%	\$15,000
Total Repair Cost					\$15,000.00

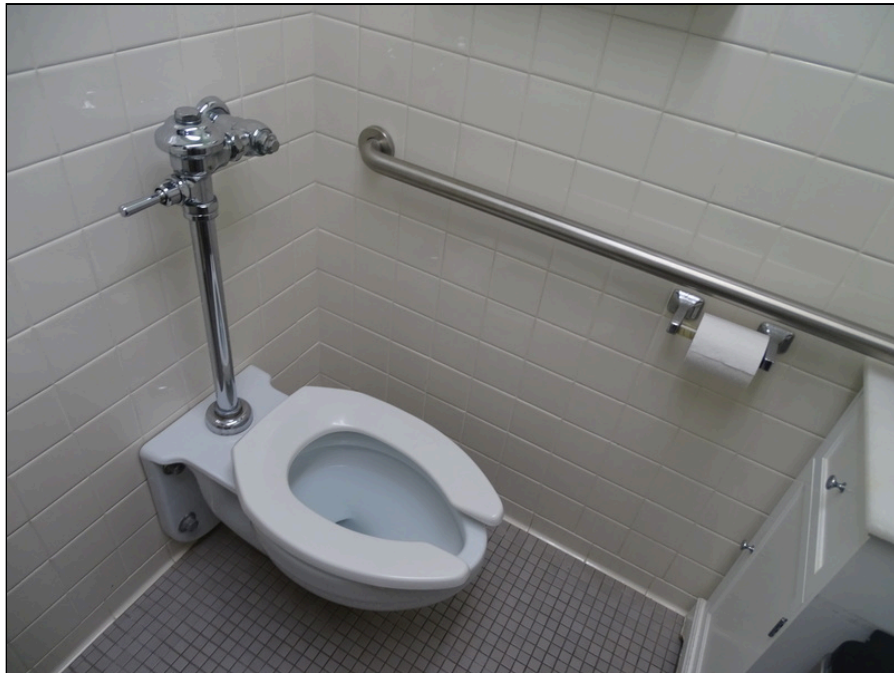
52 - Restroom without required accessible floor area
