# Smith Aquatic & Fitness Center Condition Assessment Report

March 13, 2020

**VAE Project No. 20001**

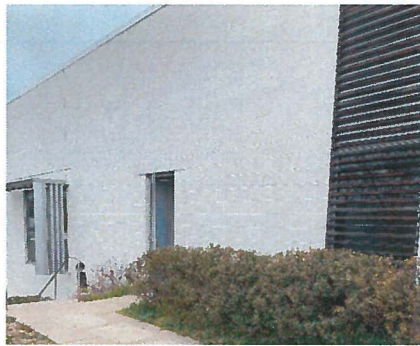
**Figure 5**

A second floor egress door on the south side of the building near the restroom corridor was propped open upon arrival of both visits. On the initial visit, staff indicated propping the door was routine to resolve odor and fresh air complaints from the reception desk. The door was closed for a limited period to see what impacts closure would have on pressure within the building. Building pressures were planned to be observed (or felt) with pressure differentials on doors throughout the second floor. VAE staff suspended this operation and reopened the door within a couple minutes in response to commentary and coughing overheard from staff at the reception desk.

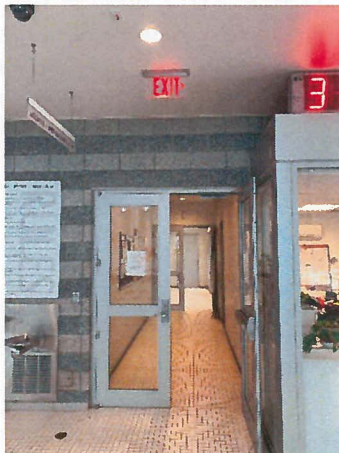
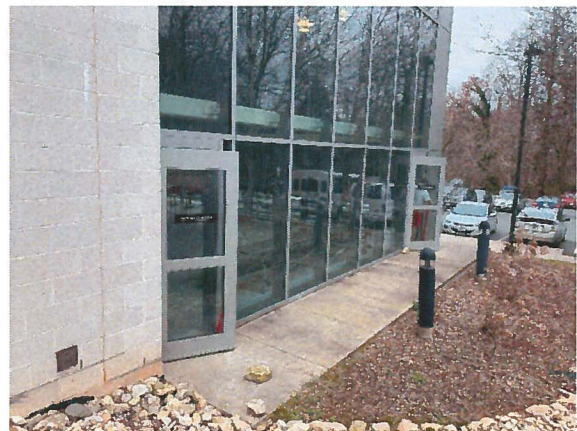
Double doors 116B and 109 had a minimum of one leaf propped open upon arrival both visits. Doors were closed for a limited period on the follow-up visit. A piece of paper was used around the perimeter of several doors to detect air flow generally in the direction of the Natatorium. Exterior doors on the north wall of the Natatorium were propped open both visits.

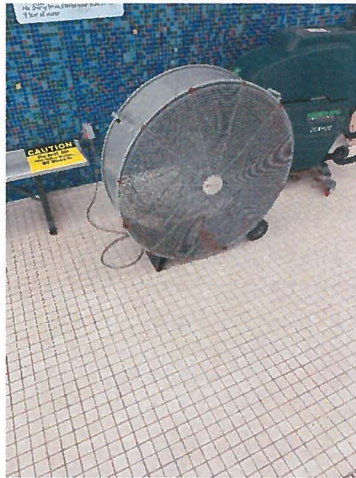
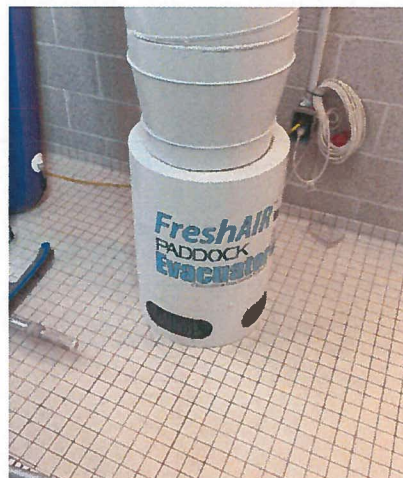
Large circulation fans are present on the pool decks within the Natatorium. The Aquatics Director indicated the fans promoted a feeling of fresh air to the lifeguards. The fans are sometimes used to increase exhaust at by propping open the two doors on the north end of the Natatorium. A Paddock Evacuator system was added to the Natatorium approximately five years ago. A small fan and evacuator are placed near the water slides in the northeast corner of the Natatorium. The larger component of the system includes fans that blow air against and down the north wall of the Natatorium with the return excavator located near the floor at the opposite end of the space. The intent is draw air at low velocity across the top of the pools to remove chlorine. Circulation fans located at floor level and discharging perpendicular to the Paddock Evacuator air flows most likely disrupt functionality of the evacuator system.

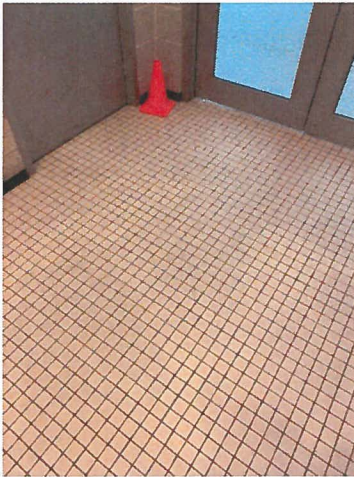
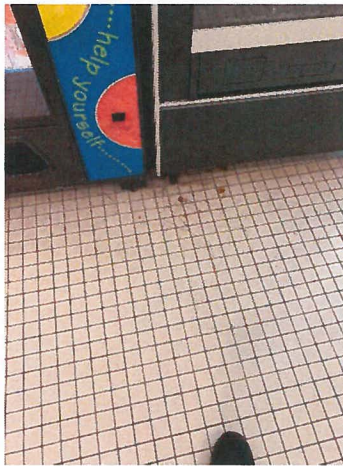
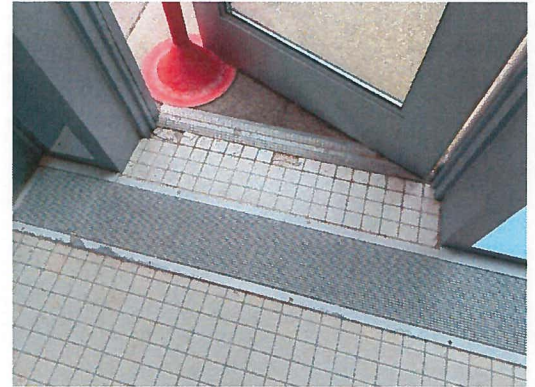
A few 2x2 tiles are missing at the threshold of the Natatorium egress door in the southwest corner of the building.

1. Missing or cracked ceramic floor tile in Family Changing Room 102 and at threshold of the Natatorium egress door in the southwest corner of the building could be replaced while the facility is closed for renovations.

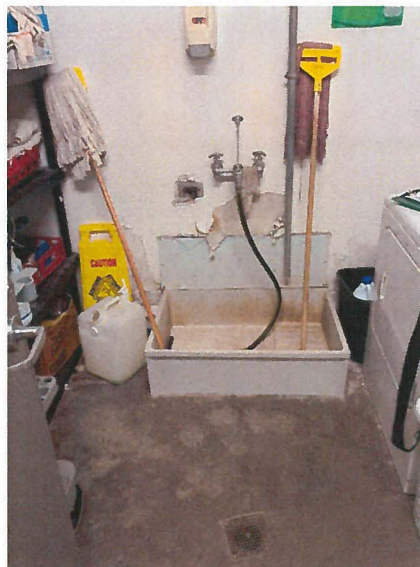
**Figure 13**

Interior walls are generally in good condition. Marks are apparent on walls from use throughout the building. Marks are apparent on the ground face CMU walls of Wet Classroom 110 apparently from storage of tables and chairs against the wall. Gypsum wall board appears wet behind the mop sink in Janitor/Supply Room 106.

2. Provide storage racks in Wet Classroom 110 for table and chair storage to minimize marks on the walls.
3. Remove moisture-laden gyp board behind the mop sink in Janitor/Supply Room 106, remove any mold found, install moisture resistant gyp board, and expand the extent of fiberglass protective wall panels above the mop sink.

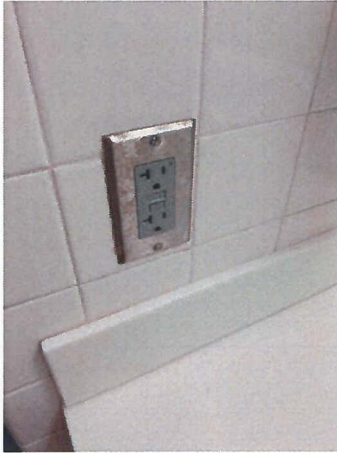
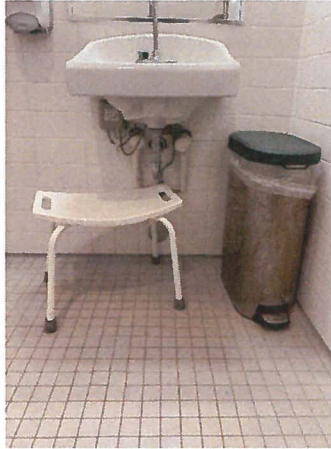
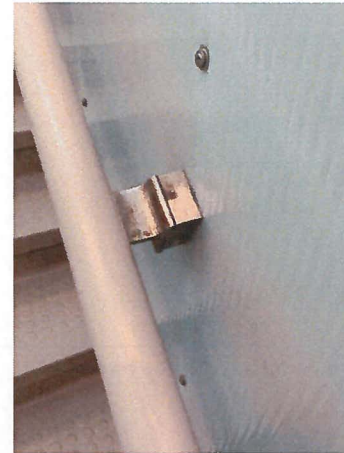
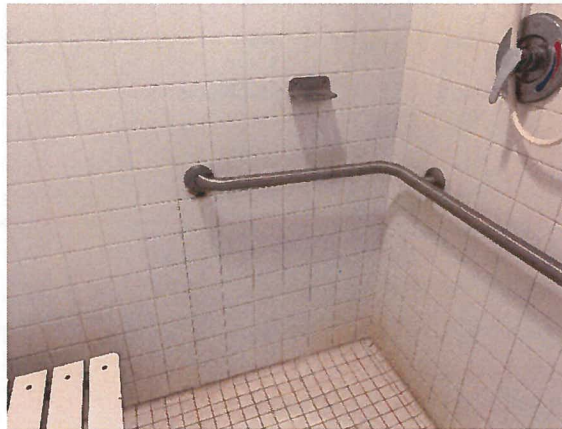
Stainless steel electrical device cover plates appear corroded in some areas, mainly in the restrooms on both levels of the building. Stainless steel trash cans in Changing Rooms 103 and 104 off located Family Changing Area 102 also appear corroded. In addition, stainless steel brackets supporting handrails along the stair between both floors appear corroded. ADA grab bars are corroded at the wall connection point in ADA showers in both the men's and women's toilet rooms within the locker rooms.

4. Clean corrosion from stainless steel surface including electrical device cover plates in restrooms, trash cans in family restrooms, and handrail brackets on interior stair and/or replace devices as required.

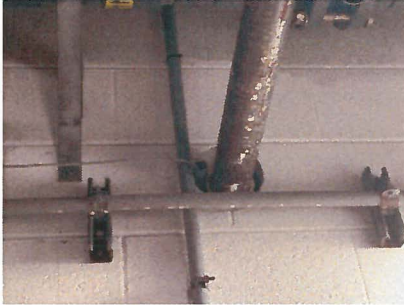
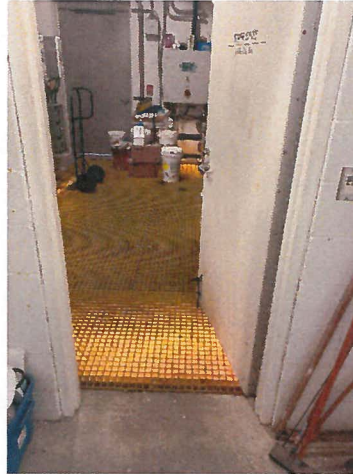
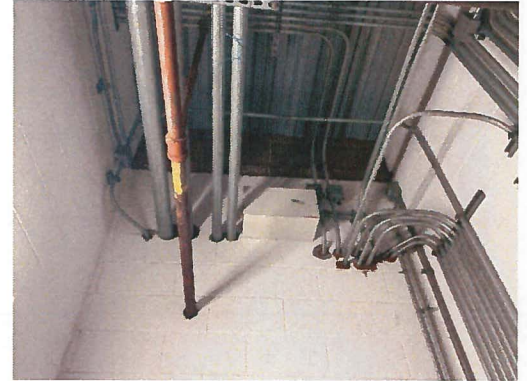
Room 112 was observed running with the control set to high. Anything not exhausted out of Filter/Water/Sprinkler Room 112 may migrate into the above ceiling area on the lower level of the building. This may also migrate through any penetrations not properly sealed in the second floor slab.

5. Seal all penetrations through walls and along the top of walls associated with Filter/Water/Sprinkler Room 112 and Electrical Room 111.
6. Perform smoke testing or other visual means to properly evaluate the leakage around the mechanical room. Reinforce prior closure along top of masonry walls around second floor mechanical room. Seal acoustical deck above walls around perimeter of second floor mechanical room. Further evaluation open in the perimeter walls and floors of the second floor mechanical room once all equipment and ductwork are demolished in pending renovations.

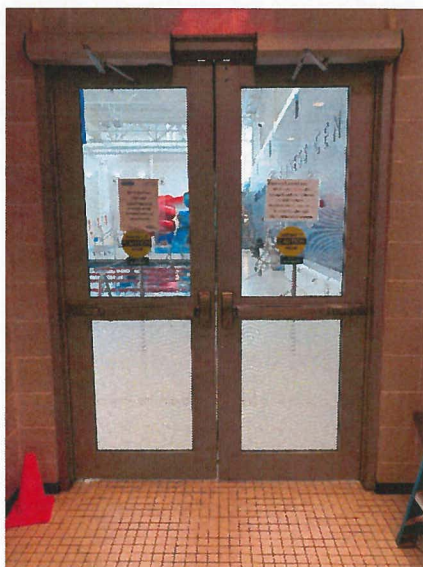
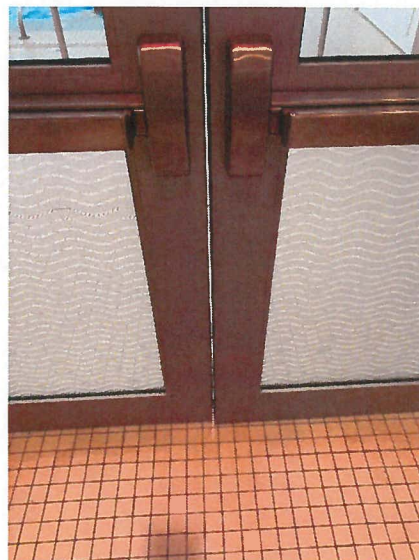
- The Pool Equipment Room does not house any pool treatment equipment and therefore sealing of penetrations is not as critical. There are openings at the top of walls to adjoining spaces and around pipe penetrations. The exhaust fan was observed to be running and set to high.
- Interior doors 112A and 112B between Filter/Water/Sprinkler Room 112 and Electrical Room 111 have no weatherstripping or seals to inhibit air movement to adjoining spaces. This may prove important if Door 112A is not routinely propped open for ease of access.
- Daylight is visible and sweeps are not present along the bottom of most interior doors. Jamb and head seals are present on most interior doors. Seals along the heads of Doors 116A and 116B are tacky and appear compromised. Double doors 116A, 116B, 102 and 109 have brush type seals where the doors join, but daylight is apparent between the doors.

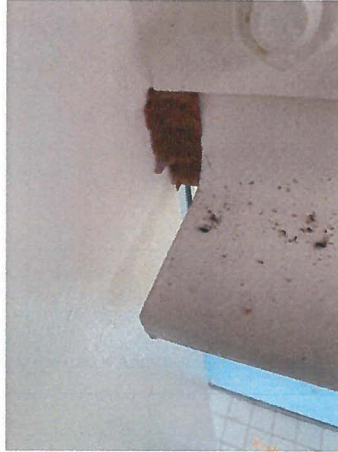
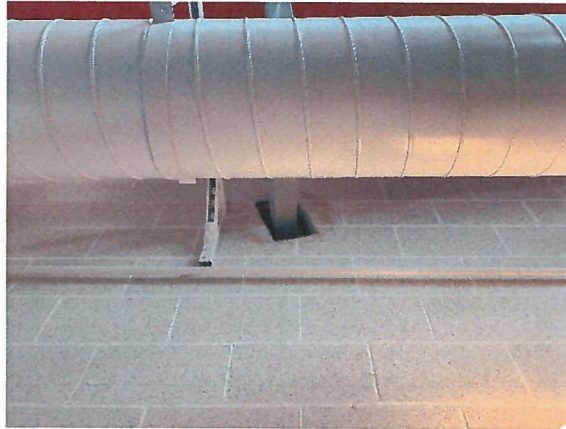
- Spray foam insulation used to seal openings between steel beams and columns along exterior west wall near top of the low level windows is crumbling to touch and at end of service life. This is likely the result of chemical attack.
- Braces for the Natatorium slide structure penetrate the masonry walls without any type of closure or sealant. This appears to be more of an aesthetic concern versus building performance based concern.

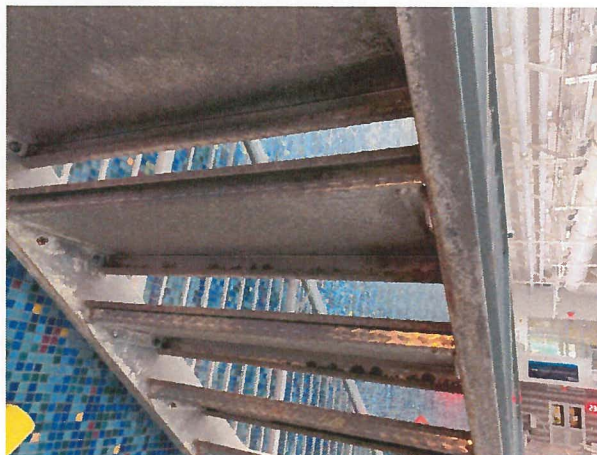
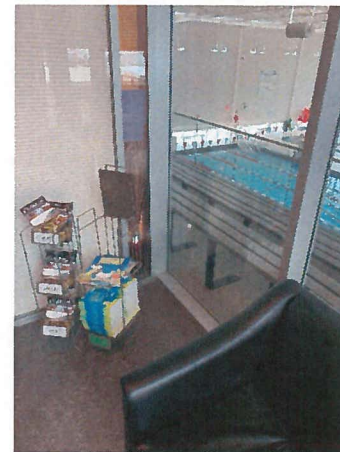
- There is moderate rusting on Natatorium slide access stair structure. In addition, the slide is faded.
- Storefront systems that separate the Natatorium 116 from other spaces include 1/4" laminated (non-insulated) glazing. This appears to be design intent per the original drawings. Glazing seals appear in good condition.

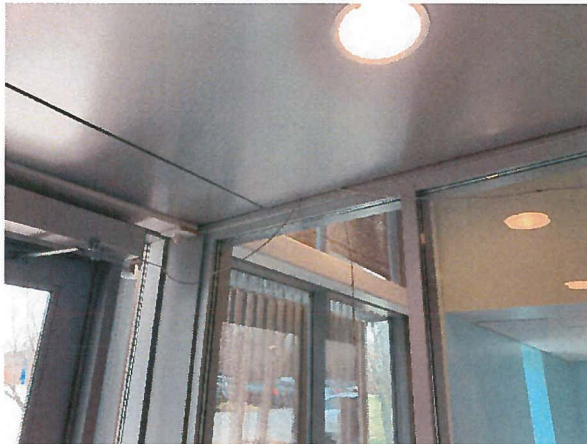
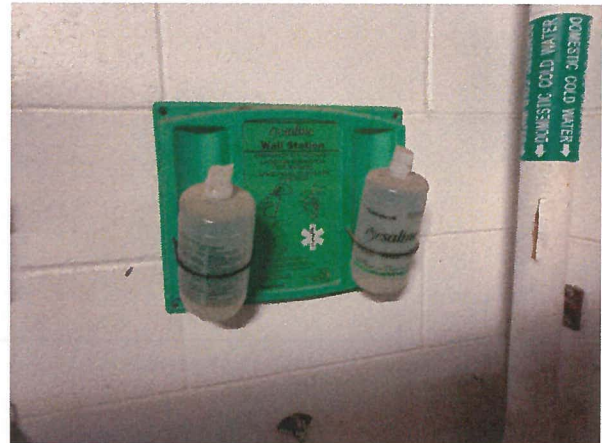
- Control wiring for the automatic door opener is exposed in the ceiling of Vestibule 200.
- The eyewash station in Filter/Water/Sprinkler Room 112 is not readily observable above the mop sink in the southwest corner of the space. The portable eyewash bottles are covered with dust. Shelf life of most portable eyewash stations is two to three years.

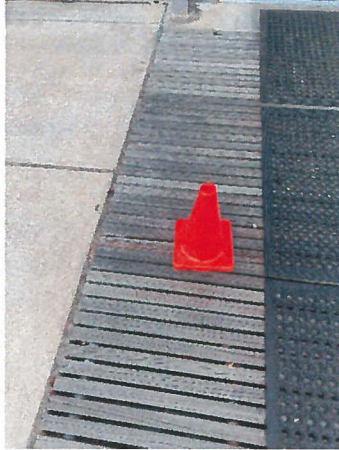
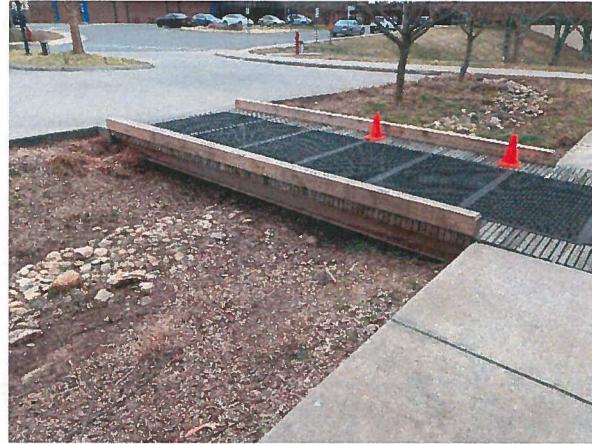
- Safety cones are located along the wooden walkway to the main building entrance. Boards appear rotten. In addition, black non-slip mats along the walkway may contribute to decay of the wood by retaining moisture beneath and give off heat and smells, particularly during warmer months.

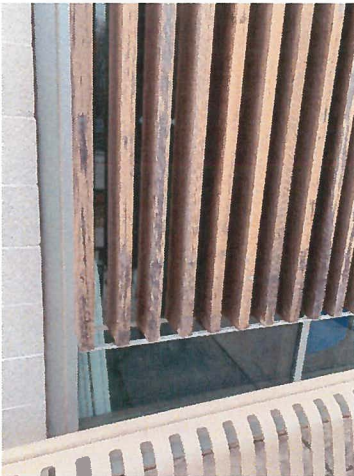
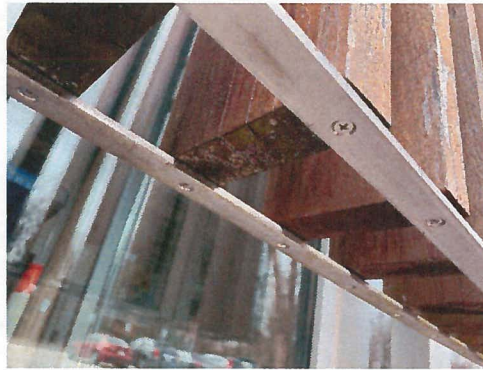
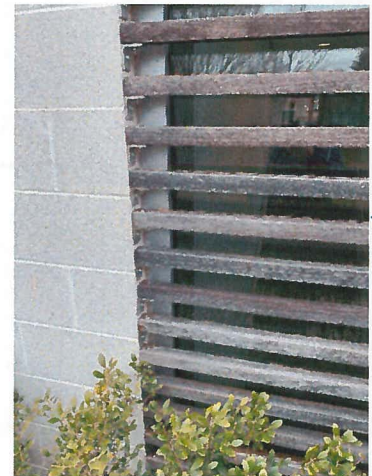
- Exterior wood cladding, primarily associated with window, storefront, and curtain wall at various locations around the building exterior is aged.

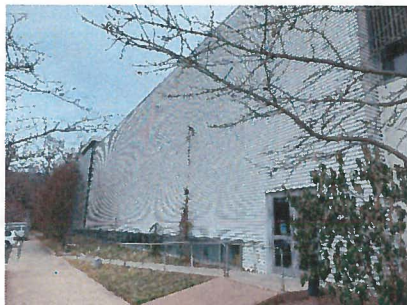
**Figure 41**

- Cables to support vertical vine growth along the west exterior wall have limited use. Only one is in use for vertical vine growth. One cable is missing and at least two others are loose at the bottom and hanging free.

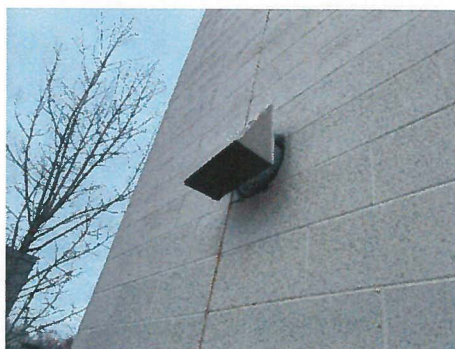
**Figure 44**

- A sloped exhaust cover on the south exterior wall and very near the southwest building corner is not properly sealed to the CMU. The cover appears to have shifted outward, possibly, when the interior duct was cut off and capped as one of the boilers was relocated exterior of the building.

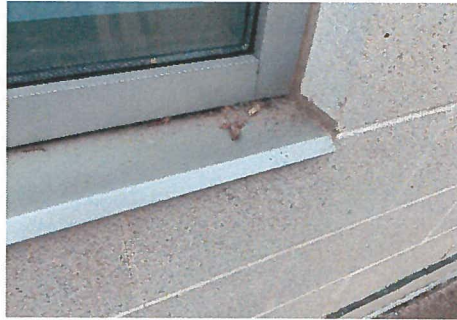
**Figure 45**

- Window glazing, frames, and sealant generally appear in good condition. The windows are dirty, specifically, the windows associated with the Wet Classroom. No sealant is present along the base of most window units by design to avoid damming up the drain pan sill flashing; however, dirt and other debris collecting in the joint have the potential of damming up the sill flashing.

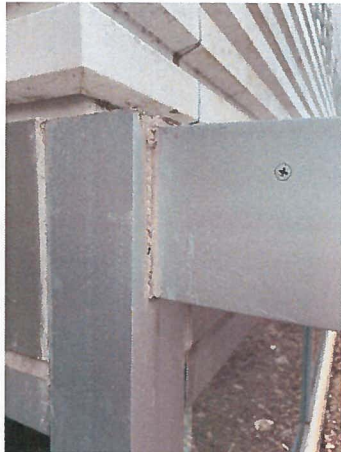
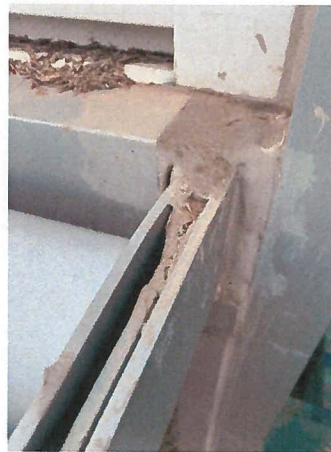
- A significant amount of caulk was used between exterior wall finishes and brackets supporting the sunshades around window, storefront, and curtain wall opening. Caulking is cracked in numerous locations.

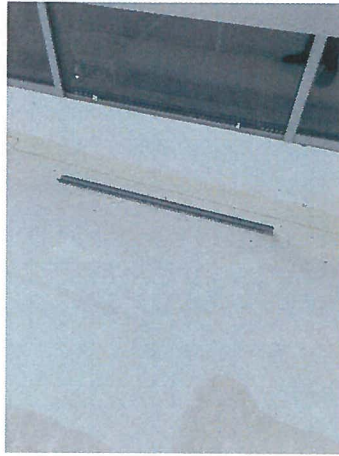
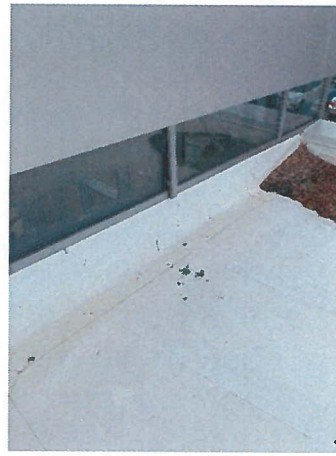
- Trim observed laying on the roof and loose in another location along the windows in the clerestory above slide area of Natatorium.

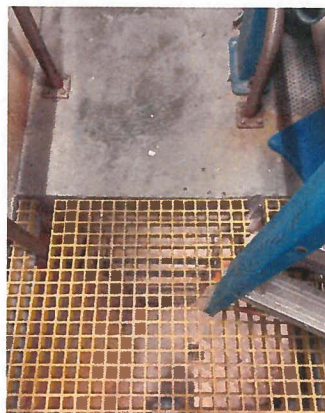
**Figure 51**

A fiberglass grating panel at access ladder for pump area beneath Filter/Water/Sprinkler Room 112 is only supported on three sides of the panel; side parallel to ladder is not supported. Panel deflects when walking on it.

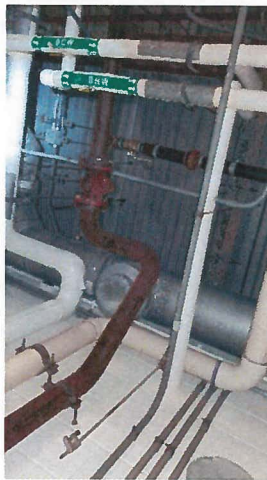
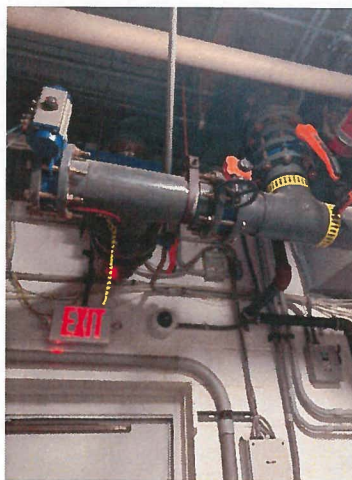
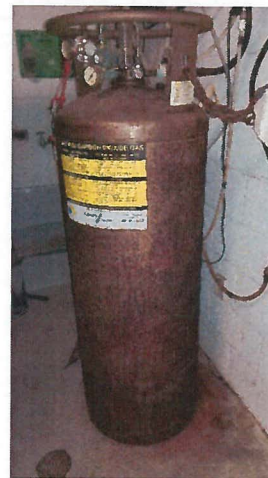
Equipment in the second floor mechanical room appears in good condition for its age. It does not appear that chlorine migration has caused corrosion. The same cannot be said for the first floor mechanical room. Corrosion was observed on metal pipe and fittings along with support hangers. Some of the pipe could be brushed cleaned and painted with a rust inhibiting primer and paint system, such as the steel gas and sprinkler pipe. Some flange bolts, pipe hangers, and iron pipe fittings are badly corroded. Some of the insulation on the domestic water has been damaged. The carbon dioxide cylinder is badly corroded.

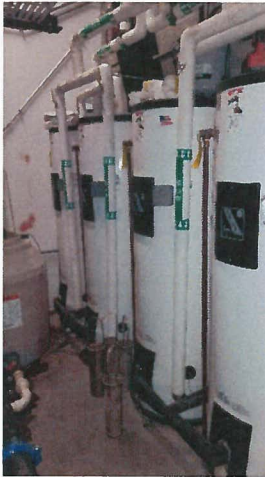
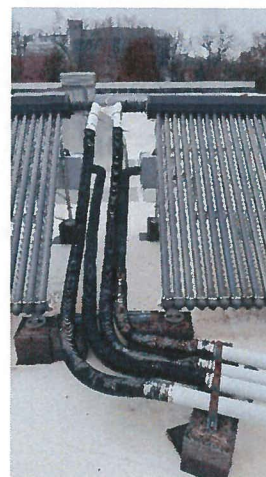
The domestic water heating system consists of (4) solar water storage tanks which feed through (5) gas-fired instantaneous heaters which in turn feed through a 30-gallon electric water heater. The solar panel arrays have broken tubes and the solar heaters are not in use. This is not the first time the facility has experienced broken tubes and the cause has not been identified. The sketch available for the solar heating system does not indicate the use of glycol or show a glycol tank, but the facility mentioned that glycol is used. The flexible sections of the outer conduit for the transfer lines on the roof are aging and have cracked and split in places; however, the copper pipe that could be observed inside appears to be intact. The 30-gallon electric water heater sits in a drain pan and appears rusted.

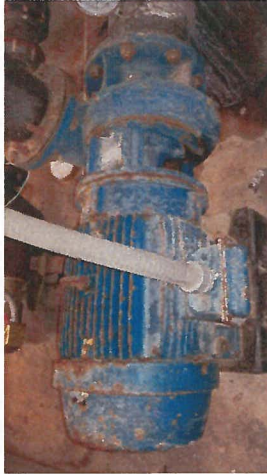
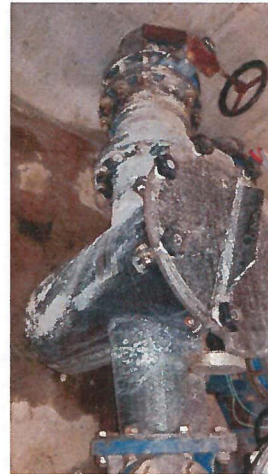
The pool filter and treatment equipment in the first floor mechanical room varies in condition. Plastic components appear to be in good condition. Metal pipe shows corrosion. The worst conditions are in the pump room below the grating. Components in this area show significant corrosion and the pump casings are rusting. These elements will likely require replacement within 5-10 years.

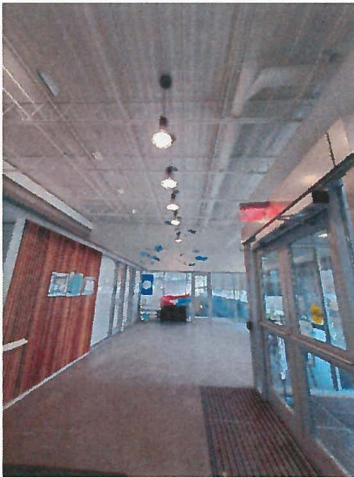
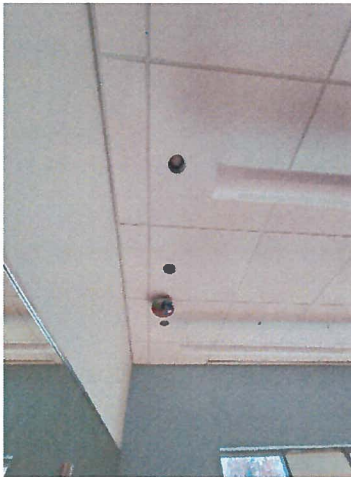
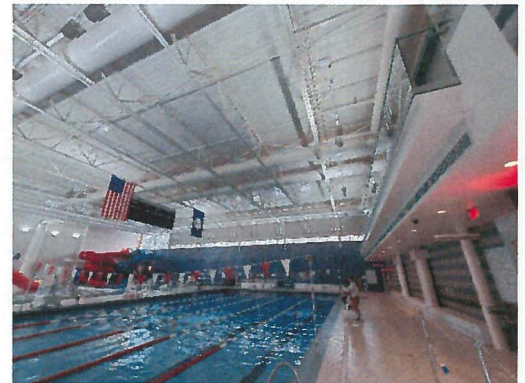
The facility lighting is mostly fluorescent lighting. The lighting levels and lighting controls all appear to be in good condition except for the Natatorium lighting. The Natatorium lighting was originally high intensity discharge (HID) metal halide type lighting. The HID metal halide lighting fixtures have been upgraded to light emitting diode (LED) type lighting technology. The low lighting levels and distribution does not meet the Illuminating Engineering Society (IES) lighting levels and distribution standards. There are dimly lit areas within the pool that could create a safety hazard. The existing light fixtures are pendant mounted along the pool deck approximately 23' to 24' above the finished floor. The light fixtures are very difficult to access for maintenance purposes due to minimal width of pool deck and proximity to the pool edge. Chlorine concentrations in the Natatorium has resulted in corrosion of light fixtures, lamps, and lamp holders. It is not clear if the existing light fixtures were rated for Natatorium use or if high chlorine levels damaged the original fixtures.

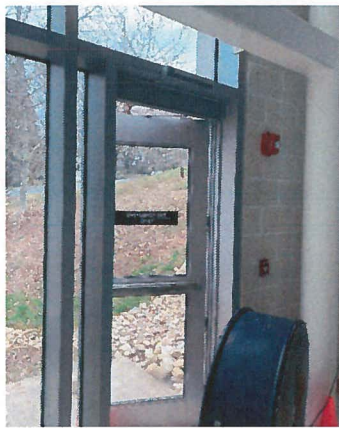
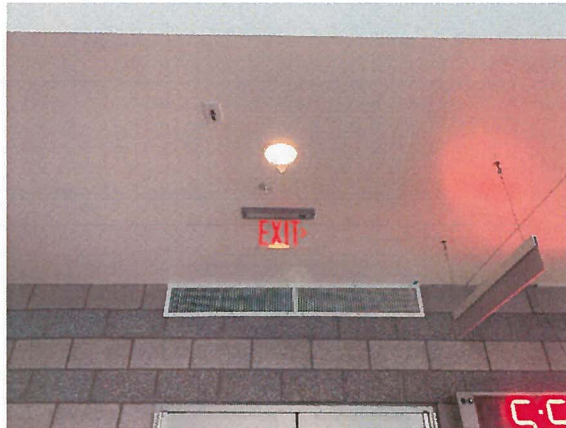
Exit signs generally appear to be installed where required to lead the occupants to the egress path. It appears an exit sign above the Natatorium egress door toward center of the south wall was previously removed and not reinstalled. The original mounted remains in place. This may have occurred when temporary fans were affixed to this door opening and removed when the Paddock Evacuation System was installed. An exit sign near Door 115A (from Family Changing Room 102 into the Natatorium) and pointing toward the double egress doors on the east side of the Natatorium does not appear illuminated. Light from a nearby recessed can light appears to be illuminating the exit sign.

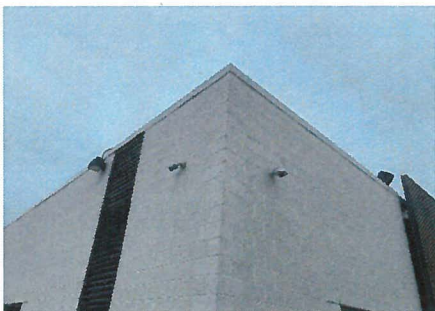
**Figure 77**

The building has minimal exterior building mounted general lighting. The original construction of the building did not have any building mounted general lighting. The city added two (2) LED type light fixtures installed at the roof level to light up the main entrance and side entrance. These two light fixtures are on a manual time switch control device. Ground mounted bollard light fixtures are installed near the building exit egress doors on the sides and rear of the building, but do not appear to be on any backup power system as required by the Virginia Construction Code (VCC). On the left side of the building the bollard light fixtures appear to have been installed on non-compacted soil and concrete bases. One fixture is leaning downslope, approximately 30 degrees from vertical.
