THE ENERGY HOUSE
608 RIDGE STREET
CHARLOTTESVILLE, VIRGINIA

ECS PROJECT NO. 46:6713

CITY OF CHARLOTTESVILLE - FACILITIES DEVELOPMENT

Reference: Facility Condition Assessment Report for The Energy House, 608 Ridge Street,
Charlottesville, Virginia

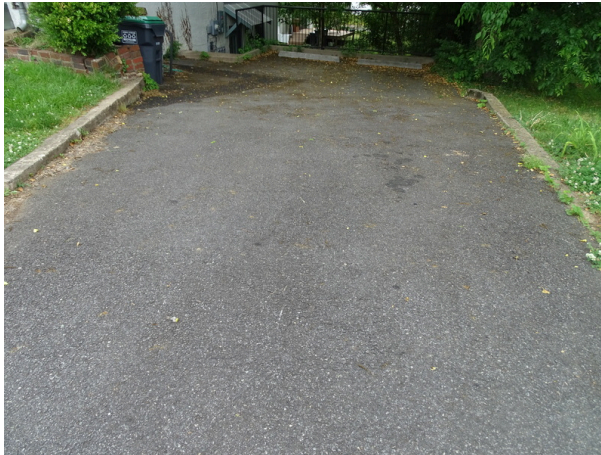
Asphalt-paved parking is located on the southwest side of the site. The asphalt pavement was observed to be in generally good condition. The expected useful life of asphalt pavement is 20 years. Please refer to Section 3.8 regarding accessible parking space requirements.

Asphalt parking area

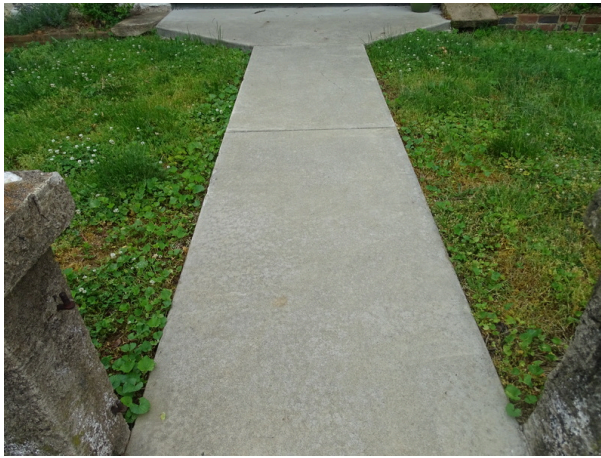
At the west side of the building, a Concrete sidewalk of undetermined thickness is provided. Regularly spaced control joints were observed. The Concrete sidewalk was generally in good condition. The concrete steps were observed to be in generally good condition.

Concreted sidewalk

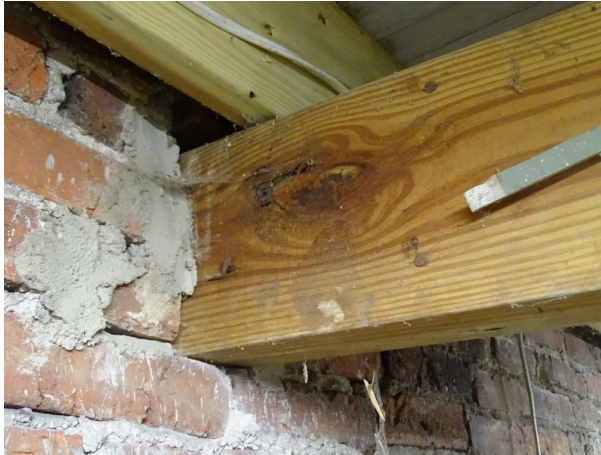
The structure of the building consists of Wood framing with brick masonry bearing exterior walls. The structural frame of the building was generally in good condition.

Structural framing

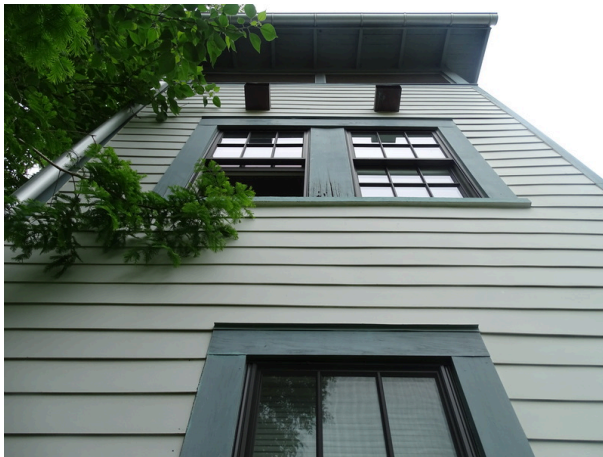
Building exterior at east side of the building

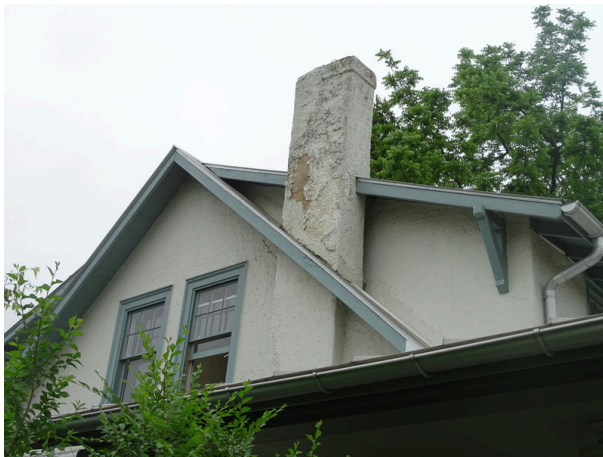
Wood Trim condition

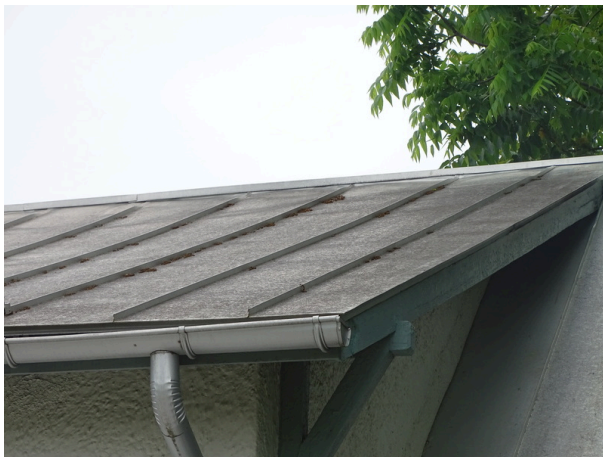
Metal roofing system south side of the building

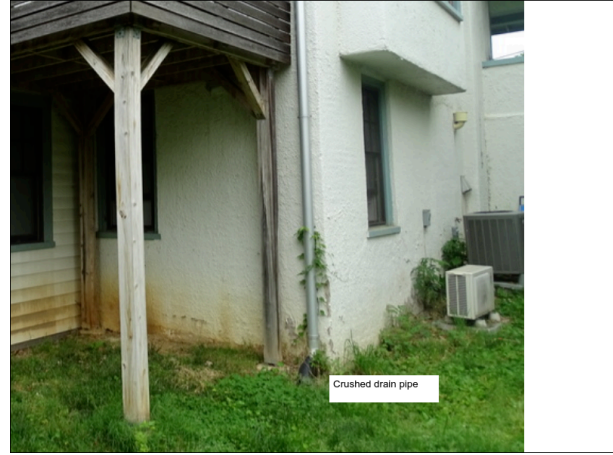
Building exterior at northeast side of the building

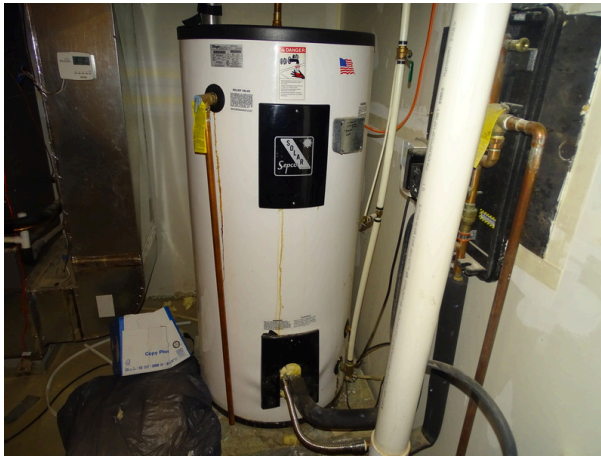
Domestic hot water to the building is provided by a Solar thermal water heater located in the basement. The Solar thermal water heater was manufactured by Vaughn in 2011. The expected useful life of Solar thermal water heater is approximately 12 to 15 years. We recommend the Solar thermal water heater be replaced during the report period.

Solar thermal water heater

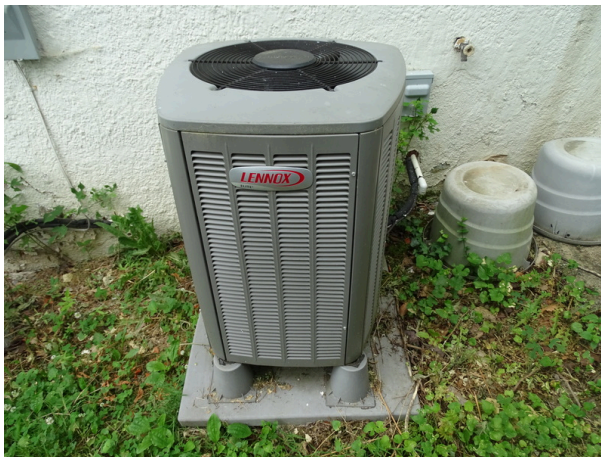
Heat Pump

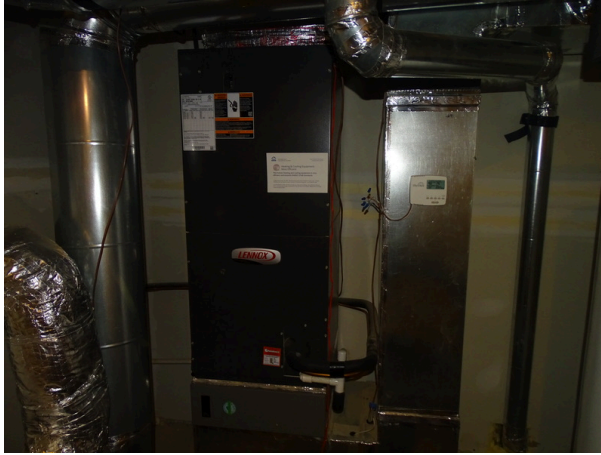
Air Handler Unit

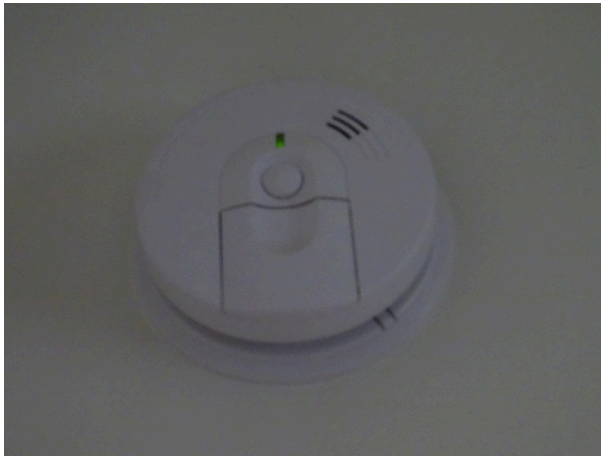
The fire alarm system was observed but not tested. Smoke detectors were observed in some portions of the building but were missing or disabled in most rooms. Missing and disabled smoke detectors creates a life safety hazard. We recommend the smoke detectors are replaced immediately.

Smoke detector

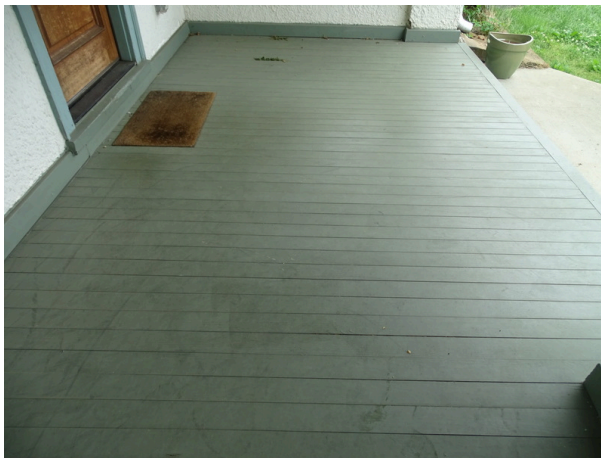
The exterior accessible route from the sidewalk to the porch and main entrance threshold does not include accessible ramps. We recommend installing accessible ramps at the exterior accessible route as an immediate item.

Accessible ramp not provided from sidewalk to porch to threshold of main entrance

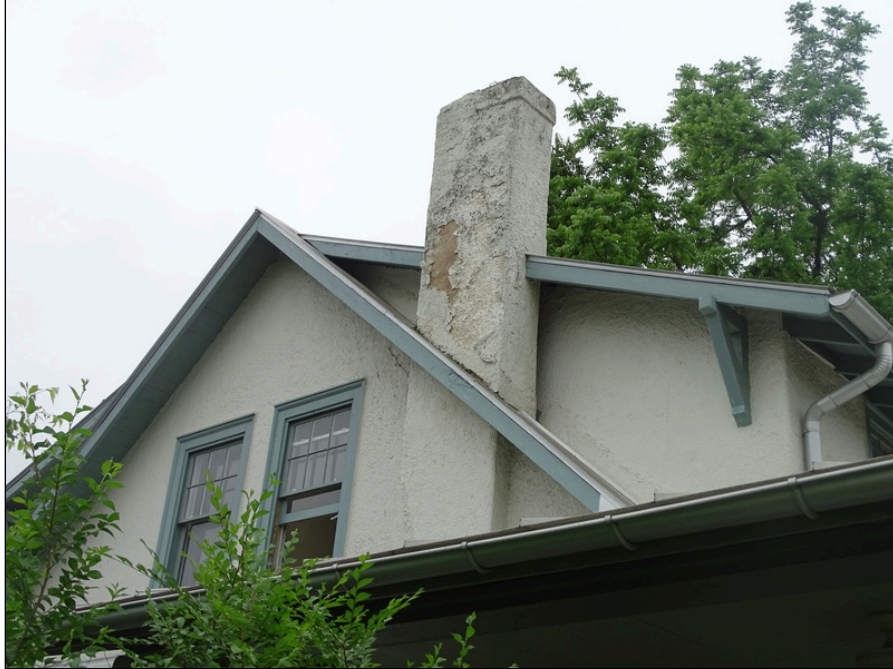
11 - Wood Trim condition

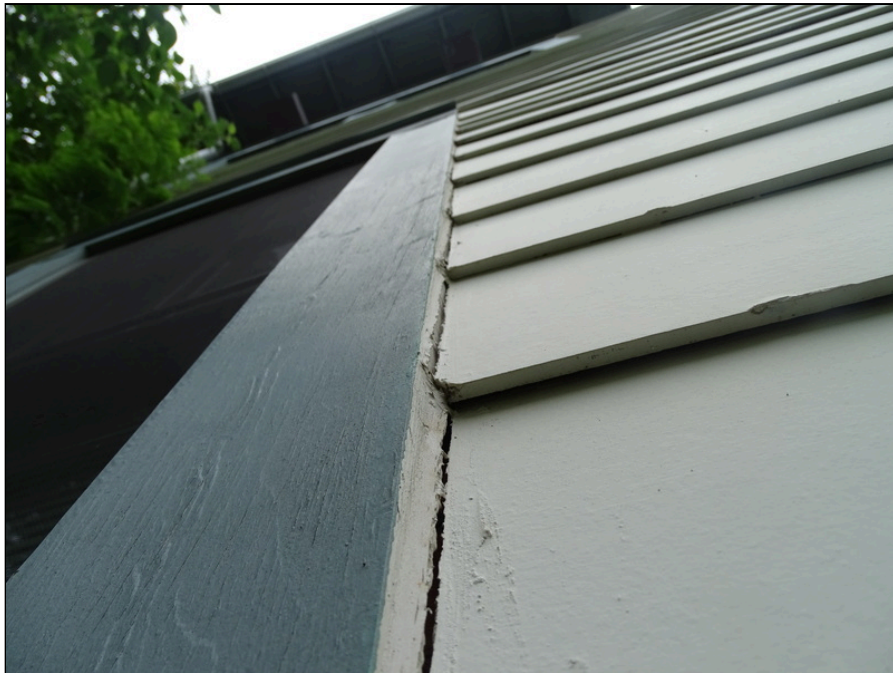
Exterior sealants are located around the window and door frames, and horizontal joints. The expected useful life of exterior sealants is approximately 10 to 12 years before replacement is needed. The exterior sealants were generally in fair condition. We recommend that the exterior sealants be replaced during the report period.

18 - Building exterior sealants - note deterioration

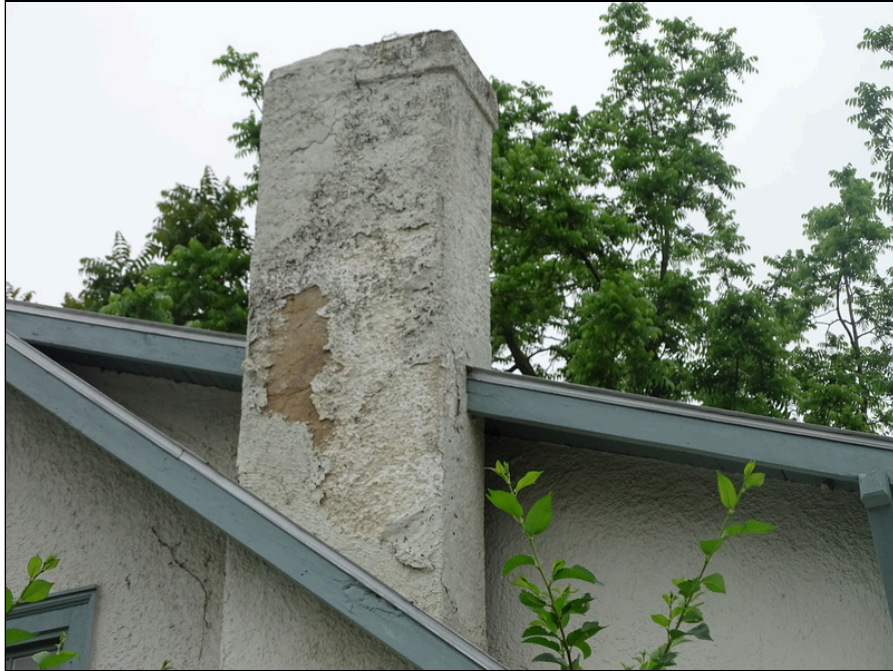
19 - Deterioration of exteriors at chimney

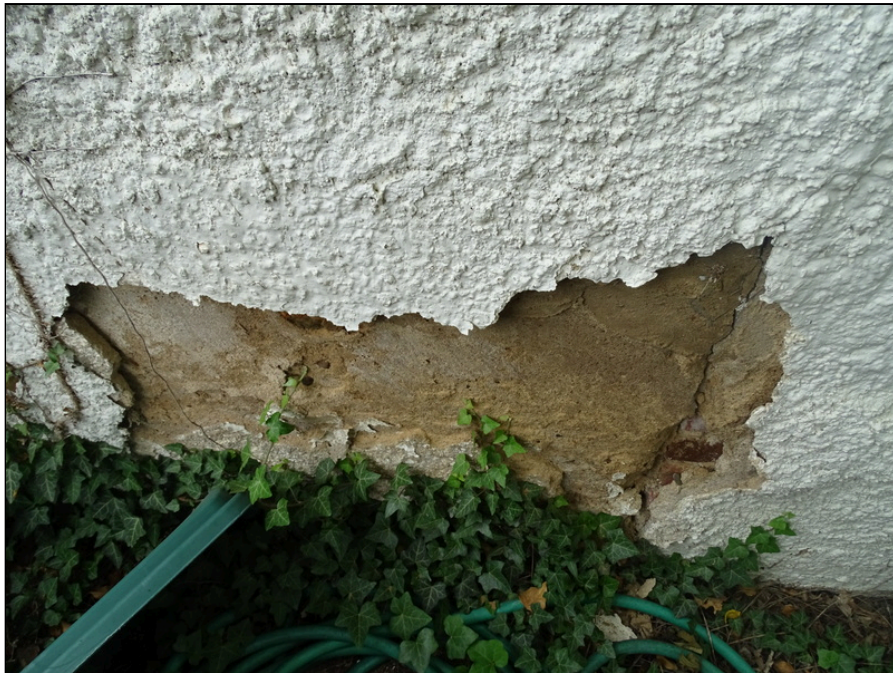
20 - Deterioration of exterior wall

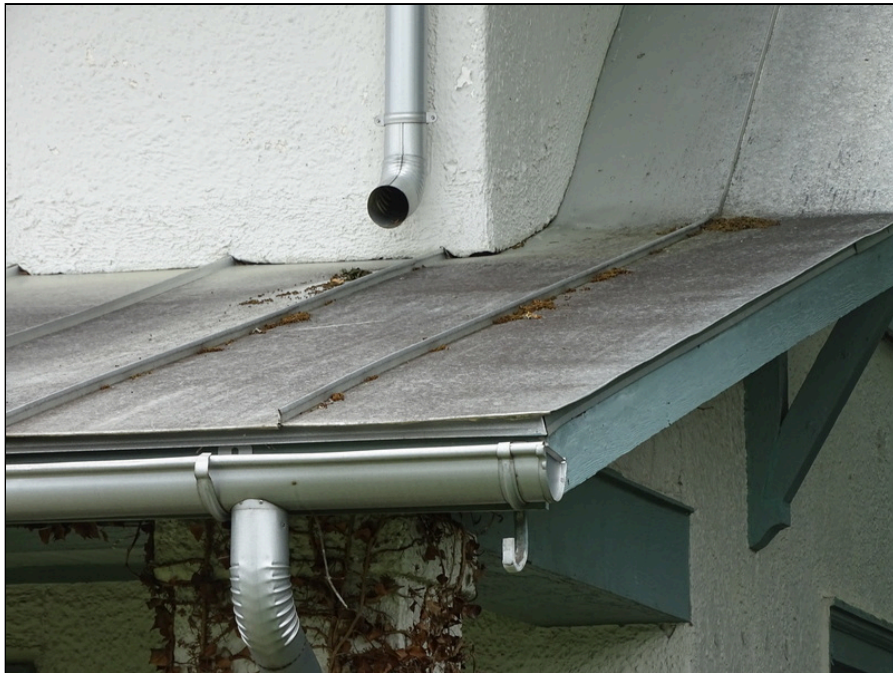
Roof drainage was provided by gutters and downspouts. The downspouts were in fair condition. Some downspouts were observed to be damaged or disconnected and discharging along the foundation walls. We recommend regular performing maintenance to the downspouts and discharge tubes to divert rainwater away from the foundation.

24 - Typical gutter and down spout

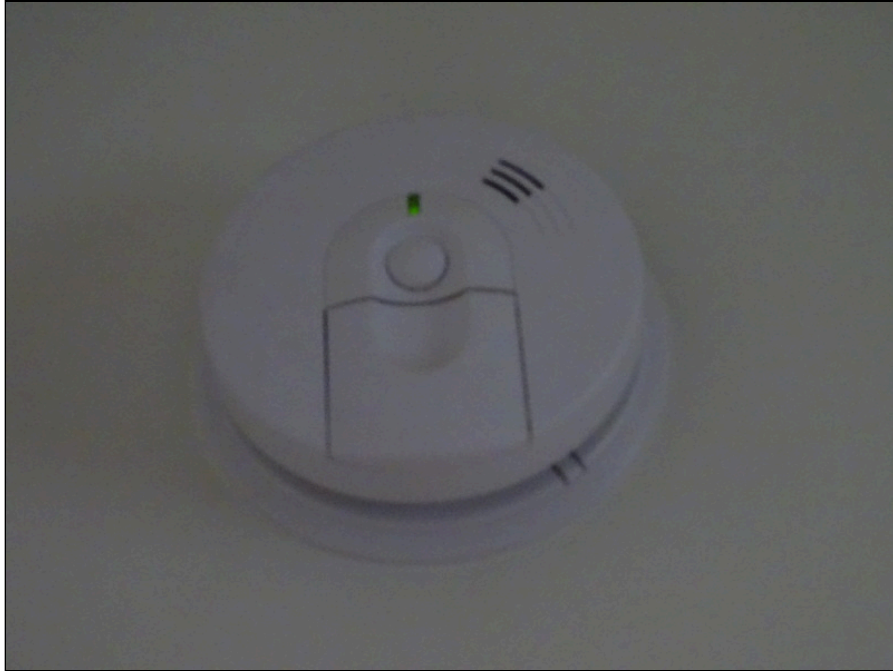
47 - Smoke detector

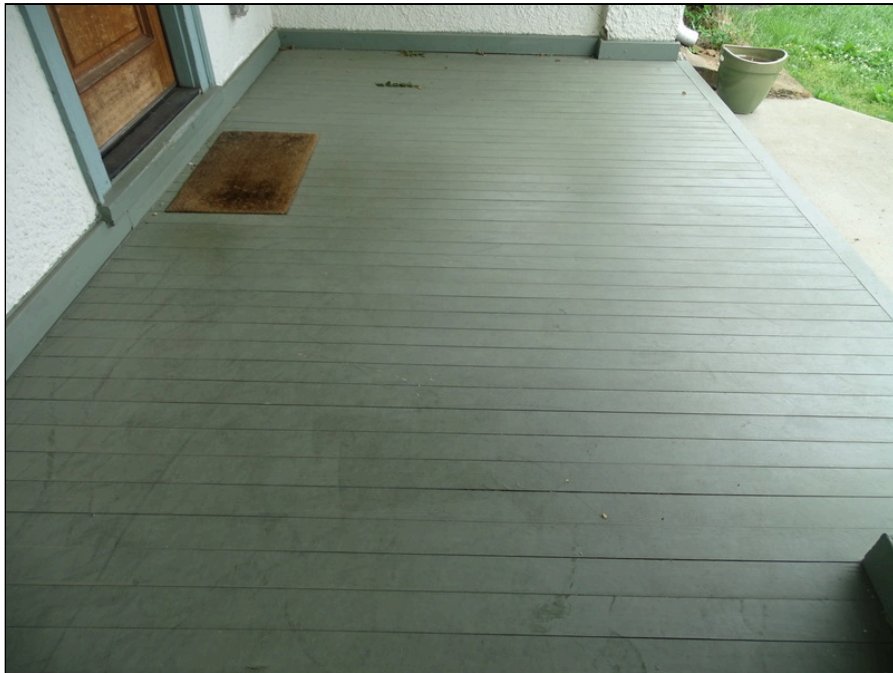
56 - Accessible ramp not provided from sidewalk to porch to threshold of main entrance
