VENABLE ELEMENTARY SCHOOL
406 14TH STREET NW
CHARLOTTESVILLE, VIRGINIA

ECS PROJECT NO. 46:6713

CITY OF CHARLOTTESVILLE - FACILITIES DEVELOPMENT

Reference: Facility Condition Assessment Report for Venable Elementary School, 406 14th Street NW, Charlottesville, Virginia

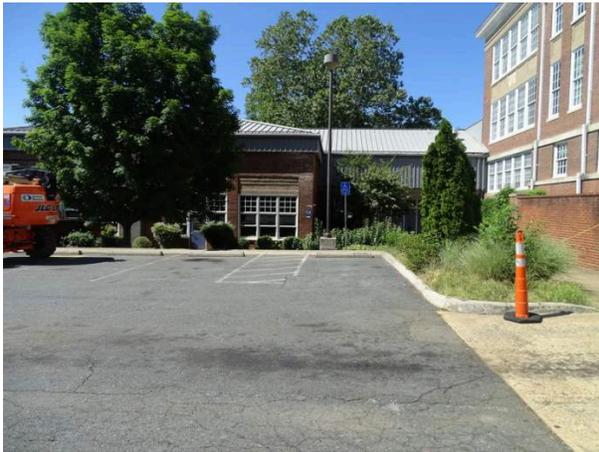
Asphalt-paved drive lanes and parking areas are located on the north and east sides of the site which also provides access to the site. Additional parking is provided along the western drive lane. The asphalt pavement was observed to be in generally good to fair condition with minor cracks observed on the pavement. Striping was in fair condition. The expected useful life of asphalt pavement is 20 years. It is understood asphalt repairs were in progress soon after our site visit. We recommend asphalt repairs near the end of the report period as needed.

Asphalt pavement - note cracking

3.2.4 Paving, Curbing, and Parking																														
ASPHALT PAVEMENT REPAIRS	20	0	20	4	EA	\$5,000.00	\$20,000	100%																					\$20,000	\$20,000

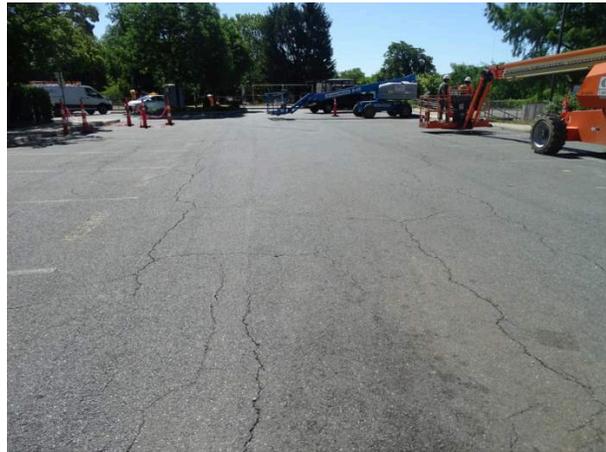
Asphalt pavement - note cracking

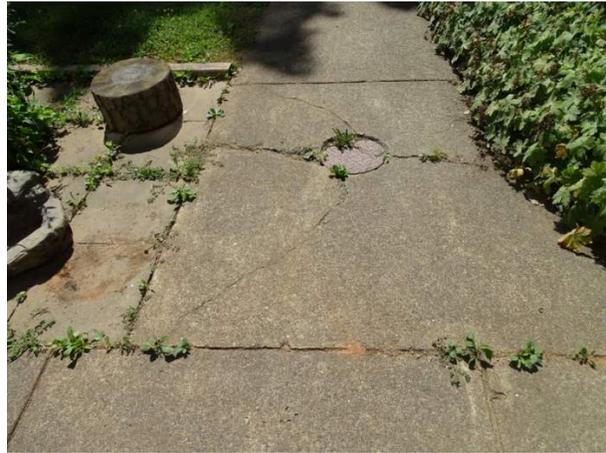
Typical concrete sidewalk - note cracking

3.2.5 Flatwork																														
REPLACE CONCRETE SIDEWALK SECTIONS AS NEEDED	25	24	1	4	EA	\$2,500.00	\$10,000	100%	\$2,500					\$2,500					\$2,500					\$2,500						\$10,000

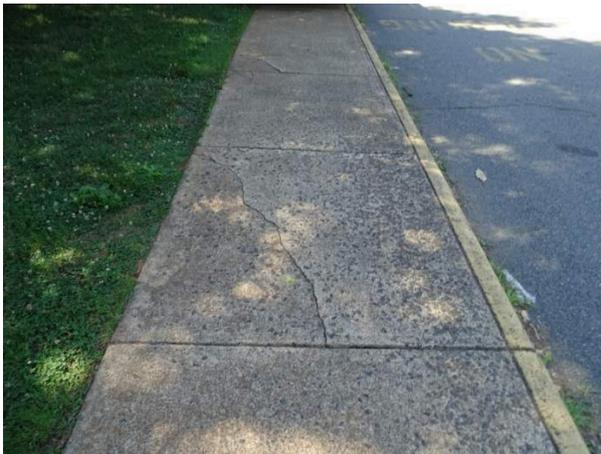
Typical concrete sidewalk - note cracking

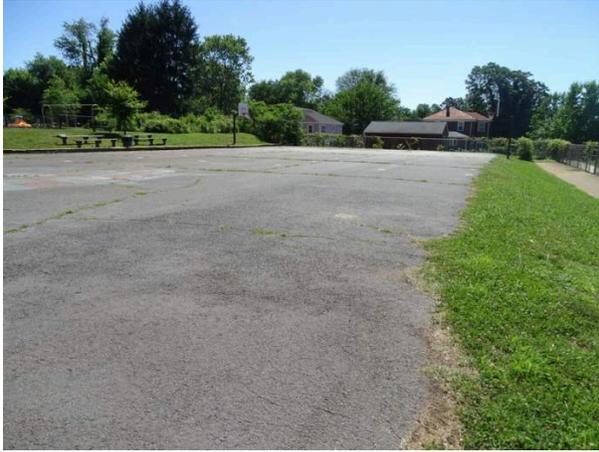
An asphalt play surface is located at the southeast side of the property. The surface was in generally fair condition with cracking and vegetative growth noted. We recommend the play surface is resurfaced during the report period.

Asphalt pavement - note cracking

3.2.7 Recreational Facilities																														
REPLACE PLAYGROUND EQUIPMENT	20	15	5	1	EA	\$45,000.00	\$45,000	100%					\$45,000																	\$45,000
RESURFACE ASPHALT PLAY AREA	20	19	1	1	EA	\$10,000.00	\$10,000	100%	\$10,000																					\$10,000

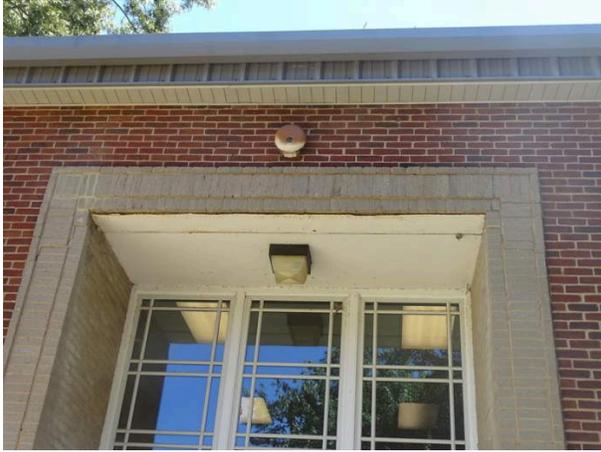
Building exterior - note cracking

3.3.3 Building Exteriors																														
REPOINT BRICKWORK AS NEEDED	20	0	20	1	LS	\$75,000.00	\$75,000	100%																					\$75,000	\$75,000
REPLACE SEALANTS	12	0	12	1	LS	\$25,000.00	\$25,000	100%												\$25,000										\$25,000
REPAIR/REPLACE WOOD CORNICE	50	49	1	1	EA	\$200,000.00	\$200,000	100%	\$200,000																					\$200,000

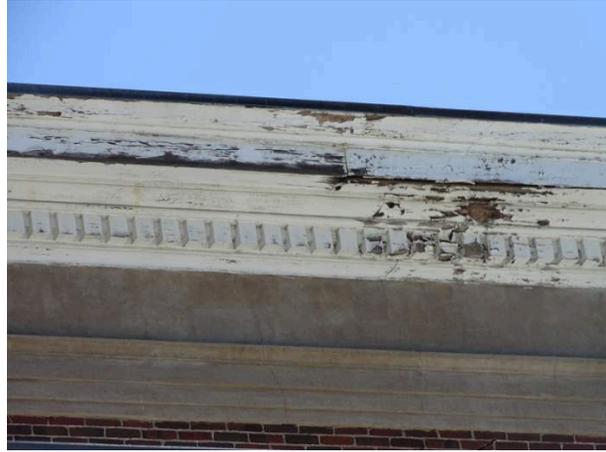
Building exterior - note rotten through cornice work

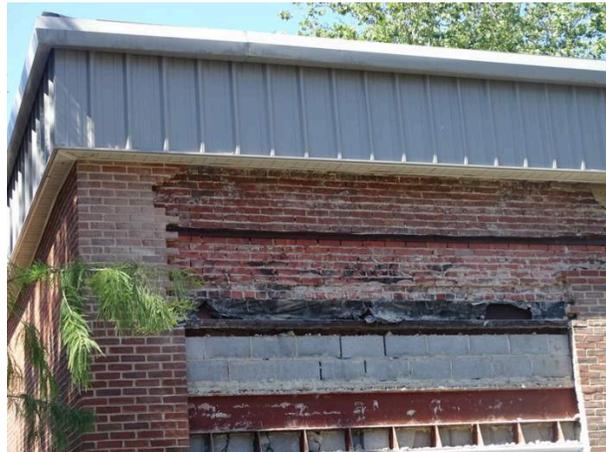
Building exterior - note deterioration

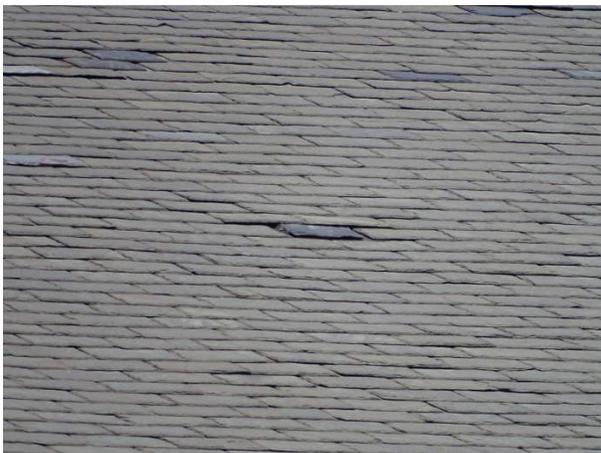
Slate shingle roofing system - note damaged and misaligned shingles

3.3.6 Roofing Systems																														
REPAIR SLATE SHINGLE ROOFING SYSTEM	50	49	1	4	EA	\$5,000.00	\$20,000	100%	\$5,000					\$5,000					\$5,000					\$5,000						\$20,000

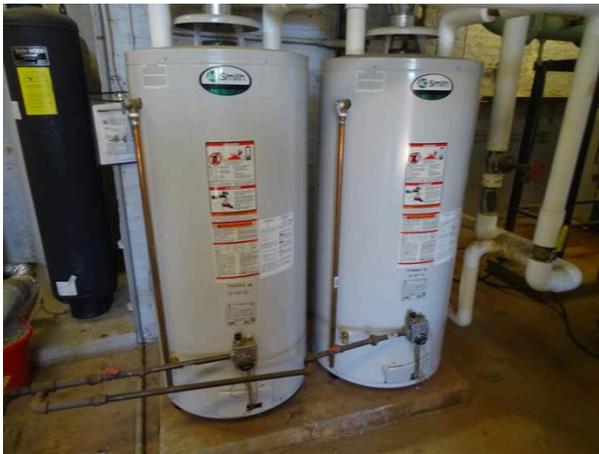
The expected useful life of a Gas domestic water heater is approximately 15 years with proper maintenance. We recommend the Gas domestic water heaters be replaced during the study period.

Gas domestic water heaters

3.4.1.2 Domestic Hot Water Production																														
REPLACE WATER HEATERS	15	9	6	2	EA	\$1,200.00	\$2,400	100%						\$2,400																\$2,400

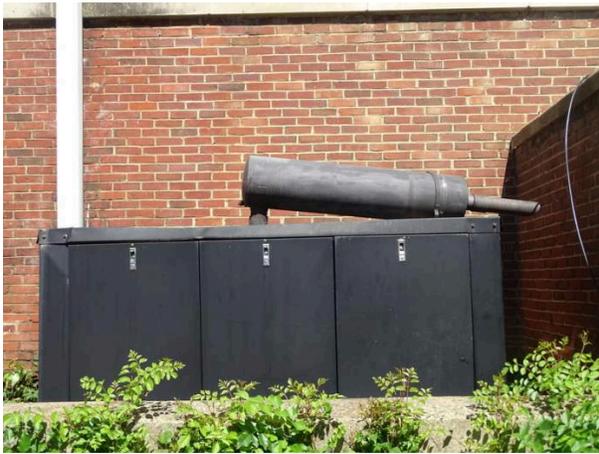
Emergency power generator

3.4.3.1 Service and Metering																													
REPLACE GENERATOR AND TRANSFER SWITCH	25	24	1	1	EA	\$30,000.00	\$30,000	100%	\$30,000																				\$30,000

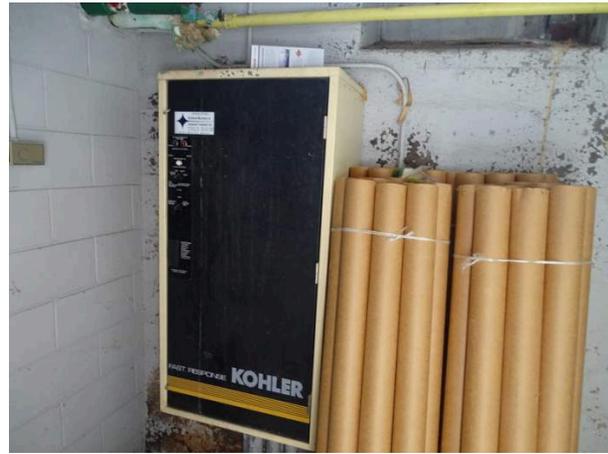
The emergency back up power generator transfer switch was manufactured by Kohler and is located in the main mechanical room. The transfer switch installation date was unknown with an expected useful life of 25 years with proper maintenance. The transfer switch should be replaced in conjunction with the generator.

Emergency power transfer switch

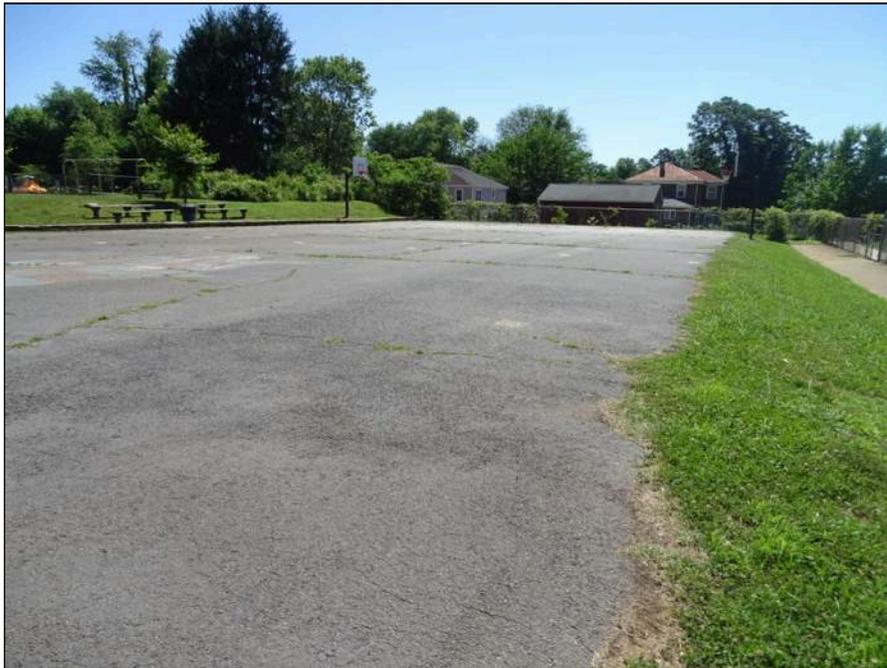
4 - Asphalt pavement - note cracking

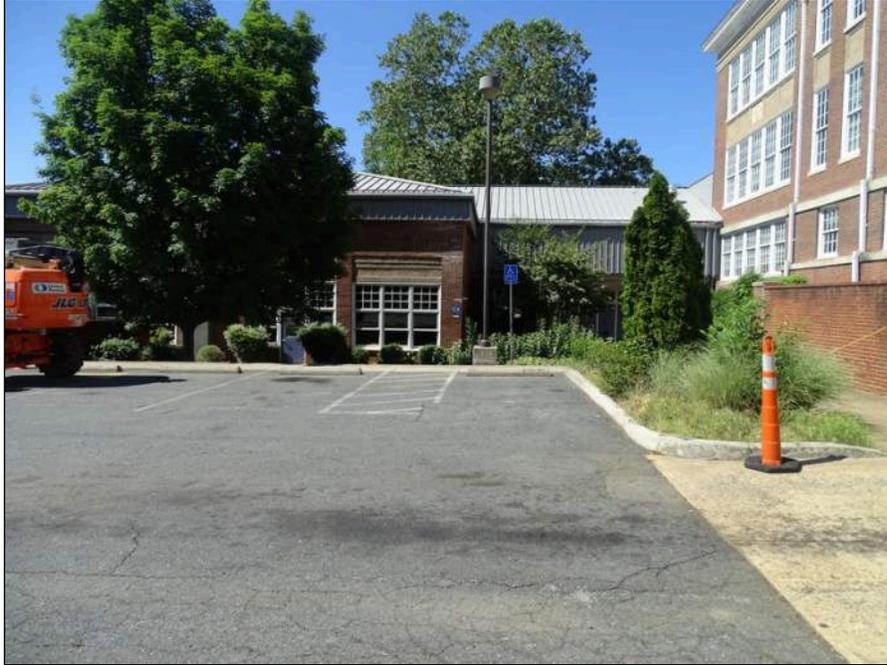
5 - Asphalt pavement - note cracking

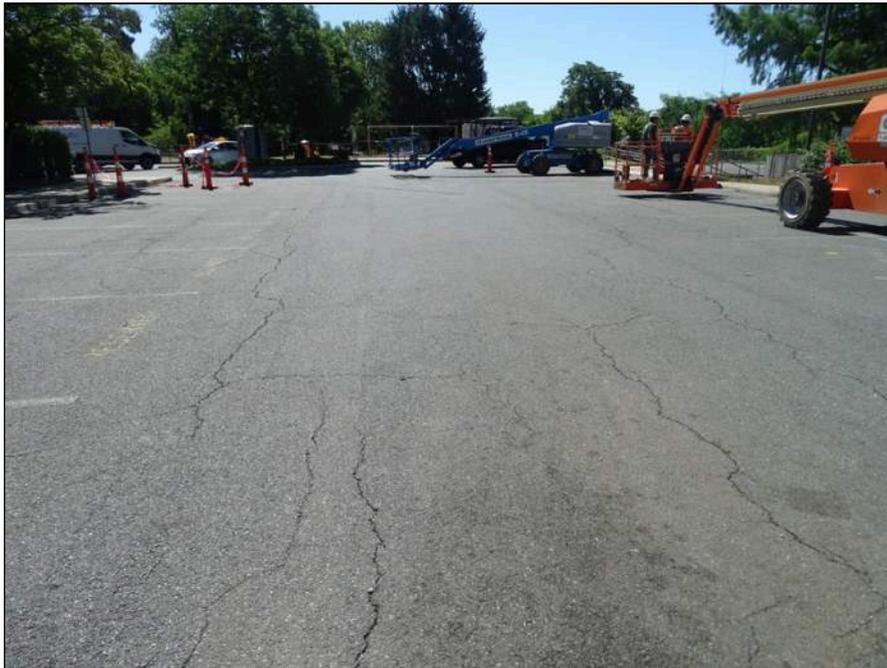
6 - Asphalt pavement - note cracking

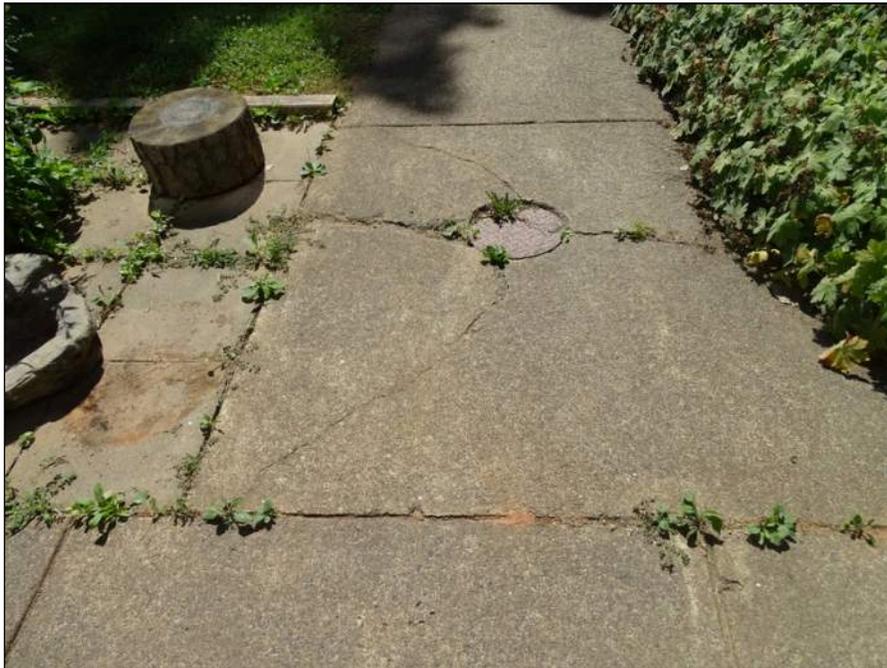
8 - Typical concrete sidewalk - note cracking

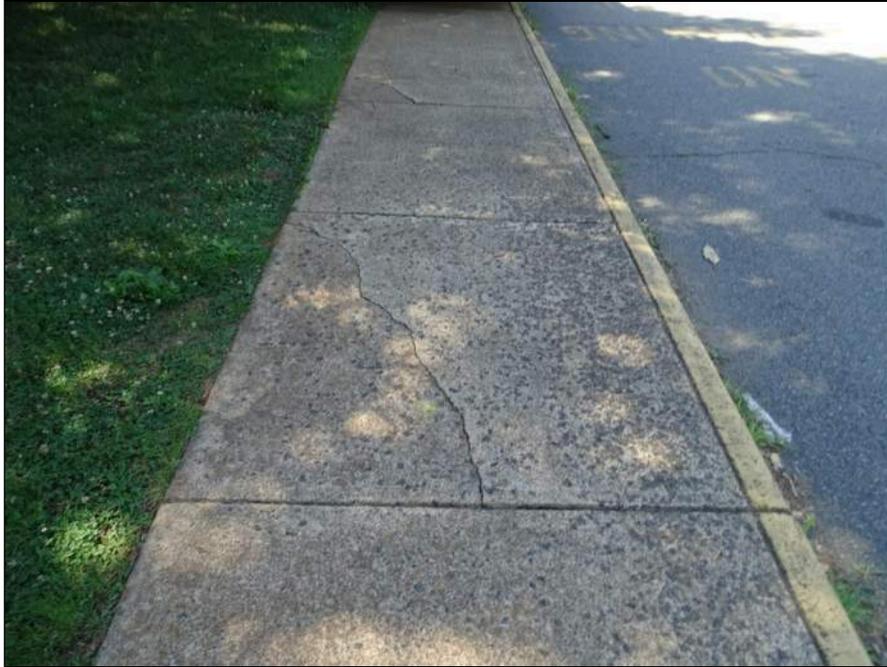
11 - Typical concrete sidewalk - note cracking

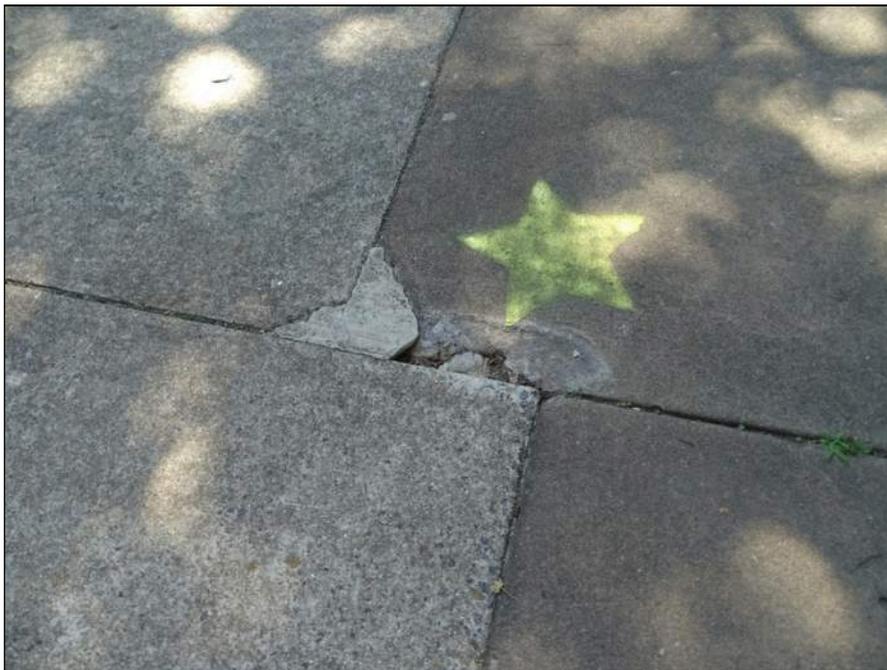
12 - Typical concrete sidewalk - note deterioration

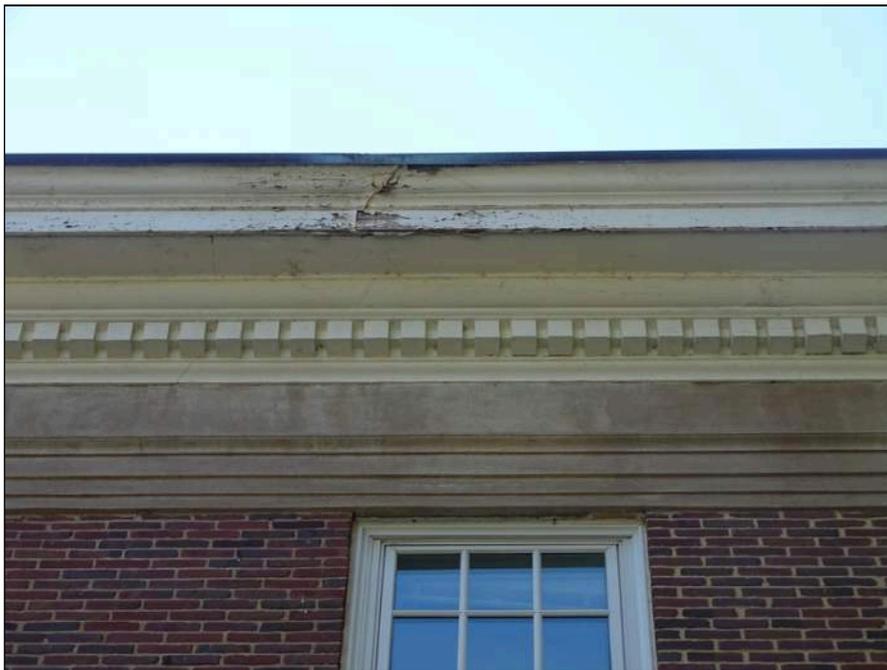
24 - Building exterior - note rotten through cornice work

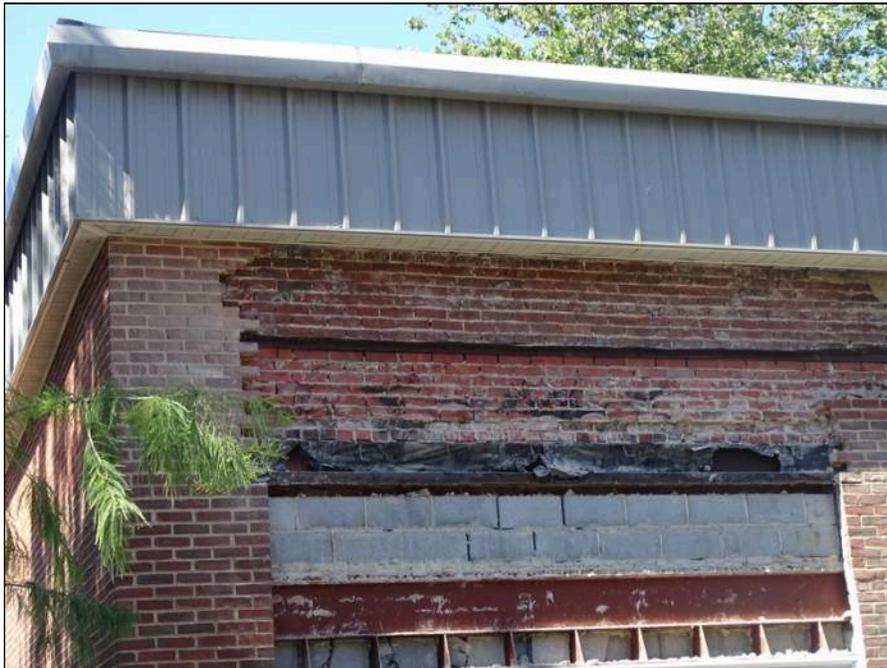
26 - Building exterior - note deterioration

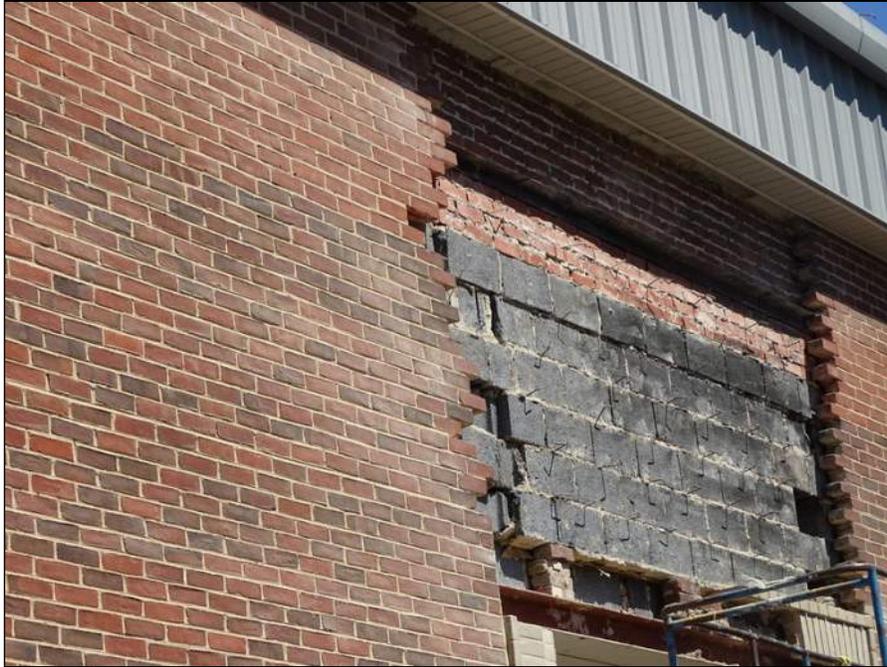
27 - Building exterior - note deterioration

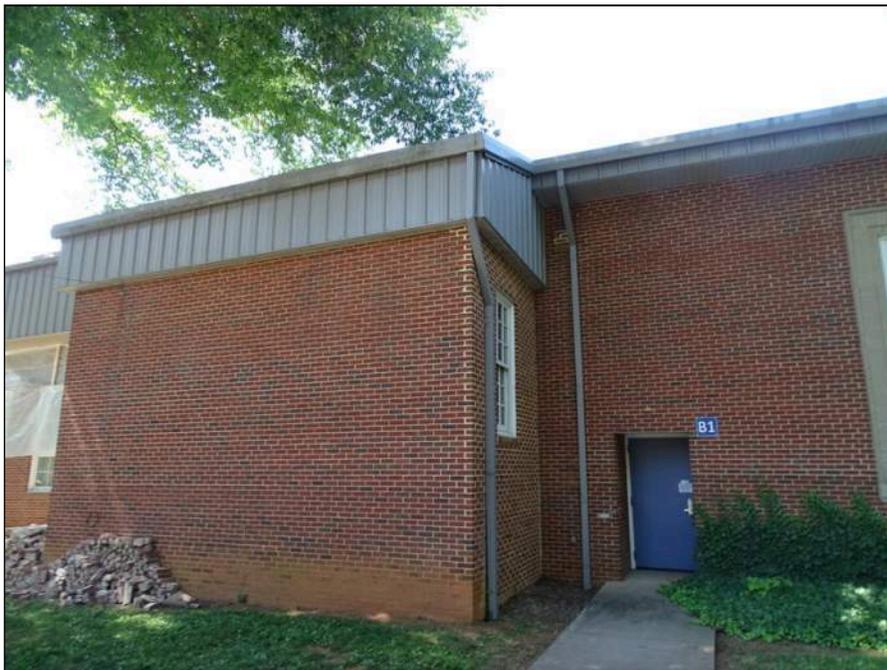
28 - Building exterior - note efflorescence

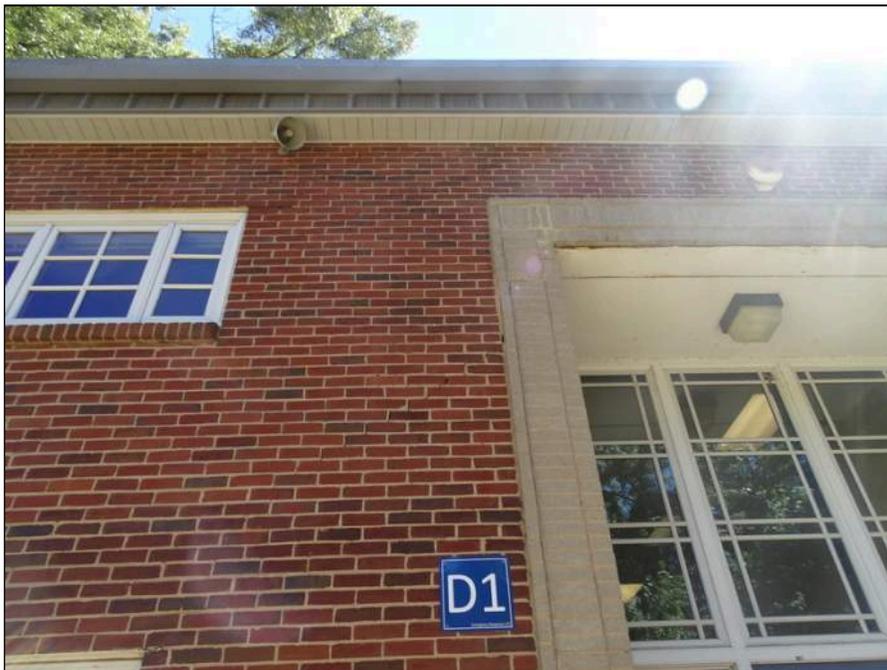
30 - Building exterior - note step cracking in brick

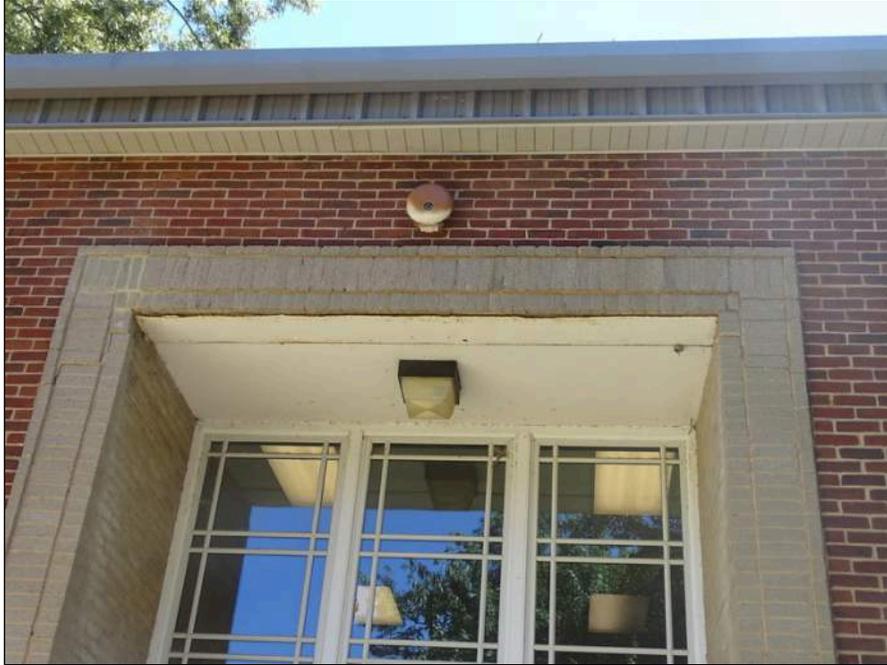
31 - Building exterior - note cracking

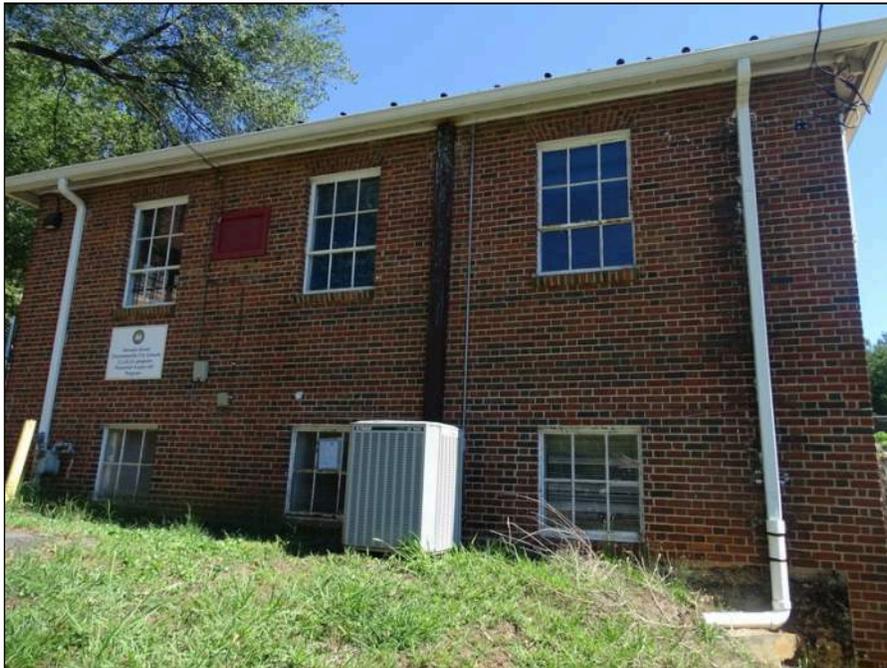
32 - Building exterior - note efflorescence

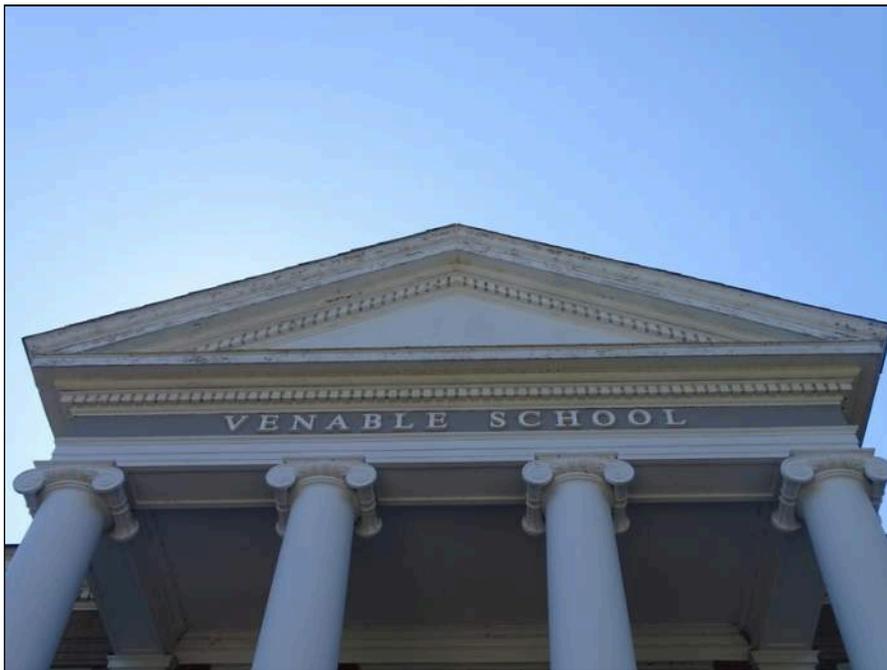
34 - Building exterior - note peeling paint

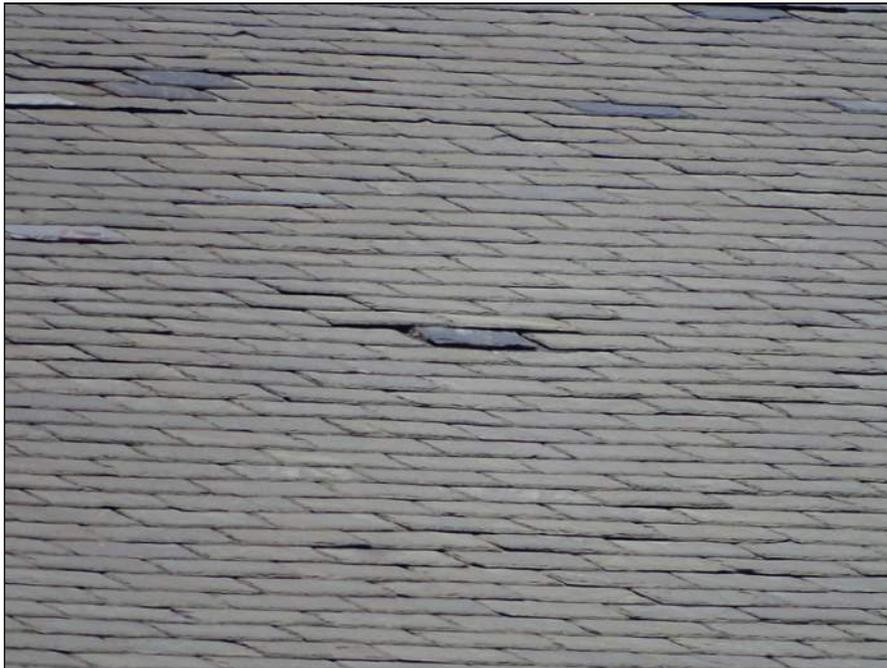
48 - Slate shingle roofing system - note damaged and misaligned shingles

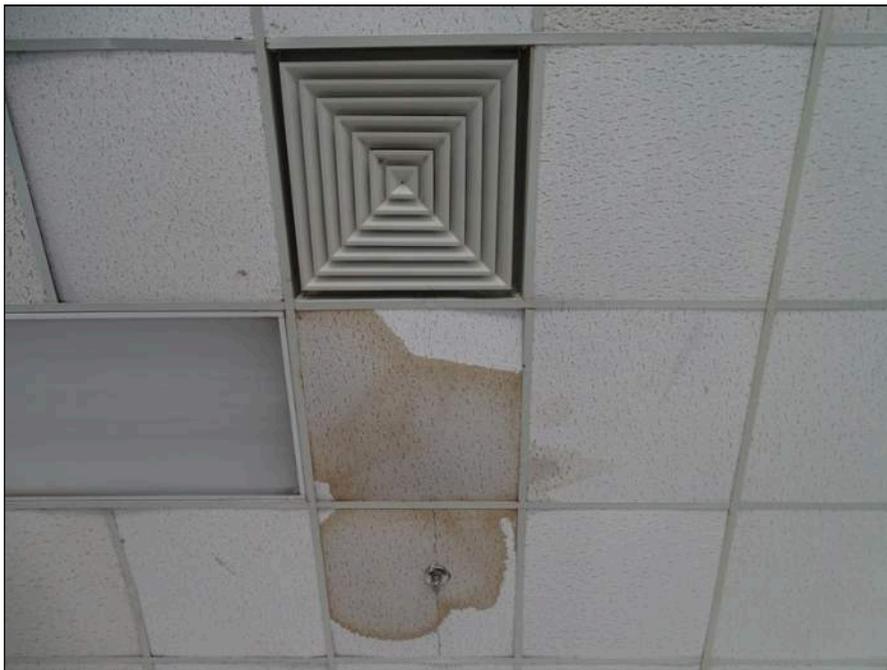
50 - water leakage
