WALKER UPPER ELEMENTARY SCHOOL
1564 DAIRY ROAD
CHARLOTTESVILLE, VIRGINIA

ECS PROJECT NO. 46:6713

CITY OF CHARLOTTESVILLE - FACILITIES DEVELOPMENT

Reference: Facility Condition Assessment Report for Walker Upper Elementary School, 1564 Dairy Road, Charlottesville, Virginia

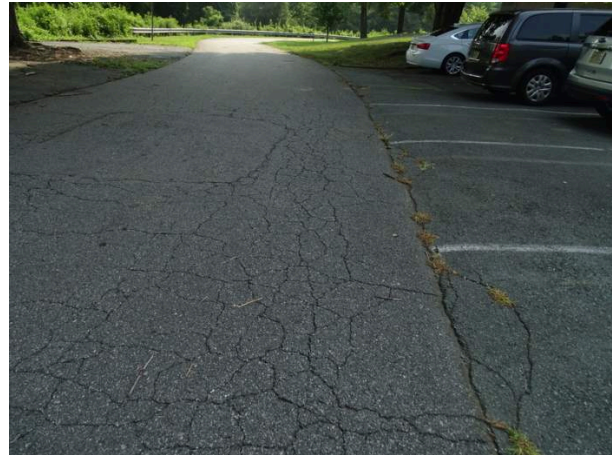
Asphalt pavement parking - note alligator cracks

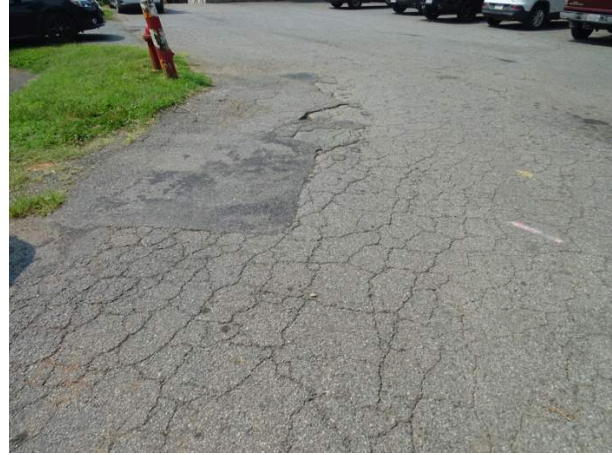
Asphalt drive lane east side of the site - note cracking

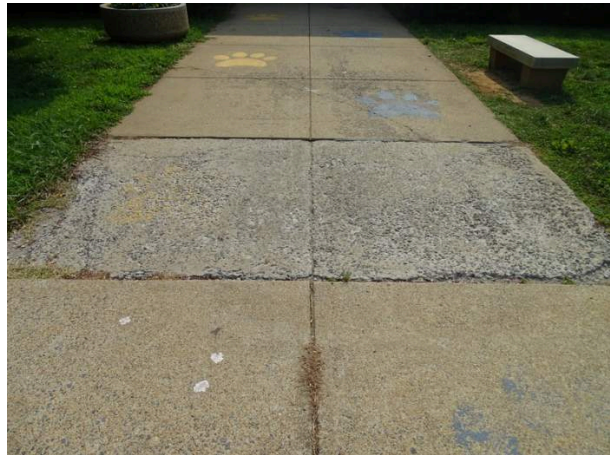
Concrete sidewalk - note deterioration

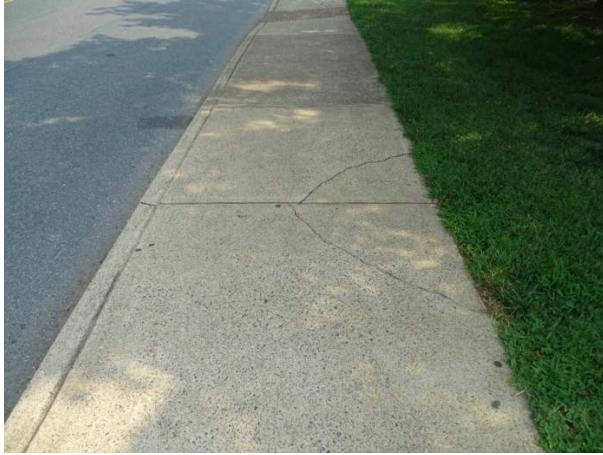
Concrete sidewalk - note deterioration

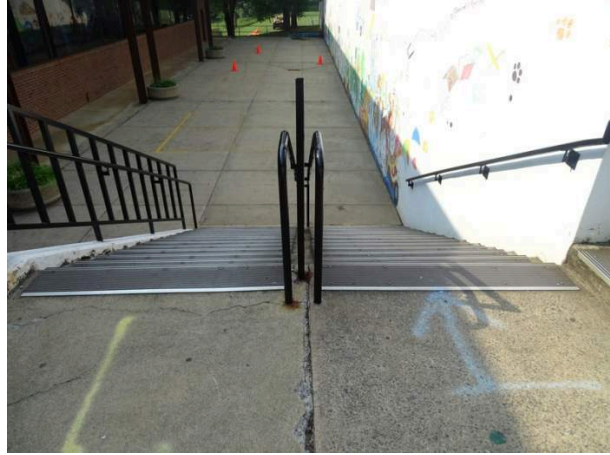
Typical concrete steps - note deterioration

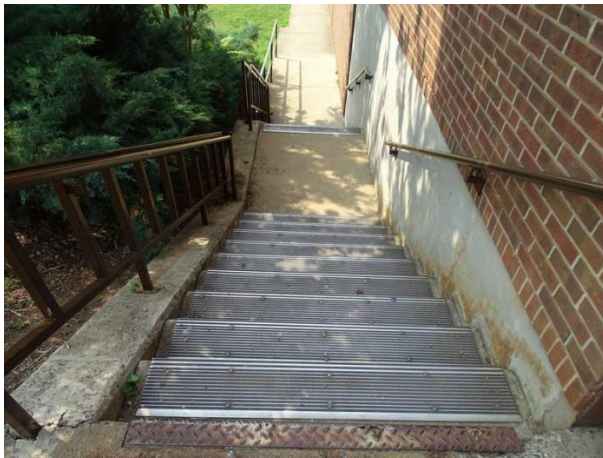
Typical concrete steps - note deterioration

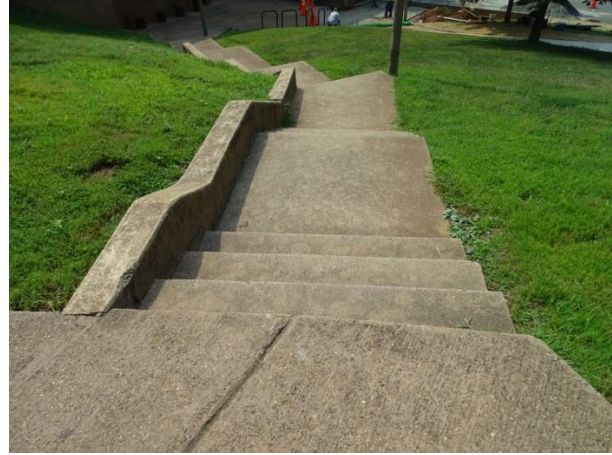
Typical concrete steps - note missing handrail

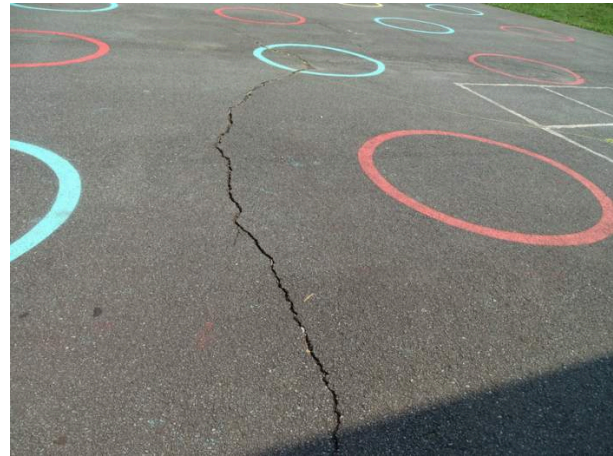
Basketball court located between main building and gym - note cracking

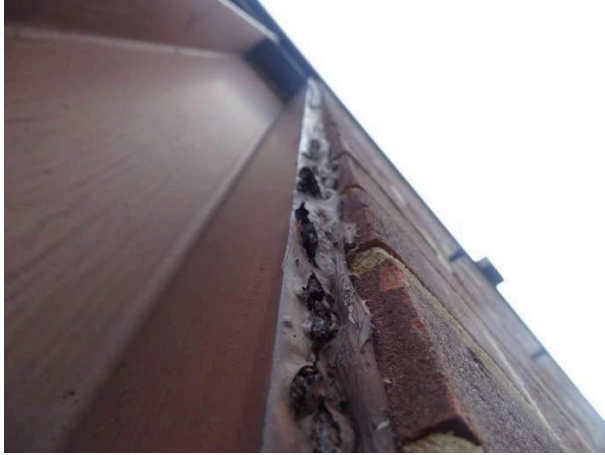
Building exterior - note sealant deterioration

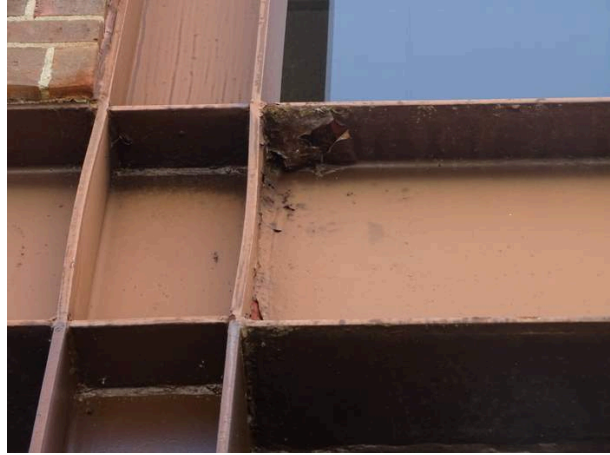
Main building entrance exterior doors upper level - note peeling paint

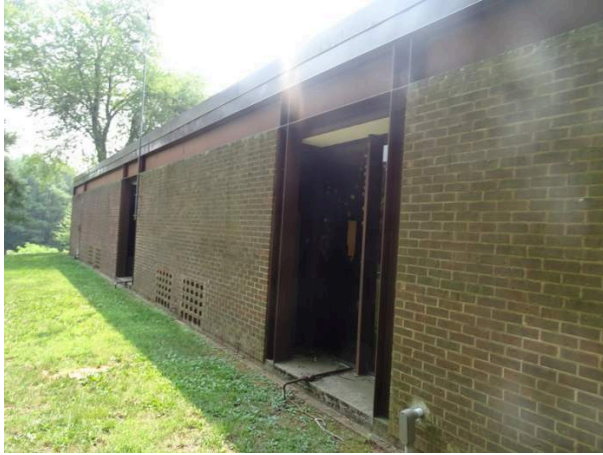
Building exterior - note deterioration

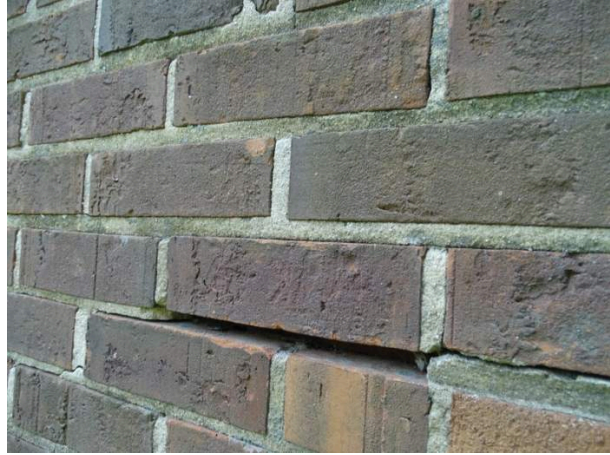
Building exterior - note deterioration

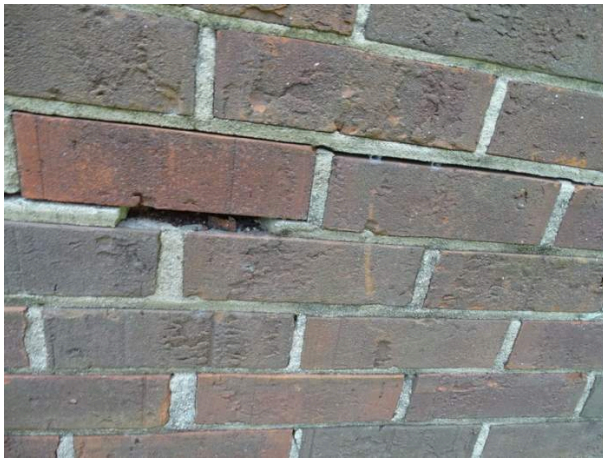
Building exterior - note deterioration

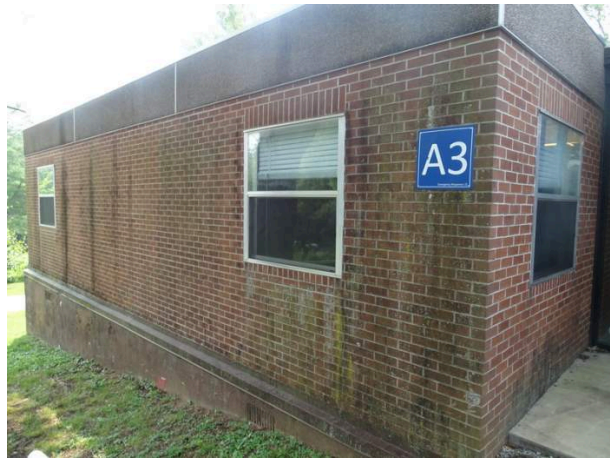
Building exterior - note deterioration

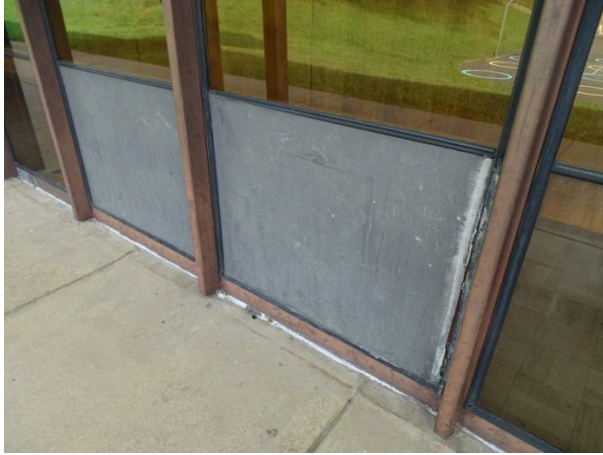
Typical exterior windows - note deterioration

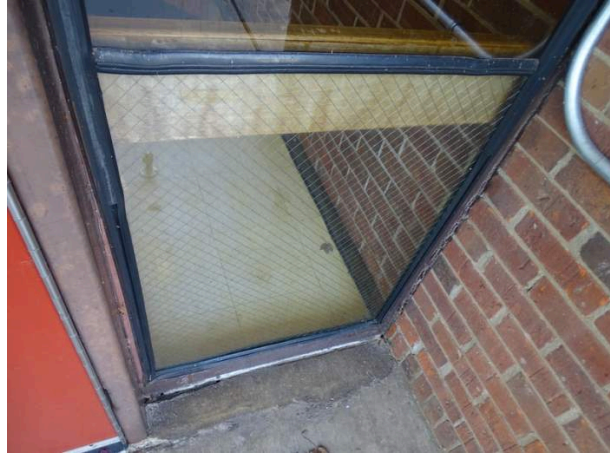
Typical exterior windows - note deterioration

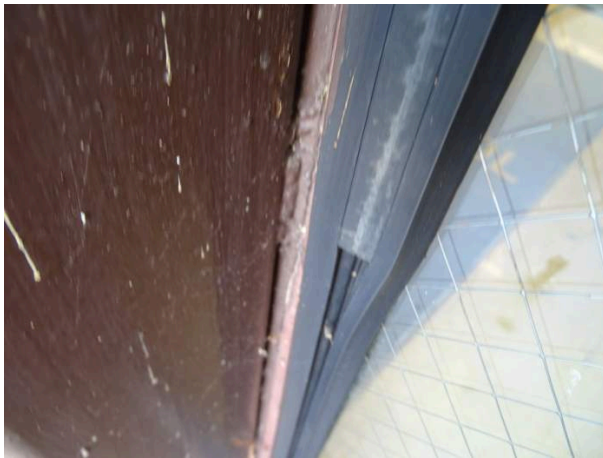
Typical exterior windows - note deterioration

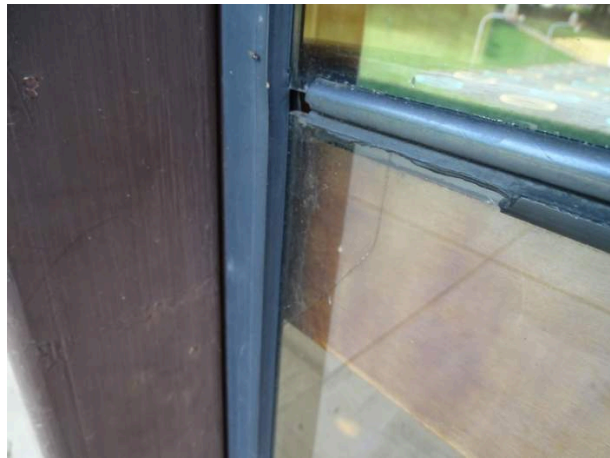
Typical exterior windows - note deterioration

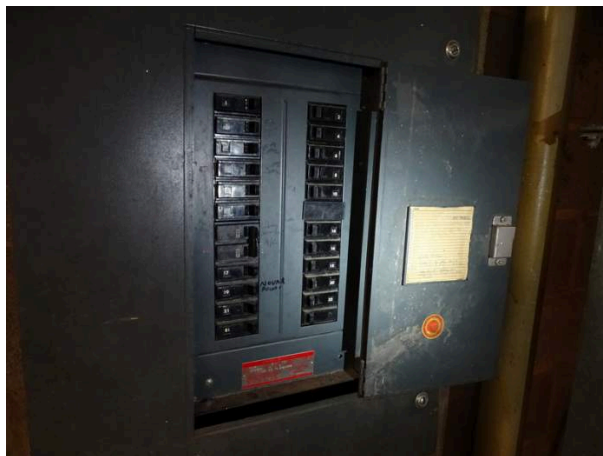
Power is distributed by copper wire from circuit breaker panels located throughout the building. The expected useful life of sub-panels is 50 years with proper maintenance. Some of the the circuit breaker panels were reportedly recently replaced. Older circuit breaker panels were observed with some rusting. The circuit breaker panels were observed to be in generally good to fair condition. We recommend replacing the remainder of the older circuit breaker panels.

Typical older circuit breaker panel

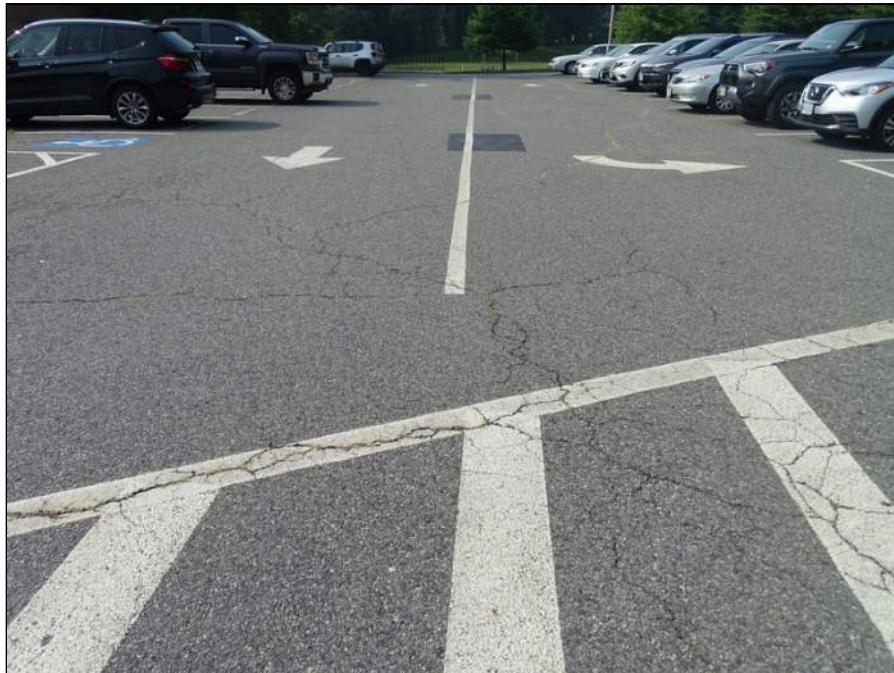
2 - Asphalt parking at west side of the site - note cracking

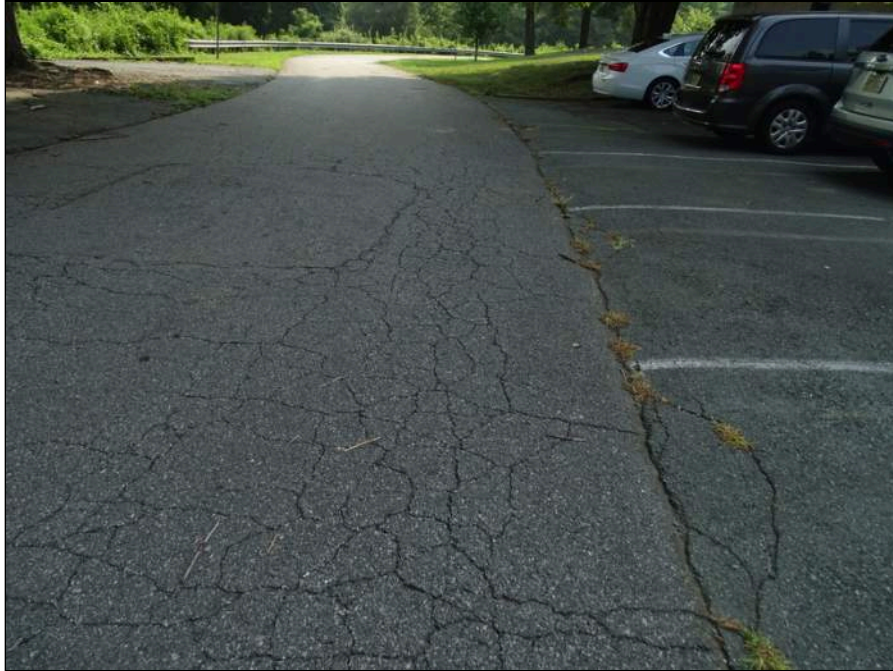
3 - Asphalt pavement parking - note alligator cracks

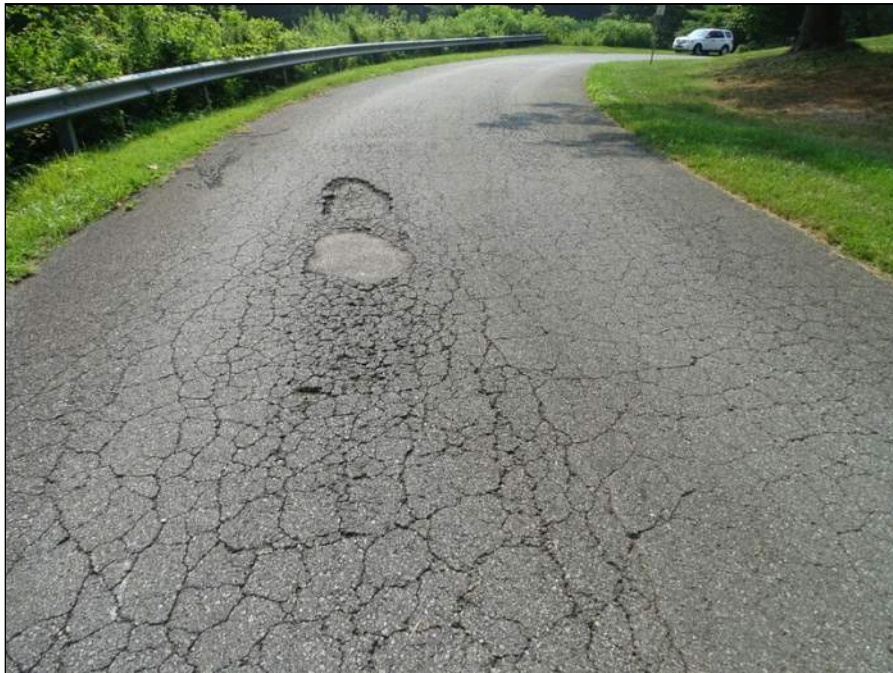
4 - Asphalt drive lane east side of the site - note cracking

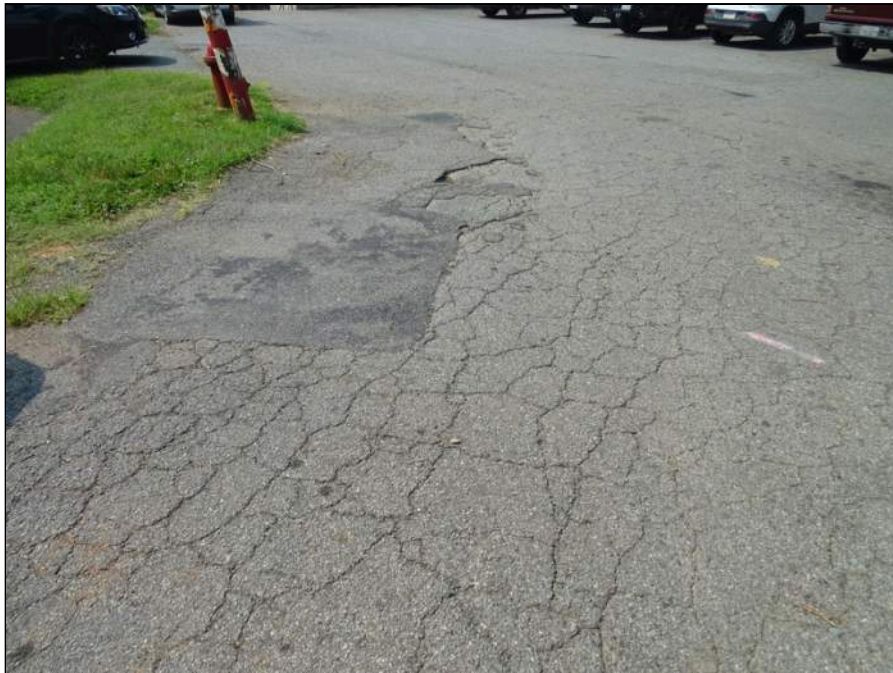
6 - Asphalt drive lane east side of the site - note cracking

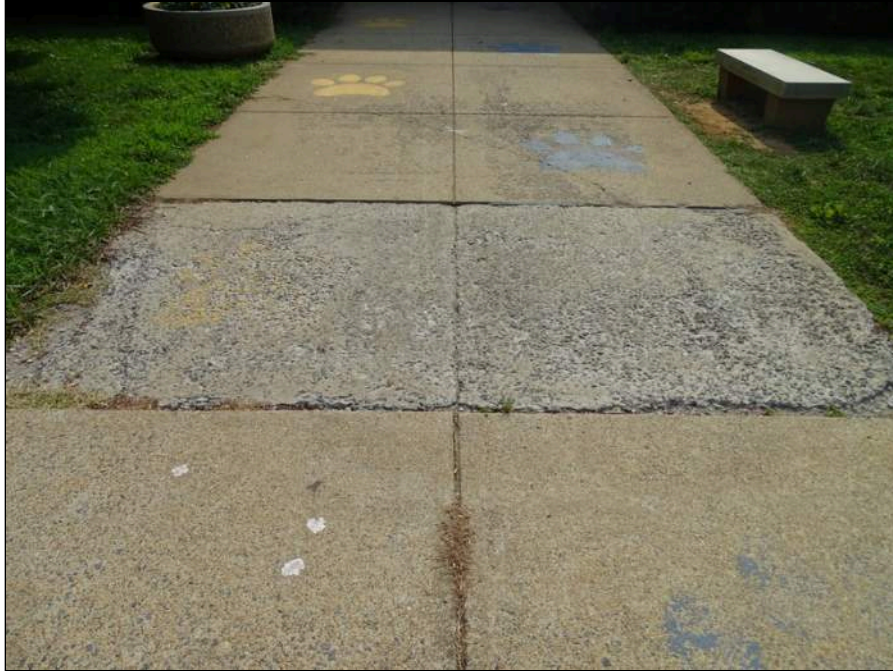
9 - Concrete sidewalk - note deterioration

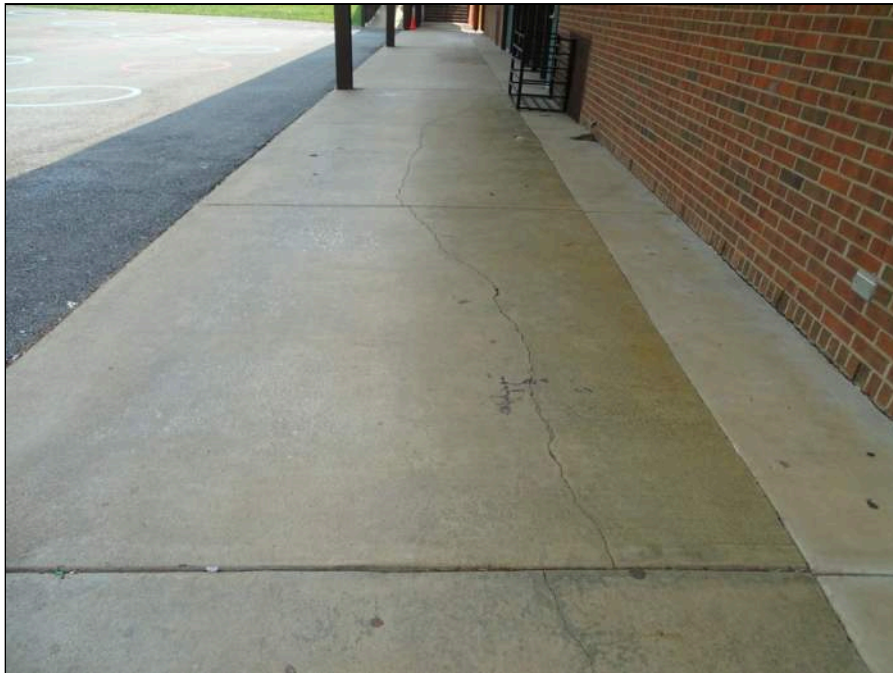
10 - Concrete sidewalk - note deterioration

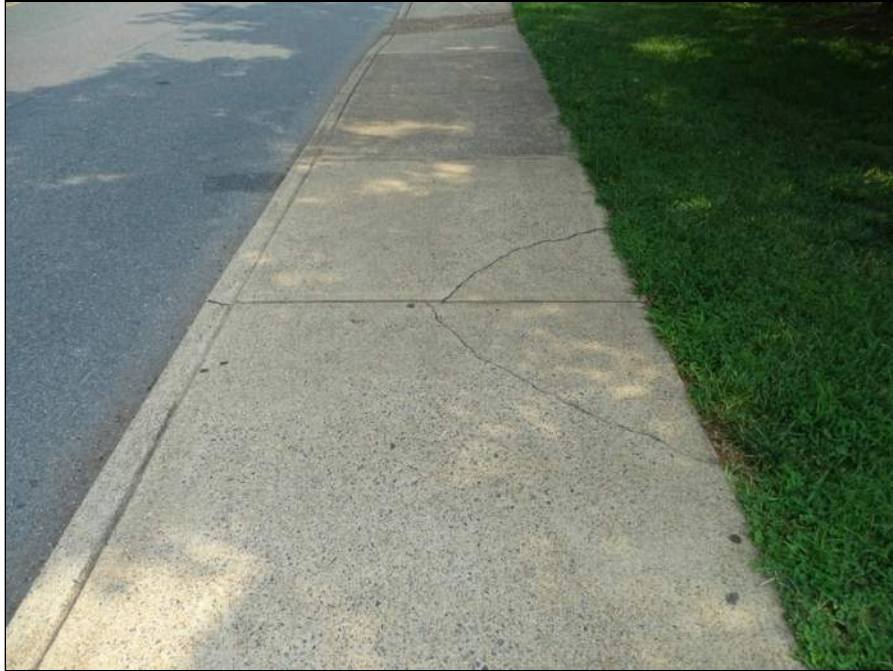
11 - Concrete sidewalk - note deterioration

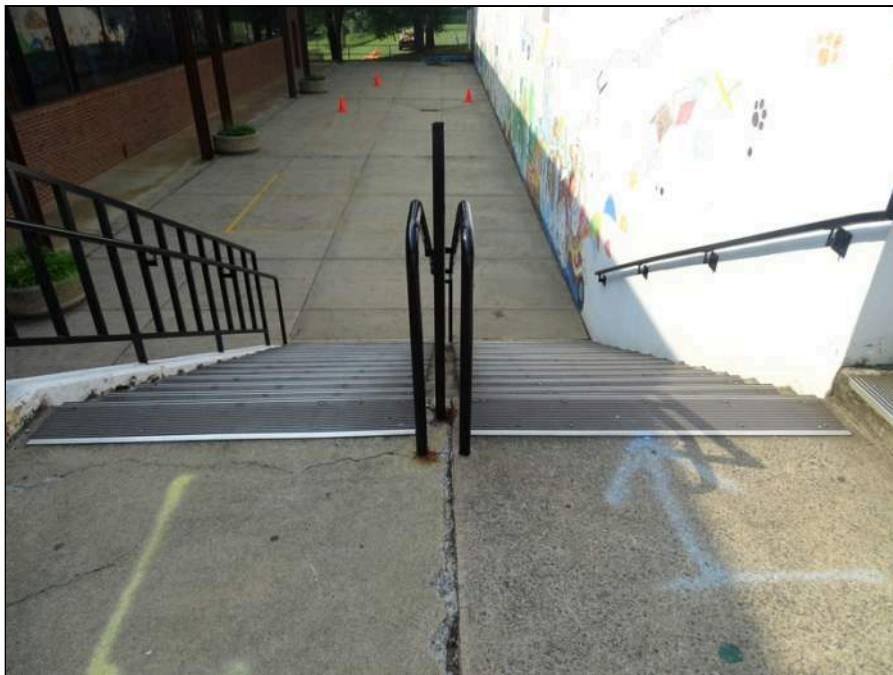
12 - Typical concrete steps - note deterioration

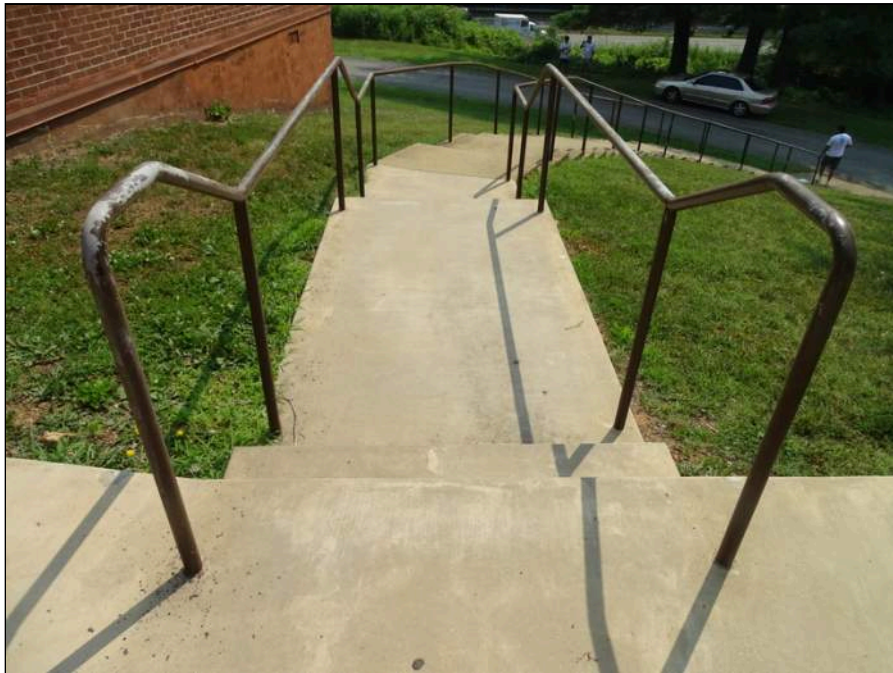
14 - Typical concrete steps handrail - note handrail deterioration

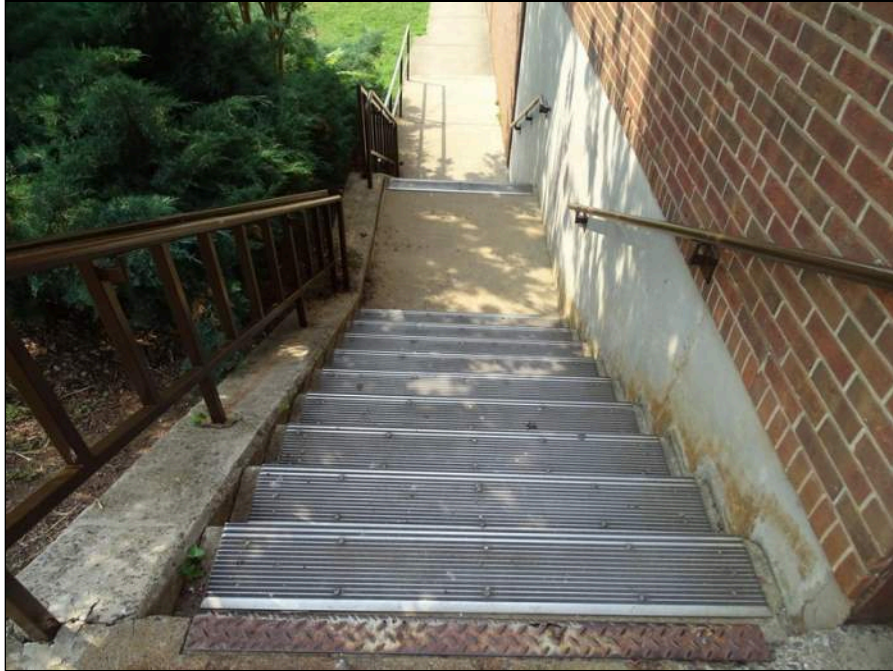
15 - Typical concrete steps - note deterioration

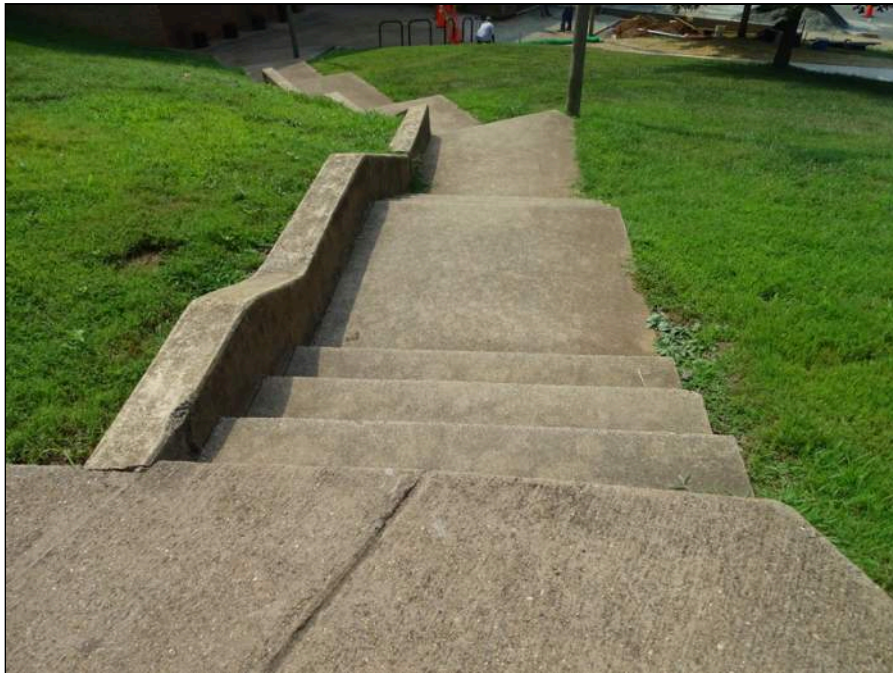
16 - Typical concrete steps - note missing handrail

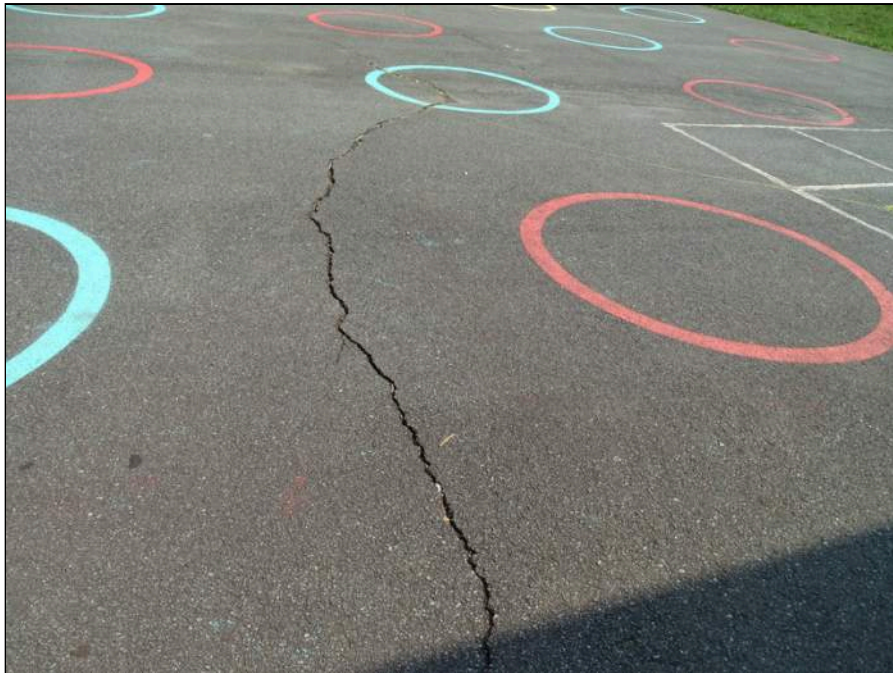
24 - Basketball court located between main building and gym - note cracking

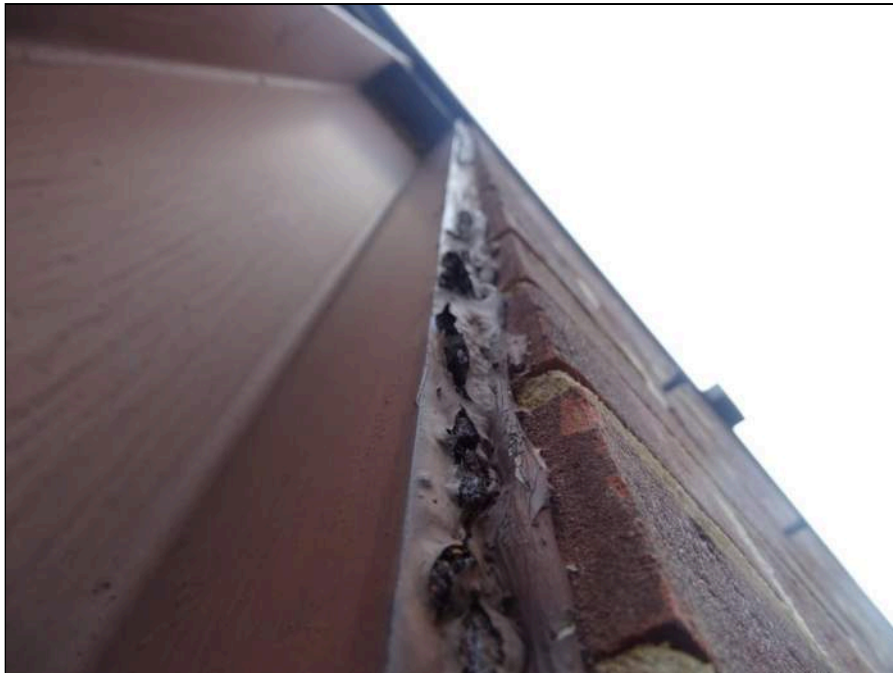
32 - Building exterior - note sealant deterioration

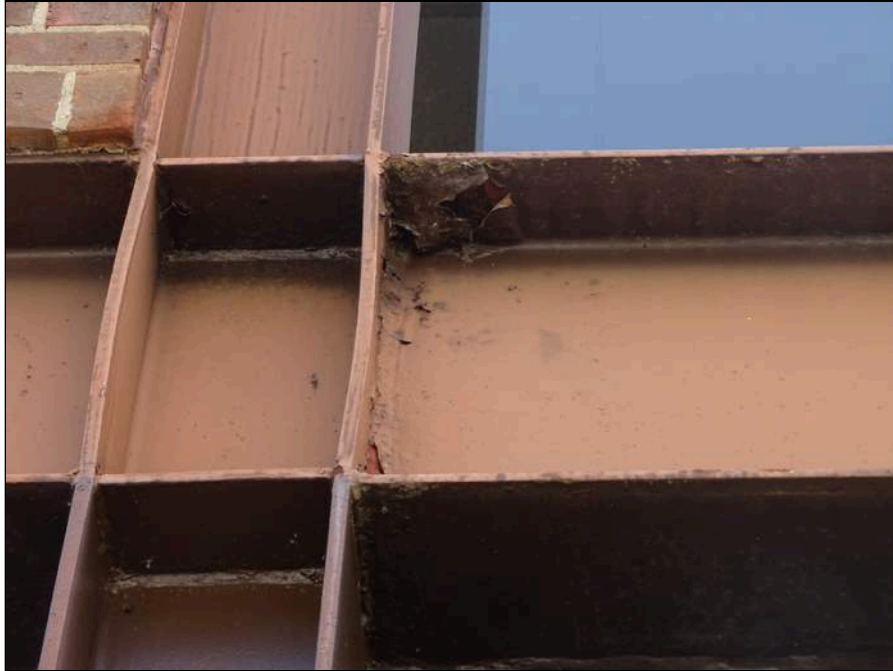
33 - Main building entrance exterior doors upper level - note peeling paint

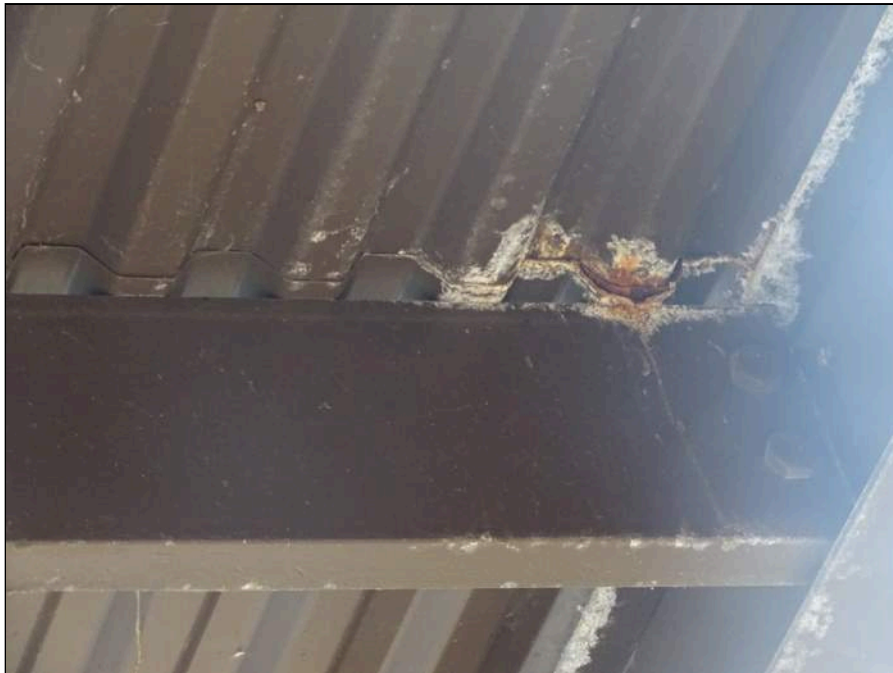
34 - Building exteriors - note deterioration

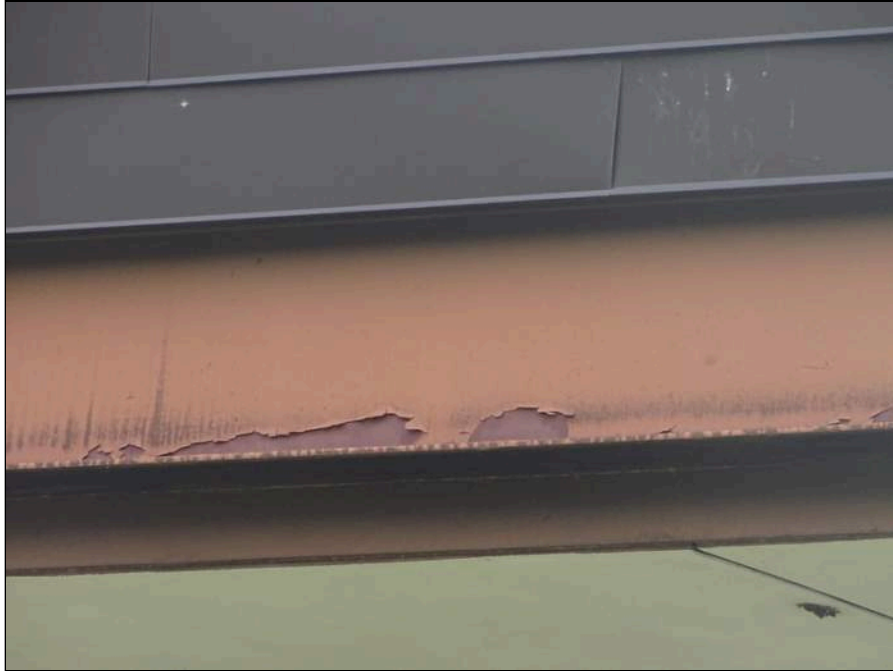
35 - Building exterior - note peeling paint

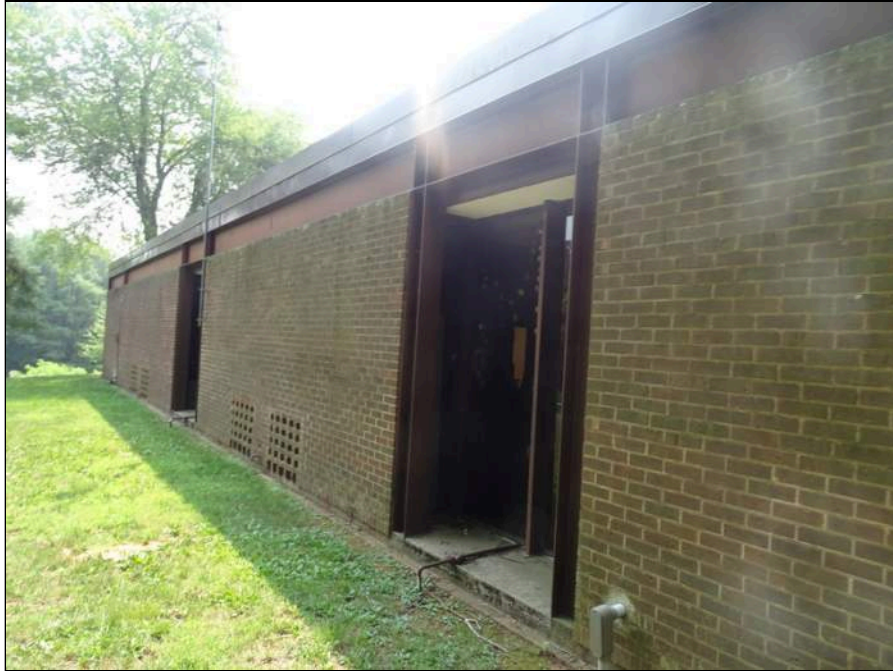
37 - Building exterior - note deterioration

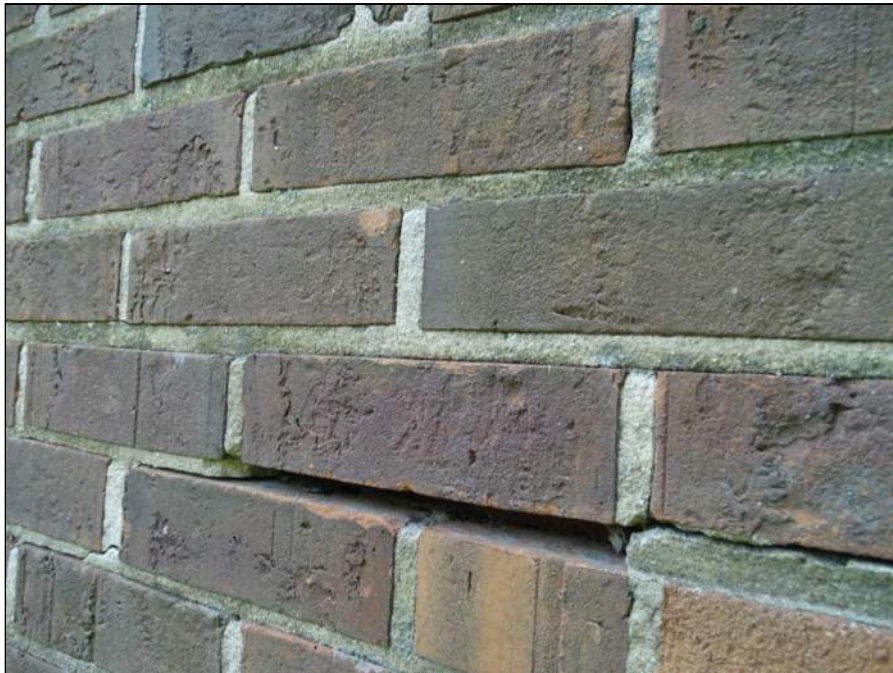
38 - Building exterior - note deterioration

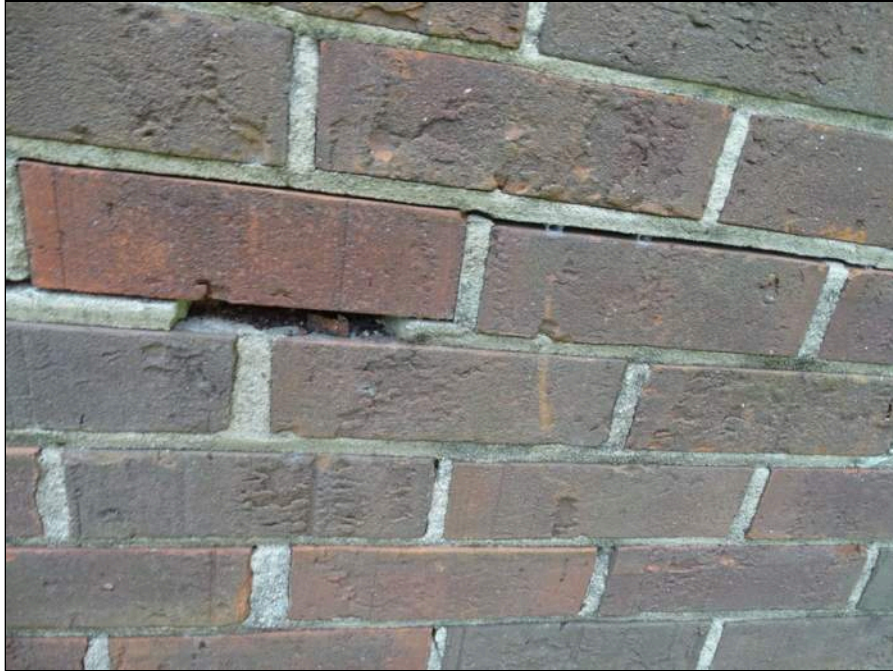
39 - Building exterior - note deterioration

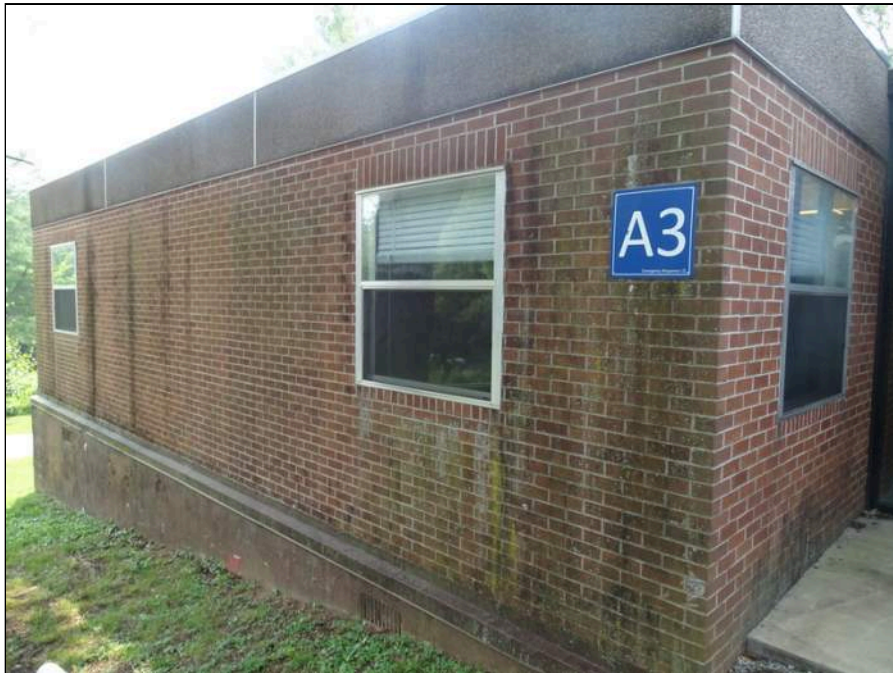
40 - Building exterior - note deterioration

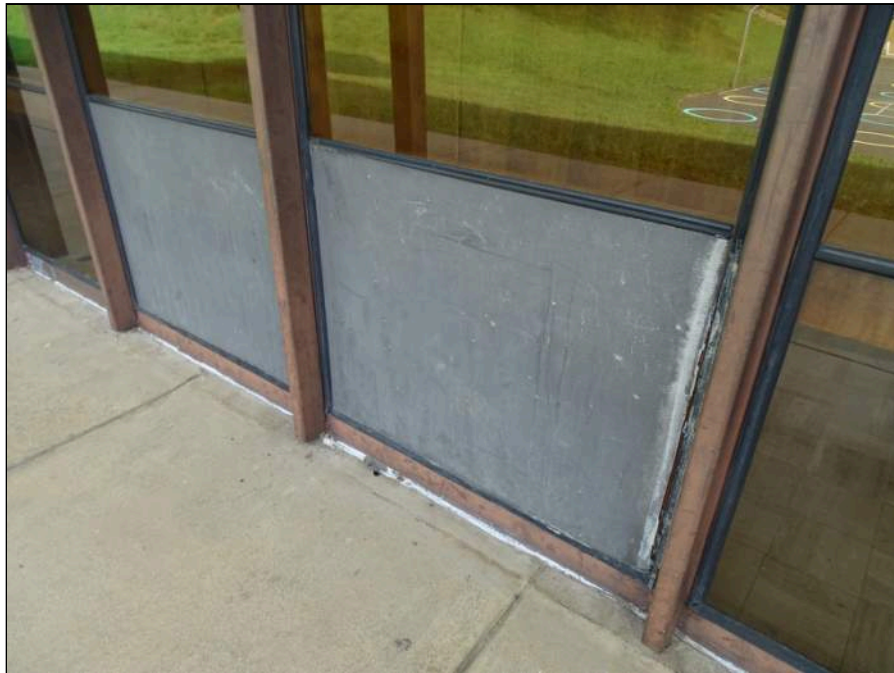
46 - Typical exterior windows - note deterioration

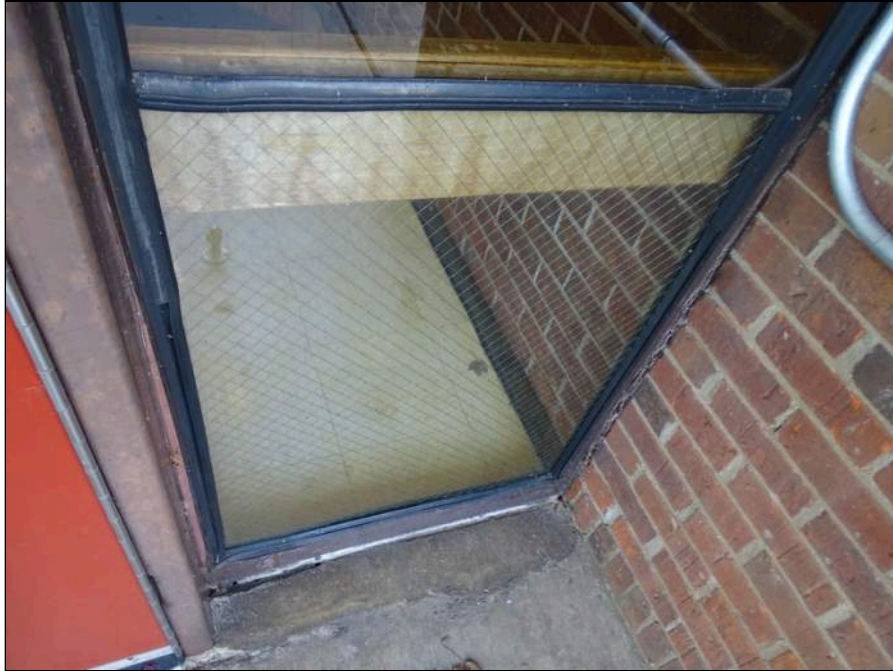
47 - Typical exterior windows - note deterioration

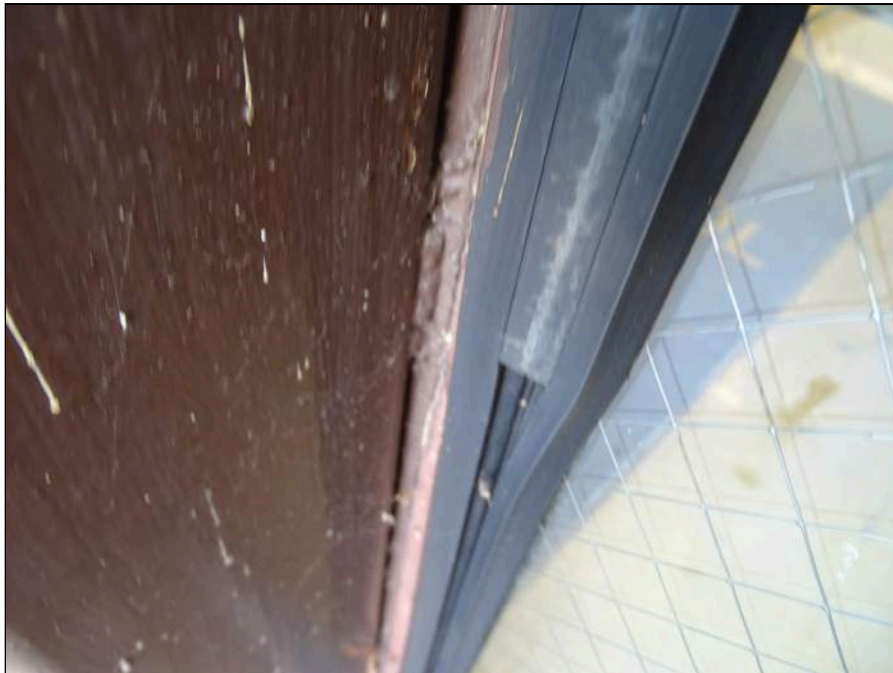
48 - Typical exterior windows - note deterioration

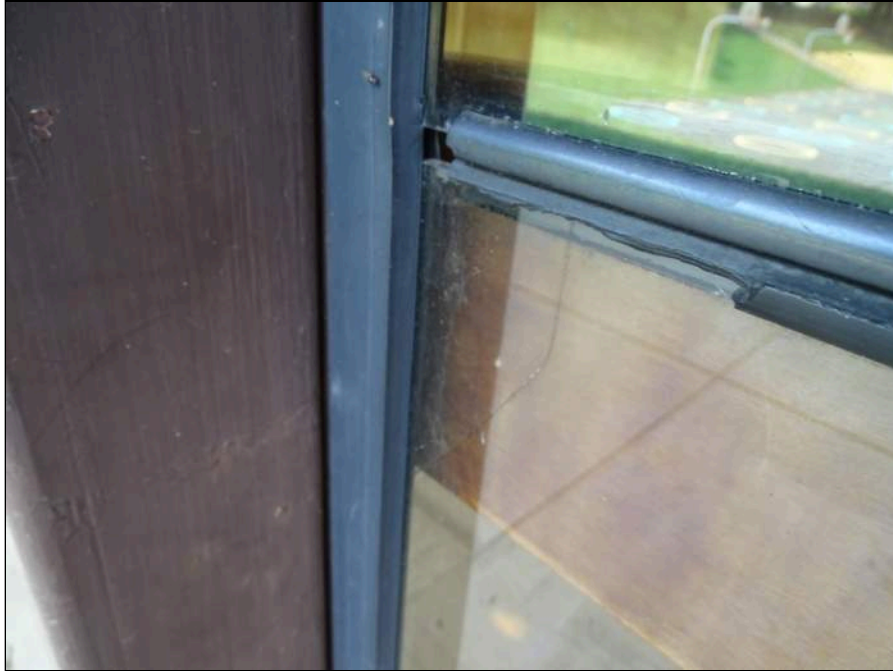
49 - Typical exterior windows - note deterioration
