WASHINGTON PARK BATH HOUSE AND SHELTER
1001 PRESTON AVENUE
CHARLOTTESVILLE, VIRGINIA

ECS PROJECT NO. 46:6713

CITY OF CHARLOTTESVILLE - FACILITIES DEVELOPMENT

Reference: Facility Condition Assessment Report for Washington Park Bath House and Shelter, 1001 Preston Avenue, Charlottesville, Virginia

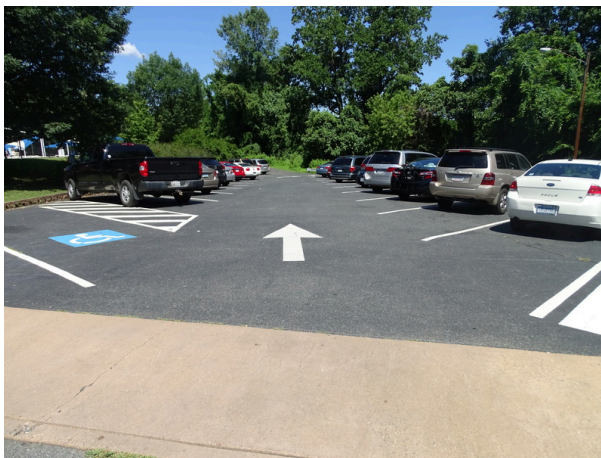
An asphalt parking lot is located on the northeast side of the site. The asphalt pavement was observed to be in generally good condition. The expected useful life of asphalt pavement is 20 years. We recommend repairing areas of asphalt pavement on an as-needed basis and have provided an allowance to overlay the asphalt pavement.

Parking lot overview - note cracking

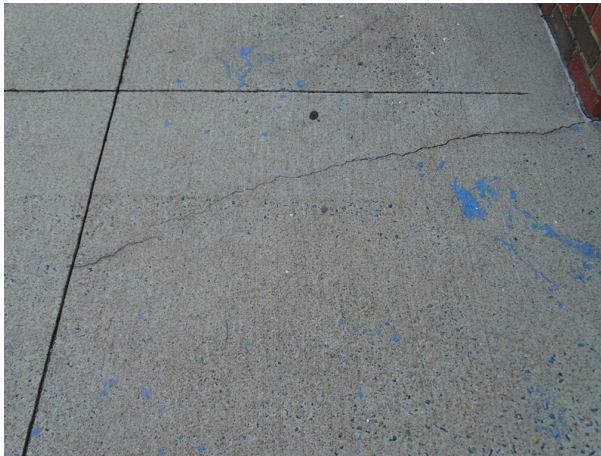
Concrete sidewalk overview - note cracking

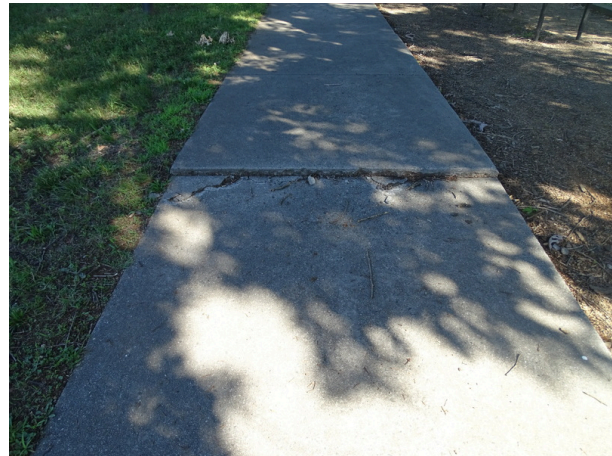
Concrete sidewalk - note tripping hazard

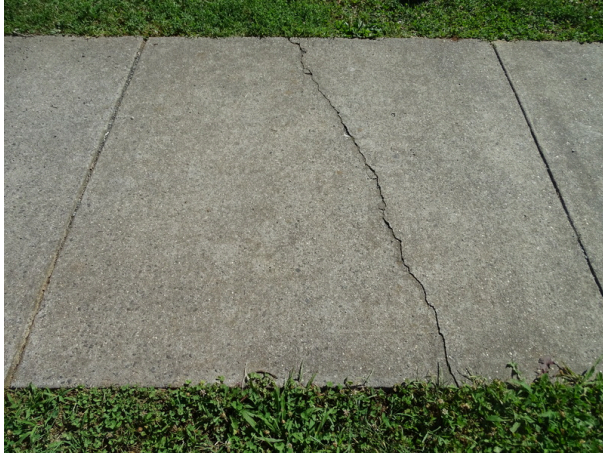
Concrete sidewalk overview - note cracking

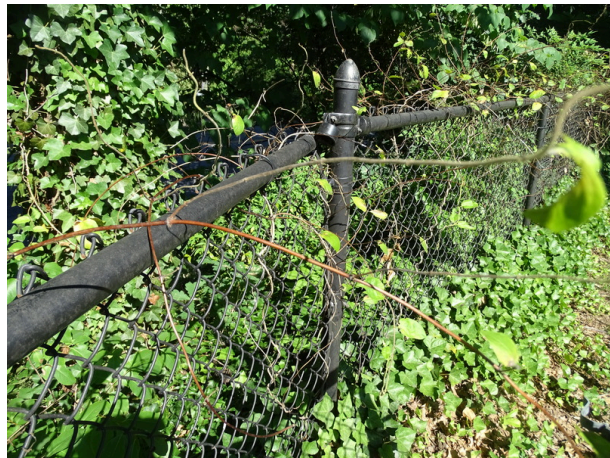
Typical landscaping and fencing - note deterioration

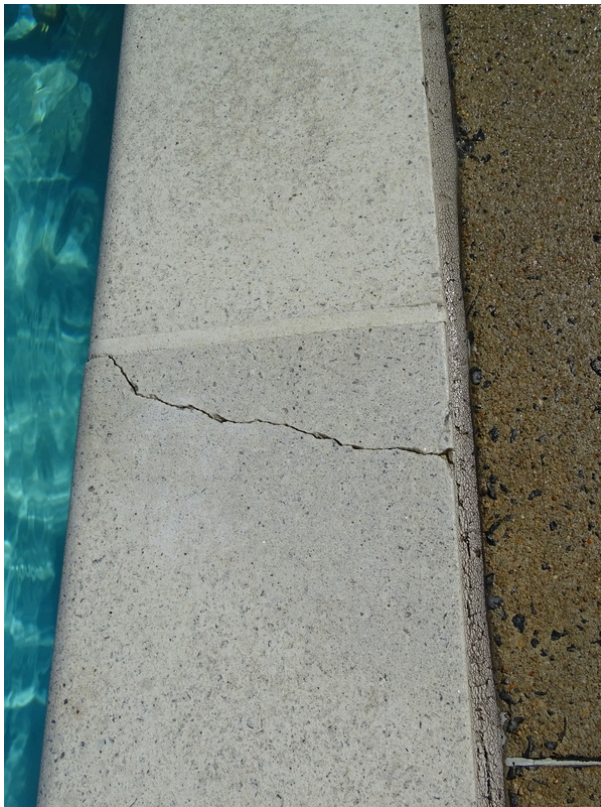
Cracked concrete coping of pool

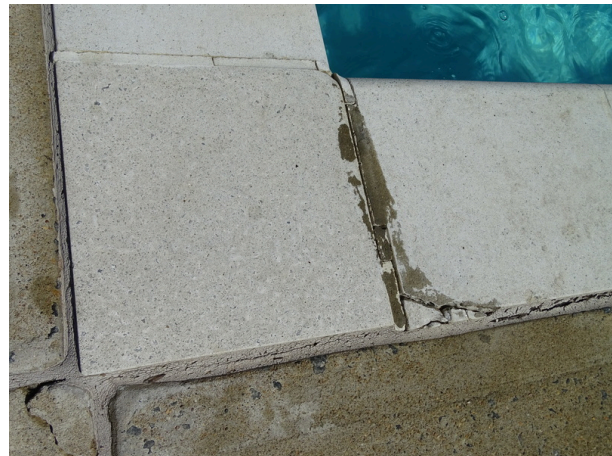
Concrete pavement overview - note sealant condition

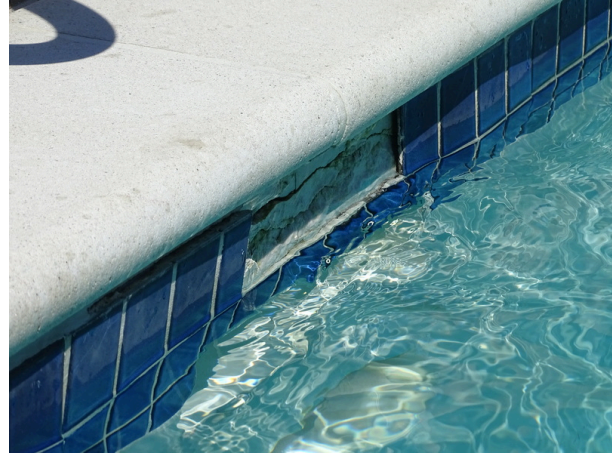
Pool tile - Missing tiles

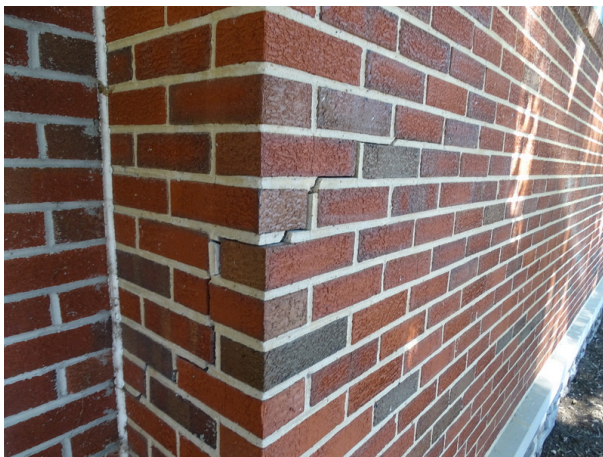
Bath house exterior - note step cracking

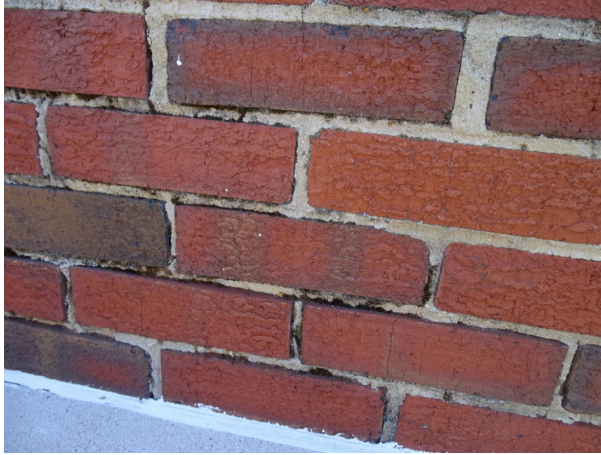
Bath house exterior - note mortar deterioration

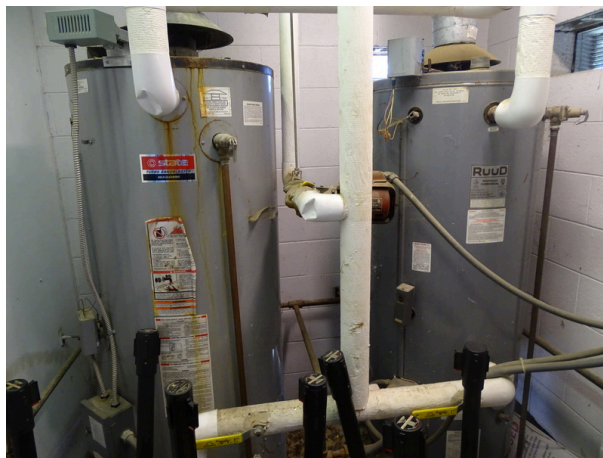
The expected useful life of a domestic water heaters is approximately 12 to 15 years. We recommend the domestic water heaters be replaced during the report period.

Bath house water heaters

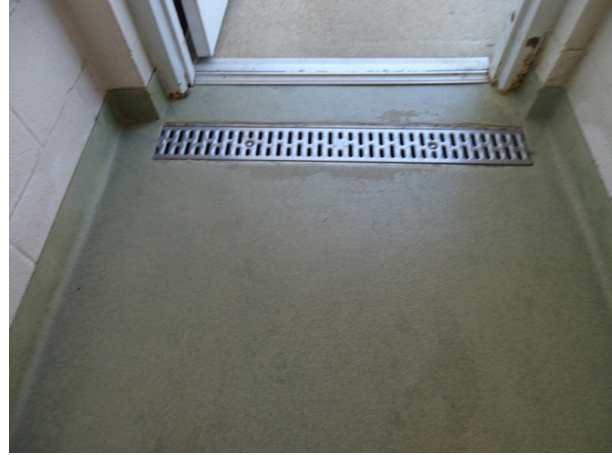
Bath house family restroom drainage - note wear

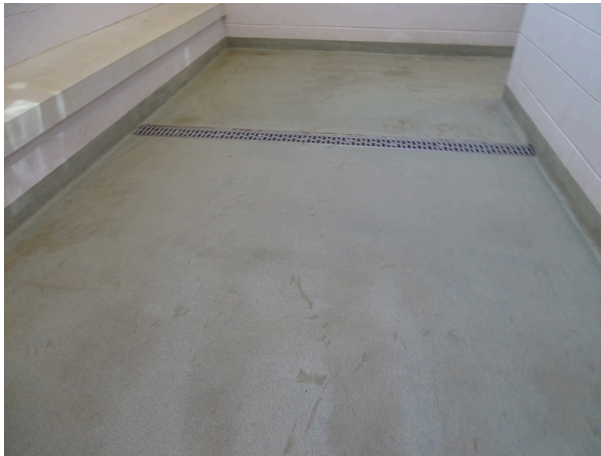
An allowance has been included to replace the epoxy flooring throughout the building. Concrete coatings typically have an expected useful life of 10 years, though the current concrete coating is showing premature deterioration.

Bath house family restroom floor - note deterioration

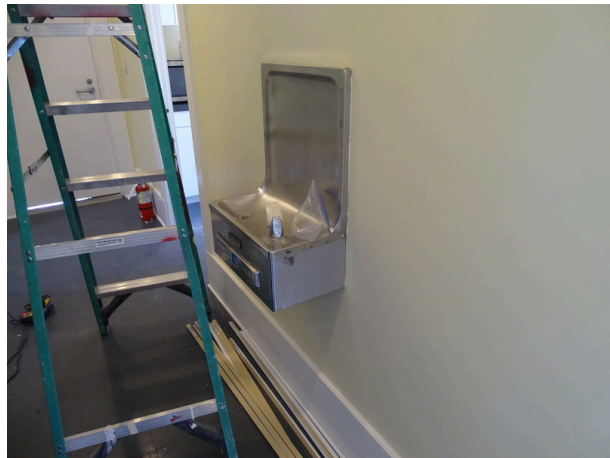
The drinking fountain at the shelter building is not an accessible type and protrudes greater than 4" into an accessible path. We recommend the drinking fountain be relocated or replaced with a unit similar to that located at the bath house and provided with cane detection to eliminate the protrusion issue.

Non-accessible, protruding drinking fountain at Shelter

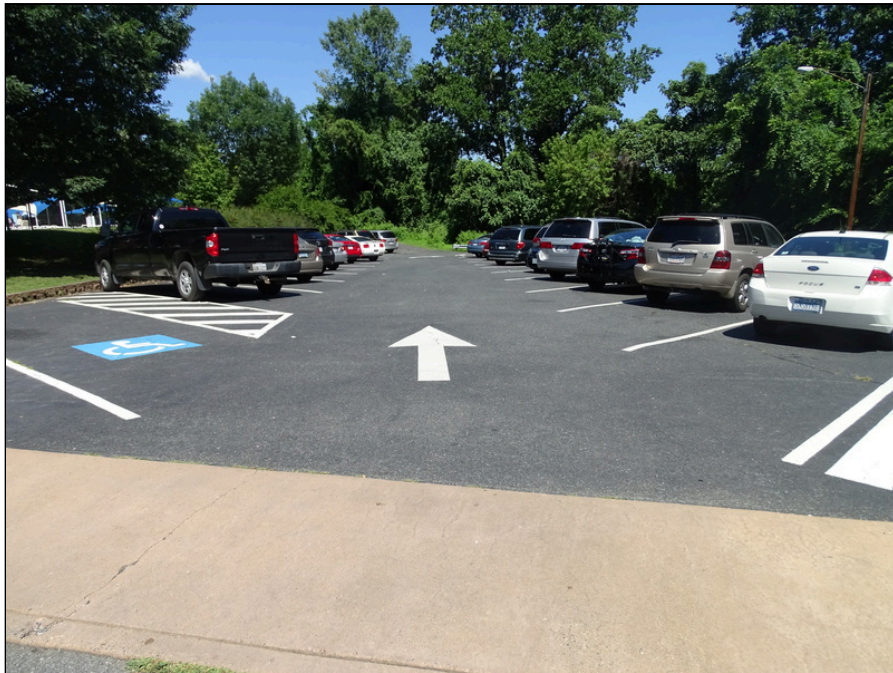
4 - Parking lot overview - note cracking

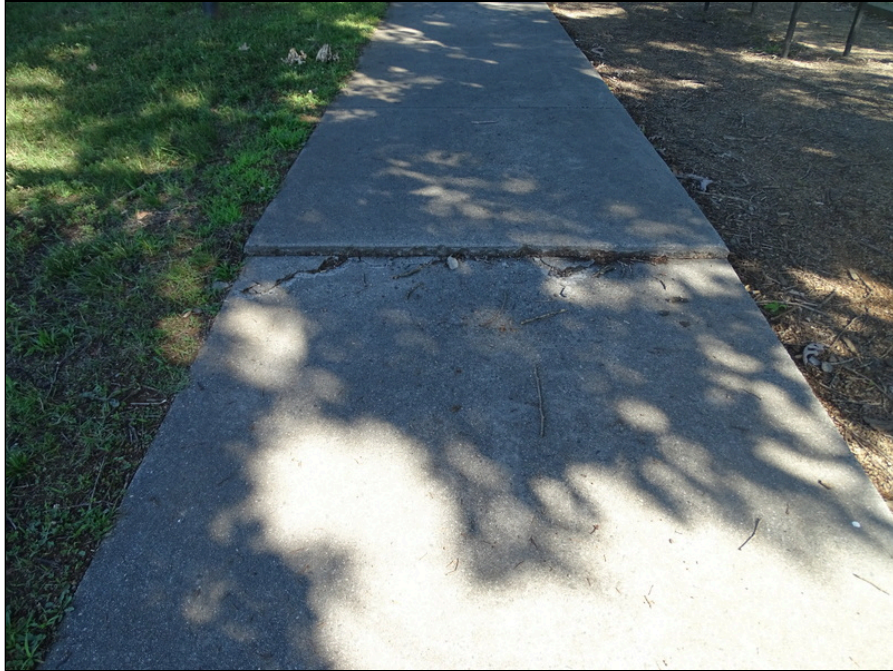
5 - Concrete sidewalk - note tripping hazard

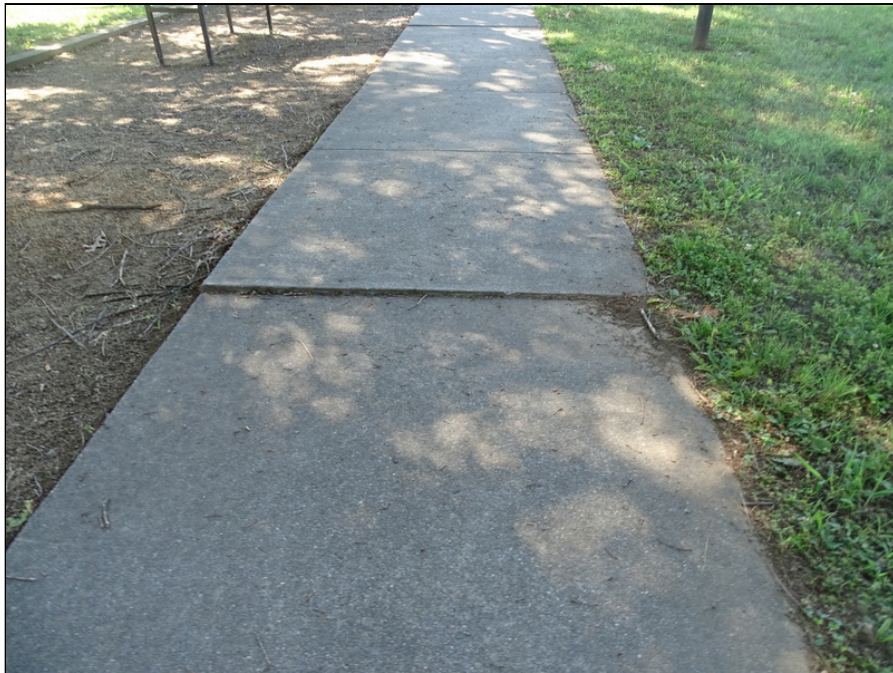
6 - Concrete sidewalk - note tripping hazard

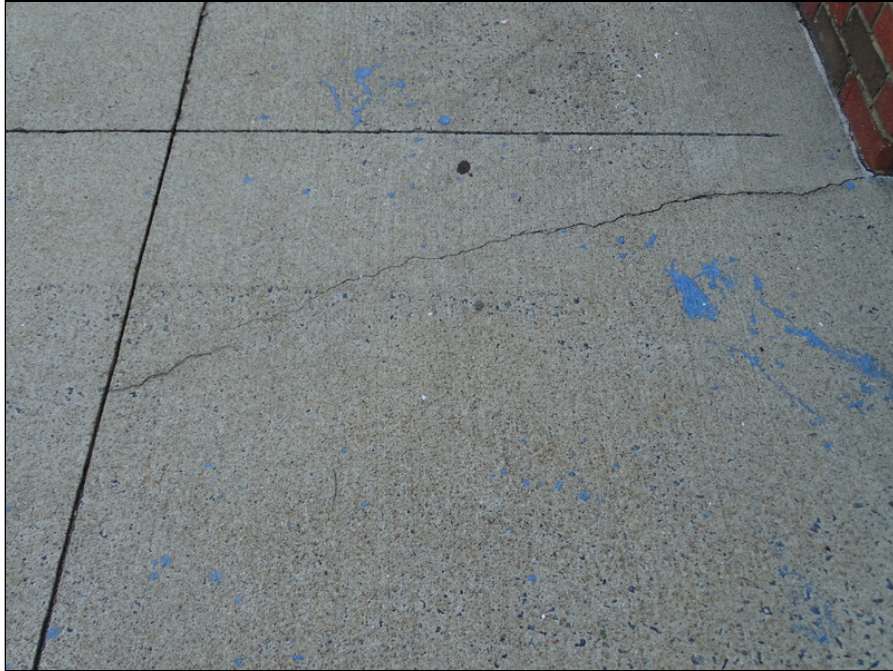
9 - Concrete sidewalk overview - note cracking

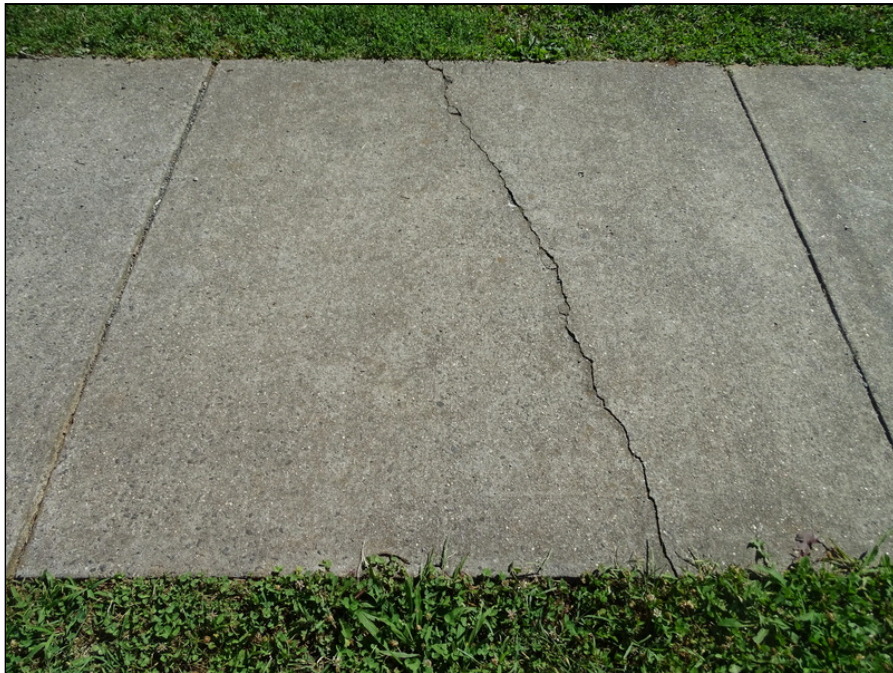
10 - Concrete sidewalk overview - note cracking

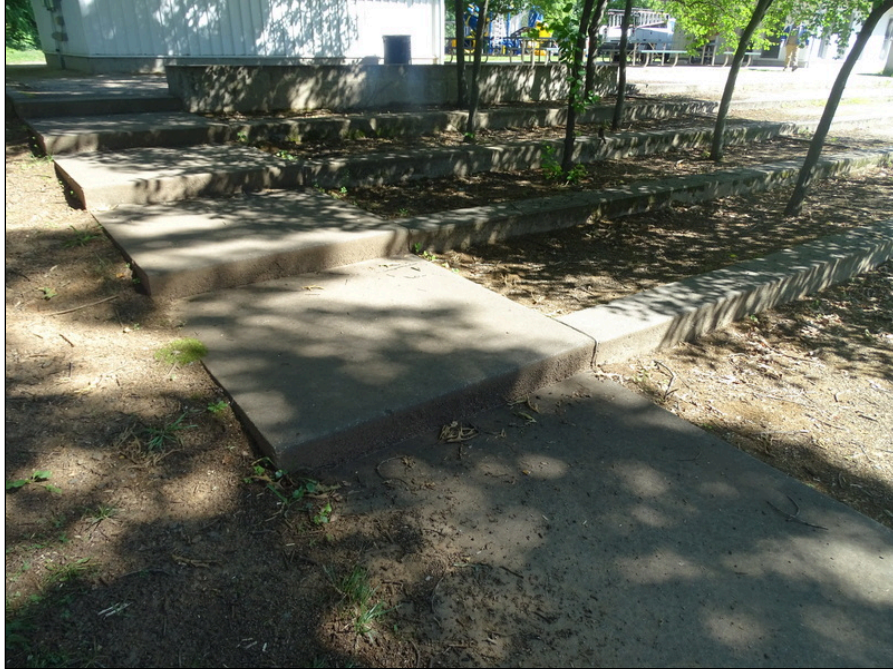
13 - Typical steps - note handrail missing

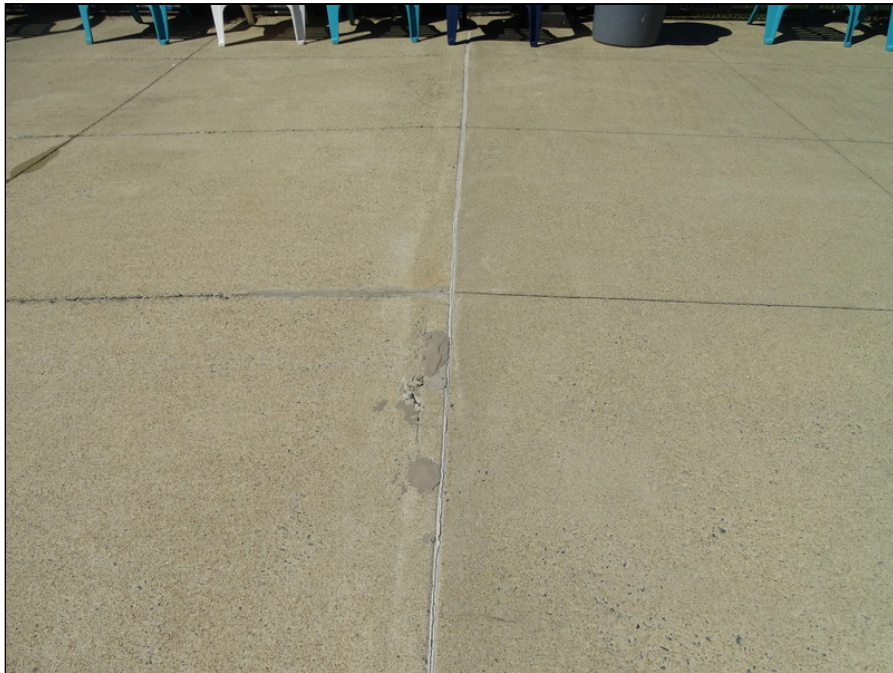
16 - Concrete pavement overview - note sealant condition

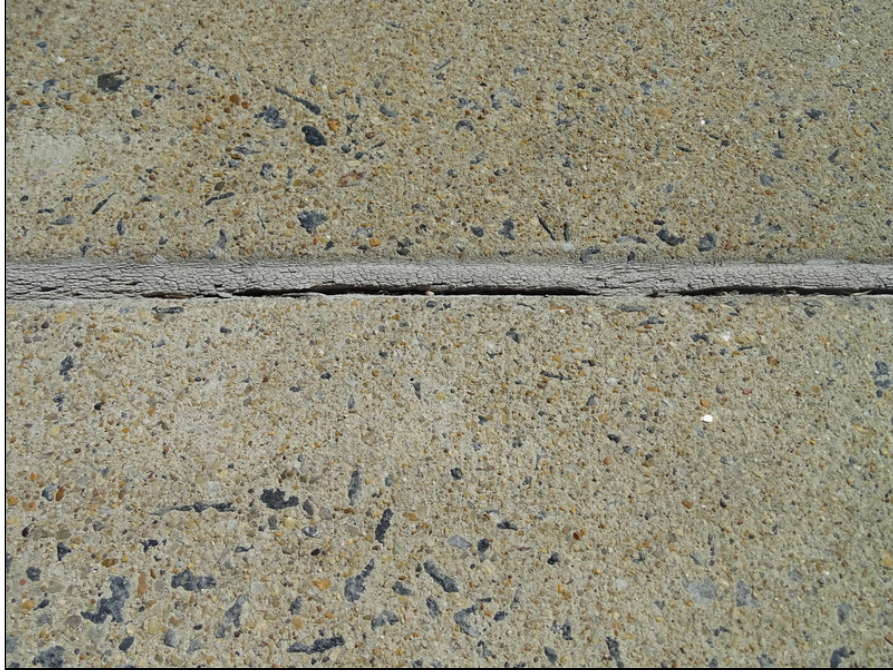
17 - Concrete pavement overview - note sealant condition

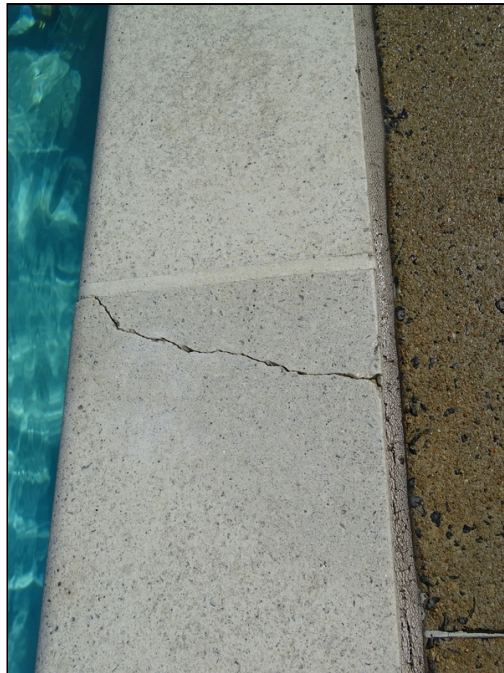
18 - Cracked concrete coping of pool

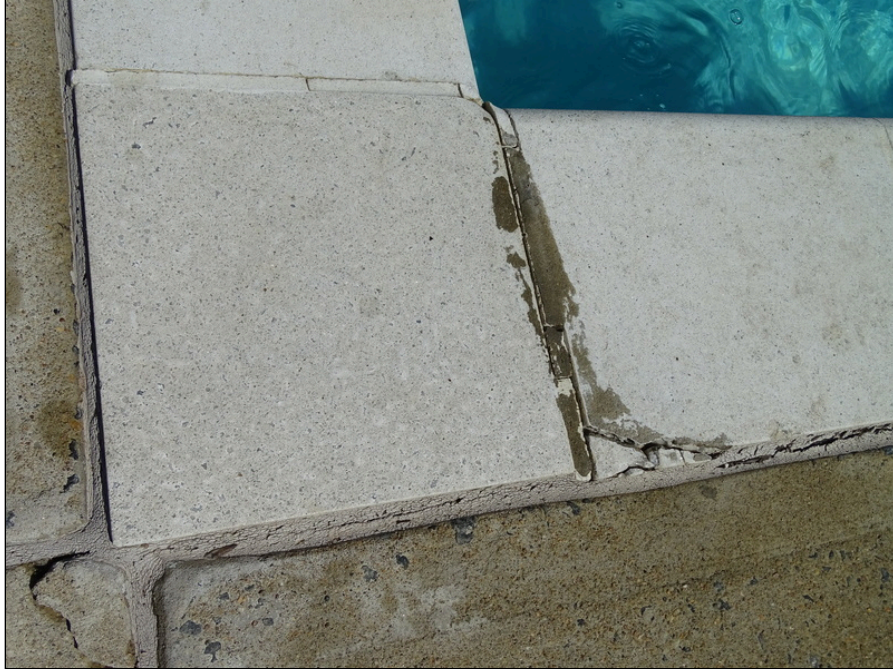
19 - Concrete pavement overview - note sealant condition

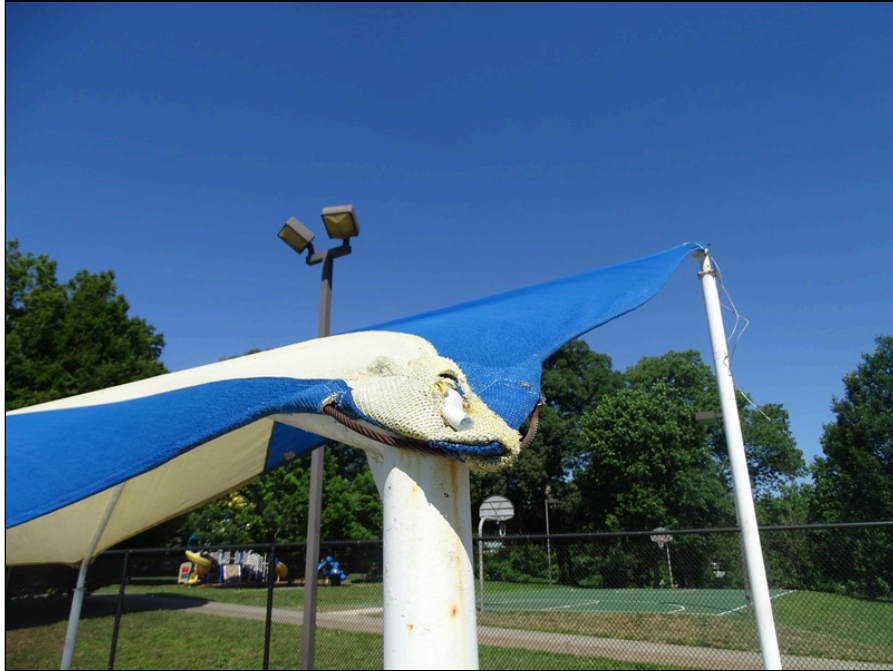
23 - Pool rest area tent overview - note deterioration

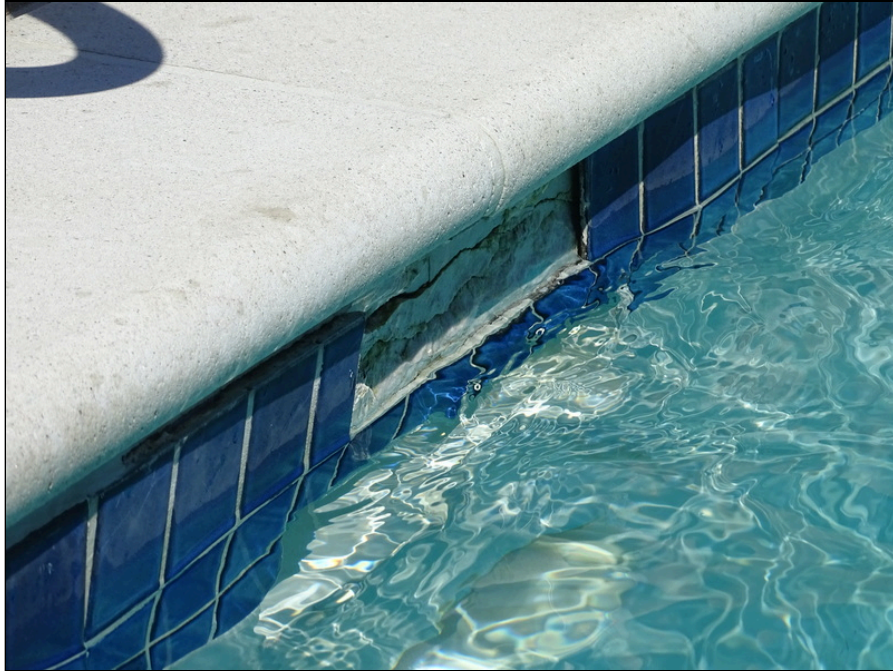
25 - Pool tile - Missing tiles

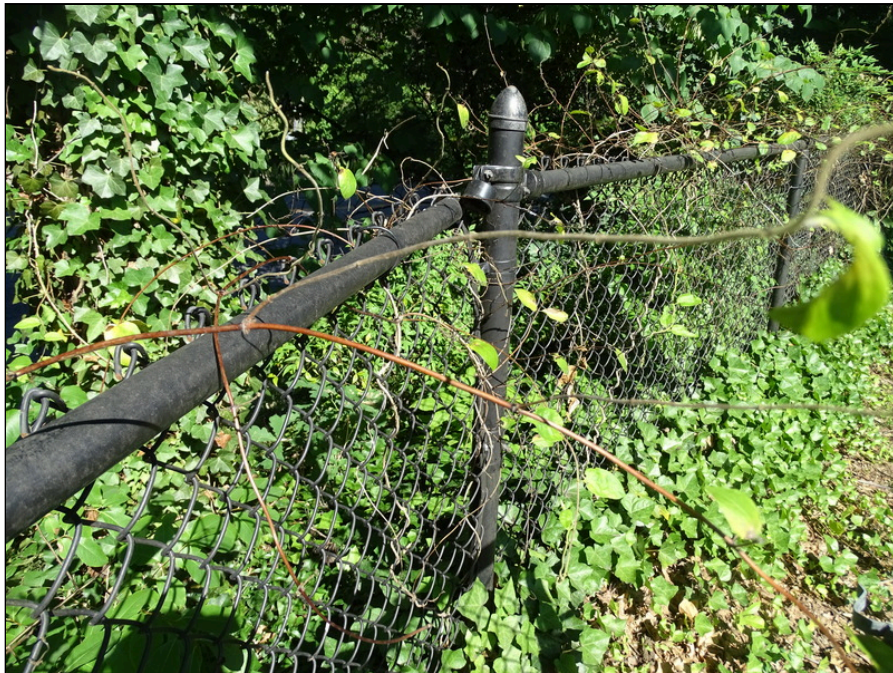
32 - Typical landscaping and fencing - note deterioration

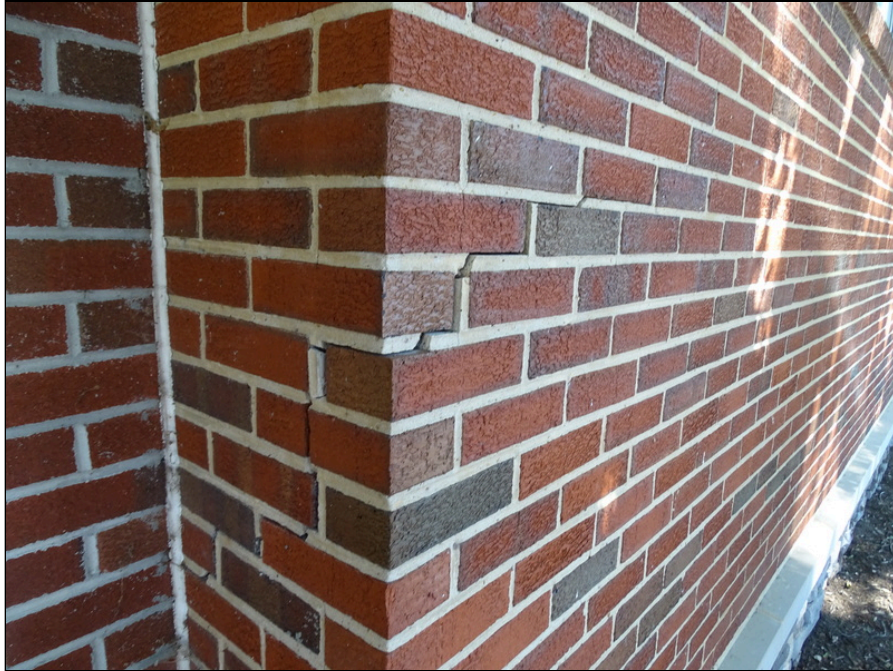
43 - Bath house exterior - note step cracking

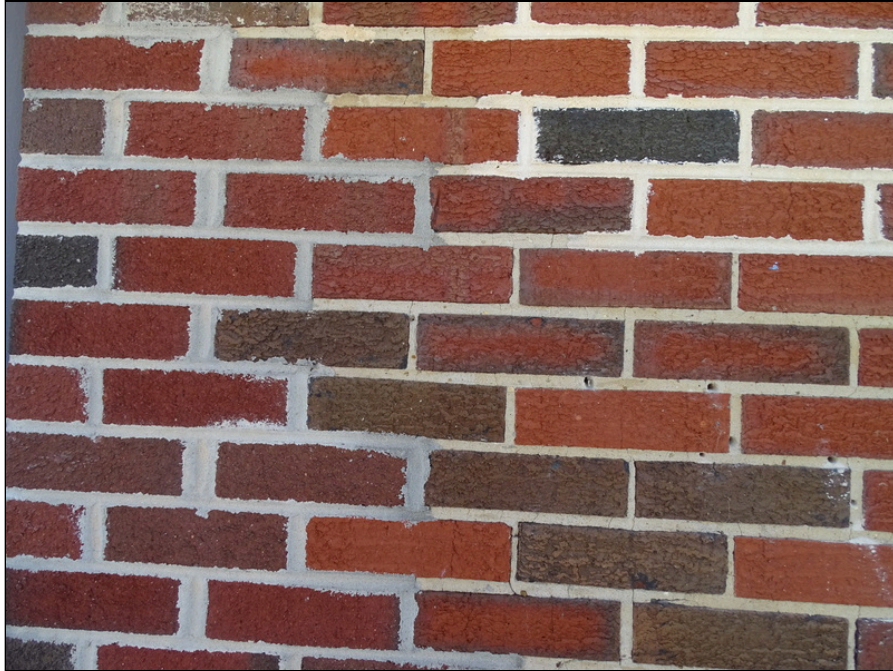
45 - Bath house exterior - note mortar condition

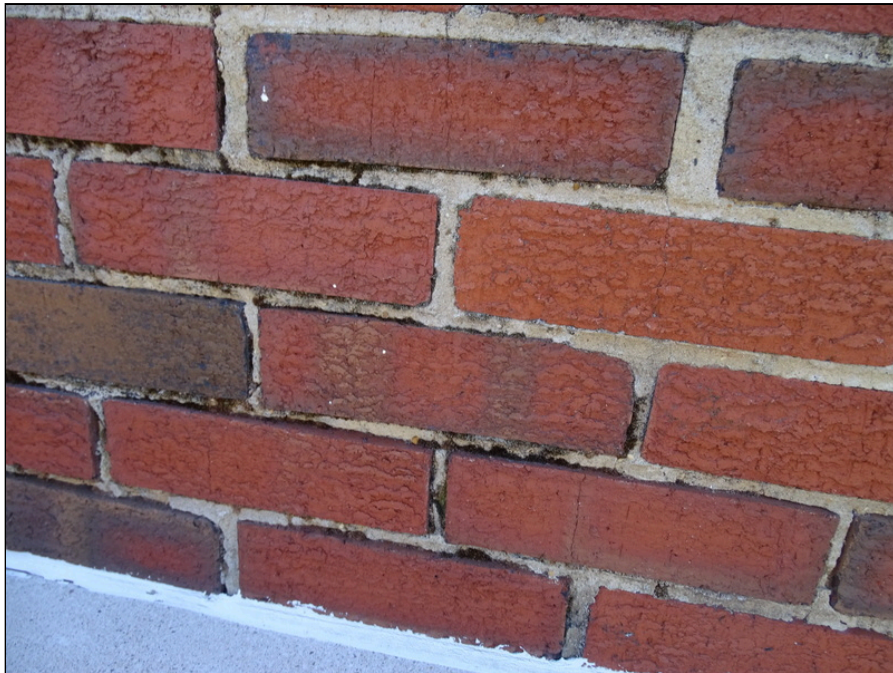
46 - Bath house exterior - note mortar deterioration

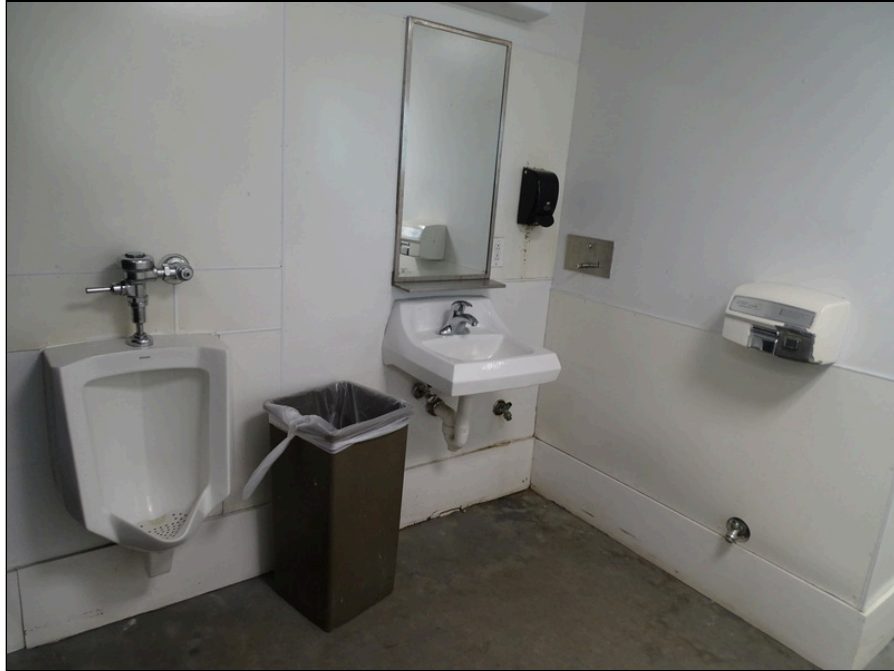
85 - Shelter restroom with stained floor

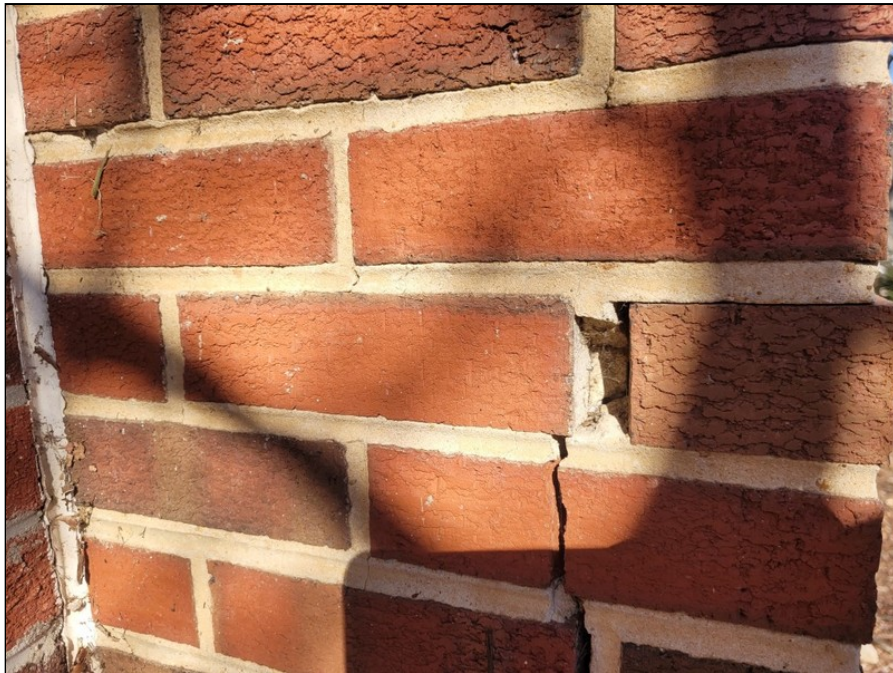
110 - Bath house brick crack

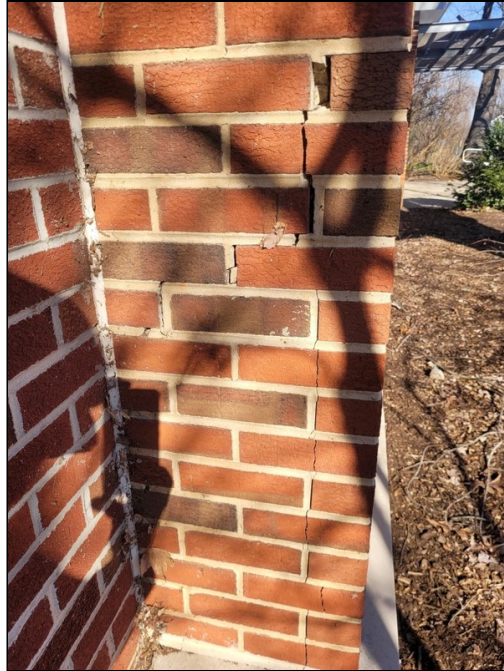
111 - Bath house brick crack
