WHEELER BUILDING
401 EAST HIGH STREET
CHARLOTTESVILLE, VIRGINIA

ECS PROJECT NO. 46:6713

CITY OF CHARLOTTESVILLE - FACILITIES DEVELOPMENT

Reference: Facility Condition Assessment Report for Wheeler Building, 401 East High Street,
Charlottesville, Virginia

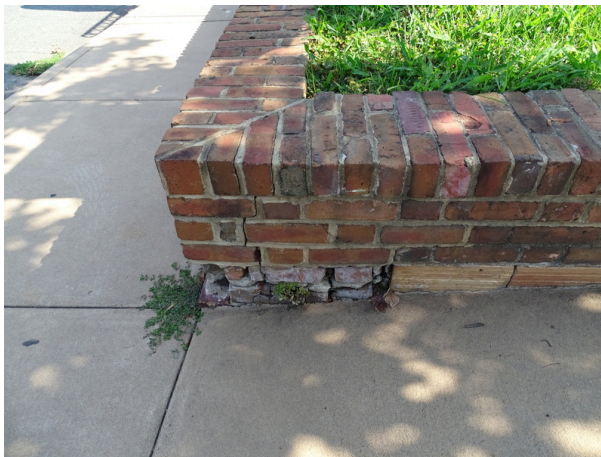
A retaining wall is located on the south and west sides of the site. The retaining wall was generally in fair condition with damage at the base in the southwest corner. This corner of the wall should be repaired in the near future to prevent further freeze/thaw damage. The vegetation should be removed from the wall/sidewalk joint and sealant installed.

Retaining wall condition on south west corner of the building

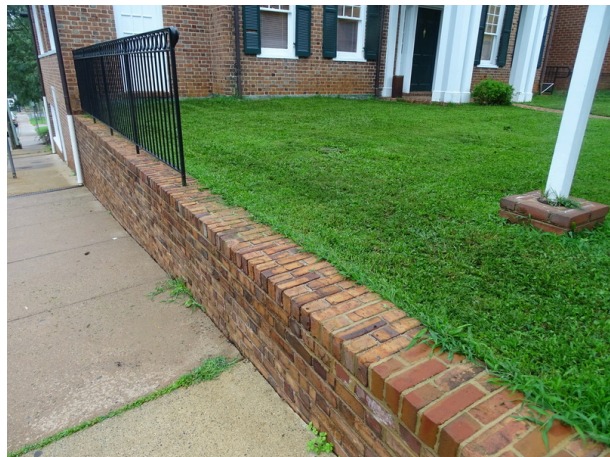
Retaining wall and metal fence at southwest side of the site

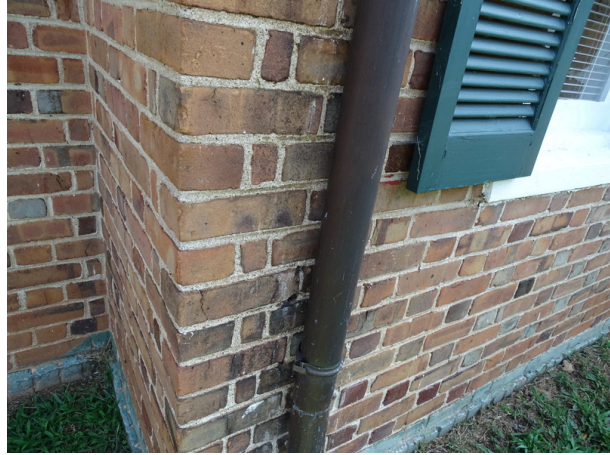
Stained wall on south side of building

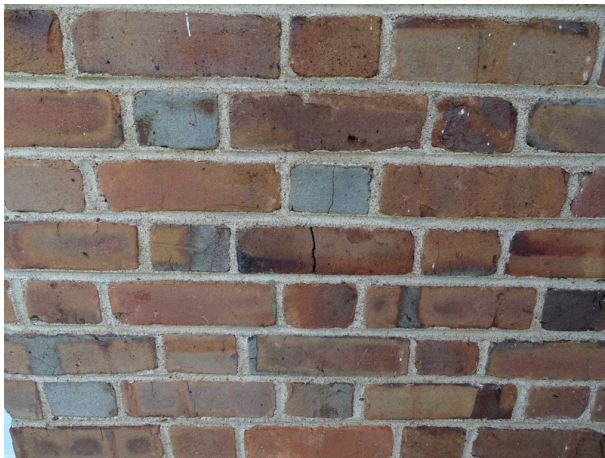
Step cracked on brick wall north

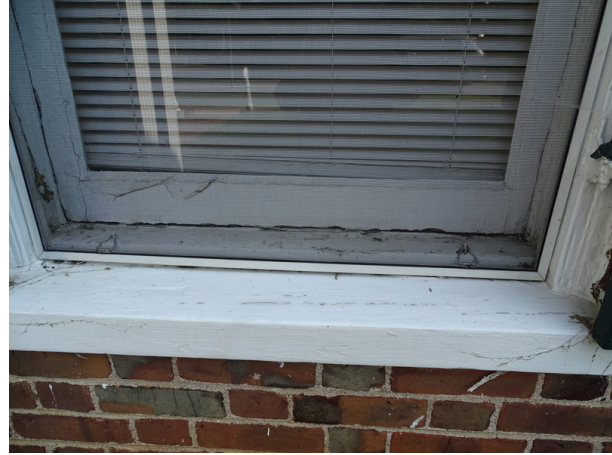
The window system for the building primarily consists of Wood frame single pane window units. The expected useful life of windows is typically 30 years. The window units were in generally in fair condition. We recommend replacing the windows during the report period.

Window condition at south side of building

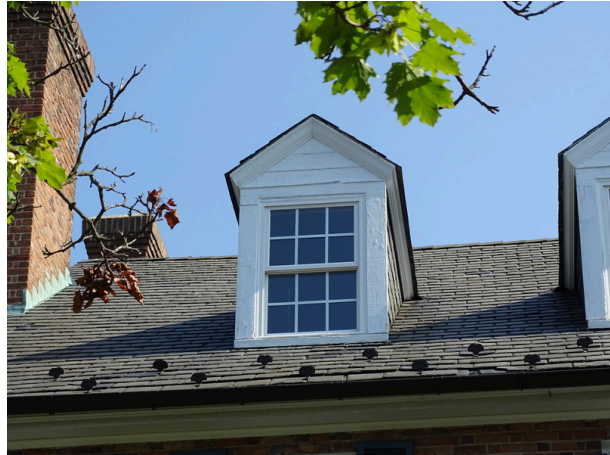
The main roofing system consists of a Slate shingle roofing system over the building. Deterioration was observed in and around the gutter on the north side of the building. Some of the slate shingles were misaligned and will need eventual repair to prevent future leakage. We recommend periodic allowance over the report period to repair misaligned slate shingles and general deterioration of the roofing system.

Slate shingle roofing system - note deterioration

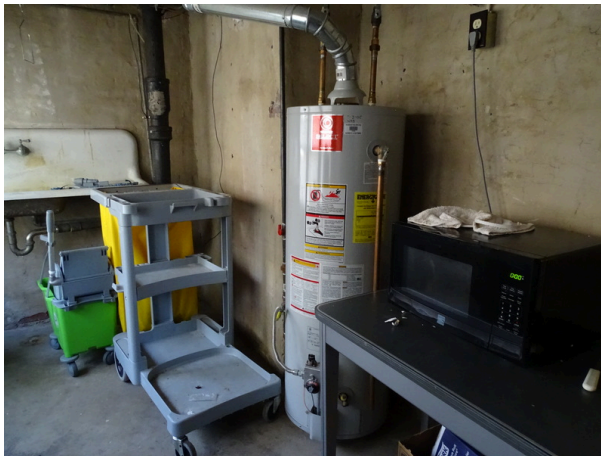
Domestic hot water to the building is provided by an Gas domestic water heater located in the basement. The Gas domestic water heater was manufactured by State. The expected useful life of an Gas domestic water heater is approximately 12 to 15 years. We recommend the Gas domestic water heater be replaced during the report period.

Gas domestic water heater

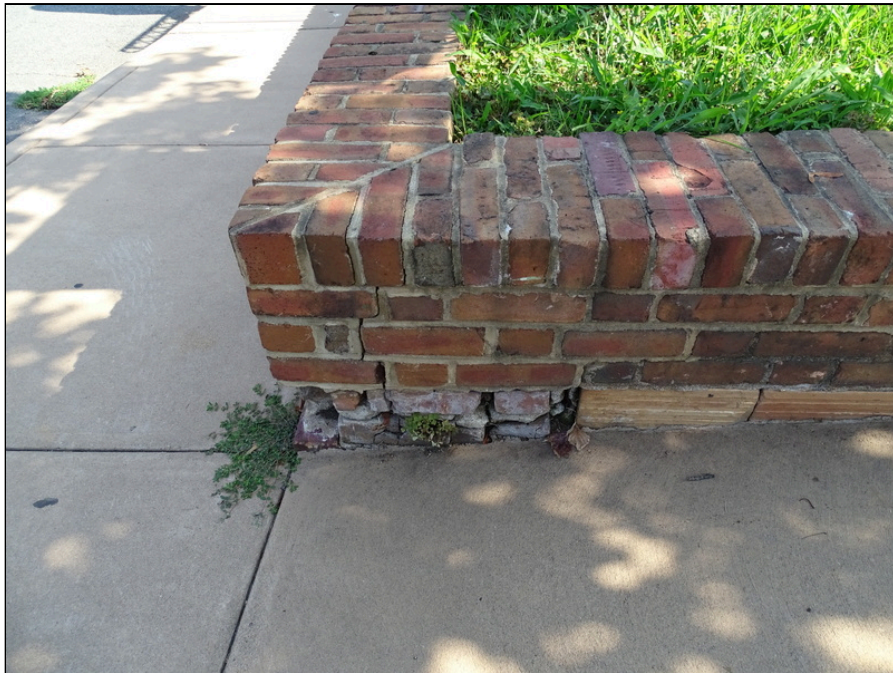
10 - Retaining wall condition on south west corner of the building

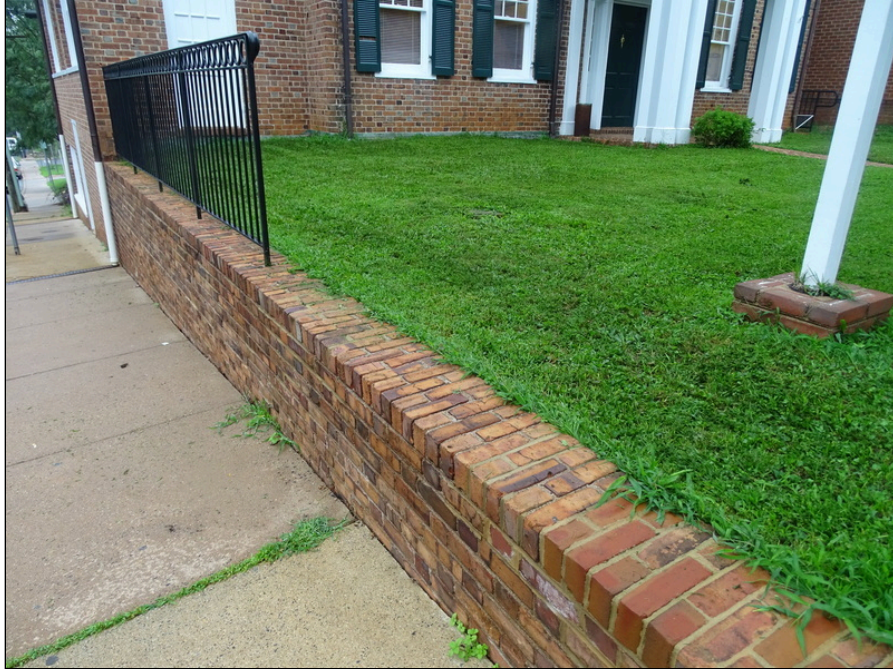
11 - Retaining wall and metal fence at southwest side of the site

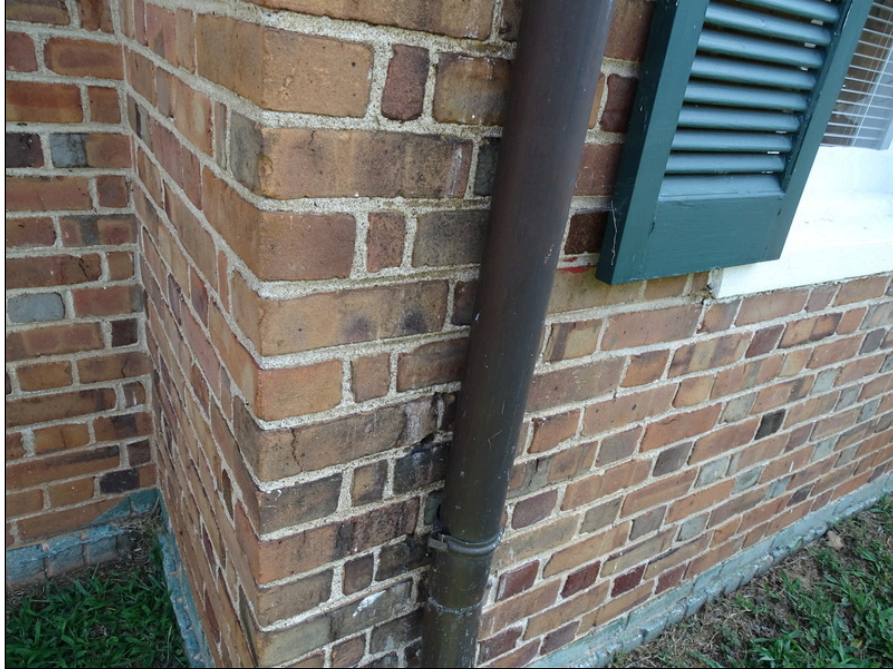
29 - Stained wall on south side of building

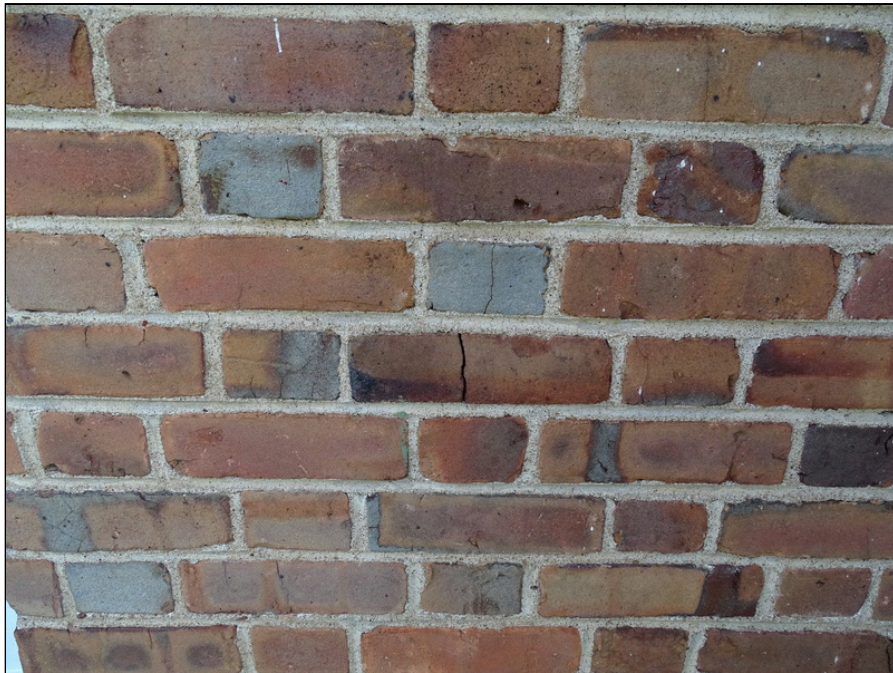
30 - Step cracked on brick wall north

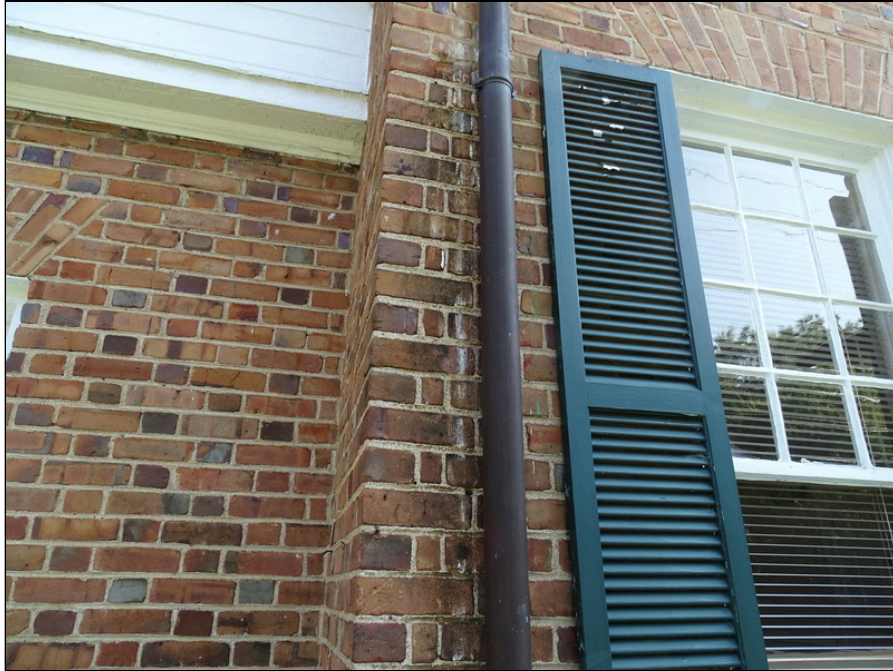
31 - Stained wall on south side of building

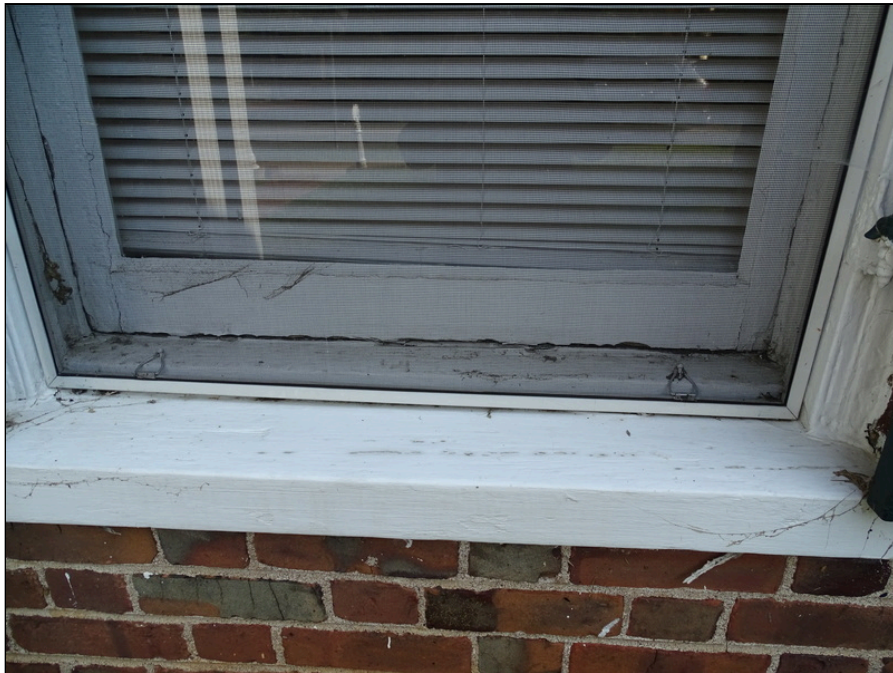
36 - Window condition at south side of building

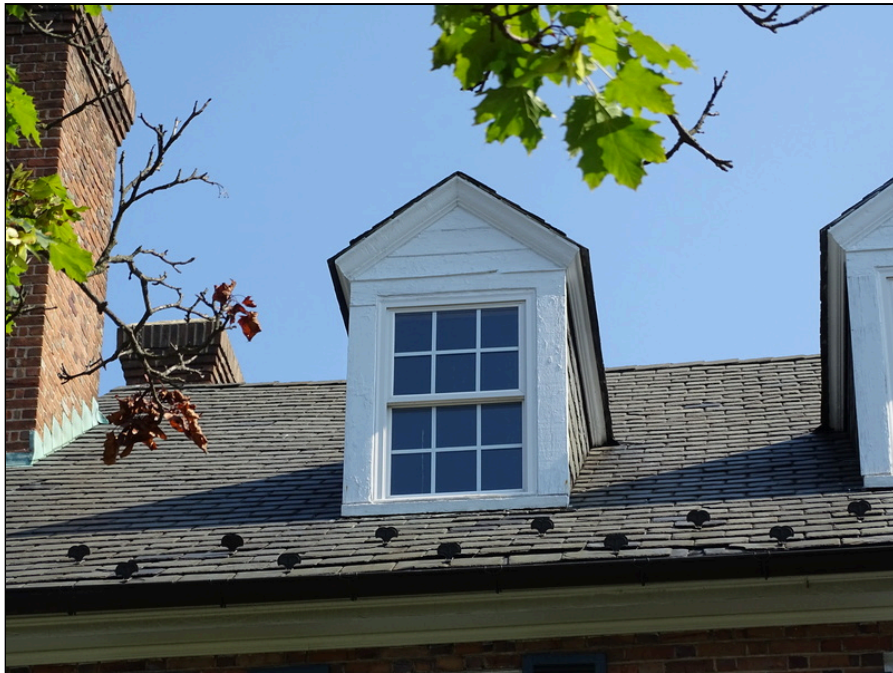
40 - Slate shingle roofing system - note deterioration

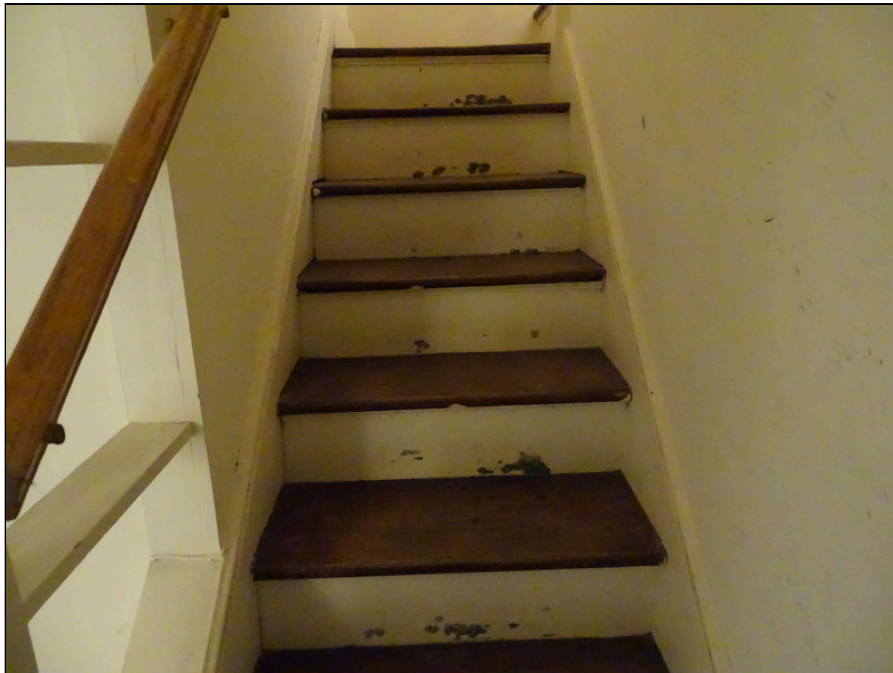
60 - Stair condition from basement to first floor

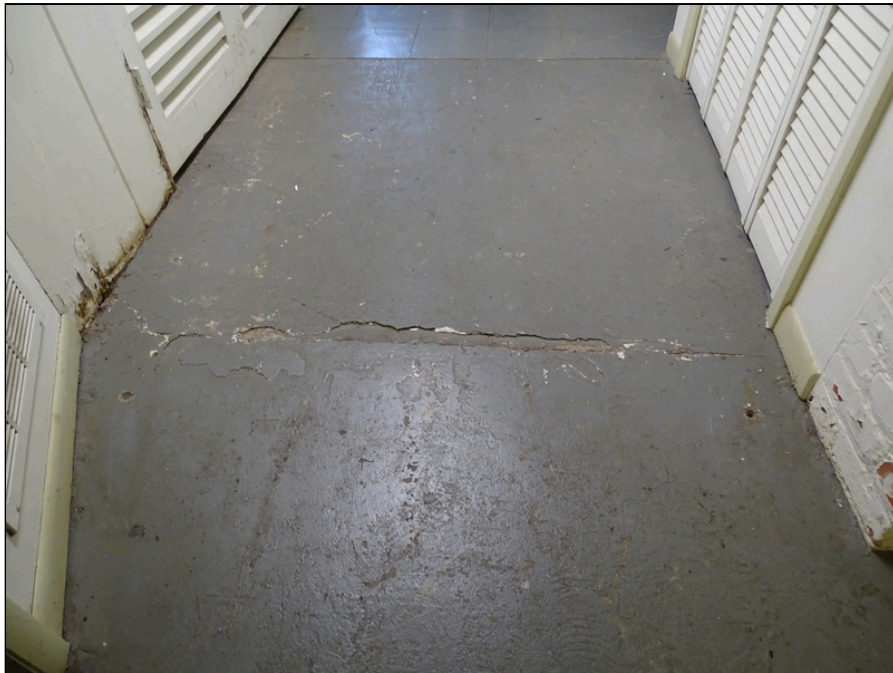
78 - Basement unfinish floor condition
