MCINTIRE SKATE PARK 425 U.S. 250 BY-PASS CHARLOTTESVILLE, VIRGINIA

ECS PROJECT NO. 46:6713

CITY OF CHARLOTTESVILLE - FACILITIES DEVELOPMENT

Reference: Facility Condition Assessment Report for McIntire Skate Park, 425 U.S. 250 By-Pass, Charlottesville, Virginia

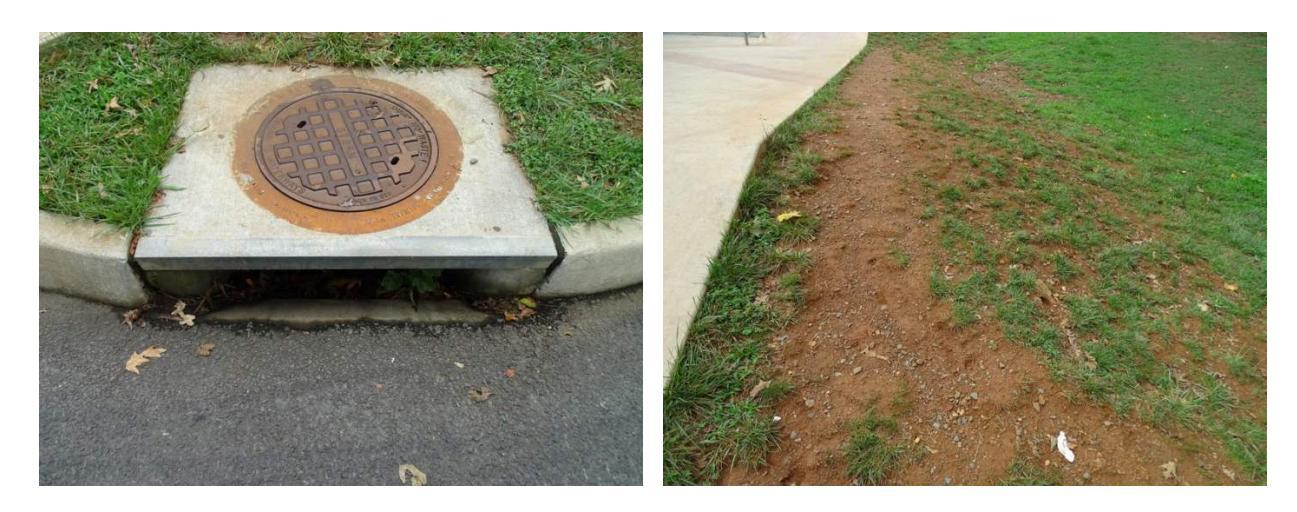
Several areas of erosion were observed around the site. We recommend repair of these areas and the addition of storm drainage elements to prevent further erosion.

Stormwater drainage

Typical landscaping - note deterioration

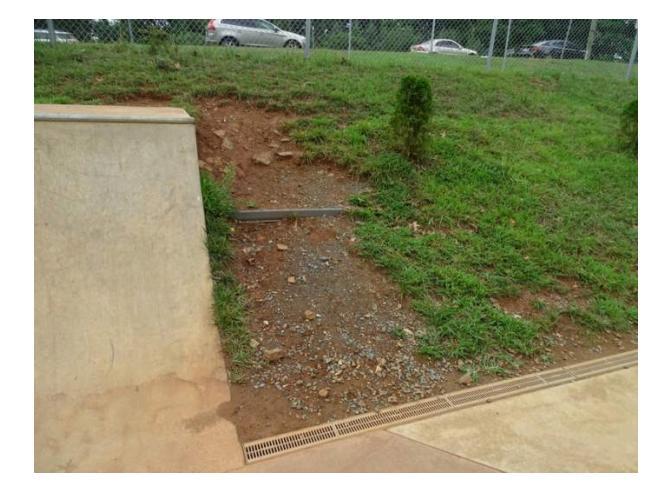
Typical landscaping - note deterioration

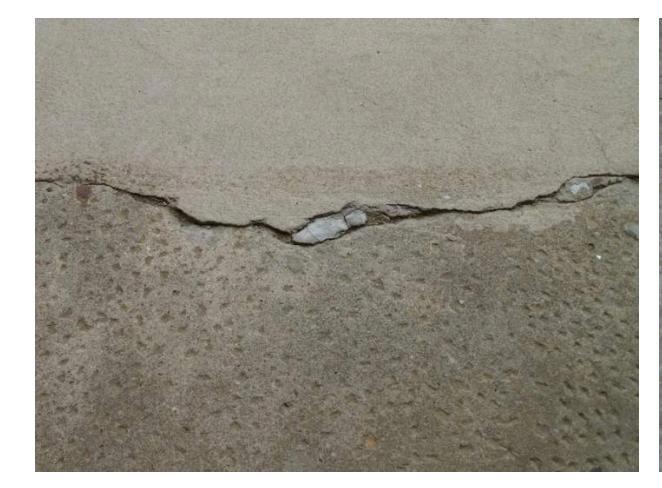
Concrete sidewalks - note cracked

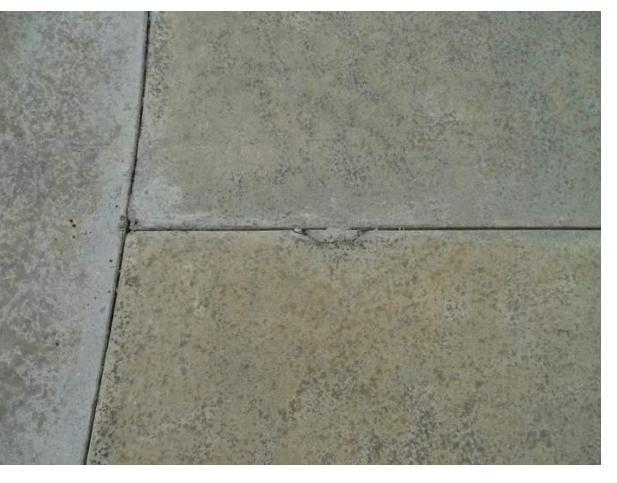
Concrete pavement - note cracked

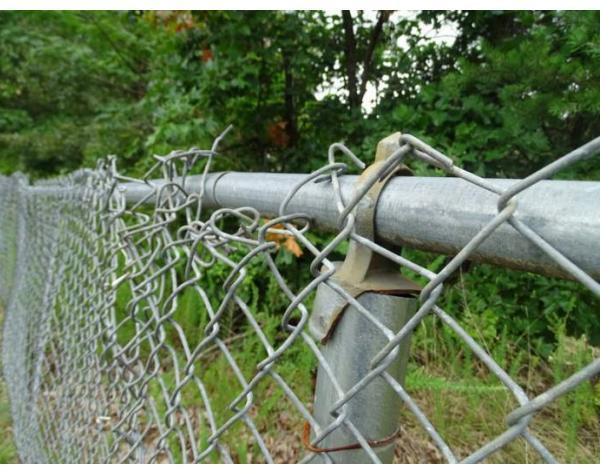
Chain-link fence - note deterioration

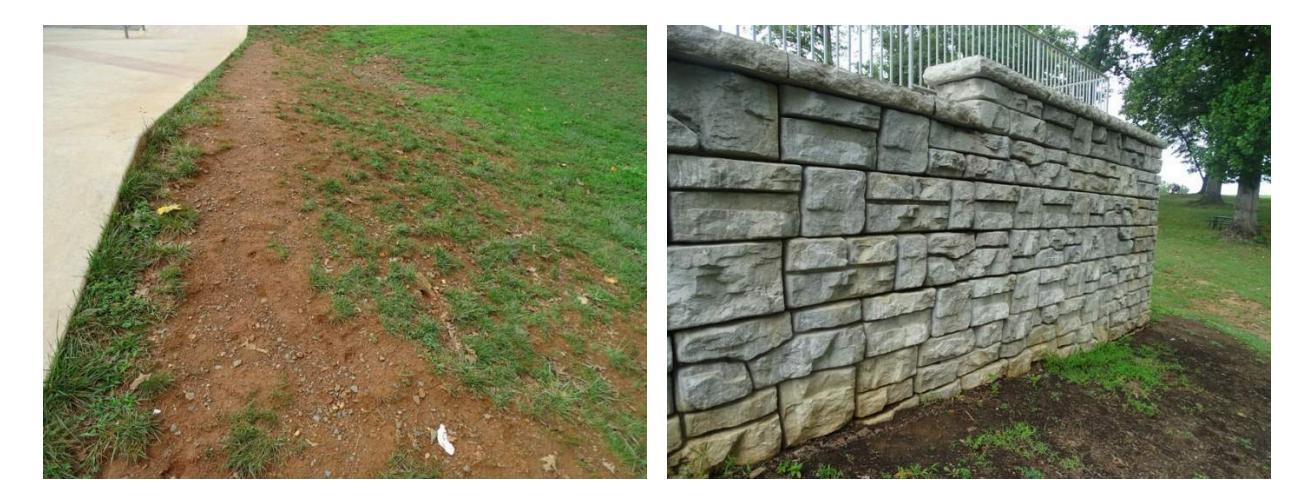
Typical landscaping - note deterioration

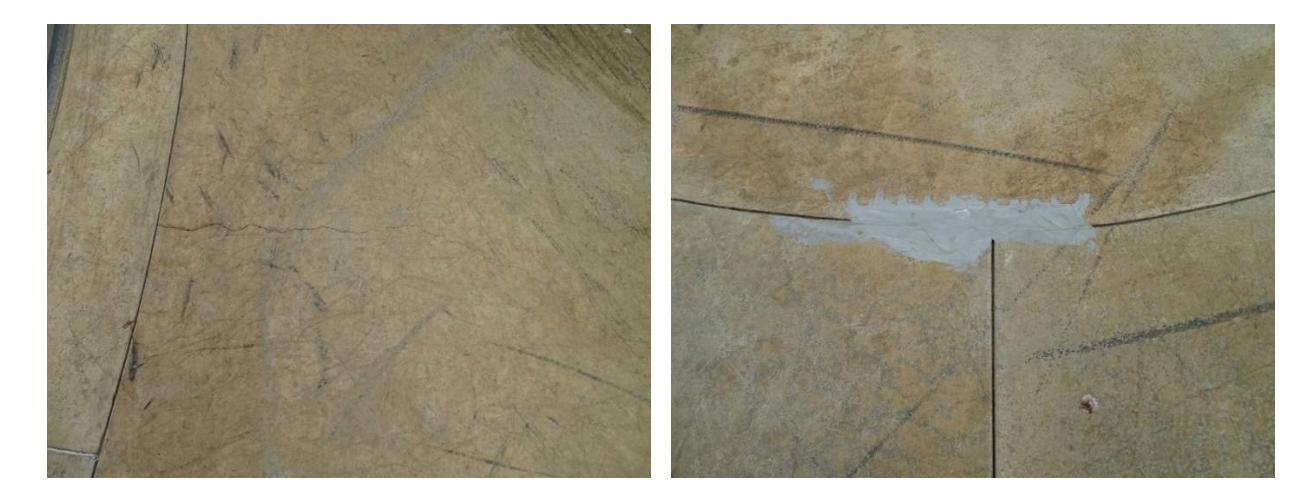
Several concrete skating features were observed across the south side of the property. The skating surface was generally in good condition with minor cracking noted. A swimming pool type feature was located to the east of the skate park area with pool coping and tile installed around the rim. Areas of the coping and tile were observed to be deteriorating and cracking. An allowance has been provided for concrete repairs during the report period.

Concrete pavement - note cracked

Concrete pavement - note sealed

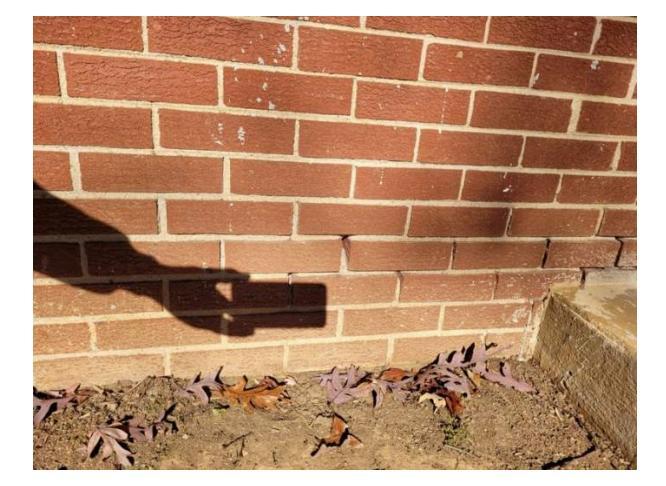
The office/storage exterior consists of brick and wood panel siding. The brick walls were generally in good to fair condition with previous repairs and areas in need of repair noted. Deterioration of the mortar joints was observed. The steel columns and beams were painted and supported the west side of the structure that was assumed to have been open at some point. Wood framed walls have been installed to close in the space for storage. The wood framed walls are flashed over the existing brick knee walls and covered with wood panel siding. Exterior sealants are located around the window and door frames and at the brick to wood transitions. The expected useful life of exterior sealants is approximately 10 to 12 years before replacement is needed. The exterior sealants were generally in fair condition. An allowance has been included to paint the exterior and replace the sealants during the study period.

Office brick - Note deterioration of mortar joints

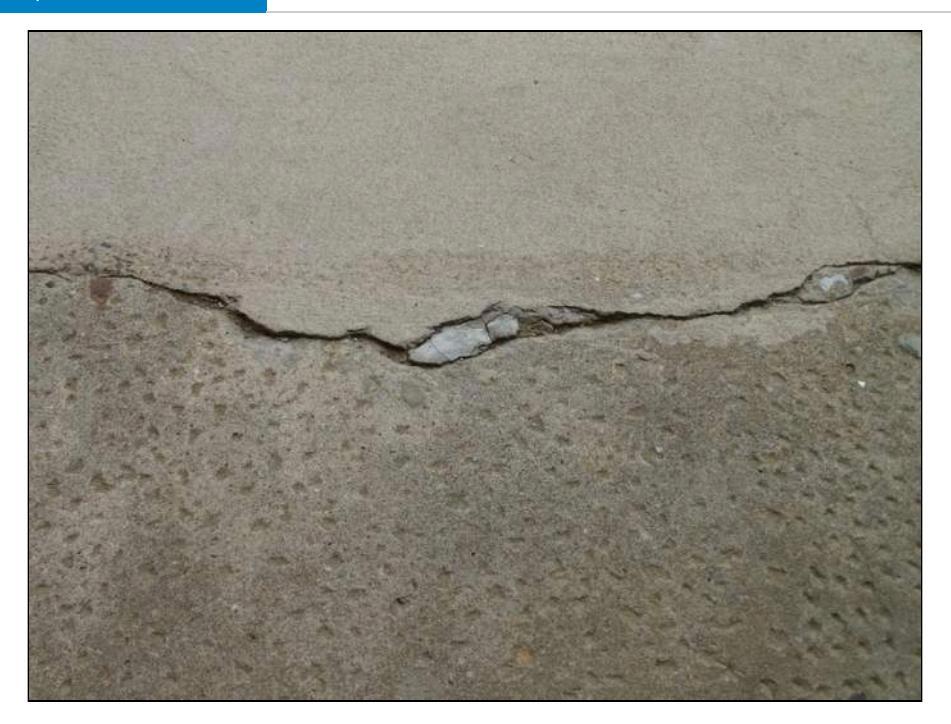
17 - Concrete sidewalks - note cracked

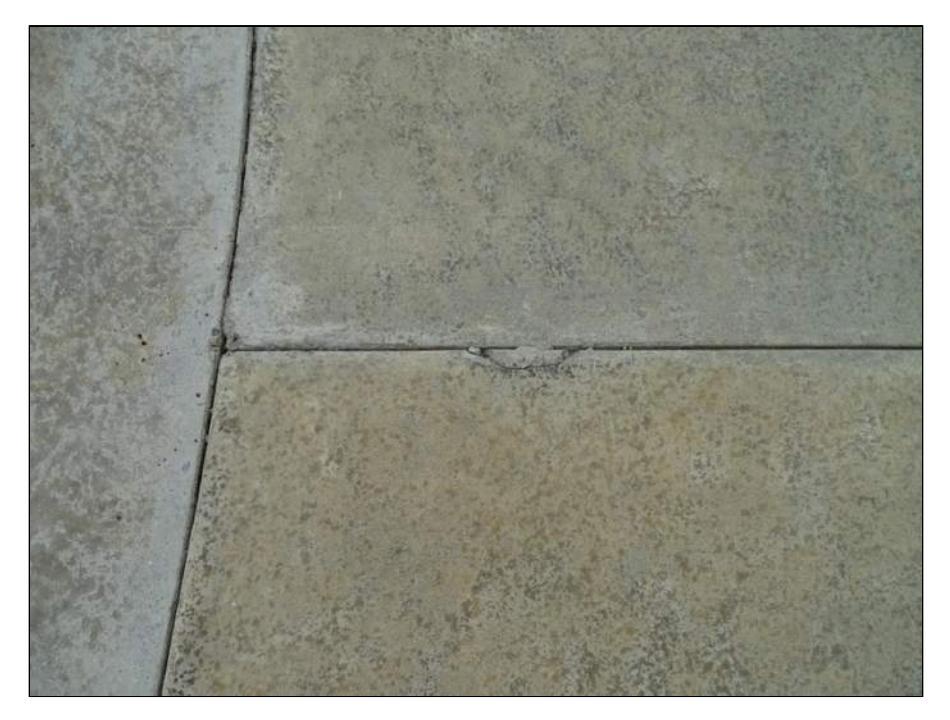
18 - Concrete pavement - note cracked

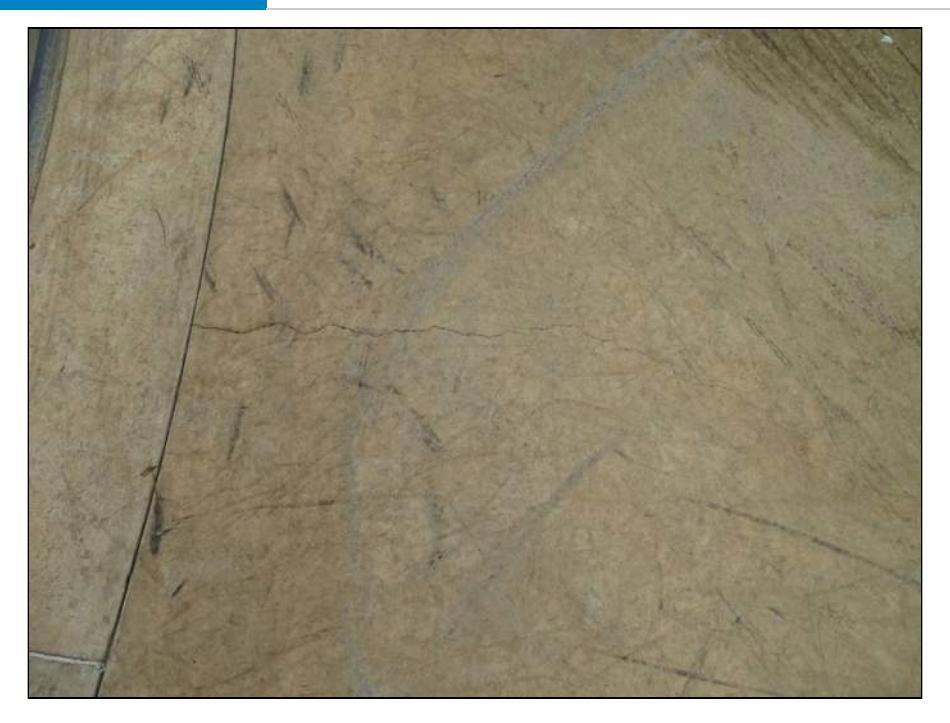
19 - Concrete pavement - note cracked

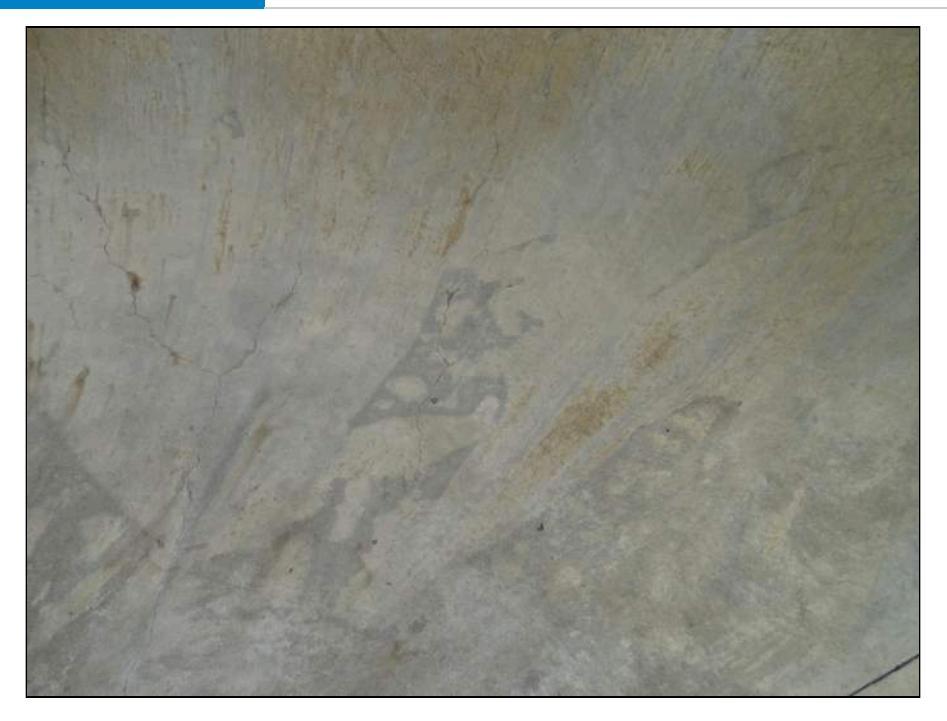
21 - Concrete pavement - note cracked

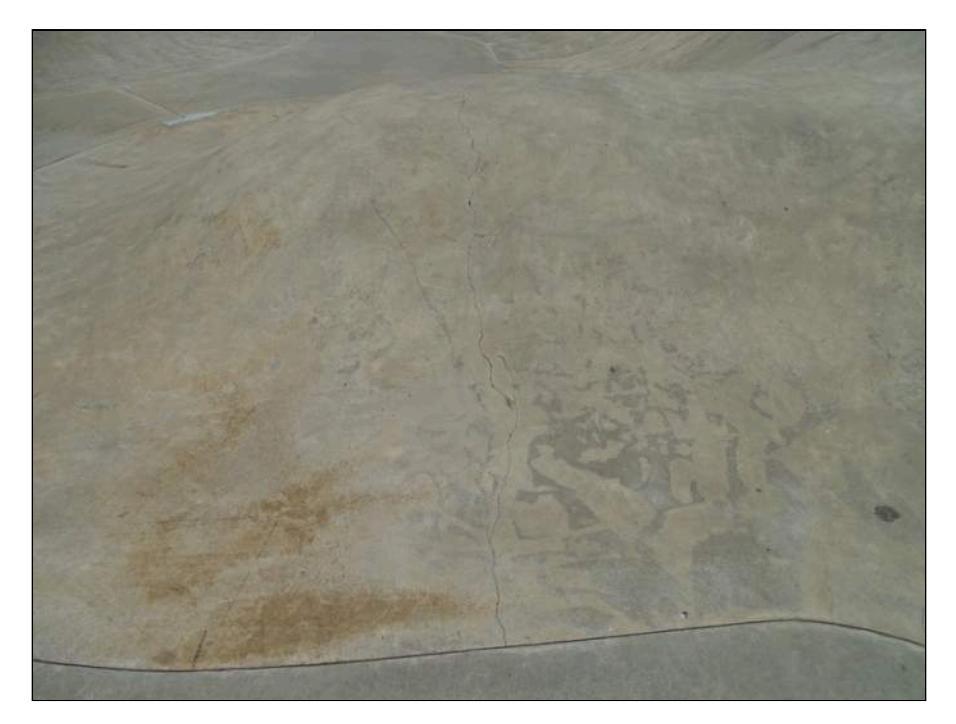
22 - Concrete pavement - note cracked

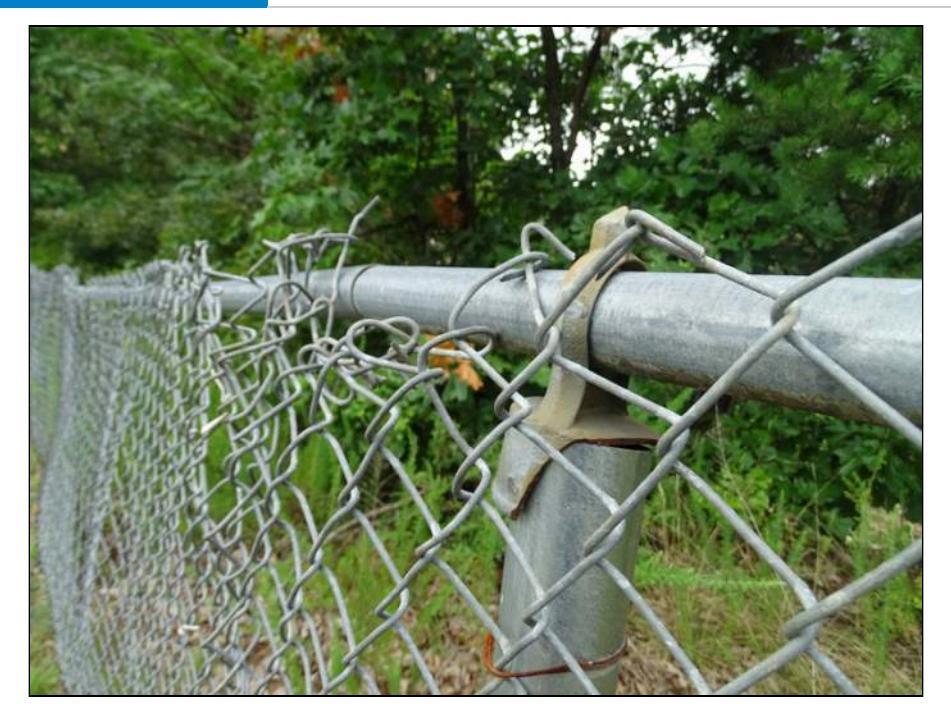
29 - Chain-link fence - note deterioration

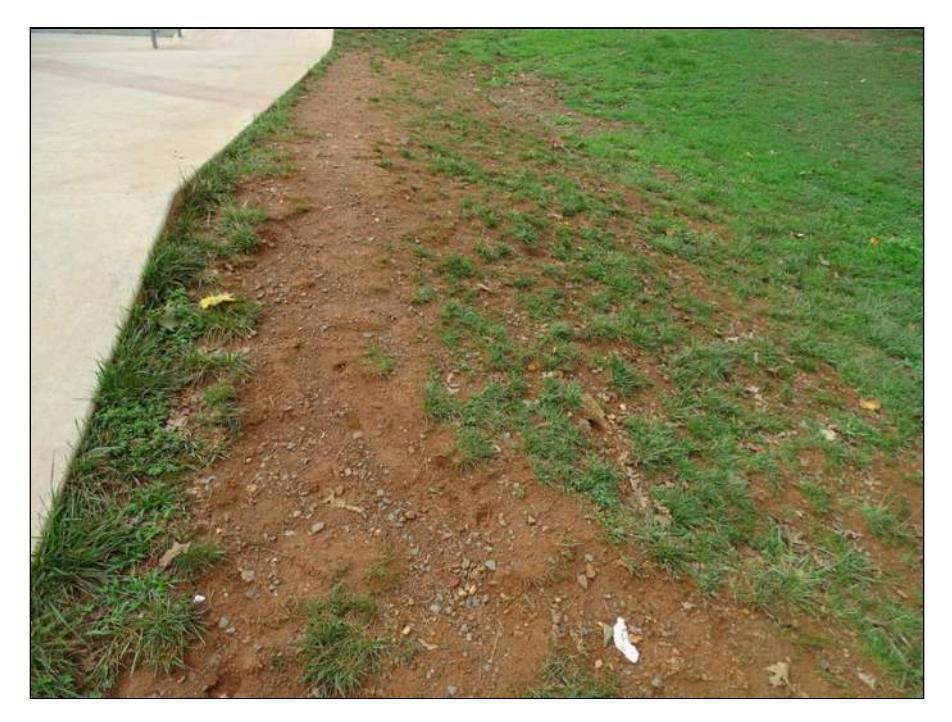
30 - Typical landscaping - note deterioration

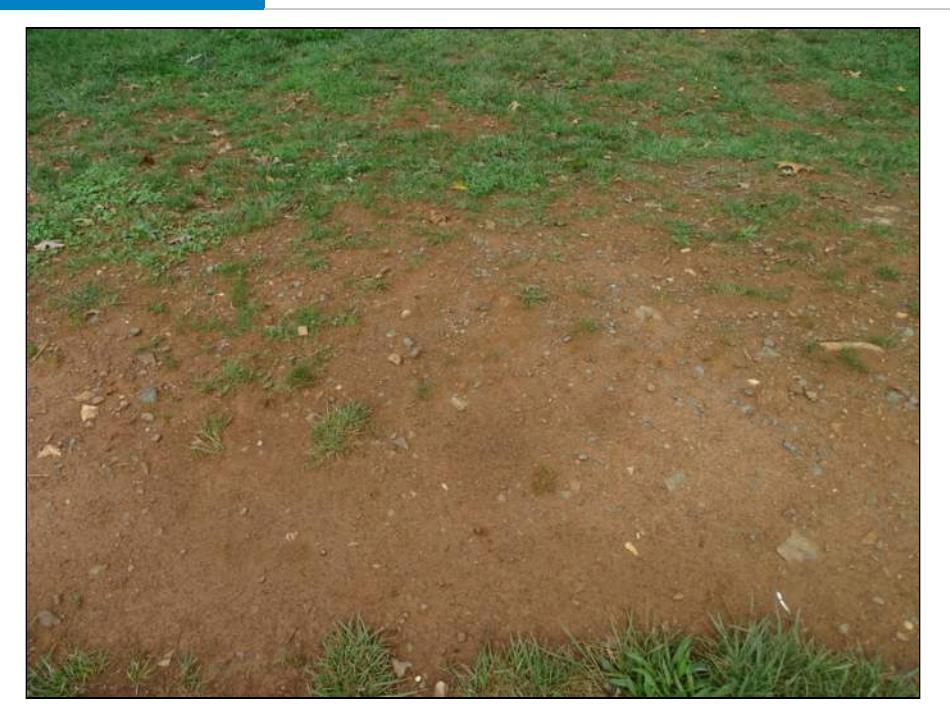
31 - Typical landscaping - note deterioration

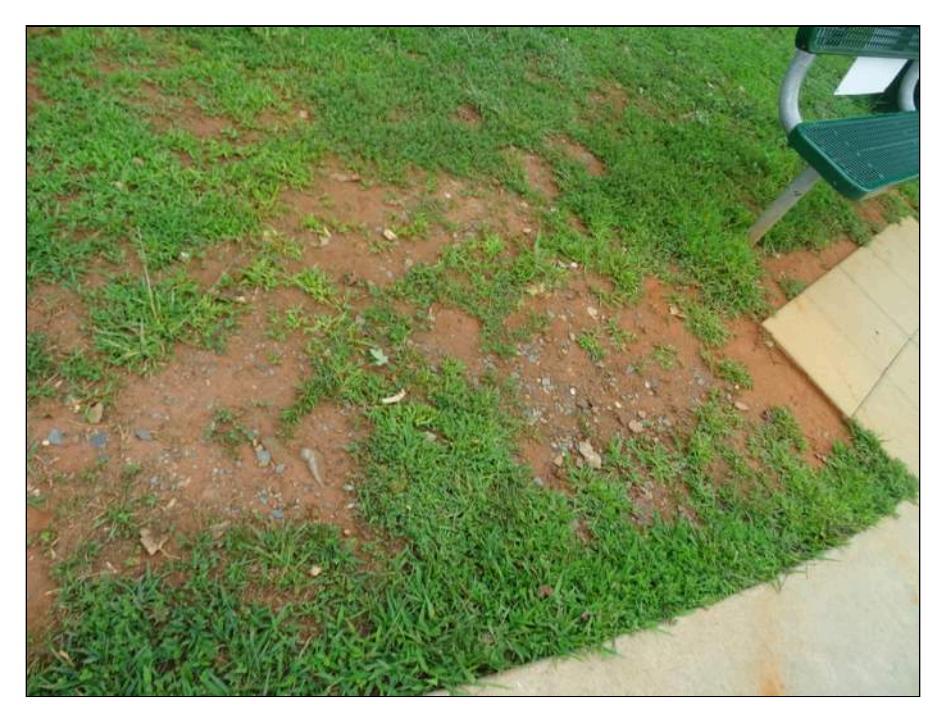
32 - Typical landscaping - note deterioration

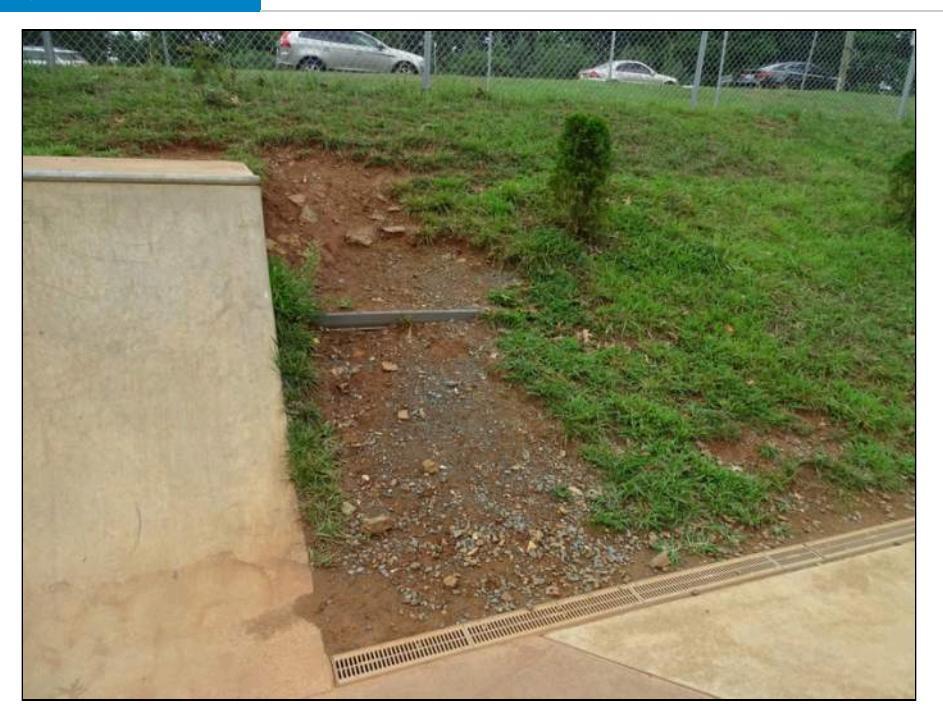
33 - Typical landscaping - note deterioration

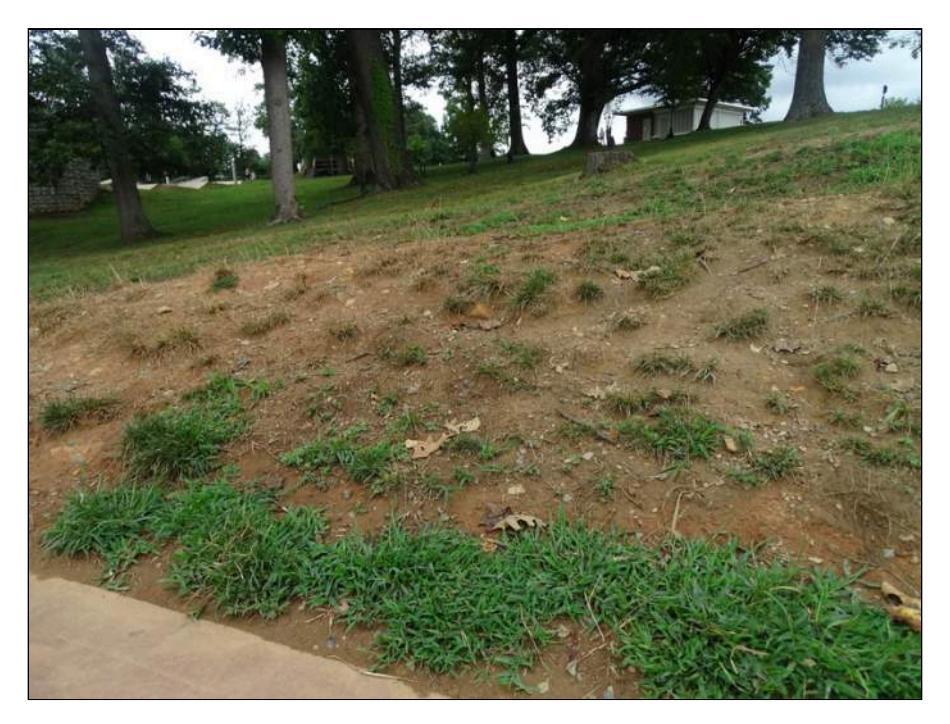
34 - Typical landscaping - note deterioration

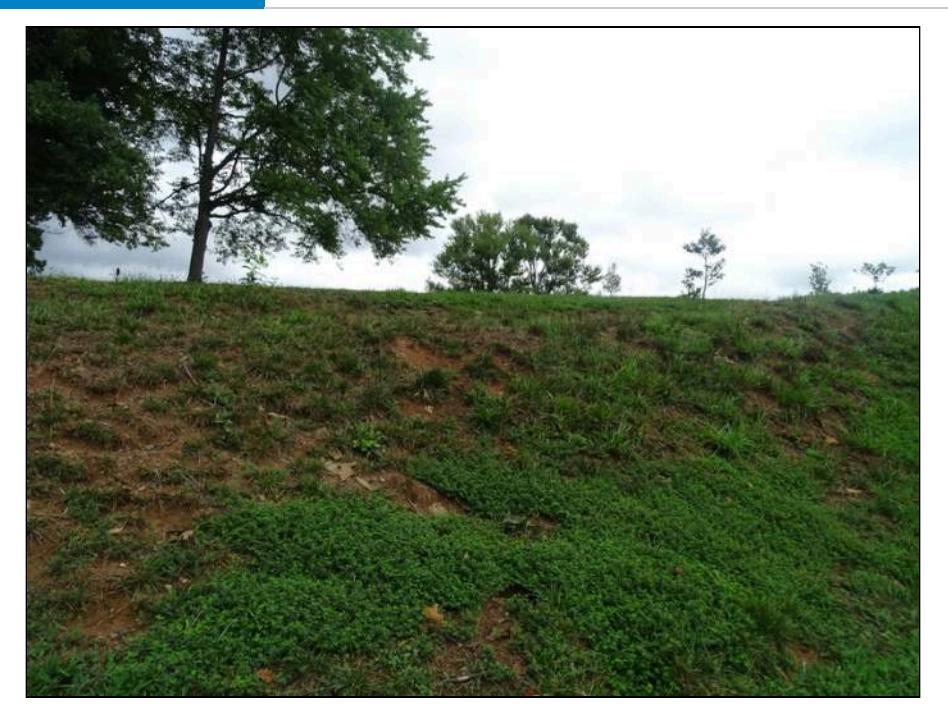
35 - Typical landscaping - note deterioration

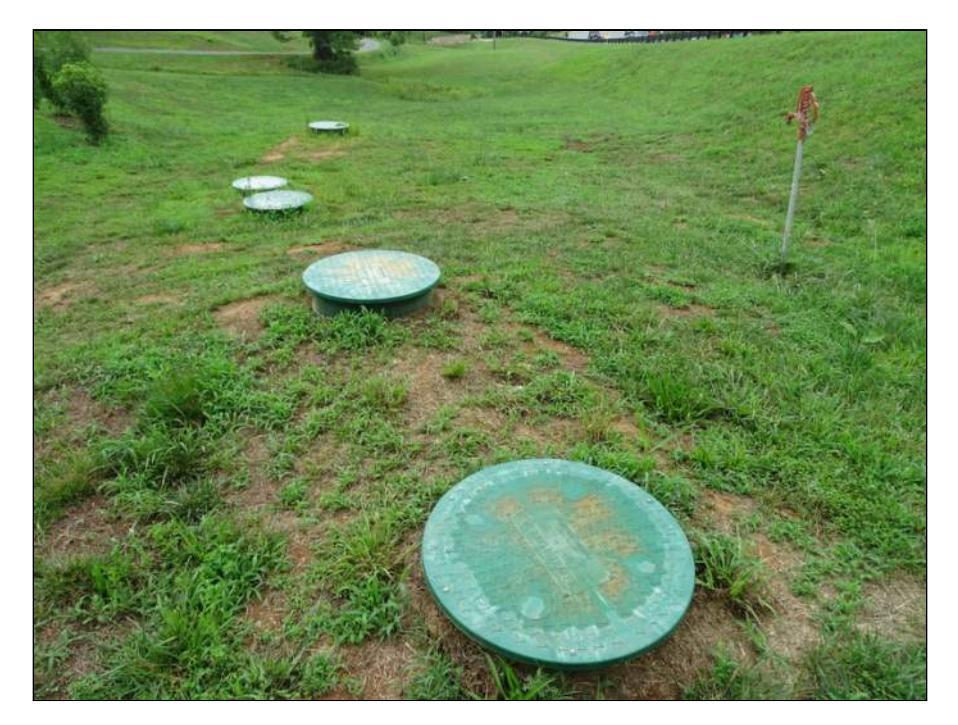
36 - Typical landscaping - note deterioration

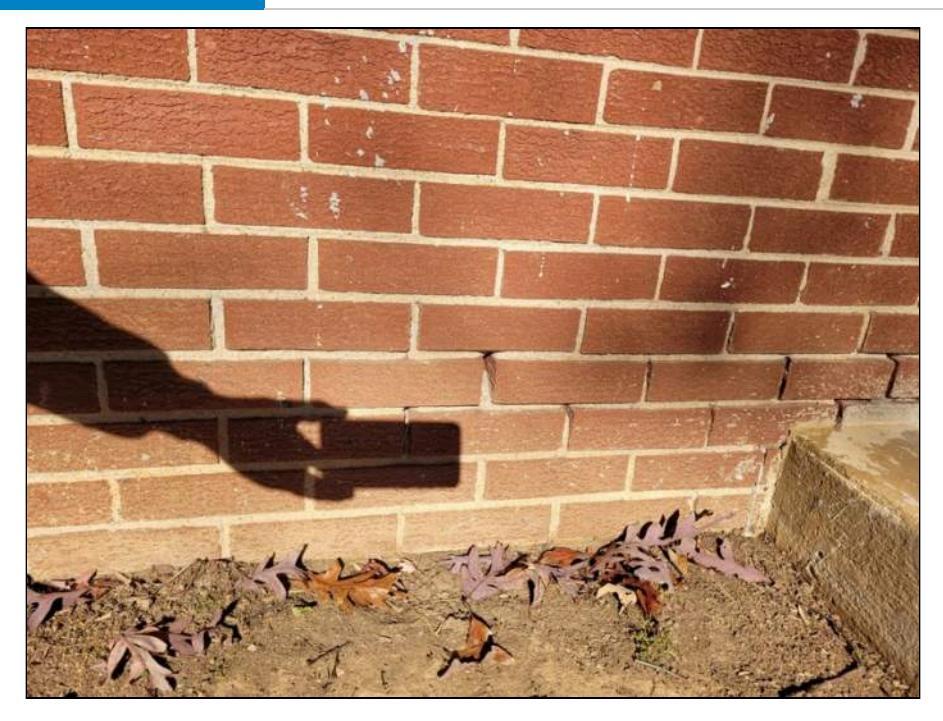
115 - Office brick - Note deterioration of mortar joints

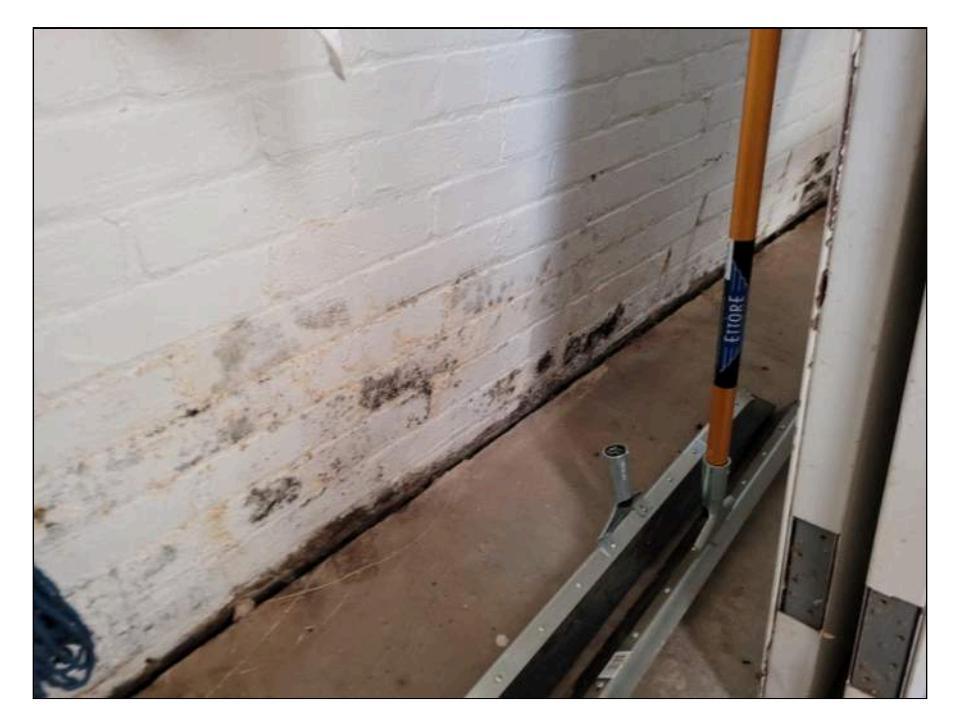
142 - Suspect substance on wall
